EL-ASNAM, ALGERIA EARTHQUAKE OF OCTOBER 10, 1980

A Reconnaissance and Engineering Report

**National Research Council
Committee on Natural Disasters**

Earthquake Engineering Research Institute

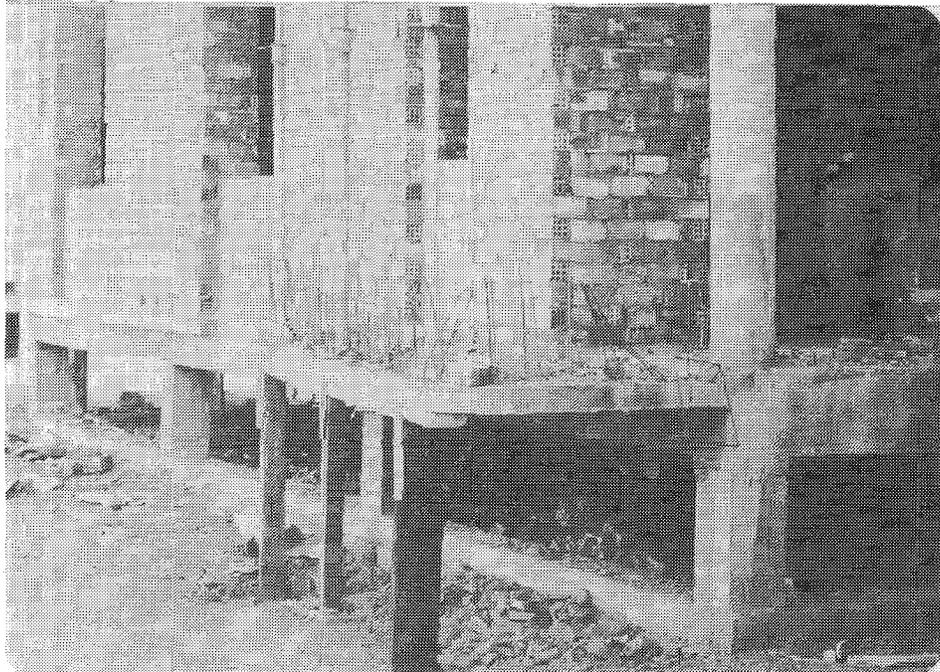
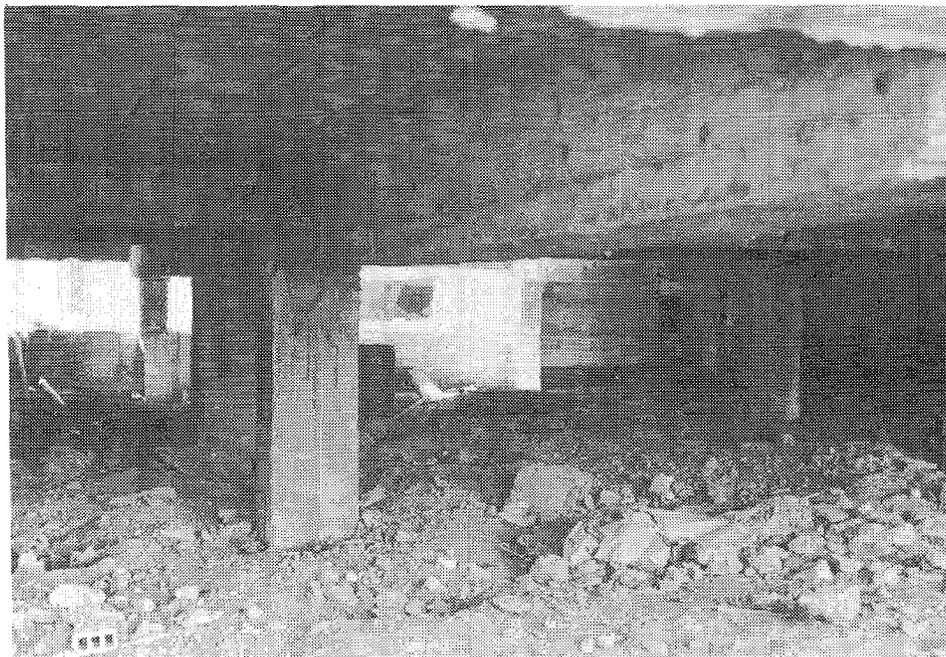
Fig. 1.19 Building Under Construction with *Vide Sanitaire*

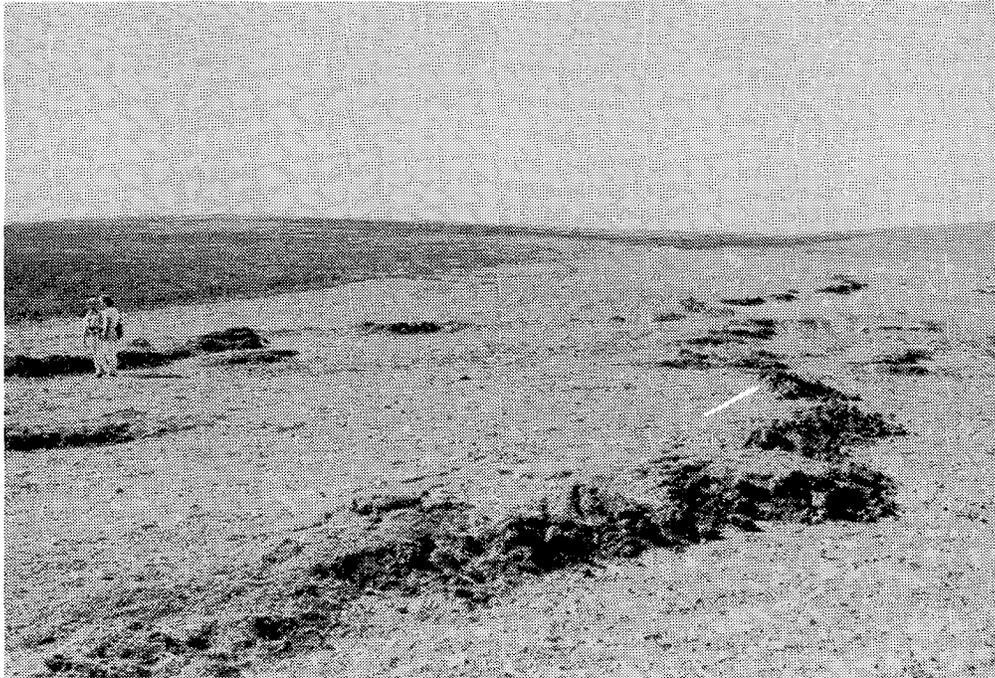
The primary fault is typically expressed as a series of low scarps and compression ridges (Fig. 2.4) that have various surface patterns. They generally occur as either subparallel en echelon breaks, or in an anastomosing pattern where the scarps and pressure ridges branch and reconverge. Both left and right stepping fracture patterns were observed, and apparent left and right lateral displacements were measured. In a few places the primary thrust occurs as a single fault scarp. Typically, the vertical displacement on individual scarps is a meter or less, and the cumulative vertical displacement across the zone of primary faulting is generally not more than 1.5 to 2 meters. Estimates of the net slip vary from less than 1 meter to about 6 meters. The average net slip appears to be between 3 and 4 meters.

Fig. 2.4 Compression Ridges Along Surface Trace of Oued Fodda Fault Southwest of Zababdja. At this location the main fault is a low angle thrust dipping 10° to 20° northwest. View is northeast.

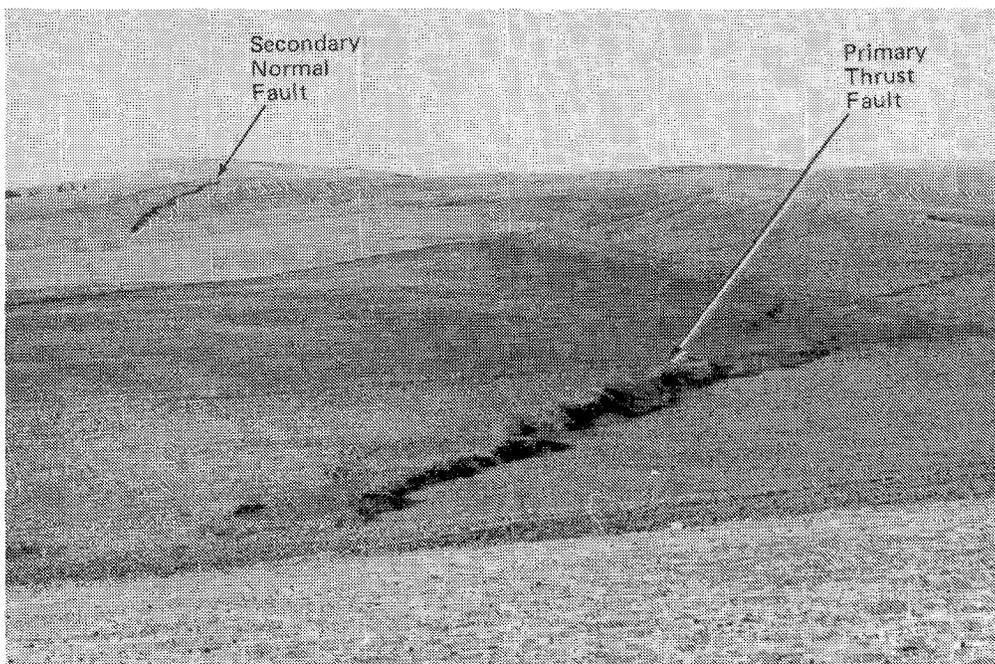
Maximum vertical displacement measured along the primary fault trace was 2.6 meters; at this location the fault intersected a sloping surface and produced a scarp 4.2 meters high (Figs. 2.5 and 2.6). The dip of the fault could not be measured at this location; however, the morphology of the scarp is similar to other locations where the fault dips steeply (45° to 55°). Assuming a 50° dip, the dip slip displacement would be 3.4 meters.

Fig. 2.5 Oued Fodda Fault North of Sendjas. View is northward.

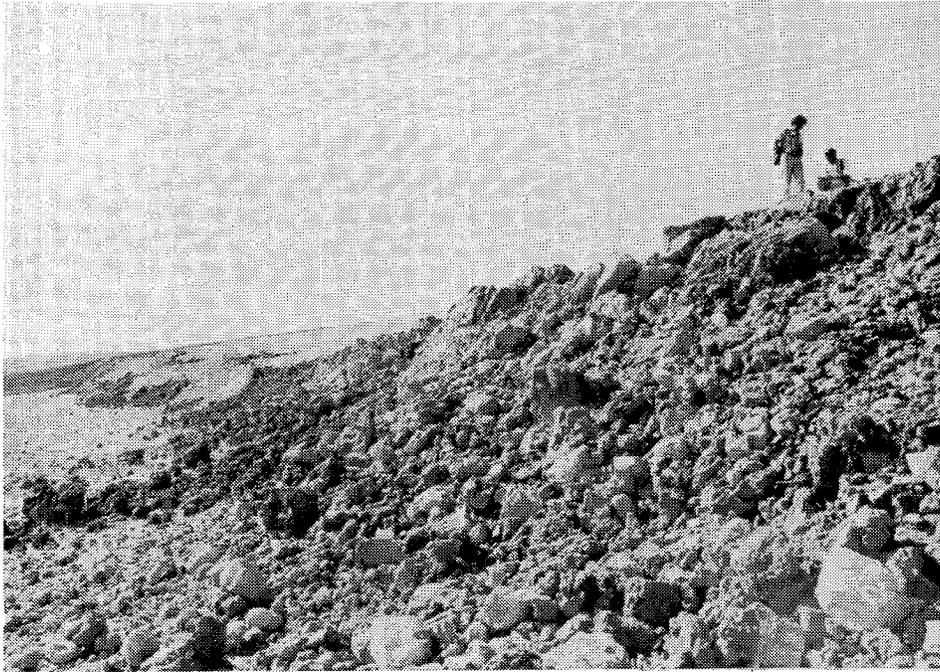
Fig. 2.6 Fault Scarp Along Oued Fodda Fault North of Sendjas. The 4.2 meter high scarp was produced by 2.6 meters vertical displacement on a reverse fault dipping approximately 50° northwest. View is southwest.

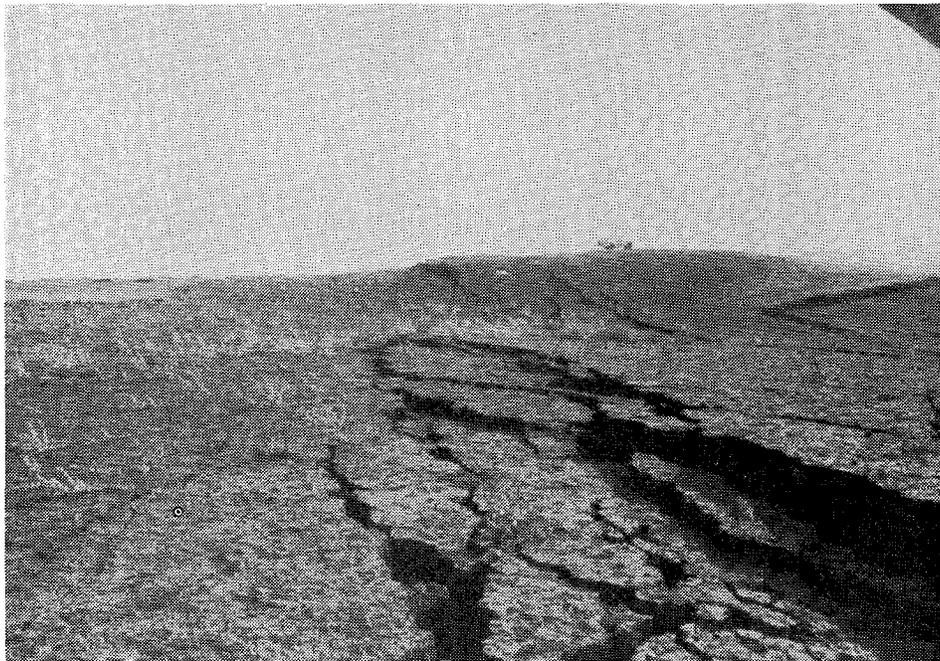
Extensive fissures and normal faulting occurred on the upthrown block of the primary thrust (Figs. 2.5 and 2.7). These fissures generally were within 2 km of the trace of the primary thrust. Both down-to-the-southeast and down-to-the-northwest displacement occurred. In most places, the displacement on the secondary high angle normal faults produced scarps that are more pronounced than those along the primary thrust fault. Vertical displacements of about a meter are common on these normal faults, and in some localities produced scarps 2 to 4 meters high. Displacement on the Oued Fodda fault was the principal source of the seismic energy released during the October 10, 1980 earthquake.

Fig. 2.7 Secondary Normal Faults on Uplifted (Northwest) Block of Oued Fodda Fault South of Oued Cheliff. View is southwest.

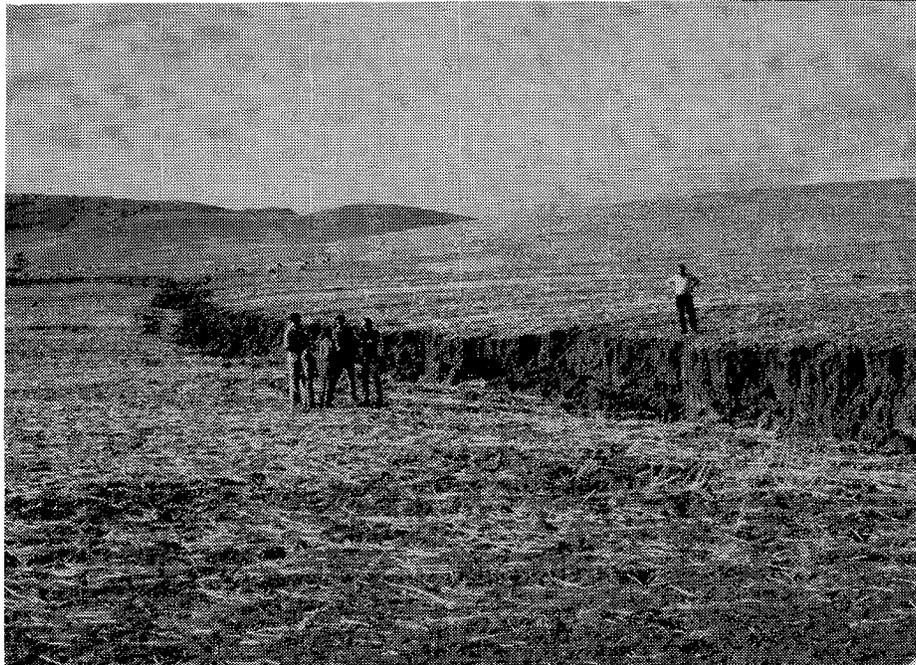
The Beni Rached fault is a high angle normal fault that appears to be a secondary splay of the Oued Fodda fault (Fig. 2.3). In most places, the surface faulting along the Beni Rached fault is expressed as a single well-defined fault scarp (Figs. 2.8 and 2.9). Vertical displacement on the fault is typically about 1 meter. Numerous small graben and extensional cracks occur on the downthrown side along the base of fault scarp. Apparent right and left lateral offsets of approximately 0.5 to 1 meter were measured locally along the fault.

Fig. 2.8 Normal Fault Scarp Near Beni Rached

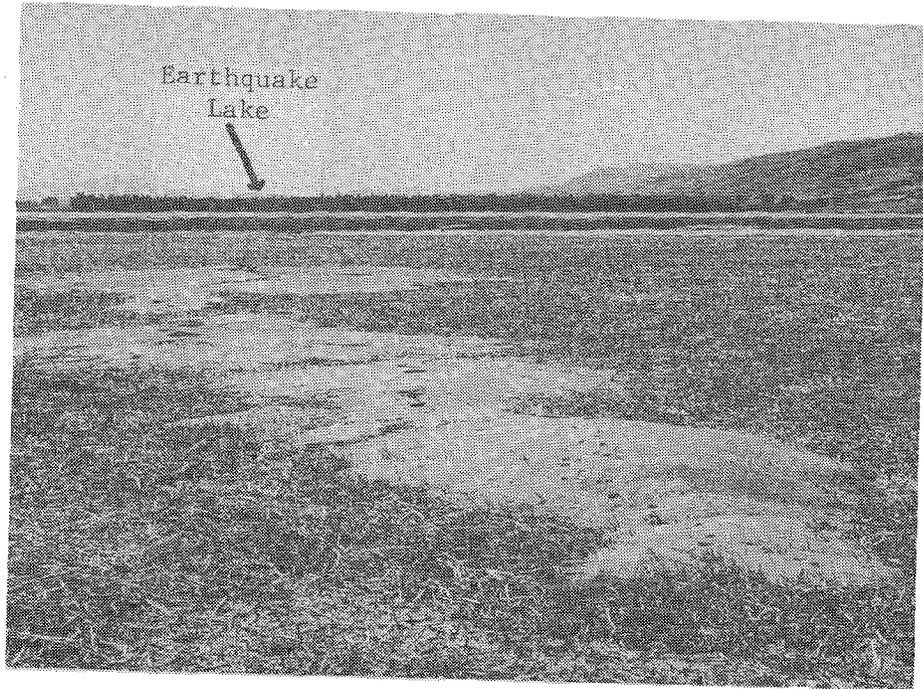
Fig. 2.12 Sand Boils and Earthquake Lake

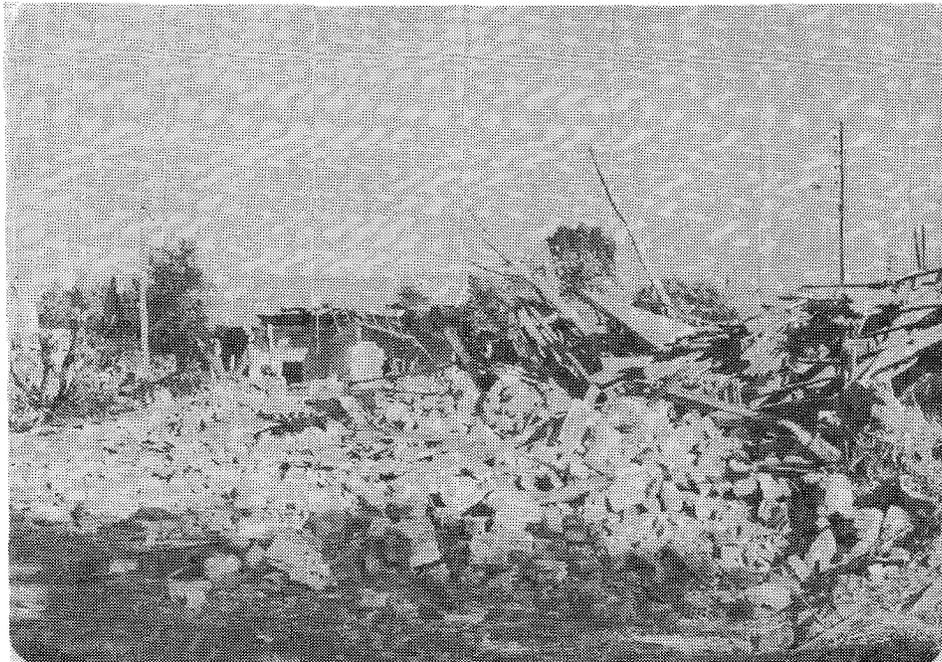
El-Abadia, 5 km north of El-Attaf, appeared virtually destroyed; most major buildings were partially or totally collapsed. However, a few older one-story masonry structures, although severely cracked, survived the earthquake. No modern buildings were observed in El-Abadia. It was reported that 600 people were killed by collapsing houses (Fig. 3.1). In the countryside the predominant form of construction is traditional adobe brick with timber rafters and tile or thatch and mud roofing. In some villages near the epicentral region, almost all housing collapsed. In the outlying villages much loss of life occurred. The major cause of death was from falling adobe bricks rather than roofing material (Fig. 3.2).

Fig. 3.2 Collapsed Stone and Adobe Huts

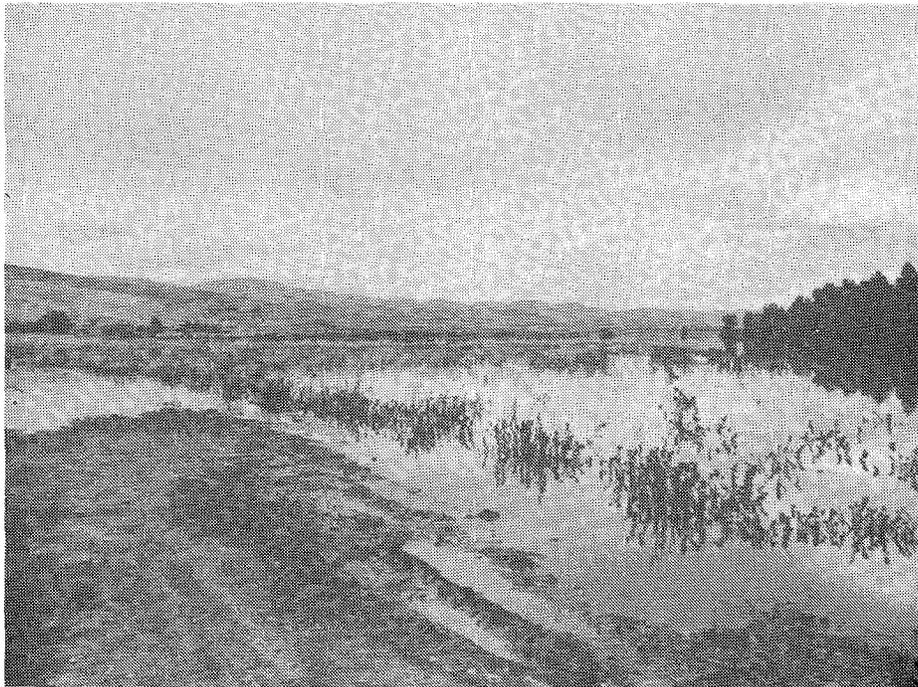
Fig. 3.7 Earthquake Lake

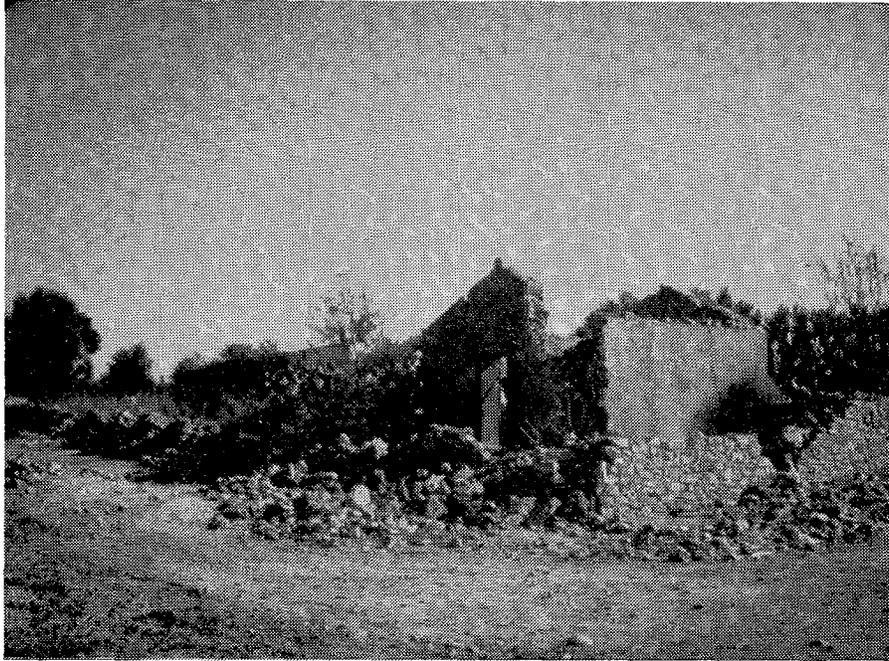
Fig. 3.8 Collapsed Stone Houses and Adobe Huts, Beni Rached

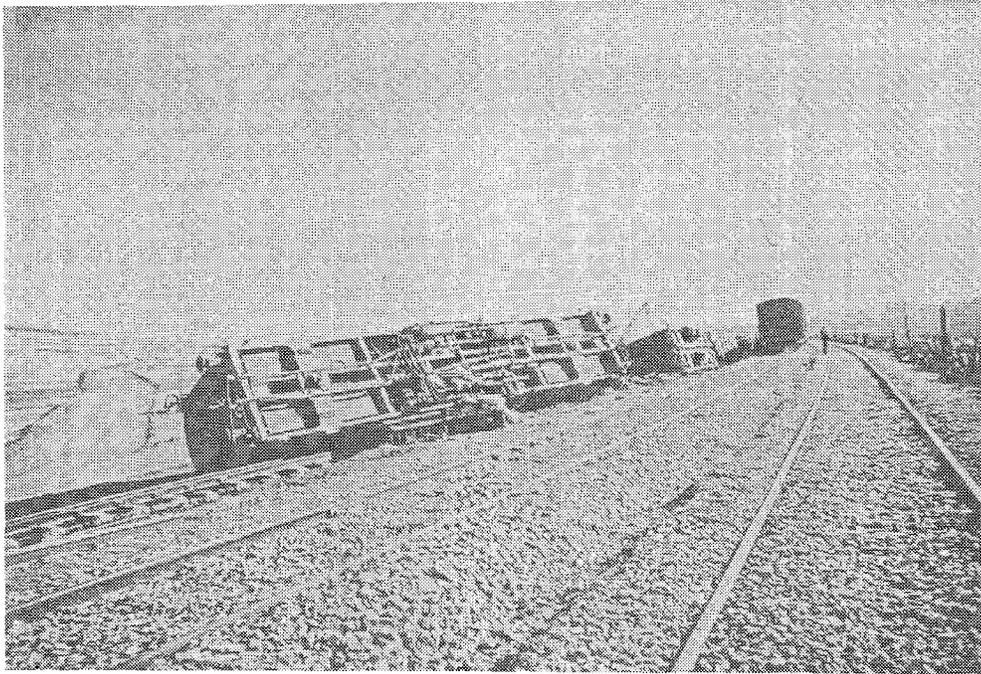
Fig. 3.11 Overturned Train

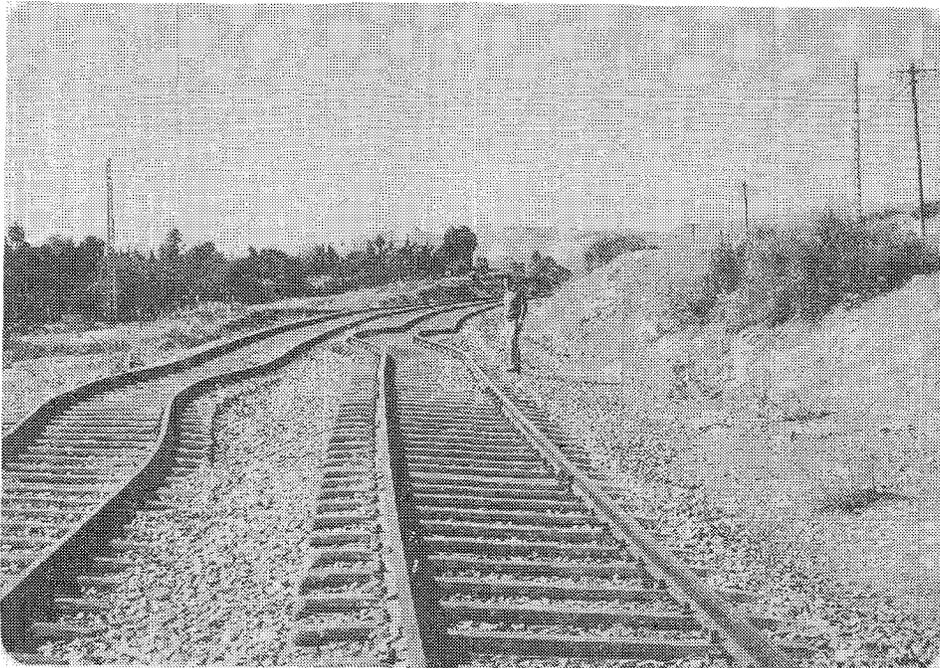
Fig. 3.12 Bent Rails Between El-Asnam and Oued Fodda

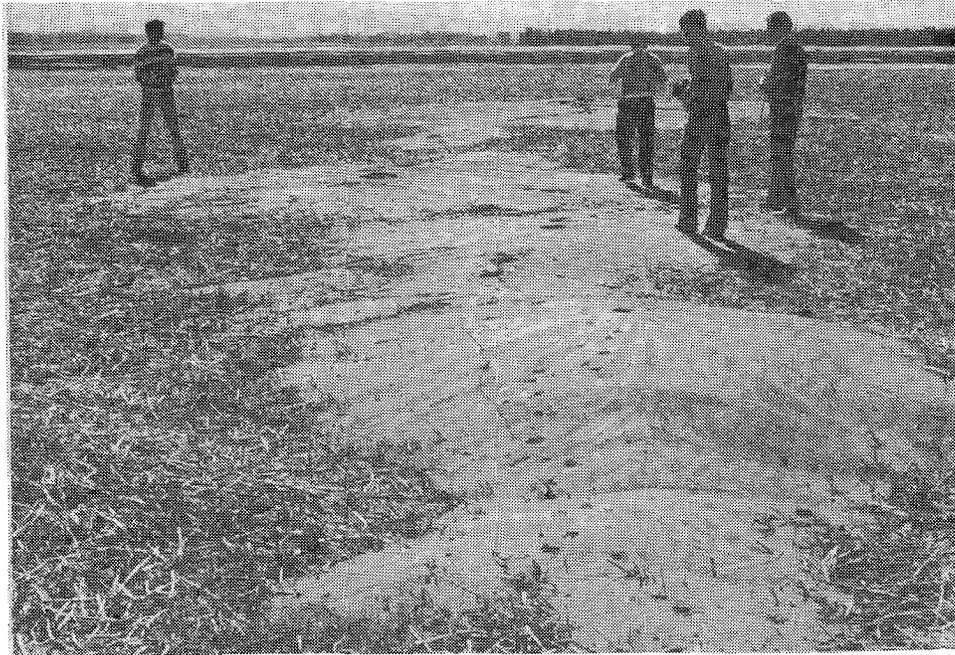
Fig. 3.13. Sand Boils at Site 3 in Vicinity of Earthquake Lake Immediately After Earthquake. Site locations are identified in Fig. 3.17.

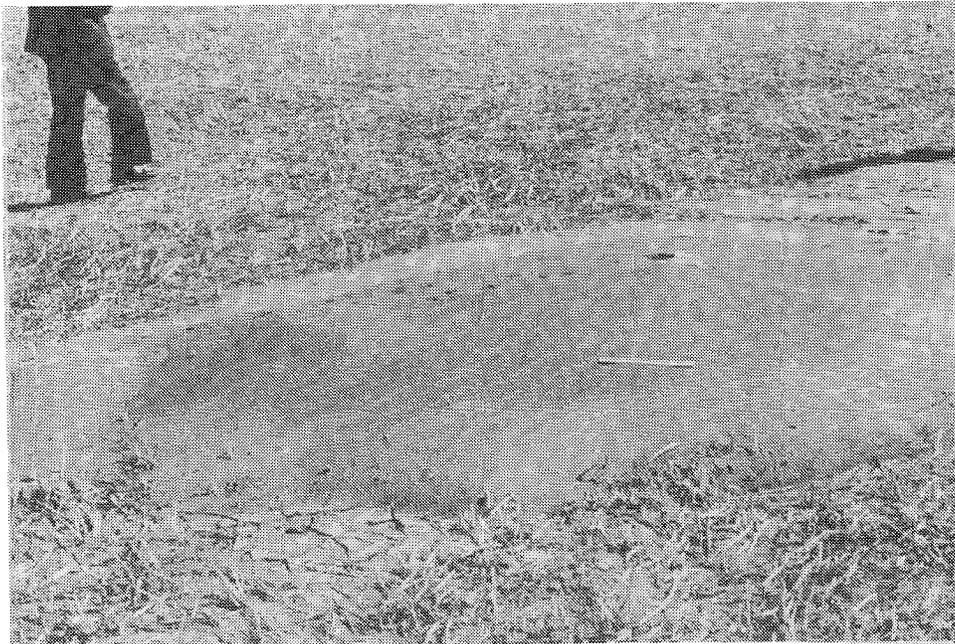
Fig. 3.14 Sand Boil at Site 3 Immediately After Earthquake

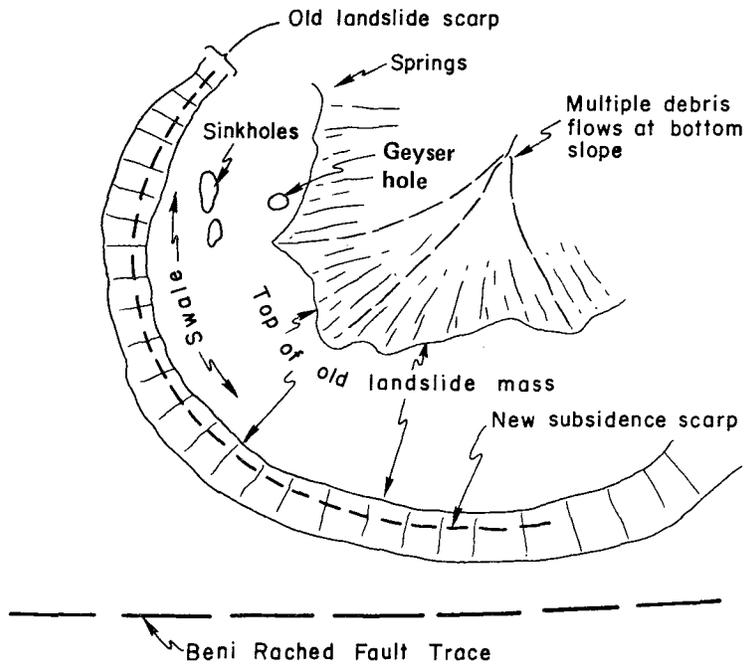
The old landslide mass occupies an area about 1 km² with a 10 to 15 meter scarp at the head of the slide. This scarp has an arcuate shape and a length of nearly 2 km. The earthquake activated the whole slide mass, as evidenced by a fresh 1 meter wide subsidence crack around the entire base of the old scarp (Fig. 3.19).

The landslide mass extended outward for about 150 meters. The surface of this mass was highly irregular and in a number of areas tilted back into the mountain, as shown in Fig. 3.20. At the rear of the back-tilted zones, the soil was wet and soft, with a conspicuous growth of green grasses. Several sinkholes into which water drained were observed. Springs existed at two locations along the downslope flanks of the back-tilted mass.

Fig. 3.18 Landslide Area at Site 8 (see Fig. 3.17)

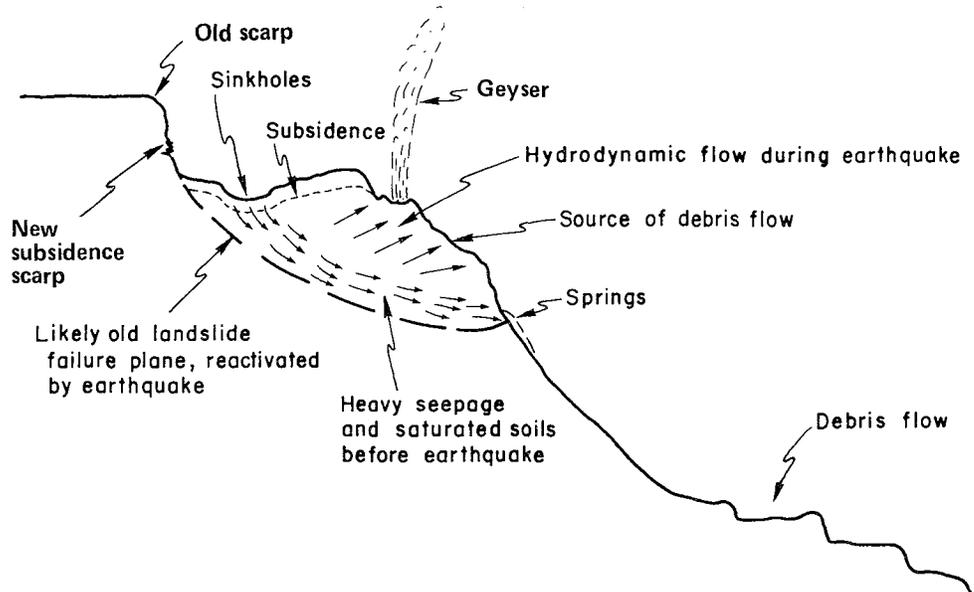
A postulated mechanism for the unusual geyser and debris flows is depicted in Fig. 3.20. Before the earthquake, the sinkholes on the back-tilted areas served as funnels for water that seeped below the landslide mass. Under normal circumstances the water flowed out at the flanks of the landslide in the form of springs; however, during the earthquake, the landslide mass as a whole slipped downward, as evidenced by the new subsidence scarp around the head of the landslide. This large-scale movement was likely due, in part, to the lubricating effect of the long-standing seepage under the landslide. The sudden downward thrust of the landslide mass impacted the water-laden soils under it and generated exceedingly high excess pore pressures. Under this unusual head, the water flowed rapidly upward through the overburden and, in one location (probably a cracked or weak zone), burst forth as the geyser. The remainder of the surface soil, now saturated and subjected to a high seepage condition, essentially liquified and moved rapidly downslope in the form of debris flows.

Because general conditions at this site remain unchanged, it is likely that the behavior observed in the 1980 earthquake will be repeated in future seismic events. The villagers noted that a significant landslide had occurred in the same location during the 1954 Orléansville (El-Asnam) earthquake.

Fig. 3.20 Mechanism for Formation of Geyser and Small Flowslides at Site 8 During Earthquake (see Fig. 3.17)

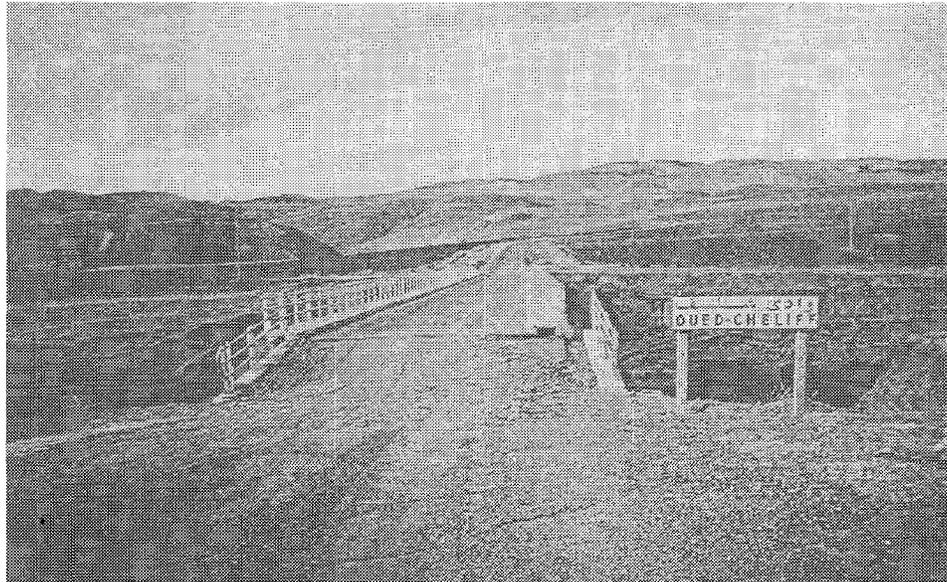
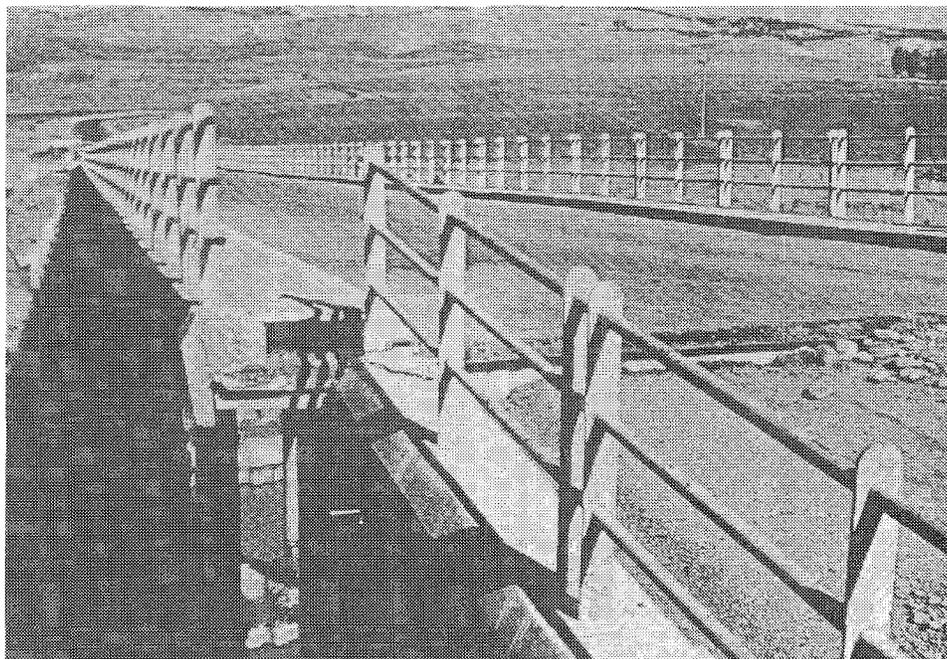
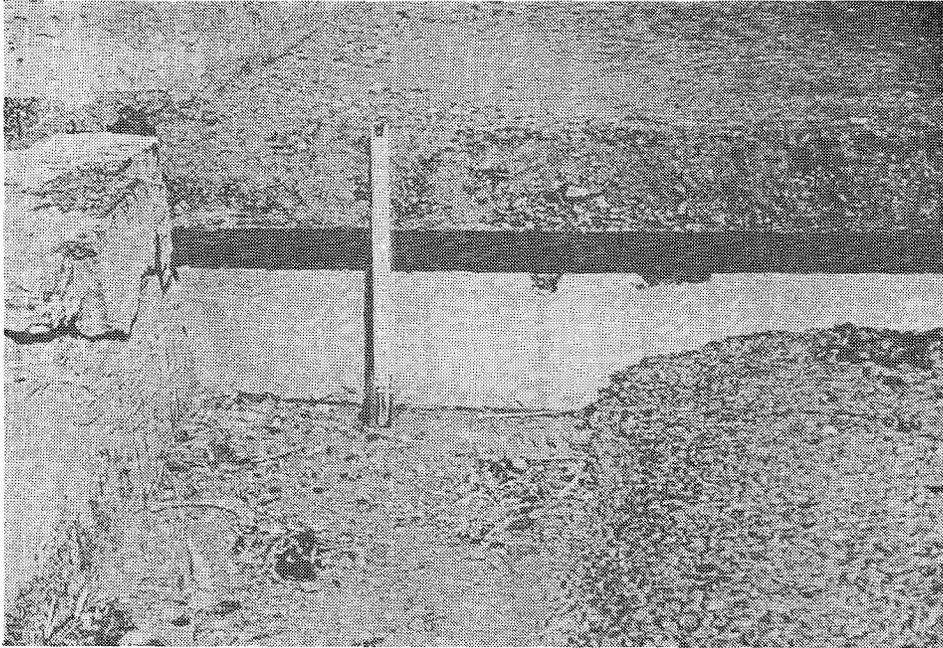
Fig. 3.22 Abutment Settlement of Bridge Across Oued Cheliff

3.4.3 Differential Settlement. Most bridge abutments settled during the earthquake, thereby damaging bridge approaches. The differential settlement was jointly due to lurching, liquefaction, and uneven compaction. Fig. 3.22 shows a bridge over the Oued Cheliff that sustained considerable damage. The abutments of this bridge moved 1 meter horizontally with respect to the bridge superstructure. This resulted in considerable damage to end supports.

(a) Overall View

(b) Horizontal Movement

(c) Vertical Movement

The most serious damage of this type was observed at a two-lane modern prestressed concrete bridge continuous over five spans. This bridge is located on a secondary highway as it crosses the Cheliff River about 15 km (9 mi.) northeast of El-Asnam and about 5 km (3 mi.) southwest of Beni Rached (Fig. 3.22). Intermediate spans are supported on twin piers, the lower ends of which are protected from scour by a steel caisson lining. Except for some cracking of concrete at the foundation in the steel caisson, there was no evidence of structural damage to the spans, piers, or foundation. There was also no evidence of pier settlement. The only faulty detailing was at each end, where the bearing beams that transferred the bridge load to the wing walls had moved (Fig. 3.22d). These bearing beams were keyed into the abutment approach structure but were not tied back; so in the case of the southern abutment, which had undergone a significant rigid body rotation, its bearing beam was almost lost. Relative movement to 1 meter (40 in.) horizontally and 0.30 meter (12 in.) vertically occurred between the approach and the deck (Figs. 3.22b and 3.22c). Along the river in the neighborhood of the bridge, considerable land movement and soil liquefaction were observed.

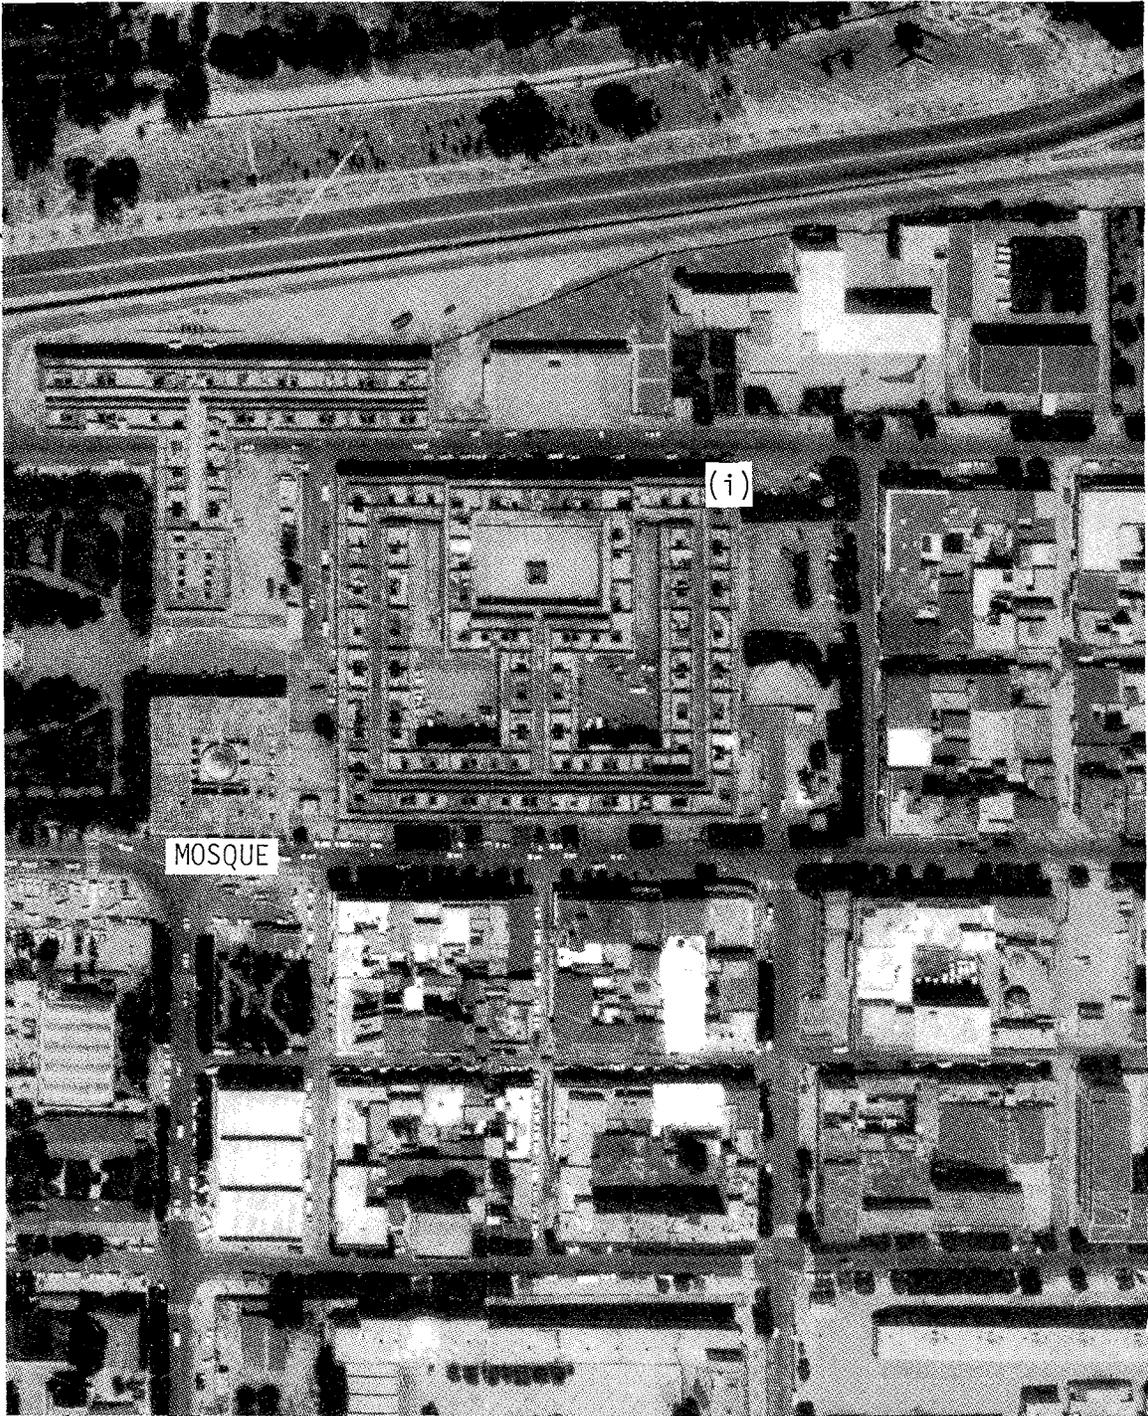
Fig. 3.23 Aerial View of Cité An Nasr

(b) After Earthquake
Fig. 3.23 (cont.)

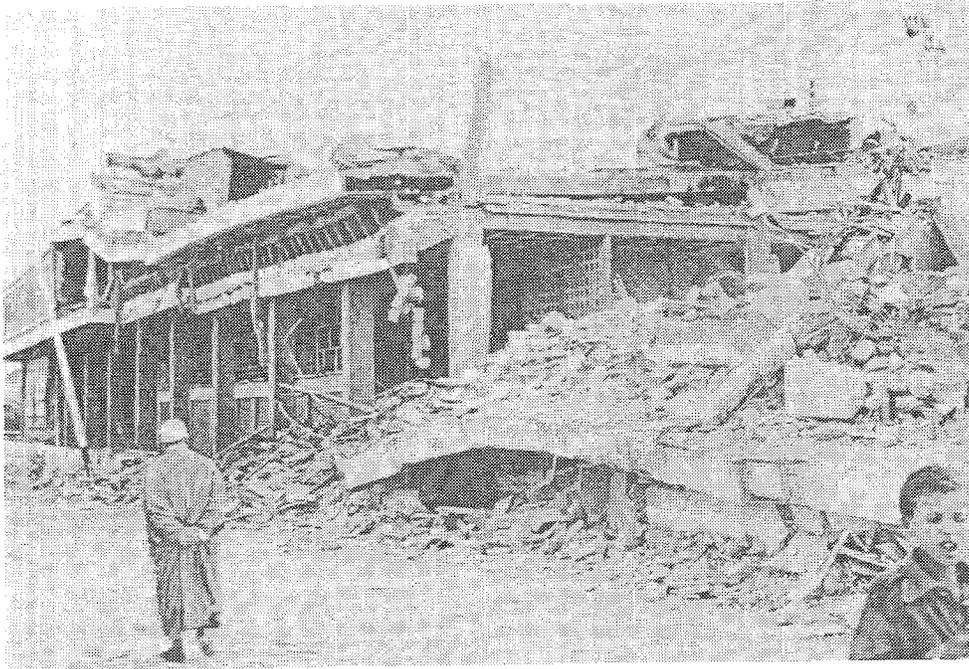
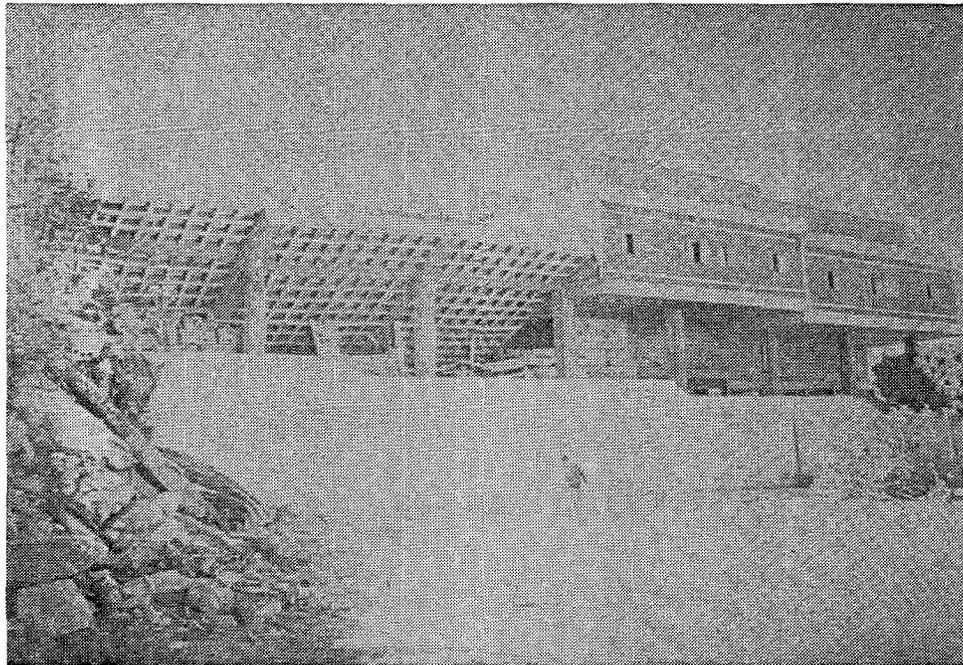
An example is the Cité An Nasr market (Nos. 14 and 18 in Fig. 1.17), which covered an area of 150 x 150 meters (492 x 492 ft) and was a complex of two to three-story buildings. These collapsed completely (pancaked) except for part of the mosque (Bldg 18 in Fig. 1.17) and one corner building which was barely standing, marked (i) in Fig. 3.23 and illustrated in Fig. 3.24. The collapse of these buildings caused a large number of deaths. Another example is the block where the Hotel du Cheliff and the hall of justice were situated (Nos. 3 and 4 in Fig. 1.17); after the quake only a small portion of the hall of justice remained standing in this block (Fig. 3.25). The main reasons for these failures are discussed later in section 4.3.1.

(a) North Side

(b) East Side

Fig. 3.24 Corner of Cité An Nasr That Remained Standing

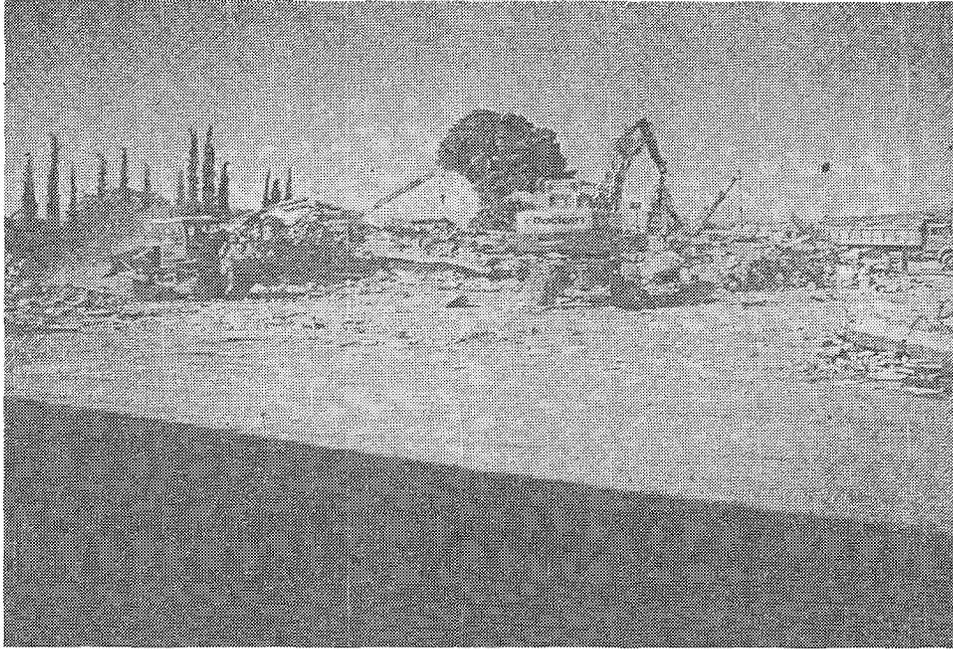
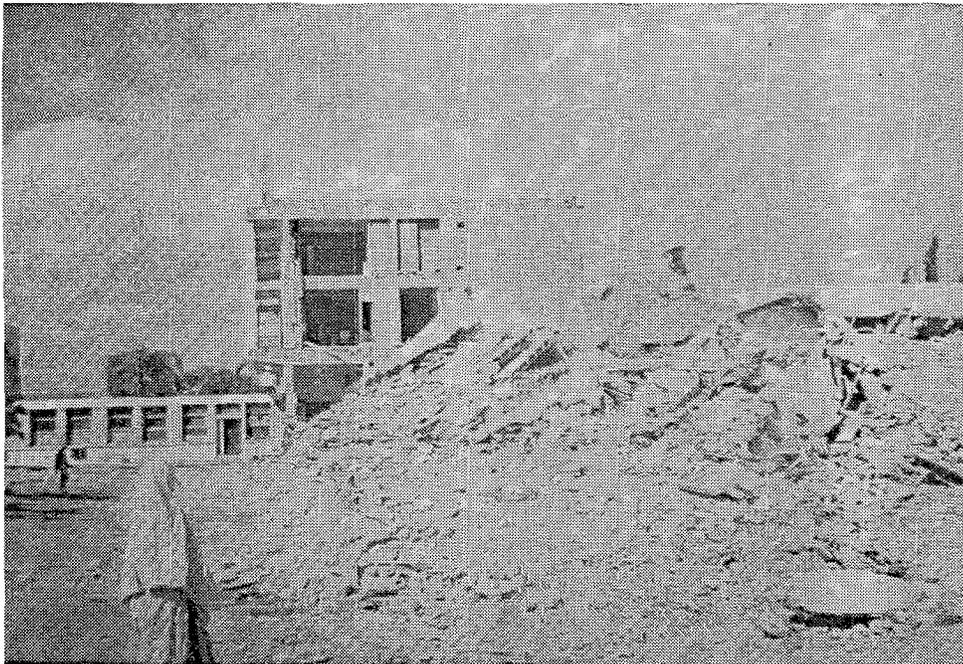
(a) Bulldozers Removing Debris of Hotel du Cheliff

(b) Only a Portion of Hall of Justice Remained Standing

Fig. 3.25 Collapsed Hotel du Cheliff and Hall of Justice

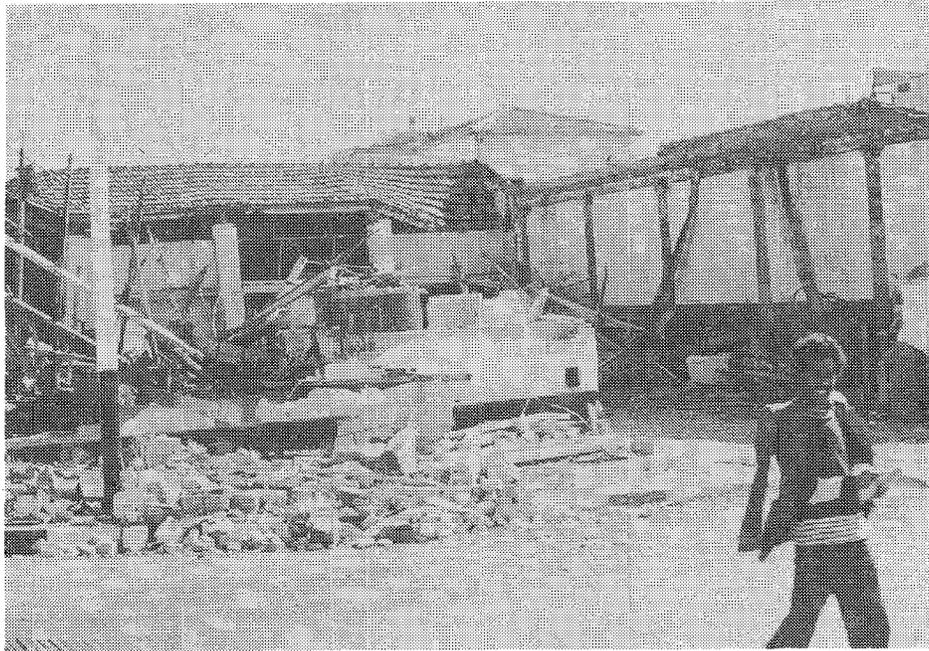
Fig. 3.28 Disaster Planning and Fire Station

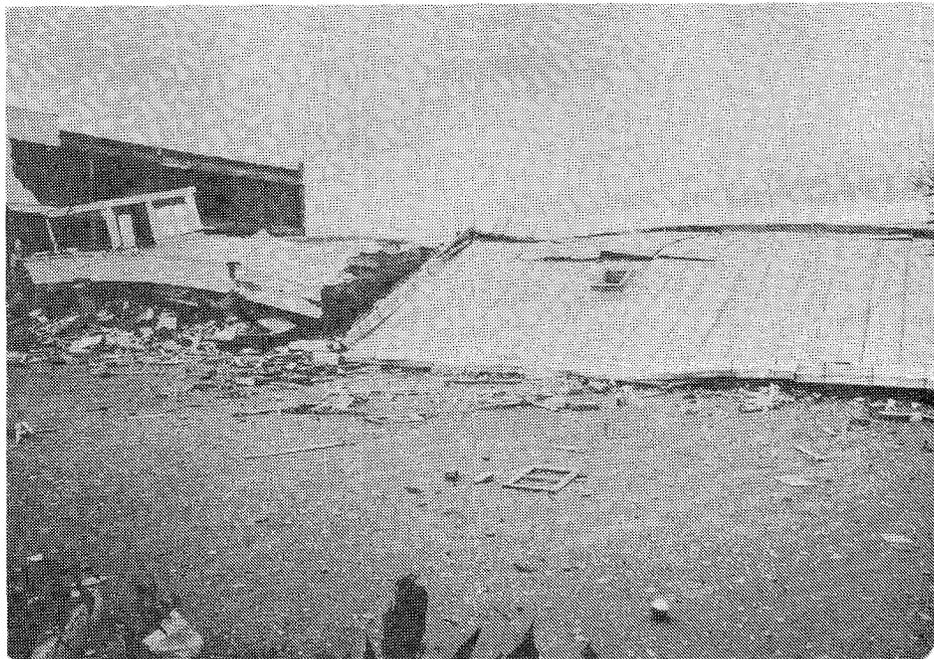
Fig. 3.29 Police Headquarters and Mayor's Office

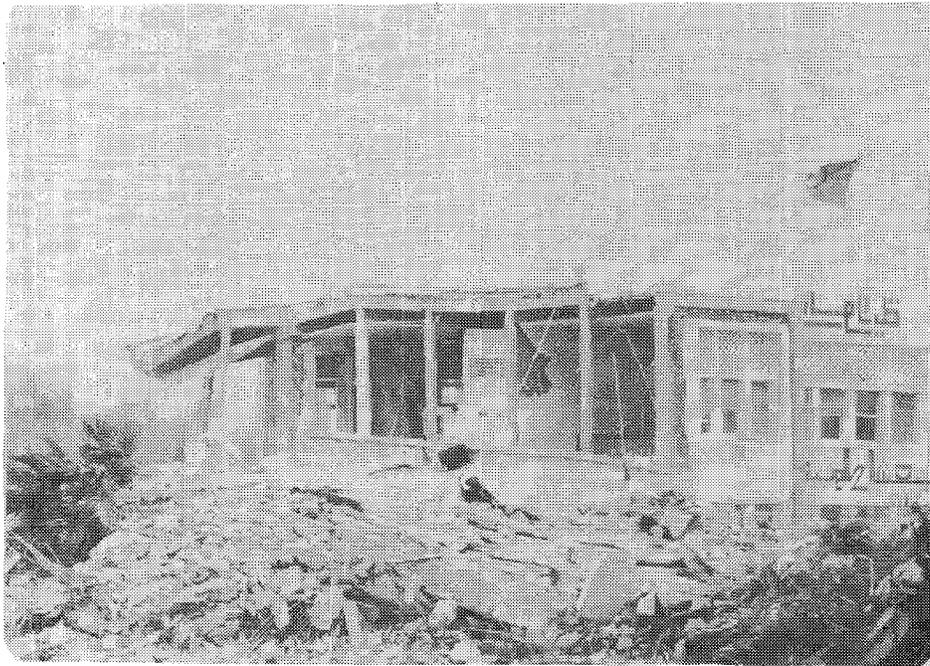
Fig. 3.30 Collapsed Portion of City Hall

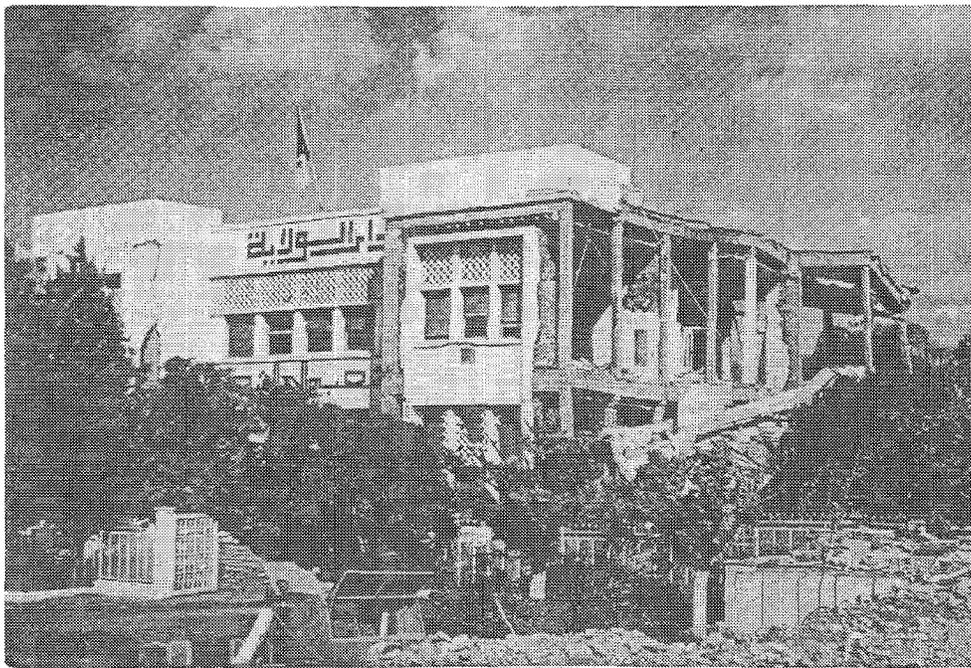
Fig. 3.31 Partially Collapsed Hotel

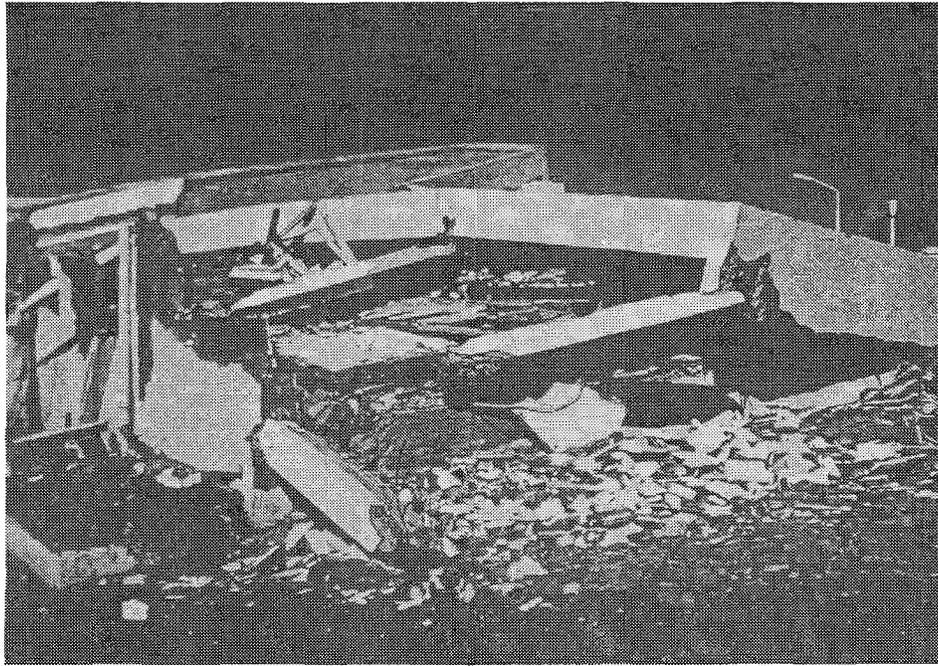
Fig. 3.32 Collapsed Commercial Building

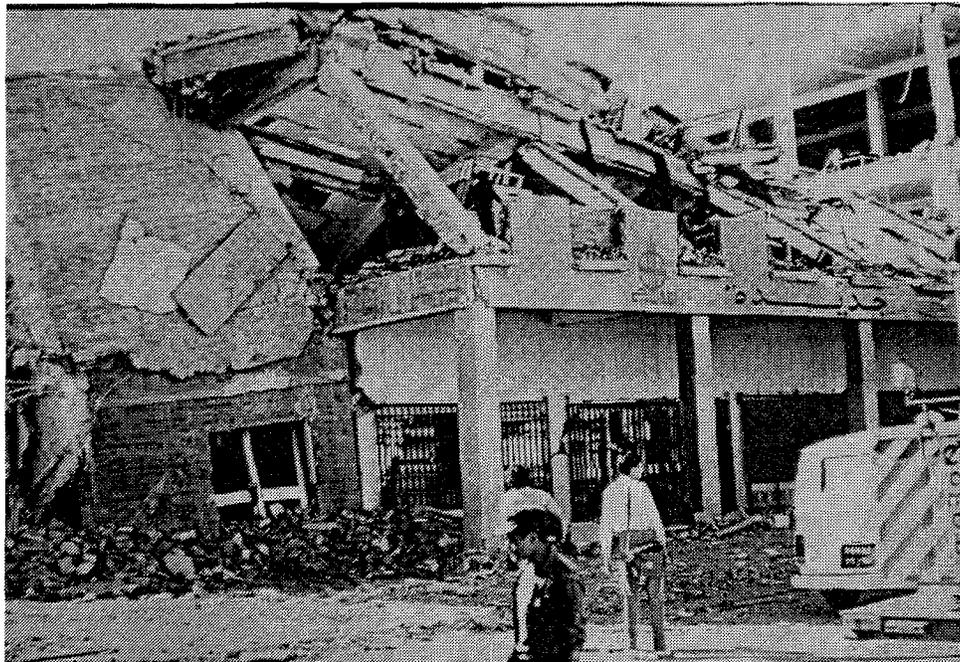
Fig. 3.33 Collapsed Store
