EL-ASNAM, ALGERIA EARTHQUAKE OF OCTOBER 10, 1980

A Reconnaissance and Engineering Report

**National Research Council
Committee on Natural Disasters**

Earthquake Engineering Research Institute

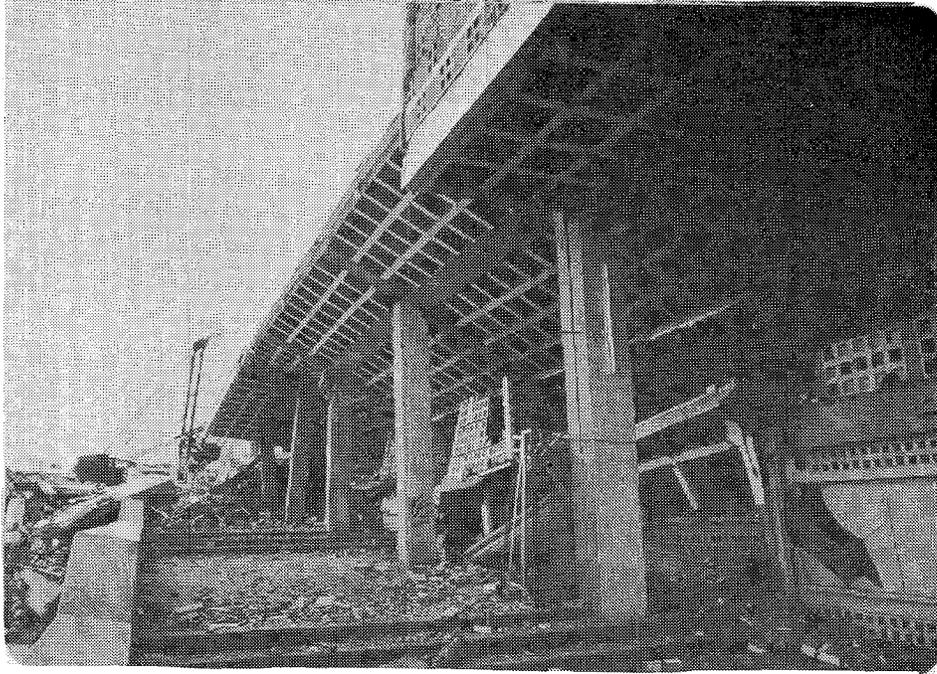
Fig. 3.34 Collapsed Cité An Nasr Market. A huge shopping mall and apartment complex covering one large block collapsed.

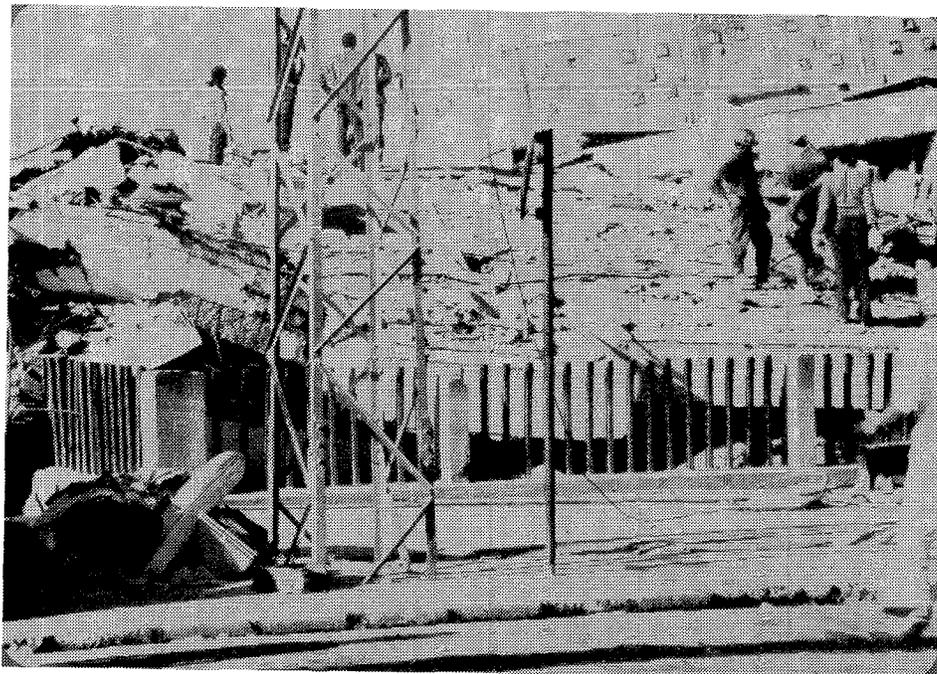
Fig. 3.35 Collapsed Cité An Nasr Market. Some 3000 people were believed dead under this structure. Pancaked floors had to be lifted carefully because of buried bodies.

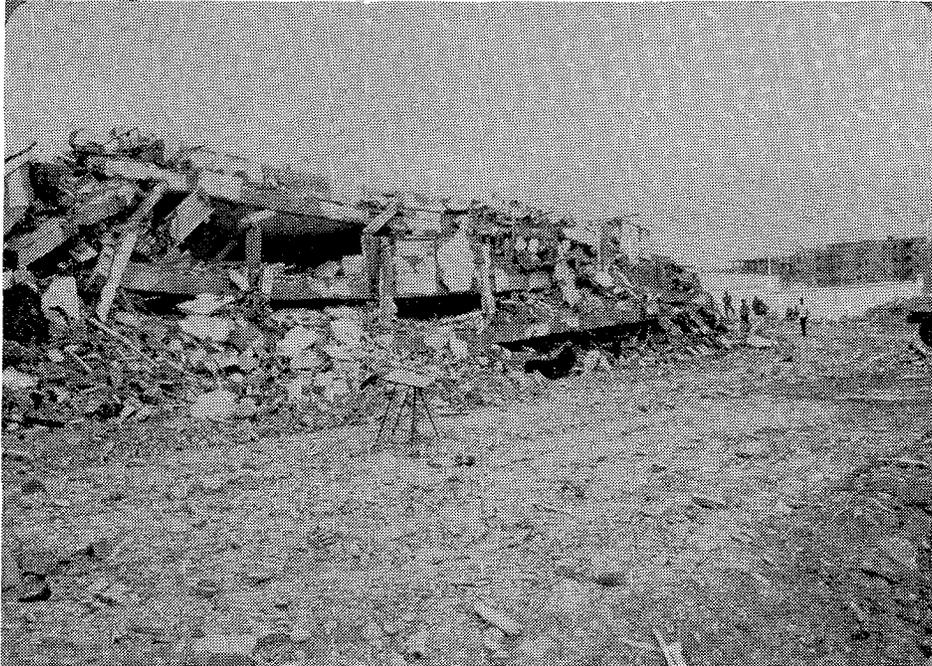
Fig. 3.36 Collapsed Three-Story RC Apartment House

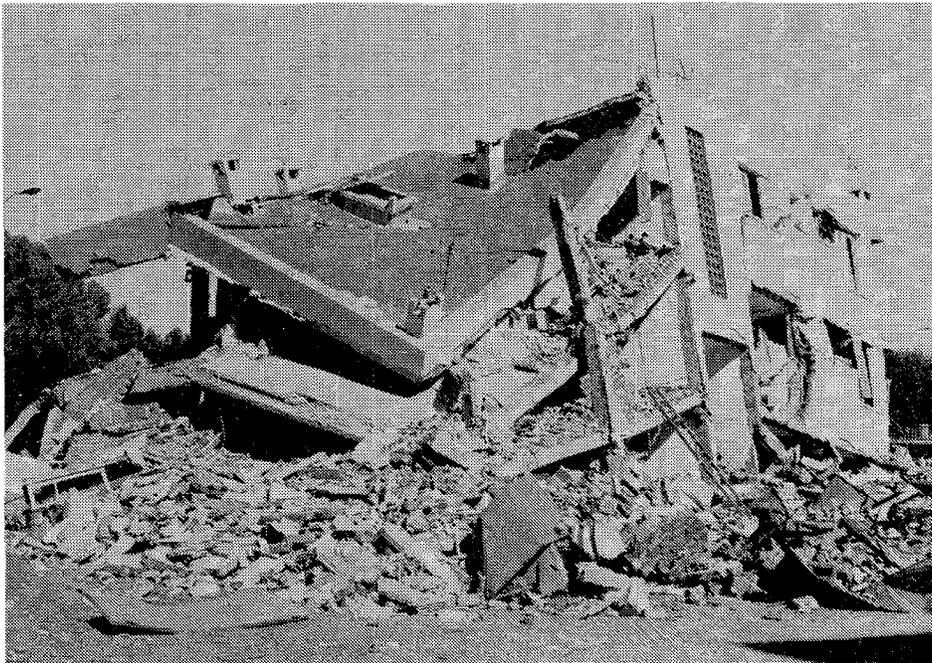
Fig. 3.37 Collapsed Three-Story RC House

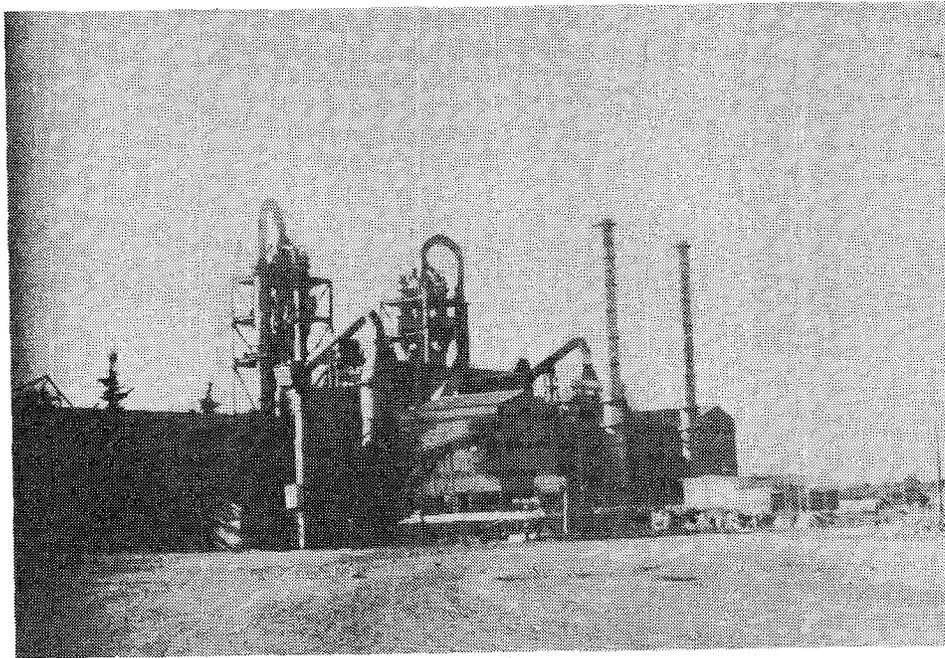
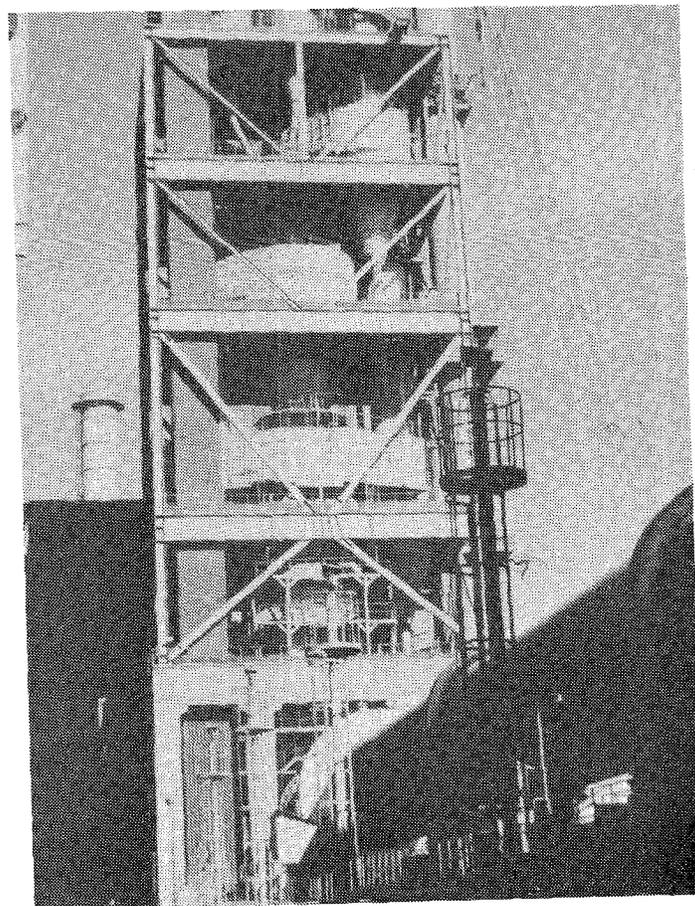
Fig. 3.40 Cement Plant 7 km West of El-Asnam

Seven km west of El-Asnam there is a cement fabrication plant. This plant has two towers approximately 45 meters (147 ft) high. The towers are constructed of reinforced concrete to about 15 meters above ground and then of structural steel (Fig. 3.40). Each of the four steel columns is anchored by six 6.5 cm bolts. A gap about 2 cm occurred between the nuts and baseplates of all four columns (Fig. 3.41). This could have been caused by three factors: yielding of bolts, pullout of bolts, or crushing of cement pad under baseplates. As can be seen in Fig. 3.41, the pad was severely crushed, which allowed a downward movement of the plates. Perhaps because of poor workmanship or quality control of the material used in the cement or mortar pad, the compression strength of the pad was insufficient even though the quality of construction was generally excellent throughout the plant. In any case, the gap indicated that large forces developed. The only other observed structural damage was failure of connections at two internal vertical steel bracing elements in the top story of the tower.

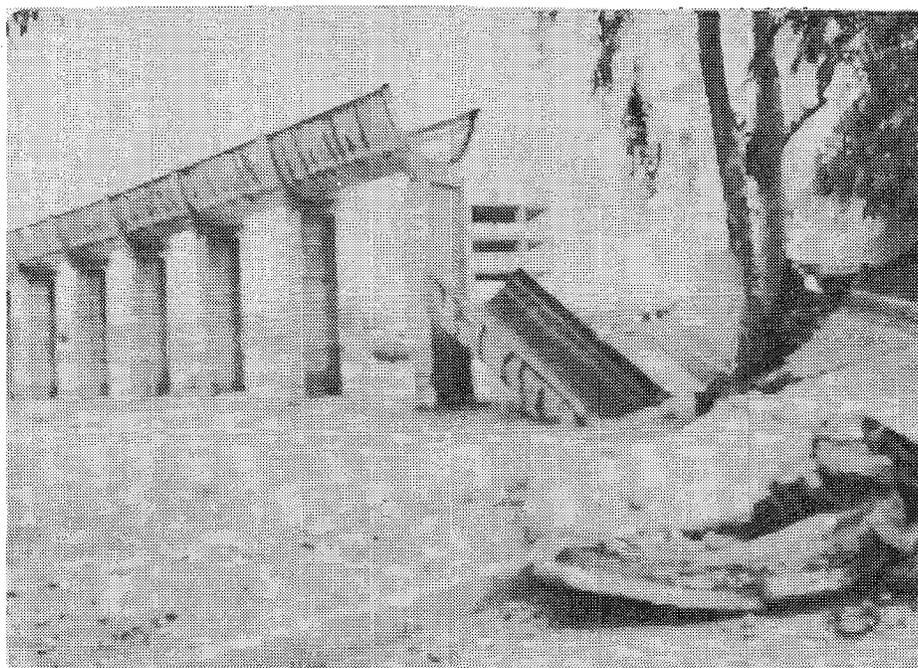
Fig. 3.42 Elevated Irrigation Channel

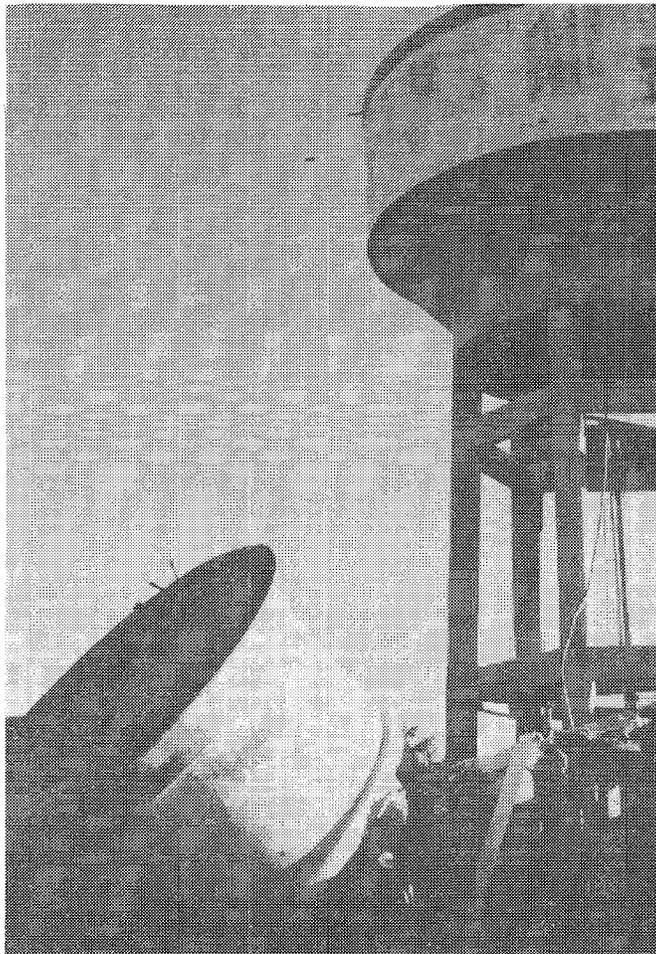
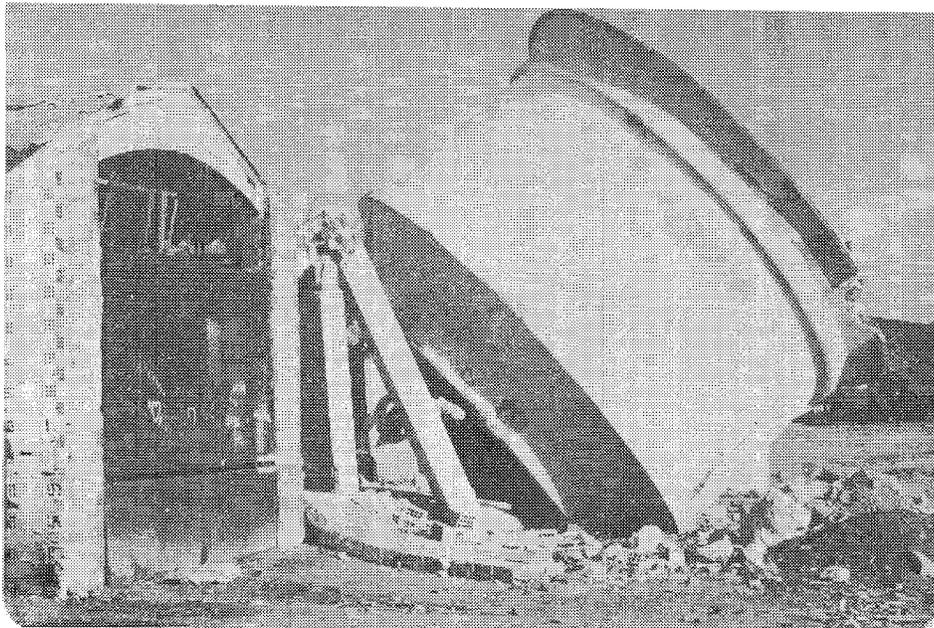
Fig. 3.43 Elevated Water Tanks in El-Abadia

In the town of El-Abadia, about 30 km east of El-Asnam, there were two elevated RC water tanks. The tower of the smaller tank collapsed; the other remained standing although there was some significant damage at the ends of the horizontal beams and at the columns at the beam-column joints. It appears that the smaller tank was empty when the earthquake struck. The main reason for the failure appears to be lack of adequate shear reinforcement in the columns and/or poor anchorage of the column reinforcement to the bottom beam supporting the tank (Fig. 3.43).

(a) View of Two Tanks

(b) Tank That Failed

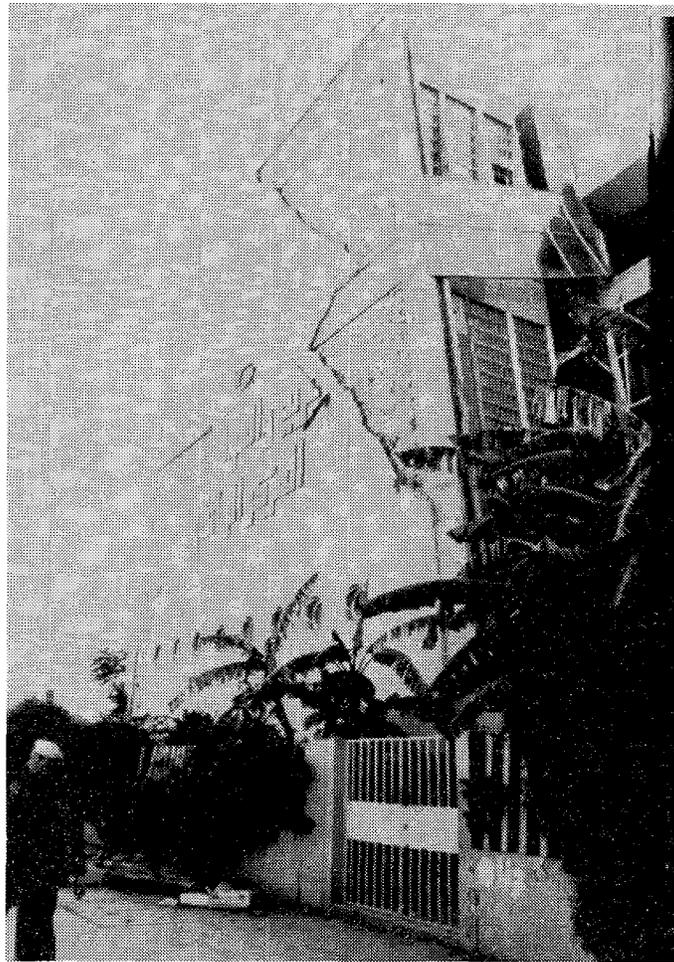
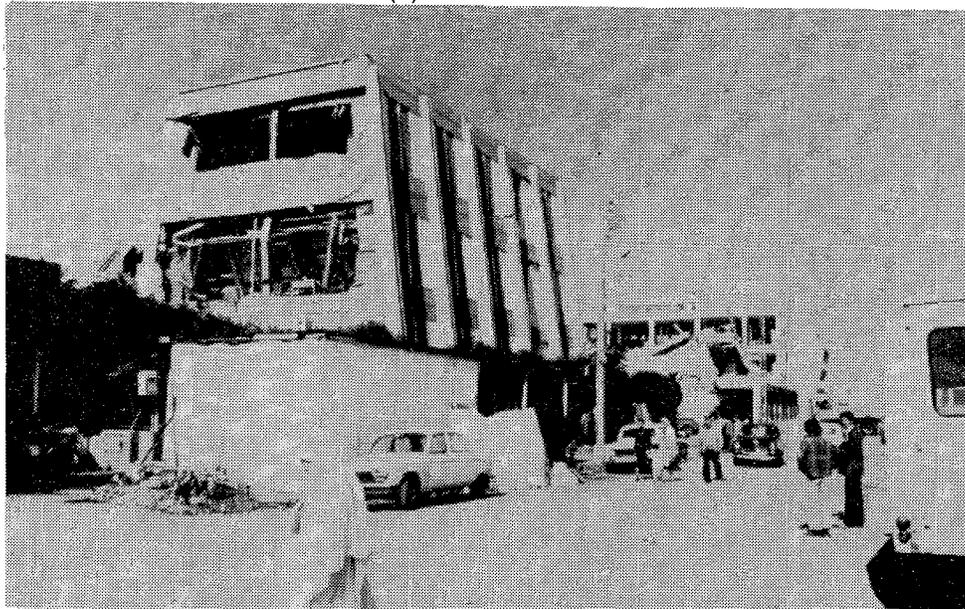
Fig. 3.45 Damaged Telephone Building

Telephone communications were interrupted because there was such severe damage to the telephone equipment that even after three weeks no attempt had been made to repair it. The building housing this equipment was a modern three-story RC moment-resisting space frame infilled with masonry (Fig. 3.45). Although the structure did not sustain major damage, in contrast to the other modern construction in the city which was destroyed, the nonstructural damage was enormous. The building appears to have undergone considerable deformation resulting in significant damage to the masonry walls and to the telephone equipment (Figs. 3-4a, b, c) . Free-standing relay racks overturned. Fig. 3.45d shows a tall chimney attached to one side of the telephone building that failed near its base, hitting the transverse walls and breaking near the top.

(a) North Side

(b) South Side

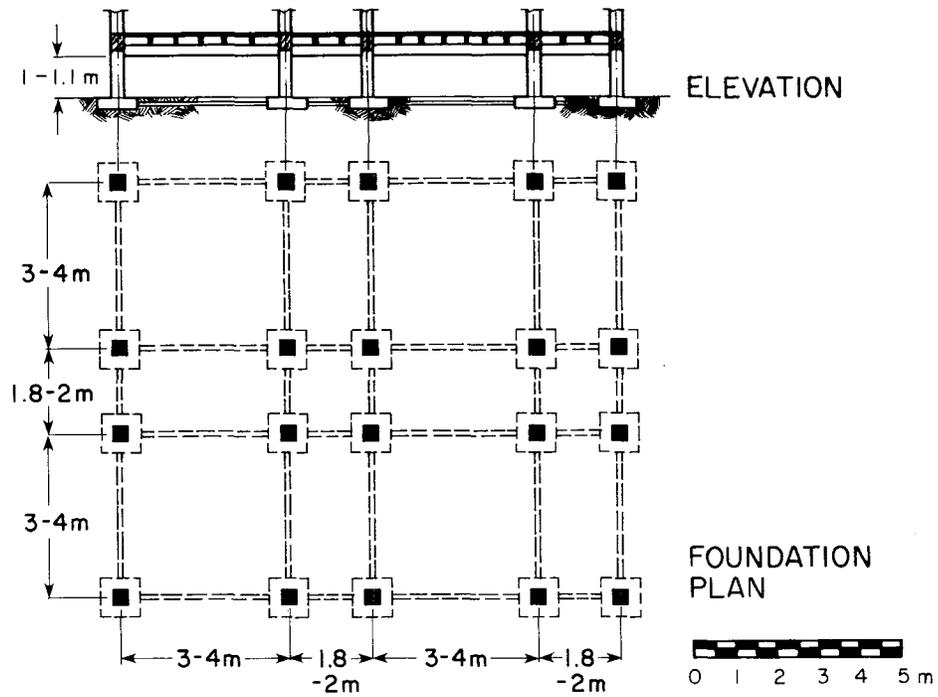
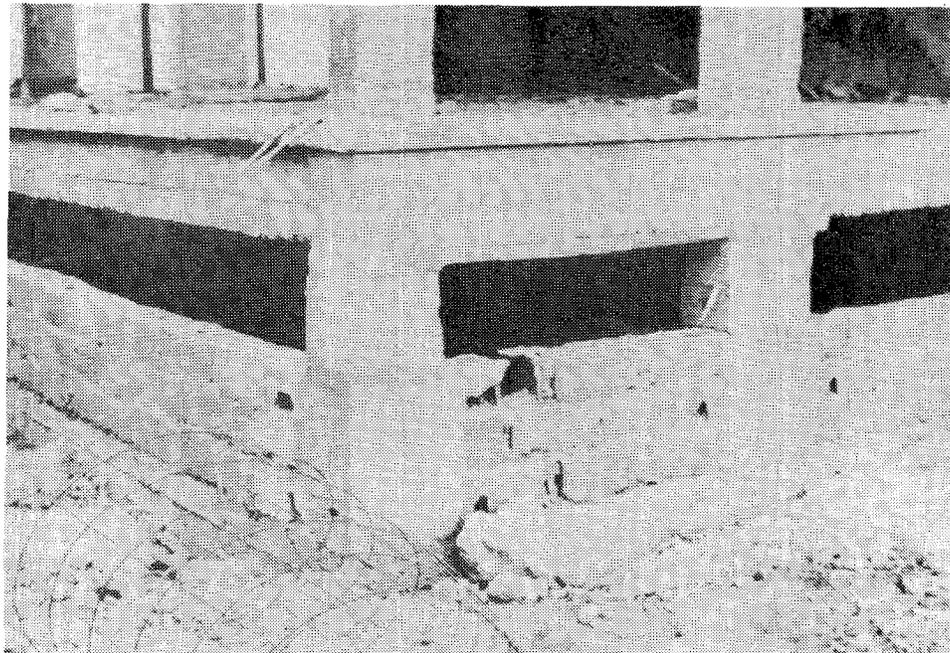
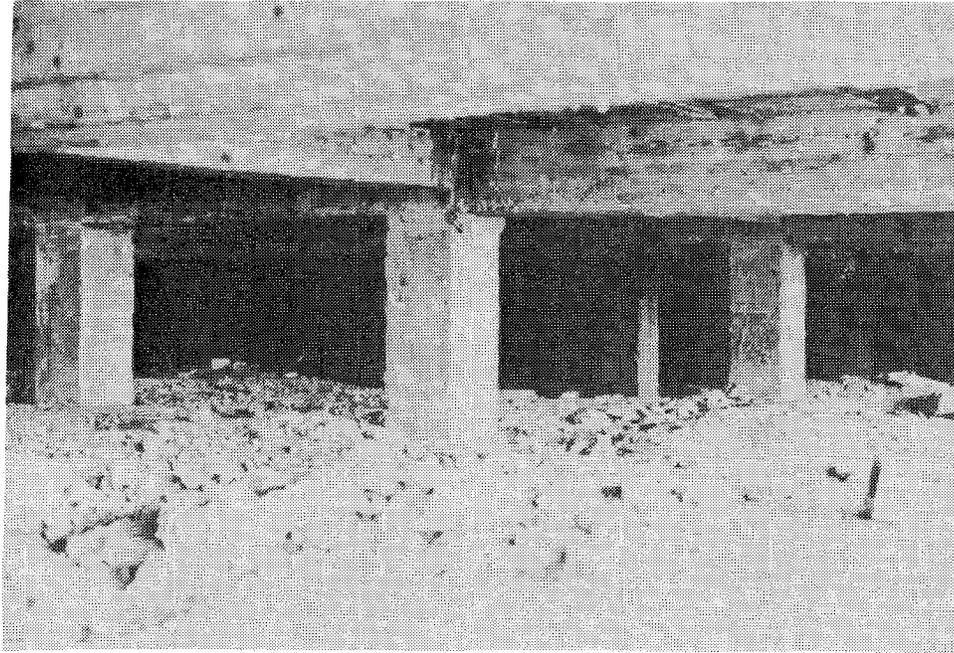
Fig. 4.2 Structural Details and Views of *Vide Sanitaire*

1. **Use of the *vide sanitaire***, a crawl space about 1 meter (3 ft) above ground level (Figs. 1.18, 1.19, 4.2, and 4.3). In most cases, the only structural elements in this space were short columns ≤ 1 meter (3 ft) tall, without any walls or partitions except for perimeter masonry walls used to enclose this space. As noted in section 1.6, in some buildings the perimeter walls were replaced by 10 cm (4 in.) concrete walls that were very lightly reinforced. Because the RC framework above this crawl space was infilled with stiff masonry walls, the *vide sanitaire* constituted a soft story with very short columns. Actually, it was not just an issue of being a soft story. As discussed in section 1.6.2, the available shear area of the stubby columns was totally inadequate. These stubby columns were sheared off by the horizontal inertia forces induced by the earthquake ground motions. As a result, the entire building was thrown out-of-plumb (Fig. 4.3). Although several buildings with this crawl space remained standing after the earthquake, they were inclined as much as 20° and dropped up to 1 meter (3 ft), producing damage in the first story, while upper stories sustained little damage to the concrete frame and infills (Fig. 4.3).

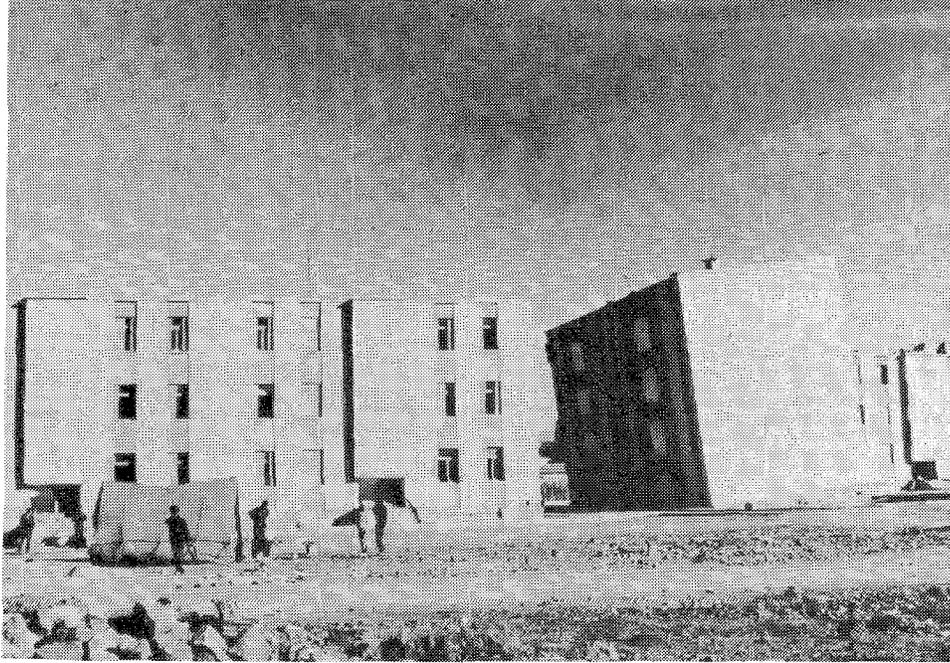
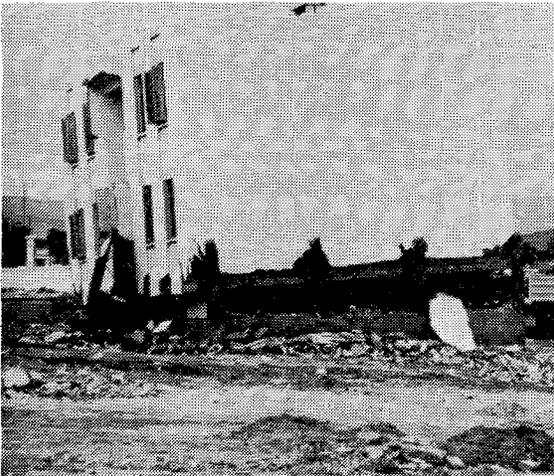
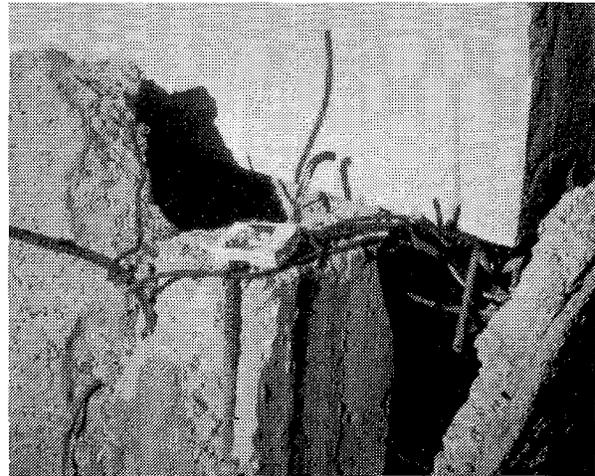
(a) Three-Story Apartment

(b) Two-Story Apartments

(c) Failed Column

Fig. 4.3 Examples of *Vide Sanitaire* Collapse

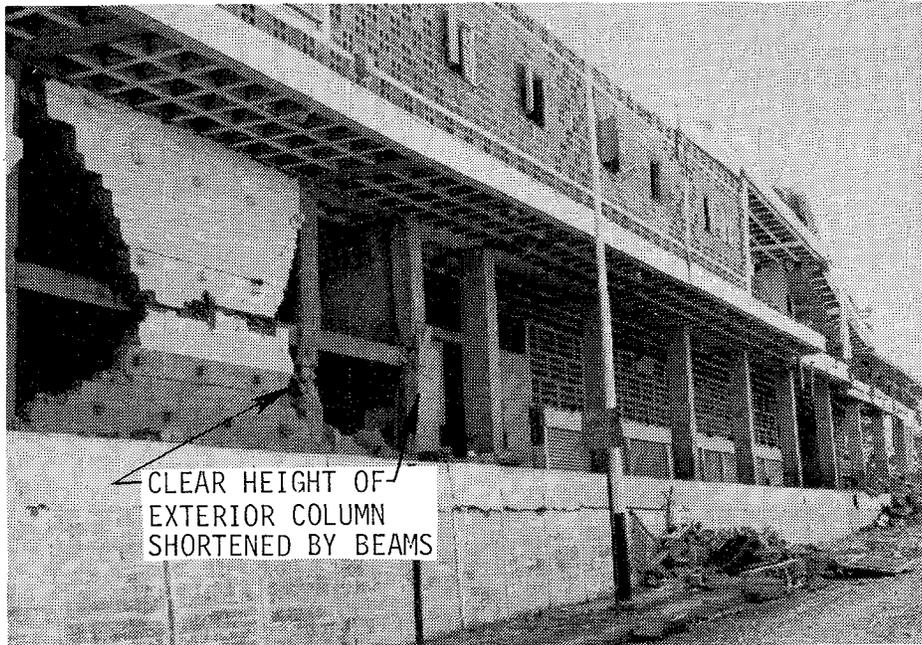
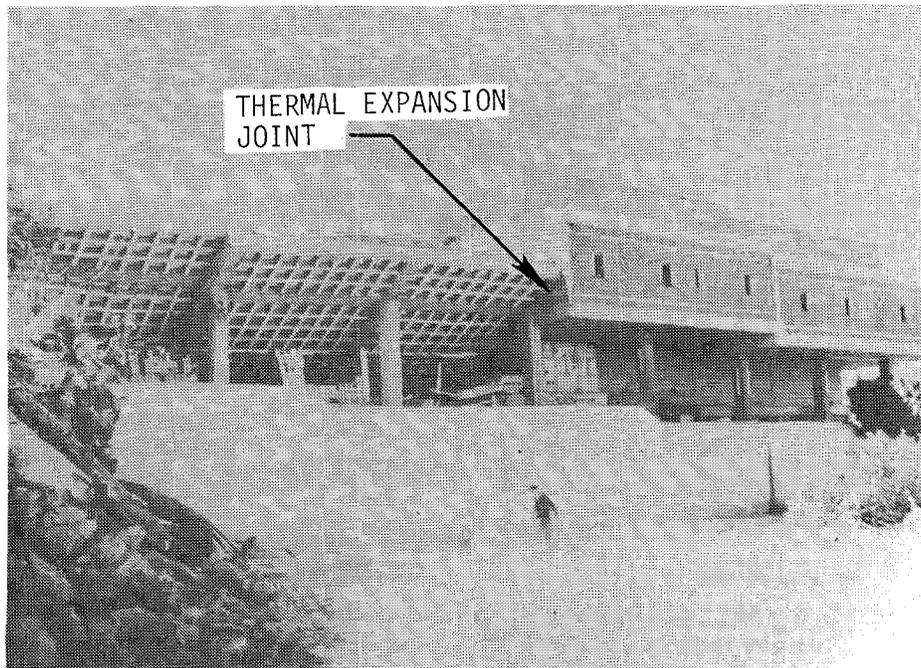
2. Use of irregular building configurations with severe discontinuities in mass, stiffness, strength, and ductility. This was the situation at the Cite An Nasr market where, as will be discussed later, in the first story there were exterior columns with a clear height of nearly 4.7 meters (15.4 ft), while the height of the interior columns was 2.3 meters (7.5 ft) or less (Fig. 4.4). Heavy stiff walls were used in the second story where the columns were 3 meters (10 ft) high. Other typical examples were observed in some of the buildings of a new medical clinic, almost completed but not yet occupied (Fig. 4.5). These buildings exemplified modern buildings with Algerian ornamentation, which added significant mass but no extra seismic resistance. The building shown in Fig. 4.5 exhibited severe stiffness and strength discontinuities at the first story and failed. It was elevated on columns (*pilotis*), more for the functional purpose of accommodating a restaurant and garage on the ground story than as a conscious carryover from the modern practice of lifting the building off the ground for visual reasons. Consequently, the building behaved as a soft first-story system with columns not designed to resist seismic loads. Corner location of a stiff stairway and an RC shear wall contributed to the collapse of one of these buildings. However, an adjacent, almost identical twin building (Fig. 4.6), differed only in the omission of free-standing ground story columns and remained standing after the earthquake. The situation is almost laboratory-like in providing a comparison in behavior of two nearly identical buildings in an earthquake, with the sole difference being ground story stiffness. The building with the soft story collapsed; while its twin, without a soft story, not only did not collapse but suffered very little damage.

(a) Exterior Columns with Clear Height of 4.7 Meters. Some of this height was shortened to less than 2.3 meters by beams.

(b) Heavy Stiff Walls at Tip of Long Cantilevers, and Thermal Expansion Joints in Second Story

Fig. 4.4 Cité An Nasr

6. **Use of thermal expansion construction joints** about each 20 meters (66 ft) or at the most 30 meters (98 ft), **without proper separation between adjacent parts of the building**, which allowed battering between buildings (Figs. 4.4 and 4.5).

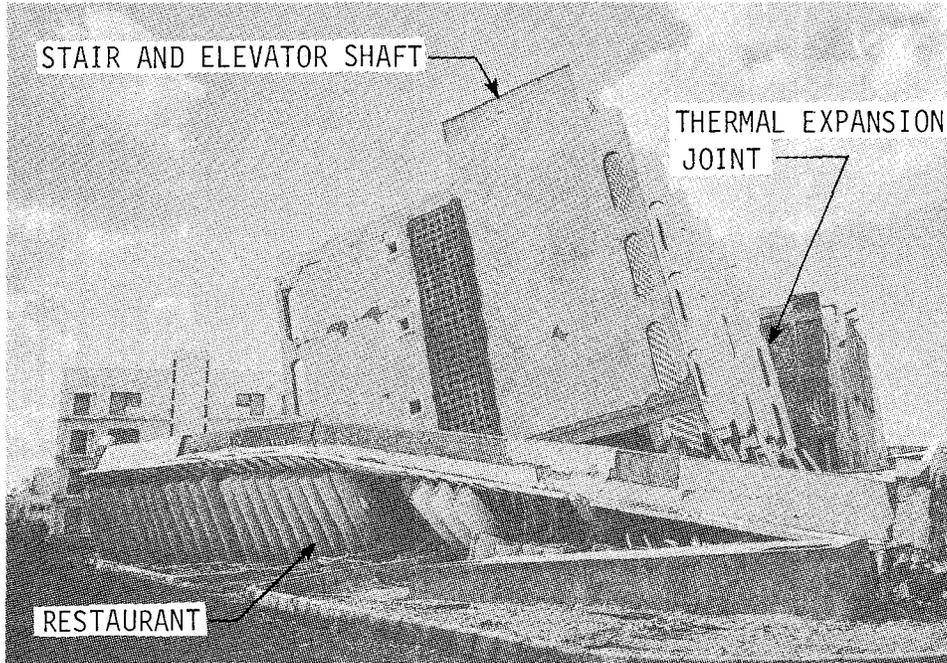
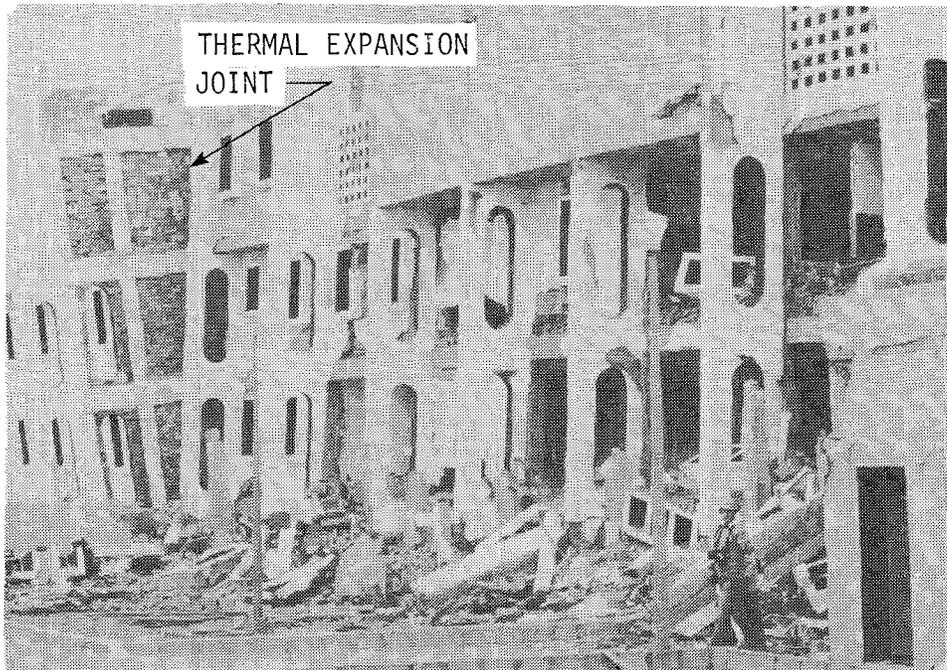
(a) Collapsed First-Story Restaurant

(b) Collapsed First-Story Garage

Fig. 4.5 New Medical Clinic, El-Asnam

7. **Use of strong girder/weak column, moment-resisting frame structural systems** (Figs. 4.7 and 4.11). Few buildings had RC shear walls. In some new apartment buildings shear walls were used, but most were built in one direction only. Shear walls were also used to construct elevator shafts in multistory buildings. Unfortunately, in some cases, these RC wall shafts were not symmetrically situated structurally and, therefore, induced large torsional moments, as in one of the three blocks of the new medical clinic (Figs. 4.5 and 4.12).

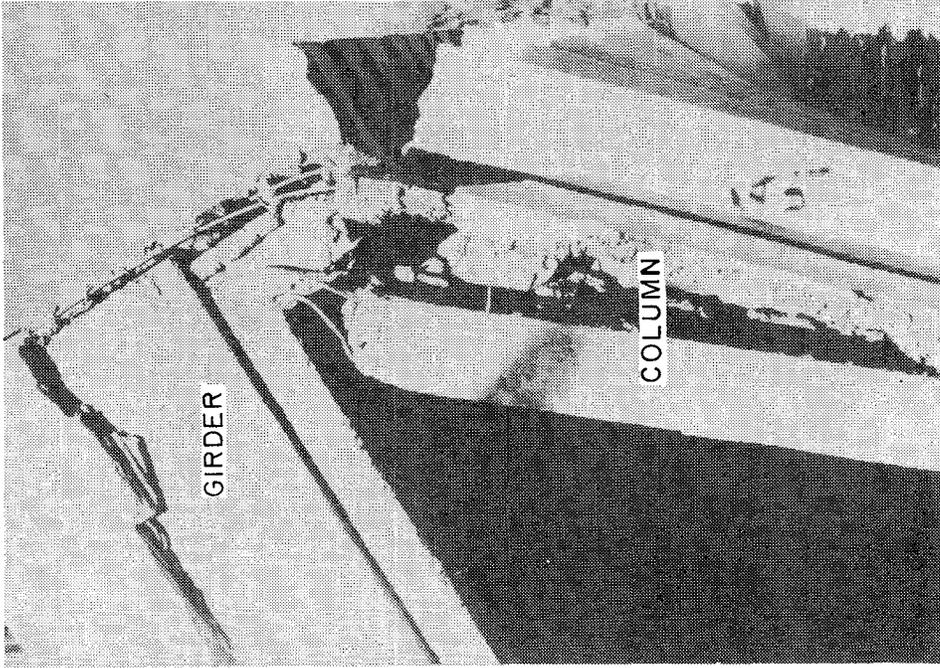
3. Use of very heavy roofs. As discussed in section 1.6, most apartment, office, and commercial buildings had a heavy, one-way slab-on-joist roof system with hollow concrete blocks filling the space between the joists (Fig. 1.16). Above the roof slab there was usually a layer of 5 to 15 cm (2-6 in.) thick of thermal insulation material, covered by a waterproofing membrane, and then the roof finishing. The joists were supported on very stiff, heavy girders supported on relatively weak columns (Fig. 4.7).

Fig. 4.7 Very Stiff and Heavy Girder Supported on Relatively Weak Columns

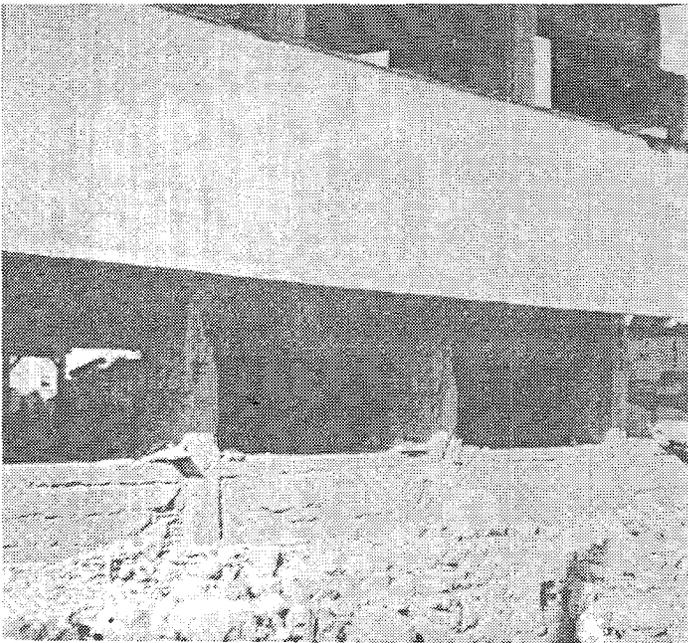
(b) First-Story Short Column Failure

(c) Closeup of Short Column Failure

Fig. 4.8 Damaged Cultural Center Building

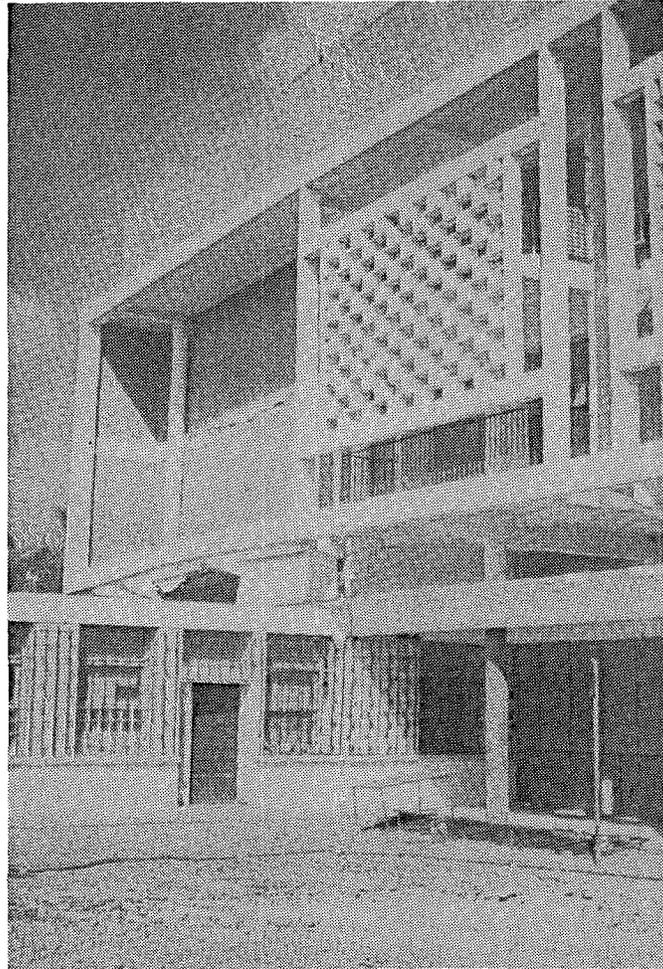
4. Use of too many heavy ornamental elements at building facades (Figs. 4.5, 4.6, 4.8, and 4.9), as well as unnecessary parapets on the roofs (Fig. 4.10). One building under construction which partially collapsed was the new cultural center (Maison de La Culture), constructed of concrete frame and masonry infill. In Fig. 4.8a two of the main buildings of this center are pictured — one collapsed completely, the other remained standing. These two buildings appear to have been identical; therefore, the reasons one collapsed and the other did not were a puzzle. The standing structure, however, provided some clues as to the contributing factors for its twin's failure. The cultural center buildings are of the more ornamental and heavy style of architecture, superimposed upon a regular modern concrete frame. The use of stiff spandrel masonry walls (*parapets*) resulted in short captive columns that increased the shear demands beyond the shear capacity supplied. The lack of good transverse reinforcement led to total failure of these columns in the case of one building and to a state close to collapse in the standing building (state of the columns is illustrated in Figs. 4.8b and c). Because of the brittle nature of the shear failure in these inadequately reinforced columns, it appears that the building that remained standing was on the borderline of collapse. The long and heavy cantilevered portion of facade (Fig. 4.8d), that seems to be more of a stylistic expression than a functional requirement except for sun shading, also contributed to the damage observed in these structures.

Fig. 4.9 Heavy Ornaments on Facade of Hall of Justice

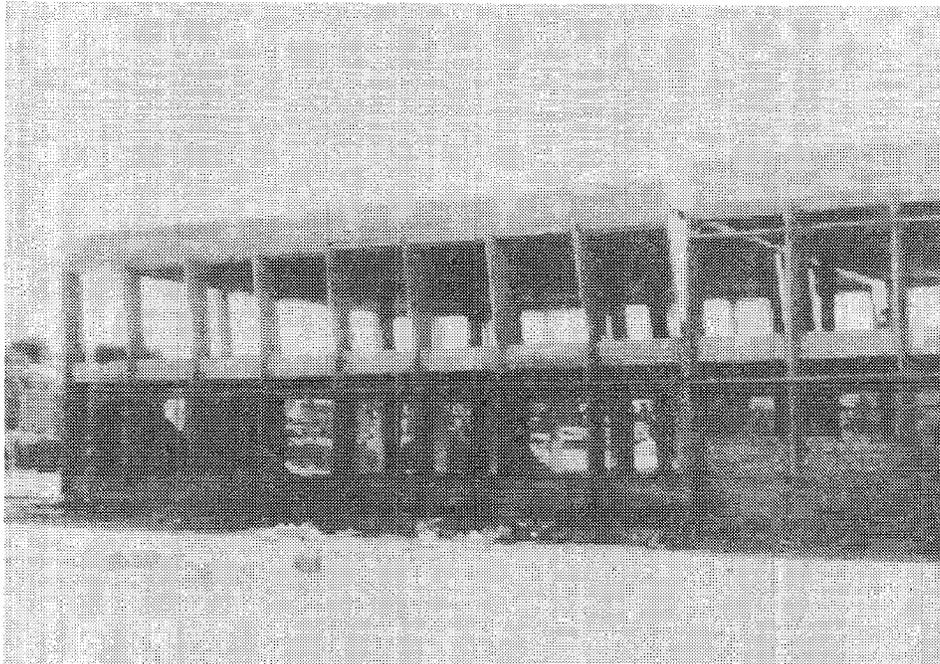
(b) Apartment House Under Construction. Note hinging of second-story weak columns.

Fig. 4.11 Strong Girder/Weak Column Construction

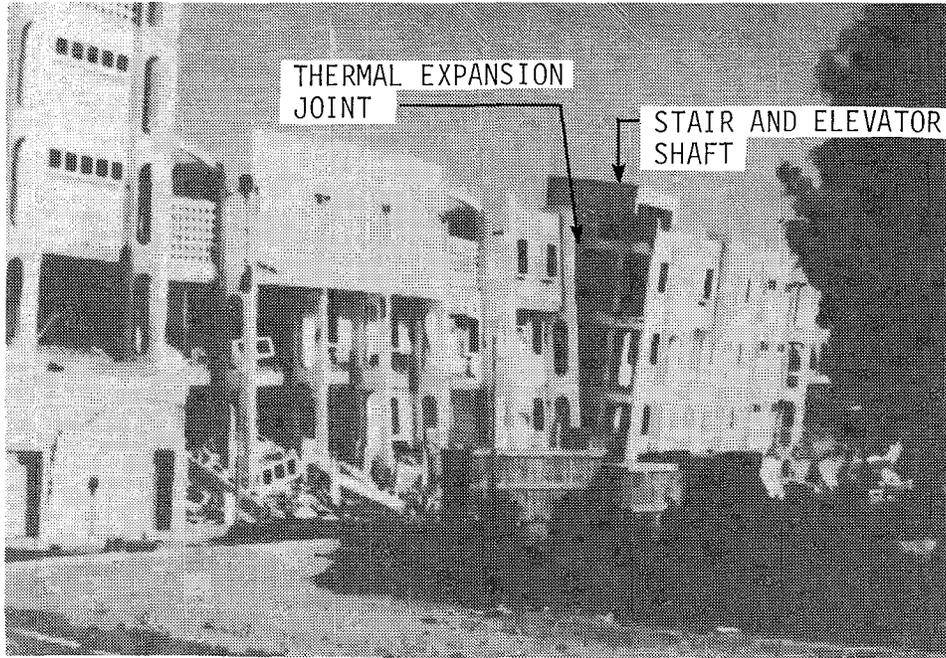
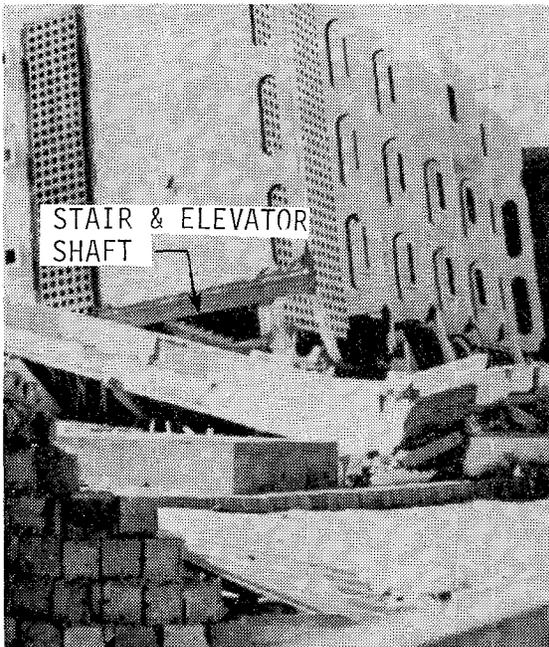
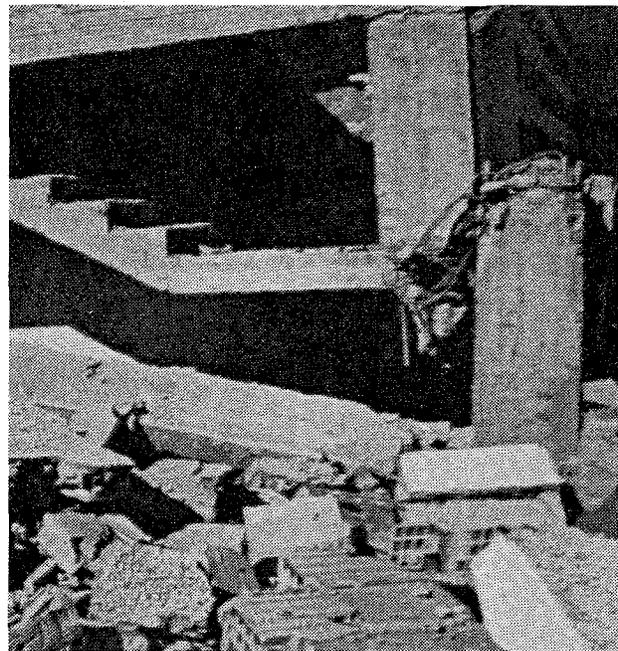
(a) Overall View of Three Blocks of Clinic

(b) Corner Where Shaft Is Located

(c) Closeup of Column Failure Due to Stairways

Fig. 4.12 New Medical Clinic. Note stair and elevator shaft at corner of building.

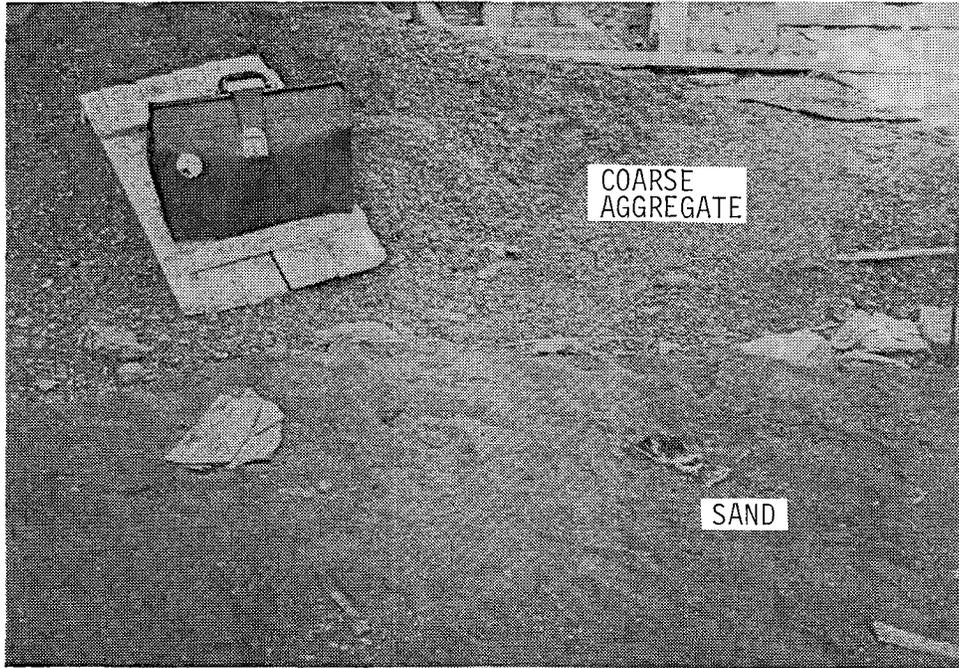
Fig. 4.16 Contaminated Aggregate Used in RC Construction

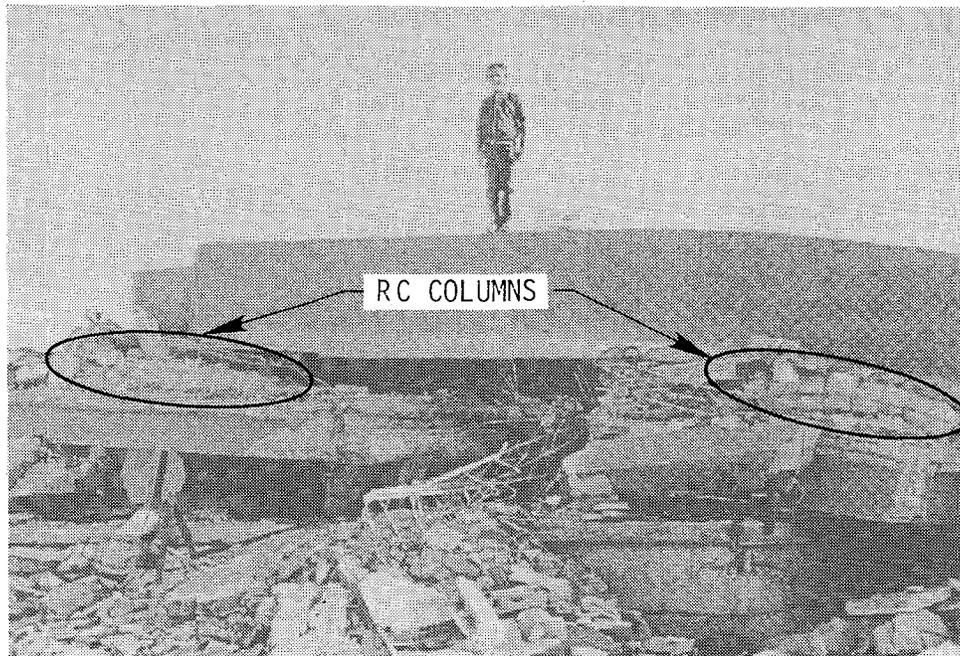
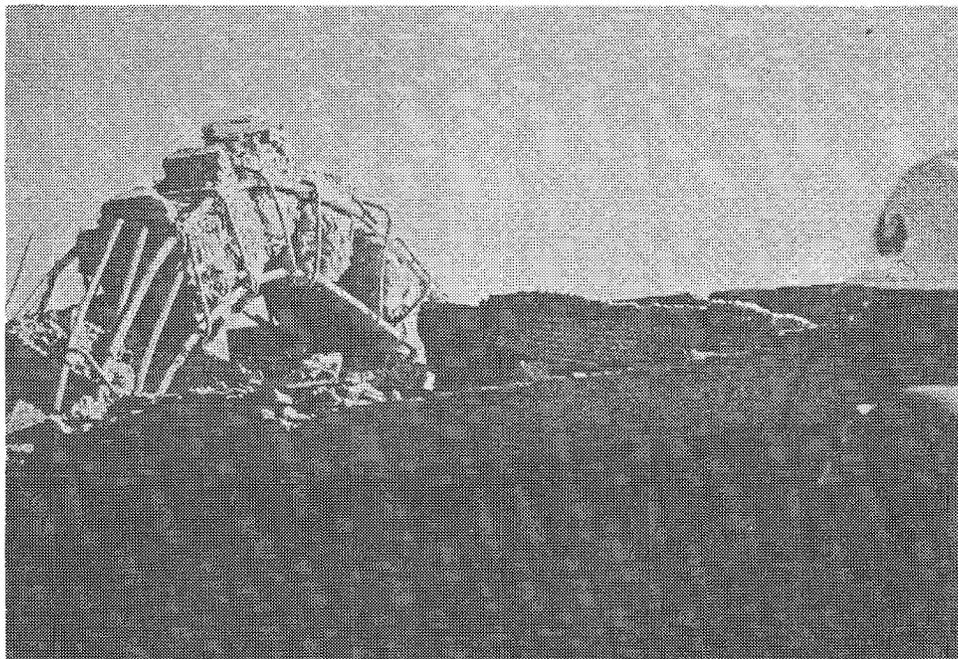
4.1.2 Poor Structural Material. As already indicated, the most prevalent structural material used was reinforced concrete, which generally was unconfined. It is well known that ductility of such a material, unless well detailed, is limited. In most cases, quality and placement of concrete were poor. It was sometimes evident that adequate amounts of cement were lacking, or there was a poor gradation of aggregate with complete lack of fine aggregate, and in some cases, the use of too coarse aggregate. In some buildings under construction, it was observed that the aggregate, particularly the sand, was of poor quality and badly contaminated with dirt (Fig. 4.16). Combinations of these factors were observed in the two-story houses under construction in Boucaa Sahnoun, a district of El-Asnam (Figs. 4.13 and 4.17).

(a) Disintegrated Concrete in Columns

(b) Lack of Confinement and Poor Quality Concrete

Fig. 4.17 Collapsed Two-Story Houses Under Construction,
Boucaa Sahnoun

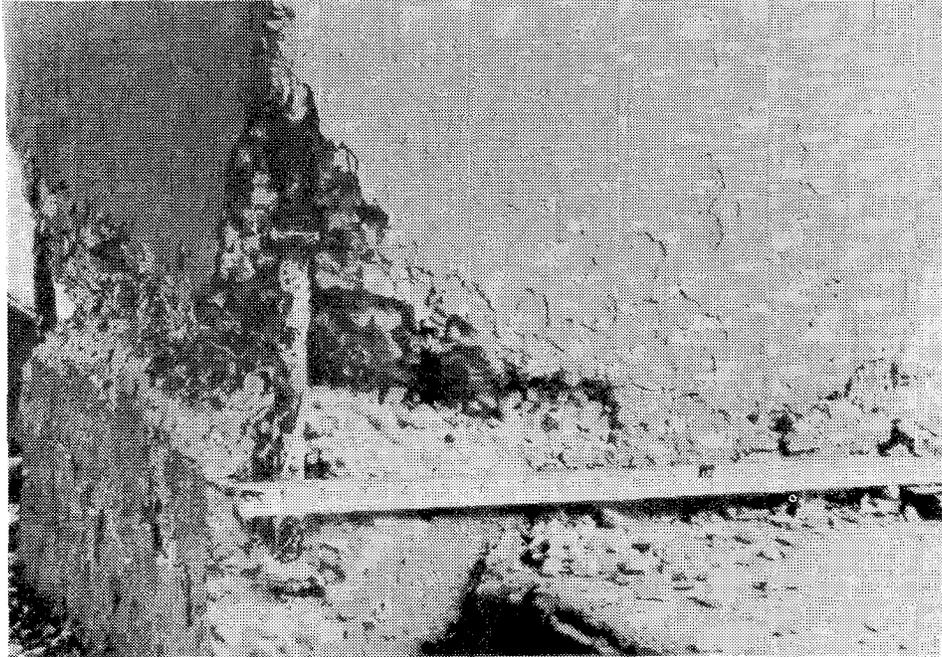
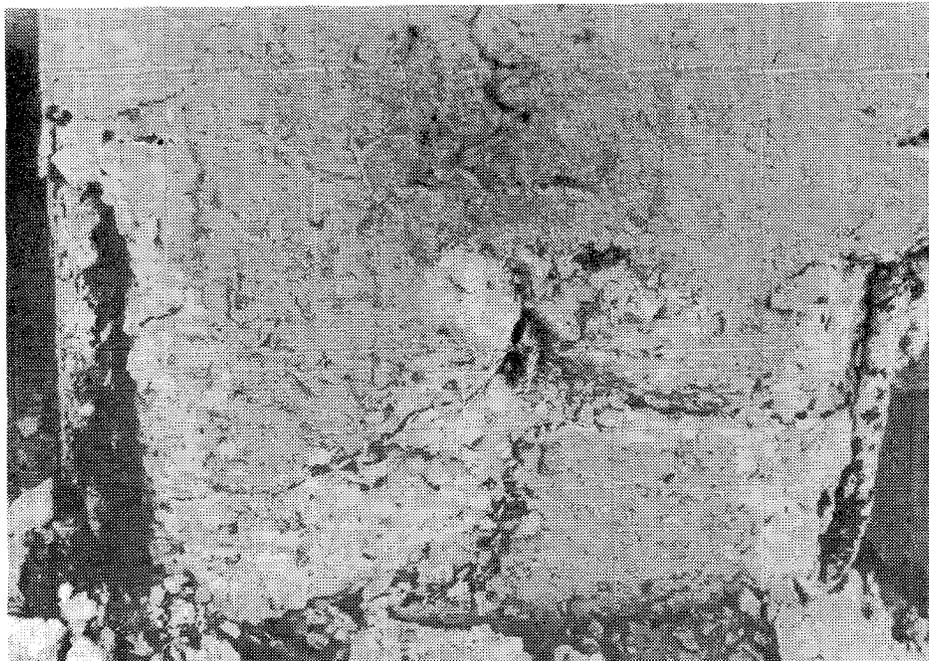
In several instances considerable honeycomb was observed with complete lack of mortar; it was possible to break away large parts of concrete with just a screwdriver or the kick of a boot (Fig. 4.18). Proper attention was not given to concrete mixing, placement, consolidation, or curing. The poor quality of the unconfined concrete was demonstrated by its disintegration in the regions of the members that were overstressed (Fig. 4.19). It was stated that the concrete compression strength in El-Asnam frequently falls below 120 kg/cm^2 (1740 psi) or less than 45 percent of minimum required design strength, which is generally 270 kg/cm^2 (3915 psi). The quantity of

(a) Concrete Removed by Kick of a Boot

(b) Honeycomb in Concrete and Placement of Reinforcement with Practically No Cover

Fig. 4.18 Examples of Poor Quality of Concrete in Columns of Cité An Nasr Building
