EL-ASNAM, ALGERIA EARTHQUAKE OF OCTOBER 10, 1980

A Reconnaissance and Engineering Report

**National Research Council
Committee on Natural Disasters**

Earthquake Engineering Research Institute

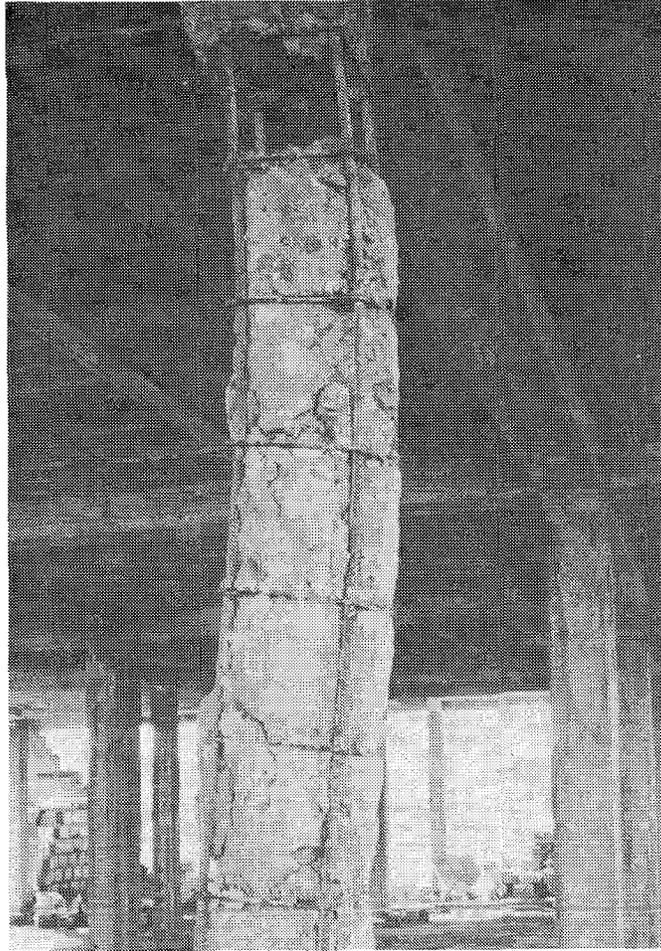
Fig. 4.19 Concrete Column That Disintegrated When Subjected to Overstress

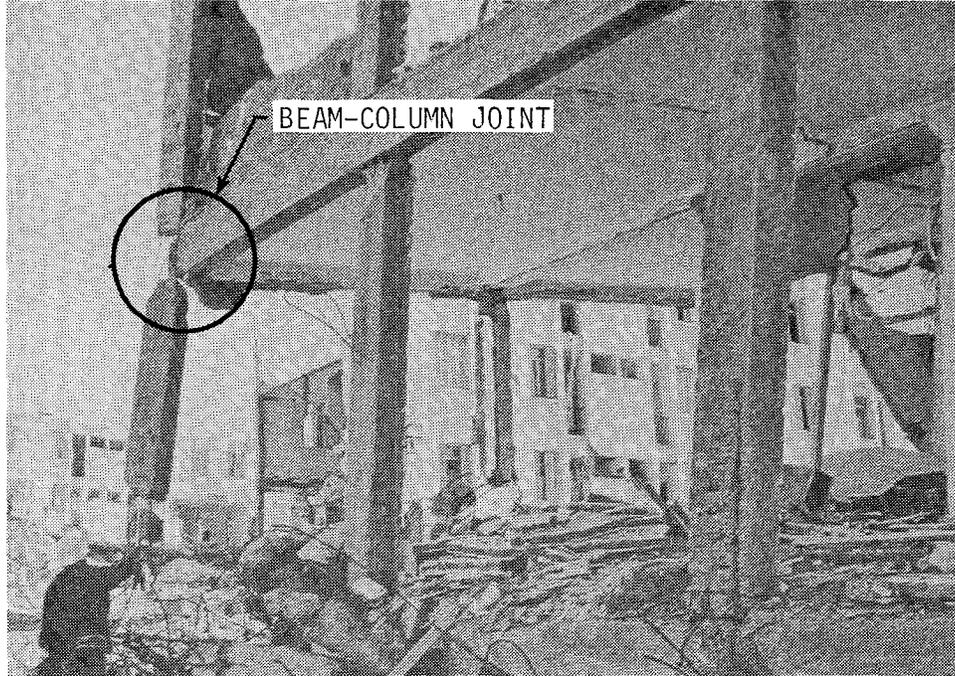
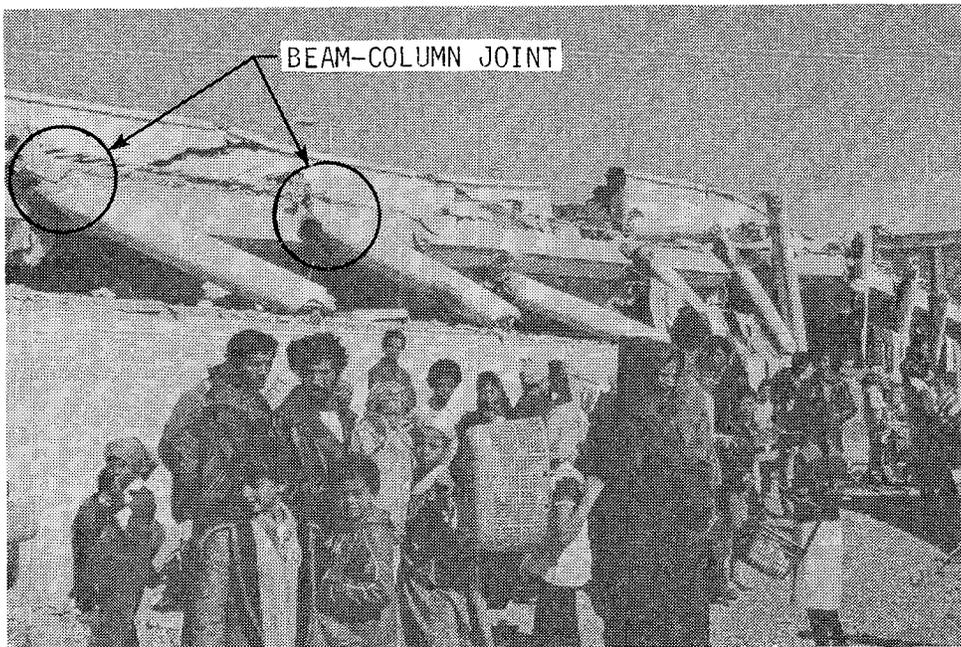
(a) Apartment Building

(b) School (see Fig. 3.27)

Fig. 4.21 Examples of Poor Beam-Column Joints

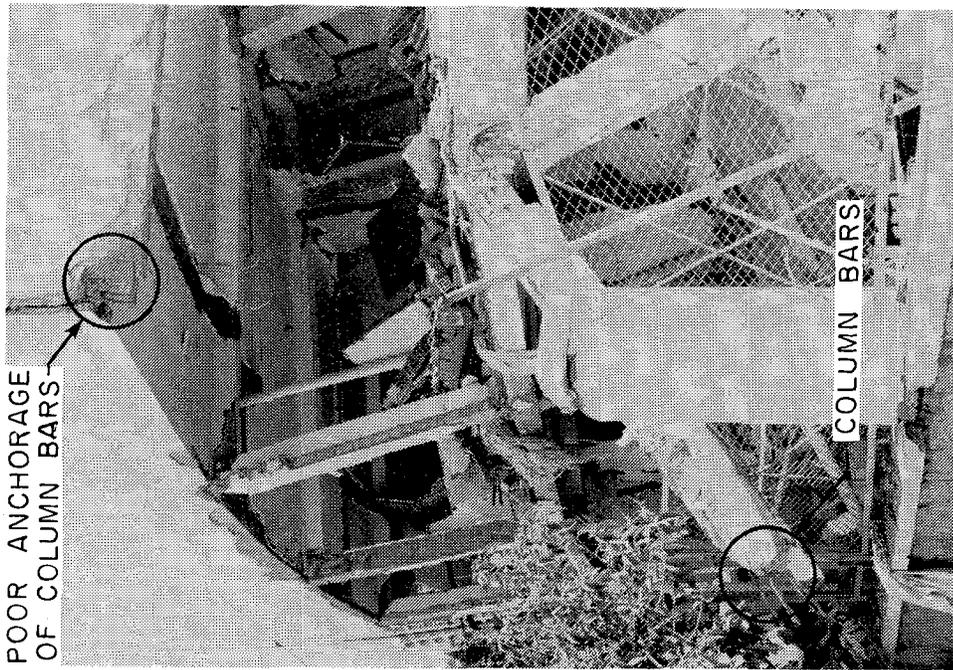
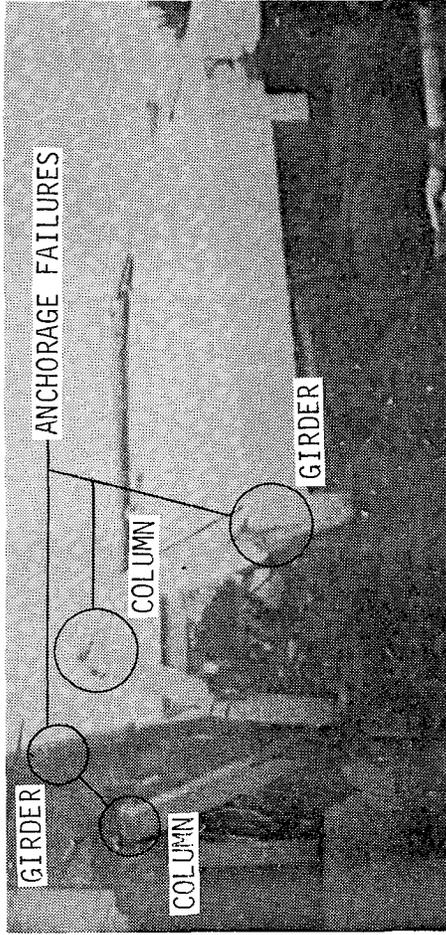
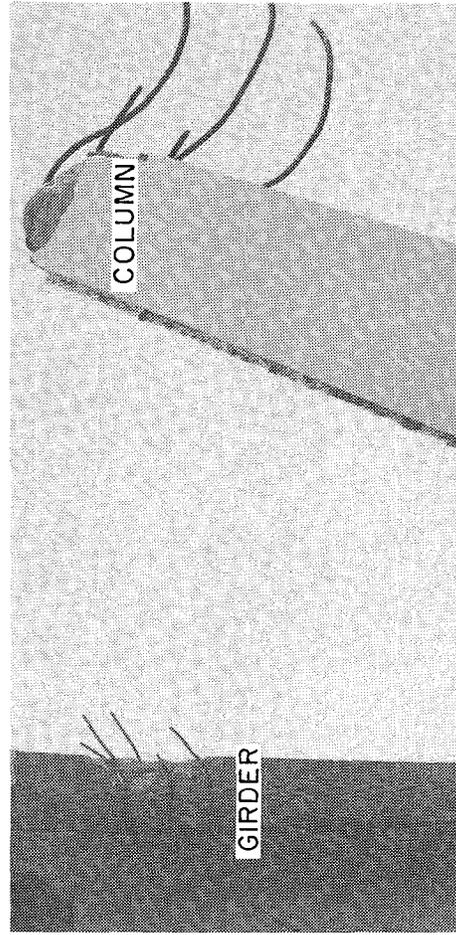
(a) Collapsed Two-Story House

(b) Collapsed Industrial Plant Office Building
(see Fig. 3.39)

(c) Closeup of Anchorage Failure

Fig. 4.22 Inadequate Anchorage of Column Reinforcement in Roof Girders

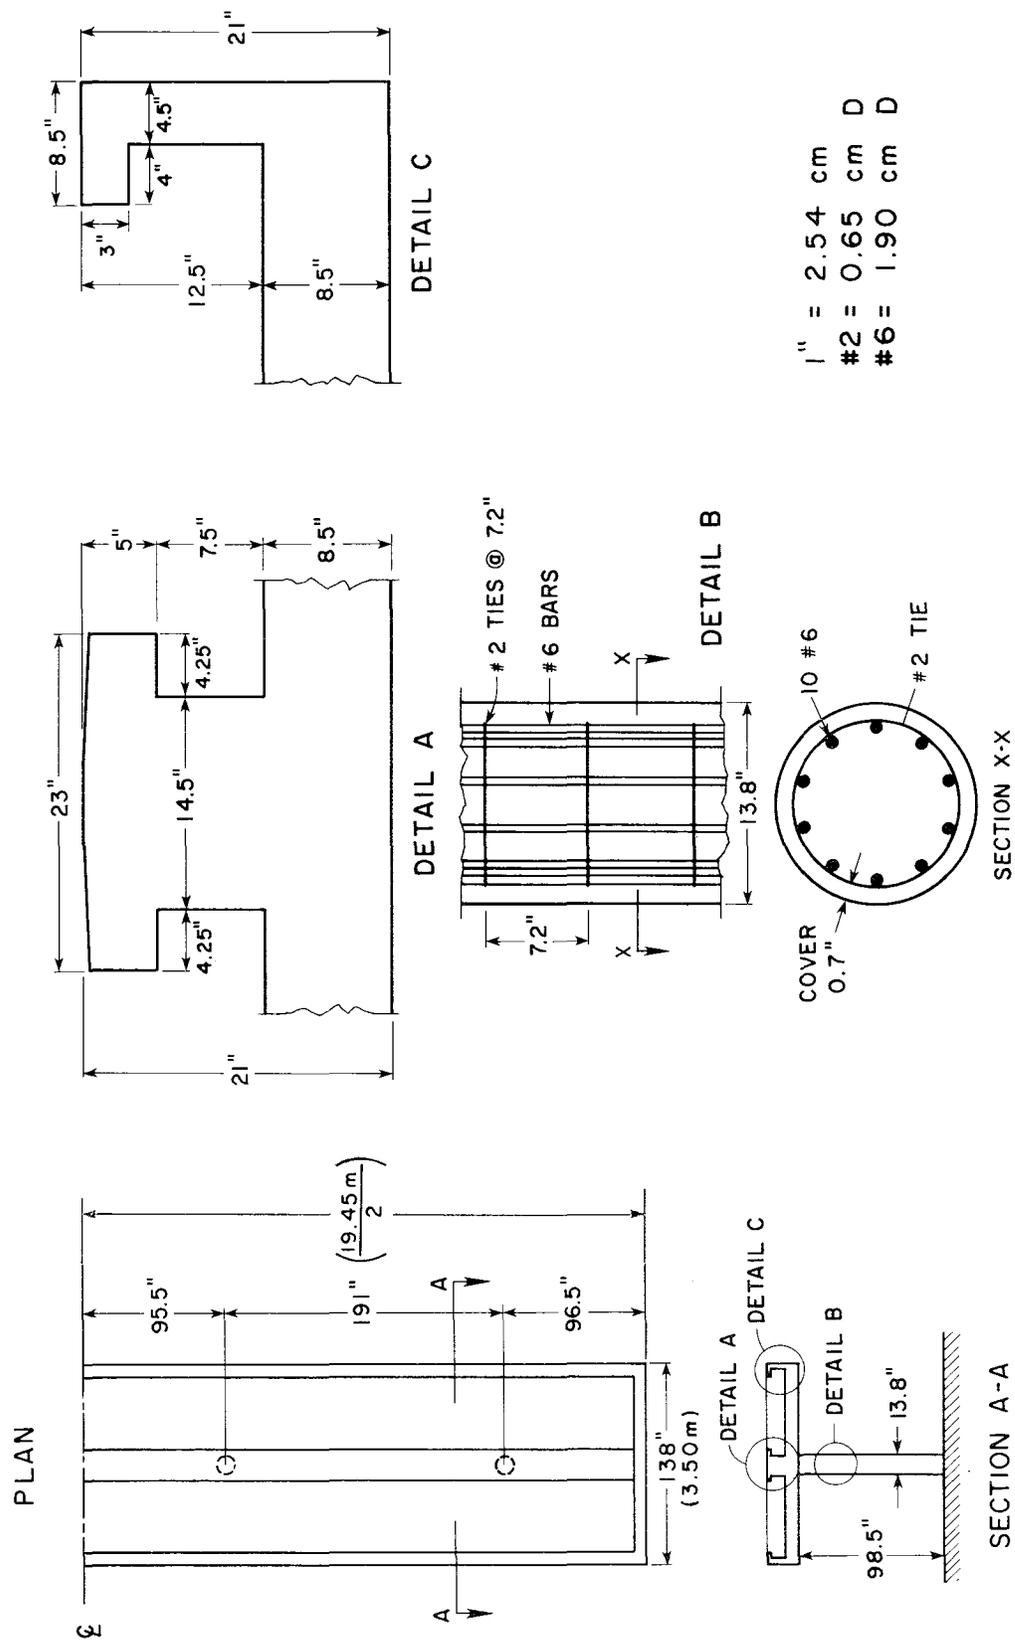
(a) Structural Drawings

The other important structural damage occurred in canopies over corridors along and between classrooms. These canopies were supported by one row of cylindrical columns 35 cm (13.8 in.) in diameter and having a clear height of 2.5 meters (99 in.) (see Fig. 4.27). While some of these canopies collapsed, as illustrated in Fig. 4.28, others located between two adjacent classroom buildings remained standing but were thrown out-of-plumb, with some significant permanent lateral deformation (Fig. 4.29). The questions are: Why did some canopies collapse while others did not? What force (or ground acceleration) could produce such collapse? Or, even more difficult to answer, what ground motion intensity would produce this type of behavior?

Fig. 4.27 Primary School Canopies

The intensity of shaking was great, effective peak acceleration of 0.35 g or more horizontally, with a vertical acceleration component that could have been of the same intensity or even higher; nevertheless, it is believed that damage of these canopies could have been avoided by proper design and construction. Both the shape selected (inverted pendulum) and the use of unnecessarily heavy mass at the top were unwise decisions. These design flaws were aggravated by the lack of good confinement of the concrete [circular ties of D6 mm (#2) at 180 mm (7 in.) spacing], as can be seen in Figs. 4.27 and 4.29a.

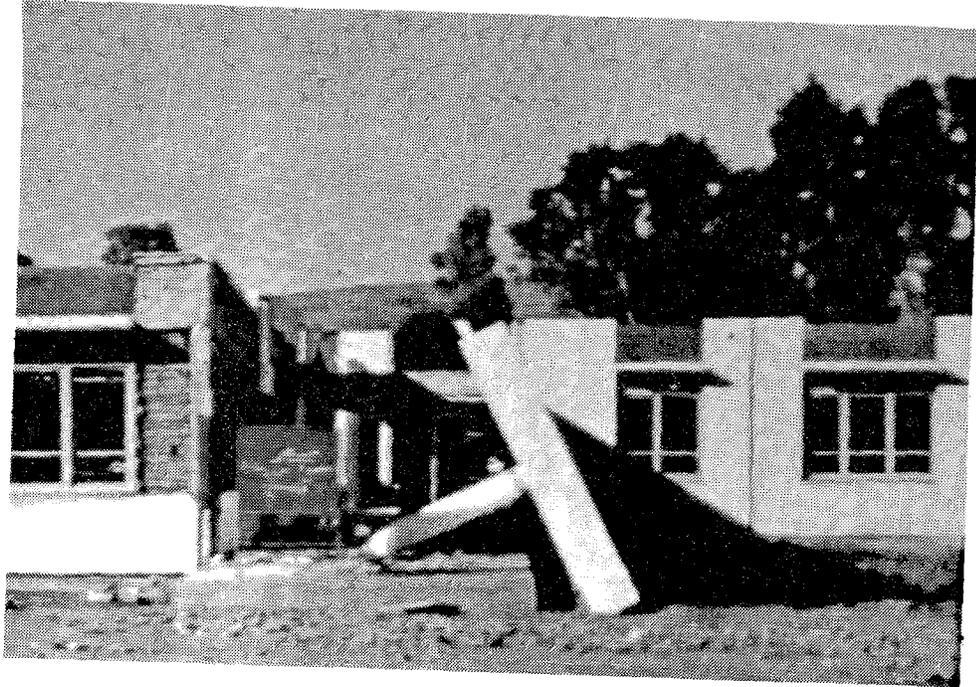
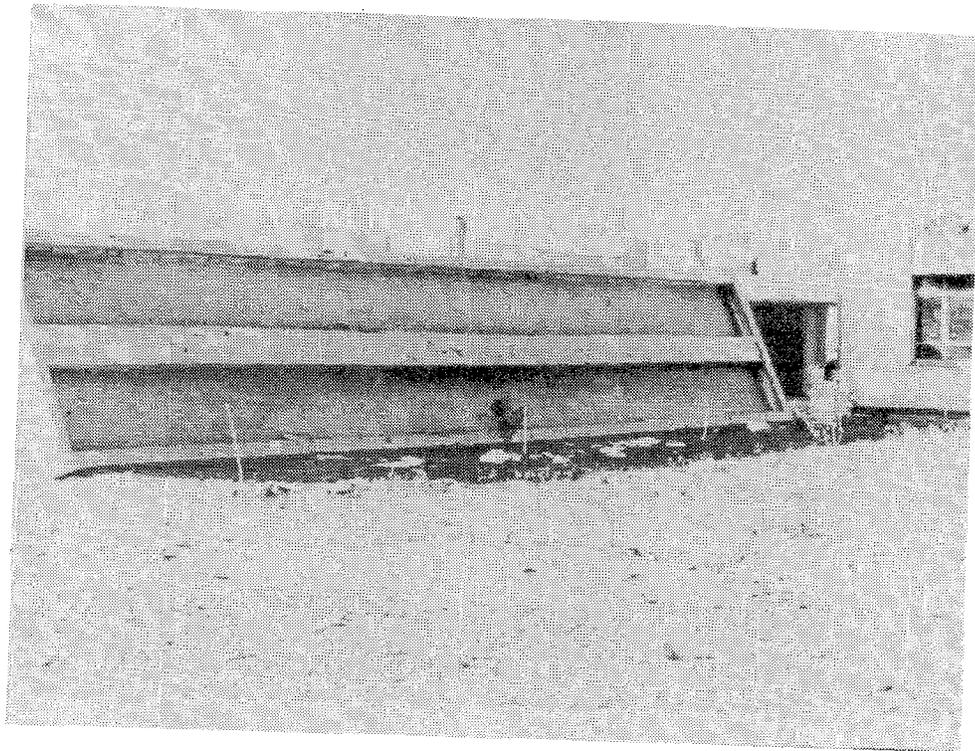
(a) Front View

(b) Side View

Fig. 4.28 Primary School Collapsed Canopy

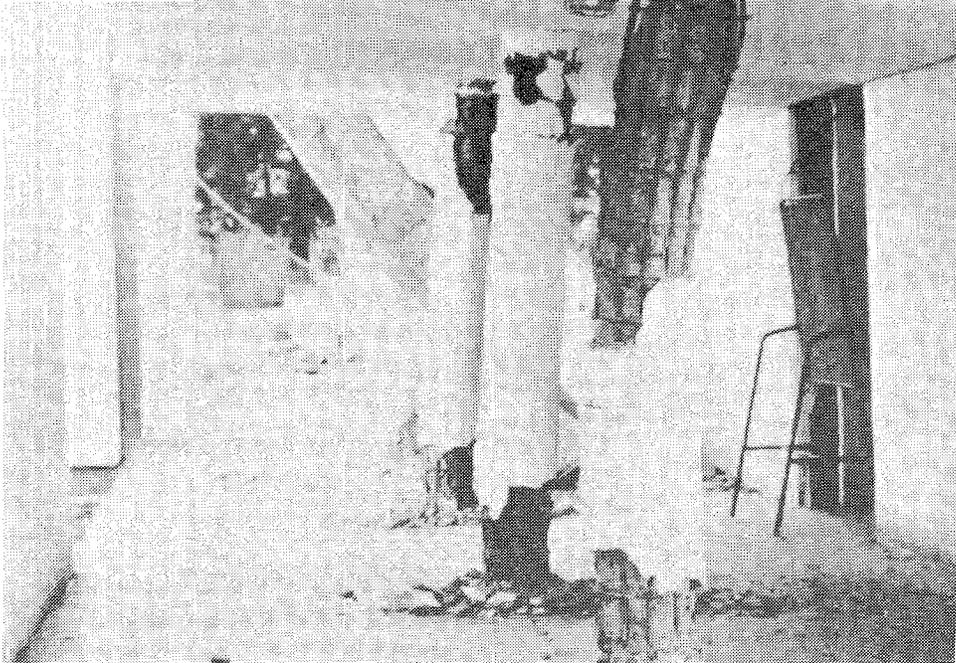
(a) Overstressed Columns with Significant Permanent Deformation

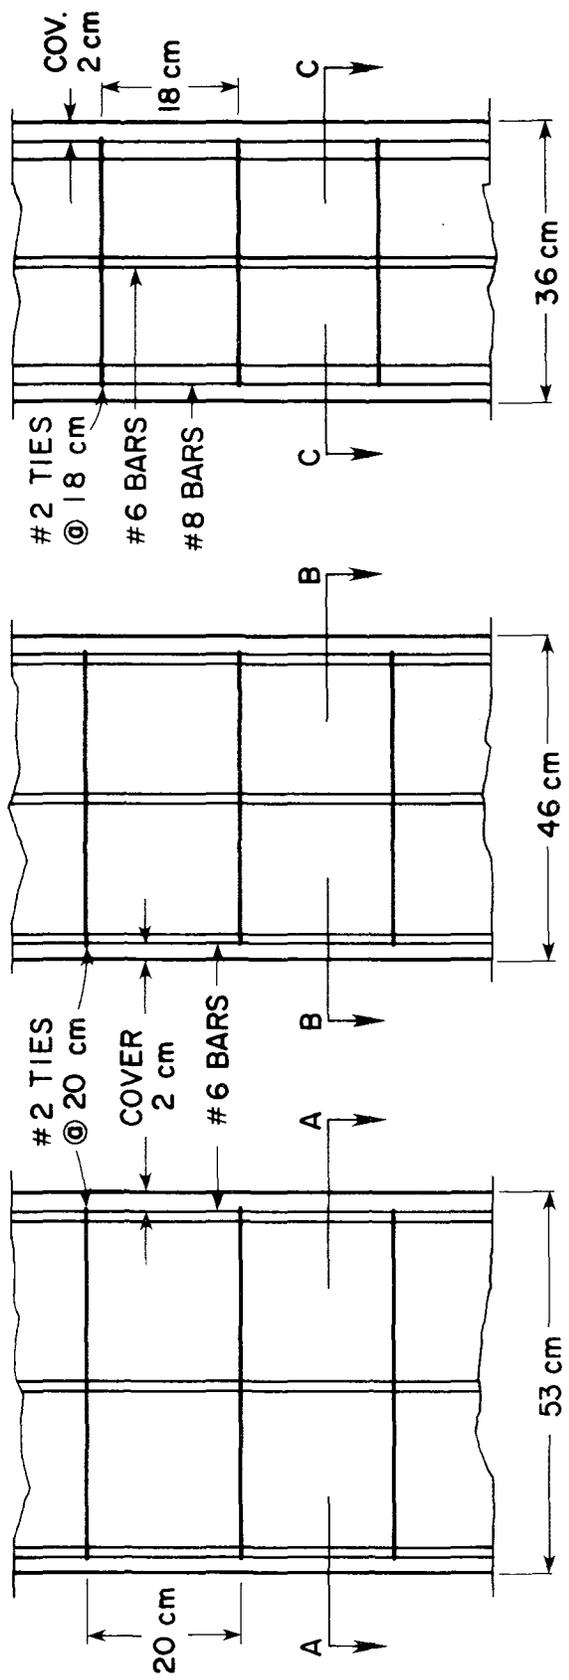
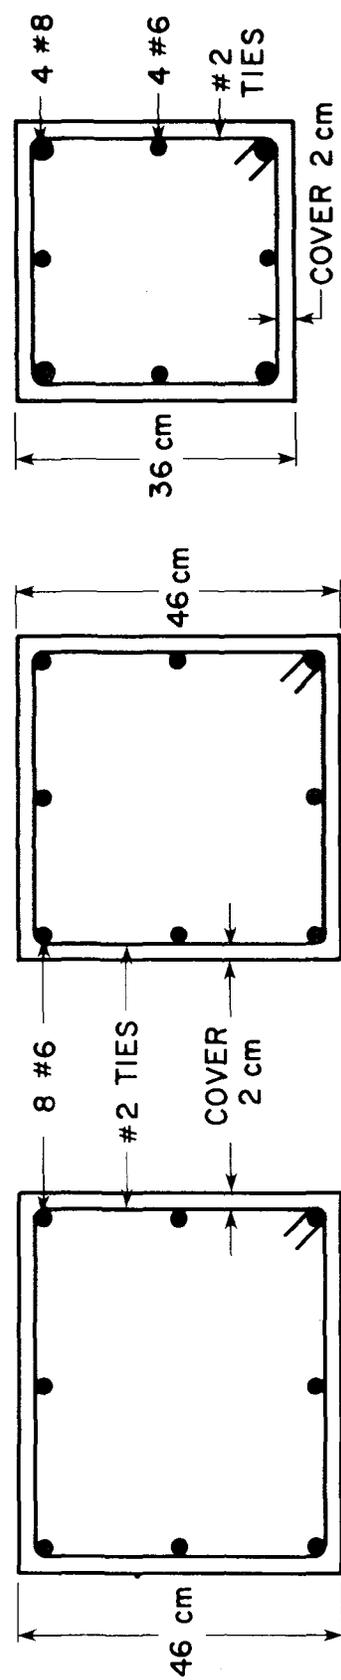
Fig. 4.30 (cont.)

(e) Column Details

in the sketches of Fig. 4.30e, reinforcement of the exterior columns consisted of eight D19 mm (#6) bars, giving a steel content below 1 percent for the largest columns. The transverse reinforcement consisted of ties of D6 mm (#2) plain bars spaced at 20 cm (8 in.).

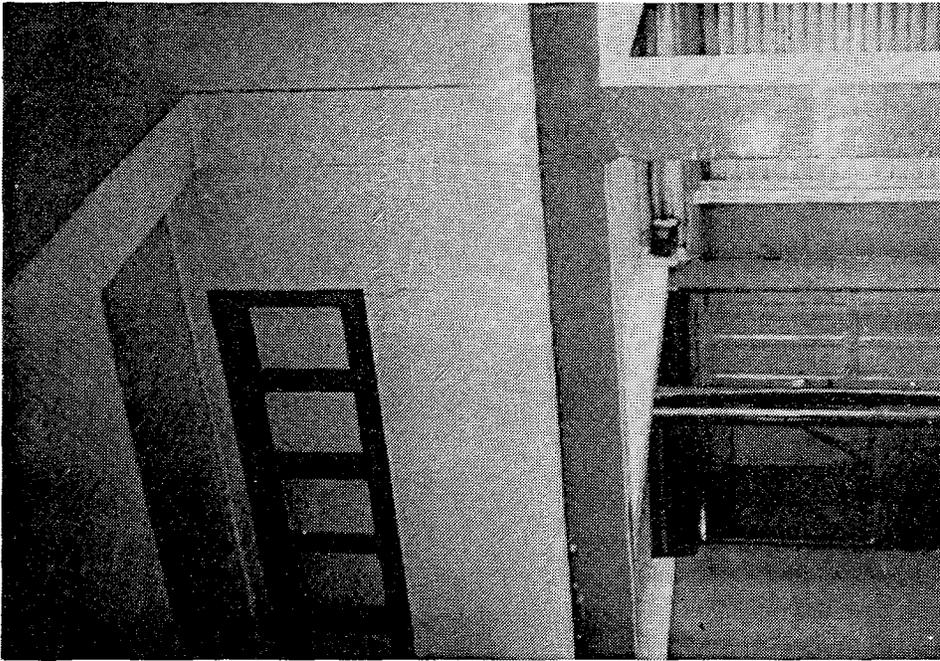
(a) Mezzanine

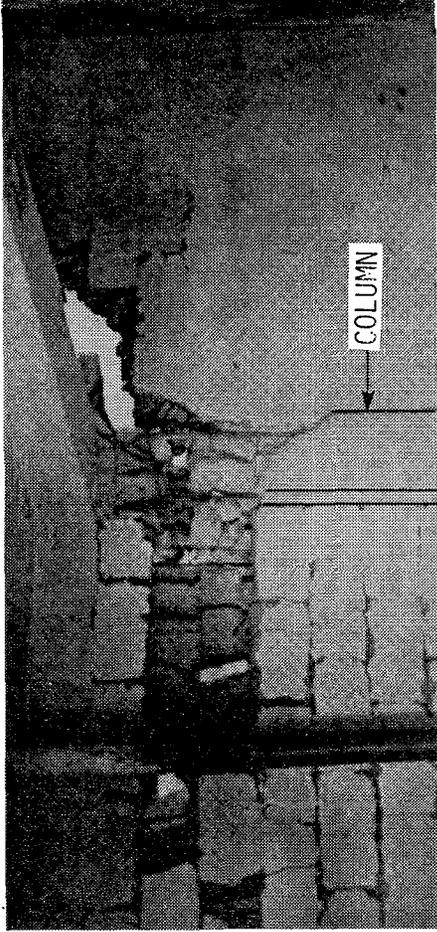
Collapse of the second story led to collapse of the first story, which should have started with the failure of the interior columns (36 x 36 cm or 14 x 14 in.). These columns, because they were captive by the infilled partitions and because of the presence of beams supporting the mezzanine, had to resist the major part of the lateral shear at the first story. Because of inadequate transverse reinforcement as well as poor concrete, these short columns could not resist such shear and failed. Fig. 4.32b demonstrates this failure. The first-story interior column failure led to cave-in of the floor (waffle slab) and failure of the external columns. Commencement of failure of the exterior columns after failure of the interior columns (and cave-in of the waffle slab) is illustrated in Figs. 3.34, 4.4b, and 4.32c.

(b) Shearing of First-Story Short Interior Column. Note lack of adequate transverse reinforcement.

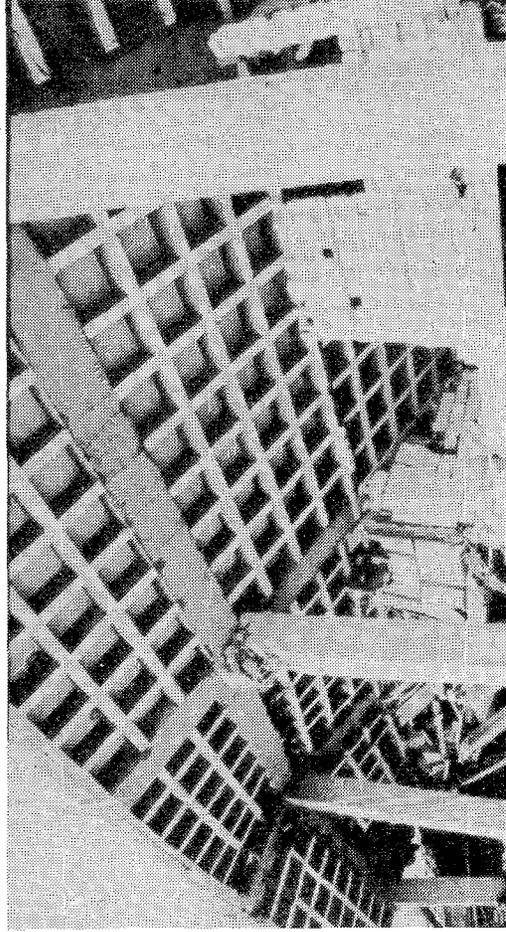
(c) Failure of First-Story Columns, Leading to Cave-in of Second-Floor Waffle Slab

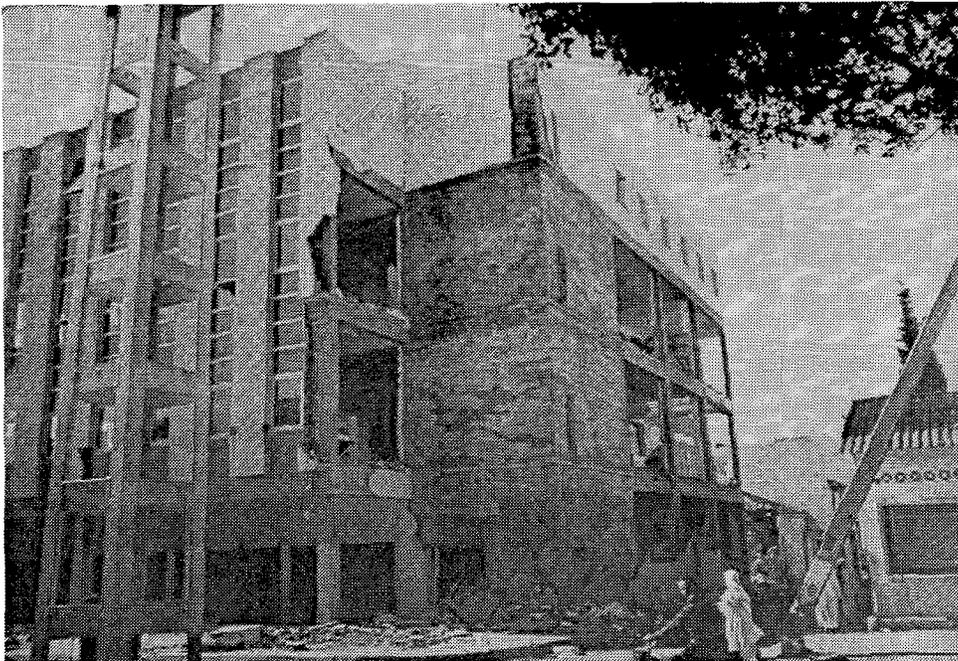
The interior bays of the frames were infilled with panels of hollow brick masonry. These panels, which were neither reinforced nor anchored to the frame, had excessive dimensions: 5.2 meters (17.1 ft) long by 4.4 meters (14.4 ft) high. It should be noted that AS 55 recommends that the masonry panels be framed (confined) by RC horizontal and vertical elements at a distance not exceeding 5 meters (16.4 ft). Today it is recognized that these panels are too large and it is preferable not to exceed 3 meters (9.8 ft). Some of these panels exploded in the earthquake, as shown in Fig. 4.35.

Fig. 4.35 Galerie Algérienne Unit That Remained Standing

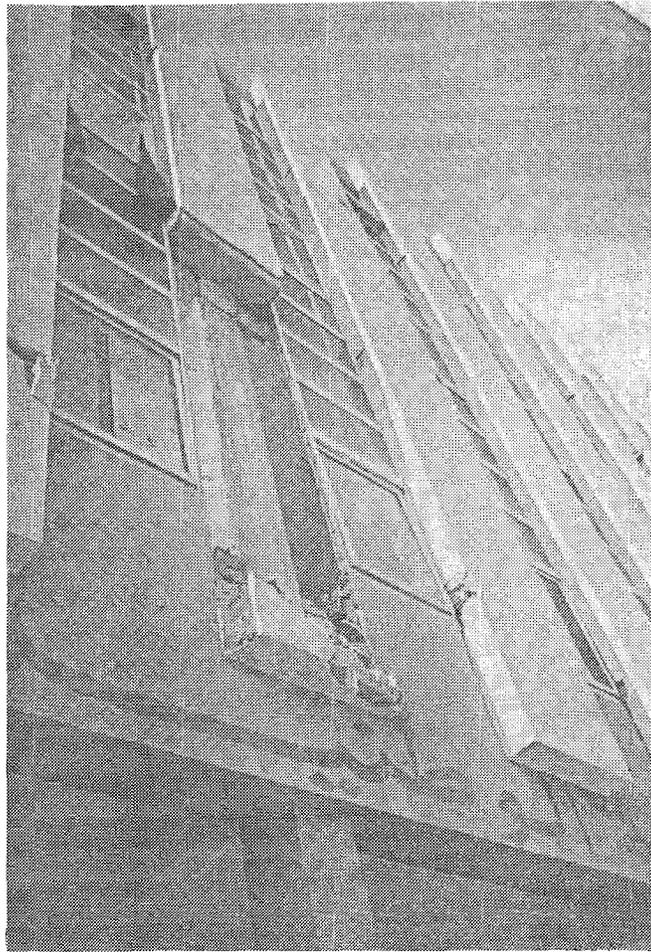
In one of the external sides of the building heavy masonry ornamental elements protruded from the facade about 200 mm (8 in.) and about 1.5 meters (5 ft) in width (Fig. 4.36). These protruding elements were supported by short RC brackets at each floor level.

Fig. 4.36 Galerie Algérienne Protruding
Masonry Ornament Supported on RC Brackets

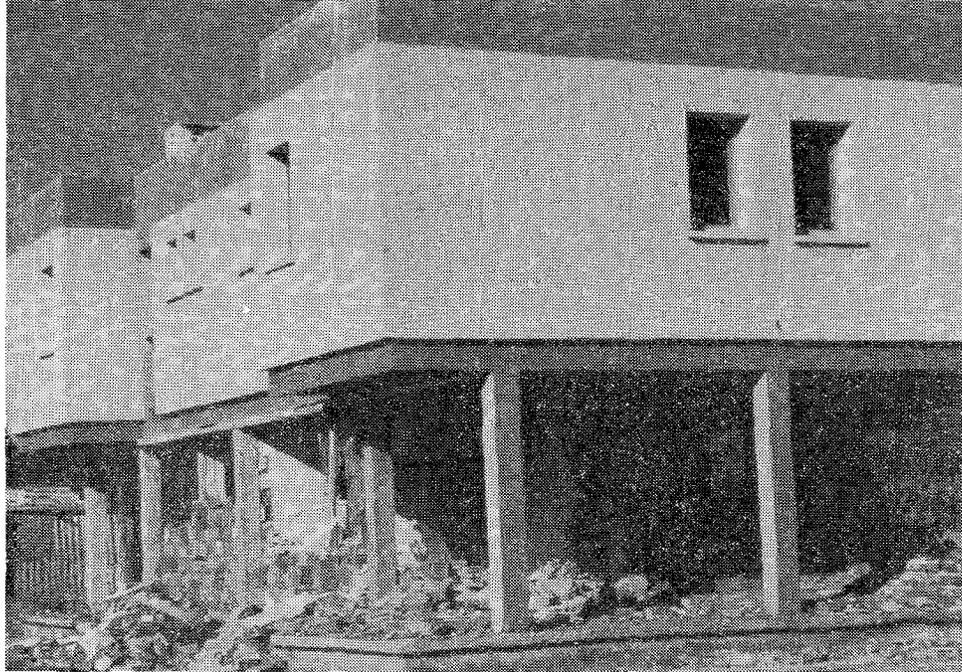
49 Villas CNEP at Boucaa Sahnoun. There were 49 two-story housing units under construction in a district near El-Asnam. These villas had a moment-resisting space frame as a structural system. The floor system consisted of heavy slabs supported on strong beams. The roof was similar to the floor but considerably heavier because of the addition of sand as insulation material. The columns were weak compared to the beams. They had a square section of about 20 x 20 cm (8 x 8 in.). While the first story was completely open, the second story was closed by heavy masonry walls (Figs. 4.13 and 4.38) plus heavy masonry partitions (see Fig. 4.39, which also illustrates the weak columns and strong beams). It is not known whether it was planned to close the first story with walls and partitions or if it had been designed to remain open as an architectural solution for peasant farmer housing (see Fig. 4.15a).

(a) Two-Story Houses: RC Frame with First Story Open and Second Story Infilled with Masonry

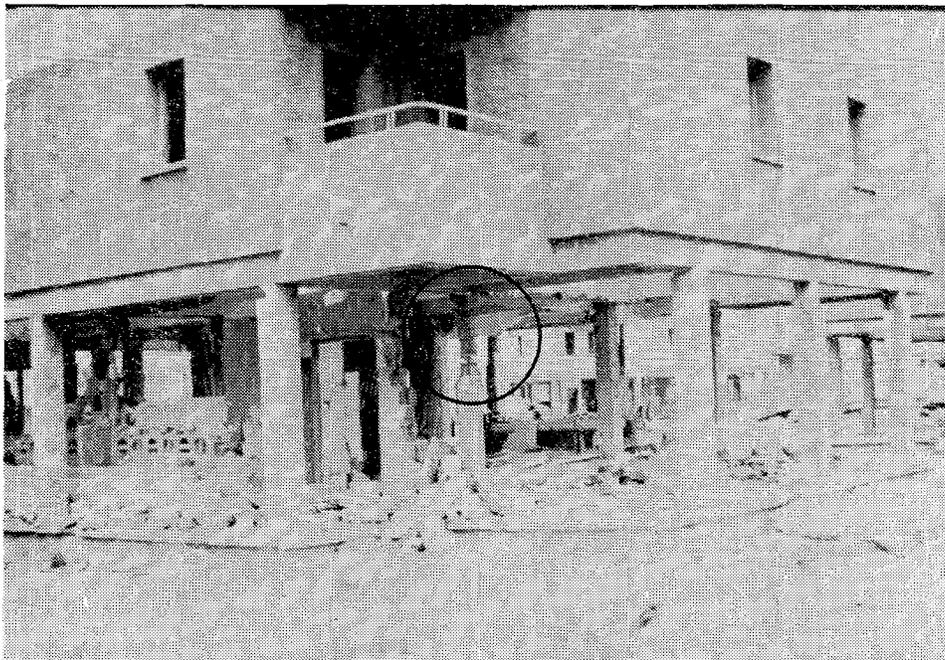
The failure of these units was triggered by hinging of the weak first-story columns and their shearing off, as shown in Fig. 4.13. In some units the effect of the impact when the first story collapsed, in addition to the effect of lateral shear in the second story, produced complete pancaking of this story, as shown in Figs. 4.17a and 4.40. These photographs depict the complete disintegration of the columns. This disintegration was due to poor design and detailing, as well as extremely poor quality concrete. These facts are illustrated by Figs. 4.17, 4.41, and 4.42. In Fig. 4.41 it can be seen that in a 20 x 20 cm (8 x 8 in.) column the spacing of ties was about 15 cm (6 in.) and the concrete had coarse aggregates larger than 7.6 cm (3 in.). Not only was the granulometry very poor, but the aggregates appeared to be dirty and there was evidence of a lack of cement. Fig. 4.42 points out the inadequate detailing of the external beam-column joint.

(b) First Story Weak Columns/Strong Girders: Note column concrete disintegrated.

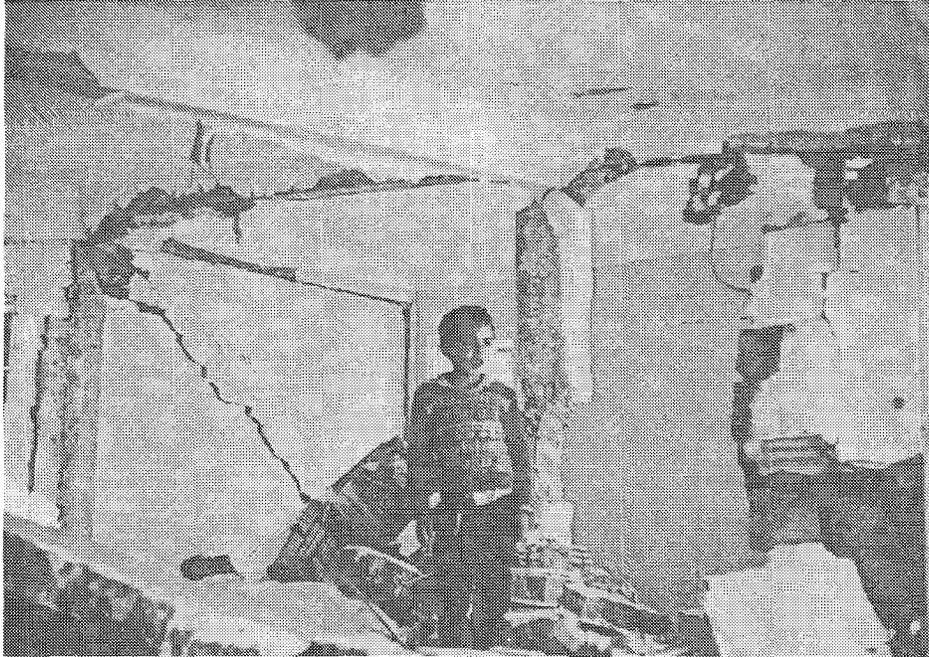
(a) Internal Partitions

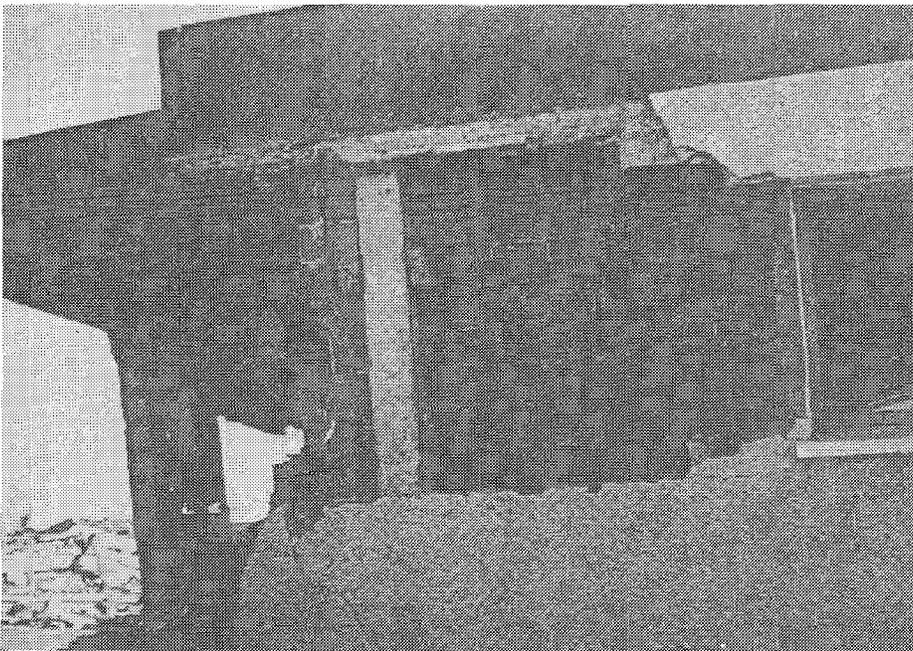
(b) Internal Partitions, Weak Columns/Strong Girders
