**Seismic Hazards In Unreinforced
Masonry Buildings
In The Pacific Northwest**

FINDINGS ON THE STRUCTURAL CONDITIONS
OF UNREINFORCED MASONRY BUILDINGS
IN SEVEN STUDY TOWNS

SEISMIC HAZARDS IN UNREINFORCED
MASONRY BUILDINGS IN SMALL TOWNS
IN THE PACIFIC NORTHWEST

April 15, 1985

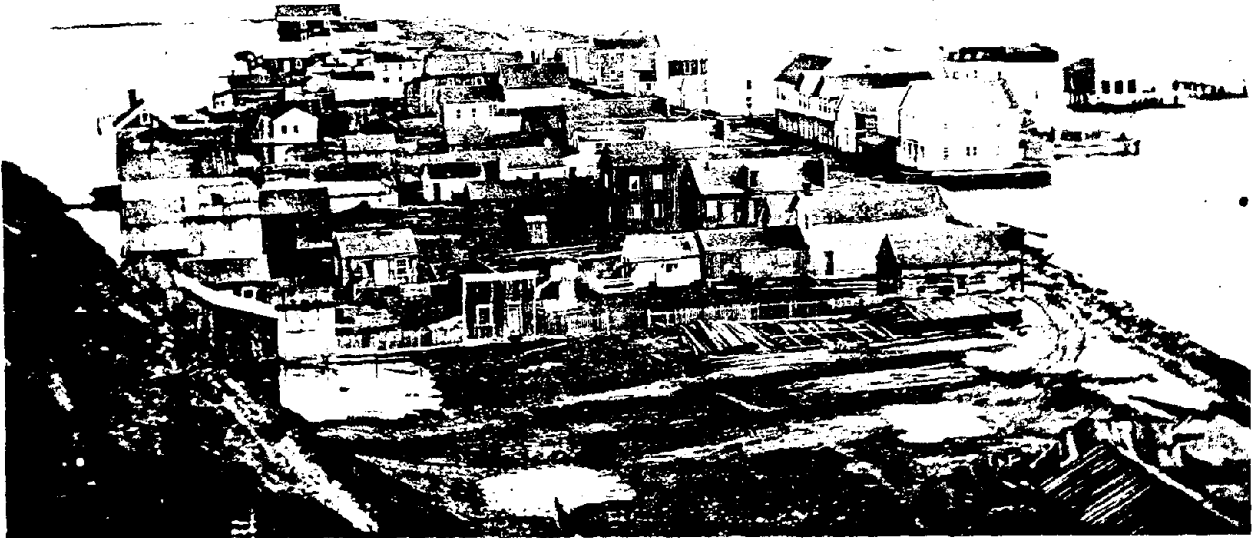
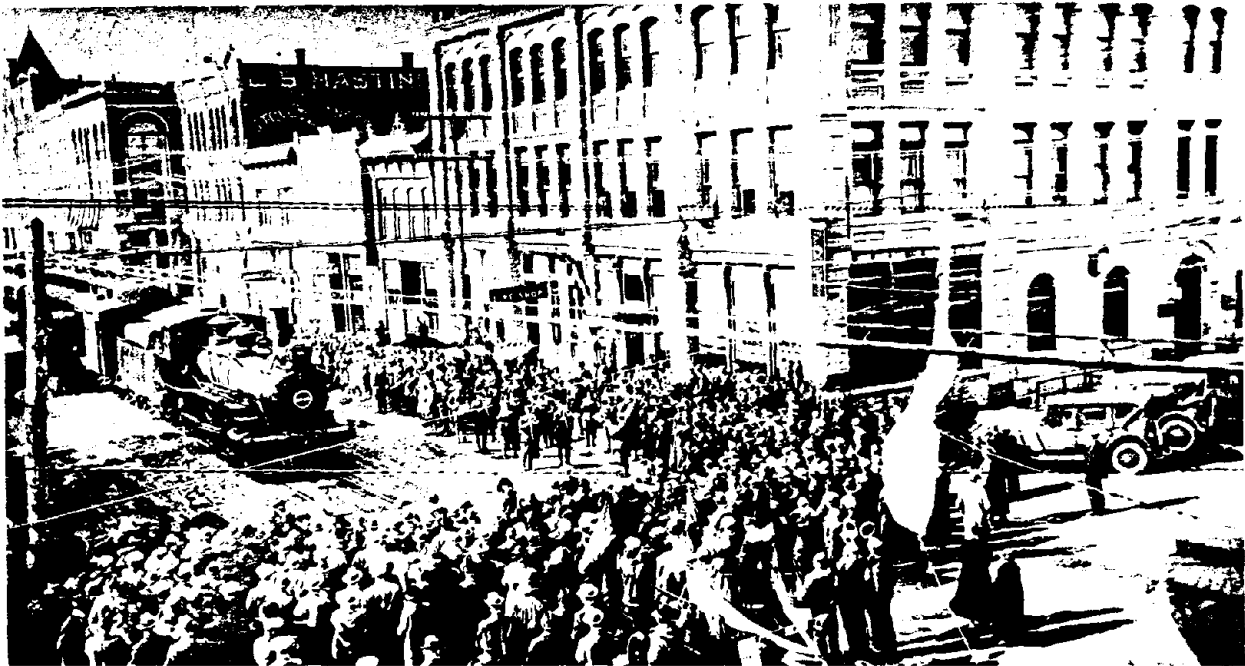
Figure 2. Transition of Woodframe to Unreinforced Masonry

Historic Factors. Though each town had a distinctly different history many historical situations were similar, and the similarity was often reflected in the condition of the brick buildings. The photographs of (figure 2) identify the transition from wood frame to unreinforced masonry that was typical in every town after fire destroyed the original buildings. Some of those similarities are as follows:

Port Townsend before 1900. Typical Collection of Woodframe Buildings that Composed the Mainstreet of the Seven Study Towns

Port Townsend Early 1900's. Typical Replacement of Woodframe Structures with Unreinforced Masonry after Fire Spread Through Town. In every Study Town this Situation was the Same.

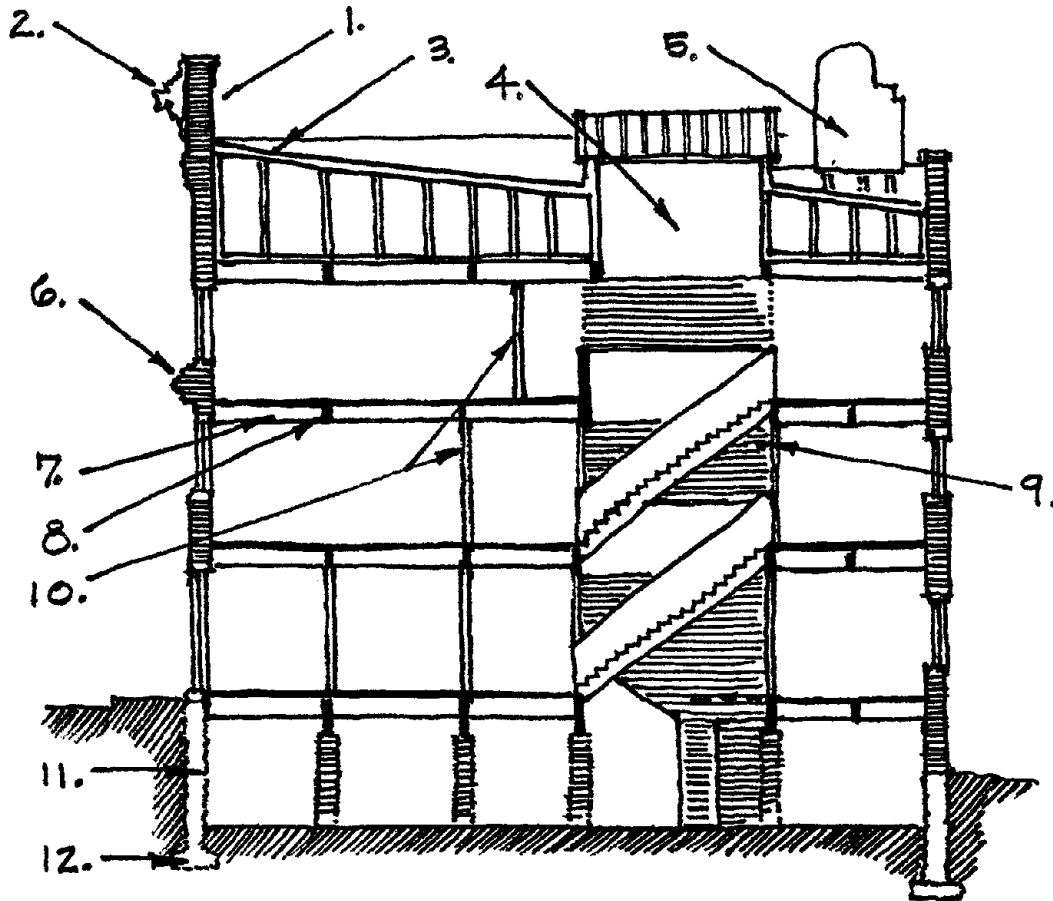
Section of Unreinforced Masonry Building and Elements Fig.10

The typical turn of the century unreinforced masonry structures were often built quite similarly in the the study towns: with timber framing of floors, interior walls, and foundation joists and beams, and brick and lime mortar forming the exterior load bearing walls. In almost every building surveyed and in the majority of other URM buildings in town of the same era, no reinforcement, the tying of and securing of brick walls or appendages, occurred to reduce the possibility of failure or separation of building elements during an earthquake. A section of a typical unreinforced masonry building and building elements is included and marked as figure 10.
