SEISMIC DAMAGE BEHAVIOR OF BURIED
LIFELINE SYSTEMS DURING RECENT
SEVERE EARTHQUAKES IN U.S., CHINA
AND OTHER COUNTRIES

Leon Ru-Liang Wang

Technical Report No. ODU LEE-02
In Lifeline Earthquake Engineering Research Series

December 1985

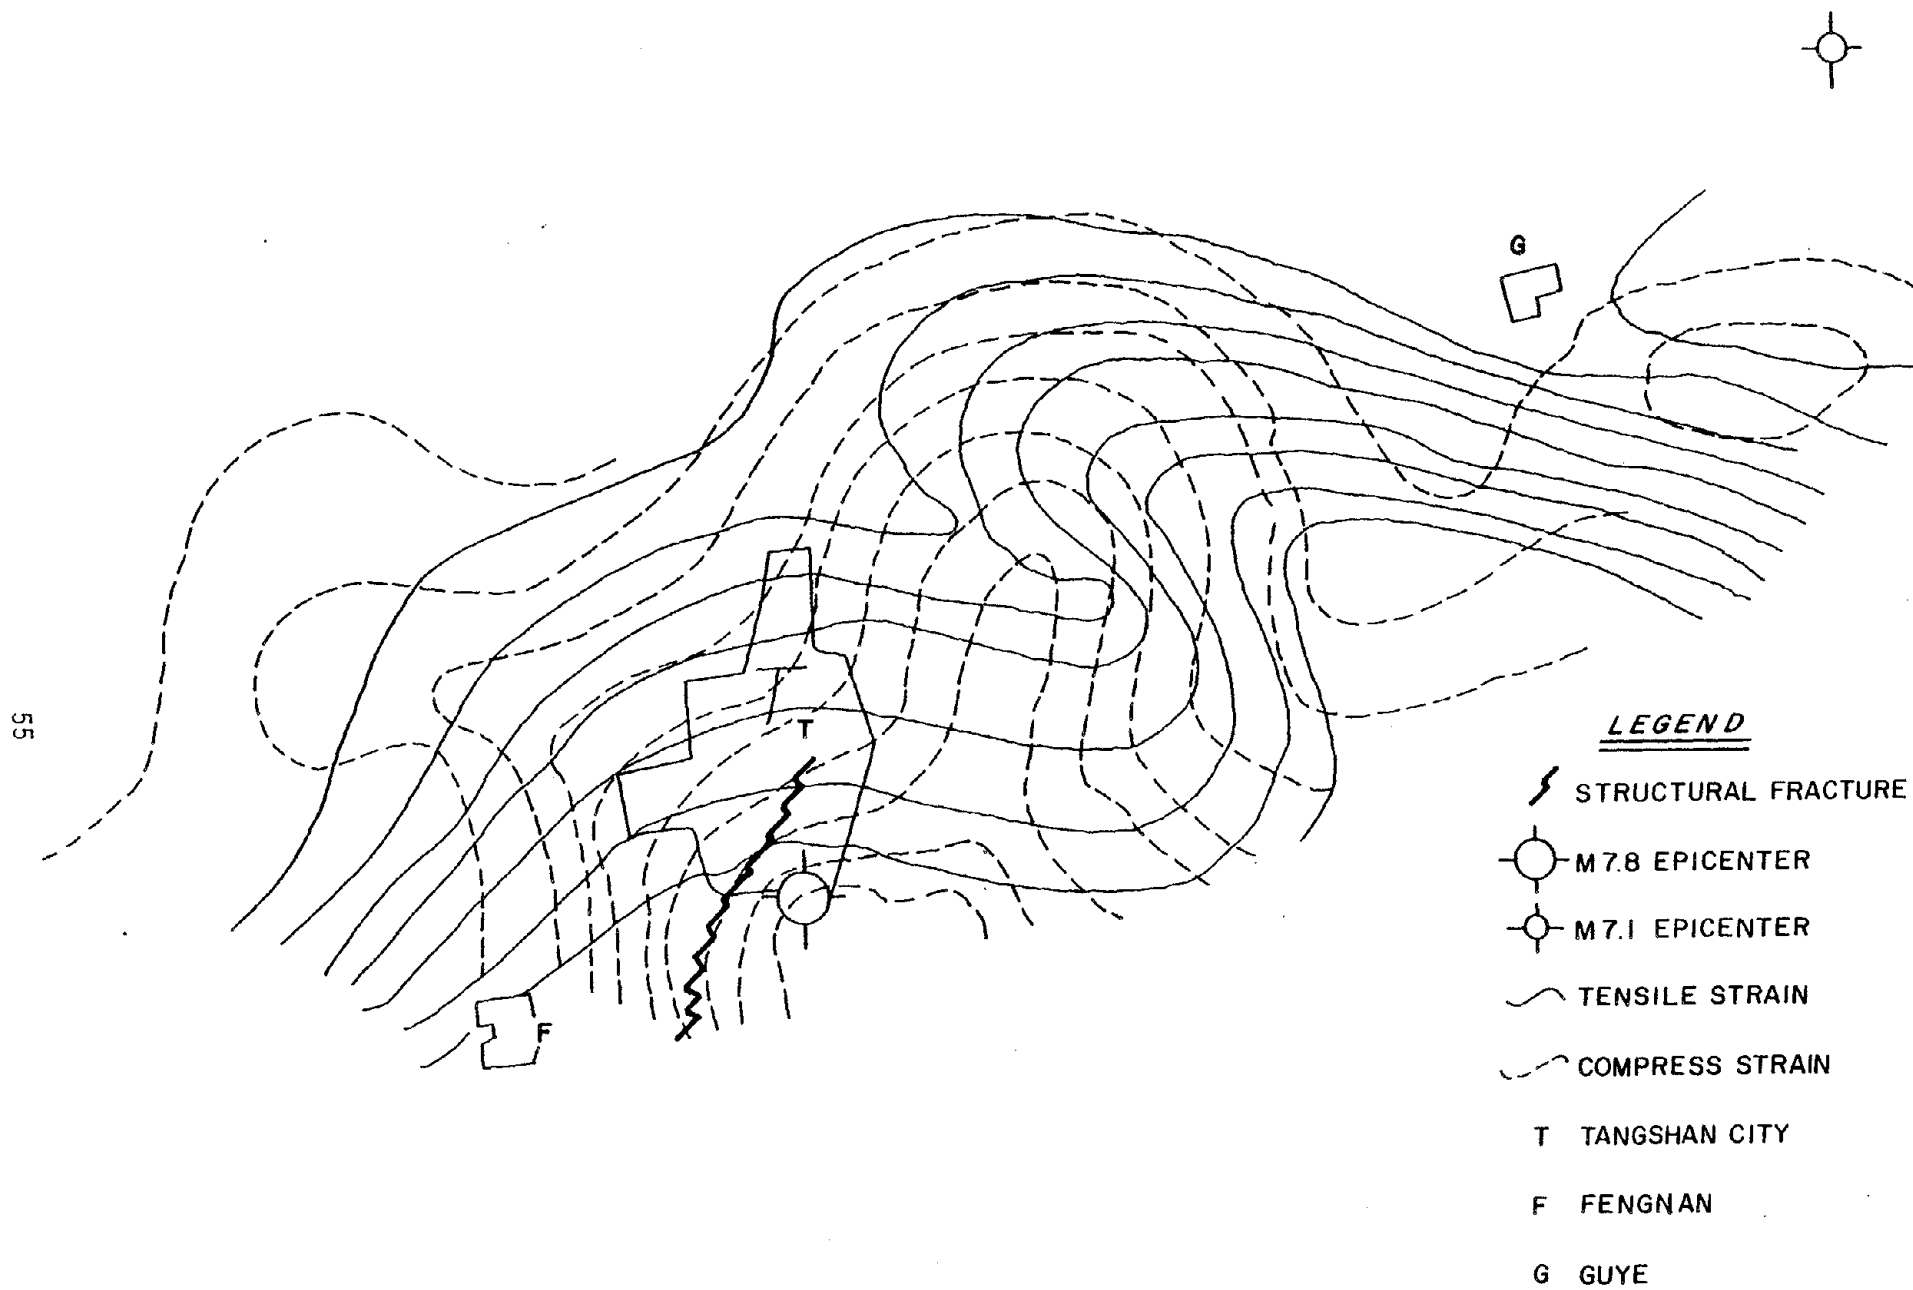
Figure 4.7 Strain Counters from Tangshan Earthquake

In general the seismic damages of buried pipes appear to have a certain regularity. For analyzing the relationship between the forms of damaged pipes and ground movements macrocosmically, the site seismic strain must be taken into account. Let the epicenter be a center in a drawing of triangular microzonation analysis. From the strain values found in each microzoned triangle zone, equivalent lines of these site strains could be plotted, as shown in Fig. 4.7. From the figure, it can be seen that

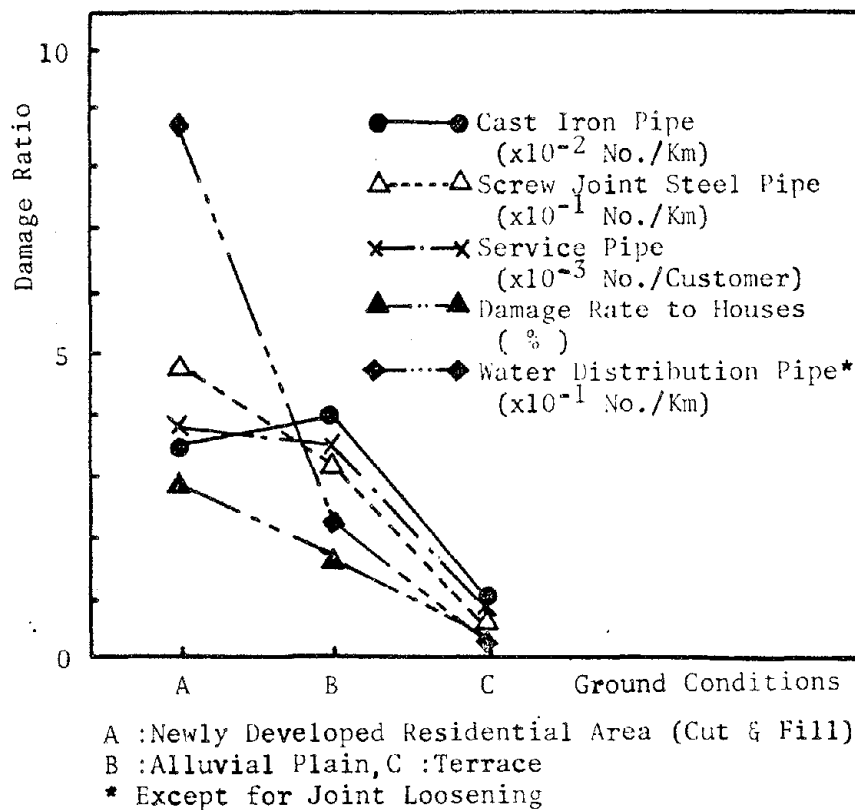
Figure 5.5 Damage Ratio VS Ground Conditions

Table 5.3 and Figure 5.5 shows the damage ratio of buried gas pipes of various kinds of materials as well as damage ratio of housings and water pipes. In this table, the damage ratio is classified by ground conditions where gas and water pipes were buried and Japanese wooden houses were standing. The damage ratio was the highest for structures in the newly developed residential districts which were made by cutting and filling the slopes, and it was the lowest for the terrace terrane, that is, central part of the city.
