REPORT NO.
UCB/EERC-87/11
SEPTEMBER 1987

RESIDUAL STRENGTH OF SAND FROM DAM FAILURES IN THE CHILEAN EARTHQUAKE OF MARCH 3, 1985

PEDRO DE ALBA
H. BOLTON SEED
EUGENIO RETAMAL
RAYMOND B. SEED

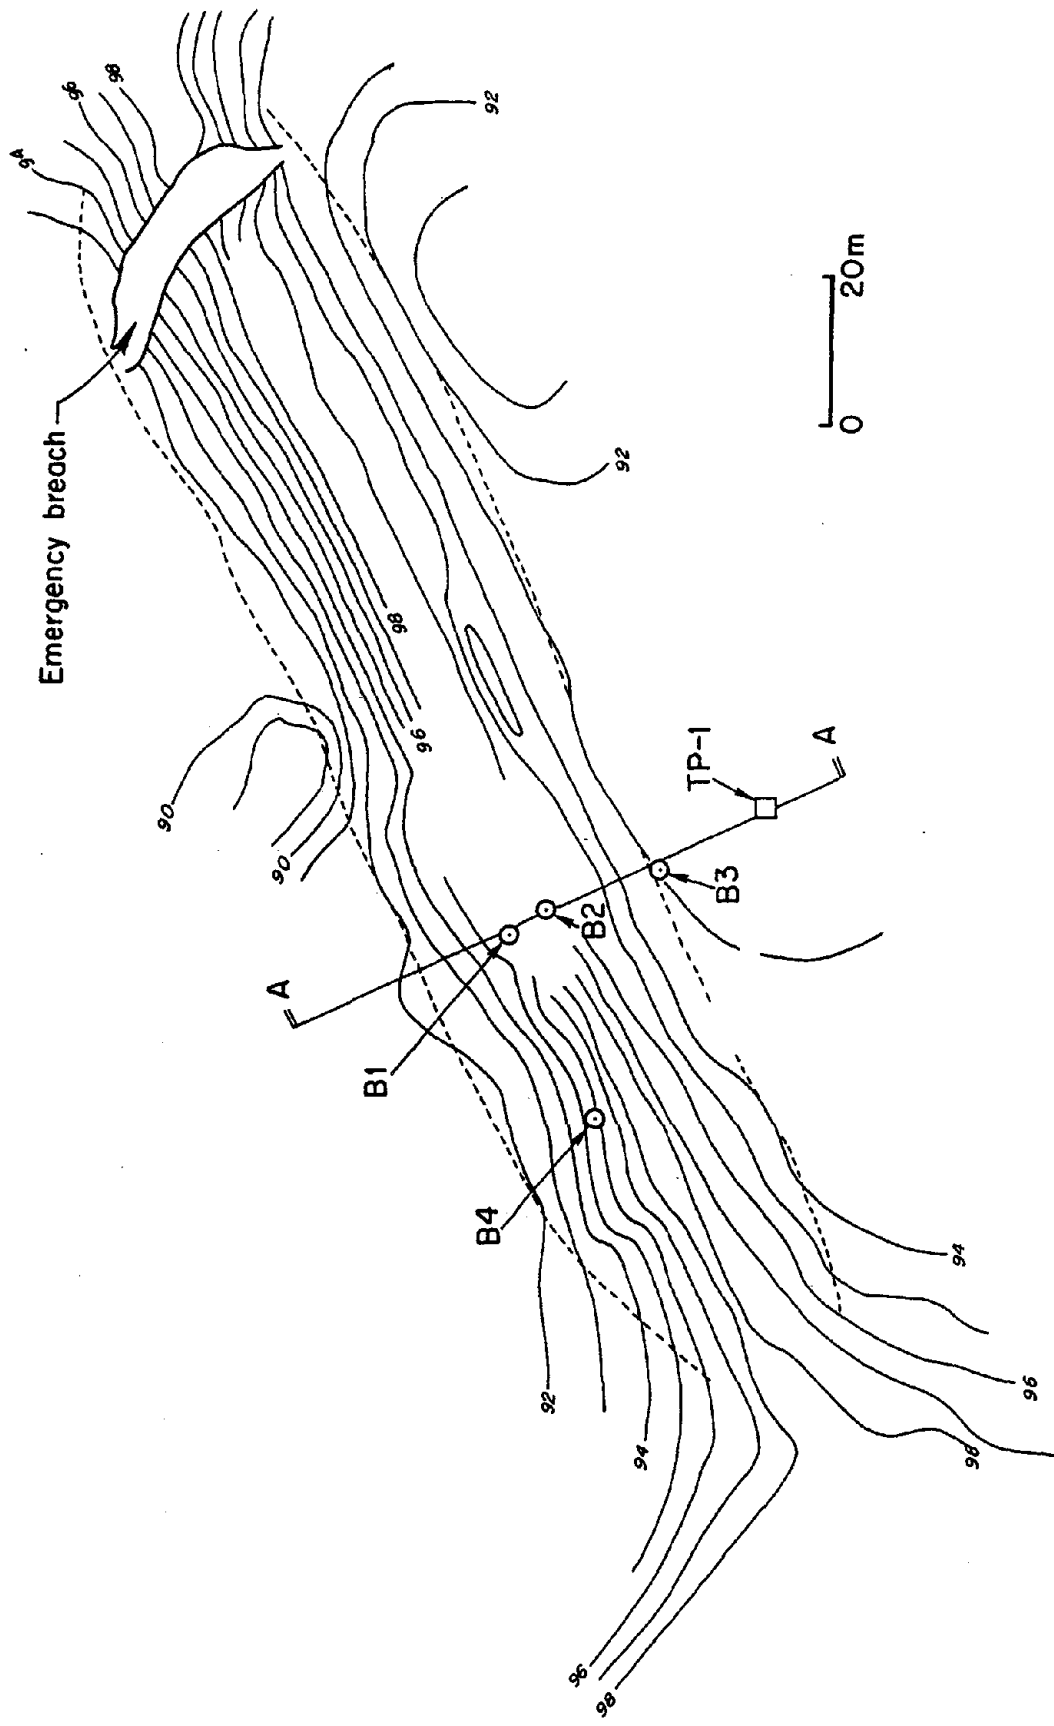
Fig. 3 PLAN OF LA MARQUESA DAM SHOWING BORING LOCATIONS

Explorations at La Marquesa concentrated on a cross-section through the most damaged part of the embankment, section A-A in Fig. 3. Results from two studies were used to define the internal geometry at this section. Retamal et al. (1985) had reported results from a test pit and two SPT-borings carried out approximately at this location during studies for a possible reconstruction of the dam. To confirm and extend these results, an additional four SPT-borings and a test pit were made in the Summer of 1986 under the direction of the writers. Three of these borings, B-1 to B-3, were made along section A-A; an additional boring, B-4, was located 28 m (92 ft) away from this section, outside the major damage zone.

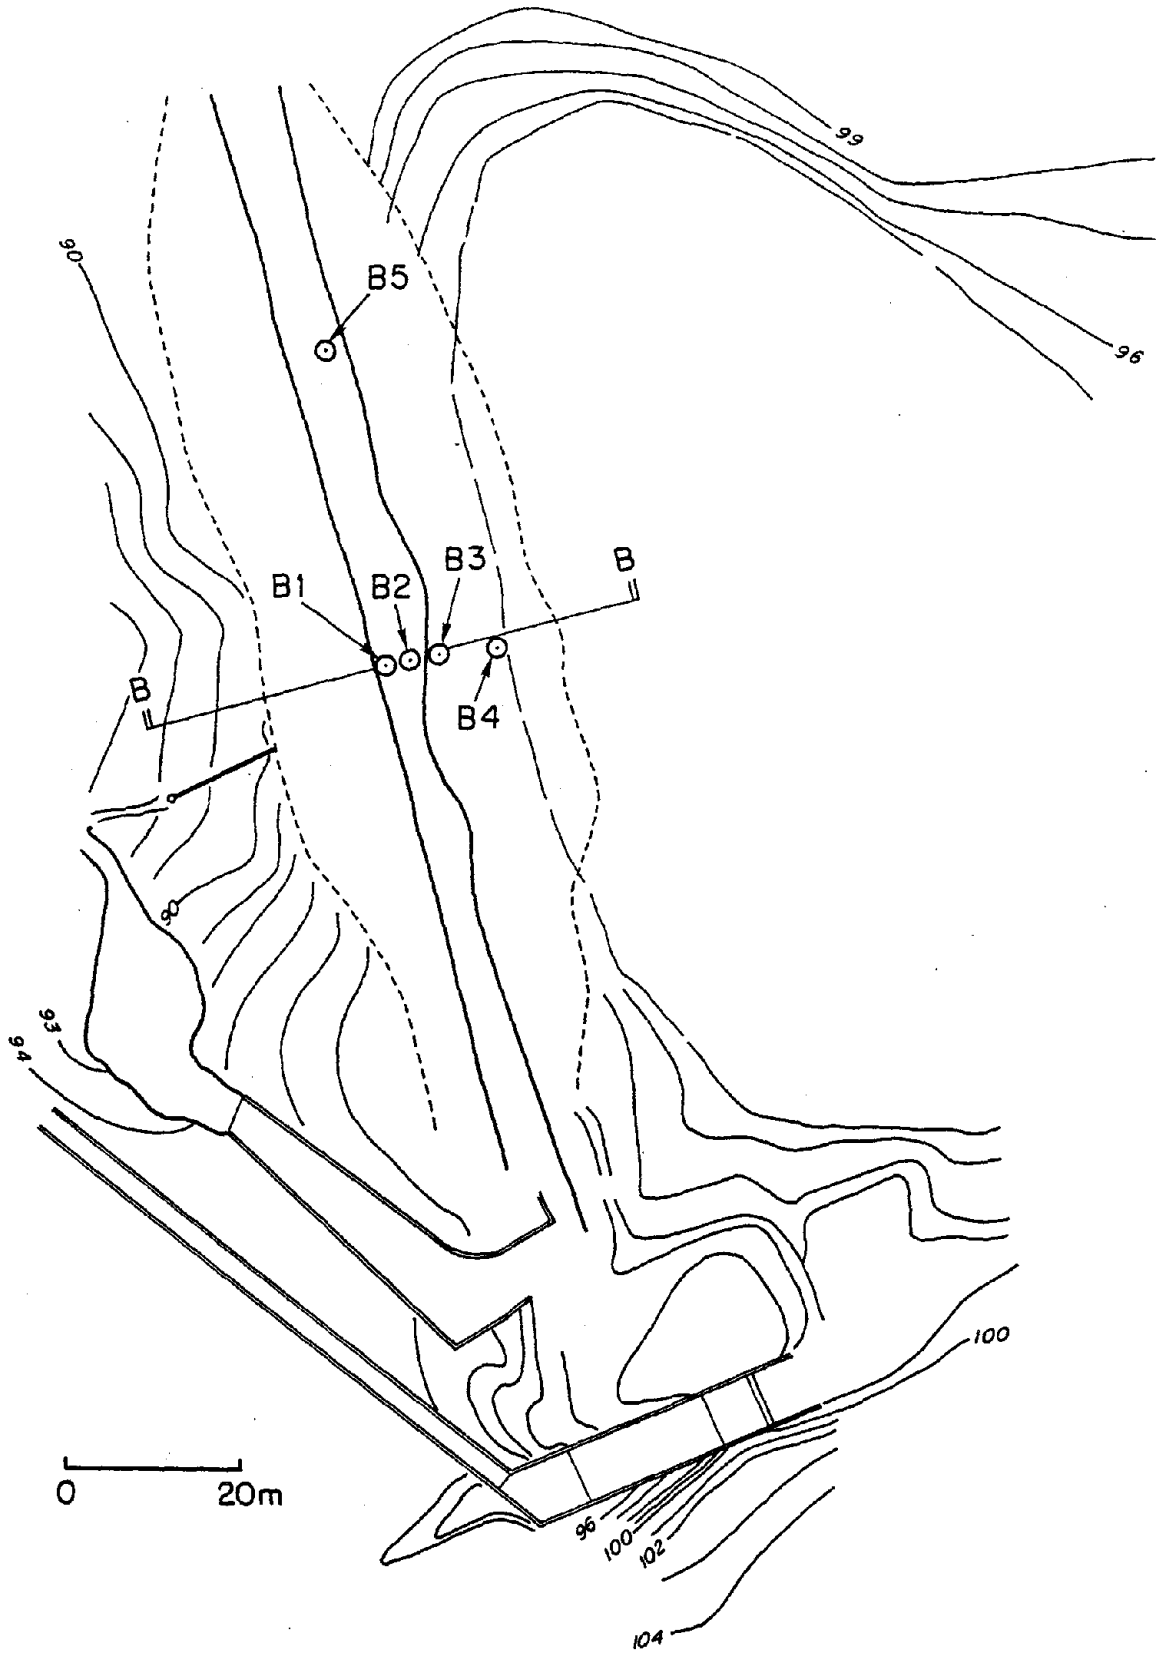
Fig. 11 PLAN OF LA PALMA DAM SHOWING BORING LOCATIONS

Exploration at La Palma Dam consisted of five SPT borings made in 1986; Borings B-1 to B-4 were carried out along cross-section BB in the major damage zone of the dam, as shown in Fig. 11. Judging from the topography, this section is in the old streambed, where major damage was concentrated. The last boring, B-5, was made at a distance of about 35 m (115 ft) towards the right abutment, in a zone where damage was minor. Borings were carried out by the same crew, and using the same procedures, as at La Marquesa Dam. The water level in the reservoir at the time the borings were made was only 50 cms (1.6 ft) below that at the time of the earthquake.

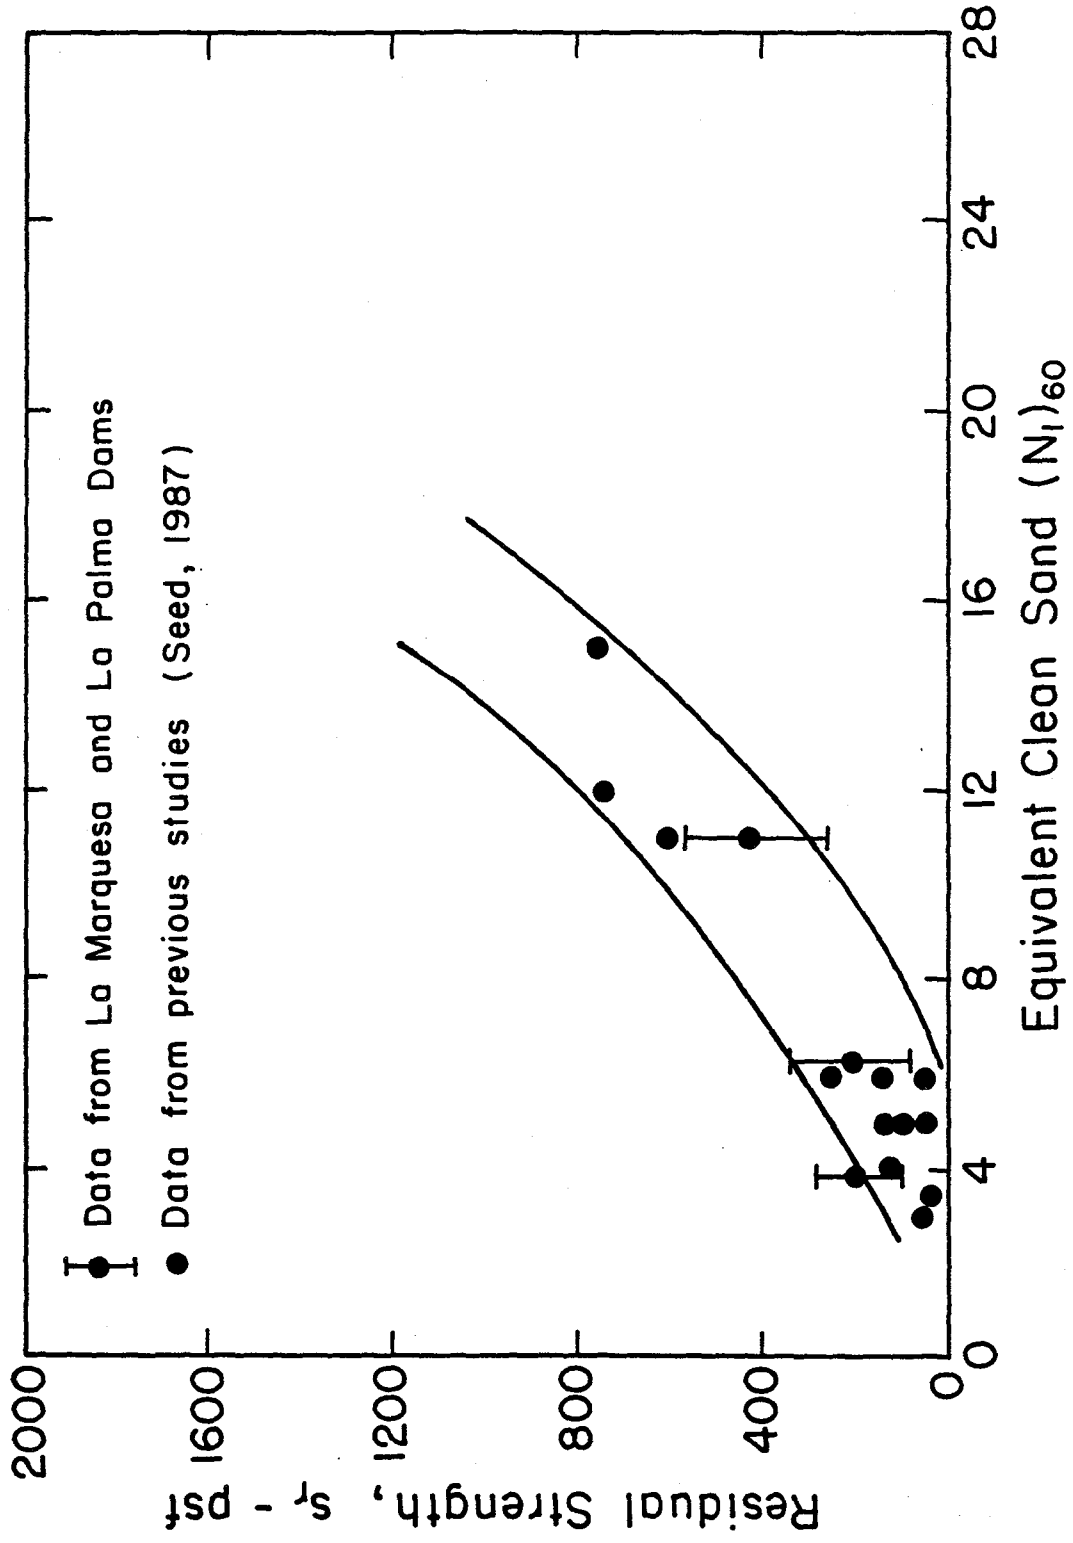
The two cases of dam failure described are of special interest because they provide examples of the performance of very low dams, in which static stresses are quite low, under strong earthquake conditions and they also provide two additional case studies to add to the relatively sparse record of case studies from which residual strengths of liquefied soil can be determined based on field performance (Seed, 1987). Thus the results of these studies can be added to the data previously compiled, as shown in Fig. 17. It may be seen that they are generally consistent with values obtained from previous studies.

Fig. 17 RELATIONSHIP BETWEEN RESIDUAL STRENGTH AND EQUIVALENT CLEAN SAND VALUE OF $(N_1)_{60}$
