JOINT U.S.-ROMANIAN SEMINAR ON EARTHQUAKES AND ENERGY

VOLUME 2: EARTHQUAKES

**EDITORS:
SAMUEL ARONI
ROMULUS CONSTANTINESCU**

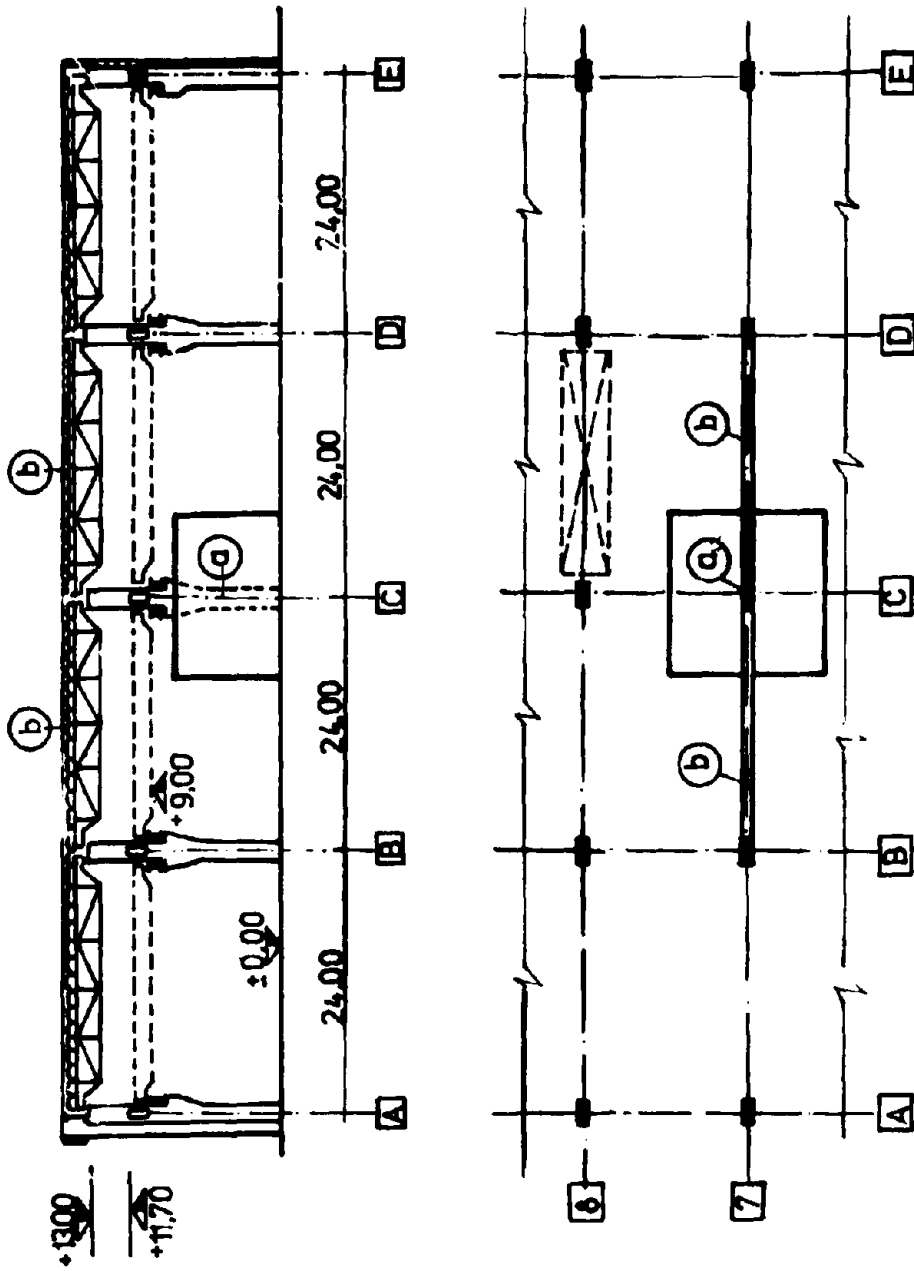
Fig. 3

5. The roof bracings generally had a good behavior, an important contribution being the interaction with the roof deck diaphragm. The vertical bracings between columns made of members with a low slenderness, resulting from the crane and wind loadings, suffered no damage. Some bracings with very slender cross diagonals of the halls failed through buckling of compressed diagonal, followed

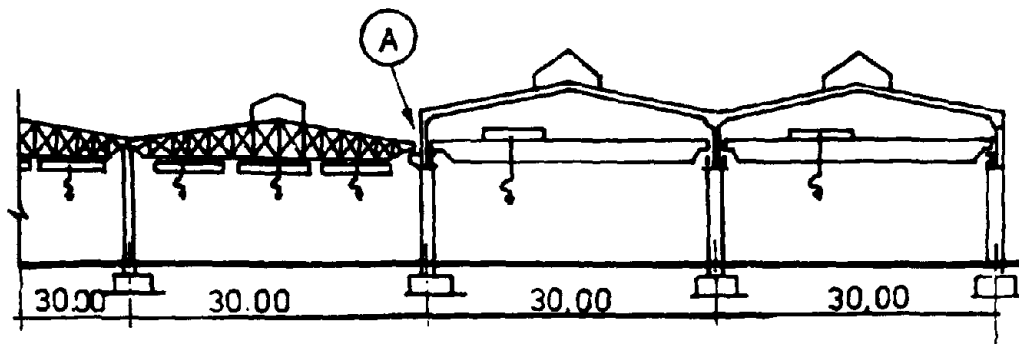
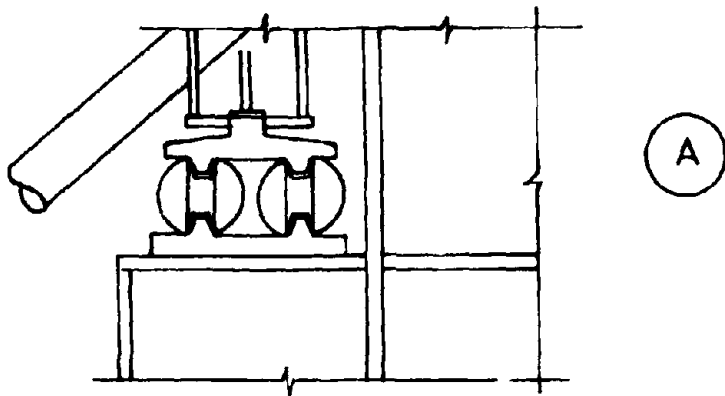
Fig.4

Some damage appeared in the roller expansion bearings. At the Tool and Units Plant in Bucharest (fig.4) the expansion joint between two steel halls with a light roof deck having very different rigidity to lateral displacements, was carried out by roller bearings. Because of the different vibration natural periods of the two parts of the hall (one with stiff columns supporting heavy cranes, the other one with elastic columns having transport equipment hanged to trusses) important relative displacements occurred, the rollers facturing the keeper plates and falling from the bearings. The trusses remained supported by the steel brackets of the columns that were provided with high bearing capacity and could therefore support the shock produced by the collapse of trusses. Special provisions have been adopted for different types of fixed connections and of the roller expansion bearings being subsequently included in the aseismic structural design.

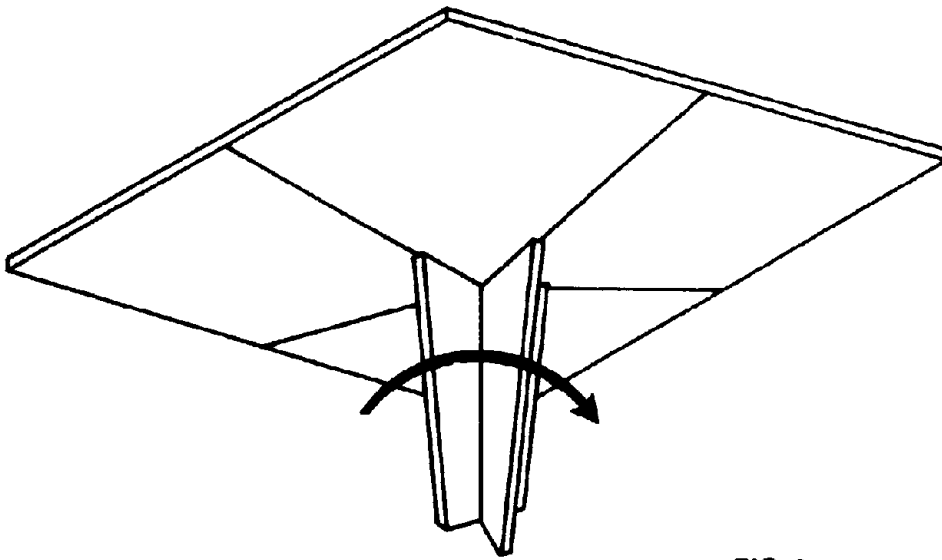
FIG.4

Two umbrella shells, as fig.4 shows, overturned about their bases, because they were not well enough fastened at the rigide level with the adjacent house. (fig.4).

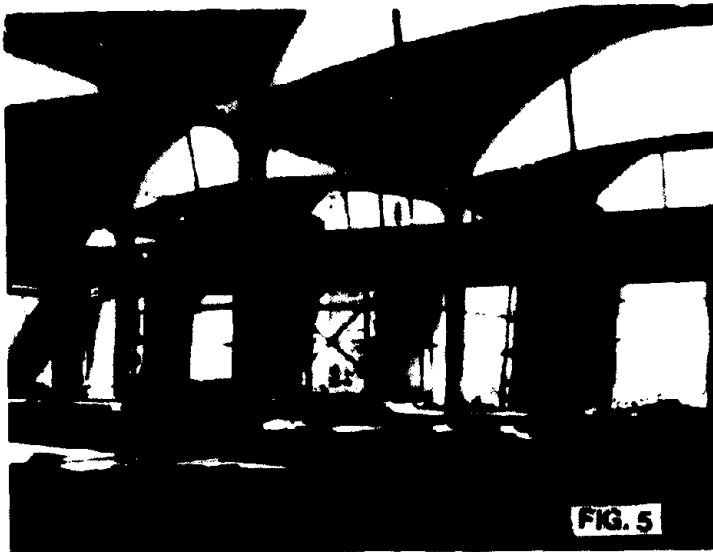
At a locomotive depot erected in 1974 (marked 1 on the map), whose roof is made of 40 conoidal shells of 6.5 cm thickness (fig.5) each resting on arches supported by columns, no trouble was recorded, in spite of the VIIth degree intensity of the earthquake.

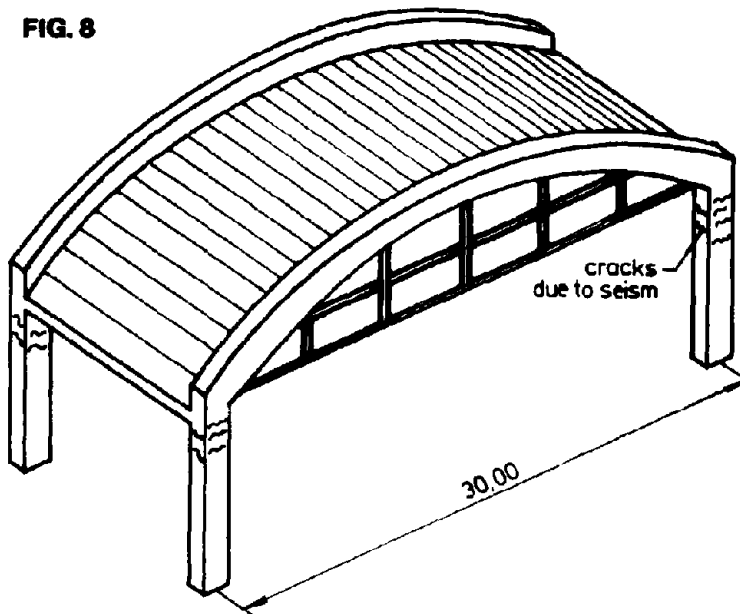
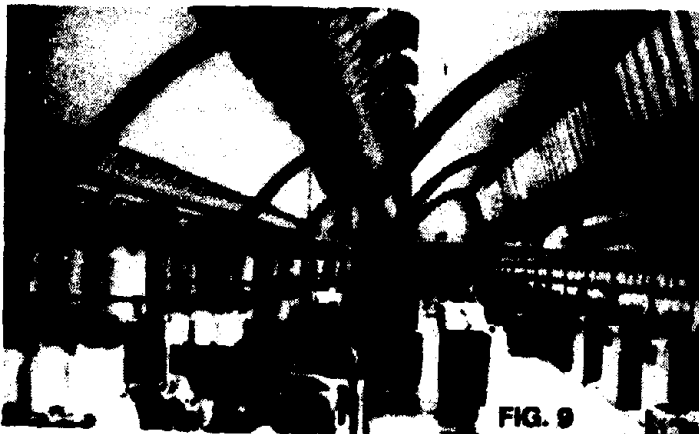
FIG. 9

Also in the capital, a big covered area of about 10,000 m² has to be mentioned. Its roof is made of a 7 cm thick cylindrical shells shaped in an original S form (photo fig.9). Cracks occurred, in this case, to the supporting frames, especially to some columns over loaded by the torsion created through some partition walls which have displaced the rigidity center. Fig.10 shows the cracks and some repairing details.

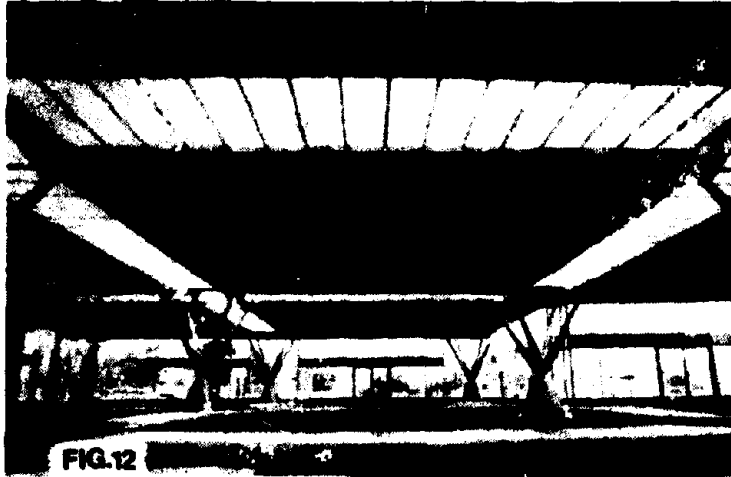
FIG. 12

A similar S-shaped shell (photo 11) was built at Savinesti (location 5 on fig.1). The shells of 6.5 cm thickness rest on frames with curves spandrels, placed at the outer shell side (fig.12).

In this case, no damage was observed,

as was the case with a veladroidal erected in Cluj (location 7 on fig.1), whose inner view appears in fig.12. This shell, made of precast elements, had a very good performance during the last earthquake.

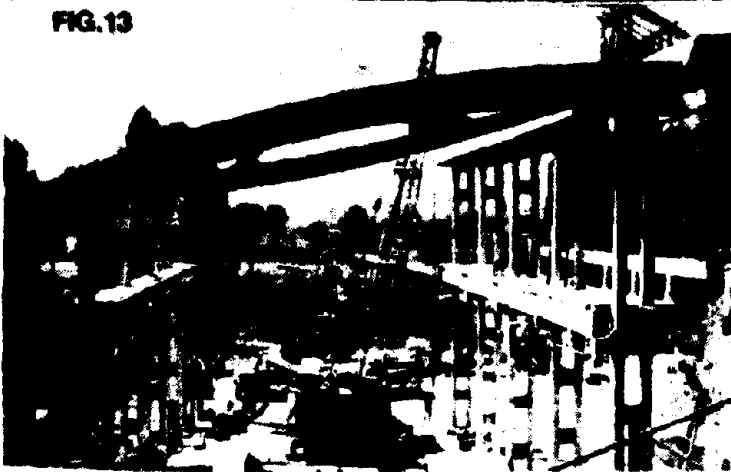
FIG. 13

The structure made of precast thin lens elements (location 8 on fig.1, photo in fig.13) has suffered no damage either.

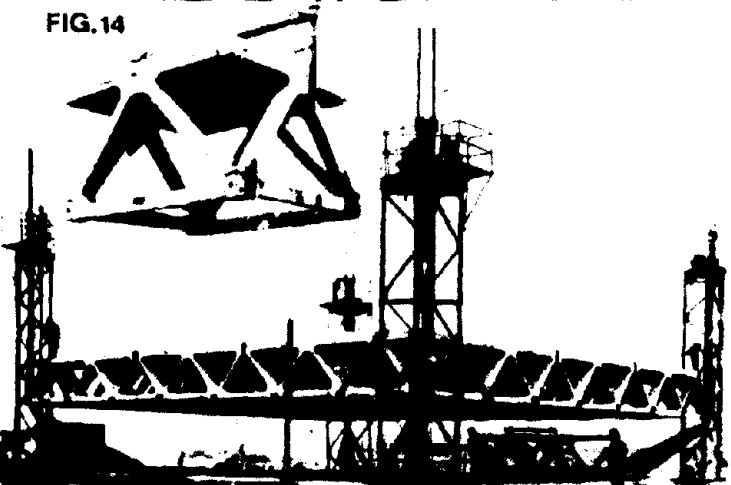
FIG. 14

Also undamaged was a double-layer grid structure made of single-type precast elements (location 9 on fig.1), which was assembled at the ground through post-tensioned cables (fig.14).

In this case, no damage of any kind could be seen in spite of the fact that intensity eight was suffered during the 1977 earthquake.

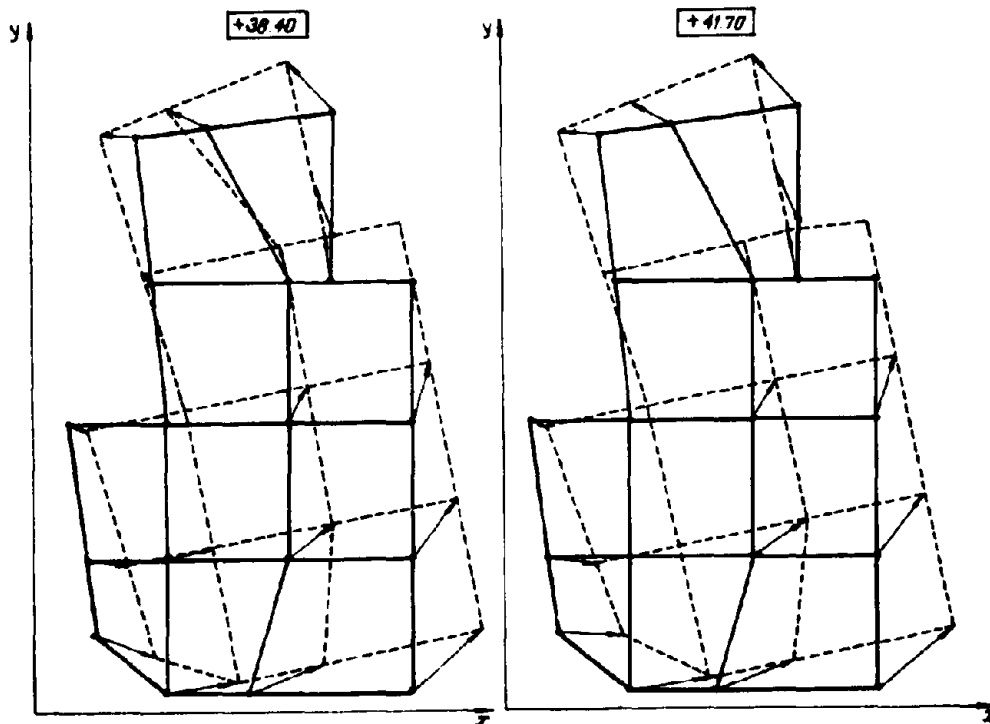
Fig. 8

Fig.8 shows the components of the first form of vibration at two of the tower levels; it can be seen that the floors suffer motions of rigid, solid type in horizontal plane (rototranslations), hence, the floors may be considered as washers in horizontal plan, i.e. correlators of the displacements of the spatial frame joints.

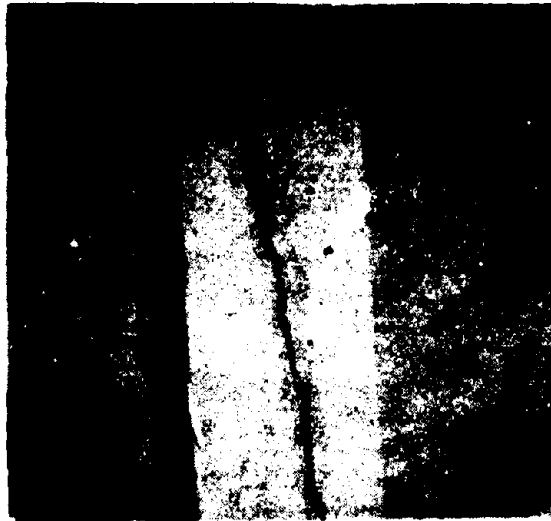
CRACK ALONG THE BEAM

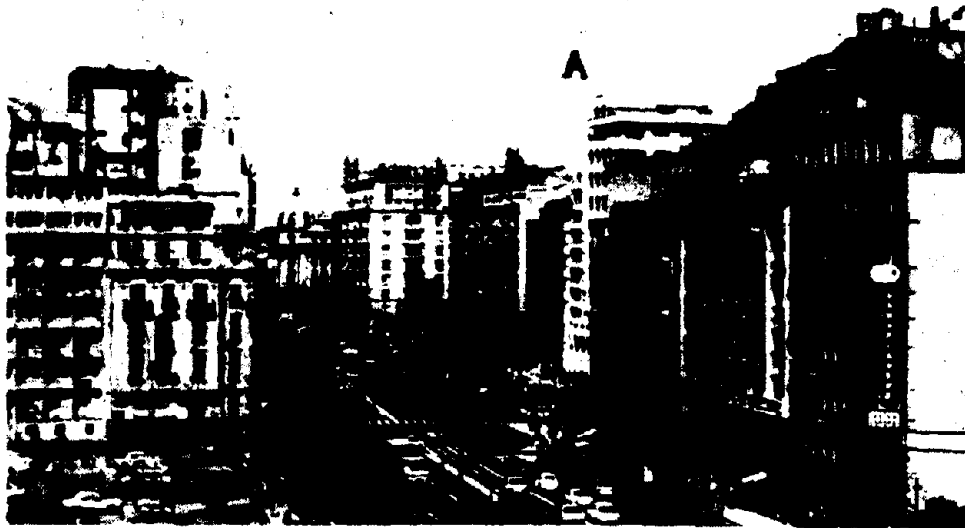
Fig.1. Right side of "Magheru Ave." in Bucharest, having mainly pre-1940 buildings. Building "A" is a reconstruction after 1977 of the collapsed building "Casata".

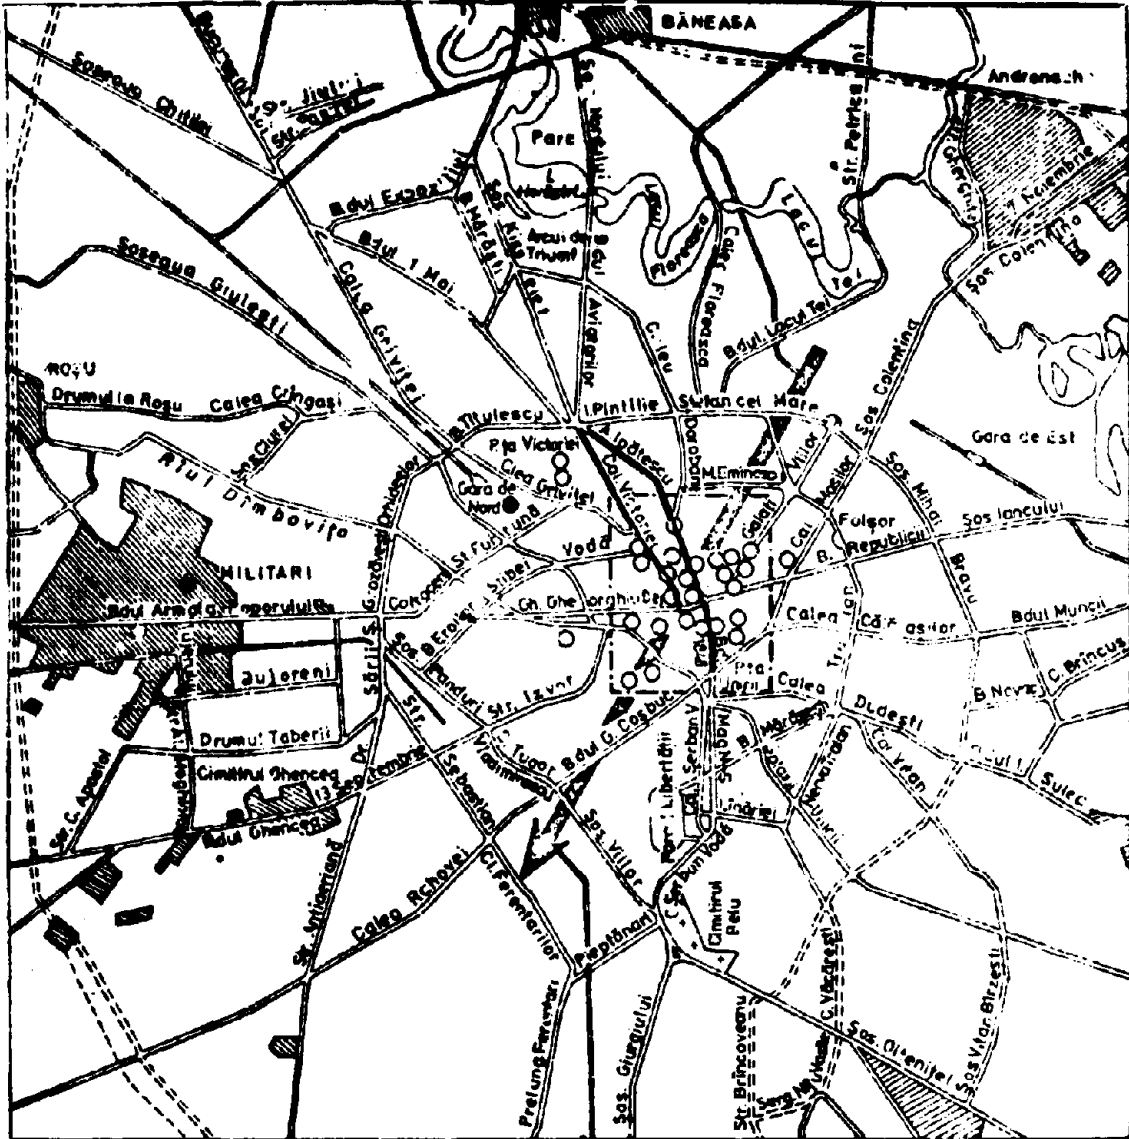
Fig.2

Collapsed buildings in the 1977 earthquake:
