# ARCHITECTURAL AND URBAN DESIGN LESSONS FROM THE 1985 MEXICO CITY EARTHQUAKE

June, 1988

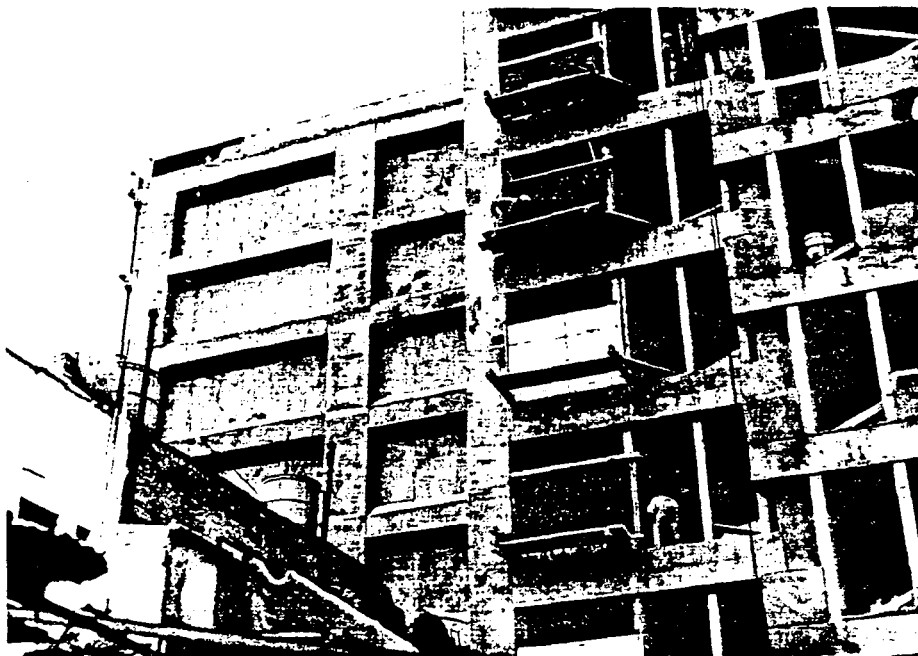
Muros De Refuerzo En  
Colindancia

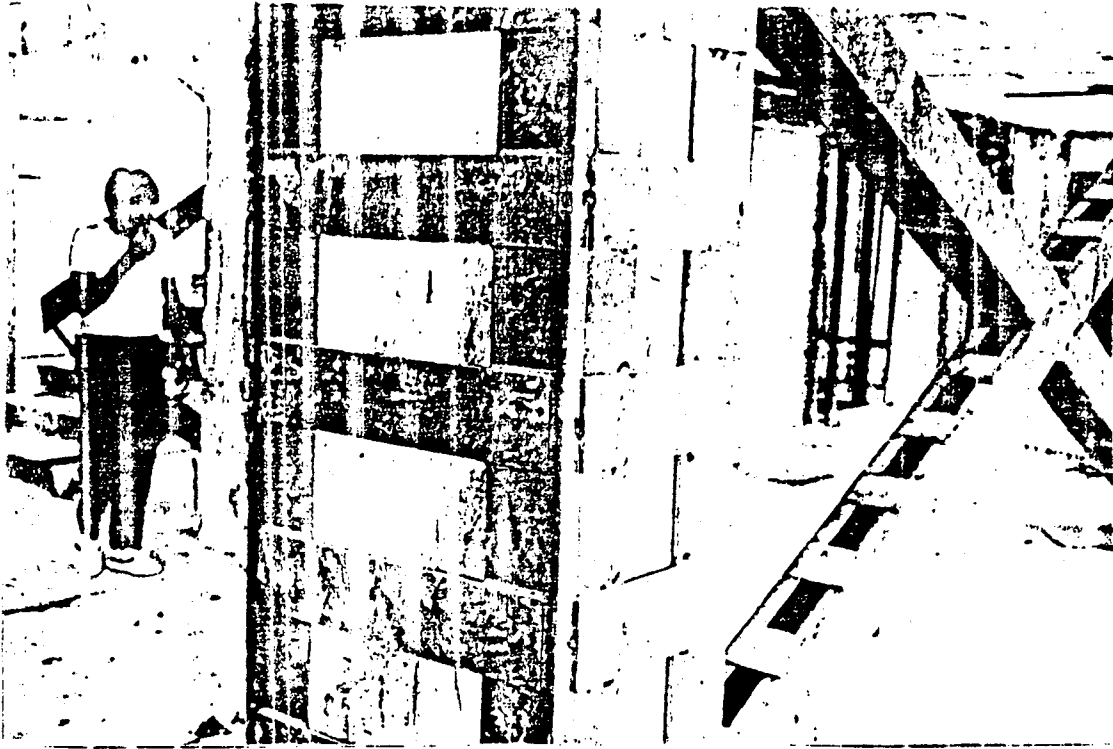
Detalle del refuerzo de columnas y anclaje de crucetas

DETALLE DE COLUMNA EN  
4° PISO.

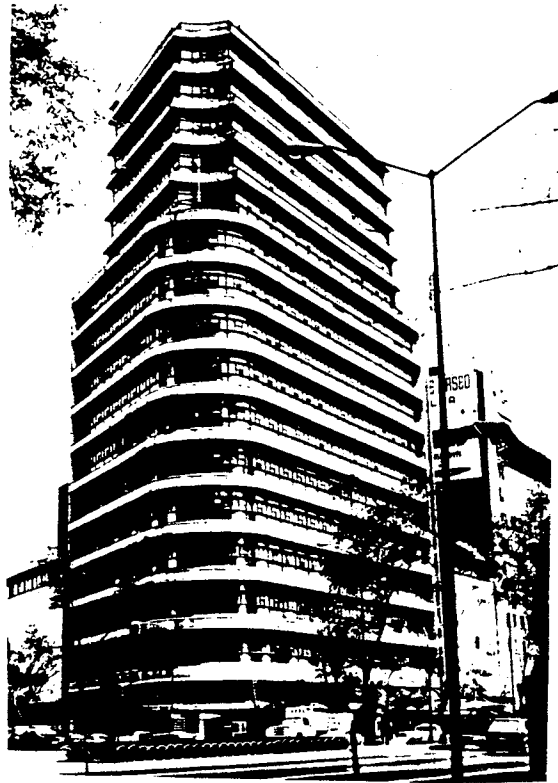
Abandoned Flat Iron Building After Earthquake  
Still Unoccupied in February 1987

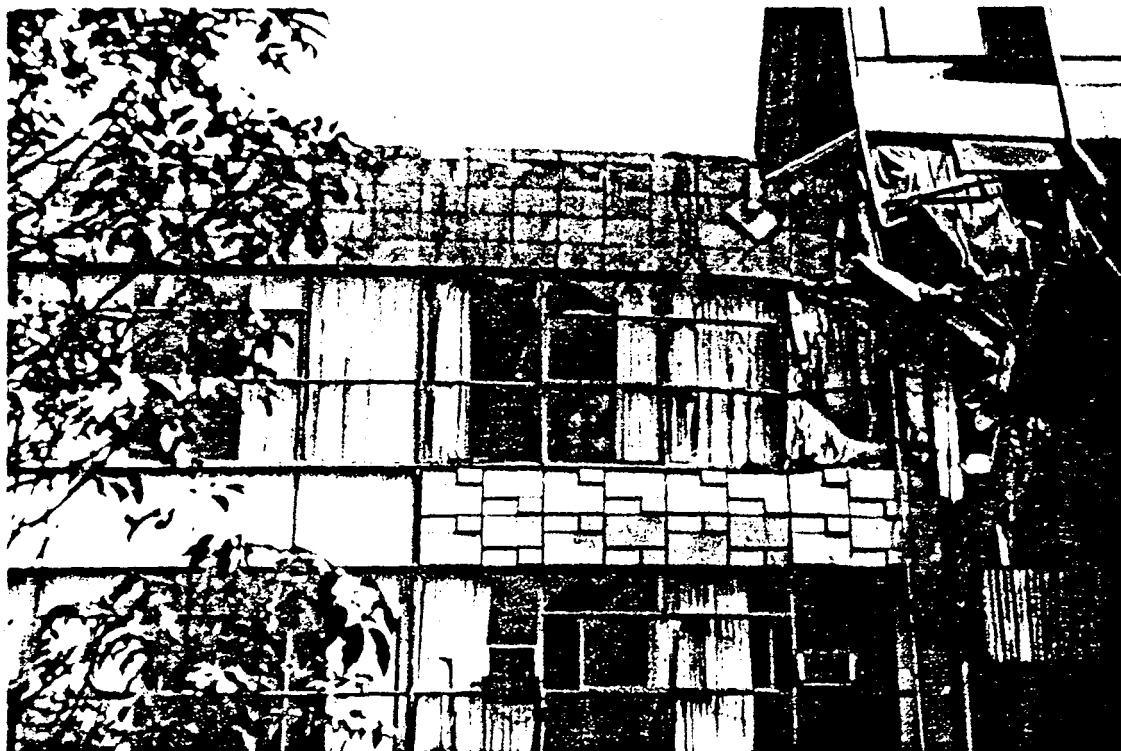
There does appear to be a strong relationship between serious glass damage and the existence and height of adjoining buildings. Of those buildings with adjoining buildings of partial height (25-75 percent of the damaged building) 34 percent experienced serious glass damage. This is in contrast to those buildings with adjoining buildings of excess heights (over 75 percent of the damaged building) which reported serious glass damage in only 16 percent of the cases, and those buildings with adjoining buildings of limited heights (below 25 percent of the damaged building) which reported serious glass damage in only 15 percent of the cases.

Buildings with partial height adjoining buildings experienced higher amounts of serious glass damage through pounding.

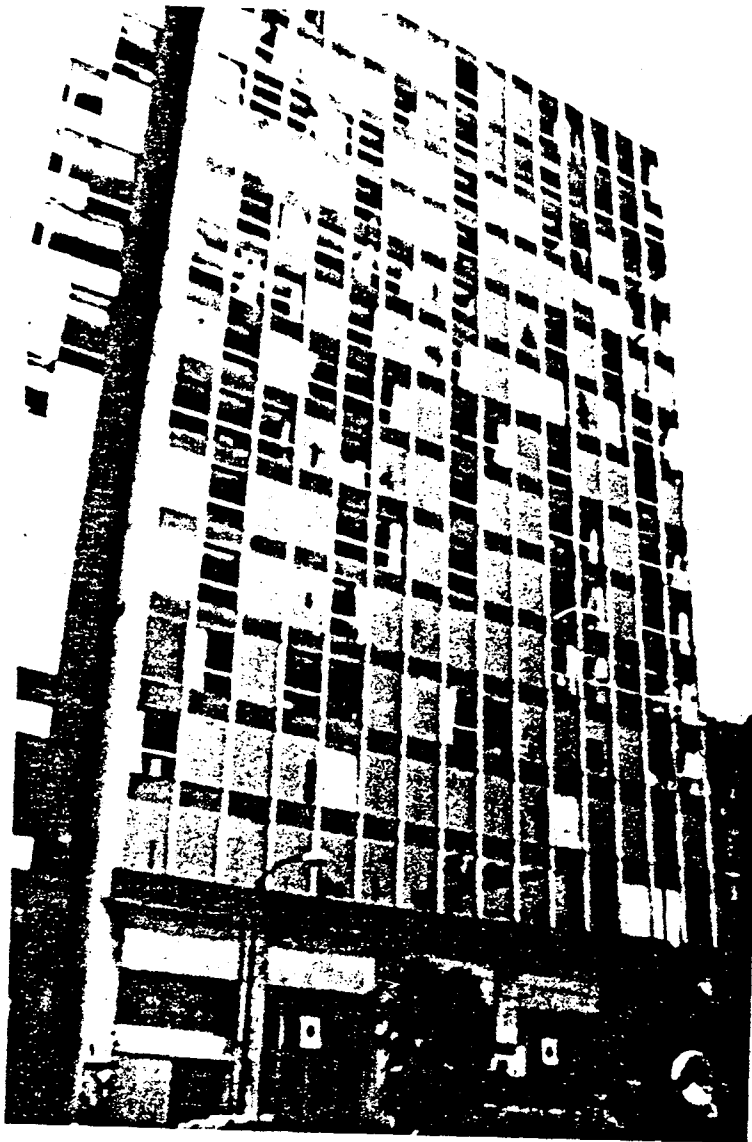
There appears to be a relationship between larger glass areas and serious glass damage. In the data base, 33 percent of the buildings had small windows (less than 2 square meters), 26 percent had medium windows (2-4 square meters), 15 percent had large windows (over 4 square meters), and 26 percent were unknown. Of those buildings with smaller windows only 14 percent experienced serious glass damage, those buildings with medium windows reported a larger 21 percent, while of those buildings with large windows an even larger 34 percent reported serious glass damage.

The larger glass panels tended to experience the more serious glass damage.
