EFFECTS OF THE 1985  
MICHOACAN EARTHQUAKE  
ON WATER SYSTEMS AND OTHER BURIED  
LIFELINES IN MEXICO

A. Gustavo Ayala and Michael J. O'Rourke

Technical Report NCEER-89-0009

March 8, 1989

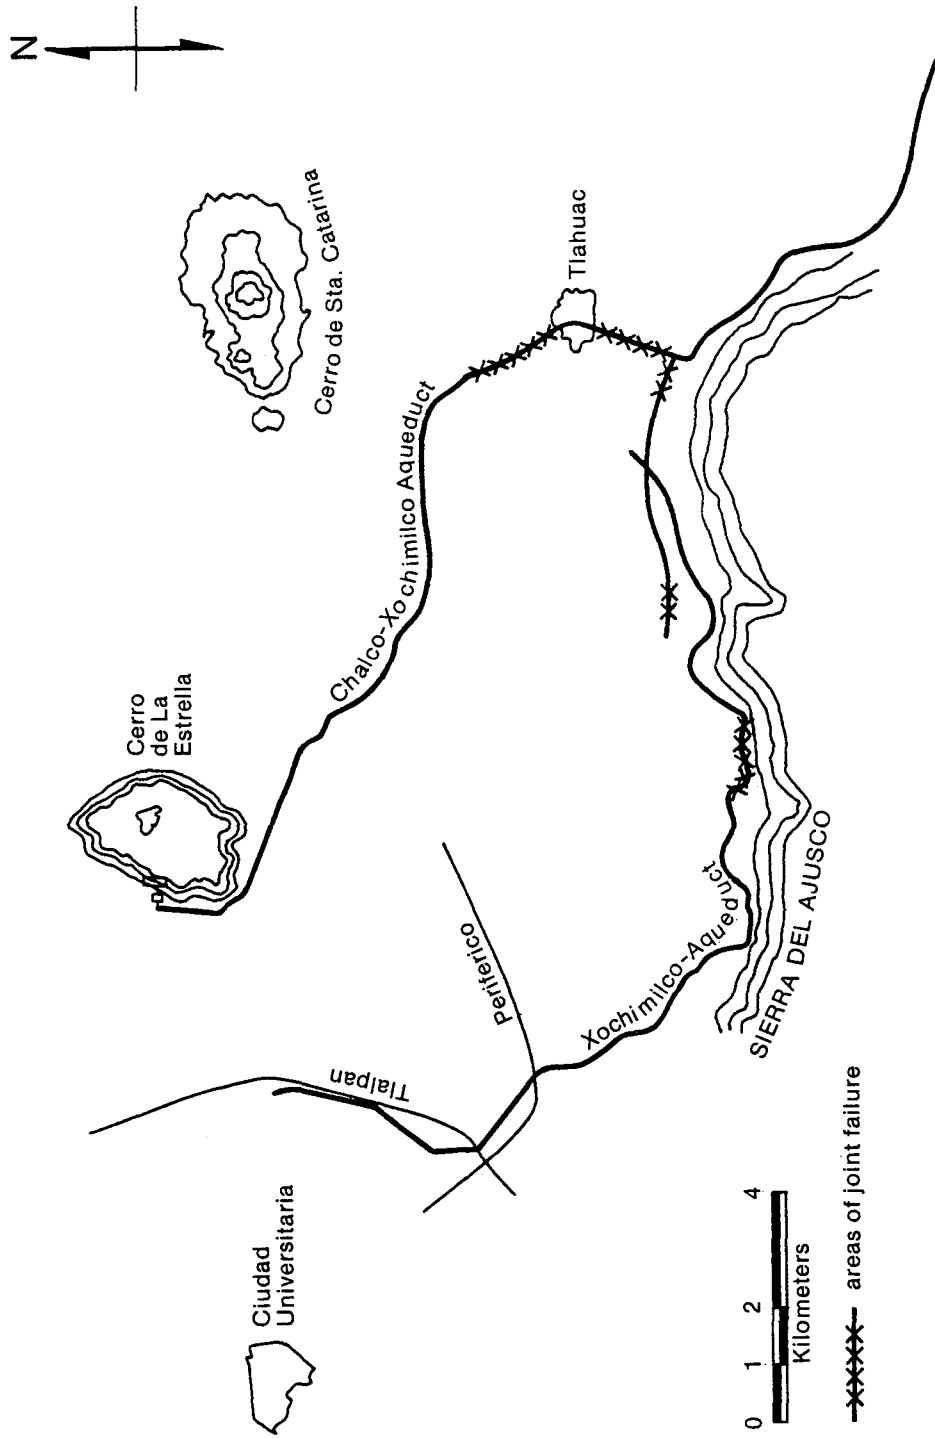
FIGURE 6-1 Aqueducts In Southeastern Mexico City Controlled By The Federal District

The damaged aqueducts were located south of the Cerro de le Estrella (Hill of the Star) and the Cerro de Sta. Catarina (Hill of St. Catarina). Two aqueduct systems pass through this area. One aqueduct system is controlled by the Federal District (D.F.) while the other is controlled by the Comision de Aguas del Valle de Mexico (CAVM). Plan views showing the aqueduct routes and damage locations along the routes are shown in figures 6-1 and 6-2 for the DF aqueduct and the CAVM aqueduct respectively. In figure 6-1, the cross-hatched aqueduct indicates the general area where leaks occurred in the D.F. aqueduct, while the specific locations of damage for the CAVM aqueduct

are shown in Figure 6-2. For almost the total length, both aqueduct systems are buried in extremely soft alluvial deposits. The 1985 Michoacan earthquake occurred at the end of the rainy season and the water table was within the 1.5 m (4.5 ft.) of the ground surface at that time.

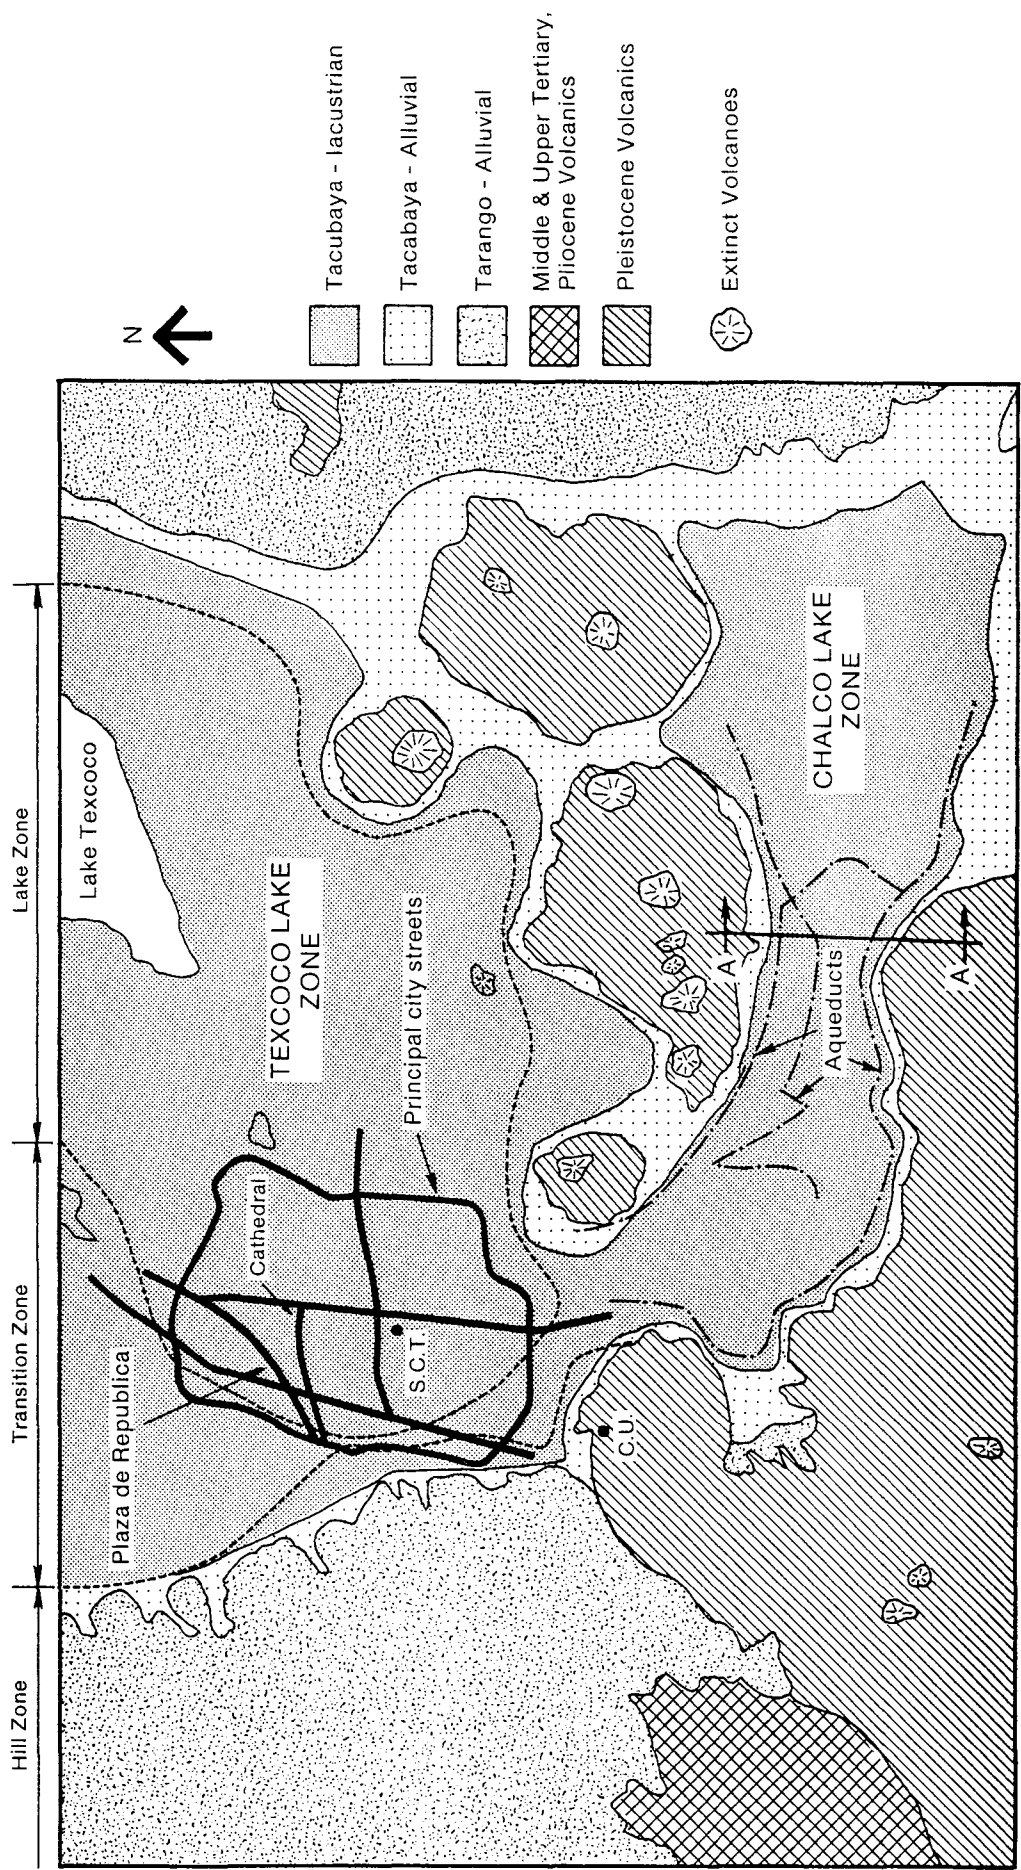
FIGURE 6-8 Location Of Damaged Aqueducts With Respect To Surrounding Mountains

Figure 6-8 shows the two damaged aqueducts located between the Cerro de la Estrella and the Cerro de Santa Caterina to the north and the Sierra del Ajusco to the south. An approximate elevation view is shown in figure 6-9. Tlahuac, which is considered to be in the Lake Zone, is located in the valley between these two groups of mountains. There were two seismographs located in Tlahuac; one at a pump station (Tlahuac Bombas, TLHB) and another at a sports club (Tlahuac Deportivo, TLHD). Two other Lake Zone seismographs were recorded north of the Cerro de la Estrella and the Cerro de Santa Catarina, at

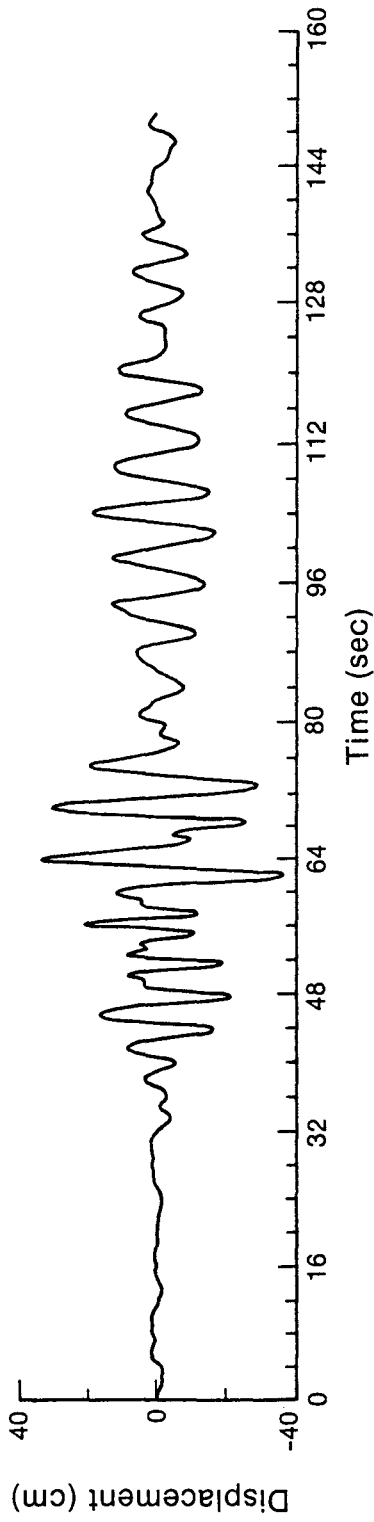
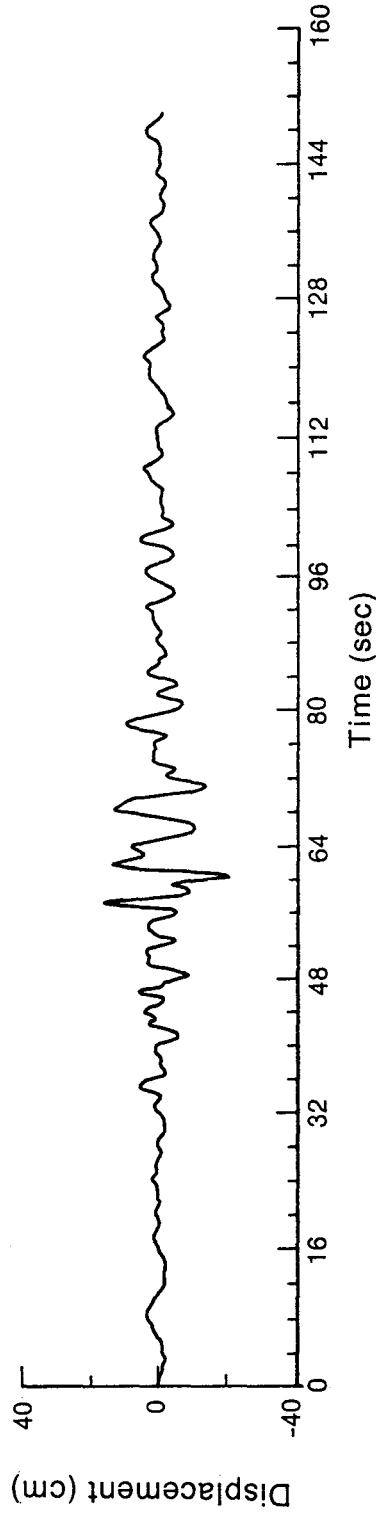
FIGURE 6-10 North-South Ground Displacement Time Histories At Tlahuac - 1985 Michoacan Earthquake

Another important factor is the large local variation in ground displacement near Tlahuac. Tlahuac Bombas and Tlahuac Deportivo are separated by about 3 km. Yet the horizontal ground displacements at THLB were roughly double those of THLD. This difference is shown graphically in figures 6-10 and 6-11. The North-South ground displacement time histories at THLB and THLD are shown in figure 6-10 while the East-West components at the two stations is shown in Figure 6-11.

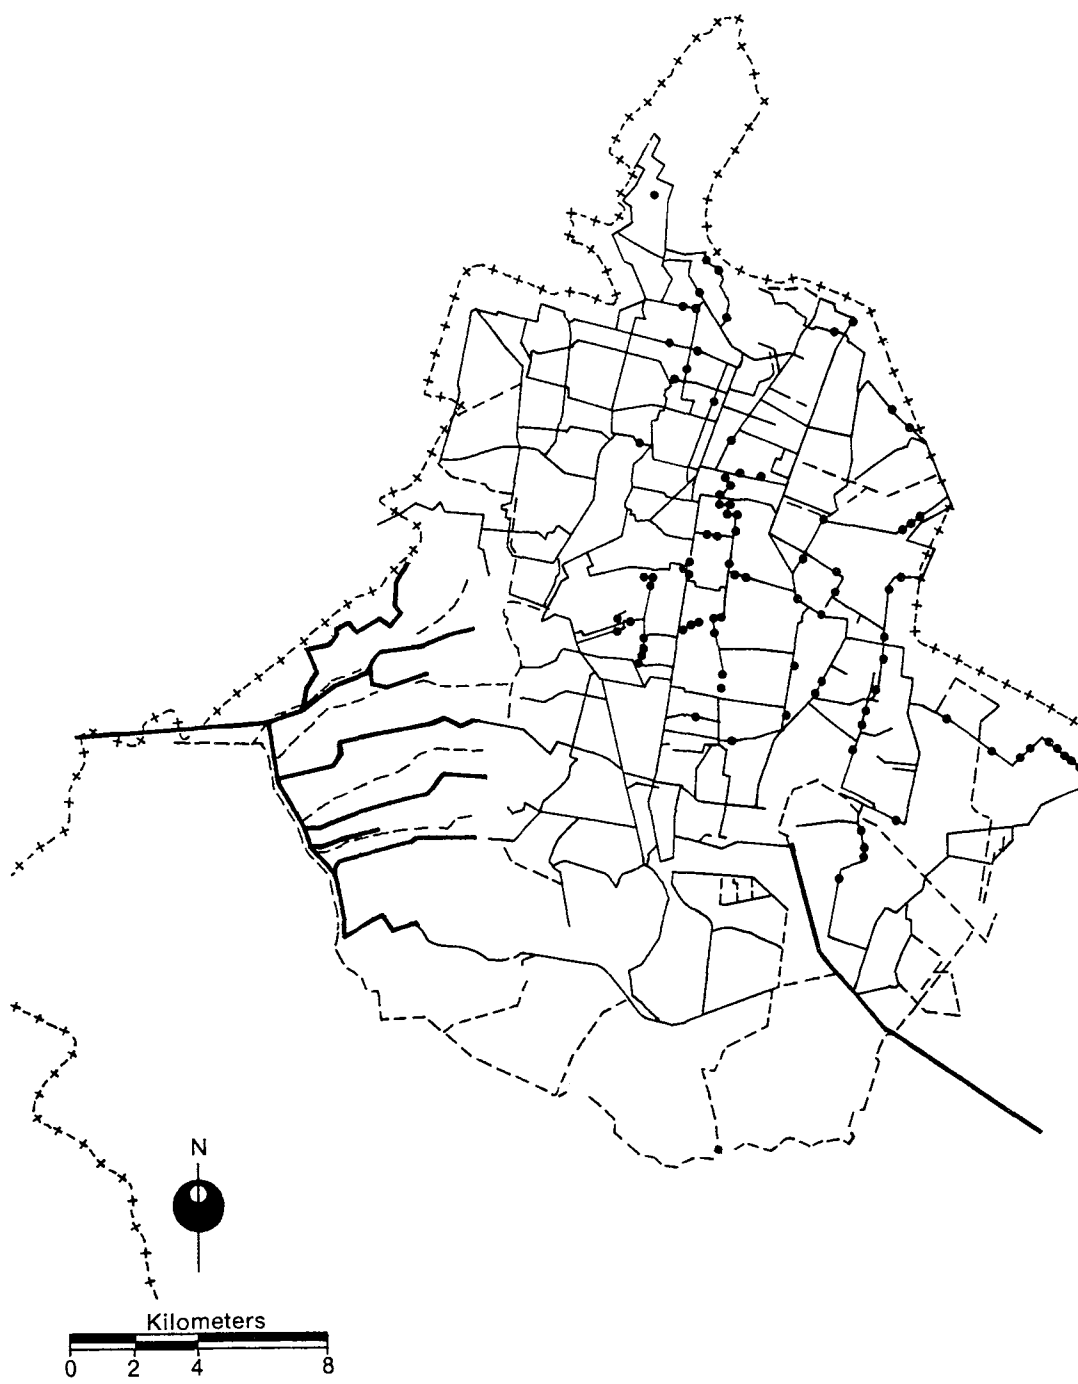
FIGURE 6-14 Well Documented Pipeline Damage In Primary Distribution System Of Federal District - 1985 Michoacan Earthquake

The geographical location of most of the D.F. primary distribution piping breaks were in the lacustrine soil region of the Texcoco and Chalco lakes (Lake Zone). These are shown in figure 6-14. On a smaller geographical scale, a substantial number of leaks/breaks occurred at joints located close to bends, T's, elbows and other hard spots such as junction boxes.

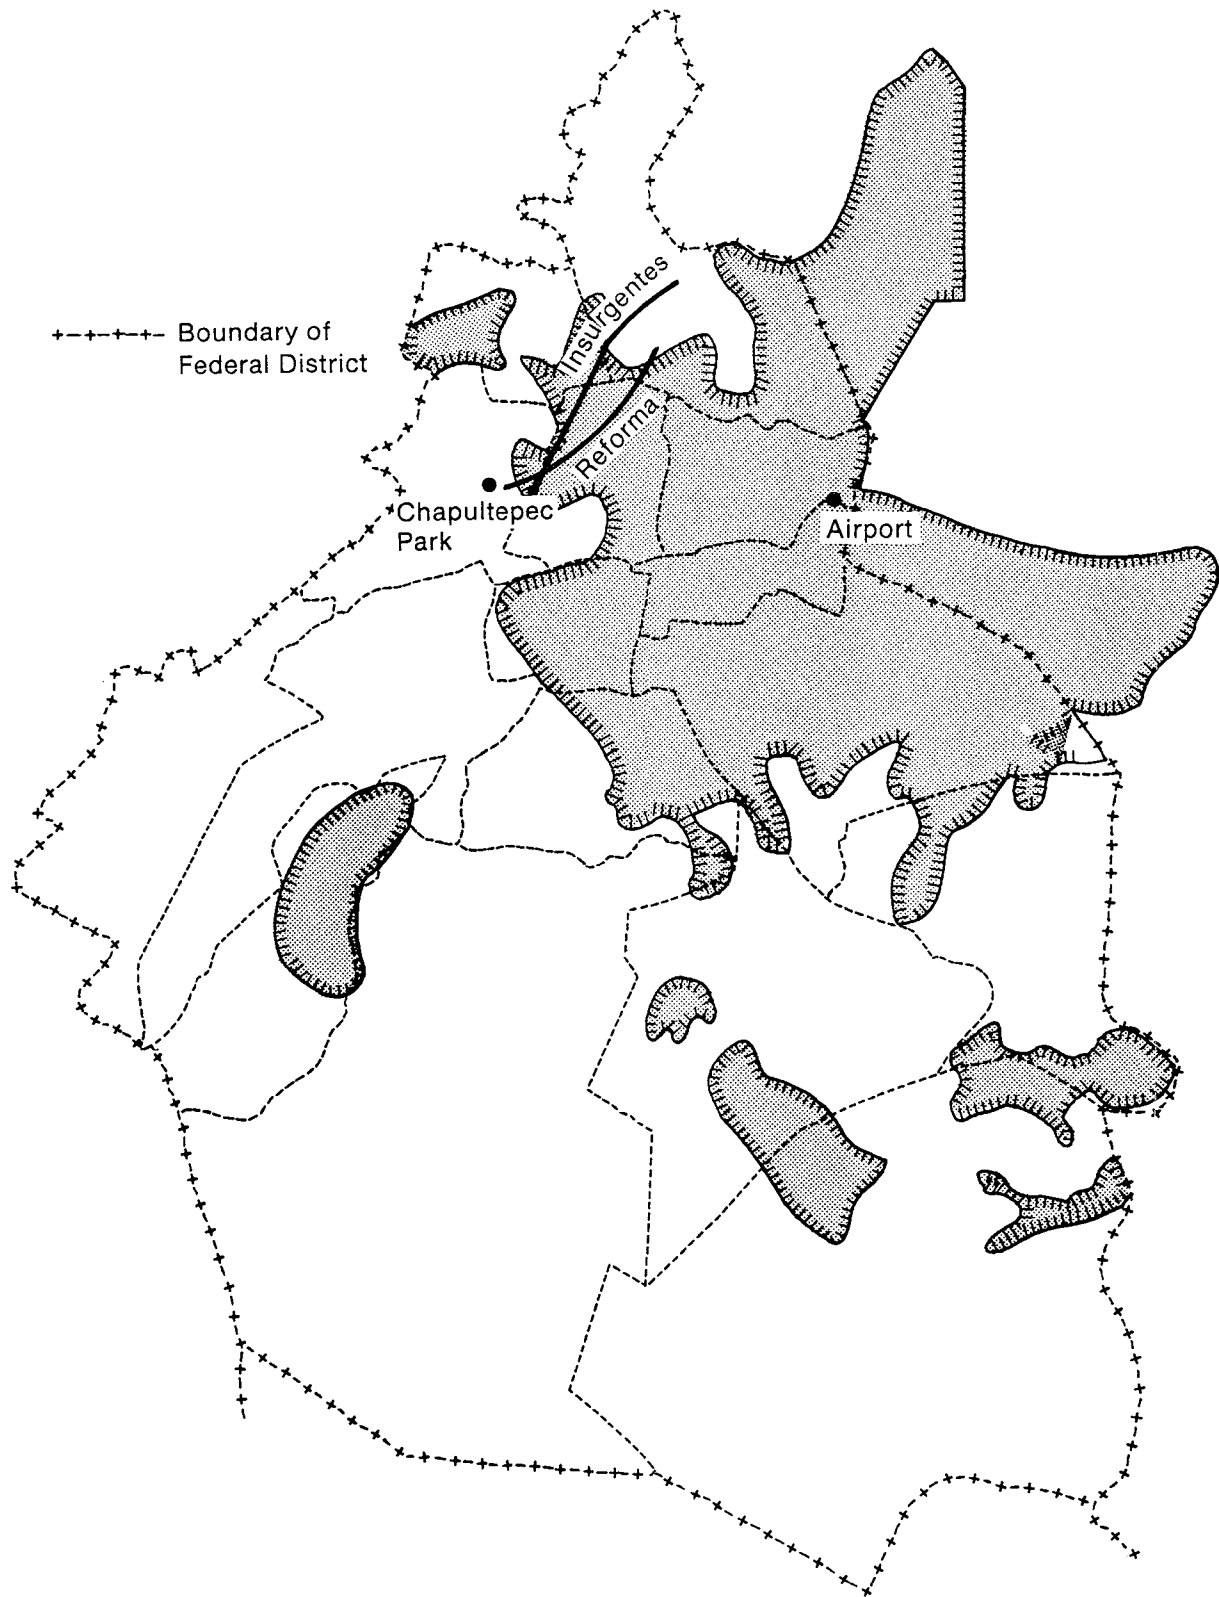
FIGURE 6-15 Areas Of Secondary Distribution System Damage - 1985 Michoacan Earthquake

The secondary distribution system controlled by the Federal District was also heavily damaged. As with the primary distribution system, secondary distribution pipelines in the Lake Zone were the most affected as shown in figure 6-15. In addition to the damage characteristics discussed above, a large number of old pipes made of clay and cast iron also broke. It appears that the older components were too rigid or too deteriorated to sustain any substantial earthquake induced deformation. Many special pieces, such as valves, connections, etc in the 2" to 18" diameter range failed. Table 6-IV present statistics of the reported damage while figures 6-16 and 6-17 show typical damage.

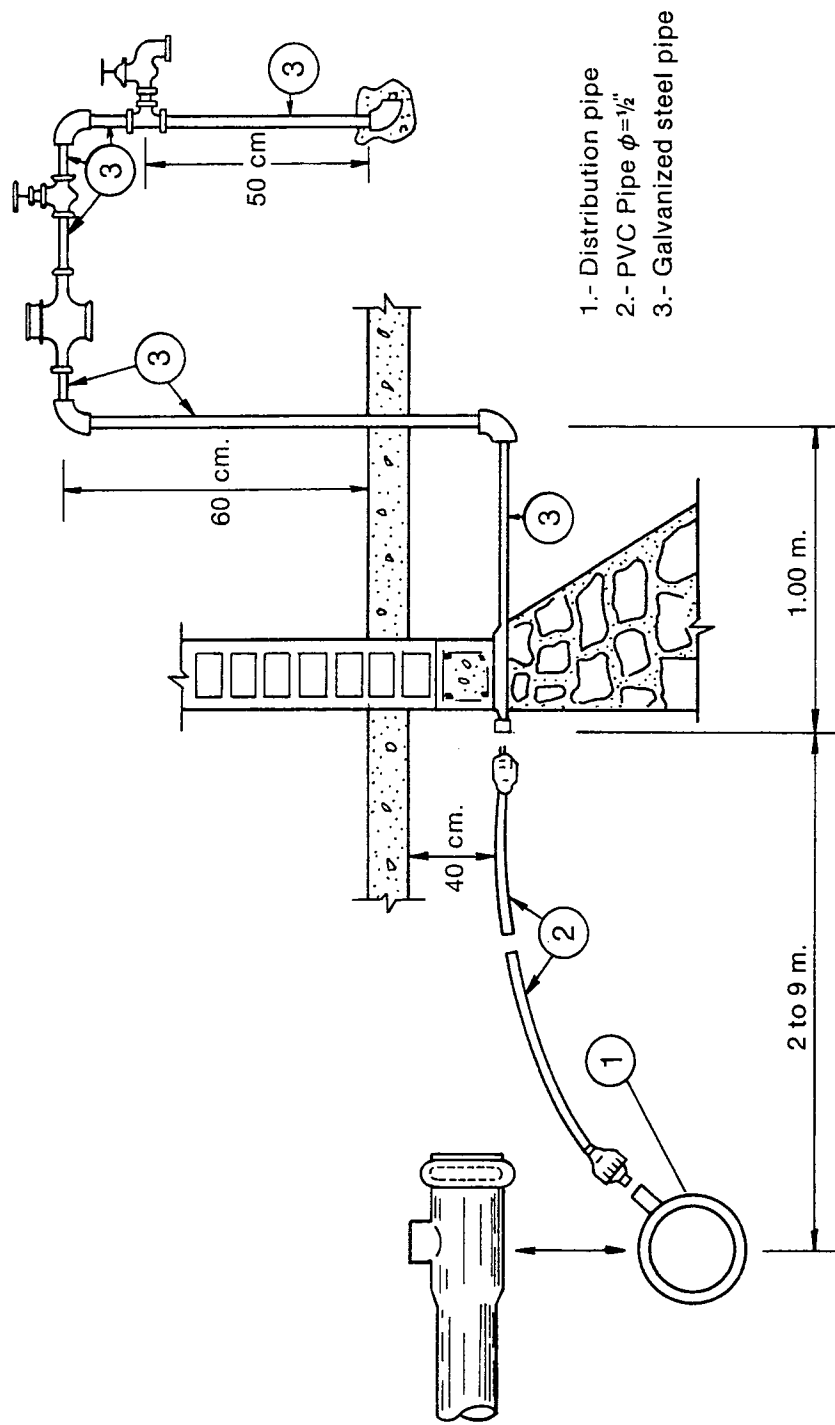
FIGURE 6-20 Typical Residential Service In The State Of Mexico (E.de.M.)

and also produced a relatively rigid connection at the street main service connection interface. On the other hand, service connections in the State of Mexico were made of plastic materials such as PVC. A typical flexible service connection that behaved successfully during the Michoacan earthquake is shown in figure 6-20.

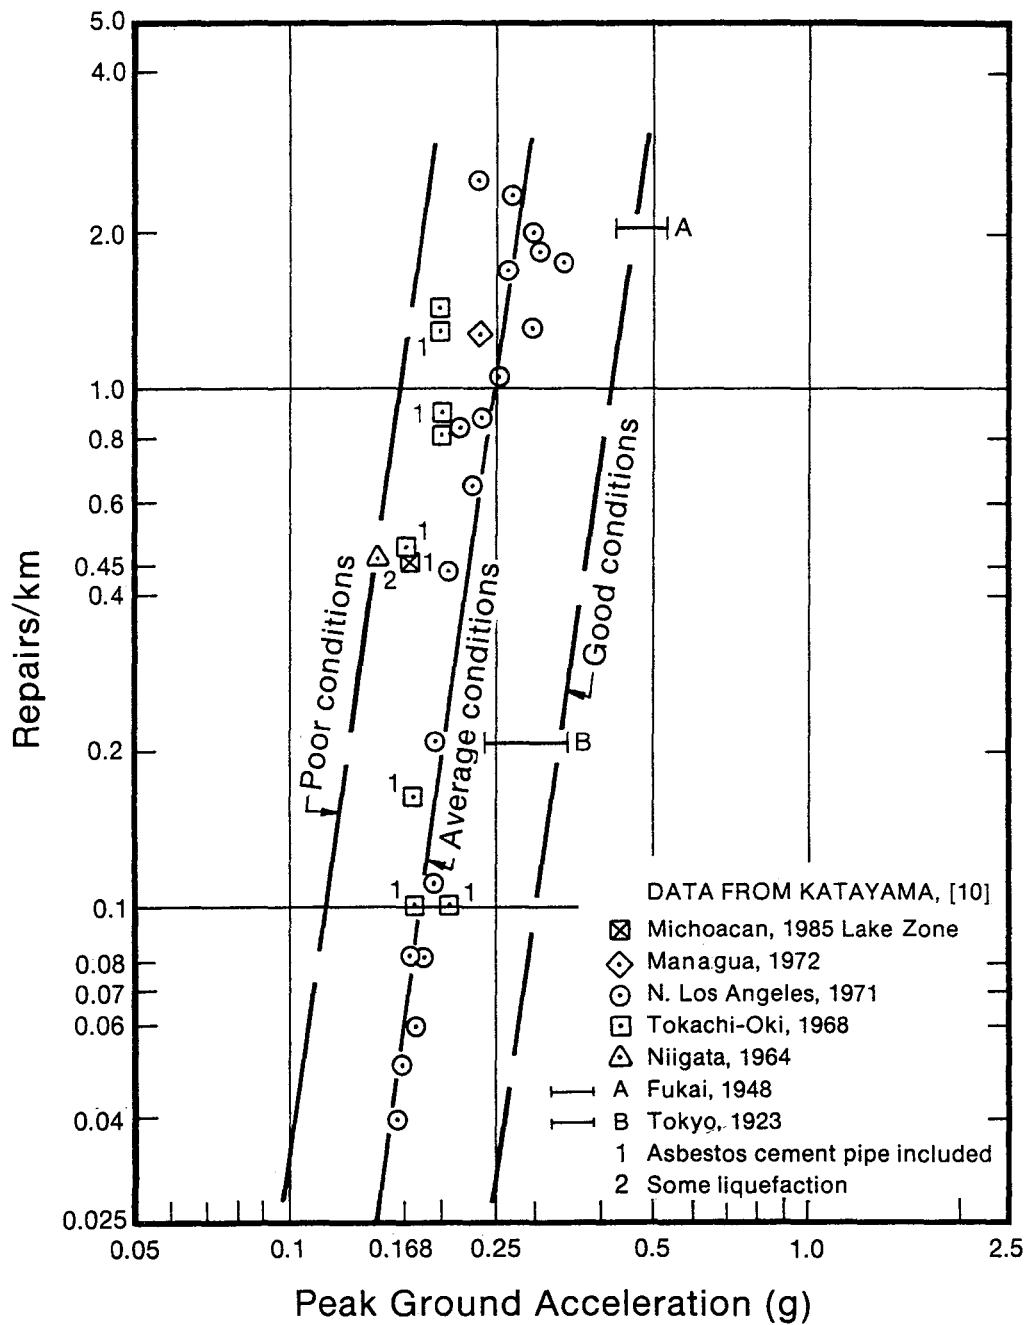
FIGURE 6-24 Pipe Repairs Per Km. Vs. Peak Ground Acceleration For Lake Zone In Mexico City 1985 And Other Historic Earthquakes

Figure 6-24 shows data on pipe repairs versus peak ground acceleration, presented by Bresko [9], and based on damage data gathered by Katayama, [10]. Mexico City data for the Lake Zone is included in this figure. It can be seen that data from Mexico City falls within the band of damage data of other major earthquakes. Bresko suggests, based on these data, that failure rates can be expressed in terms of maximum ground acceleration as

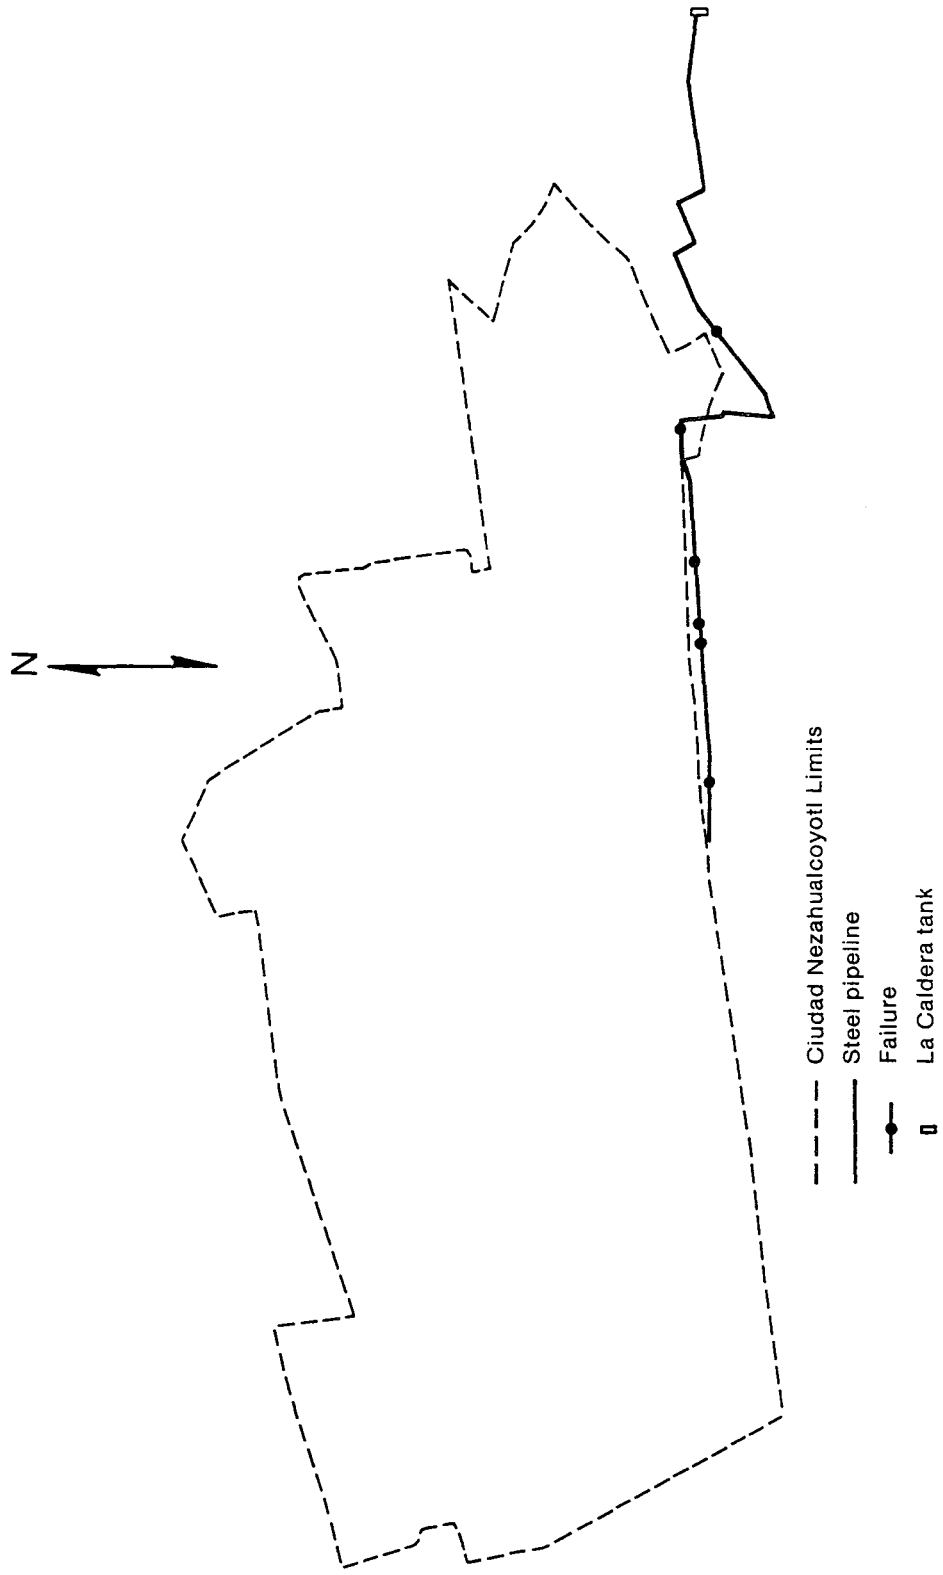
FIGURE 7-5 Reported Failures Along Steel Pipelines In Ciudad Nezahualcoyotl (E.de.M.) in 1985

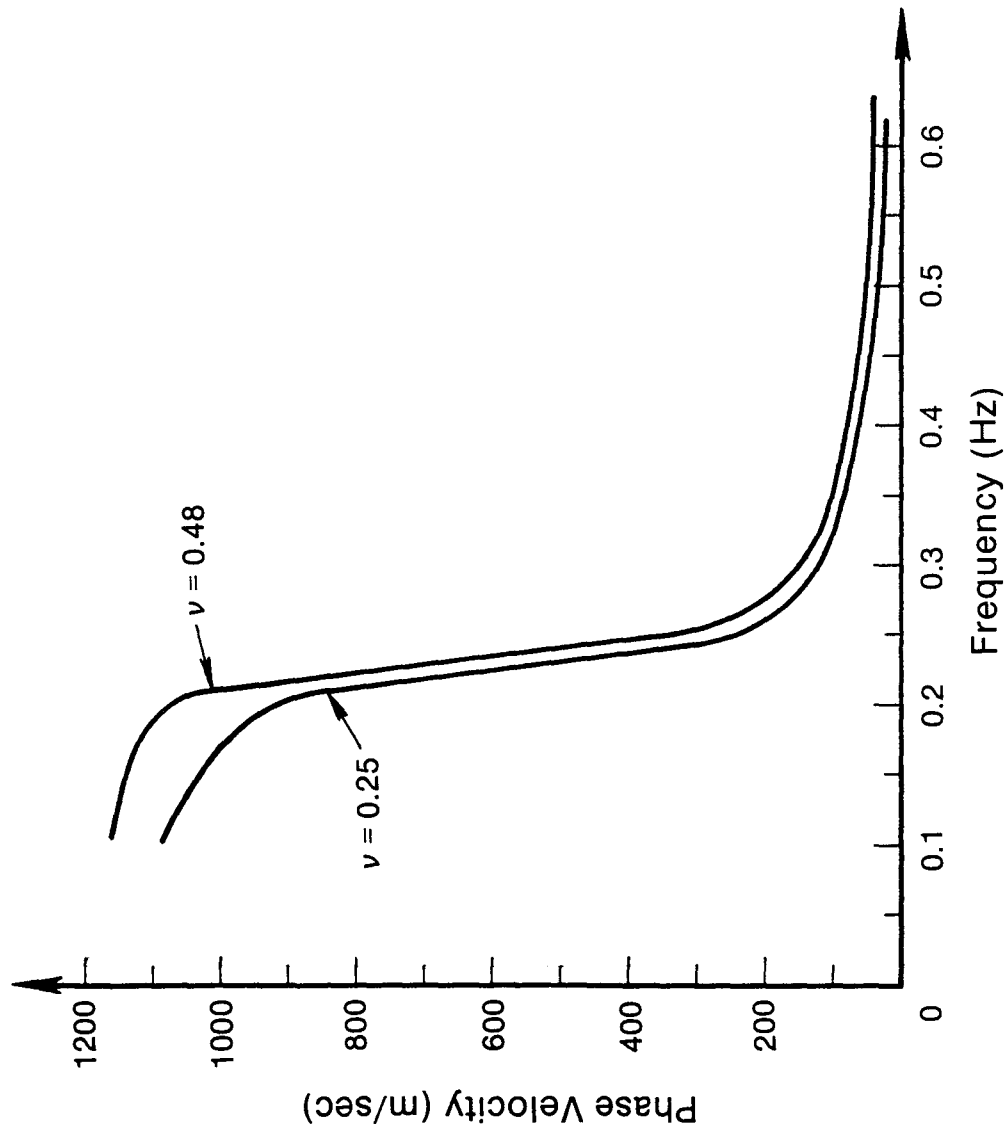
figure 7-1, the resulting R-wave dispersion curves for Poisson ratios ( $\nu$ ) of 0.25 and 0.48 are shown in figure 7-8. Notice for low frequencies (long wavelengths) the R-wave phase velocity is close to the shear wave velocity of the rock half space while at high frequencies (short wavelengths) the phase velocity is close to  $V_S$  for the soft top layer.

FIGURE 7-8 R-wave Dispersion Curve For Ciudad Nezahualcoyotl Site

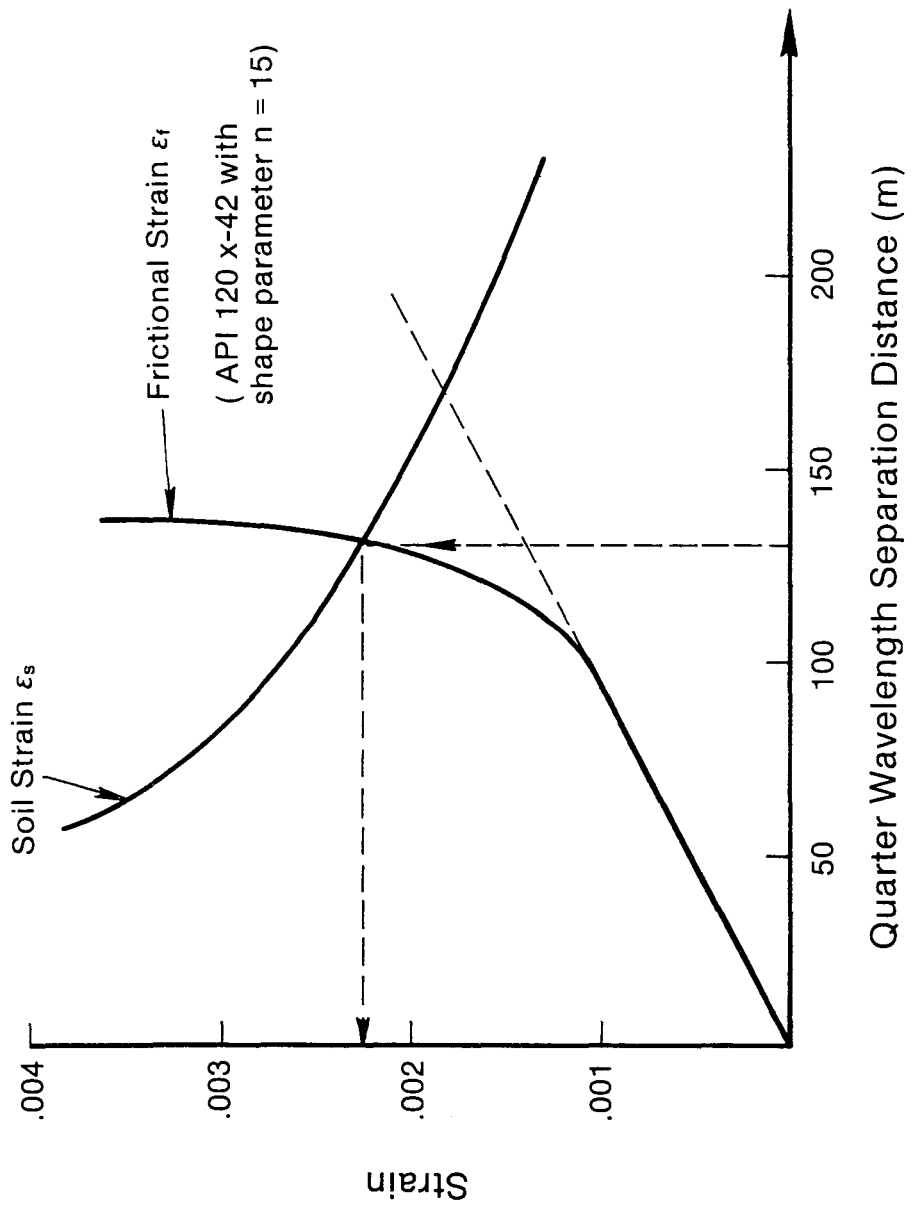
The variation of soil strain  $\epsilon_S$  with quarter wavelength separation distance is shown in figure 7-9 for an assumed Poissons ratio of 0.48. Note that the ground strain is a decreasing function of the quarter wavelength separation distance.

The actual maximum pipeline strain is the smaller of the ground strain  $\epsilon_g$  or the frictional strain  $\epsilon_f$ . Note for a quarter wavelength separation distance of about 130m,  $\epsilon_g = \epsilon_f$  and hence the actual maximum pipe strain is about 0.0023 by the procedure described above. Again using a Ramberg-Osgood model with shape parameter  $n=15$  for the API 120x-42 material, the corresponding actual maximum pipeline stress is about 40.9 ksi.

As mentioned previously, the observed locations of compressional wrinkling were at 300 to 500 meter spacings. Note that at any particular instant in time, the procedure described above suggests that areas of high compressive stress would occur at a spacing of about 520m. That is high compression regions are a wavelength apart, or 520m for the critical quarter wavelength of 130m.

FIGURE 7-9 Soil And Friction Strain For Ciudad Nezahualcoyotl Pipeline

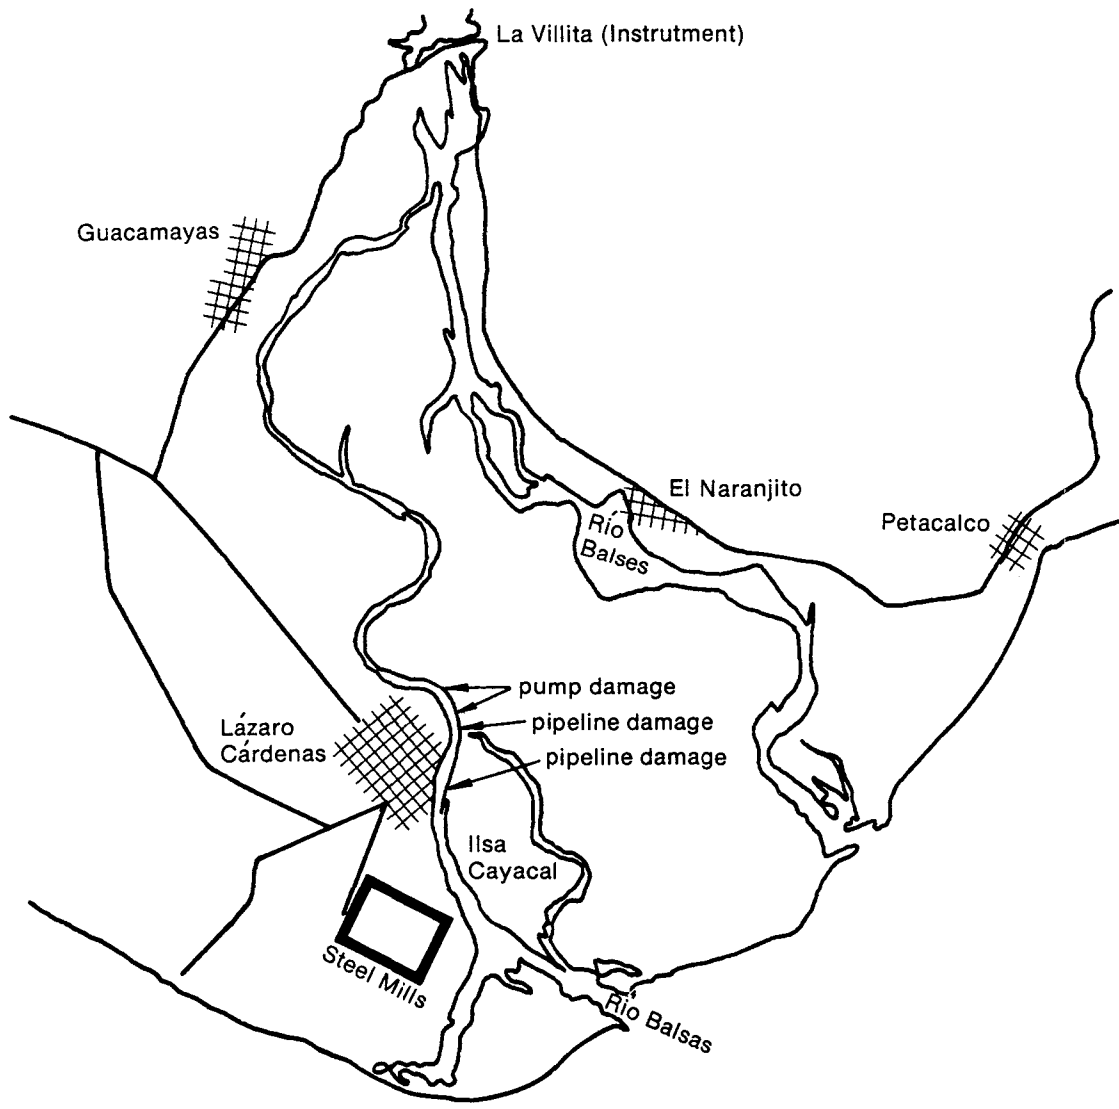
In contrast to the heavy damage experienced by the Mexico City water systems, water supply in the epicentral region was lightly damaged. In the industrial part of Lazaro Cardenas, wells, above ground pipelines and buried pipelines were damaged. The locations of water system damage in the epicentral region is shown in figure 9-1. Presented below is a description of the specific damage.

The 72"φ reinforced concrete pipeline mentioned above in (b) was buried over part of its length. Seismic damage along the buried portion of this line occurred near a thrust block.

FIGURE 9-1 Water System Damage In Epicentral Region - 1985 Michoacan Earthquake
