### **REPAIR AND STRENGTHENING OF BEAM-TO-COLUMN CONNECTIONS SUBJECTED TO EARTHQUAKE LOADING**

February 28, 1989

Technical Report NCEER-89-0013

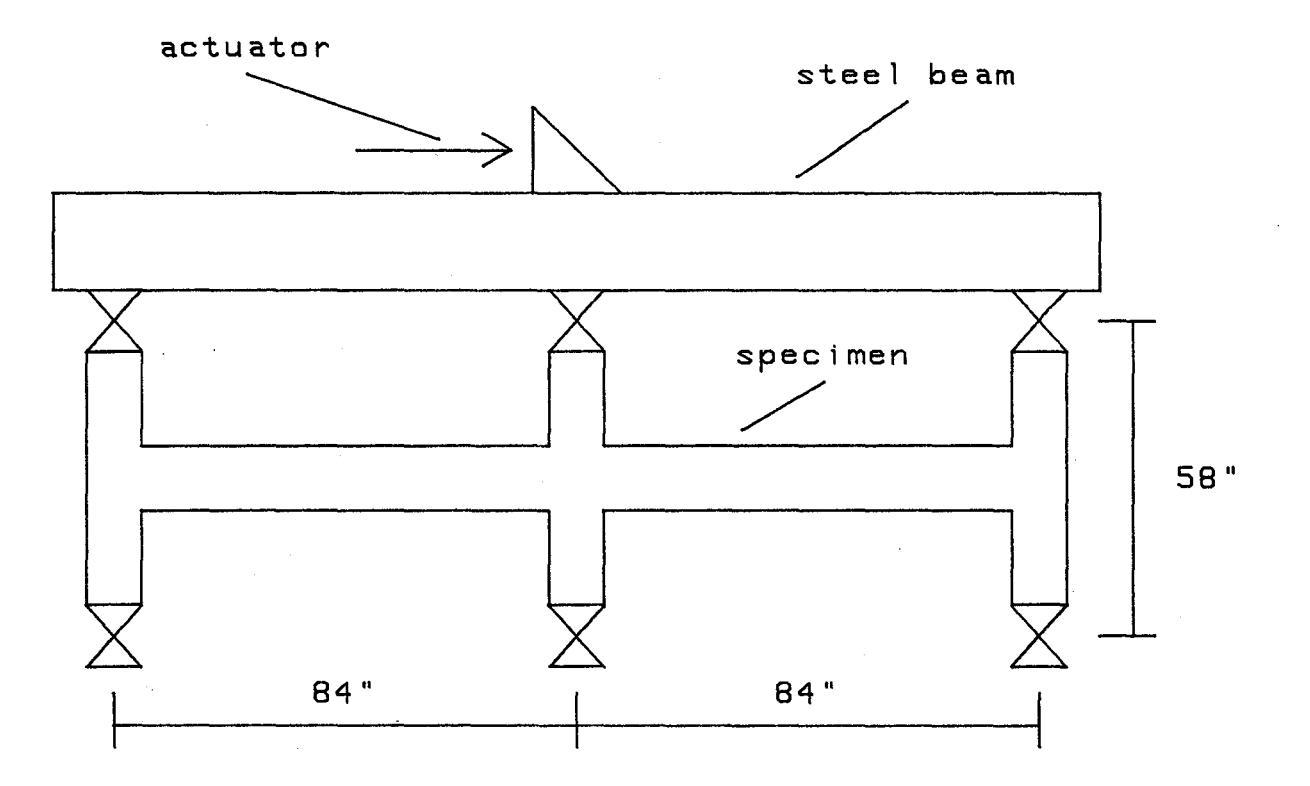
FIGURE 3-17 Test Setup Detail

The subassemblies were tested in a steel reaction frame as shown in figure 3-17. Columns were pin-connected at the top to a beam capable of horizontal movement. A single actuator was used to impose predefined cyclic displacement routine at the top ends of the columns. The bottom ends of the columns were connected to hinges that rested on hydraulic jacks for the application of axial load to the columns. A stationary link beam connected to the bottom hinges provided lateral restraint to all columns. This type of testing arrangement takes into account the P- $\Delta$  effect experienced in actual buildings. Figure 3-18 shows the actual test set up during testing of a multiple-connection subassembly. The single-connection assemblies were tested in a similar manner except that the beam ends were supported on rollers to simulate the point of inflection at mid-span as shown in figure 3-19.

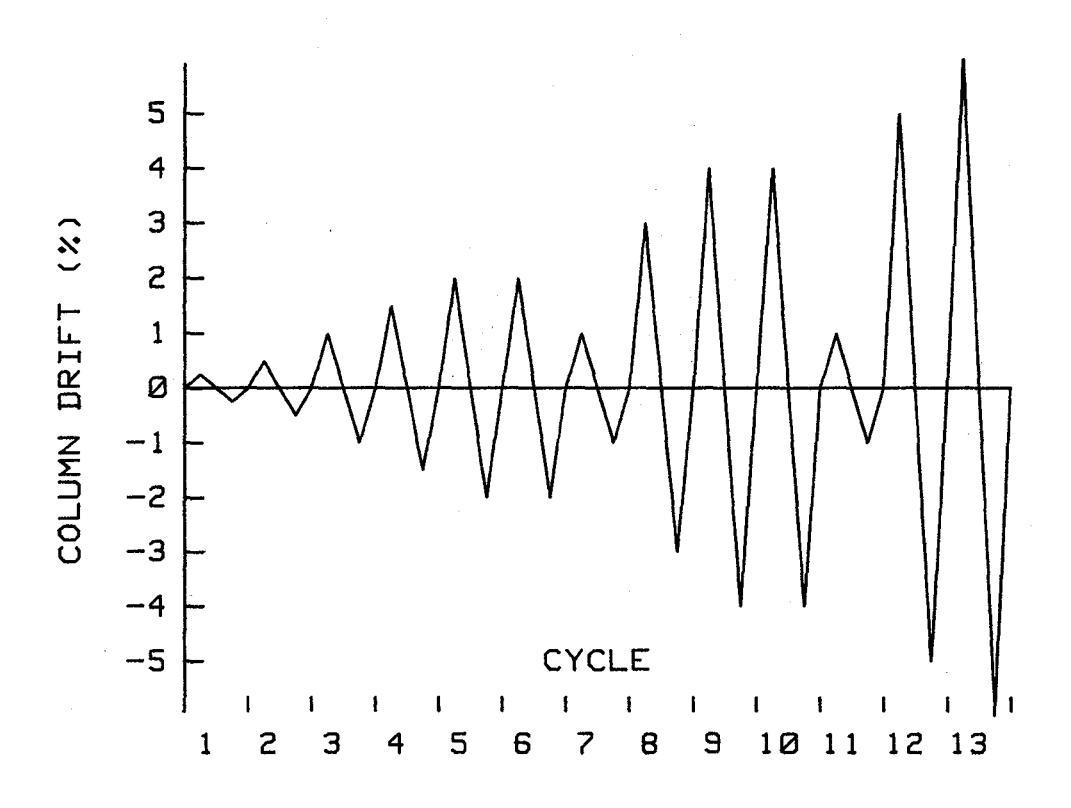
FIGURE 3-20 Displacement Routine

The specimens were subjected to a predefined displacement routine that consisted of 13 cycles of increasing amplitude. As shown in figure 3-20, certain cycles were repeated to measure the degradation of strength. Small amplitude cycles were also introduced into the loading routine to measure the lateral load stiffness of the specimen near zero displacements. Each specimen was externally instrumented to record various response parameters. The measurements and miscellaneous data recorded during each test consisted of load-displacement curves, axial forces in the columns, the distribution of lateral load among the columns, strain measurements in beam, slab, and column reinforcement, rotation of the beam flexural hinging region, and the distribution of cracks in beams, columns, and the slab where present.

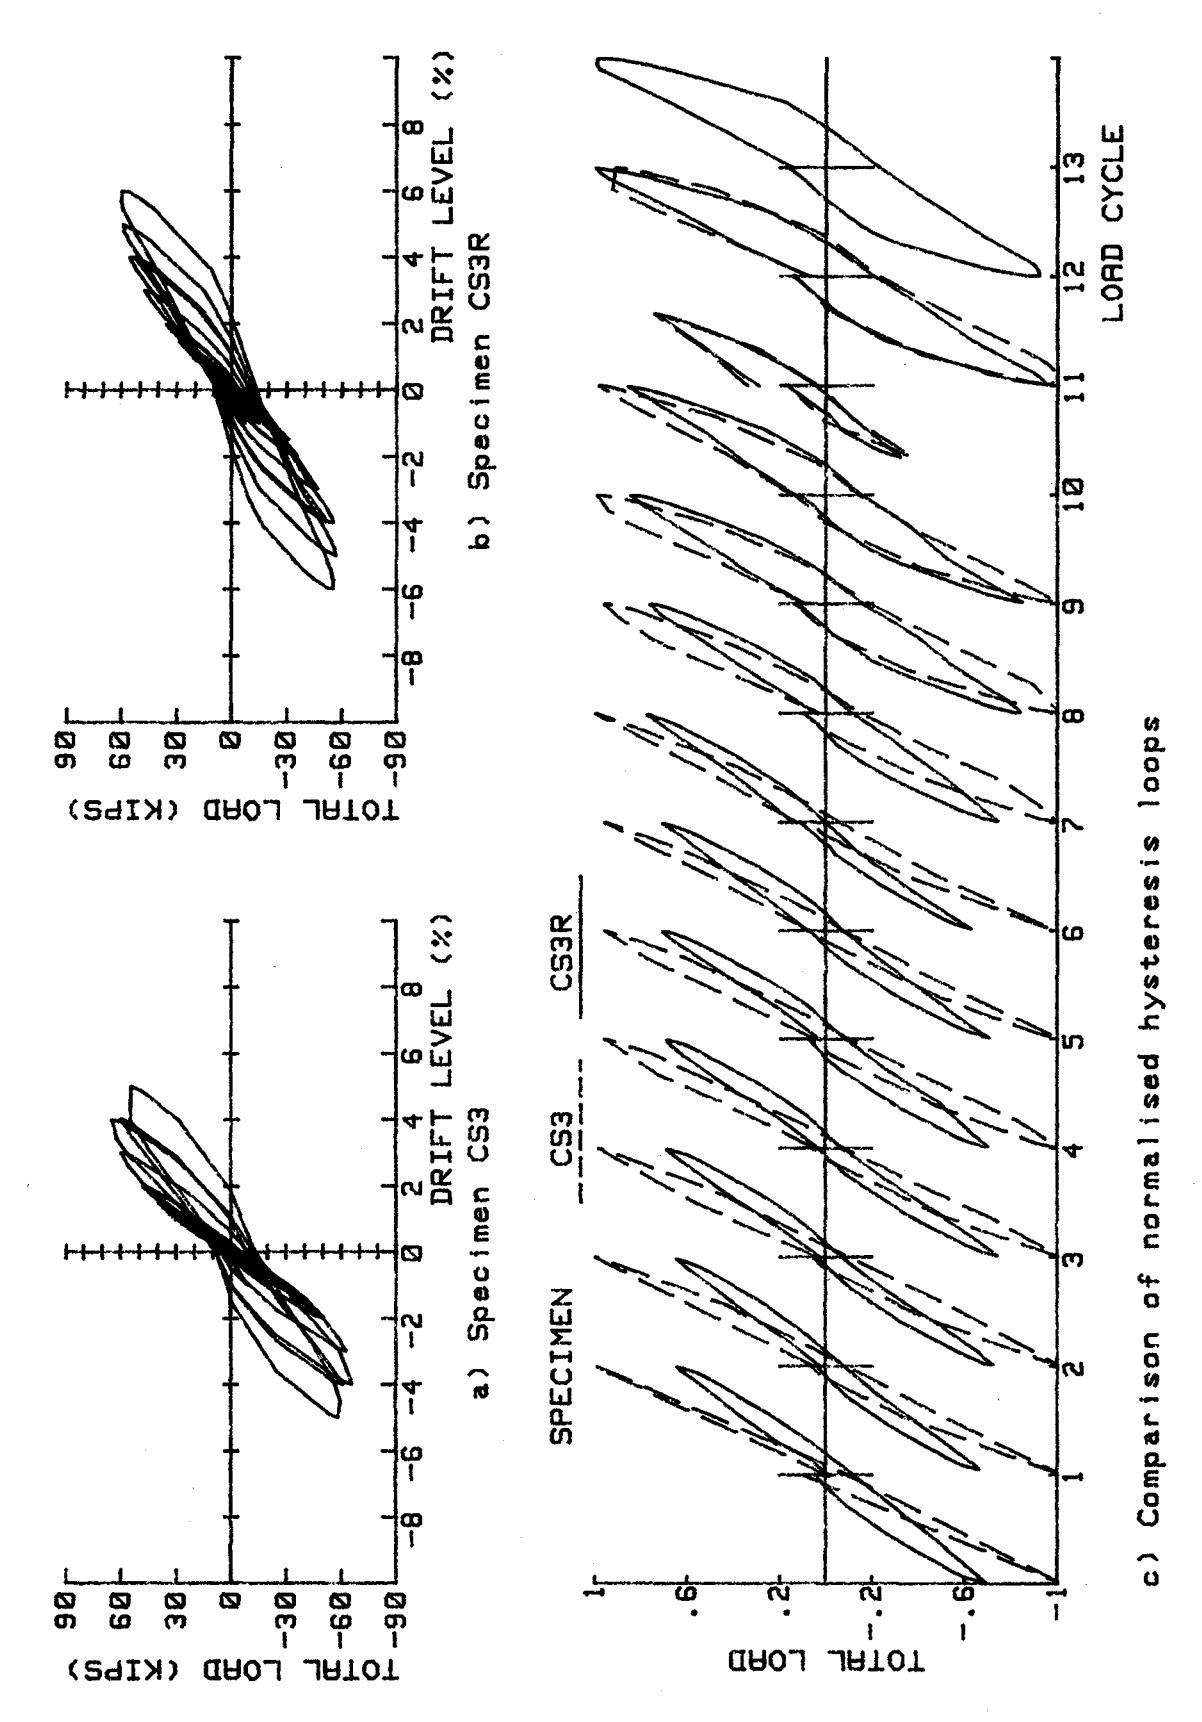
FIGURE 4-9 Load vs. Displacement Plots of Specimen CS3R

In the case of specimen CS3R, there are only small differences in the rates of decay of stiffness parameters over the duration of the test. The most noticeable difference is in the unloading stiffness, where the repaired specimen shows an improved performance. This is attributed to the better performance of the epoxy mortar due to its higher tensile strength.

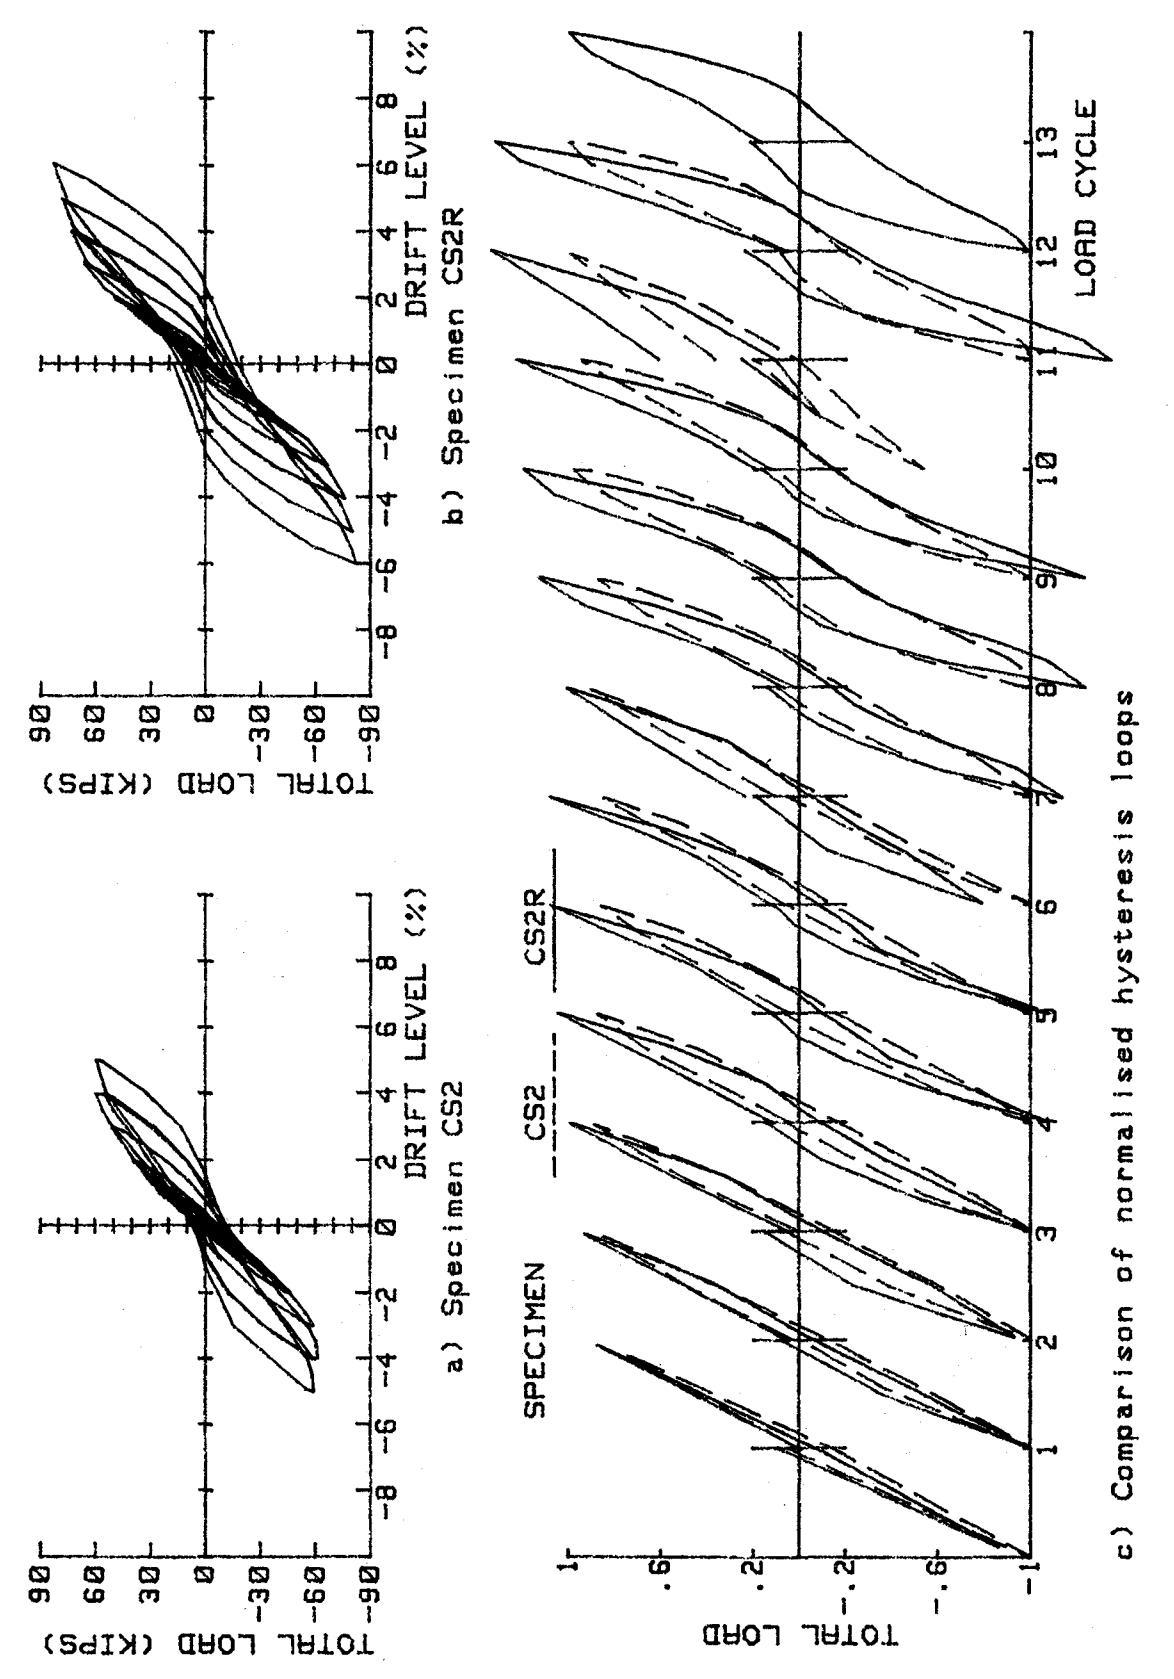
The load vs. displacement plots of specimens CS2R and CS4R are shown in figures 4-31 and 4-35, respectively. These plots show similarities in the behaviors of these two specimens after repairs. In both cases the stiffness after repairs is very much similar to that before repairs during the first few cycles indicating that the increase in stiffness resulting from the larger columns was offset by the reduced stiffness of the beams. The reduction in beam stiffness is attributed to the inadequacy of the epoxy injection process in repairing the damage. This deficiency is further indicated by pinching of the loops during the early cycles. The effect of the increased column size is manifested in an increase in stiffness during the later loading cycles.

FIGURE 4-31 Load vs. Displacement Plots of Specimen CS2R

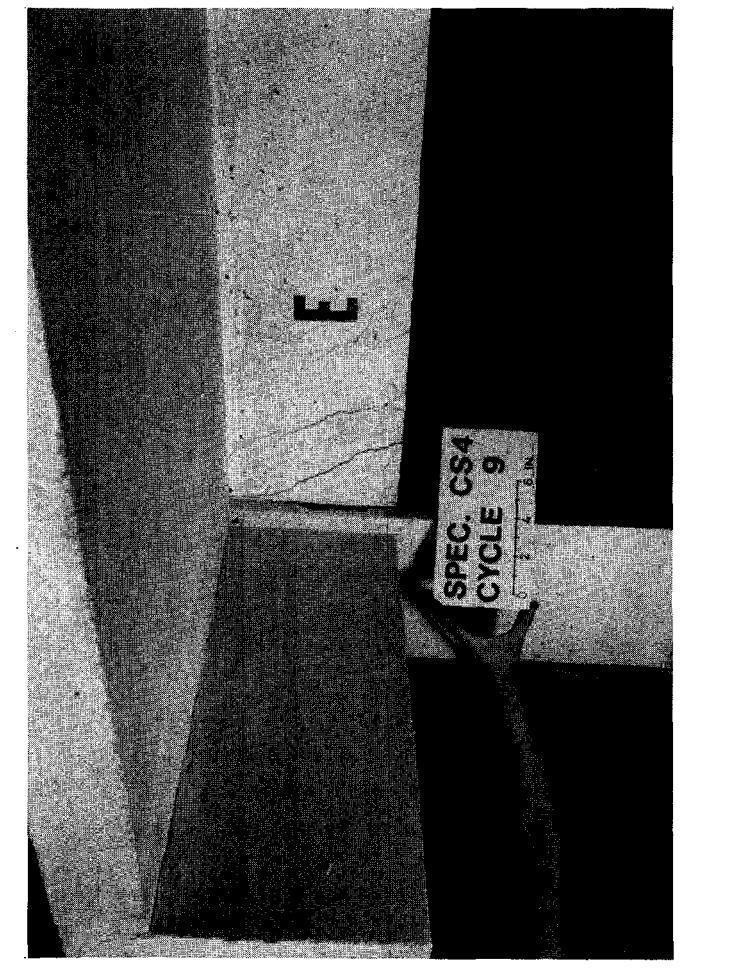
FIGURE 4-34 Damage in Specimen CS4R Before and After Repairs

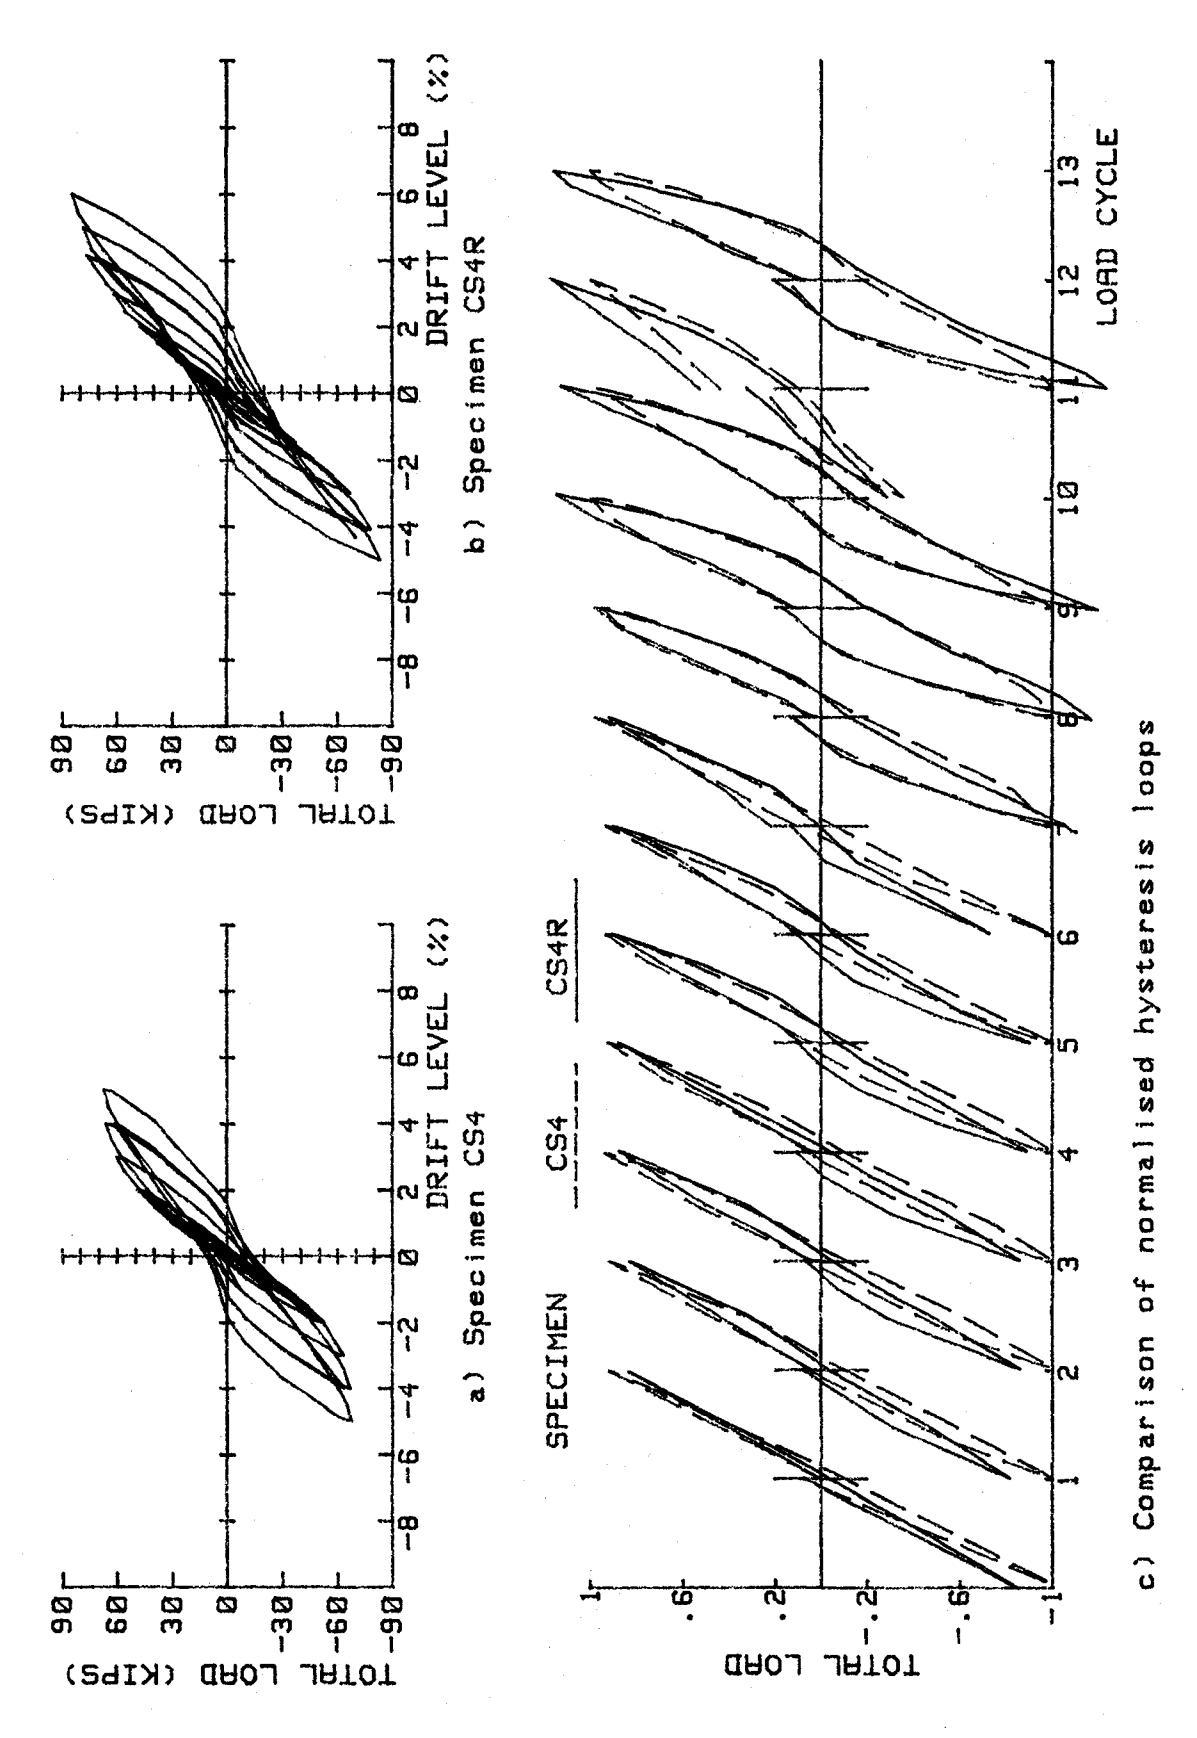
FIGURE 4-35 Load vs. Displacement Plots of Specimen CS4R

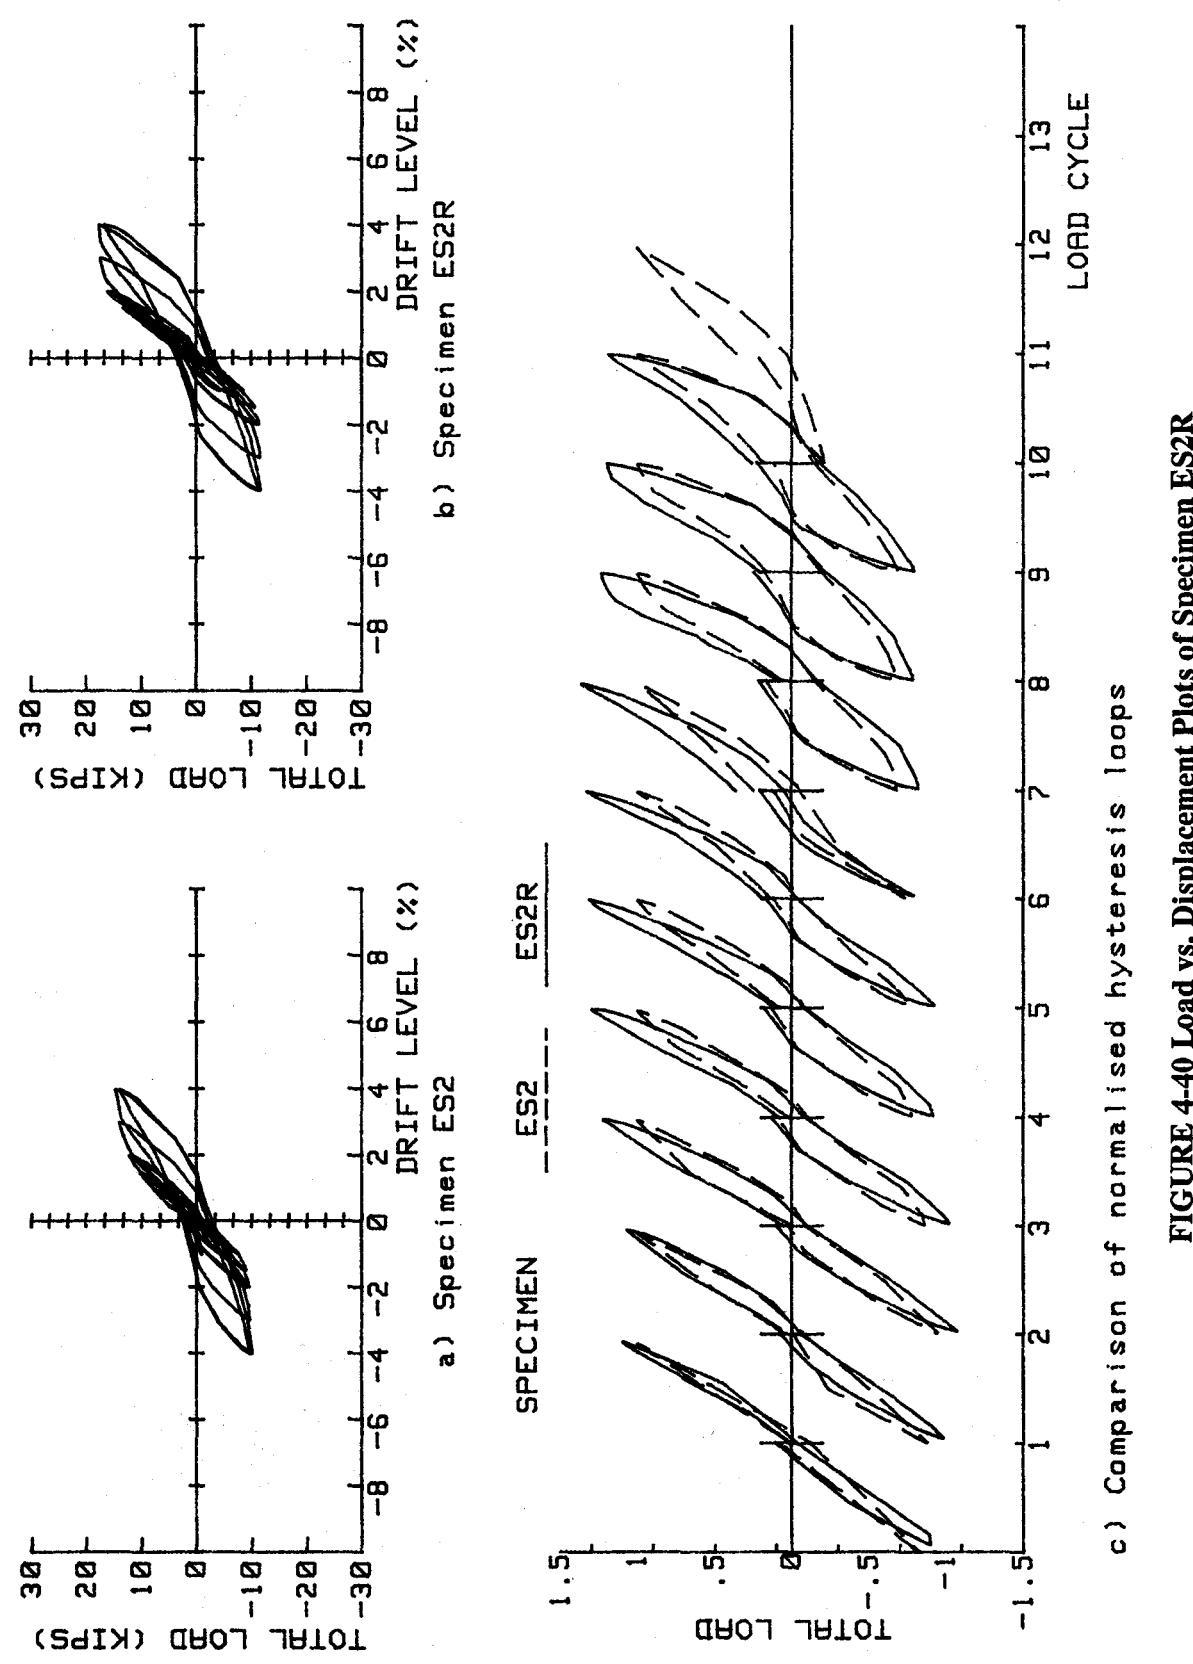
The load vs. displacement plots for these two specimens are shown in figures 4-40 and 4-45. In both cases, the specimens were stronger and stiffer after repairs even during the first few cycles. This is to be expected in repairs and strengthening with the addition of external steel elements.

FIGURE 4-40 Load vs. Displacement Plots of Specimen ES2R
