GEOTECHNICAL AND LIFELINE ASPECTS OF THE OCTOBER 17, 1989 LOMA PRIETA EARTHQUAKE IN SAN FRANCISCO

T. D. O'Rourke, H. E. Stewart, F. T. Blackburn, and T. S. Dickerman

Technical Report NCEER-90-0001

January, 1990

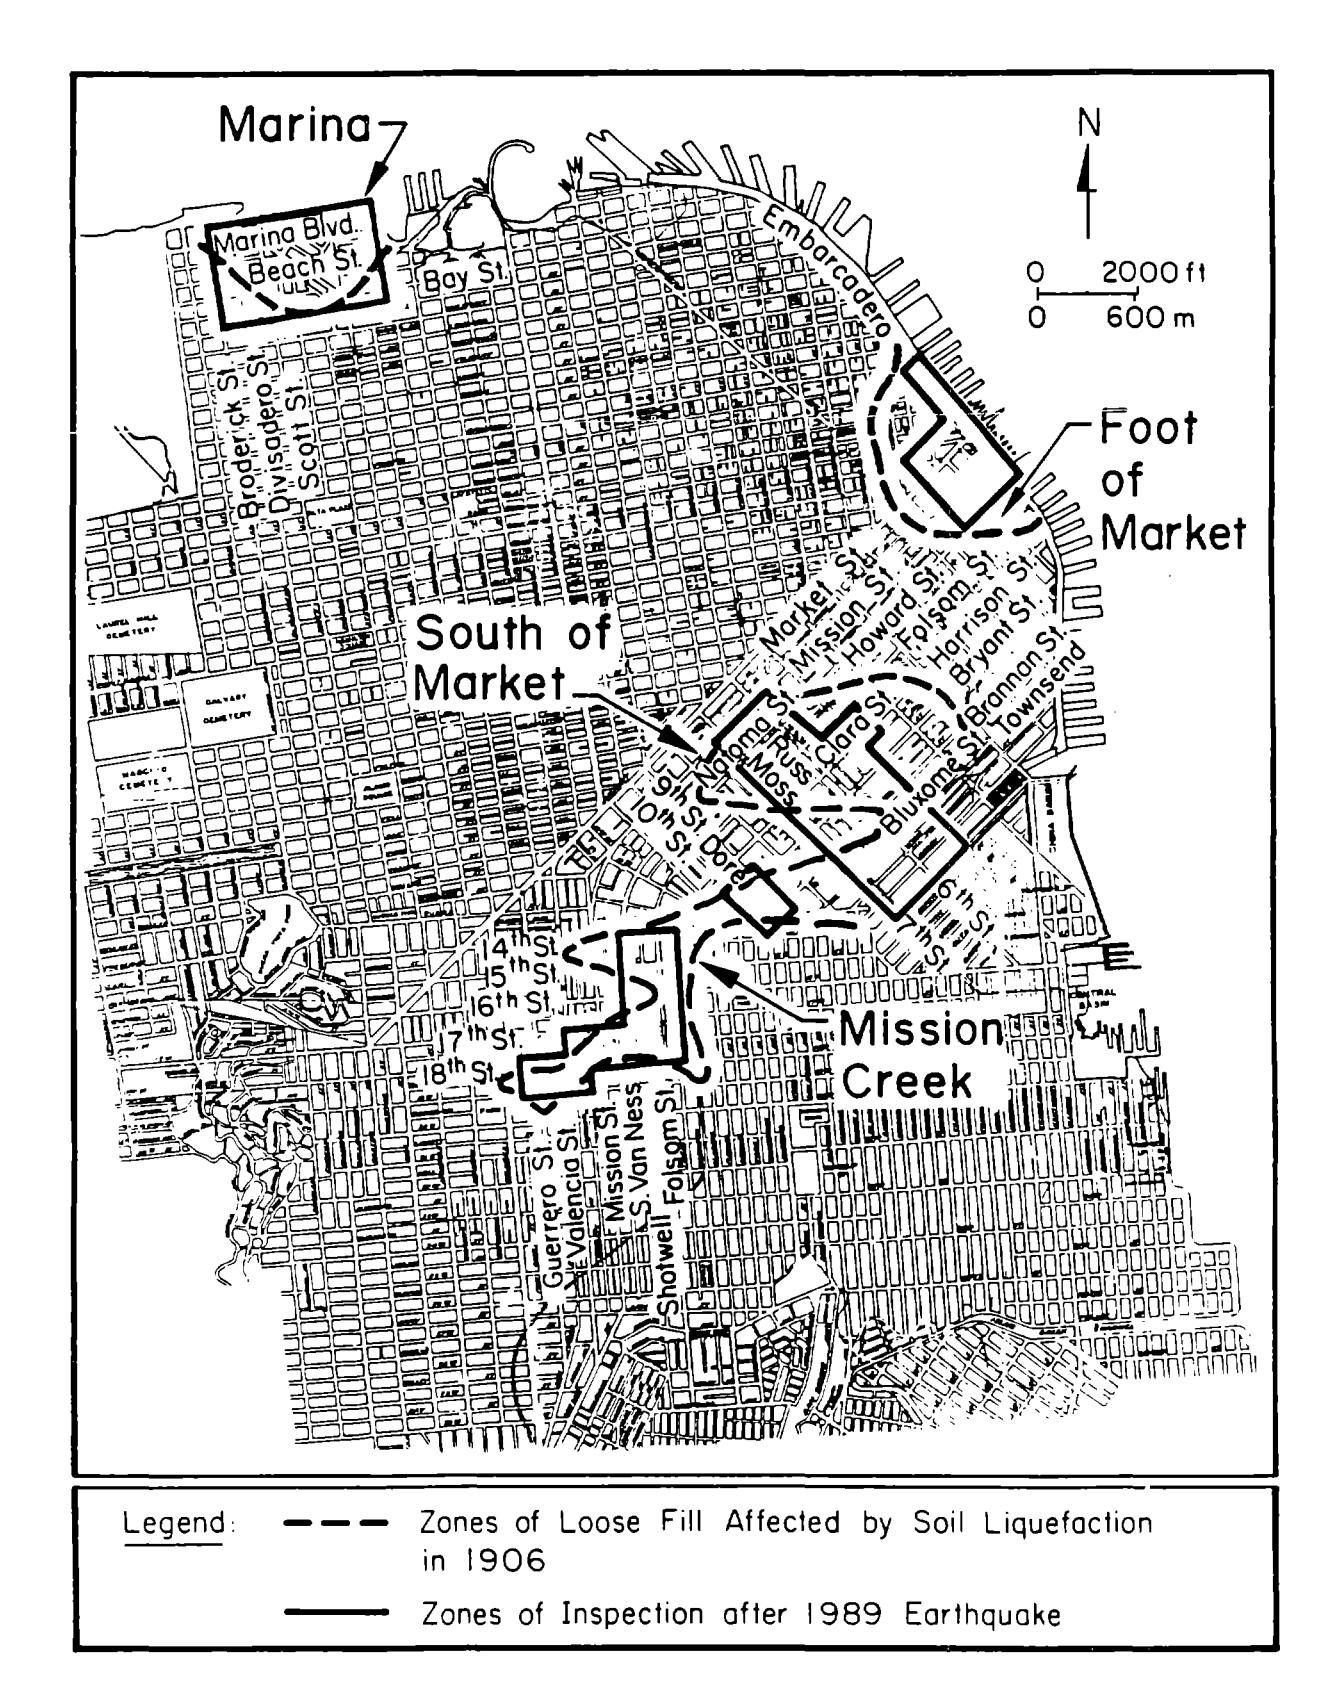
Figure 2-1 shows four areas within San Francisco for which there is historical evidence of soil liquefaction and large ground deformations during the 1906 earthquake. These areas, which are bounded by dashed lines, include the Mission Creek, South of Market, Foot of Market, and Marina districts. Each of these areas was investigated after the 1989 earthquake within the approximate boundaries shown by the solid lines.

FIGURE 2-1. Plan View of San Francisco Showing Zones of 1906 Soil Liquefaction and Inspection after the 1989 Earthquake

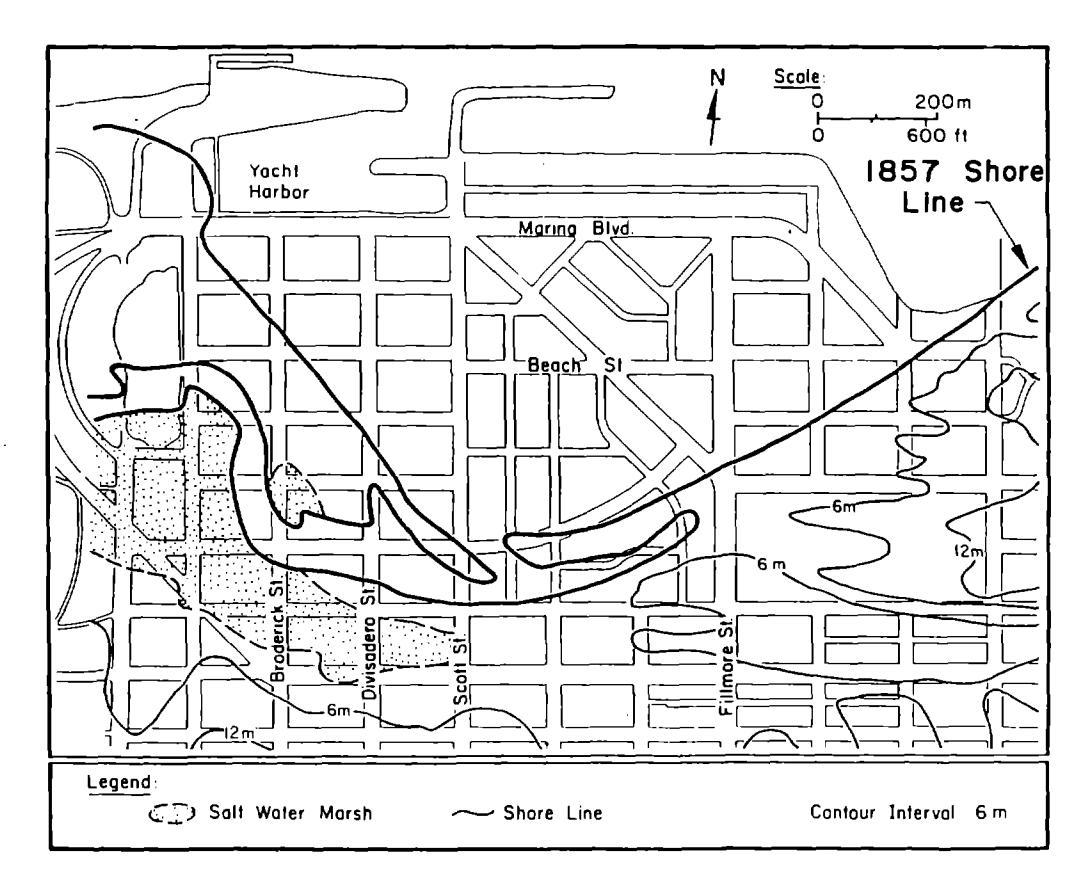
Figure 2-14 shows a plan view of the Marina on which is superimposed the 1857 shoreline, as mapped by the U.S. Coast Survey [1857]. Along its western boundary, there was a prominent sand bar known as Strawberry Island, with adjacent salt water marshes. Sand dunes, 6 to 12 m high, were located south of the shoreline and marshy ground.

FIGURE 2-14. Marina District Showing 1857 Shoreline

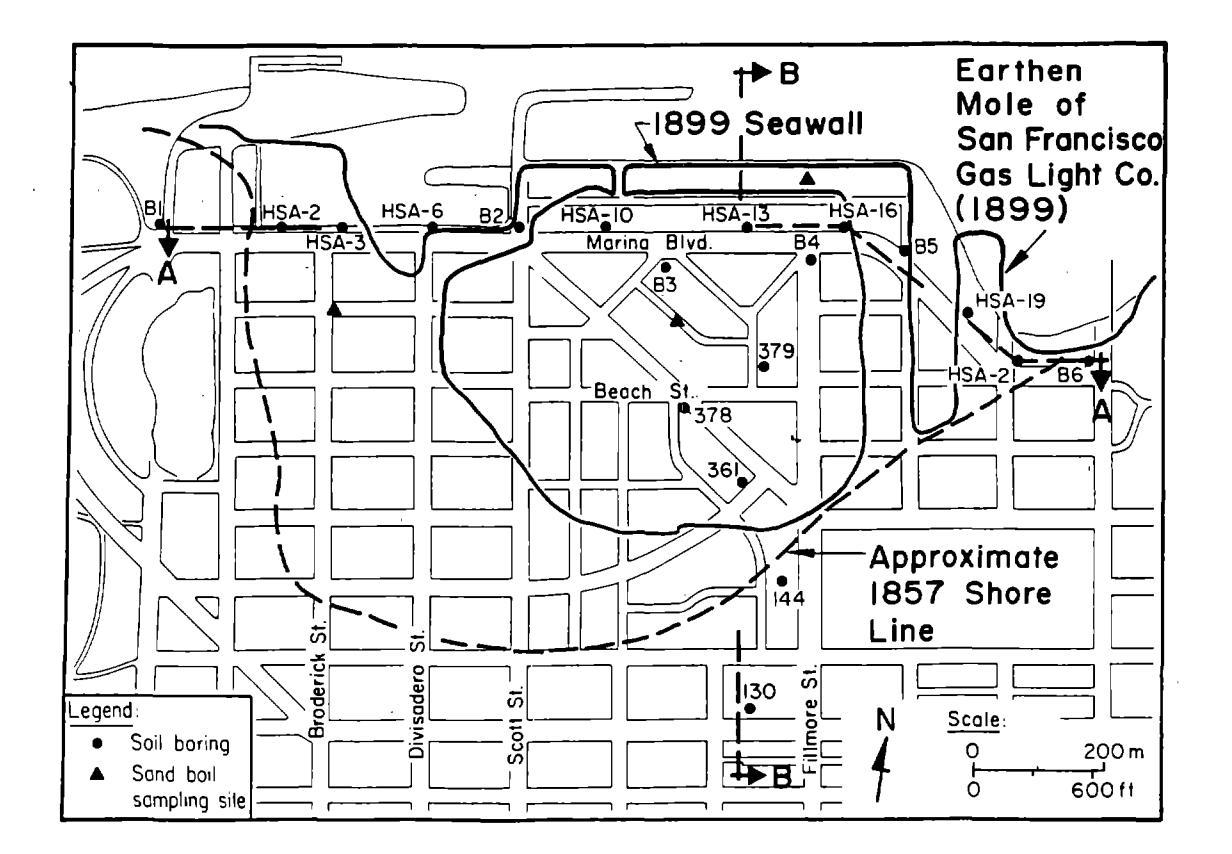
Figure 2-18 shows the locations of two subsurface cross-sections, A-A' and B-B'. Cross-section A-A' in Figure 2-19 is along Marina Blvd. from Lyon to Laguna Sts., and was developed primarily from borings performed for the North Shore and Channel Outfalls Consolidation Project [Dames and Moore, 1977]. Cross-section

FIGURE 2-18. Plan View of Soil Profile Locations for the Marina District

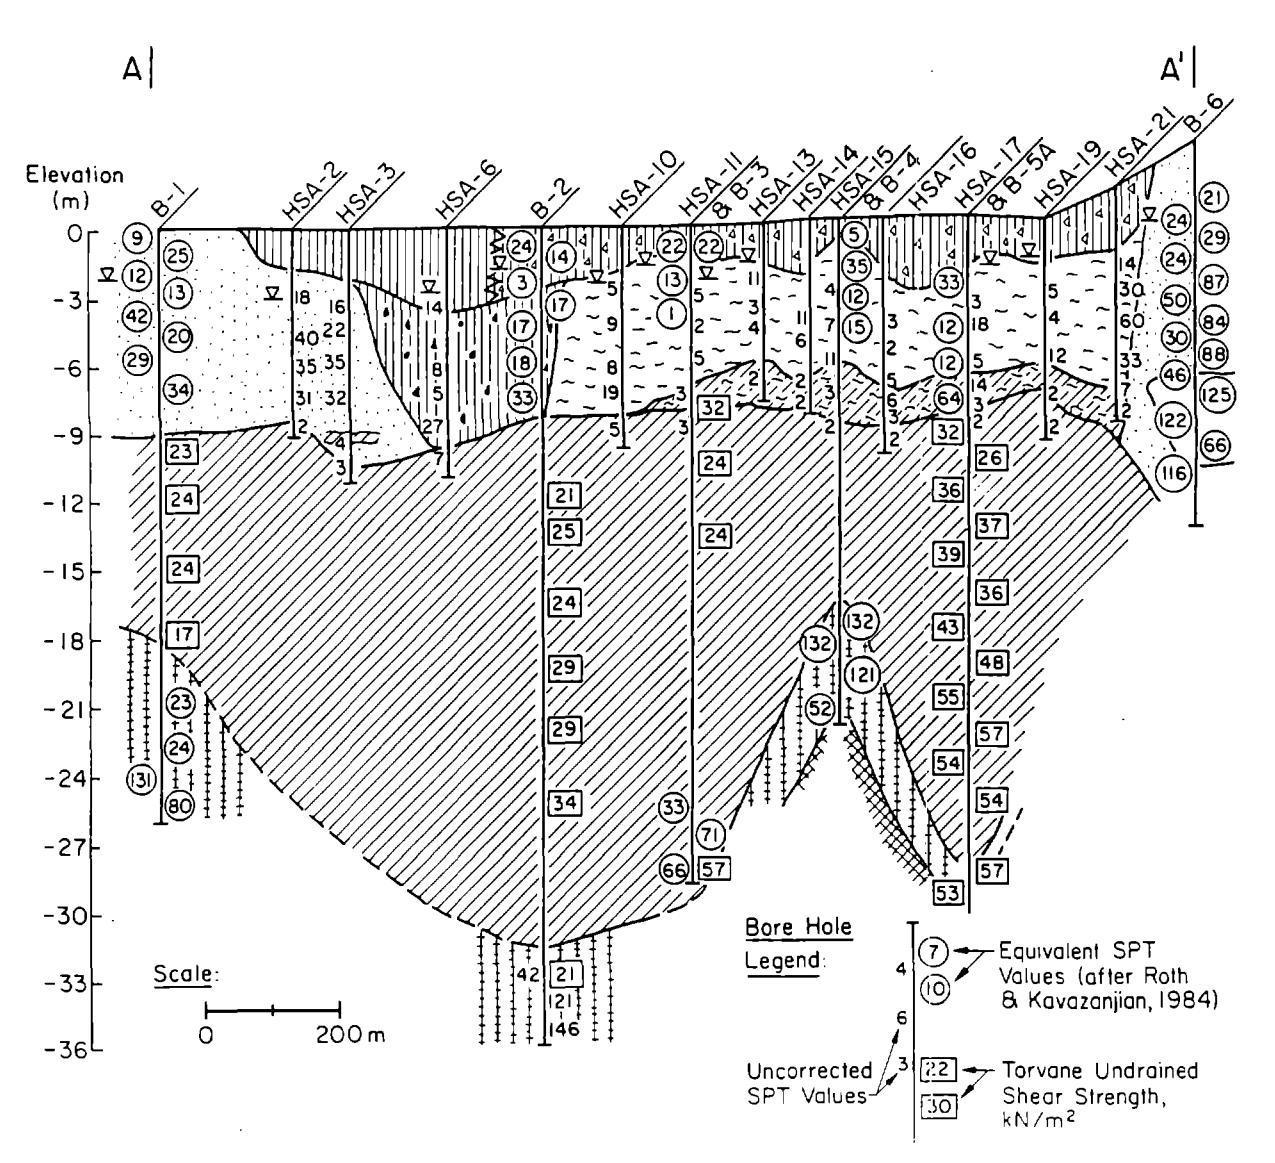
Figure 2-19 shows loose fill with a maximum depth of about 9 m extending along Marina Blvd. from approximately Baker to Buchanan Sts. This distance correlates well with the distance between locations of the 1857 shoreline shown in Figure

FIGURE 2-19. Soil Profile A-A' Along Marine Boulevard

2-14. The depth to water table is between 1.5 and 2 m in the Marina. Underlying the loose fills and natural sand deposits is a stratum of Recent Bay Mud, which varies in thickness along Marina Blvd. from 9 to 23 m and extends to a maximum depth of 32 m. Underlying the Recent Bay Mud are dense sands and stiff to hard clays. Figure 2-20 shows that weathered bedrock at a location near Lombard and Filmore Sts. was encountered at a depth of roughly 45 m below zero San Francisco datum.

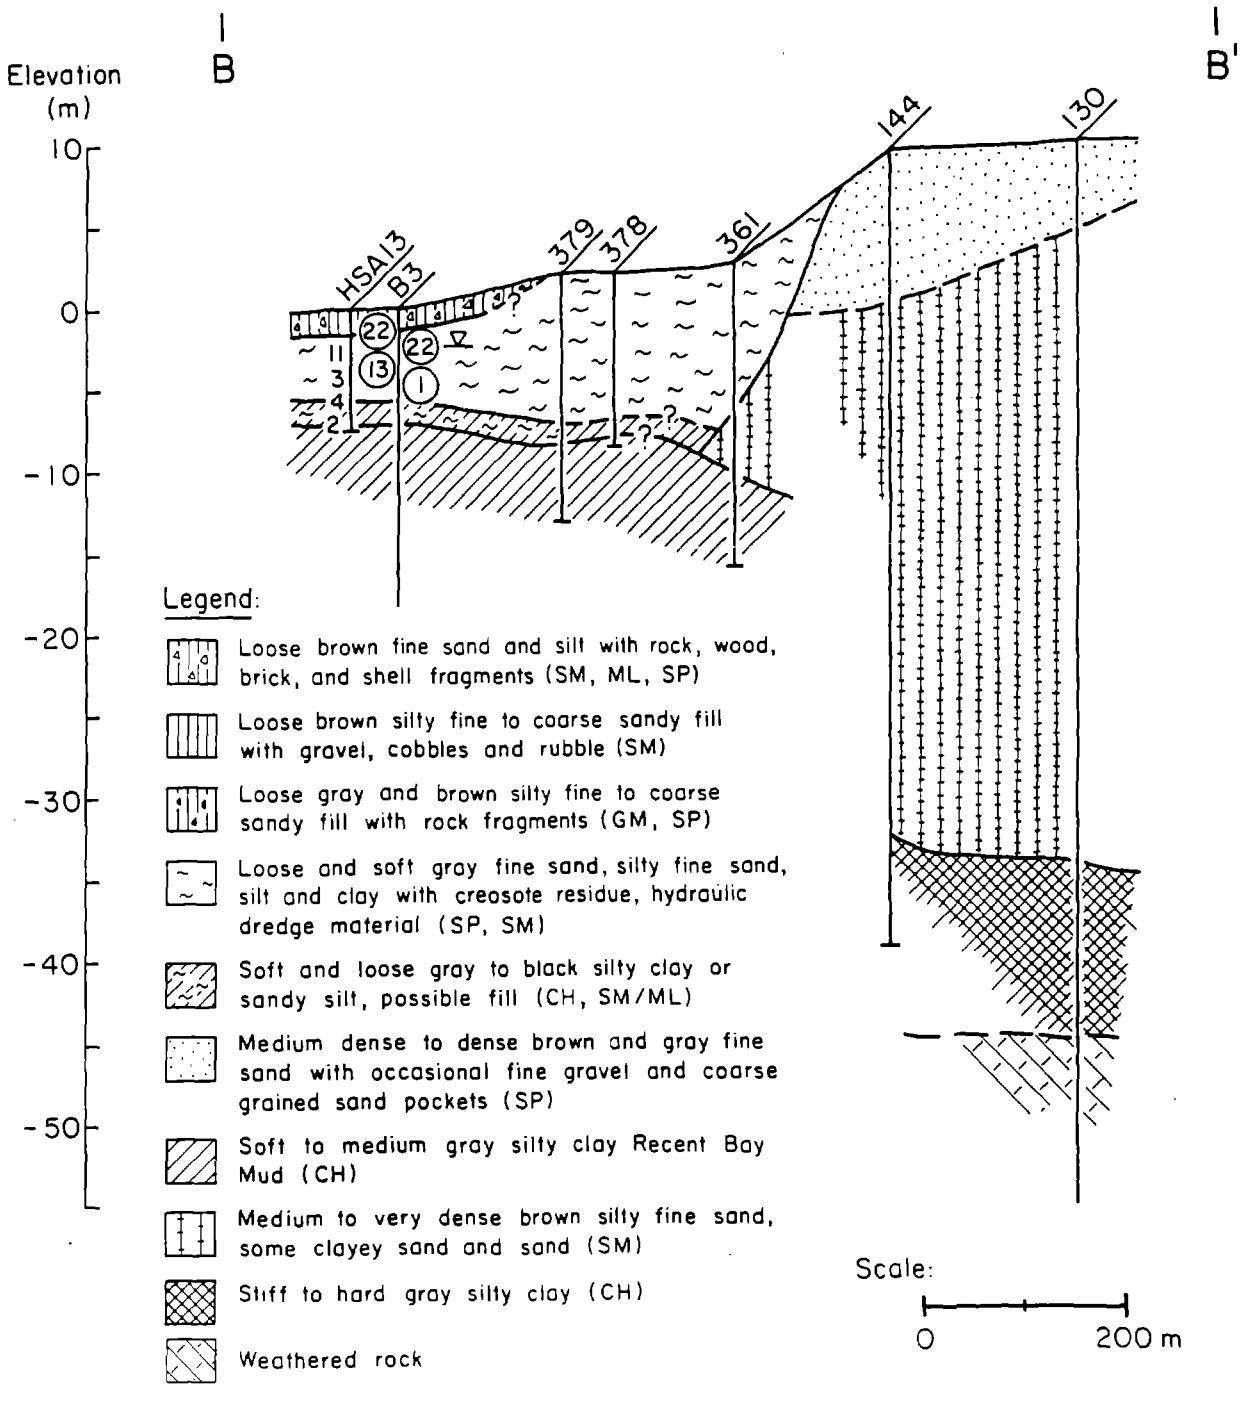
B-B' in Figure 2-20 is from Marina Blvd. to approximately Lombard St., and was developed primarily from borings performed for the aforementioned project as well as data summarized by the Institute of Transportation and Traffic Engineering [1950]. Data for each borehole are summarized in the form of uncorrected Standard Penetration Test (SPT) values, equivalent SPT, and Torvane undrained shear strengths, as explained by the borehole legend in Figure 2-19. Symbols and descriptions of the soils and rock encountered are summarized in the legend of Figure 2-20. All uncorrected SPT measurements were consistent with ASTM specifications [ASTM, 1989]. Equivalent SPT readings were estimated from blow count measurements performed with nonstandard equipment according to the recommendations of Roth and Kavazanjian [1984].

FIGURE 2-20. Soil Profile B-B' in Marina District

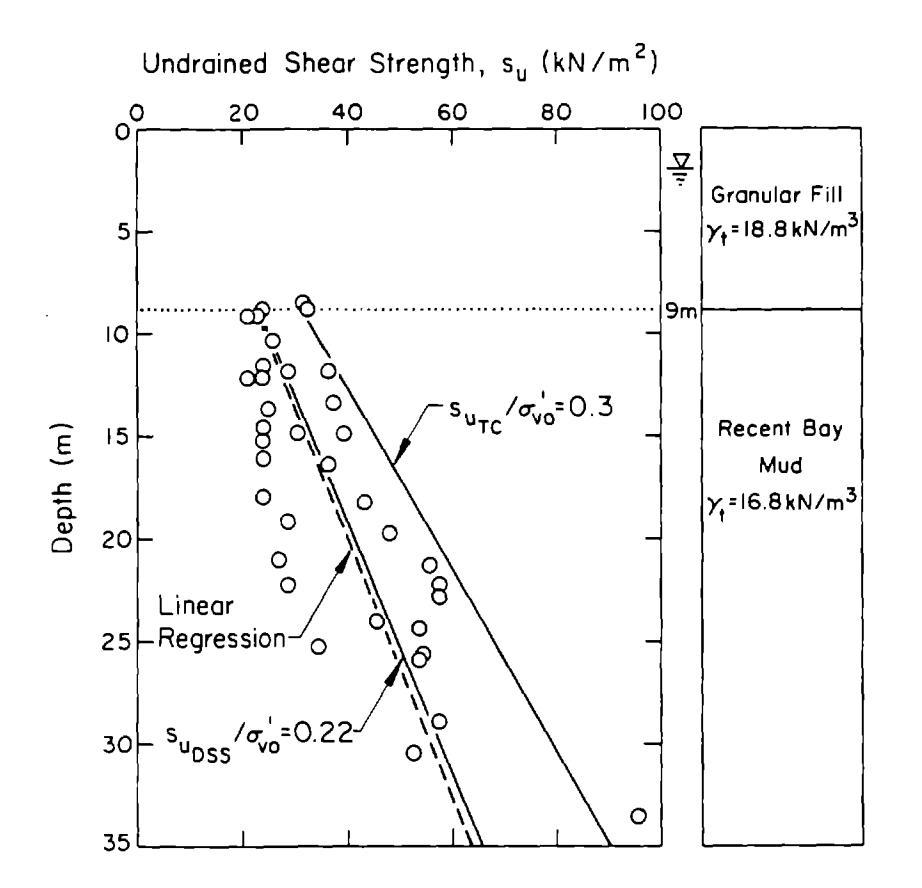
Undrained shear strengths obtained with a Torvane device indicate that the clay is soft to medium in consistency. Figure 2-21 shows a soil profile in which the

Torvane undrained shear strengths are plotted as a function of depth. For comparison, the ratios of undrained shear strength to effective vertical stress for triaxial compression $(s_{u_{TC}}/\sigma_{vo}')$ and direct simple shear $(s_{u_{DSS}}/\sigma_{vo}')$ also

FIGURE 2-21. Soil Profile and Torvane Shear Strength Characteristics of Recent Bay Mud at the Marina

are plotted. The $s_{u_{DSS}}/\sigma_{vo}'$ profile is consistent with trends recommended for a normally consolidated clay [e.g., Mesri, 1989]. Both the $s_{u_{DSS}}/\sigma_{vo}'$ and $s_{u_{TC}}/\sigma_{vo}'$ profiles are consistent with trends established for Recent Bay Mud [Dames and Moore, 1989]. The linear regression of the Torvane strengths plots close to the $s_{u_{DSS}}/\sigma_{vo}'$ line, and implies that the clay is normally consolidated. It should be recognized, however, that Torvane tests involve substantial sample disturbance and thus are useful only as an index of shear strength.

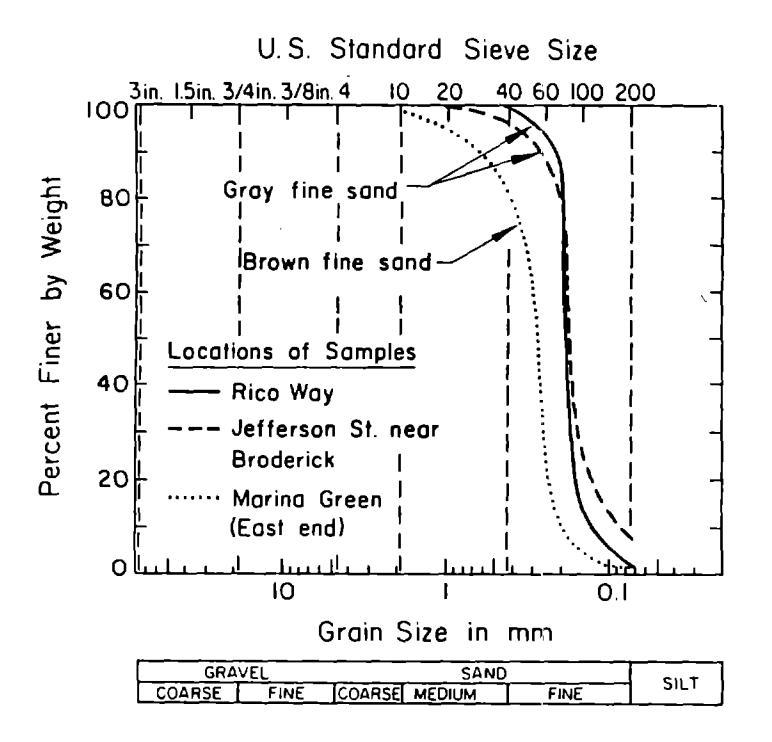
FIGURE 2-22. Grain Size Distribution Plots for Soil Collected in the Marina at Sand Boils and Vents

Figure 2-22 presents grain size distribution plots of material ejected from sand boils and vents at three different locations in the Marina, which are shown in Figure 2-18. All materials are fine uniform sand with very low to negligible fines content. The gray fine sand was subrounded to subangular in shape, composed of quartz and ferromagnium minerals. The fine brown sand contained the highest percentage by weight of quartz and also some shell fragments. A liquefaction potential analysis was performed using the empirical relationship between cyclic stress ratio and the corrected SPT values developed by Seed, et al. [1983]. As plotted in Figure 2-23, SPT values were corrected from field measurements according to the recommendations of Seed, et al. [1983]. The cyclic stress ratios for various depths were calculated assuming a maximum acceleration of 0.2 g, which is consistent with the peak horizontal component of acceleration measured at the nearby Presidio. The curve shown in Figure 2-21 is the empirical dividing line between liquefiable and nonliquefiable soils for a magnitude 7.1 earthquake. It is clear that the fill, shown as open triangles, plot within the liquefiable zone. The natural soils, shown as solid circles, fall into the nonliquefiable zone. The natural soils are predominantly sand bar and beach sand deposits. No correction in Figure 2-21 was made for silt content.

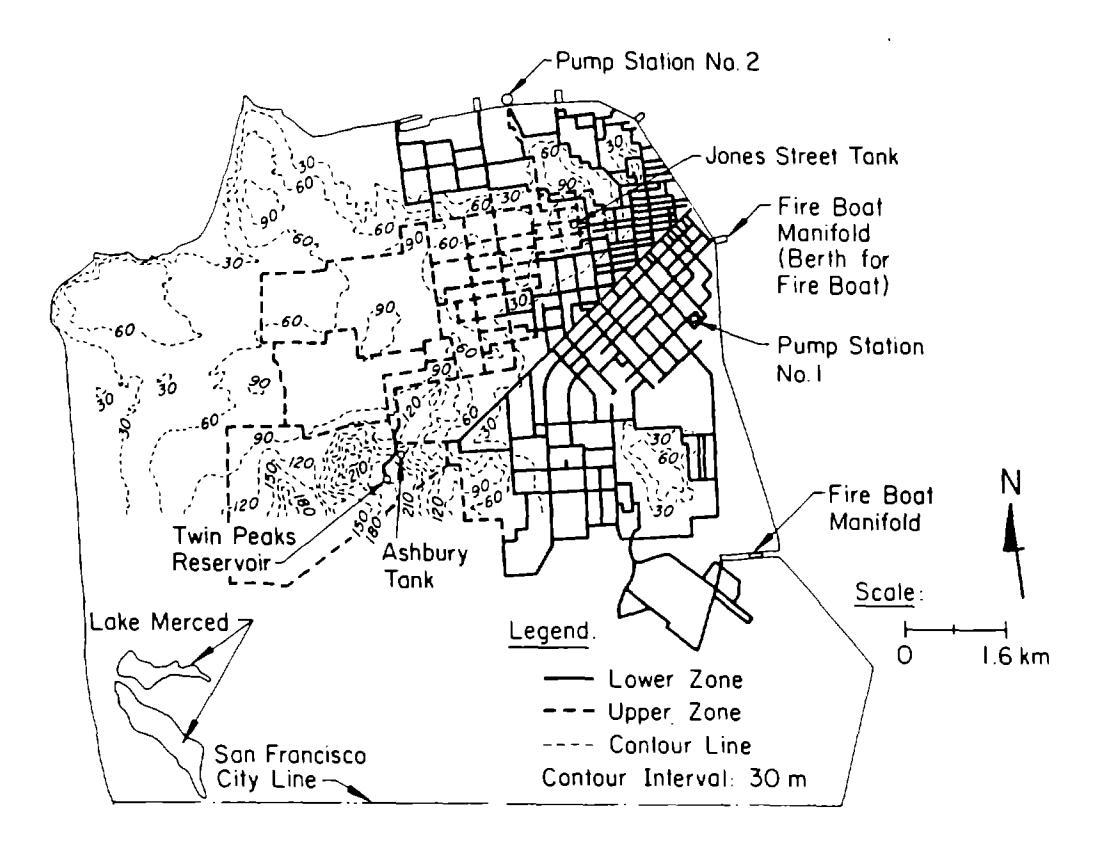
After the earthquake and fire of 1906, the AWSS was constructed to provide emergency fire protection [Manson, 1908]. This system, shown in Figure 3-3, was intended to augment the city's existing fire fighting capacity by providing a supplementary network that would work independently of, but in parallel with, the MWSS. It is separated into an upper and lower zone. Each zone operates nominally at a pressure of about 1 MPa, which is approximately 2.5 times the pressure in the domestic municipal system. The system is supplied by the Twin

FIGURE 3-3. San Francisco AWSS

The most serious damage was the break of a 300-mm-diameter cast iron main on 7th St. between Mission and Howard Sts. Water flow through this break, supplemented by losses at broken hydrants, emptied the Jones St. Tank (see Figure 3-3) of its entire storage of 2.8 million liters in approximately 20 to 30 minutes. Loss of this reservoir supply led to the loss of water and pressure throughout the lower zone of the AWSS. This resulted in an especially sensitive condition in
