INVESTIGATION ON THE CAUSE OF NUMEROUS UPPER FLOOR FAILURES DURING  
THE 1985 MEXICO CITY EARTHQUAKE

Roberto Villaverde

Department of Civil Engineering  
University of California, Irvine

November, 1989

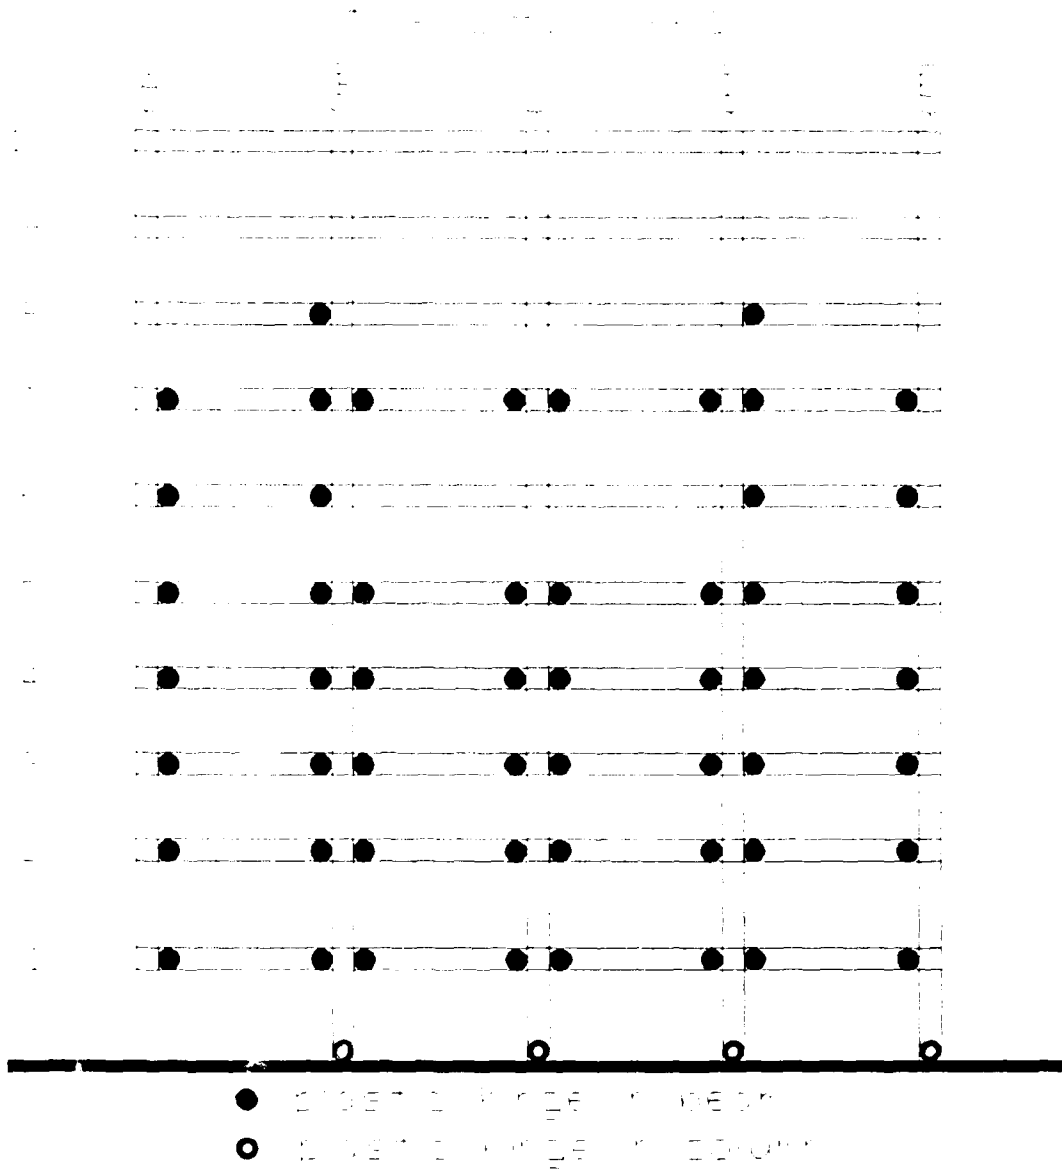
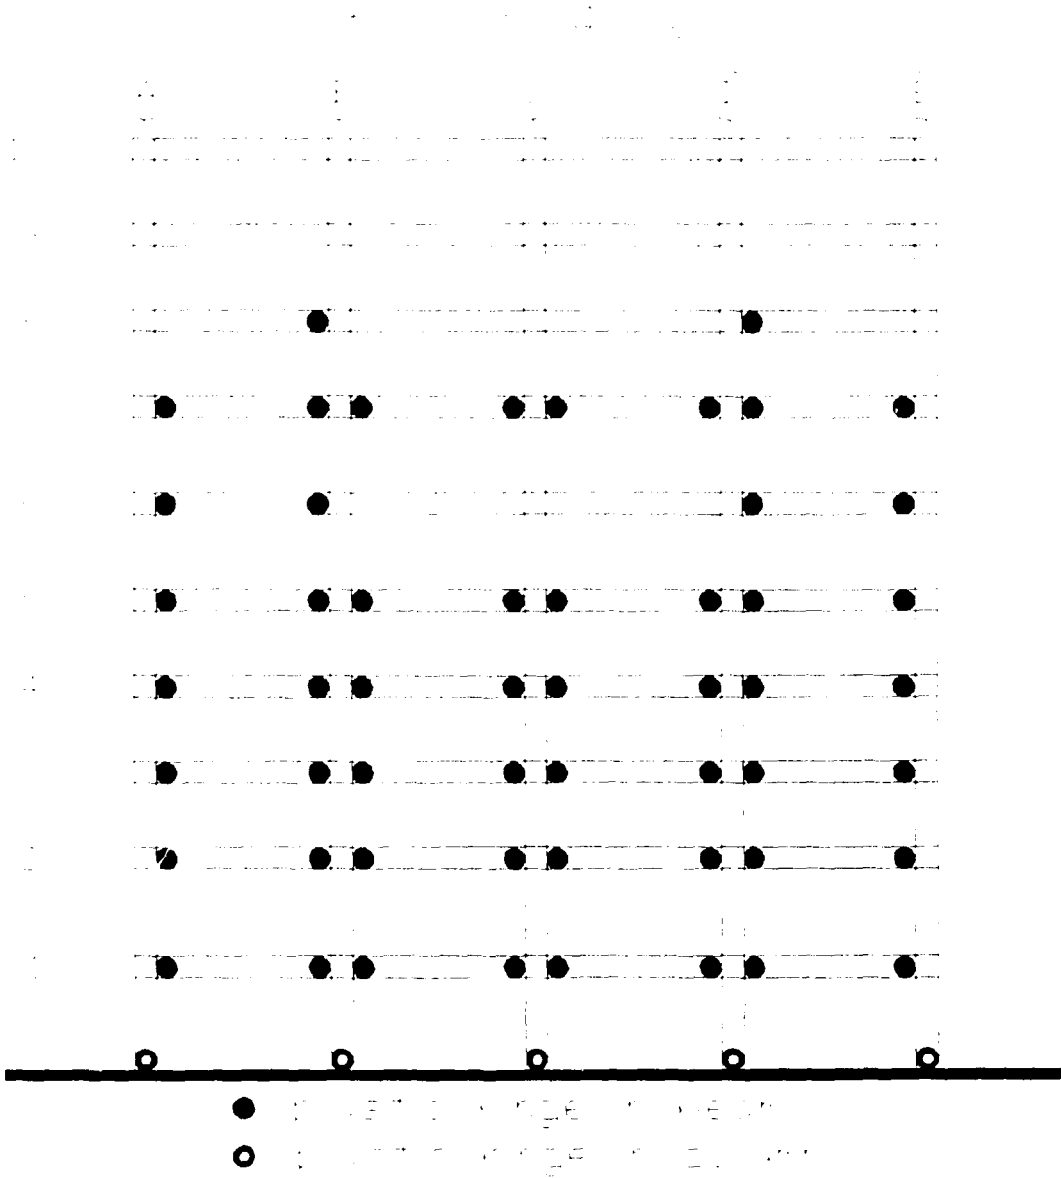
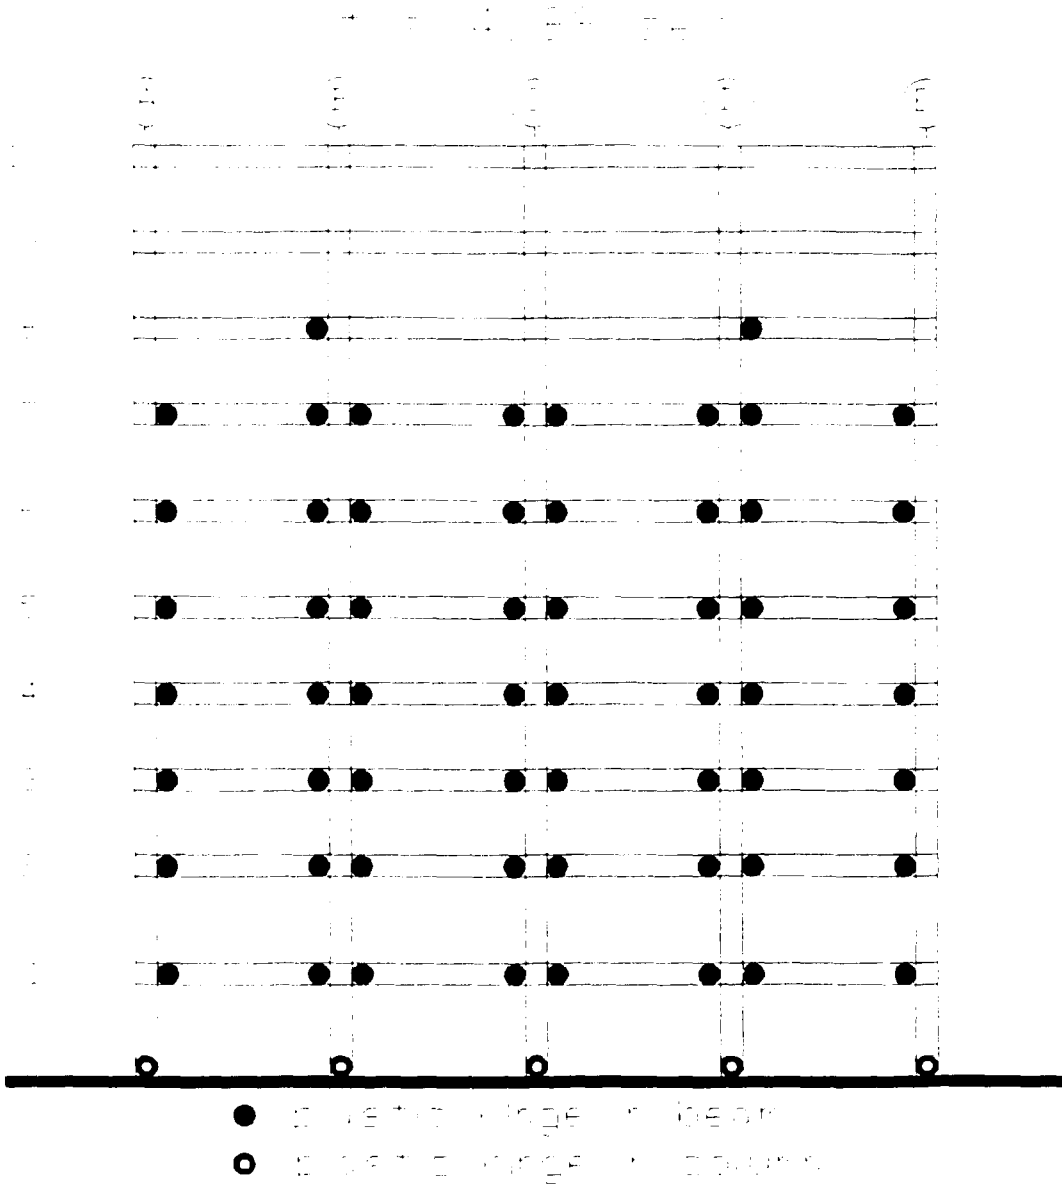
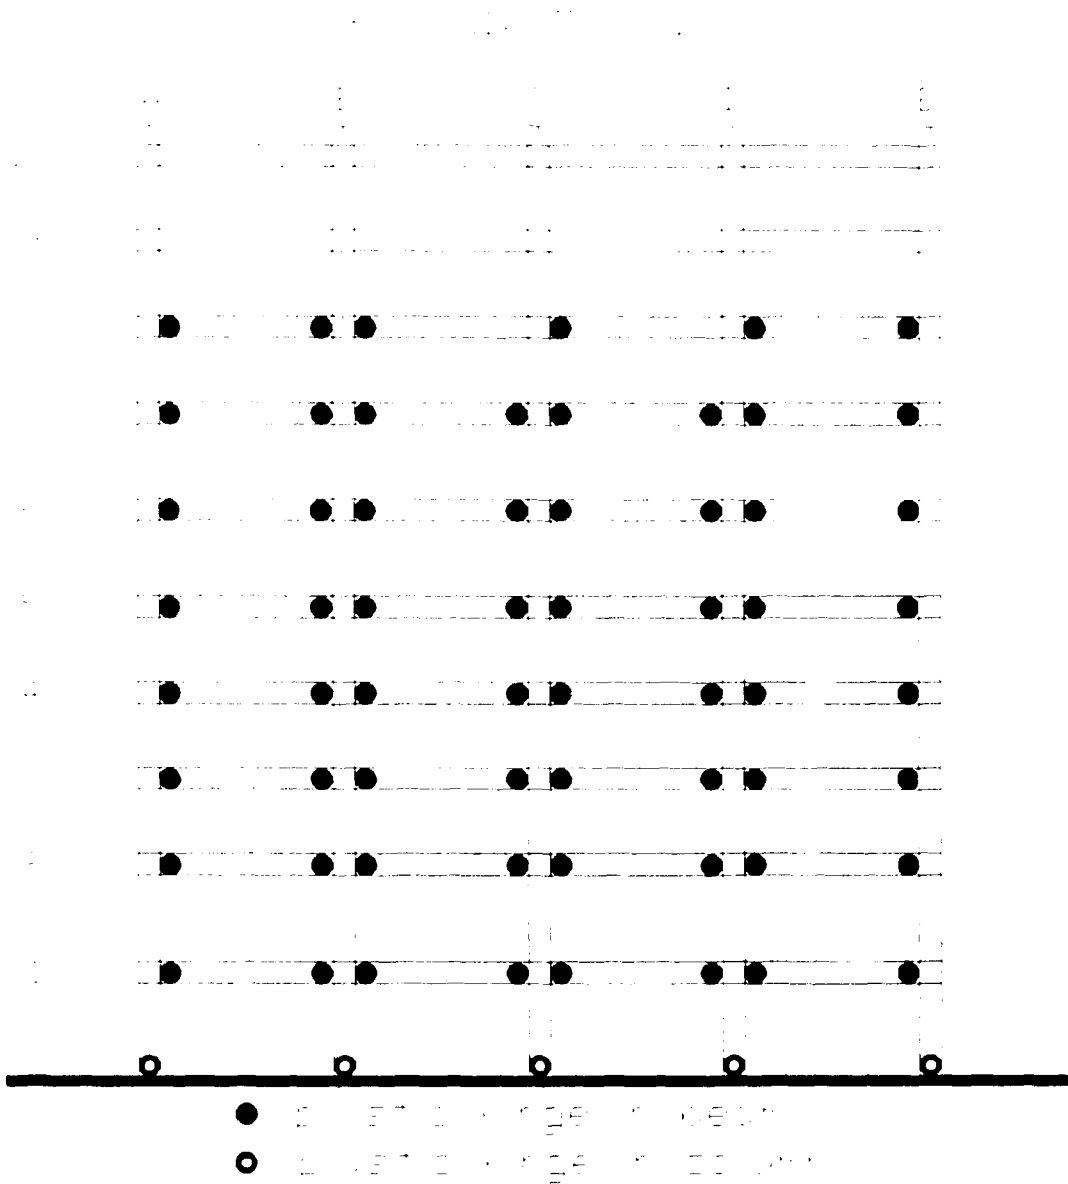
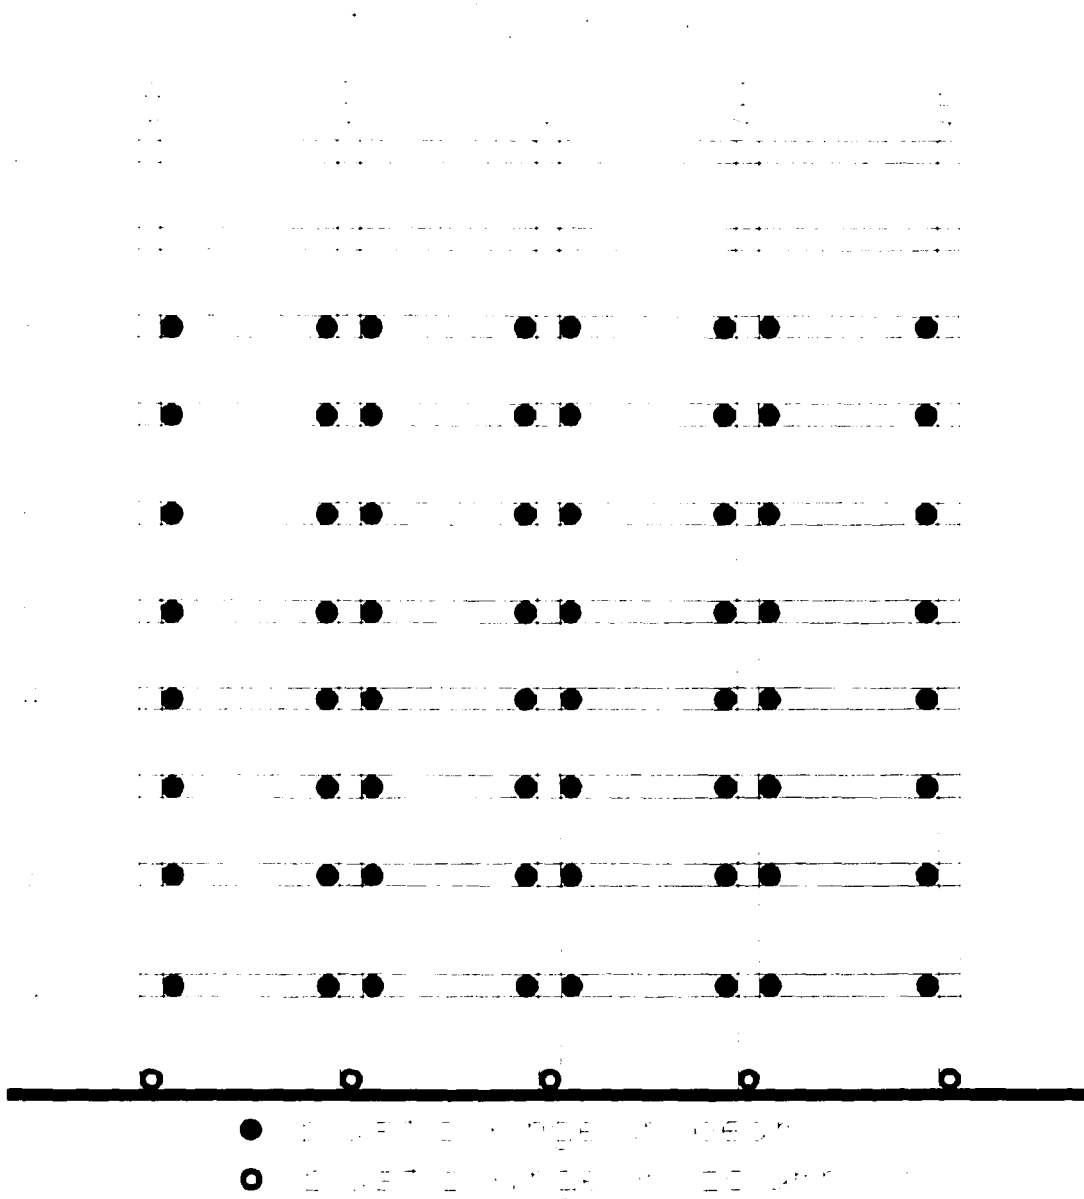
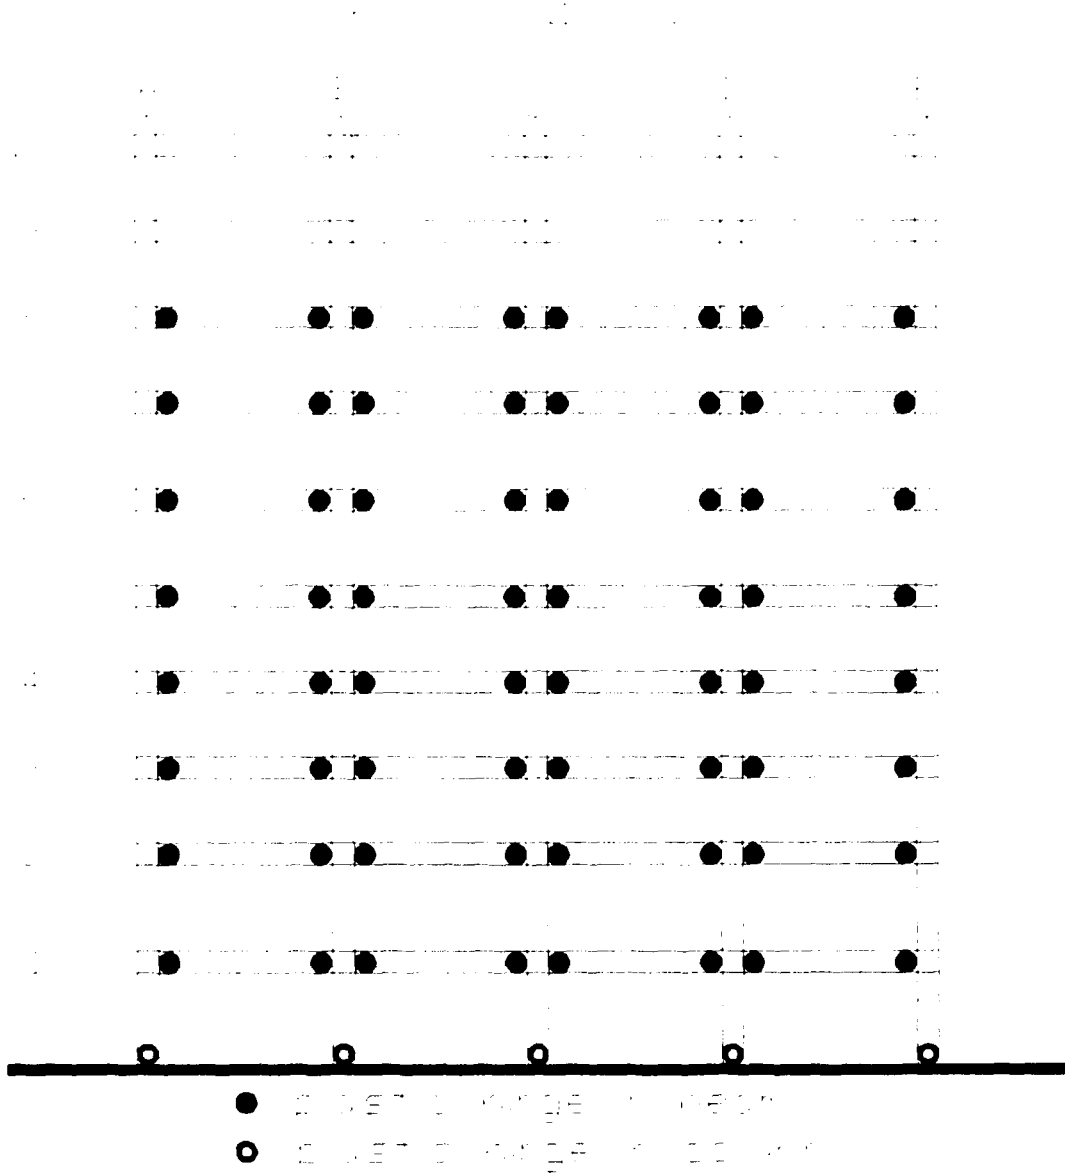
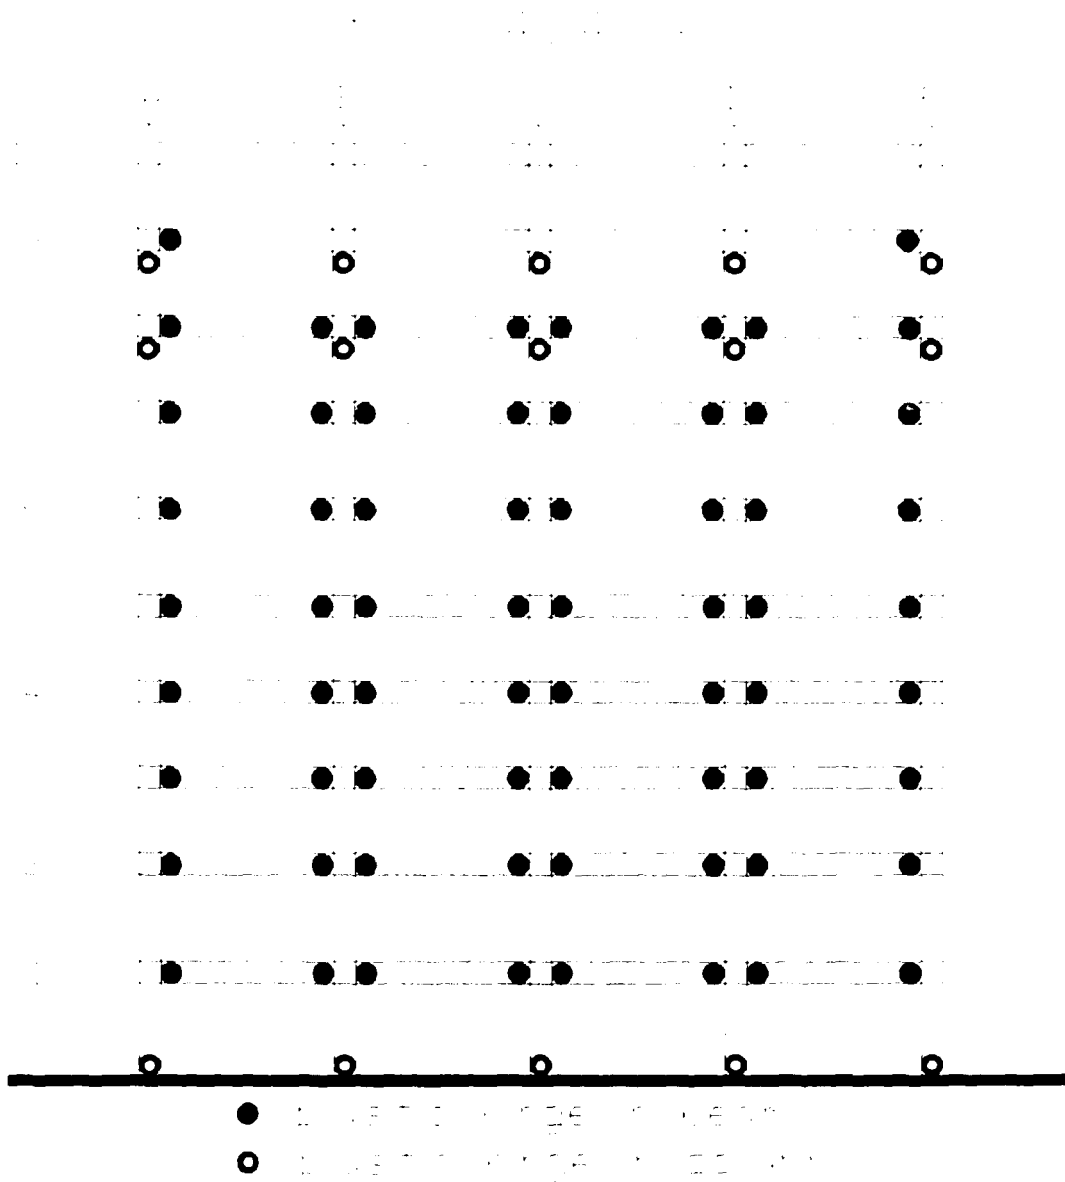
The results of the analysis are presented in Figures 3.13 through 3.20. These figures show how the formation of plastic hinges at the beams and columns of the frame progresses throughout the duration of the excitation. It can be seen from them that under the S60E component of the SCT ground acceleration record the frame remains elastic (i.e., no plastic hinges) for about the first 24 seconds and that after that time plastic hinges form at the lower ends of the columns of the first floor and at the ends of a large number of the lower beams of the frame. Subsequently, the formation of plastic hinges propagates upwardly to other beams and, eventually, at about 64 seconds after the beginning of the excitation, plastic hinges develop at the upper ends of all the columns of the 8th and 9th stories. Thus, owing to the formation of plastic hinges at these columns, it is clear that after this time the frame would develop a failure mechanism in which, first, the columns of the 9th story undergo large lateral displacements, then these columns fail by instability, and ultimately the 9th and 10th stories collapse (see Figure 3.21).

Figure 3.13. Plastic hinges in interior longitudinal frame of designed 10-story building after 23.36 sec. of the SCT, S60E, ground motion

Figure 3.14. Plastic hinges in interior longitudinal frame of designed 10-story building after 29.20 sec. of the SCT, S60E, ground motion

Figure 3.15. Plastic hinges in interior longitudinal frame of designed 10-story building after 35.04 sec. of the SCT, S60E, ground motion

Figure 3.16. Plastic hinges in interior longitudinal frame of designed 10-story building after 40.88 sec. of the SCT, S60E, ground motion

Figure 3.17. Plastic hinges in interior longitudinal frame of designed 10-story building after 46.72 sec. of the SCT, S60E, ground motion

Figure 3.18. Plastic hinges in interior longitudinal frame of designed 10-story building after 52.56 sec. of the SCT, S60E, ground motion

Figure 3.19. Plastic hinges in interior longitudinal frame of designed 10-story building after 58.40 sec. of the SCT, S60E, ground motion

Figure 3.20. Plastic hinges in interior longitudinal frame of designed 10-story building after 64.24 sec. of the SCT, S60E, ground motion

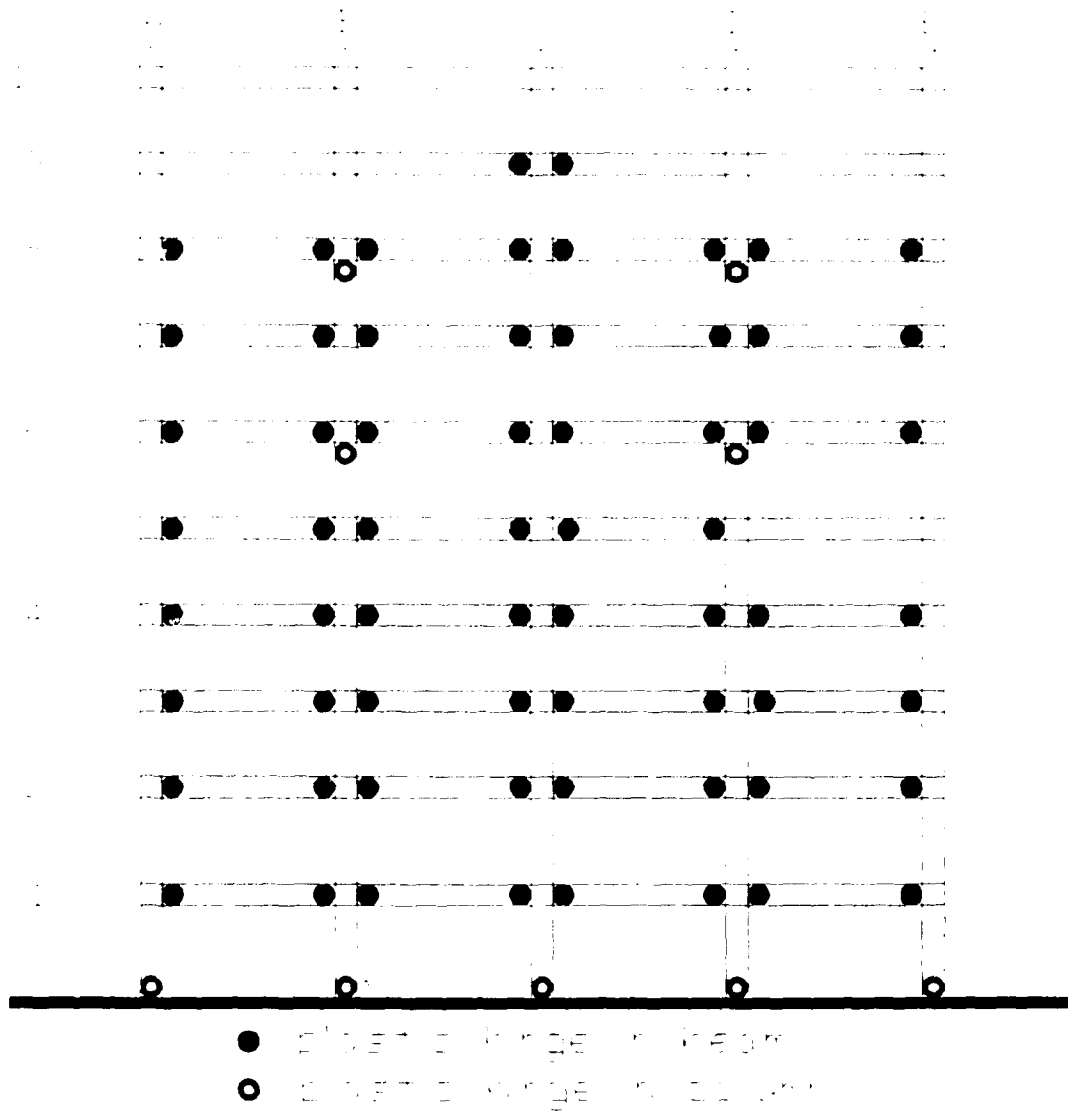
Figure 3.24 summarizes the results of the analysis. This figure shows where plastic hinges are formed after the analyzed frame is subjected to 70 seconds of the exciting ground motion. It can be seen that although plastic hinges were formed at some of the columns of the sixth and eighth stories, in this case the frame did not develop enough plastic hinges to form a collapsing

Figure 3.24. Plastic hinges in interior longitudinal frame of redesigned 10-story building after 70 sec. of the SCT, S60E, ground motion

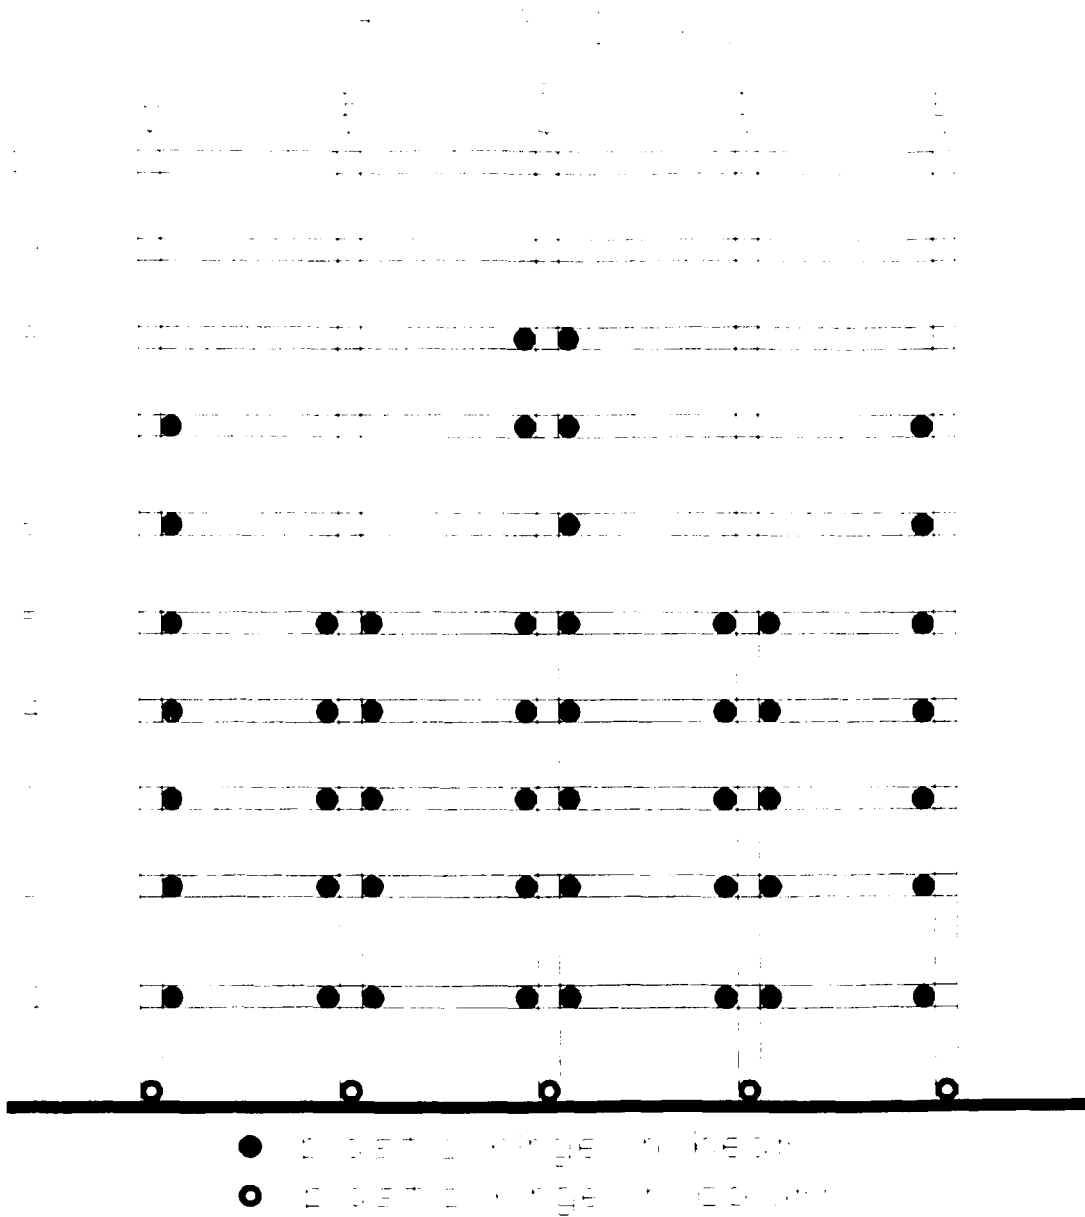
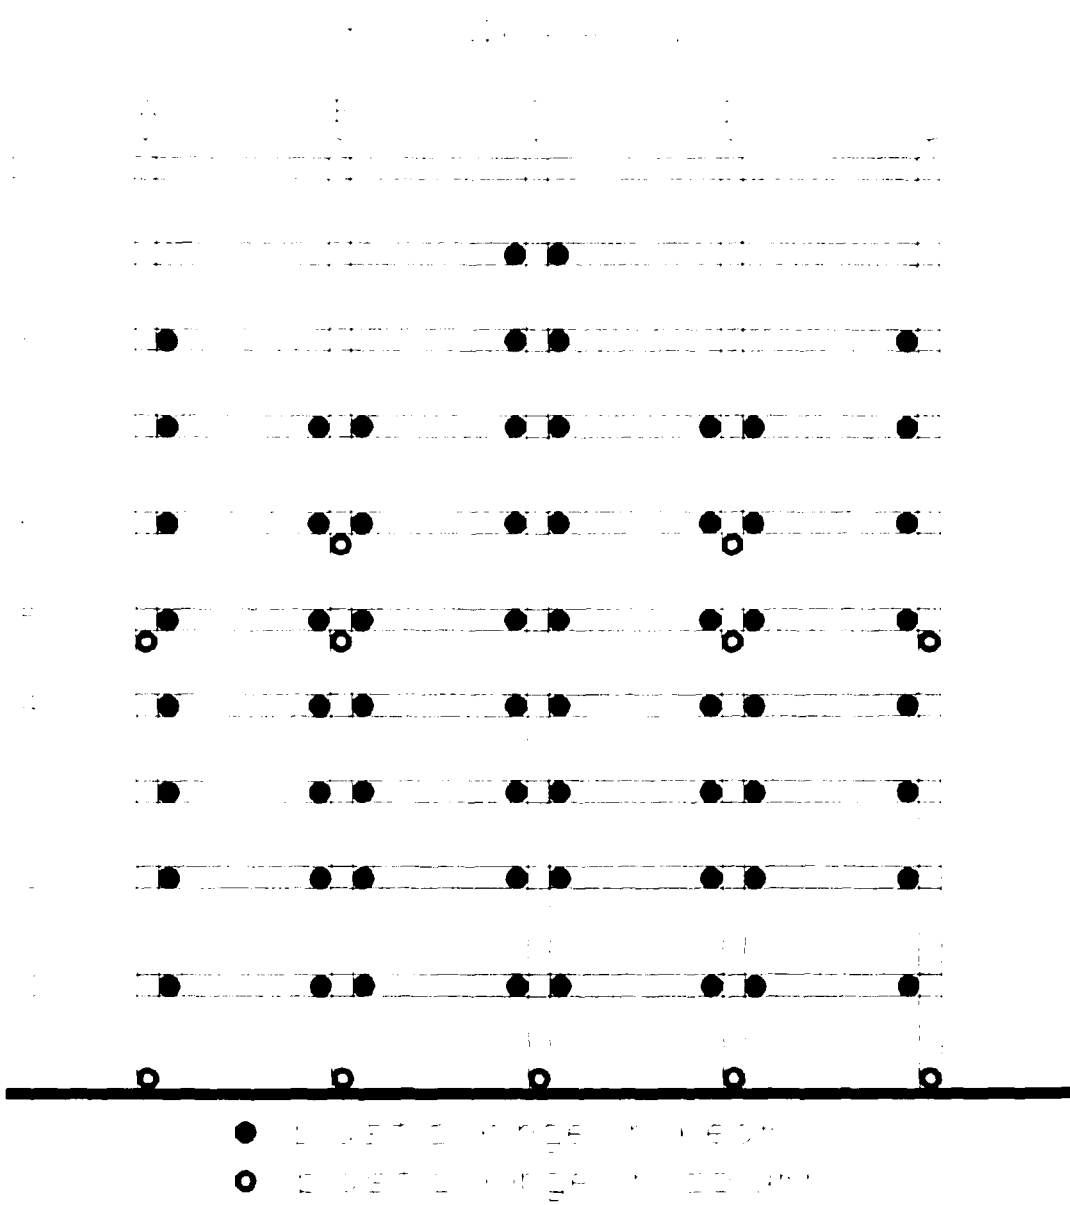
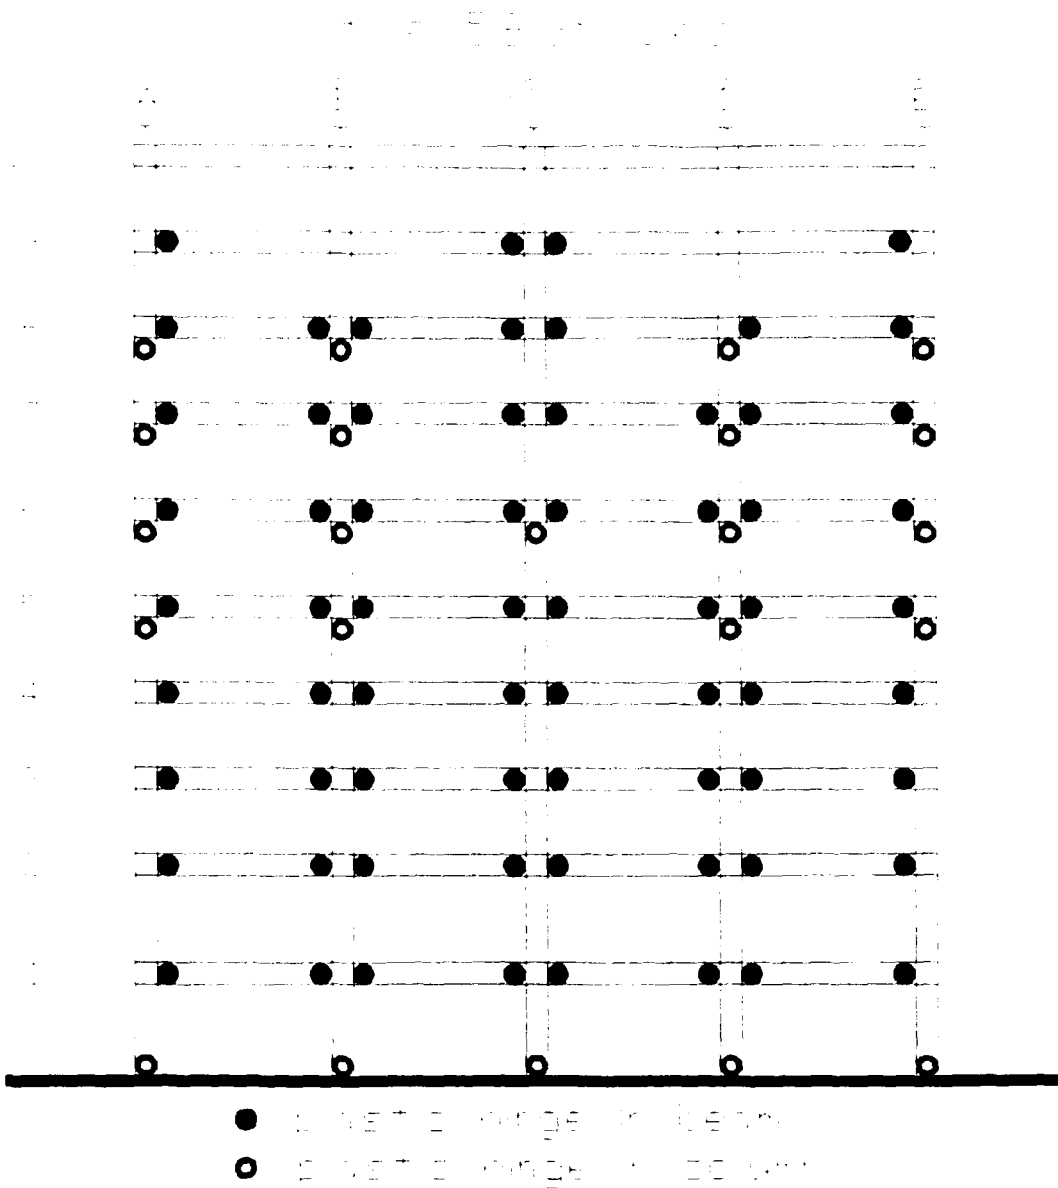
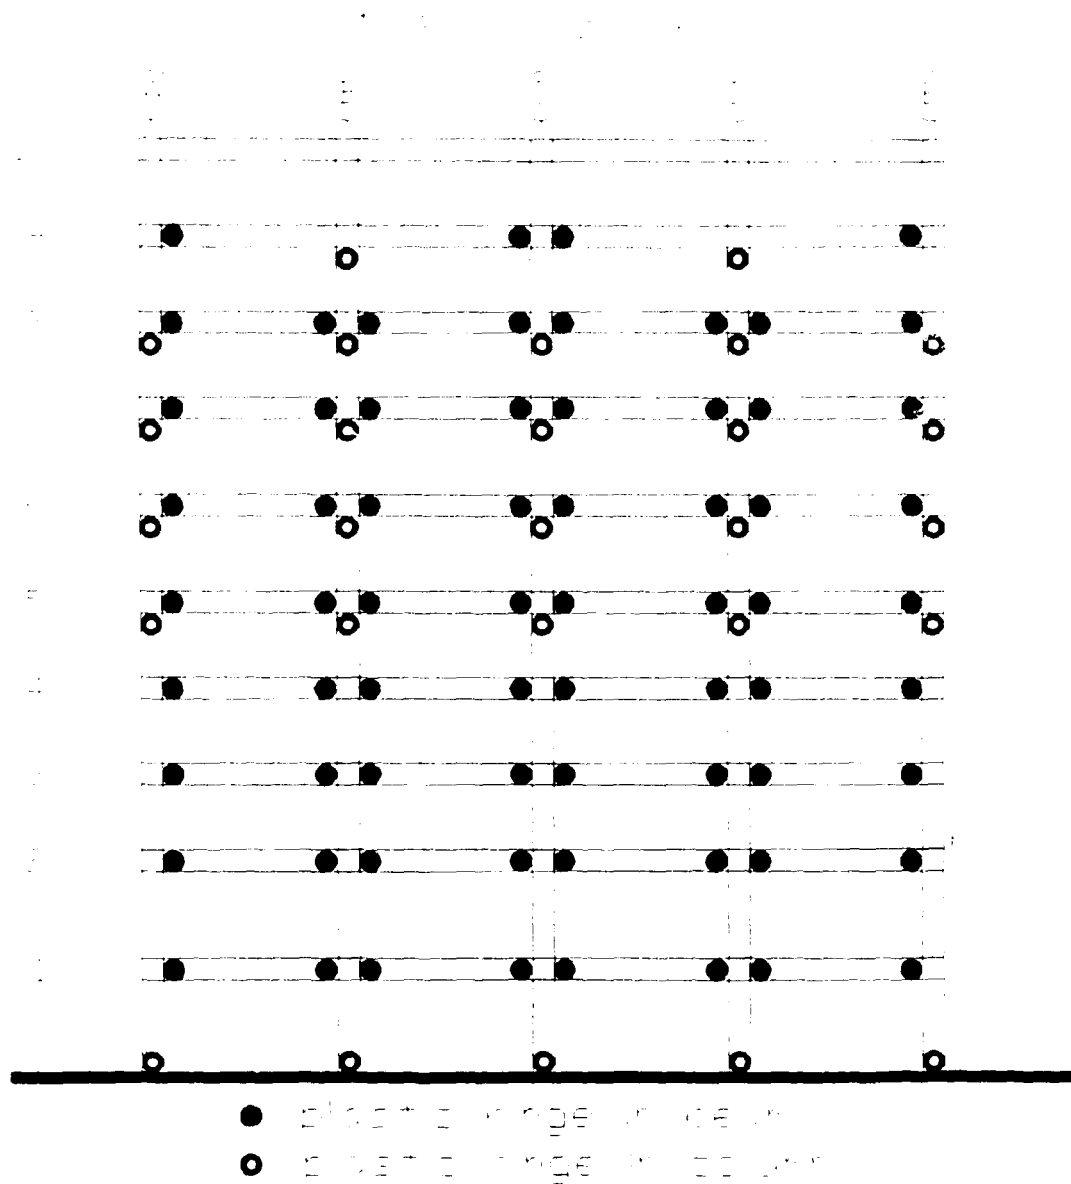
Based on the results presented above, it was logical at first to accept the fact that indeed the stiffer building was not susceptible to an upper floor collapse, and hence that the upper floor failure mechanism observed in the previous case could be explained on the basis of the flexibility of its upper stories. On second thoughts, however, it was realized that a possible reason the redesigned frame did not develop enough plastic hinges to form a failure mechanism could have been that the considered excitation did not induced, because of the dynamic characteristics of this particular structure, a sufficiently strong response. To verify, then, this idea, the analysis was repeated with a magnified ground motion obtained by multiplying the accelerations of the SCT, S60E, record by a factor of 1.5. The results, presented as for the first design in a way that shows how plastic hinges develop with time, are depicted in Figures 3.25 through 3.29. As expected, it can be seen from these figures that in this case too the structure was eventually led to the collapse of its upper stories.

Figure 3.25. Plastic hinges in interior longitudinal frame of redesigned 10-story building after 23.34 sec. of 1.5 times the SCT, S60E, ground motion

Figure 3.26. Plastic hinges in interior longitudinal frame of redesigned 10-story building after 35.01 sec. of 1.5 times the SCT, S60E, ground motion

Figure 3.27. Plastic hinges in interior longitudinal frame of redesigned 10-story building after 46.68 sec. of 1.5 times the SCT, S60E, ground motion

Figure 3.28. Plastic hinges in interior longitudinal frame of redesigned 10-story building after 58.35 sec. of 1.5 times the SCT, S60E, ground motion

Figure 3.29. Plastic hinges in interior longitudinal frame of redesigned 10-story building after 70.02 sec. of 1.5 times the SCT, S60E, ground motion

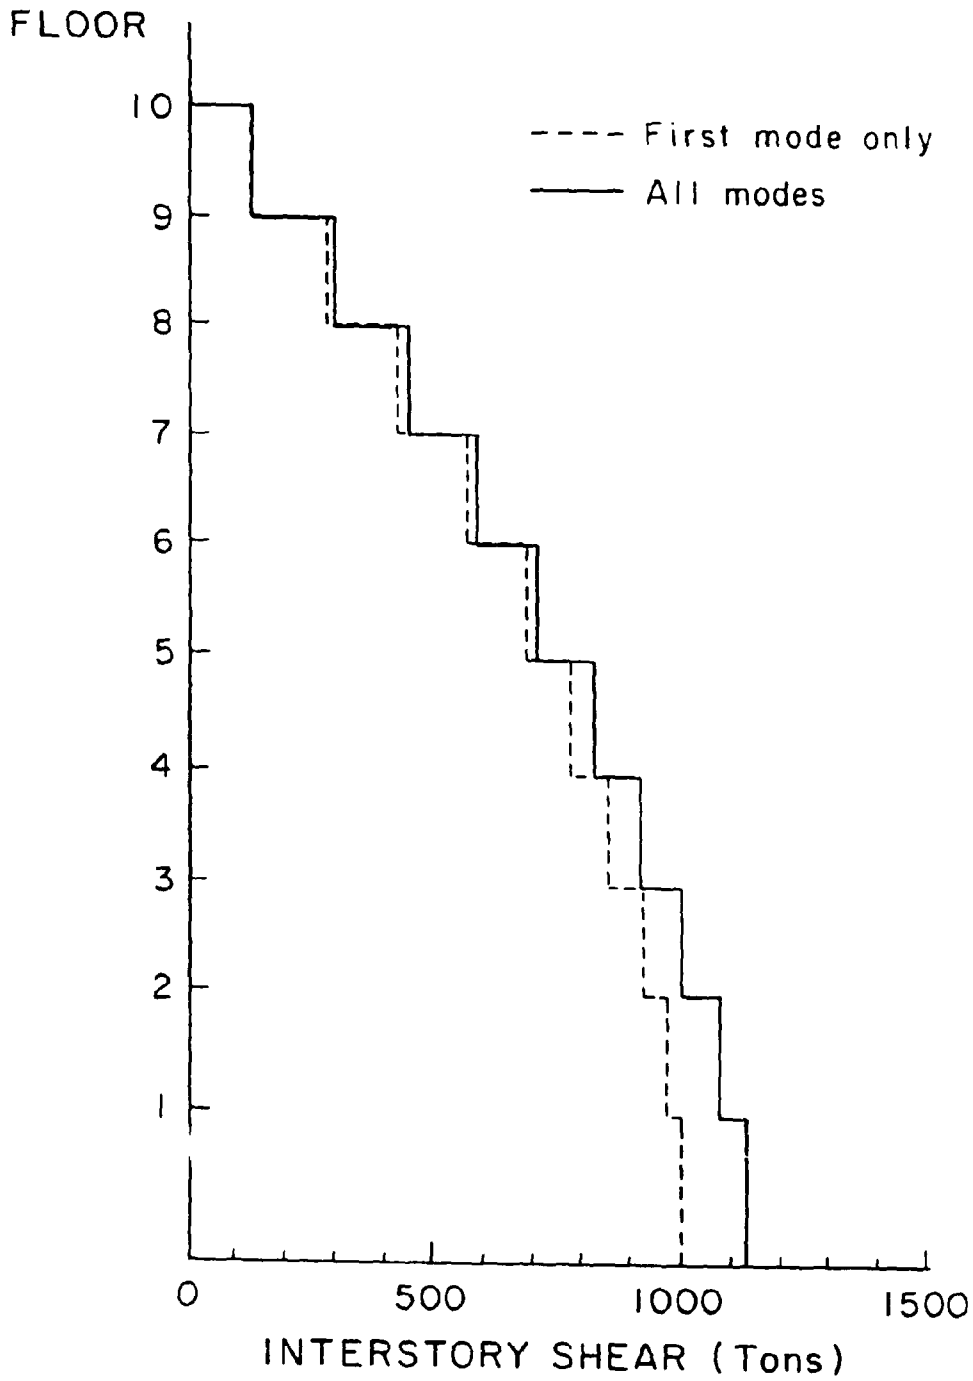
floor collapses was an evaluation of the degree of approximation involved in the use of this method. For this purpose, the maximum interstory shears induced by the SCT, S60E, ground motion on the interior longitudinal frame analyzed in Section 3.6 were calculated, by means of a dynamic analysis and under the assumption of a perfectly elastic structure, considering first only the response in its first mode and then the response in all of its modes. The comparison between the two sets of values obtained is presented in Figure 4.1, from which it can be seen that the higher modes of this structure did not contribute significantly to its total response to the ground motion used in the analysis. Furthermore, from this comparison one may conclude that the distribution of the actual lateral forces on the frame, when subjected to above ground motion and before it reached its first yielding, could not have been significantly different from the distribution of the lateral forces for which the frame was designed. Accordingly, it was concluded too that the plastic hinges which appeared in the columns of the eighth and ninth stories of the frame during the nonlinear time-history analysis carried out in Section 3.6 could not have been induced by not taking into account higher-mode responses in the design of the frame.

Figure 4.1. Maximum interstory shears in interior longitudinal frame of designed 10-story building when frame is assumed perfectly elastic and subjected to the SCT, S60E, ground motion.

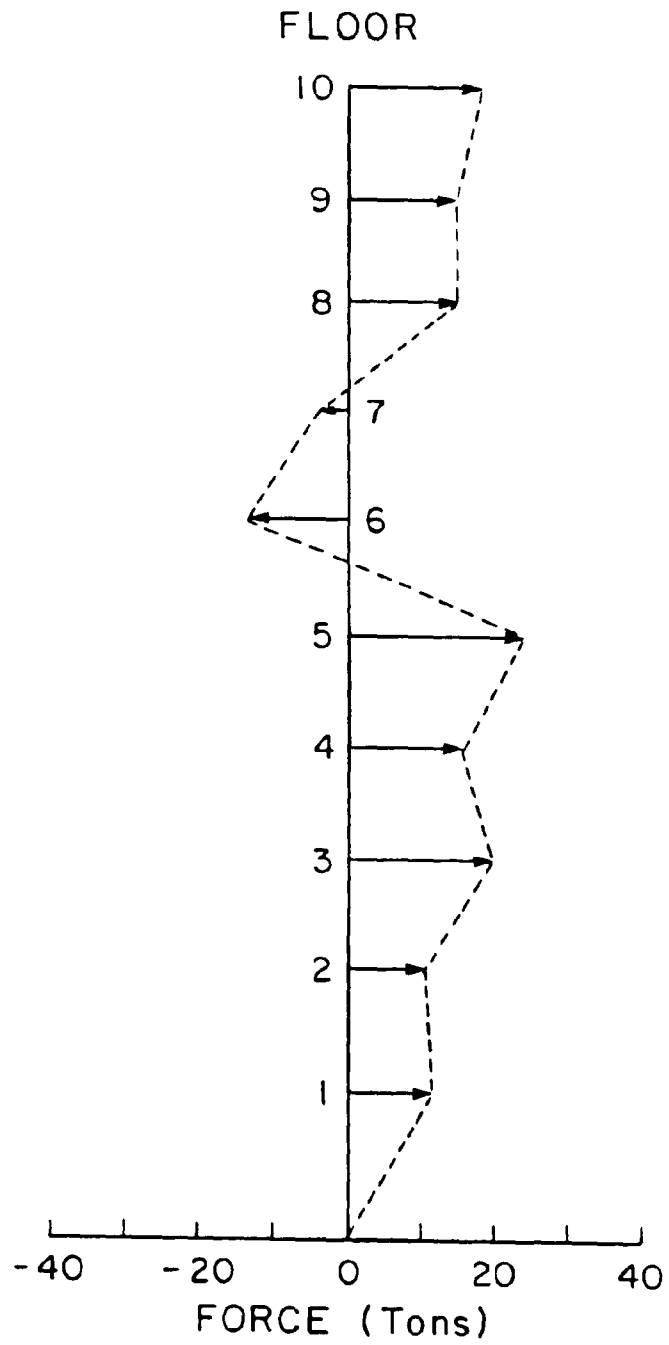
investigate how the shear forces were distributed along its height just before such plastic hinges were formed. The outcome of this investigation is summarized in Figure 4.2, where are given the instantaneous magnitudes and directions of such forces 58.35 seconds after the beginning of the excitation.

Figure 4.2 unambiguously shows that at the time of 58.35 seconds, which is about six seconds before the first plastic hinges in the upper columns of the frame were detected in the analysis reported in Section 3.6, the structure was vibrating in a mode that resembles the third mode shape of a shear beam. Thus, to further investigate this finding, the natural periods of the frame were calculated for the case when, as indicated in Figure 4.3, the lower ends of the columns of its first story are hinged and the flexural stiffnesses of its beams from the first to the eight floors are neglected. The obtained first three such natural periods are listed in Table 4.1.

The fact that the distribution of lateral forces seconds before the plastic hinges in the upper columns of the frame were formed corresponded to a distribution that is typical of a third mode, and the fact that at that instant the third natural period of the structure was close to 2 sec., i.e., the dominant period of the SCT record (see response spectrum in Figure 3.2), clearly suggested that around that time the structure was vibrating predominantly in its third mode and in resonance with the ground

Figure 4.2. Lateral forces on interior longitudinal frame of designed 10-Story building 58.35 sec. after beginning of excitation

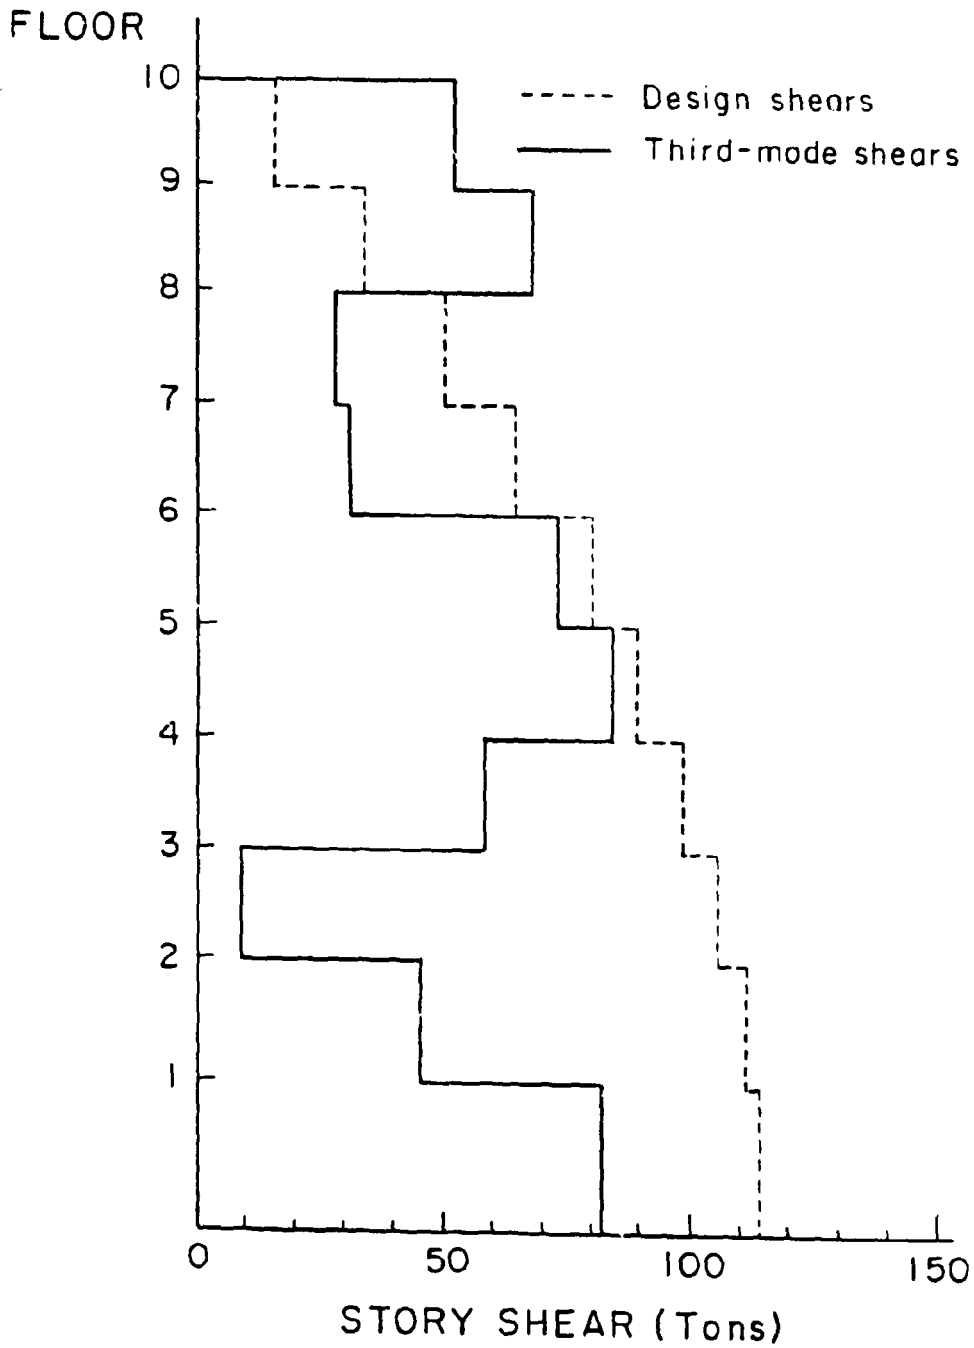
motion. This in turn suggested that perhaps the cause of the formation of such plastic hinges was that the structure was designed to vibrate primarily in its first mode, but that in actuality it was vibrating, some time after incurring into its post-elastic range, in its third mode. Thus, to confirm this idea, a comparison was made between the interstory shears for which the frame under investigation was designed and those induced by the SCT ground motion when it is assumed that that the frame vibrates purely in its third mode, that the natural period of its third mode is 2 seconds, and that the corresponding damping ratio is 5 per cent. The comparison is depicted in Figure 4.4, from which it can be observed that if the structure indeed vibrates under the conditions stated above, it will exceed its design shears only at its top two stories.

Figure 4.4. Absolute values of interstory shears in interior longitudinal frame of designed 10-story building
