RECONNAISSANCE REPORT ON THE NORTHERN IRAN EARTHQUAKE OF JUNE 21, 1990

M. Mehrain

Technical Report NCEER-90-0017

October 4, 1990

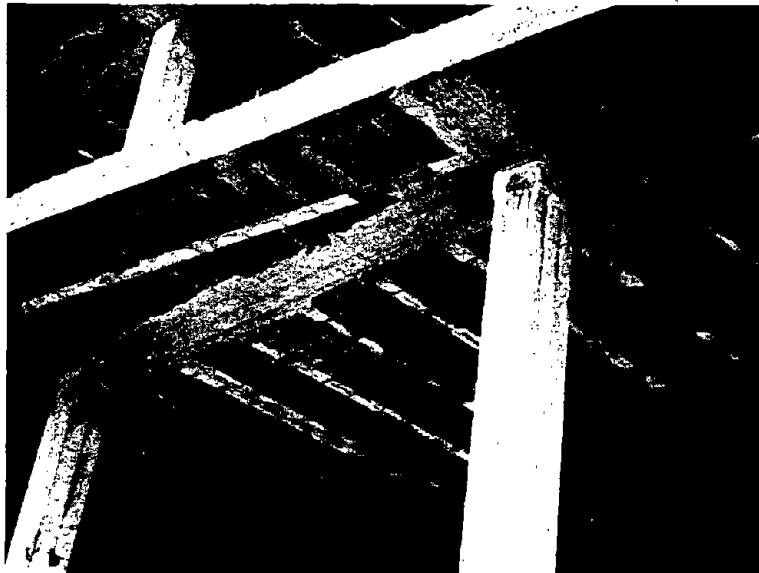
This system provides a flat surface under the floor structure (Fig. 3-14) to receive gypsum trowled-on ceiling.

Figure 3-14 Typical concrete frame construction in Iran
