Case Studies of Liquefaction and Lifeline Performance During Past Earthquakes

Volume 1
Japanese Case Studies

Edited by
M. Hamada and T. D. O'Rourke

Technical Report NCEER-92-0001

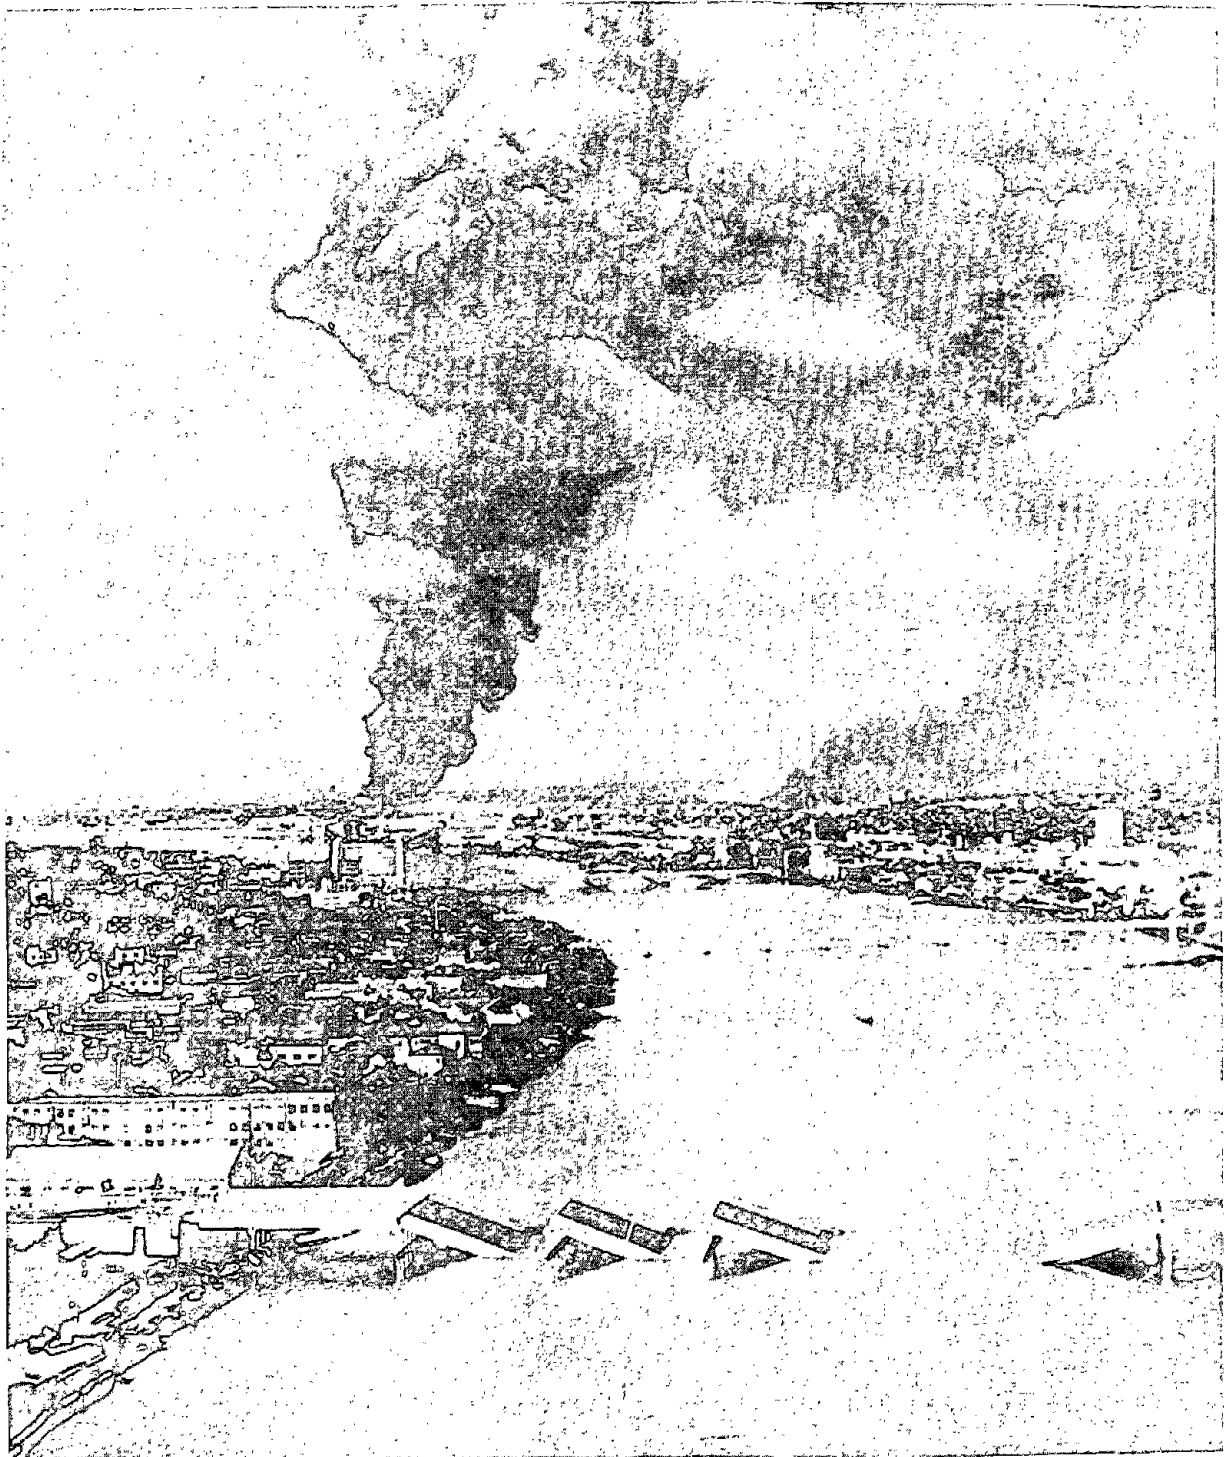
Niigata City suffered severe damage from soil liquefaction during the 1964 earthquake. The Showa Bridge, which had been completed only 3 months prior to the earthquake, collapsed due to liquefaction in the river bed. A number of lifeline facilities, buildings, quaywalls, and oil storage tanks were extensively damaged.

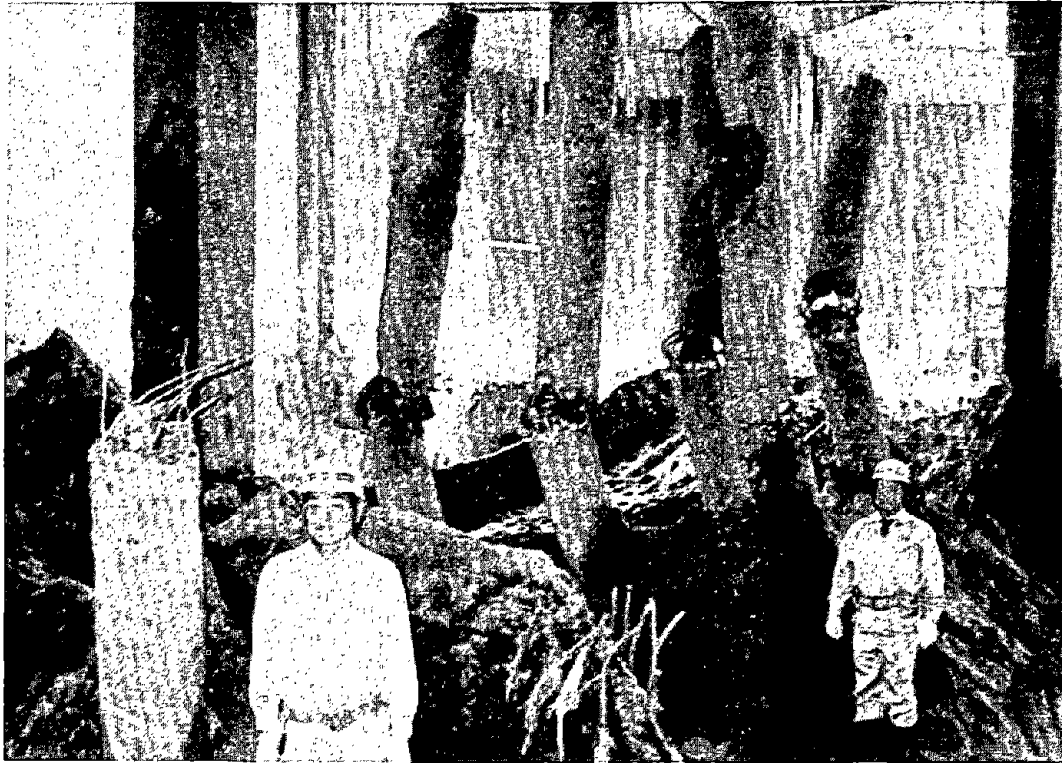
Reinforced concrete piles with a diameter of 35 cm were completely severed due to liquefaction-induced ground displacements in Niigata City. This evidence was discovered about 20 years after the earthquake when the foundation ground was excavated for reconstruction of a building. (S. Kawamura, 1985).

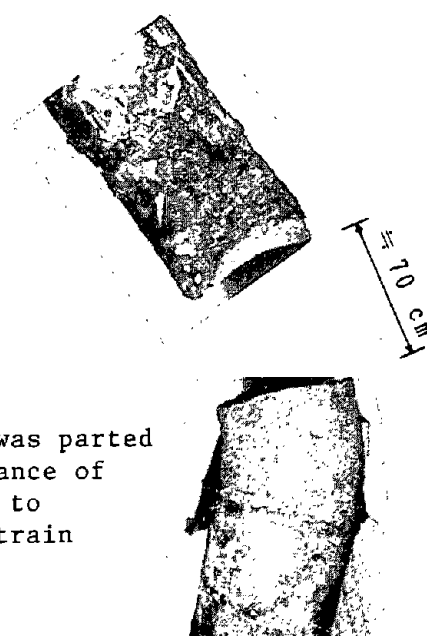
Gas pipe was parted by a distance of 70 cm due to tensile strain

Two broken ends bit into each other due to compressive strain

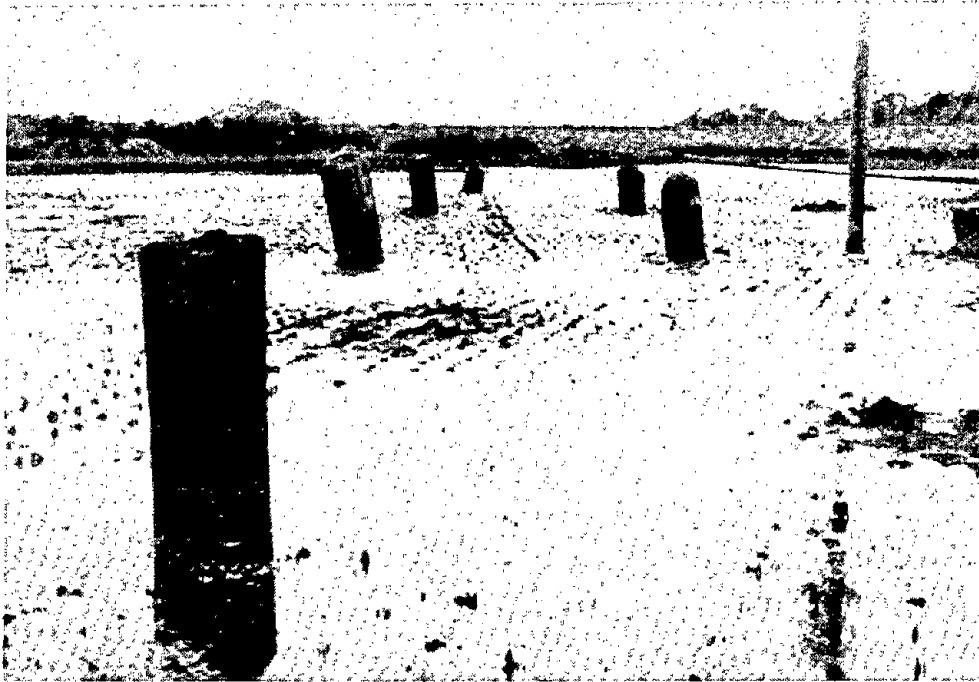
Reports issued shortly after the earthquake documented liquefaction-related damage as follows: (1) Wooden piers, which might have been driven about 700 years ago, surfaced in a rice field at Machiya, site 1 in Figure 4 (Figure 5);¹¹⁾ (2) The open caissons of Banyu Bridge on National Route 1 tilted extremely, rose buoyantly and moved as shown in Figure 6 (site 2 in Figure 4);¹²⁾ and (3) All housing wells in the Suga area, site 3 in Figure 4, filled completely with the deposits of sand.¹³⁾

Figure 5 Seven Wooden Piers Which Buoyantly Rose about 1.5 m in a Rice Field during the Kanto Earthquake (Imperial Earthquake Investigation Committee, 1925)¹¹⁾

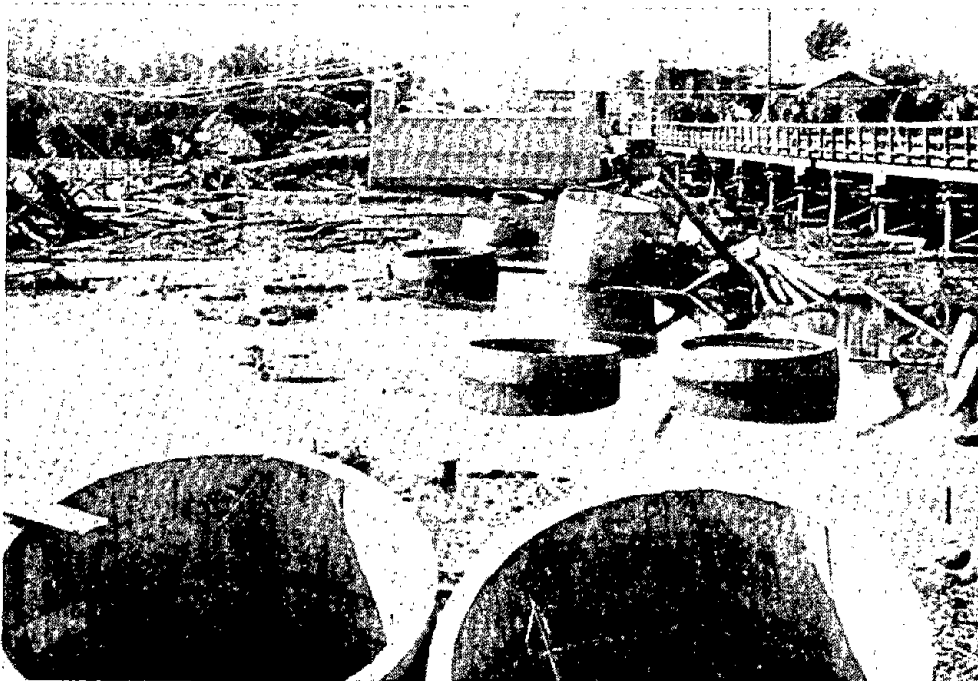
Figure 6 Tilting, Rising up and Lateral Movement of Open Caissons of Banyu Bridge over Sagami River (Japan Society of Civil Engineers, 1927)¹²⁾

Open caissons of the bridge on Route 1, which was under construction at the time of the earthquake, leaned, rose buoyantly, and were displaced as mentioned before (Figure 6). Abutments on both banks tilted toward the river. The inclination of the abutments was about 4 degrees and 12 degrees for the left and right banks, respectively.¹²⁾ The damage to the two bridges indicates that ground displacement occurred in a direction towards the Sagami River in addition to the displacement towards Okawa Creek.

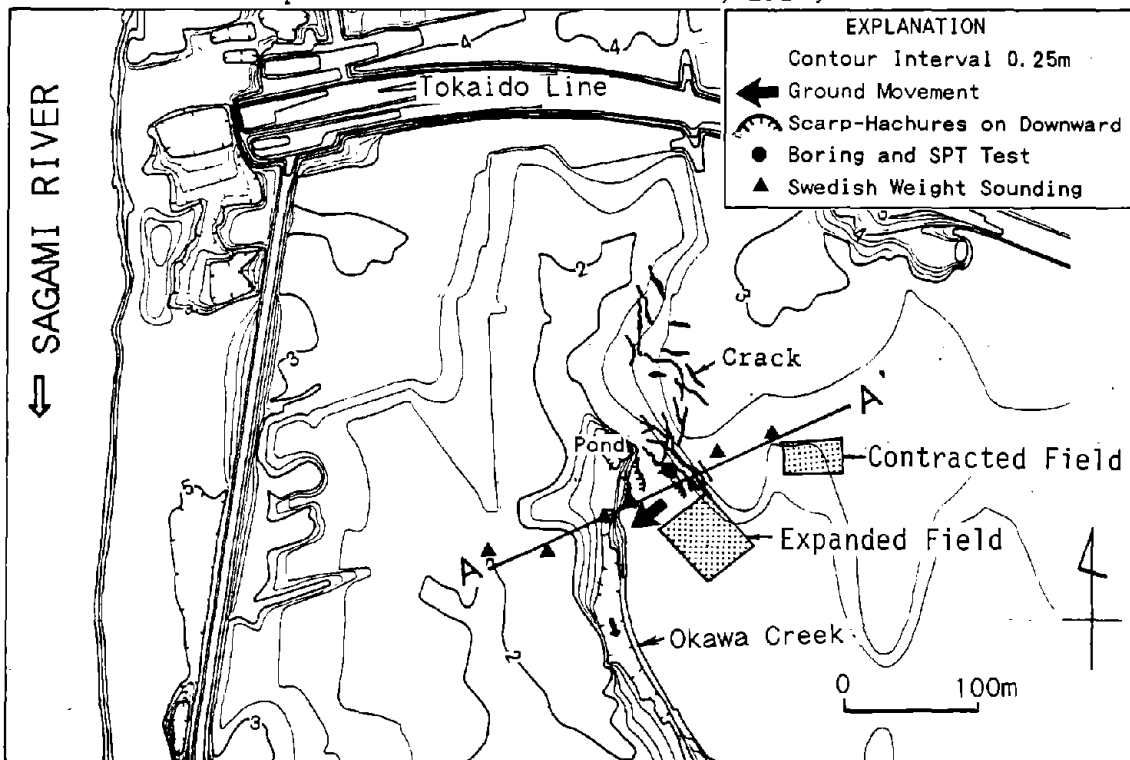
An aerial photograph showing ground cracks in the Nakajima area was found in a damage report of the Kanto earthquake (Figure 7).¹⁵⁾ Based on an interpretation of this photo and a field inspection, the locations of ground cracks were drawn onto a topographic map (Figure 8). The contours of the map were delineated by means of stereo pair aerial photos taken in 1946, one of which is shown in Figure 4. The ground cracks occurred on the edge of an abandoned channel bar, where the contours converge to show locally steep relief.

Figure 8 Contour Map of Nakajima Showing Locations of Ground Cracks and Ground Deformation Generated by Lateral Ground Movement and Location of Borings and Soundings for the Cross Section A-A' in Figure 12

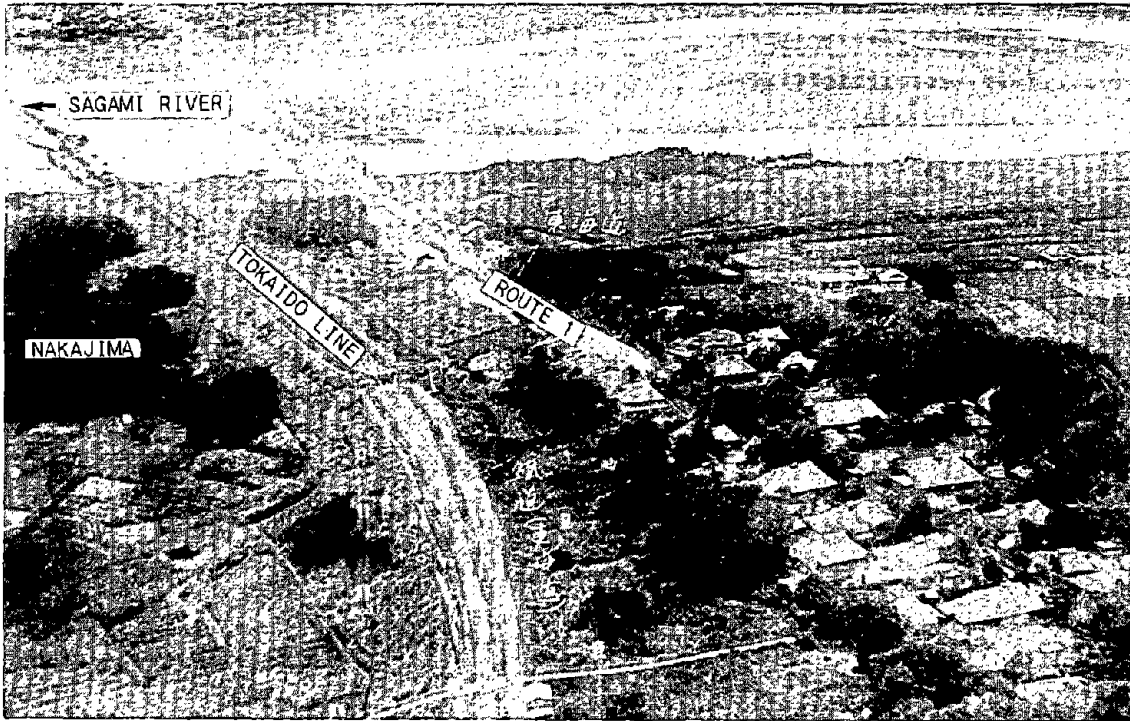
Sagami River (Figure 9 and Figure 10). Between Chigasaki Station and the Sagami River, the embankment of the railway cracked, settled, and collapsed due to the earthquake (Figure 11). Abutments of the railway bridge across the Sagami River became inclined and were displaced streamward by 18 cm due to the ground movements. The ground movements also displaced, tilted, and broke twenty-seven piers of the railway bridge, as shown in Figure 10.¹²⁾

Figure 9 Damage to Embankment of Tokaido Line and Route 1 Caused by Ground Failure in Nakajima Area (Kanto Headquarters of Martial Law, 1924)18)

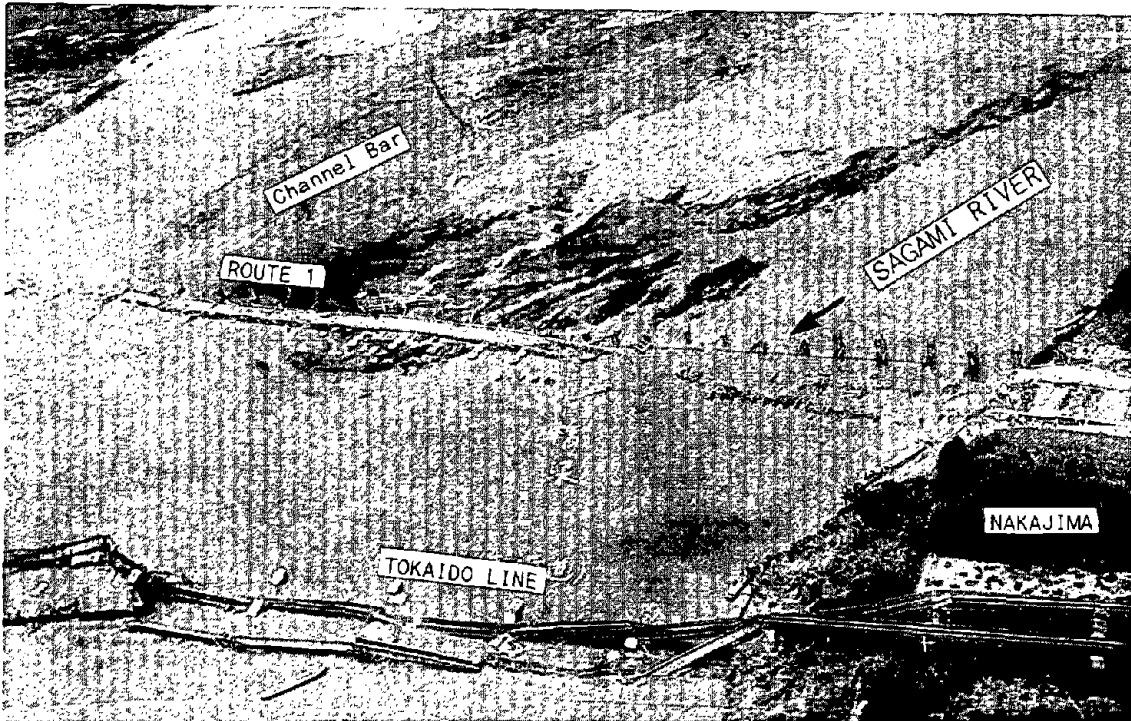
Figure 10 Damage to Bridge over Sagami River (Kanto Headquarters of Martial Law, 1924)18)

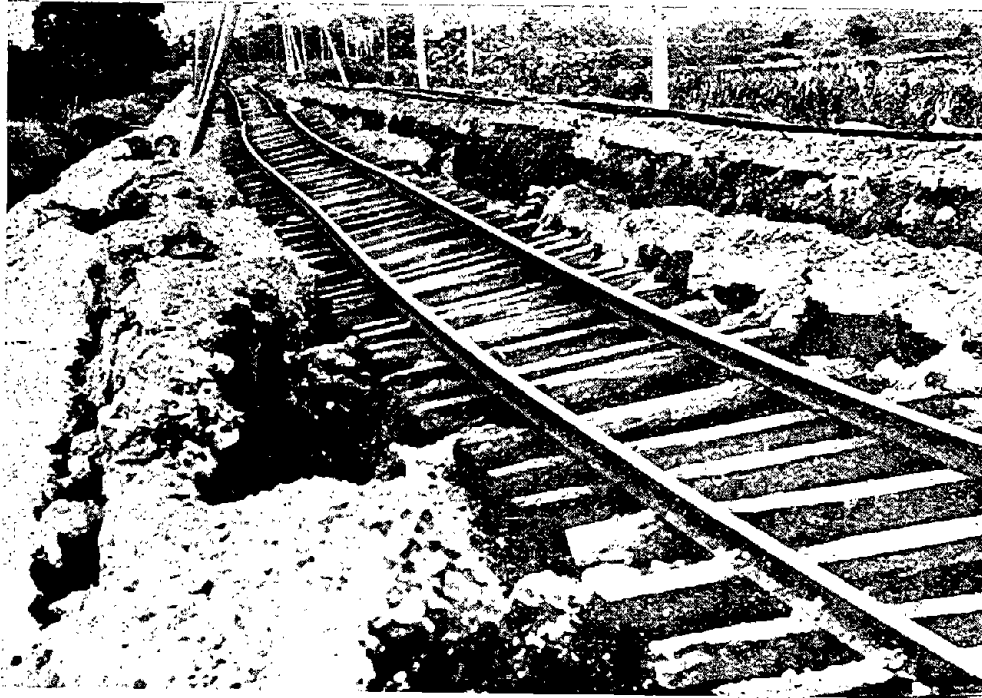
Figure 11 Collapse of Embankment of Tokaido Line in Nakajima Area (Japan Society of Civil Engineers, 1927)¹²⁾

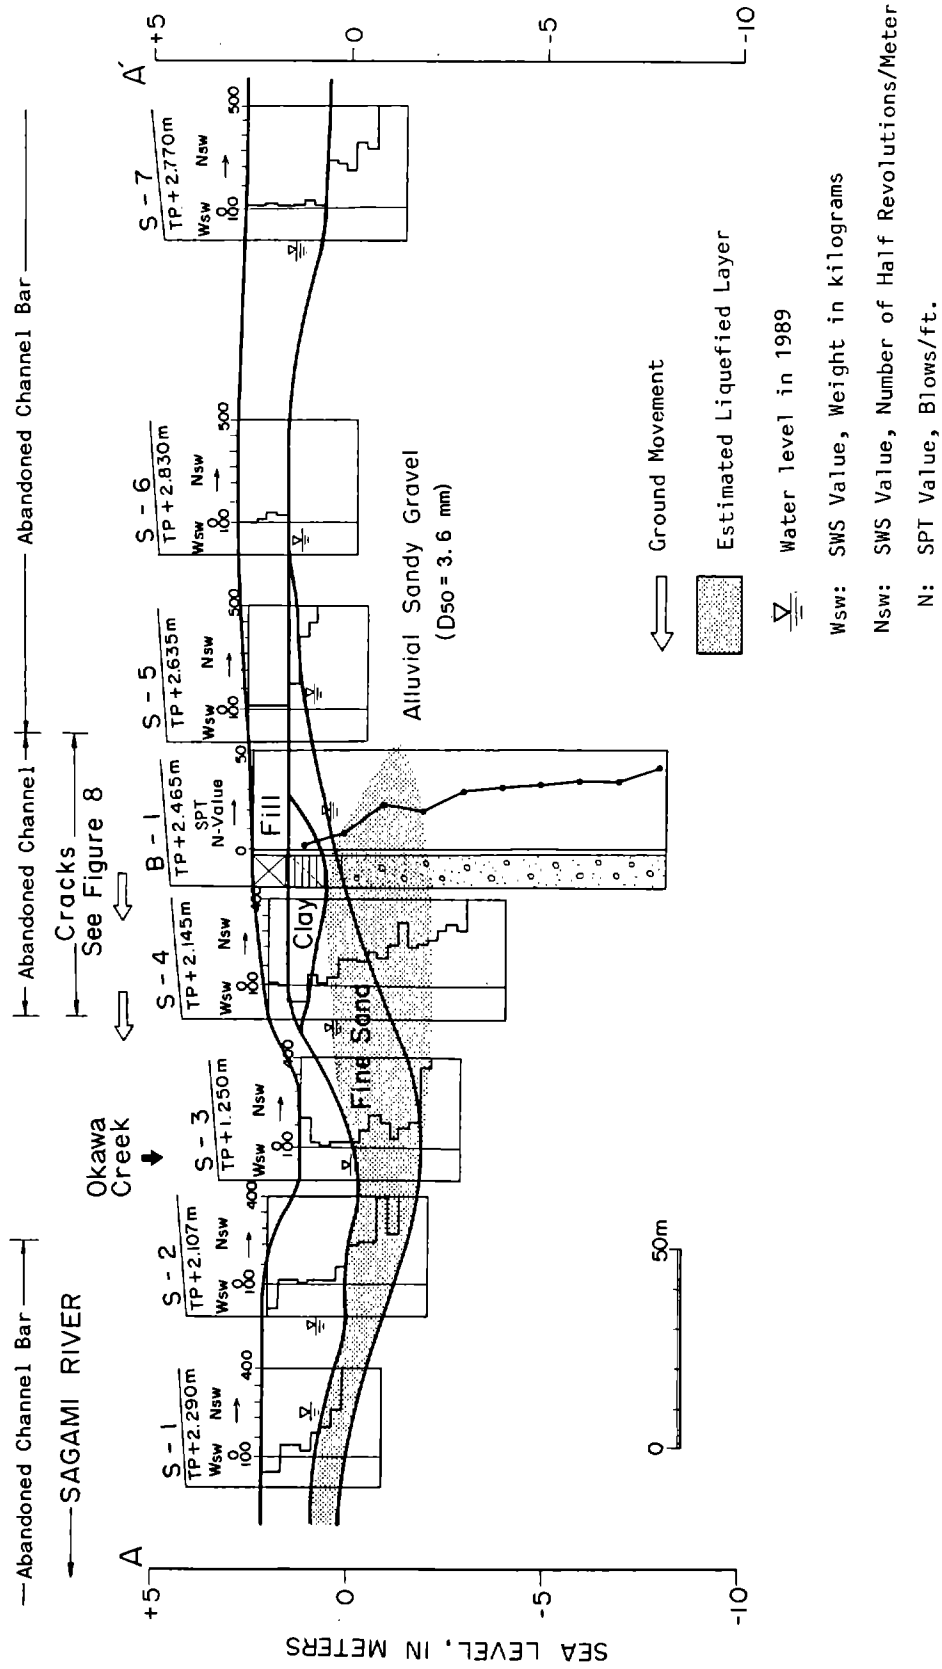
Figure 12 shows a geotechnical cross section along line A-A' in Figure 8 as interpreted from the standard penetration test (SPT)* and Swedish weight sounding test (SWS).** The present ground surface is situated 2-3 m above sea level and slopes slightly toward Okawa Creek with a gradient of about 0.5%. The top 1-2 m is composed of agricultural clay fill. Loose fine sand lies beneath the fill, and moderately dense sandy gravel underlies the fine sand. Both of these (gravel and sand) are channel bar or channel deposits. A clay lens containing sand exist over the fine sand layer only at bore holes B-1 and S-4 where ground cracks occurred. The water level at the time of drilling (June, 1989) ranges in depth from 1.3 m-1.9 m. But it is likely that the groundwater level in this area has become appreciably lower since 1923.

Figure 12 Cross Section of Sediments at Nakajima Area Showing Geotechnical Features and Estimated Liquefied Layer

The grain size distribution curves for samples taken from the sand and gravel layers are plotted in Figure 13. The sediment may be too coarse and well drained to liquefy. However, a feasible explanation for the ground failure in this area is liquefaction of the fine sand and sandy gravel. This assumption is based on the following description given by the residents: "A great quantity of water gushed forth," "the sand boils were composed of coarse sand and a few pebbles." In the case of the Nakajima area, the low permeability of the agricultural clay fill and the clay lens beneath the fill, are likely to have promoted the development of excess pore water pressure in the underlying sand and gravelly deposits.

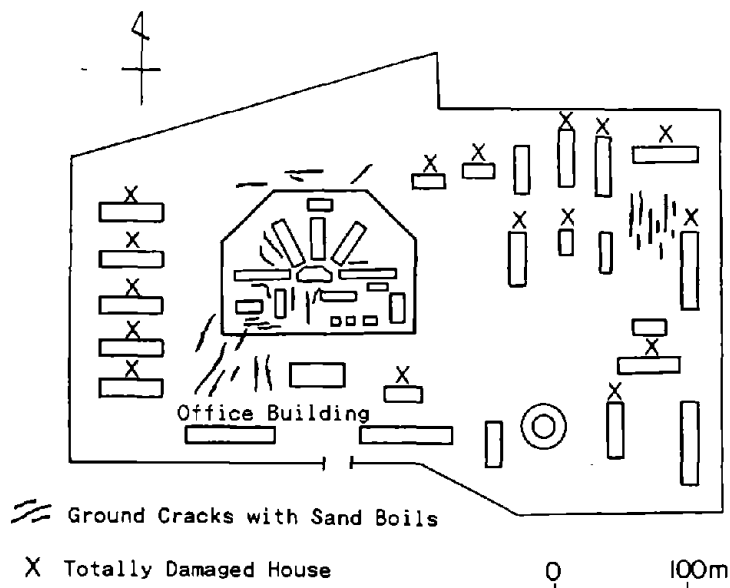
According to the Geological Survey of Japan,²⁰⁾ at Kosuge Prison, site C in Figure 14, numerous ground cracks formed on the premises as seen in Figure 15, and sand and water gushed out of these cracks. The water flooded the premises to a depth of about 30 cm. Larger cracks formed in the yard west of the office building.

Figure 15 Plan View of Kosuge Prison Showing Locations of Ground Cracks and Totally Damaged House (Geological Survey of Japan, 1925)²⁰⁾

At least three of the cracks measured up of 1 m wide, were deeper than 1 m, and about 30 m in length.

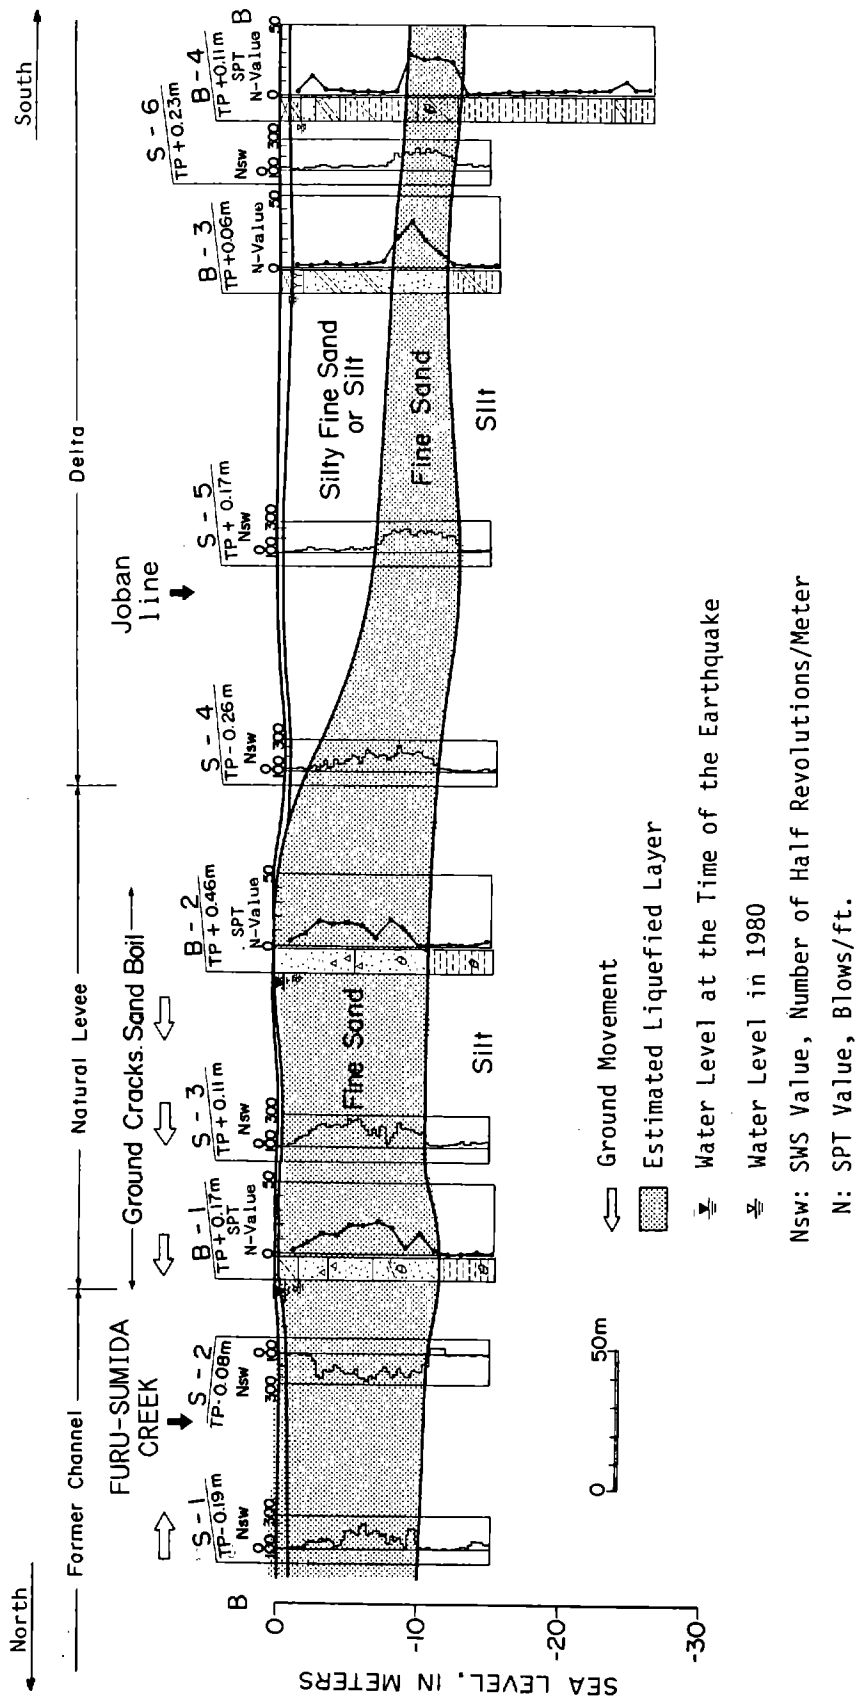
Figure 18 shows a geotechnical section along the line B-B' in Figure 16 as interpreted from the bore hole data and Swedish weight sounding tests. The ground surface currently is nearly at sea level and slopes gently toward the Furu-Sumida Creek. The inclination of the ground is only 0.4% now, but it was a little steeper at the time of the earthquake. The difference in ground level was about 2 m between site B-2 and the river according to the residents, whereas, it is now about 0.5 m due to leveling after the earthquake.

Figure 18 Cross Section of Sediments at Nishi-Kameari, Tokyo, Showing Geotechnical Features and Estimated Liquefied Layer

The upper surface of the estimated liquefied layer is slightly inclined toward the river as is the ground surface. The estimated liquefied layer has a maximum thickness of 11 m in the section where severe ground cracks and sand boils occurred. On the contrary, in the section south of the Joban Line where no surficial effects of liquefaction were observed, it is about 3 m in thickness and covered with a 7-9 m thick non-liquefied layer.

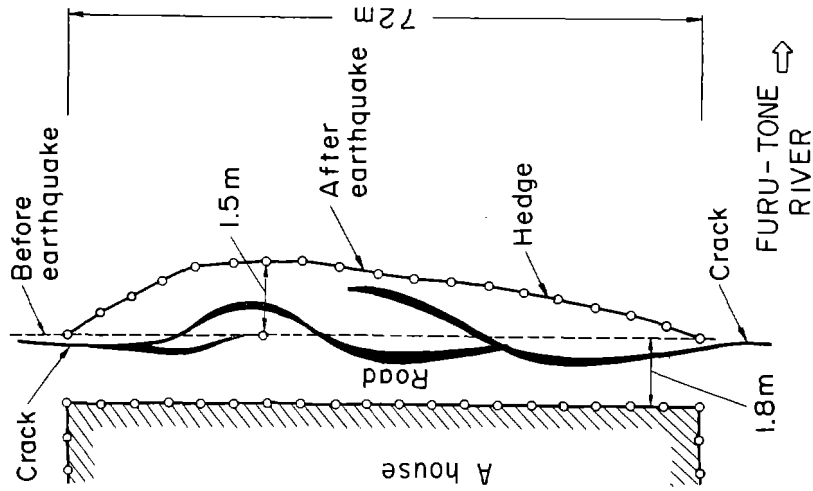
After the earthquake, road running in front of a house cracked and became curved with a maximum displacement of 1.5 m toward the river over a distance of 70 m (Figure 24). Figure 25 shows the road as it is now, still curved. Many residents in this vicinity provided additional information about the ground failures and displacements that occurred during the 1923 event. They identified locations described in the existing damage report.²⁰⁾ The eyewitnesses recalled that the ground cracks reached a maximum of approximately 300 m in length, 2 m in width, with vertical offsets of 1-2 m. A bicycle and a wooden bathtub fell into the cracks and were never found. Many houses partially collapsed because their foundations fractured and split apart due to the ground cracks. The ground in this neighborhood apparently moved in a direction toward the river, and the area along the Furu-Tone River subsided.

Figure 24 Ground Cracks and Offset Displacement
 in Roadway in Kawakubo Area (Geological
 Survey of Japan, 1925)20)

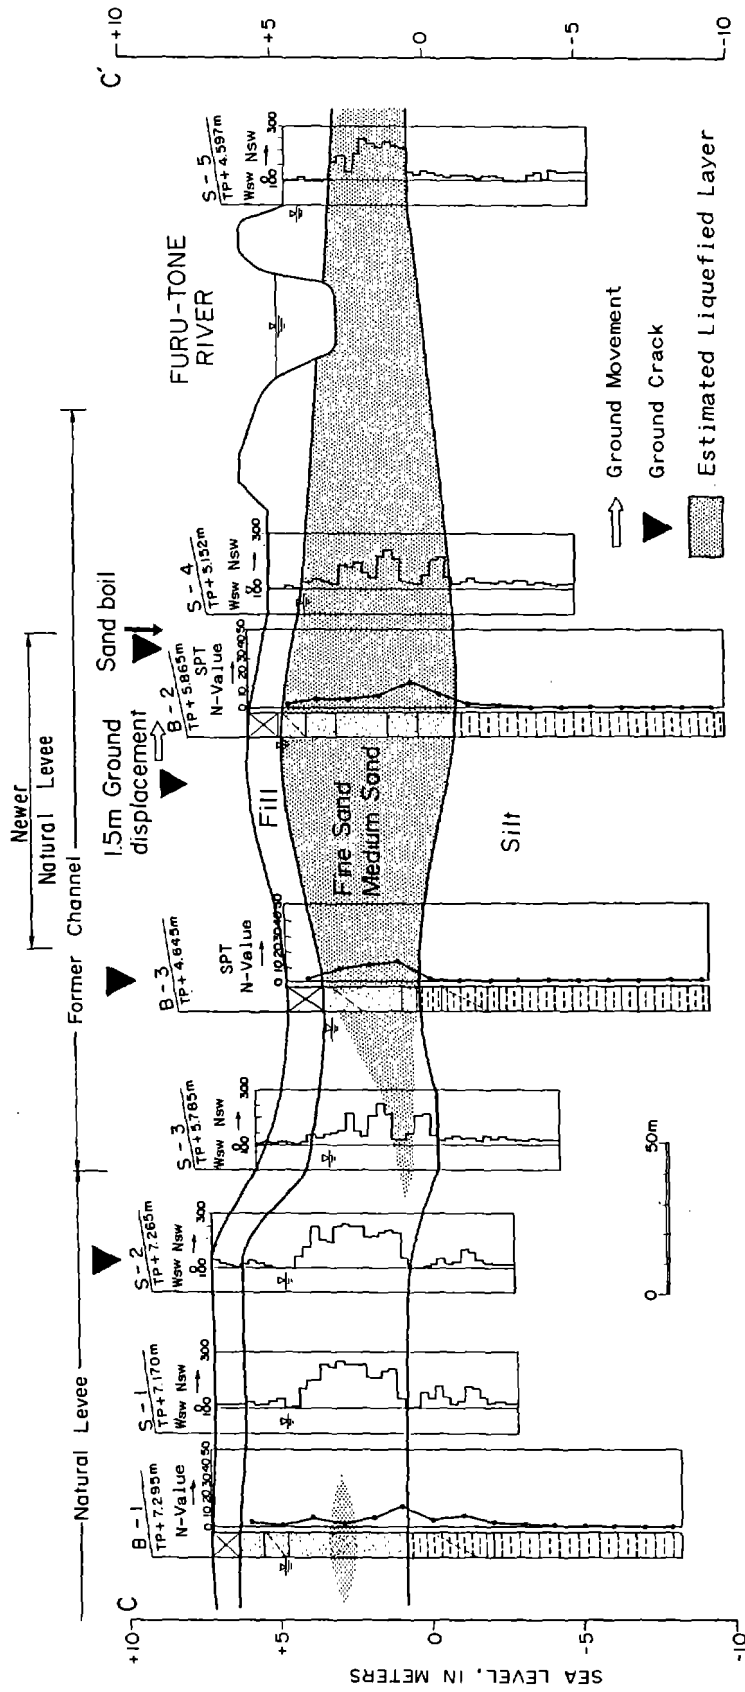
An estimation of liquefaction based on the procedure outlined in the Japanese Highway Bridge Code¹⁰⁾ was also conducted, assuming that a peak acceleration of 0.20 g occurred at the site. According to the estimation, the sand layer underlying the areas within the former and present river channels, liquefied as shown by the shaded portion in Figure 27.

Figure 27 Cross Section of Sediments at Kawakubo Showing Geotechnical Features and Estimated Liquefied Layer

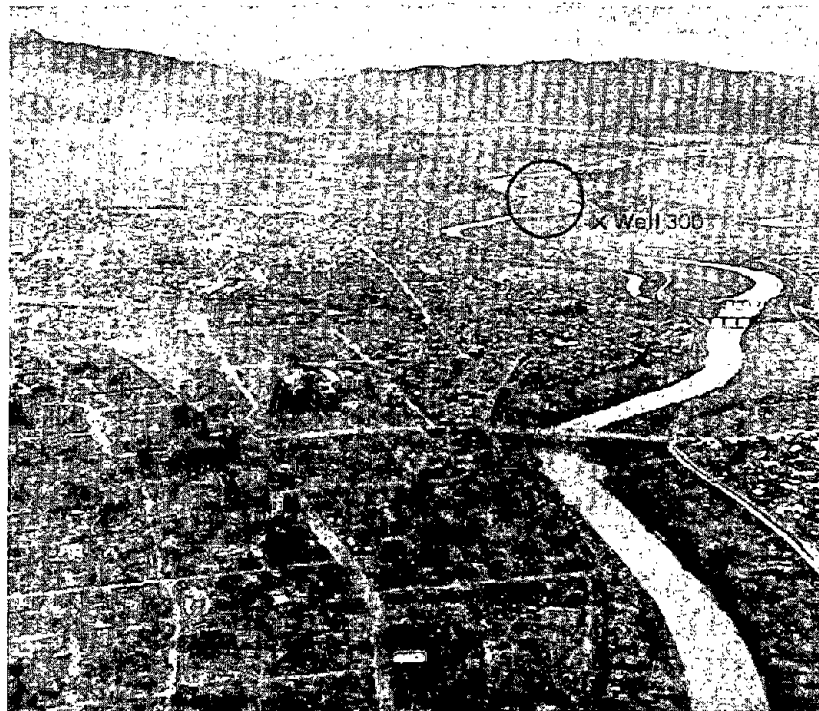
Photo 1
Central Fukui City
after the Earthquake

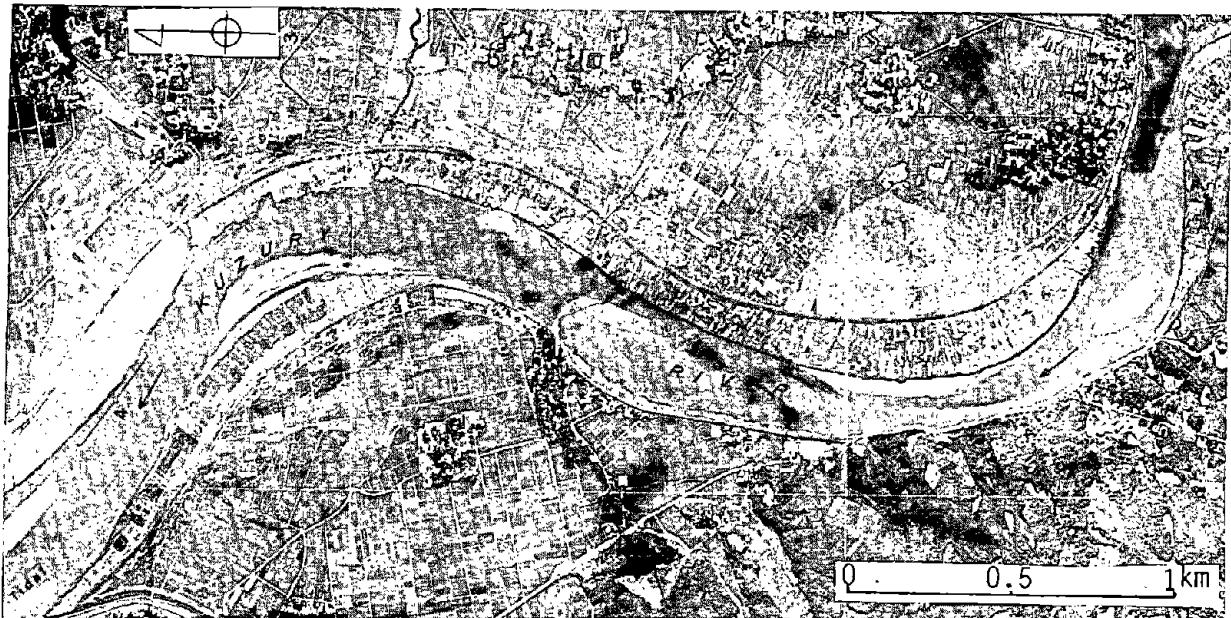
Photo 2 Sand Boils along The Main Channel of the Kuzuryu River
(White-colored area shows the sand boiled out of the ground)

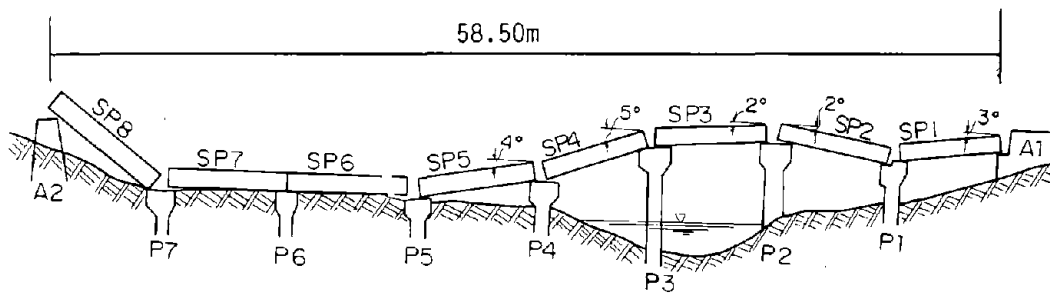
The Nagaya Bridge is located 5 km from the epicenter at Point ① in Figure 6. Eight spans of reinforced-concrete I-beam over a total length of 58.5 m were supported on concrete piers. Three piers, P5, P6, and P7, sank to ground level due to liquefaction and the beams fell to the ground as shown in Figure 7. It was reported that the piers sank almost vertically.

Figure 7. Damage to Nagaya Bridge (Point ① in Figure 6)

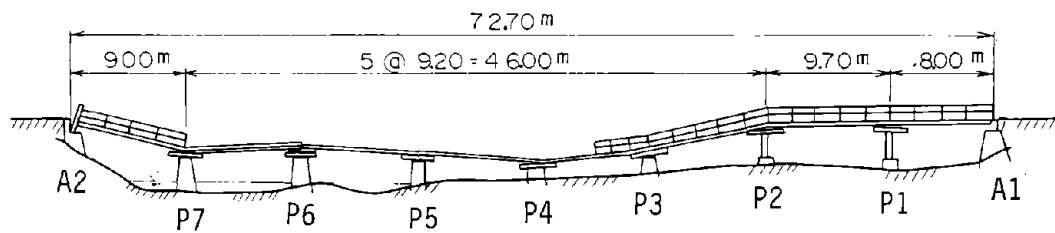
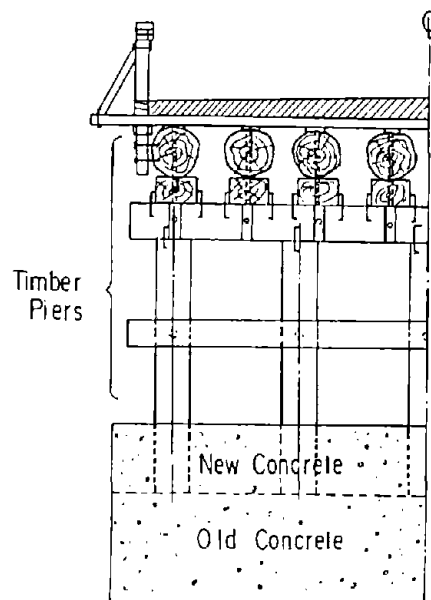
The Nagaune Bridge, with a total length of 72.2 m, is located about 4 km from the epicenter at Point ② in Figure 6. Eight spans of wooden beams were supported upon timber piers with concrete foundations, as shown in Figure 8. Piers P3 to P6 sank due to loss of bearing capacity in the foundation soils

Figure 8. Damage to Nagaune Bridge (Point ② in Figure 6)

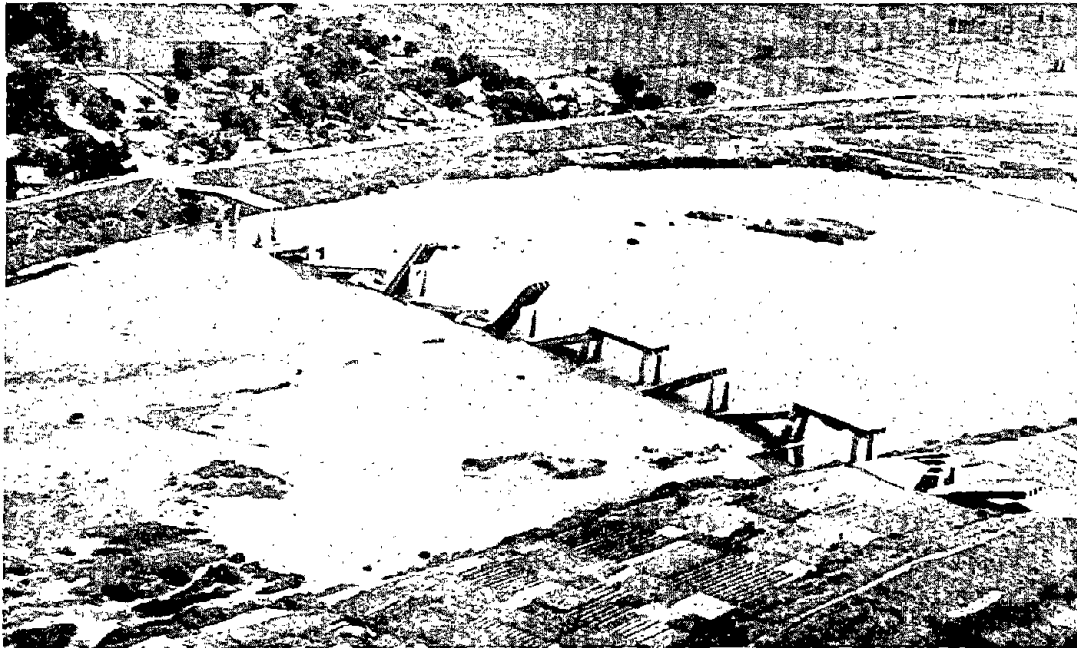
Photo 3 Collapse of Nakatsuno Bridge (Point ③ in Figure 6)¹⁾

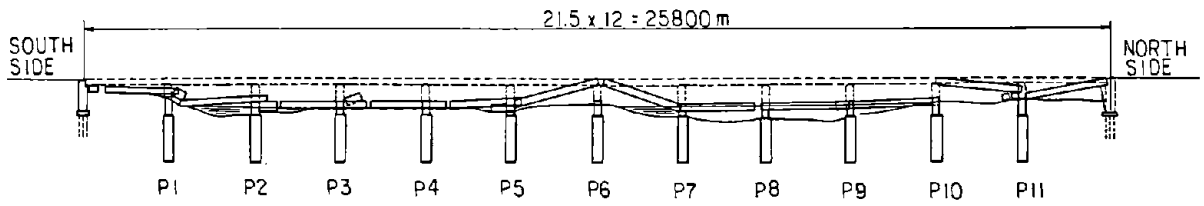
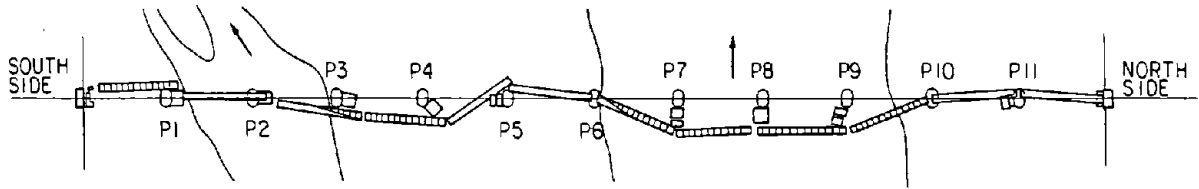
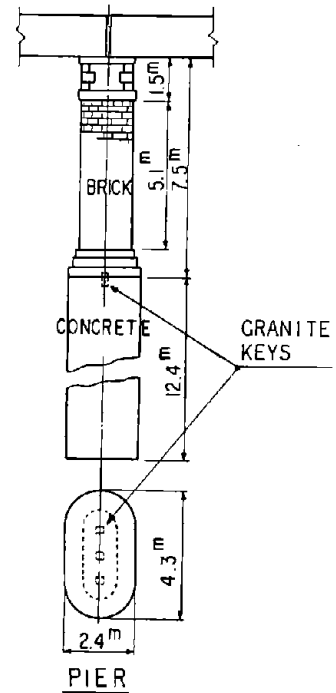
Figure 10. Damage to the JNR Bridge (Point ④ in Figure 6)1)

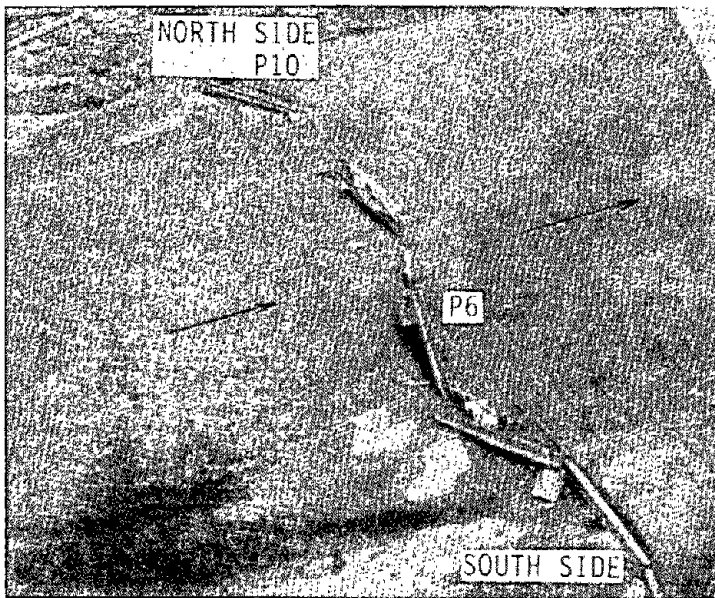
Photo 4 Collapse of the JNR Bridge (Point ④ in Figure 6)1)

(b) Damage to Pier 6

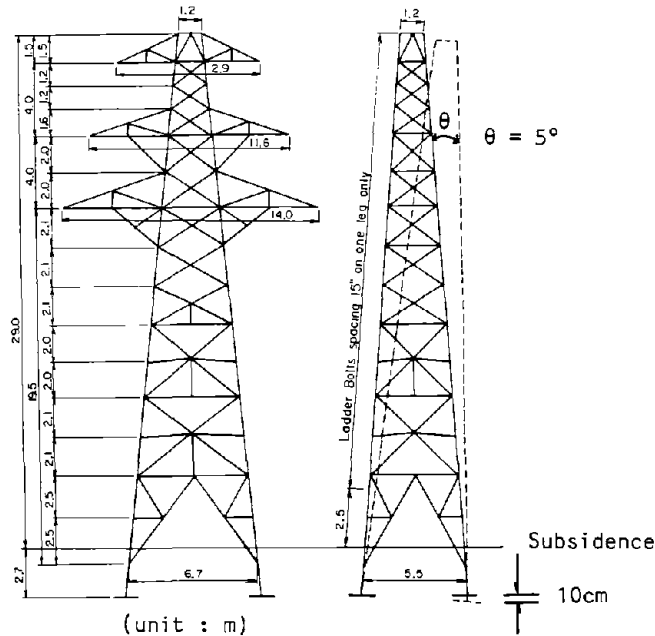
Large inclination of electricity pylons seriously affected electricity supplies after the earthquake. Figure 11 shows one example of the damaged pylons at Point ⑦ in Figure 6. One pylon with a height of 29 m stood on a concrete block foundation in a paddy field. The foundation sank about 10 cm due to liquefaction and the pylon heeled over by about 5°. Many sand boils were found around the foundation.

Figure 11. Inclined Electricity Pylon (Point ⑦ in Figure 6)

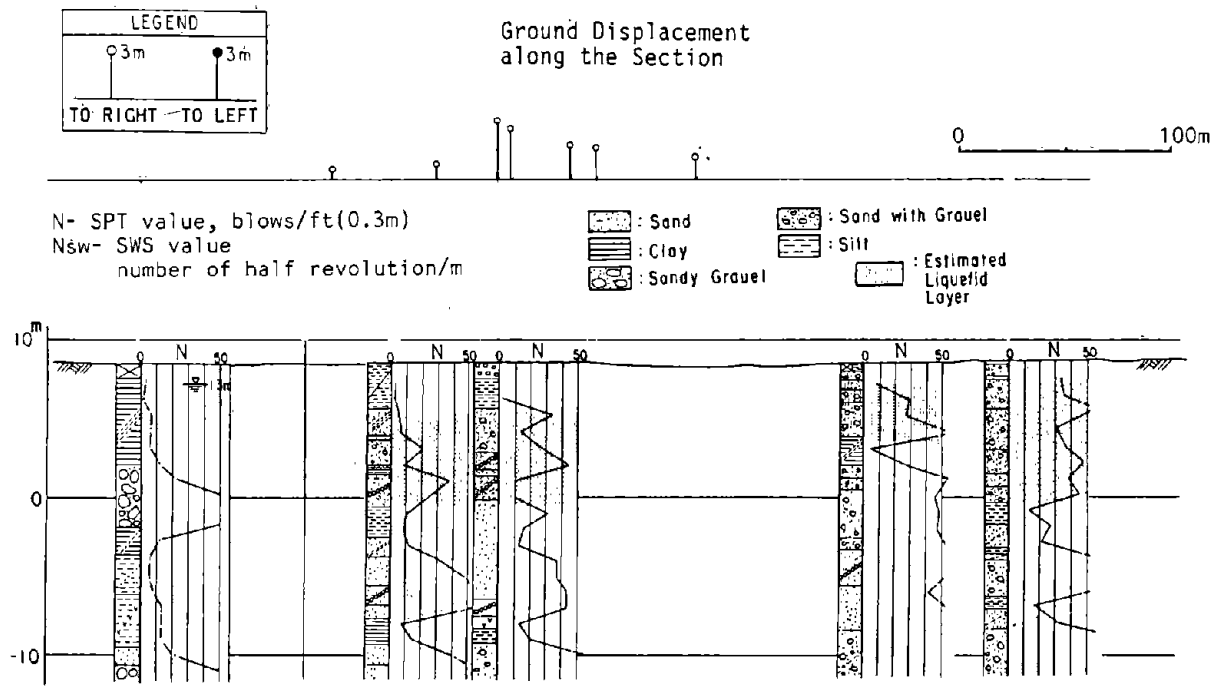
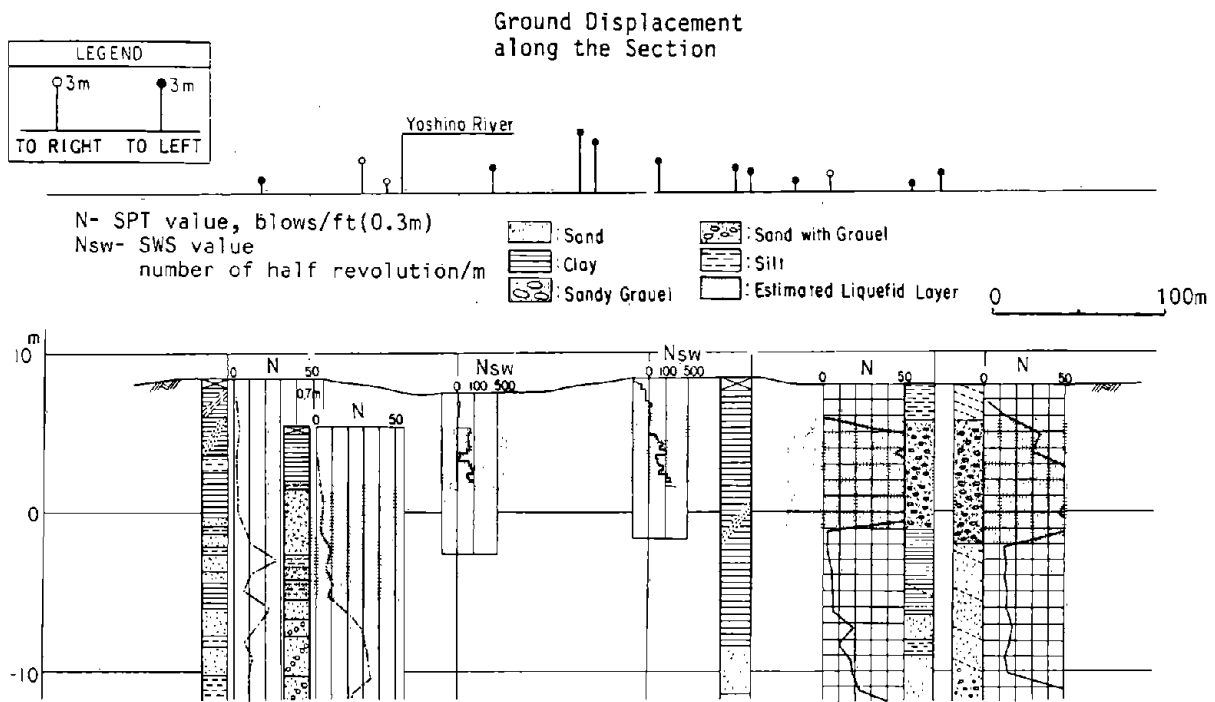
Along section 4-4', where the maximum ground displacement in the horizontal direction reached 3.9 m, the liquefied layer was estimated to have a thickness of 7 m to 9 m. The ground surface is mostly flat along this section.* The correlation between the direction of the ground displacements and the inclination of the estimated liquefied layer cannot be discussed in this case because of the lack of reliability of the estimates.

Along section 5-5, where the ground displaced toward the Yoshino River with a maximum magnitude of 3.5 m, the estimated thickness of the liquefied layer was 5 m to 10 m. The ground surface inclined toward the Yoshino River, but no statistically significant correlation could be found between the magnitude of the ground displacements and the gradient of the ground surface, as shown in Figure 15.

Figure 18. Soil Condition Profiles

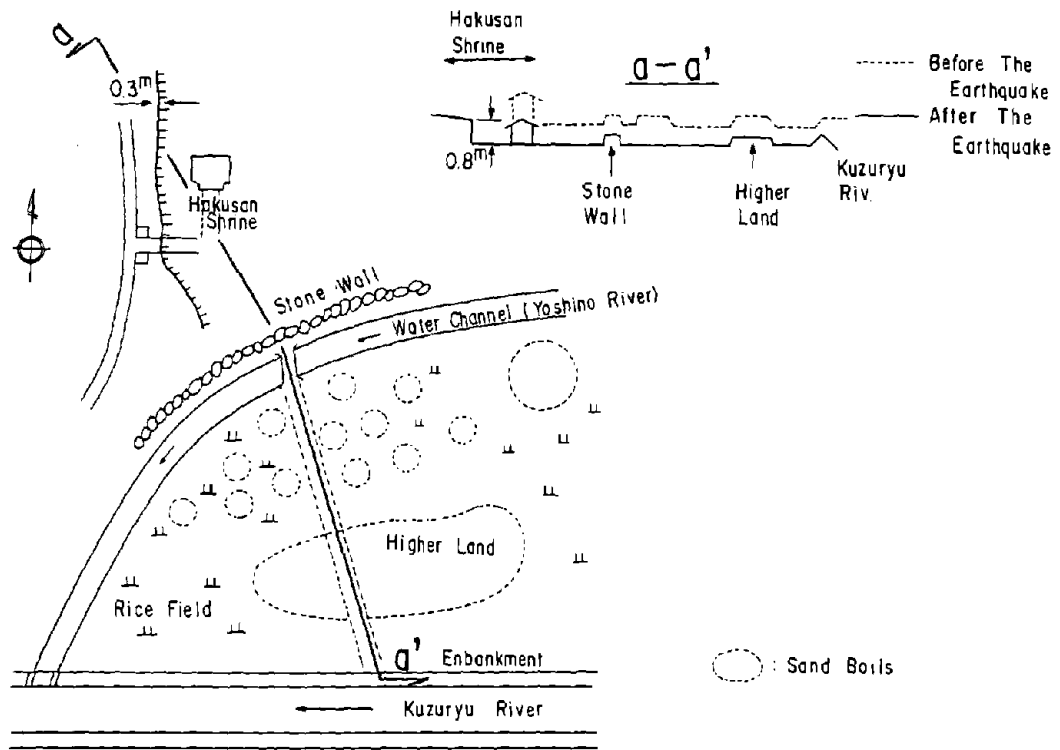
Figure 19 has been developed on the basis of reports of ground failures in the vicinity of the Hakusan Shrine at Shimomorita-Sakuramachi, located on the north bank of the Yoshino River.³⁾ A ground fissure 150 m in length and 0.3 m wide occurred in a south-north direction in the grounds of the shrine. The ground east of the fissure subsided by 0.8 m, and moved in a north-northeast direction. The bed of a water channel, about 100 m southeast of the shrine (which can be considered as the Yoshino River), rose about 1 m to almost the same elevation as the road. The area with a higher elevation between the water channel and the Kuzuryu River suffered severe subsidence, and many sand volcanos with a diameter of about 1.0 m were found in the rice fields. The reports of ground failures in Shimomorita-Sakuramachi³⁾ were verified by interviews with the eyewitnesses in the area. Their remarks can be summarized as follows:

Figure 19. Ground Failures in the Vicinity of Hakusan Shrine
