Case Studies of Liquefaction and Lifeline Performance During Past Earthquakes

Volume 1
Japanese Case Studies

Edited by
M. Hamada and T. D. O'Rourke

Technical Report NCEER-92-0001

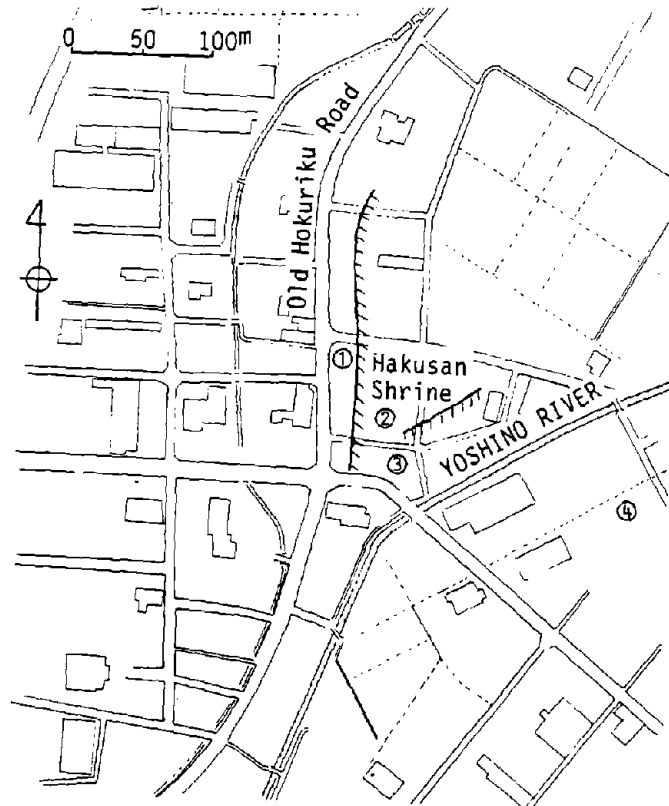
Figure 20. Ground Failures in Shimomorita-Sakuramachi and Vicinity

Point ① in Figure 20: A large ground fissure with a width of 20 to 30 cm occurred in the grounds of Hakusan Shrine almost parallel to the Old Hokurido road (generally in a north-south direction), and the ground to the east of the fissure subsided by 0.5 m to 1.5 m. This fissure continued to the north for about 200 m from the shrine. Between this large fissure and the Yoshino River, small fissures appeared, and fine blue sand and water boiled out. Some eyewitnesses said that the ground surface undulated greatly in the vertical direction during the earthquake.

Point ②: A ground fissure parallel to the Yoshino River appeared under a house. The fissure was 20 to 30 cm wide immediately after the earthquake, but it expanded to 30 to 40 cm by the next morning. Ultimately, it became 1 m wide and over 1.8 m deep. Water and sand boiled out of a well up to 1 m high during the earthquake. The boil action continued for 2 to 3 days after the earthquake. Besides this case, many instances of water and sand boils from wells were reported in the area.

Point ④: In the rice fields between the Yoshino and Kuzuryu Rivers, many sand and water boils and ground fissures were observed. The heights of the sand and water boils were 0.5 to 2.0 m, and they continued for a long time after the earthquake, but no houses collapsed in this area. On the contrary, on the western side of the large ground fissure (Point ①), on the natural levee, most houses collapsed. Concerning the duration of water and sand boils, most eyewitnesses said that they continued after the earthquake motion ceased, but it should be noted that some stated that the boils ended with the earthquake motion. One eyewitness in this area said that high columns of water were observed in the Kuzuryu River during the earthquake.

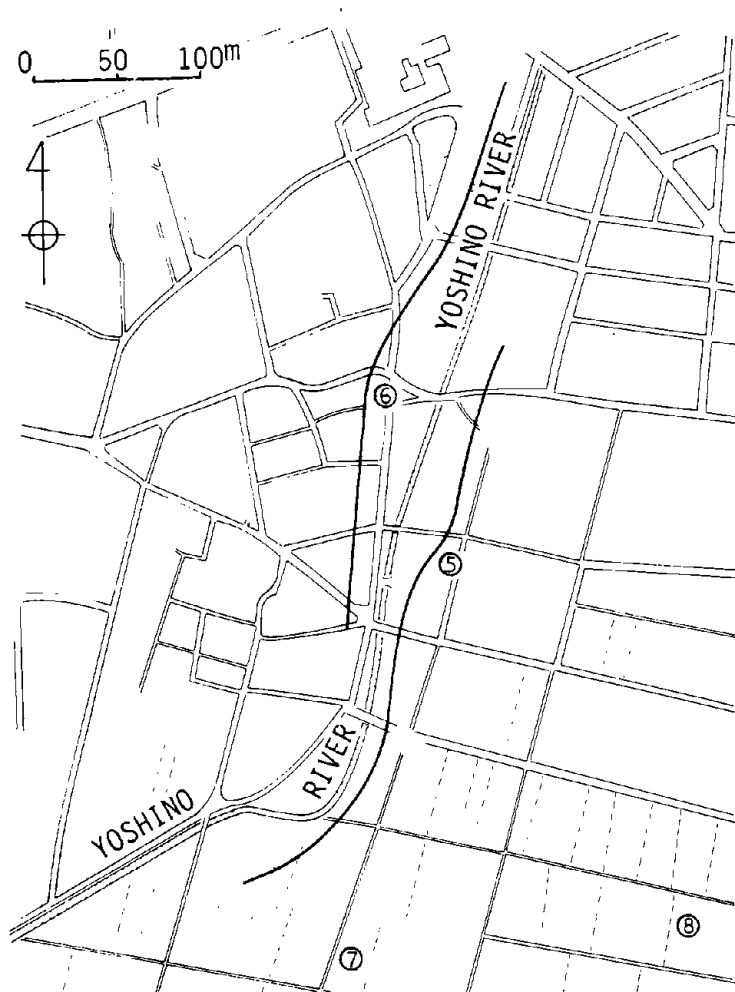
Point ⑤ and ⑥ in Figure 21: Along both banks of the Yoshino River, ground fissures with widths of 1 to 2 m and lengths of about 300 m occurred. On the west bank, the ground subsided 0.5 to 1.0 m between the fissures and the river. The river was reduced in width and the river bed rose up as a result of extensive sand boils. Residents had to dredge the riverbeds to prevent flooding. On the east side of the Yoshino River, boils of water and sand were particularly severe, and the area was flooded to a depth of 0.5 to 1.0 m. The boundaries of real estate were altered due to lateral movement of the ground, so that many land conflicts arose.

Point ⑤: The width of the ground fissure at this point was about 1.0 m immediately after the earthquake, but it increased to 3 m several hours after the earthquake. A horse fell into the fissure. Ultimately, the fissure filled up with sand a week after the earthquake.

Point ⑥: A stone warehouse at this point sank by a full 6 m, the roof ending up level with the ground surface. On the west side of the Yoshino River, it was reported that the land expanded and that straight roads became curved due to the large displacements of the ground toward the river. Furthermore, many wells had to be abandoned since the well casings were bent.

Point ⑦: Between the Kuzuryu River and the Yoshino River, most of the rice fields were abandoned after being covered by a considerable amount of boiled sand. Most people who saw the boils said that the sand ejected was fine and blue.

Figure 21. Ground Failures in the Uenohonmachi Area

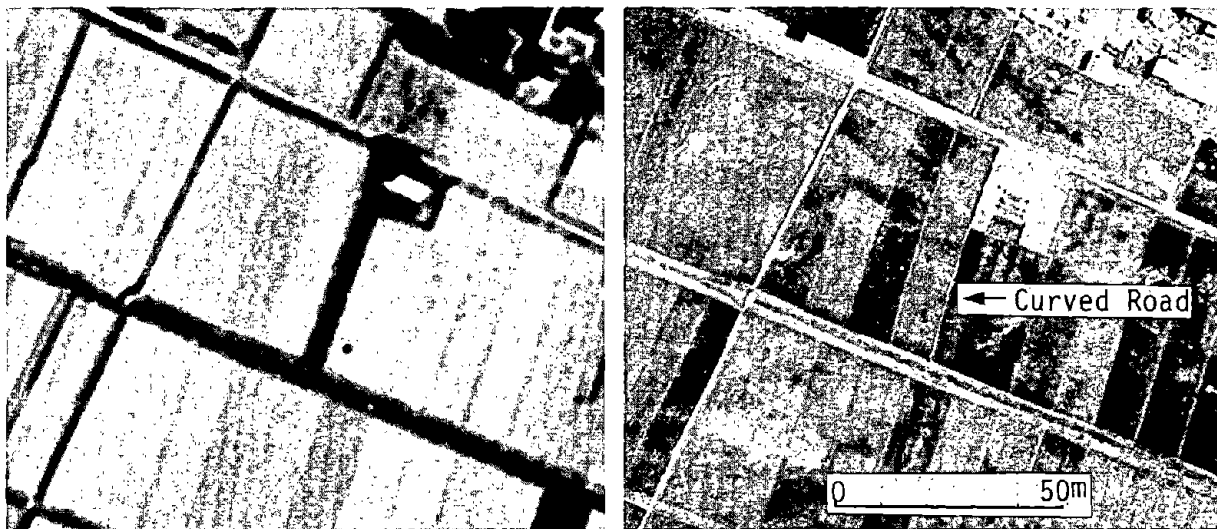
(a) Before the Earthquake
 (b) After the Earthquake
 Photo 8 Road Curvature due to Permanent Ground Displacement
 (Point ⑧ in Figure 21)

Point ⑧: An agricultural road, which had been straight, was distorted by the earthquake. The maximum displacement at the mid-point of the road was about 4 m. This statement can be verified by aerial photographs taken before and after the earthquake, as shown in Photo 8.

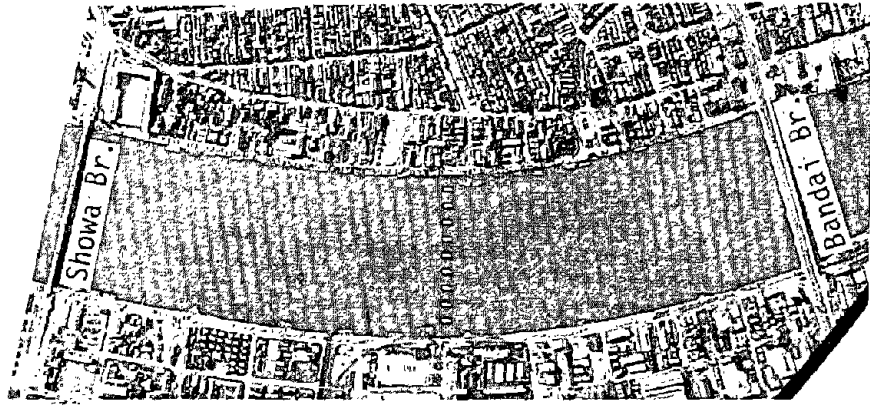
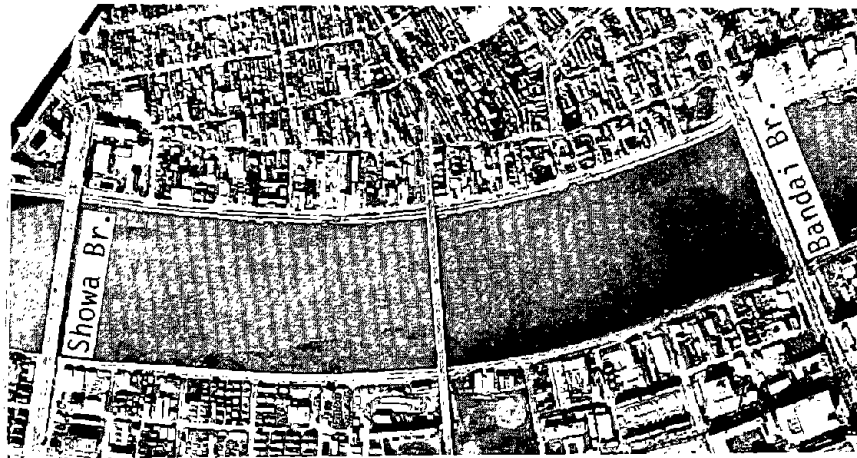
Most of the revetments of the Shinano River, which were built of steel sheet piles and wooden piles, collapsed during the earthquake. It can be surmised that the ground near the river moved toward the river after the collapse of the revetments. However, most of the measuring points of permanent ground displacements shown in Figure 5 are located far enough from the revetments to escape the influence of the collapse, and so the results in Figure 5 indeed show that ground over a wide area along the river bank moved toward the river. This means that the river's width was greatly reduced by the earthquake. To verify this fact, an aerial photograph survey was performed, focusing on the change in river width. The change was estimated by subtracting the river width measured on aerial photographs taken two years before the earthquake, from that measured on photographs taken in 1975, by which time the bank revetments had been completely restored. Photo 2 shows the aerial photographs used for these measurements and Figure 6 shows the change in river width. Between Bandai Bridge and Yachiyo Bridge, where permanent ground displacements with a maximum extent greater than 8 m occurred on both banks, the river width was reduced by 16 to 23 m, while between Showa Bridge and Kawagishi-cho, where large permanent ground displacements reaching a maximum of about 11 m occurred only on the left bank, the river width was reduced by 7 to 13 m.

These measured contractions in river width are somewhat larger than the sum of permanent ground displacements, as shown in Figure 5, on both banks of the river. However, taking into account the fact that new revetments were constructed after the earthquake by driving steel sheet piles in front of the

Photo 2 Aerial Photographs of the Shinano River

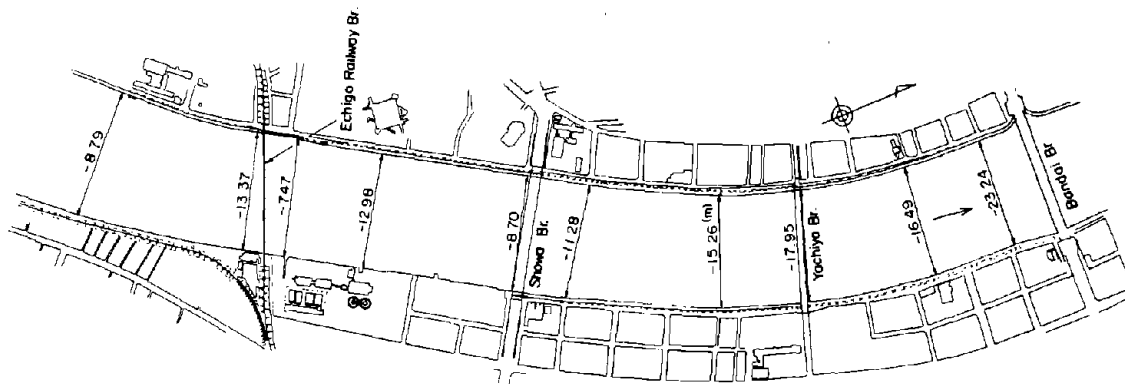
Figure 6. Reduced Width of the Shinano River due to the 1964 Niigata Earthquake (m), (-: Reduction of Width)

collapsed revetments, it can be concluded that reductions in river width, after adjusting for the effects of new construction, coincide quantitatively with the permanent ground displacements measured on the river banks.

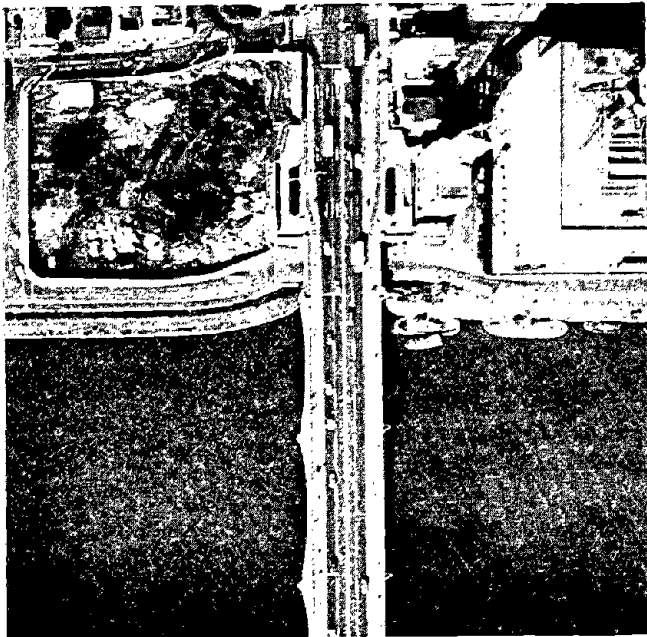
(1) Movement of the river bank (Point ① in Figure 5(a))

Photo 3 shows the left bank of Bandai Bridge two years before the earthquake (a), four hours after the earthquake (b), and seven years after the earthquake (c) by which time the revetment had been restored. Before the earthquake, the revetment had been straight and perpendicular to the bridge axis. The photograph taken four hours after the earthquake shows that the area on the left bank was flooded when the river revetments collapsed. It is notable that the revetment curves greatly in the neighborhood of the abutment of Bandai Bridge in the photograph taken seven years after the earthquake. This indicates that, in the neighborhood of the abutment, the ground displacement was reduced because of the rigidity of the bridge, which is a concrete arch bridge, while the ground further from the abutment moved towards the river freely due to collapse of the revetment. As a result of the large ground displacements toward the river, buildings and houses along the banks slipped into the river. Photo 4 shows an example of houses which slipped into the river on the left bank near Bandai Bridge.

Photo 3 Aerial Photographs of the Left Bank of Bandai Bridge

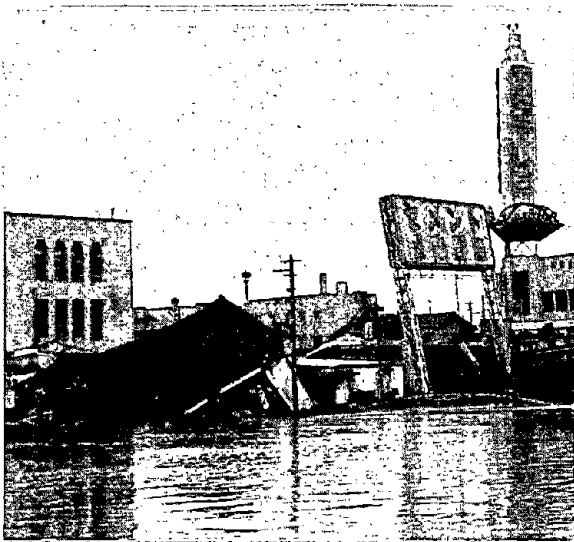
Photo 4 Houses Fallen into the River on the Left Bank of Bandai Bridge

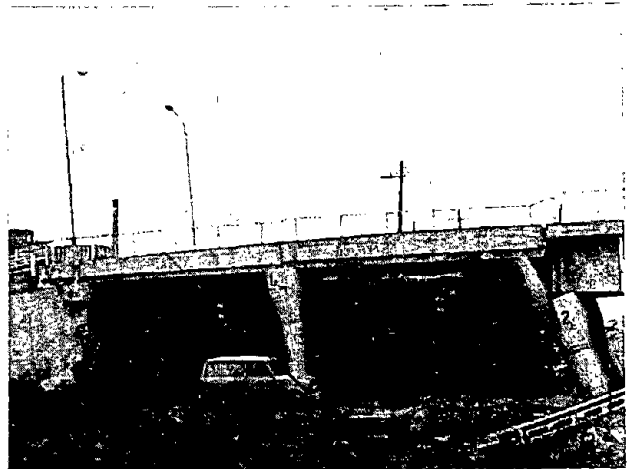
Photo 5 Damage to Yachiyo Bridge

(2) Damage to Yachiyo Bridge (Point ② in Figure 5(a))^{5),6)}

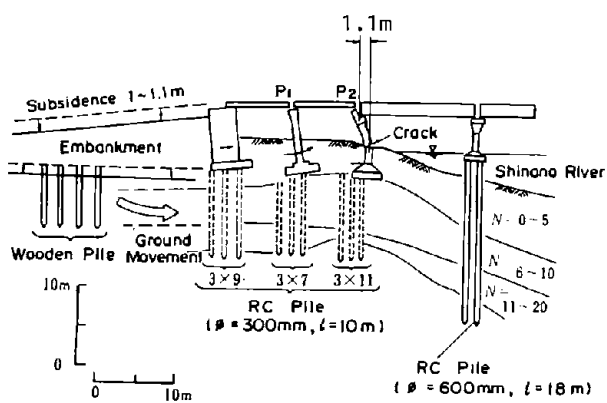
Figure 9. Damage to Yachiyo Bridge(5),6)

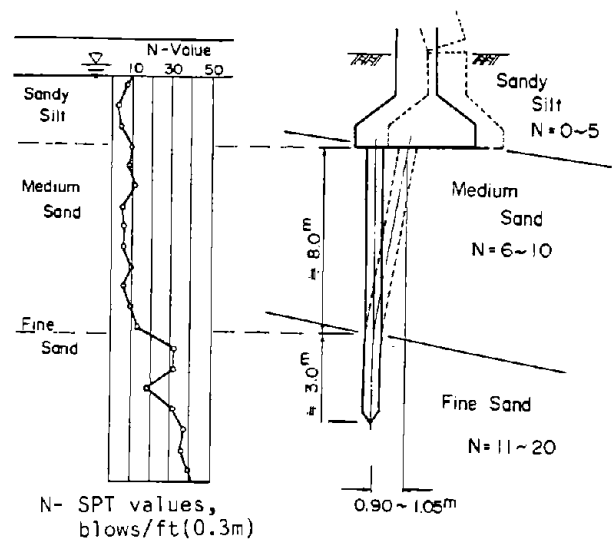
Figure 10. Damage to a Foundation Pile of Yachiyo Bridge(P₂)⁷⁾

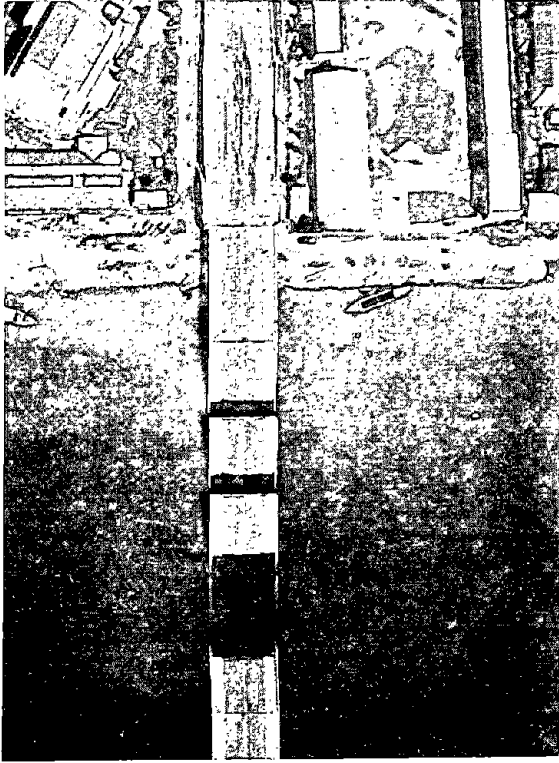
The collapse of Showa Bridge was one of the worst instances of damage to a structure caused by the Niigata earthquake. The construction of the bridge had been finished only five months before the earthquake. As shown in Photo 6 and Figure 11, five simply supported steel girders between piers P₂ and P₇, each of about 28 m-span, fell into the water. It should be noted that the fallen girders were on the left side of the stream.

The piers were constructed by driving steel pipe piles which had a considerable flexibility in the direction of the bridge longitudinal axis. As shown in Figure 11, the two girders on Pier 6 rested on movable bearings (M in Figure 11). That is, the girders were not fixed to the pier. In contrast, on the other piers, one bearing was movable and the other was fixed (F in

Photo 6 Collapse of Showa Bridge

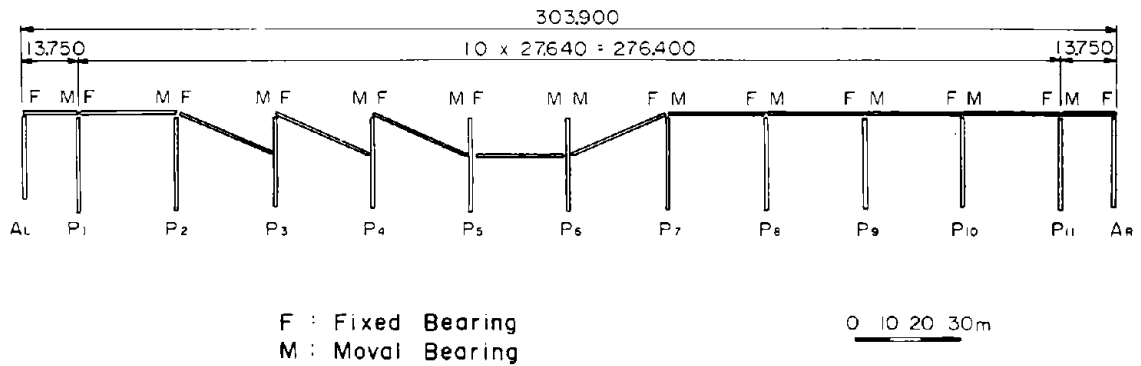
Figure 11. Collapse of Showa Bridge⁸⁾

Figure 11). Therefore, the natural period of Pier 6 was different from that of the other piers due to the lack of additional mass from the girders.

In a previous report,⁸⁾ the collapse of the bridge was explained on the basis of dynamic structural response. Because of the difference in natural periods, relative displacements arose between Pier 6 and the neighboring piers. They exceeded the allowable displacement and triggered the collapse of the bridge. However, this explanation is subject to contradictions, and other causes of failure need to be considered, as mentioned below.

If the direct cause of the collapse of the girders was relative displacement resulting from the difference in dynamic characteristics of neighboring piers, as described above, the collapse should have occurred during the earthquake itself. However, according to the acceleration measurements taken at Kawagishi-cho, the period for which the acceleration was dominant lasted less than 15 seconds (Figure 2). Therefore, it is not reasonable to consider dynamic relative displacement as the main cause of the collapse.

By taking into consideration the permanent displacements measured on the left bank of Showa Bridge (Figure 5(b)), the damage to the foundation piles, the estimated liquefied layer (Figure 8(b)), and the statements of witnesses, an alternative explanation can be given as a more acceptable reason for the collapse of the girders. The ground on the left bank and in the riverbed liquefied as a result of the earthquake motion and moved toward the river center. The ground displacements continued even after the earthquake motion ceased, until the excess pore water pressure dissipated. The permanent ground displacement on the left bank reached several meters, substantially deforming the foundation piles and causing the girders to fall.

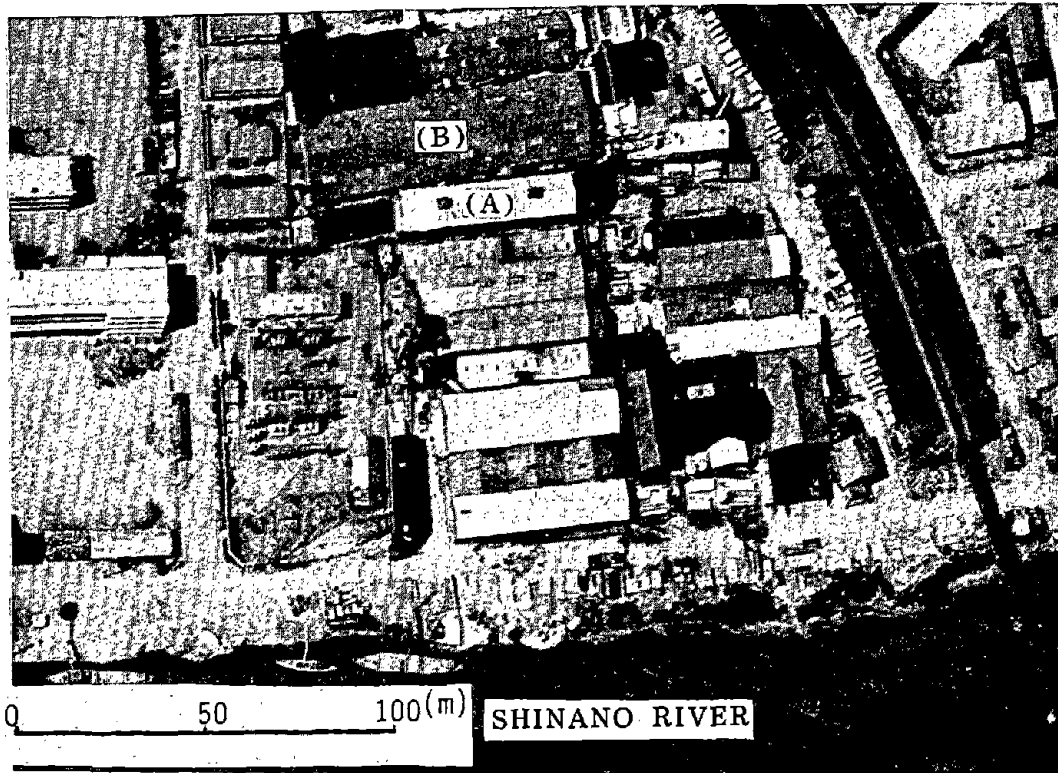
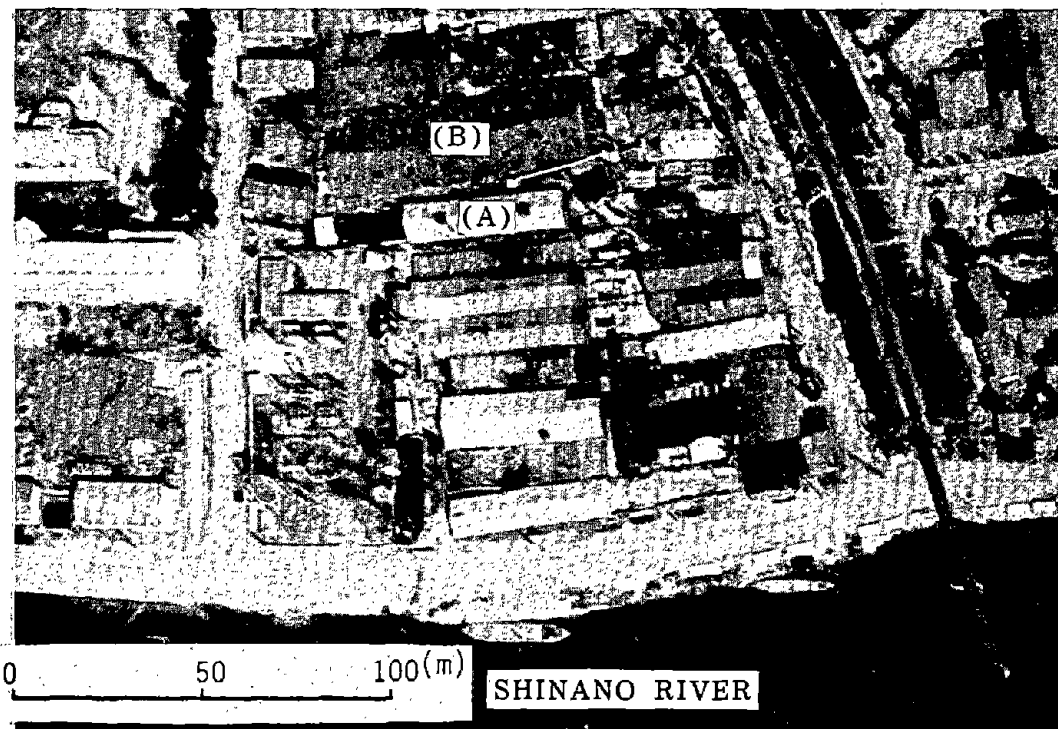
In Kawagishi-cho, the ground displacement reached over 11 m as shown in Figure 5(d). Photo 7(a) was taken two years before the earthquake and Photo 7(b), four hours after the earthquake. It is worth noting that the riverbank became more sharply curved after the ground moved towards the river and that the distance between the two buildings (A) and (B) in the photos increased. Building (B) was deformed due to relative displacement between the two sides of the building. In the post-earthquake photograph, numerous sand boils and fissures can be seen.

Photo 7 Aerial Photographs of Kawagishi-cho and Hakusan (See Figure 5(d))

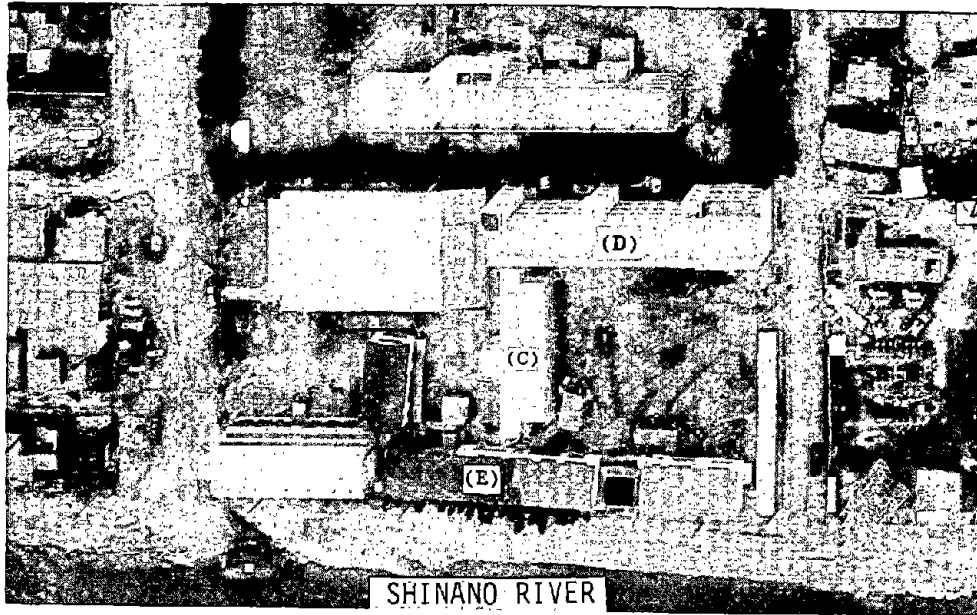
Meikun High School (Point ④ in Figure 5(d)) is located along the Shinano River in Kawagishi-cho. The buildings of the high school suffered severe liquefaction damage and large ground displacements. Photo 8 shows the school after the earthquake, while Figure 13 shows a schematic drawing of the movement and deformation of the buildings, sand boils, and ground fissures. The building (C), a two-storey reinforced concrete building, which was connected with building (D), a four-storey reinforced concrete building became separated by a distance of 2 m due to the ground displacement toward the river. A school teacher stated that the buildings swayed and moved toward the river like a ship on the ocean.

Photo 8 Aerial Photographs of Meikun High School after the Earthquake (1964)

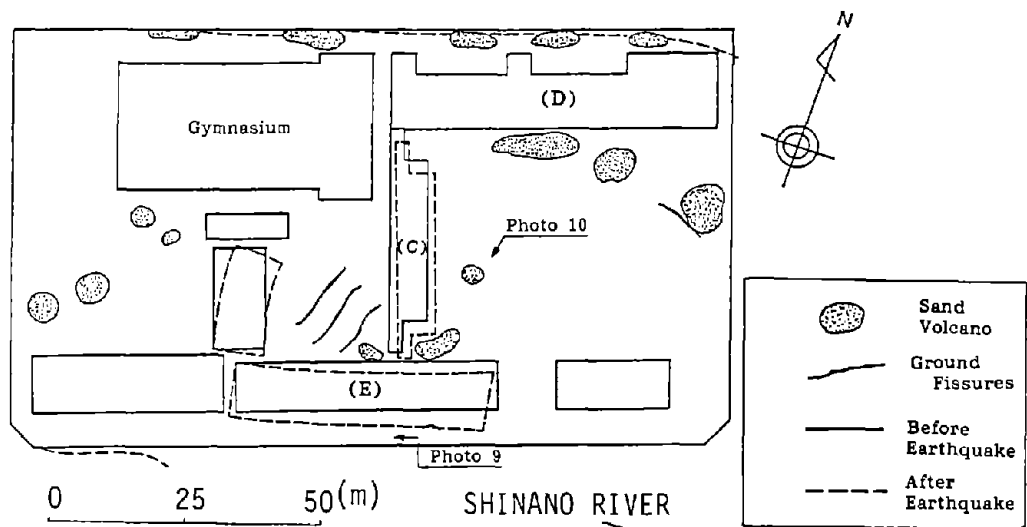
Figure 13. Movement and Deformation of Meikun High School Buildings, Sand Boils, and Ground Fissures

The two-storey wooden building (E) also moved about 3 m towards the river. Due to the relative displacements in the horizontal direction and differential subsidence of the ground, the building was distorted as shown in Photo 9. On the high school playground, numerous sand volcanoes and fissures were observed. Photo 10 is one example of the sand volcanoes.

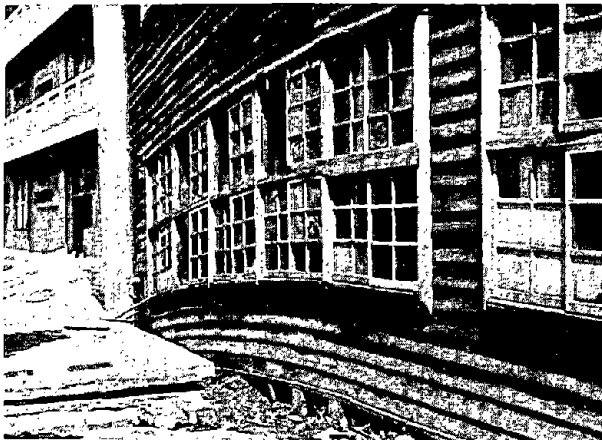
Photo 9 Distorted Building at Meikun High School

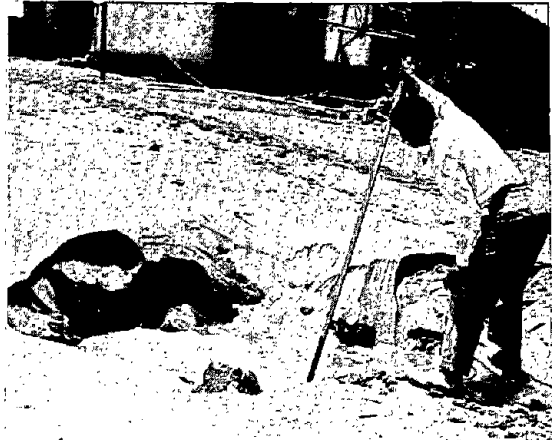
Photo 10 Sand Volcano in Playground at Meikun High School

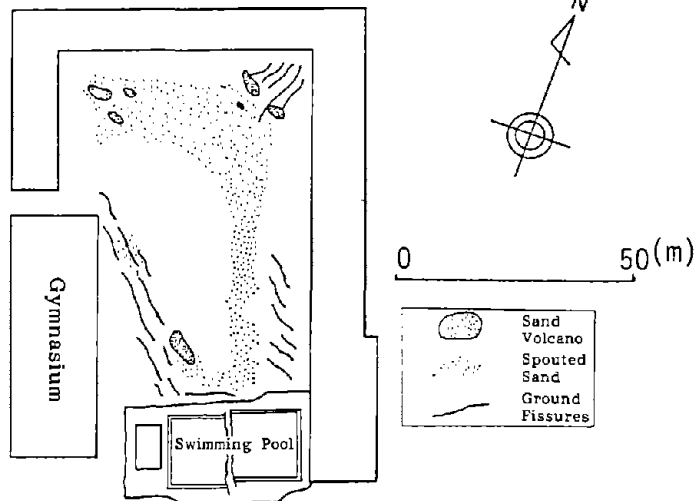
The Hakusan Primary School is downstream from the collapsed Showa Bridge on the left bank. It also suffered severe damage as a result of liquefaction. Photo 11 and Figure 14 show post-earthquake aerial picture and sketch, respectively, of the school. A certain amount of sand spouted from the ground, and the fissures can be seen. In the vicinity of the primary school, the magnitude of the permanent ground displacements was 2 to 3 m as shown in Figure 5(b). The side walls of the swimming pool collapsed due to differential displacement in the horizontal direction. Photo 12 shows the broken walls of the swimming pool. A teacher witnessed vertical ground waves with an amplitude of about 1 m, and then the formation of large fissures on the ground surface. After that, sand and water spouted from the fissures.

Figure 14. Damage to Hakusan Primary School

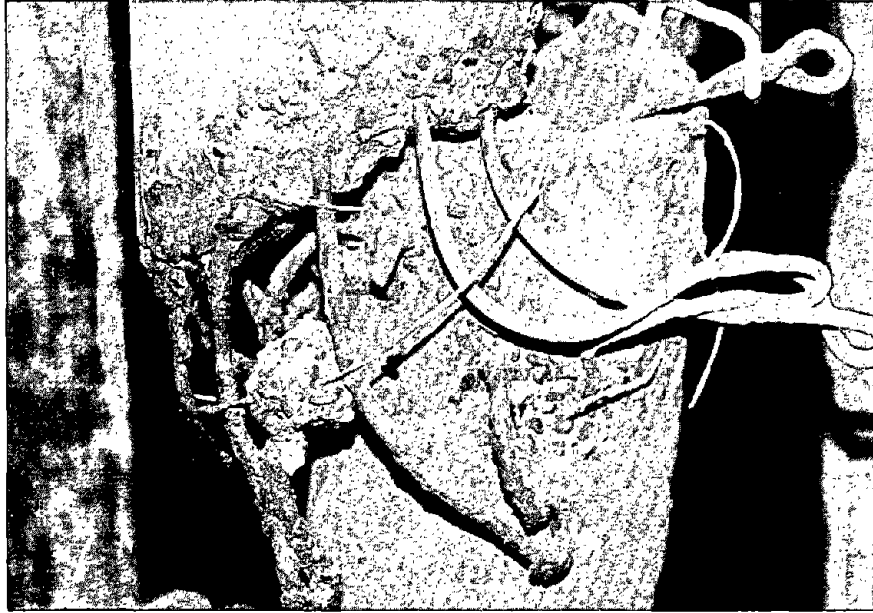
Figure 16 illustrates the damage to the two piles and the SPT-values of the ground, and Photo 13 shows the damage. Pile No. 2 was damaged at two points. At the upper point the concrete was crushed and the steel reinforcing bars were severely bent as shown in Photo 13(a). At the lower point, there are several horizontal cracks caused by large bending moments (Photo 13(b)).

As shown in Photo 13(a), at the upper damage point of Pile No. 2, there is a slight shear displacement of the lower part of the pile relative to the upper part. This suggests that the lower liquefied ground layer moved more than

(a) Upper Part of No. 2 Pile

Photo 13 Damage to the Foundation Piles of Niigata Family Court House

the upper non-liquefied ground. It appears, therefore, that slippage occurred between liquefied soil and non-liquefied soil beneath the building.

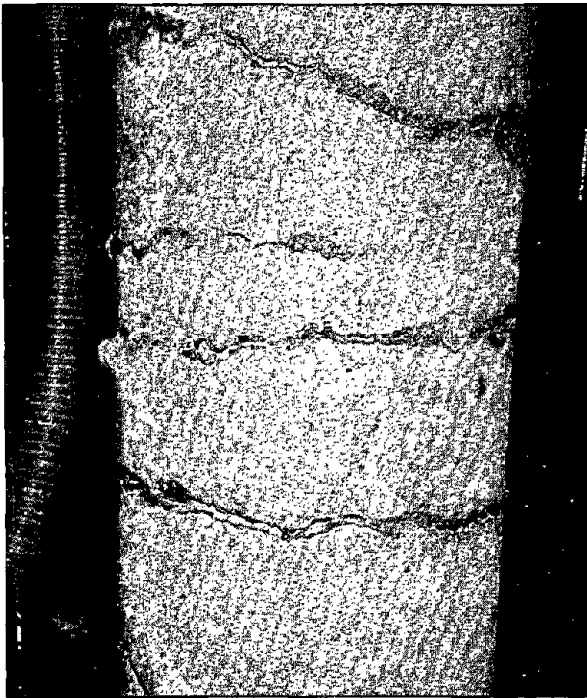
(b) Lower Part of No. 2 Pile
(Bending Cracks)

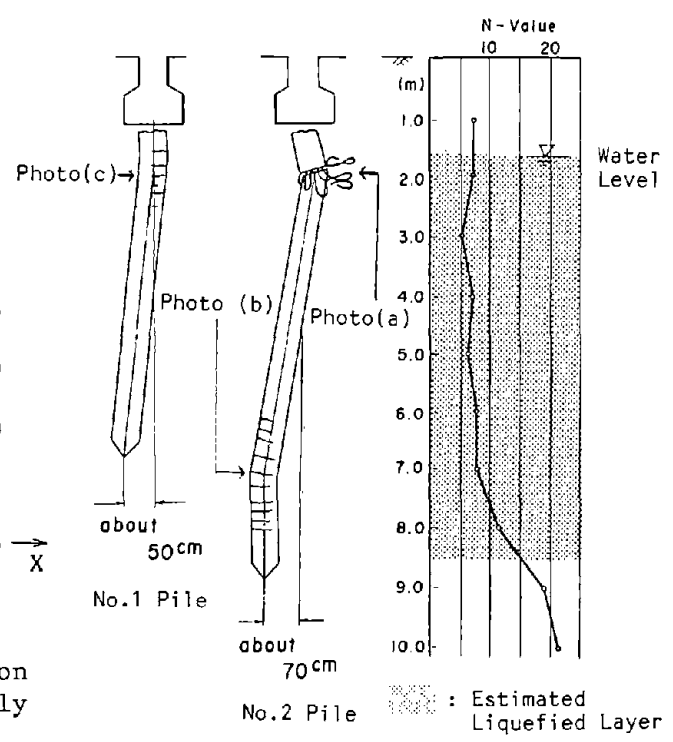
The SPT-values, measured according to SPT procedures down to -8 m, are mostly less than 10, but they increase suddenly below -8 m. It can be assumed that the soil layer below the ground water level (-1.7 m)* and above about -8.5 m liquefied during the earthquake, while the lower layer did not liquefy. It is noteworthy that the two points of damage in the No. 2 pile roughly coincide with the boundaries between the estimated liquefied and non-liquefied layers.

Figure 16. Damage to Piles and SPT-values of the Ground

Compared with the No. 2 pile, the damage to the No. 1 pile was remarkably light. As shown in Figure 16, few horizontal bending cracks were caused in the upper part of the pile. The reason for the light damage to the No. 1 pile is that it did not reach into the basal non-liquefied layer. The tip of the pile was in the liquefied layer. The boundary condition at the tip of the No. 1 pile was more flexible than that of the No. 2 pile.

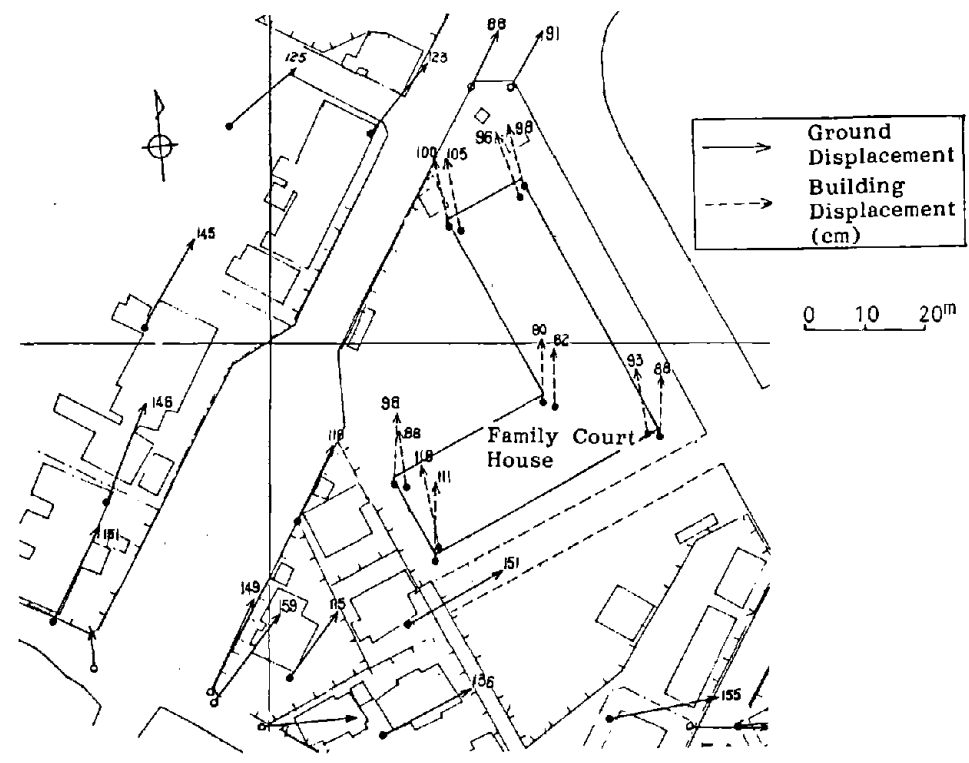
Figure 17. Permanent Ground Displacement in the Vicinity of Niigata Family Court House

The building moved by about 1 m toward the northern direction and some differences in the direction can be observed between the ground displacements and the building displacements. Because the plan was used to determine the coordinates of the building before the earthquake, there may be some errors in the measurement of the building displacements. However, it can be concluded that the foundation piles failed due to the liquefaction-induced ground displacement, shown in Figure 17.

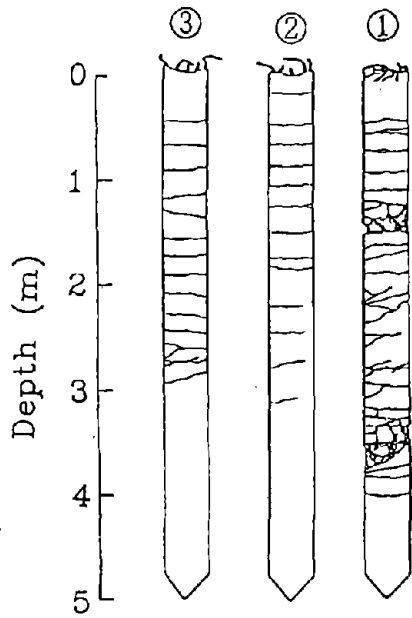
The No. 1 pile was severely damaged at two points. On the other hand, cracks 5 to 20 mm wide appear with nearly equal spacing in the Nos. 2 and 3 piles. As shown in Figure 19, the SPT-values, N, of the soil to 12 m are around or below 10. So it is thought to have been liquefied during the earthquake. The soil layer below 12 m is considered not to have been liquefied because of its high SPT-values. In the case of the S-building, the tips of the piles, which were designed as friction piles, did not reach into the lower non-liquefied layer. The reason the damage was light is that the piles had more flexible boundary condition compared with the No.2 pile of the Family Court House Building and the piles of NHK-Building mentioned in 4.4.3(1).

Figure 18. Damage to the Foundation Piles of S-Building¹¹⁾

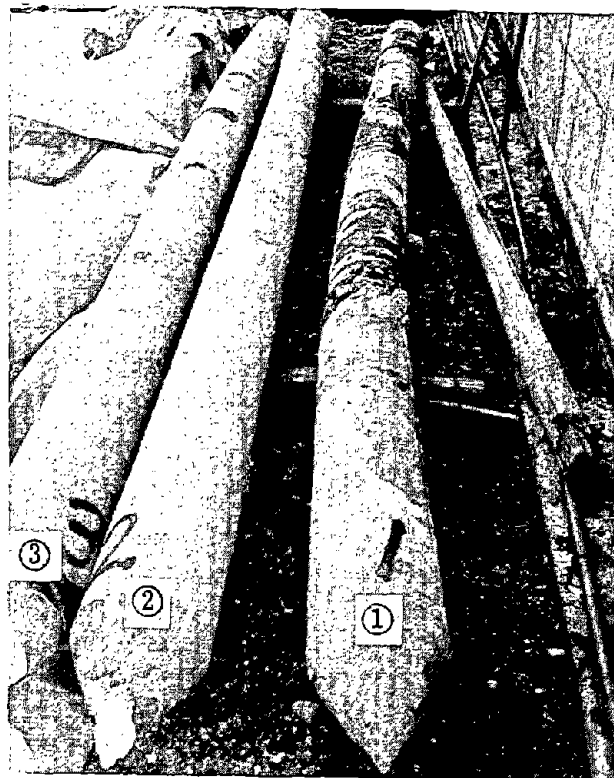
diameter. Three piles were extracted using a water-jet auger during reconstruction of the building, 24 years after the earthquake. Photo 14 shows the extracted piles, and Figure 18 shows the crack pattern schematically.

Photo 14 Damage to the Foundation Piles of S-Building¹¹⁾

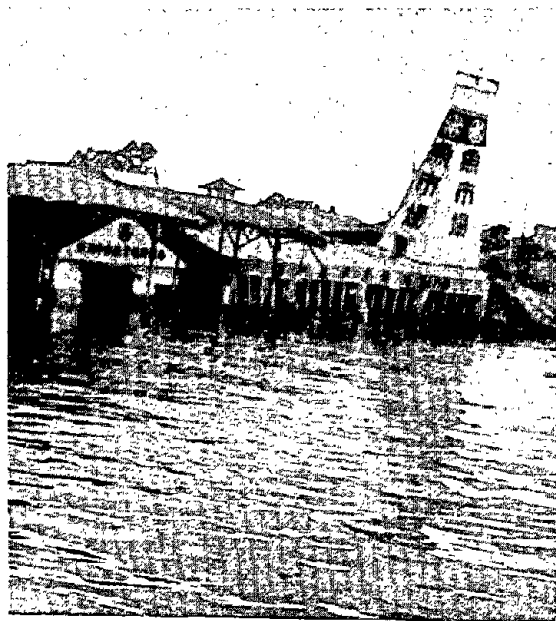
Photo 16 Partially Sunk, Tilting Building in the Downstream Area on the Left Bank of the Shinano River, Point ① in Photo 15¹¹⁾

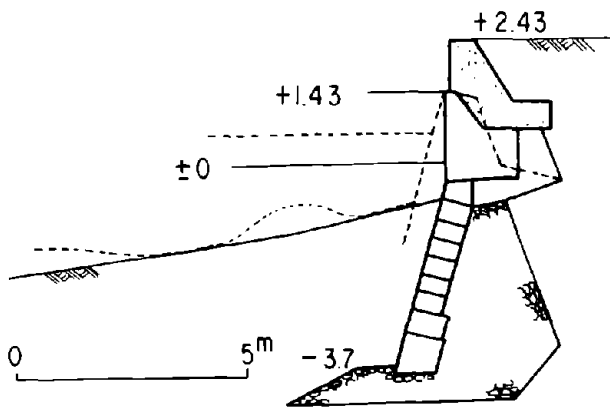
Figure 26. Damage to the Kurinoki River (Point ② in Figure 22(a))12)

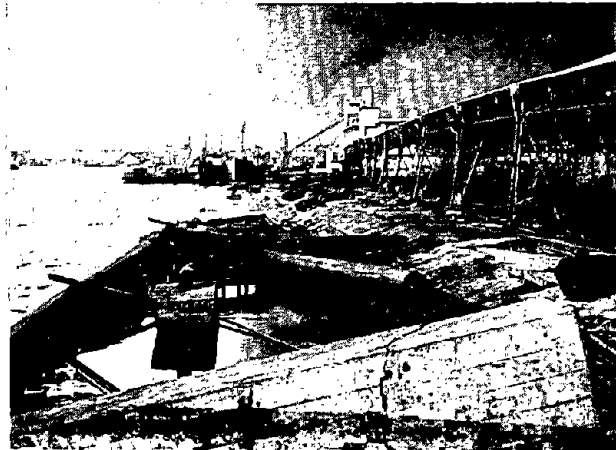
The quay walls at Fishery Pier were constructed by driving steel sheet piles in front of existing concrete piers, as shown in Figure 25. The greater part of the quay wall slid toward the water and sank into the water as shown in Photo 18 (Point 1 in Figure 22(a)). The quay wall along the right bank of

Photo 18 Damage to the Quay Wall at the Fishery Pier (Point ① in Figure 22(a))

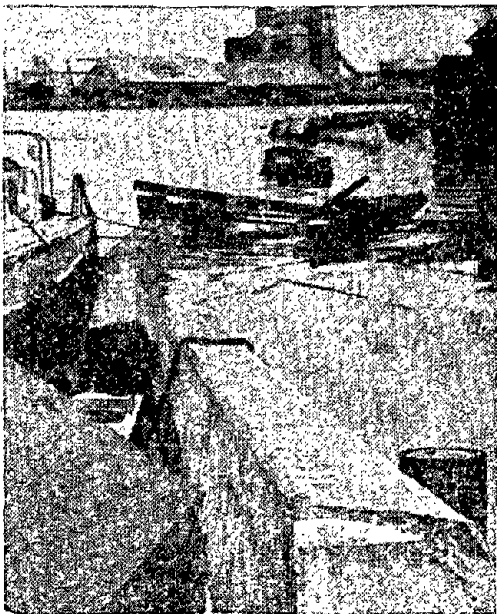
Photo 19 Damage to the Quay Wall on the Right Bank of the Old Kurinoki River (Point ② in Figure 22(a))12)

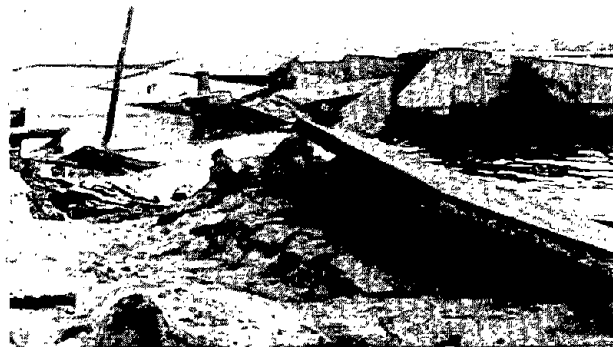
Photo 20 shows the catastrophic damage to the quay wall at the top of the North Pier (Point ③ in Figure 22(b)). The quay wall, constructed with steel sheet piles, moved about 2 m toward the water and inclined sharply. Photo 21 shows another example of damage to the quay wall of the North Pier (Point ④ in Figure 22(b)). This part of the quay wall was constructed of concrete blocks, and but it moved and inclined severely. The warehouse behind the quay wall also moved and inclined as shown in Photo 21.

Photo 20 Damage to the Quay Wall of the North Pier (Point ③ in Figure 22(b))12)

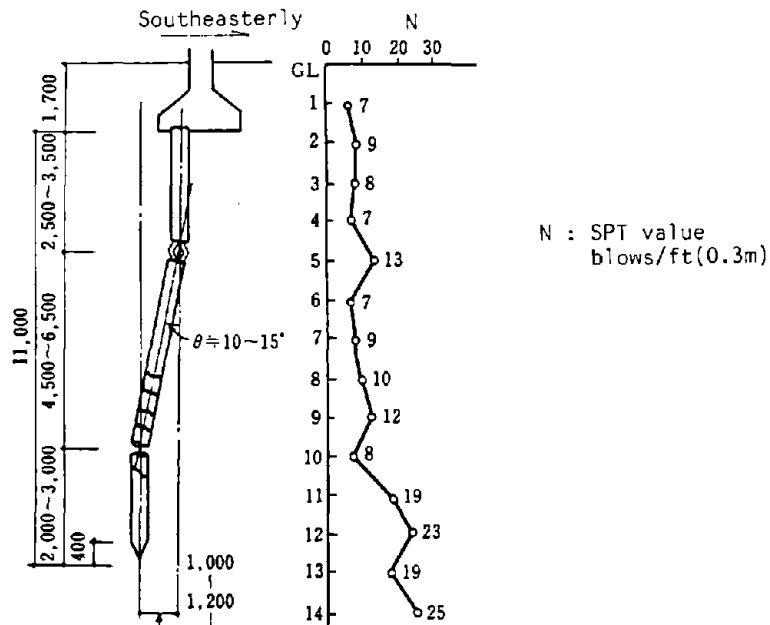
Figure 29. Damage to Foundation Piles of the NHK-Building
(Point ① in Figure 27(b)) (S. Kawamura et al)¹³⁾

As shown in Figure 29 and Photos 24 and 25, the piles were fractured in a similar way to those of the Family Court House shown in Figure 16 and Photo 13. The breakage was discovered at two positions, 2.5 to 3.5 m from the upper end of the piles and 2.0 to 3.0 m from the bottom. Seventy-four of the total of 204 piles were investigated, and it was found that all of them were similarly damaged. From this damage, the horizontal permanent deformation of the piles was estimated to be 1.0 to 1.2 m as shown in Figure 29.

The subsurface soils at the building site consist of a loose sandy layer with SPT-values of 5 to 10 down to -10 m, as shown in Figure 29, and this is thought to have liquefied during the earthquake. As is the case for the

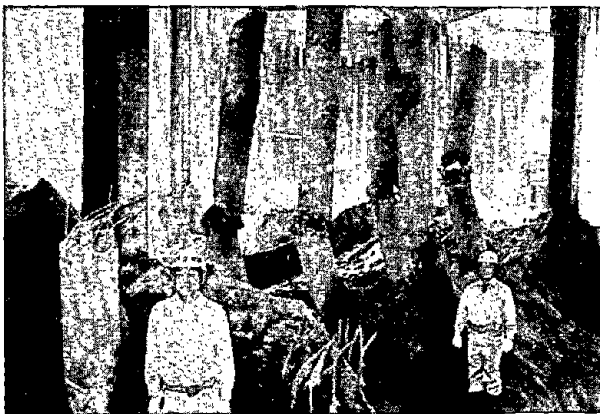
Photo 24 Damage to Foundation Piles of the NHK-Building (Point ① in Figure 27(b)) (S. Kawamura et al.)¹³

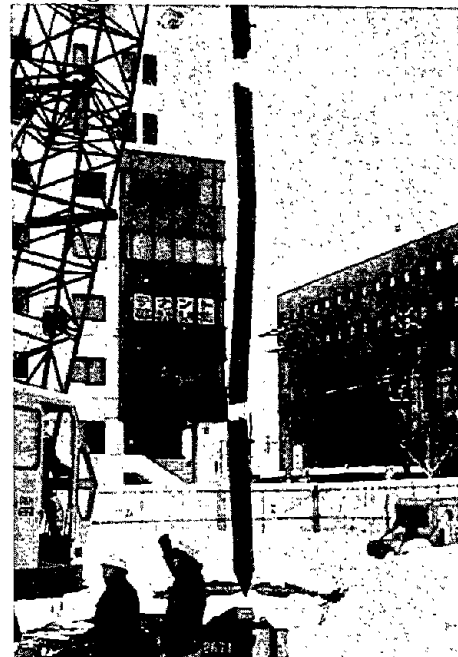
Photo 25 Damaged Pile of the NHK-Building (S. Kawamura et al.)¹³

Family Court House, the lower damaged points generally coincide with the boundary between the estimated liquefied layer and the lower non-liquefied layer. Regarding the failure process of the piles, numerical simulations were conducted, and it was concluded that horizontal permanent displacements of the liquefied ground are the direct cause of the pile failure.^{11),14)}

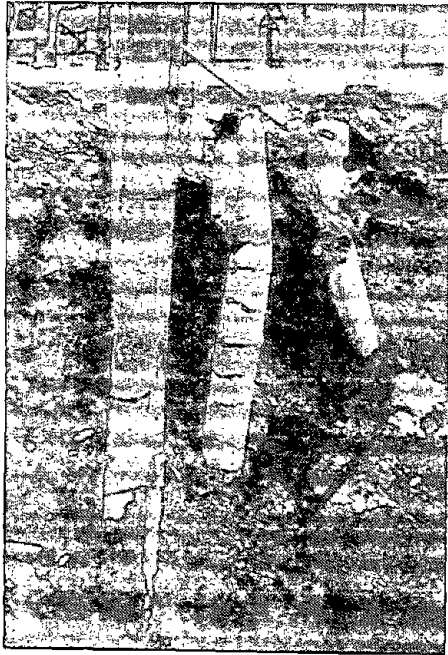
Photo 26 shows the damage to the 35 cm diameter reinforced concrete piles of the Hotel Niigata building which is located at Point ② in Figure 27(a). This damage was also found at the time of reconstruction of the building 23 years after the earthquake. The hotel suffered severe damage due to liquefaction. Photo 27 shows that a concrete purification tank at the site was lifted by about 2 m because of its buoyancy in the liquefied soil.

Details of the damage to the foundation piles could not be assessed as clearly for the Hotel Niigata as it could for the NKK Building. Excavation of the foundations was carried out in a short time period by power shovels, thereby preventing direct access by researchers to many of the piles as they were exposed. Nevertheless, it was reported by construction personnel that all the piles were catastrophically broken as shown in Photo 26.

Photo 26 Damage to Foundation Piles of the Hotel Niigata Building

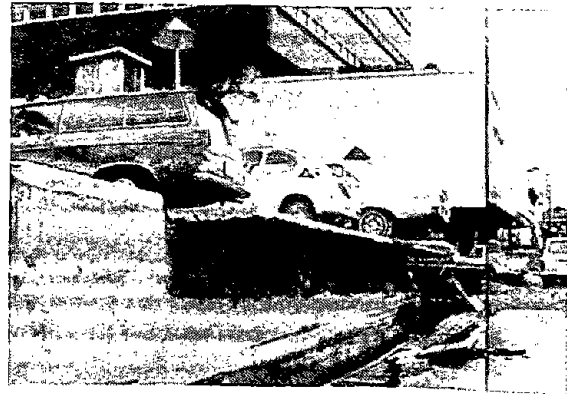
Photo 27 Concrete Purification Tank Raised to the Surface at the Hotel Niigata

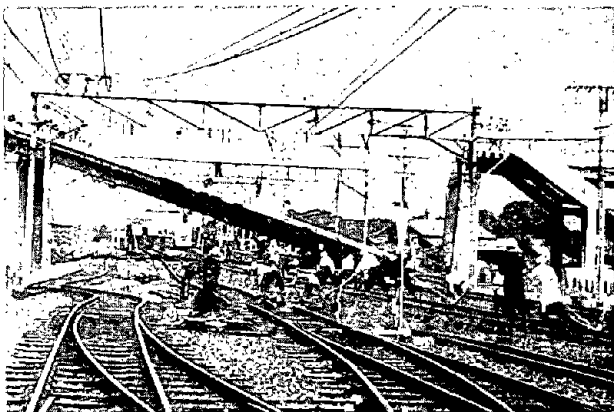
Photo 28 Collapse of the East Bridge over Railway (Point ④ in Figure 27(b))¹⁶

The East Bridge over the railway is located to the east of Niigata Railway Station, at Point ④ in Figure 27(b). A simply supported steel girder with a span of 26.6 m fell because of the earthquake, as shown in Photo 28, and crushed a locomotive. The two piers which supported the girder stood on concrete piles of diameter 30 cm and length about 7 m. Figure 34 shows the cracks in a pile extracted after the earthquake. Cracks caused by the bending moment were found not only on the upper portion, but also, towards the bottom. Furthermore, cracks occurred on only one side of the piers. This suggests that the piles were not damaged by repeated inertia force from the superstructure, but by liquefaction-induced ground displacement, which is considered to increase monotonically.

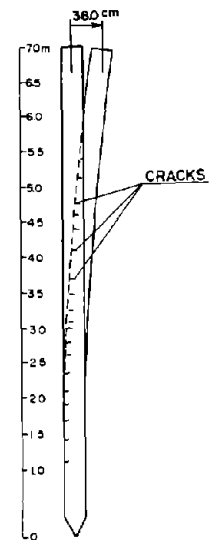
Figure 34. Bending Cracks in Concrete Piles of the East Bridge over Railway (Point ④ in Figure 27(b))¹⁶

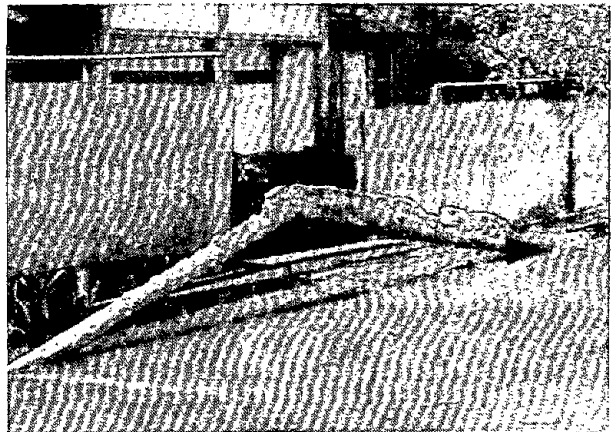
Photo 30 Buckling of a Buried Gas Pipe

Many similar bucklings of buried pipes were observed. Photos 30 and 31 show other examples of such buckling. These examples were steel pipes for natural gas supply with a diameter of 8 cm.

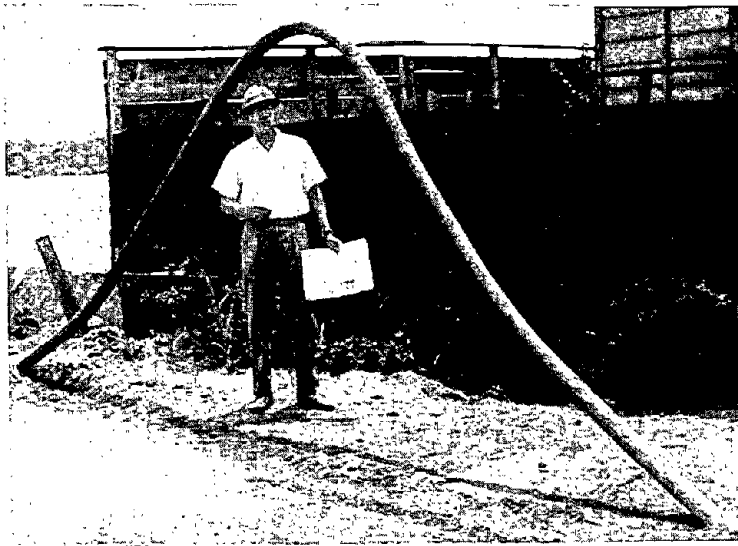
Photo 31 Buckling of a Buried Gas Pipe

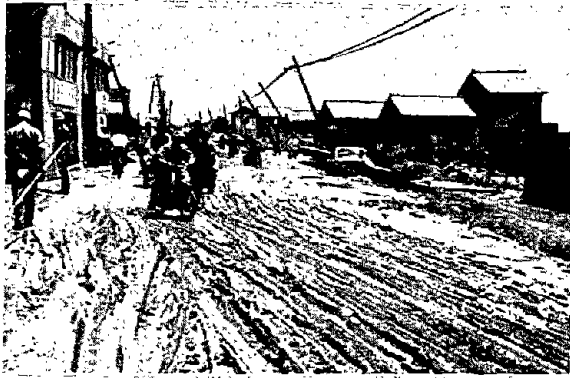
The ground to the west along Route 7 moved toward the northwest by a maximum of 6 m (Figure 37(a)), while to the east along Route 7 it was displaced generally toward the south by a maximum of 5 m (Figure 37(b)). This means that Route 7, which had been straight before the earthquake, was greatly distorted by the earthquake. According to a survey of the road after the earthquake conducted by the Ministry of Construction,¹⁸⁾ the road moved toward the north with a maximum displacement of 2.7 m in the western area and toward the south with a maximum of 5.6 m in the eastern area, as shown by the dotted line in Figure 37. The results of this survey coincide well with the results of the aerial survey. Photo 32 shows Route 7 after the earthquake.

Photo 32 Route 7 after the Earthquake 18)
