Case Studies of Liquefaction and Lifeline Performance During Past Earthquakes

Volume 1
Japanese Case Studies

Edited by
M. Hamada and T. D. O'Rourke

Technical Report NCEER-92-0001

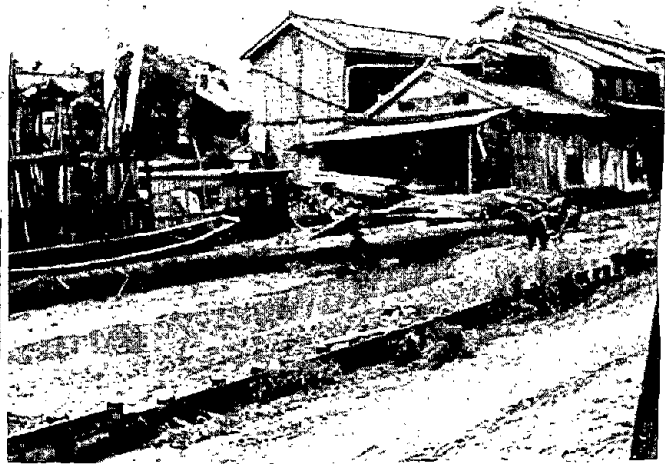
Photo 33 Risen Portion of the Tsusen River

According to measurements of vertical displacements, shown as numbers in parentheses in Figure 37, most parts of the area subsided due to liquefaction. The primary school and its vicinity, where the horizontal ground displacements began, subsided greatly with a maximum drop of 2.0 m. On the contrary, the ground rose at many points in the neighborhood of the Tsusen River where the horizontal ground displacements ended. Many witnesses remarked that near the Tsusen River a considerable amount of sand and water spouted from the ground, and the riverbed rose above water level in some places, enabling people to cross the river on foot. Photo 33 shows the Tsusen River after the earthquake where the riverbed rose.

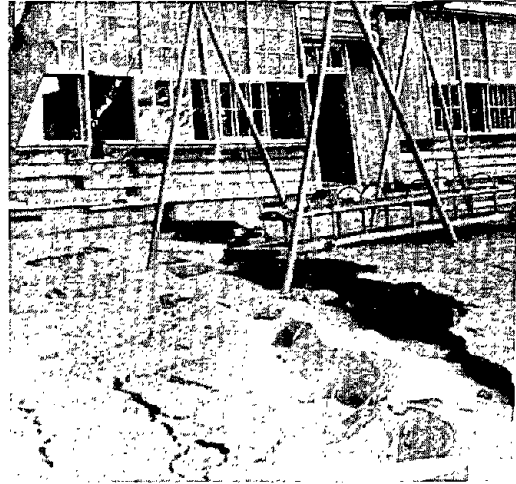
The Ohgata Primary School is located on a natural levee from where the horizontal displacements originated toward the lower land. Numerous ground fissures were caused in the vicinity of the school due to the tensile strain of the ground, and this resulted in severe damage to the school structures as shown in Photos 34-38. The locations and the orientations of these photographs are shown in Figure 40.

Photo 35 A Ground Fissure Underneath a Wooden School Building

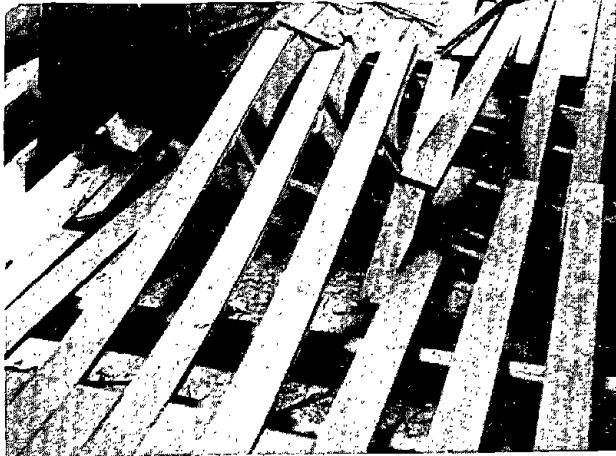
Photo 36 Broken Wooden Floor due to Ground Fissure

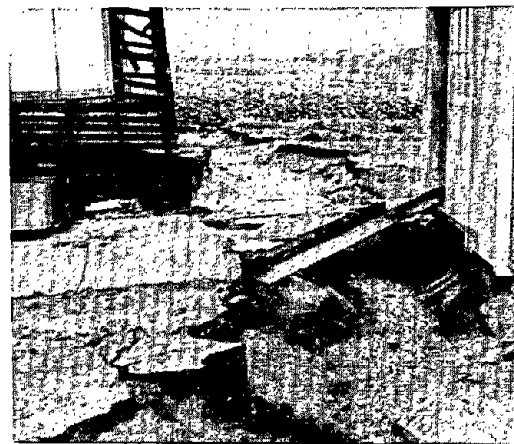
Photo 34 shows one example of a ground fissure in the playground. The grassy ground cracked and liquefied sandy soil can be seen. Witnesses in this area reported that several fissures with a width of about 3 m were formed. A school teacher allegedly fell into a fissure in the playground, and was rescued by neighborhood residents. Photo 35 shows another example of a ground fissure underneath a wooden school building. Photo 36 was taken inside the building. The buildings shown in Photo 37, which were connected before the earthquake, were completely separated by a wide ground fissure over a distance of about 3 m.

Photo 37 Separation of Two Buildings

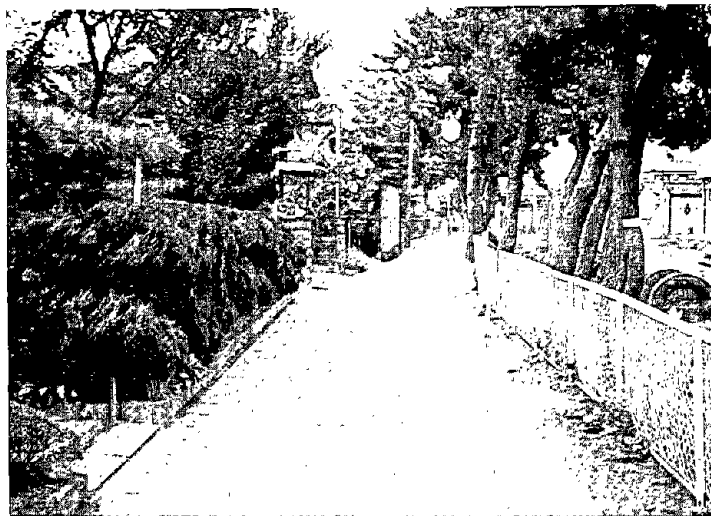
Many statements that the road, which had been straight before the earthquake, was deformed by the earthquake were collected from witnesses in the vicinity of Ohgata Primary School. One example of road deformation is shown in Photo 38, taken at the western boundary of the school playground. One resident along this road remarked that he thought the playground undulated towards his house during the earthquake, and that the road became curved.

Photo 38 Deformed Road Resulting from the Earthquake

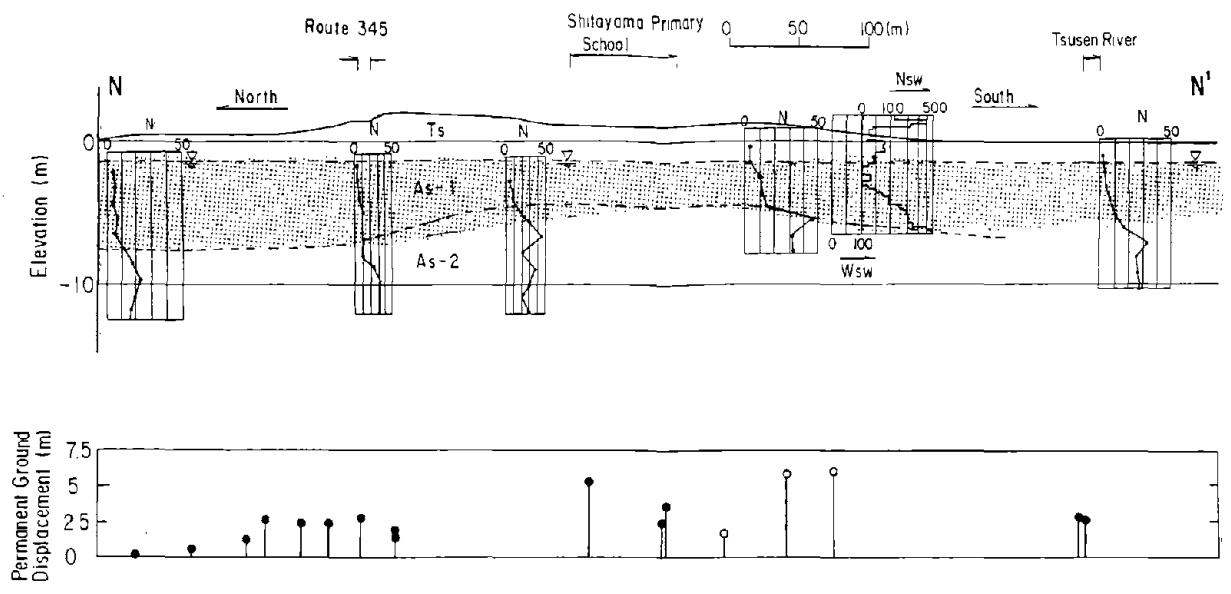
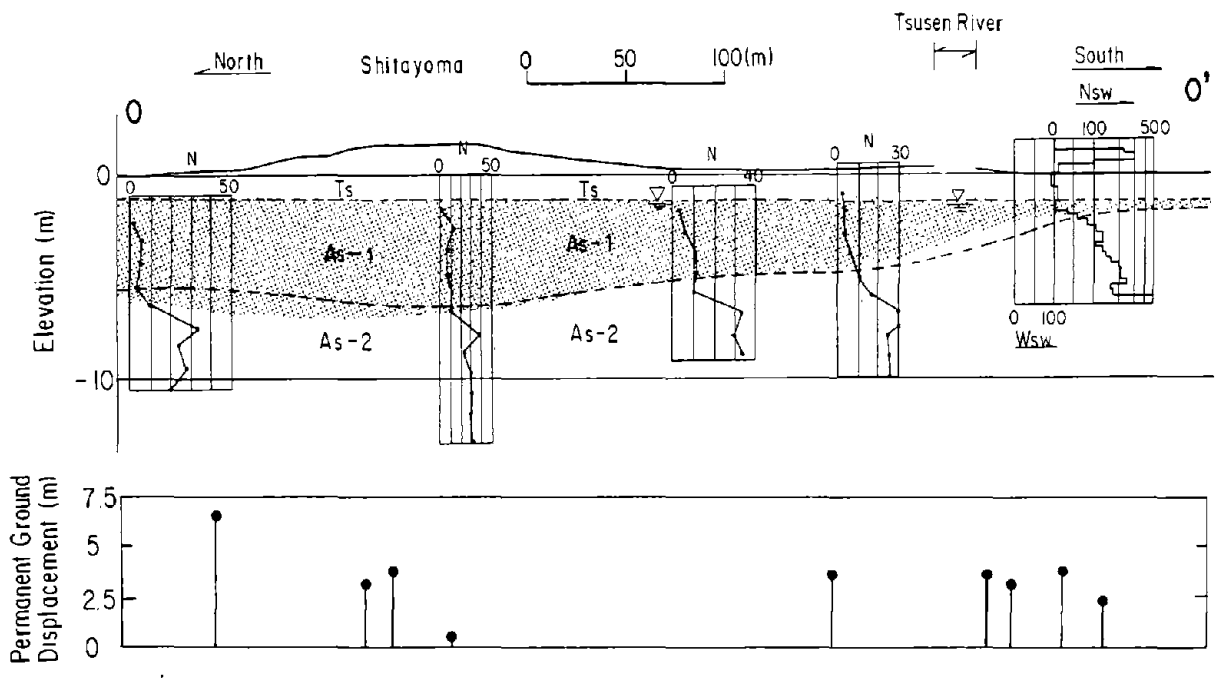
Figure 44. Soil Conditions and Estimated Liquefied Layer

Figure 44 shows soil profiles along sections N-N' and O-O', which are marked in Figure 42. Estimated liquefied soil layers are shown in the figure along with SPT-values and SWS-values, N_{sw} and W_{sw}. Soil profiles for this area in addition to those discussed below can be found in Appendix B.

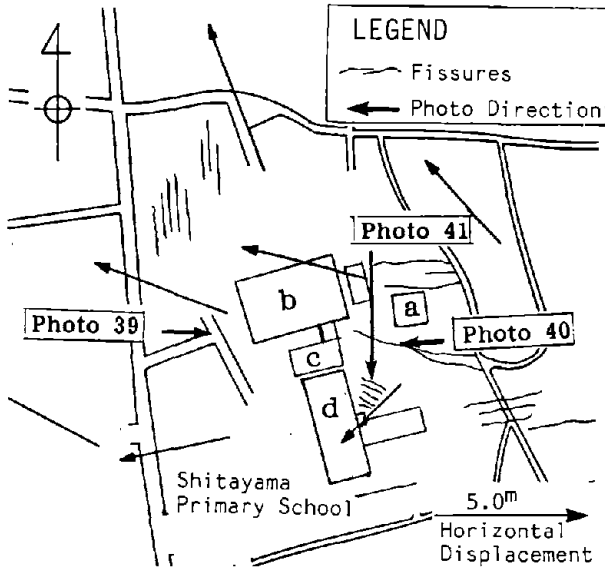
Figure 45. Permanent Ground Displacement and Ground Fissures at Shitayama Primary School

Shitayama Primary School is located on the top of the natural levee, from where most permanent ground displacements in the horizontal direction spread out in a radial direction. Figure 45 shows details of the ground displacements and ground fissures in this area. The wooden buildings of the school suffered severe damage due to the ground displacements. Photo 39 shows damage to the gymnasium at the primary school, which was caused by displacement of the foundations due to tensile strain in the ground. Photo 40 is another example of damage resulting from tensile strain in the ground, in which brick wall was pulled apart. In the playground of the primary school, numerous ground fissures resulted from the ground tensile strain as the ground moved in radial directions. Photo 41 shows one example of a ground fissure in the playground.

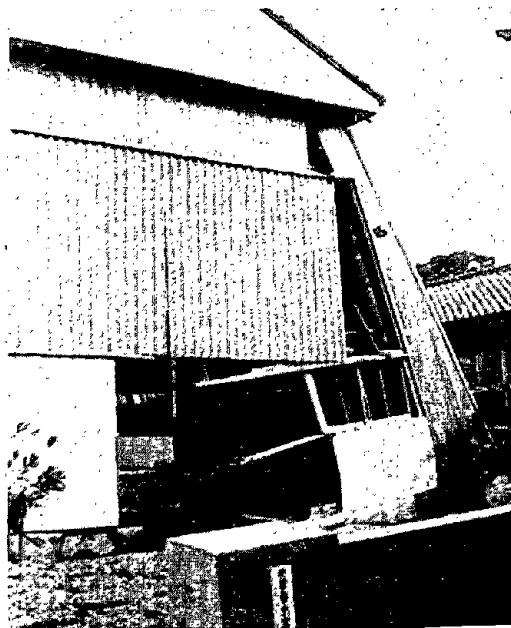
Photo 39 Damage to the School Gymnasium due to Displacement of the Foundations

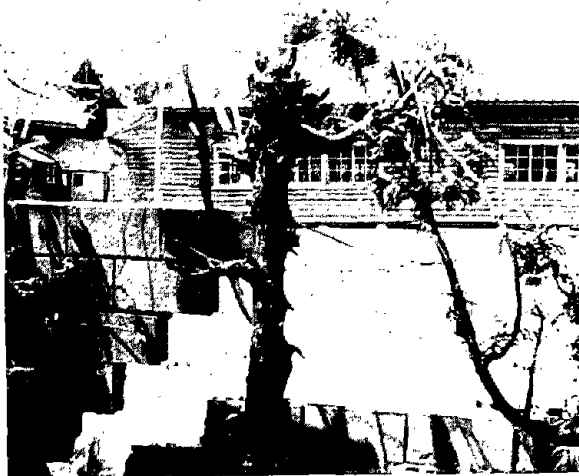
Photo 40 Separation in a Brick Wall due to the Tensile Strain in the Ground

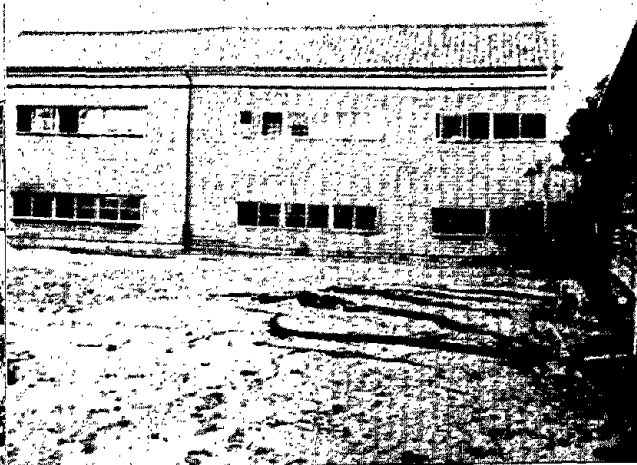
Photo 41 Ground Fissures in the School Playground

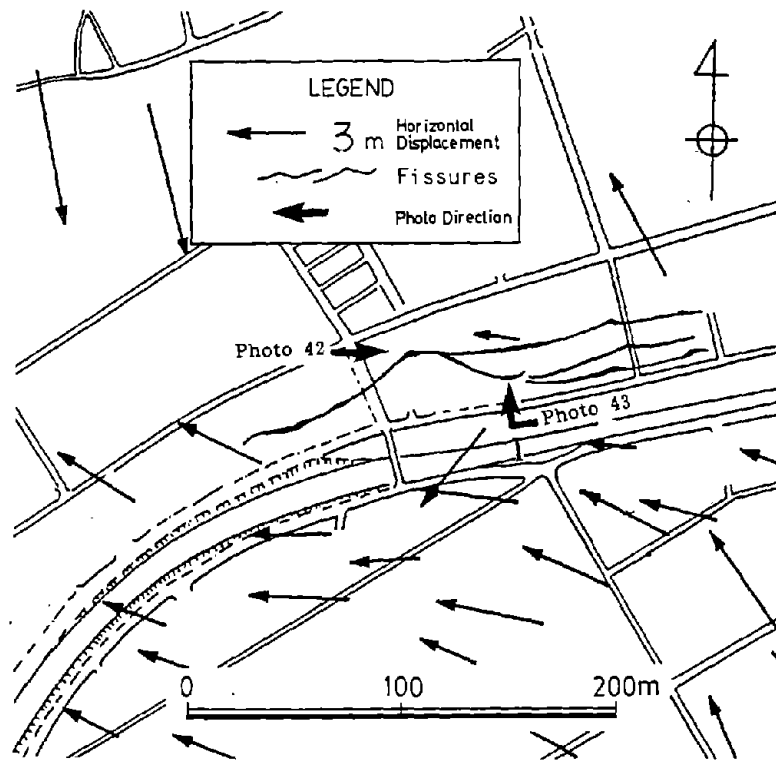
Figure 46. Permanent Ground Displacement and Ground Fissures in Shinkawa-cho and Nearby

Along the Tsusen River in Shinkawa-cho and nearby, the ground moved toward the north by a maximum of about 5 m, and ground fissures parallel to the river were dominant on the north bank of the river as shown in Figure 46. Photo 42 shows a shrine building, which collapsed into a ground fissure about 3 m wide, and Photo 43 is another example of a ground fissure with a vertical differential displacement of about 1.5 m.

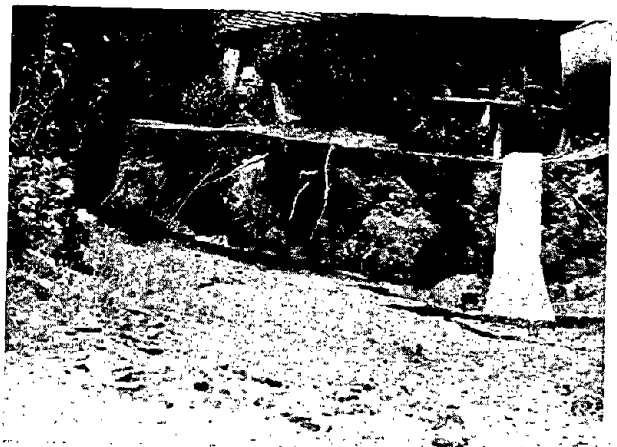
Photo 43 Ground Fissure with Vertical Displacement of about 1.5 m

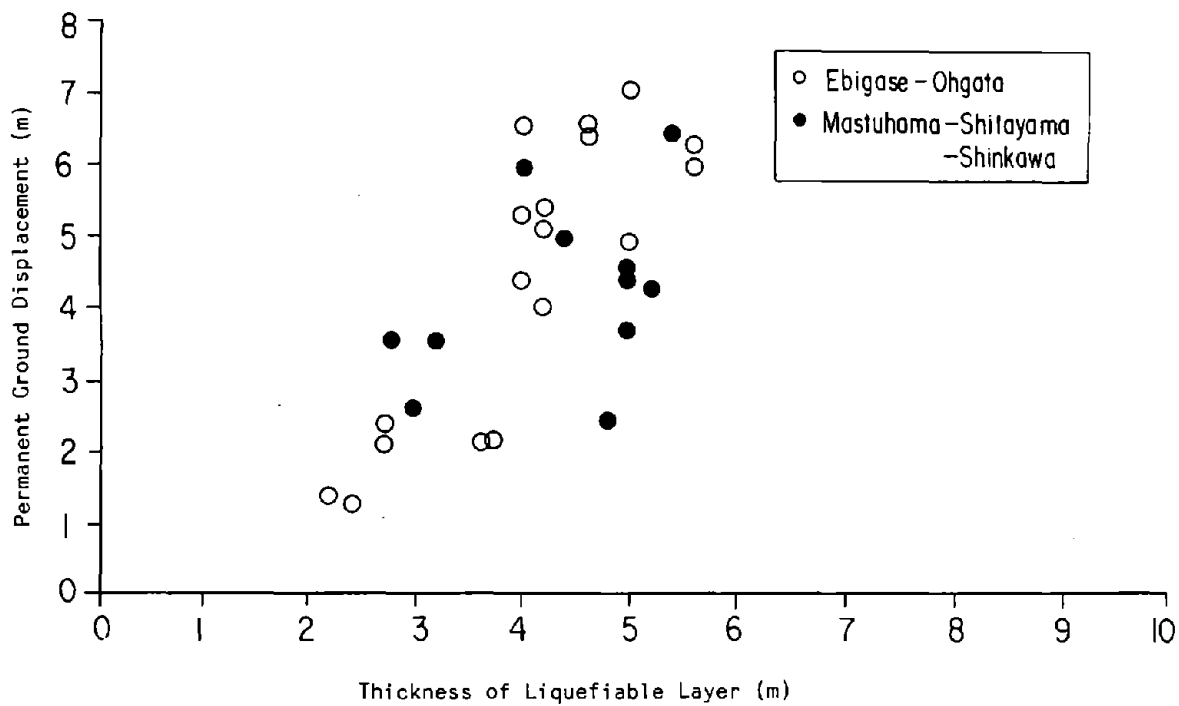
Figure 47 Correlation between Magnitude of Ground Displacement and Thickness of Estimated Liquefied Layer

Figures 47 and 48 show the effects of the thickness of the liquefied layer and the gradient of the ground surface on the magnitude of the ground displacements, respectively. A comparatively good correlation between the magnitude of the ground displacements and the thickness of the liquefied layer can be seen in Figure 47. However, no significant correlation could be found with the gradient of the surface, as shown in Figure 48. Although the horizontal distances over which the gradients were estimated were varied from 5 times to 30 times the thickness of the liquefied layer in Figure 48 (a) and (b), respectively, the correlation improved only by a marginal amount.

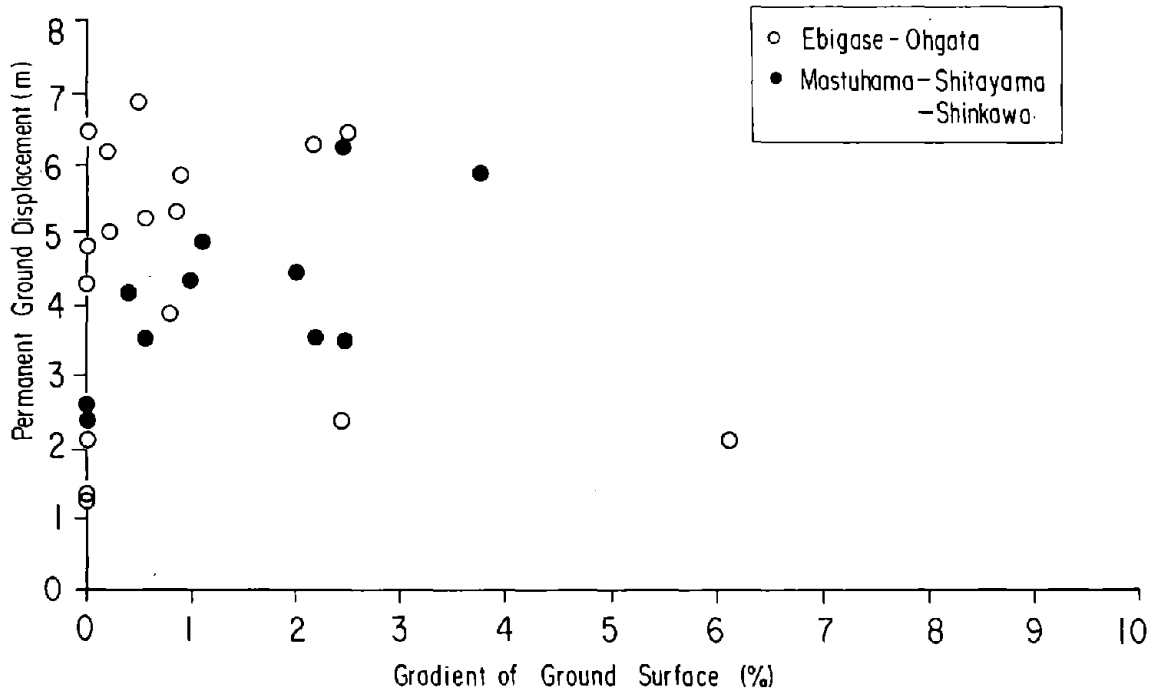
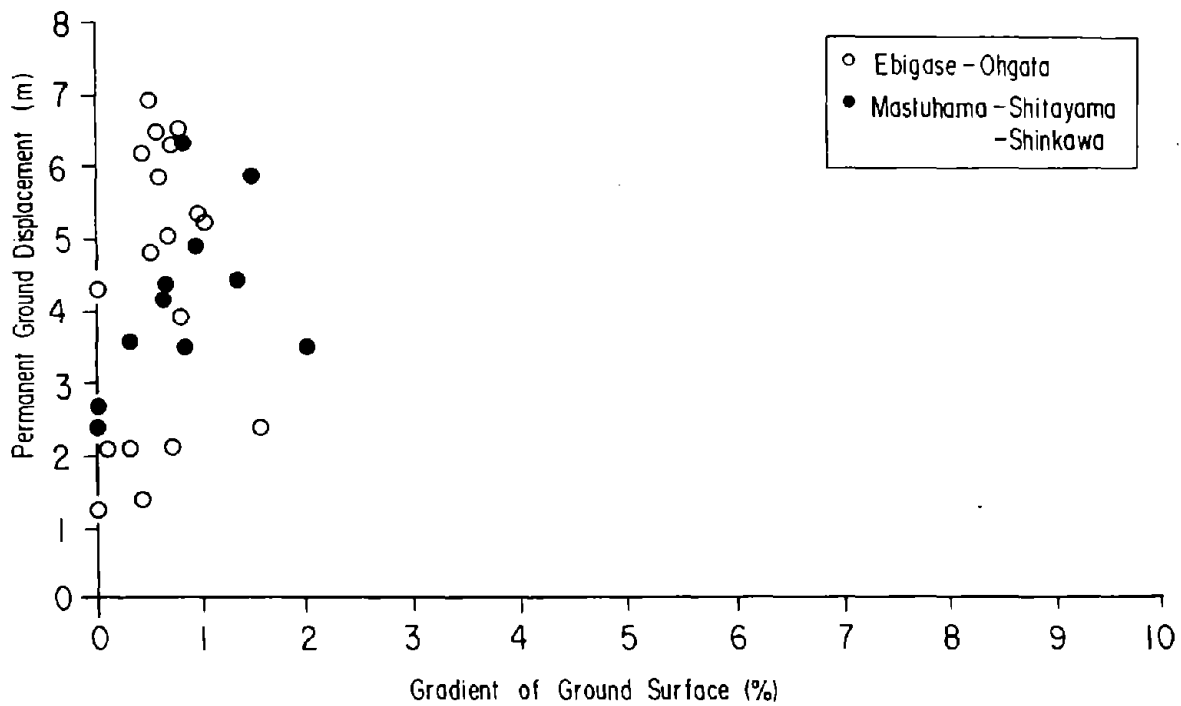
Figure 48. Correlation between Magnitude of Ground Displacement and Gradient of Ground Surface

The lack of correlation between the magnitude of the ground displacement and the gradient of the ground surface appears to contradict the fact that the ground moved from higher to lower elevations, as mentioned in 4.5.1 and 4.6.1. However, this contradiction can be resolved if it is assumed that ground displacements were caused by fluid behavior of the liquefied soil. The gradient of the liquid surface has little influence on the magnitude of

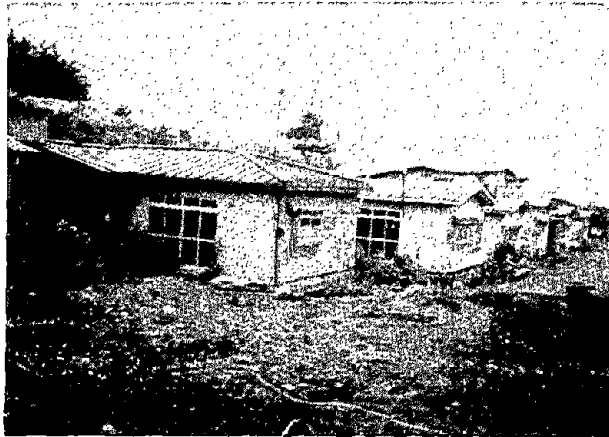
Photo 3 Undulating Ground Surface on the Northern Slope of Maeyama

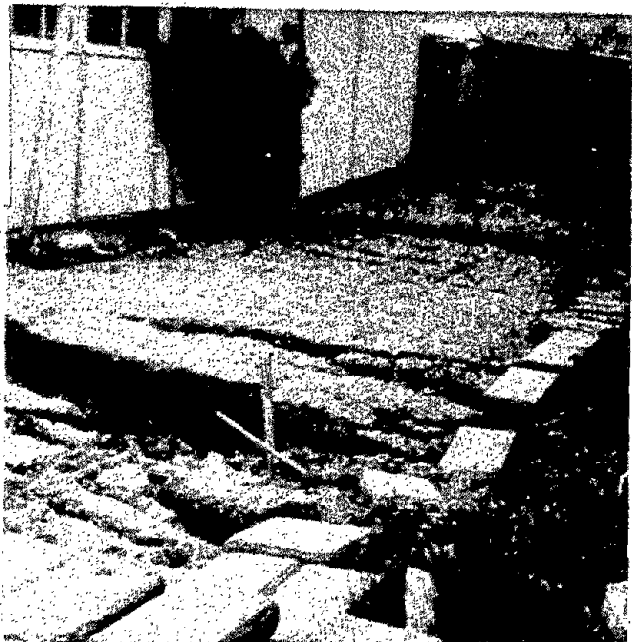
Photo 5 Fissure with Subsidence on the Northern Slope of Maeyama

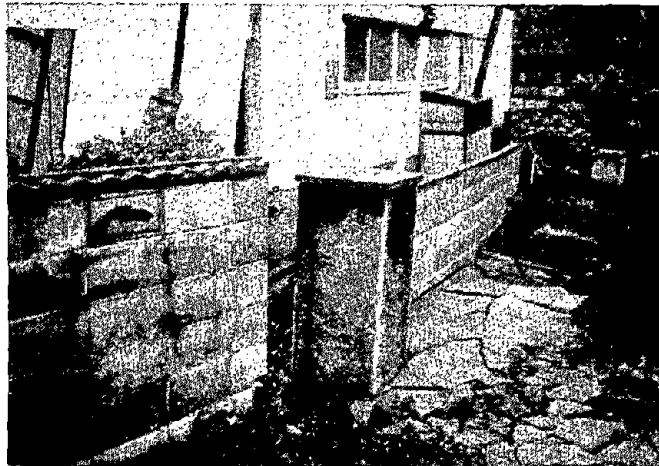
Photo 4 Fissure with Subsidence on the Northern Slope of Maeyama

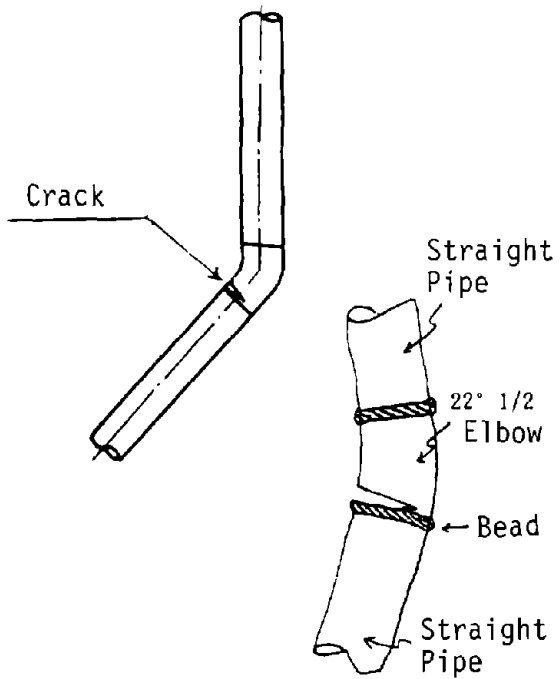
Point ① The pipe was damaged at a 22° elbow, as shown in Figure 10. Photo 6 and Figure 10 show that a bending crack occurred on the inside of the elbow. As shown in Figure 11, the ground south of the damaged point moved toward the south and southeast. It can be concluded that this ground displacement caused a tensile strain in the pipe and an excessive bending moment at the

elbow portion, resulting in the crack.

Figure 10. Damage to the Gas Pipe at Point No.1

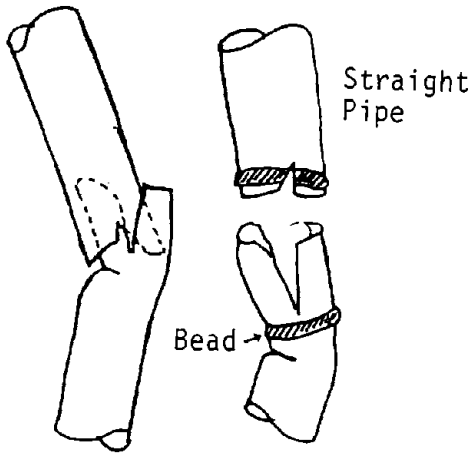
Point ② The pipe was torn in the axial direction as shown in Photo 7. The two broken ends were driven into each other as shown in Figure 12. This failure was found at a small-angle bend portion (Figure 13). As for the engaged ends of the broken pipe, it may be conjectured that there were two stages to the failure process. The first stage was the severing of the pipe and its separation. The second was the driving together of the two broken ends under an excessive compressive load.

As shown in Figure 13, the ground moved northwest to the north of the damaged point, primarily perpendicular to the pipe axis. To the south, the ground moved north in the direction of the pipe axis. First, the pipe could have been broken by bending moment due to the lateral displacement of the ground to the north. Later, the pipe could have been compressed due to the axial displacement of the ground to the south, and the two broken ends then were driven into each other. If this hypothesis is correct, it can be concluded that there was a time lag in the occurrence of the two permanent ground displacements.

Figure 12. Damage to the Gas Pipe at Point No.2

Photo 7 Damage to the Gas Pipe at Point No. 2

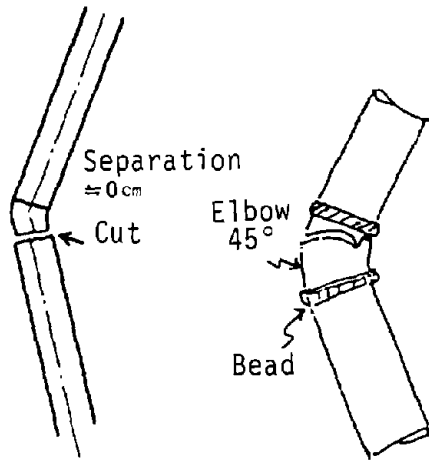
Point ③ The pipe was found to have been severed by a tensile strain as shown Photo 8. The elliptical deformation of the pipe cross section, however, indicates that the pipe was compressed and bent at the elbow by a compressive force applied through the straight portion before separation. The separation of the severed ends was very slight, and the ends were mostly in contact with each other. This damage assessment shows that the pipe was first compressed and then put under tensile strain. As shown in Figure 15, the ground to the south of the damage point moved northwest, in the direction of the pipe axis, causing compressive strain in the pipe. However, ground displacement which could have caused tensile strain in the pipe apparently did not occur in the vicinity of the pipe.

Figure 14. Damage to the Gas Pipe at Point No.3

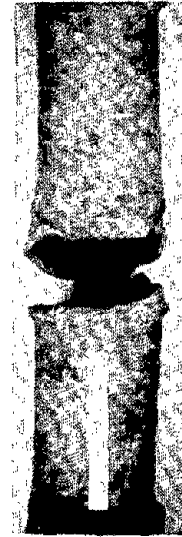
As mentioned later, at Point ④, which is about 250 m southeast of Point ③, a large tensile force due to ground displacement was caused in the pipe. This force was enough to separate the pipe. It is probable that this tensile force affected the pipe at Point ③ also under the condition that the soil surrounding the pipe lost its stiffness due to the liquefaction. In this case, it is also necessary to assume that there was a time lag between the occurrence of the ground displacements in the vicinity of Point ③ and the ones at Point ④. However, in the case of Point ③, the possibility cannot be ruled out that the pipe was not fractured by the permanent ground displacements, but by the ground vibration, namely by a repetitious force.

Photo 8 Damage to the Gas Pipe at Point No.3

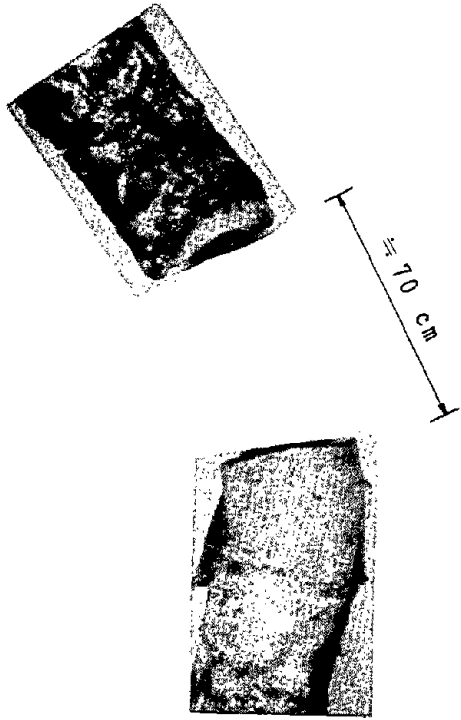
Point ④ The pipe failed at the welded joint of a 45° elbow. It was discovered upon excavation that the two broken ends were separated by about 70 cm, as shown in Photo 9. A large bending moment at the elbow, due to tensile force applied from the straight portion of the pipe, caused the breakage. The permanent ground displacements along the damaged pipe were over 2.0 m to the north of the damaged point, and it was generally oriented outwards from the pipe axis, as shown in Figure 16. These ground displacements caused tensile stress in the pipe resulting in a large bending moment in the direction shown in Figure 16. Accordingly, the pipe was severed at the elbow by both a bending moment and tensile force. After that, the two severed ends moved separately, as illustrated by the solid line shown in Figure 17 due to slippage between the pipe and the ground caused by the release of the tensile force in the pipe.

Photo 9 Damage to the Gas Pipe at Point No.4

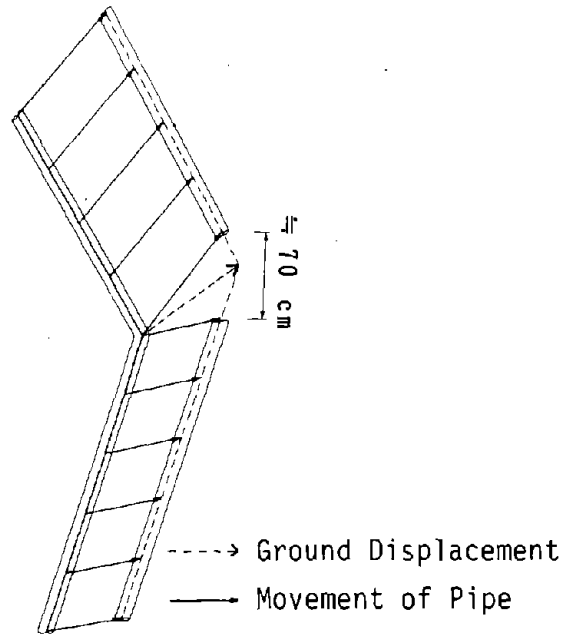
Figure 17. Movement of the two Broken Ends of the Pipe

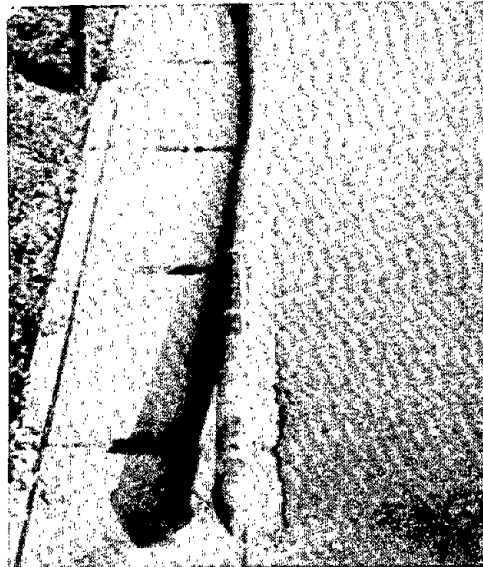
Many wells were damaged due to liquefaction and became unusable in Noshiro City. A typical example of damage to a well casing is shown in Photo 10, and illustrated in Figure 18(a). The location of the well is shown in Figure 5(a). The casing was bent at two positions. The upper one just about at the groundwater level and the lower one about 1.0 m below water level. There is no data from SPT borings nor Swedish weight sounding tests (SWS) in the vicinity of the damaged well. Figure 18(b) shows the data from the nearest SWS, which is about 100 m northwest of the well.

The deformation pattern of well casings in Noshiro City is almost the same as the damage to foundation piles in Niigata City.³⁾ Through an investigation of the damage to piles and the soil condition in Niigata, it was concluded that liquefaction-induced ground displacements were the direct cause of the damage. As shown in Figure 5(a) the ground surface was displaced by about 1.0 m in a mostly southern direction. It also can be concluded that liquefaction-induced ground displacements bent the well casings.

Photo 10 Damage to Well Casing

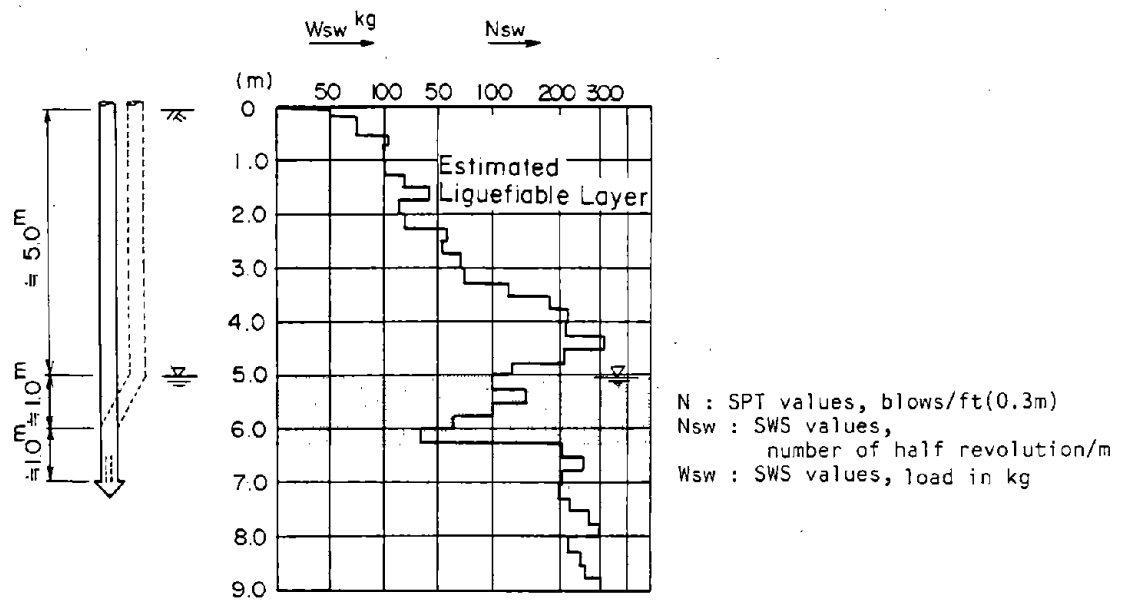
As mentioned previously, data from more than 100 Swedish weight sounding tests and about 60 standard penetration tests, including existing data, were collected in Noshiro City. According to these data the SWS value, N_{sw} , is found to be roughly ten times the SPT value, N . Figure 18(b) shows that a liquefiable layer exists between -5.0 m and -6.2 m. The upper boundary of the liquefiable layer, which is at ground water level,* coincides with the upper bend in the casing, while the lower boundary roughly coincides with the location of the lower bend.

(a) Damage to Well Casing

Figure 18. Damage to Well Casing

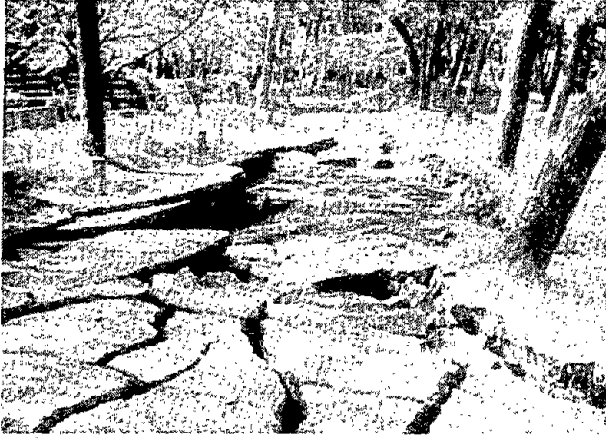
Figure 20 gives details of the permanent ground displacements from Aoba-cho to Shonan-cho. Many ground fissures occurred in the areas where the horizontal ground displacements began, while sand and water boils were observed in the area where the ground displacements decreased in magnitude. Photos 11 and 12 shows typical examples of ground fissures in the graveyard at Aoba-cho and the sand boils in Shonan-cho, respectively. The locations and the orientations of the photos are shown in Figure 20.

Photo 11 Ground Fissure in the Aoba-cho Graveyard

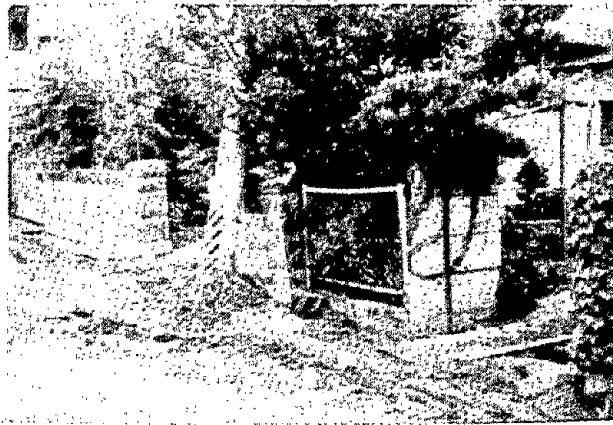
Photo 12 Sand Boil in Shonan-cho

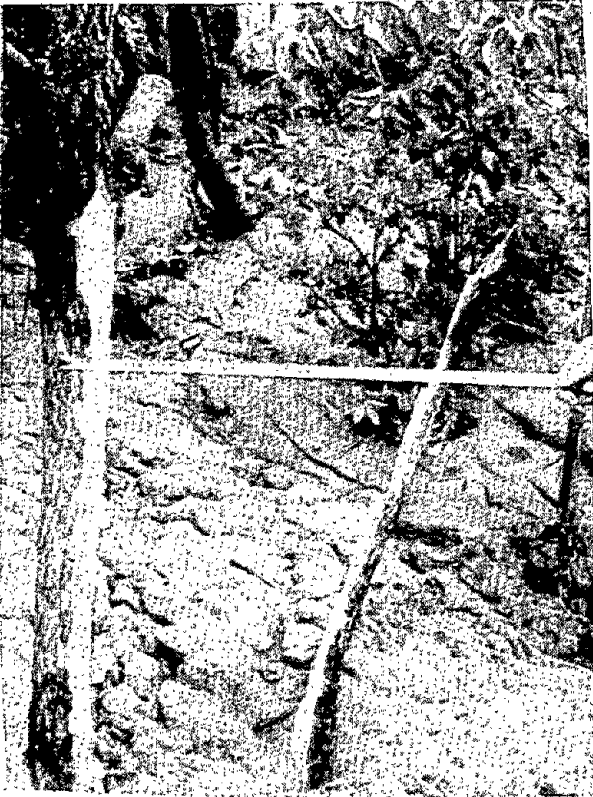
Photo 13 shows one interesting piece of evidence of the occurrence of large ground strain. The photo shows a tree split by the ground displacements in Aoba-cho.⁷⁾ The location and orientation of the picture are shown in Figure 22, along with the horizontal vectors of the permanent ground displacements in the surrounding area. Figure 22 also shows the permanent ground strains as calculated from the measured displacements. A large tensile strain of about 2% occurred in the vicinity of the tree, and the direction of the tensile strain coincides with that of the split. It can be conjectured that the tensile strain parted the roots of the tree, and the fracture extended to the trunk. Photo 14 shows another example of a large ground tensile strain, a wide fissure in the neighborhood of the split tree.

Photo 13 A Tree Split by Liquefaction

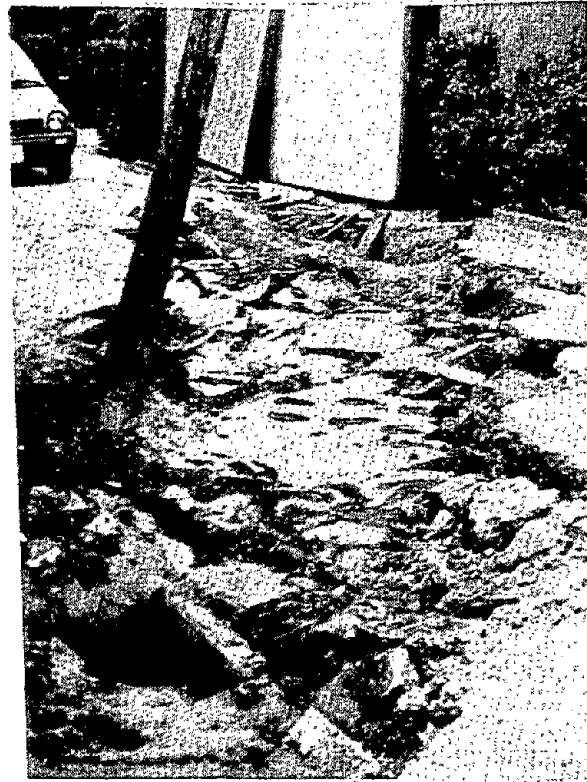
Photo 14 Ground Fissure in the Vicinity of the Split Tree

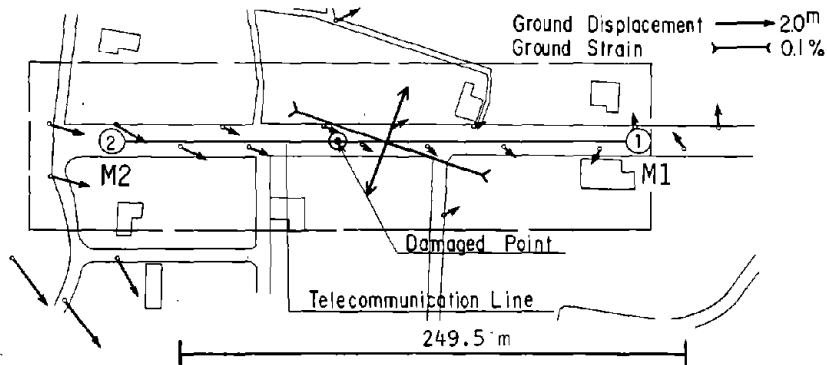
Photo 15 shows the buckling of a steel conduit in which a telecommunications cable was severed. The diameter and thickness of the steel conduit with screw joints are 89 mm and 4 mm, respectively, while the diameter of the cable inside the conduit is 42 mm. The breakage occurred at the location shown in Figure 25, between the two manholes separated by a distance of about 250 m. In the vicinity of manhole No. 2, the ground was displaced to the right by about 1.5 m, predominantly in the axial direction. In the area of manhole No. 1, however, the ground displacements were nearly perpendicular to the direction of the conduit axis. This means that a compressive strain was caused along the conduit. Figure 25 also shows the strain as calculated from the measured ground displacements. This strain is compressive and has a magnitude of about 0.5%. It is conjectured that the conduit was easily buckled by such a compressive strain, given that the surrounding ground lost its strength due to the liquefaction.* Photo 16 shows the protrusion of the conduits at the two manholes No. 1 and No. 2, as a result of the compressive strain.

Figure 25. Permanent Ground Displacements and Strains in the Vicinity of the Damaged Telecommunications Cable

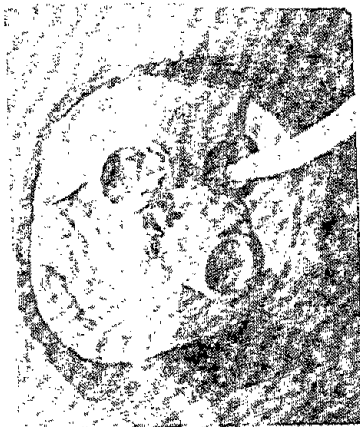
Photo 16 Protrusion of Telecommunications Conduits into Manholes

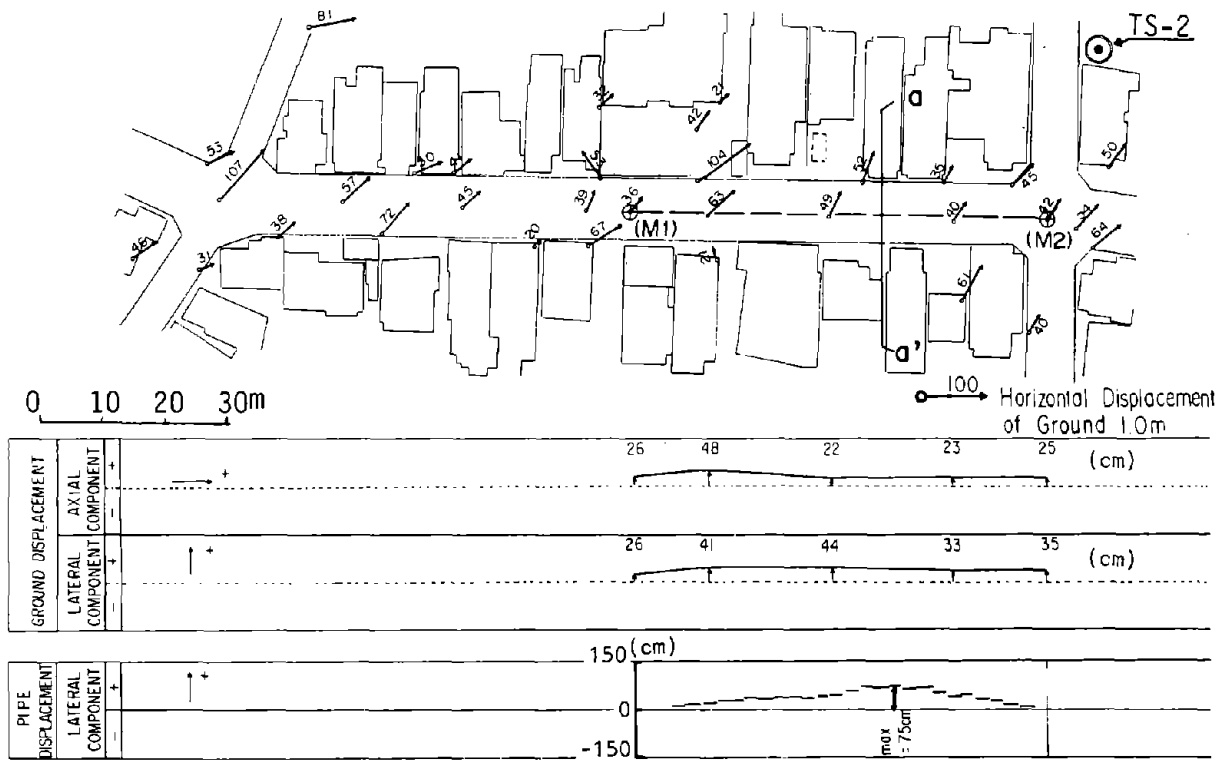
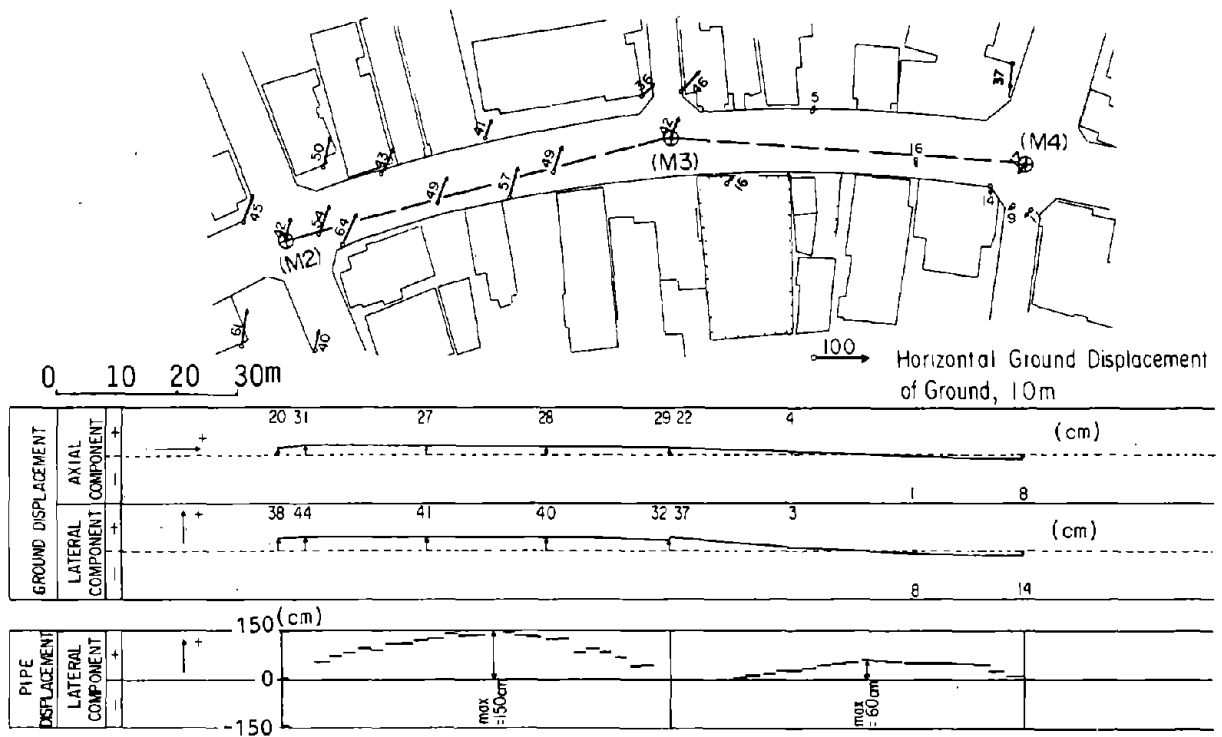
Figure 27 shows the movement of the pipe along the Shinyanagi-cho Route in comparison with the permanent ground displacements at the ground surface. The figure shows the components of the ground displacements in the axial and the lateral directions. Between manholes No.1 and No.2 (Figure 27(a)), the lateral components of the displacements at the ground surface are 26 to 44 cm, but the maximum displacement of the pipes reached 75 cm. Here, it should be noted that the movements of the pipe were measured as relative displacements with respect to the two neighboring manholes. That means that the absolute displacement of the pipe was more than 75 cm. The results outlined in Figure 27(a) show that the pipes moved much more than the ground surface. Similar results were obtained between manholes No.2 and No.3 as well as between No.3 and No.4 (Figure 27(b)). Between No.2 and No.3, the maximum movement of the pipe reached 150 cm, but the displacements at the ground surface were about 40 cm. Figure 28 illustrates the pipe movement and the displacement at the ground surface in the cross section along line a-a' in Figure 27(a), where movement of the pipe was a maximum. The absolute displacement of the pipe is calculated to be 105 cm by adding the maximum relative displacement of 75 cm to the mean displacement of the two manholes, 30 cm. However, along line a-a' the displacement at the ground surface was measured to be only 38 cm.

Figure 27. Movement of Wastewater Pipe and Ground Displacements (Shinyanagi-cho Route)

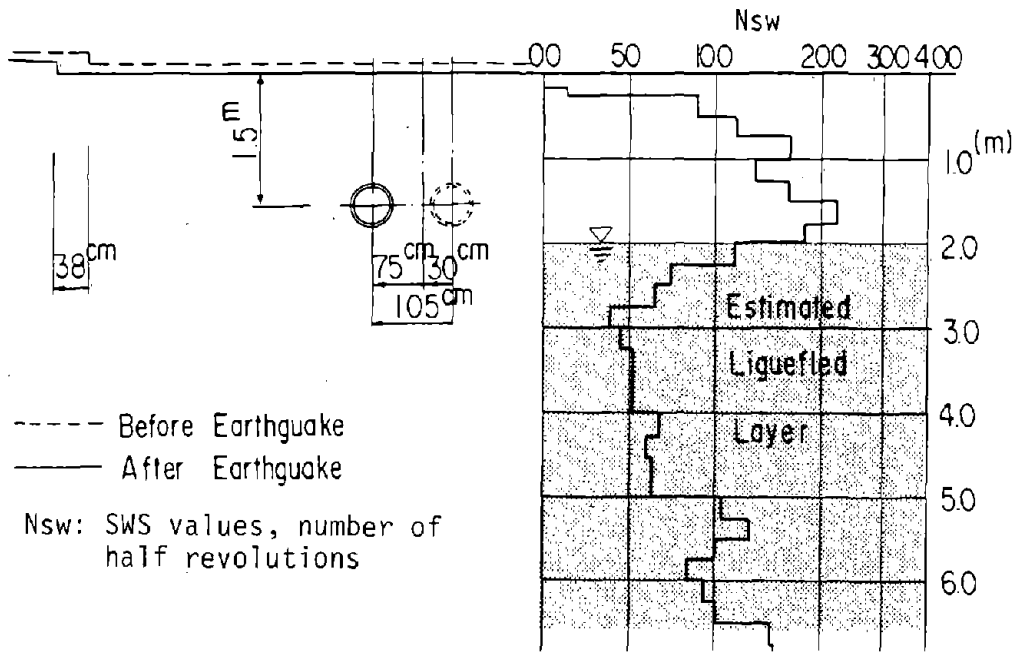
A SWS test, the location of which is shown in Figure 27(a) as TS-2, was conducted in the neighborhood of the damaged wastewater pipes two years after the earthquake. The result is shown in Figure 28 along with the displacement of the pipe in the cross section. The subsurface mostly consists of dune sand. As mentioned previously, the SWS values, N_{sw} , is about ten times the N-value obtained from SPT borings. The results of the SWS in Figure 28 show that a liquefiable layer exists between -2.0 m and -6.5 m. The upper boundary of the estimated liquefied layer is at the groundwater level. The wastewater pipe was not in the estimated liquefied layer, but in the

Figure 28. Movement of Wastewater Pipe and Ground Displacements in Cross-Section a-a'

overlying non-liquefied layer. It should be noted that the groundwater level was measured at the end of July, which was in dry season, two years after the earthquake. The earthquake occurred at the end of May. A possibility cannot be denied that the groundwater was at a higher level during the earthquake. Furthermore, it is probable that some of the soil above the groundwater liquefied due to the upward permeation of the groundwater. If this hypothesis is correct, the results shown in Figures 27 and 28 suggest that the liquefied layer moved much more than the non-liquefied layer nearer the ground surface.

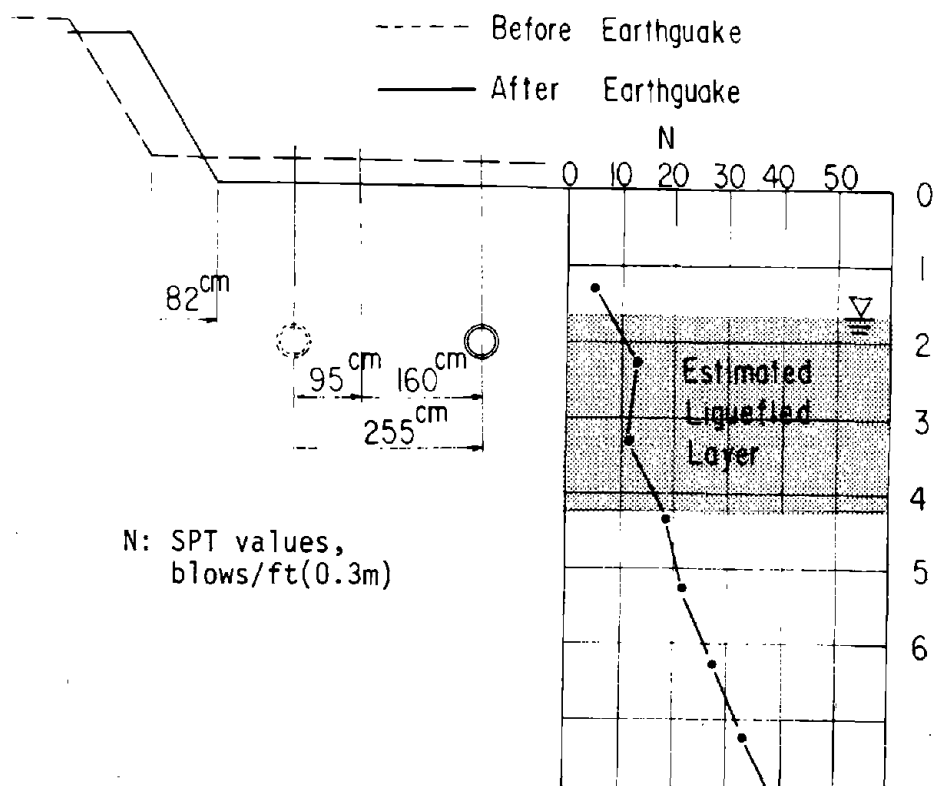
Similar results were observed along Haginodai Route, as shown in Figures 29 and 30. Figure 29 shows that the maximum movement of the pipe was 160 cm, but the ground displacements in the lateral direction were limited to 80 to 110 cm. Figure 30 shows the pipe movement in cross section b-b' in comparison with the displacement of the ground surface. The total displacement of the pipe is estimated to have been 255 cm, a figure arrived at by adding the relative displacement between the manholes and the pipe, 160 cm, to the mean displacement of the manholes, 95 cm. On the contrary, the displacement at the ground surface was limited to only 82 cm. Figure 30 also shows the soil profile with N-values at a site about 50 m north of the wastewater pipes. The subsurface consists of sandy fill and the sand dune. The groundwater is located at -1.7 m below the ground surface, and the soil layer between -1.7 m and around 4.2 m can be judged to have liquefied.* The wastewater pipe was located in this liquefiable layer.

Figure 30. Movement of Wastewater Pipe and Ground Displacements in Cross-Section b-b'

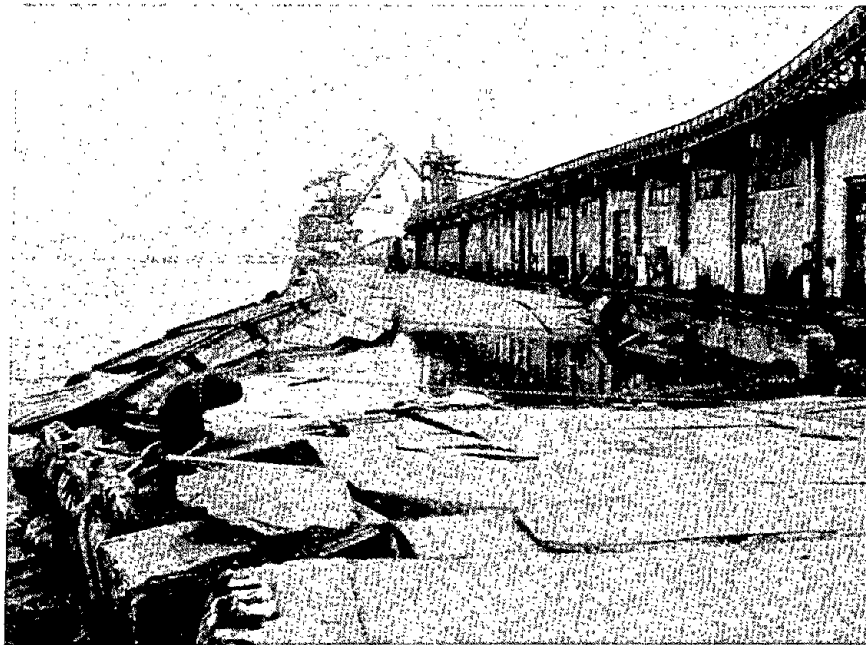
Akita Harbor suffered severe damage to its quay walls due to liquefaction during the 1983 Nihonkai-Chubu earthquake. Most of the damage consisted of the collapse and large inclination of steel sheet pile quay walls, collapse of concrete-block quay walls and the movement of caisson quay walls. Figure 39 outlines the locations of liquefaction in the Akita Harbor area.¹⁰⁾ In particular, Gaiko, the South Pier, the North Pier and Nakajima Pier were severely damaged due to liquefaction. Photo 17 shows one example of the damage to a quay wall made of steel sheet piles at Nakajima Pier. The quay wall was severely tilted and the concrete slab behind the quay wall sank significantly.

Photo 17 Damage to Sheet Pile Quay Wall (Nakajima Pier)
