Case Studies of Liquefaction and Lifeline Performance During Past Earthquakes

Volume 1
Japanese Case Studies

Edited by
M. Hamada and T. D. O'Rourke

Technical Report NCEER-92-0001

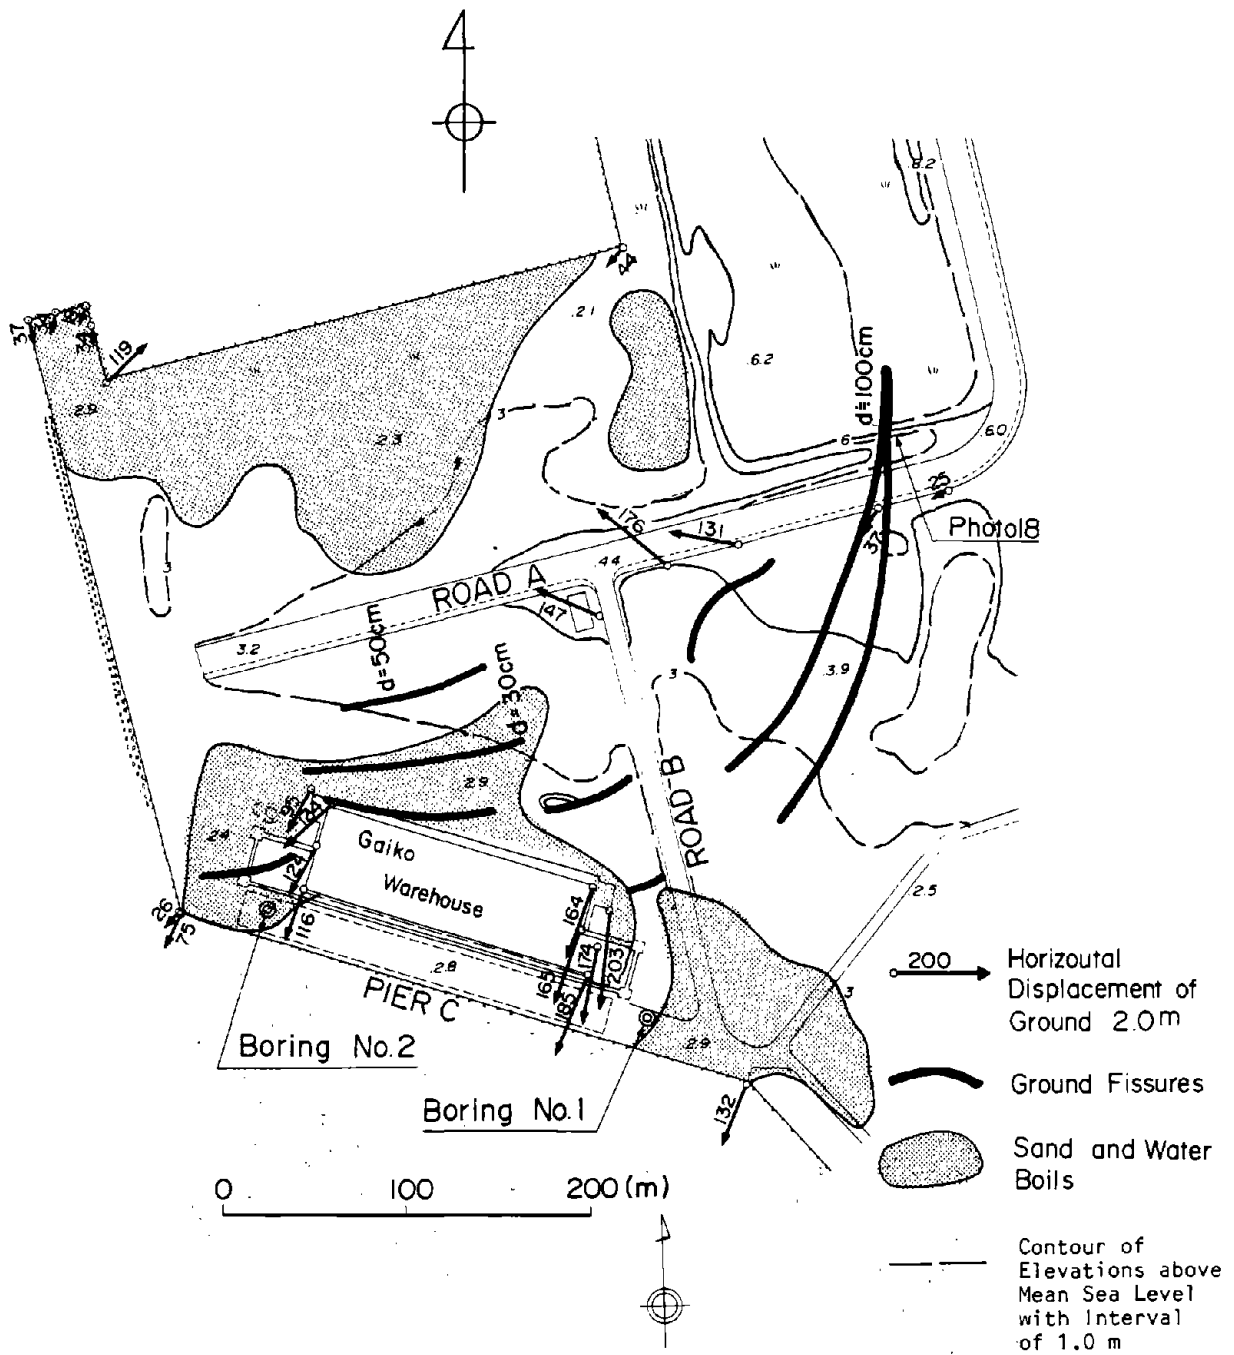
Figure 40 shows the permanent ground displacements, locations of ground fissures and sand boils. The Gaiko Warehouse and the ground around it moved seaward with a maximum displacement of about 2 m. In front of the warehouse (facing away from the sea), ground fissures 30 to 50 cm wide were observed. The permanent ground displacements are generally perpendicular to the ground fissures. It is noteworthy that the ground surface slopes slightly in a southerly direction toward Pier C at a gradient of about 0.5%.

Figure 40. Permanent Ground Displacements, Ground Fissures and Sand Boil at Gaiko Wharf

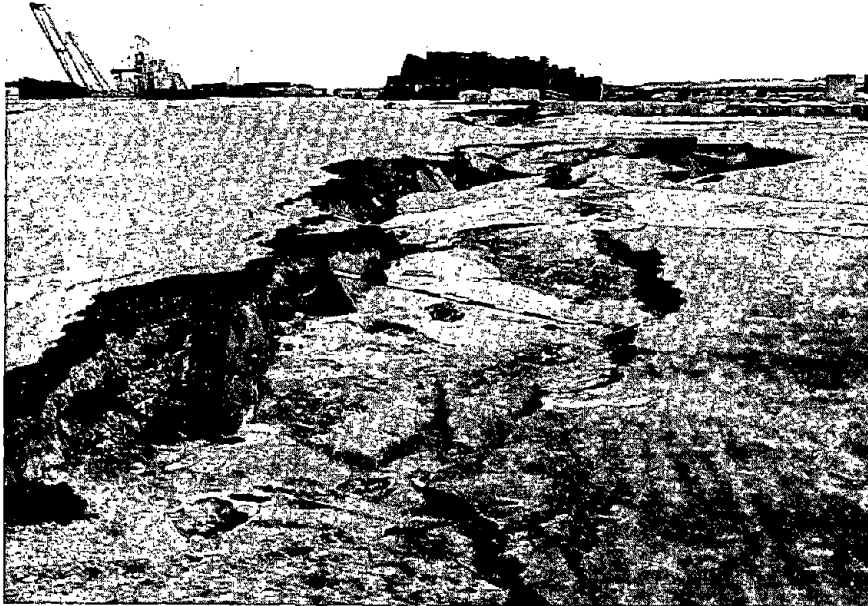
Near the corner of Road A and Road B, the ground surface was displaced to the northwest. Behind the ground displacement, large ground fissures with a maximum width of about 1.0 m were observed. Photo 18 shows one example of these ground fissures, the location and orientation of which is shown in Figure 38. It is also noteworthy that the ground surface is inclined

Photo 18 Ground Fissure at Gaiko Wharf

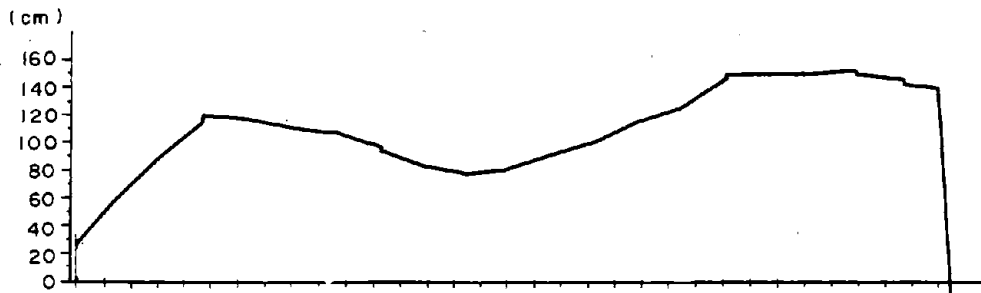
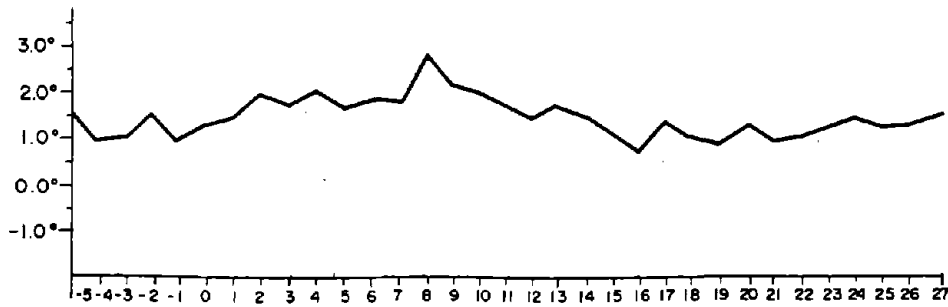
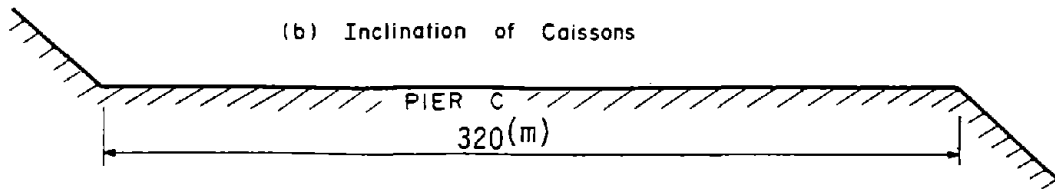
The quay wall of Pier C was built of concrete caissons 16.0 m long, 13.0 m wide, and 14.5 m high, as shown in Figure 42. Figure 43 shows the horizontal displacement at the top of the caissons and their inclinations.¹¹⁾ The caissons moved seaward with a maximum displacement of about 1.5 m. They were inclined by about 3 degrees. The magnitude of the displacement of the caissons mostly coincides with that of the surrounding ground measured by aerial survey.

Figure 43. Movement and Inclination of Caissons of Pier C at Gaiko Wharf 11)

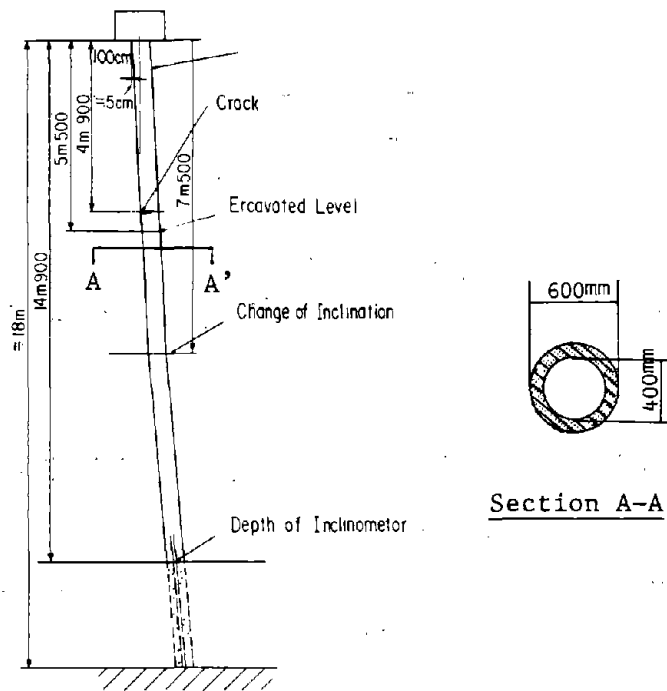
The Gaiko Warehouse was built on prestressed concrete piles 60 cm in outer diameter and about 18 m long. After the earthquake, the floor slab was removed and the ground was excavated to a depth of -5.5 m. Horizontal cracks which could have been caused by a bending moment were found at a depth of -4.9 m. Below -5.5 m, damage to the piles was inspected by inserting an inclinometer into the inner space of the pile. During this inspection, it was found that the inclinometer could not be inserted deeper than about

-14.9 m and that the inclination of the piles changed at a depth of -7.5 m.

From these findings, it is likely that the piles were damaged at levels of -7.5 m and around -15 m. The damage at -7.5 m is comparatively light because the inclinometer could be inserted deeper than this. The damage at about -15 m, however, was much more severe, indicating that the concrete might have been crushed, closing up the hollow pile. This depth basically coincides with the boundary between the liquefiable layer and the lower non-liquefiable layer, described in 6.1.2 and shown in Figure 41.

Figure 44. Damage to Prestressed Concrete Pile of Gaiko Warehouse

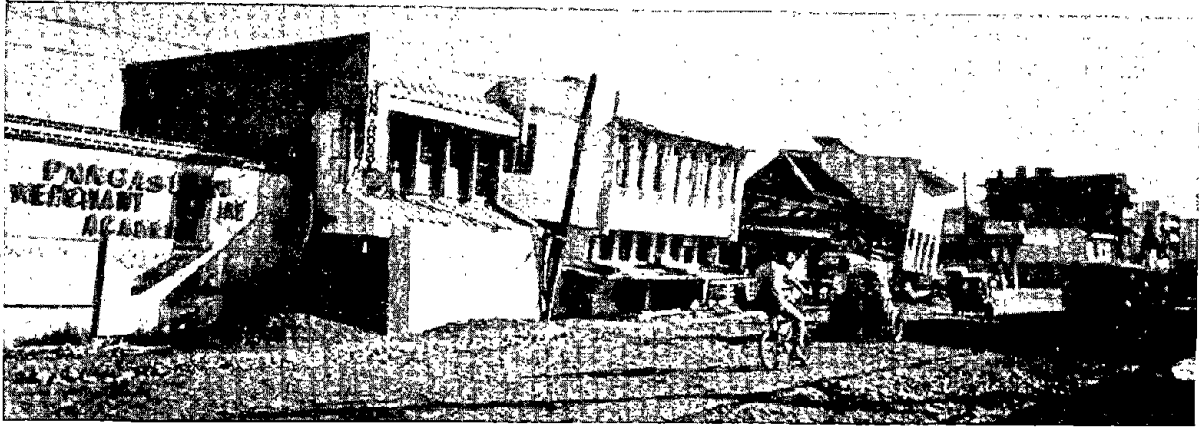
The buildings along Perez Boulevard suffered the most severe damage in the city, as shown in Photo 2.

Photo 2. Settlement and tilting of buildings along Perez Boulevard. Note the height of the eaves.

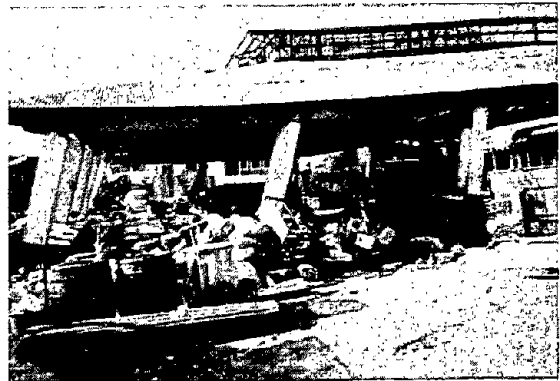
Photo 4. Perez Market, at the right bank of the Pantal River. The foundation of the building was pulled toward the river (to the left) by lateral spreading of the ground.

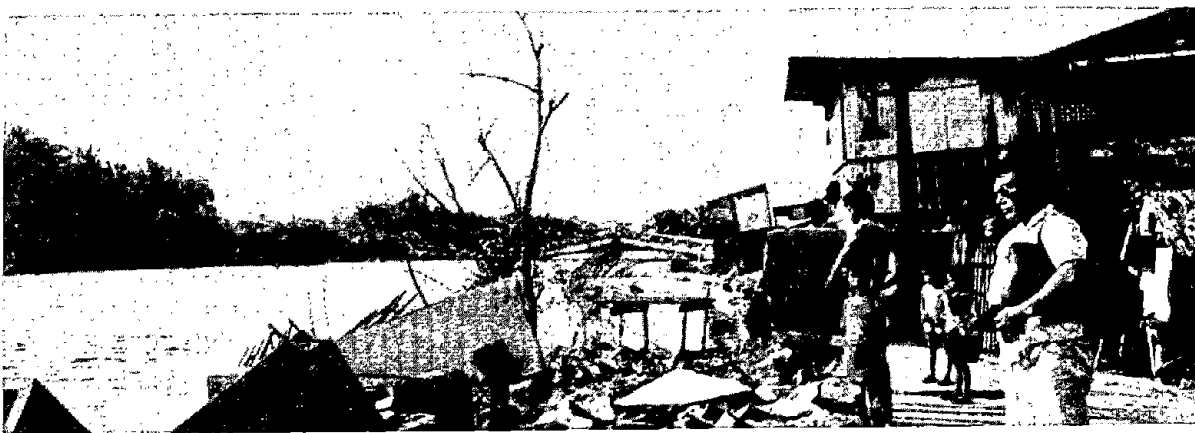
Photo 5. Riverbank behind Perez Market. The fence broke and collapsed into the river. Magsaysay Bridge is seen in the distance.

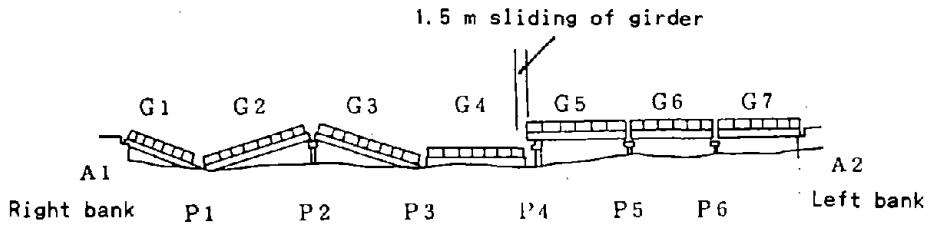
Magsaysay Bridge, and caused serious damage to structures as shown in Figure 6. The Magsaysay Bridge, a 7-span reinforced concrete (RC) bridge on Perez Blvd., suffered the collapse of three spans of concrete plate girders. Two piers toppled because of liquefaction-induced loss of bearing capacity and lateral spreading of the riverbank (Figure 7, Photo 3). The foundations of Perez Market, a one-story RC building located southeast of the Magsaysay Bridge, was pulled about 1 to 2 m toward the river center, causing serious inclination of the building as shown in Photo 4. In this area, numerous sand boils were observed even two months after the earthquake. The riverbank was estimated to have moved by at least 5 m toward the river center, thus splitting apart the concrete fence shown in Photo 5. According to a resident, who was present at the time of the earthquake, the ground began to move during the ground shaking and stopped when the shaking stopped. Nipa houses made of palms to the north of Perez Market were carried into the river and were knocked down.

Figure 7. Sketch of Damage to Magsaysay Bridge (after Iemura¹²)

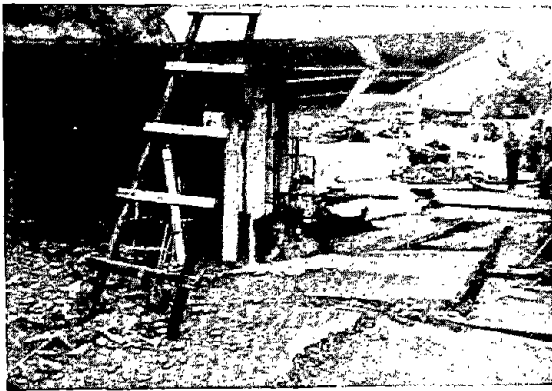
The Asia Career Building, a 5-story RC building with a one-story section, located northeast of Magsaysay Bridge, subsided by more than 1 m, but was hardly damaged as regards the structural elements of the high-rise portion. The one story section was forced into the ground as a result of settlement of the high-rise portion and was extensively damaged as shown in Photos 6 and 7. According to the design drawings, the foundation consists of a 40 cm thick continuous footing embedded at a depth of 80 cm. A one-story wooden house to

Photo 6. The Asia Career building comprised a 5-story portion and 1-story portion. The high rise portion sank by about 1.5 meters at maximum (Courtesy of Dr. I. Towhata)

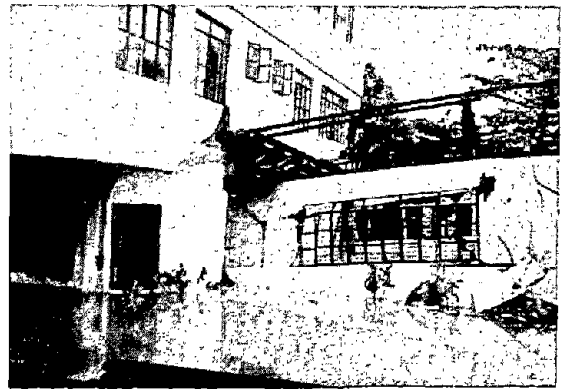
Photo 7. The Asia Career building. The low rise portion was dragged down by the settlement of the high rise portion (Courtesy of Dr. I. Towhata).

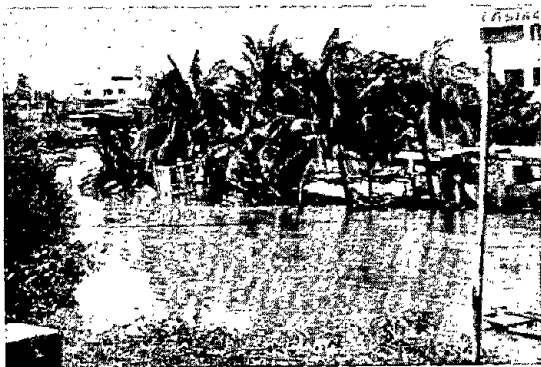
the north of the Asia Career Building moved by about 3 m toward the river and completely collapsed (Photo 8). Sand boils were found in the vacant lot between the wooden houses and the Asia Career Building. Several cracks, about 10 cm wide and 1 to 2 m long, appeared in the lot northeast of the wooden houses located about 30 m from the river, so this point is presumed to be the head scarp of the lateral spreading. According to one resident, the ground began to slide slowly just after the earthquake and soon stopped moving.

Photo 8. Lateral spreading of the right bank along the Pantal River to the north of the building in Photos 6 and 7. A wooden house was carried into the river and completely destroyed.

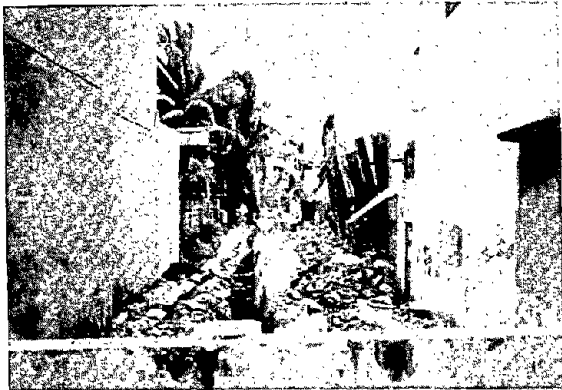
had been reclaimed from a fish pond using coconut leaves in around 1950 and then filled with beach sand in 1960. There was a creek at the back (to the north) of the site, the width of which was reduced to 2.5 to 3 m after the earthquake from its pre-earthquake width of 5 m (Photo 10)." According to a visual survey conducted by the authors, the pavements were separated by about 3 m from the roadway.

Photo 10. A creek flows from west to east to the north of Perez Boulevard. It is presumed to be an old channel of the Pantar River.

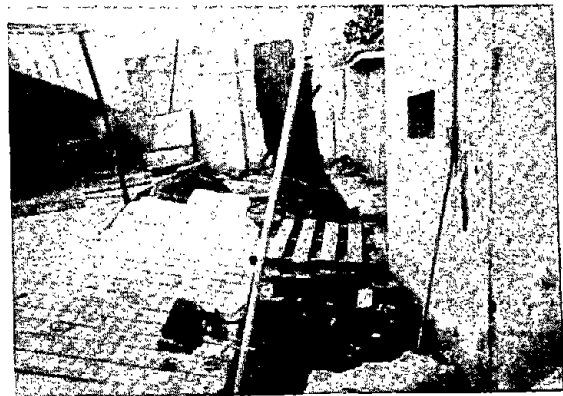
The concrete block fence leading from north to south and the concrete slab collapsed completely in the service yard behind the 4-story RC building located at site 4 in Figure 8. The fence and slab were separated from the building by about 115 cm (Photo 11). The fissures filled with sand boils, which indicates that liquefaction-induced lateral movement of the ground had taken place. The floor heaved by about 75 cm in the north and sank by 20 cm in the south relative to the floor. A resident said, "I went out when I felt the earthquake, but I could do nothing except sit down because of the strong ground motion. I saw the block fence crack. The crack opened up during the vibration and stopped as the vibration diminished."

Photo 11. Backyard of the building next to the Fernandez Building to the east. Concrete slabs and the fence cracked and broke because the foundation ground moved toward the creek (to the left) in Photo 10.

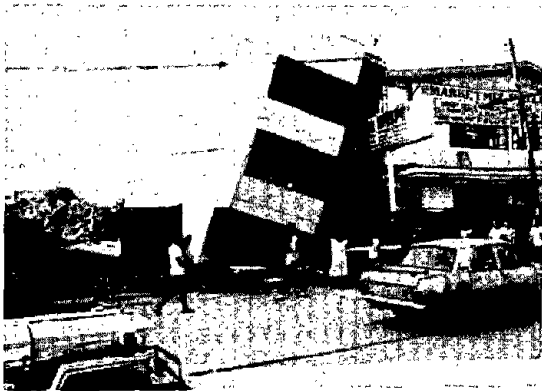
The 4-story RC Lam Wai Nam Building, located at site 4 in Figure 8, tilted over by 18 degrees from the vertical (Photo 12). This was the largest tilt observed in the city. The tilting was restrained upon contact with the neighboring Felipe Siapno Building (Marketmix) which caused damage to the Felipe Siapno Building. The Lam Wai Nam Building was being demolished at the time of our survey (at the end of September, 1990). The foundation ground was covered with bad-smelling water and methane gas was bubbling up from the water. This gas was presumed to come from the humus soil which had formed from the coconut leaves used for reclamation.

Photo 12. A 4-story RC building tilted significantly due to liquefaction. The store next to this building was struck and damaged by this building. Both were condemned.

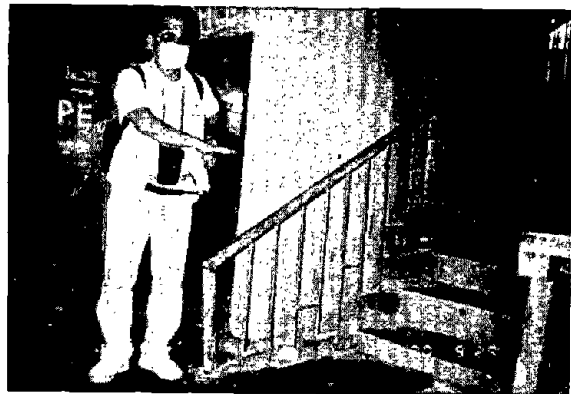
Photo 13. Damage of Luzon College due to liquefaction. The handrail was as high as the man's hand before the earthquake.

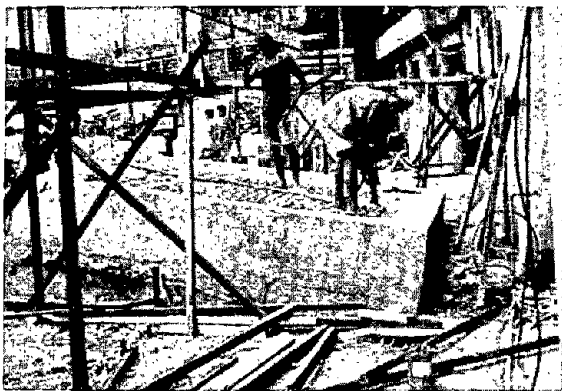
Luzon College was established in 1950, and has about 1,000 students. As shown in Figure 5, the site is located between Perez Boulevard and a creek to the north. No liquefaction effects were found to the north of the creek. The boundary between the liquefied and nonliquefied areas seems to be this creek. Sand boils and cracks were abundant on the site. A 5-story RC school building supported by a continuous-footing foundation subsided by about 1 meter at maximum. Settlement was larger near the creek. Photograph 13 shows the damage inside the school building and a stairway handrail that settled by about 50 cm. In addition, two underground septic tanks floated up under buoyancy by about 40 cm due to liquefaction (Photo 14).

Photo 14. Floating of an underground septic tank at Luzon College.

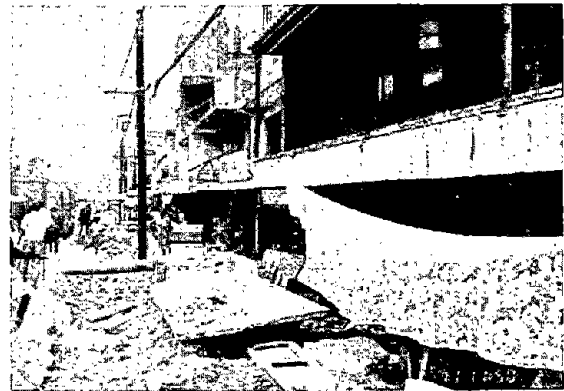
Photo 15. Damage along Angel Fernandez Avenue. The road was cracked by 1 meter on the north side of the street (right side). An electric pole was snapped and the buildings subsided by about 1 meter.

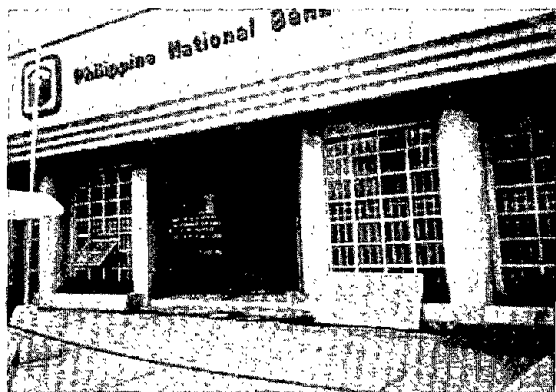
The Philippine National Bank (site i in Figure 5) faces Angel Fernandez Avenue to the south and the Pantal River to the north. The building is a one-story RC building with modern facade (Photo 16). The damage seemed minor when seen from the outside. A small amount of settlement was visible, but no cracks could be seen in the exterior wall. Inside the building, however, the concrete floor slab was cracked and buckled, load bearing columns had settled into the ground, and boiled sand was observed around the columns. The damage was more severe to the north, i.e. in the direction of the river, where differential settlement, cracks, and buckling of the walls and floor, and deformation of furniture and interior walls were observed. Wide fissures parallel to the river were observed on the concrete slab in the rear yard, indicating that the site had moved towards the river. The exterior wall was cracked, indicating that the foundations were dragged toward the river (Photo 17).

Photo 16. Philippine National Bank looking from Angel Fernandez Avenue. The buildings seems to have settled a little but no damage could be found on the exterior wall.

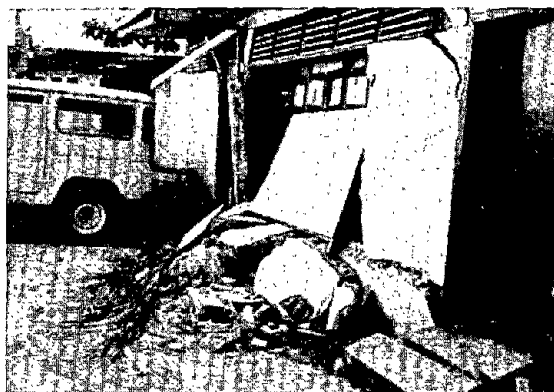
Photo 17. Damage to the exterior wall of the Philippine National Bank looking from the rear. The building was pulled by a lateral ground movement toward the Pantal River (to the left).

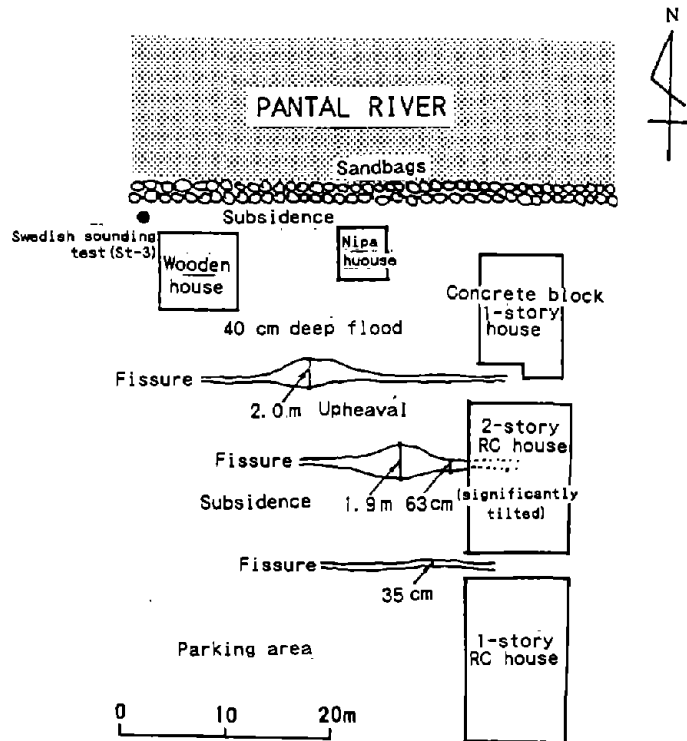
Figure 9. Damage around the Bus Terminal
5-18

Figure 9 shows a sketch of the area around the bus terminal (site j in Figure 5). East of the vacant lot, three structures lining the river, namely, a one-story block house, a 2-story RC building, and a one-story RC building, were found to have tilted significantly in response to ground displacement into the river (Photo 18). Several houses on the river bank to the north of the vacant lot had settled. A resident who has lived in the area for 6 years said, "The ground surface used to be horizontal before the earthquake, but it

was inclined toward the river after the earthquake. The concrete slab of the house had a crack 70 cm wide. I was outside at the time of the earthquake. The ground cracked first, and then sand boiled up in the crack next. Afterwards, the house began to move. The movement was slow at the beginning, and became fast later on. It continued even after the earthquake. I can feel settlement continuing even now, although the amount is very small." Another resident living next to the previous one said, "Fissures appeared during the earthquake at the front yard, then, dark, bad-smelling mud blew up there and covered the ground up to the knee. The ground motion was strong, and the ground moved by about 3 meters toward the river. I felt the movement begin during the earthquake, and it continued even after the earthquake."

North of the bus terminal, the riverbank was distorted by 3 m at maximum over a length of about 50 m. Sand boiled up widely near the riverbank. Several cracks were found oriented parallel to the river in the vacant lot north of the bus terminal. Three of these fissures were remarkably wide, ranging from 1.5 to 2 m in width, and a maximum of 30 cm vertical movement was observed in the ground surface across them.

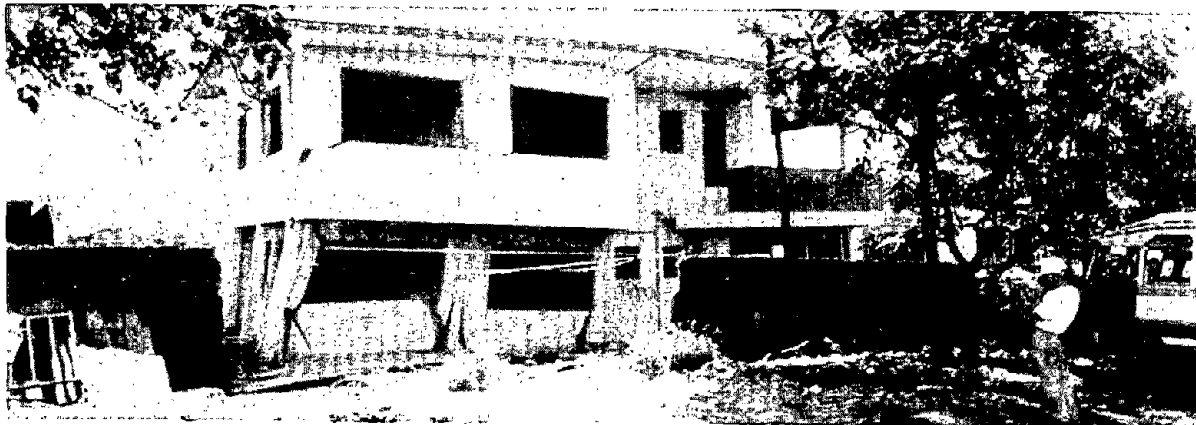
Photo 18. Damage to an RC house in the north of central Dagupan. The northern part of the site (left side of the photo) faces the Pantal River. Since the foundation ground moved toward the river, the building separated at several points. Many sand boils and cracks parallel to the river were seen around this point.

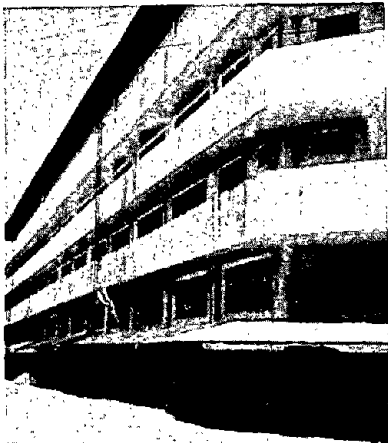
Photo 19. A 5-story RC building in the middle of Fernandez Street. It settled by more than half of the height of the first floor.

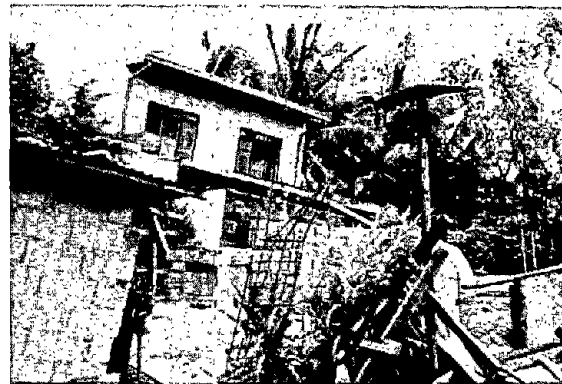
Photo 20. A house located at the left bank of the Pantal River. Since the foundation ground moved toward the river, the building tilted severely toward the river and its foundations failed.

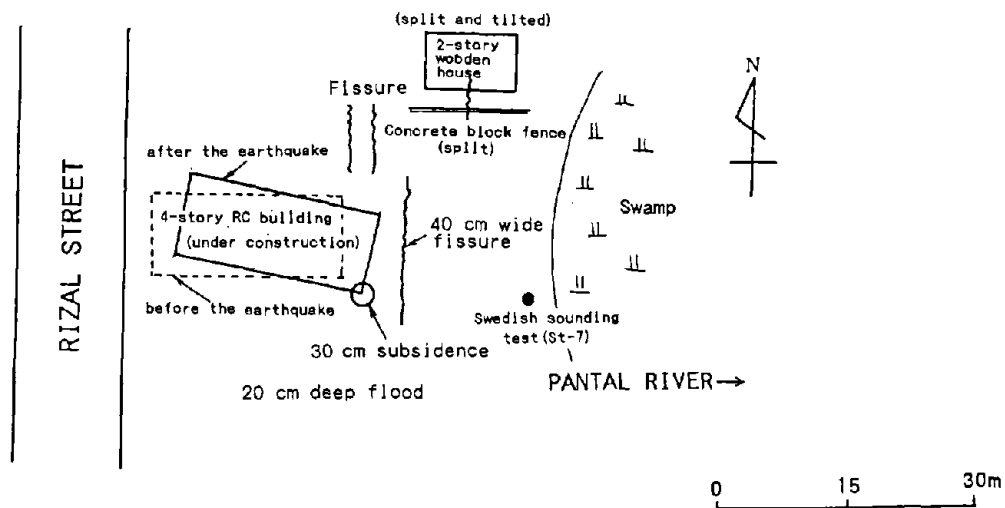
Figure 10. Damage in the Central Section of Rizal Street

As with the previous four streets, the buildings on both sides of this street were damaged due to liquefaction, but the settlement was smaller, being limited to several tens of centimeters. Figure 10 is an enlarged view of the area around site n in Figure 6. The construction manager for a new 4-story RC building said, "The frame was just about to be completed at the time of the earthquake. The building settled by about 30 cm at the southeast corner and rotated slightly in a clockwise direction. The foundations are of a continuous footing construction. Several cracks 40 cm wide and extending parallel to the river appeared to the east of the building. A sand/water mixture boiled up and water covered the ground to a depth of about 20 cm." A 2-story wooden house northeast of the building tilted severely toward the river. Both this house and the block fence were pulled apart due to the lateral ground movement toward the river (Photo 20). The river bank at this site forms a swamp which appears to be an abandoned channel, and the ground failure described was especially severe within this former channel.

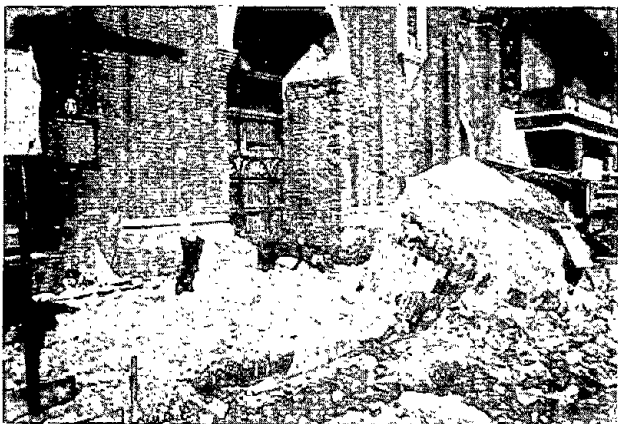
Photo 21. Collapse of tower of an old Catholic church facing Zamora Street, thought to have been caused by ground shaking (Courtesy of Mr. T. Nakajima).

Some damage to structures occurred in non-liquefied areas. Such damage appeared to have been caused by ground motion. Photograph 21 shows an example of damage due to ground motion. Only two buildings had been built with pile foundations. Both were located in nonliquefied areas. No damage was observed to the Macador Hotel building at site A in Figure 11. Several cracks due to ground motion were observed on the nonstructural walls of the Insular Life building located at site B in Figure 11 (photo.37).

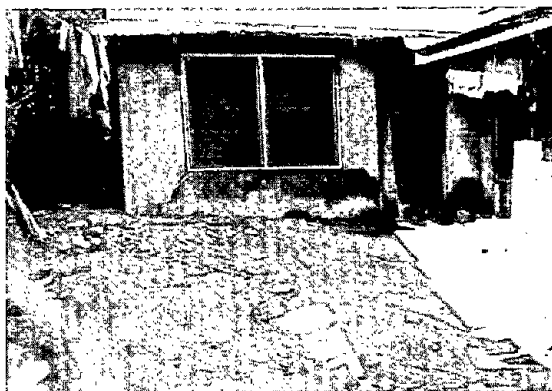
In the residential zone along Nable Street located north of the Pantal River, large numbers of sand boils were observed in house yards. The wooden houses settled by about 50 cm (Photo 22). The concrete protection structures along the riverbank were distorted by about 1 m toward the river, apparently a smaller movement than on the opposite bank of the river. A 59-year old man who lived at site r in Figure 5 in a 2-story Spanish style wooden house built at the end of the 19th century said: "The ground vibrated in the horizontal direction at first and later in the vertical direction. The ground cracked and bluish, bad-smelling sand boiled up all over the place. The water covered the ground to knee level. An outhouse sank by about 50 cm, and a masonry wall suffered cracking, 20 cm wide, running from east to west. The ground then began to move slowly. It began to move during the earthquake and continued after the earthquake. According to my parents, a big earthquake occurred here in 1892 and a 1-m-wide crack formed parallel to the river, but they did not say whether sand boils occurred or not."

Photo 22. Sand boils in the residential area along the Pantal River in Pantal district. Almost all houses settled by several tens of centimeters.

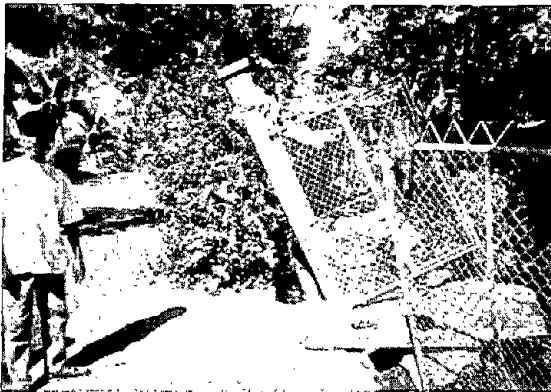
A resident living to the east of the previous house said that his house had settled by about 60 cm as a result of the earthquake, and boiled sand had piled up to about 30 cm. The gate tilted toward the river, and a fence running perpendicular to the river split apart by about 1 m (Photo 23). At

Photo 23. Damage to a gate on the right bank of the Pantal River in the Pantal District, a result of lateral spreading of the ground.

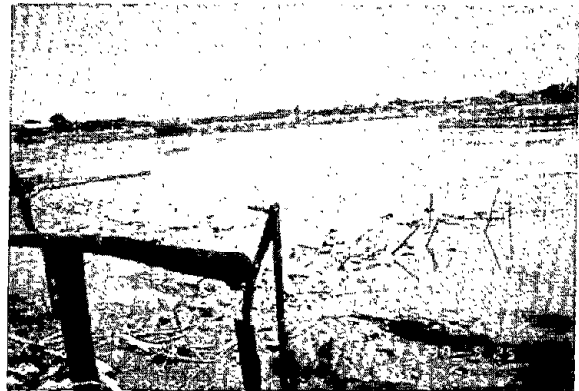
North of the residential area were fish ponds. Ground cracks and sand boils were abundant in the uncultivated fields around the ponds. Almost all the cracks at this location ran from east to west, and their maximum width was 1.3 m. According to some residents, "The area used to be a rice field until 1972, and was developed into fish ponds because of salination. The depth of the fish pond was about 1.3 meters. Sand boiled from the bottom of the pond, continuing for about 1 minute and 20 seconds. Sand was deposited to a depth of more than 40 cm." (Photo 24)

Photo 24. Fish pond north of Central Dagupan filled with sand boils.

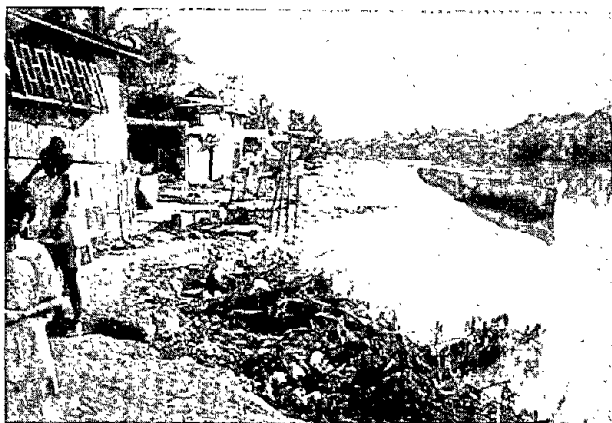
A concrete wall along Calimlim Street sank, moved, and was destroyed. A river protection structure was pushed toward the center of the river by about 10 m between u and v in Figure 5 (Photo 25) as a consequence of liquefaction-induced vertical and lateral movements of the ground. According to a resident, the revetment was constructed recently using 9-meter-long RC wall segments, supported with tie rods. Houses along the Pantal River tilted toward the river, and some homes were washed away. The ground cracked along the street, and sand boiled out from the cracks. The temperature of the

Photo 25. Damage on the right bank of the Pantal River in the Pogo Chico District. The revetment moved by about 10 meters toward the river center (Courtesy of T. Nakajima).

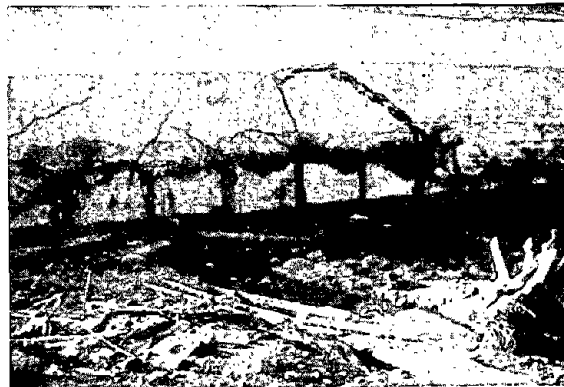
expelled water was about 60°C. The RC wall segments have a 25 cm x 60 cm cross-section (Photo 26). Since they project about 1.5 m above the ground surface, the length under the ground is estimated to be 7.5 m. The tie rods were attached every 3 m (5 wall segments).

Photo 26. Nine-meter-long RC wall segment with 25cm x 60cm cross section. They were supported by tie beams every 3 m, but moved toward the river center due to lateral spreading.

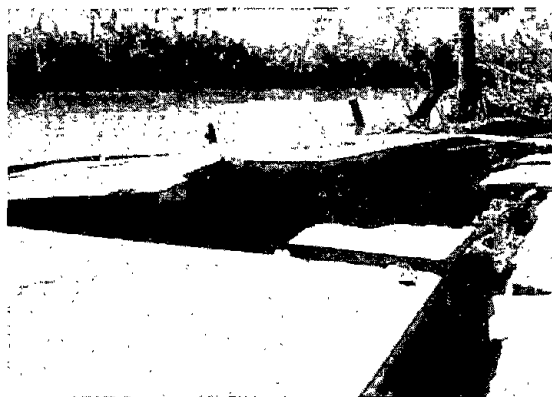
Photograph 27 shows large fissures in a concrete slab at the Carlesberg Beer Company located at site w in Figure 5 which had a maximum width of 290 cm. The width of the ground fissure under the slab reached 350 cm. Several fissures, similar to those in Photo 27 were observed extending parallel to the river on this site. Those nearer the river are wider. The cumulative horizontal displacement across these fissures amounted to at least 8 m toward the river. Two warehouses collapsed almost completely. The presence of open ground fissures beneath these buildings and nearby sand boils indicates that liquefaction-induced ground failure was the primary cause of the damage. According to employees, "Black sand/water mixture boiled up and flowed to a depth of 1.5 m, and this continued for about 30 minutes. The river protection began to move during the ground motion, ending up 5 m into the river."

Photo 27. Cracks on a concrete slab due to lateral movement of the ground on the left bank of the Pantal River flowing through the south of Central Dagupan. The revetment moved by about 5 m toward the river center.

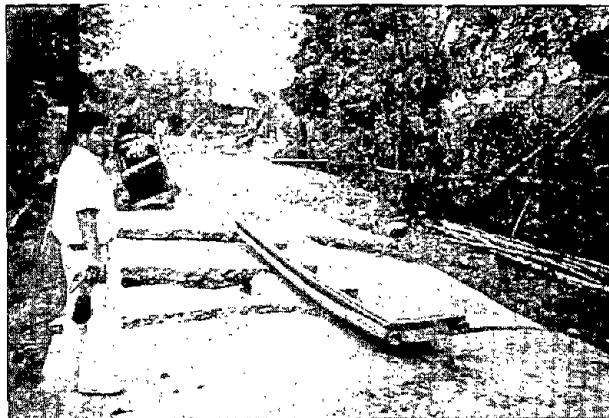
At site B in Figure 4, misalignment and vertical undulation of the roadway occurred due to lateral movement of the ground (Photo 28). At site C in Figure 4, the ground cracked and slipped due to lateral spreading toward the river (Photo 29).

Photo 28. Misalignment and vertical undulation of the roadway on the bank of the Pantal River in the Lasip Grande District. This side is the Pantal River (Courtesy of Mr. T. Nakajima).

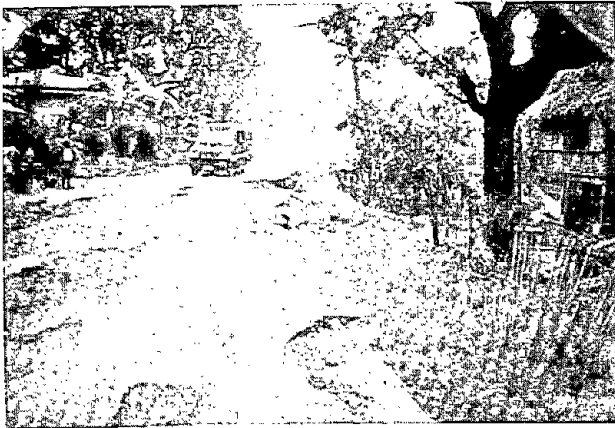
Photo 29. Head scarp of lateral spreading on the roadway in the Lasip Chico District. A branch of the Pantar River is to the right (Courtesy of Mr. T. Nakajima).

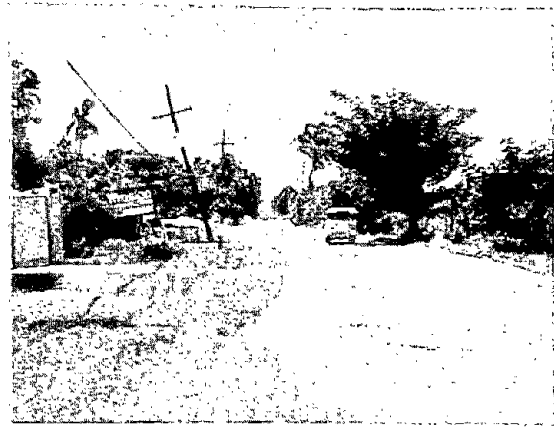
At site F in Figure 4, the road assumed a curved shape as shown in Photo 30, with a maximum lateral displacement of about 2 m inland. The road used to be straight before the earthquake according to a resident. The site is the

boundary between sand dunes and the marshy lowland. The ground movement occurred from the dunes in the direction of the lowland.

Photo 30. The Dagupan-San Fabian Road was straight before the earthquake, but was displaced by about 2 meters to the inland side (right). Electric poles tilted due to the lateral ground movement.

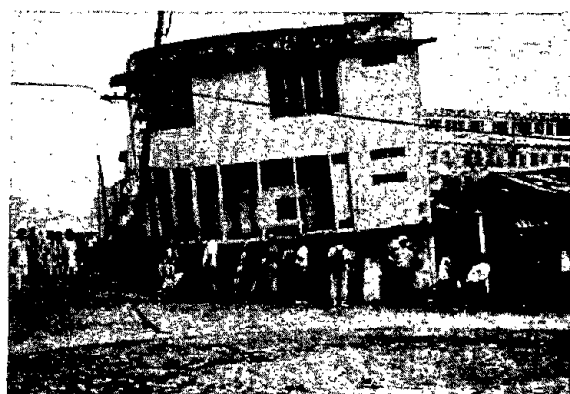
Differential settlement was also abundant. Typical damage due to differential settlement is shown in Photo 32. In addition, Photos 2, 12, 13, 15, and 19 are examples of affected buildings. More than half of the buildings in Central Dagupan tilted by more than 1 degree from the vertical.⁹⁾ The building shown in Photo 12 tilted by 18 degrees, the largest angle measured in Central Dagupan. An adjacent building prevented it from overturning completely.

Photo 32. Differential settlement of a building due to liquefaction along Perez Boulevard.

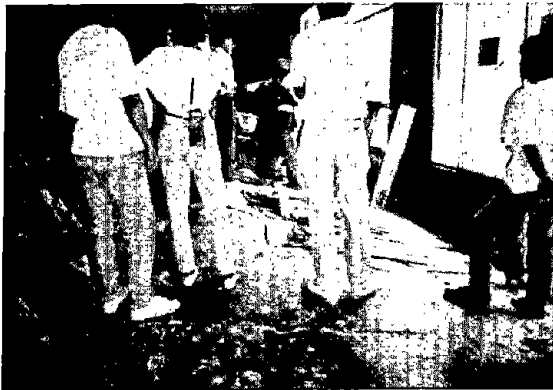
Settlement of buildings also caused great damage to non-structural elements. Floors, for example, heaved up because the surrounding ground beneath load bearing walls and columns suffered relative settlement, as exemplified in Photo 33. Many examples of damage to exterior walls were also observed.

Photo 33. Heaving of the earth floor slab due to settlement of the structure.

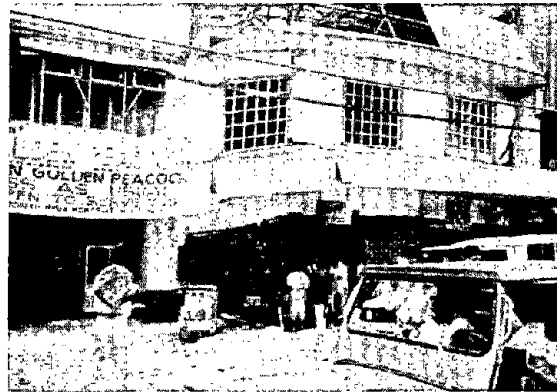
Structural damage associated with the settlement or tilting of adjacent buildings was also observed. One typical case of this type is shown in Photos 34 and 35, in which the settled building dragged down the neighboring structure. If two buildings were directly connected or in contact with each other, and one building settled more than the other building, for example, it pulled the adjacent building down. This type of damage occurred even in a building consisting of quite different structural portions. Photos 6 and 7 are an example of this type, in which the one-story portion was dragged and damaged by the settlement of the 5-story portion. The house shown in Photo 12 (on the right) was damaged because the neighboring building tilted over and struck it.

Photo 34. Building displaced and damaged due to settlement of the adjacent building along Angel Fernandez Avenue (Courtesy of Kiso Jiban Consultants).

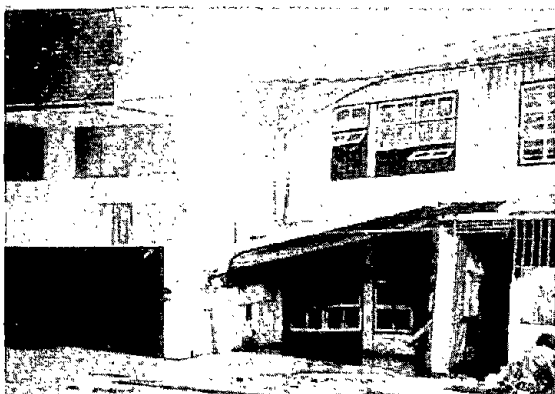
Photo 35. Building displaced and damaged due to settlement of the adjacent building along Fernandez Street (Courtesy of Kiso Jiban Consultants).

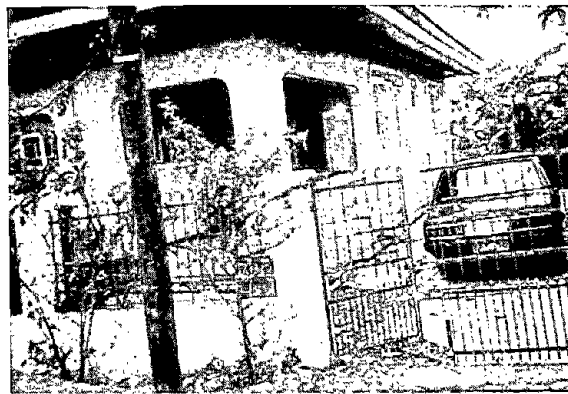
Liquefaction also occurred over a widespread area outside Central Dagupan where most of the structures are one- or two-story wooden houses. Little large-scale settlement and differential settlement of houses occurred because these houses are not as heavy as the RC buildings in Central Dagupan. However, local ground deformations, such as ground cracks, relative subsidence, and ground undulations, caused severe structural damage to some of these houses (Photos 22 and 36).

Photo 36. Settlement and tilting of a house due to liquefaction.

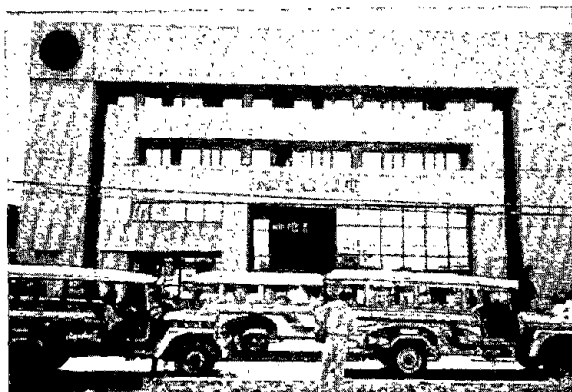
Photo 37. The Insular Life building, one of two buildings constructed with pile foundations in Dagupan City. The building is located in the non-liquefied area. Several small cracks were observed on the non-structural exterior walls and these were caused by ground shaking.

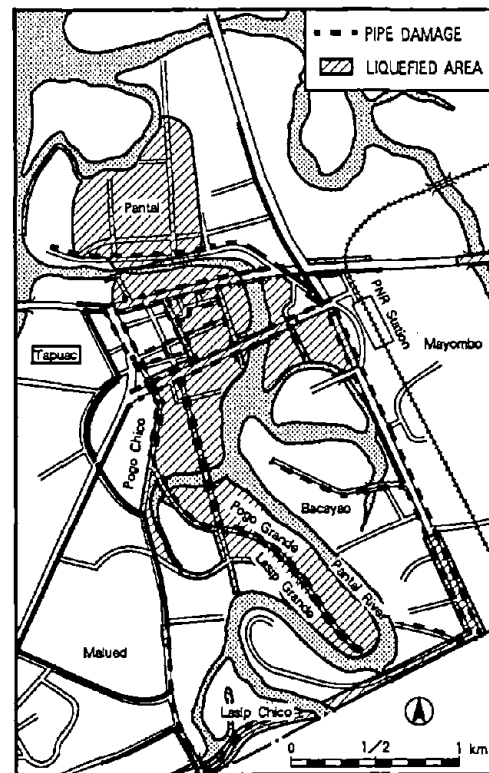
Figure 13. Damaged lines in the Water Supply System

Figure 13 represents the damaged lines which the city water department decided to abandon after the earthquake. The actual location of the damage was not investigated because the pipes were considered too old to repair and too deep to excavate. The spatial extent of the liquefied area is also illustrated in the figure. The abandoned lines include all kinds of pipe materials and are distributed over the liquefied area as shown in Figure 13.

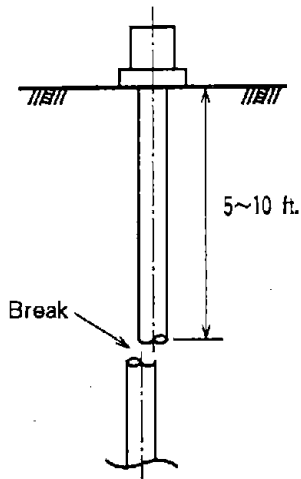
Figure 14. Damage to Well Casings

Besides the damage to buried pipes, some well casings were distorted by shear deformation at a depth of 1.5 to 3.0 m as shown in Figure 14. These deformations are thought to have been induced by lateral spreading of the surface layer in the liquefied area. These wells were abandoned because greater damage at lower levels in the casings was suspected. It should be mentioned that the distribution pipes were buried at the same depth as some of the observed damage to well casings.

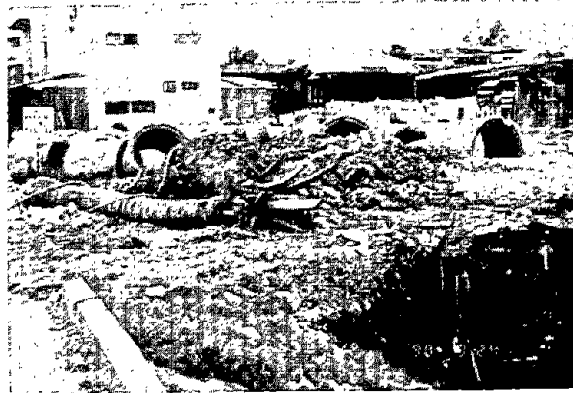
Figure 16 shows the locations of heavily damaged sewage mains along major streets in the city. Photo 38 shows an excavated sewage pipe.

Photo 38. Excavated main sewage pipe cracked by the earthquake.

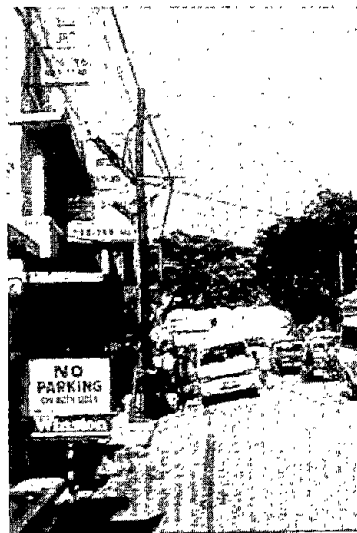
Photo 40 shows very unusual damage to a reinforced concrete pole behind a wooden pole erected after the earthquake. The concrete pole was severed near the top and pulled to the left because the top of the pole was connected to a house through a wire. The house moved to the left horizontally as a result of lateral spreading of the liquefied ground. Electricity supplies to 20,000 houses were cut off due to the damage of the poles and the distribution lines during the earthquake. It was possible, however, to restore services to approximately 70% of these houses within three days after the earthquake.

Photo 40. An electric pole wired to a house was severed due to lateral movement of the house.

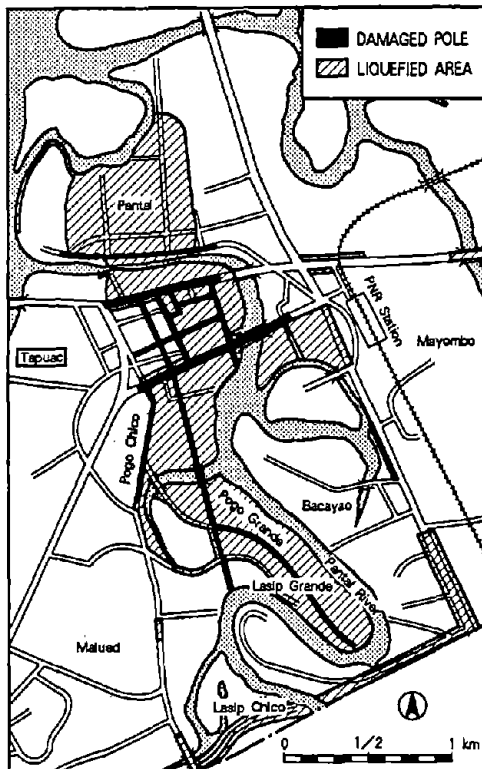
Figure 18. Damaged Electricity Distribution Lines

Most of the electric poles in the distribution system either sank, inclined, or collapsed in the liquefied area. The maximum vertical displacement of the poles amounted to 2 m, in a case where a heavy transformer was fitted to the pole. Figure 18 shows the damaged distribution lines along which damaged poles were noted. Other damage included leakage of insulating oil from transformers on 30 poles.

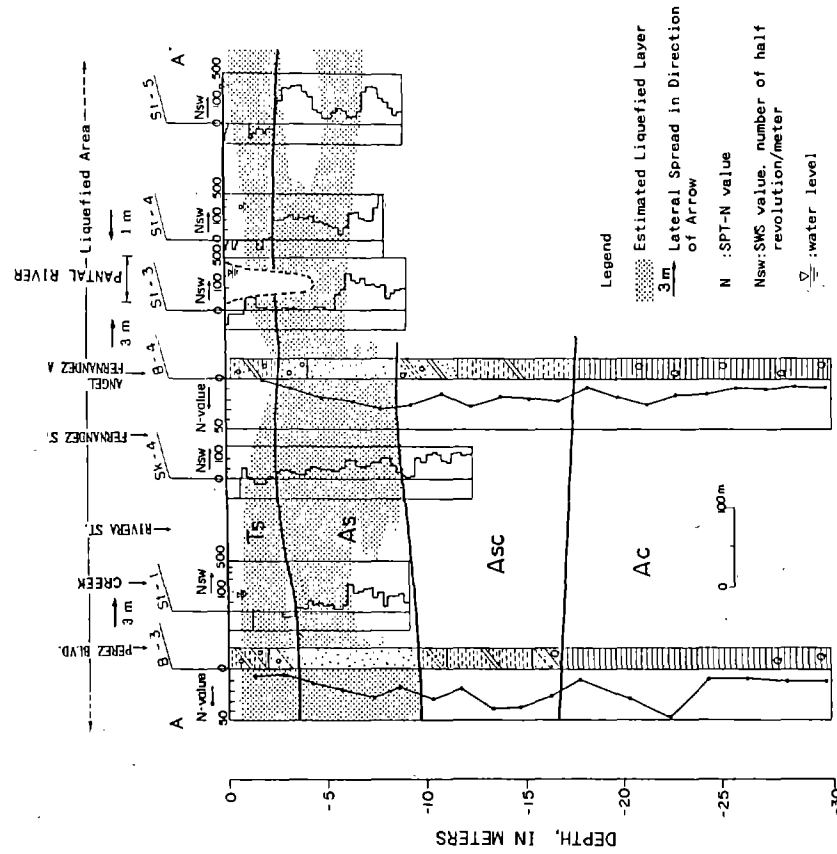
Figure 20. Cross Section of Sediments along Section A-A' Showing Geotechnical Features and Estimated Liquefied Layers

Looking at Figures 20 to 25, it is clear that in areas where liquefaction effects were observed on the ground, the thickness of the liquefied layer is on the order of 5 to 10 m. In addition, the unliquefied layer above it is thin, being less than 3 m deep near the St-2 site in Figure 23 where tilting and settlement of the buildings were extreme. Furthermore, the thickness of the liquefied layer reached about 10 m in areas where damage due to lateral spreading was seen, including the area near Magsaysay Bridge (B-1 and B-11 in Figure 23). On the contrary, where the liquefied layer was thinner than 3 m, and where there exists a fairly thick non-liquefied layer above the liquefied layer, no liquefaction effects were observed.
