Case Studies of Liquefaction and Lifeline Performance During Past Earthquakes

Volume 1
Japanese Case Studies

Edited by
M. Hamada and T. D. O'Rourke

Technical Report NCEER-92-0001

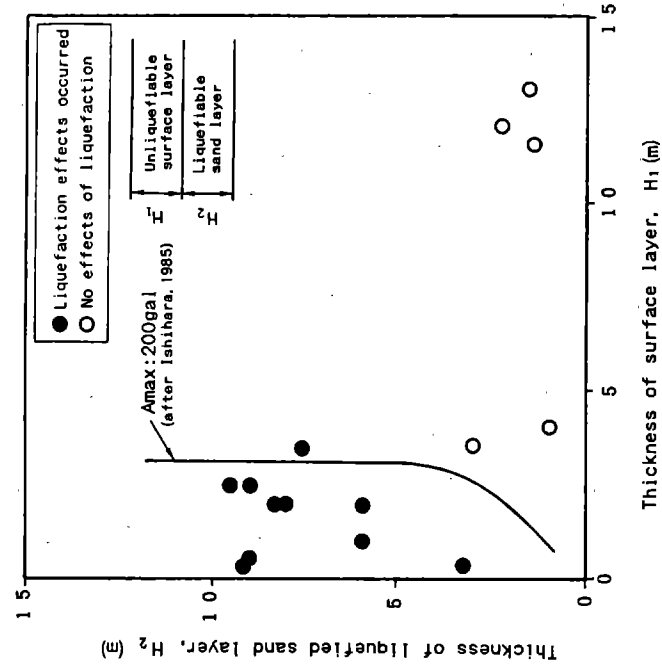
Figure 27. Relationship between the Thickness of the Liquefied Layer and the Thickness of the Non-liquefied Layer above it in Areas Where Liquefaction Effects Were Observed and Not Observed

The relationship between the thickness of the liquefied layer and the thickness of the overlying nonliquefied layer in Dagupan City is shown in Figure 27. The boundary which distinguishes the occurrence of damage due to liquefaction under the peak acceleration of 200 gals, as proposed by Ishihara,¹⁴) is also shown in the figure. The situation in Dagupan City generally agrees with Ishihara's proposal.

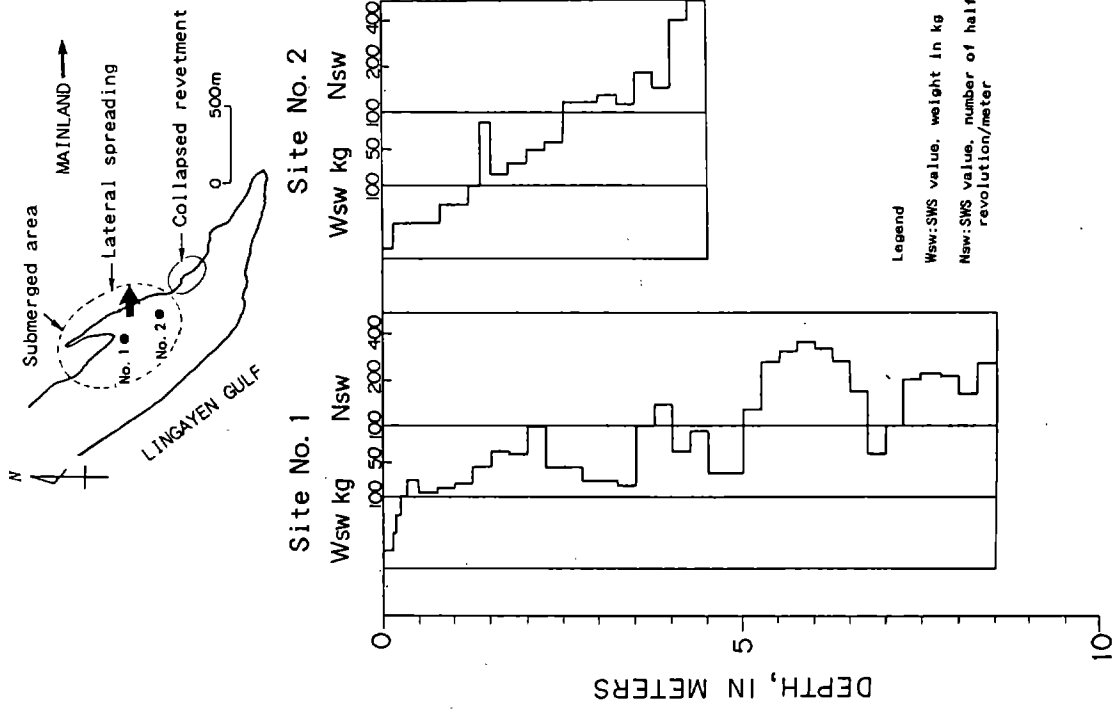
Figure 28. Records of Swedish Cone Penetration Tests in Barrio Narvacan

Photos 43 and 44 show the village at low tide. There were sea walls protected by boulders on the shore to the south of the village facing the main island, and these slipped and sank due to liquefaction. Figure 28 shows the records of SWS testings conducted by the authors at two sites in the village. The soil to a depth of 2.3 to 3.5 m below the surface is a loose deposit (N_{sw} is less than 60), with an estimated SPT-value of about 10.

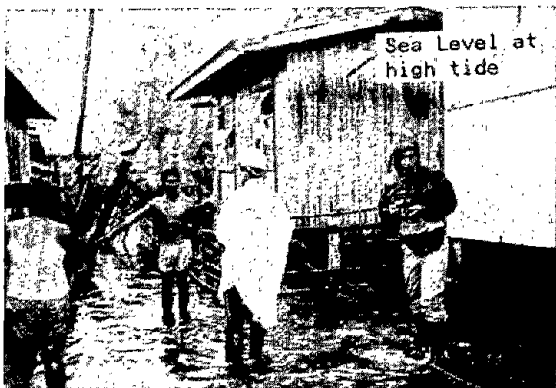
Photo 43. Damage in Barrio Narvacan. Traces of water at high tide are seen on the eaves. (Courtesy of Dr. M. Hakuno).
