Case Studies of
Liquefaction and Lifeline
Performance During Past Earthquakes

Volume 2
United States Case Studies

Edited by
T. D. O'Rourke and M. Hamada

Technical Report NCEER-92-0002

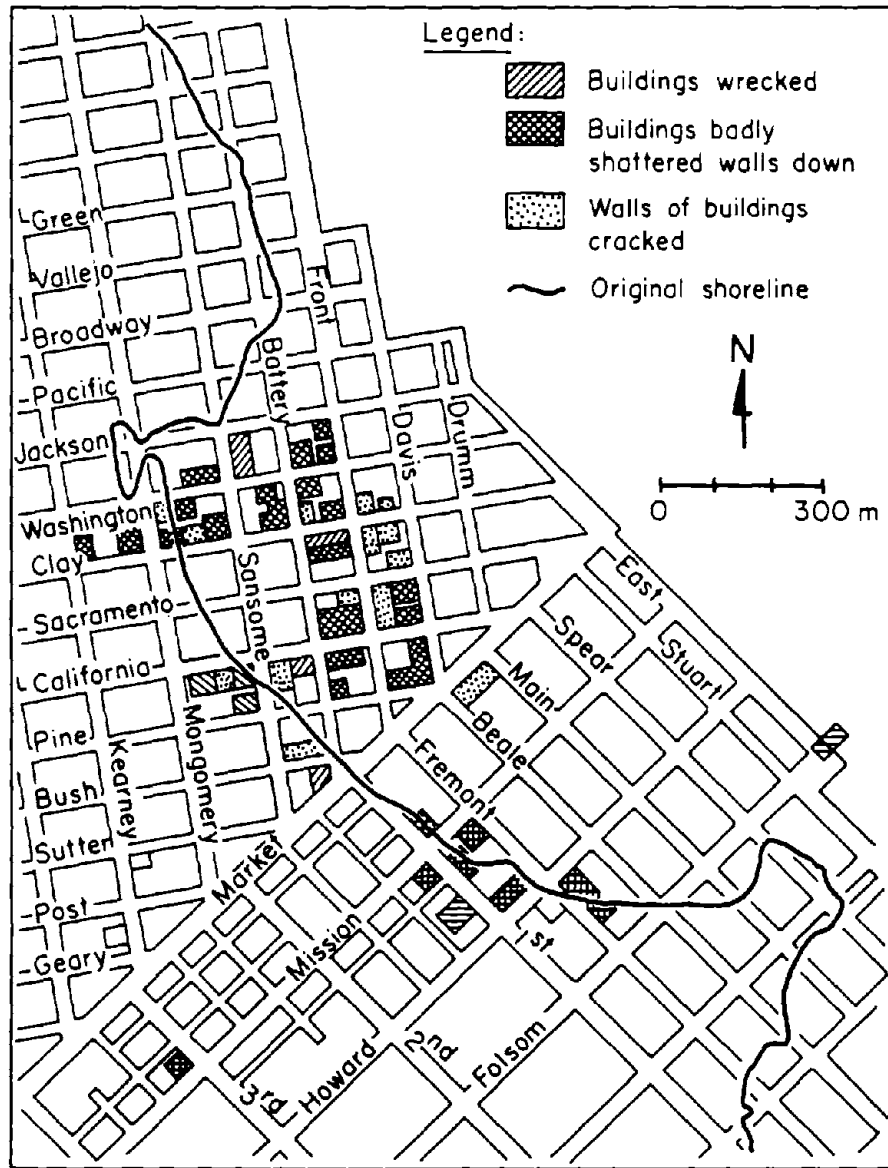
Figure 2. Building Damage in the Foot of Market Area After the 1868 Earthquake (after Lawson, et al., 1908)

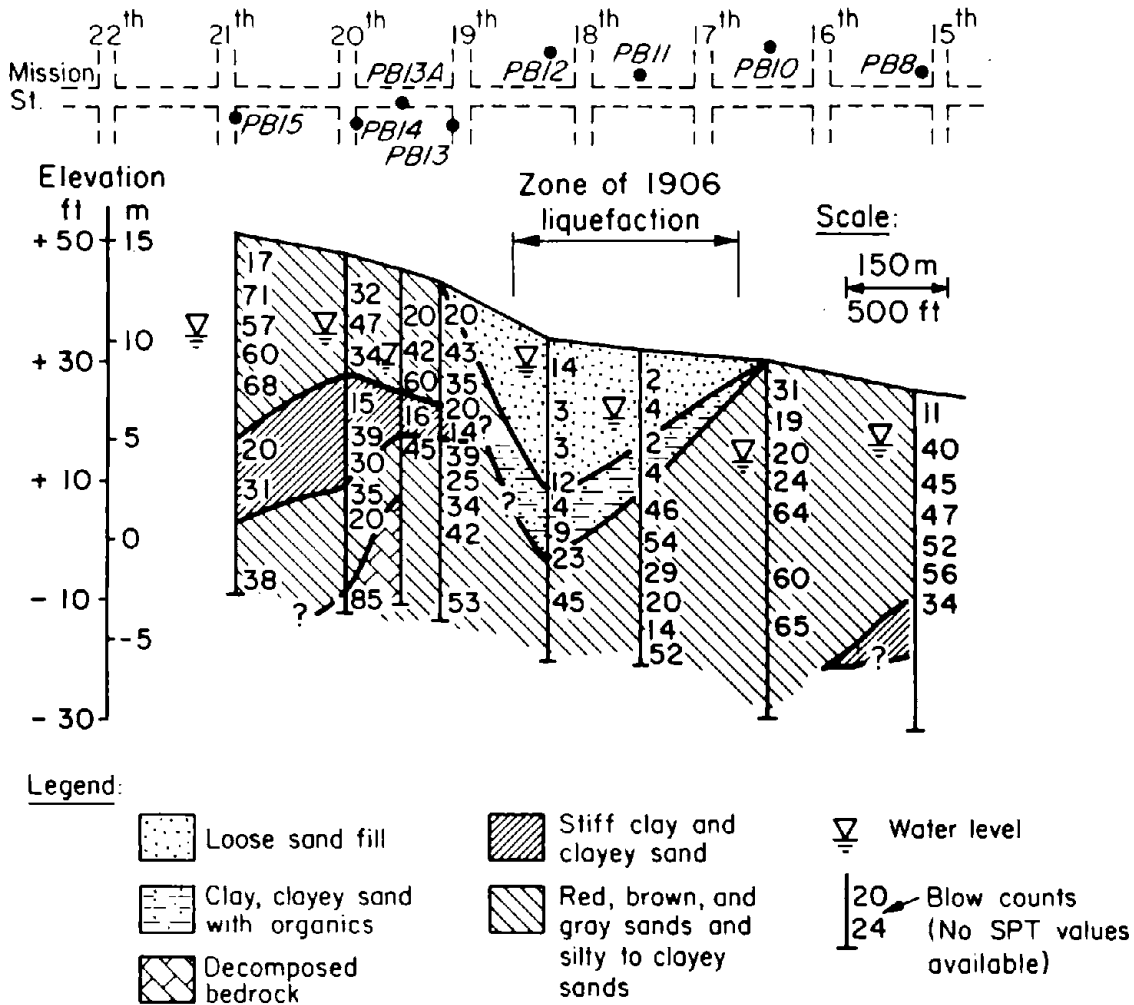
In general, the cross-section in Figure 8 is consistent with the subsurface topography mapped in Figure 7. The soil borings show loose sandy fill between 17th and 18th Sts., with a maximum depth of approximately 10 m near 18th St.

Figure 8. Soil Profile Along Mission St. in Mission Creek Area

The lateral extent of this fill correlates well with the width of the old Mission Creek channel at this location. The fill is underlain by relatively soft organic clay, which again correlates well with the previously mapped marsh conditions at this site.

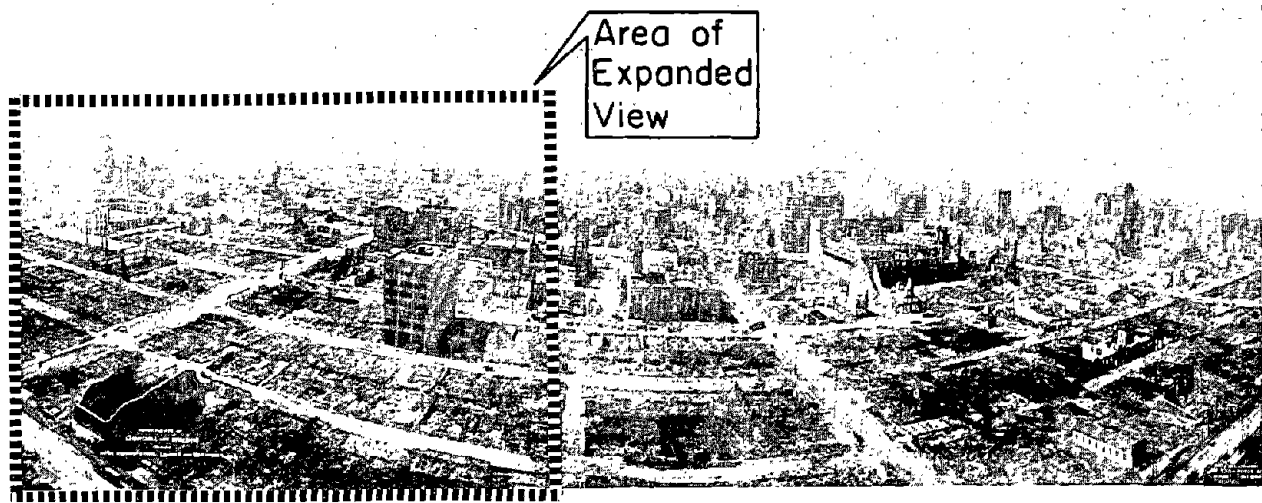
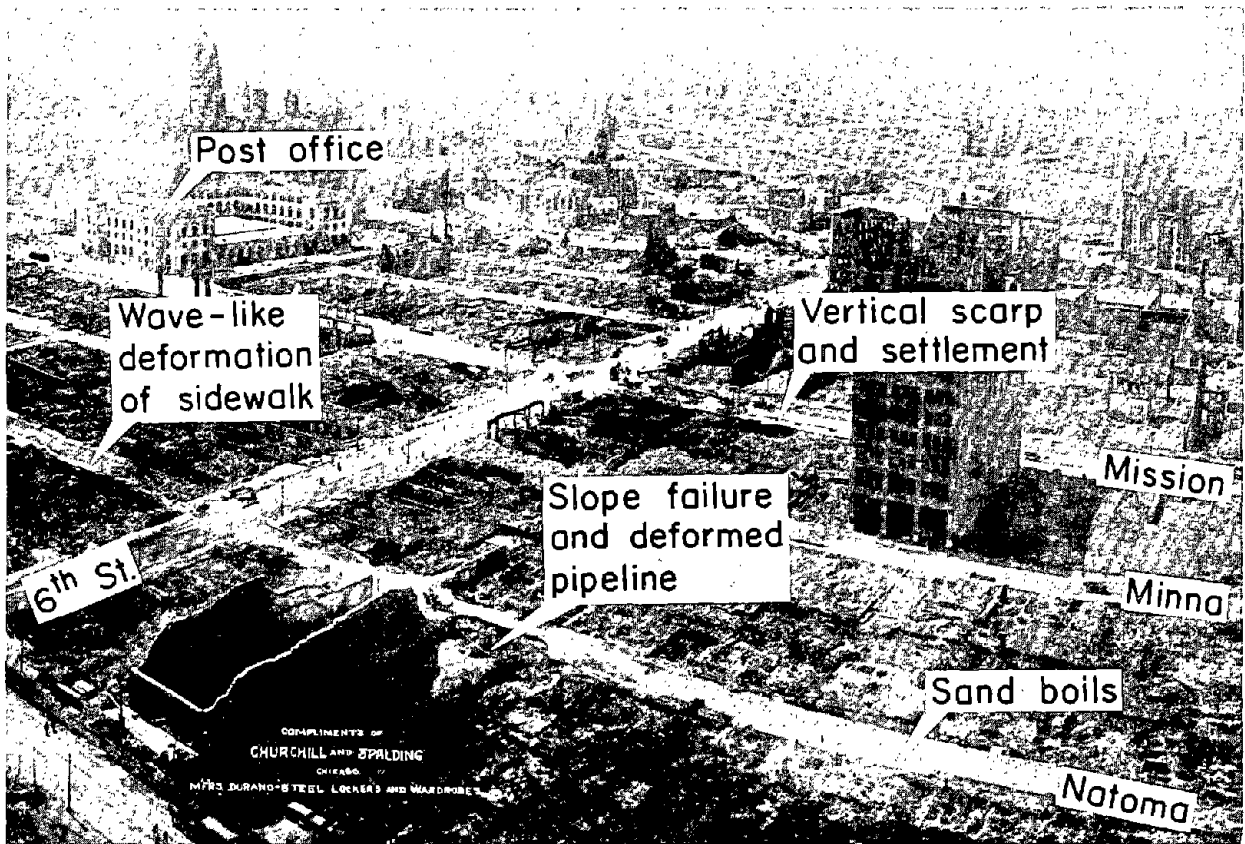
Reynolds, in reporting on the condition of buried electrical conduits, stated: "Along 7th St. from Mission to Howard, the earth was displaced from 5 to 8 ft (1.5 to 2.4 m) in a direction lengthwise to conduit. This caused some of the manholes to crush... The conduit was pulled apart at other places, and cables were wrenched and torn apart from their boxes..."

One block east of the damage on 7th St., there was a multiple collapse of timber frame hotels along the west side of 6th St. from Natoma to Howard St.

Figure 14. Aerial Photograph Showing Liquefaction-Induced Ground Deformation in the South of Market Area (Laurence, 1906)

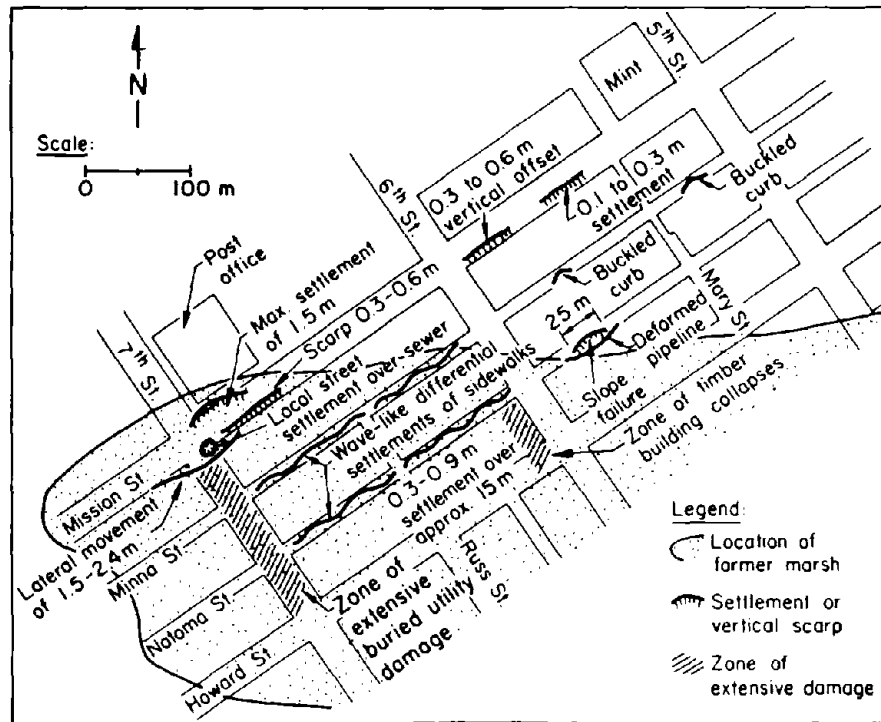
Figure 15. Detailed Map Showing 1906 Ground Deformation in the Area Bounded by Mission, Howard, 7th, and 5th Sts.

Hansen and Condon (1989) maintain that the Nevada, Lormor, Ohio, and Brunswick Houses collapsed in a domino effect, starting with the Nevada House at 6th and Natoma. These hotels allegedly were founded on a filled depression which formed during the 1868 earthquake. It is of interest to note that the building collapses proceeded in a downslope direction, consistent with the direction of liquefaction-induced lateral movements. Water mains were broken in this area, thereby depriving firefighters of water as fire erupted along 6th St. (Hansen and Condon, 1989).

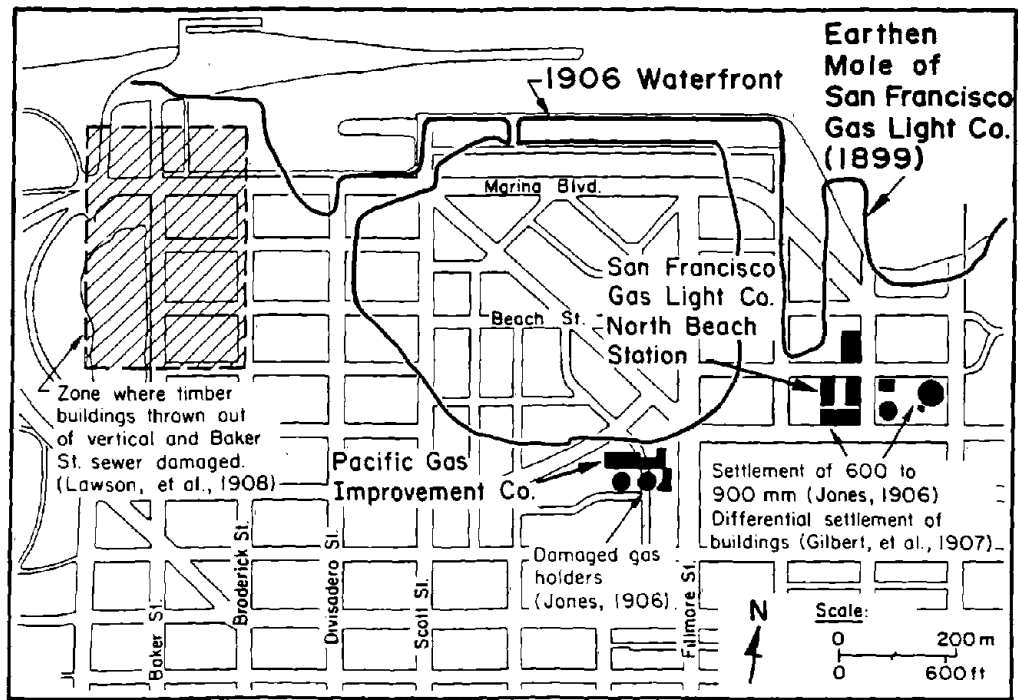
Figure 21. 1906 Waterfront and Earthquake Damage Relative to Current Marina Street System

Although the Marina was not extensively developed in 1906, there are nevertheless several historic accounts of damage in this area (Jones, 1906; Gilbert, et al., 1907; Lawson, et al., 1908), some of which are summarized in Figure 21. Lawson, et al. (1908), for example, drew attention to evidence of severe ground shaking in the hatched zone of Figure 21, extending from North Point St. between Lyons and Broderick to the shore. In this area, timber structures were thrown out of vertical, reminiscent of the shear deformation sustained by four-story timber buildings during the 1989 earthquake. Moreover, the Baker St. sewer was damaged, which implies that permanent ground deformation occurred in

The most extensive observations of damage are associated with the coal gasification plants, which were located in the southwestern part of the Marina in 1906. Gilbert, et al. (1907) reported that not a building at the San Francisco Gas and Electric (renamed from the original San Francisco Gas and Light Co.) plant escaped damage, and that the ground settled very considerably at this location. Jones (1906) reported from 600 to 900 mm of settlement adjacent to the principal gas holder at the North Beach Station. The settlement ruptured the 600-mm diameter outlet connections of the holder, causing all the stored gas to escape.

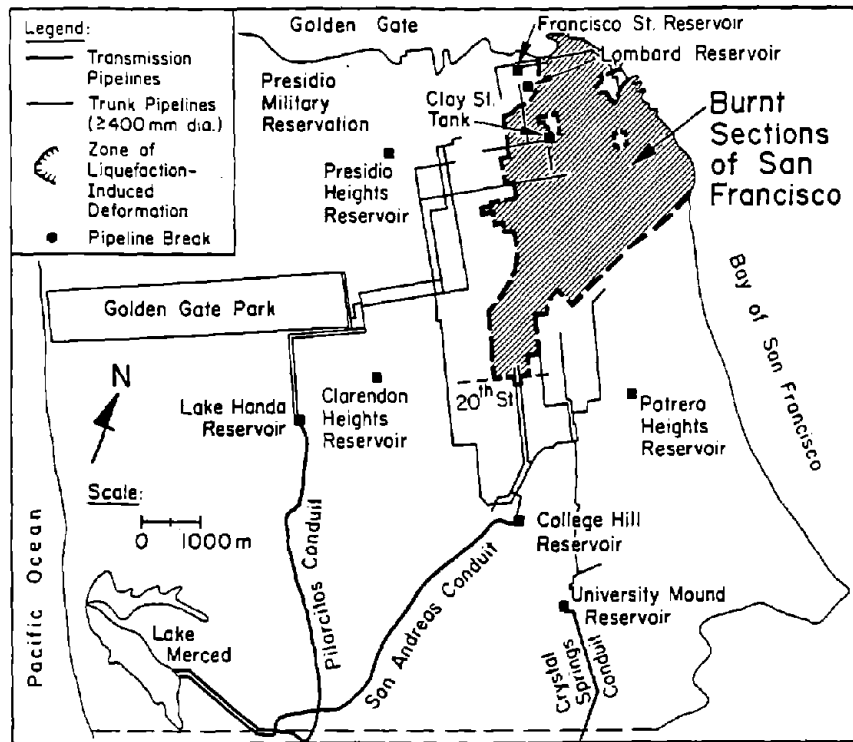
Figure 24. San Francisco Water Supply and Area Burned During the Fire

Two pipelines, 400 and 500 mm in diameter, were broken by liquefaction-induced lateral spreading and settlement across Valencia St. north of the College Hill Reservoir. These broken pipes emptied the reservoir of 53 million liters, thereby depriving firefighters of water for the burning Mission District of San Francisco. As indicated in previous studies (Scawthorn and O'Rourke, 1988), this local deformation ranks as one of the most devastating events of the 1906 earthquake.

the fire. All trunk lines of the College Hill and University Mound Reservoirs downstream of the pipeline ruptures are removed from this figure to show the impact and lack of hydraulic conductivity caused by severing these conduits.

The southernmost extent of the fire, as shown in Figure 24, was 20th St., where a firebreak had been created by dynamiting houses on the north side of the road. Hansen and Condon (1989) indicate that water was available in this vicinity from abandoned cisterns on Shotwell St. at both 19th and 22nd Sts., local flooding from a broken pipeline at 17th and Howard Sts., and a private water works on 16th St. The broken pipe on Howard St. was one of the main trunk lines of the University Mound Reservoir which crossed the zone of liquefaction-induced ground movement over the old Mission Creek. Water also was conveyed to the firebreak along 20th St. from a portion of the system still operating on 20th and Church St., just one block west of the burnt area.

As is evident in Figure 24, the Lake Honda Reservoir was able to provide a continuous supply of water to the western portion of the city. The fire eventually was stopped along a line roughly parallel to Van Ness Ave., where water still was available from the Lake Honda Reservoir. Moreover, the southern and southeastern extent of the fire is bounded by areas south and southeast of the trunk system ruptures. It is likely that these unburnt areas had water from the University Mound Reservoir.

Figure 24 shows a strong correlation between burnt sections of the city and those sections cut off from the College Hill and University Mound Reservoirs by ground failures. Of especial note is the rapid spread of the ignitions south of Market, where water supply was entirely interrupted due to the large ground deformations along Valencia St. and in the immediate South of Market areas. This rapid spread was due to three causes: 1) lack of water for available fire department engines, 2) highly combustible high density wood frame construction, and 3) insufficient fire department engines, which were drawn to concentrate at major fires threatening whole districts, such as at fire Nos. 14 - 17, where water was available, even if in limited quantities.

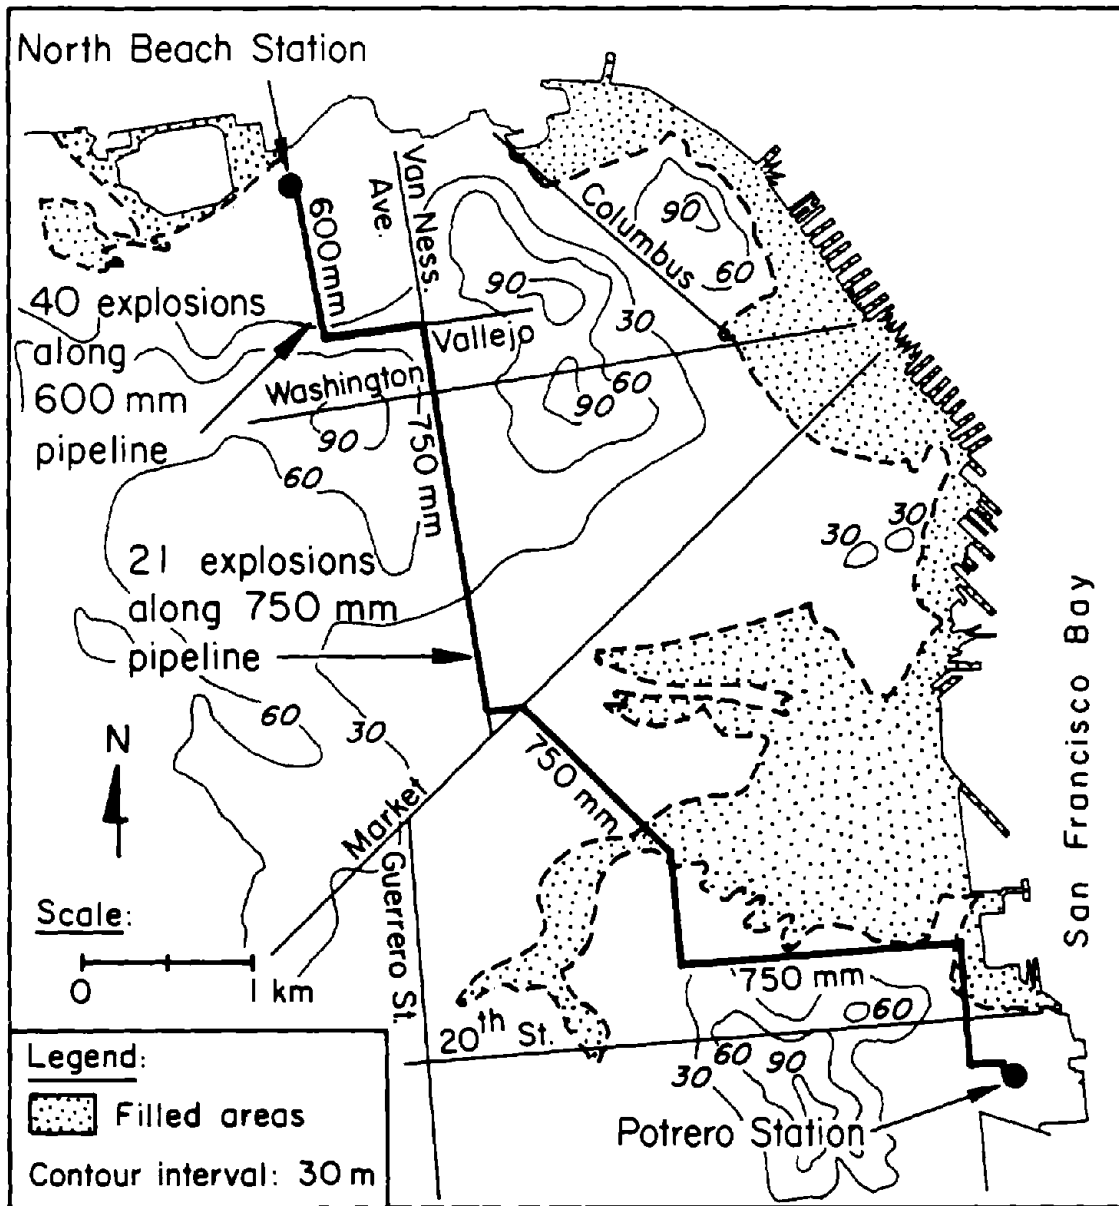
Figure 29. Gas Pipeline Feeder System in 1906 San Francisco

A large diameter (600 to 750 mm) cast iron feeder, or trunk, pipeline existed between the North Beach and Potrero Stations, as shown in Figure 29. Jones describes the explosions which occurred in the feeder system:

"On the thirty-inch (750-mm) main, running from the Potrero works on Kentucky, Mariposa, Potrero Avenue, Tenth, Market, and Fell to Van Ness Avenue, and thence along Van Ness to Broadway, there were twenty-one explosions. In nearly every case, the explosion took place at a line drip or cross, where the main was weakest, and the earth around the main was thrown up, leaving openings of various sizes up to twelve feet wide and thirty feet long, and on the line of the twenty-four inch (600-mm) feeding main connecting the two stations there were as many as forty breaks due to explosions."

Settlement and lateral displacement of fill at Vallejo St. and Van Ness Ave. (see Section 10.4) ruptured a 600-mm-diameter gas feeder main where it turned

from Van Ness Ave. to Vallejo St. The pipe at this location was pulled apart 550 mm (Jones, 1906). At this location, there were other prominent failures of water and sewer mains, apparently associated with unstable soil used to fill a ravine leading to the former Washerwoman's Lagoon.

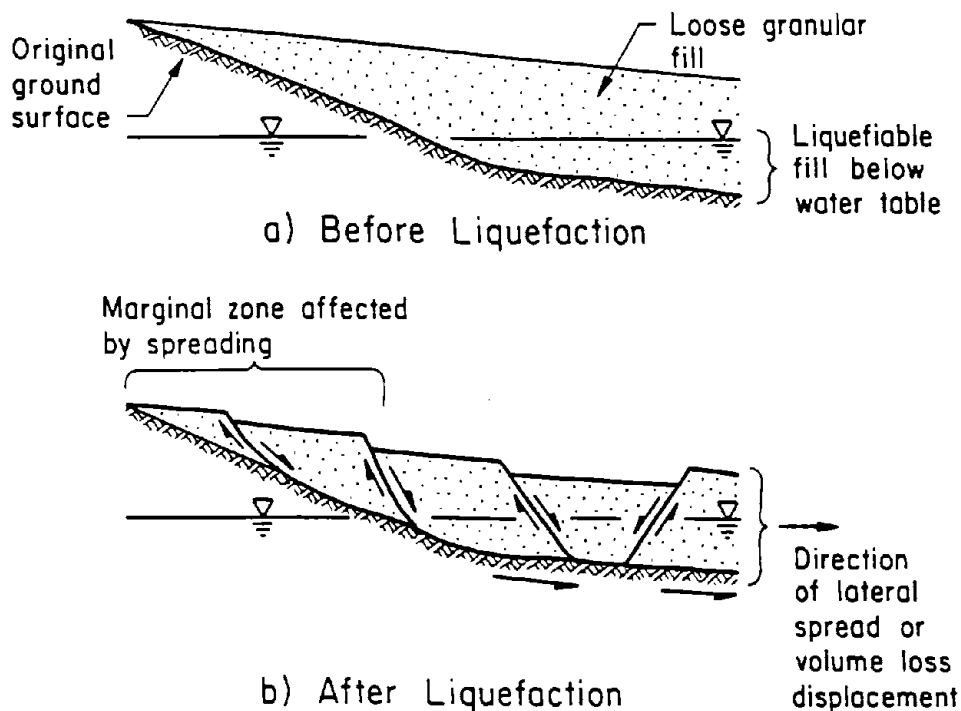
Figure 31. Idealized Section Through Lateral Spread

The distribution of pipeline breaks along and slightly removed from the margins of the previous marsh areas also is noteworthy and deserves further explanation. Figure 31 shows a cross-sectional view of an area filled with loose granular soil. As liquefaction leads to lateral spreading and consolidation of the underlying sediments, there is a tendency for soil displacements to converge toward the center of the filled area. This lateral extension of the soil promotes subsidence scarps and graben-type features that are consistent with the occurrence of surface depressions. The movement relieves the horizontal restraint against the margins, causing slumping of the fill, even at fill locations above the water table. The slumping is abetted by seismic shaking. This mechanism of marginal slumping effectively extends the zone of influence of soil liquefaction. It leads to a pattern of displacement and associated pipeline damage which is removed from the exact location of the former marsh and bay areas. As a consequence, pipeline breaks occur along elevation contours higher than the original water levels.

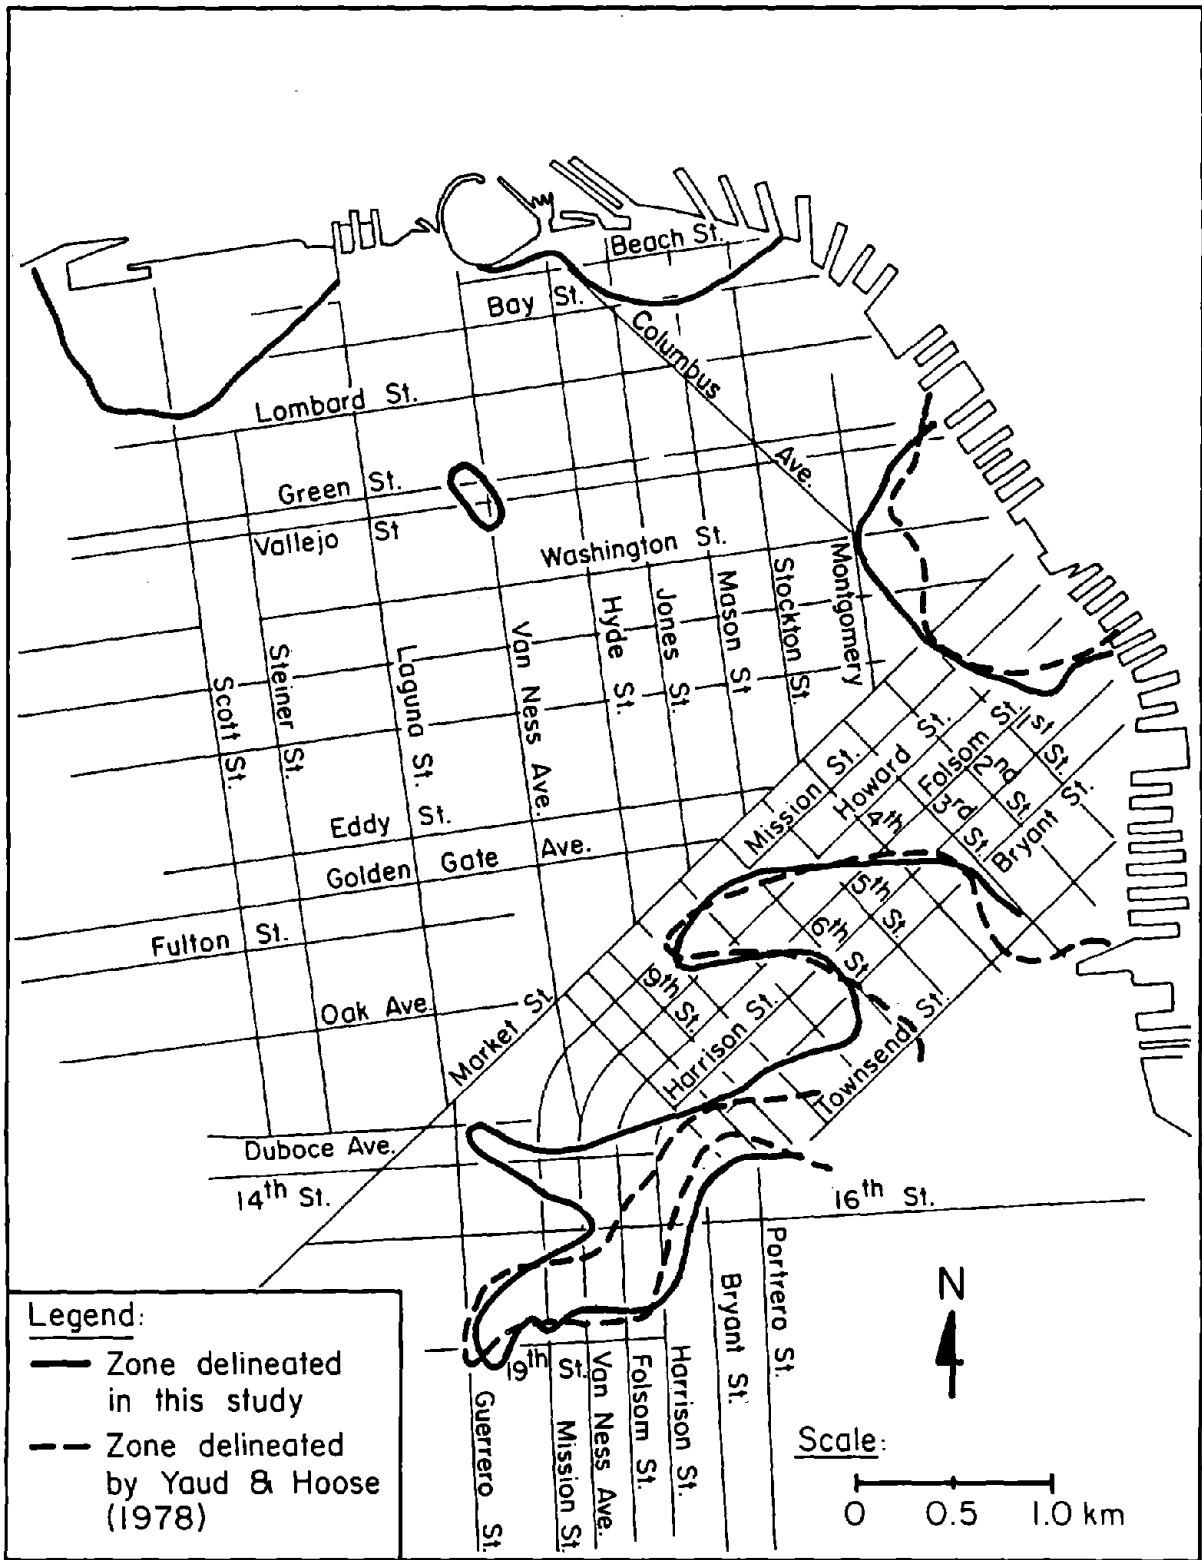
Figure 32. Zones of Potential Large Ground Displacements in San Francisco

By combining the locations of pipeline breaks, patterns of ground displacement, and previous topographical features, it was possible to develop a system for mapping zones of liquefaction hazards in San Francisco. Figure 32 shows the zones of potentially large ground movements, mapped as a result of this study, in relation to the zones of ground failure delineated by Youd and Hoose (1978).

There is a close agreement between the two studies for the Foot of Market and South of Market Zones. Additional information about the previous topography and locations of pipeline breaks has permitted refinements in the delineation of the Mission Creek Zone. In particular, an additional area looping westward along 14th St. is shown on the basis of the original topography, pipeline breaks located by Schussler (1906) and Manson (1908), and damage to sewers reported by Hyde (1906).

Zones are shown for the Marina and North Beach areas. The Marina includes sandy soils placed by end dumping and hydraulic filling as well as a sand bar, known previously as Strawberry Island. Detailed information about the soils in the Marina is provided elsewhere in this volume by O'Rourke, et al. (1991).

The North Beach area includes soils which were placed by end dumping into the bay both before and after the 1906 earthquake. This area includes Pier 45, where sand boils and lateral spreading were observed after the 1989 Loma Prieta

earthquake. In Figure 32, only the areas of settlement delineated by Schussler (1906) and fill placed after 1906 were used to identify soils near North Beach which are potentially susceptible to ground deformation. The lack of historic evidence for ground movements at other locations in the North Point area resulted in their exclusion from the map.

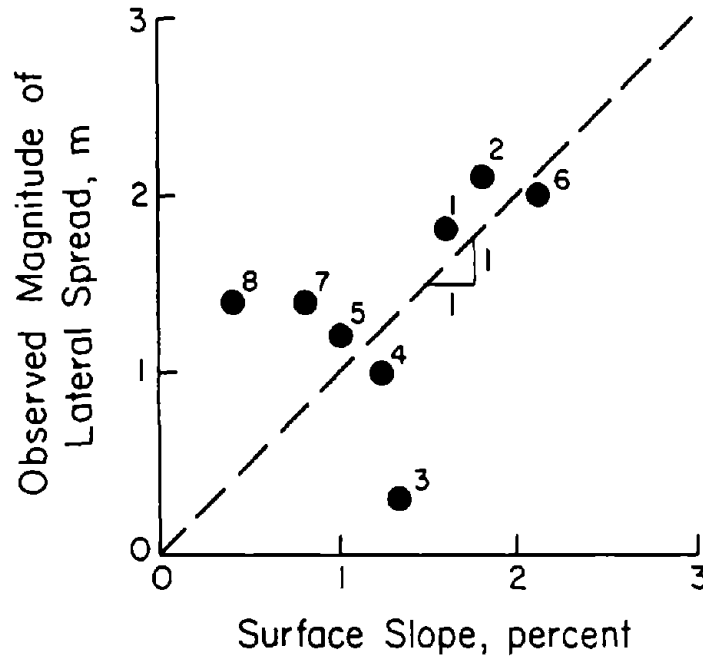
Figure 33. Plot of Magnitude of Lateral Movement versus Surface Slope at Locations of 1906 Lateral Spreading

As shown in Figure 33, the magnitude of lateral displacement follows a trend of increasing ground movement relative to increasing slope gradient. The 1:1 slope in the figure is shown solely as a reference, and does not indicate a statistical fit between this line and the data. In fact, regression analyses do not show a statistically meaningful trend. For example, the best linear fit of the data has an $r^2 = 0.18$, which represents a relatively poor correlation for explaining the variability of the observations.

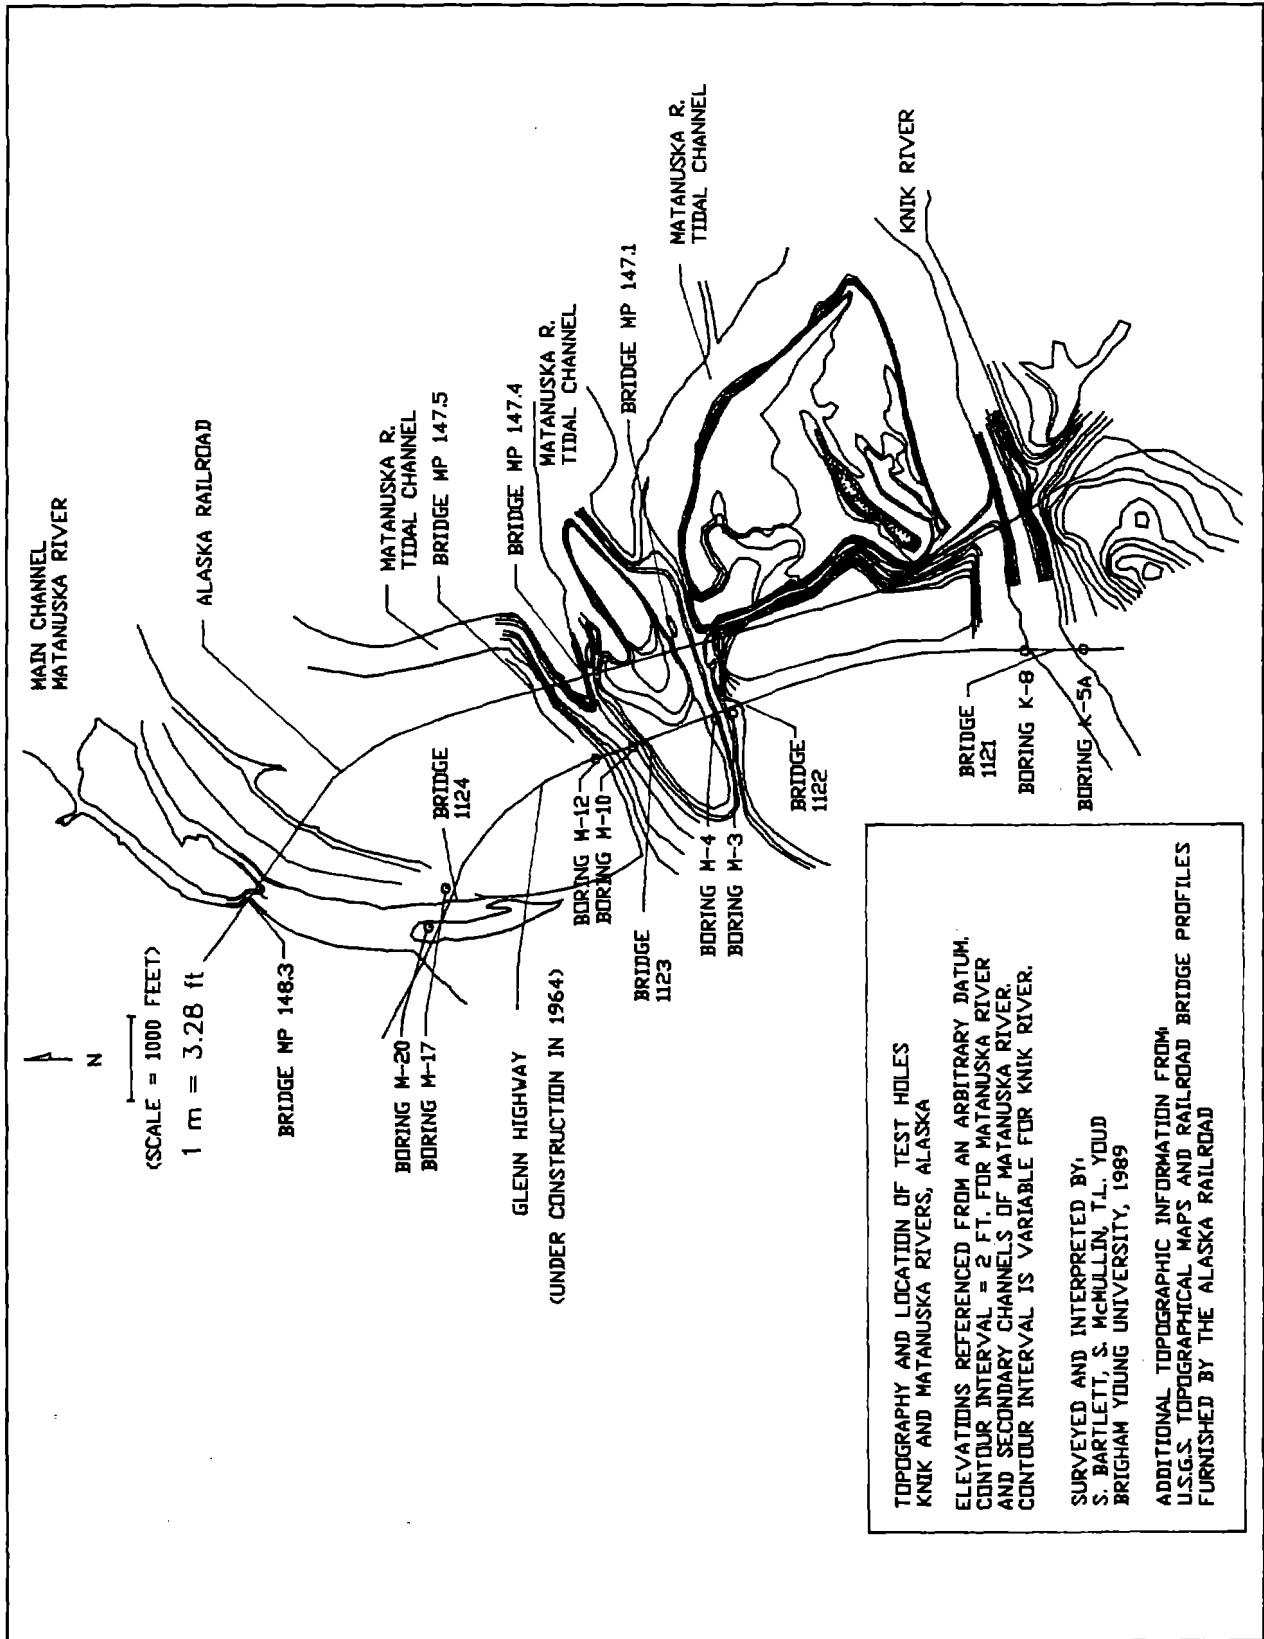
Figure 10 Topography of Knik and Matanuska River, Alaska.

Lateral spreads and ground fissures along the banks of the Knik and Matanuska Rivers caused slight to moderate damage to 5 railroad bridges (Figure 10). These bridges are located approximately 100 km from the zone of energy release and mark the northern extent of significant damage to the Alaska Railroad. Fissures from channelward movement were widespread and especially large in point bar, channel bar and channel deposits on the active flood plain. McCulloch and

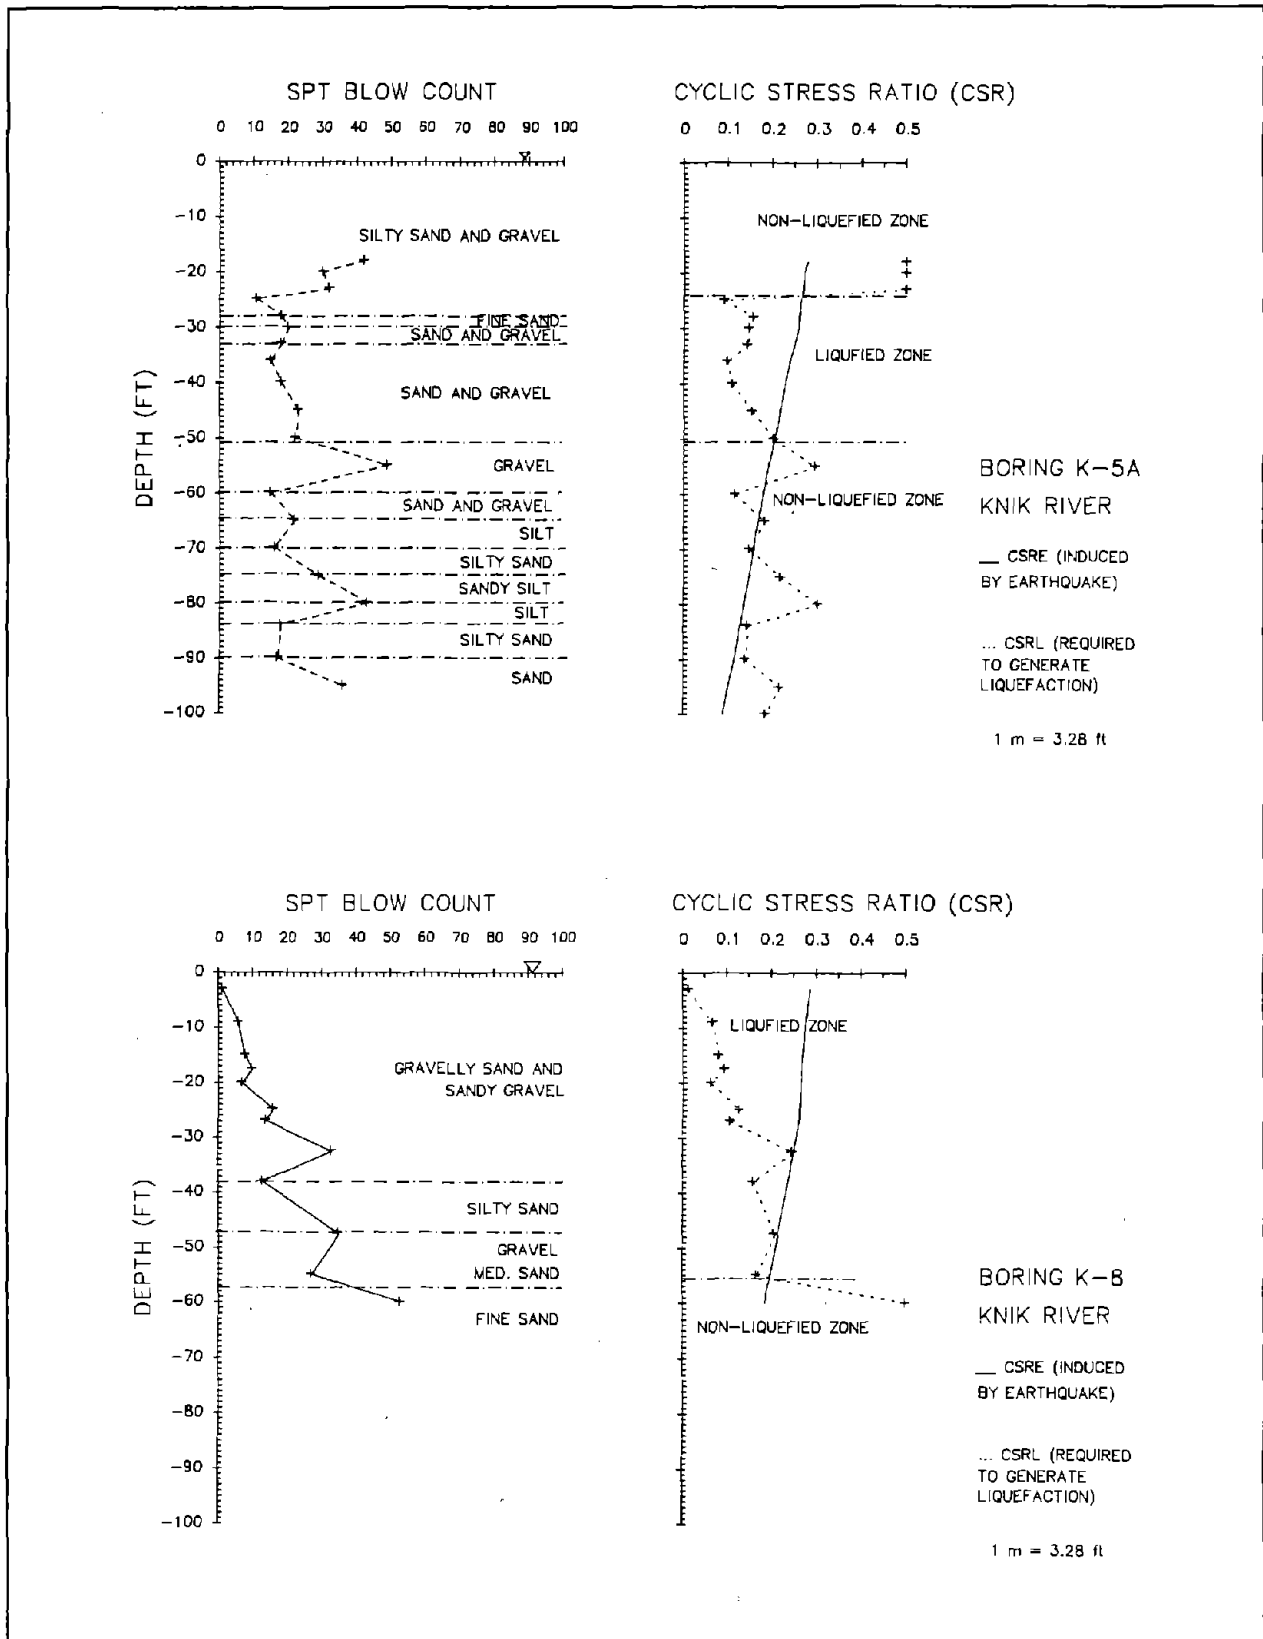
Figure 13 SPT Profile and Analysis, Bore Holes K5A and K8.

Liquefaction analysis using the simplified procedure (see Section 3.5) for Borehole K5A indicates that the majority of the liquefiable sediment is in a zone 8 to 15 m below the surface (Figure 13). The SPT values for this zone average 17 and range from 11 to 23. Liquefaction analysis for Borehole K-8 shows liquefiable sediment to a depth of approximately 17 m below the surface (Figure 13). The SPT values for this zone average 17 and range from 6 to 35. Below 17 m the soil is not liquefiable as indicated by considerably higher penetrations resistances.

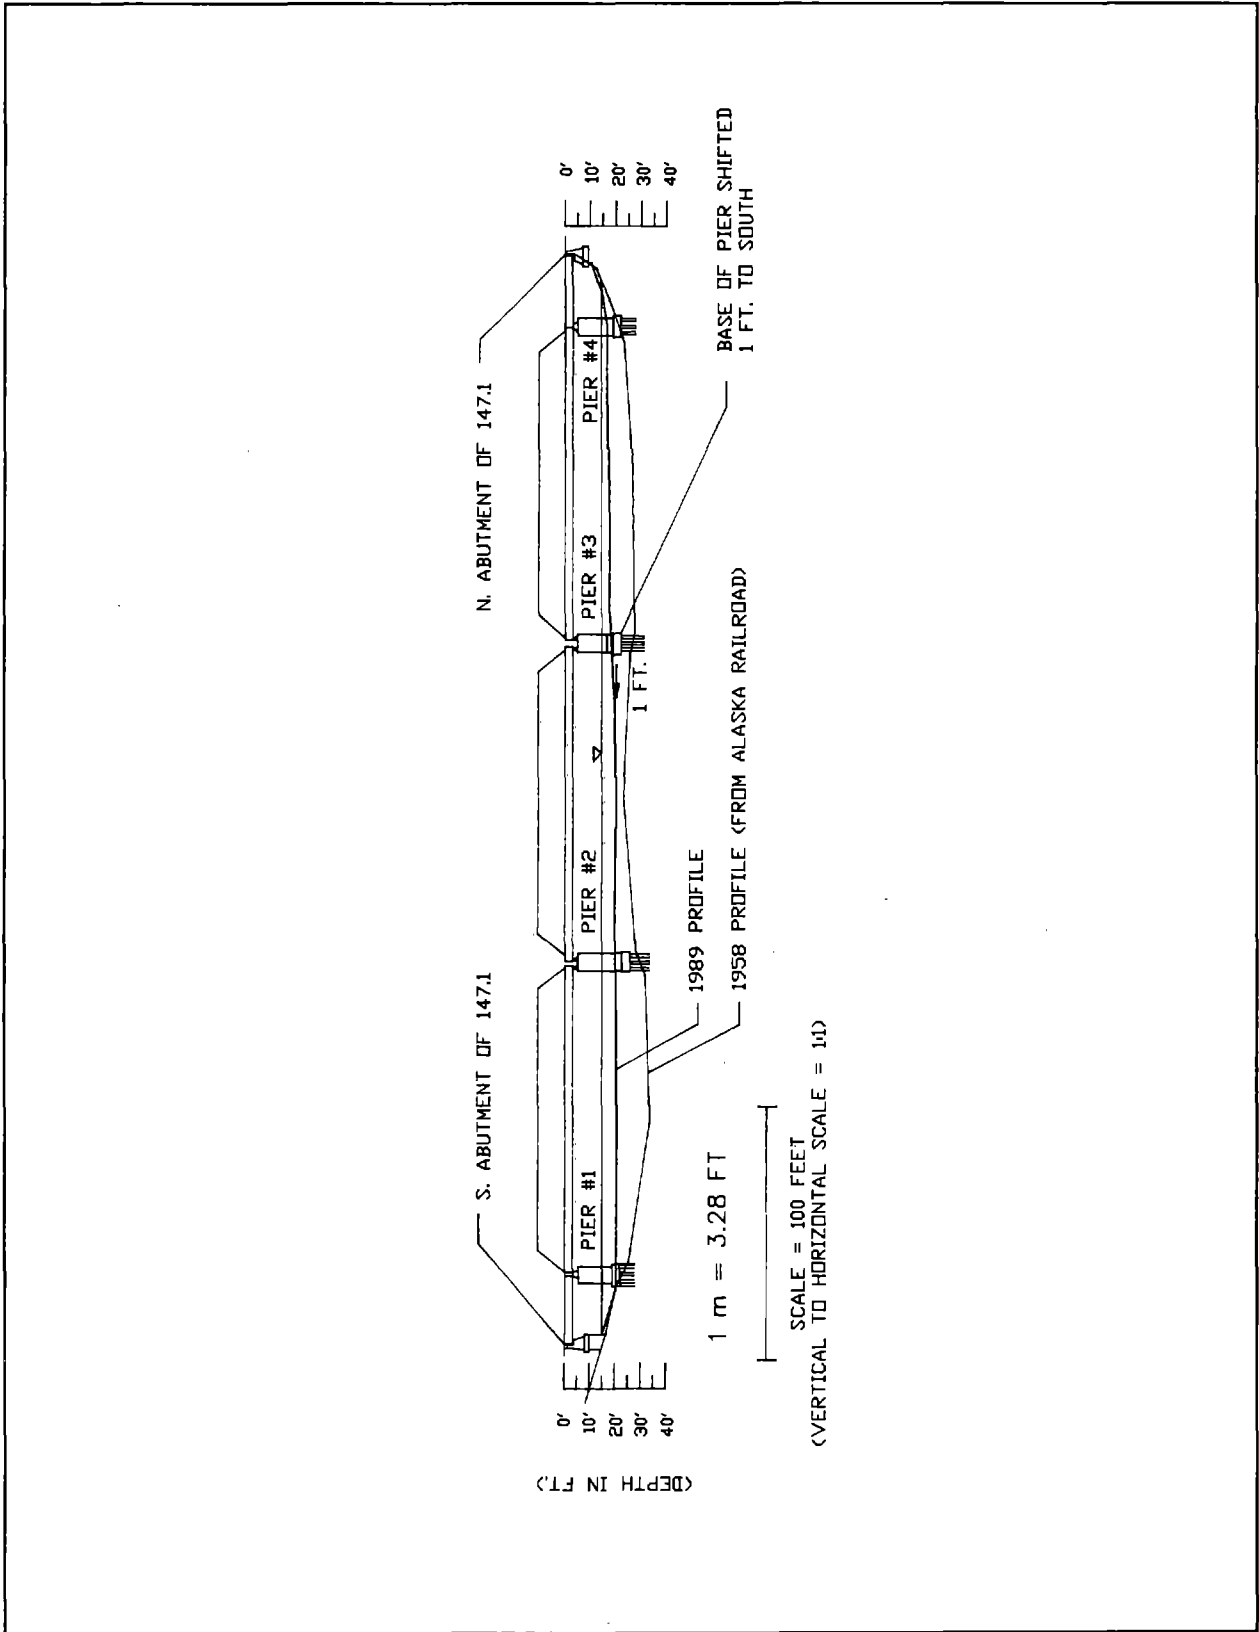
Figure 18 Profile of and Displacements at Bridge Milepost 147.1

We sounded the channel bottom beneath Railroad Bridge 147.1 in July of 1989. At this time, the channel had incised 2.4 to 3.0 m below the floodplain and the channel bottom averaged 6 m below rail elevation (Figure 18). However, comparison of our 1989 channel sounding with a 1958 sounding by the Alaska Railroad (Figure 18) revealed that between 0.6 to 3.6 m of deposition has occurred in the channel between 1958 and 1989. Thus, the 1958 channel cross-section probably more closely represents the channel configuration at the time of the earthquake.

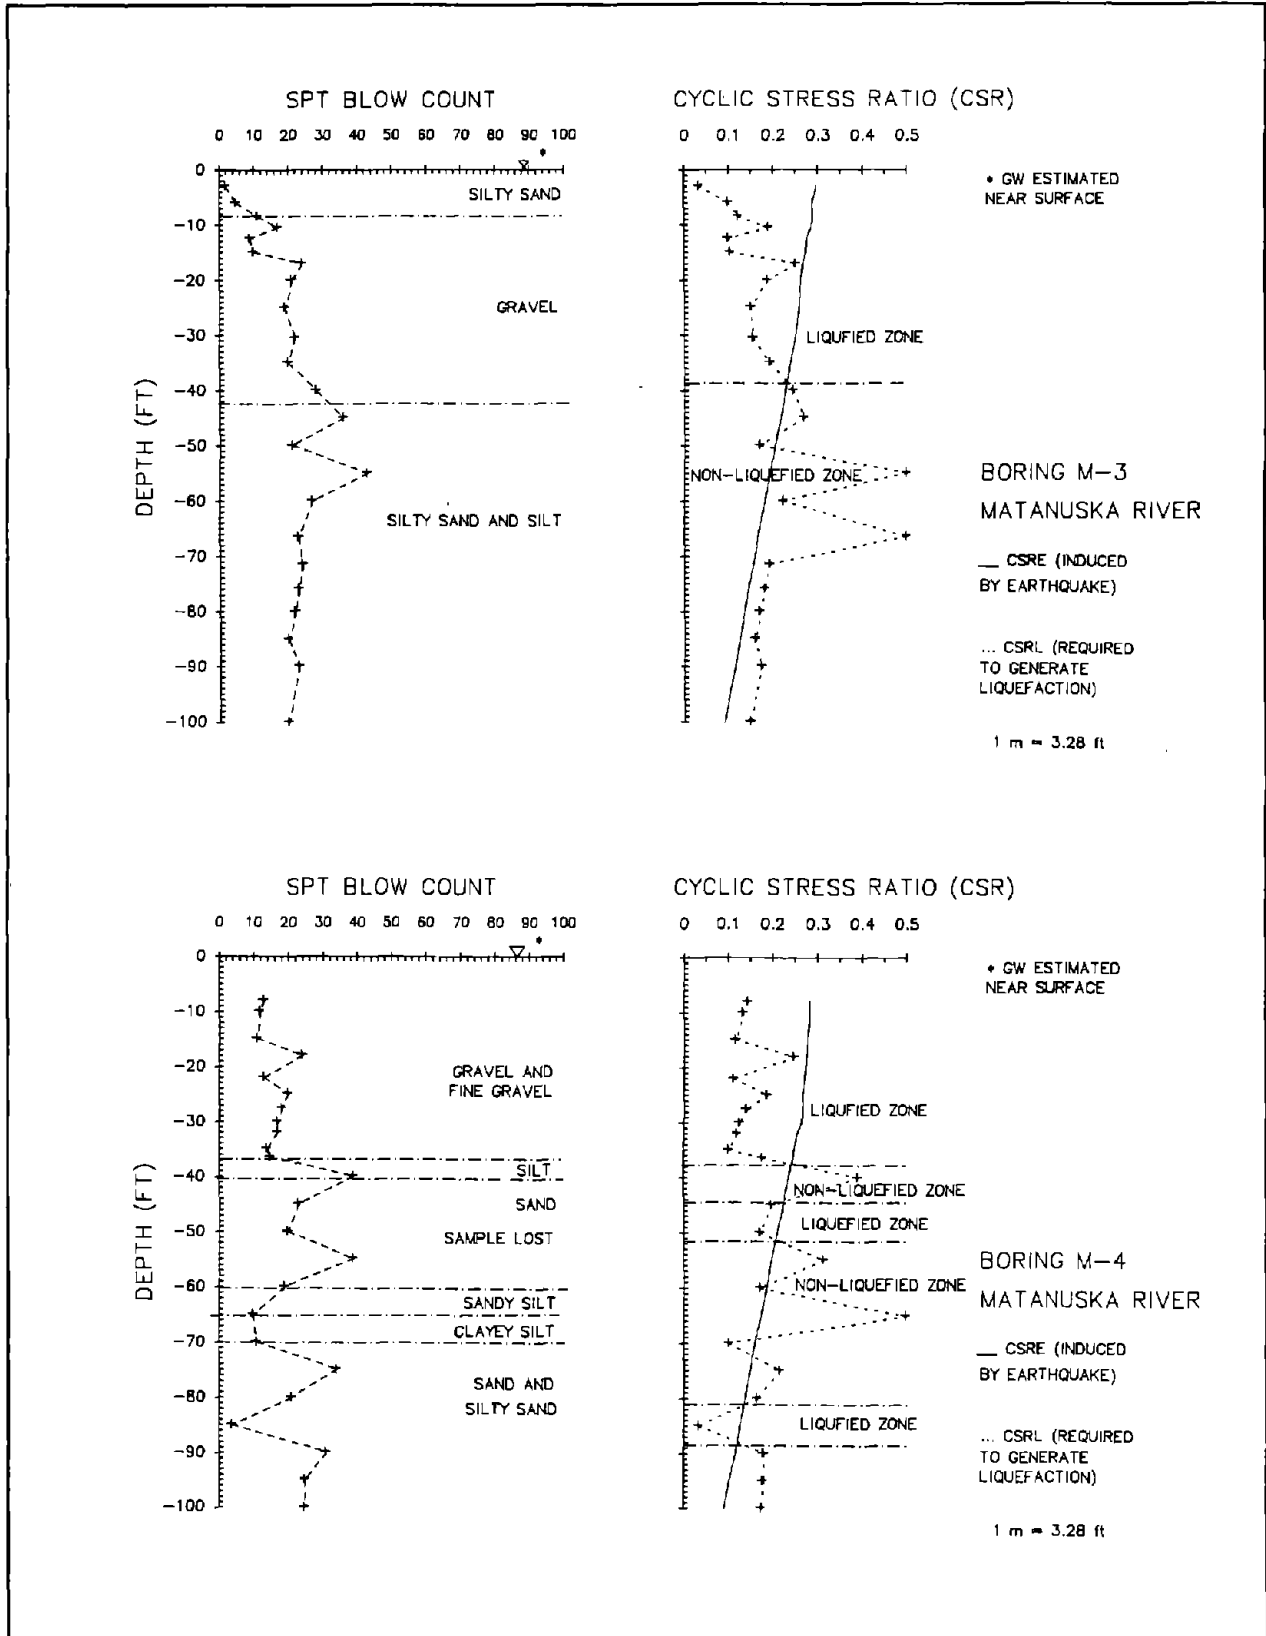
Figure 19 SPT Profile and Analysis, Bore Holes M-3 and M-4.

Liquefaction analysis for Borehole M-3 indicates that a sandy gravel is liquefiable in a zone from the surface to a depth of 12 m (Figure 19). The SPT values average 15 and range from 9 to 24 in this zone. At Borehole M-4, the majority of the liquefiable sediments are restricted to the upper 12 m of the profile. Analysis indicates liquefaction susceptibility in gravel and fine sandy gravel to a depth of 12 m (Figure 19). The SPT values in this zone average 16 and range from 11 to 24. Marginal susceptibility to liquefaction is also indicated in several thin zones of silty sand and sandy silt beginning at a depth of 12 m to a depth of 24 m. The SPT N value of 4 at a depth of 26 m appears to be anomalously low. The sediment at that depth probably did not liquefy or liquefaction was too deep to have affected the bridge.
