Case Studies of
Liquefaction and Lifeline
Performance During Past Earthquakes

Volume 2
United States Case Studies

Edited by
T. D. O'Rourke and M. Hamada

Technical Report NCEER-92-0002

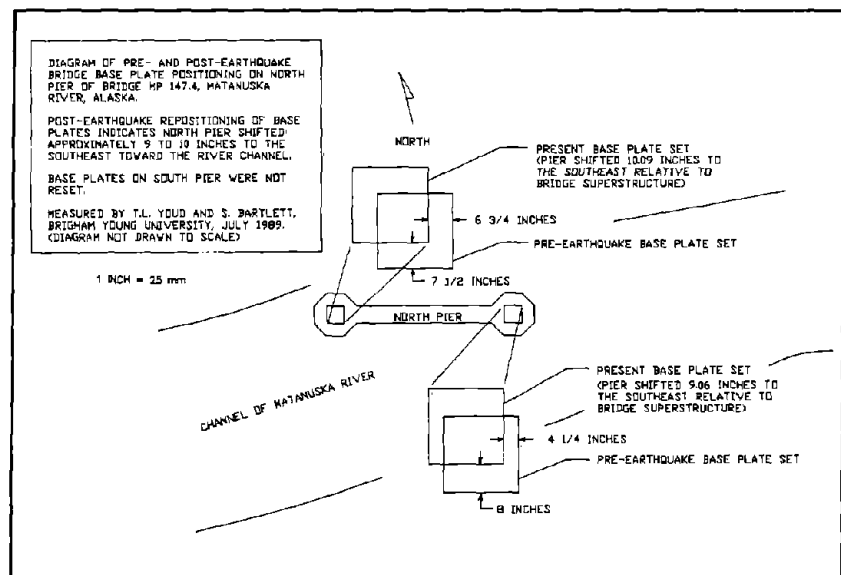
Figure 22 Pre- and Post-Earthquake Base Plate Positions, Bridge Mile Post 147.4.

From our observations of the bridge footings and concrete pier caps, channelward movement of the north pier during the earthquake apparently sheared the anchor bolts which tied the footing to the pier. Detachment of the pier from the truss enabled the pier to move channelward without significantly damaging

the bridge. Following the earthquake, the bridge truss was reused and realigned by resetting the span footings on the pier. In so doing, footings on the north pier were repositioned from 190 to 200 mm to the north and from 110 to 170 mm to the west and rebolted to the pier (Figure 22). The footings on the south pier were not repositioned. By comparing the present base plate set with the pre-earthquake base plate set, we calculate that the north pier had shifted approximately 230 to 250 mm southeastward toward the channel. This displacement

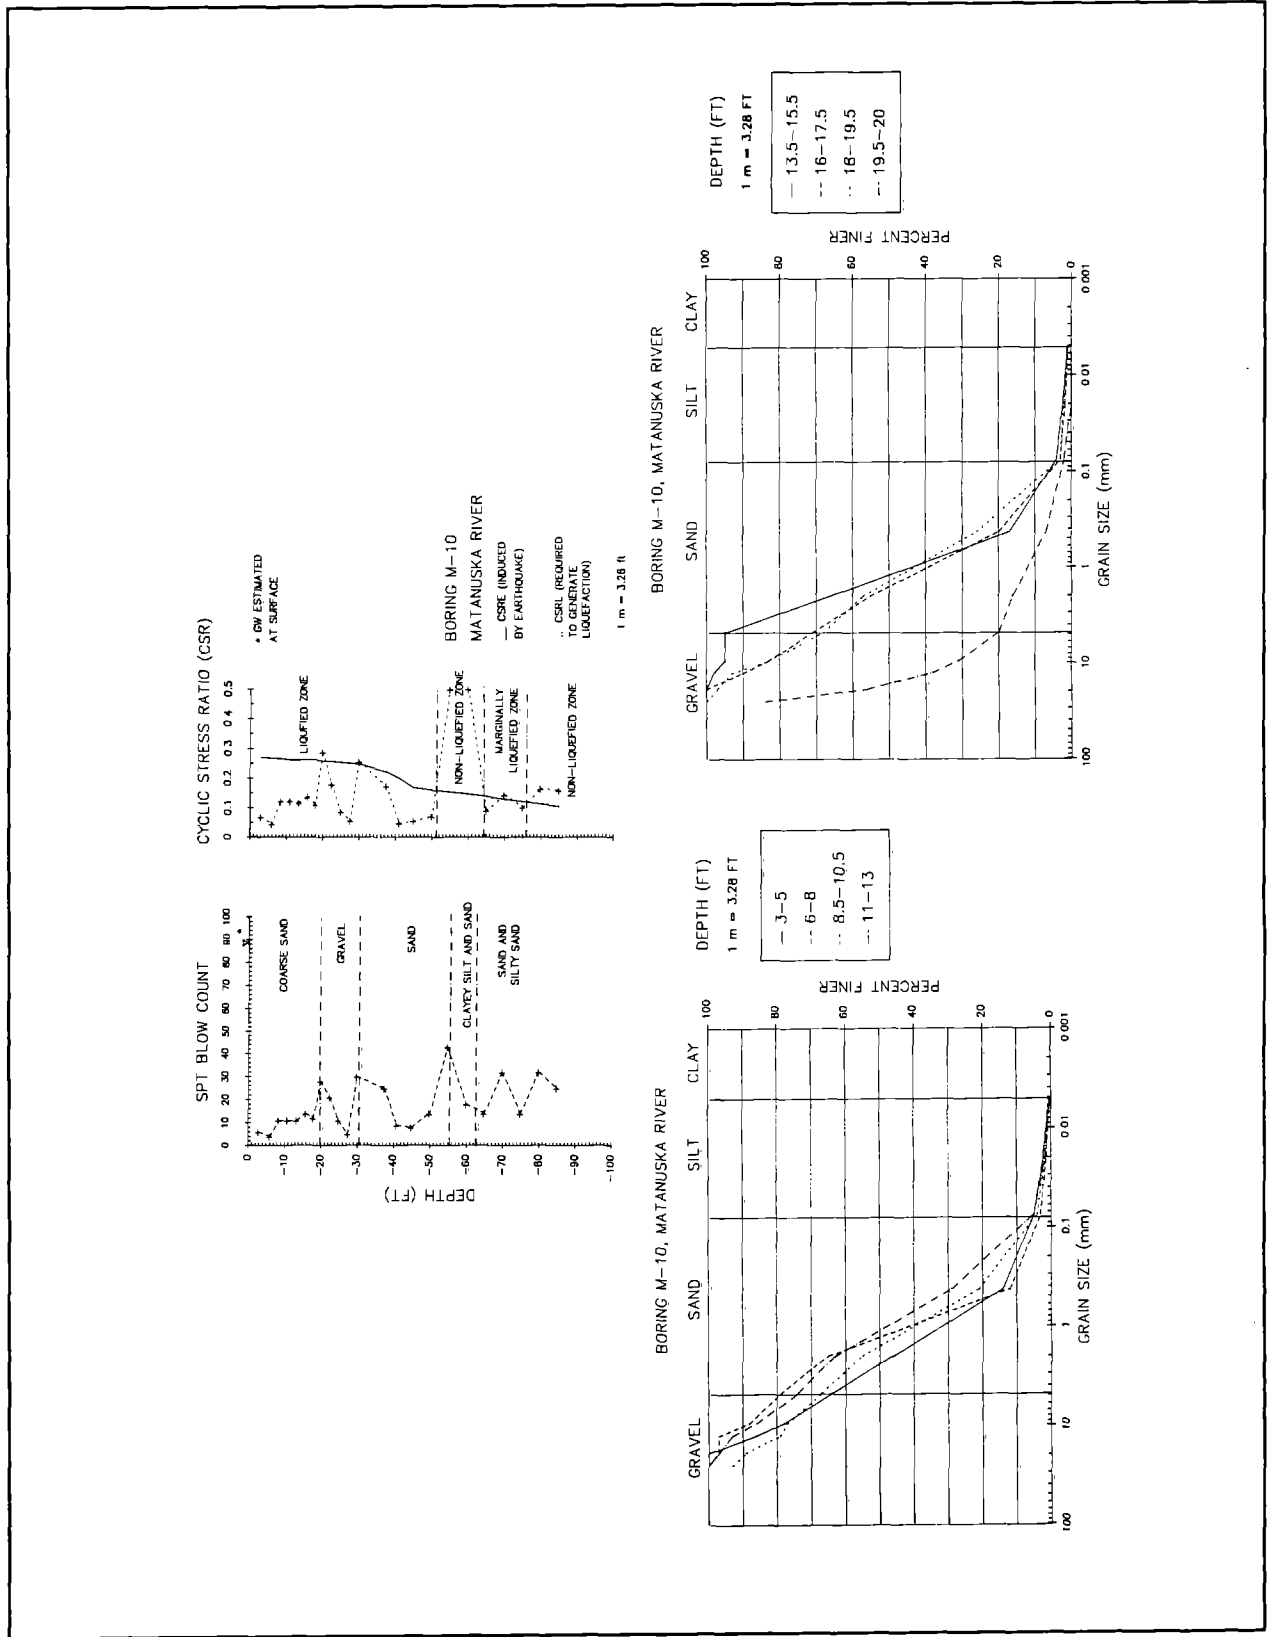
Figure 23 SPT Profile and Grain-Size Data, Bore Hole M-10.

A liquefaction analysis for Borehole M-10 indicates that the upper 17 m of the profile may have liquefied during the 1964 earthquake (Figure 23). The SPT values for this zone average 13 and range from 4 to 30. Some marginal liquefaction is also indicated in sand and silty sand starting at 19 m and extending to a depth of 23.5 m. A SPT value of 14 was measured in this layer.

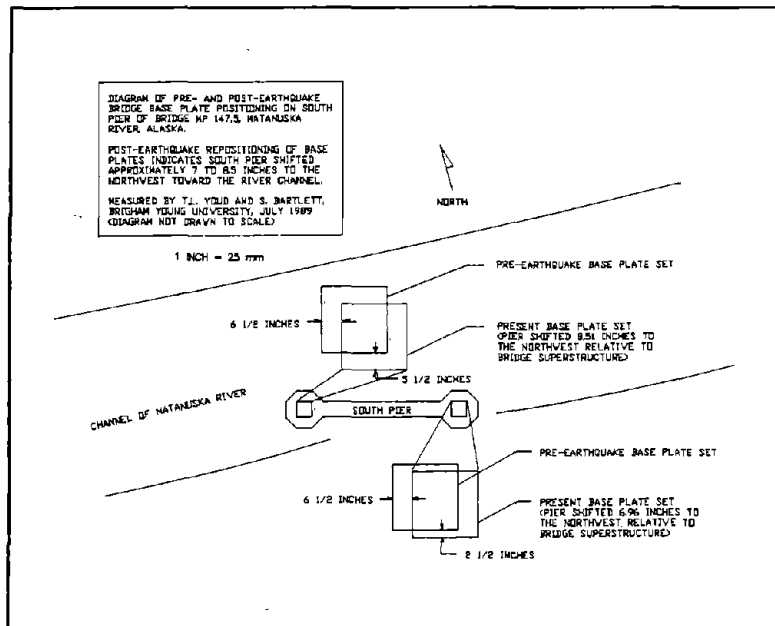
Figure 25 Pre- and Post-Earthquake Base Plate Positions, Bridge Mile Post 147.5.

McCulloch and Bonilla did not report any displacement at the south abutment or piers. Our inspection of the top of the southern-most pier showed that the footings had been reset after the earthquake. As we did for Bridge Milepost 147.4, we compared the pre- and post-earthquake base plate sets (Figure 25). From this comparison, we noted that the southern-most pier displaced approximately 75 to

125 mm northward toward the channel and about 150 to 175 mm westward downstream. Thus, amount of streamward displacement measured at the southern-most pier is very similar to the streamward displacement reported at the north end of the bridge.

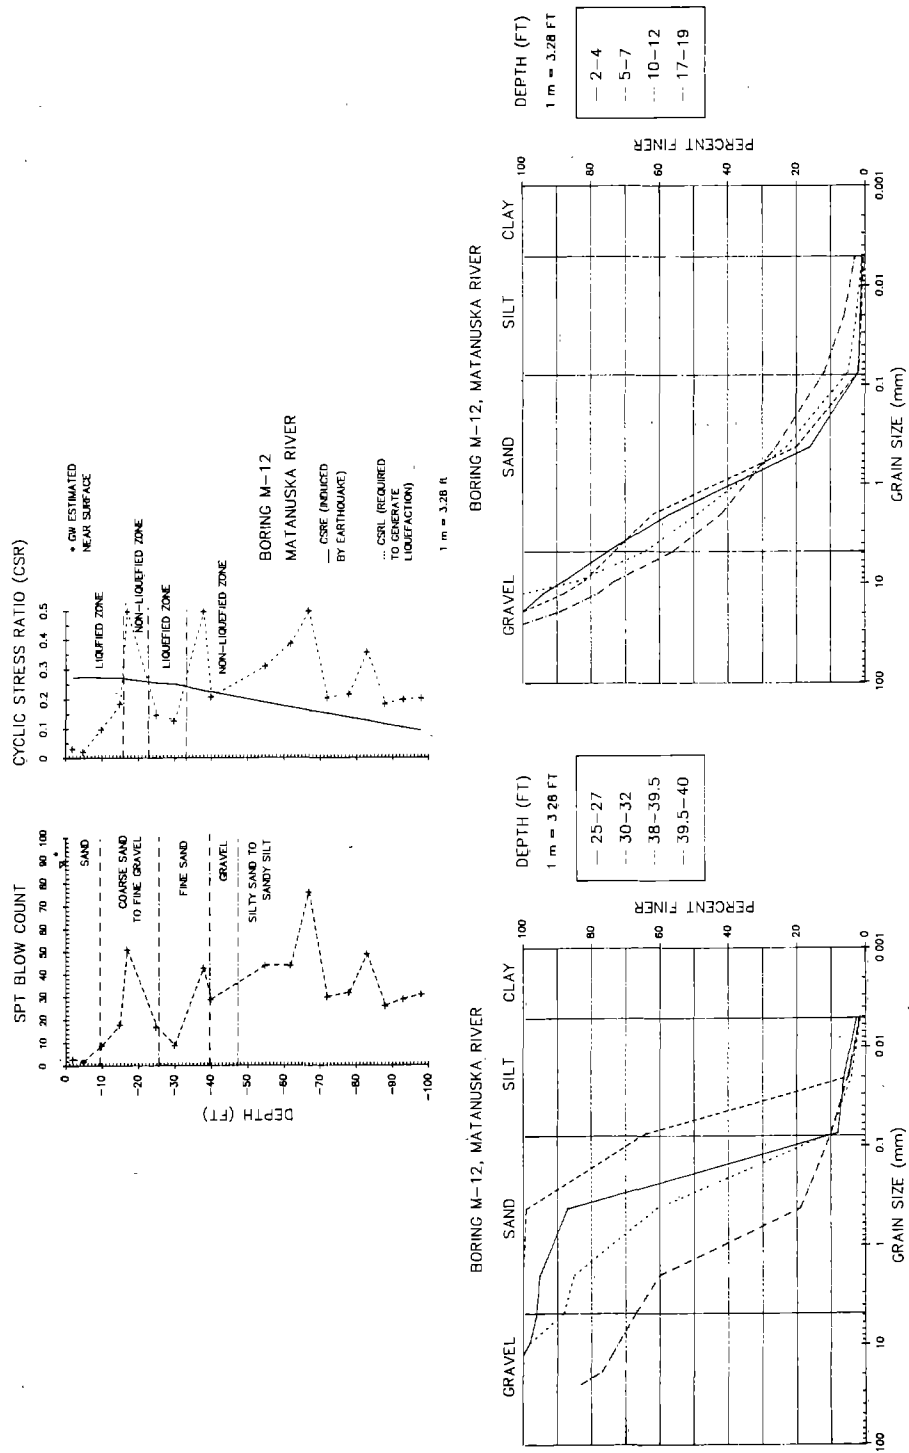
Figure 26 SPT Profile and Grain-Size Data, Bore Hole M-12.

Liquefaction analysis reveals that most of the profile is liquefiable to a depth of 11 m, except in a thin zone at 6 m where an unusually high N of 51 was reported in a fine gravel (Figure 26). The SPT values in the liquefiable zones range from 2 to 18, with an average of 11. Below 11 m, N increases sufficiently to make most of the remainder of the profile nonliquefiable.

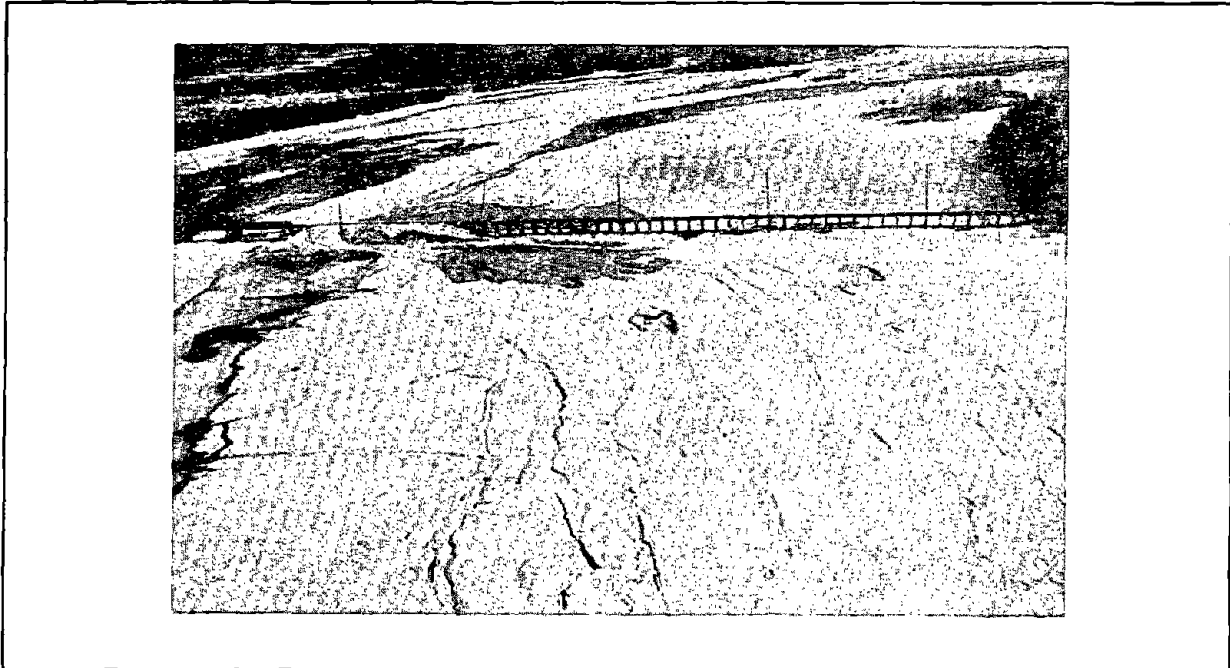
Figure 27 Broken Trestle at Southern End of Bridge Milepost 148.3.

South of the bridge, the tracks are supported by 180 m of wooden trestle over a large point bar deposit. Lateral spread of the point bar toward the channel caused large ground fissures to develop under the trestle. Approximately 30 m of trestle near the bridge's southern end was irreparably damaged (Figure 27).

consisted mostly of ground and embankment settlement or was partly comprised of horizontal ground displacement. Ground fissures on the oblique appear to a few meters wide (Figure 27). Lateral spread displacement of the same order likely occurred beneath and caused the damage to the trestle.

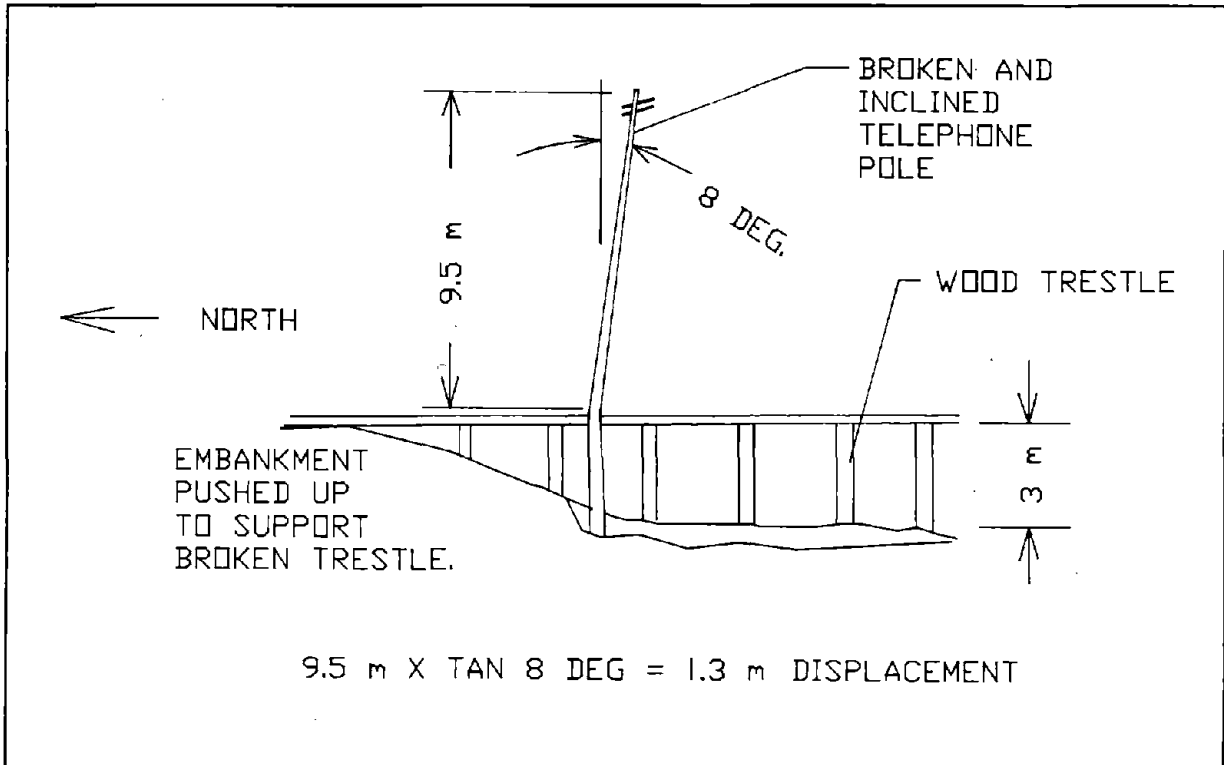
Figure 28 Estimation of Ground Displacement at Damaged Trestle from Inclination of Broken Telephone Pole, Bridge Mile Post 148.3.

The broken and tilted telephone pole (second telephone pole from left end of bridge - see Figure 27) offers an opportunity to estimate the horizontal ground displacement at the damaged trestle. The base of the telephone pole appears to have moved toward the river, breaking the pole approximately 3 m above its base. Tension in the telephone wires seem to have restrained the top of the pole from moving appreciably. Thus, assuming that the top of the pole remained stationary and using the pole's height and its angle of inclination, we calculate that base of the telephone pole shifted approximately 1.3 m toward the channel. Thus, several pieces of evidence indicate that ground displacement in the vicinity of the broken trestle was approximately 1.3 m (Figure 28).

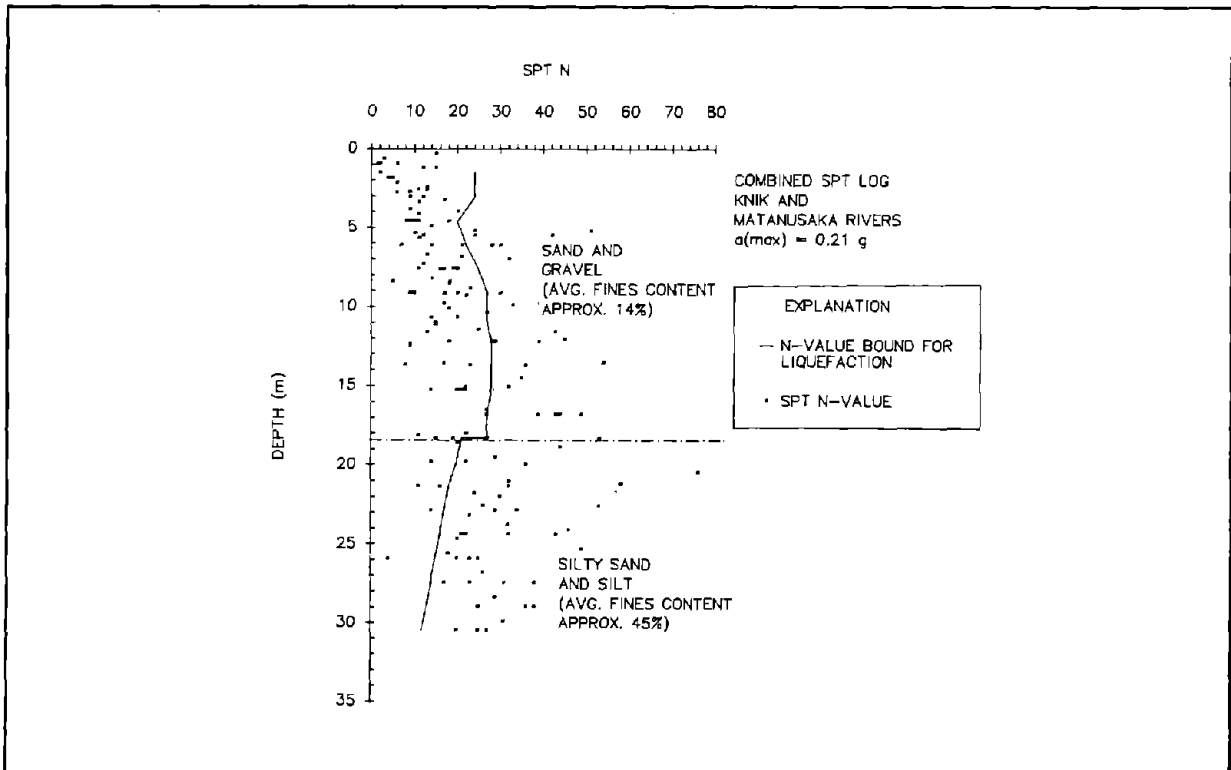
Figure 34 Combined SPT Log for the Knik and Matanuska Rivers.

Liquefaction analysis for a composite log of the 8 boreholes at the Knik and Matanuska Rivers reveals that much of the upper 20 m of the profile is potentially liquefiable (Figure 34). These liquefiable sediments are mostly sand and gravels with SPT values less than 20. Silty sands and silts below the liquefiable sands and gravels are predominantly nonliquefiable. (As input for this analysis, we used a maximum site acceleration of 0.21 g, M_w of 9.2, a dry and moist unit weight for the soil of 15.7 and 18.9 kN/m³, respectively. Also, we adjusted the cyclic stress ratio required for liquefaction, CSRL, for an average fines content of 14 percent).

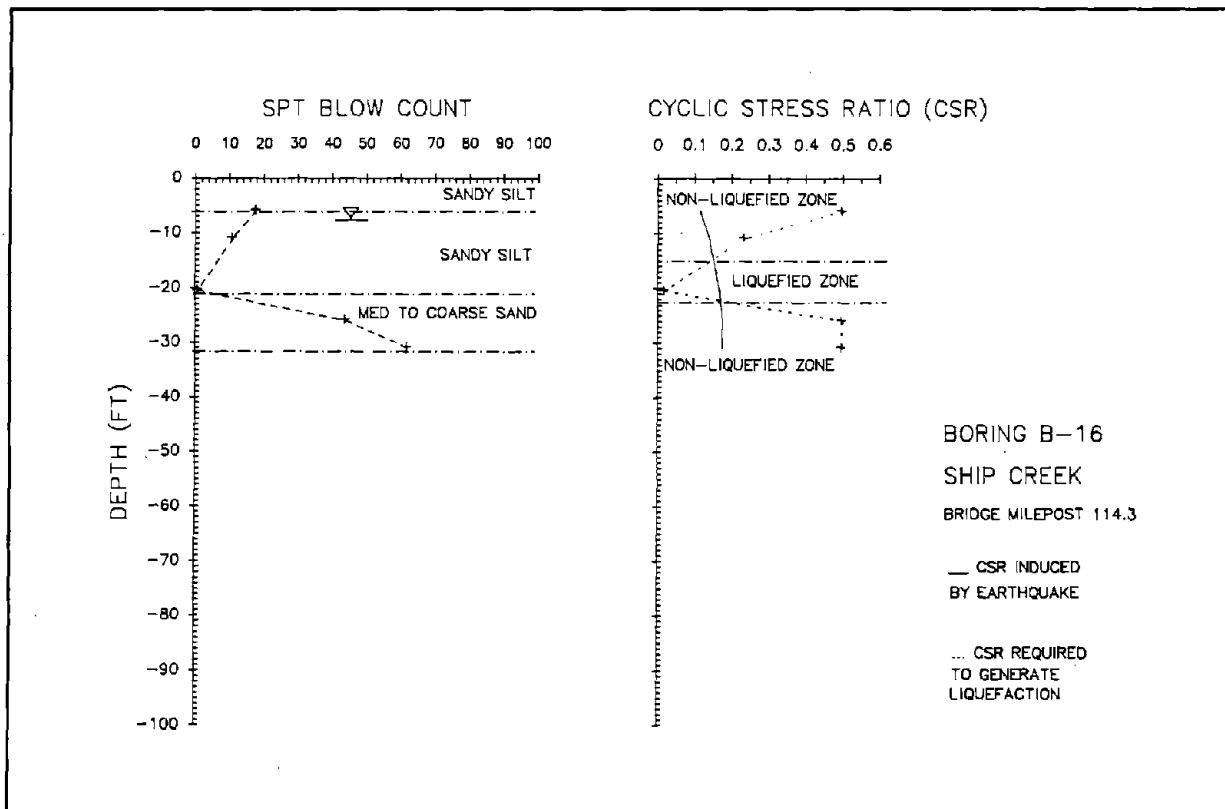
Figure 37 SPT Profile and Analysis, Bore Hole B-16, Ship Creek.

Liquefaction analysis of Borehole B-16 indicates that a zone from 4.5 to 6.5 m deep is liquefiable (Figure 37). The SPT values in this 1.5 m thick zone average 4 and range from 1 to 7. The SPT values in the underlying sand beginning at 6.5 m are too high to make the sand liquefiable.

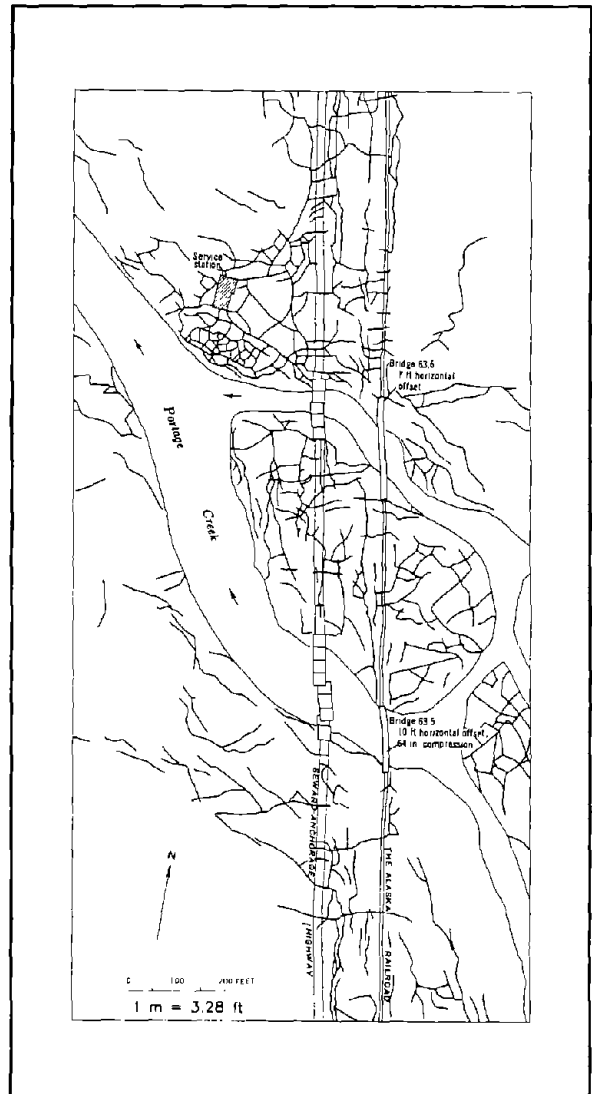
Figure 45 Ground Cracks at Portage Creek near Railroad Bridges at Mile Posts 63.5 and 63.6 (after McCulloch and Bonilla, 1970).

Ground fissures were prevalent on both sides of the southern bridge (Figure 45). One hundred and twenty meters south of the bridge, the rail was pulled apart 0.3 m by a crack which crossed the railroad and highway embankment. On the small island which separates the railroad bridges, an orthogonal pattern of fissures offset sections of the adjacent highway 0.6 m. The railroad embankment on the island settled as much as 1.6 m (McCulloch and Bonilla, 1970). McCulloch

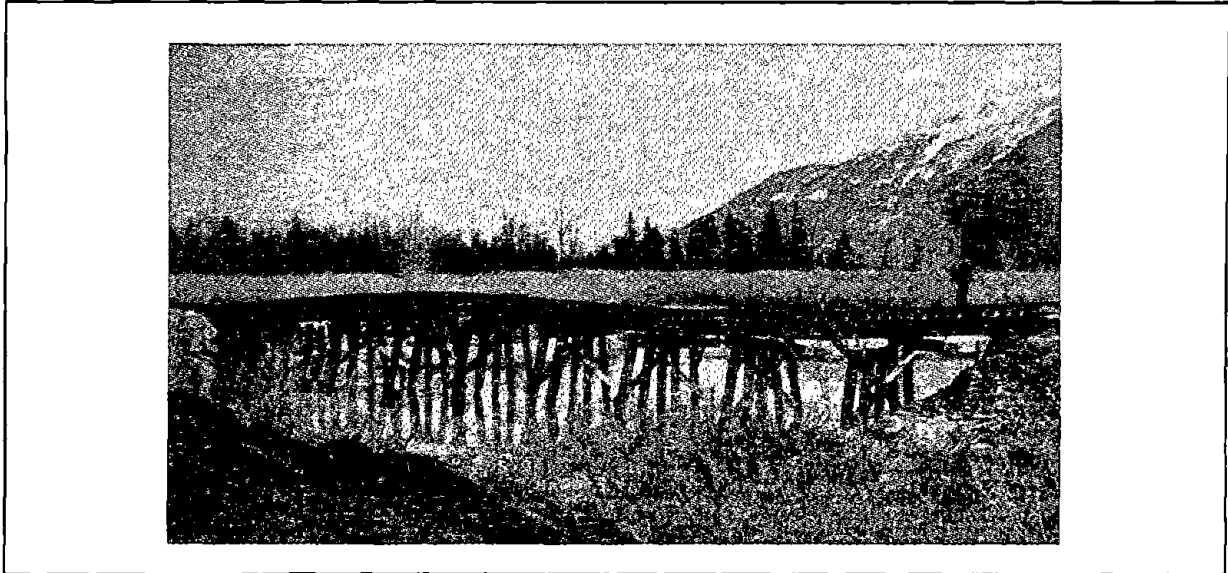
upward about 1 foot [Figure 46]. At the south end, compression also tore about 56 feet of rails from the ties that were frozen in the ballast and bowed the rails 10 1/2 feet to the west. At the north bulkhead the stringers rammed 2 inches into the fillers. Compression was accompanied by a considerable amount of streamward shifting of the piling, and the bridge was skewed horizontally about 10 feet, its south end moving east relative to its north end (McCulloch and Bonilla, 1970)."

Figure 46 Damage to Railroad Bridge at Mile Post 63.5 (south abutment is on right-hand side, from McCulloch and Bonilla, 1970).

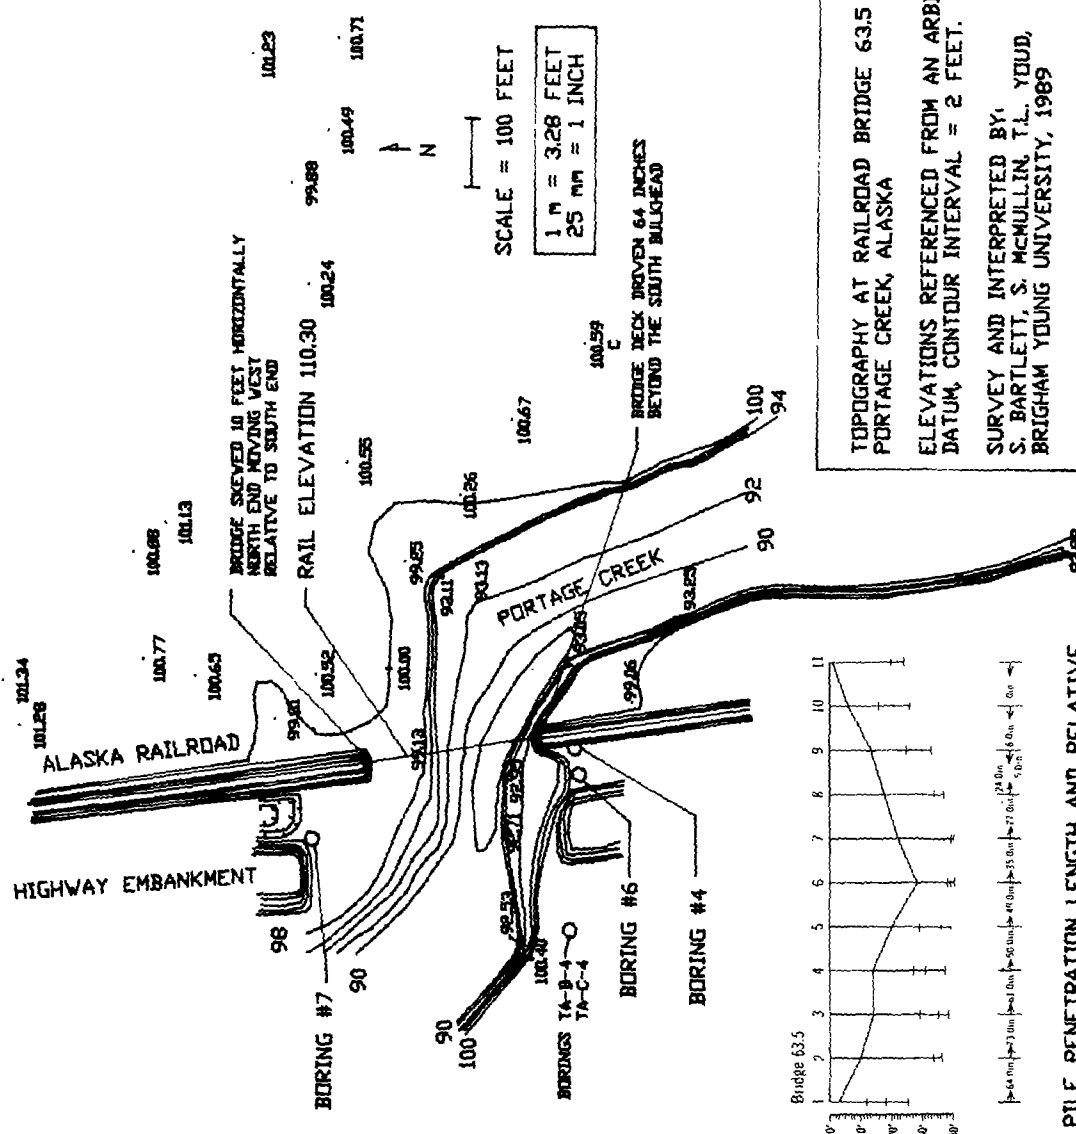
The inset on Figure 47 shows the depth of pile penetration and channelward pile displacements for Bridge 63.5. It appears that the south end of the bridge (left end of inset) displaced streamward considerably more than the north end. The second pier on the south end of the bridge displaced 1.85 m toward the channel. The end pier on the north side of the bridge did not displace. Because the alignment of the bridge was oblique to the channel, lateral spread toward the channel skewed the railroad bridge deck approximately 3 m (inset on Figure 47).

Figure 47 Contour Map and Pile Displacements at Milepost 63

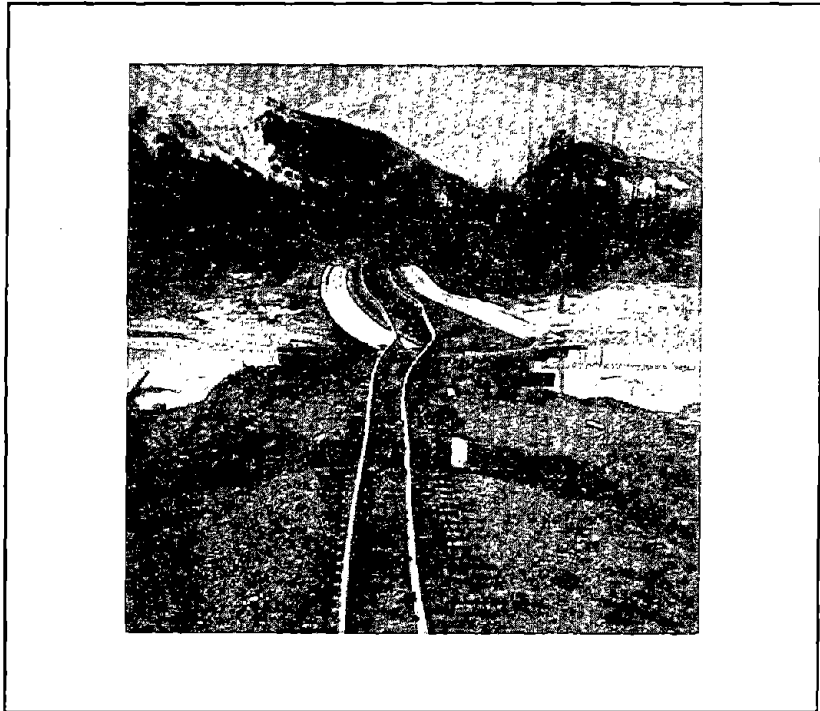
"Six tension fractures lying within, and produced by, the 200-foot-wide zone of stream-margin cracking crossed the embankment north of Bridge 63.0. One fracture in the zone, about 35 feet north of the bridge was about 3.5 feet wide, and the embankment south of the fracture shifted 1 foot to the west [Figure 52 - foreground].

". . . [The deck] was compressed approximately 7 feet. The compression produced a sharp lateral kink in the deck with a deflection of about 8 feet and the stringers were broken at the apex of the kink. . . . [the] bents not torn free of the bridge were dragged laterally through the sediments by the deflecting deck, and most bents shifted streamward."

Figure 52 Damage to Bridge at Milepost 63.0 (looking south - from McCulloch and Bonilla, 1970).

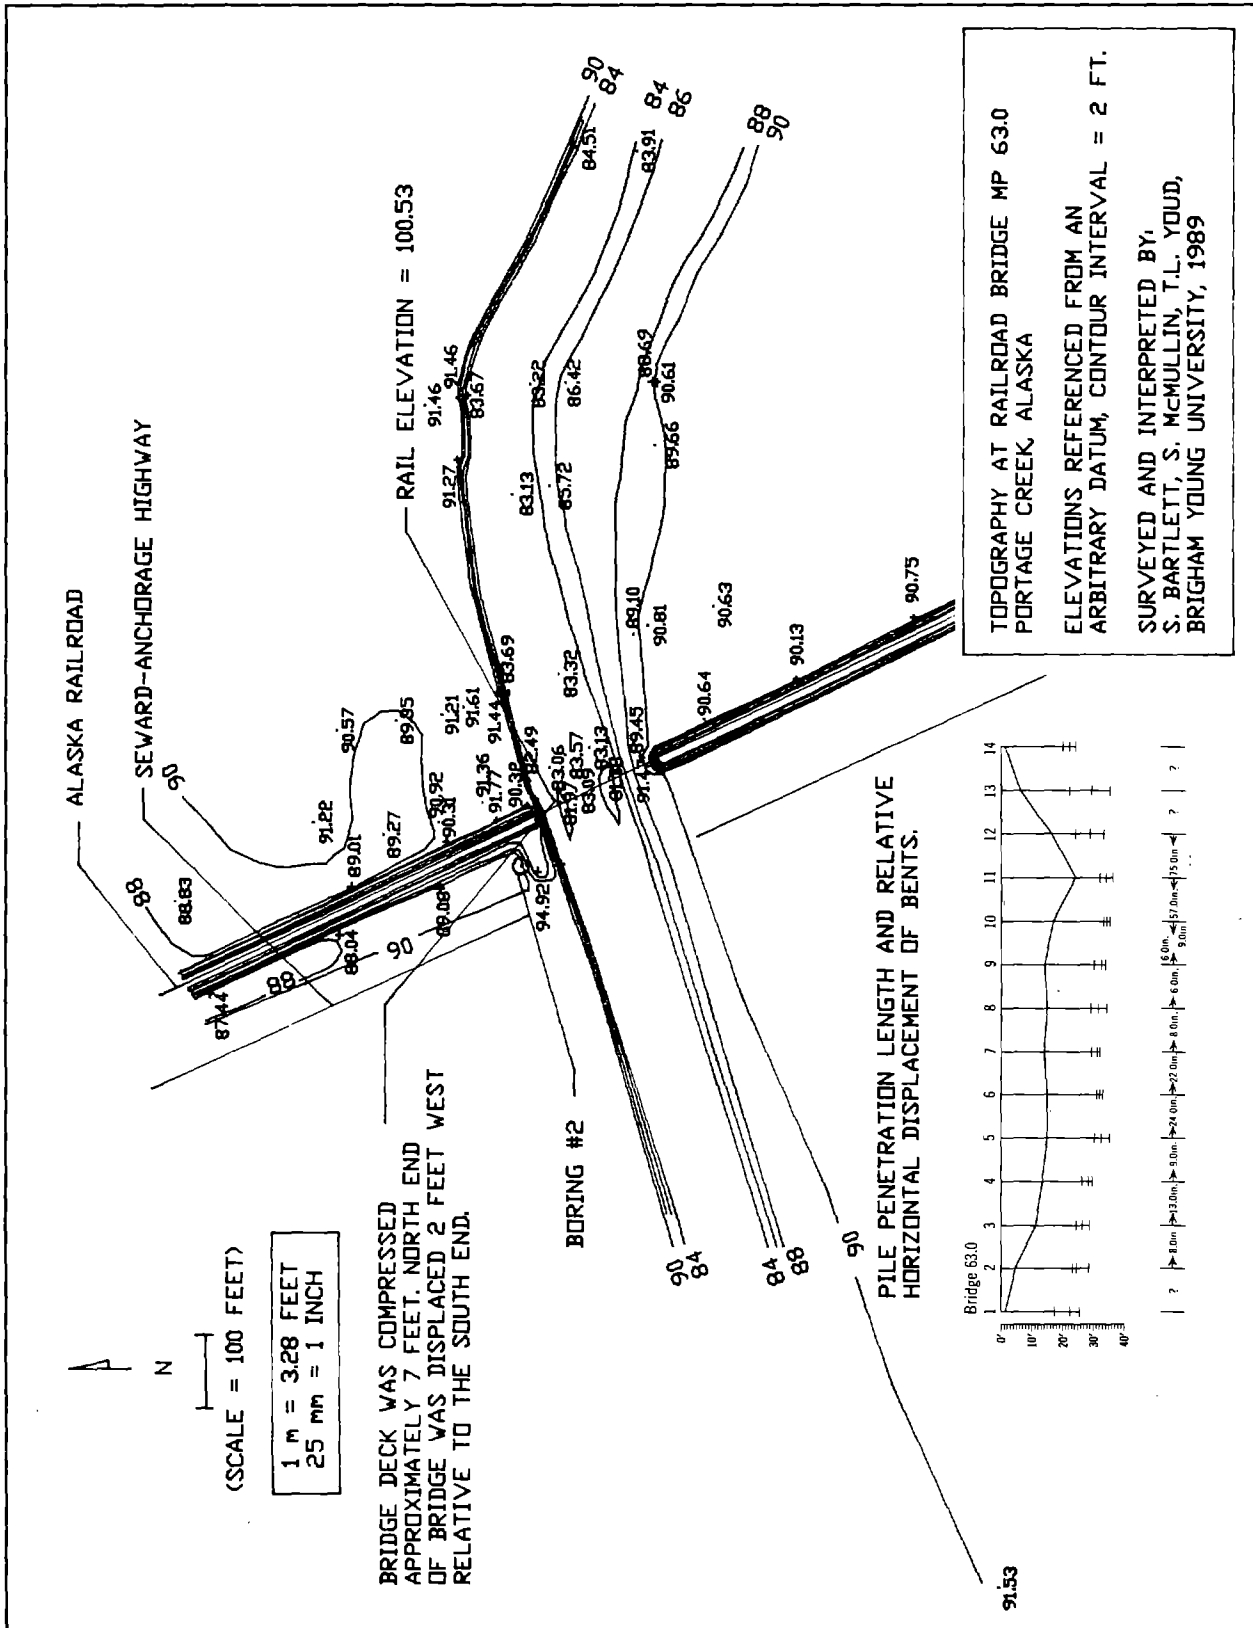
An inspection of the channelward pile displacements recorded by McCulloch and Bonilla suggests that the most of the displacement occurred on the north side of the bridge (see inset on Figure 53 also see Plate #3, McCulloch and Bonilla, 1970). In addition to 2.1 m of deck compression, McCulloch and Bonilla show that the north abutment displaced 0.36 m downstream (inset on Figure 53).

Figure 53 Topography and Displacements at Bridge Mile Post 63.0.

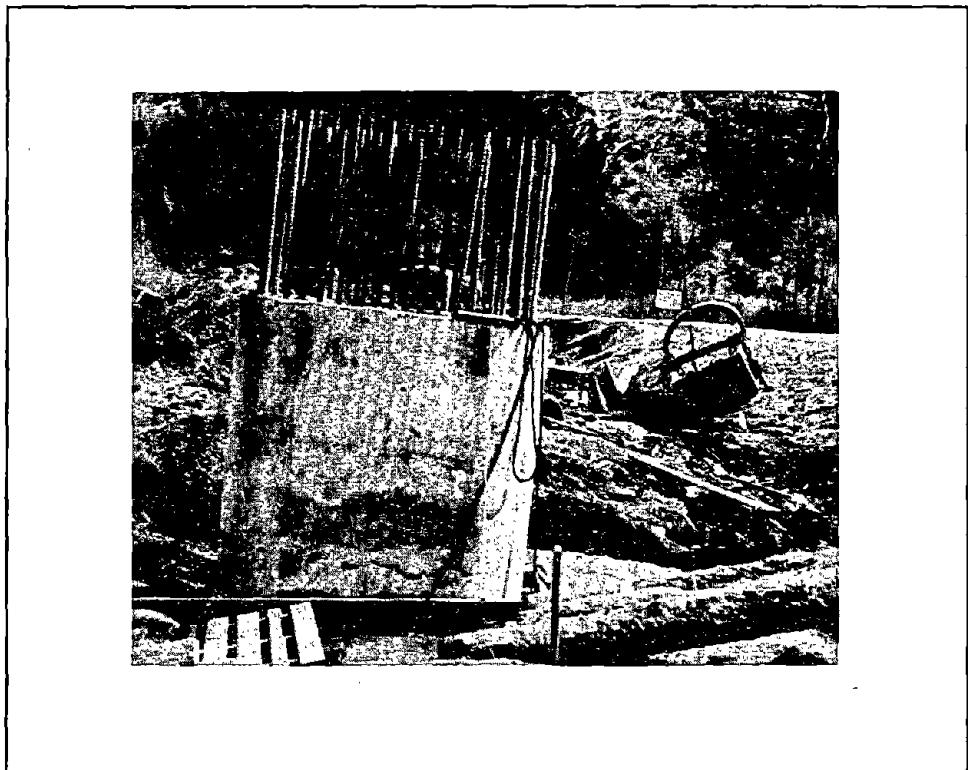
"Four of the heavy concrete piers had been completed to top of shaft [Figure 61]. These piers (each supported on 21 concrete-filled steel-tube piles, extending an average of about 90 feet below adjacent streambed level) underwent tilting and lateral displacement during the earthquake. Damage surveys revealed a maximum of 8 ft. lateral displacement of the shaft tops downstream and up to 15 deg. tilt upstream. . . Longitudinal movements were less [Figure 62].

Figure 61 Photograph of Displaced Highway Pier (looking east, from McCulloch and Bonilla, 1970). reproduction of

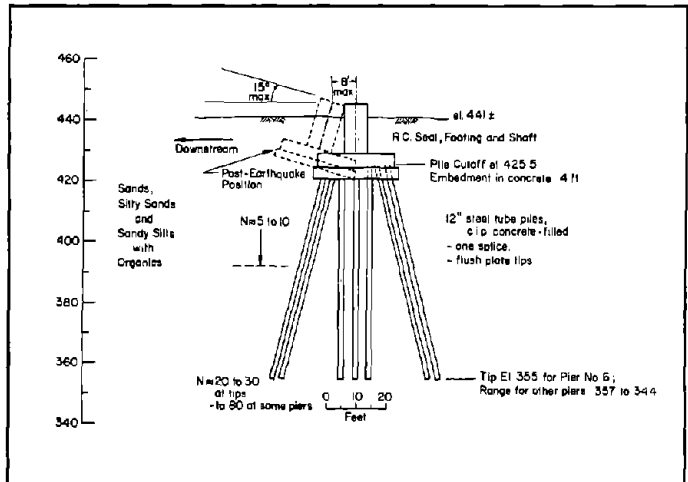
Figure 62 Construction and Displacement of Concrete Pier, Bridge 605A (after Ross et al., 1973).

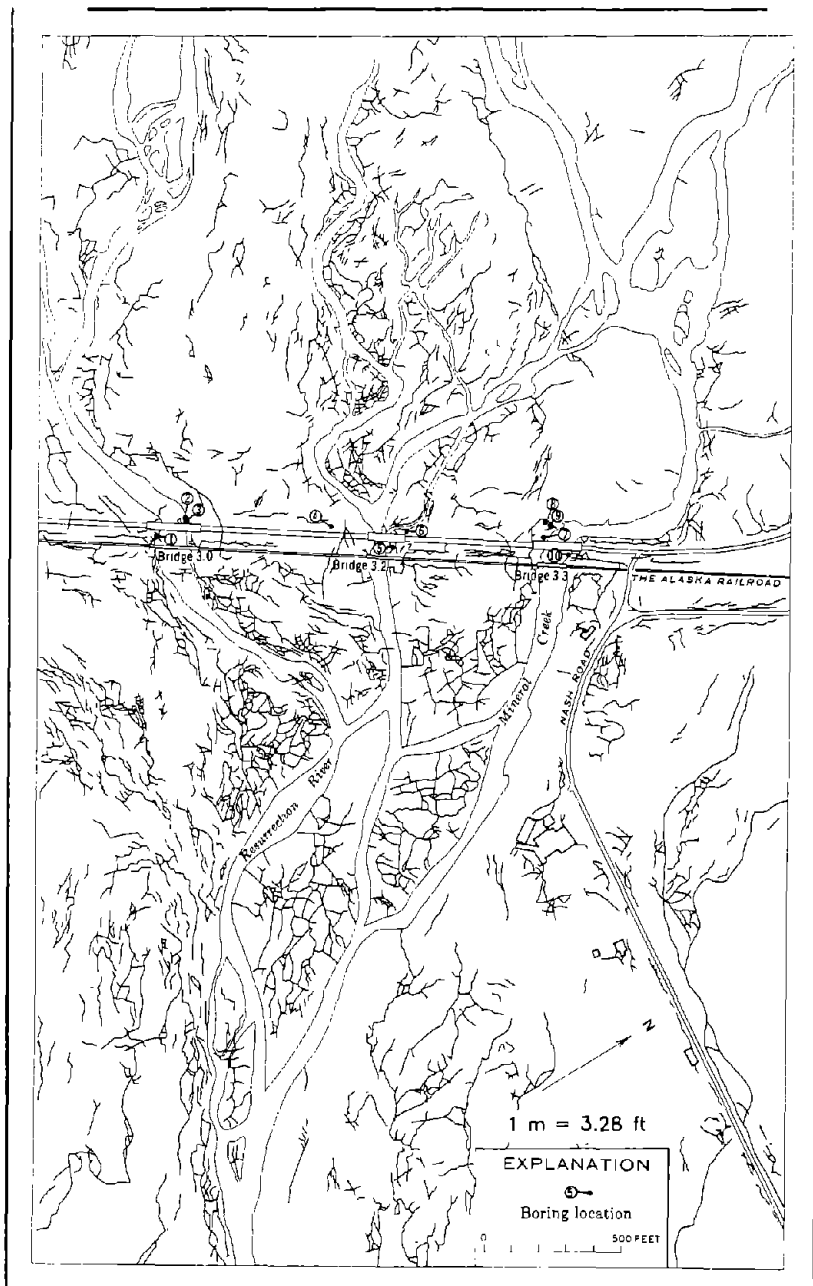
A few kilometers north of Seward, the Alaska Railroad and Seward-Anchorage Highway cross the floodplains of Resurrection River and Mineral Creek (Figure 1). Ground fissures and displacements were abundant on the Resurrection River floodplain after the earthquake (Figure 67). McCulloch and Bonilla describe the nature of liquefaction ground failure as follows:

Figure 67 Ground Fissures, Bridge and Bore Hole Locations, Resurrection River and Mineral Creek (after McCulloch and Bonilla, 1970).

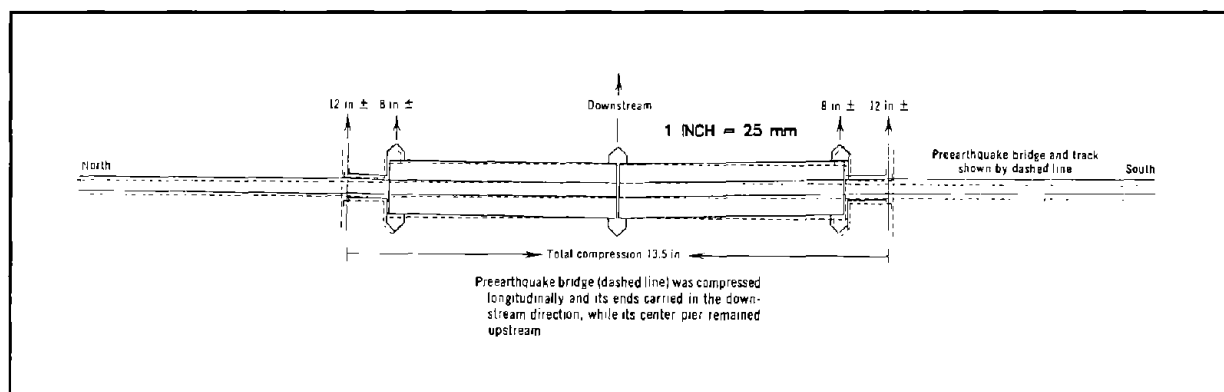
Figure 68 Displacements at Bridge Milepost 3.0 (after McCulloch and Bonilla, 1970).

"Compression at deck level totaled 13 1/2 inches. The steel deck beams were driven 4 and 5 1/2 inches into the ends of the wood stringers, and the wood stringers were driven 1.5 and 2.5 inches into the bulkheads. . . . Piles at the bulkheads and piers were shifted streamward. All moved with no detected vertical rotation. The horizontal displacement ranged from 1 1/2 to 11 inches. . . . In addition to moving streamward, the outer piers shifted 8 inches downstream of the central pier, and the bulkheads and approach fills were carried 4 to 5 inches more; the central pier was thus left 12 to 13 inches upstream of the approaches [Figure 68] (McCulloch and Bonilla, 1970)."

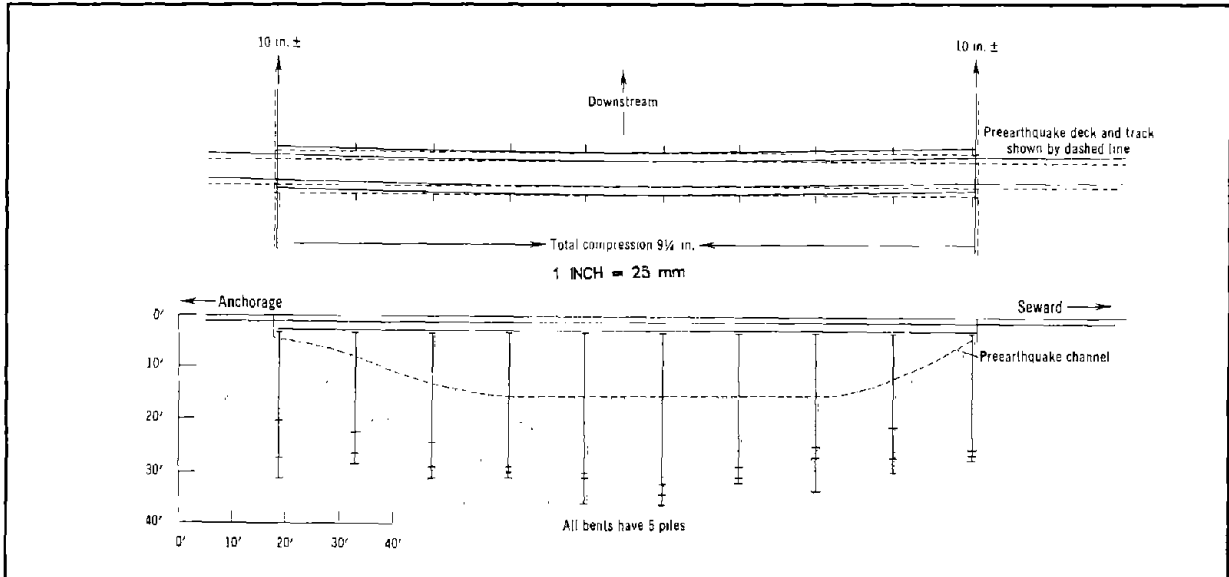
Figure 69 Displacements at Railroad Bridge Milepost 3.2 (after McCulloch and Bonilla, 1970).

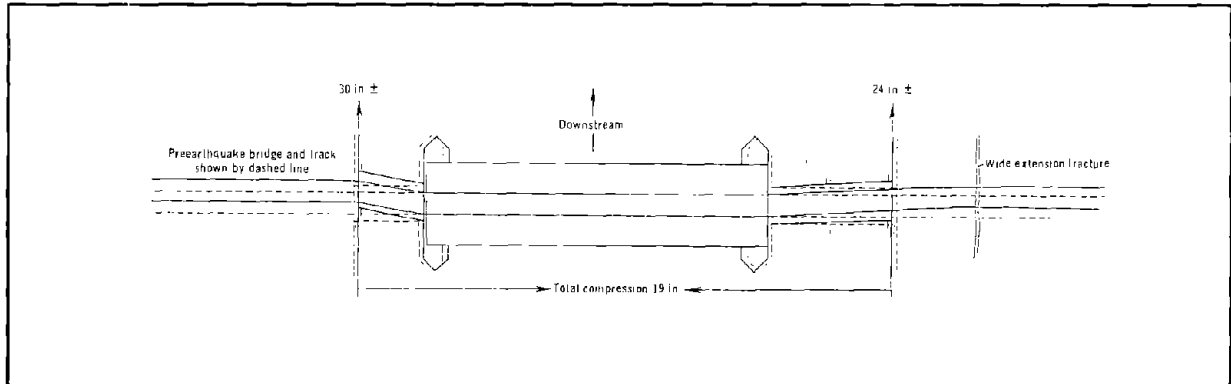
"Compression, totaling about 19 inches developed at the deck level, driving stringers into bulkheads and into the central steel spans. At the north bulkhead the stringers were shoved at least an inch past the piles, forcing the bulkhead bents into the fill. ... At the south bulkhead the stringers drove about a foot past the piles. ... Piles in the bents and piers shifted streamward ranging from

Figure 70 Displacements at Railroad Bridge Milepost 3.3 (after McCulloch and Bonilla, 1970).

1 to 20 inches. ... As at the adjacent bridges, the grade was shifted to the southeast, parallel to the stream which skewed the approach spans and left the central span about 30 inches upstream (McCulloch and Bonilla, 1970, see Figure 70)."

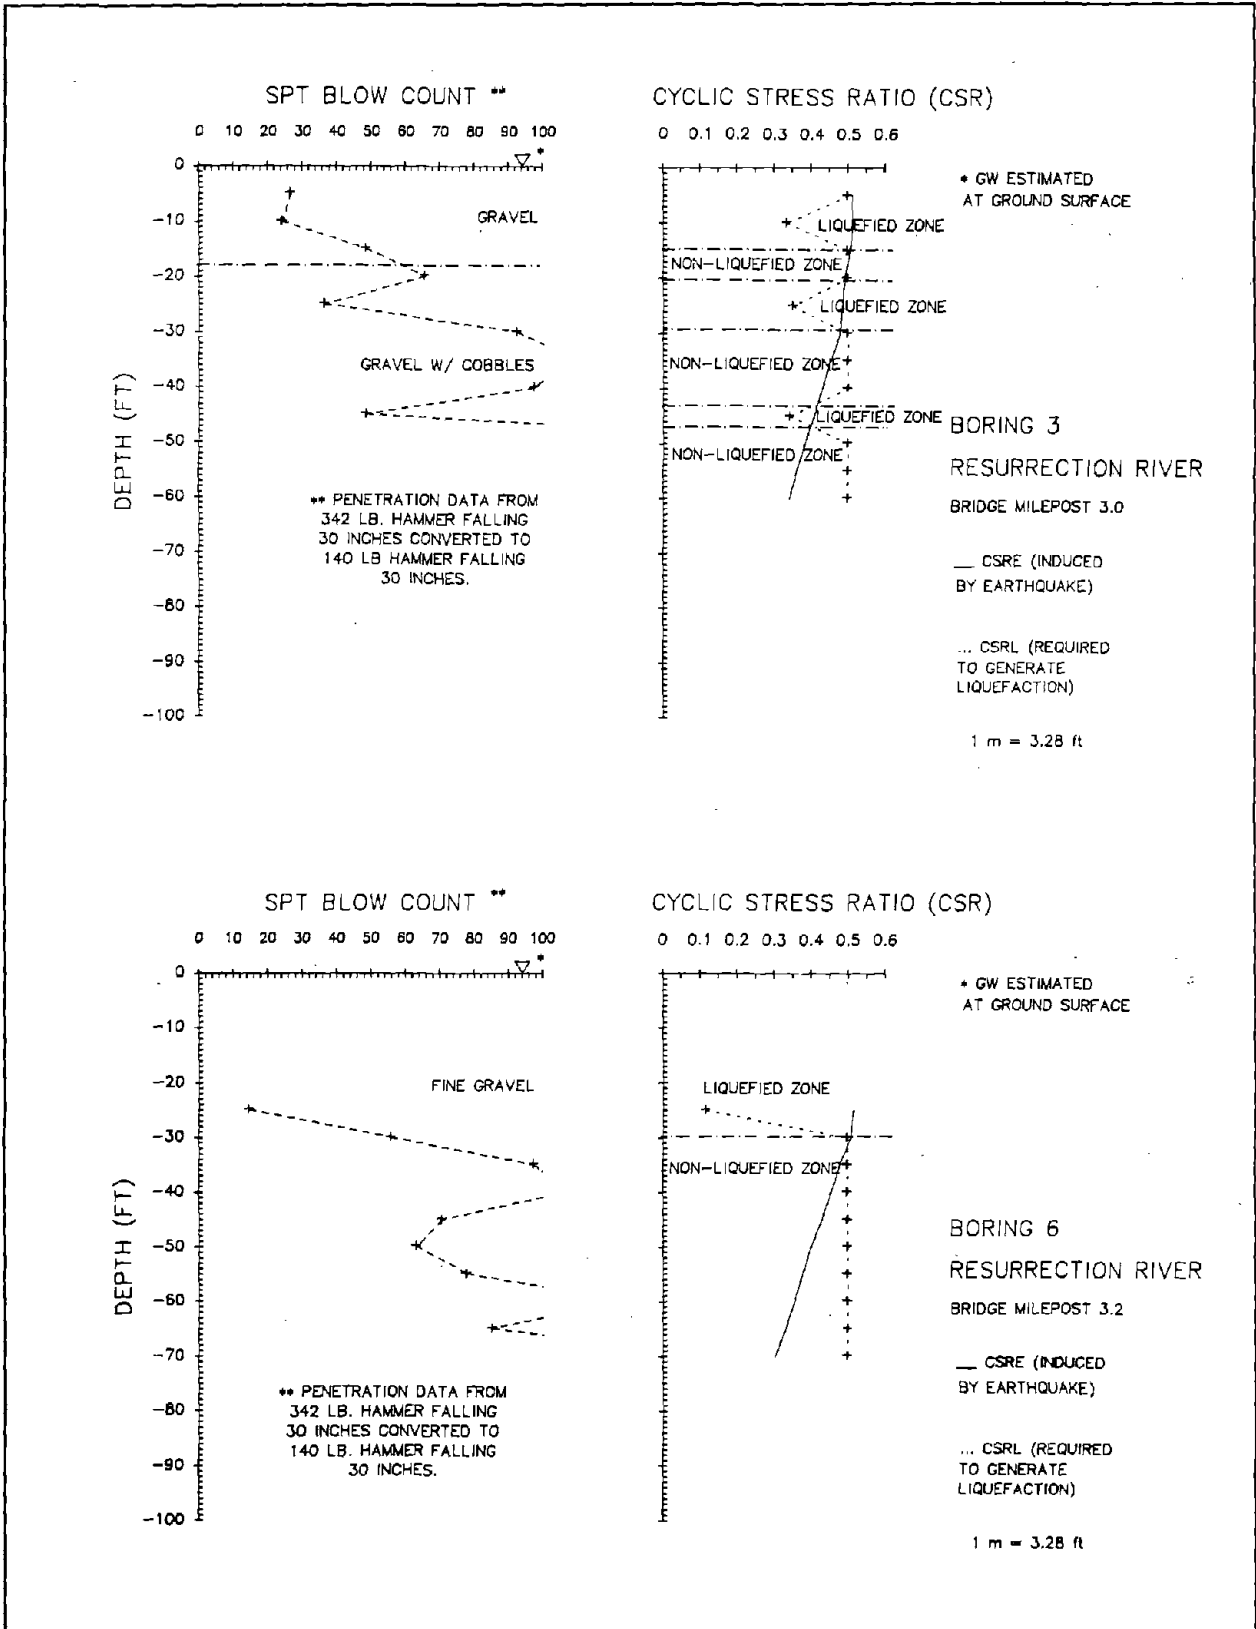
Figure 74 Penetration Profile and Analysis, Bore Holes 3 and 6.

Also, we have included a chart showing the range of grain-size distribution for SPT samples taken near the Highway Bridge at Mineral Creek (Figure 73). Also included is a SPT log at the same locality (Borehole 9, Figure 75). Our liquefaction analyses of these four boreholes indicate that some layers of gravel and fine gravel are liquefiable in the upper 20 m of the profile (Figures 74 - 75).
