Case Studies of
Liquefaction and Lifeline
Performance During Past Earthquakes

Volume 2
United States Case Studies

Edited by
T. D. O'Rourke and M. Hamada

Technical Report NCEER-92-0002

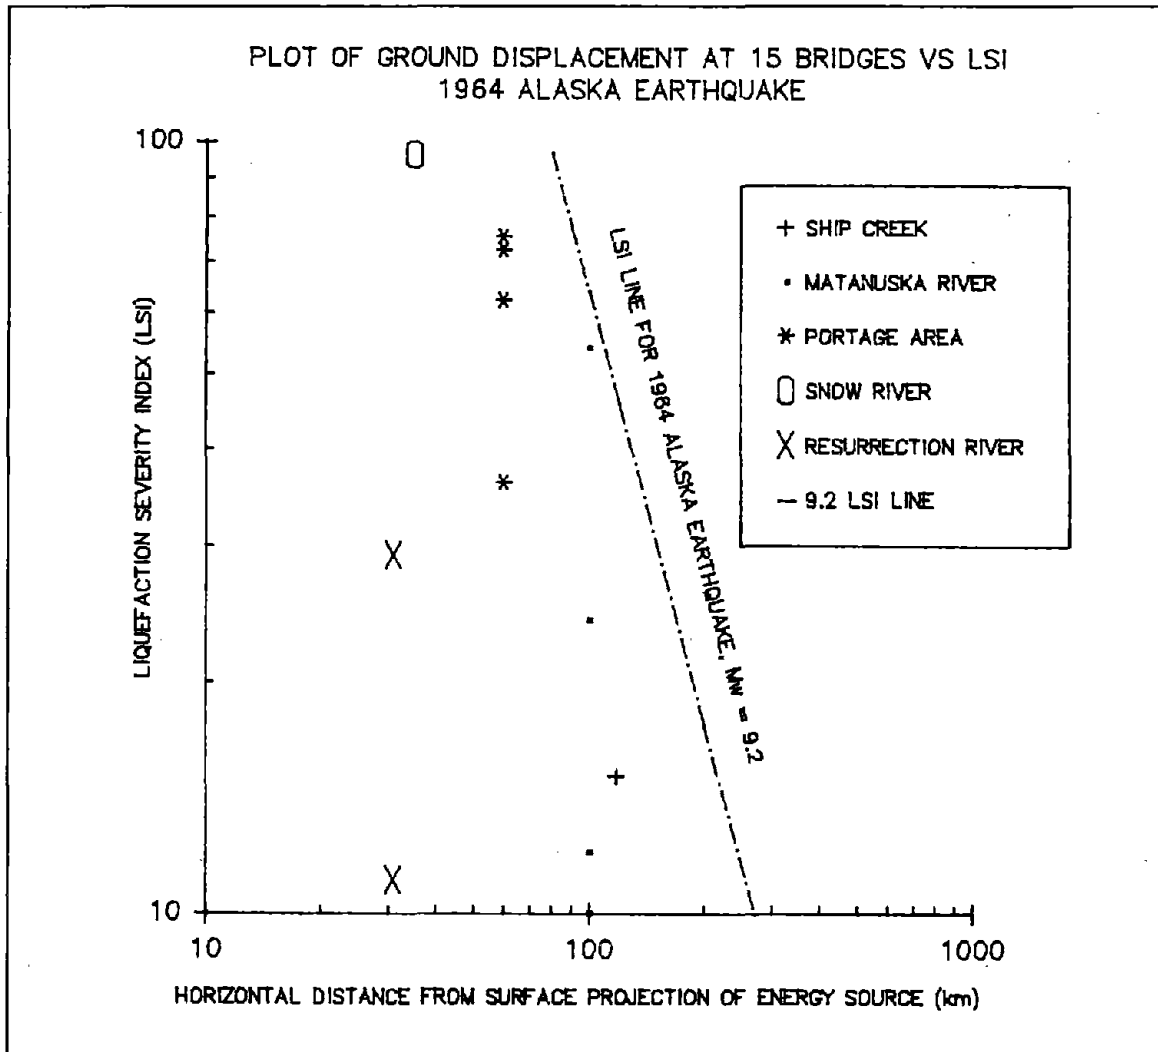
Figure 76 LSI Values for Damaged Bridge Sites.

ground displacement of lateral spreads on liquefiable, gently-sloping, late-Holocene fluvial and deltaic deposits. LSI is calculated by dividing the maximum horizontal ground displacement of lateral spreads, measured in millimeters, by 25. Figure 76 plots the LSI values at the damaged bridge sites reviewed in this study versus the horizontal distance from the surface projection of energy source in kilometers. Also, the LSI line for the 1964 Alaska earthquake predicted from the Youd-Perkins LSI equation is plotted as the dot-dashed line on Figure 76.

We draw three important conclusion about the severity of liquefaction-induced ground failure from the examination of Figure 76. (1) No horizontal displacement, measured at the damaged bridges, exceeded the LSI line predicted for the 1964 Alaska earthquake. Thus, the LSI appears to be a conservative upper bound for most of the ground displacements incurred by the 1964 Alaska earthquake. (2) Distance from the seismic energy source is a major factor controlling displacement. For example, horizontal ground displacement was larger near Portage (up to 3 m) than at the Matanuska River (up to 1.4 m). The bridges located near Portage were much closer to the zone of seismic energy release than those in the Matanuska Valley (60 and 100 km respectively). (3) The amount of horizontal ground displacement is also influenced by the density, texture and uniformity of the subsurface soil. For example, the maximum displacement of 0.75 m at the Resurrection River is smaller than might be expected for a locality so near the zone of seismic energy release. (Peak accelerations and duration of strong ground motion at the Resurrection River were estimated to be about 0.4 g and 90 s respectively). The apparent reasons for these smaller displacements at the Resurrection River compared to other sites were the thinner liquefiable layer (3 to 5 m) and the gravelly texture of the liquefied material. Thus, for comparable distances from the zone of seismic energy release, relatively thick uniform sandy sediments with low SPT values experienced larger ground displacements than thinner more heterogeneous gravelly sediments with higher SPT values.

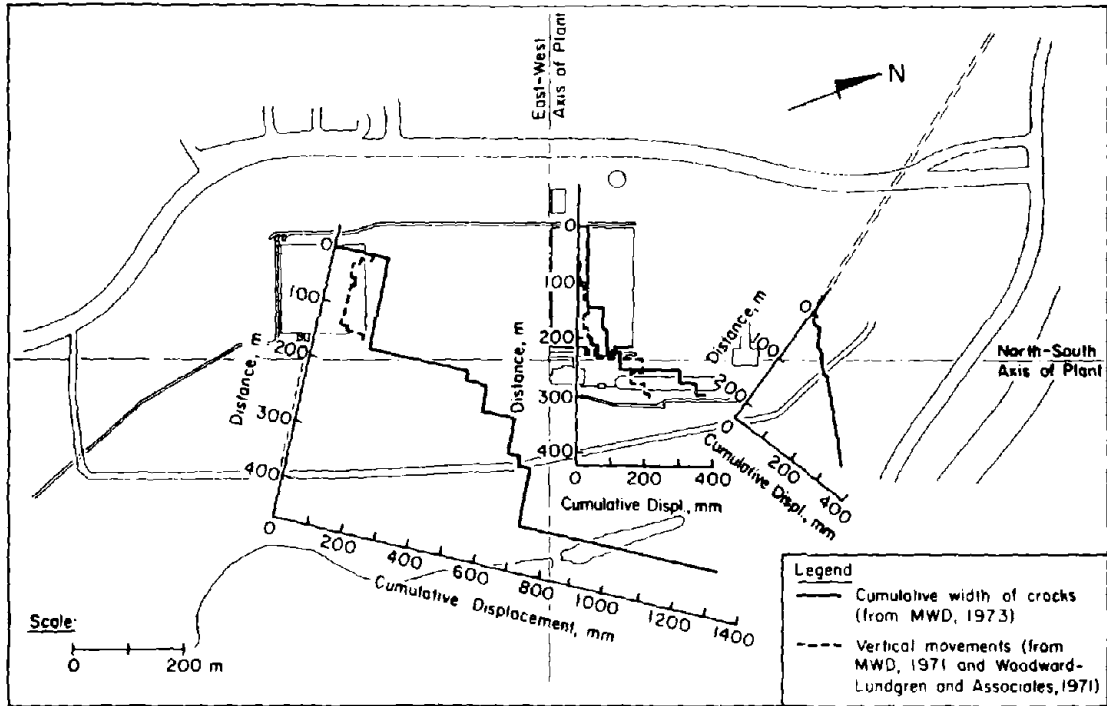
Figure 9. Cumulative Displacements Across the Joseph Jensen Filtration Plant

which provide records of cumulative lateral and vertical movement in the east-west direction. They include the 1) FWR and Overflow Conduit, 2) Filters, Settling and Mixing Basins, MCB, and Influent Conduit, and 3) the Balboa Inlet Tunnel. As part of this study, site survey information, photos, field notes, and post-earthquake measurements of these structures were used to develop cumulative displacement plots, as shown in Figure 9.

The air photo analyses show lateral movements along the Utility Corridor, typically 2 to 3 m, in an easterly direction toward the reservoir. At the eastern terminus of the Overflow Conduit, air photo measurements show lateral movements of 1.3 to 2.2 m, which agrees reasonably well with the total cumulative movement shown at this location in Figure 9.

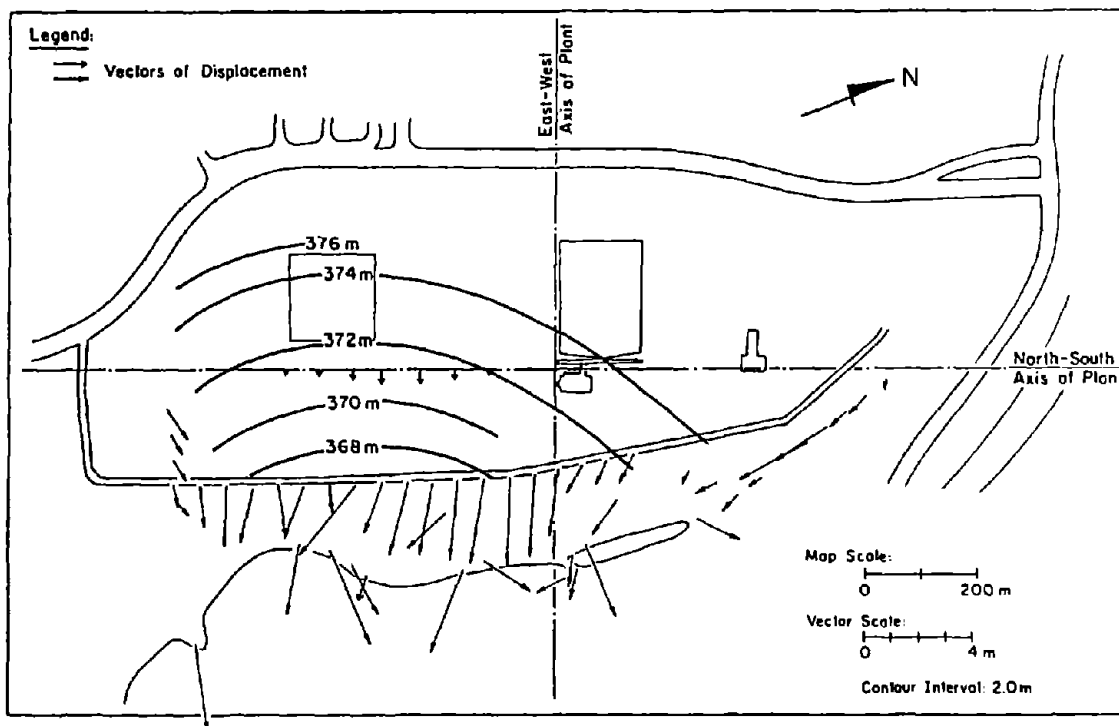
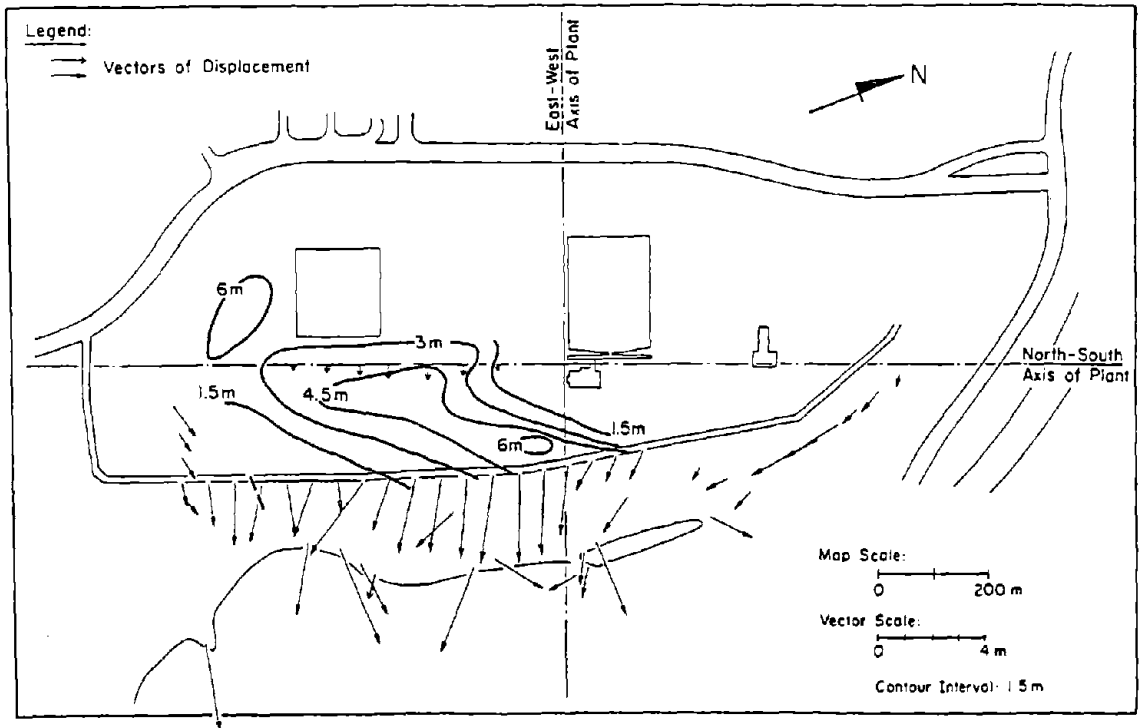
Figure 19. Contours of Equal Elevation for the Base of Loose Saturated Alluvium at the Joseph Jensen Filtration Plant

Figure 20. Contours of Equal Thickness of Loose Saturated Alluvium at the Joseph Jensen Filtration Plant

Figures 19 and 20 show the depth to the bottom and thickness of the loose, saturated alluvium, respectively. Vectors of displacement, mapped by photogrammetric techniques, also are shown in the figures.

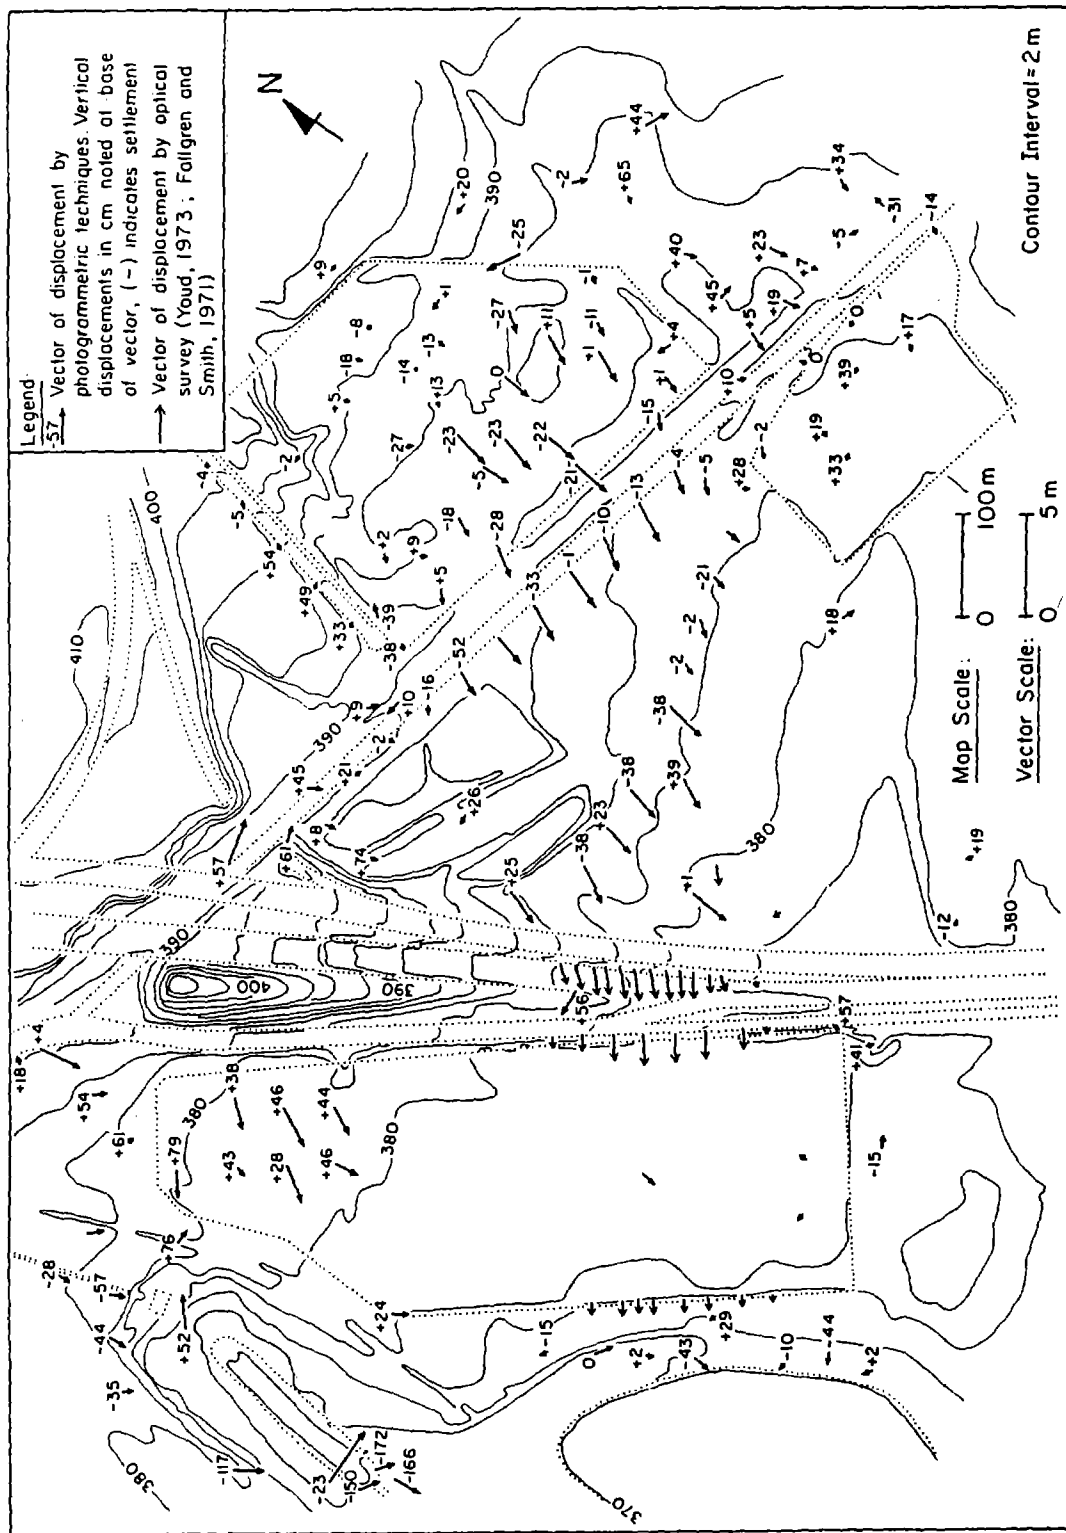
Figure 23. Displacements Determined from Air Photo Analyses and Optical Surveys, East of Upper Van Norman Reservoir

The displacement vectors and ground ruptures show a well-defined zone of movement in which the general orientation of displacement changed from a direction almost due south near the Juvenile Hall to a southwest direction at Route 5. In addition, an abrupt change in the magnitude of horizontal displacement occurred across an approximately 2.4-m-deep flood control channel immediately to the east of the Sylmar Converter Station. Downslope of the drainage channel, the magnitude of the horizontal displacements increased. The average inclination of the ground surface throughout the area of lateral spreading was 1.5° , with a maximum slope through the Juvenile Hall of about 3° .

The magnitude and direction of the vectors of ground movement predominantly result from liquefaction, soil slumping, and landsliding. A lesser component of the ground deformation vectors is the result of regional tectonic movements. As explained in detail in Appendix B and as shown in Figure B.3, the magnitude and direction of regional tectonic movements northeast of the Upper Van Norman Reservoir are estimated to be 0.69 m westward and 0.3 m up (Yerkes, et al., 1974).

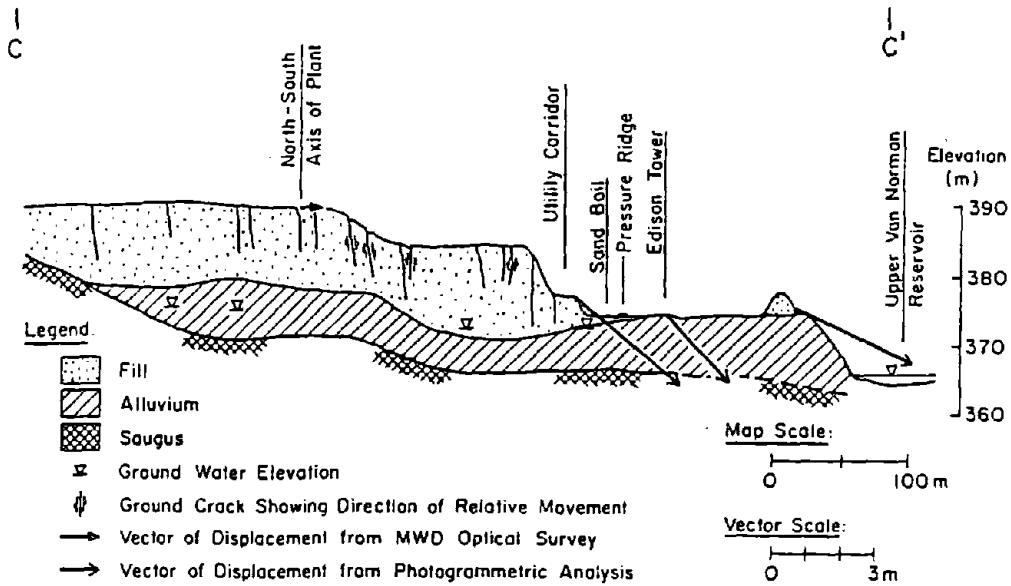
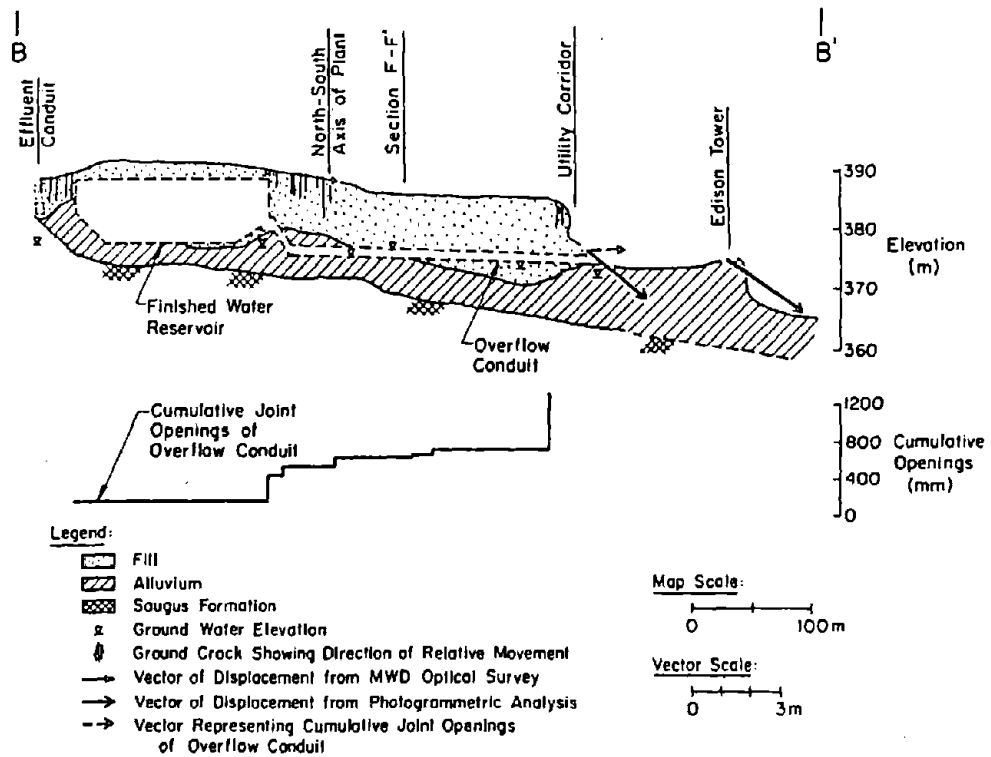
Figure 32. Cross-Sectional Views of Joseph Jensen Filtration Plant Showing Large Ground Deformation and Cumulative Joint Openings of Overflow Conduit Along Sections B-B' and C-C'

the figures represent horizontal and vertical components of displacement as determined by photogrammetric analyses. The solid-headed vectors represent the horizontal and vertical components of displacement as determined by optical surveys conducted by MWD (Youd, 1973). Figures 32a and b also show the ground cracks projected below ground surface, and an exaggerated scale profile of the sand boils and pressure ridge.

The landslide at the Joseph Jensen Filtration Plant has been described by Converse, Davis, and Associates (1971) as liquefaction of the loose alluvium, followed by eastward movement of the east face of the fill slope and subsequent graben formation in the areas west of the fill slope. The vectors of movement east of the utility corridor are approximately the same magnitude, implying that this section moved as a discrete unit. The thickest deposits of loose saturated alluvium are located beneath this block, as shown by the contours presented in Figure 20. Moreover, this location of thick alluvium corresponds with the debris deposits shown in historic photographs, as well as former stream channels, as indicated in Figure 31b.

As the eastern part of the soil deposits moved toward the reservoir, tensile stresses developed in the fill which were relieved by cracks, joint openings in conduits, and grabens. Further west, in the zone where the Influent Conduit, MCB, and the west edge of the FWR are located, shaking and loss of lateral support led to settlement and eastward lateral movement. The zone of ground deformation was, thereby, effectively extended into other areas of the

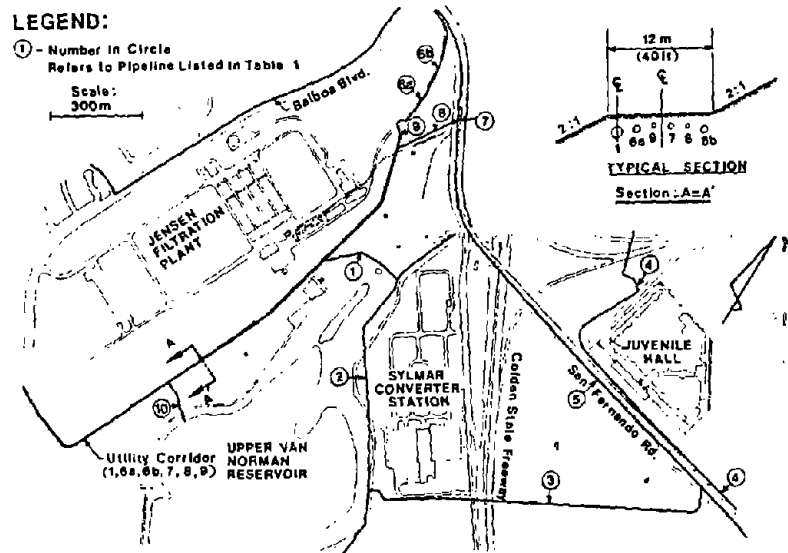
Figure 34 shows a plan view of the Upper Van Norman Reservoir area, on which are superimposed major transmission and trunk pipelines affected by permanent ground movements during the earthquake. In total, 11 transmission and trunk pipelines crossed areas of lateral spreading and liquefaction-induced large ground deformations. Table 1 summarizes information about the pipelines that includes dimensions, installation date, composition, joint type, coating, depth of soil cover, and nominal operating pressure at the time of the earthquake. The outside diameter (O.D.) and wall thickness for each pipe are listed. Each pipeline is numbered for purposes of referencing the pipeline as shown in the figure with information summarized in the table. In general, the pipelines were buried in medium to dense sand and silty sand above the water table. Transmission pipelines for natural gas, liquid fuel, and water were involved, representing different dimensions, joint design, operating

Figure 34. Pipelines Affected by Permanent Ground Movements Near Upper Van Norman Reservoir (after O'Rourke and Tawfik, 1983)

On the west side of the reservoir, most of the pipelines were buried along a utility corridor. A typical cross-section of the corridor is shown as an inset in Figure 34. Lines 6a and 6b in the corridor were identical with respect to dimensions, construction, and operating pressures.

Most of the pipelines in the utility corridor were not damaged, including the three lines operated by the Southern California Gas Company and one operated by the Mobil Oil Corporation (see Figure 34 and Table 1). Some gas pipelines were cut and rewelded after the earthquake, principally to relieve residual stresses and make adjustments for deformations caused by the ground movements. Pipeline 8, operated by the Getty Oil Company, failed in tension across a weld at the northern boundary of the landslide area.

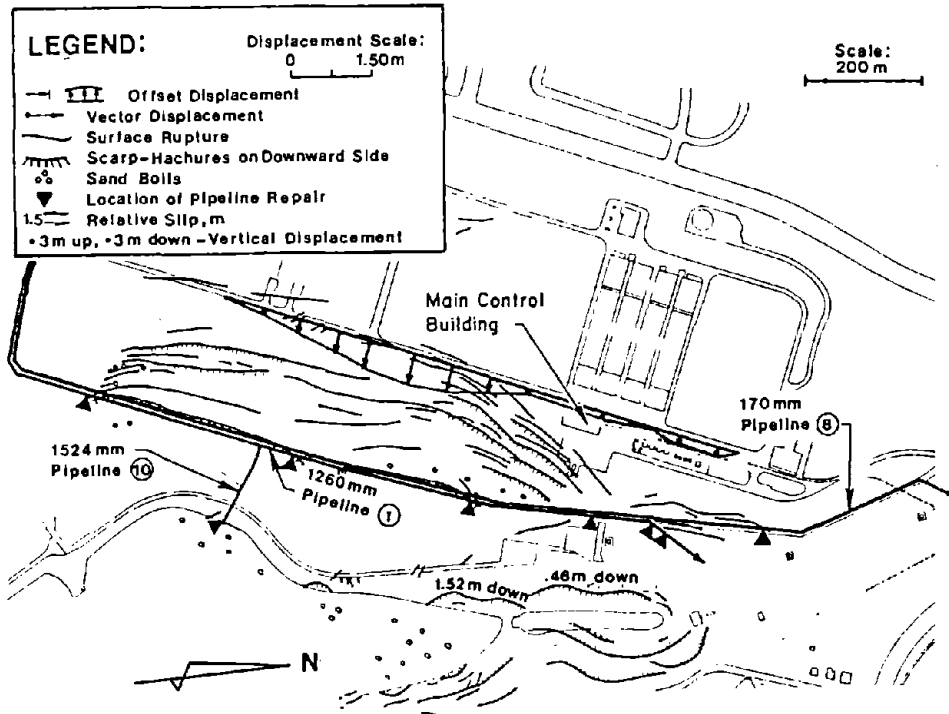
Figure 35 shows a plan view developed by O'Rourke and Tawfik (1983) of the area west of the Upper Van Norman Reservoir on which are superimposed ground ruptures associated with liquefaction-induced slope failures in this locality. The locations of pipeline damage were determined from repair records provided through the courtesy of the LADWP and the Getty Oil Company. The information in the repair records was supplemented by discussion with utility personnel.

Figure 35. Locations of Pipeline Repair, West Side of Upper Van Norman Reservoir

The most prominent damage was sustained by Pipeline 1. Damage to this pipeline, known as the Granada Trunk Line, occurred in three principal ways, including deformations at a bend, welded slip joints, and mechanical couplings. The most severe damage occurred where the pipeline branches to the northeast and leaves the utility corridor. The combined bend at this location involves a change in both horizontal direction and vertical elevation as the pipeline angles down the 1V:2H slope of the utility corridor embankment.

Severe bending deformation occurred near this location, with approximately 0.5 m of transverse displacement over an axial distance of 3 to 4 m. Immediately to the northeast, a mechanical coupling had been installed with a special harness to allow up to 50 mm of axial displacement. The coupling was severely battered and compressed. Its harness was deformed substantially. Damage to another mechanical coupling was observed at the southernmost boundary of the landslide area. South of the combined bend, there were several locations of severe compressive wrinkling at welded slip joints. The Subcommittee on Water and Sewerage (1983) reports that there were eight slip joints damaged. Only three locations of repair between the combined bend and the damaged mechanical joint at the southern boundary of movement could be confirmed by reference to repair records, and these are shown in the figure. Discussions with utility engineers indicates that most of the damaged slip joints were located within 300 m south of the combined bend.

Pipeline 10 was damaged at its eastern end. This pipeline transports water from the overflow conduit of the Joseph Jensen Filtration Plant to the Upper Van Norman Reservoir. The overflow conduit was affected by ground movements in two areas, including a 0.6-m opening about 150 m west of its connection with Line 10 and a 0.3-m opening near its western connection with the FRW. Pipeline 10 was damaged at two mechanical couplings that joined the pipeline to a discharge structure at the west side of the reservoir. The couplings were severely battered and compressed.

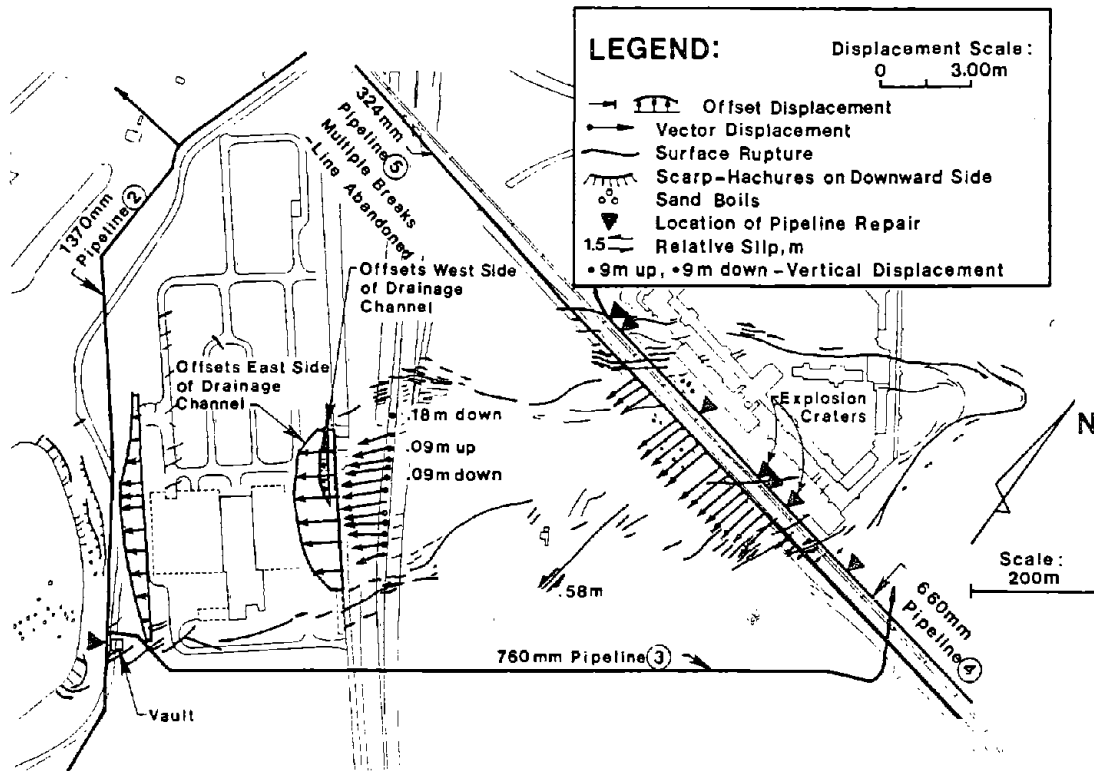
Figure 36 shows a plan view developed by O'Rourke and Tawfik (1983) of the area east of the Upper Van Norman Reservoir, on which are superimposed transmission pipelines and ground ruptures associated with the lateral spreading in this locality. The approximate locations of pipeline damage, as well as the locations of explosion craters, are indicated. The explosion craters were 3 to 4 m in diameter and were formed by the sudden release of high pressure gas.

The locations of pipeline damage were determined from repair records provided by SCG and LADWP. Two locations of pipeline repair coincide with the locations of explosion craters. The craters were fixed independently of the repair records by means of oblique air photographs. The information in the

Figure 36. Locations of Pipeline Repair, East Side of Upper Van Norman Reservoir

spread, where the pipeline was subjected to substantial tension from left lateral soil movement across the pipe. The records indicate that tensile failures were repaired at the three locations near the southern boundary of soil movement.

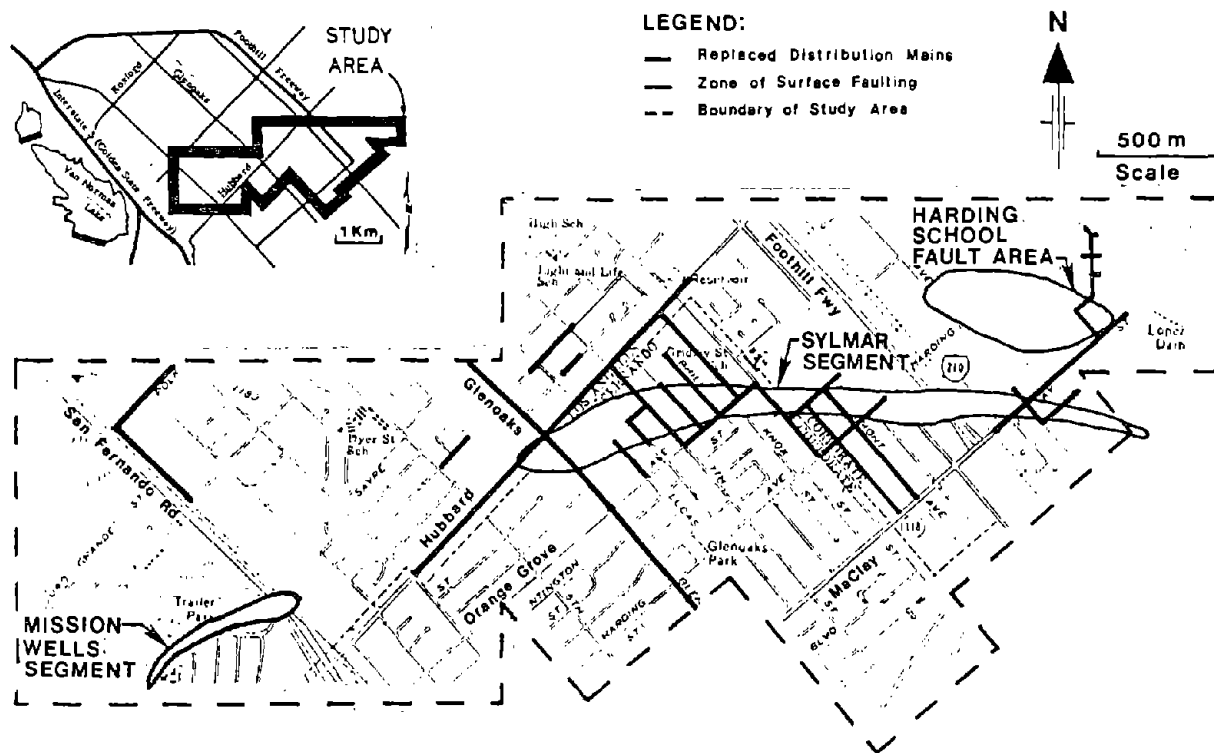
Figure 37. Plan View of Surface Faulting and Replaced Gas Distribution Pipelines (after McCaffrey and O'Rourke, 1983)

Pipeline segments from 100 m to 2 km in length were replaced within several months after the earthquake. The replaced pipelines are shown in Figure 37. At locations where two or more pipelines were adjacent to each other under the same street, only the replaced pipeline is indicated. Sixteen percent of the total length of all distribution lines in the study area was replaced. There was a high concentration of replacements within and adjacent to the Sylmar segment, with replacements made for 67% of the total length of all lines within the segment. The number of replacements was influenced by the orientation of pipelines relative to the trace of the fault. Sixty-two percent of the total length of northwest-oriented pipelines within the Sylmar segment was replaced, whereas 79% of the total length of northeast-oriented pipelines was replaced.

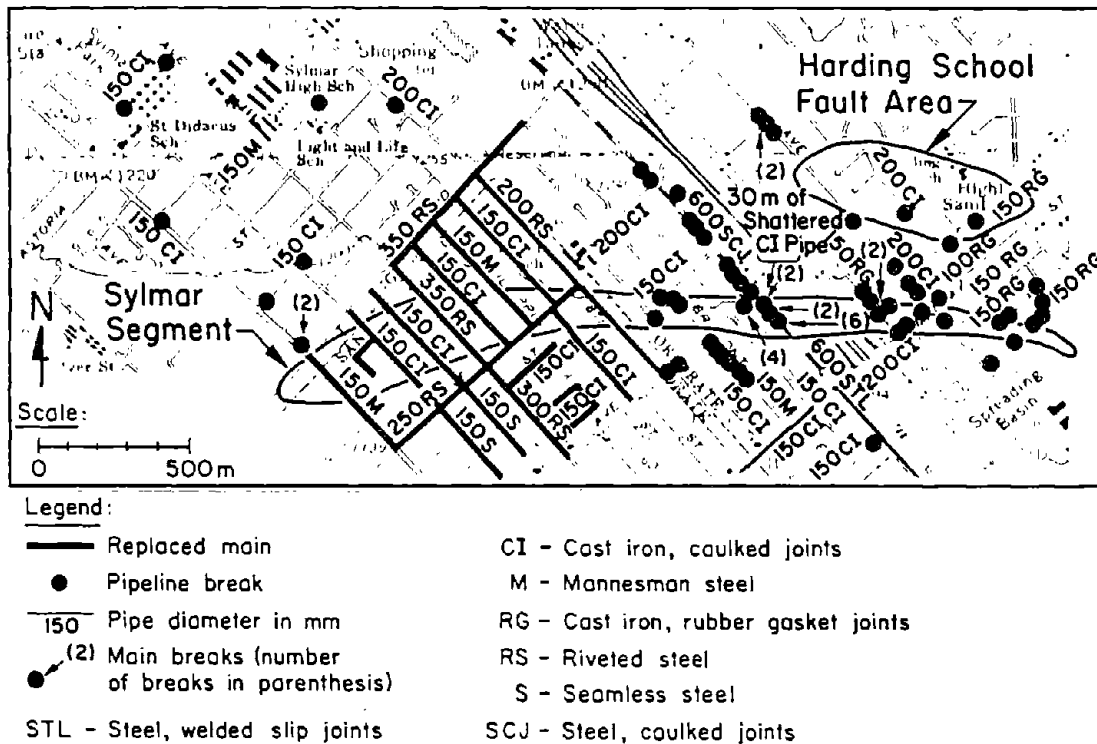
Approximately 20 km of pipelines were replaced in the City of San Fernando, with over 14 km replaced as shown in Figure 39. Every water pipeline in the

Figure 39. Plan View of Replaced and Repaired Water Distribution Pipelines

city, which crossed or was immediately adjacent to the Sylmar segment of the San Fernando fault, was replaced. The replaced pipelines included mains constructed of riveted steel, continuous steel, and cast iron.

Figure 39 also shows the locations of individual pipeline repairs by the LADWP in relation to the Mission Wells and Sylmar segments of the fault and to the Harding School fault area. It is apparent that there is a high concentration of repairs within the zones of surface faulting. Within and adjacent to the Sylmar segment, there was substantial damage to a 600-mm-diameter steel pipeline. The line was constructed with welded slip joints both within and south of the fault zone, and with cement-caulked joints north of the fault zone. It is likely that the compressive forces generated by thrust within the fault zone were responsible for slip joint failures. The left lateral strike slip motion of the fault would have produced a net tension in this northwest-oriented line north of the fault, thereby causing pullout failure at the cement-caulked joints. Two repairs on a 200-mm-diameter pipeline with welded

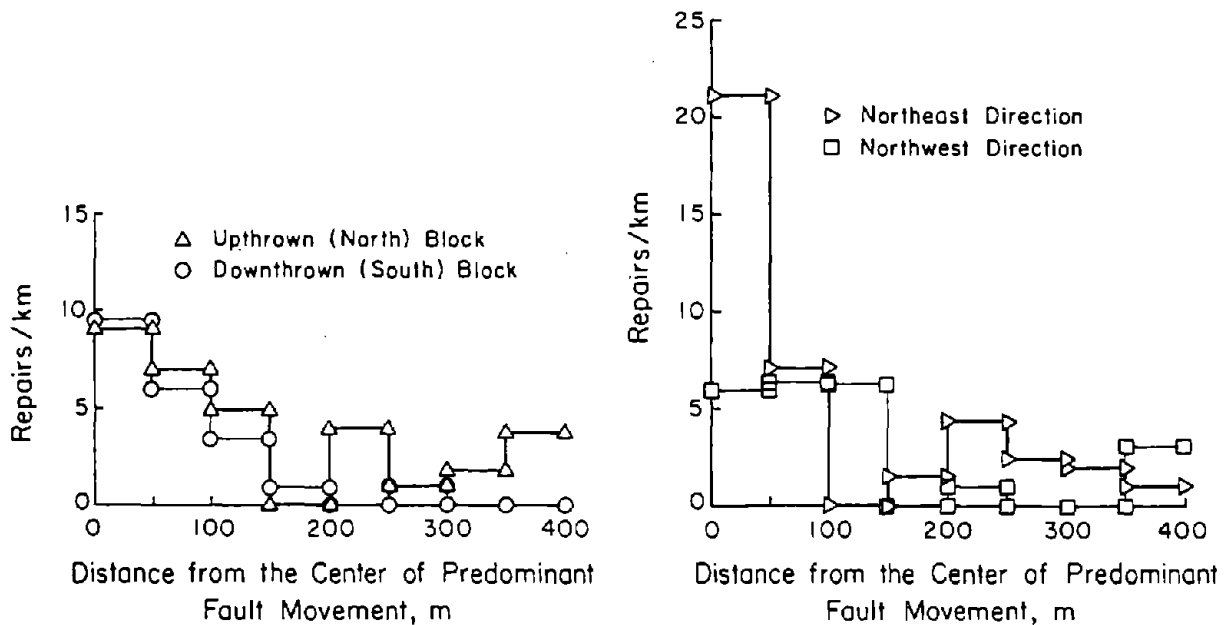
Figure 40 shows the number of gas main repairs per kilometer of pipeline plotted as a function of distance from the center of predominant fault movement. The repairs were determined for 50-m-wide intervals. The left side of the figure shows the number of repairs on the upthrown and downthrown sides of the fault normalized with respect to the total pipe length in each 50-m-wide interval on the upthrown and downthrown sides, respectively. In a similar manner, the right side part of the figure shows the number of repairs on the northeast and northwest-oriented pipelines normalized with respect to the total pipe length in each 50-m-wide interval for each group of northeast and northwest-oriented pipelines, respectively.

The relatively high number of repairs within 100 m of the fault centerline is related directly to the magnitude and severity of fault movement. At a distance greater than 200 m, there is a significant difference in the level of damage, with the greater number of repairs per kilometer on the upthrown block.

Figure 40. Gas Pipeline Repairs as a Function of Distance from the Fault Zone (after McCaffrey and O'Rourke, 1983)

strains from both the thrust and left lateral strike slip components of fault movement. The number of repairs per kilometer of pipeline at or near the fault centerline was nearly four times higher for the northeast, compared to the northwest-oriented, pipelines.

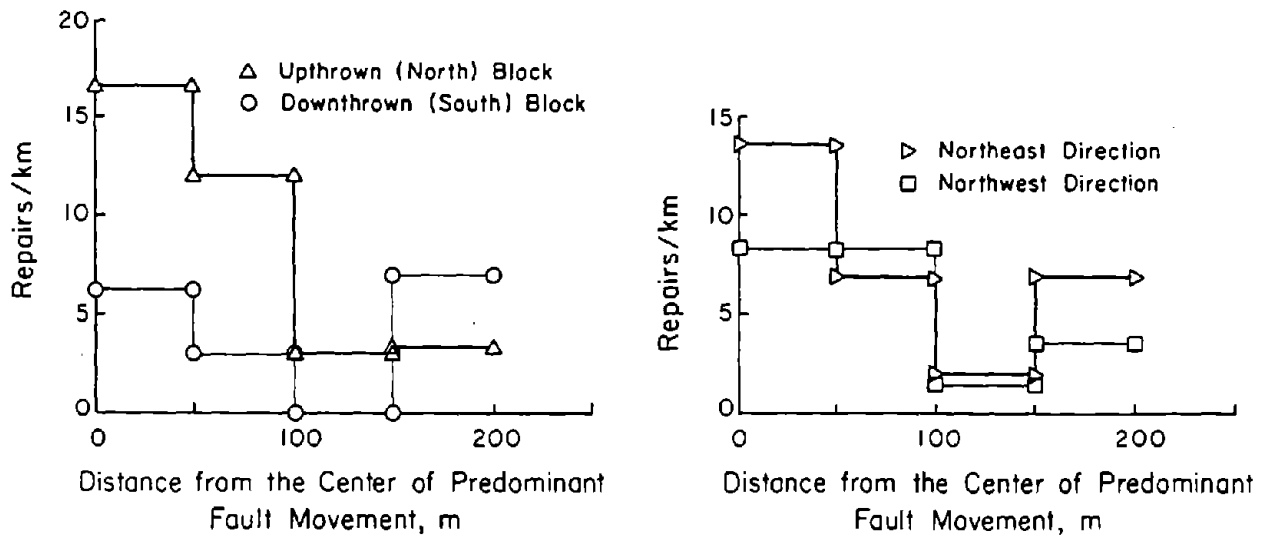
Figure 41 shows the number of water main repairs per kilometer of pipeline plotted in a similar fashion to Figure 40. The repair rate declines with increasing distance from the fault. Damage on the upthrown side of the fault apparently was more intense than on the downthrown side. Damage also was more severe for northeast-oriented lines near the center of surface faulting, presumably because the additive effects of thrust and left lateral slip resulted in excessive compressive strains. As shown in the figure, roughly 30 m of cast iron main shattered from compressive forces within the zone of faulting along a northeast-oriented street. At distances exceeding 50 to 100 m, the effect of pipeline orientation is less pronounced. Because cast iron pipelines are jointed, they are vulnerable to pullout forces which would have been

Figure 41. Water Pipeline Repairs as a Function of Distance from the Fault Zone

most severe in response to left lateral slip on northwest-oriented lines.

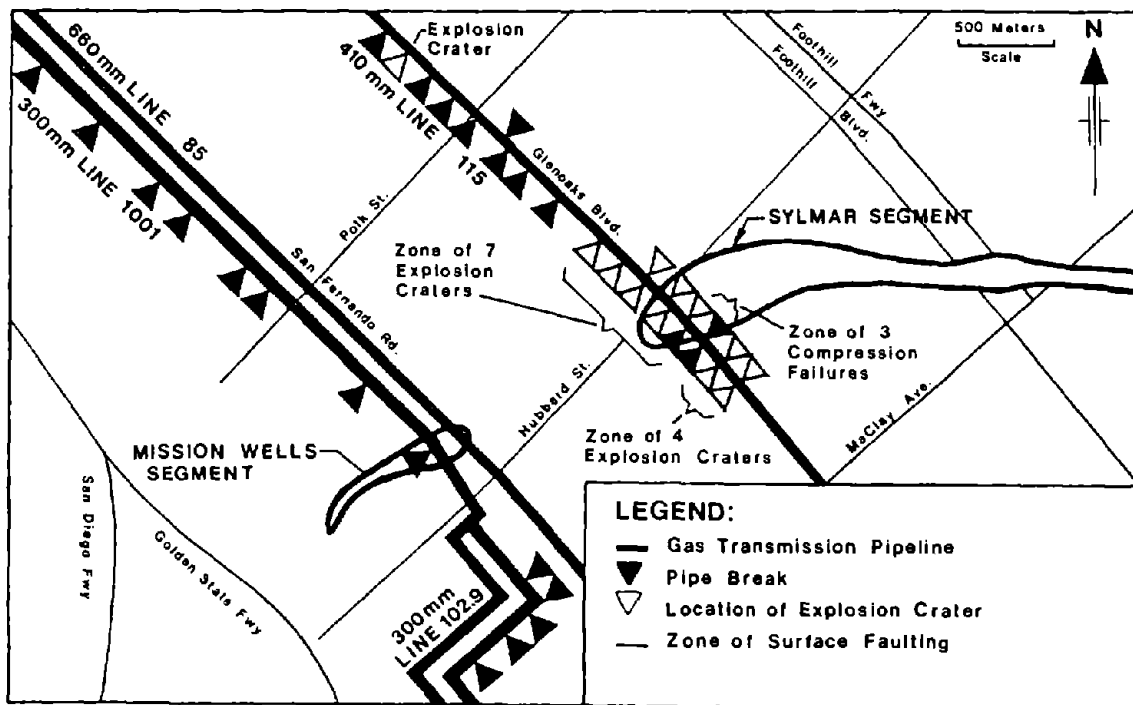
Figure 42 shows a plan view of the San Fernando area, on which are superimposed the transmission pipelines and outlines of the Mission Wells and Sylmar segments of the San Fernando fault. The approximate locations of pipeline damage, as well as the locations of explosion craters, are indicated. The explosion craters typically were 3 m to 5 m in diameter, and were formed by the sudden release of high pressure gas.

Figure 42. Plan View of Breaks and Explosion Craters for Gas Transmission Pipelines (after O'Rourke and McCaffrey, 1984)

The presence of explosion craters implies that damage to Line 115 occurred rapidly, before escaping gas at a given rupture could diminish pressures at other break locations. Most of the explosion craters were associated with tensile failures at welded joints, and at least one crater was located at a point of severe compressive wrinkling of the pipeline at the southern edge of the fault. Explosion craters at the fault edge and at substantial distances from the zone of faulting suggest that damage north of the fault occurred within a very short time of the damage from permanent ground movements at the fault. There were some fires caused by escaping gas, one of which was reported by Steinbrugge, et al. (1971) at the location of the southernmost crater on Line 115.

There was no damage to Line 85 in the area shown by Figure 42, even though the pipeline crosses the Mission Wells segment. Line 85 originally had been constructed with oxyacetylene welds, but later was repaired and rewelded using electric arc techniques.

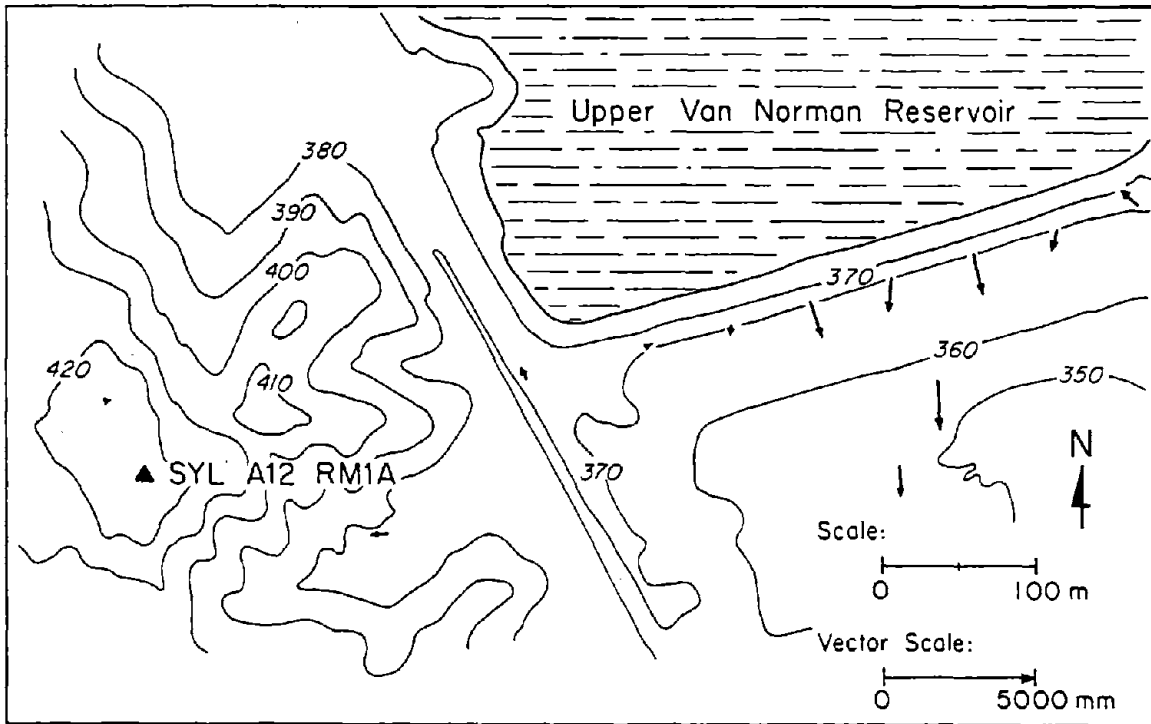
Figure B.6. Vectors of Displacement Determined from Air Photo Analysis Along the Crest and West of the Upper Van Norman Reservoir

are shown in Figure B.6. These measurements show that a maximum of 1.3 m of horizontal downstream movement and 1.4 m of settlement occurred at the utility poles located along the crest of the dam.

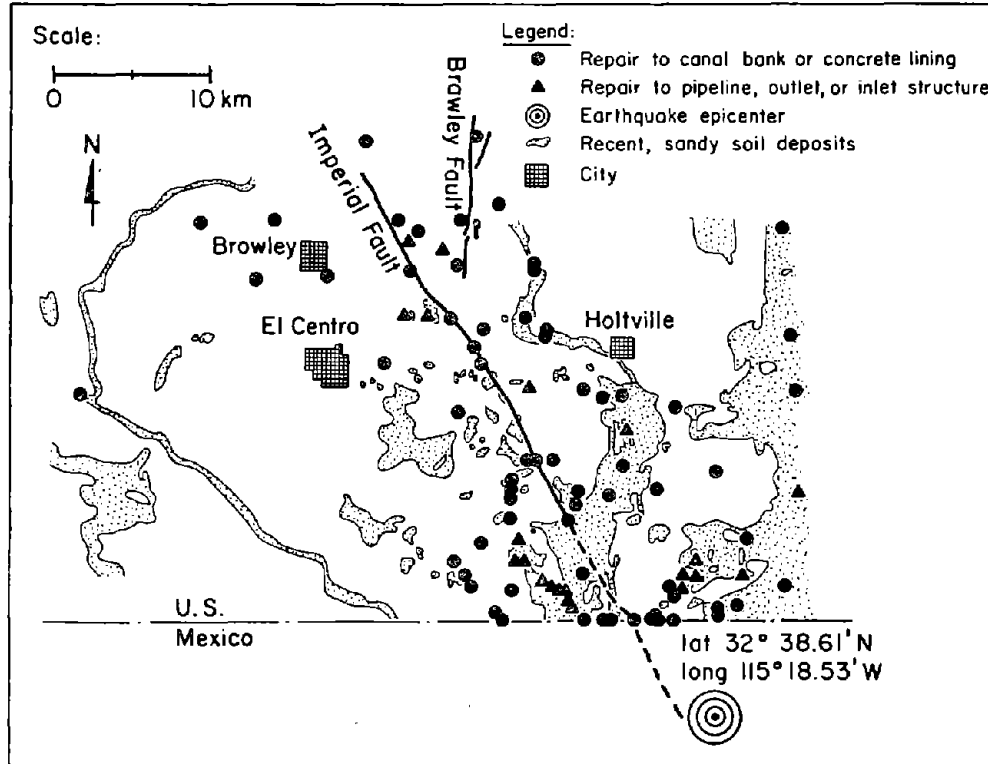
Figure 11. Relationship Between Repairs to Irrigation and Drainage Systems and Recent Soils (Soil Distribution after Strahorn, 1924)

Figure 11 shows a plan view of the Southern half of the Imperial Valley on which are superimposed circles and triangles representing repairs to the drainage and irrigation network as reported by the Imperial Irrigation District (1980a, b, c). The triangles represent damage to pipelines, inlets, and outlets and the circles represent repairs to cracked canals or where slumps occurred. Also shown in the figure are the outlines of the sandy soils as reported on the US Department of Agriculture (USDA) soil survey map of 1924 (Strahorn, et. al., 1924). These sandy soils are described as gravelly, fine, loamy, or coarse sands, riverwash, and dune sand. The areas not identified as sandy soils are clay and silty clay deposits.

The drainage and irrigation network forms a grid over the area affected by the 1979 earthquake. Thus, a correlation may be drawn between rates of repair and soil type. Other than repairs to canals which crossed the fault, about half of the repairs were in or on the margins of sandy soils, and half were in clayey soils. Since the sandy soils comprise only about 20% of the total land area, it is estimated that four out of five repairs would occur in canals in sandy soils

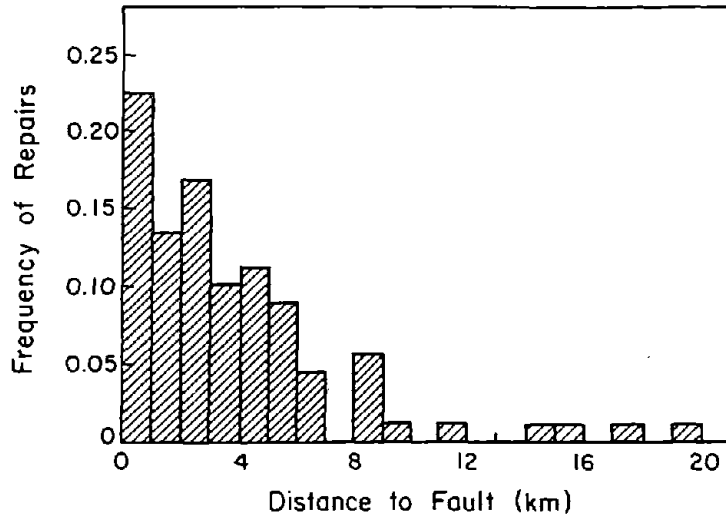
Figure 12. Frequency of Repairs to Irrigation and Drainage Facilities versus Distance to Imperial or Brawley Faults

Figure 12 presents the frequency of repairs as a function of the shortest distance to the Imperial or Brawley faults. At each repair location the shortest distance to either the Imperial or Brawley fault was measured. Each bar on the histogram represents the fraction of total repairs within a 1 km wide band parallel to, and on both sides of, the corresponding fault. The total number of repairs was 89. A clear trend of decreasing damage as the distance to the fault increases can be seen in this plot. Because the spatial distribution of irrigation and drainage systems was more or less uniform over the whole area, Fig. 12 reflects mainly the effect on damage of attenuation of ground shaking intensity with distance. Approximately 50% of the repairs occurred within

3 km of either fault and about 95% of the repairs occurred within 10 km of either fault. The frequency of repairs was evenly distributed east and west of the faults.

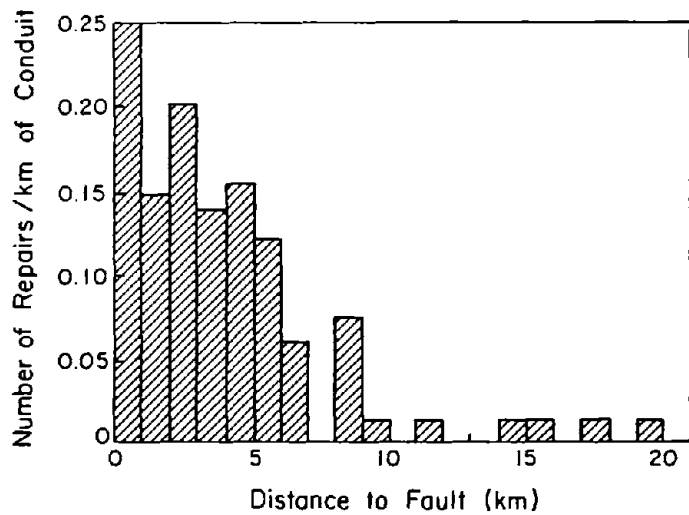
Figure 13. Number of Repairs/km versus Distance to Imperial or Brawley Faults

The rate of repair, expressed as repairs/km, is shown in Fig. 13 as a function of distance from either fault as defined above. The length of canal and pipeline within 1-km-wide bands either side of the causative faults was estimated by measuring the length of canals in each square mile section of the U.S. Geological Survey Quadrangle maps. The mean length of the canals in any section was found to be 4.8 km/square mile, which equals 1.82 km/km². The similarity in shape of the histograms in Figs. 12 and 13 relates to the fact that the density of irrigation conduits is relatively constant within the area of study.

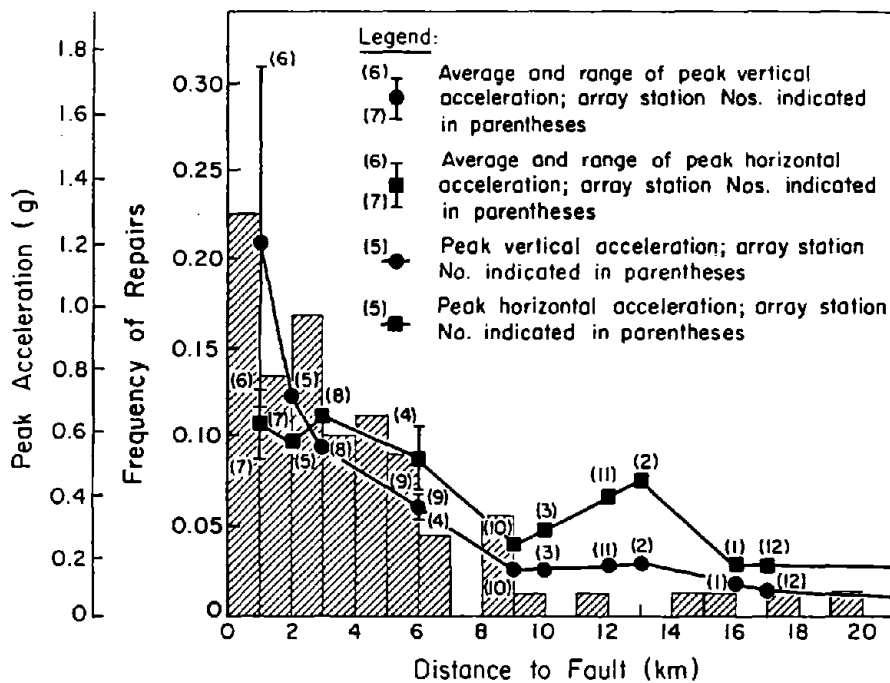
Figure 14. Frequency of Repairs to Irrigation and Drainage Facilities and Peak Vertical Acceleration versus Distance to Imperial or Brawley Faults

1 km from the Brawley fault, the peak horizontal acceleration was 0.72 g and at Array Station 7, which is 1 km from the Imperial fault, the peak horizontal acceleration was 0.52 g. The average peak horizontal acceleration, 0.62 g, is plotted as a square, and the peak horizontal acceleration range, 0.52 to 0.72 g, is represented by a vertical bar in the figure. The average peak vertical accelerations at Array Stations 6 and 7 are also plotted in the figure in a similar manner.

The attenuation curve for the peak vertical acceleration in Fig. 14 closely follows the trend of the frequency of repairs as a function of distance to the corresponding fault. The peak horizontal acceleration also shows a trend generally consistent with repair frequency, although the trend is not as well matched with repairs as that of the vertical accelerations. For distances to the fault up to about 9 km, both acceleration and repair frequency decrease rapidly with distance. Beyond 9 km, the frequency of repairs is low and more or less independent of distance; a similar trend is present in the acceleration curves, with the horizontal acceleration increasing somewhat between 9 and 13 km.

Clearly the need for repairs increased as the accelerations became more severe. Such a trend can be represented by an exponential function which is relatively simple in form and easy to evaluate.
