Case Studies of
Liquefaction and Lifeline
Performance During Past Earthquakes

Volume 2
United States Case Studies

Edited by
T. D. O'Rourke and M. Hamada

Technical Report NCEER-92-0002

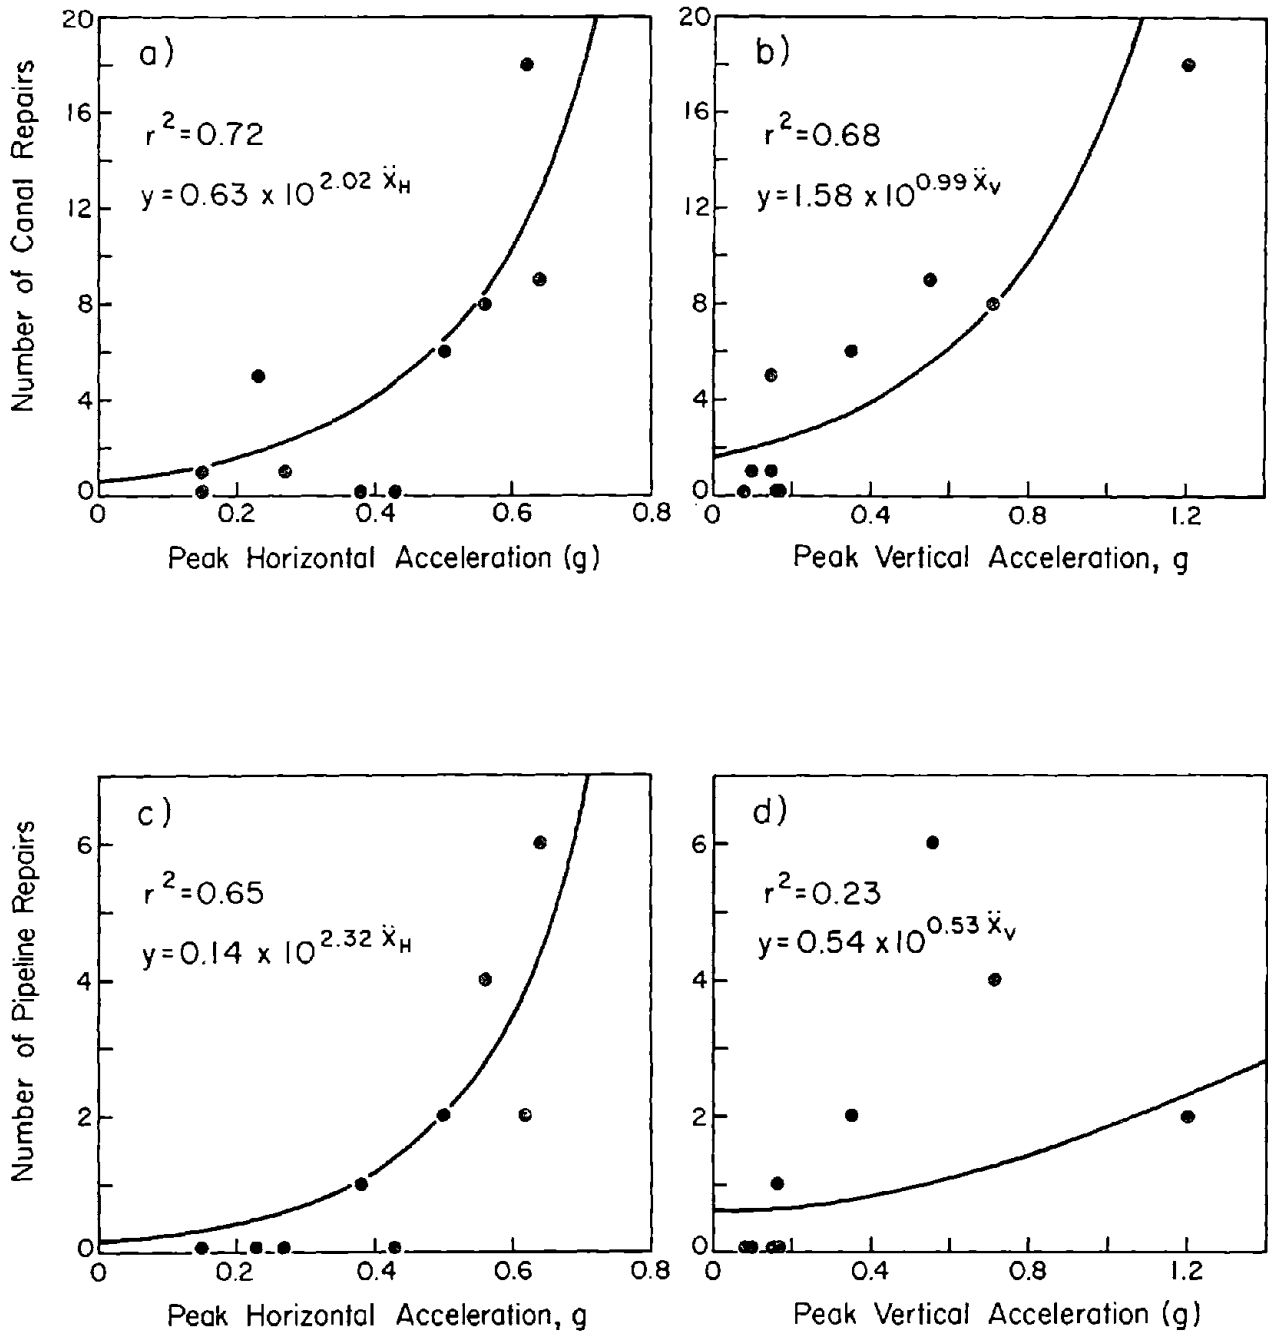
Figure 15. Relationships Between Number of Repairs to
a) Canals vs. Peak Horizontal Acceleration
b) Canals vs. Peak Vertical Acceleration
c) Pipelines vs. Peak Horizontal Acceleration
d) Pipeline vs. Peak Vertical Acceleration

To establish an upper bound relationship between number of repairs and peak acceleration, exponential regressions were developed as shown in Figs. 15a to 15d. These regressions represent conservative estimates of damage because their exponential form, by definition, requires that points of zero repair are discounted from the relationships. The number of repairs is related to the number of repairs per kilometer by dividing number of repairs by the approximate length of canals within a 1-km wide band.

There appears to be a well defined trend between the number of canal repairs and both peak horizontal and vertical acceleration. As shown in Figs. 15a and 15b, the coefficients of determination, r^2 , are 0.72 and 0.68 for exponential

regressions relating non-zero repairs and peak vertical and horizontal accelerations, respectively.

Figures 15c and 15d show the number of pipeline repairs in the irrigation and drainage system as a function of peak horizontal and peak vertical accelerations. Figure 15c shows that the non-zero number of repairs correlates reasonably well with peak horizontal acceleration. In contrast, Figure 15d does not show a clear relationship between number of pipeline repairs and peak vertical acceleration. The lack of a correlation between pipeline damage and vertical acceleration is consistent with theoretical models. Vertically oriented ground motion causes mainly bending deformation in horizontal pipes and the associated pipeline strains are from one to two orders of magnitude less than the longitudinal strains caused by horizontally oriented components of ground motion (O'Rourke, et al., 1985).

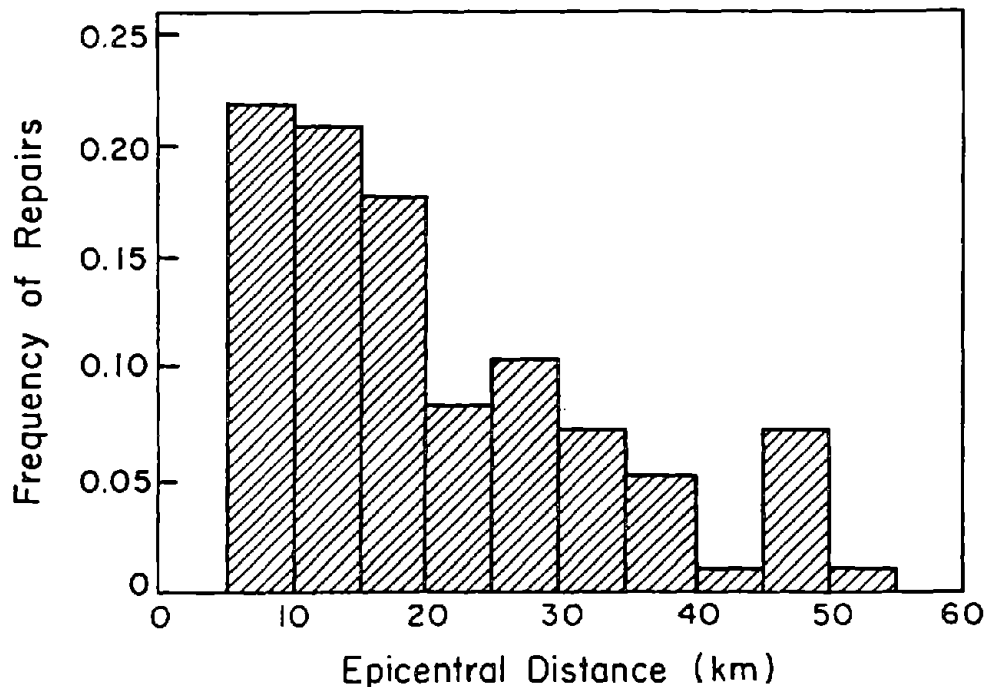
Figure 16. Frequency of Repairs to Irrigation and Drainage Facilities versus distance to Epicenter

The frequency of repairs was also investigated with respect to distance from the earthquake epicenter. Circular arcs centered at the epicenter were drawn at radial increments of 5 km. The number of repairs within each band was then counted. The results of the analysis are presented as the histogram of Fig. 16. The number of repairs decreases as the epicentral distance increases. Moreover, 60% of the repairs are within 5 to 20 km of the epicenter. Data were not available for the closest 5 km, which were located in Mexico. An anomalously large group of 7 repairs was observed at a distance of 45 to 50 km from the epicenter. These data can be attributed to the aftershock which occurred near Brawley around midnight on the 15th of October. This aftershock was reported by the residents of Brawley to have been stronger than the main shock: MMI VIII versus MMI VII, respectively, Nason (1982).

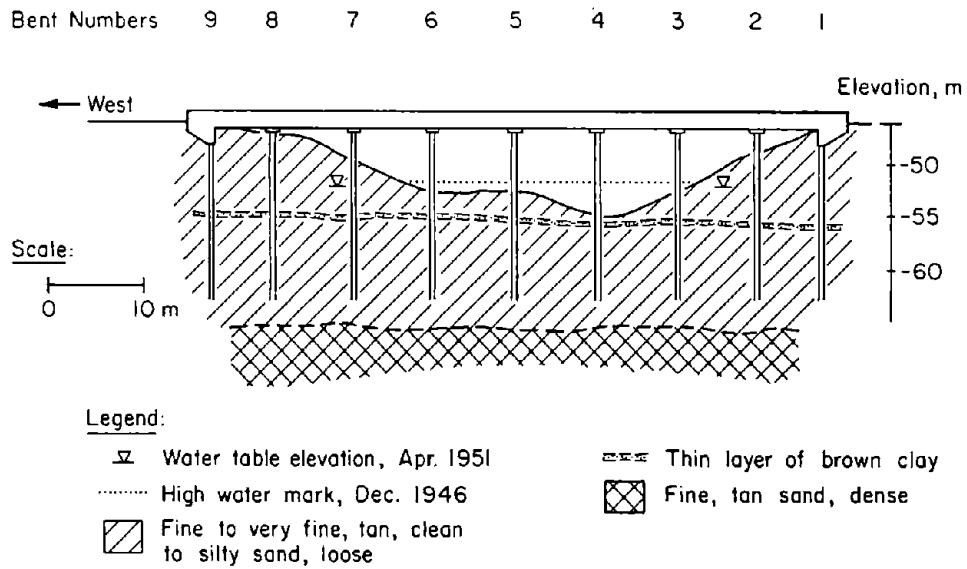
Figure 18. Profile View of Bridges 58-05 R/L at New River Showing Presumed Subsurface Conditions

A longitudinal view of the bridges is shown in Fig. 18. The subsurface conditions are presented qualitatively in the figure on the basis of borings prepared by the California Division of Transportation in 1951. The soils were described in the boring logs as fine to very fine loose sand with laminations of clay, silt, and silty sand to depths of 7-12 m below the ground surface. Underlying the loose, fine sand is dense, fine, clean sand. At the time of the exploration borings, the water table was located as shown in the figure. No in-situ penetration or laboratory tests were performed.

Before the 1979 earthquake, settlement and downslope movement of the embankment soils had been observed and epoxy had been applied to cracks in the concrete at the tops of piles. The maximum pre-earthquake soil movements were estimated to

be 175 mm; equivalent to the estimated maximum movement that resulted from the earthquake (Degenkolb and Jurach, 1980).

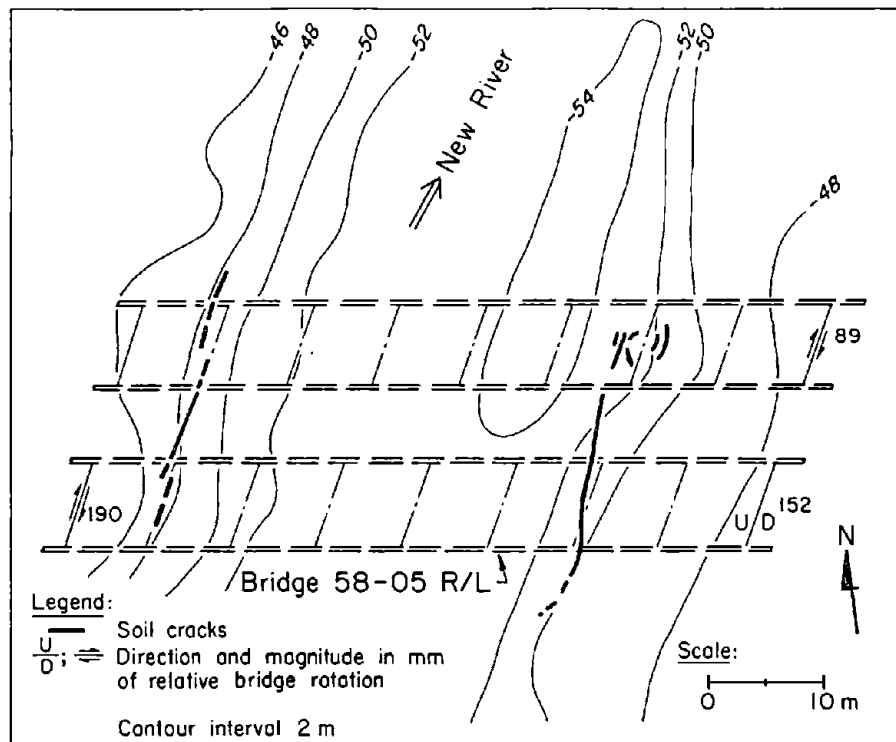
Figure 19. Plan View of Bridges 58-05 R/L Showing Ground Surface Topography and Location of Ground Cracks (after Youd and Wiczorek, 1982)

A plan view showing the location of earthquake-induced ground cracks and the relative movements of the bridges is shown in Fig. 19. Ground cracks and soil slumping were observed on both the east and west river banks. Soil slumped

toward the river at least 100 mm (Youd and Wieczorek, 1982). Conical depressions had formed on the downslope side of the base of the piles, and soil was compressed around the upslope faces. Settlement around the piles was measured as 40 mm. No sand boils were seen beneath the bridges.

Accounts of damage to the bridges were presented by Youd and Wieczorek (1982), Degenkolb and Jurach (1980), and Wosser, et al. (1982). Damage was relatively slight. Counterclockwise rotation of the superstructure in a horizontal plane cracked and tilted the support piles and the wingwalls. The tops of piles at Bent 2 (see Fig. 18) had open horizontal cracks on their northern faces and spalls on their southern. Similarly, the top of the piles at Bent 8 had open horizontal cracks on their southern faces and spalls on their northern faces. The piles at Bents 2 and 8 were tilted 3.2° in the direction of bridge rotation (Youd and Wieczorek, 1982). The relative rotation of the bridges and the pattern of concrete damage at the tops of the piles was most likely caused by southwestern movement of the foundation soils on the east bank of the river and northeastward movement of the foundation soils on the west bank of the river.

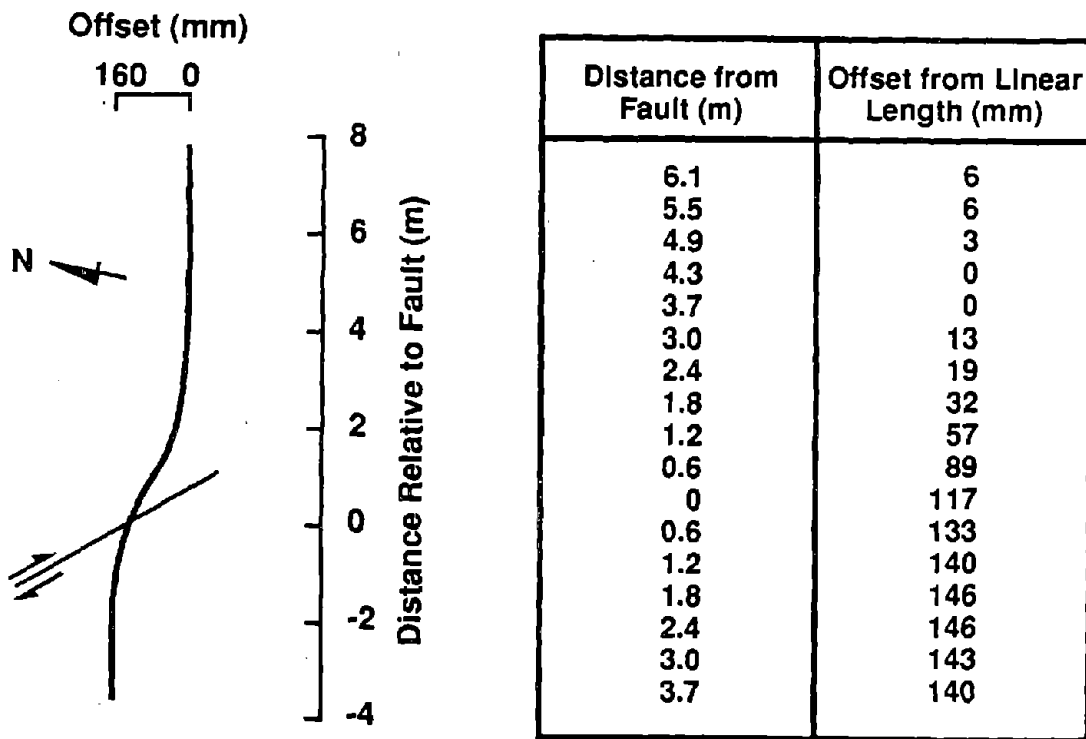
Figure 20. Deformed Shape of 114 mm Natural Gas Pipeline Along Highway S-80 after Excavating 9.8 m Long Trench

A detailed description of the pipeline inspection along Highway S-80 is provided by McNorgan (1989). The inspection of the pipeline by SCG began with a 9.8 m-long excavation centered at the fault. Upon removal of the backfill it was noted that the pipeline was deformed in an S-shape. The displacements perpendicular to the pipeline, relative to its position at the western edge of the trench, were measured by SCG personnel (McNorgan, 1989). A sketch of the pipeline-fault intersection, the deformed shape of the pipeline, and the results of these initial measurements are presented in Fig. 20. The measurements disclose a maximum offset of approximately 146 mm within a 9.6 m wide zone astride the fault centerline.

Due to the orientation of the pipeline with respect to the fault movement, net tensile stresses within the pipeline were induced by the right-lateral fault displacement. Stresses in the pipeline were relieved by excavating the backfill. Since no pipeline damage was observed, the excavation was backfilled without further remediation.

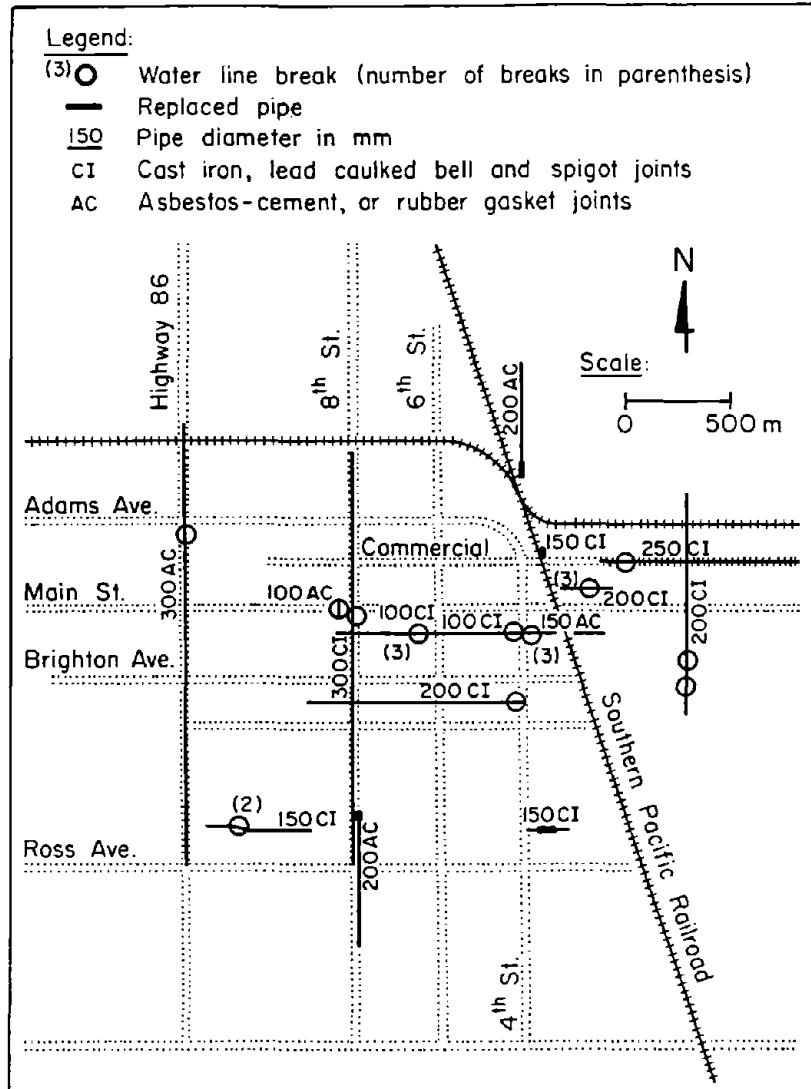
Figure 21. Plan View of the City of El Centro Showing Repaired and Replaced Water Lines

The City of El Centro is located 30 km north of the earthquake epicenter and 10 km west of the nearest fault break. A MMI of VII was estimated for El Centro (Nason, 1982). After the earthquake, 25 pipeline breaks were found in the water supply network (Eguchi, 1982). Water line repair and replacement locations compiled by the City of El Centro are shown in Fig. 21. The repair

records were checked with studies performed by Eguchi (1982). Three types of pipelines were in service at the time of the earthquake: cast iron pipes, asbestos cement pipes, and steel mains. The pipeline diameter in millimeters for each damaged line is shown in the figure. The locations of pipeline breaks are shown as open circles with a number adjacent to the circle indicating the number of breaks. Replaced line segments are indicated by heavy solid lines.

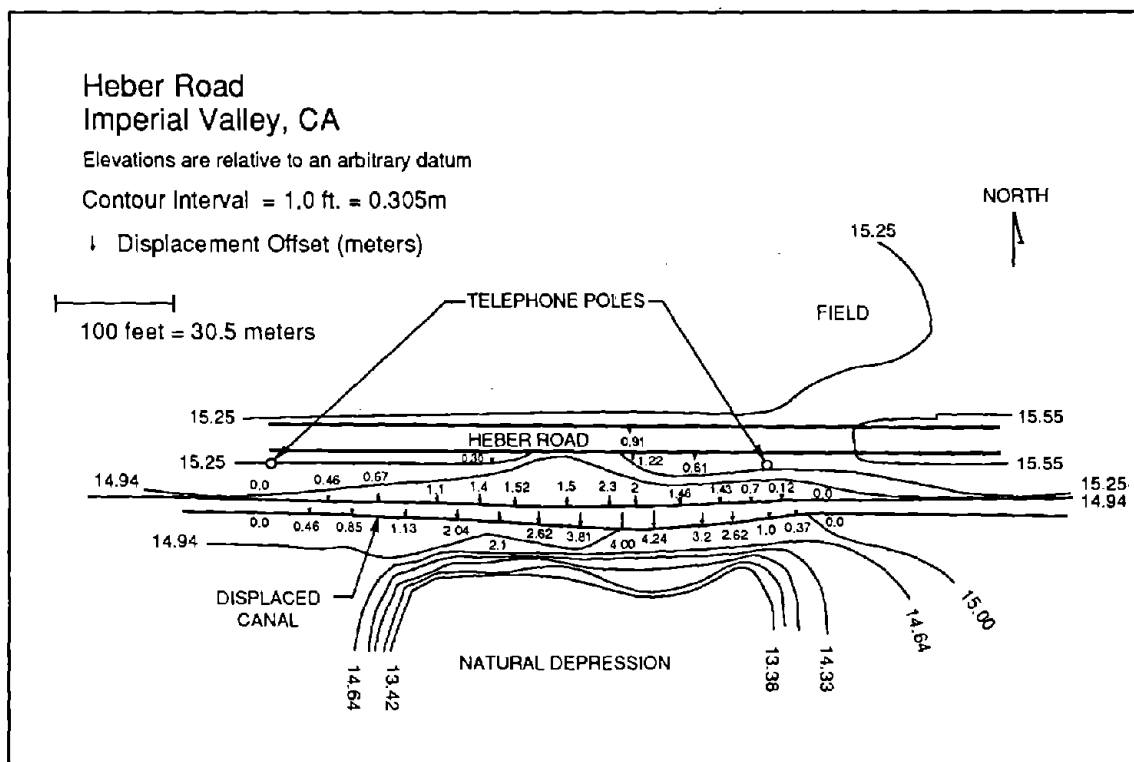
Figure 23. Heber Road Site Deformation Due to the 1979 Earthquake (Measurements and Mapping by S. F. Bartlett and T. Y. Youd)

It must be noted that both Youd and Bennett (1983) and Castro (1987) utilized the maximum and average observed displacements reported at the time (2.1 and 1.7 m, respectively). These numbers are consistent with displacements measured north of the canal in the subsequent survey shown in Fig. 23, but they are smaller than those measured at the southern edge of that canal (4.2 m maximum displacement).

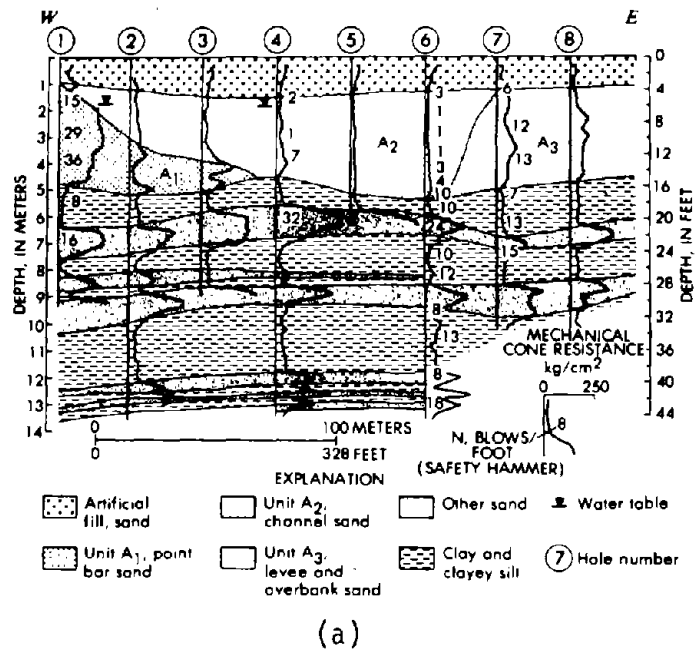
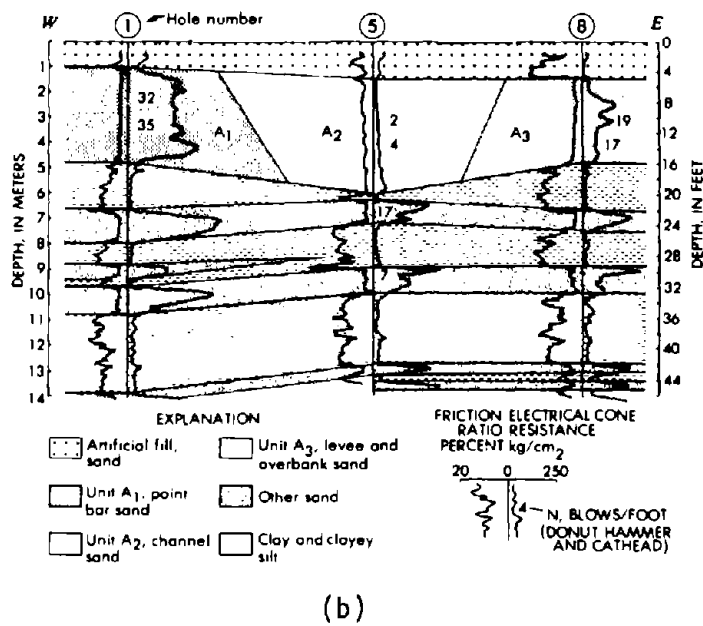
A 0.9 m to 1.5 m thick layer of sandy fill caps the Heber Road site. Beneath the fill, the cross-section contains a 3.4 m to 4 m thick layer composed of silt and fine sand with three distinct subunits. A dense fine sand of point-bar origin (Unit A₁) lies beneath the fill in the western

part of the section. This sand is characterized by static cone point resistances of 110 kg/cm² to 180 kg/cm² (mechanical) or 120 kg/cm² to 260 kg/cm² (electrical) and SPT-values of 29 to 36 blows/ft (safety hammer) or 32 to 35 blows/ft (donut hammer). The central part of the section contains loose, very fine sand and silty sand that is a natural channel fill deposited by the ancient stream (Unit A₂). This sand is characterized by static cone point resistances of 10 kg/cm² to 40 kg/cm² (mechanical) or 10 kg/cm² to 50 kg/cm² (electrical) and SPT-values of 1 to 7 blows/ft (safety hammer) or 2 to 4 blows/ft (donut hammer). The eastern part of the section contains moderately-dense sand and silty-sand overbank deposits (Unit A₃ characterized by static cone point resistances of 25 kg/cm² to 75 kg/cm² (mechanical) or 20 kg/cm² to 125 kg/cm² (electrical) and SPT-values of 9 to 13 blows/ft (safety hammer) and 17

to 19 blows/ft (donut hammer). The water table depth was at about 1.8 m during the tests in December 1979 and January 1981, and at about 2.6 m during the tests in May 1982. Below the fluvial sand units lie alternating, continuous layers of medium-stiff lacustrine clays and dense channel or deltaic sands. The electrical point cone resistance (CPT) values given above are consistent with results from similar tests at the Heber Road site reported by Douglas and Martin (1982).

Surficial effects of liquefaction were concentrated over Unit A₂ (Channel Fill, CF), the old channel, the loosest saturated sand in the section. Clearly, this is the unit that liquefied during the 1979 earthquake. Pore water pressures may have risen in the other sand units including Units A₁ (Point Bar, PB) and A₃ (Levee, L), but other than the linear array of sand boils over a drain line east of the channel, no surficial liquefaction effects occurred beyond the channel.

Figure 24. Soil Profile of Heber Road Site (Youd and Bennett, 1983)
 a) Cross-section of sediments
 b) Logs showing electrical CPT records and SPT N-values

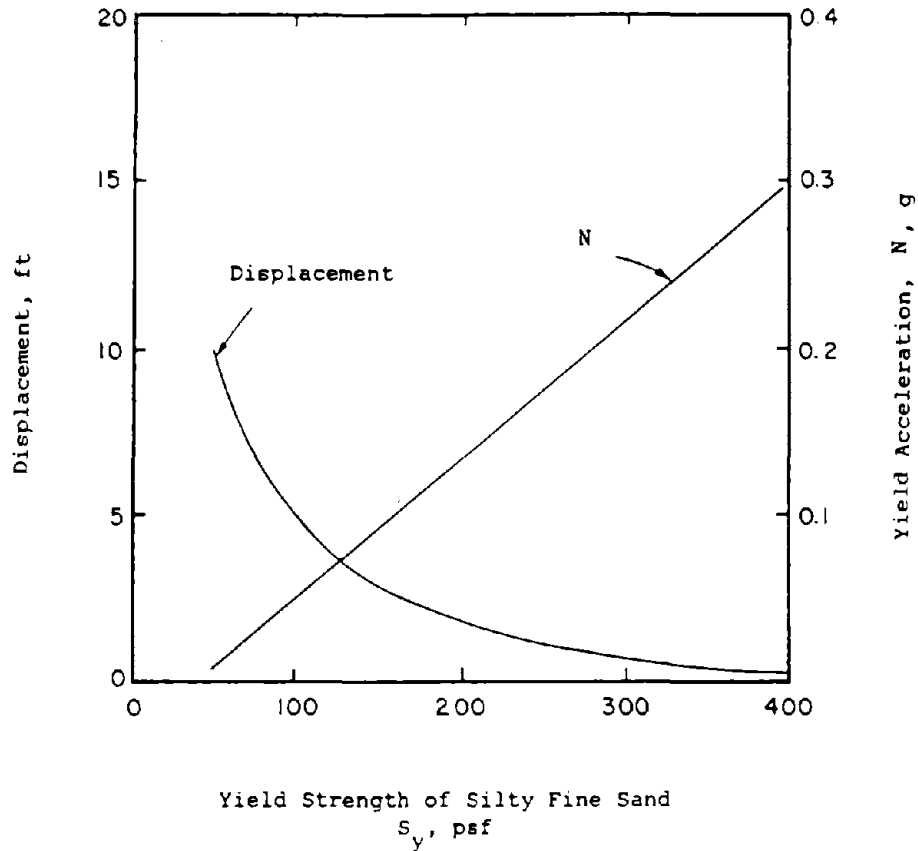
Figure 29. Calculated Displacements for Heber Road Using Newmark's Sliding Block Method (Castro, 1987)

Castro (1987) used the same Bonds Corner record, $a_{max} = 0.8 \text{ g}$, and the G_{max} field data obtained by Sykora and Stokoe (1982) to analyze the Heber Road site. In his method he used the Newmark type analysis to evaluate the lateral displacement (Fig. 29). He concluded that only the yield acceleration of Unit A₂ was less than the average acceleration computed for the sliding block during the earthquake, thus suggesting that only this unit would experience large deformations. This is in agreement with the field observations. He backfigured from the 1.68 m measured average displacement of the road, a value of 4.79 Kpa yield strength from Fig. 29. This is consistent with the very loose condition of the soil as indicated by the low measured blow counts (SPT) of 0 to 1 blow/ft and cone penetration resistance (CPT) of about 490 to 1471 Kpa.

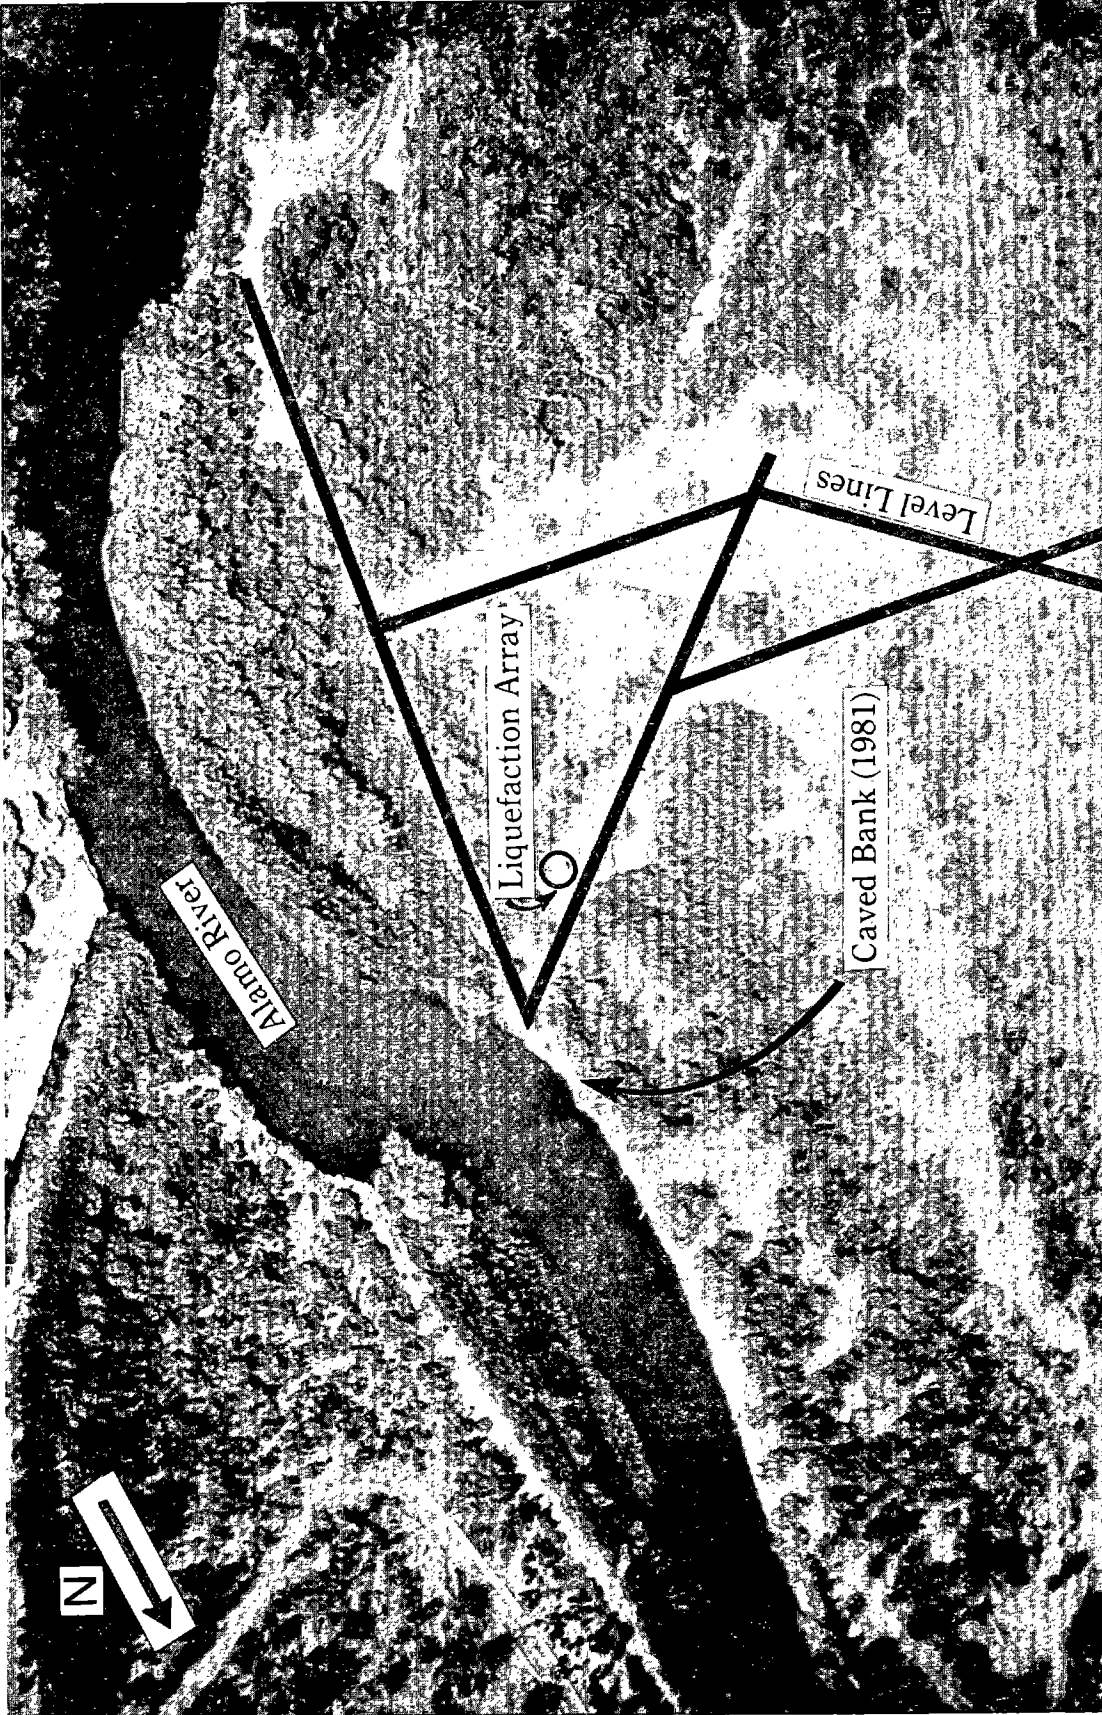
Figure 32. Aerial Photograph Showing Alamo River Location of Wildlife Array, and Slump in the Bank of Alamo River

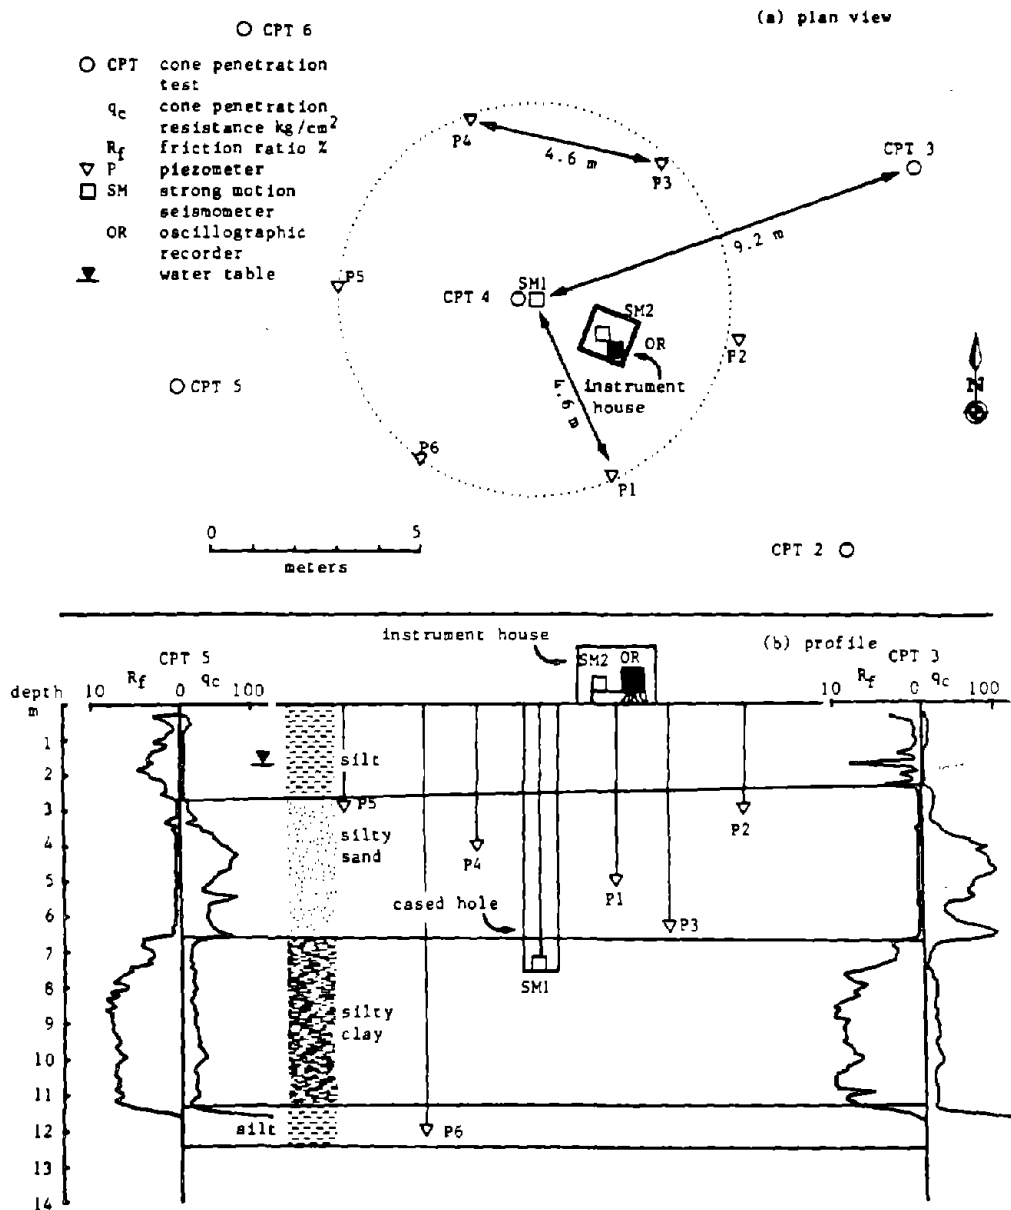
Figure 37. Cross-Section of Wildlife Site Showing Location of Piezometers (Bennett, et al., 1984)

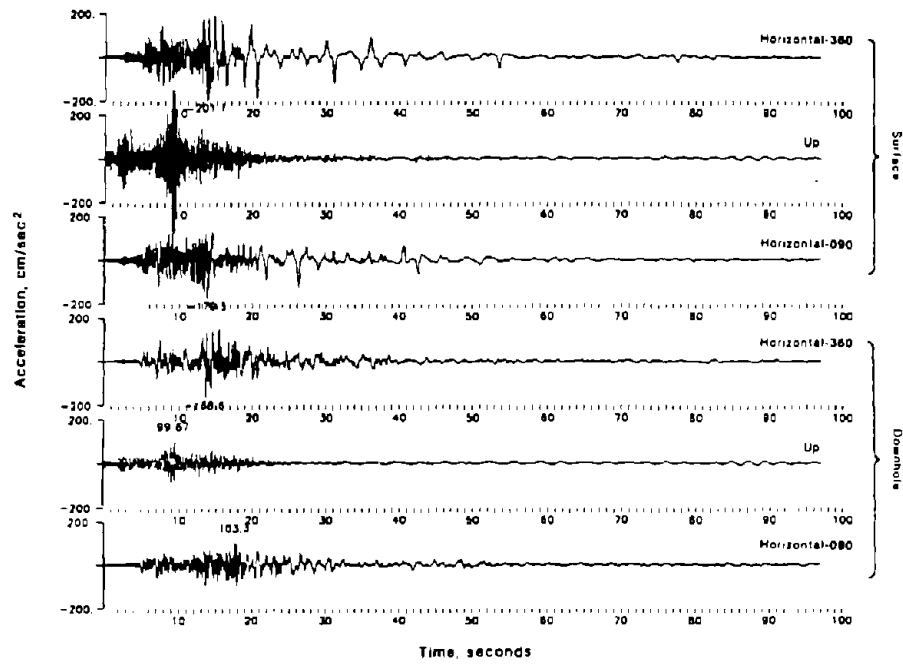
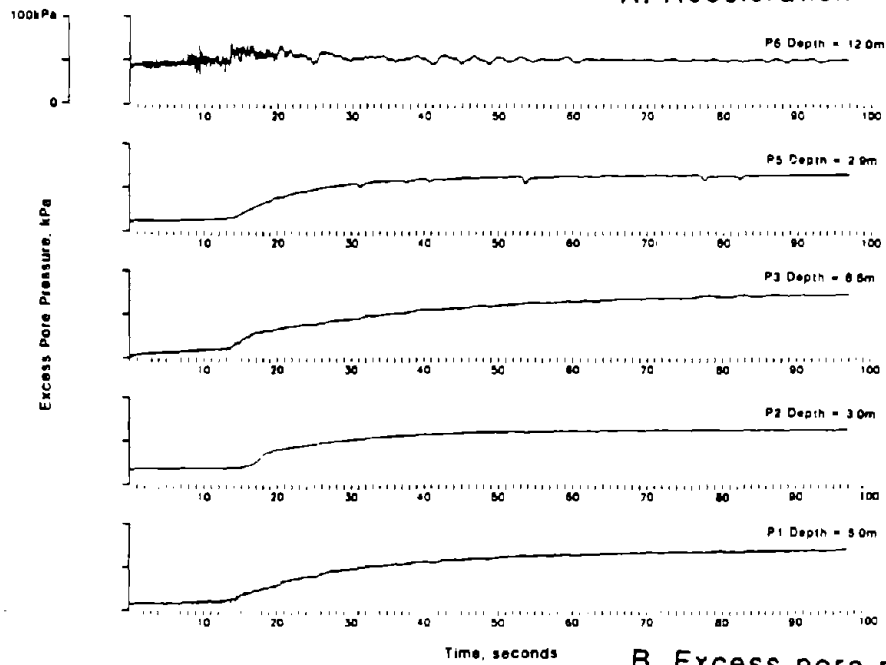
Figure 38 shows that there was a time delay in the pore pressure increases with respect to the strong part of the shaking. The pore pressures continued to rise after the strong ground shaking had essentially ceased, with about half of the total increase occurring during the latter period. As reported by Youd and Bartlett (1988), possible reasons for this continued rise include:

Figure 38. Instrumental recordings from the November 24, 1987 Superstition Hills Earthquake (Holzer, et al., 1989a)

It is interesting to note that the ground surface accelerogram of Figs. 38 and 39 exhibits a dozen or so high frequency spikes as high as 0.12 g, predominantly negative, with their timing corresponding precisely to simultaneous fast transient pore pressure drops in the shallow piezometers, P_2 and P_5 . These accelerations/pore pressure spikes are probably associated with the dynamics of the lateral spreading (Holzer, et al., 1989a; Dobry, et al., 1989).

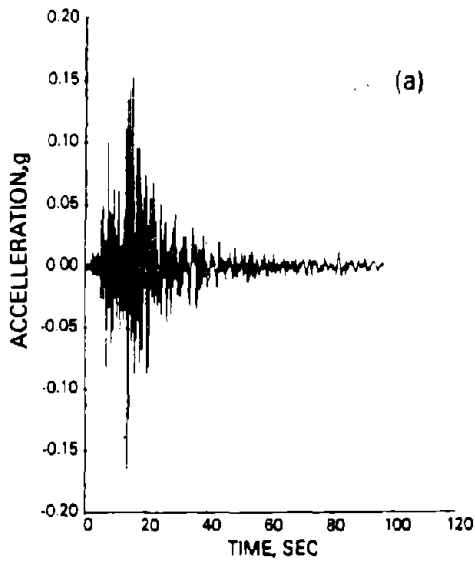
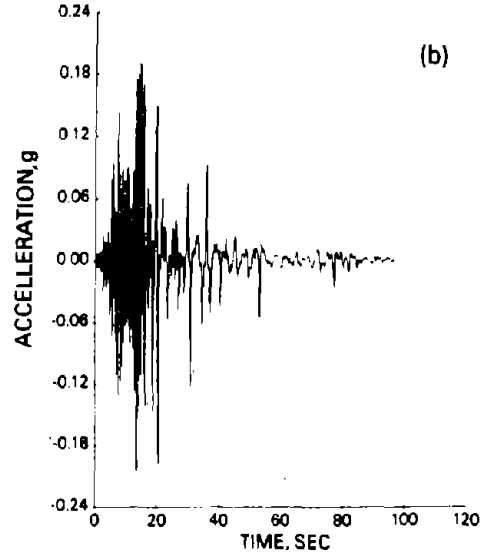
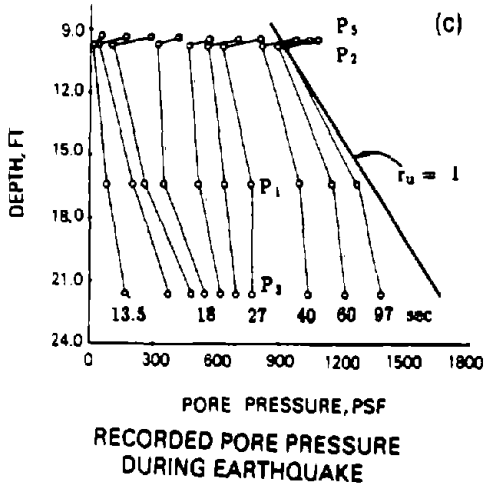
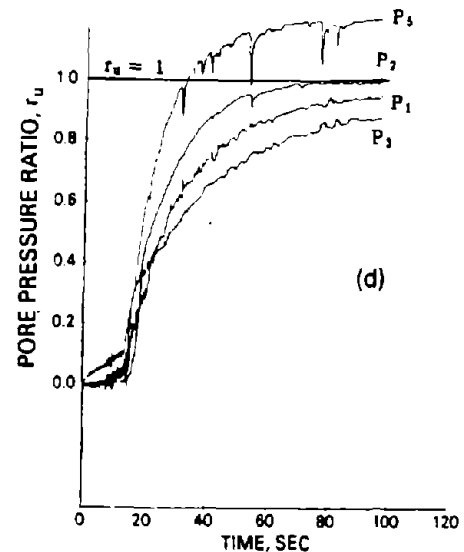
Figure 39. Recorded Accelerations (NS Components) and Piezometric Readings at Wildlife Site During the November 24, 1987 Earthquake (Dobry, et al., 1989)

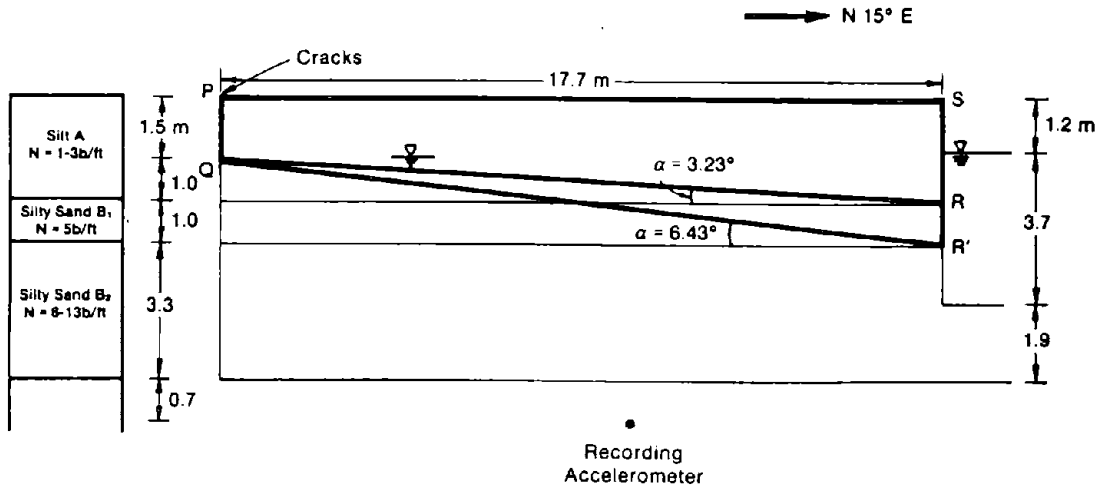
Baziar and Dobry (1991a, b) evaluated the 180 mm lateral spreading in the N15°E direction shown in Fig. 40, using Newmark's sliding block method of analysis. Figure 41 presents the two sliding blocks analyzed, under the assumption that the failure occurred in the top loose to very loose sandy silt and silt layers. In Fig. 41, it was assumed that the vertical crack which opened 17.7 m from the river (see Fig. 40), marked the end of the sliding block. In the analysis, it was assumed that the block could only slide toward the free face along the river,

Figure 41. Soil Profile and Assumed Failure Planes for Newmark Analyses, Wildlife Site, November 24, 1987 Earthquake (Baziar & Dobry, 1991a)

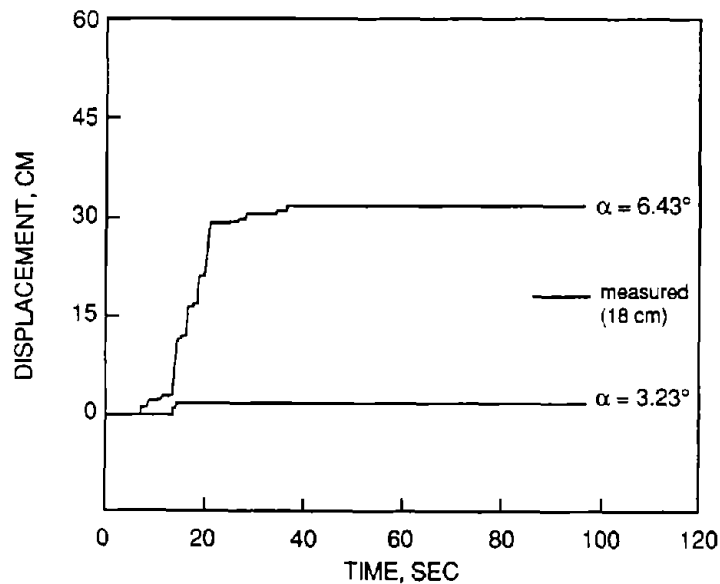
Figure 43. Measured and Predicted Displacement at Wildlife Site Using Newmark Analysis and Recorded Accelerogram, the November 24, 1987 Earthquake (Baziar & Dobry, 1991b)

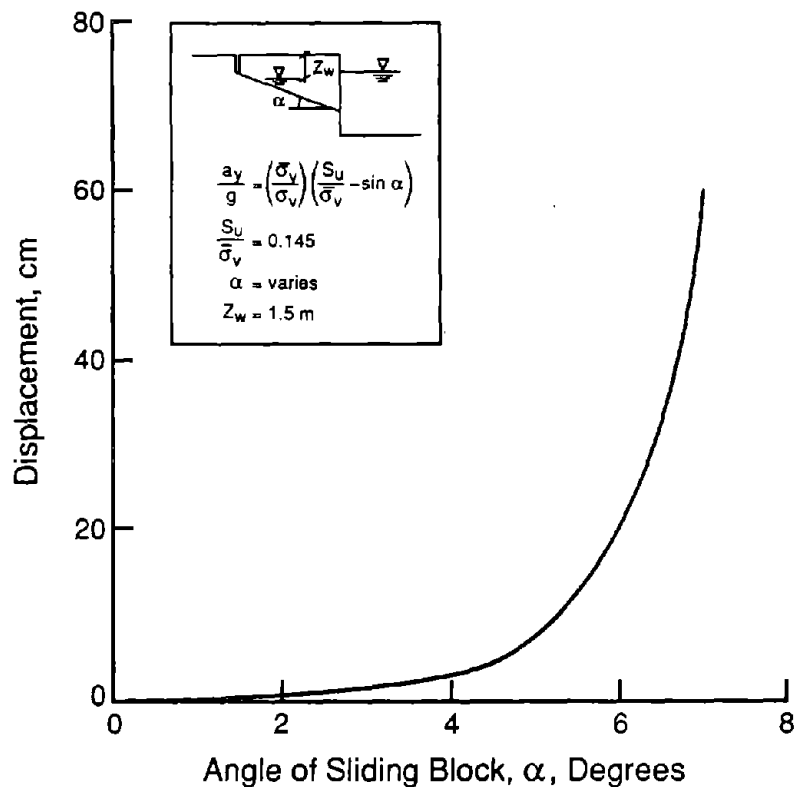
Figure 42 presents the results of laboratory tests on loose reconstituted layered silty sand deposited in water used to determine the residual shear strength of the soil, S_u , used in the analysis. These tests provided an estimated in-situ $S_u = 0.145 \bar{\sigma}_v$, where $\bar{\sigma}_v$ = vertical effective overburden pressure, which was in turn used to obtain the yield accelerations at which either of the two blocks in Fig. 41 started sliding toward the river. Figure 43 shows the comparison between predicted (19 and 317 mm) and measured (180 mm) lateral ground displacements (see Baziar and Dobry, 1991b for more details). The two predicted displacements bound the measured value, and this provides a degree of confidence about the residual shear strength and failure mechanisms assumed in the analyses. On the other hand, the sensitivity of the calculated displacement, which varies by a factor of 17 when either of the two failure mechanisms of Fig. 41 is assumed, illustrates the uncertainties involved in the analytical prediction of permanent ground displacements due to lateral spreading. Figure 44 shows how the predicted displacement in this case increases as the slope angle α in Fig. 41 goes from $\alpha = 0^\circ$ to $\alpha = 7.0^\circ$.

Figure 44. Effect of Sliding Block Angle of the Wildlife Site on Predicted Displacement (Baziar & Dobry, 1991b)

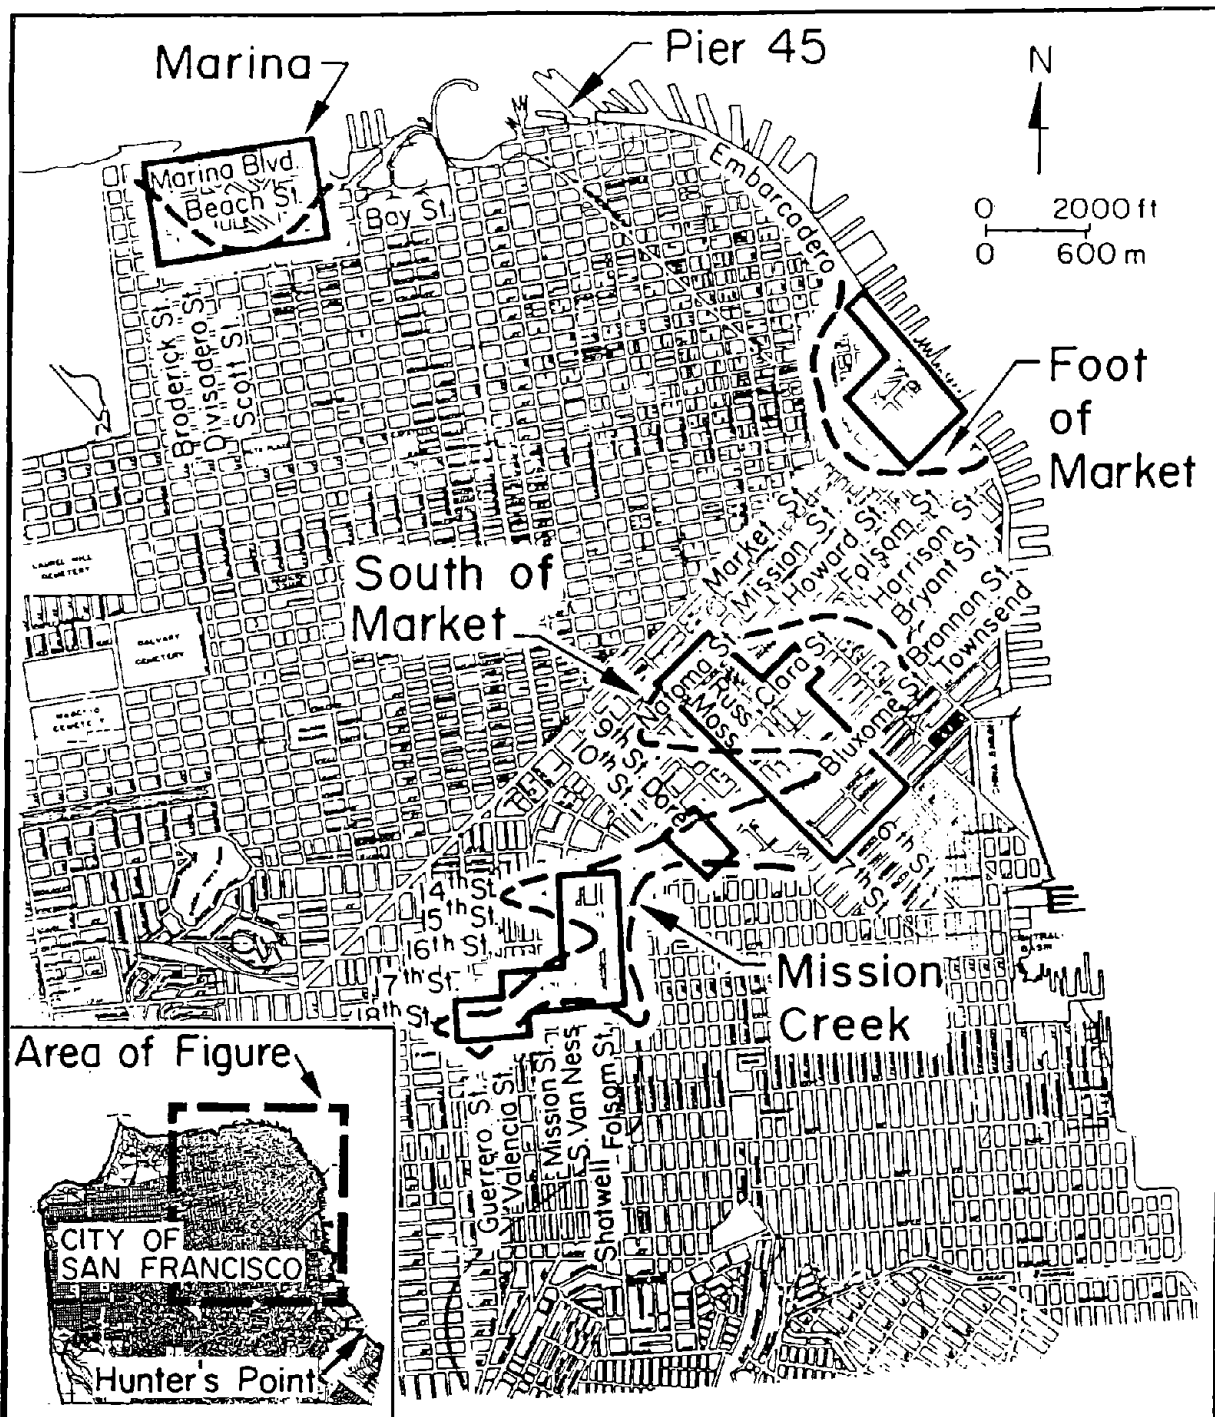
The areas of prominent soil liquefaction in 1989 and 1906, shown in Figure 8, include the Mission Creek, South of Market, Foot of Market, and Marina districts. Each of these areas was investigated after the 1989 earthquake within

Figure 8. Plan View of San Francisco Showing Zones of 1906 Soil Liquefaction and Inspection After the 1989 Earthquake

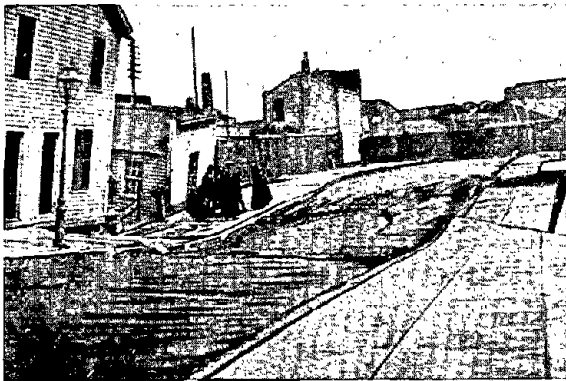
Photo a. Large Differential Settlement on Dore St. Between Bryant and Brannon Sts. in 1906 [after Lawson, et al., 1908]

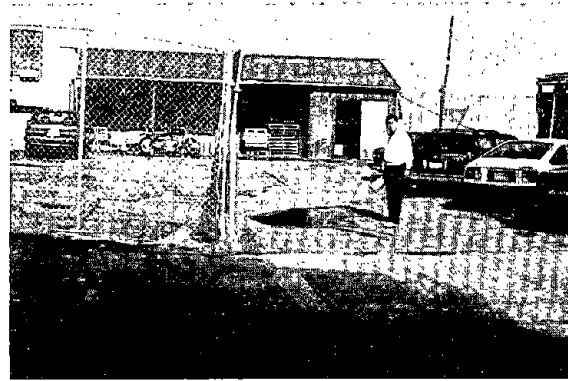
Photo b. Differential Settlement Along Dore St. Just North of Bryant St. in 1989 (photograph by T.D. O'Rourke)

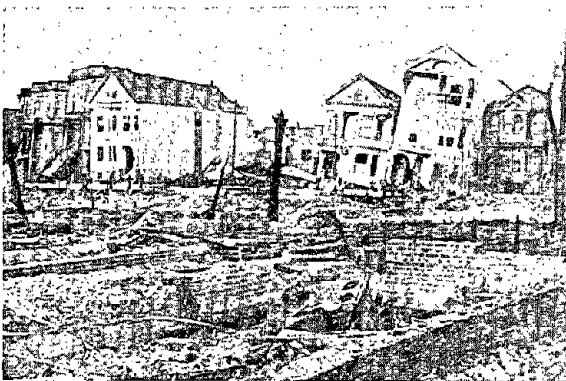
Photo c. Racking and Settlement of Houses on South Van Ness Between 17th and 18th Sts. in 1906 [after Lawson, et al., 1908]

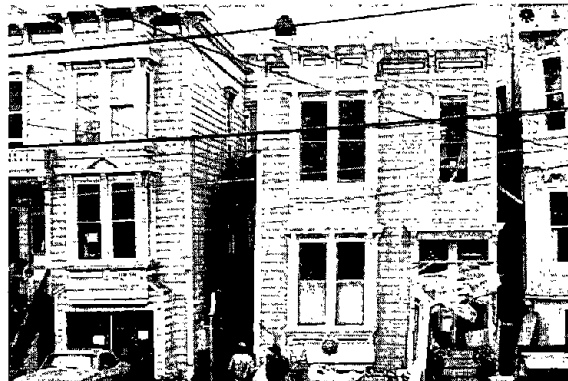
Photo d. Racking and Settlement of Houses on Shotwell St. Between 17th and 18th Sts. in 1989. These Houses are Directly Behind the Location of Houses in Photo c (photograph by T.D. O'Rourke)

structures in 1989 on the west side of Shotwell St. between 17th and 18th Sts. In contrast to this damage, the area west of Mission St. apparently was unaffected by soil liquefaction, even though lateral spreading and subsidence of 1.5 to 2.0 m were observed at Valencia and Guerrero Sts. in 1906.

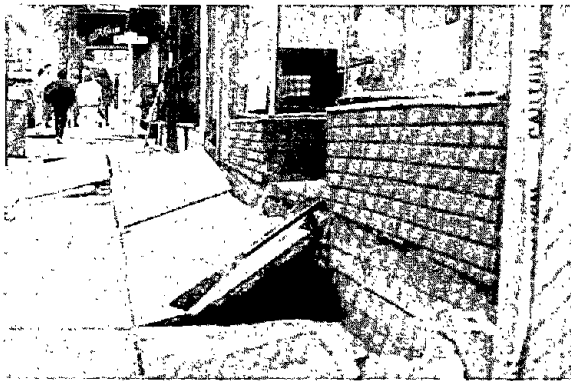
Sand boils were observed along curb and building lines at various locations on 7th, 6th, Natoma, Russ, Moss, Clara, Bluxome, and Townsend Sts. From Mission to Folsom St., 10 to 30-mm-wide cracks were observed down the centerline of 7th St., with differential settlement to the east and west of the cracks. As shown in Photo a, differential movement of roughly 300 mm was observed at the southeast corner of Natoma and 7th Sts., with severe deformation of the two and three-story timber frame buildings at this location. The differential movement was caused by both settlement along the sidewalk and uplift of the building. The building was founded on a continuous concrete mat with contiguous basement walls. This water-tight foundation was subjected to buoyancy forces. When the building was demolished, uplift deformation of the foundation mat could be seen clearly in the remains of the mat and basement walls exposed by removal of the superstructure. This building and adjacent ground deformations were close to the location where a 300-mm-diameter water main ruptured, which will be

Photo a. Differential Movement of 100 to 300 mm Adjacent to Building at Corner of 7th St. and Natoma St. (photograph by T.D. O'Rourke)

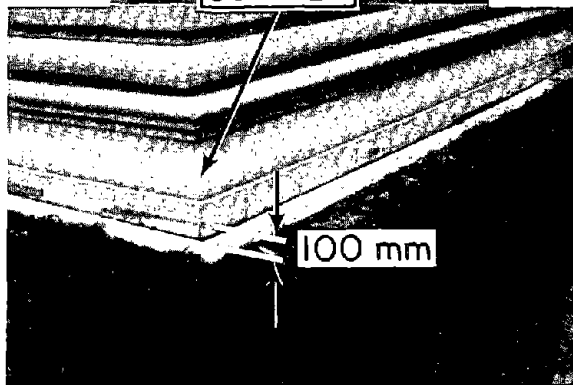
Photo b. Settlement of 100 mm at U.S. Post Office, Corner of 7th and Mission Sts. (photograph by J. Isenberg)
