Case Studies of
Liquefaction and Lifeline
Performance During Past Earthquakes

Volume 2
United States Case Studies

Edited by
T. D. O'Rourke and M. Hamada

Technical Report NCEER-92-0002

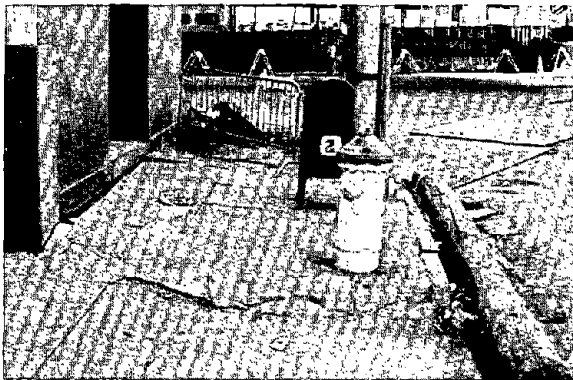
Photo c. Differential Settlement at Corner of 6th St. and Townsend St. (photograph by T.D. O'Rourke)

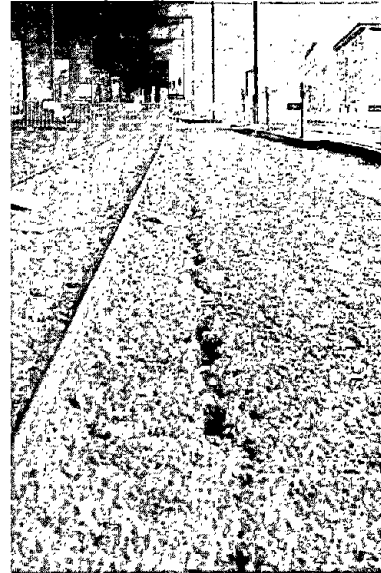
Photo c shows a prominent 25-mm-wide crack which opened beneath the Embarcadero Freeway, running parallel to the seawall for the full distance between Howard and Mission Sts. The crack indicates lateral movement toward the bay at a distance of about 20 m behind the seawall. Differential settlements of 25 to 100 mm were observed adjacent to the pile-supported columns of the Embarcadero Freeway, as shown in Photo d.

Photo c. Open 25-mm Crack Beneath the Embarcadero Freeway Between Howard and Mission Sts. Showing Movement Toward the Bay (photography by T.D. O'Rourke)

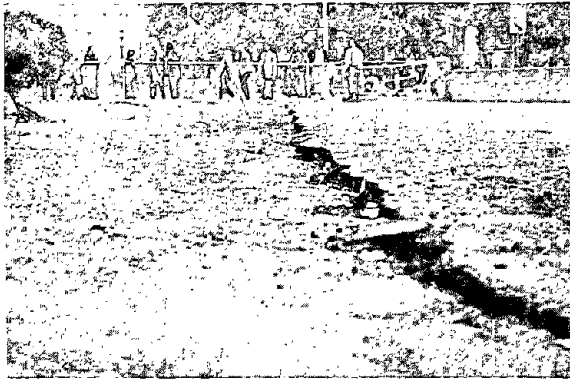
Photo a shows a prominent crack, with as much as 100 mm of vertical offset, which occurred in 1989 immediately north of the intersection of Market St. and Embarcadero. The crack extended roughly 60 m in a northeasterly direction from the intersection. In comparison, Photo b shows fissures after the 1906 earthquake in the pavement along East St. (now the Embarcadero) about two to three blocks south of Market St. These fissures are evidence of vertical and lateral movements of approximately 600 to 900 mm toward the bay.

Photo a. Differential Settlement on the Embarcadero Near the Intersection of Market St. in 1989 (photograph by T.D. O'Rourke)

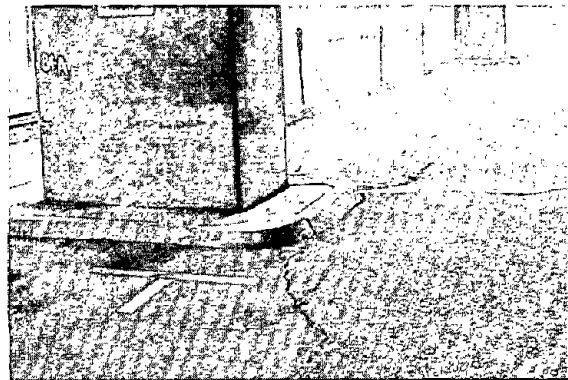
Photo d. Differential Settlement Adjacent to Pile-Supported Column of Embarcadero Freeway Near Mission St. (photograph by T.D. O'Rourke)

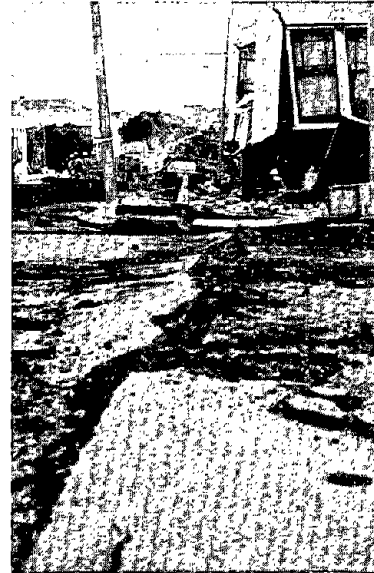
Photo c. Buckled Pavements and Ground Deformations at Corner of Divisadero St. and Jefferson St. (photograph by T.D. O'Rourke)

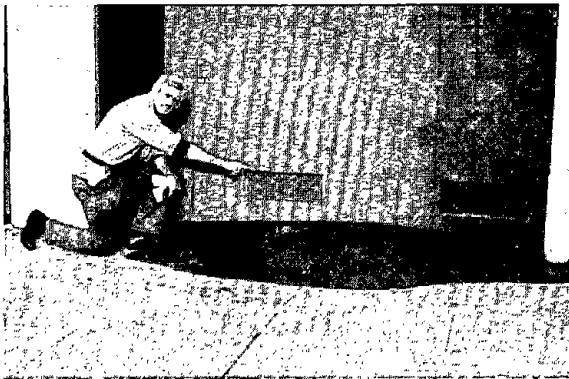
Photo a. Sand Ejected from Garage of Building on Scott St. (photograph by H.E. Stewart)

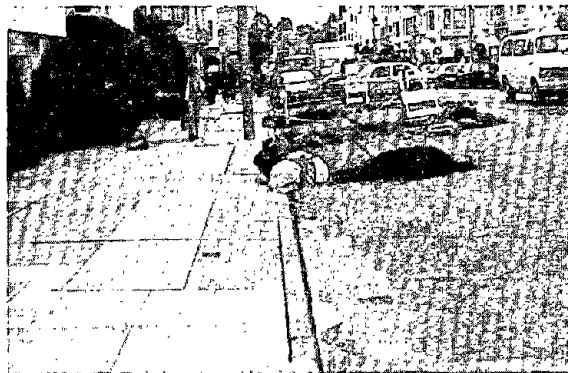
Photo d. Ruptured Pavement and 75 to 125 mm of Settlement, N. Point St. (photograph by T.D. O'Rourke)

The pattern of cracking and surface ruptures in the streets did not show a coherent sense of displacement or lateral movement in a preferred direction. Conspicuous permanent settlements and lateral displacements were confined to relatively small areas. For example, local differential settlements and lateral movements of 50 to 100 mm were observed at the northwest corner of Beach and Divisadero, southwestern corner of Divisadero and Jefferson, and on North Point St. approximately 60 m west of Webster. Photo d shows ruptured street

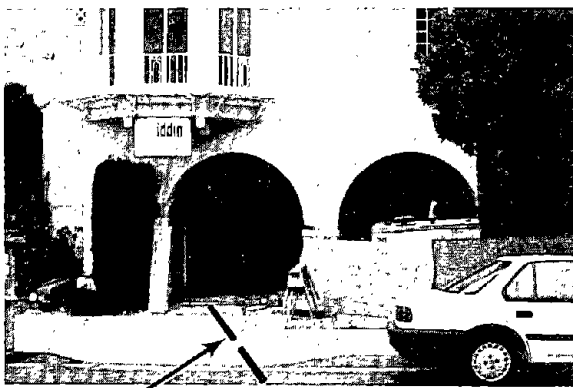
Photo b. Building Damaged by 300 mm of Differential Settlement Over Pile-Supported Sewer (photograph by T.D. O'Rourke)

Photo b shows severe distortion of a building on Cervantes Blvd. that had been constructed over a pile-supported 2.3-m outfall sewer. The building was subjected to 300 mm of differential movement when a bearing wall on liquefied soil settled relative to a bearing wall over the sewer. Buckled and fractured sidewalks and street pavements were apparent throughout the Marina District. Most buckled streets had compressive ridges oriented in a north-south direction, which appears to be perpendicular to the direction of strongest seismic shaking. Photo c shows the intersection of Divisadero and Jefferson Sts. Differential settlement and the buckled pavements of roadways and sidewalks are evident in the photo.

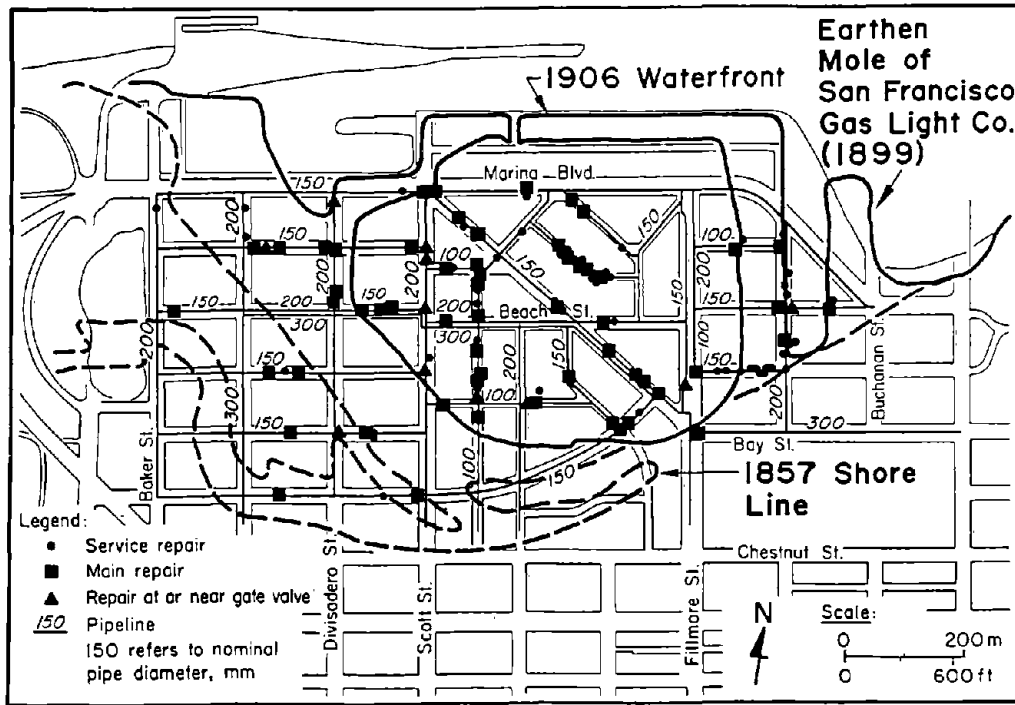
Figure 21. Map of the Marina Showing Locations of Pipeline Repairs to the MWSS

Figure 21 shows a plan view of the MWSS pipelines and repairs relative to the current street system, 1906 waterfront, and 1857 shoreline. Repairs were made at locations of sheared or disengaged service connections with mains, flexural

round cracks in mains, and longitudinally split sections of main. In some cases, damage was concentrated at or near gate valves. These devices tend to anchor the pipelines, and therefore may contribute to locally pronounced deformation and stresses. The figure shows the locations of repairs to: a) services, b) mains, and c) sections at or near gate valves.

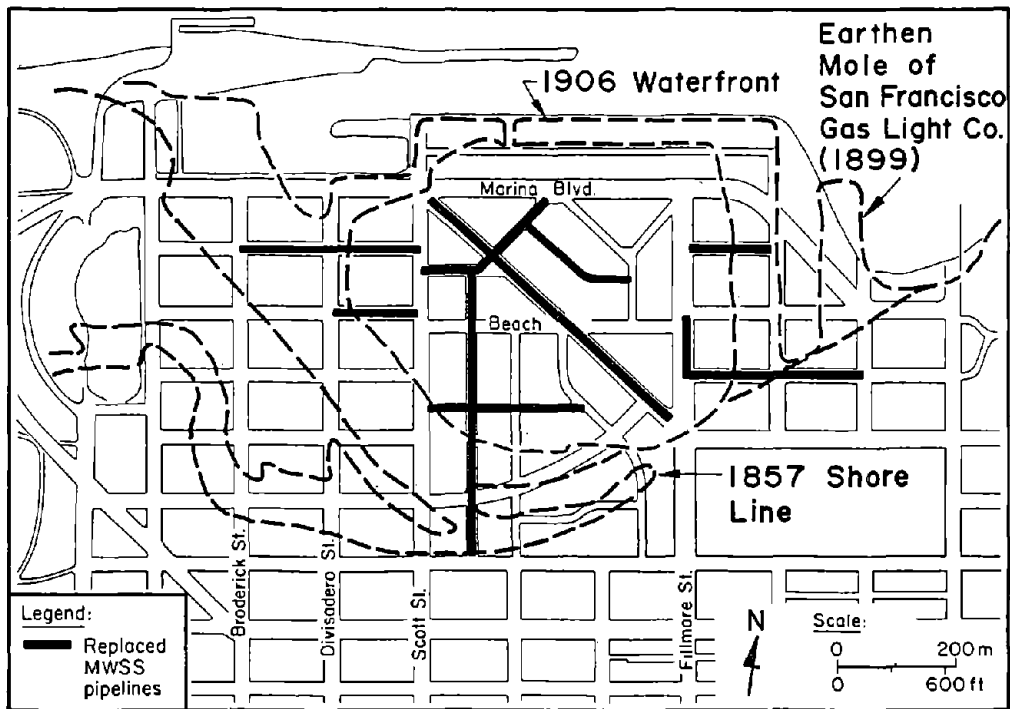
Figure 22. Map of the Marina Showing AWSS Pipelines Replaced as a Result of the 1989 Earthquake

Figure 22 shows a plan view of the MWSS water mains which were replaced after initial repair. These mains were most heavily damaged in areas of largest surface settlement, and therefore most likely to be subject to continuing rupture and maintenance difficulties in the future. Approximately 2.7 km of mains were replaced, primarily in or immediately adjacent to areas underlain by hydraulic fill.

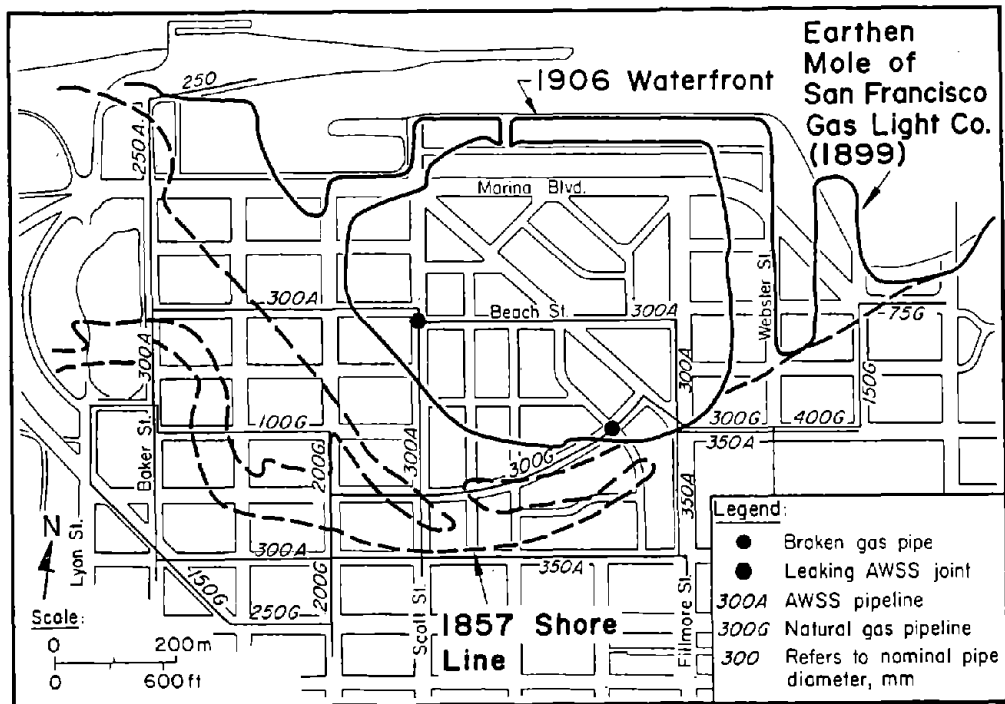
Figure 23. Map of the Marina Showing the Locations of Damage to the AWSS and High Pressure Gas Distribution System

Even though substantial damage was sustained by the MWSS in the Marina, there was only one instance of AWSS repair in this area. The repair occurred at a leaking joint at Scott and Beach Sts., as shown in Figure 23. It should be

recognized that Figure 23 shows both the AWSS and high pressure gas distribution network in the Marina. The AWSS and natural gas mains are labeled "A" and "G," respectively. The term "high pressure" is intended to distinguish pipelines conveying gas at approximately 200 kPa from low pressure distribution lines at approximately 2 kPa.

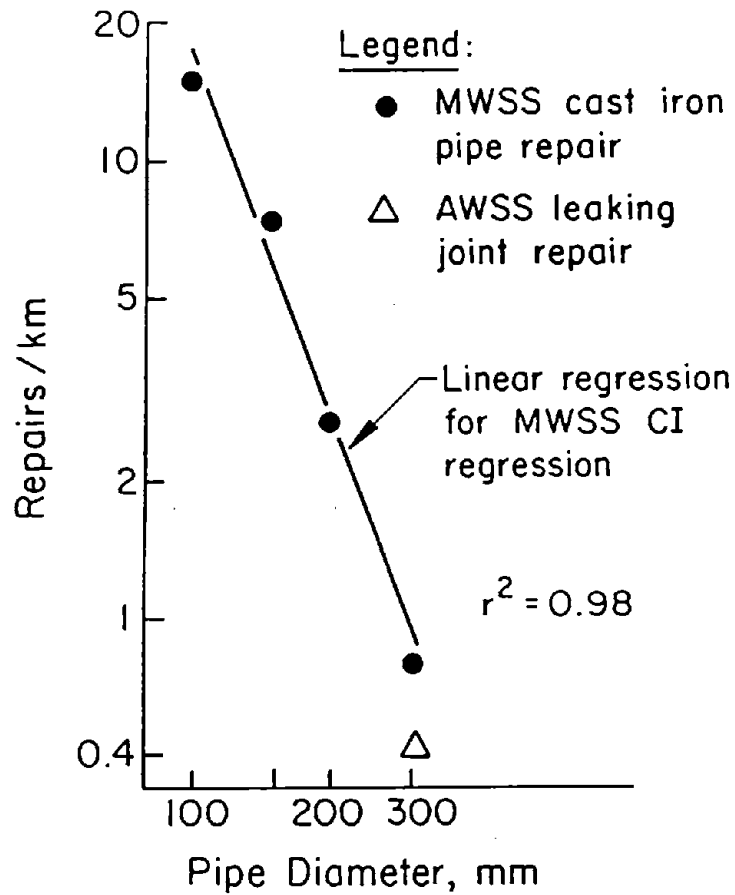
Figure 24. Linear Regression of Repair Rate of MWSS vs. Nominal Pipe Diameter

In Figure 24, the repair rates for MWSS and AWSS pipelines are plotted as a function of nominal pipe diameter. The slope of the linear regression is approximately -3, which implies that pipeline repair was inversely proportional to the cube of the pipe diameter. Since the moment of inertia of a given pipe is a function of diameter cubed, the regression analysis indicates that damage was influenced strongly by the longitudinal bending resistance of the

pipelines. Hence, it appears that bending stress caused by differential settlement of the underlying soil was the main cause of pipe failure, and that resistance of such stress, resulting from flexible AWSS joints and increasing pipe diameter, was responsible for the lowest repair rates.

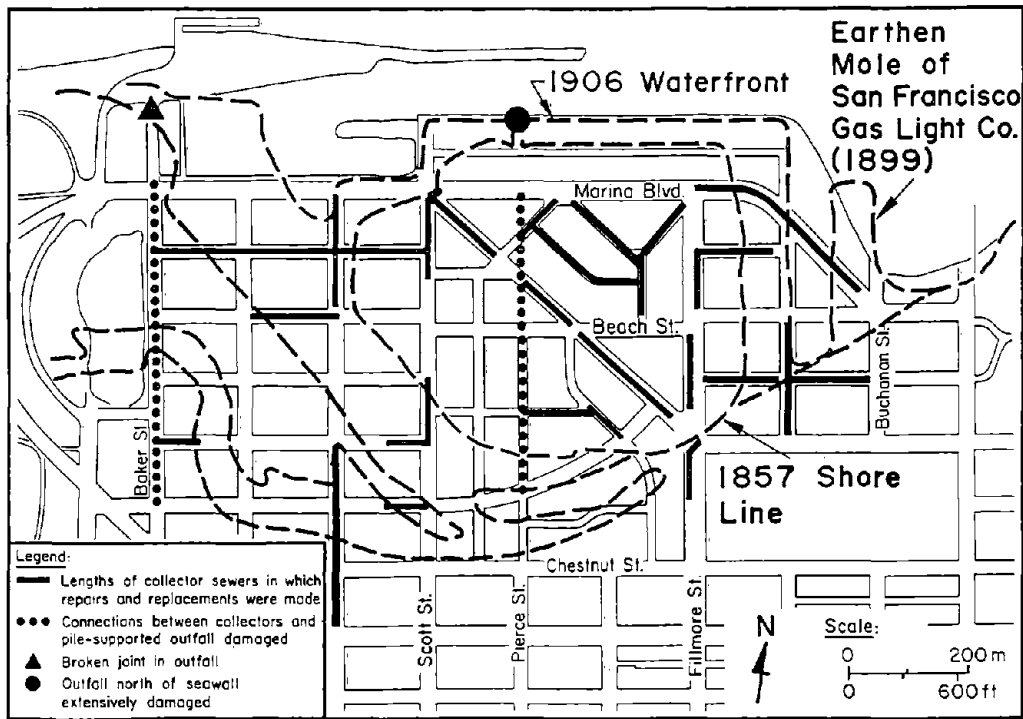
Figure 25. Map of the Marina Showing Locations of Replaced and Repaired Wastewater Conveyance Pipelines

Within the area bounded by Baker St., Marina Blvd., Buchanan St., and Chestnut St., there were 9.8 km of vitrified clay pipe collector sewers, of which approximately 2 km were replaced or repaired as a result of the earthquake. The lengths of pipelines in which repairs and replacements were made are shown in Figure 25 on the basis of records provided by the Clean Water Program. Much of the damage was in the form of cracked and crushed joints. Approximately 1.4 km of vitrified clay pipe was replaced with stronger clay pipe, utilizing gasketed joints. Nearly 73% of the replaced or repaired pipes were located in or immediately adjacent to (within half a block) areas of hydraulic fill.

The spatial patterns of damage in Figures 25 and 27 and their close relationship with the pattern of settlement in Figure 26 show a strong link between pipeline damage and differential movement. Differential movement is most heavily concentrated at the boundaries among the fill, natural soils, and old seawalls. It is important to note that damage to the relatively large 300-mm MWSS main (see Figure 21) and 300-mm gas pipeline (see Figure 23) both occurred very close to the boundary between hydraulic fill and the 1857 shoreline, where differential settlements were concentrated.

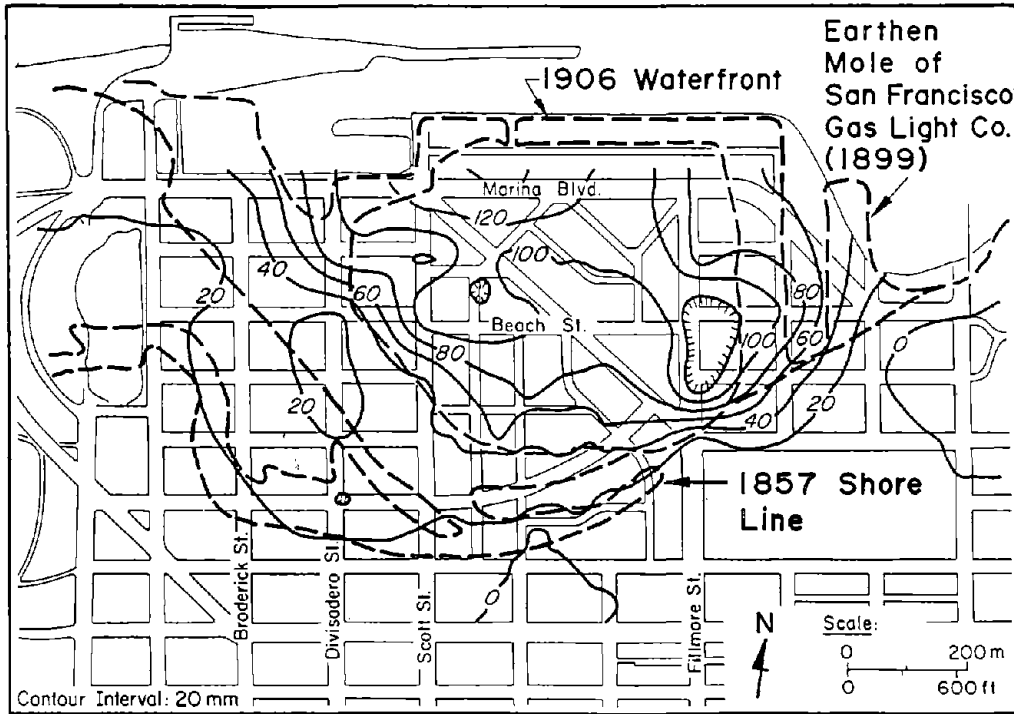
Figure 26. Map of the Marina Showing Contours of Settlement Caused by Post-Liquefaction Consolidation

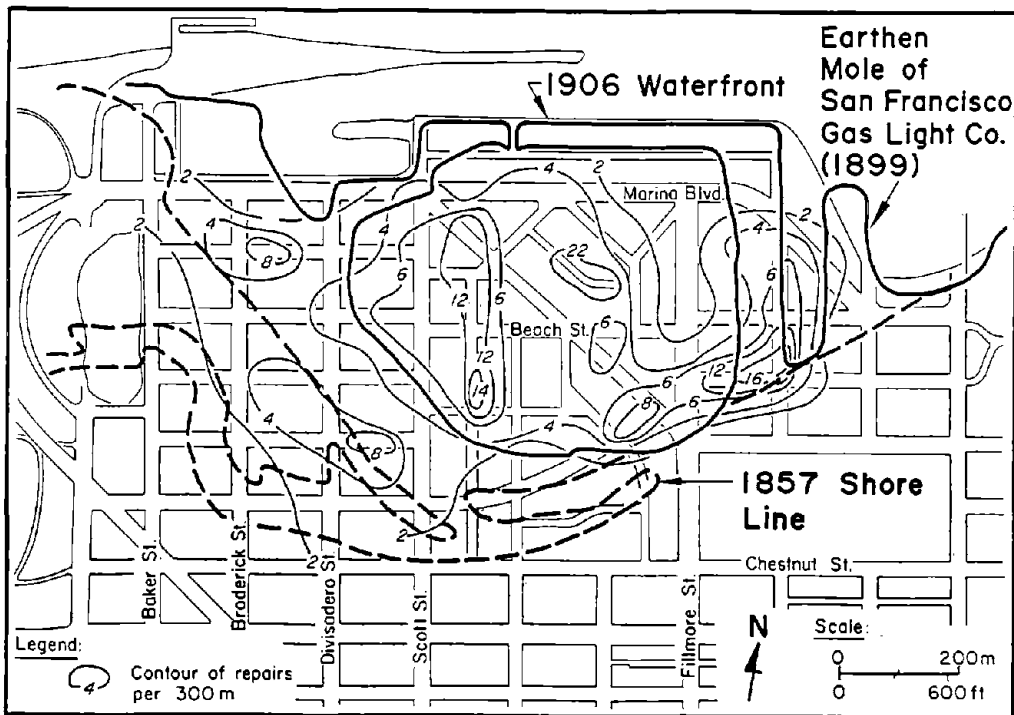
To represent the distribution of MWSS damage, the Marina was divided into a grid of approximately 40 cells, and the number of repairs per length of pipeline in each cell was counted. Each repair rate then was normalized with respect to a reference length of 300 m to provide a consistent basis for evaluation. Contours of equal repairs per 300 m of pipeline were drawn and superimposed on the street system and previous shorelines, as illustrated in Figure 27. The contours of pipeline repair rates are related closely to the settlement contours, hydraulic fill, and 1857 shoreline. Inspection of Figures 26 and 27 shows that the locations of closely spaced settlement contours, indicating the largest local settlement slopes, correspond to the locations of relatively high pipeline repair rates. High concentrations of pipeline repair fall within the area of hydraulic fill. The heaviest repair concentration occurs at the junction of the hydraulic fill, seawall, and 1857 shoreline, except for an isolated area on Rico Way, where unusual stresses were generated as a result of pipeline construction along the curved street.

Figure 27. Map of the Marina Showing Contours of Repair Rates for the MWSS

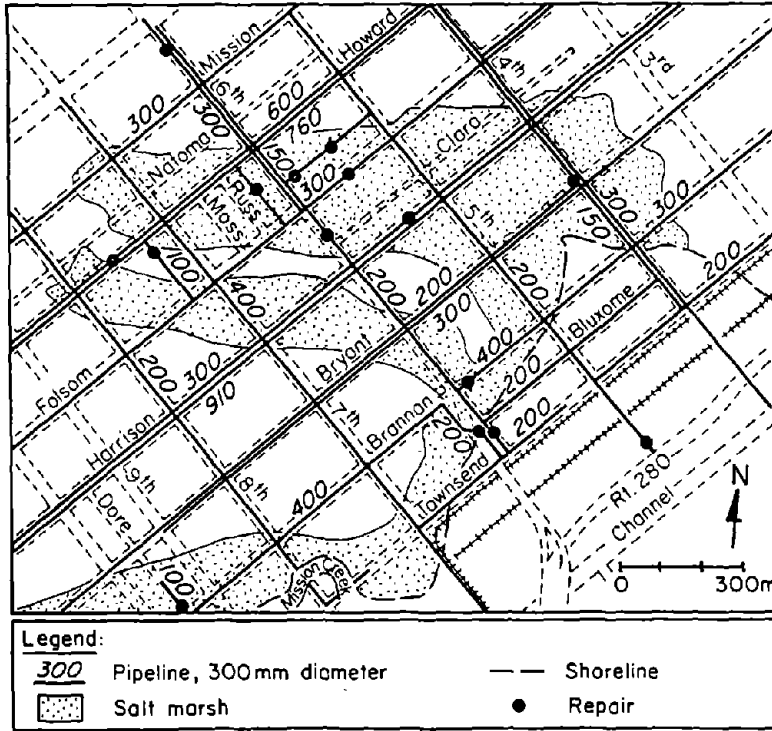
locations where loose sandy fills had been placed over deposits of soft to medium clay. Figures 28 and 29 show pipeline repairs in the South of Market area for the MWSS and AWSS, respectively. The pipeline repairs, pipeline network, and current street system are shown relative to salt marshes and the shoreline of Mission Bay, which once were located at this site. The marshes and shoreline were established by reference to topographical maps prepared by the U.S. Coast Survey (1853; 1857). The area was filled during the years between 1850 and 1865, primarily with material excavated from nearby sand dunes (Dow, 1973; Roth and Kavazanjian, 1984).

The highest concentration of pipeline repairs was in the area bounded by 8th, Mission, 5th, and Harrison Sts. As described in Section 4.2, differential settlements and fractured pavements (indicating lateral movement) were observed throughout this area. Although the level of damage was much more severe in 1906, it is interesting to note that some of the pipeline damage in 1989 occurred in the same general area as in 1906. For example, Reynolds (1906), in reporting on the condition of buried electrical conduits, stated: "Along 7th St. from Mission to Howard, the earth was displaced from 5 to 8 ft (1.5 to 2.4 m) in a direction lengthwise to conduit. This caused some of the manholes to crush... The conduit was pulled apart at other places, and cables were wrenched and torn apart from their boxes..." Numerous additional descriptions of buried lifeline damage in the South of Market and other locations of 1906 San Francisco have been compiled, and the reader is referred to these sources for additional information (e.g., Youd and Hoose, 1978; O'Rourke and Lane, 1989).

Figure 28. MWSS Pipeline Repairs in South of Market Area

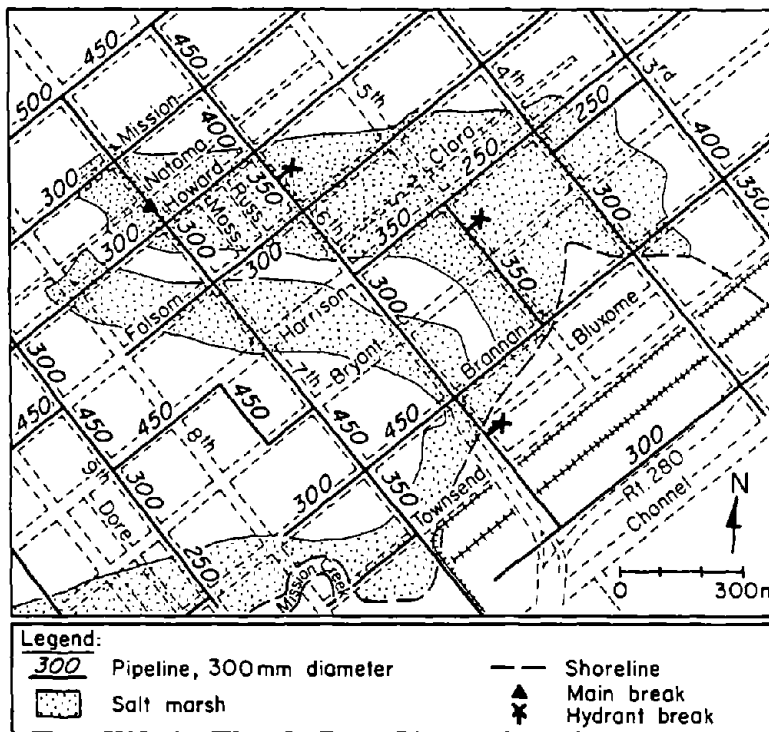
Figure 29. AWSS Pipeline and Hydrant Repairs in South of Market Area

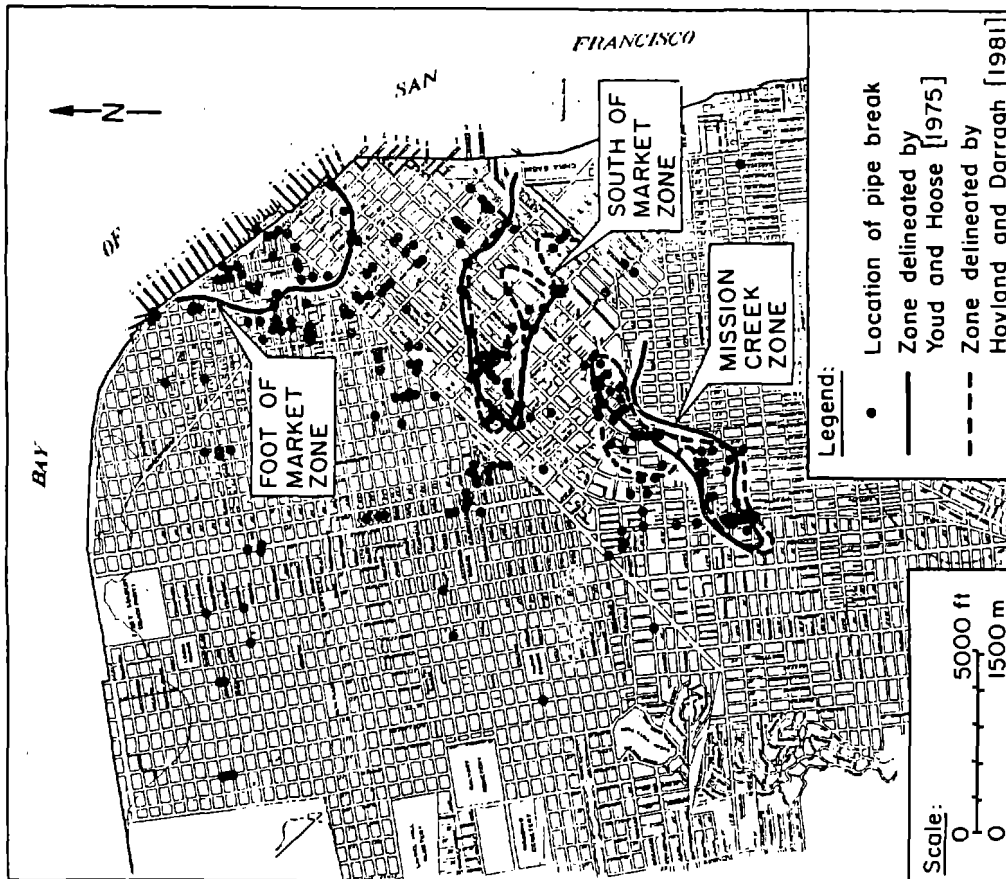
Figure 30 shows a plan view of the location of breaks in the water distribution system of San Francisco after the 1906 earthquake (O'Rourke, et al., 1985). This plot of pipeline breaks was developed on the basis of maps by Schussler (1906) and Manson (1908), which show the locations of principal water main ruptures. Superimposed on the plot are the boundaries in which lateral spreading from soil liquefaction was observed during the 1906 earthquake. The boundaries of lateral spreading are plotted on the basis of zones delineated by Youd and Hoose (1975) and Hovland and Darragh (1981). The agreement among the zone boundaries from the different studies is good. Although the zones of lateral spreading account for only 5% of the built-up area of 1906 affected by strong ground shaking, approximately 52% of all pipeline breaks occurred inside or within one city block of these zones.

By comparing Figures 30 and 31, it is clear that pipeline breaks in 1989 and 1906 were clustered at similar locations in liquefaction-prone areas. The consistency in damage patterns, combined with the facts that: 1) pipelines tend to deform as the ground deforms, and 2) a pipeline network covers a broad area, provides an opportunity to use the pipeline system as an observational tool which reflects local earthquake severity. At the same time, the damage observations establish an empirical framework from which to estimate the potential levels of pipeline repairs relative to local geologic and geotechnical site characteristics.

Figure 30. Water Supply Pipeline Breaks and Zones of Soil Liquefaction Caused by 1906 San Francisco Earthquake (after O'Rourke, et al., 1985)

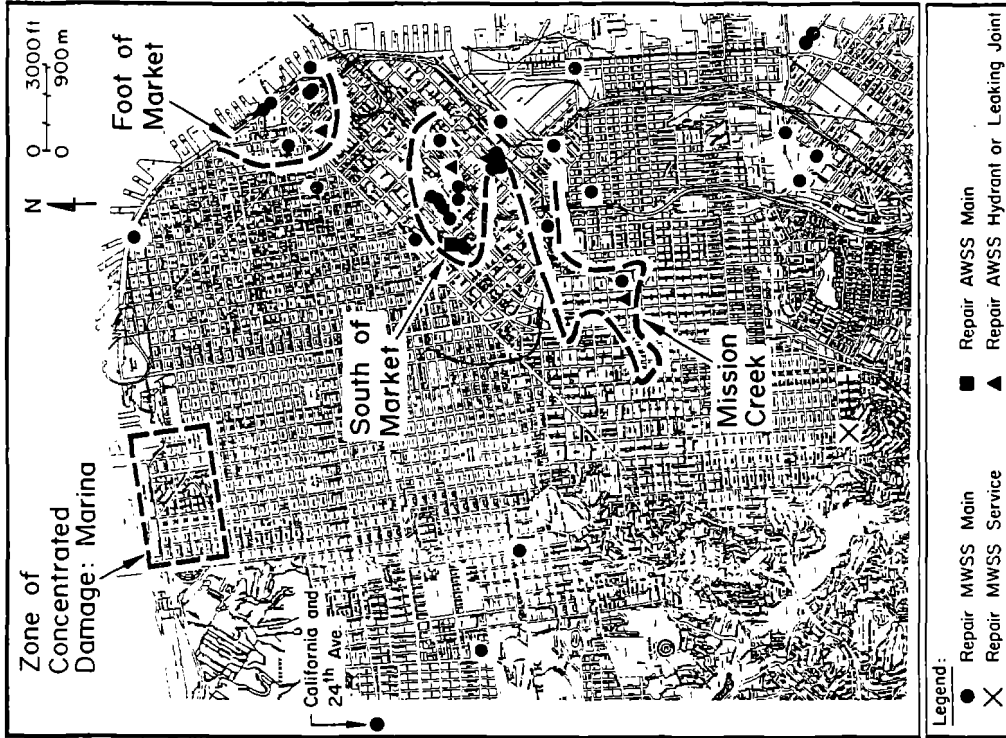
Figure 31 shows the locations of water pipeline system repairs after the 1989 Loma Prieta earthquake. Zones of potential soil liquefaction, based on maps by Youd and Hoose (1975) and Hovland and Darragh (1981), also are shown. Repairs to both the MWSS and AWSS are indicated by the appropriate symbols. The site of the Marina is shown, but because of the extensive MWSS damage at this location, repair plots are not indicated.

Figure 31. Water Supply Pipeline Breaks and Zones of Soil Liquefaction Caused by 1989 Loma Prieta Earthquake

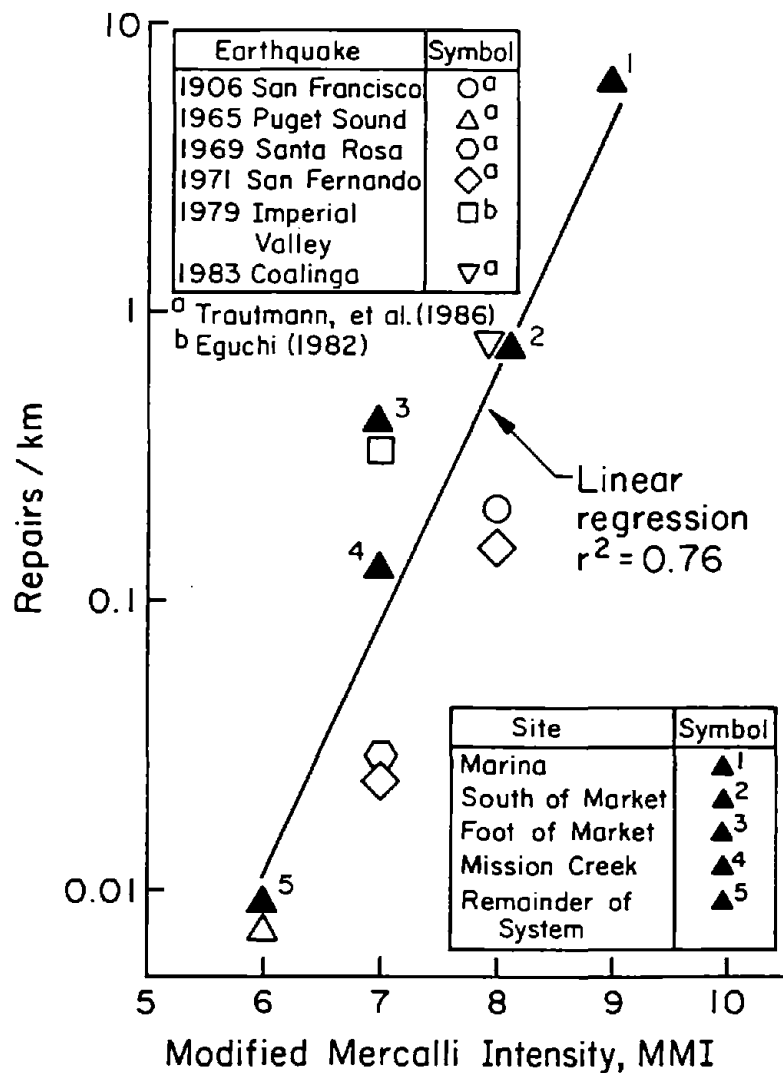
Table 4 shows substantial differences in pipeline repair rates for different sectors of the city. In effect, the repair rate is an index of seismic intensity. In Figure 32, the repair statistics for Loma Prieta are combined with repair statistics for other earthquakes to explore further the relationship between pipeline damage and MMI. All data in the plot represent systems composed entirely or predominantly of cast iron lines.

As illustrated in the figure, there is a linear trend of repairs/km with MMI. Moreover, the trend in the Loma Prieta data is consistent with that of the other western U.S. earthquakes. It should be recognized that the data in Figure 32 have been plotted without distinguishing damage related to traveling ground waves in comparison to damage caused by permanent ground movements. For MM VIII or larger, damage will be affected principally by permanent ground movements in areas vulnerable to soil liquefaction. Such empirical evidence implies that cast iron pipeline damage varies exponentially with MMI. Repair

Figure 32. Repair Rate of Cast Iron Pipeline Systems versus Modified Mercalli Intensity

rates increase by roughly an order of magnitude for each single digit advance in the MMI scale.

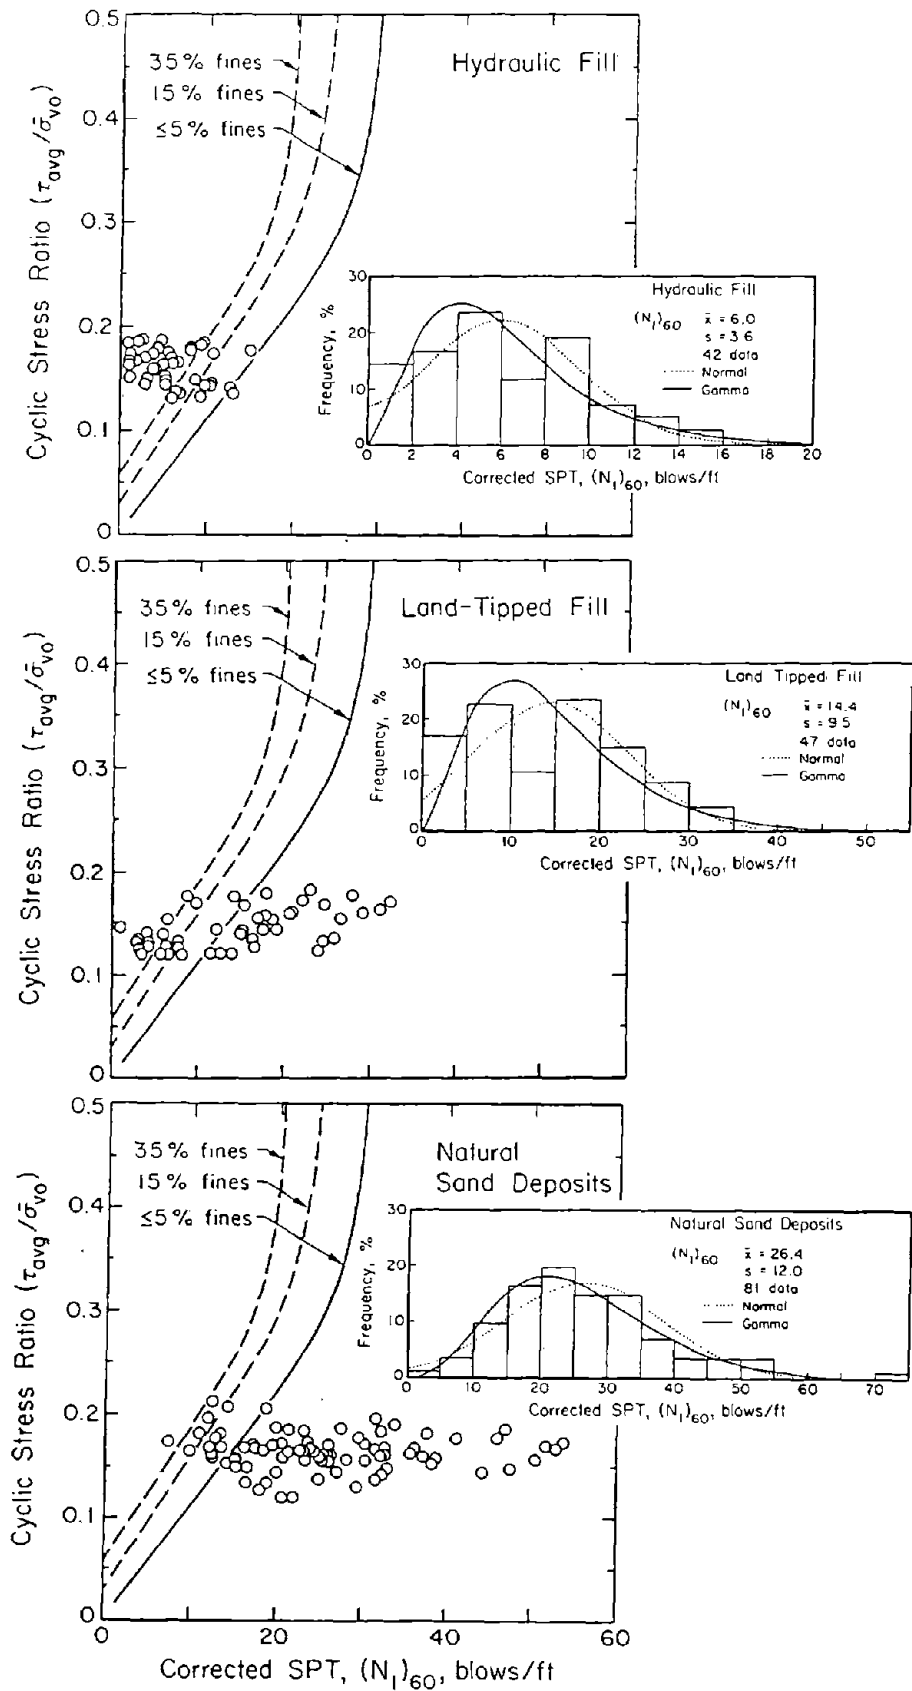
Figure 41 shows the cyclic stress ratio plots for the three soil types. In each figure, the empirical dividing lines for various fines contents between liquefiable (left side) and non-liquefiable (right side) soils are plotted for a magnitude 7.1 earthquake. The fines content refers to percentage weight of the soil which is silt-sized or smaller (0.075 mm). In each figure, a histogram showing the frequency distribution of corrected SPT values, $(N_1)_{60}$, is given. In-situ density of the soil is related to $(N_1)_{60}$ so that each histogram provides a measure of the variation in soil density as inferred from SPT measurements. Normal and gamma probability density functions are fitted to the data. The mean, \bar{x} , standard deviation, s , and number of data in each sample are listed. The mean and standard deviation pertain to a normal distribution.

Figure 41. Cyclic Stress Ratio Plots of Three Soil Types in the Marina

The most striking feature of the plots is the relatively high susceptibility to liquefaction displayed by the hydraulic fill. The corrected SPT values for at least half of the measurements in the sample are less than 6. This implies that the hydraulic fill would have a very low undrained residual shear strength, perhaps lower than 5 kPa, based on empirical relationships suggested by Seed (1987).

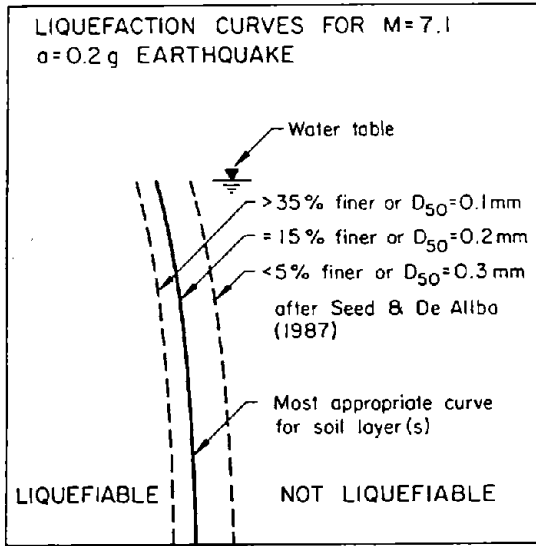
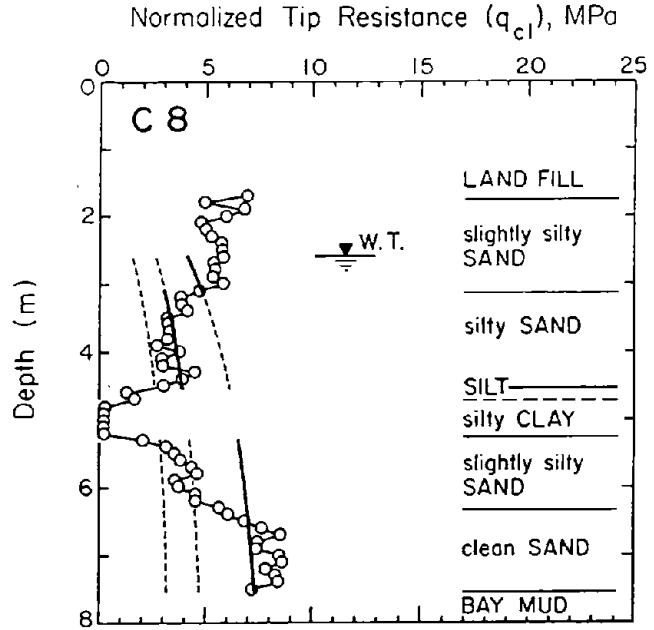
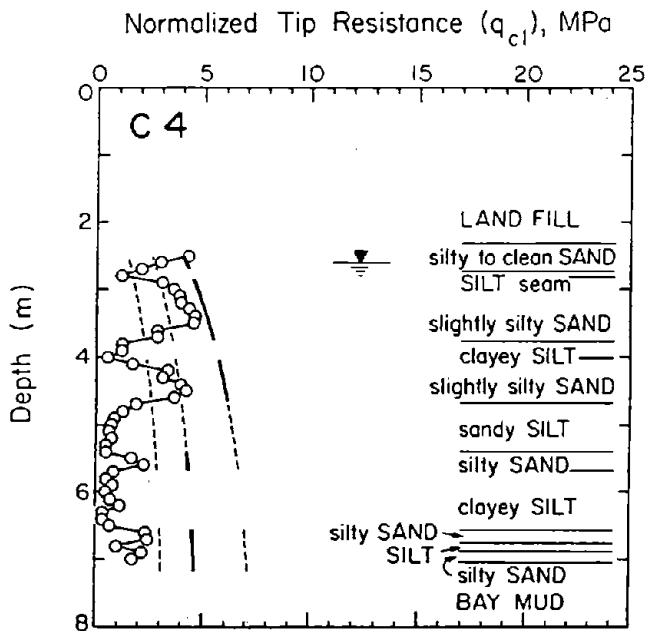
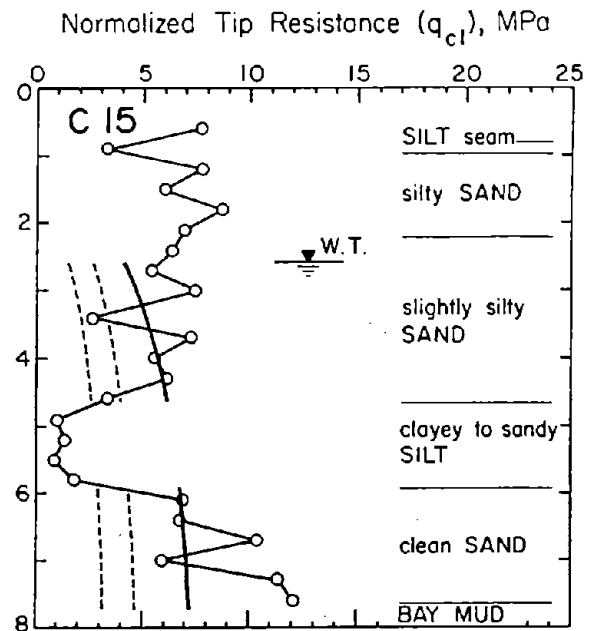
Figure 43 presents the CPT profiles for three soundings in the hydraulic fill, which from north to south are designated as C8, C4, and C15 (see Figure 11). The q_{c1} values are shown at 0.3-m (1-ft) intervals. For example, C8 indicates the presence of liquefiable sands and silty sands between the depths of 3 and 4.5 m, and again at 5.5 to 6.5 m. Between 4.5 and 5.5 m, the cone penetrated silt and silty clay, which can be interpreted as not susceptible to liquefaction. Accordingly, no darkened line is indicated for this depth interval. The measurements at C4 show the presence of liquefiable sands and silty sands, generally from 2.6 to 7 m, with thin intervening layers of clayey silt, which can

Figure 43. Soil Profiles with CPT Values Plotted as a Function of Depth

be interpreted as not susceptible to liquefaction. The measurements at C15 show only occasional thin seams of sand and silty sand, which clearly are susceptible to liquefaction.

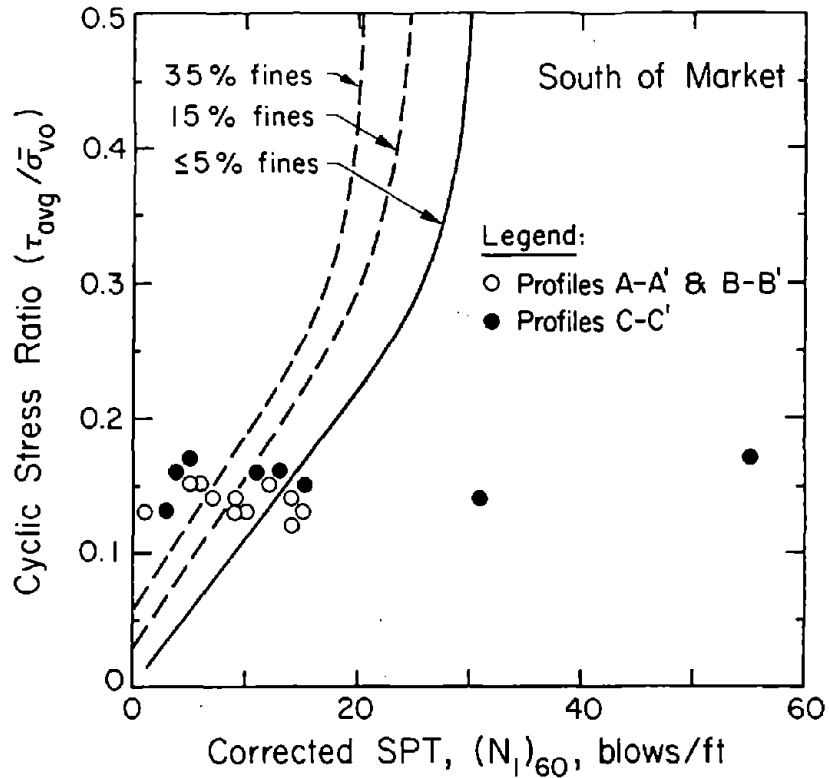
Liquefaction potential analyses were performed for the fill and upper gray sands using the empirical relationship between cyclic stress ratio and corrected STP values developed by Seed, et al. (1983; 1985), in accordance with the procedures described in Section 9.1. The cyclic stress ratios for various depths were calculated assuming a peak acceleration of 0.2 g. Figure 48 shows the cyclic stress ratio plots for the sandy fill along cross-sections A-A' and

Figure 48. Cyclic Stress Ratio Plot for Fills and Sands in the South of Market Area

B-B' and for the upper brown fill and gray sands along cross-section C-C'. Only the corrected SPT values for soil below the water table were used. In the figure, the empirical dividing lines for various fines contents between liquefiable (left side) and non-liquefiable (right side) soils are plotted for a magnitude 7.1 earthquake. The borehole data indicate that the fills and sands are relatively clean, with many samples having less than 5 to 10% by weight of fines. With the exception of two anomalously high values, the $(N_1)_{60}$ data indicate that the fill in the South of Market area is highly susceptible to soil liquefaction for an event comparable in magnitude and intensity to those experienced during the Loma Prieta earthquake.

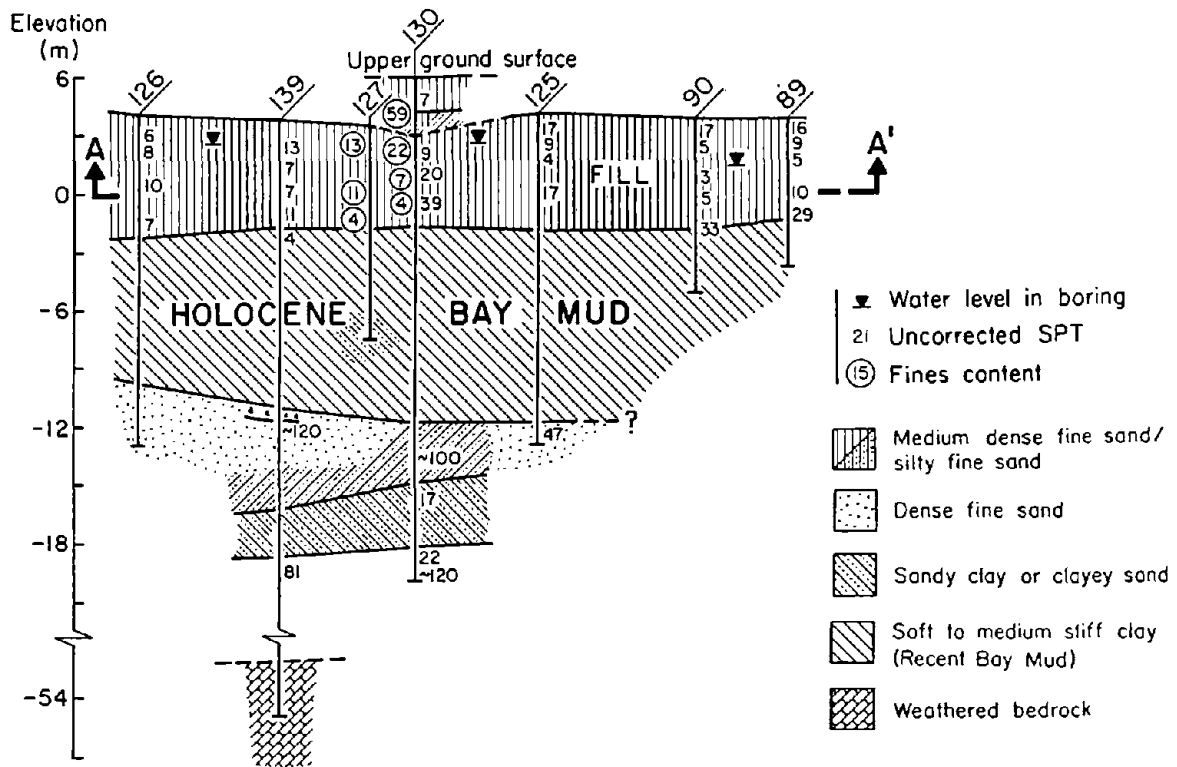
Figure 50. Soil Profile Along Cross-Section A-A' in the Mission Creek Area

Figures 50 and 51 show the soil profiles, with a water table approximately 1 to 3 m below ground surface on the eastern half of the site. A higher level of fill (approximately 2.5 m higher) exists on the western half of the site. A retaining wall and embankment slope separate the eastern and western portions of the block. Uncorrected SPT values are listed adjacent to each boring in the

profiles as uncircled numbers. The circled numbers indicate the percentage by weight of fines from split spoon samples retrieved from the elevations shown in the figure.

Below the retaining wall and embankment, there are approximately 4 to 6 m of loose to medium dense fill. As indicated by several relatively low SPT values, the fill is very loose in some locations. Overall, the fill is a relatively clean, uniform, fine-grained sand. The fill is underlain by about 9 m of Holocene bay mud, with approximately 40 m of dune sands and stiff clays, to weathered serpentine bedrock at a depth of roughly 60 m from the ground surface.

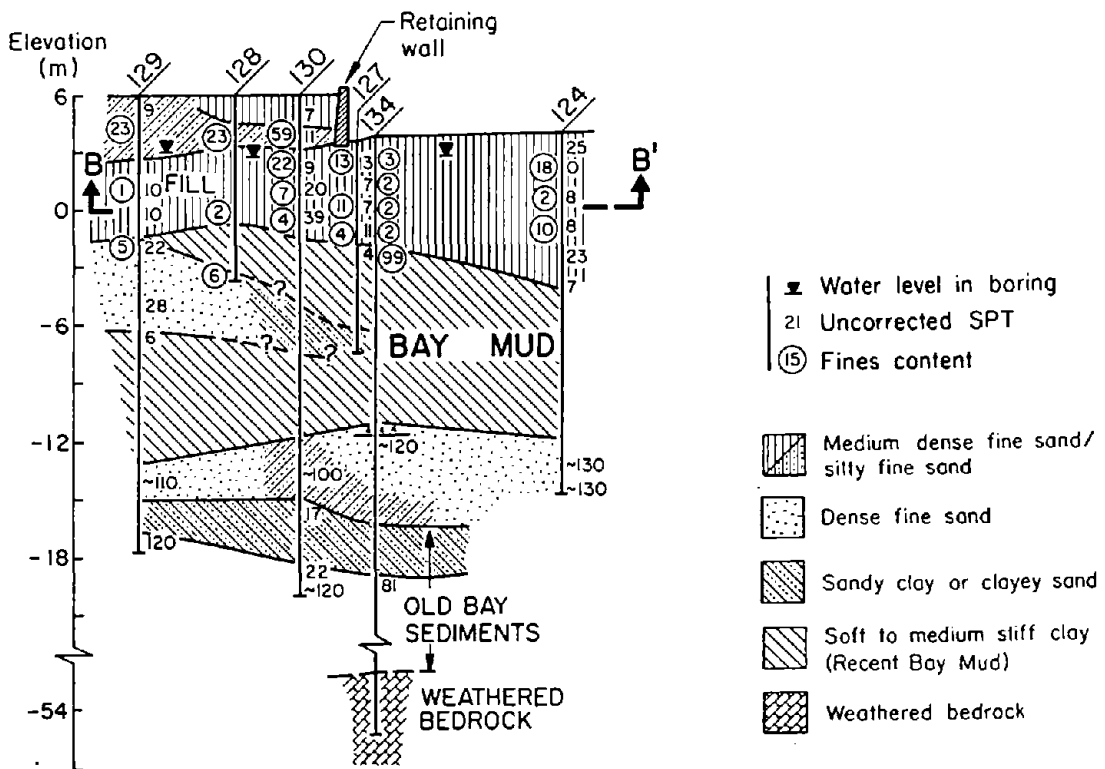
Figure 51. Soil Profile Along Cross-Section B-B' in the Mission Creek Area

Figures 50 and 51 present soil profiles along cross-sections A-A' and B-B', respectively. The cross-sections and corresponding boreholes are shown in Figure 49. Borehole data were acquired from site investigations performed after the Loma Prieta earthquake, as part of a reconstruction effort for the two to four-story timber-frame buildings damaged by liquefaction-induced differential settlement at this site.

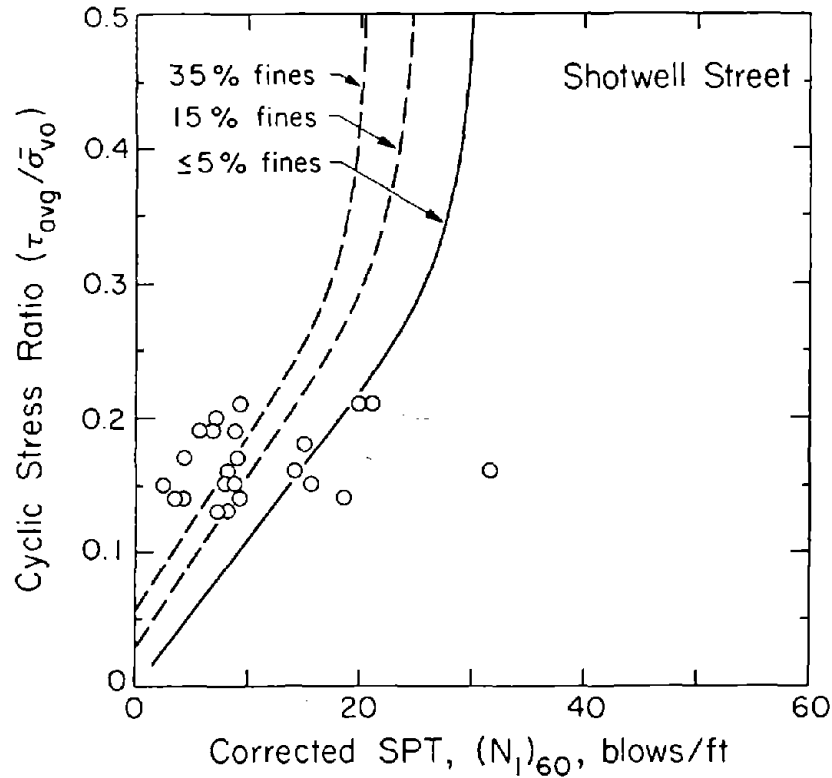
Figure 52. Cyclic Stress Ratio Plot for Fill at a Site of Liquefaction in the Mission Creek Area

Liquefaction-potential analyses were performed for the fill using the empirical relationship between cyclic stress ratio and corrected STP values developed by Seed, et al. (1983; 1985), in accordance with the procedures described in Section 9.1. The cyclic stress ratios for various depths were calculated assuming a peak acceleration of 0.2 g. In a manner similar to Figure 48, Figure 52 shows the cyclic stress ratio plots for the sandy fill along cross-sections A-A' and B-B'. Only the corrected SPT values for soil below the water table were used. In the figure, the empirical dividing lines for various fines contents between liquefiable (left side) and non-liquefiable (right side) soils are plotted for a magnitude 7.1 earthquake. The fill is relatively clean, with many samples having less than 5 to 10% by weight of fines. The $(N_1)_{60}$ data indicate that the fill at the South Van Ness and Howard St. site is highly susceptible to soil liquefaction for an event comparable in magnitude and intensity to those experienced during the Loma Prieta earthquake.
