REPORT NO.
UCB/EERC-90/21
DECEMBER 1990

OBSERVATIONS AND IMPLICATIONS OF TESTS ON THE CYPRESS STREET VIADUCT TEST STRUCTURE

MARTIN E. BOLLO
STEPHEN A. MAHIN
JACK P. MOEHLE
ROY M. STEPHEN
XIAOXUAN QI

Report to the California Department of Transportation

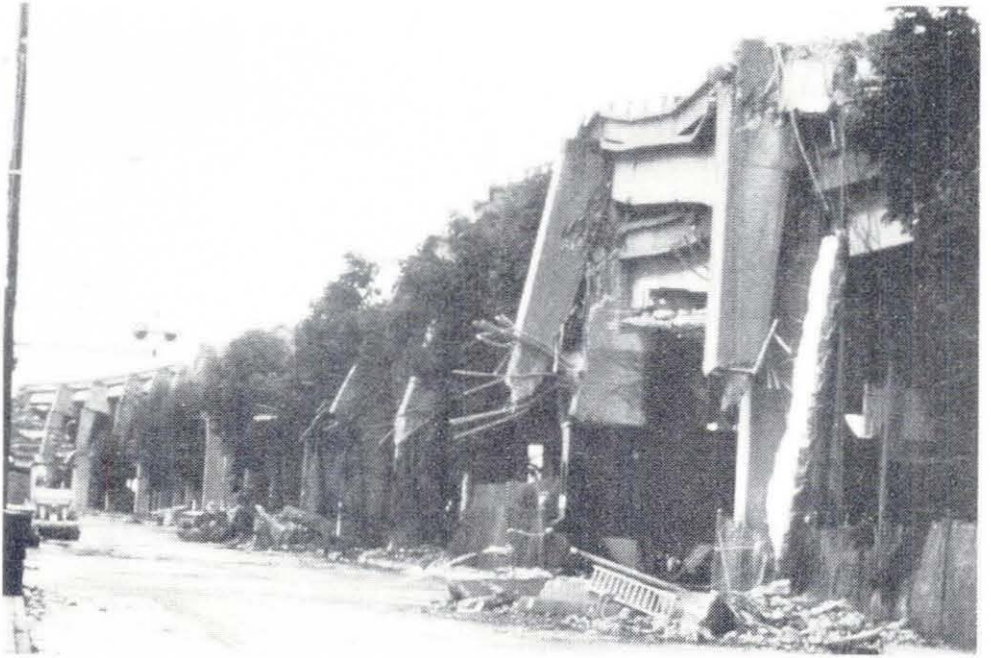
Fig. 1.12 Collapse of the I-880 Cypress St. Viaduct.

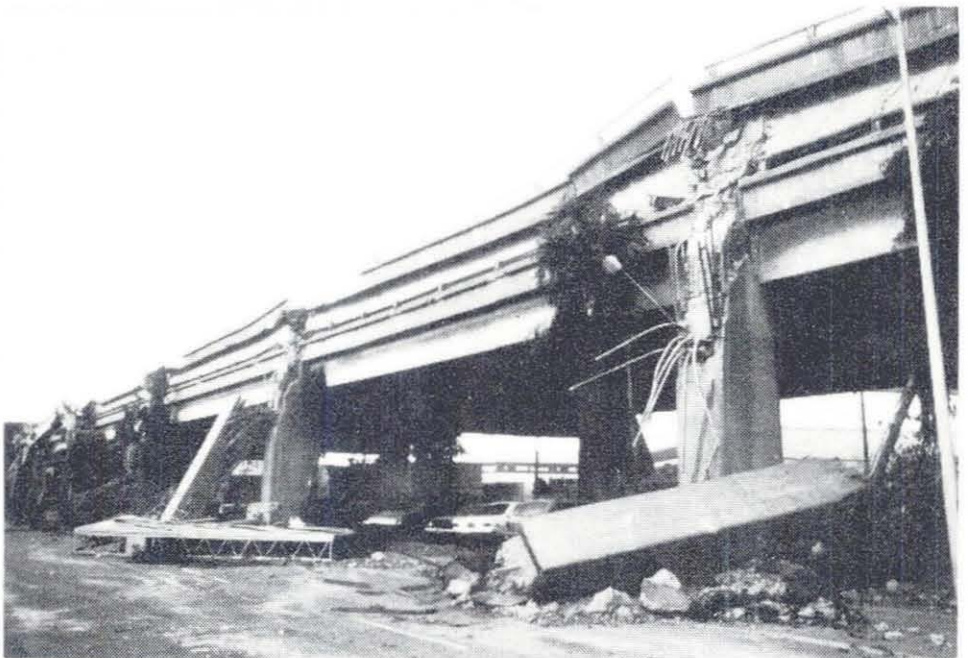
Fig. 1.13 Collapse of the I-880 Cypress St. Viaduct, illustrating the 'popping out' of the second story columns.
