**Observations on Water System and
Pipeline Performance in the Limon Area of Costa Rica
Due to the April 22, 1991 Earthquake**

M. J. O'Rourke

D. Ballantyne

Technical Report NCEER-92-0017

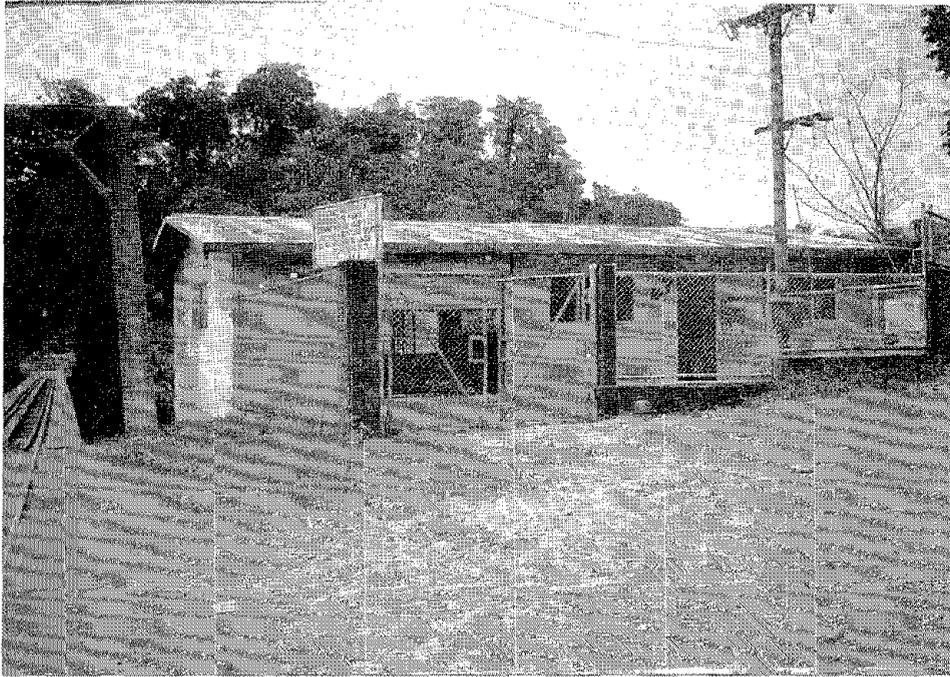
FIGURE 2-1 Undamaged Raw Water Pump Station on the Banano River

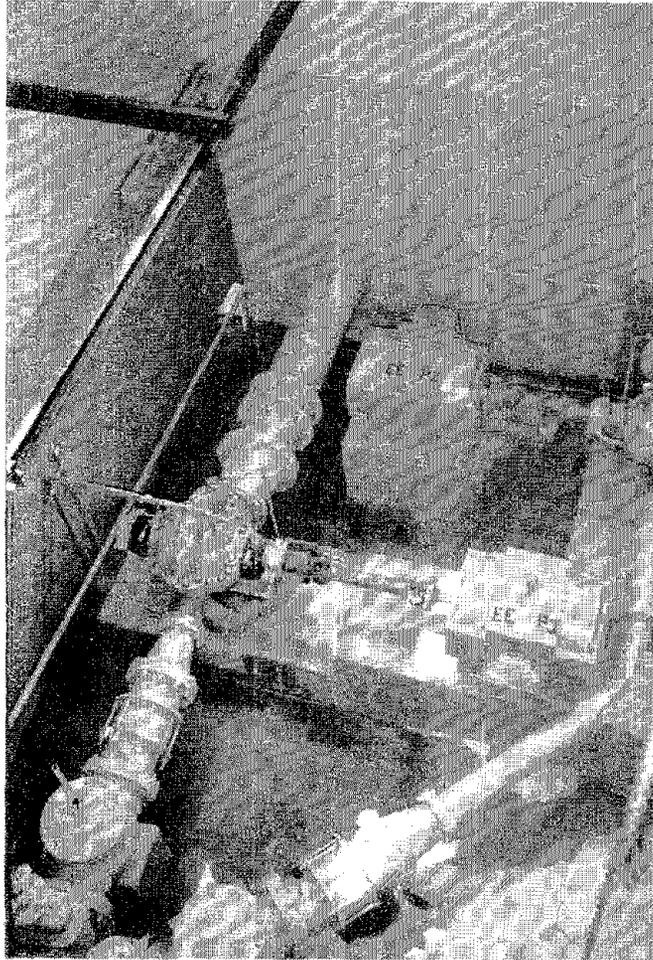
FIGURE 2-2 Split Case Pump in Raw Water Station on the Banano River

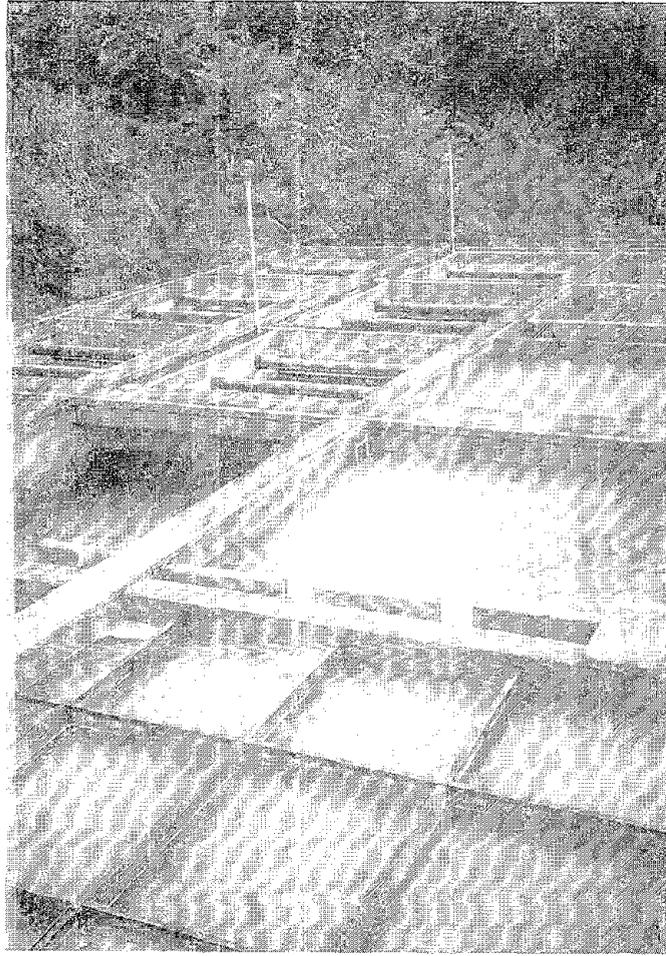
Asbestos cement baffles in the flocculators and asbestos cement clarifier plates were broken as shown in Figure 2-6 through 2-9. One concrete channel cracked. Glassware in the lab and the portable radio, sitting on the shelf, were undamaged. There was no reported damage to the filters.

FIGURE 2-6 Operating Flocculators in Foreground with Clarifiers Beyond

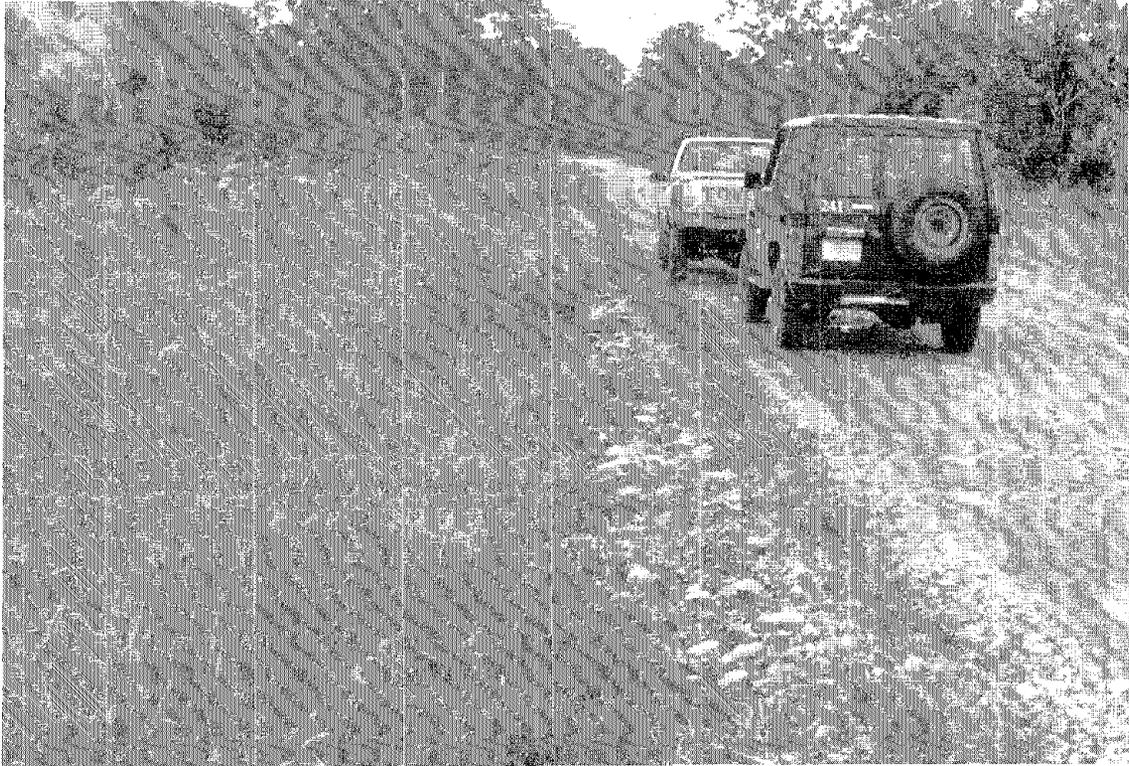
FIGURE 3-16 Dirt and Gravel Road Adjacent to Unrepaired Transmission Pipe Leak in Figure 3-14.

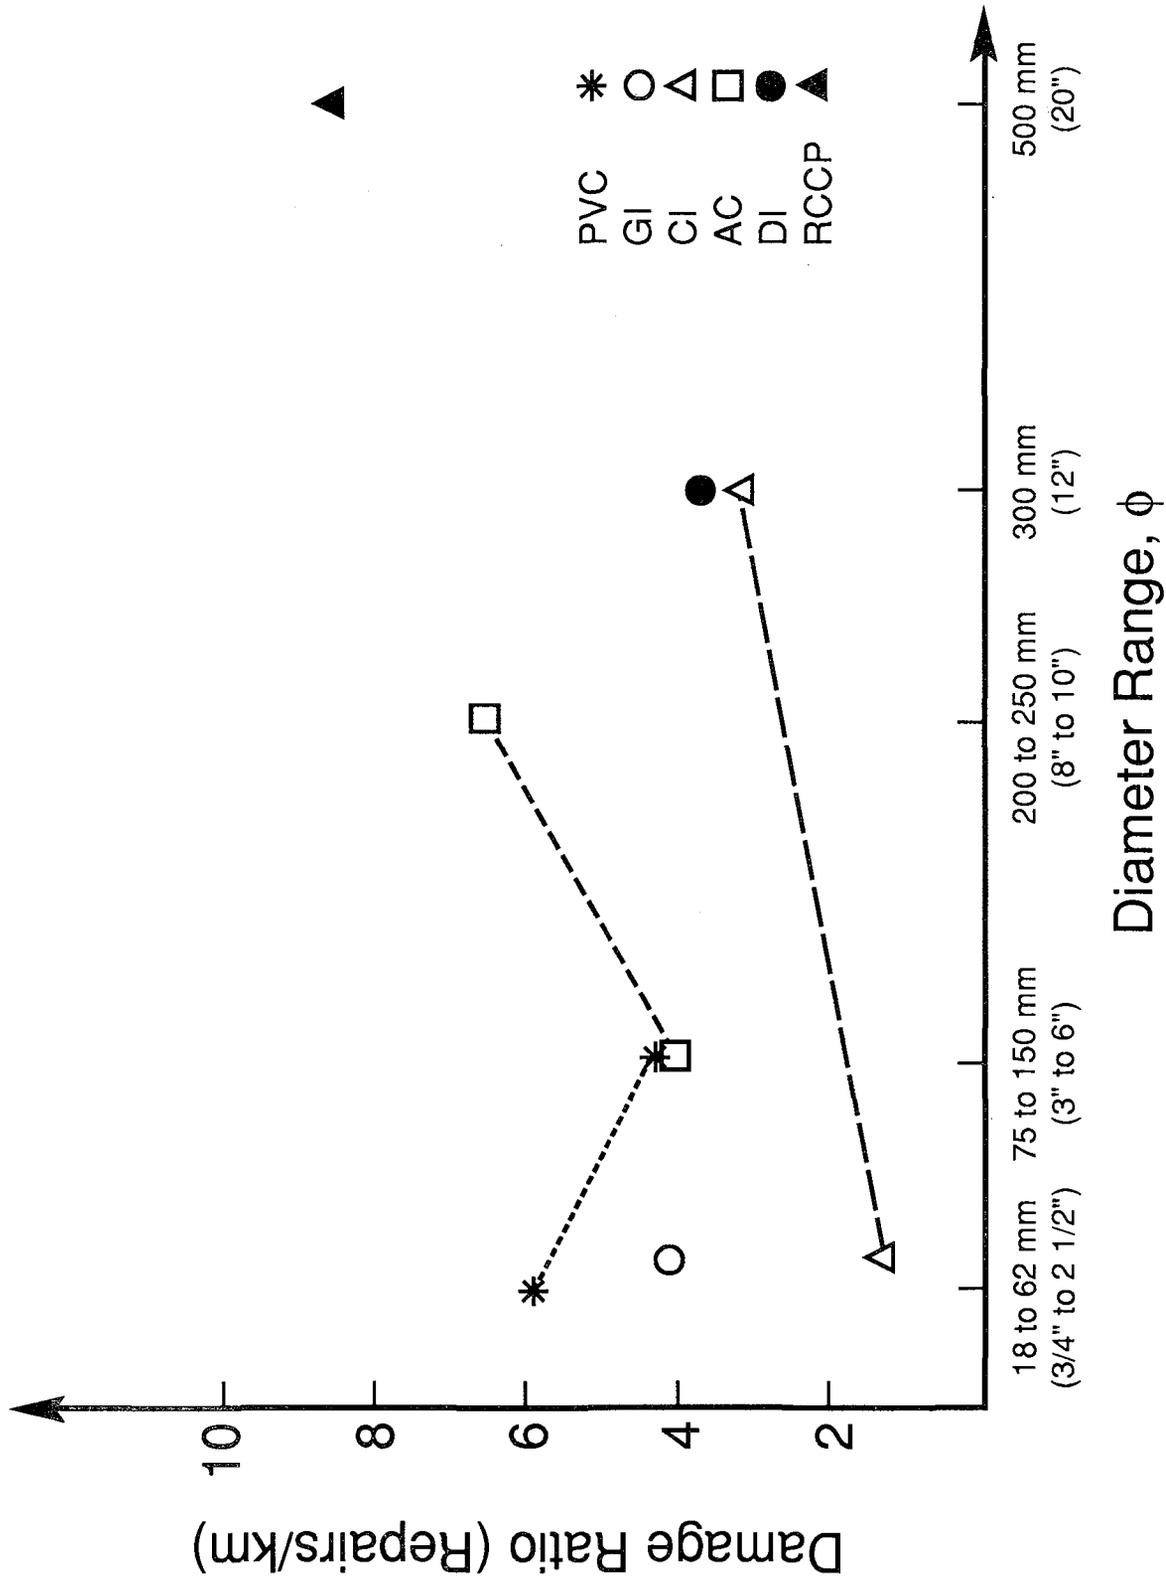
FIGURE 3-18 Damage Ratios for Distribution and Transmission Pipe Versus Diameter Range

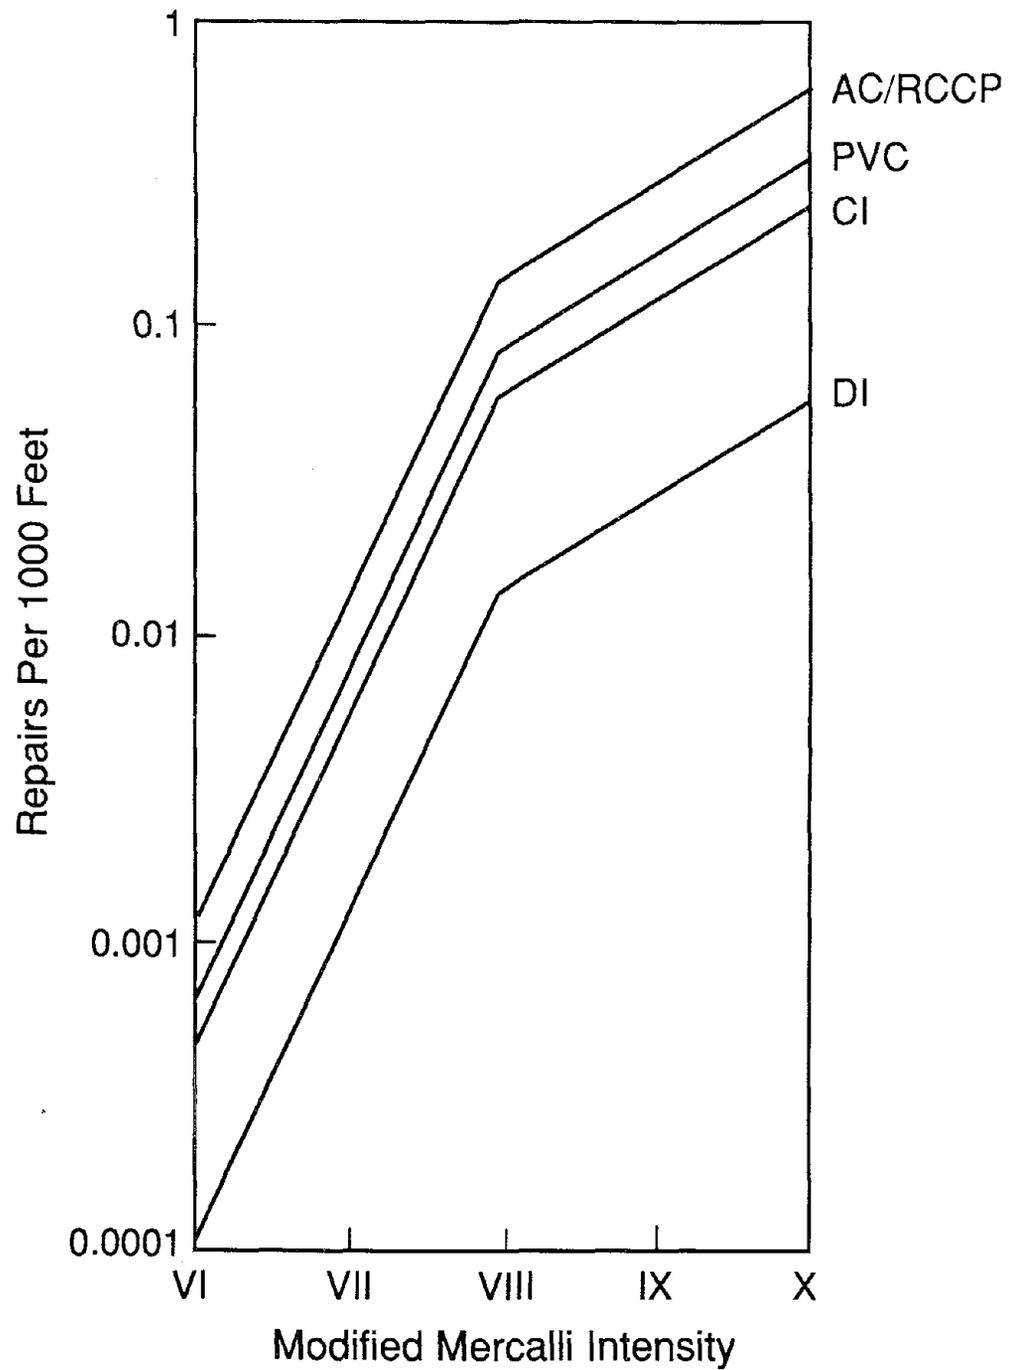
As shown in Figures 1-2 and 1-3, the estimates MMI in the Limón area was VIII or IX. From Figure 4-1 for MMI of VIII one expects 0.37 repairs/km (.11 repairs per 1000ft) for AC and CONC. pipe while one expects 0.26, 0.18 and 0.04 repairs/km for PVC, CI and DI respectively. For MMI of IX one expects 0.82, 0.49, 0.36 and 0.09 repairs/km for AC/CONC, PVC, CI and DI respectively.

FIGURE 4-1 Wave Propagation Damage in Repairs per 1000 feet Versus Modified Mercalli Intensity, AC = Asbestos Cement, CI = Cast Iron, DI = Ductile Iron, PVC = Polyvinyl Chloride, RCCP = Reinforced Concrete Cylinder Pipe (after Eguchi, 1991).

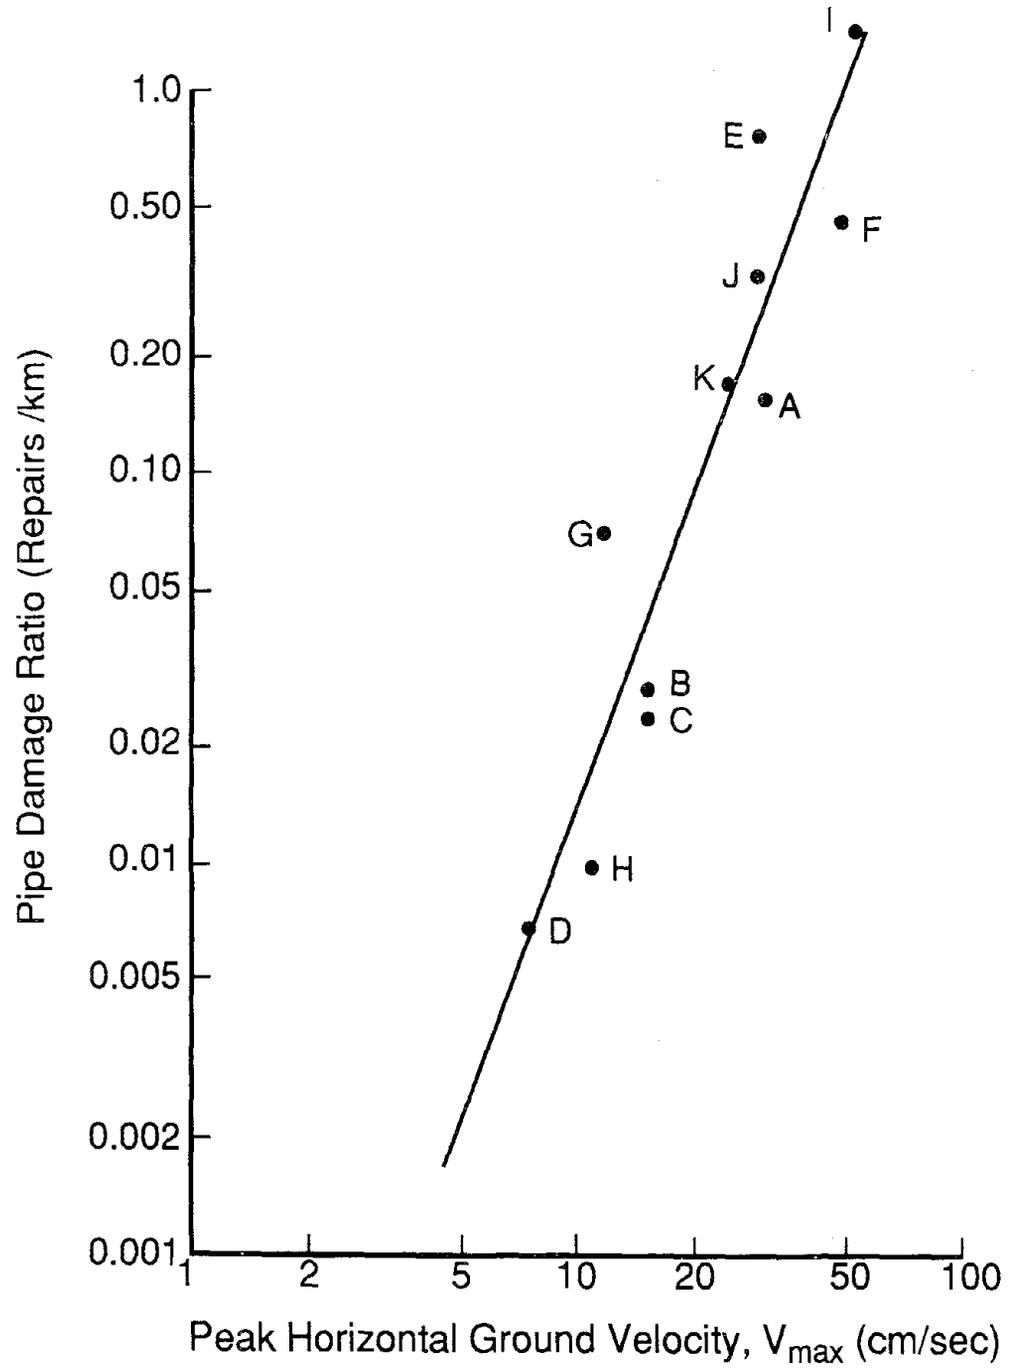
Attempts by O'Rourke and Ayala to establish material specific relationship, from their data, proved unsuccessful. No attempts were made to establish diameter specific relationships. O'Rourke and Ayala [19] attribute the scatter to variations in C or unusual soil conditions, such as corrosive soils or variable subsurface conditions. A map showing soil conditions and the pipeline network in the Limón area is not currently available. Also, there was some PGD within the city as shown in Figure 4-3. However, for most of the pipe breaks we were unable to determine whether they are due to WP or PGD. Hence a more detailed estimate of wave propagation damage using Figure 4-2 is not possible.

Figure 4-2 presents expected damage to AC, CI and RCCP due to WP effects only. Specifically the O'Rourke and Ayala [19] relation predicts 0.10 and 1.0 repairs per km for Hard and Soft site respectively in the Limón area as shown in Table 4-II. From Tables 3-I and 3-III, the number of repairs to AC, CI and RCCP pipe from both WP and PGD effects were 81, 75 and 120 over lengths of 16.8, 40.9 and 14.0 km respectively. This yields

FIGURE 4-2 Wave Propagation Damage to Common Water System Pipe (after O'Rourke and Ayala, 1992)

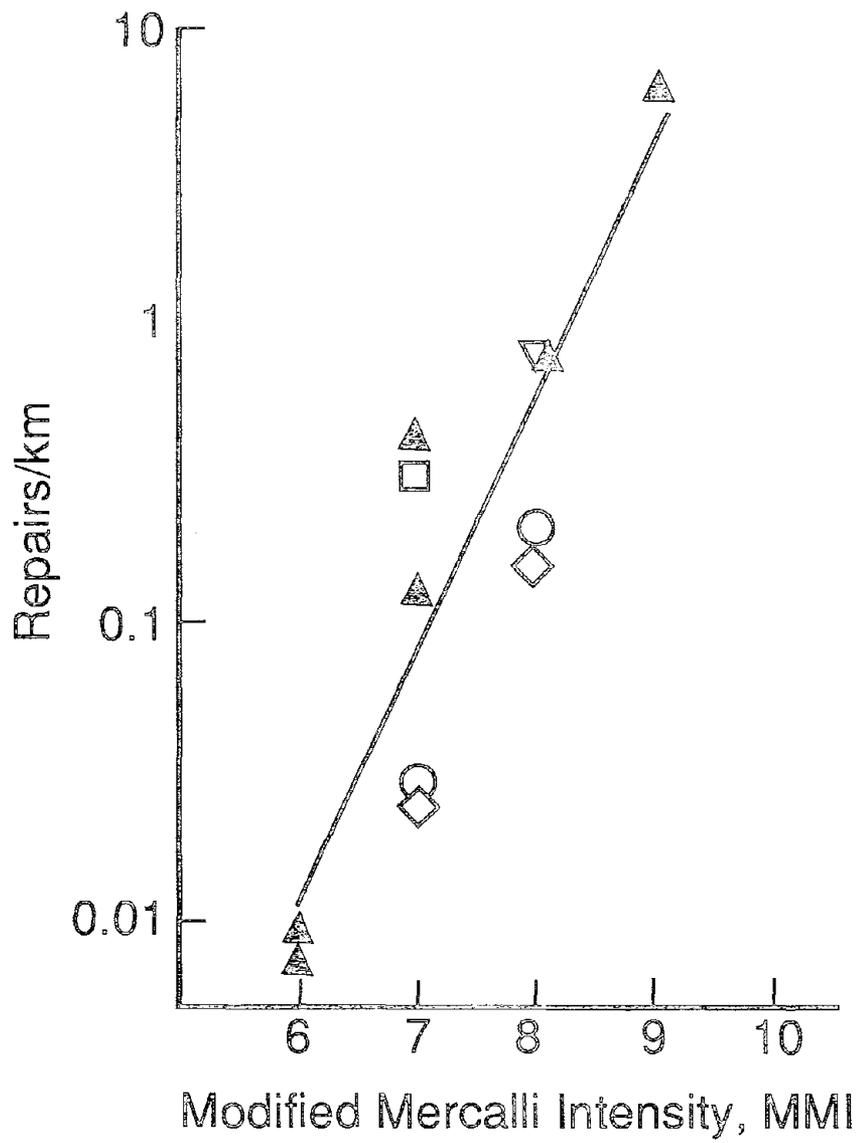
As noted in Section 1, the estimated MMI for the April 22, 1991 Costa Rica earthquake was VIII or IX in the Limón area. From Figure 4-4, one expects about 0.55 and 4.2 repairs per km in CI pipe for MMI of VIII and IX respectively.

Figure 4-4 and 4-5 present expected damage to CI pipe due to both WP and PGD effects. Specifically the O'Rourke et al [20] relation predicts 0.55 and 4.2 repairs per km for the observed MMI of VIII or IX respectively, while the Barenberg [18] relation predicts 6.0 and 60.0 repairs per km for the observed uplifts of 0.55 and 1.5 m respectively. This information is summarized in Table 4-I.

FIGURE 4-4 Combined Damage Rate for Cast Iron Pipe (after O'Rourke et al., [20])

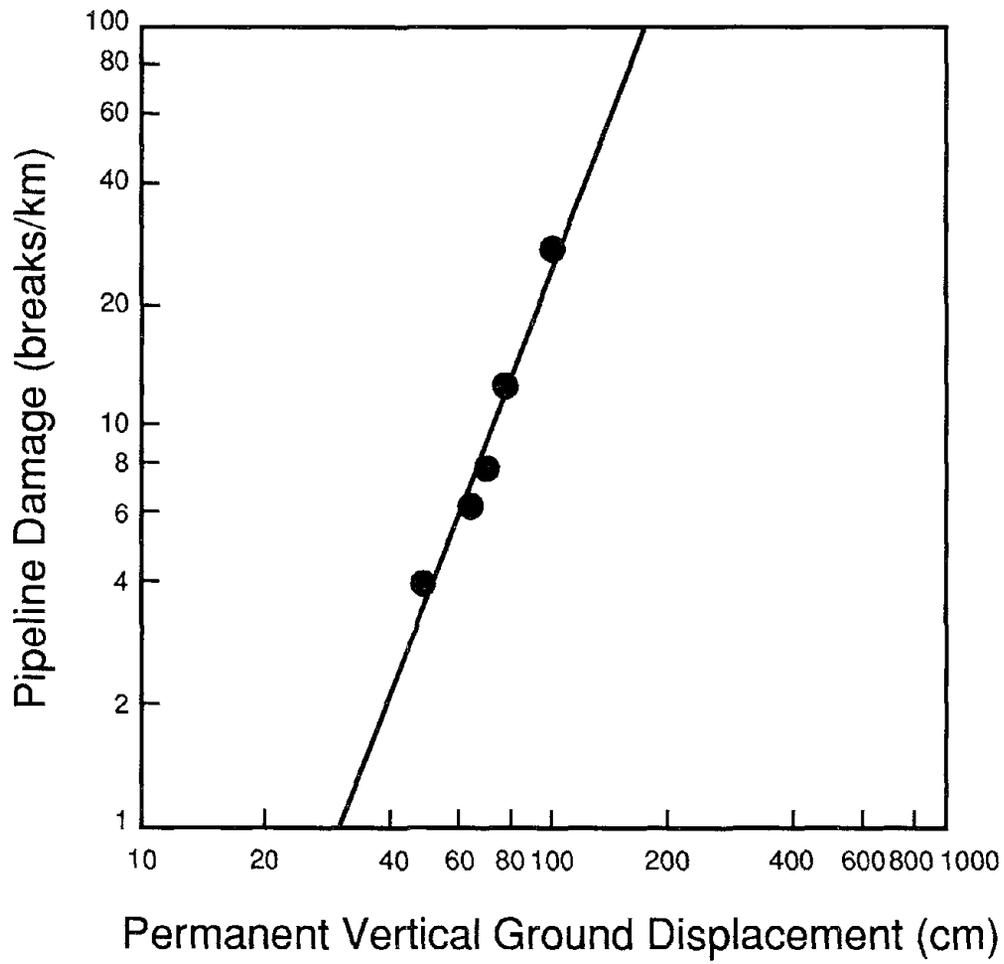
Using data from the Northeast San Fernando Valley during its 1971 earthquake, Barenberg [18] correlated vertical PGD with damage to CI and steel pipe with semi-rigid or poorly welded joints. The relationship is shown in Figure 4-5, and as with Figure 4-4, both WP and PGD damage are combined. The PGD used by Barenberg is the average vertical uplift in a 1 square mile sector. One suspects that pipe damage is more directly related to differential movements or ground strain within an area, however the average uplift in an area may also be a rough measure of differential movements.

As noted in Section 1, the coseismic uplift in Limón was about 1.5 m while the uplift at Bomba on the Banano River was about 0.55 m. From Figure 4-5, one expects combined damage ratios of about 6.0 and 60.0 repairs/km for average vertical PGD of 55 cm and 150 cm respectively.

FIGURE 4-5 Combined Damage Rates for Cast Iron and Steel Pipe (after Barenberg, [18])

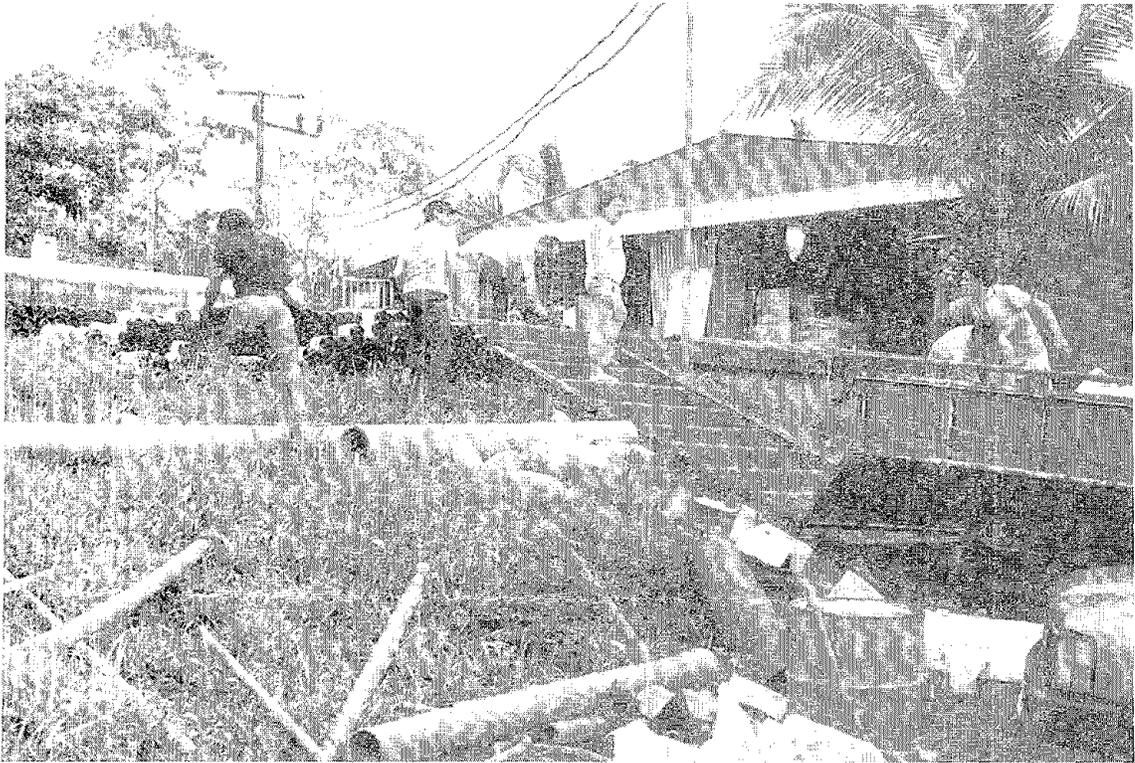
FIGURE 5-1 Workers Unloading Potable Water at the AyA Operations Yard in Limón, on May 3, 1991.

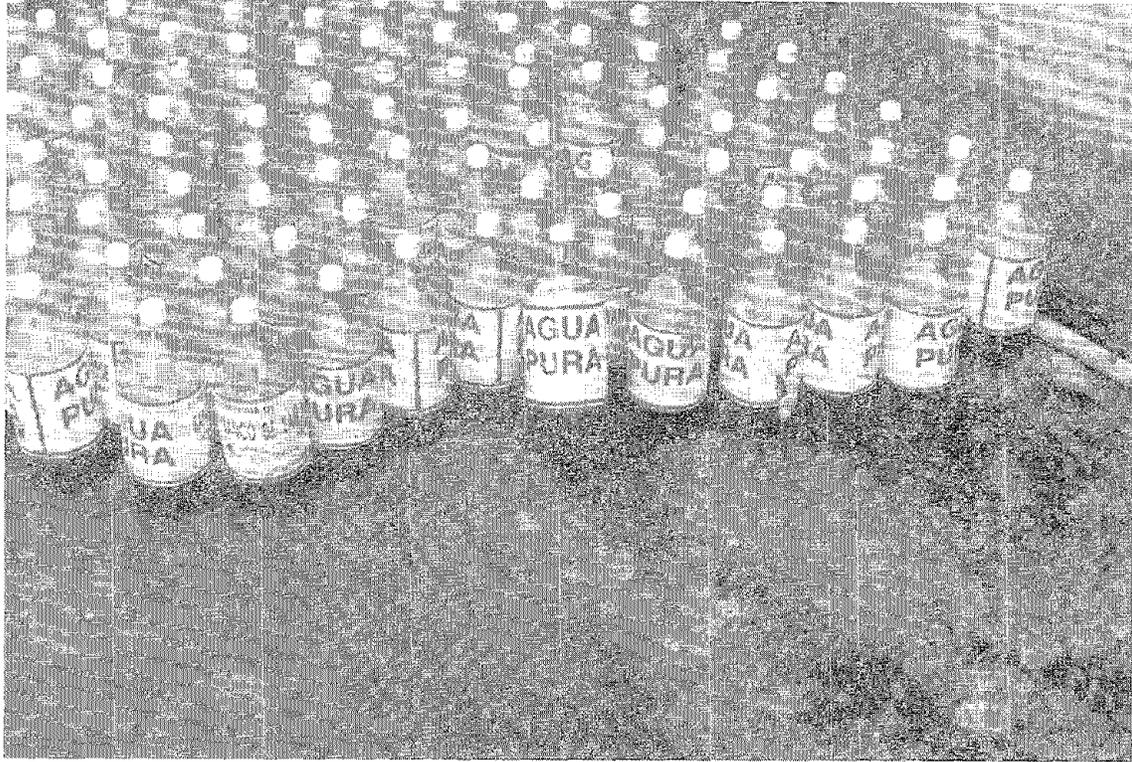
FIGURE 5-2 Two Liter Plastic Coca Cola Bottles Trucked to Limón from San José, Used for Temporary Potable Water Distribution.
