**The Island of Guam Earthquake of
August 8, 1993**

S.W. Swan and S.K. Harris
EQE International
44 Montgomery Street, Suite 3200
San Francisco, California 94104

Technical Report NCEER-93-0017

September 30, 1993

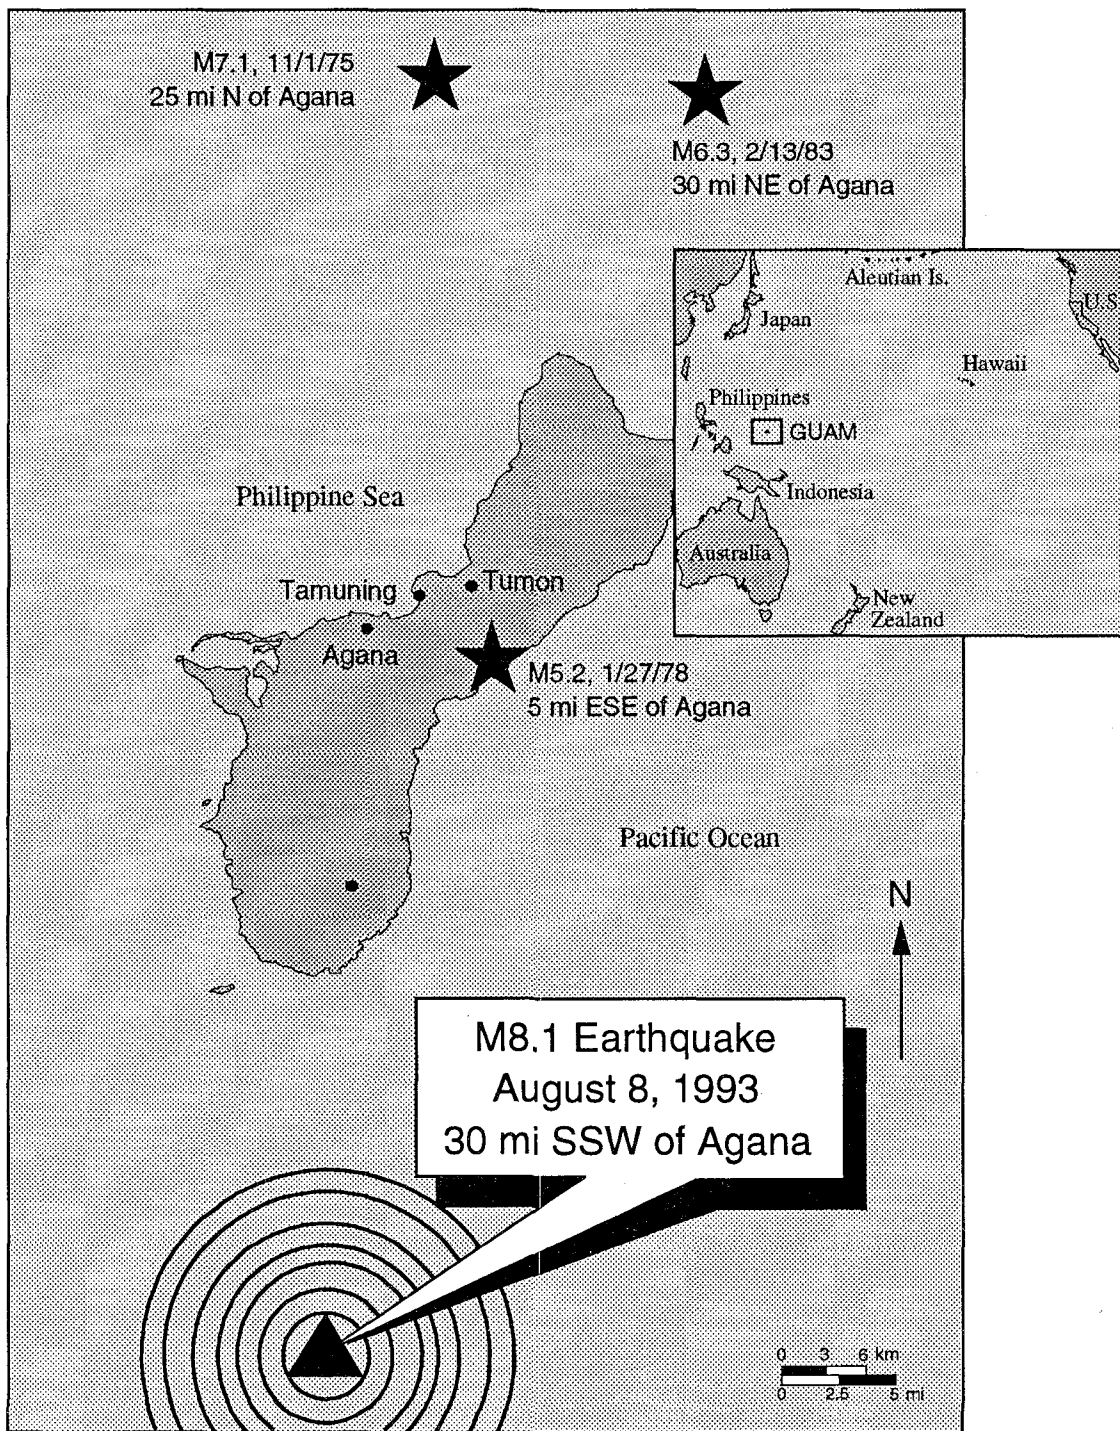
FIGURE1.DRW 71081-01 9/21/93

Estimates of the epicentral location initially placed it north of Guam toward the neighboring island of Rota. Further study indicated that the fault movement was in the Marianas trench about 50 km to the south of Guam (Figure 3-1). In this region the trench curves toward the southwest beneath the Marianas Island chain. The westward movement of the Pacific plate relative to the Philippine plate combines strike-slip sliding with subduction compression. Based on a moment-tensor solution of long distance seismic waves by the USGS, the August 8 earthquake appears to have been a shallow-dipping subduction thrust toward the northwest, combined with a limited amount of strike-slip movement along the trench. The orientation of the fault plane is more-or-less normal to Guam, so that the rupture did not approach the island. The fault plane was estimated to be centered some 60 km beneath the ocean floor. This relatively deep source (compared to California earthquakes for example) reduced the intensity of shaking on the island.

Figure 3-1: The map shows the best-estimate location of the August 8 epicenter relative to the island of Guam. Locations are also shown for other earthquakes occurring near the island within the last 20 years.

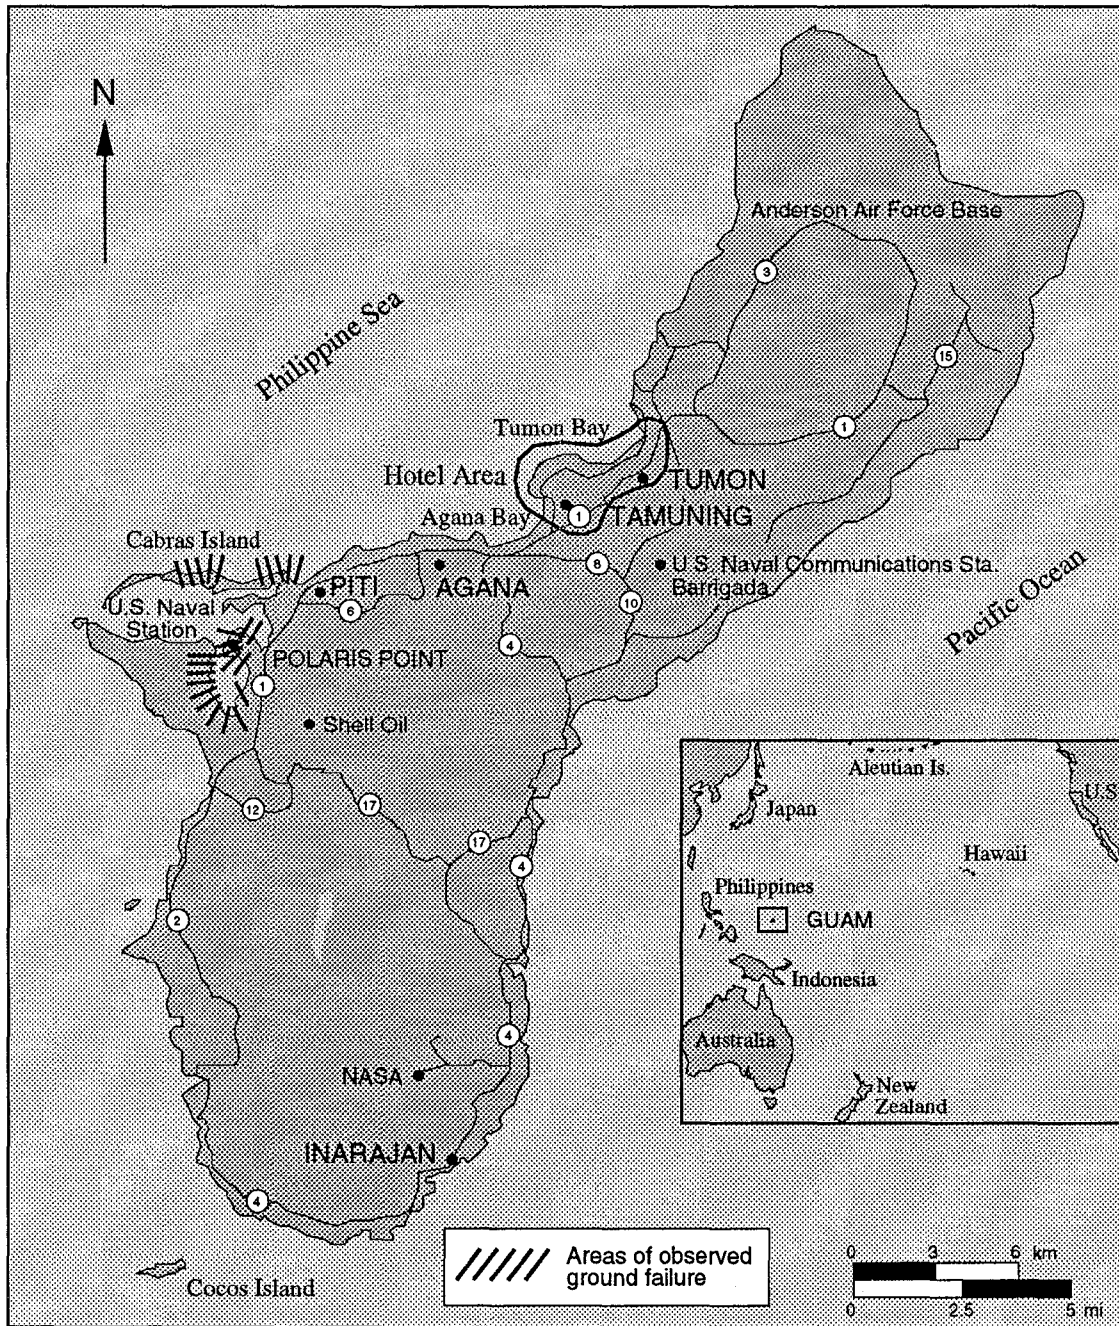
FIGURE2.DRW 71031-01 9/21/93

Nearly all of Guam's surface would be described as firm soil or rock (Figure 4-1). Permanent ground displacement from the earthquake, in the form of settlement or spreading, was therefore rare. The largest region of soft soil bounds Apra Harbor, location of the commercial port and the U.S. Navy port on the west side of the island. The harbor area is a combination of coral reef surrounded by natural alluvium and artificial fill.

Figure 4-1: Most of Guam is relatively firm soil or rock, with the exception of the port area of the western shore. The most intense ground shaking appeared to occur near the port, including areas of soil liquefaction. The tourist hotel district around Tumon Bay, sited on the coral reef, appears to have experienced moderate ground shaking.
