**Engineering Aspects of the October 12, 1992  
Egyptian Earthquake**

**A.W. Elgamal, M. Amer, K. Adalier and A. Abul-Fadl**

Technical Report NCEER-93-0018

October 7, 1993

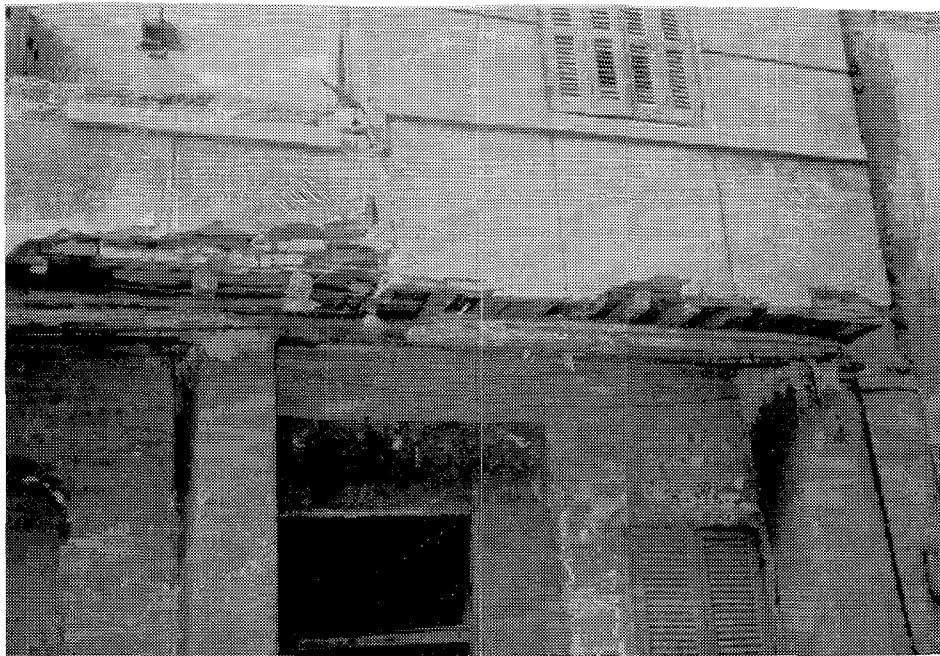
Thousands of older structures (50 - 200 years old or more) in the cities of Cairo and El-Faiyum are built of masonry or stone with mortar or cement bonding. The floor/roof systems in these structures are often composed of wood beams with or without steel reinforcement strips. Aside from typical cracks due to the imparted shear loads (figures 1-7 and 1-8), much destruction was observed in non-structural elements such as: i) plaster finish on outside (figures 1-9 through 1-12) and inside walls (figure 1-13); ii) heavy masonry and plaster decorative ornaments (figure 1-14); iii) balcony and roof parapets (figure 1-15), and sometimes entire nonstructural walls (Khater, 1992). Many of the casualties and loss of property resulted from such falling objects during the earthquake.

**FIGURE 1-12** Fallen plaster along wood beam ceiling, Misr Elkadima district.

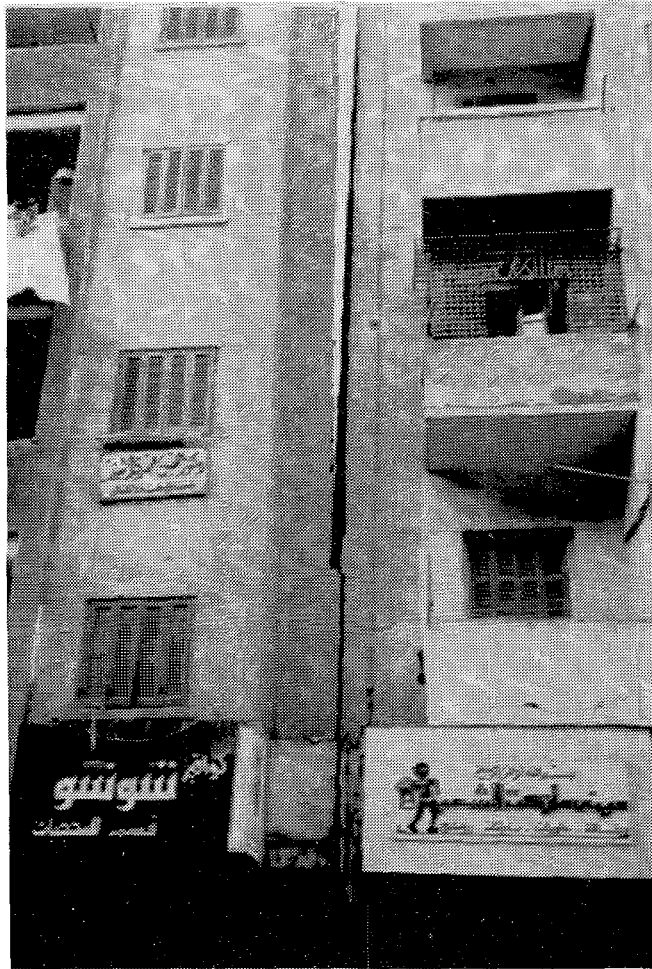
Many side-by-side buildings were found to show signs of relative settlement after the earthquake. Such buildings were often reported to have collided during the earthquake, causing a loud fearful rumble. The most visible signs of earthquake-induced deformation were manifested in: i) opening of a permanent gap between adjacent buildings (figures 1-16 through 1-24); and ii) tilting of some buildings relative to the adjacent structures (figures 1-25 through 1-29). In general, a portion of these deformations might have existed before the earthquake.

**FIGURE 1-17** Open crack between reinforced concrete building 2 (Magless Elshaab Street, close to Elsayyeda Zenab).

FIGURE 1-18 Close-up of Figure 1-17.

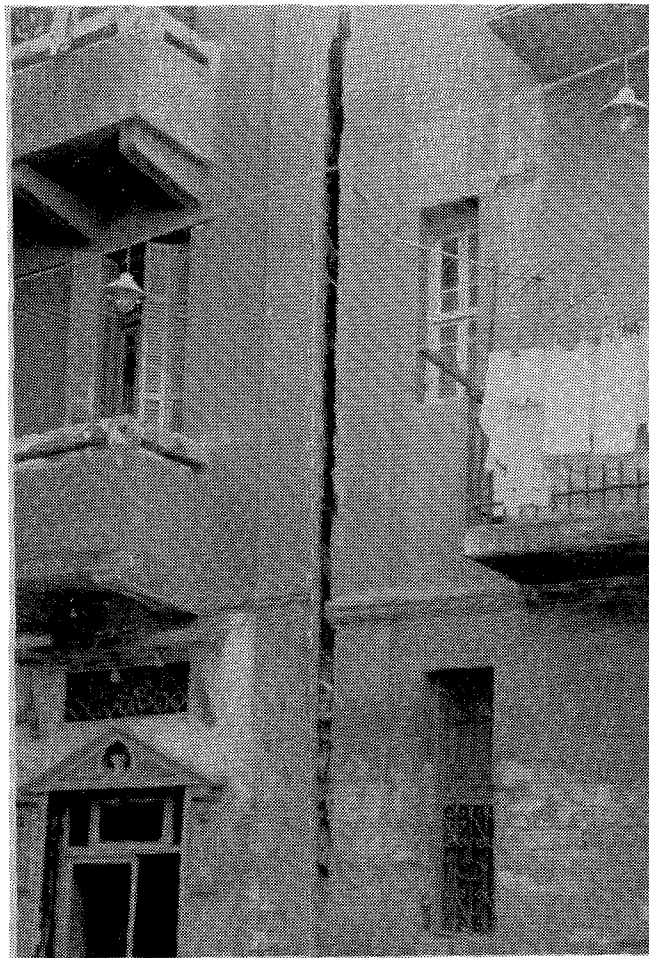
**FIGURE 1-20** Open crack between reinforced concrete building 4 (Kadri Street, Elsayyeda Zenab).

**FIGURE 1-21** Close-up of Figure 1-20.

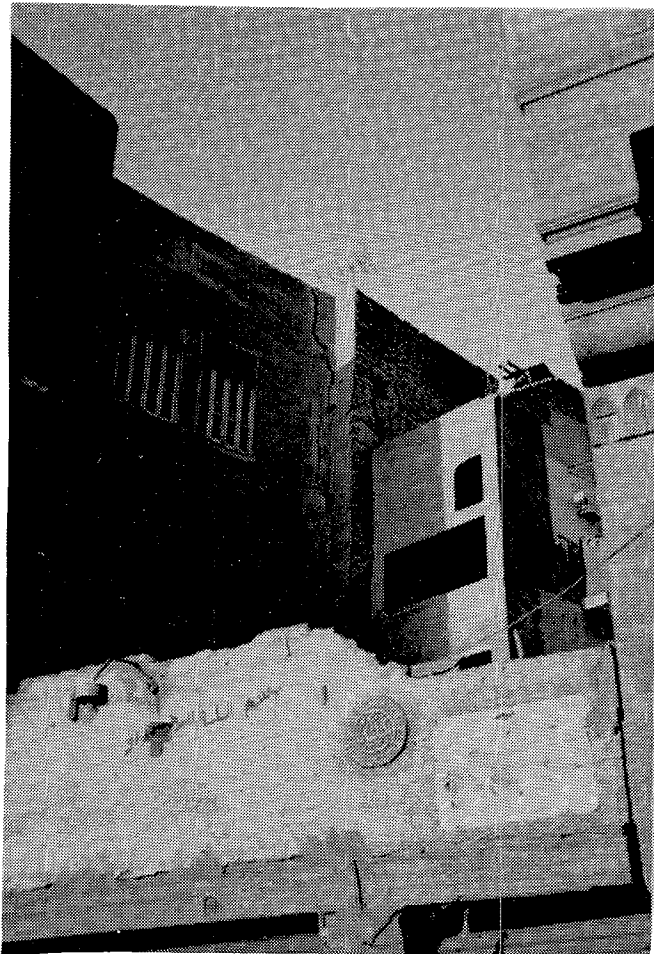
**FIGURE 1-23** Open crack between reinforced concrete building 6 (Elkalaa district).

**FIGURE 1-24** Close-up of Figure 1-23

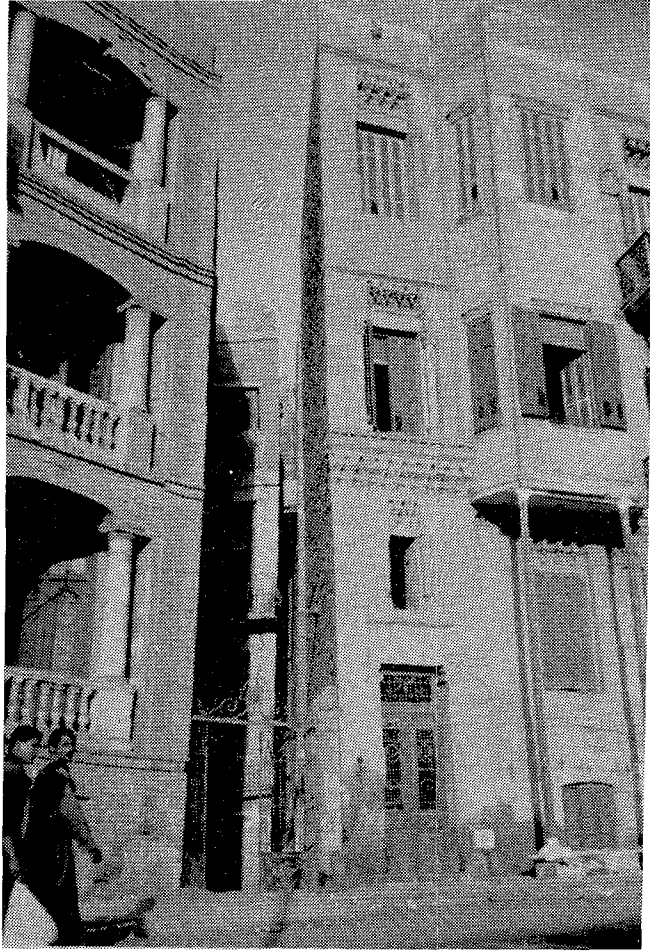
**FIGURE 1-28** Group of tilting buildings; tilt increased after earthquake and buildings were evacuated (Elkalaa district, across from Elsultan Hassan Mosque).

FIGURE 1-29 Close-up of Figure 1

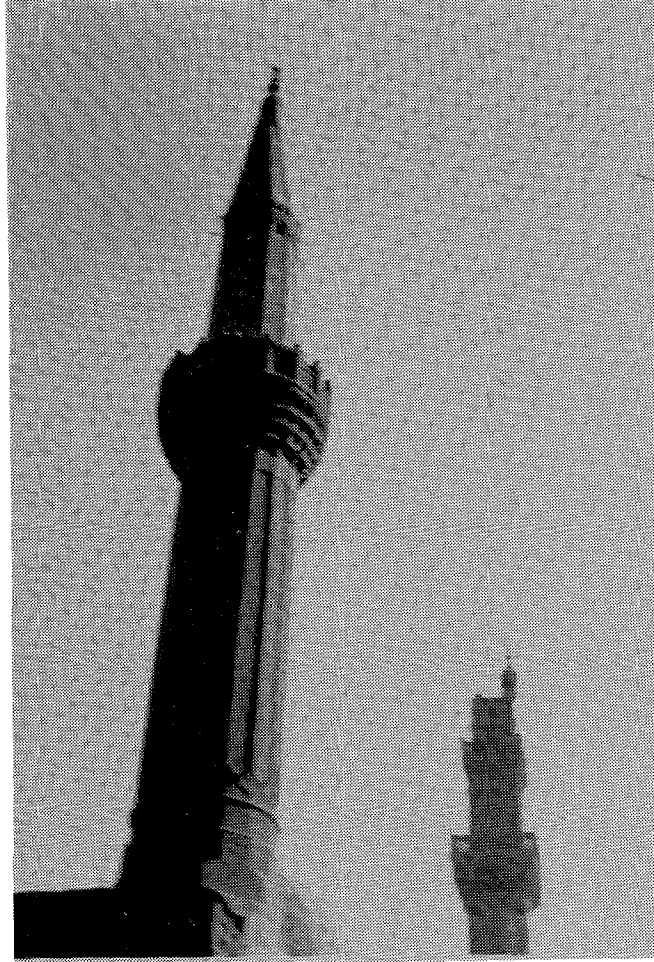
The top sections of a number of Mosque minaretes suffered partial or full collapse (figure 30) during the earthquake. At Al-Hanafi Mosque, three of the four unreinforced stone top minaret sections toppled and fell to the street (figures 1-31 through 1-36). Cracks, mostly initiated prior to the earthquake, were abundant between minarets and attached buildings due to the difference in inertial properties at Sultan El-Ghuri Mosque (figures 1-37 through 1-42). Shear cracks were intensified along window openings in large load bearing stone walls (figure 1-43). In figures 1-44 through 1-46, a partially collapsed masonry minaret top is shown.

**FIGURE 1-31 Al-Hanafi Mosque: missing minaret top (Elsayyeda Zenab district).**

**FIGURE 1-32** Close-up of Figure 1-31.

A large program of retrofit and rehabilitation is necessary for these invaluable historical structures. Along with aseismic retrofit, the elevated groundwater table problem must be resolved in order to protect the underlying masonry foundations (Wight, et al. 1992; Sykora, et al. 1993). Many tilting minarets (figures 1-47 through 1-49) should be reinforced, and restored to their original vertical position as part of this retrofit process.

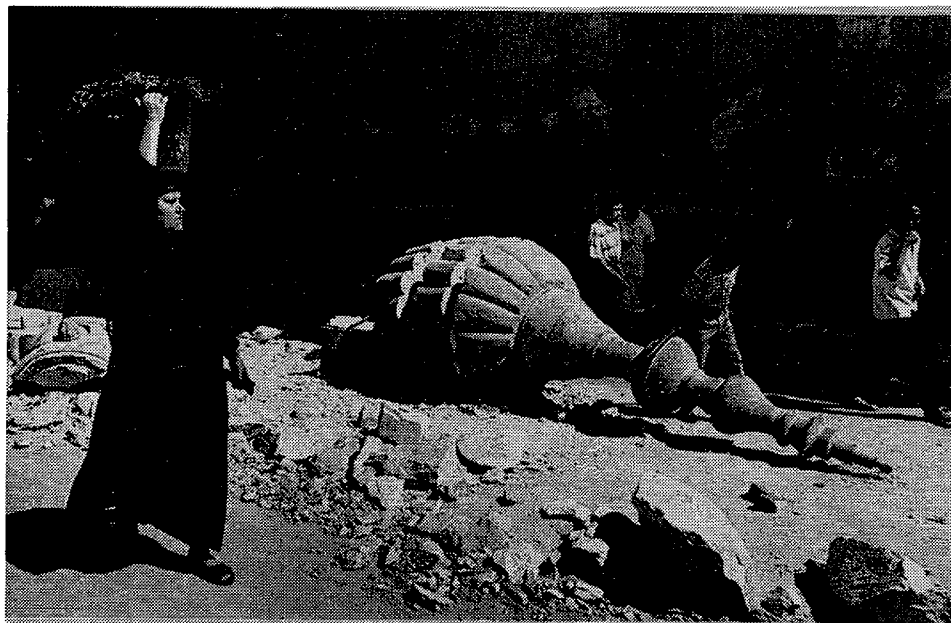
**FIGURE 1-33b** Toppled minaret tops  
(Al-Hanafi Mosque).  
[National Geographic, Vol. 183, No. 4, April  
1993.]

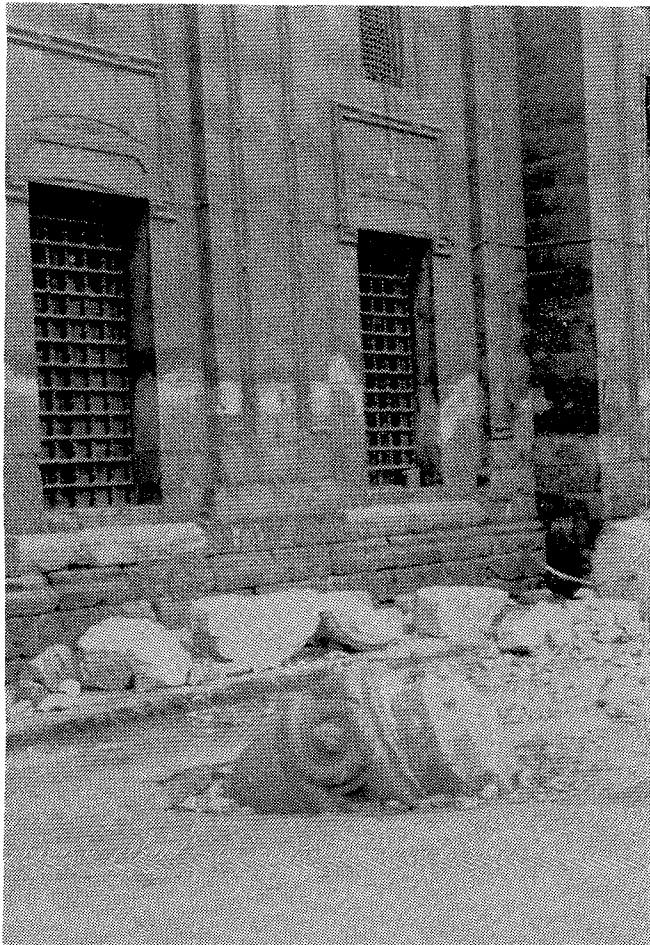
**FIGURE 1-34** Toppled minaret tops  
(Al-Hanafi Mosque).

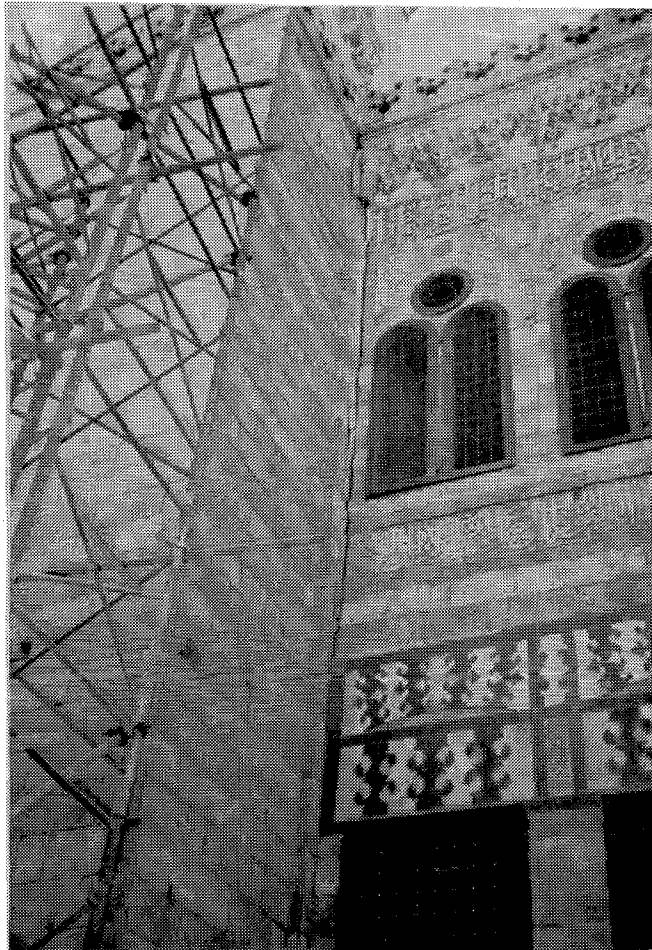
**FIGURE 1-37** Crack between minaret and Mosque (El-Ghuri Mosque); cracks aggravated by earthquake; Schaffelding was placed for routine maintenance before earthquake.

**FIGURE 1-38** Close-up of Figure 1-37.

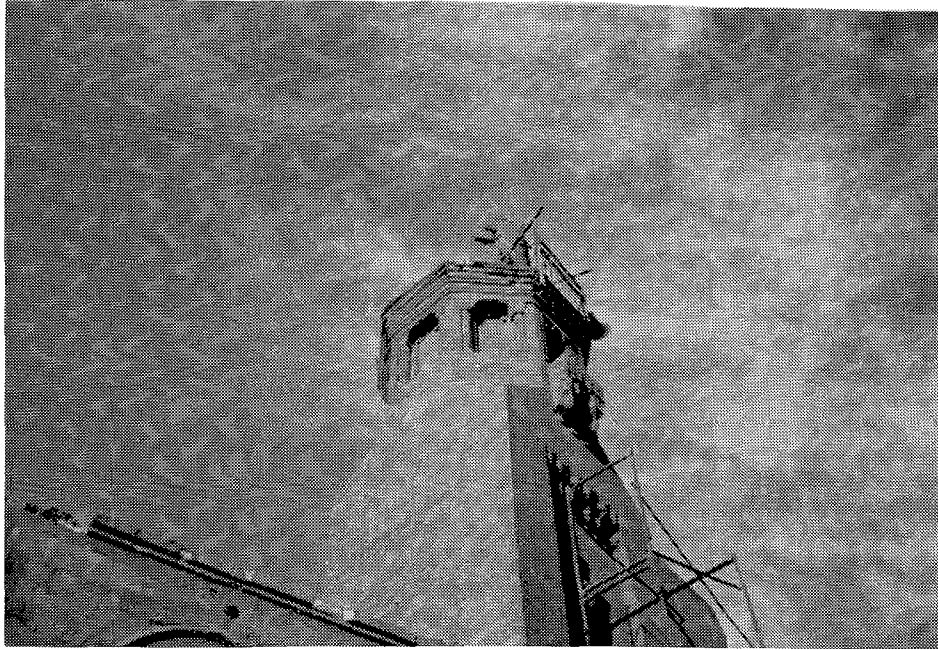
**FIGURE 1-44** Partially collapsed masonry minaret top (Port-Said Street, Sayyeda Zenab district).

**FIGURE 1-45** Close-up of Figure 1-44.

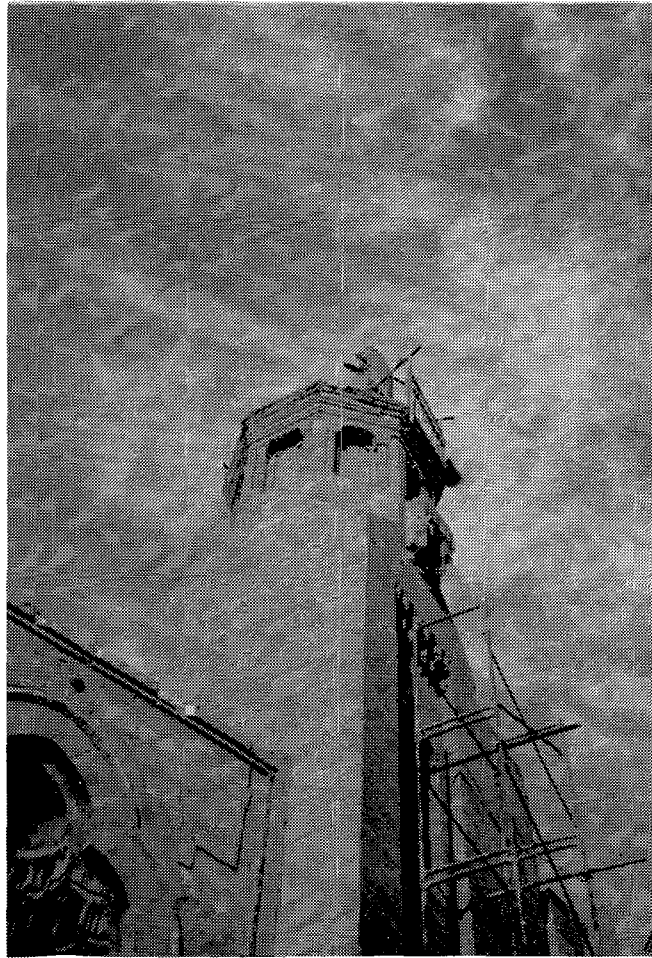
**FIGURE 1-46** Close-up of Figure 1-44.

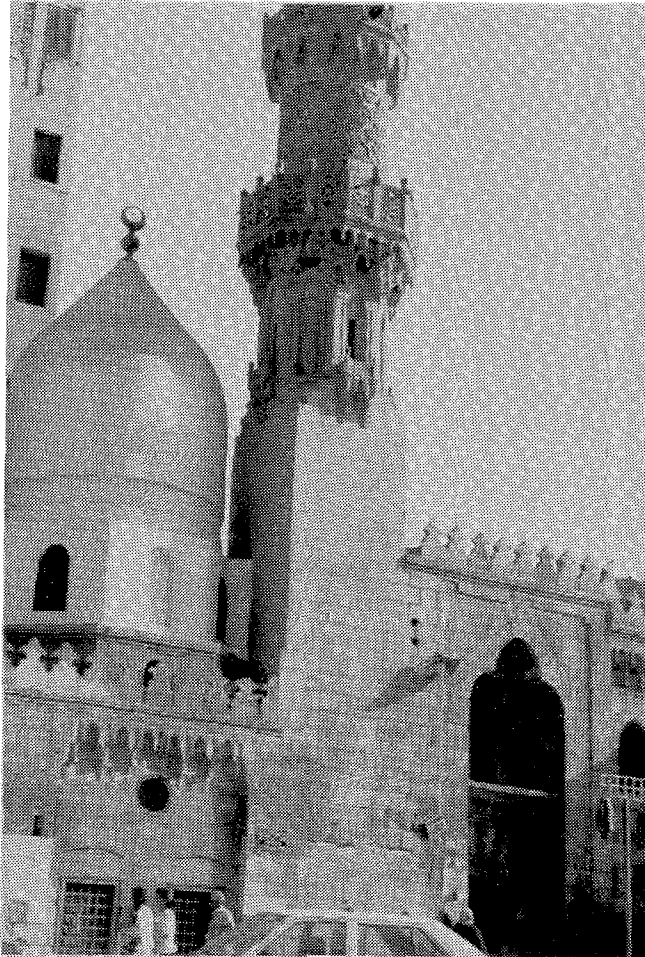
**FIGURE 1-47** Slightly tilted minaret (tilting increased due to earthquake).

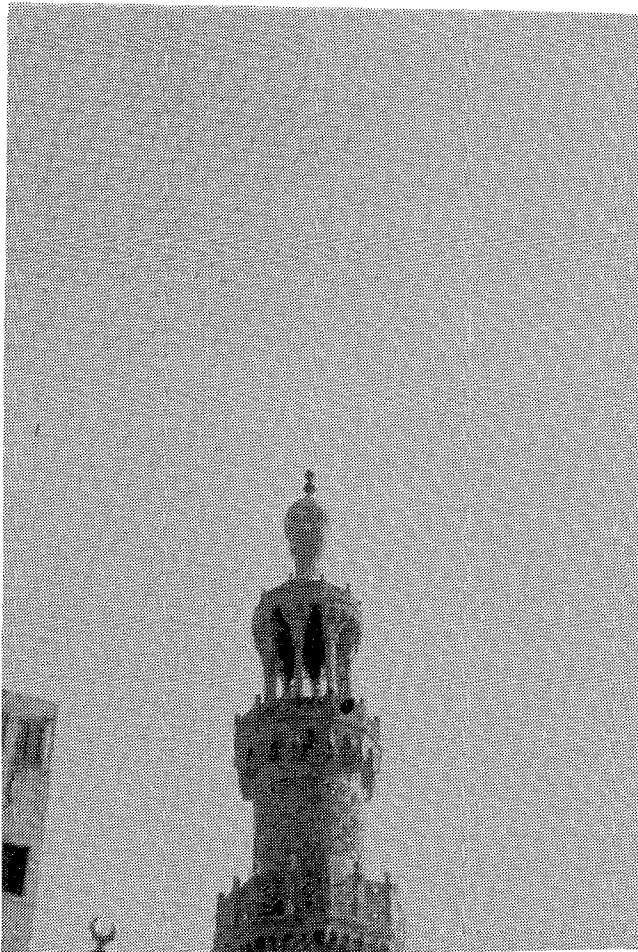
**FIGURE 1-48** Tilted minaret of Figure 1-47 shown relative to adjacent building.

**FIGURE 1-49** Close-up of Figure 1

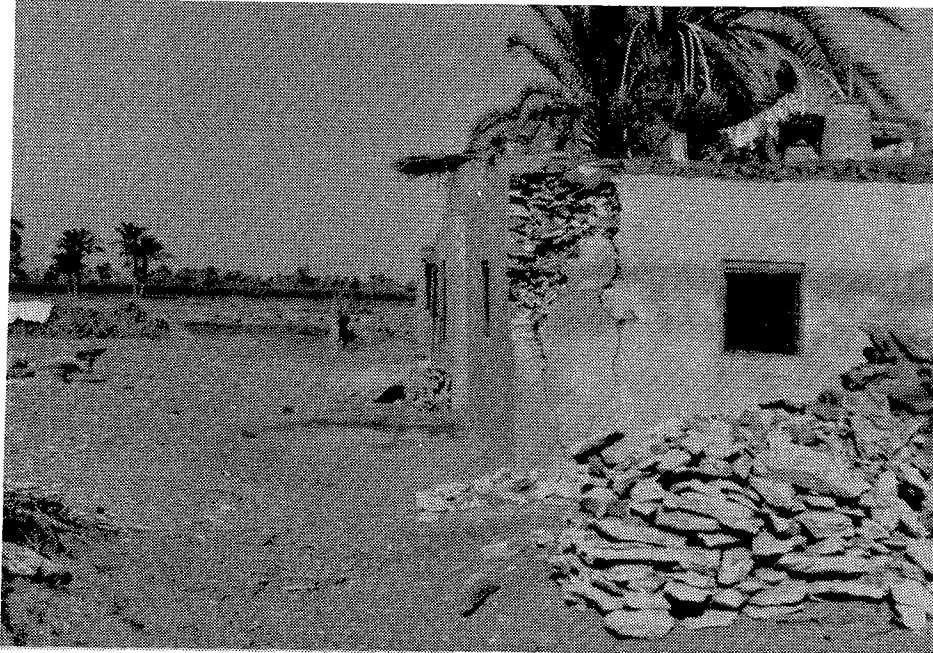
**FIGURE 1-50** Poorly cemented collapsed structure of adobe and stone fragments.

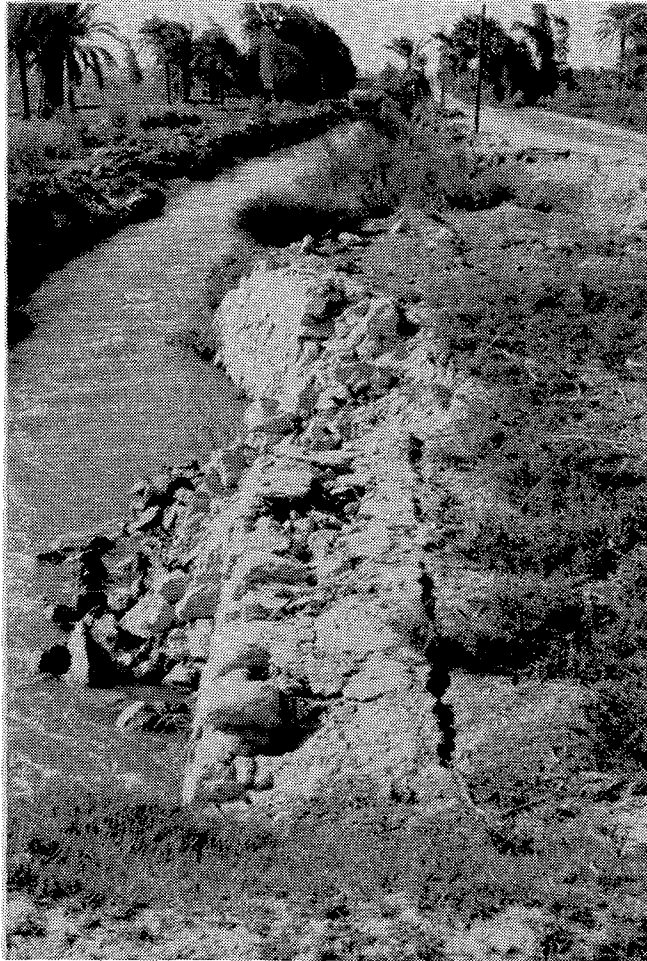
In figure 1-55, cracks along the end of a short 1.5 m high gravity retaining wall were observed. A vertical crack appears along the wall-soil interface, and an inclined crack demarks the deformed soil wedge boundary. Figures 1-56 and 1-57 show the failure of a retaining wall constructed of cemented stone along with a portion of the supported backfill soil. Soil liquefaction associated with the occurrence of large sand boils was observed close to the epicenter. As a consequence, a main road suffered a maximum settlement of about 1.75 m. This liquefaction case history is discussed in the following sections.

**FIGURE 1-56** Partially collapsed cemented stone wall and backfill.

**FIGURE 1-57** Close-up of Figure 1-56.

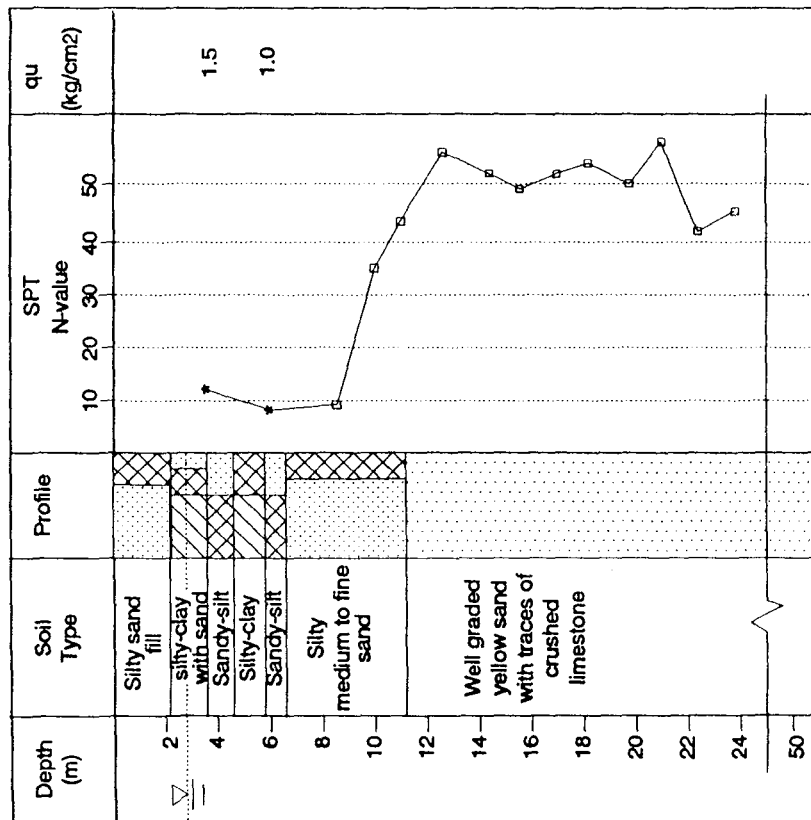
A soil profile and SPT-values from a boring near the road, taken after the earthquake is shown in figure 2-5a. In figures 2-5b and 2-5c, CPT values at a nearby location along with corresponding SPT values (Das, 1990) are shown. The SPT and CPT results denote

FIGURE 2-5a Soil profile near the road settlement area.

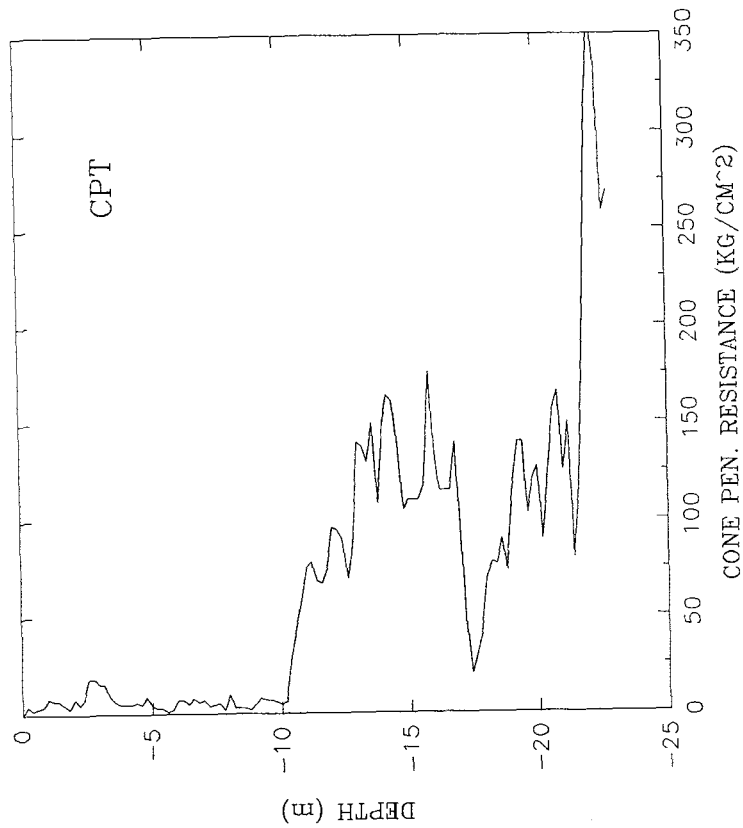
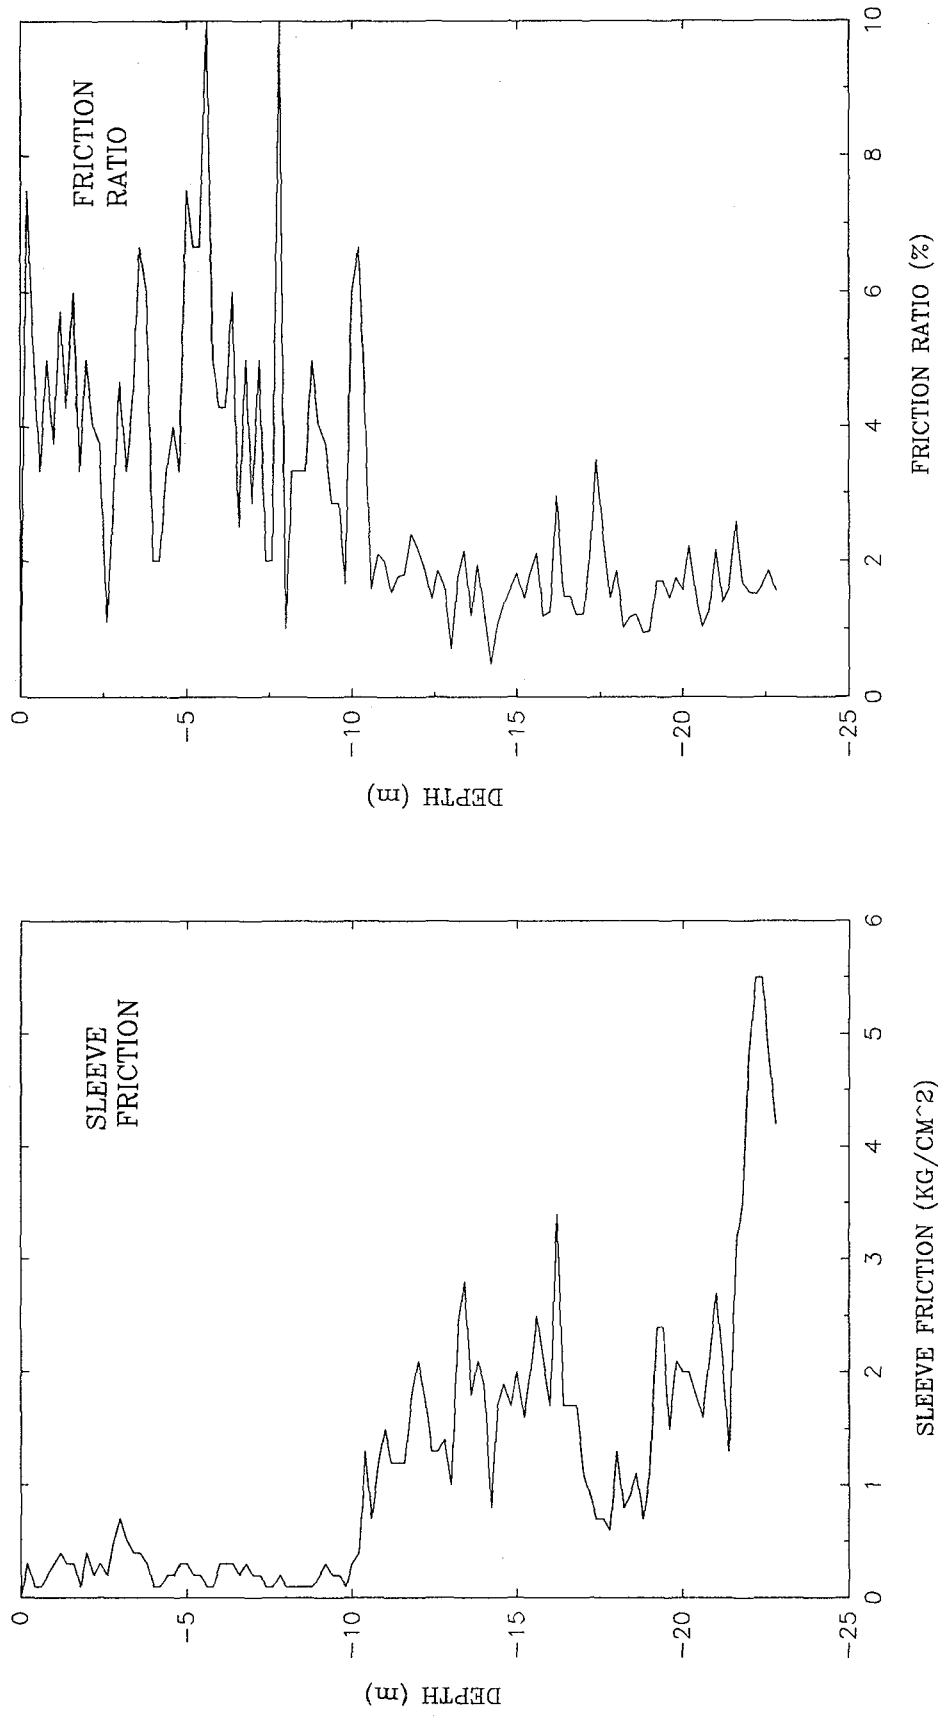
FIGURE 2-5b CPT values measured near road settlement area (location near boring of Figure 2-5a).

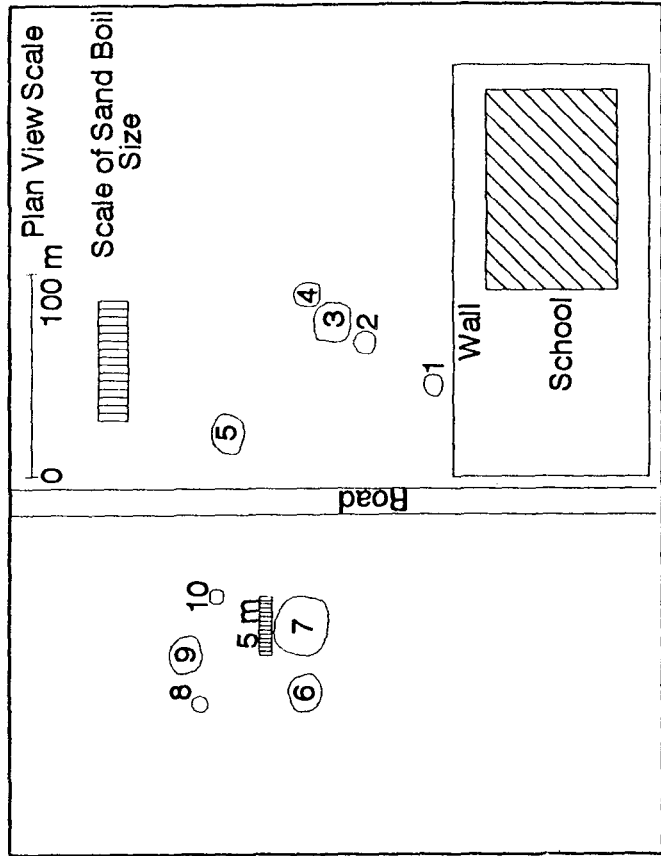
FIGURE 2-6 Schematic of sand boil locations at Bedsa Village.

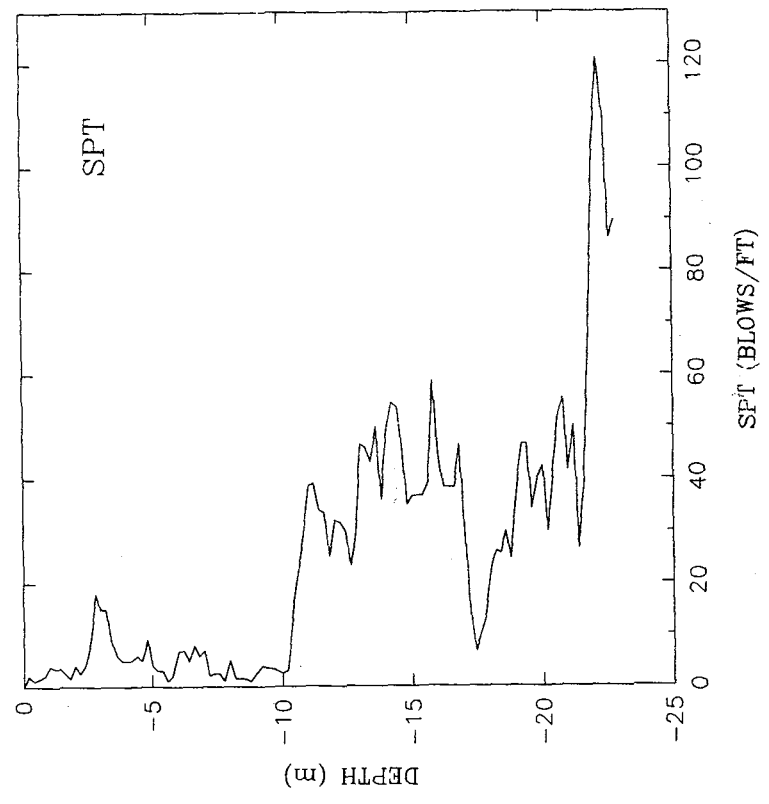
FIGURE 2-5c SPT values calculated from measured CPT values (Figure 2-5b) for road settlement area.

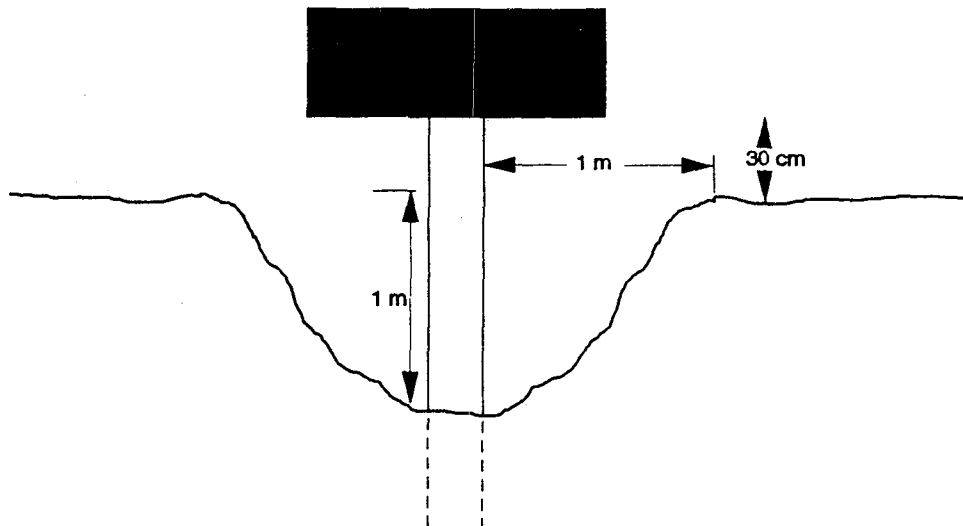
FIGURE 2-7b Schematic of sand boil formed around steel pipe (Figure 2-7a) after earthquake (observed on videotape). Crater No. 1 of Figure 2-6.

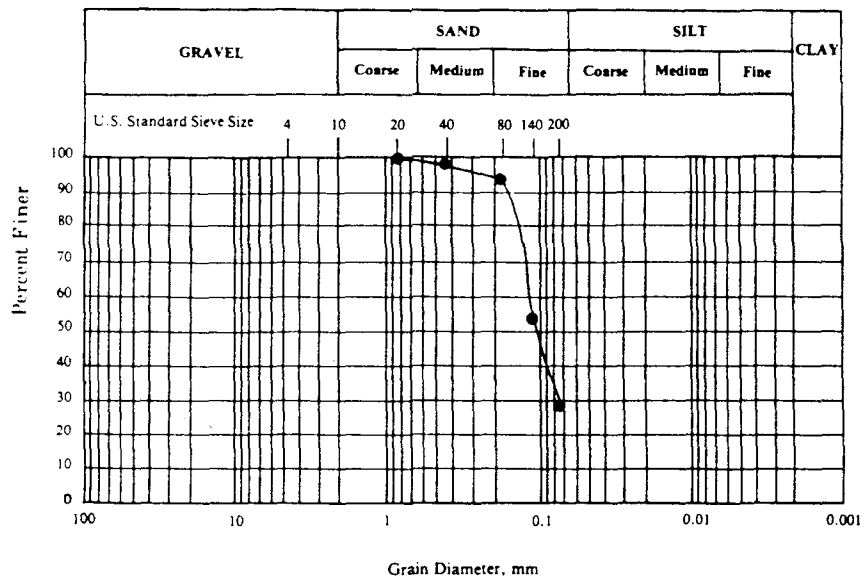
**FIGURE 2-13** Preliminary grain size distribution of ejected material.

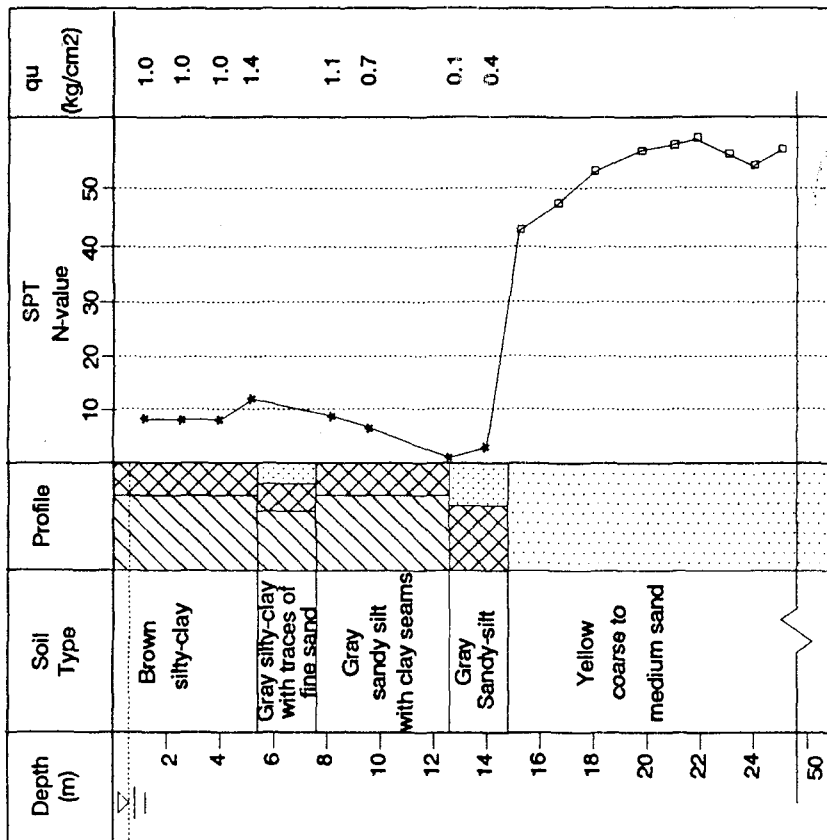
**FIGURE 2-14a Soil profile near sand boils at Bedrsa.**

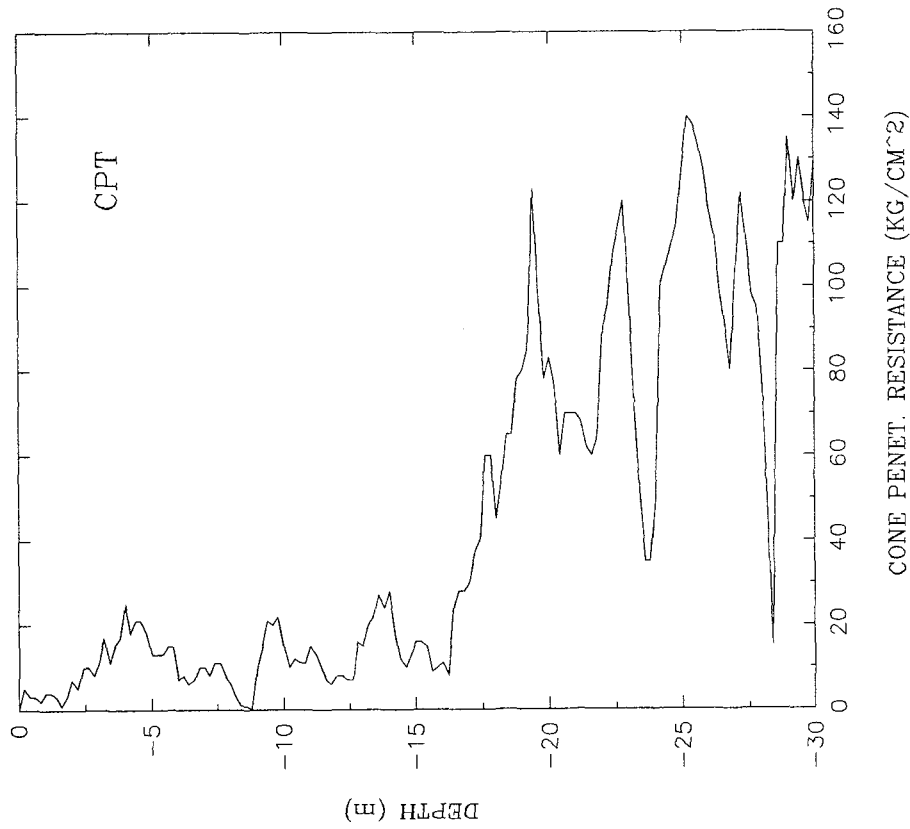
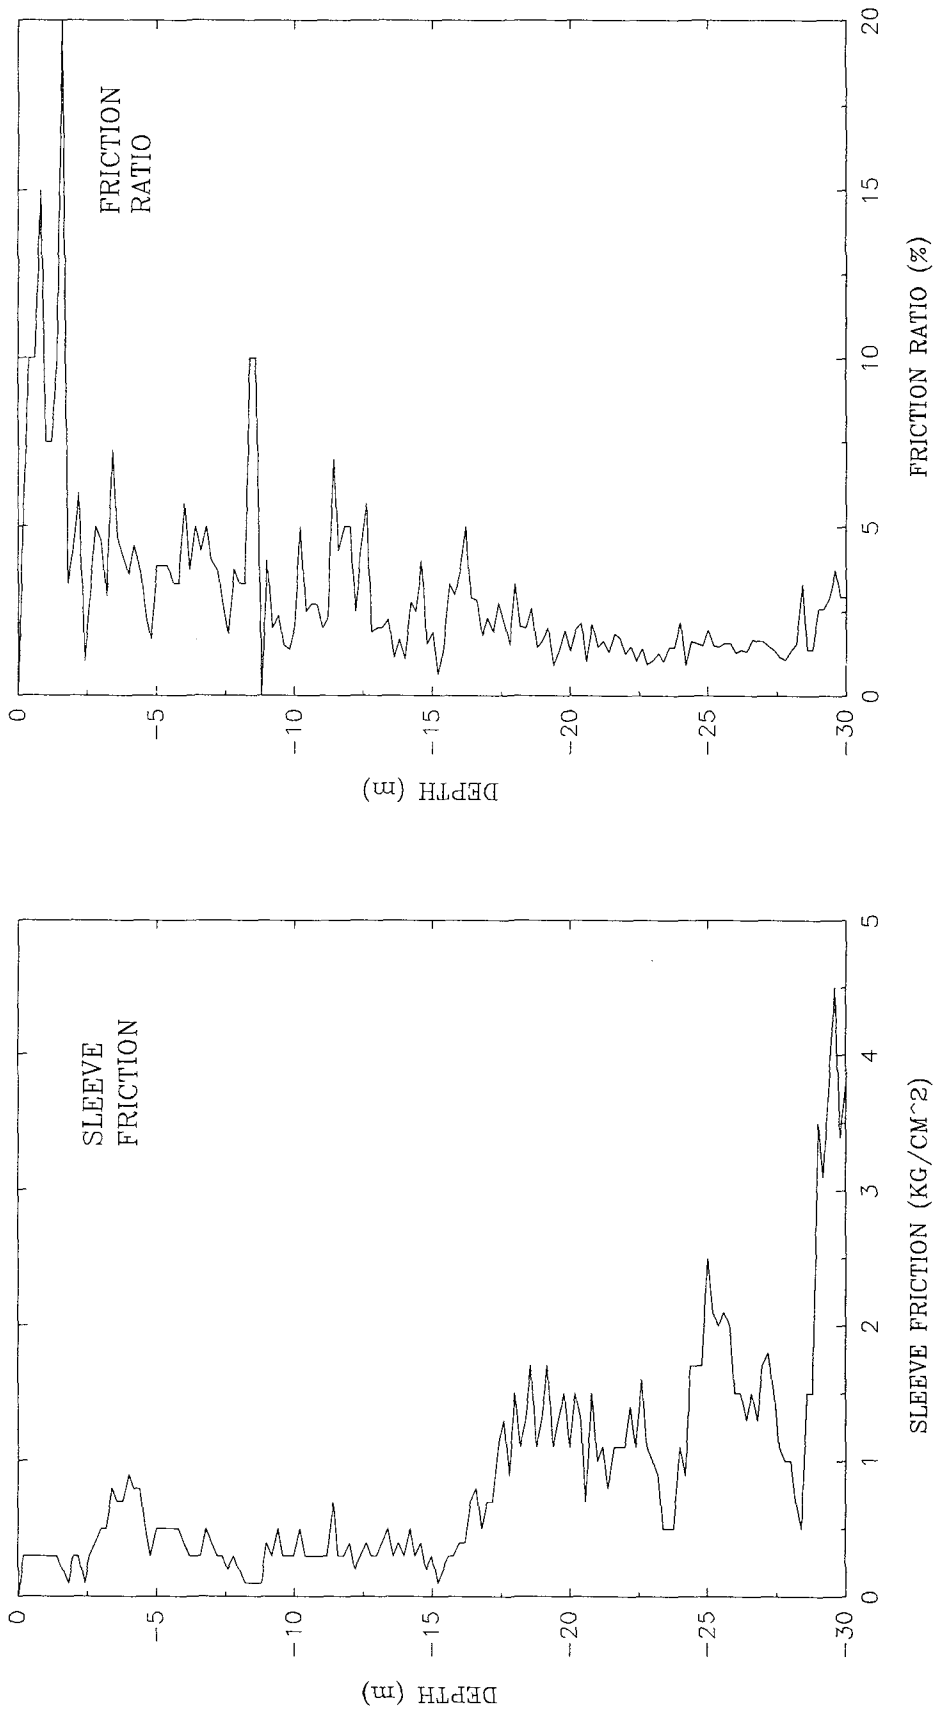
**FIGURE 2-14b CPT values measured near sand boils at Bedrsa (location near boring of Figure 2-14a).**

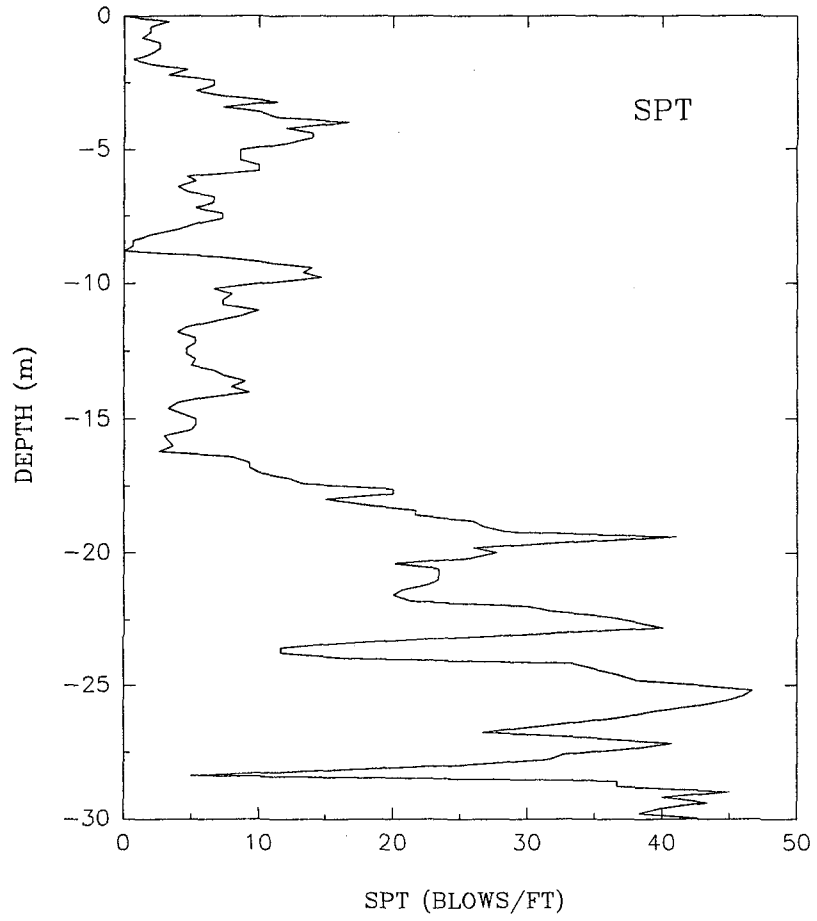
**FIGURE 2-14c SPT values calculated from measured CPT values (Figure 2-14b) for the area near sand boils at Bedsa.**
