**Reconnaissance Report of Damage
to Historic Monuments in Cairo, Egypt
Following the October 12, 1992 Dahshur Earthquake**

Technical Report NCEER-93-0016

August 19, 1993

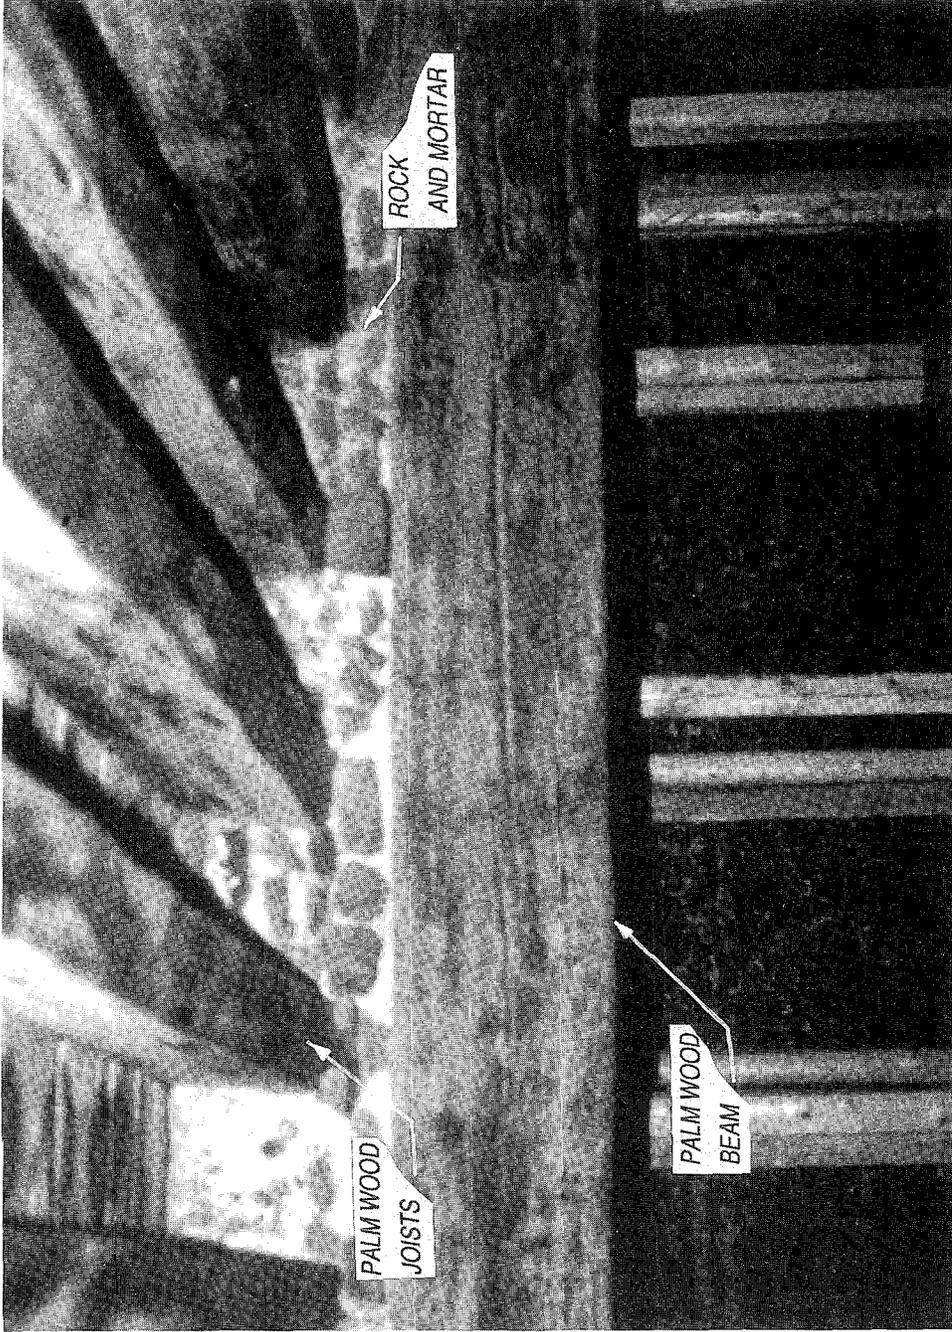
Groundwater is very close to the ground surface at many monuments and likely to be at or above footing level. The masonry (limestone) block acts like a wick from capillary action (sometimes referred to as rising damp). Moisture continues to creep vertically in the stone until the capillary pressures equilibrate, generally well above the ground surface. Excessive moisture is evident up to a couple of meters above the ground level in the walls of several historic monuments. An example is shown in figure 4-4. The impact of groundwater is detrimental not only to masonry block but to wood, too. The increased humidity caused by evaporation of water in the foundation of the el-Moalloqa Church (shown in figure 4-5) has caused the rapid deterioration of palm wood floor joists.

FIGURE 4-5 Structural floor system at el-Moalloqa Church

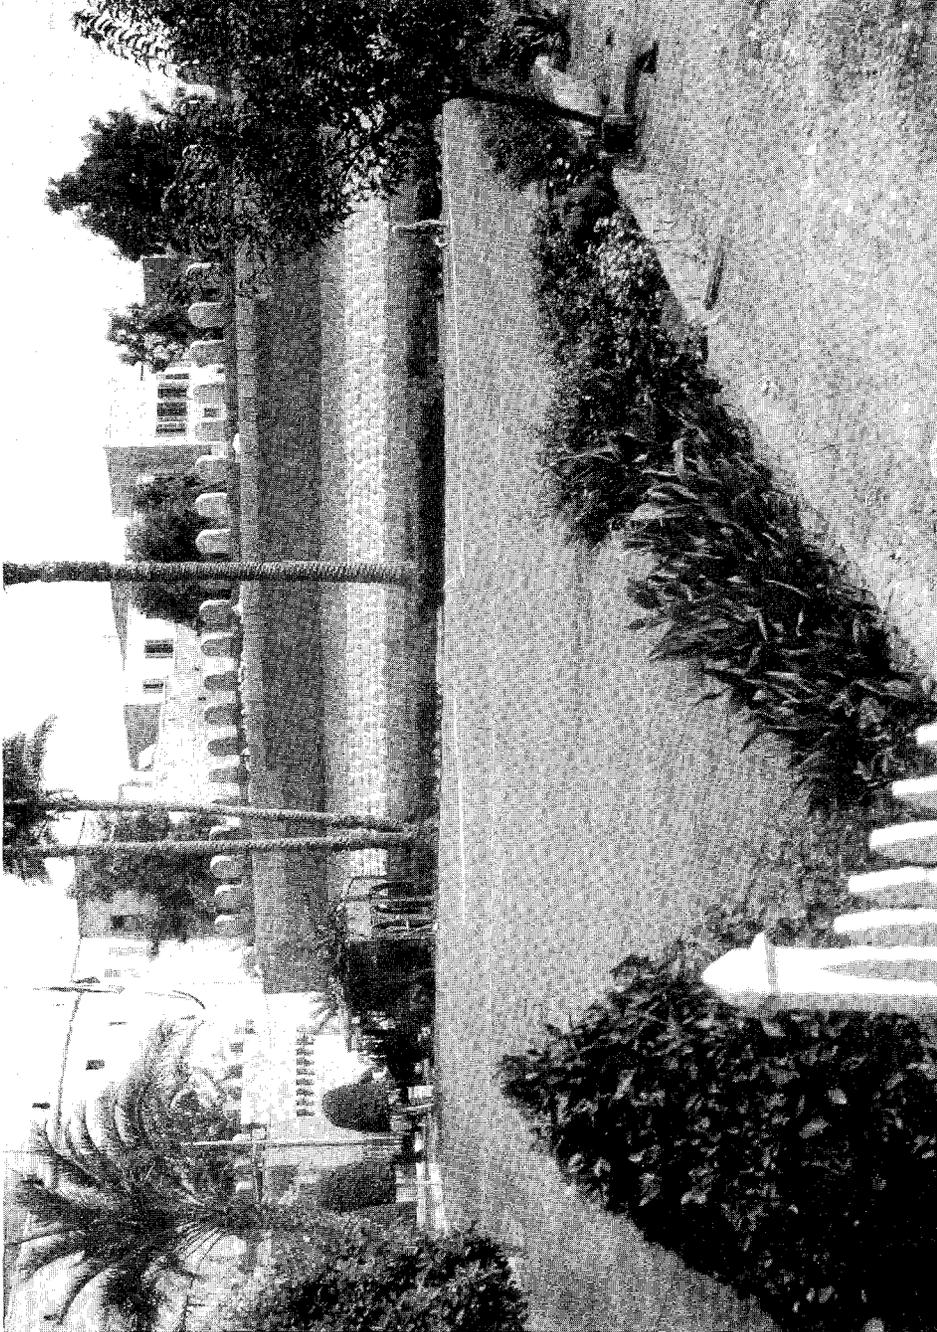
Watering is also taking its toll on masonry retaining walls at the Citadel. The custodians maintain lush grass, bushes, and trees within the complex as shown in figure 4-8 from extensive watering. These gardens and lawns apparently were created in 1984 (SPARE 1984b). The consequence of watering is the steady seepage of water through the walls of the Citadel. This is clearly evident on the east and west sides. A view of the western portion of the wall is shown in figure 4-9. The preservation of the masonry stone will require a change in the current practice of maintaining the flora at the Citadel or a return to a more historic appearance with drought-resistant plants and trees.

FIGURE 4-8 Manicured lawn of Citadel in Southern Enclosure looking northeast toward Bâb al-Gabal

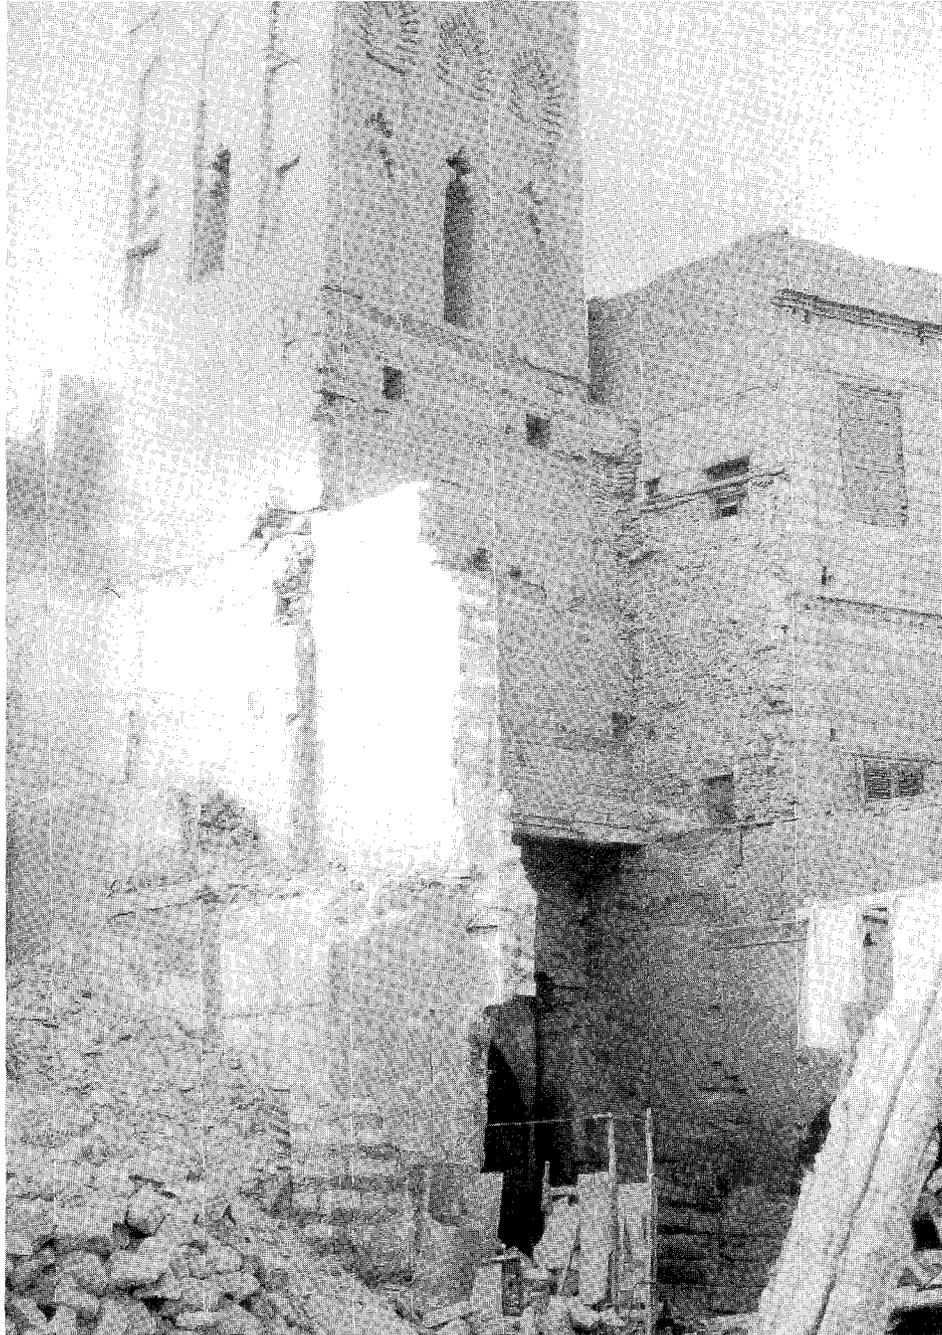
FIGURE 4-17 Base of Minaret of as-Sâlih Negm ad-Din Ayyûb
looking north from remains of madrasa

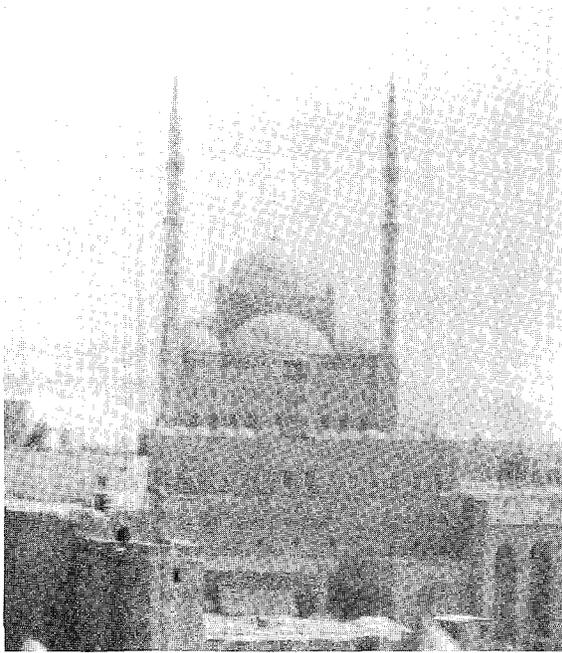
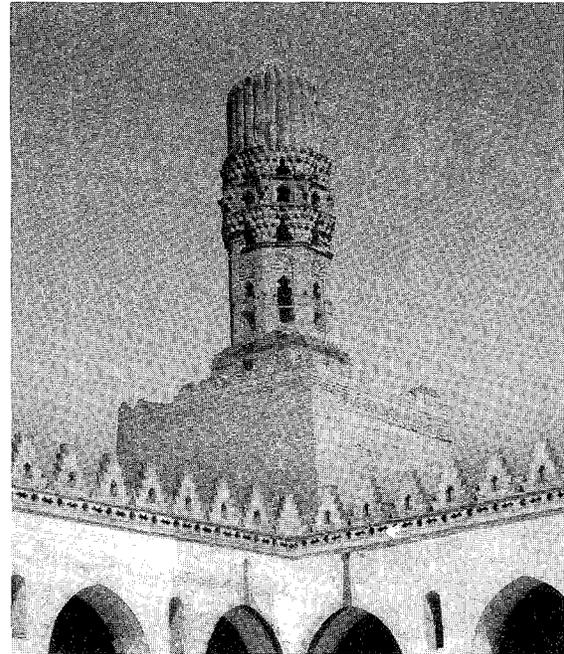
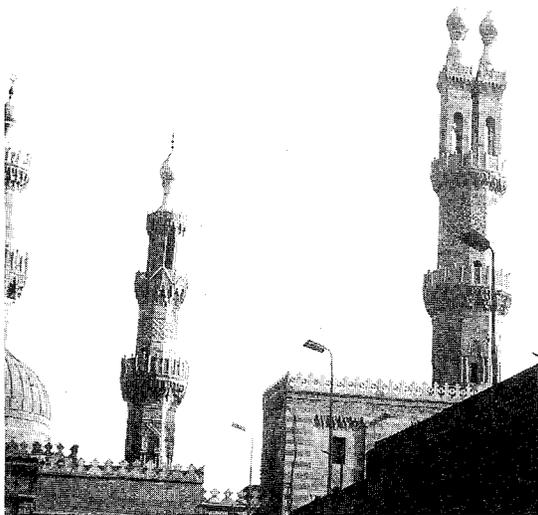
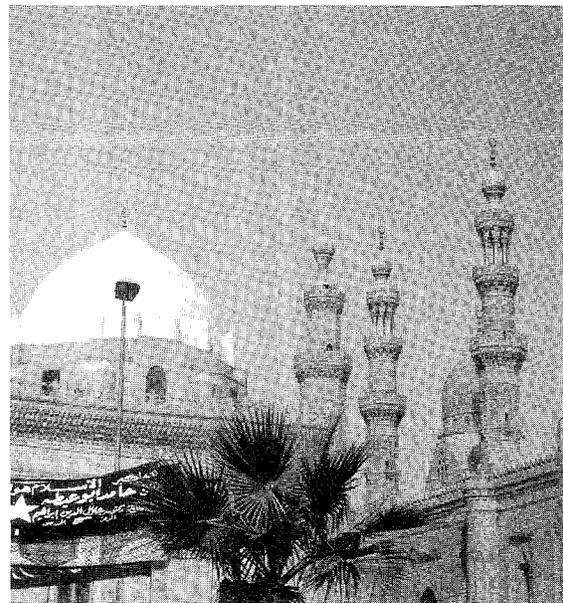
FIGURE 5-1 Different styles of minarets in Cairo

Portions of minarets have periodically fallen in Cairo due to earthquakes, deterioration, or poor design. For example, a minaret at the Mosque of Sultān Hasan fell shortly after construction and killed 200 children (Behrens-Abouseif 1985). Many of these minarets are likely to be in a state of marginal safety because of inadequate ties to the adjacent structure and poor foundation conditions. The general poor performance of minarets during this past earthquake attest to this conclusion.

The minarets in Cairo are not simple structures that can be adequately modeled with simple one-degree-of-freedom models. Unlike tall, slender minarets like those at the Mosque of Muhammad 'Ali al-Kabir shown in figures 4-9 and 5-1a (designed after minarets of Istanbul), most minarets in Cairo have varying cross-sections (and therefore moments of inertia) with some very weak portions (stalactites for mabkhara type used in earlier designs and at the base of bulb for later designs). Examples of variations are shown in figures 5-1b, c, and d and previously in figures 4-26 and 4-42. Therefore, computer modeling of minarets should be used to understand the behavior of different designs to suggest and model alternative retrofits and assist in the design of new minarets.
