PB94-181500
4. Title and Subtitle Hokkaido Nansei-oki Japan Earthquake of July 12, 1993		5. Report Date December 23, 1993

Hokkaido Nansei-oki, Japan Earthquake of July 12, 1993

Technical Report NCEER-93-0023

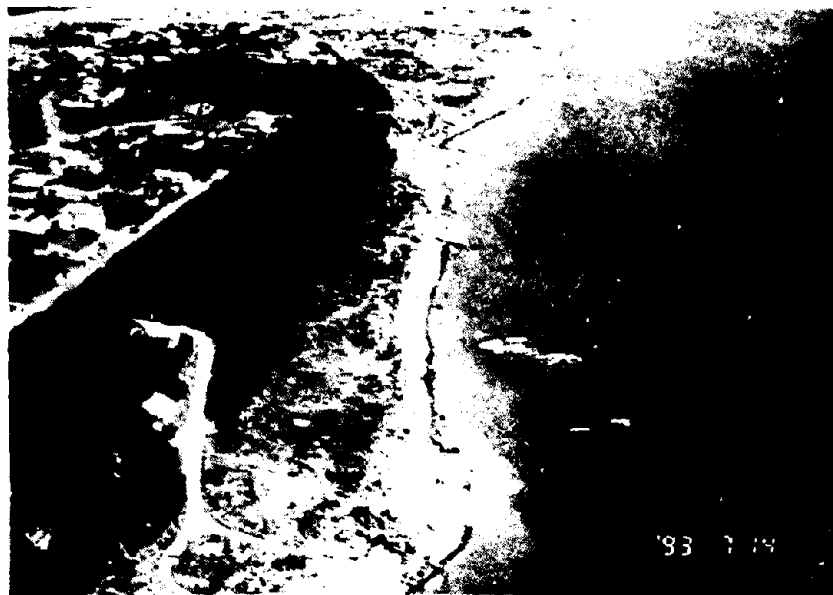
Figure 5-3: Evidence of tsunami inundation along the western shoreline of Okushiri Island just north of Aomae town. The run-up is about 15 m. All the telephone power lines are new; the old ones were destroyed. The vegetation remains along the road railing are from the tsunami. All buildings in this area along the coast at or near sea level were destroyed (lower photograph; courtesy of K. Kawashima).

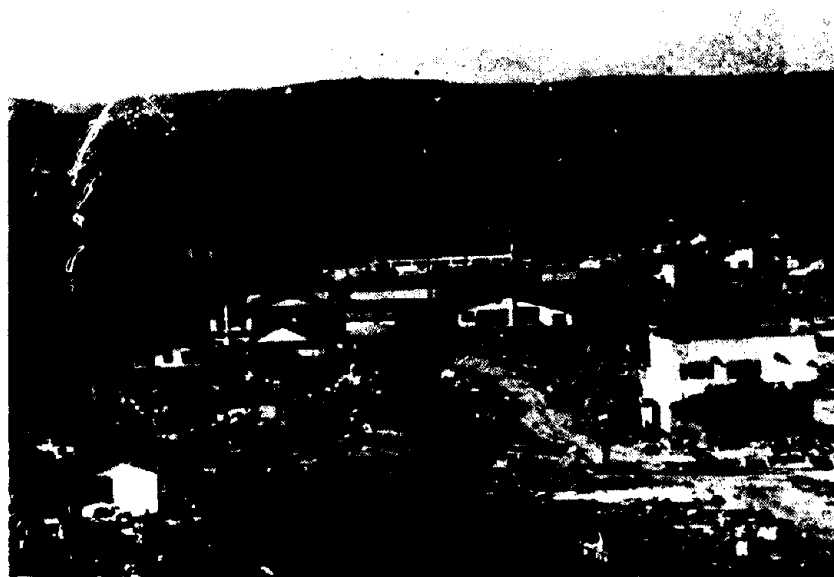
Figure 6-13: A partial view of the central part of Aonae showing tsunami destruction and a surviving steel-frame building on the left. It protected a small wood-frame building (shown in the next photograph)--the only such survivor in this area.

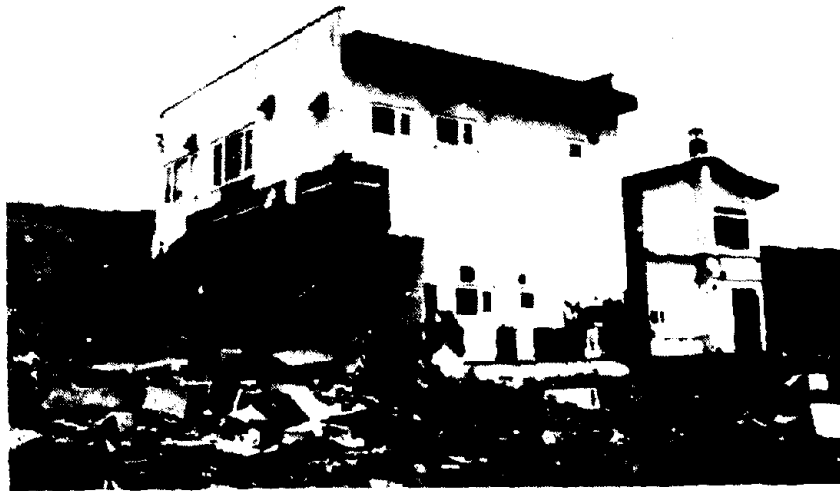
Figure 6-14: The only observed steel-frame building in the tsunami-devastated parts of Aonae. The building suffered some settlement damage (lower photograph), probably due to shaking. Its first-floor interior finishes were damaged extensively, and at least 15 cm of sand was deposited on the ground floor slab. The building is probably repairable, the estimated loss is less than 50% of value. Note the surviving wood-frame building, which was saved by its steel neighbor.

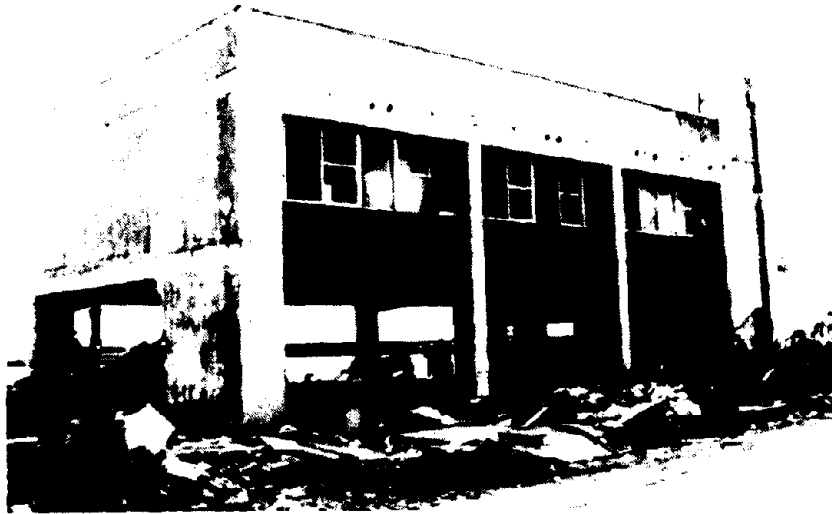
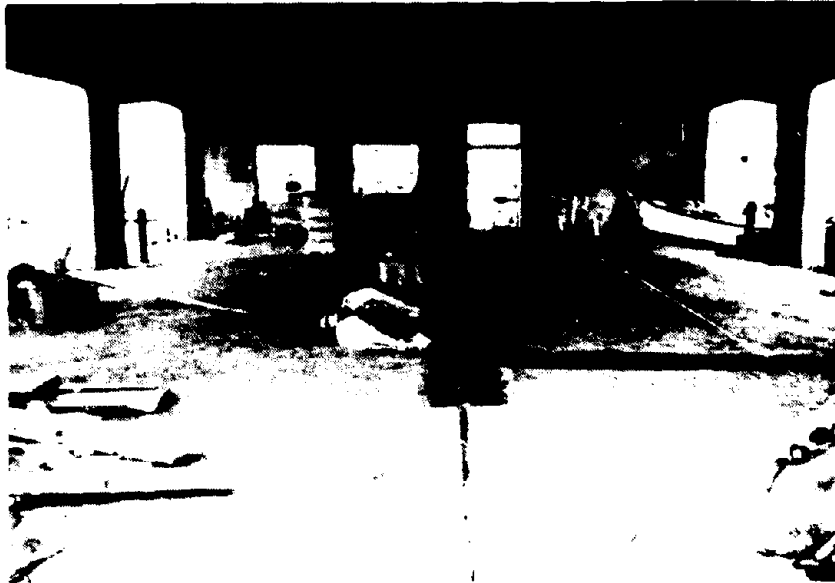
Figure 6-16: A two-story concrete-frame building survived the earthquake and tsunami with light structural damage. It is located at the front of the harbor. The ground floor finishes were completely destroyed. The damage to the left concrete wall is probably from tsunami-borne debris such as the overturned forklift in the center. The ground-floor concrete slab of the building was severely distorted from settlement, probably induced by the shaking—not by the tsunami. The structure appears to be repairable.

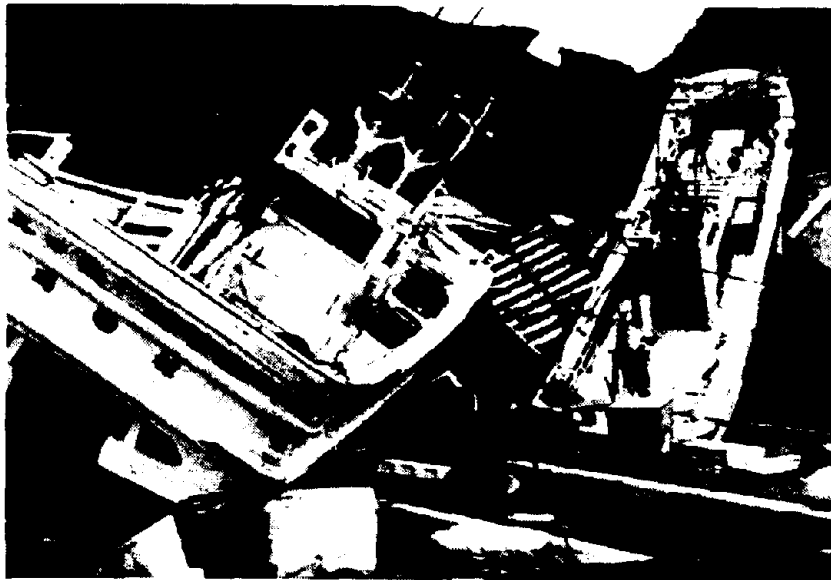
Figure 7-7: Many boats were deposited far inland, some among buildings. It is believed that much fuel was spilled in this way, contributing to the fire and its spread.

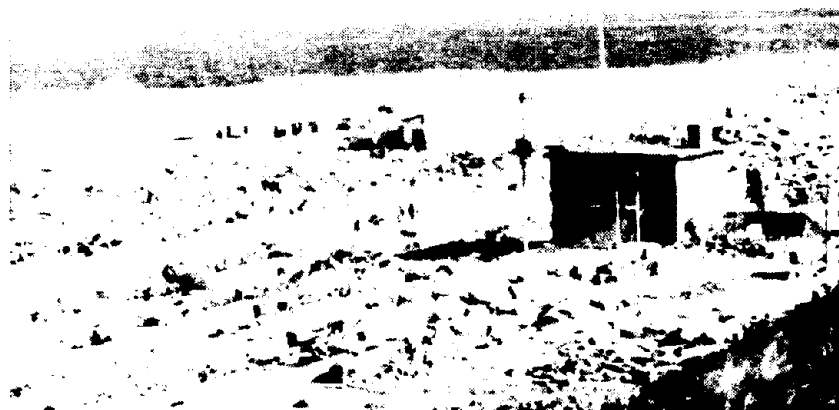
Figure 7-8: A view, looking southeast, of the central port area of Aonae showing tsunami and fire devastation. The only surviving buildings are more substantial concrete-frame buildings. No steel buildings were found in this area.

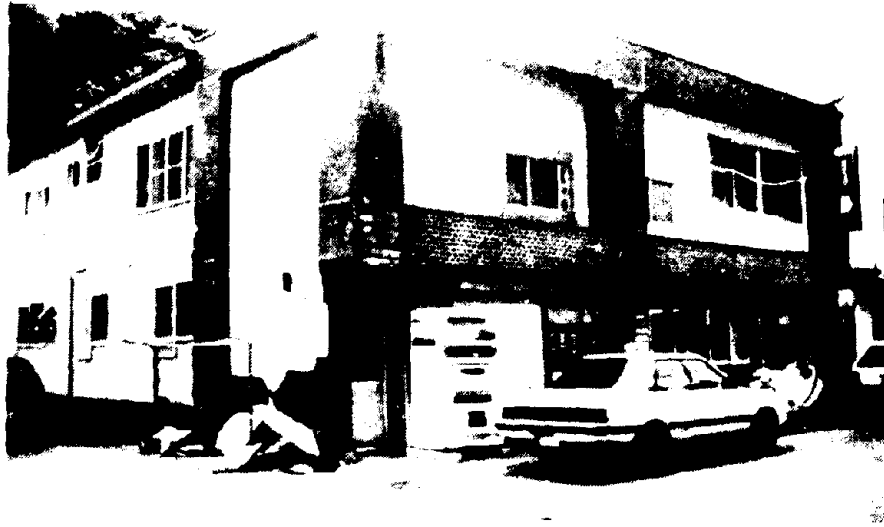
Okushiri-cho is the main port of Okushiri Island. At mid-island on the east coast, it is perhaps the closest point to Hokkaido. Residential construction is conventional Japanese one- and two-story wood-frame buildings. In the Hokkaido region, these buildings usually have corrugated metal roofing rather than heavier clay tile. Shaking damage to Okushiri-cho's residential construction in the July 12 event was minimal, with no known building collapses and a few chimney collapses (chimneys were generally lightly reinforced concrete). The commercial buildings are also typically one- and two-story wood frame. They also performed well (Figure 8-2).

Figure 8-2: Lightly damaged commercial buildings in Okushiri-cho. Typically these buildings are wood-frame with stucco. Note the damaged stucco and brick veneer.

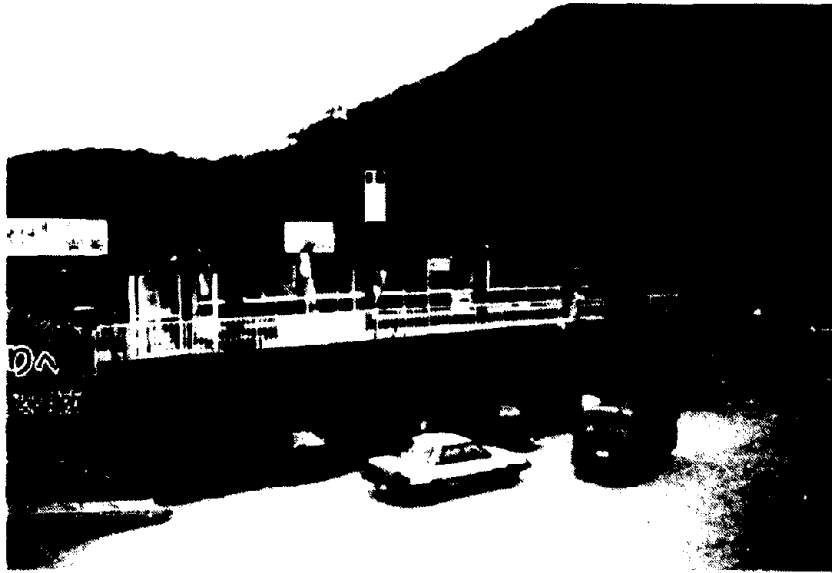
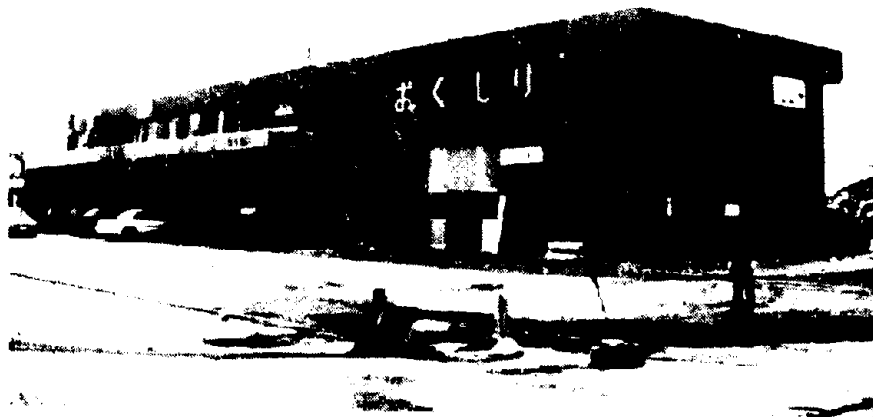
Specific buildings of note in Okushiri-cho included the Ferry Building, a two-story reinforced concrete frame with relatively large, approximately 40-cm columns. Located on the main pier, the building's first story was inundated by the tsunami (Figure 8-3), which swept away large glass windows and all interior furnishings. The building sustained settlement of one column on the south side, resulting in shear cracking of beams, but was otherwise structurally undamaged, with the second floor relatively undisturbed. The City Offices (Figure 8-4) are a two-story, stuccoed, wood-frame building, probably built in the 1950s and located approximately 1 km from the shore, up a river valley on apparently firm soils. There was no observable structural damage to

Figure 8-3: The reinforced concrete-frame Ferry Building in Okushiri. The ground-floor finishes were extensively damaged by the tsunami. The building had some damage due to local settlement in one corner.

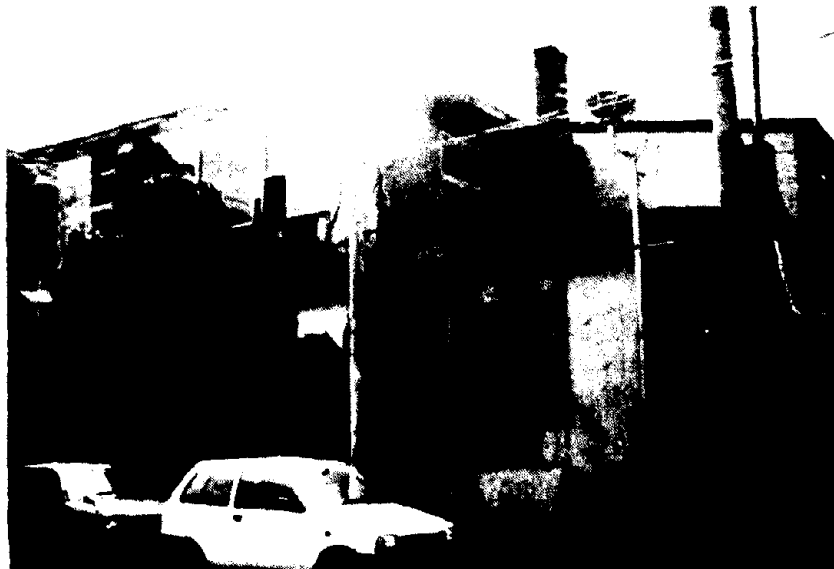
Figure 8-4: The light wood-frame and stucco City Offices Building in Okushiri-cho (upper photograph) and a smaller building (lower photograph) suffered extensive damage to their stucco facades but not major structural damage. These rather flimsily built structures suffered probably as much damage from shaking as any building observed in the town.

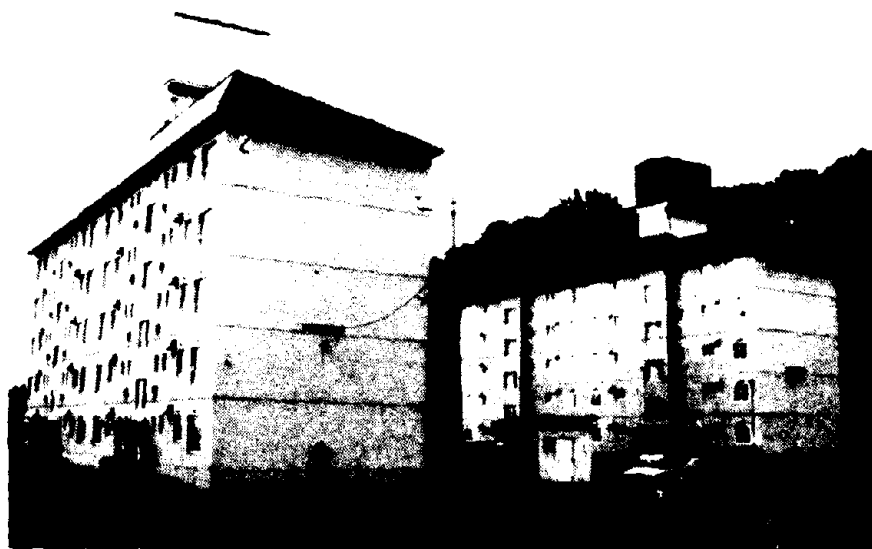
Figure 8-6: Undamaged five-story reinforced concrete shear wall apartment buildings in the outskirts of Okushiri-cho. Minor settlement of fill around the buildings was observed. Several large landslides in steep terrain were visible from the buildings.

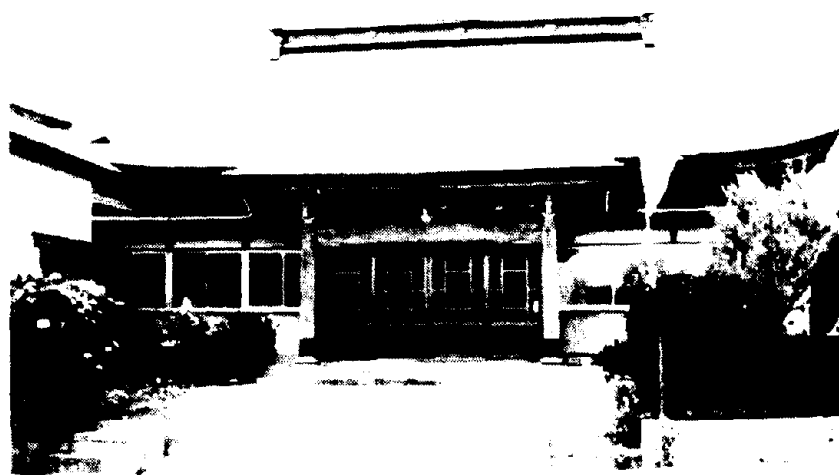
Figure 8-8: A practically undamaged temple building, which was not affected by the fire and the tsunami. This is probably structurally one of the weakest wood-frame buildings in Aonae, indicating that the intensity of the ground motion on rock or stiff soils was not high in the central port area. The temple is located below the Aonae lighthouse.

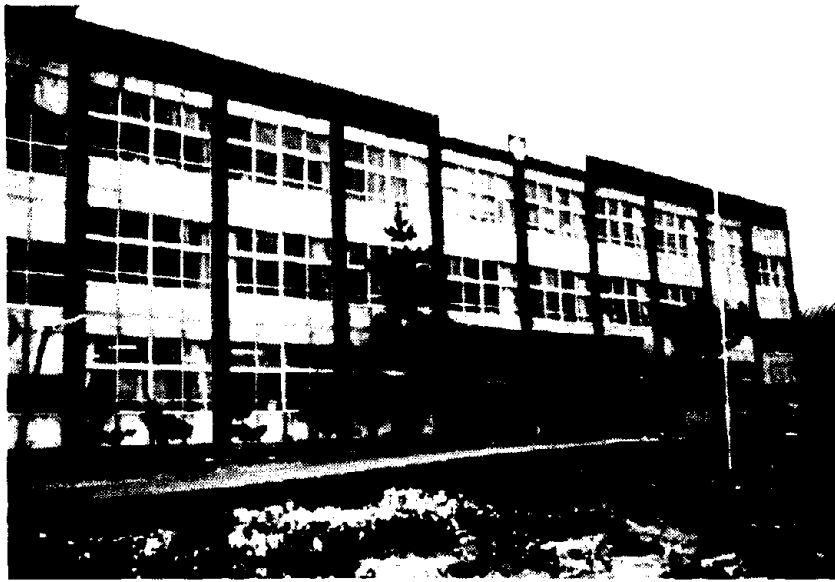
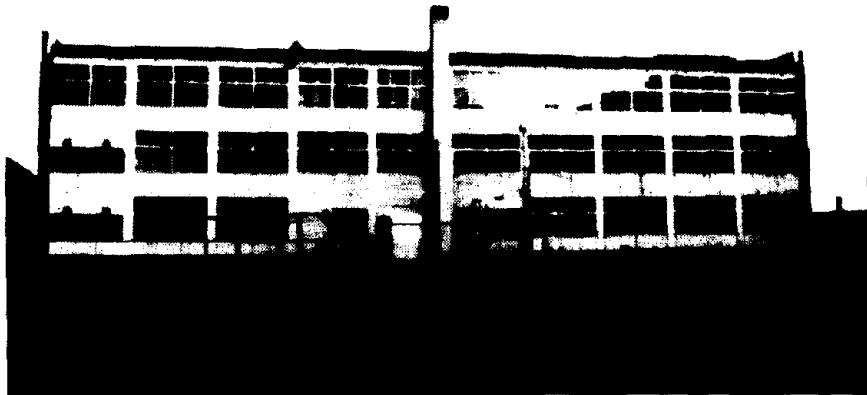
Figure 8-9: Aonae Elementary School, a typical 1950s through early 1970s nonductile concrete-frame building (preceding the lessons learned from the 1971 San Fernando, California, Earthquake). The school, on level ground at sea level, suffered extensive cracking of frame and concrete-block infill-wall elements. These types of buildings have historically suffered extensive damage in Japan (Sendai Earthquake of 1978) and California in 1971, 1979, 1989, etc.). Extensive strengthening of these kinds of buildings has been carried out for all California public schools of similar construction.

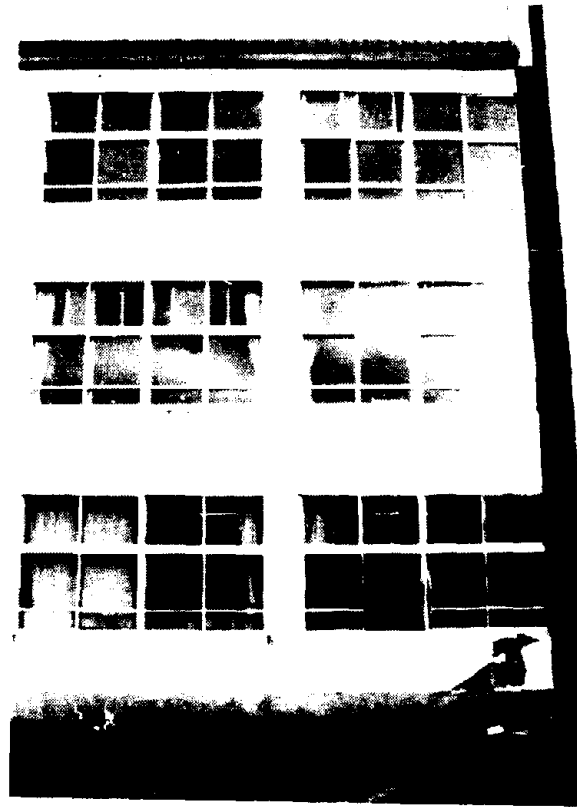
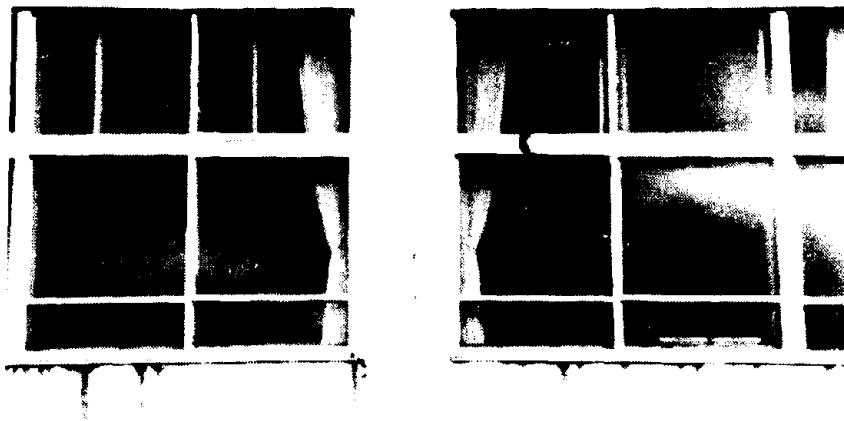
Figure 8-11: The damaged west facade of the Aonae Elementary School. Spandrel and other infill wall cracking has propagated into the columns.

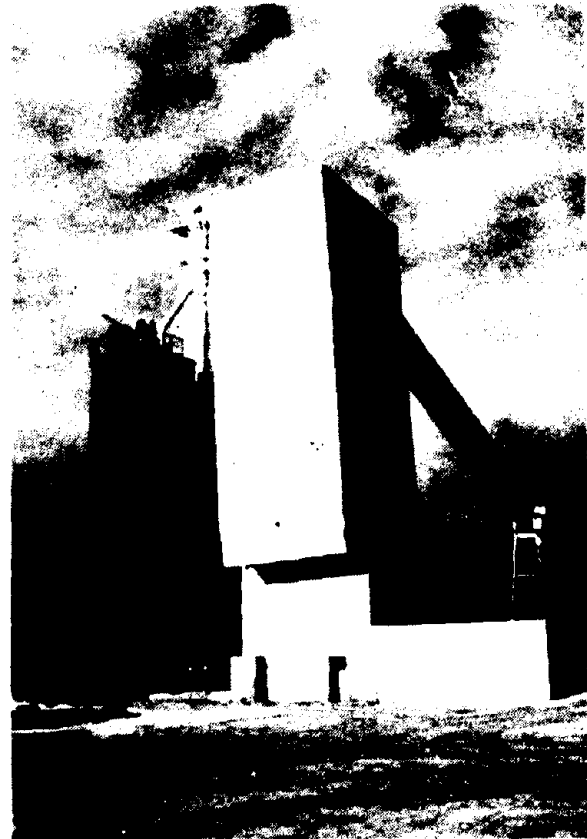
Figure 8-14:

OCBP; close-up of the steel-frame hopper superstructure that buckled. The ground-level columns appeared undamaged. Note that the superstructure has dropped about 50 cm.

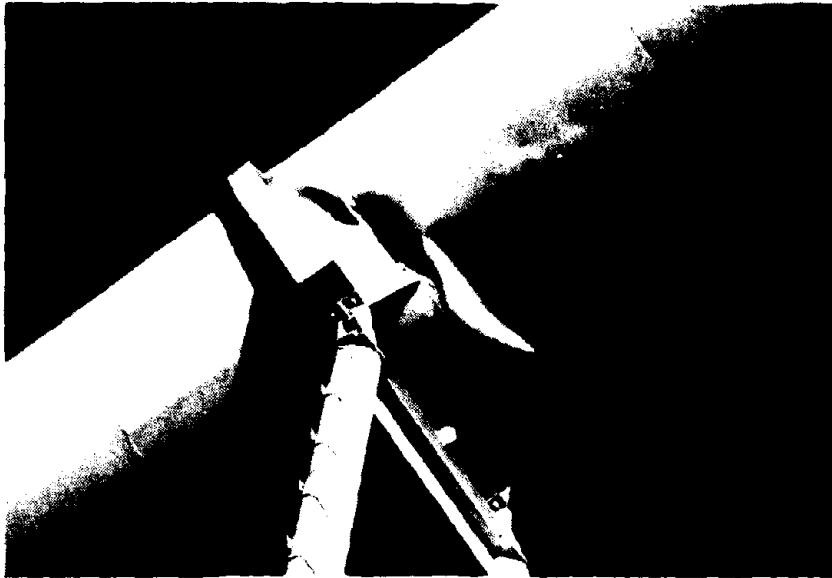
Figure 8-16: OCBP; damage to the large-bore hopper ducting due to differential displacements at its supports--caused by the buckling and shortening of the hopper structure.

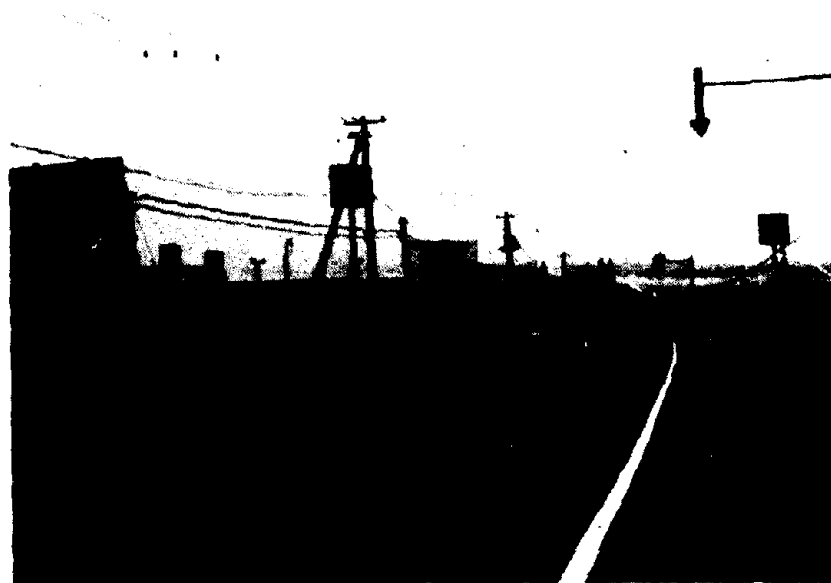
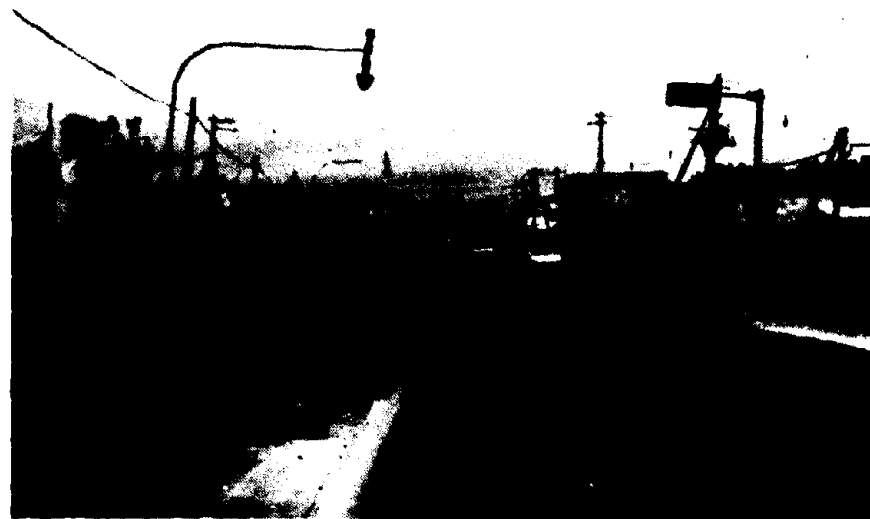
Figure 9-1: Typical damage to roads, at Highway 5 south of Oshamanbe, from liquefaction and/or lateral spreading. Many of the coastal stretches of the road had a roller-coaster appearance following the earthquake.

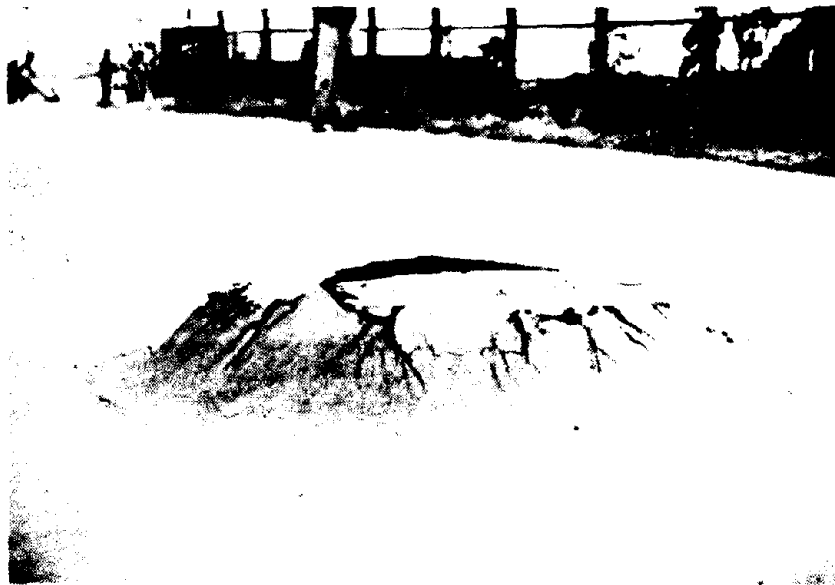
Damage from liquefaction was continuing to occur to roads in the area. Figure 9-6 shows an example of damage from buoyant underground structures that was occurring about 10 to 12 days after the earthquake as the softer soils continued to settle.

Figure 9-6: Manhole pushed up in Oshamanbe area from settlement. This 30+ cm settlement occurred mostly about 10 to 12 days after the earthquake and was continuing to increase.

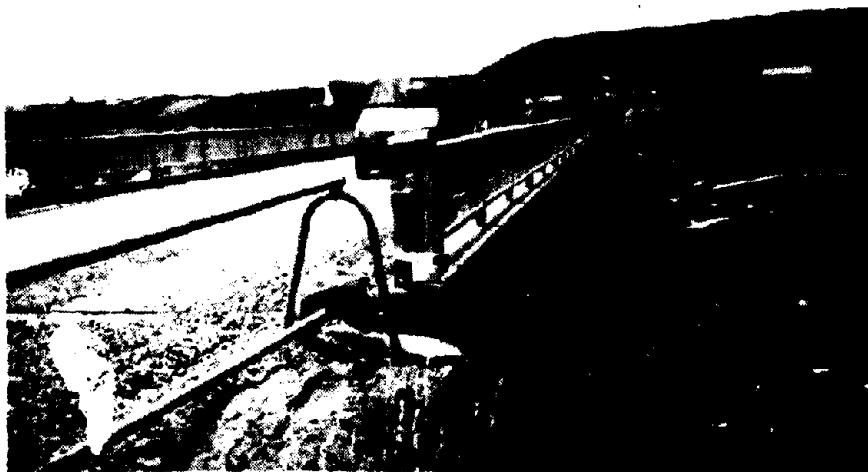
Several bridges were inundated by the tsunami. No bridges that were observed suffered serious structural damage due to tsunami run-up. The bridge leading to Aonae along the east shore coast road from Okushiri-cho is an example (Figure 9-7).

Figure 9-7: A two-lane bridge at Aonae on the coastal road from Okushiri-cho. The bridge was inundated by the tsunami. It suffered minor damage, such as slumping and erosion of abutment fill. One- and two-story wood-frame structures in its vicinity were obliterated by the tsunami.

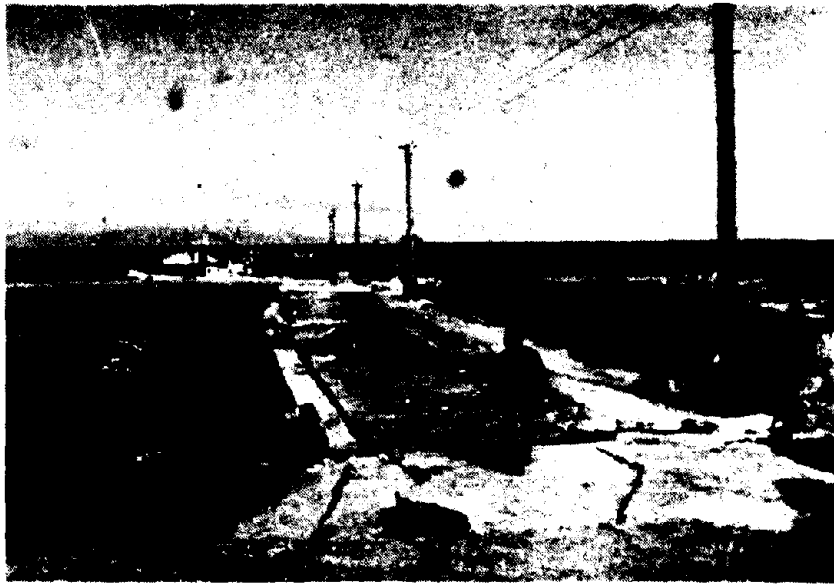
Figure 9-35: Typical damage from the earthquake to port facilities. These two examples are from Okushiri-cho Port.

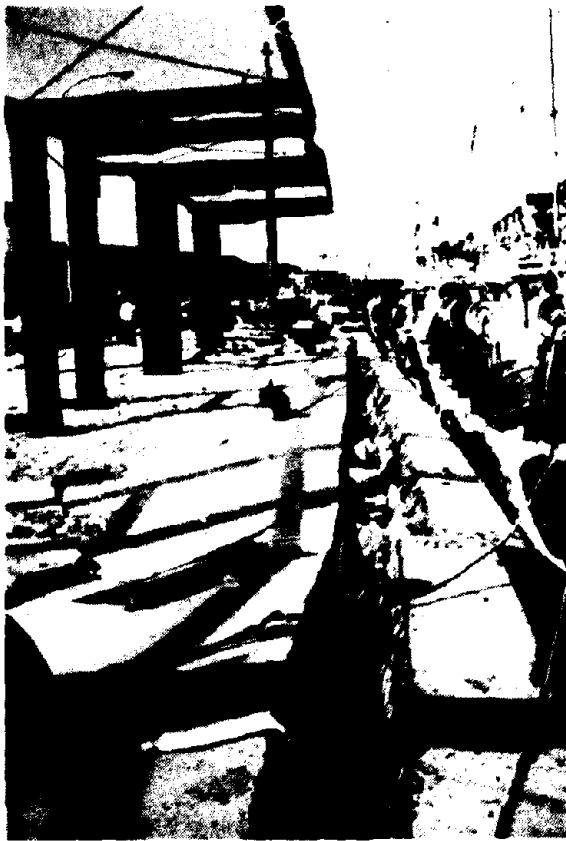
Figure 9-36: Damage to waterfront facilities at Okushiri-cho Port. The illustrated damage is due to soil failures from liquefaction, settlement, and lateral spreading of walls. Some of the damage is due to tsunami scour. Note that despite the severe damage to its foundations, the steel structure shown in both photographs has maintained its overall integrity, illustrating the large ductilities available in steel structures when properly designed and constructed.

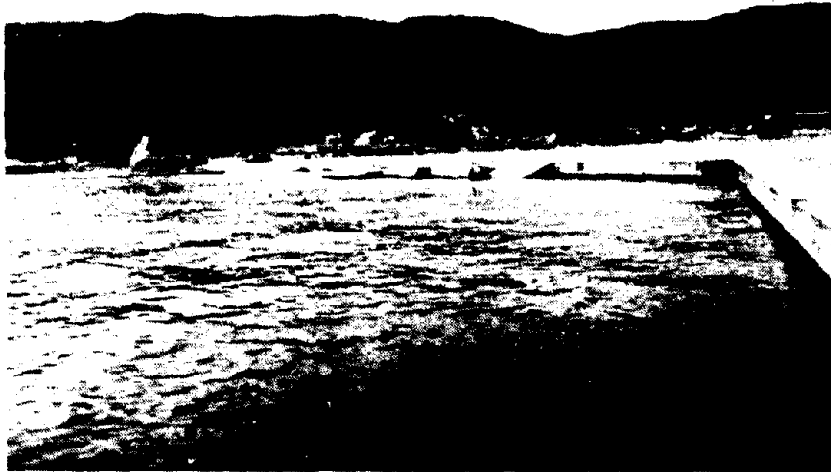
Figure 9-37: Damage to a breakwater at the Port of Okushiri-cho. These large concrete sections were probably displaced by lateral spreading of ocean-bottom deposits, although the tsunami may have caused the damage.

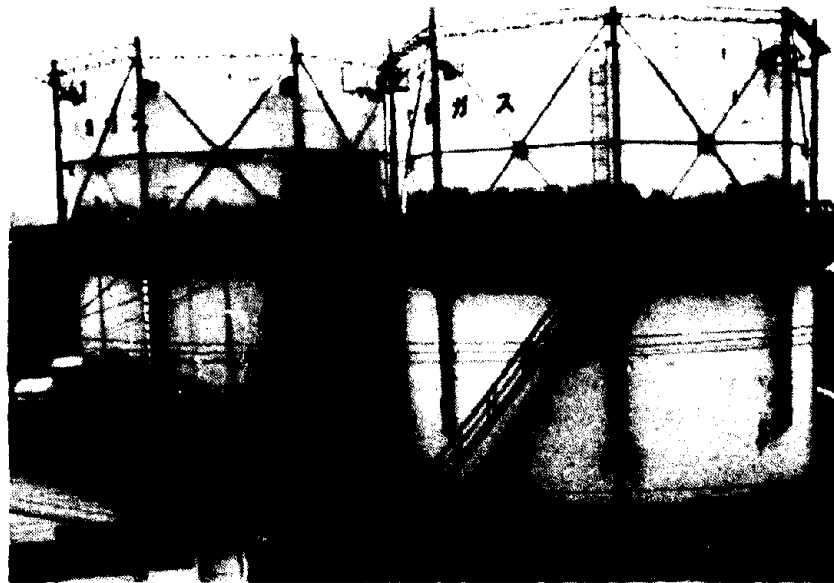
In general, few tank failures were observed. Figure 9-38 shows gas holding tanks in the Oshamanbe area on soft soils. The tanks were not damaged, but the underground piping had been damaged by ground settlement. Note the excavated piping. Similar damage was observed throughout the affected area.

Figure 9-38: Gas holding tanks in the Oshamanbe area on soft soils. The tanks are not damaged, but the underground piping has been damaged by ground settlement, which can lead to total loss of the tank contents. Note the excavated piping. Similar damage was observed throughout the affected area.

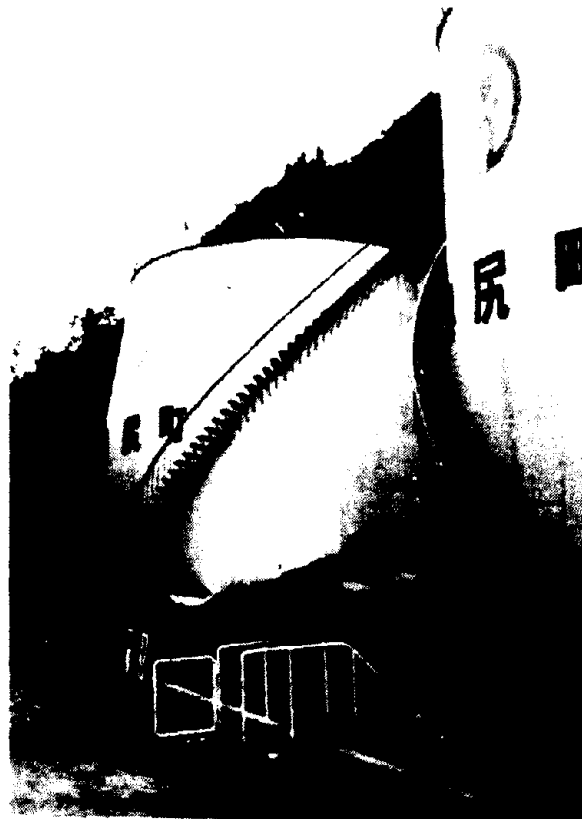
Figure 9-39 shows fuel oil tanks in the port of Okushiri. The tank on the left buckled due to landslide impact (the same landslide that caused the collapse of the Hotel Yo Yo)--note that the tank on the right is undamaged.

Figure 9-39: Fuel oil tanks in the port of Okushiri-cho; the tank on the left buckled due to landslide impact (the same landslide which caused the collapse of the Hotel Yo Yo)--note that the tank on the right is undamaged.

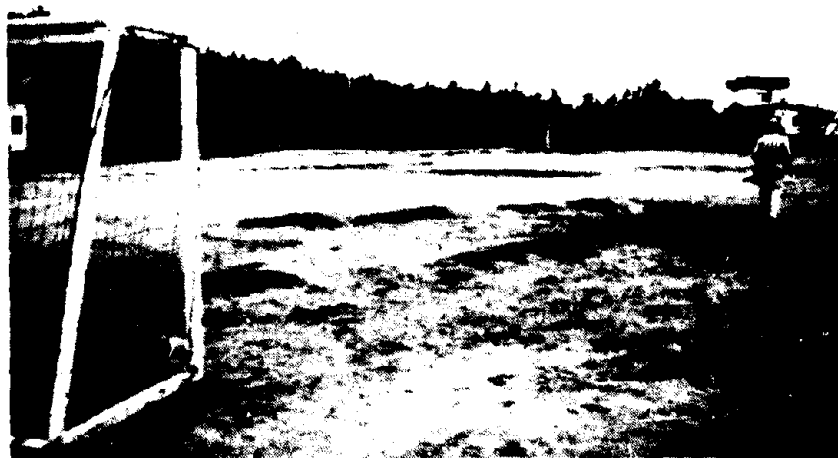
Figure 10-1: Oshamanbe Elementary School; damage to the sports fields from liquefaction, lateral spreading, and settlement.

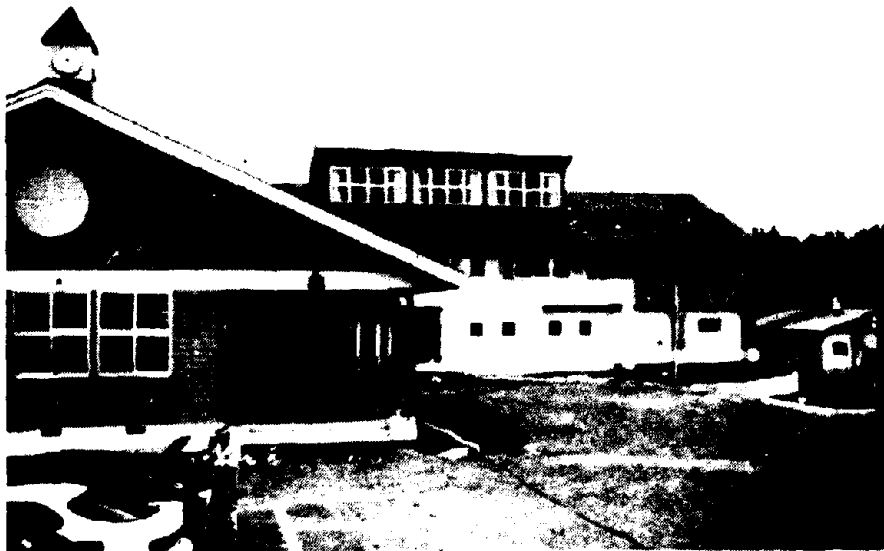
Figure 10-2: Oshamanbe Elementary School; settlement of up to about 1 m and extensive liquefaction occurred. The school is built on top of a 2-m-high fill in a rice paddy area. The school is new. No structural damage other than shearing of piles just below the pile caps was observed. The buildings are a combination of wood frames, concrete frames with shear walls, and steel frames.

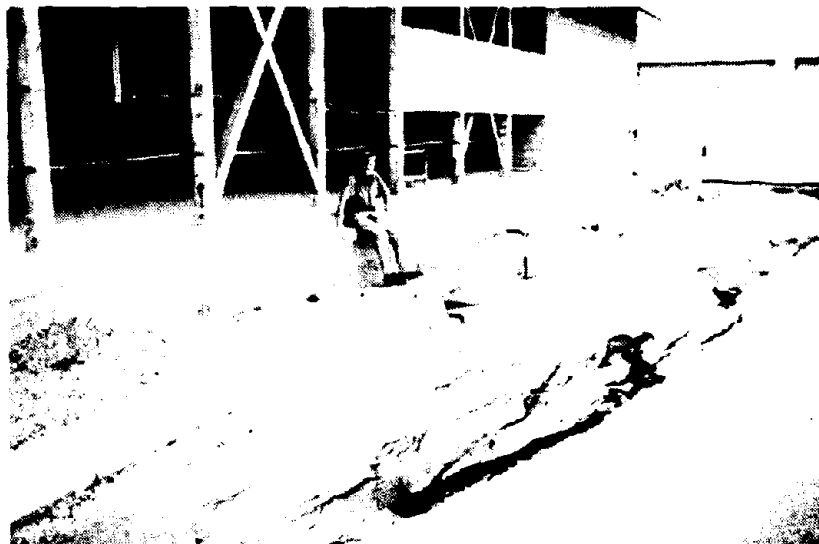
Figure 10-3: Oshamanbe Elementary School; settlement at the entrance of about 1 m.

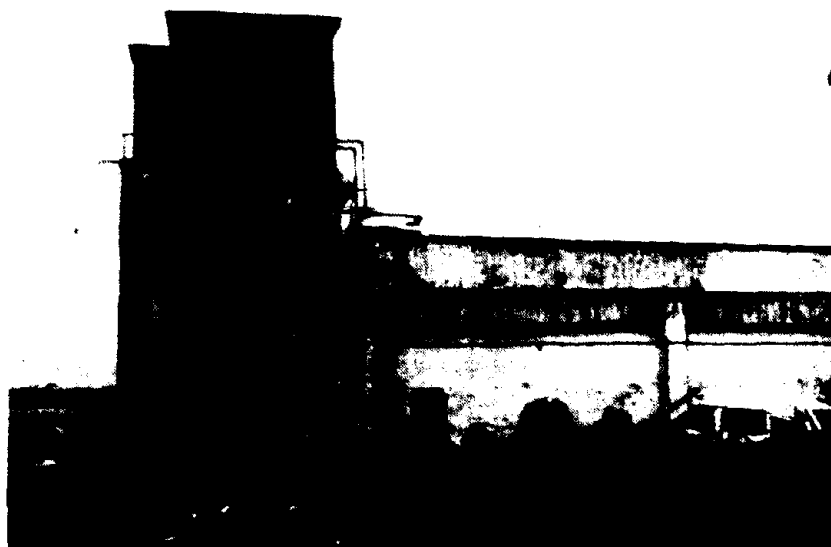
Figure 10-11: Differential settlement at these two reinforced concrete structures at the waterfront of the port of Aonae caused tilting of the taller structure on the left (and to the left). Note the gap between the higher and lower structures.

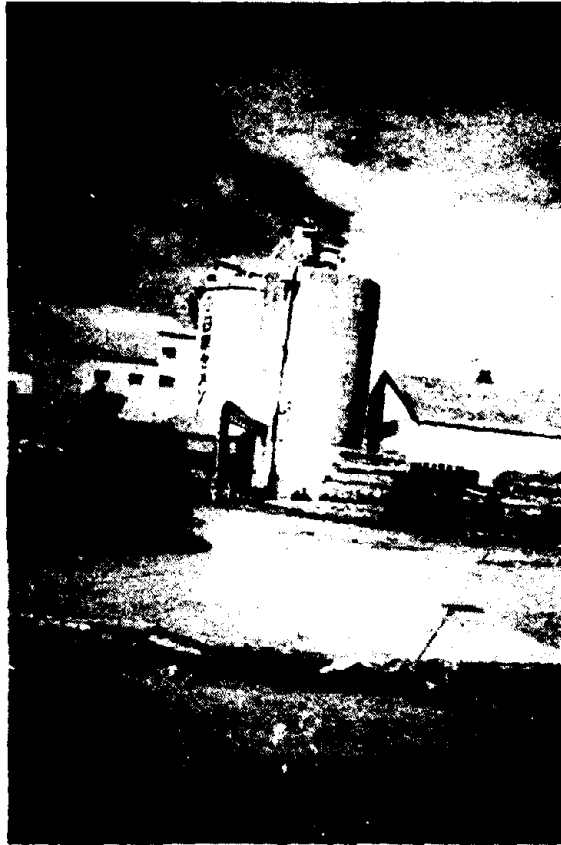
Figure 10-13: Liquefaction effects at the port of Hakodate--a tilted reinforced concrete silo and a buoyant manhole. Photographs courtesy of T. Leslie Youd.
