REPORT DOCUMENTATION PAGE		1. REPORT NO. NCEER-94-0005	2.
4. Title and Subtitle The Northridge, California Earthquake of January 17, 1994: General Reconnaissance Report		5. Report Date March 11, 1994

**The Northridge, California Earthquake
of January 17, 1994:
General Reconnaissance Report**

Technical Report NCEER-94-0005

March 11, 1994

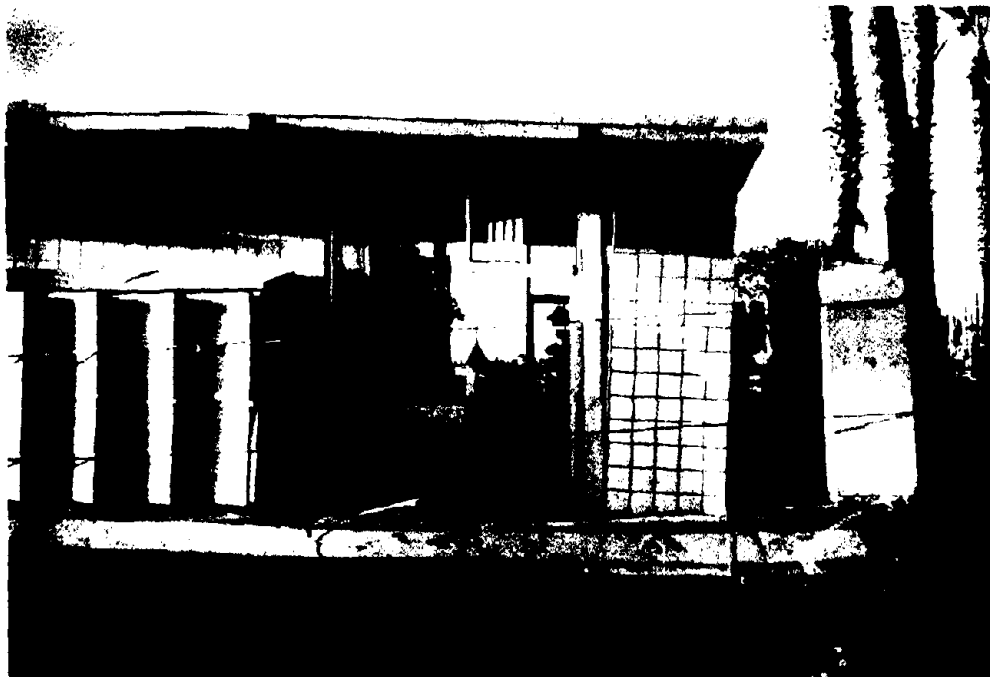
FIGURE 2-9 Liquefaction-induced Settlement of a Building on the Pier in Redondo Beach

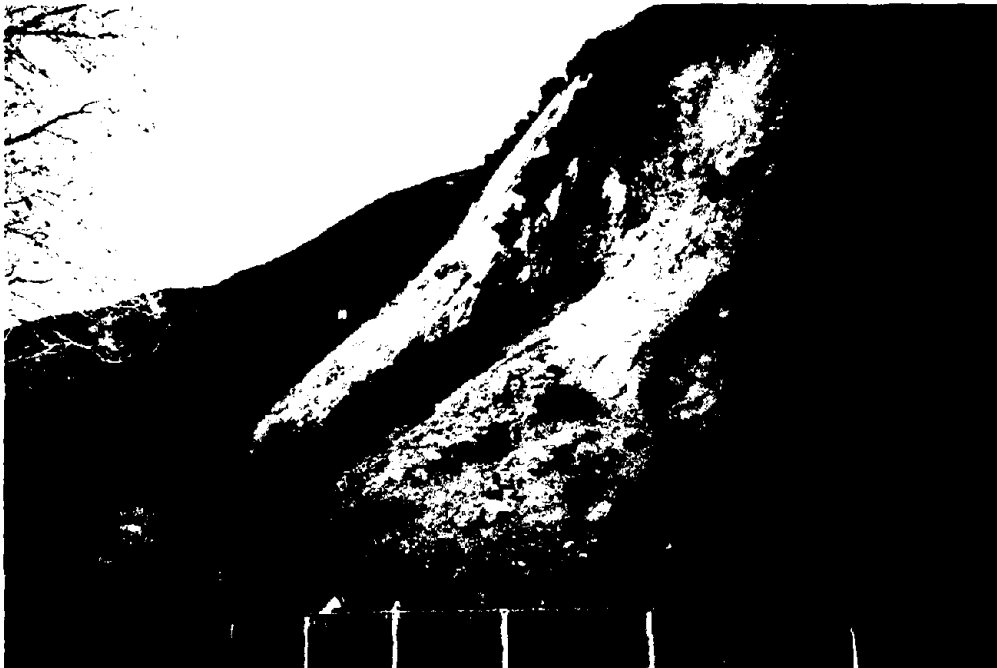
There were a number of rock slides that were observed mostly in the region north of the epicenter. Figure 2-10 shows photographs of typical rock slides. In Santa Monica, along the Pacific Coast Highway, spectacular landslides occurred damaging many of the homes built on cliffs overlooking the ocean. Figure 2-11 shows a section of this landslide. Also, in Simi Valley,

FIGURE 2-10 Rock Slides in the Region North of the Epicenter

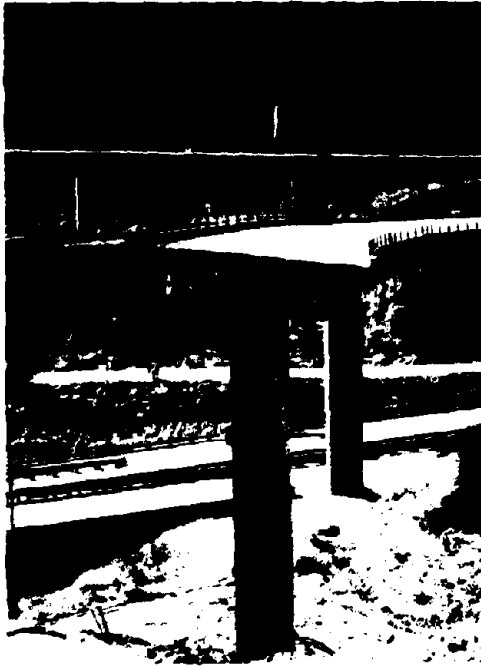
The North Connector is also a 10-span continuous, cast in place, concrete box girder bridge. Constructed in five segments, the total length is in excess of 1,500 feet with a radius of curvature of 550 feet. As with the Southbound Separation and Overhead, the southernmost end segment collapsed and again the sequence of collapse may have been the shear failure of a short squat end pier (pier 2) followed by shear failure of the superstructure at the face of pier 3 and unseating of the girder at the abutment (Figure 3-6). In the absence of rigorous analysis, the sequence of failure is uncertain but it is possible that pier 2 attracted a much higher proportion of the lateral load than assumed in design because of its relatively short height. Further, there was probably a significant reduction in the axial load in the pier due to both the severe curvature in the bridge and the high vertical accelerations in the ground motion. This reduction in axial load may have reduced the shear capacity of the column to less than the demand leading to the failure of the pier.

**FIGURE 3-6 SR14/I-5 North Connector -
Collapsed End Spans After Demolition**

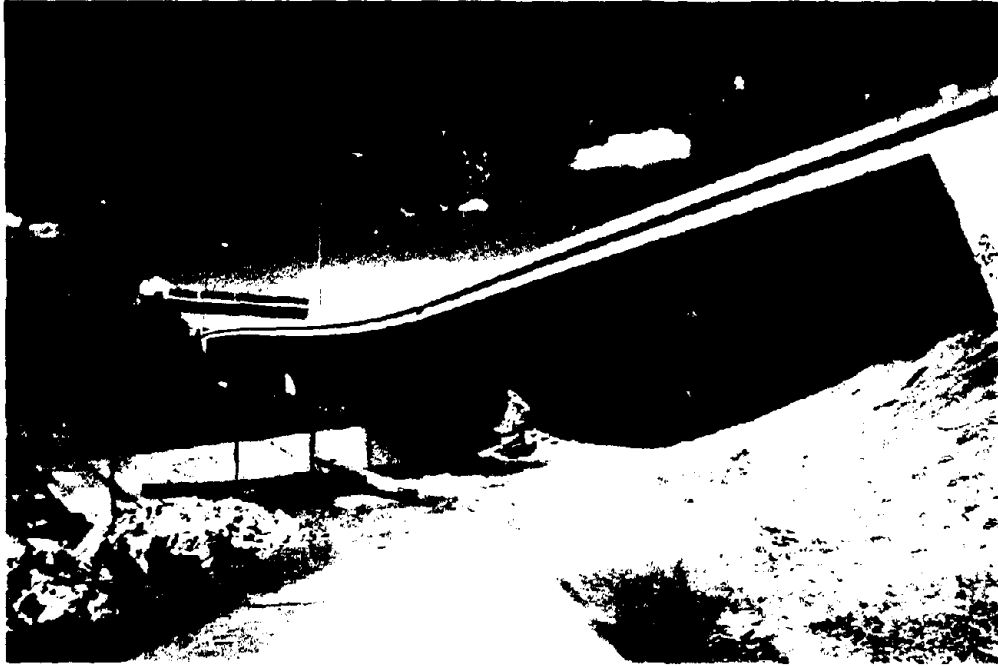
**FIGURE 3-8 Bull Creek Canyon Channel Bridge -
Side View**

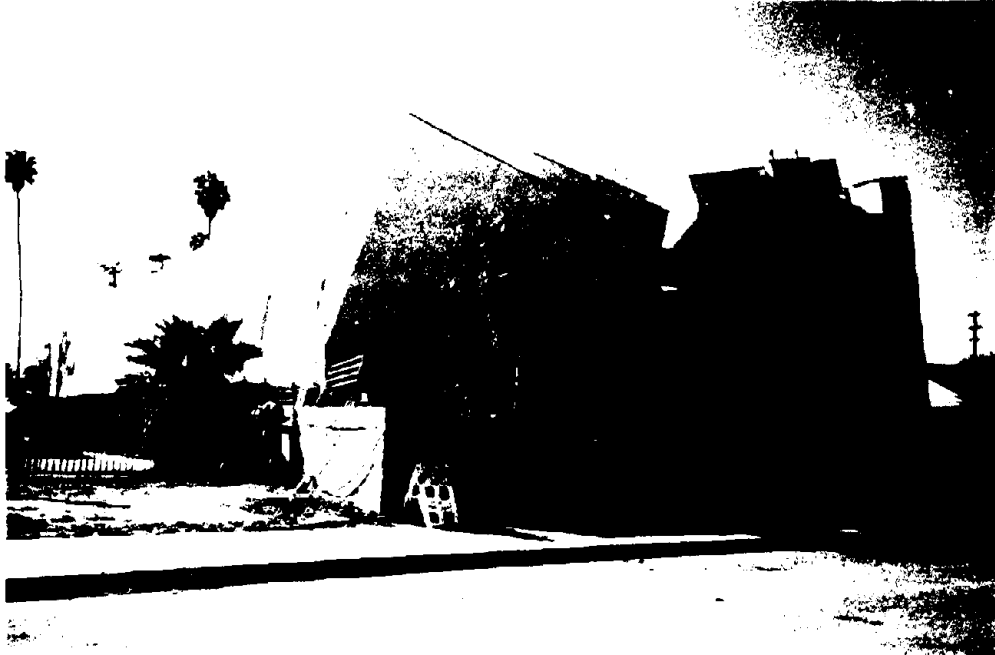
A large number of two- to four-story wood frame apartment buildings collapsed due to lack of suitable lateral resisting systems (see Figures 3-16 to 3-19). Most of the collapsed buildings were poorly engineered (or pre-engineered) using wood frames covered by stucco walls (or sheet rock panels) without diagonal braces or plywood shear walls (see Figure 3-20). Most buildings were based on shallow foundations and had carports at the ground floor leaving open spaces without walls or other bracing systems. Such structures developed flexible (and weak) first stories with subsequent first story column side sway collapse mechanisms. The single largest number of casualties occurred in the collapse of such a structure on Reseda Boulevard in Northridge (see Figure 3-21).

FIGURE 3-16 Apartment Buildings on Sherman Boulevard in Van Nuys

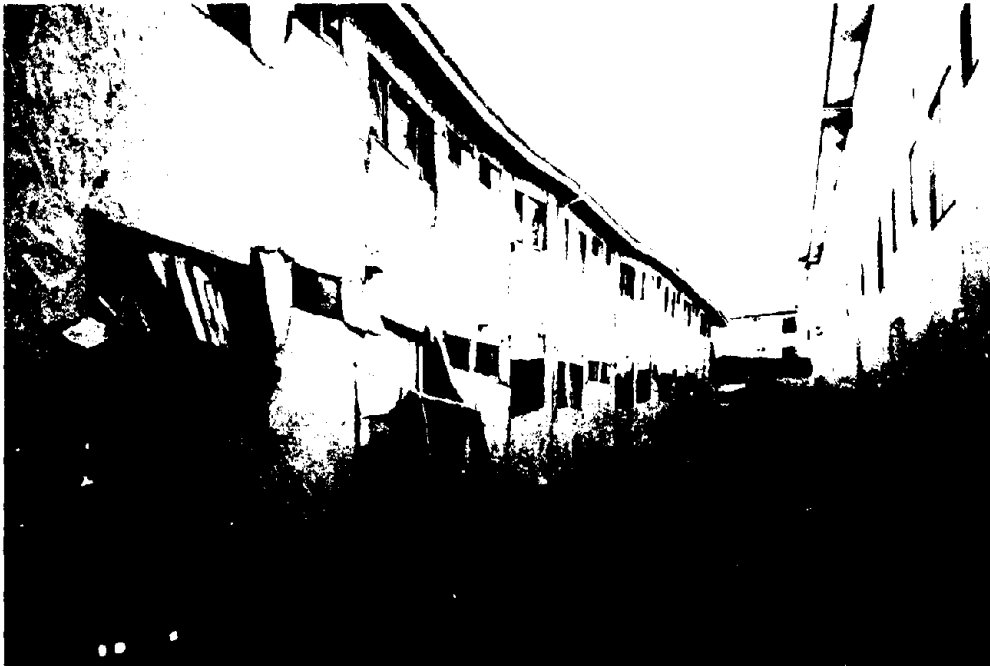
FIGURE 3-17 Wood Frame Apartment House with Collapsed Carport on Reseda Boulevard in Northridge

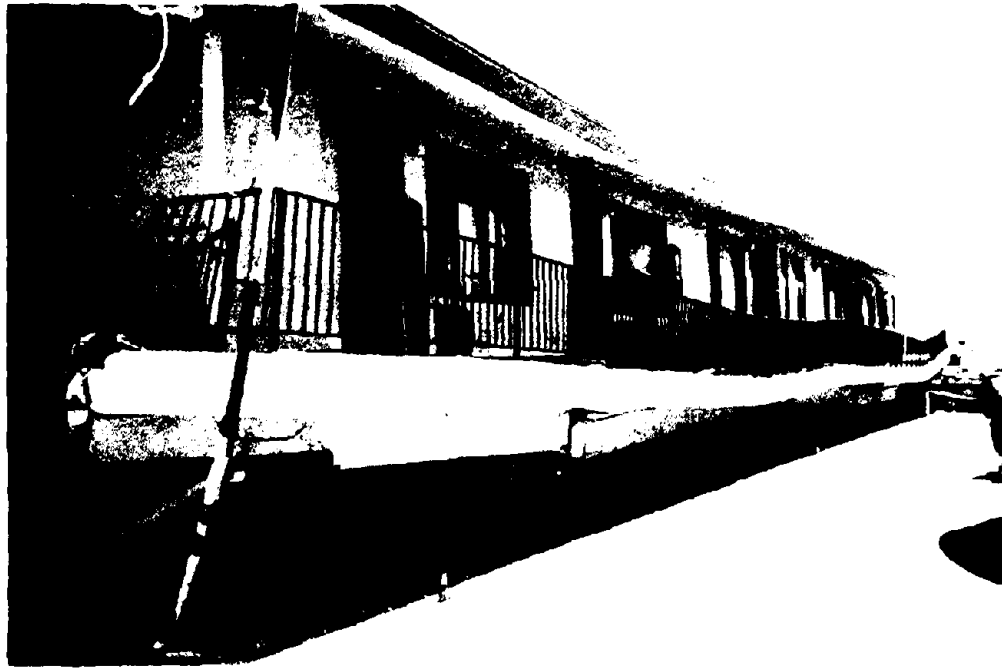
FIGURE 3-18 Wood Frame Apartment with Collapsed Carport on Reseda Boulevard in Northridge

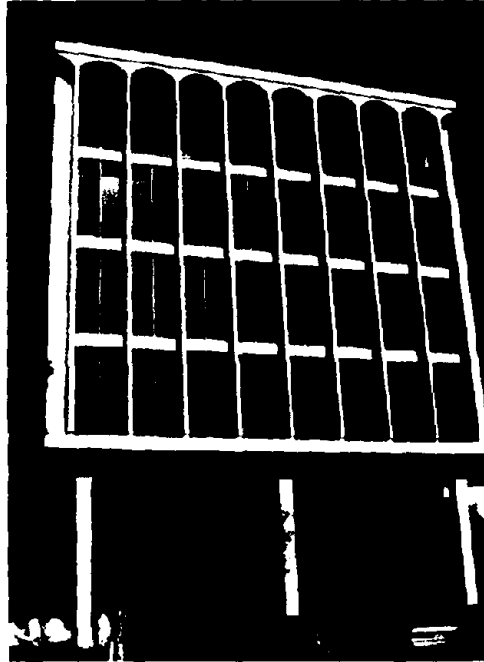
FIGURE 3-36 Five-Story Office Building Near Epicenter
