REPORT NO.
UCB/EERC-94/08
JUNE 1994

EARTHQUAKE ENGINEERING RESEARCH CENTER

**PRELIMINARY REPORT ON THE
PRINCIPAL GEOTECHNICAL ASPECTS
OF THE JANUARY 17, 1994
NORTHRIDGE EARTHQUAKE**

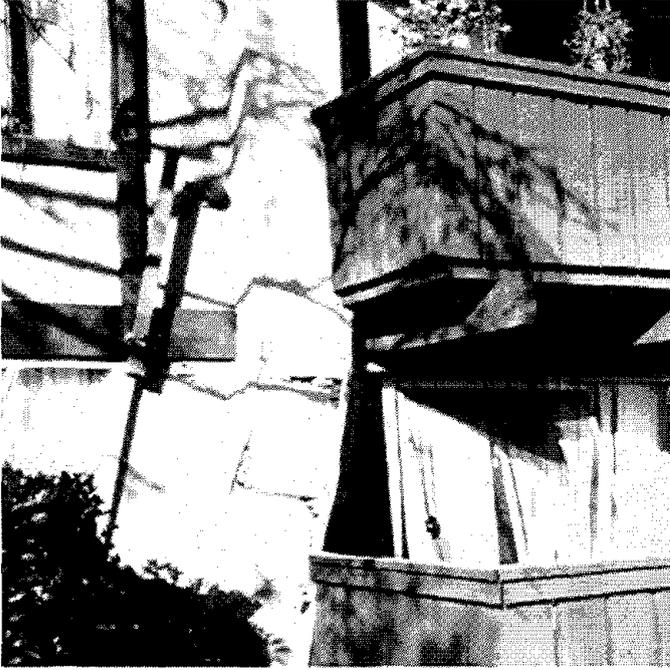
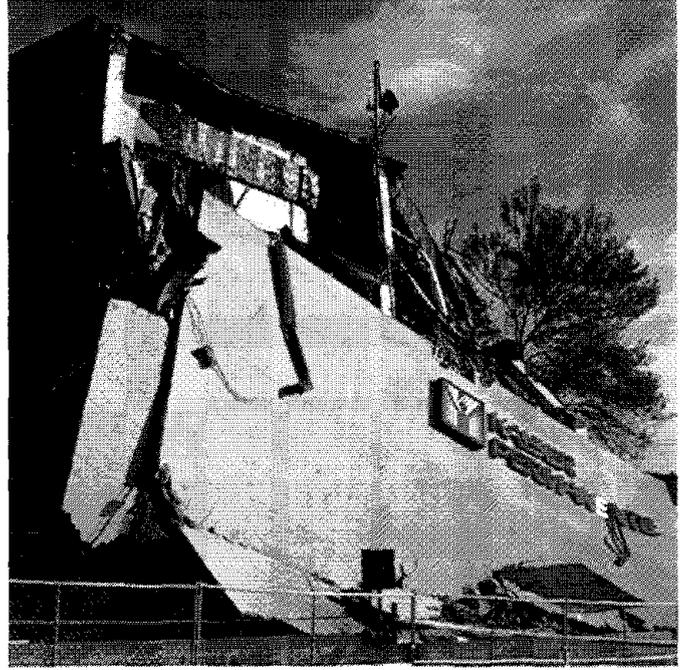
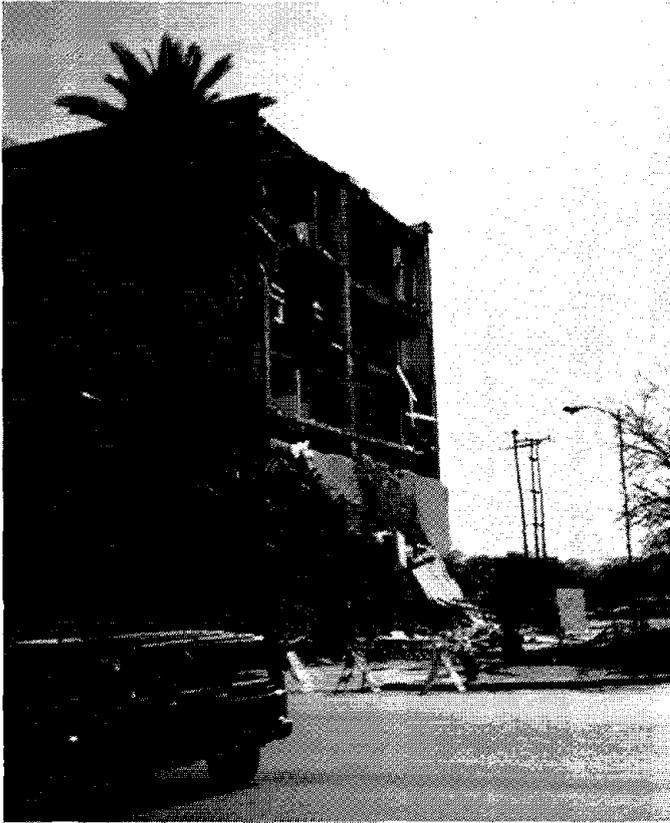
A cursory survey of damage concentration in the epicentral region by members of the U.C. Berkeley Geotechnical Group reconnaissance team indicated that damaged structures in the epicentral area included residential and commercial buildings of all types of construction, typically from one to three stories in height. Collapse of several modern multi-story concrete parking structures and damage to shopping malls was also observed. Structures with soft bottom stories and unreinforced masonry (URM) buildings were particularly vulnerable. Partial collapse of the first floor of a three-story wood-frame apartment complex in Northridge, shown in Figure 3.28(a), resulted in the deaths of 16 people. Residential homes generally suffered from collapsed chimneys and failure of masonry walls, as well as diagonal shear cracking in stucco walls. Dramatic failures also occurred at the Kaiser Permanente Office Building on Balboa Boulevard in Granada Hills and at a 5-story building at Sherman Way and Lindley Avenue in Reseda, shown in Figures 3.28(b) and 3.28(c), respectively.

Fig. 3.28: Damaged structures in the Northridge epicentral area

- (a) Soft story collapse of a three-story wood frame apartment building in Northridge
- (b) Partially collapsed 5-story Kaiser Permanente office building in Granada Hills
- (c) Heavily damaged 5-story building at Sherman Way and Lindley Ave. in Reseda

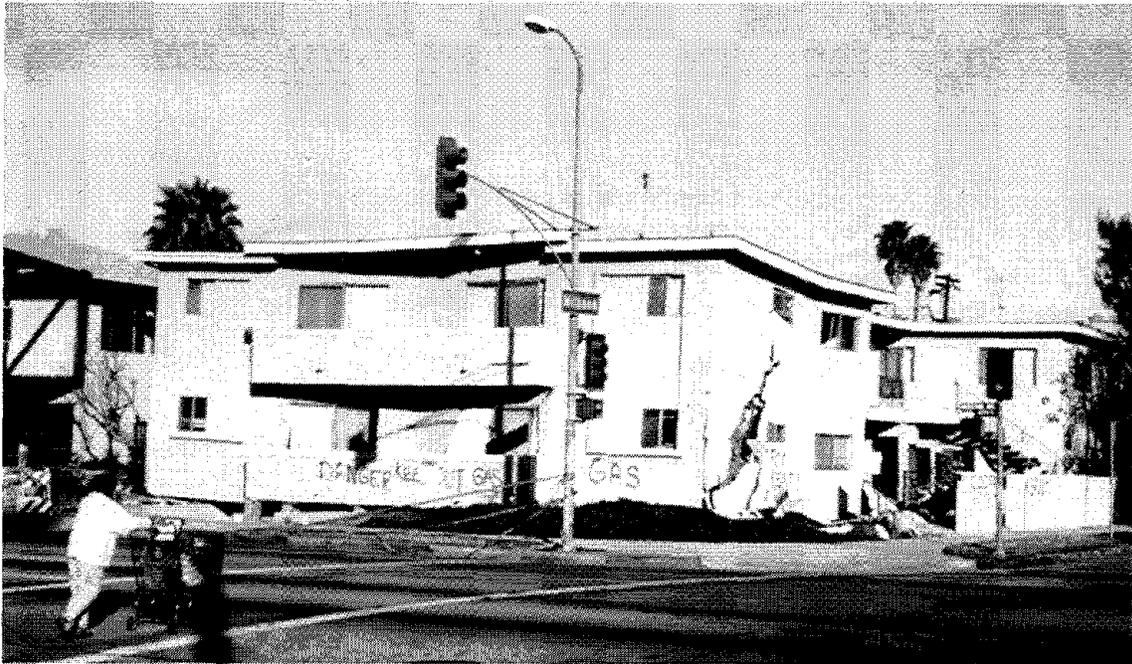
As in the epicentral area, two- to four-story apartment buildings with soft stories were extensively damaged. Figure 3.29(a) shows the partial collapse of a two-story apartment building located at Hazeltine Avenue and Milbank Street. A yellow-tagged four-story apartment building of fairly recent construction is shown in Figure 3.29(b). This structure is located on Fulton Avenue near the banks of the Los Angeles River. Residential homes in the area are typically one story in height and generally suffered from chimney collapses and diagonal shear cracking in walls, although more serious structural damage was also observed. Cracking in shear walls was observed in a 13-story reinforced concrete building in the downtown area, as shown in Figure 3.29(c), and a 12-story hotel in the vicinity was red-tagged as shown in Figure 3.29(d).

(a): Heavily damaged apartment building with soft story at Hazeltine Avenue and Milbank Street

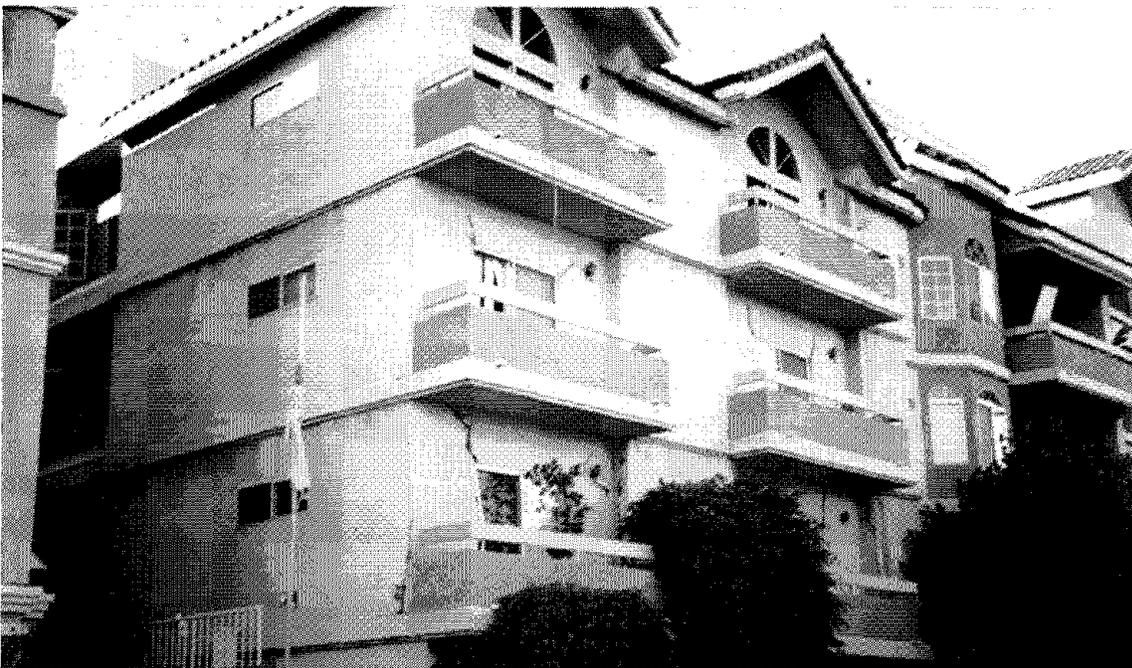
(b): Yellow-tagged 4-story apartment building on Fulton Way, near the banks of the Los Angeles River

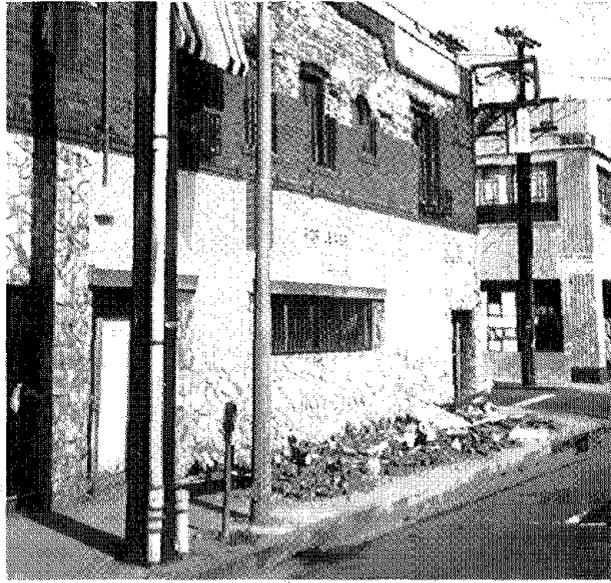
In the Hollywood area, shear cracking and chimney damage to single-story residences, as well as damage to soft story apartments and buildings of up to 12 stories in height, were observed. Typical damage to a URM building is shown in Figure 3.31.

Fig. 3.31: Damage to an URM building in Hollywood

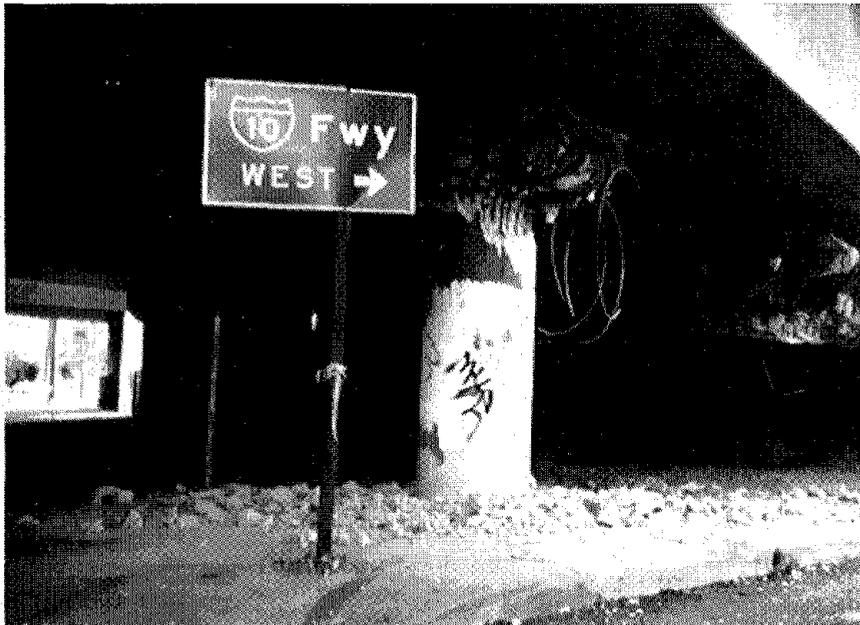
An example of damage in the central Los Angeles area with possible contributions from site effects is the collapse of the Interstate 10 overcrossing structure (Bridge No. 53-1609) at Venice and La Cienega Boulevards, shown in Figure 3.32, and just to the east at the Interstate 10 overcrossing (Bridge No. 53-1580) at Fairfax and Washington. The site of both bridges is part of the drainage area for Ballona Creek and is a recovered swamp area. The two bridges are also located in the shaded areas shown in Figure 4.92, which show zones of saturated Holocene deposits. Based on boring logs and personal communication with the California Department of Transportation (Caltrans), soils with low blow counts are found within the shaded zones along Interstate 10 shown in Figure 4.92; outside of this zone, the soils become denser. It should be noted that other highway bridges in this zone of relatively loose soils did not collapse.

Fig. 3.32: Collapse of the I-10 overcrossing structure at Venice and La Cienega Boulevards.

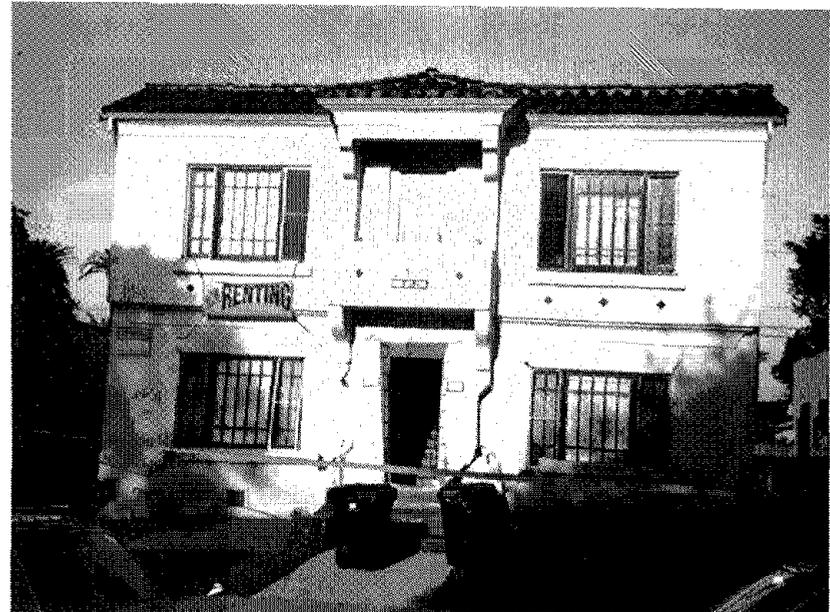
Structures in the central Los Angeles area typically appeared to be small residences, one- to three-story warehouses and commercial buildings, and low-rise apartments. Again, damage to URM buildings and apartments with soft stories was observed. Much of the damage appeared to be to residential structures; cracks in walls, collapsed chimneys, and shifting off of foundations was observed. A typical damaged home is shown in Figure 3.33.

Fig. 3.33: Typical damage to a two-story residence in Central Los Angeles

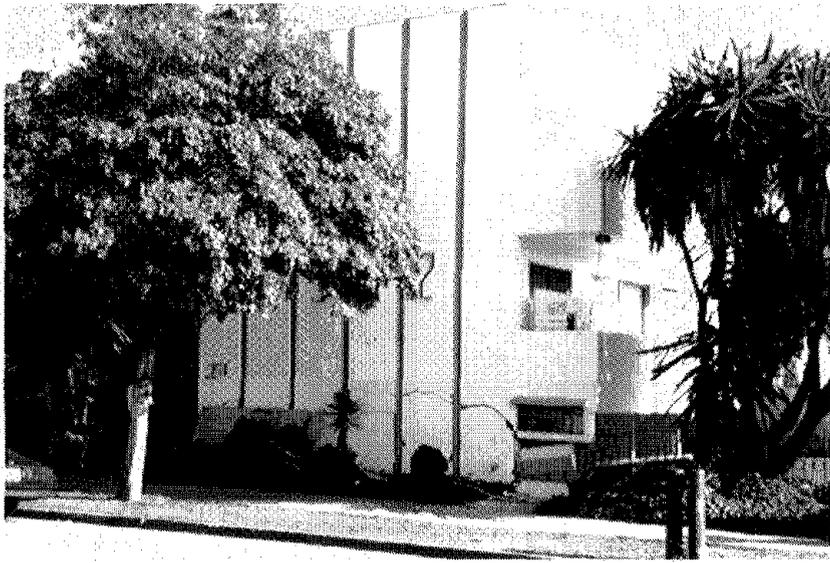
Damage to low-rise apartment buildings with soft stories was again observed. A typical building is shown in Figure 3.36(a). Cracks in the shear walls of a 6-story commercial building are shown in Figure 3.36(b). An example of typical damage to a URM building is presented in Figure 3.36(c). At least 34 URM buildings were red-tagged and 51 URM buildings were yellow tagged in the City of Santa Monica. Red tags were also issued to five health care facilities in Santa Monica. North of Santa Monica in Pacific Palisades, extensive damage was observed along Chataqua Boulevard. The area is underlain by Holocene deposits, and an example of typical damage is shown in Figure 3.36(d).

(a) Typical damage to a soft story apartment building

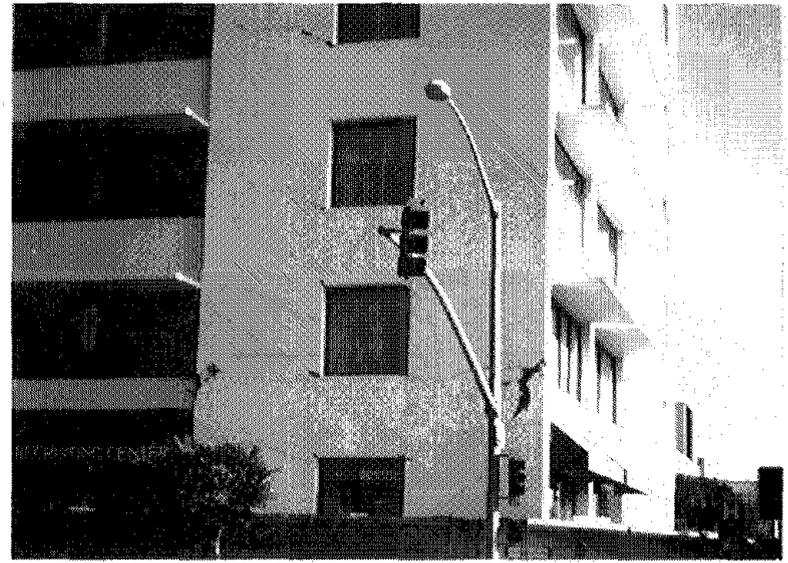
(b) Cracks in the shear walls of a 6-story commercial building

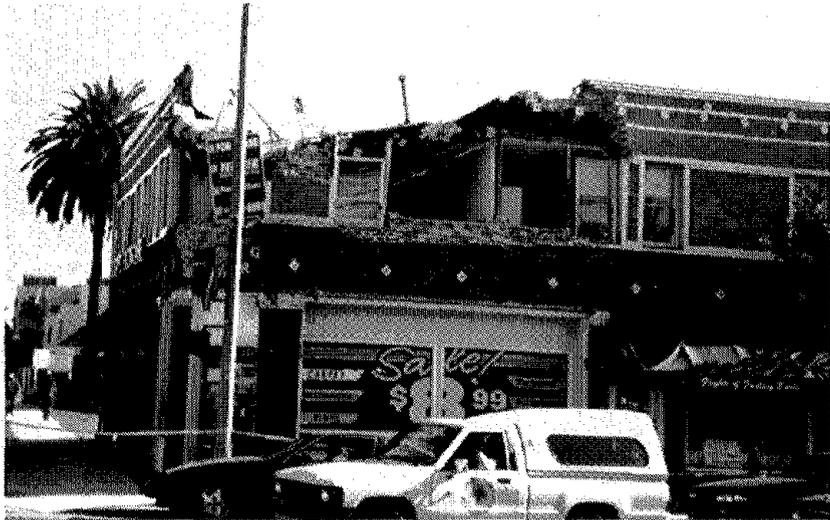
(c) Heavily damaged URM building

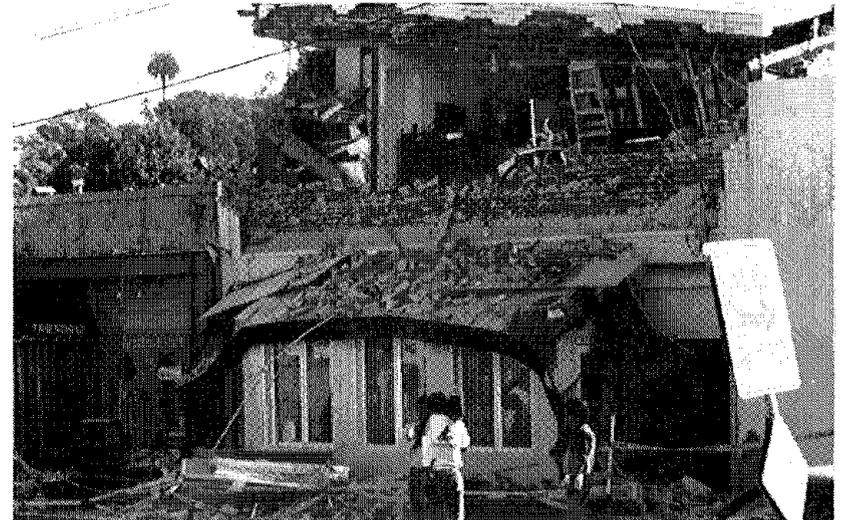
(d) Typical damage along Chataqua Boulevard

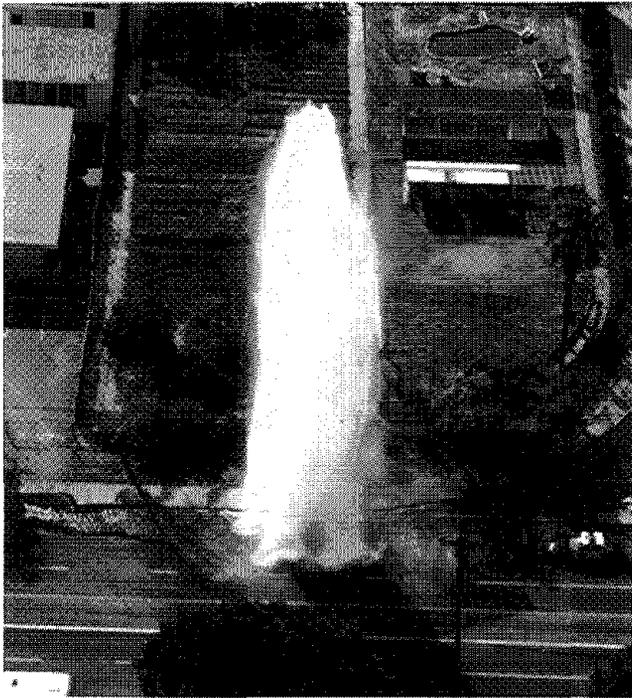
Damages due to ground failures in communities within the San Fernando Valley such as Granada Hills, Northridge, San Fernando, and Sherman Oaks were significant and widespread. Broken water lines such as that shown in Figure 4.2 disrupted water service to some areas for weeks. Also broken were numerous gas lines, leading to devastating fires which destroyed a number of homes as shown in Figures 4.3 and 4.4. As shown in Figure 4.3, some of these fires were spread by "burning water" which resulted from ignition of leaked natural gas being carried along by the flow from broken water pipes. Most of the damage in these areas was of a less spectacular nature, however, and occurred as relatively minor, but very pervasive, damage to pavements and utility lines distressed by localized lateral compression, extension, and differential settlements.

Fig. 4.2: Geyser from broken water pipe in Sherman Oaks

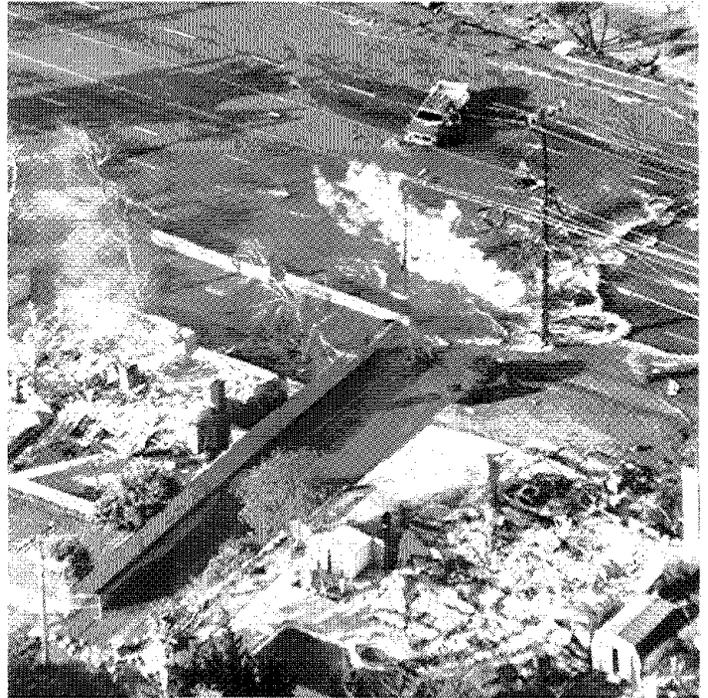
Fig. 4.3: Flooding, fires, and burned homes in Granada Hills along Balboa Boulevard. Photo by Los Angeles Times.

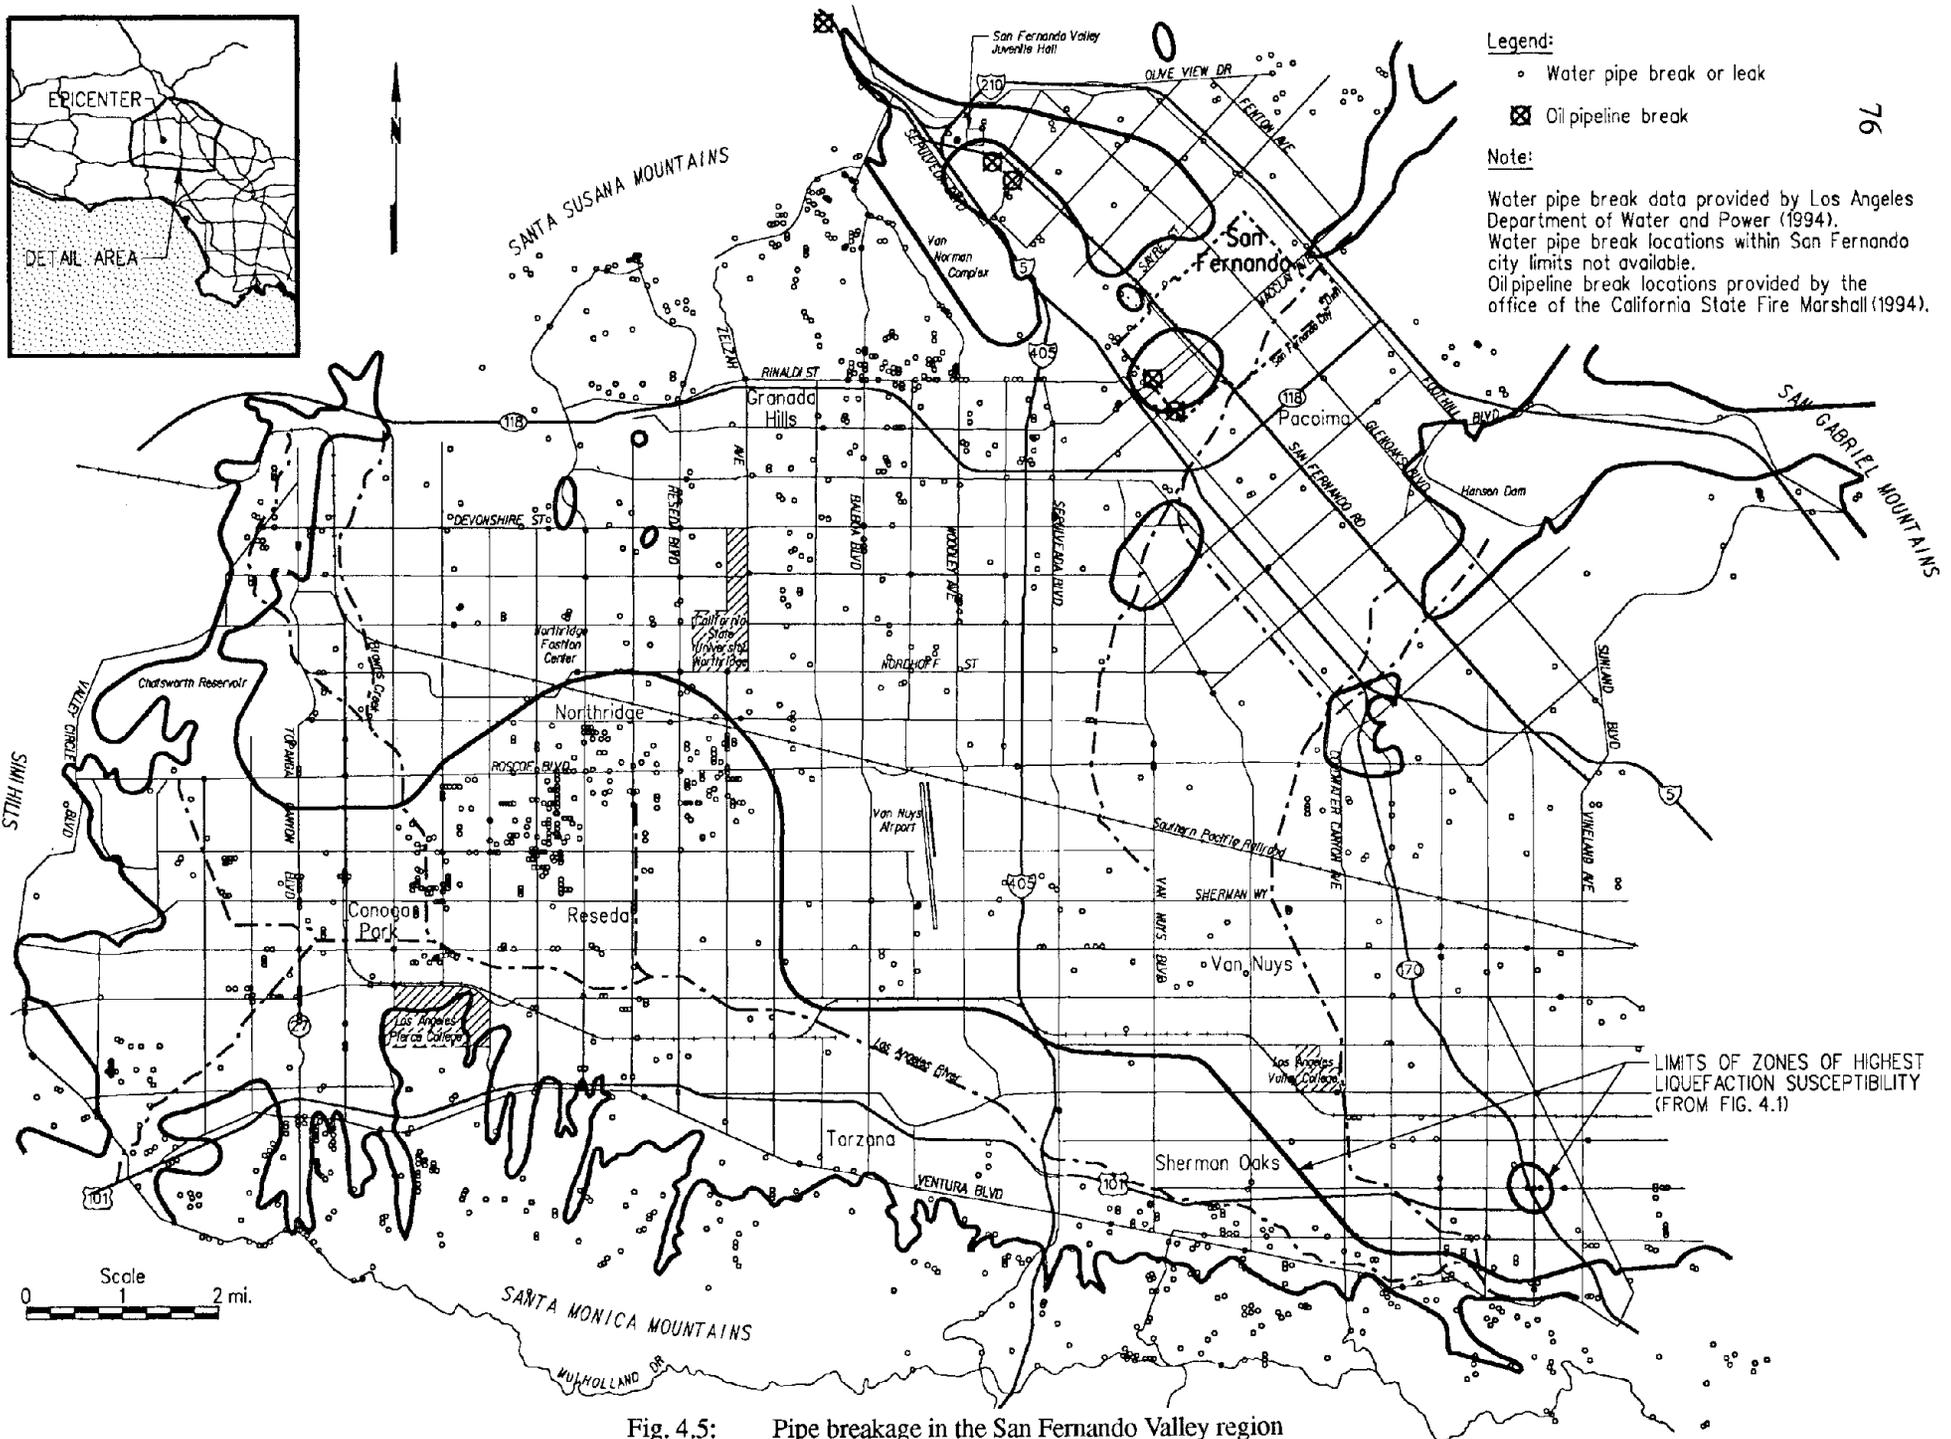
Fig. 4.5: Pipe breakage in the San Fernando Valley region

As shown in Figures 4.5 and 4.6, the locations of unsafe, or red-tagged structures in the Granada Hills area correlates reasonably well with the locations of ground failures as indicated by pipe breaks and leaks. Some of these damaged structures were the product of fires started from ruptured gas lines, thus decreasing the robustness of the apparent correlation between structural damage and ground failure. Nonetheless, the quality of the correlation, particularly in the area north of Rinaldi Street and west of Balboa Boulevard, suggests that ground failure may have contributed to the occurrences of structural damage in the area.

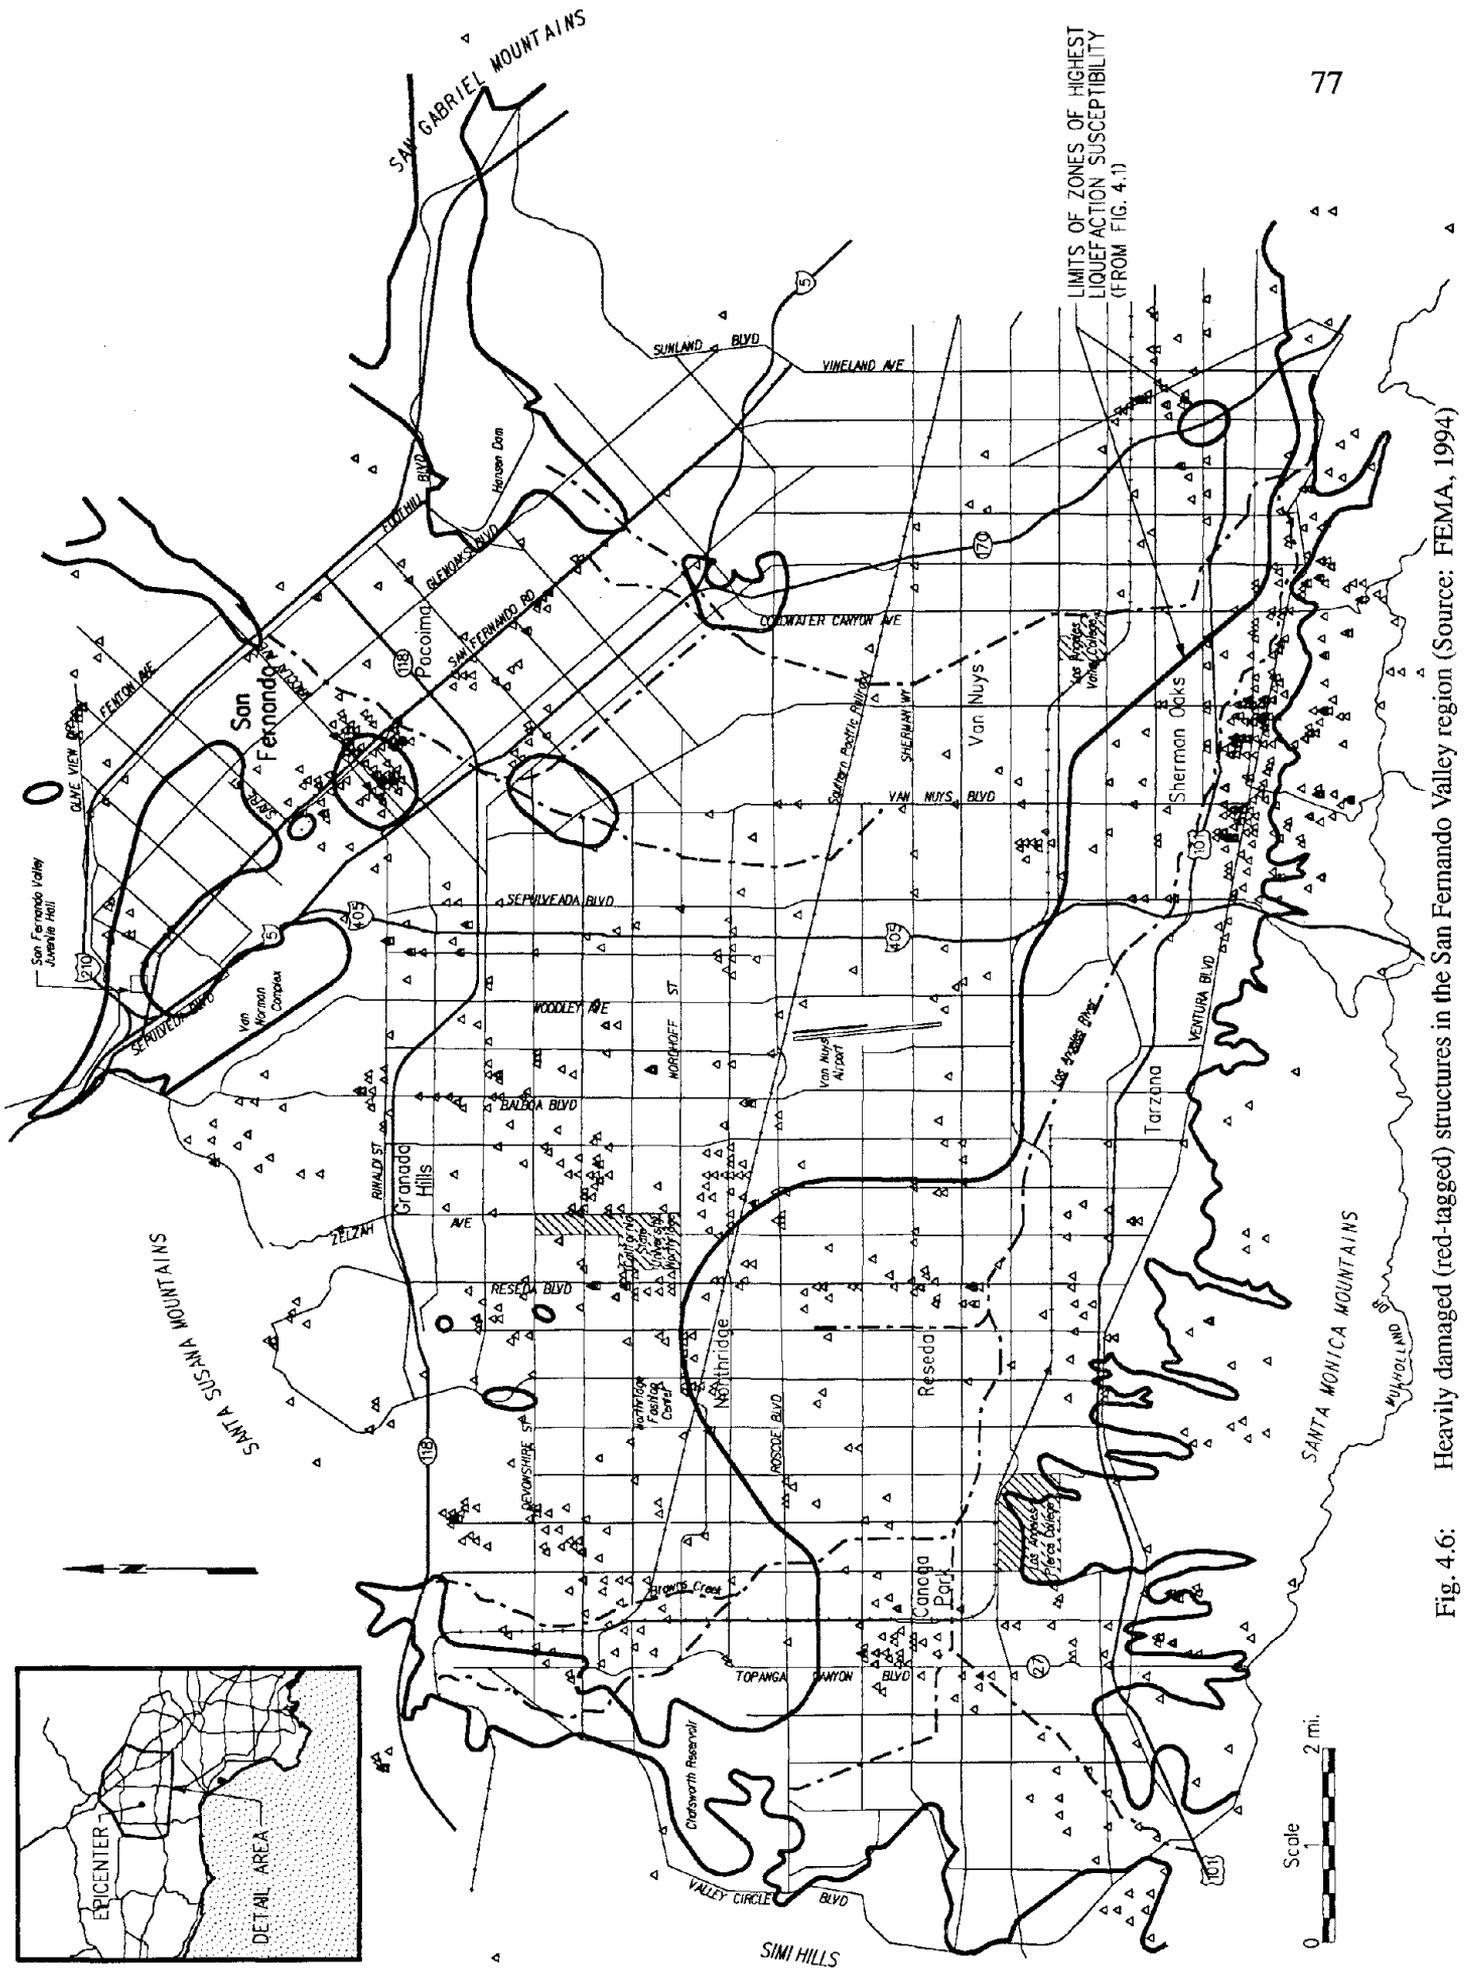
Fig. 4.6: Heavily damaged (red-tagged) structures in the San Fernando Valley region (Source: FEMA, 1994)

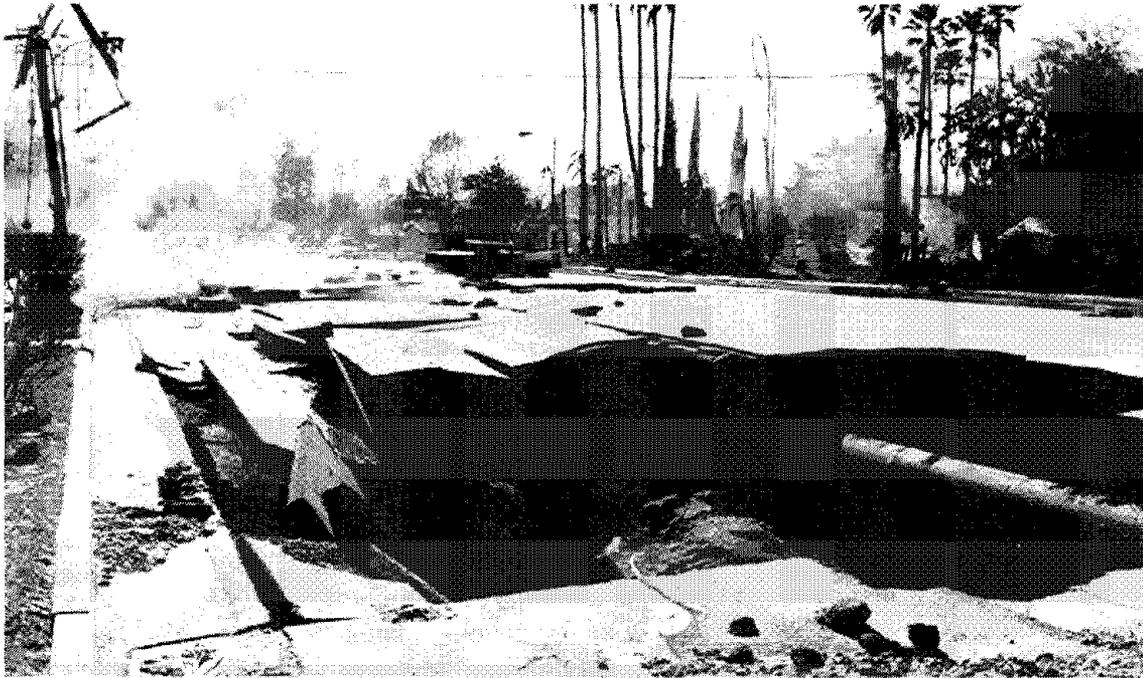
Fig. 4.7: Ground crater and fire resulting from pipe breakage, Balboa Boulevard, Granada Hills. Photo by Los Angeles Times.

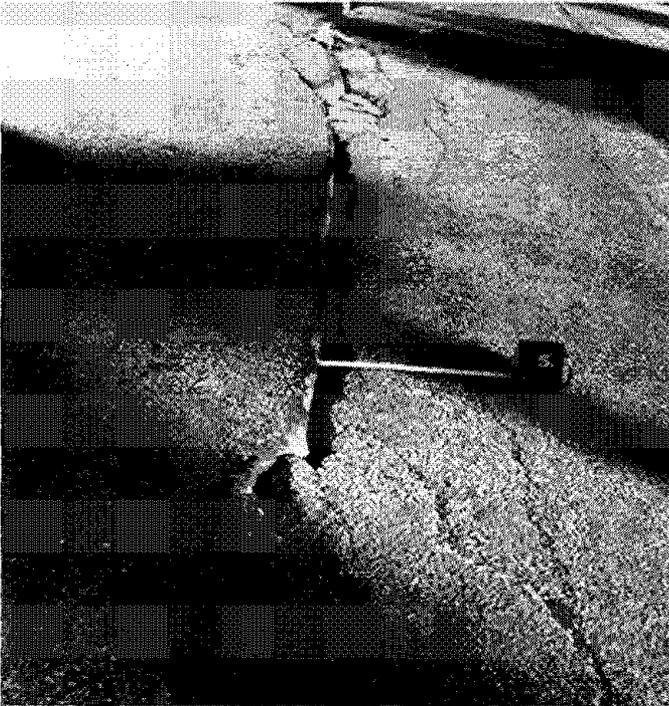
In addition to pipe breakage, the area also experienced widespread ground cracking, primarily in lateral extension and settlement, although some lateral compression was also observed. Figures 4.9 to 4.11 show examples of pavement breakage in neighborhoods just north of Rinaldi Street due to localized differential settlement, lateral extension, and lateral compression, respectively. Figure 4.12 shows evidence of extensional ground movements adjacent to a house. Surficial lateral and vertical differential offsets in pavements were generally on the order of 2 to 6 inches, but in isolated instances, differential lateral extension and compression of up to one foot and more were observed. The ground cracking in these areas was not accompanied by sand boils or sand fissures, and the distress often formed a distinct linear pattern oriented in an east-west direction, generally sub-parallel to the slope contours.

Fig. 4.9: Pavement crack from settlement and extension on Rinaldi Street near Balboa Boulevard, Granada Hills

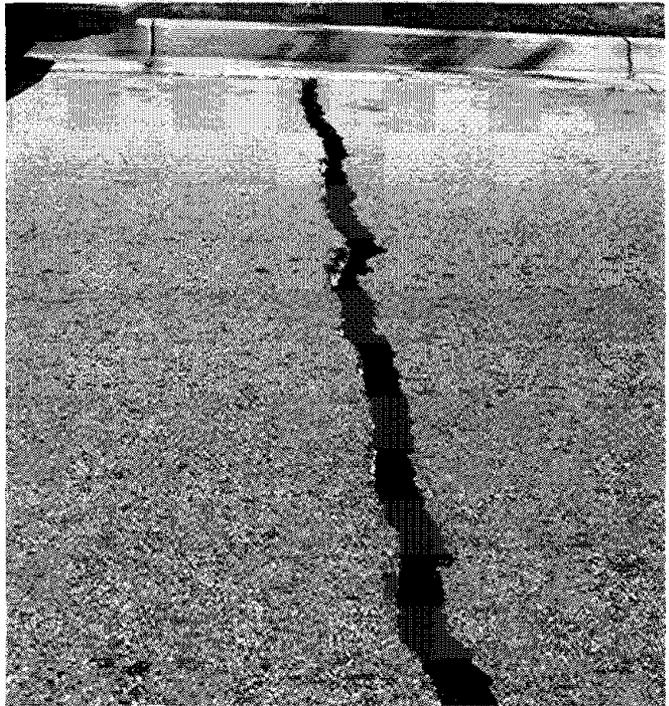
Fig. 4.10: Pavement crack from extensional ground movements, Granada Hills

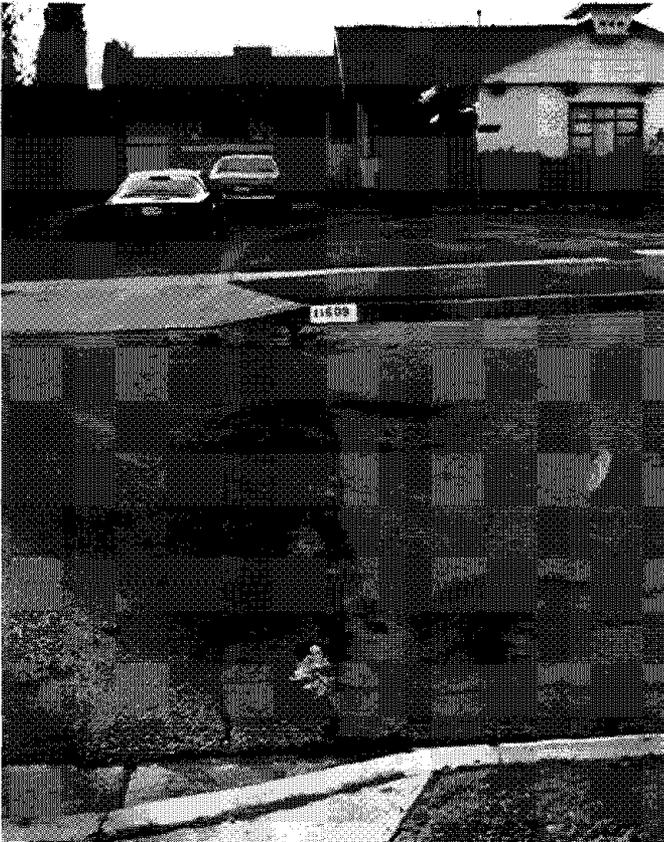
Fig. 4.11: Pavement buckling in compression, Granada Hills

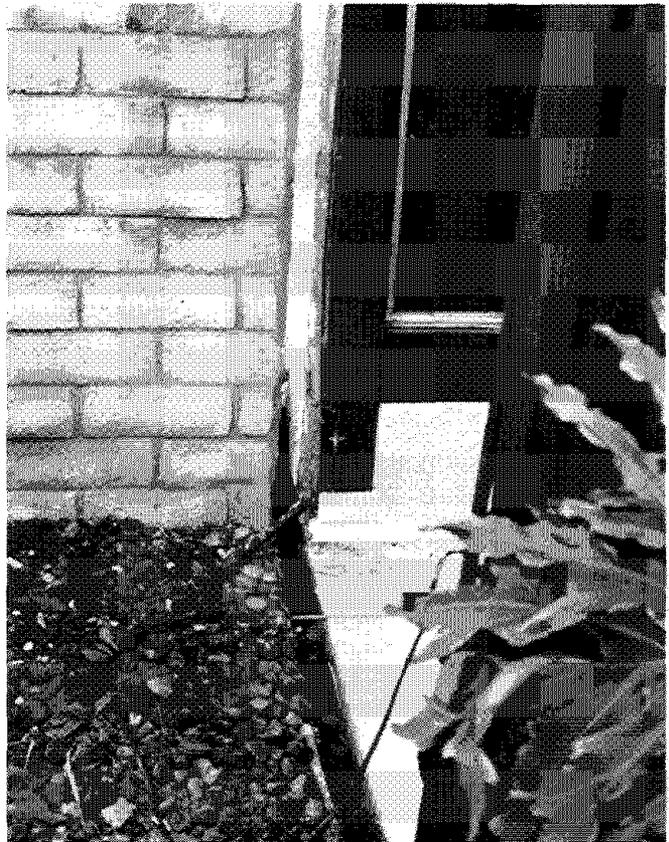
Fig. 4.12: Evidence of extensional ground movement near a house. Small masonry wall and adjacent ground separated from house.

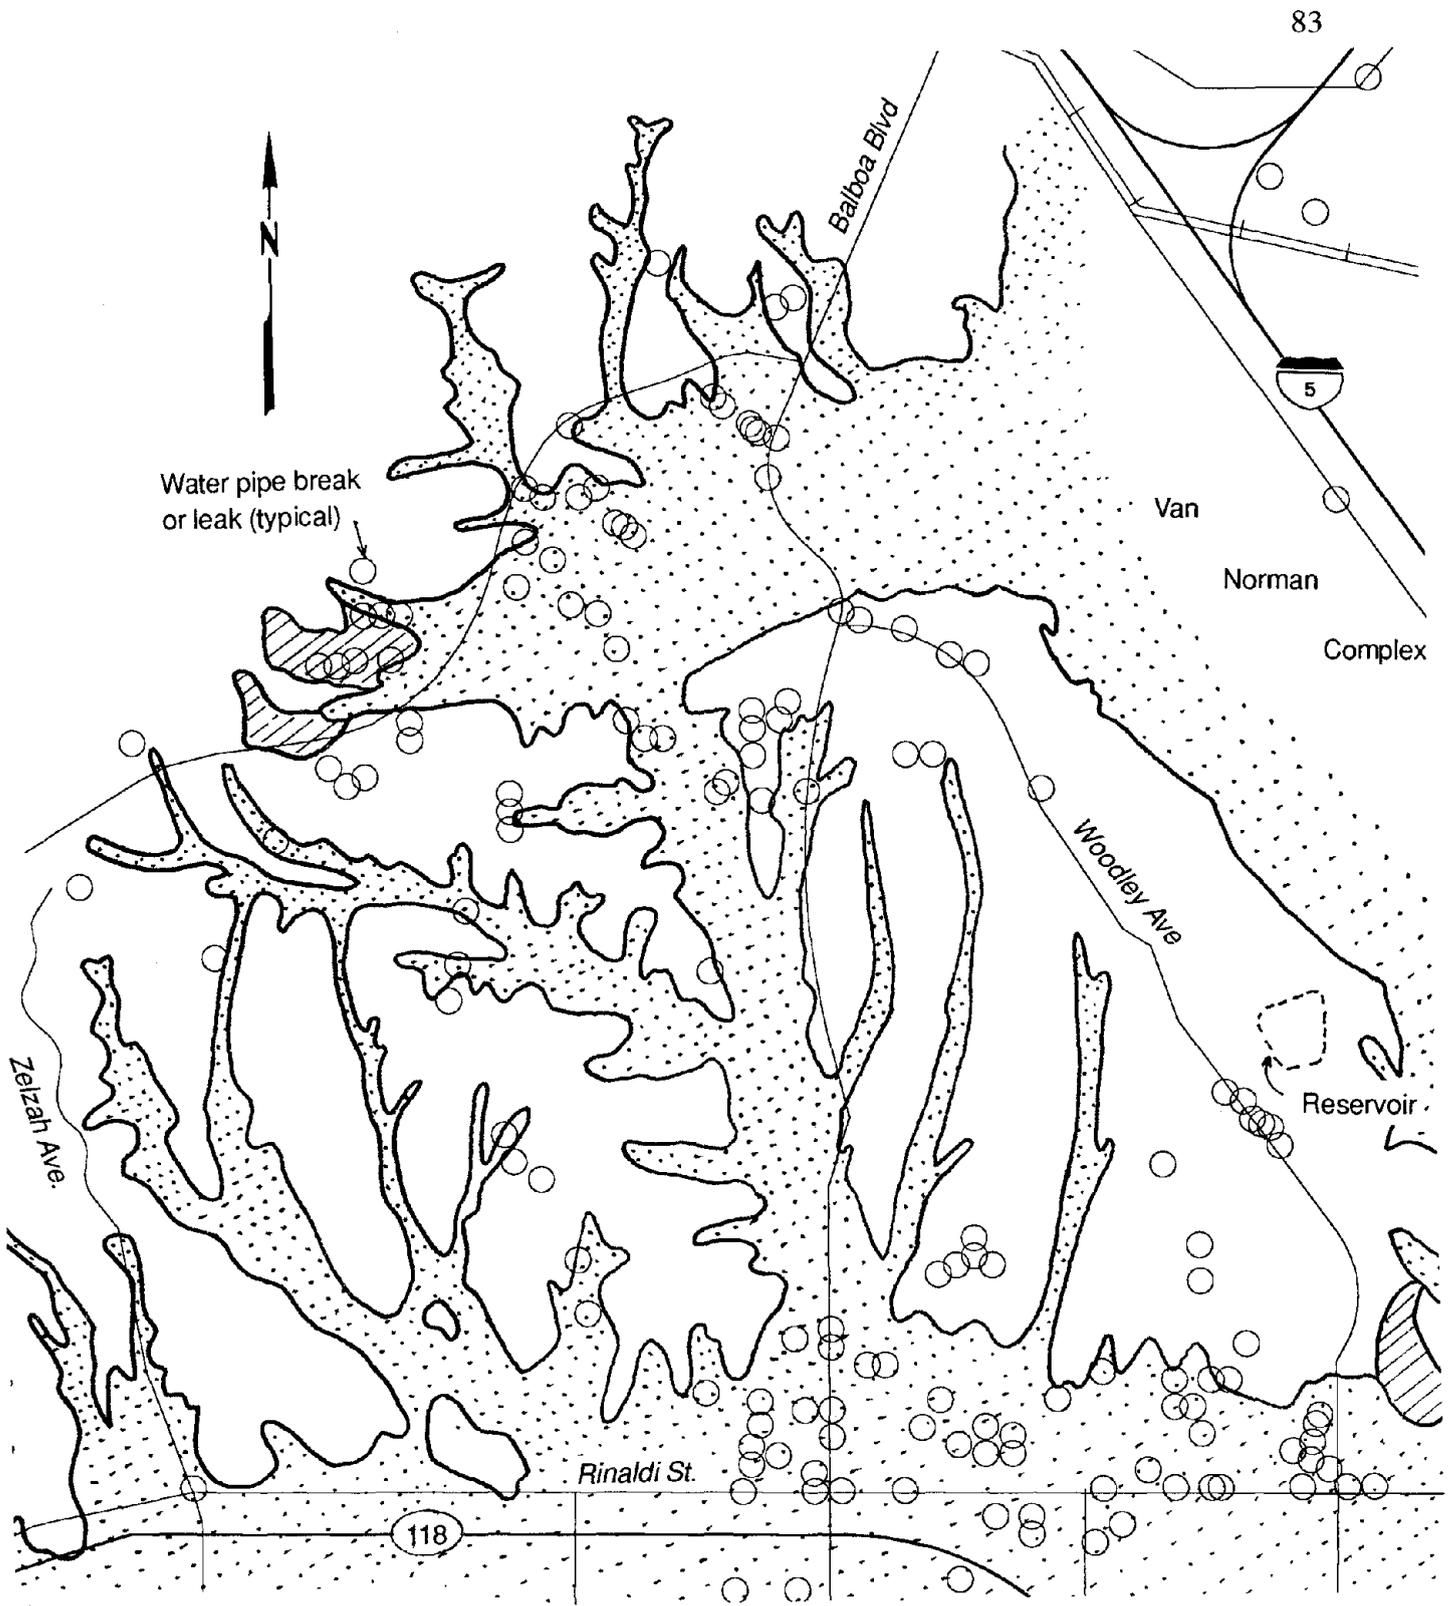
Further north, where the soil cover is much thinner and rock is found at the surface in some areas, the potential for surficial ground failure from tectonic movements might appear to be somewhat more likely. Figure 4.13 shows the locations of pipe breaks and leaks in the portion of Granada Hills north of Highway 118 along with mapped bedrock and soil areas (Dibblee, 1991, 1992). Despite the essentially uniform distribution of pipes through most of the area, concentrated pipe breakage zones occurred primarily within alluvial soil deposits. This pipe breakage pattern suggests that ground failure was generally confined to these soil materials, and was relatively infrequent in bedrock. If significant localized tectonic deformations had occurred, a more uniform distribution of breaks through the different geologic materials would be expected. Hence, it appears that tectonic deformations did not significantly contribute to ground failure-induced damage in the Granada Hills area.

Fig. 4.13: Map of Granada Hills area north of Highway 118 showing pipe breakage and geologic conditions (pipe break data courtesy of Los Angeles Department of Water and Power; geologic conditions adapted from Dibblee, 1992)

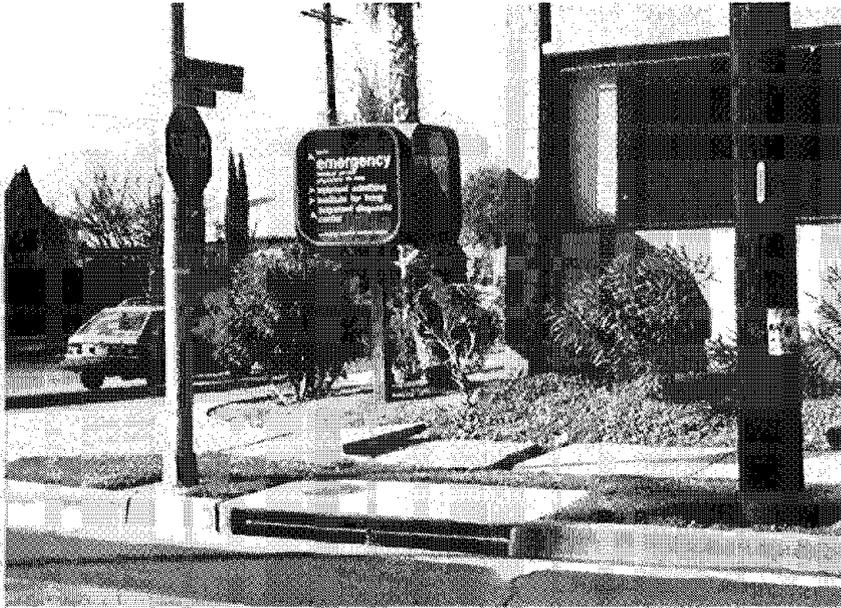
A broad zone of ground failure occurred in the Northridge-Reseda-Canoga Park area southwest of the CSU Northridge campus as evidenced by concentrated pipe breakage (as shown in Figure 4.5) as well as widespread lateral spreading and settlement. Typical examples of pavement distress are shown in Figures 4.14 to 4.16, which show sidewalks and streets damaged by localized lateral ground movements and settlement in the Northridge area. At some locations, significant pavement distress was not accompanied by obvious ground failure, as with the heaved sidewalk with no apparent ground compression in the adjacent ground or curb shown in Figure 4.17. Sand boils were generally not observed in the area.

Fig. 4.14: Sidewalk buckled from lateral compression, Northridge Hospital Medical Center

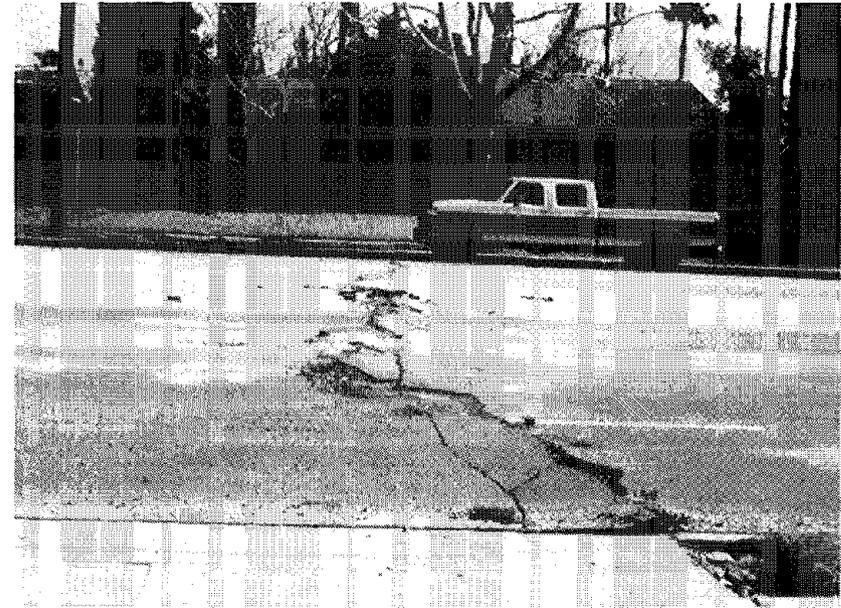
Fig. 4.15: Localized compression feature and pavement damage in Northridge

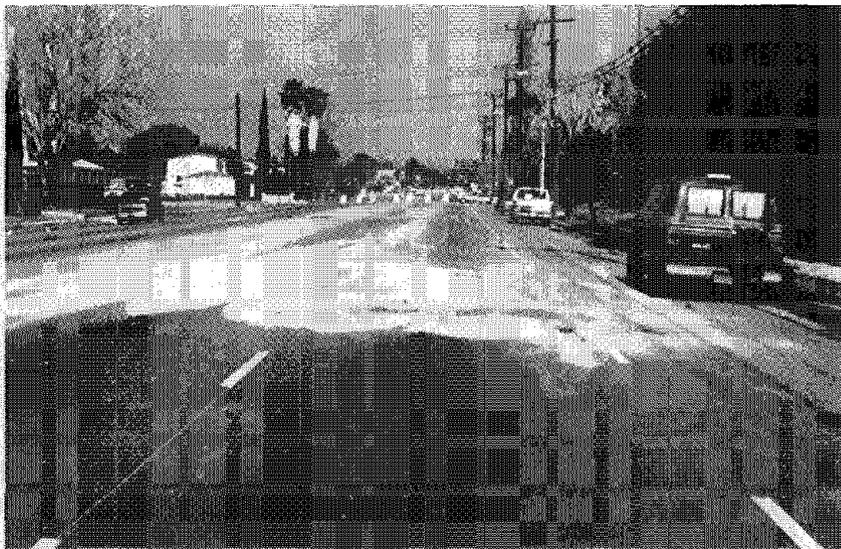
Fig. 4.16: Evidence of ground movements and sand washed onto street from utility pipe break, northeast Northridge
