REPORT NO.
UCB/EERC-94/08
JUNE 1994

EARTHQUAKE ENGINEERING RESEARCH CENTER

**PRELIMINARY REPORT ON THE
PRINCIPAL GEOTECHNICAL ASPECTS
OF THE JANUARY 17, 1994
NORTHRIDGE EARTHQUAKE**

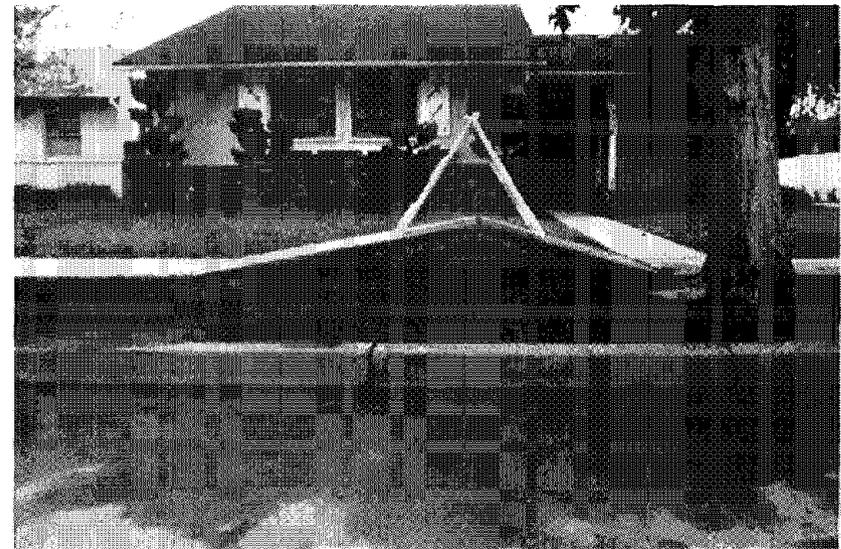
A broad zone of ground failure occurred in the Northridge-Reseda-Canoga Park area southwest of the CSU Northridge campus as evidenced by concentrated pipe breakage (as shown in Figure 4.5) as well as widespread lateral spreading and settlement. Typical examples of pavement distress are shown in Figures 4.14 to 4.16, which show sidewalks and streets damaged by localized lateral ground movements and settlement in the Northridge area. At some locations, significant pavement distress was not accompanied by obvious ground failure, as with the heaved sidewalk with no apparent ground compression in the adjacent ground or curb shown in Figure 4.17. Sand boils were generally not observed in the area.

Fig. 4.17: Uplifted sidewalk in Northridge with no apparent adjacent ground failure (photo courtesy of John Tinsley, U.S. Geological Survey)

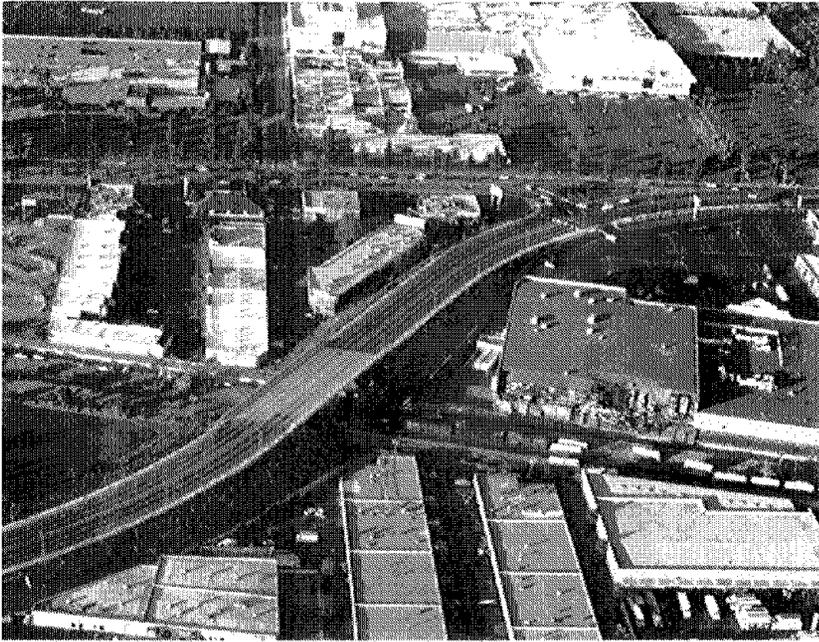
In addition to the apparent occurrence of soil liquefaction, strong shaking in the Northridge area also induced settlements in sandy fills for several bridge abutments which appear to have resulted in large part from dynamic ground compaction. Figure 4.18 shows an aerial overview of the Nordhoff Way bridge over the Southern Pacific Railroad tracks. Significant settlement of the abutments for this bridge occurred as a result of dynamic ground compaction, as shown in Figure 4.19. Numerous bridge abutments throughout the epicentral area experienced similar settlements, although the magnitude of such settlements was typically much less than that shown in Figure 4.19. A train de-railment also occurred beneath the Nordhoff Way bridge, as shown in Figure 4.20. The de-railment was probably caused by toppling of the train from inertial forces associated with strong shaking. No evidence of ground failure was observed at the de-railment site 28 hours after the earthquake, but much of the ground had been disturbed by repair efforts.

Fig. 4.18: Aerial view of Nordhoff Way bridge over Southern Pacific Railroad tracks, just south of Northridge Fashion Center. Also note train de-railment below bridge and collapsed parking garage in background.

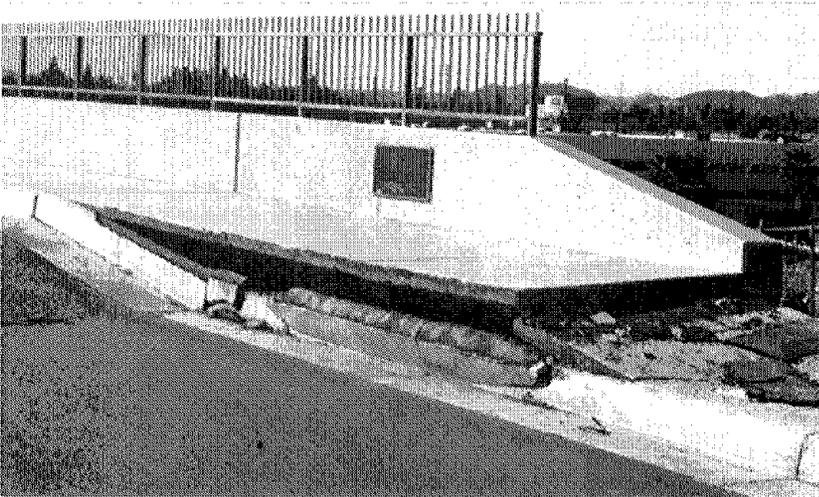
Fig. 4.19: Abutment settlement at Nordhoff Way bridge over Southern Pacific Railroad tracks

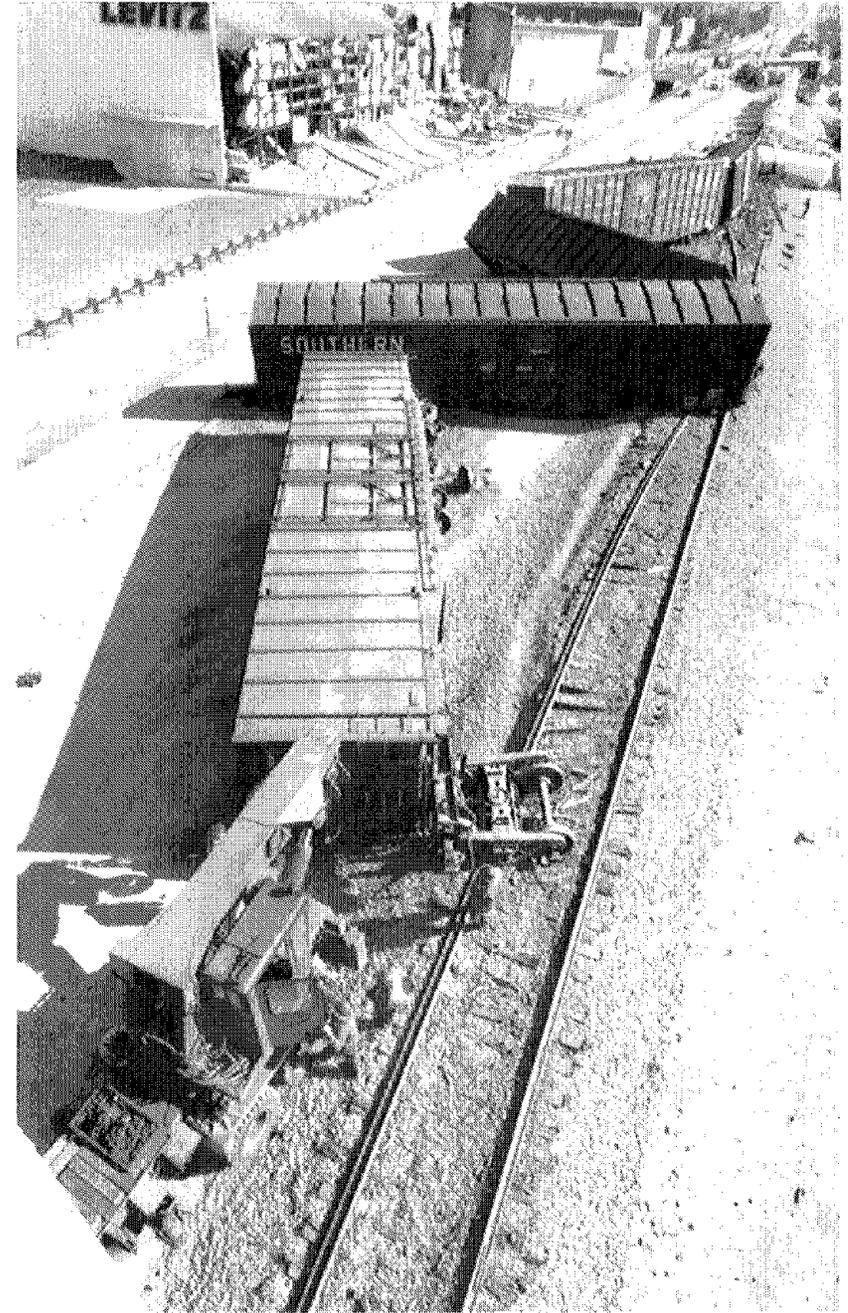
Fig. 4.20: Train de-railment beneath Nordhoff Way bridge over Southern Pacific Railroad tracks. Photo by Los Angeles Times.

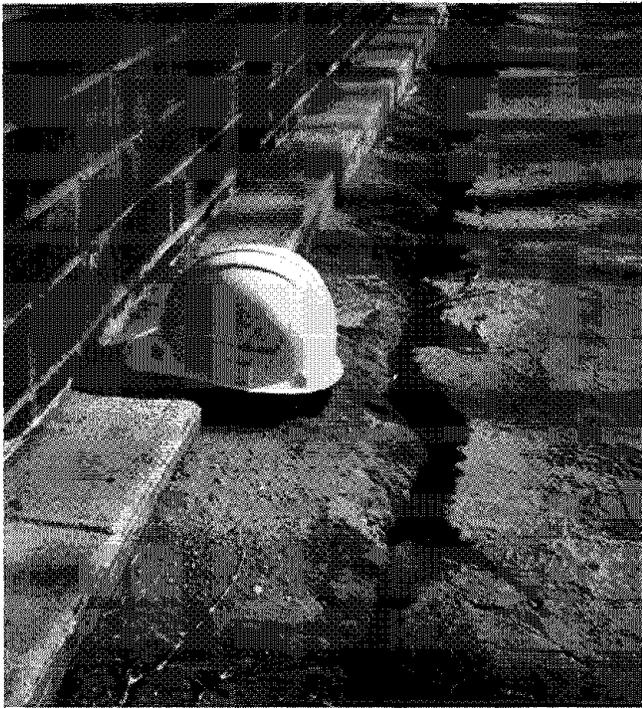
Near the top of the apparent slide feature, extensional ground movements were observed at several locations within the Juvenile Hall complex. The buttress fill underlying the southern structures at the site appeared to perform reasonably well, although some ground fissures developed outside of, and parallel to, the footings of some buildings, as shown in Figure 4.22. In addition, some structural distress to the southern Juvenile Hall buildings was observed (Figure 4.23), though this distress has not generally been attributed to ground failure (Leighton and Associates, 1994). Outside of the buttress fill, typical extensional features in the parking area included fissures up to 4 inches wide and several feet deep, as shown in Figure 4.24. According to maintenance personnel, many of these fissures in the parking area developed parallel to a large sewer line.

Fig. 4.22: Ground fissure with extensional movement near edge of building, Juvenile Hall facility

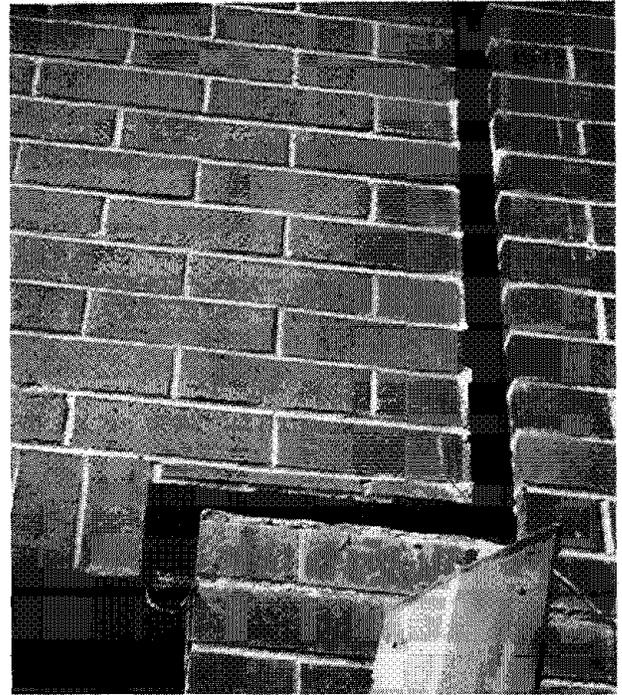
Fig. 4.23: Separation of walls at San Fernando Valley Juvenile Hall Facility

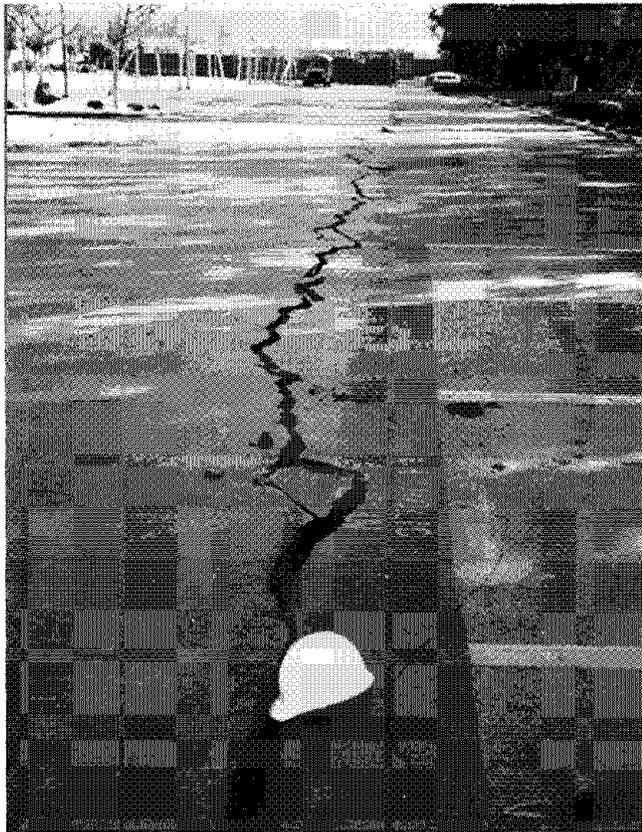
Fig. 4.24: Ground fissure from extensional movement, parking lot at Juvenile Hall facility

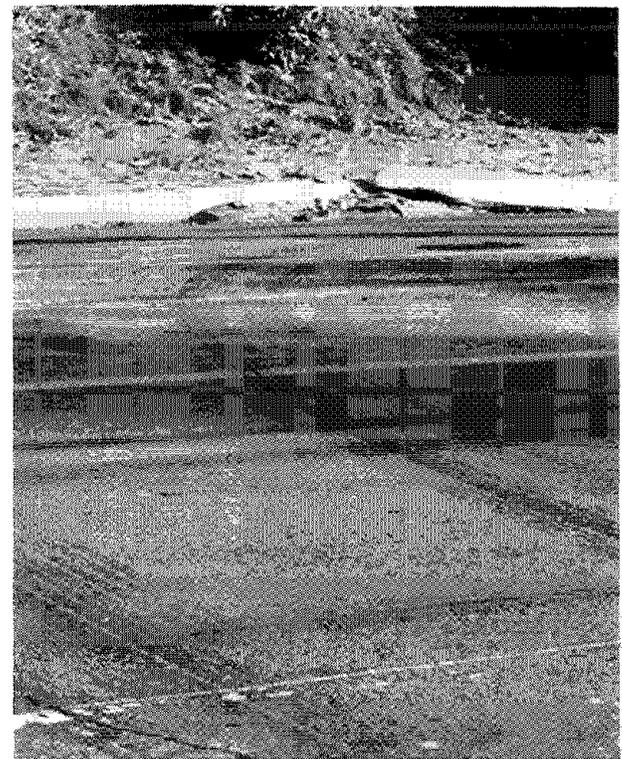
Downslope of the Juvenile Hall facility, evidence of ground movements was observed in the form of pavement cracking and curb buckling along San Fernando Road (Figure 4.25), 3 to 4-inch bowing of train tracks adjacent to San Fernando Road in the downslope direction, and minor ground cracking further downslope in the Van Norman Complex. Ground cracking in the east end of the Van Norman Complex was observed in a canal along the east side of the former Upper Van Norman Lake, and adjacent to foundations for a power line tower near the Sylmar Converter Stations. In addition, slide movements may have contributed to reported settlements of up to a foot around the Sylmar Converter Station (Dames and Moore, 1994). As noted previously, these distress features generally appeared to have occurred within the approximate boundary of the 1971 slide, thus suggesting that some of the original (1971) slide mass had been at least partially re-activated.

Fig. 4.25: Damage to curb on east side of San Fernando Road

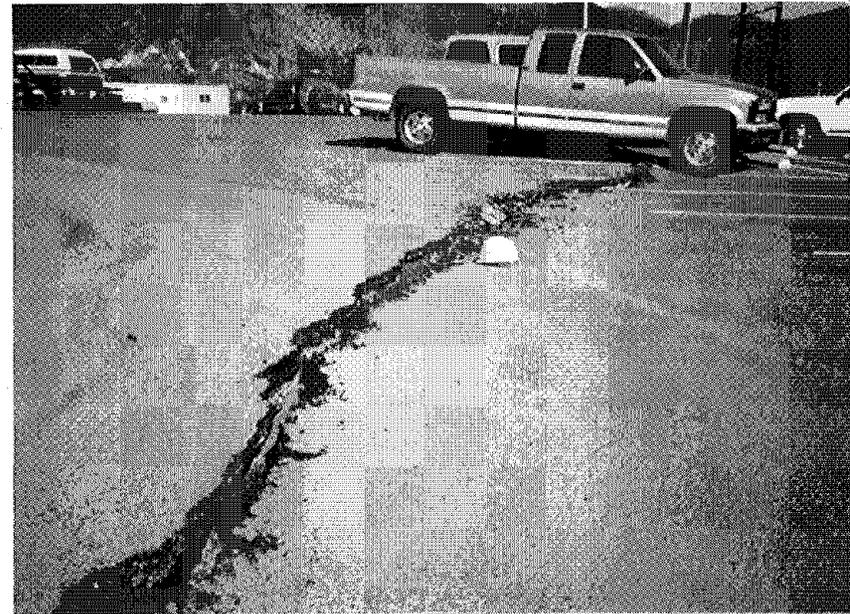
Fig. 4.27: Ground fissure with extensional movement and differential settlement, parking lot of main control building, Jensen Filtration Plant

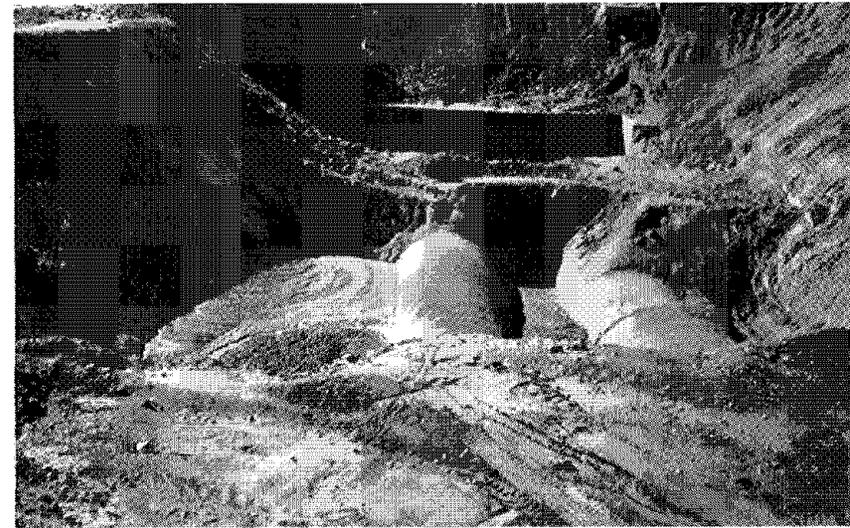
The temporary closure of the Jensen Filtration Plant was primarily necessitated by the rupture of several buried pipes, including a break in one of two influent aqueducts north of the main control building. Figure 4.29 shows the ruptured section of an 85-inch diameter

Fig. 4.29: Broken section of influent pipe during repair operations, Jensen Filtration Plant. (photo courtesy of Les Harder)

steel influent pipeline during repair operations which took about 2½ days to complete. In addition, numerous irrigation and chlorination lines were broken just south and north of the parking lot of the main control building, respectively. Towards the southern end of the facility, the fill surface around the perimeter of a 50 million gallon finished water reservoir settled approximately 2 to 4 inches relative to the reservoir. It is not known whether these movements resulted from dynamic compaction of the fill materials or re-consolidation of underlying liquefied alluvial soils. The northwestern portion of the plant, which is founded on bedrock materials, did not appear to have experienced significant ground failure during the Northridge Earthquake.

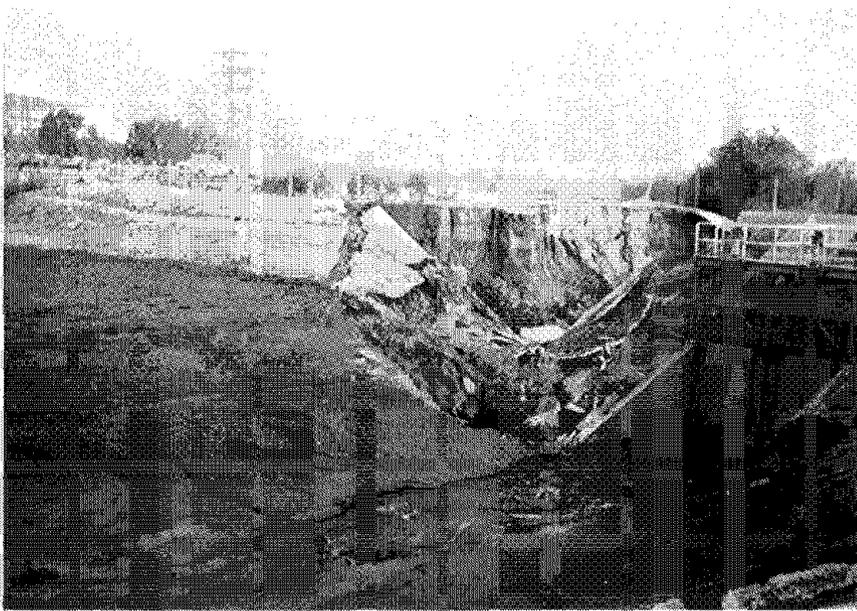
Fig. 4.31: Failed embankment section at south end of San Fernando Tailrace

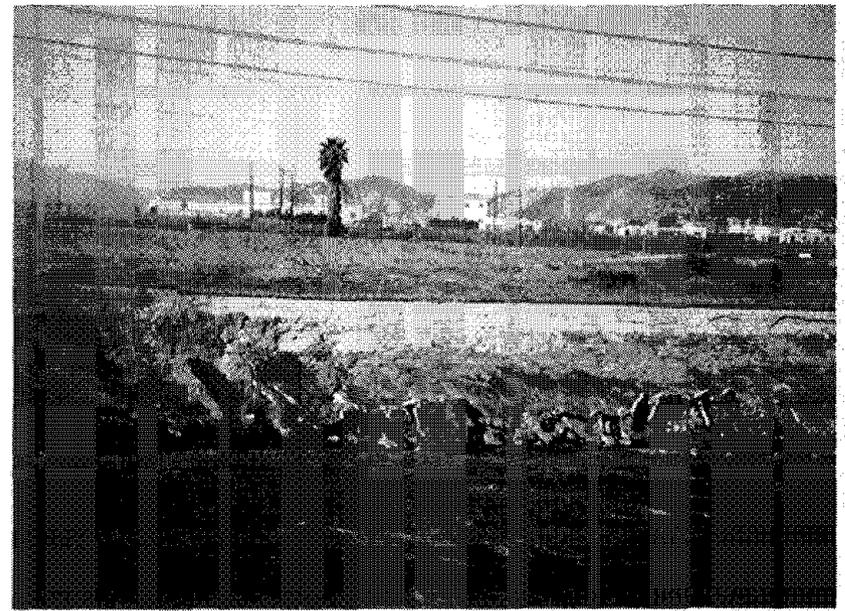
Fig. 4.32: Buckling and compression of gunite pond lining, San Fernando Tailrace

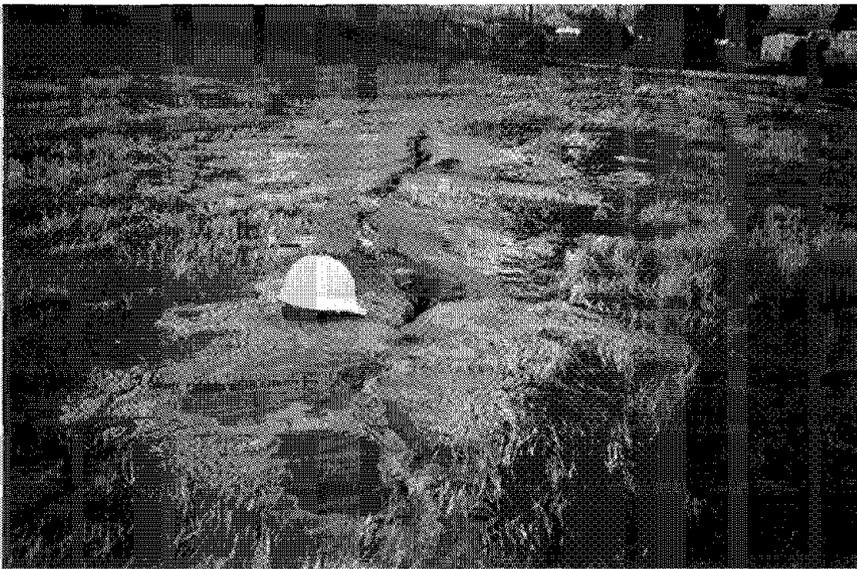
Fig. 4.33: Sand fissure at top of west slope near San Fernando Tailrace.

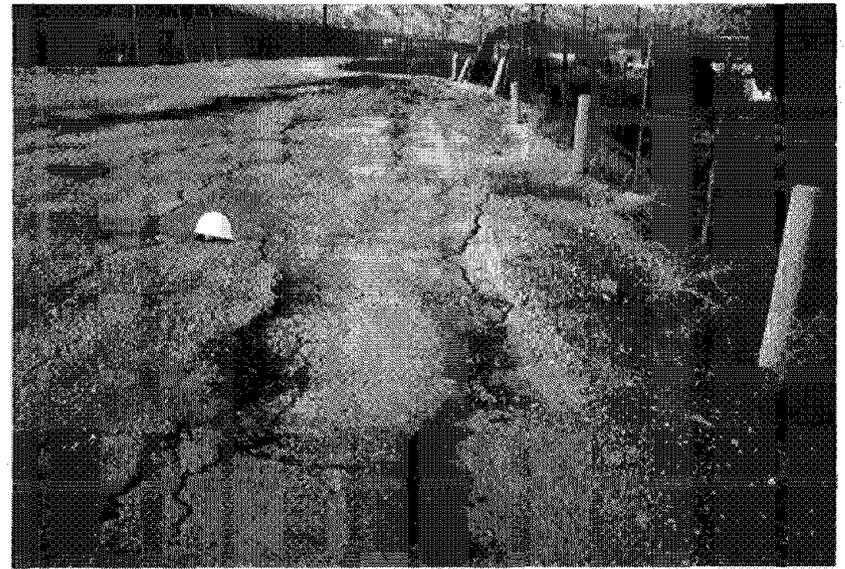
Fig. 4.34: Slumping of road area near top of pond side slope, San Fernando Tailrace

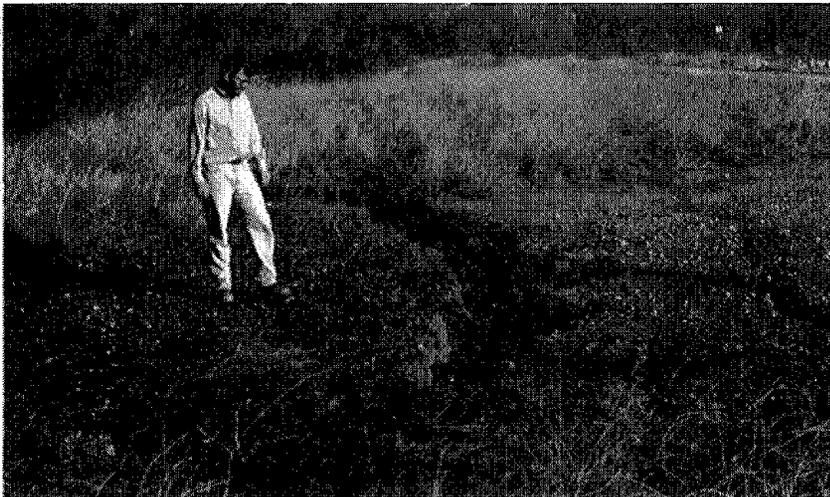
Fig. 4.37: Ground fissure across road embankment north of pond within bed of former Upper Van Norman lake

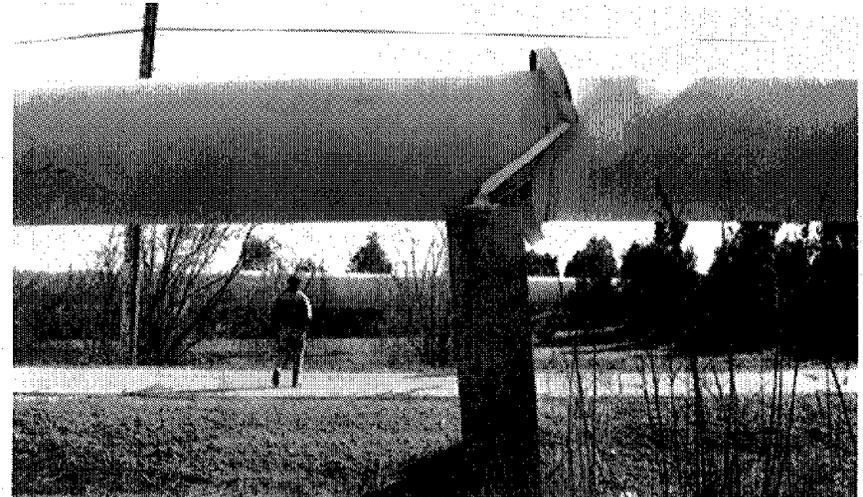
Fig. 4.38: Failure of pipe support due to liquefaction-induced foundation movements (photo courtesy of Ross Boulanger)

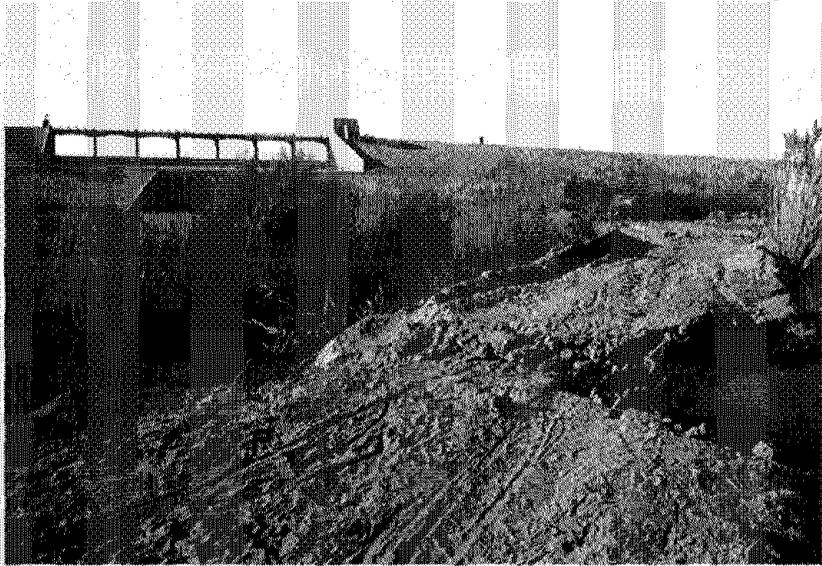
Fig. 4.39: Road damaged by liquefaction-induced lateral spreading in lake bed behind Hansen Dam

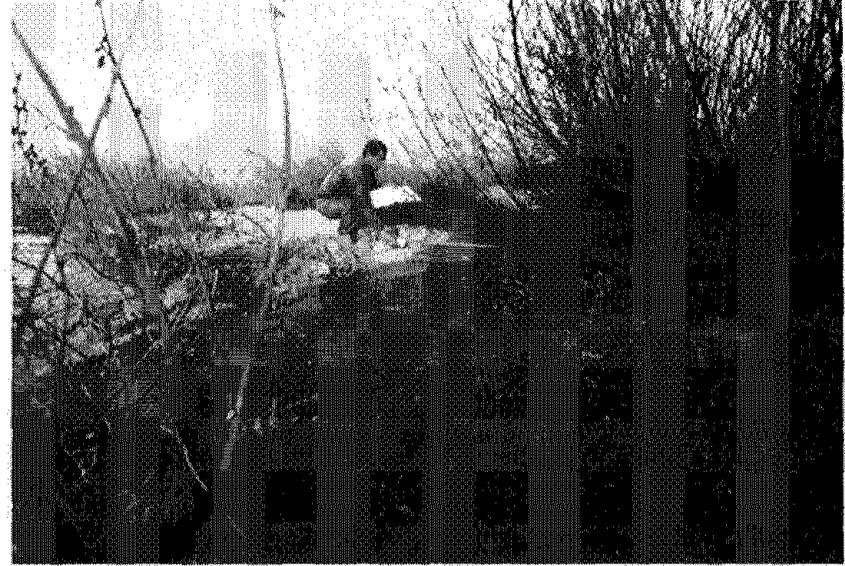
Fig. 4.40: Sand fissure in lake bed behind Hansen Dam

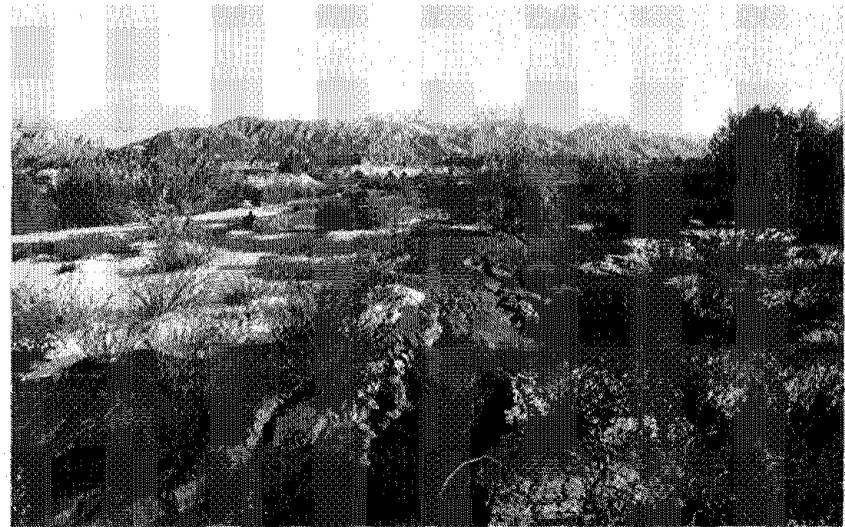
Fig. 4.42: Ground cracking and ejecta from sand fissures upstream of Hansen Dam

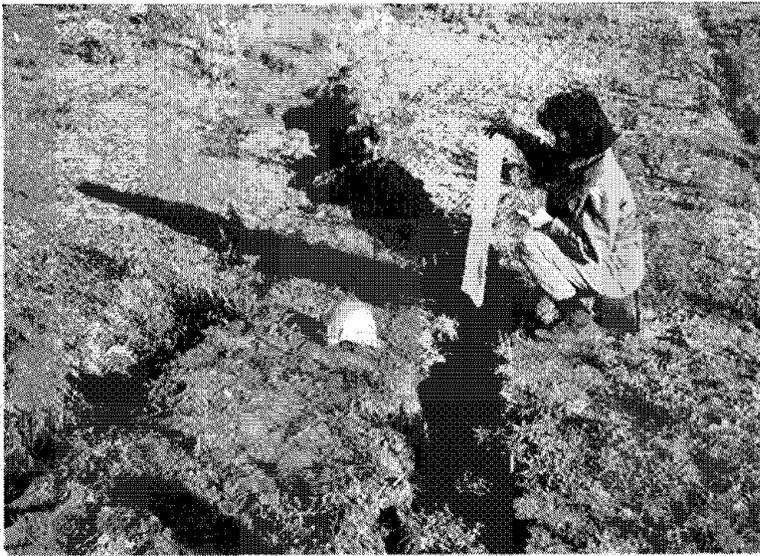
Figures 4.45 and 4.46 show lateral spreading and settlement at Rory Lane, located near the Simi Arroyo Channel within an area in the eastern portion of Simi Valley which experienced significant ground failure. Extensive ground cracking with up to 8-inch lateral and vertical offsets developed in this area, as well as several large sand boils near the channel. This ground cracking and settlement appears to have resulted from lateral ground displacements towards the channel due to liquefaction-induced strength loss of the underlying alluvial soils. At another location near the channel, pronounced ground failure disrupted pavement and pipes at the intersection of Christine Avenue and Hope Street, just east of Rory Lane. Figure 4.47 shows warping of Christine Avenue and damage to a masonry wall at this location due to lateral spreading and settlement. Ground cracking and pavement distress in the eastern portions of Simi Valley not immediately adjacent to the Simi Arroyo Channel was generally relatively modest. A typical example of pavement buckling in these areas from lateral ground compression is shown in Figure 4.48, taken at Kuehner Drive near Katherine Road. In the central portion of Simi Valley below Tapo Canyon, very little pavement distress or ground cracking was observed.

Fig. 4.45: Ground fissures from settlement and lateral spreading near Rory Lane, Simi Valley

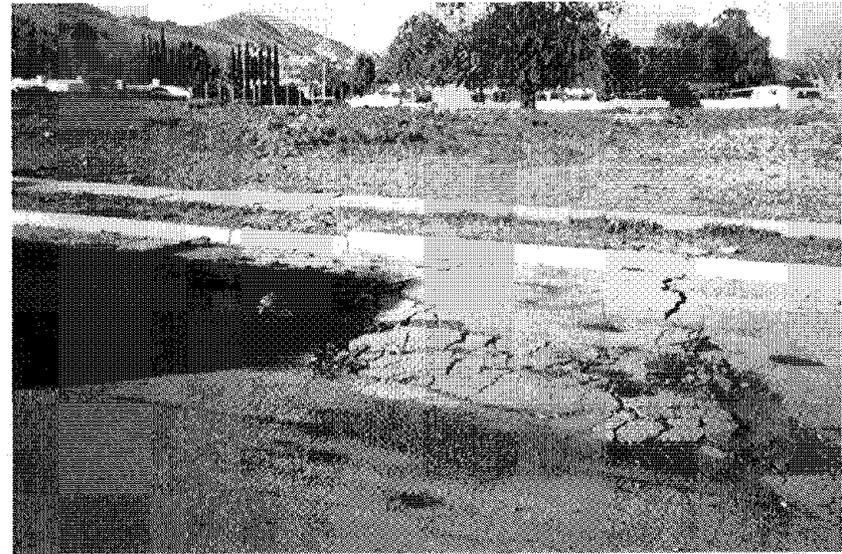
Fig. 4.46: Ground fissure from settlement and lateral spreading near Rory Lane, Simi Valley

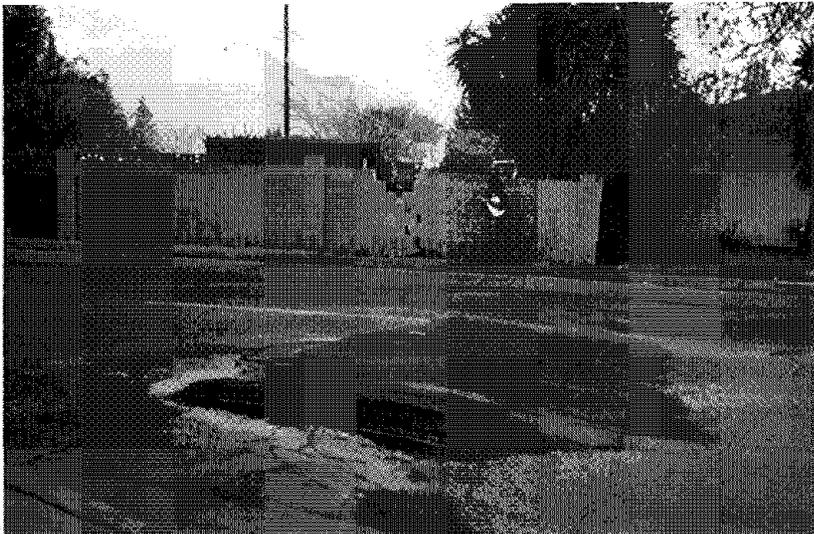
Fig. 4.47: Damage to pavement and masonry wall from settlement and lateral spreading, Hope Street at Christine Avenue, Simi Valley

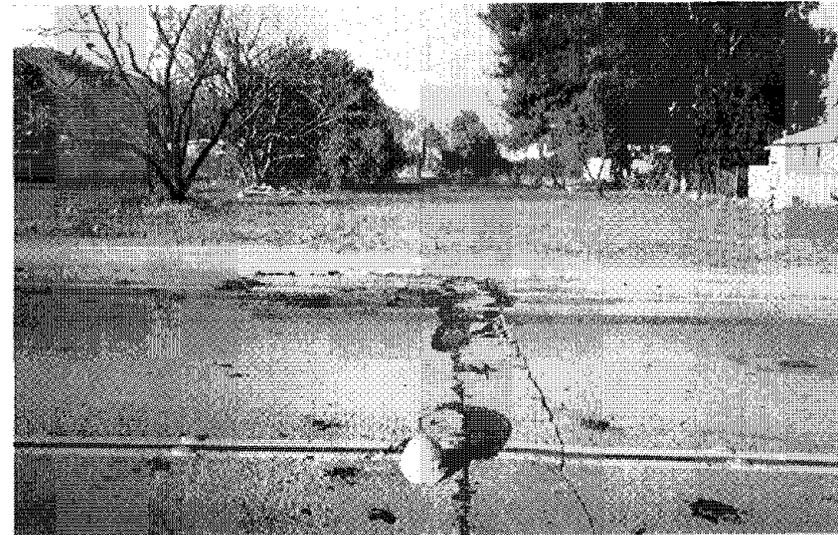
Fig. 4.48: Pavement buckling from lateral compression on Kuehner Drive near Katherine Road, Simi Valley

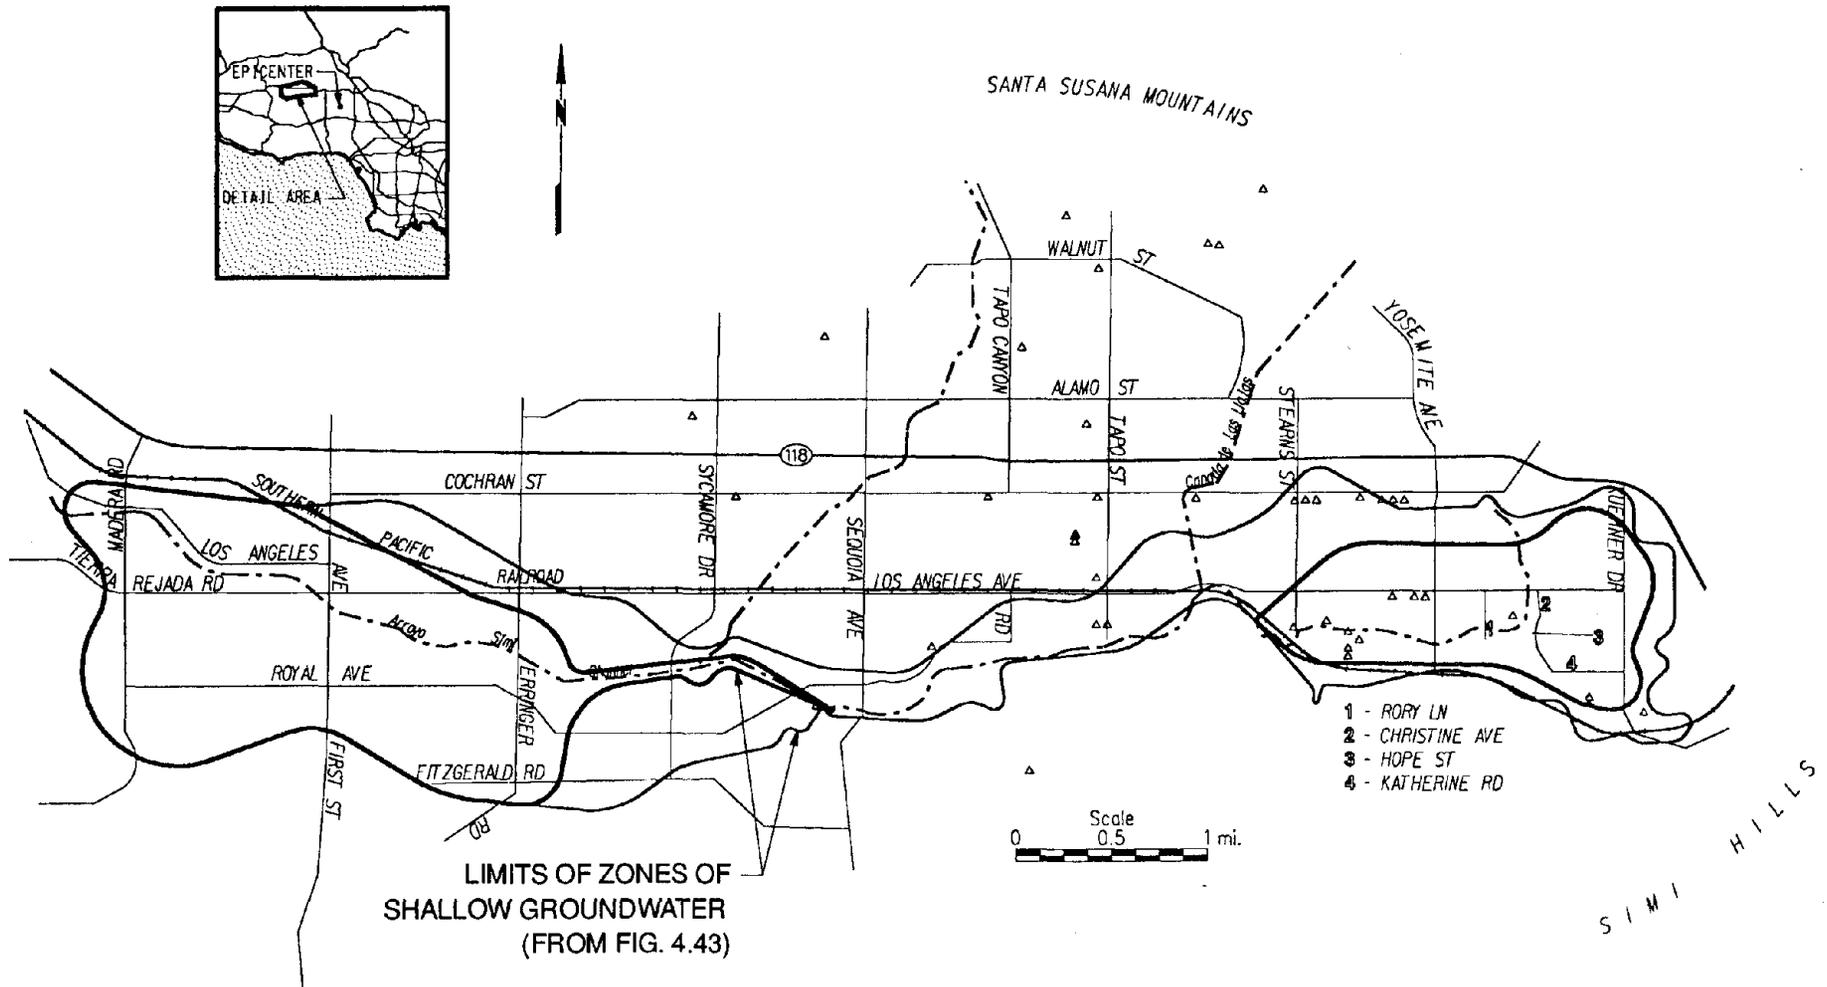
Figure 4.49 shows the distribution of unsafe structures as indicated by red post-earthquake inspection tags along with the outline of high groundwater zones from Figure 4.43 (FEMA, 1994). While a significant number of the red-tagged structures are located in zones which experienced liquefaction in the eastern Simi Valley area, it is not obvious to what extent liquefaction-induced ground movements may have influenced structural performance as this area also experienced relatively high ground shaking levels (Figure 3.4). In general, it appears that a majority of the structural damage in Simi Valley resulted from strong shaking and inertial forces, and was not strongly influenced by ground failure.

Fig. 4.49: Heavily damaged (red-tagged) structures in Simi Valley (Source: FEMA, 1994)

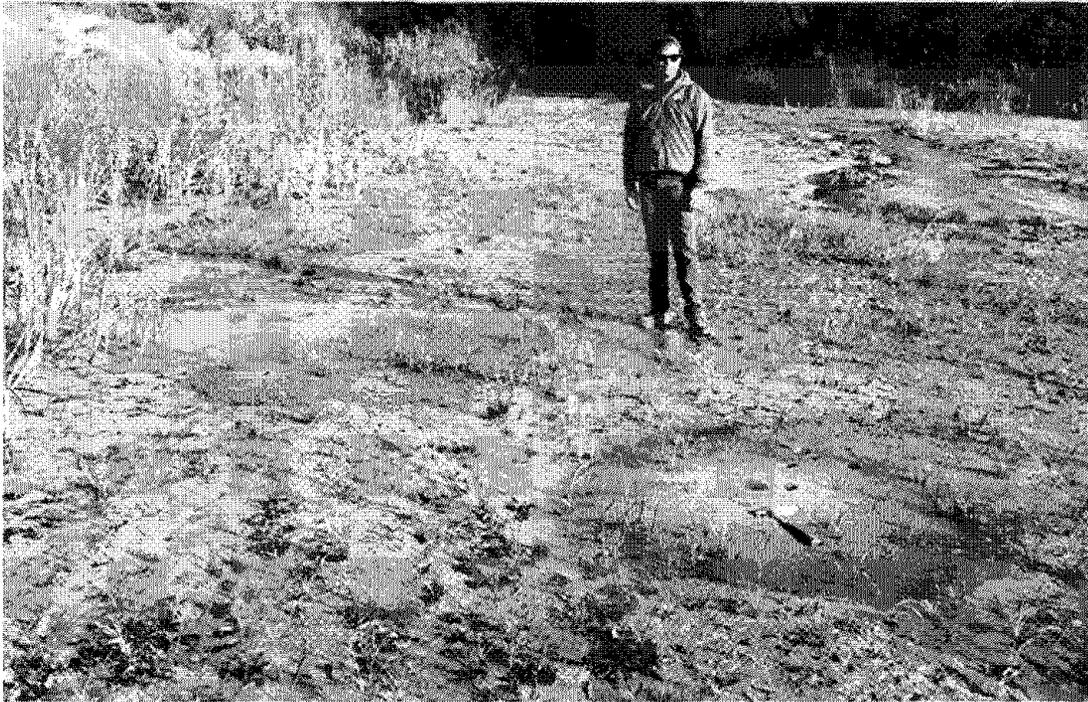
It should be noted the northern-most area found to have experienced liquefaction during the Northridge Earthquake was along the banks of Gorman Creek. This area is located approximately 40 miles north of the epicenter (about 32 miles north of the northern-most extension of the fault plane), and is beyond the limits of the map in Figure 1.3. Peak horizontal ground accelerations in the area are estimated to have been less than 0.1g. Liquefaction caused numerous sand boils to form along the creek at this location as shown in Figures 4.50 and 4.51, but caused no damage as the area is undeveloped.

Fig. 4.50: Evidence of liquefaction in the form of sand boils along Gorman Creek, approximately 40 miles north of the epicenter (photo courtesy of Les Harder)

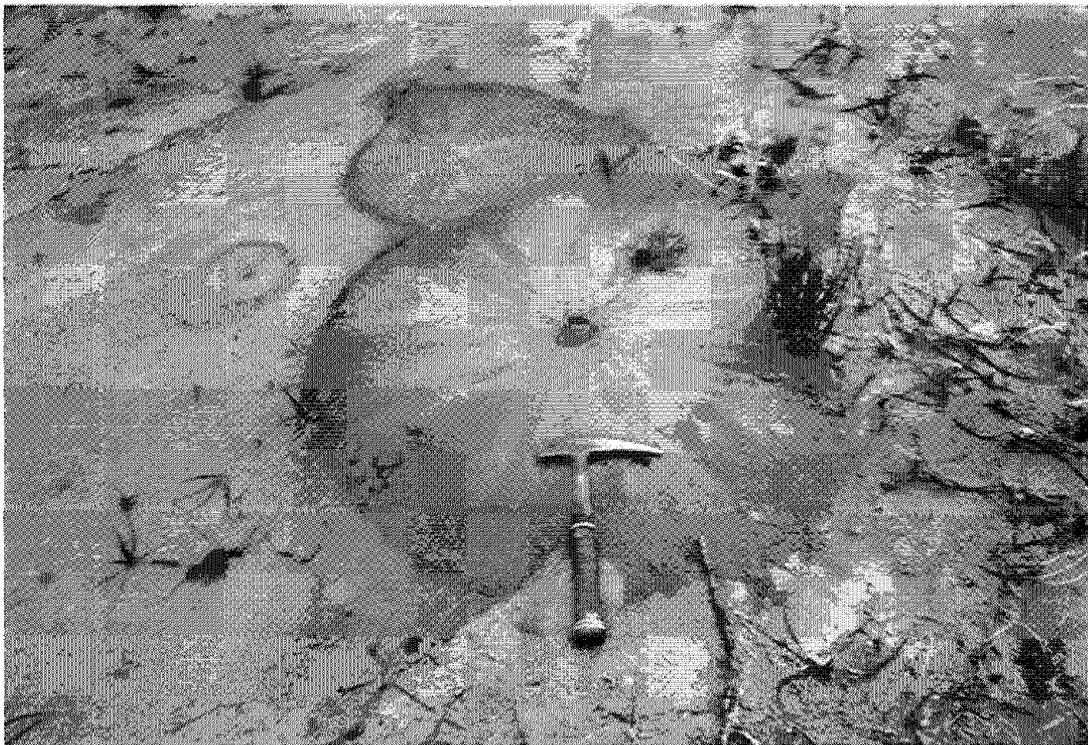
Fig. 4.51: Sand boils along Gorman Creek (photo courtesy of Les Harder)

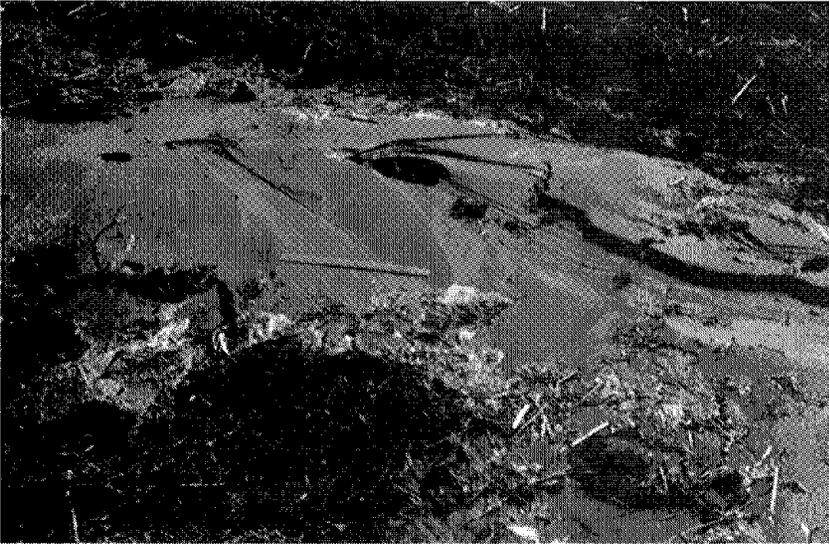
Linear ground breakage features, which are parallel to the axis of the canyon, were observed along the northern and southern margins. Sand boils were noted in several locations throughout the canyon, generally in close proximity to the stream channels (Figure 4.53). The locations of observed ground failures are plotted on the topographic map shown in Figure 4.52. In most locations, movements are distributed over wide zones of ground cracking. An aerial view of typical deformations along the base of a hill within the canyon is shown in Figure 4.54. Deformations appeared to be more pronounced at the base of small hills along the margins of the main canyon walls, and in many locations the cracks follow the contours around the toe of the hill. However, the dense grasses and other vegetation inhibited mapping of cracks in several small swale areas between hills. Where ground deformation features could be mapped through these swales, the cracks cut across the alluvial deposits at the toe of the swale linearly, remaining approximately parallel to the overall trend of the canyon.

Fig. 4.53 Sand boil within Potrero Canyon

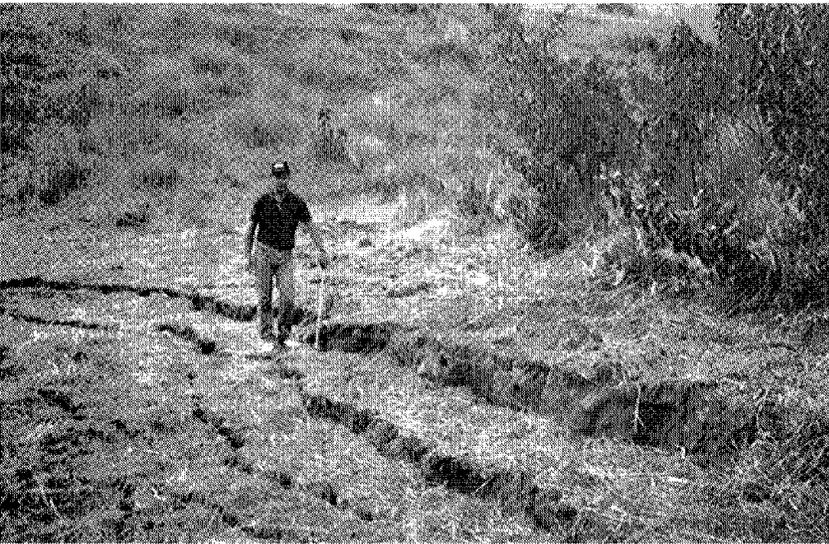
Along the northern margin of the canyon, fractures are primarily extensional, with substantial differential vertical offsets and minor right lateral offsets. Multiple ground fractures within zones 5- to 50-foot wide accommodate as much as two feet of vertical movement. A zone of parallel extension cracks with almost two feet of relative vertical displacement is shown in Figure 4.55. Typical right-lateral ground deformation is shown in Figure 4.56.

Fig. 4.55: Wide zone of extension cracks at the soil to bedrock contact in Potrero Canyon

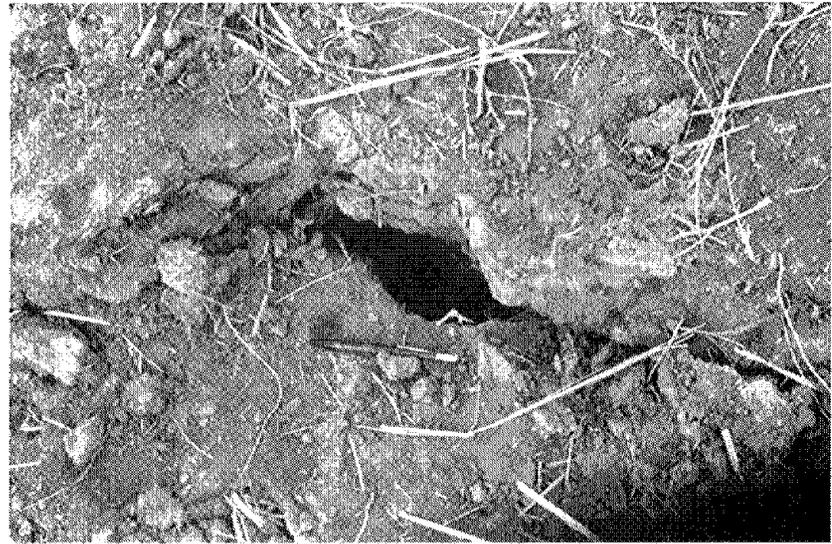
Fig. 4.56: Example of right lateral displacement along the northern margin of Potrero Canyon

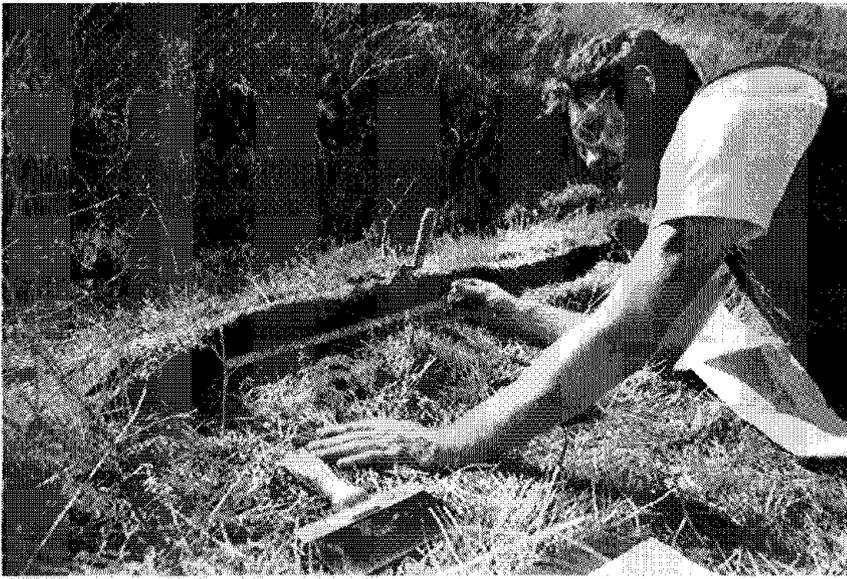
Along the southern margin of the canyon, linear features are both compressional and extensional, with minor left lateral offsets. In numerous locations, compression was characterized by shallow thrusting along distinct shear surfaces that dip to the south at approximately 30 to 40 degrees with up to 8 inches of dip-slip displacement. Trenches across these features revealed that slippage of the A soil horizon occurred, held together by grass roots. The shear surfaces dipped south, into the hills, only for a short distance before curving upward and becoming parallel with the surface of the hill. Head scarps above these features could not be found. However, it would not take a large amount of extension across the height of the hills to account for the 8 inches of thrusting at the bases. Figure 4.57 shows measurement of a thrust feature.

Fig. 4.57: Shallow thrusting of A soil horizon

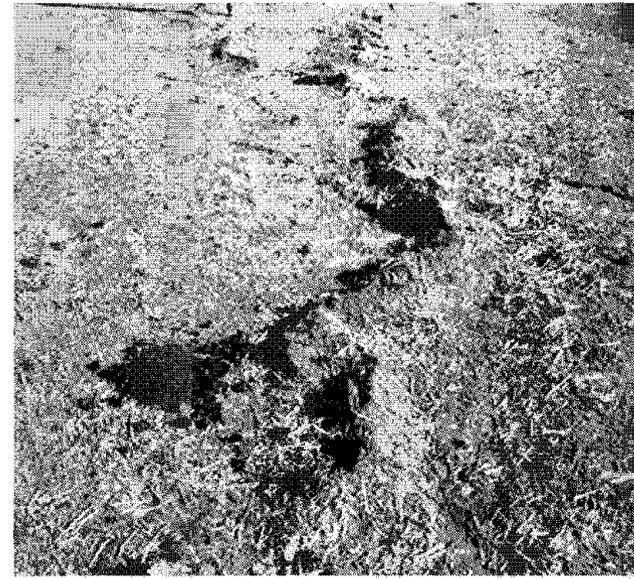
Compressional features were also noted at the entrance to many of the smaller valleys within the canyon. These features are also largely linear, but extend outward from the margins to the center of the valley (Figure 4.58). This is consistent with lateral spreading of the sediments downslope. Compressional features develop as these sediments ride up on the sediments in the main canyon. In one location the ground surface was raised more than 4 inches relative to the surrounding ground. A similar feature was found where the canyon narrows. Evidence of localized compression within one of these valleys at the east end of the canyon was demonstrated by the movement of the pipe shown in Figure 4.59. The pipe was pushed up and to the right due to a shortening of 5 inches along its length.

Fig. 4.58: Compression feature where canyon narrows

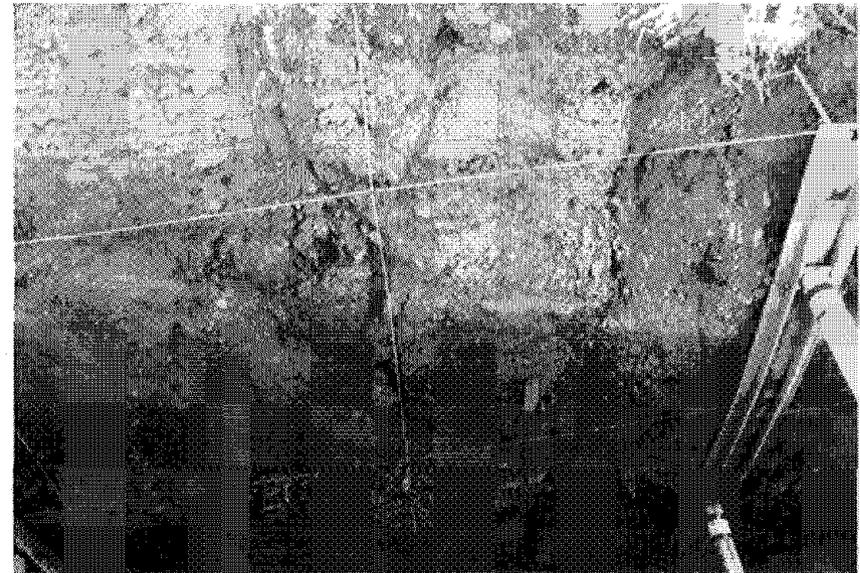
Fig. 4.60: Trench on the southern margin of Potrero Canyon. Note the vertical cracks and the contact between the darker, lower unit and the lighter, upper unit

The United States Geological Survey (USGS) has completed extensive mapping and trenching of the canyon (David Schwartz, 1994). Trenching on the southern margins of the canyon exposed vertical cracks extending into bedrock and bedding plane shears whose orientations support dynamic compaction. Figure 4.60 shows vertical cracks in a trench on the southern margin of the canyon. The crack just to the right of the shoring accommodated a few inches of slip, as can be seen by the offset of the contact between the darker, lower unit and the lighter, upper unit. Bedrock offsets and infilled cracks reveal two prior tectonic events which produced approximately the same magnitude of vertical offsets. These events are being dated, and preliminary results indicate that the most recent event occurred approximately 1200 years ago, and the earlier event occurred during late Holocene.
