REPORT NO.
UCB/EERC-94/08
JUNE 1994

EARTHQUAKE ENGINEERING RESEARCH CENTER

**PRELIMINARY REPORT ON THE
PRINCIPAL GEOTECHNICAL ASPECTS
OF THE JANUARY 17, 1994
NORTHRIDGE EARTHQUAKE**

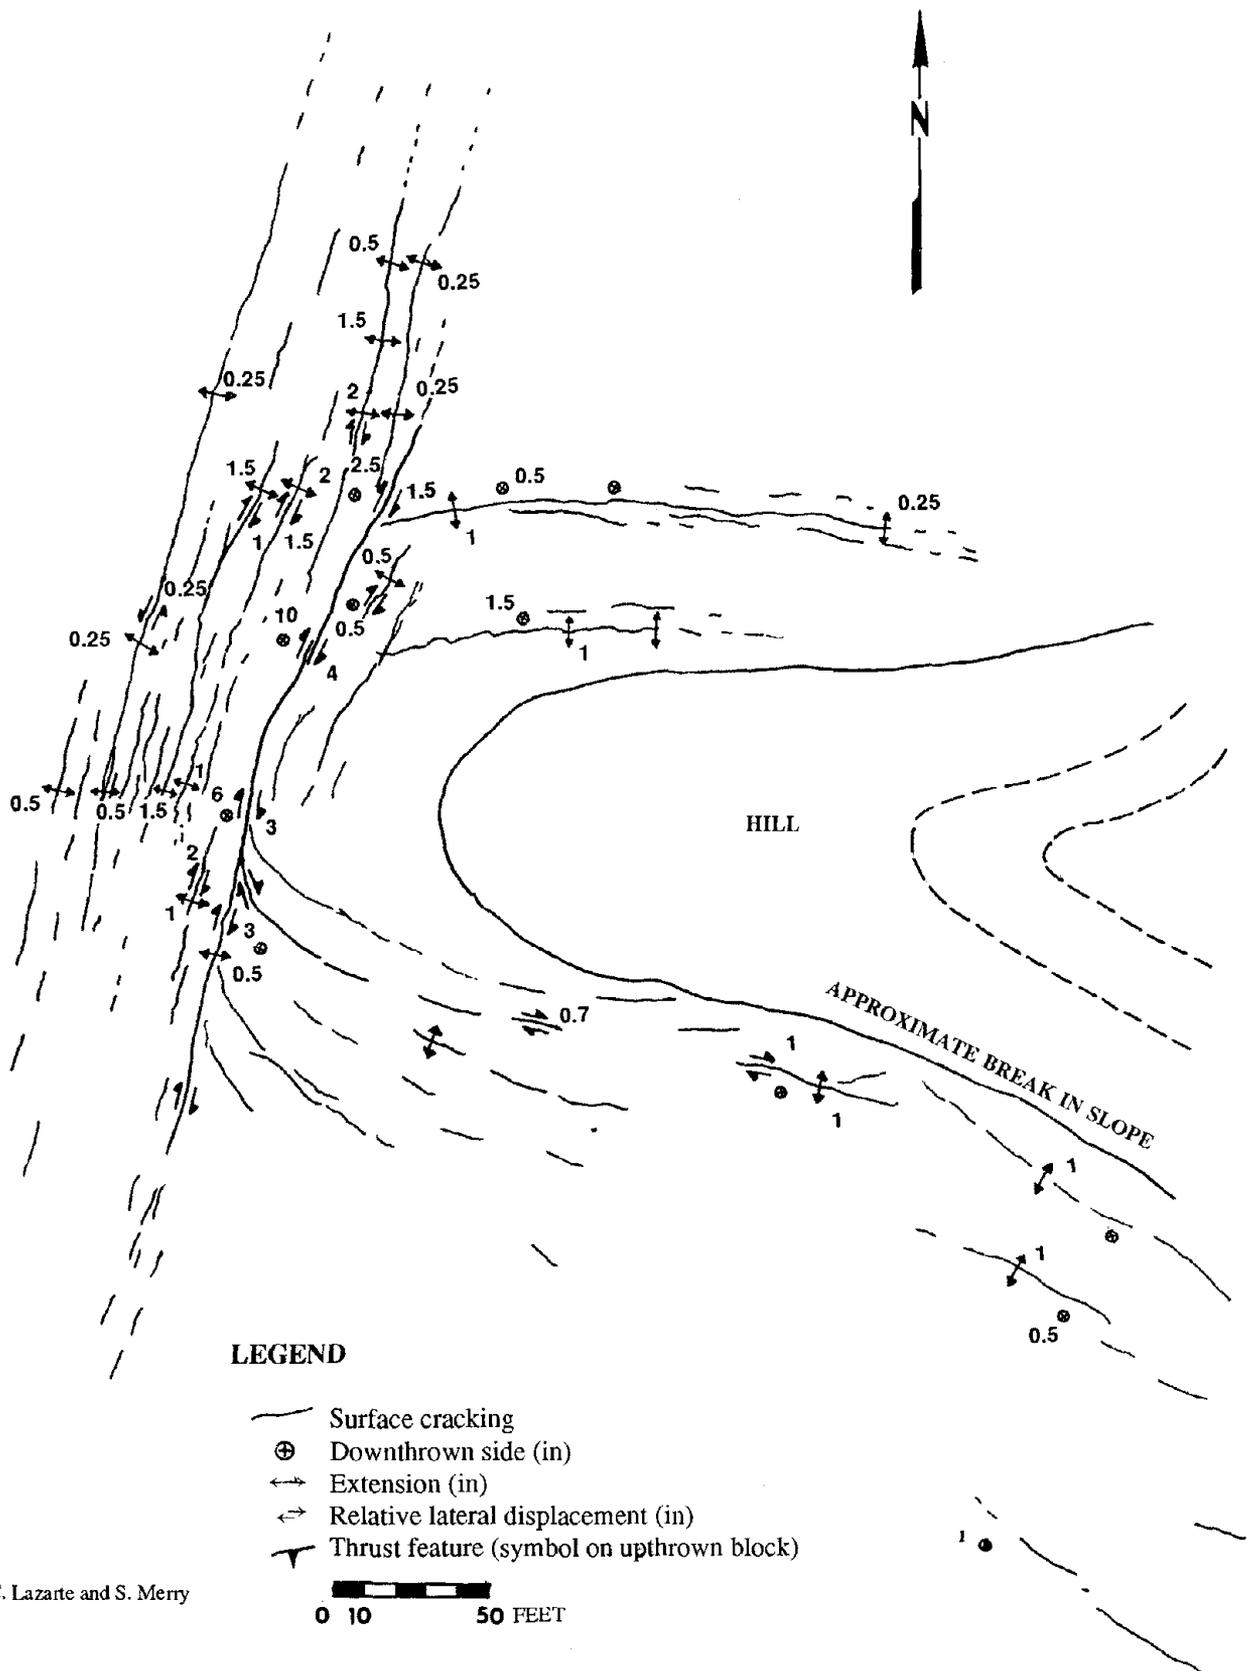
Several small areas were mapped in detail, with the orientations and offsets on individual cracks measured. These detailed maps indicate the pattern of cracking typical throughout the canyon. Figure 4.61 is a map of the area labeled in Figure 4.52 as Site A. General ground movements at this location are to the west, with a small component to the north. These are consistent with the overall slope of the ground surface. The hill appears to influence the cracking pattern very little, as the majority of fractures remain linear. Figure 4.62 is a map of Site B shown in Figure 4.52. This site is along the southern margin of the valley. The complex pattern of cracking includes both extensional and thrust features. It should be noted that the zone of cracking is often more than 75 feet wide, extending from the bottom of the hill out into the nearly flat valley. The terrain in this zone slopes down to the north at an approximate slope angle of 8 degrees.

Fig. 4.61: Detail map showing crack patterns at Site A from Figure 4.52

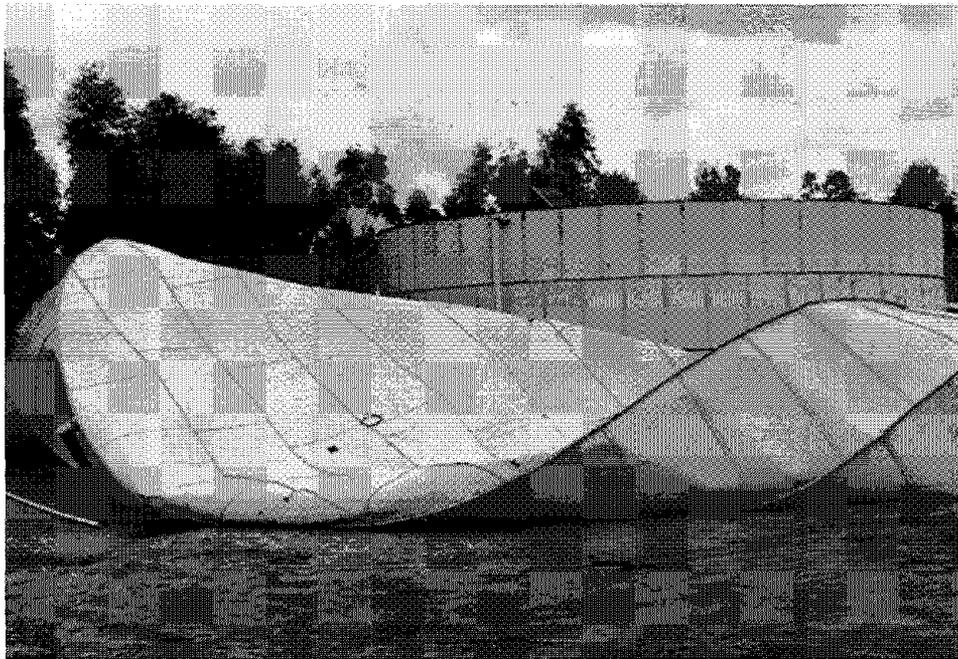
Fig. 4.66: Failed water storage tank, Santa Clarita (photo courtesy of Valencia Water Company)

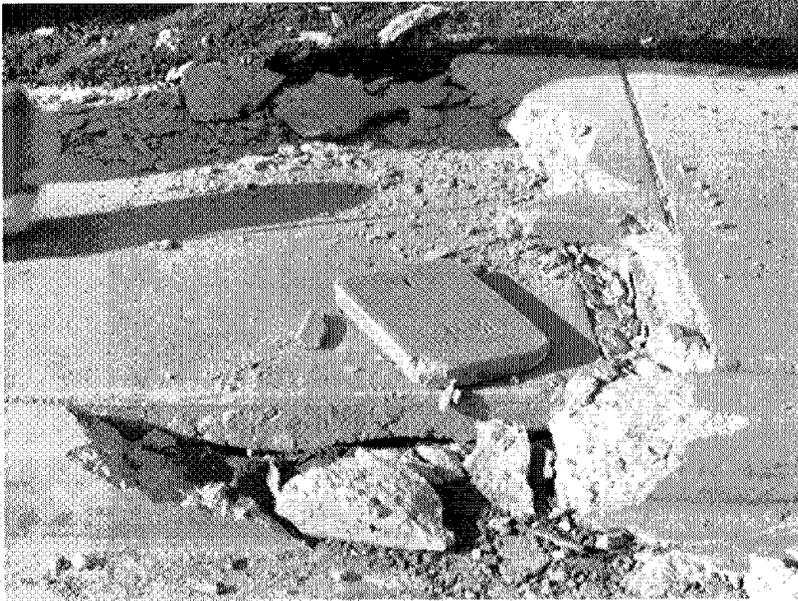
Pronounced lateral ground movements and settlements also occurred in other valley areas of Santa Clarita. A small developed area west of Interstate Highway 5, just north of Lyons Canyon experienced significant, though very localized, damage to structures, pavements and buried pipes. Figure 4.68 shows a water meter and sidewalk damaged by lateral compression at this location, while Figure 4.69 shows a water pipe damaged by localized lateral movements and settlement slightly northwest of this area at Larwin Tank. Further northwest near Pico Canyon, a concentration of structural and pipeline damage occurred along McBean Parkway. Many of the housing developments in these areas are constructed over large fills, and the observed ground failure may have resulted from dynamic compaction of the fill soils.

Fig. 4.68: Crushed water meter and sidewalk from lateral ground compression, Wintergreen Court, Santa Clarita (photo courtesy of Valencia Water Company)

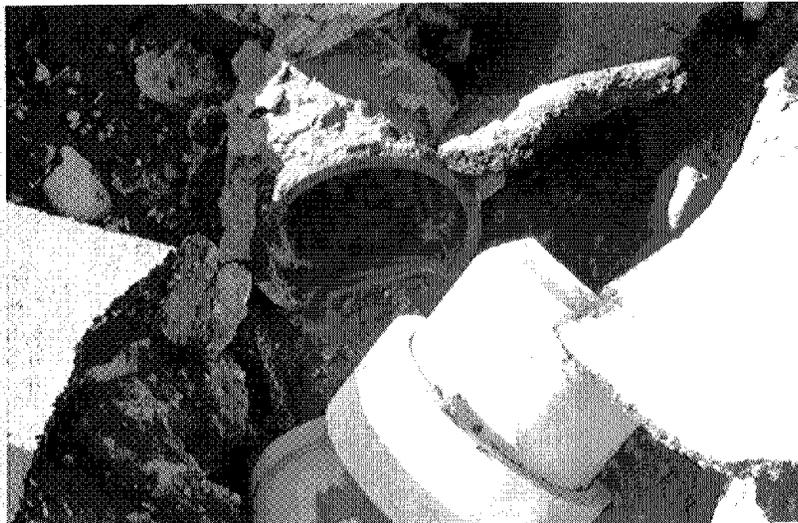
Fig. 4.69: Broken water pipe near Larwin Tank, Santa Clarita (photo courtesy of Valencia Water Company)

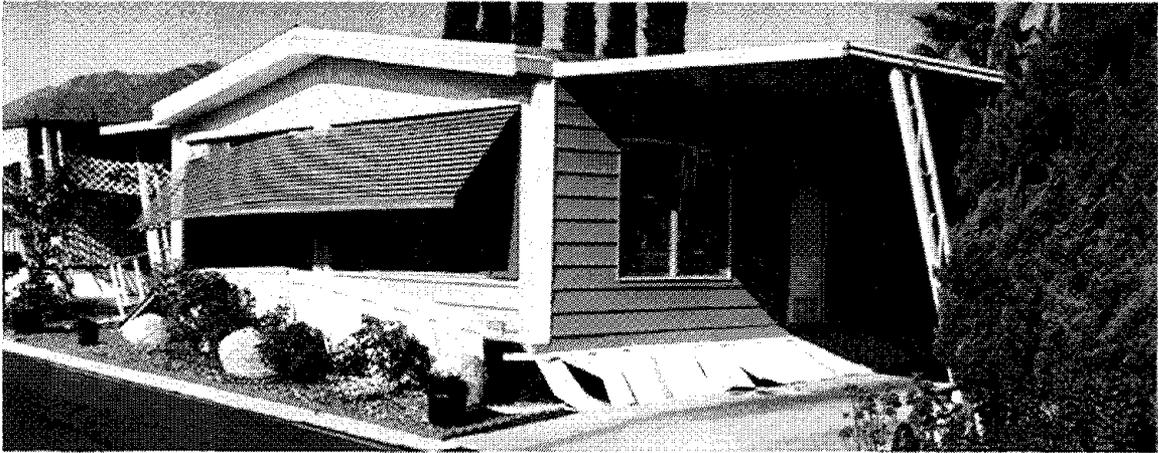
Fillmore was heavily impacted by structural distress during the Northridge Earthquake, as shown by the concentration of red-tagged structures in Figure 3.23. However, no significant evidence of ground failure in the form of ground cracking or major pipe breakage was observed in field reconnaissance of the area. It is likely that much of the severe structural damage in the area resulted from strong shaking overwhelming a number of inadequately designed structures, as shown in Figure 4.71.

Fig. 4.71: Damaged mobile home in Fillmore. Numerous structures were severely damaged in Fillmore in the absence of any apparent large-scale ground failure.

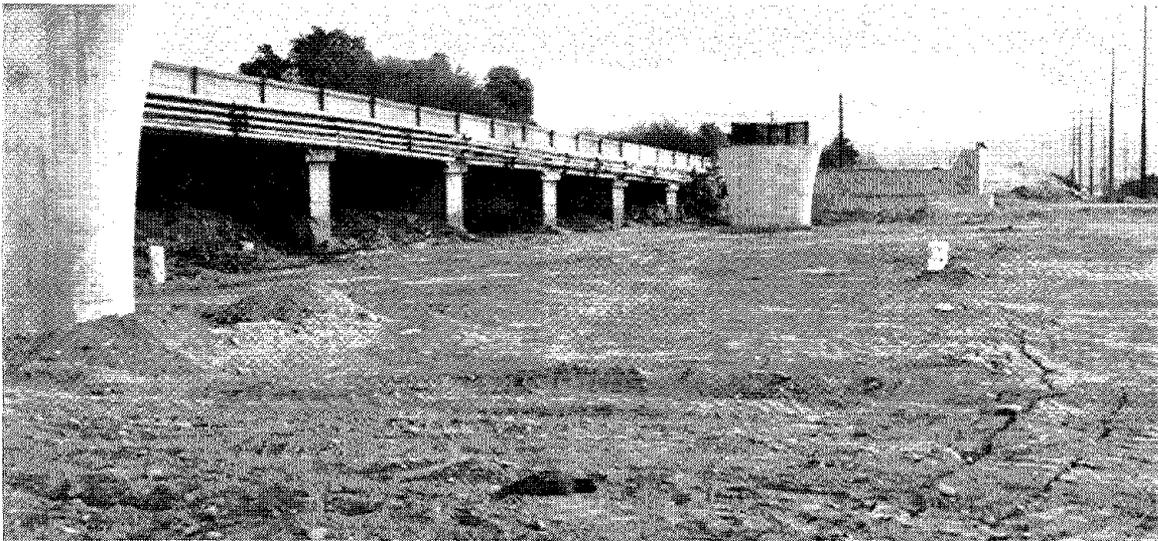
Near the Highway 23 crossing over the Santa Clara River, sand boils were observed near a bridge pier for an overcrossing under construction, and cracks induced by lateral spreading were found approximately 15 feet away from the pier. The ground cracking and sand boils observed at this location are shown in Figures 4.72 and 4.73. This liquefaction in the river bank area caused no apparent damage to the bridge structure.

Fig. 4.72: Ground cracking from lateral spreading in river bed area near Highway 23 crossing over Santa Clara River

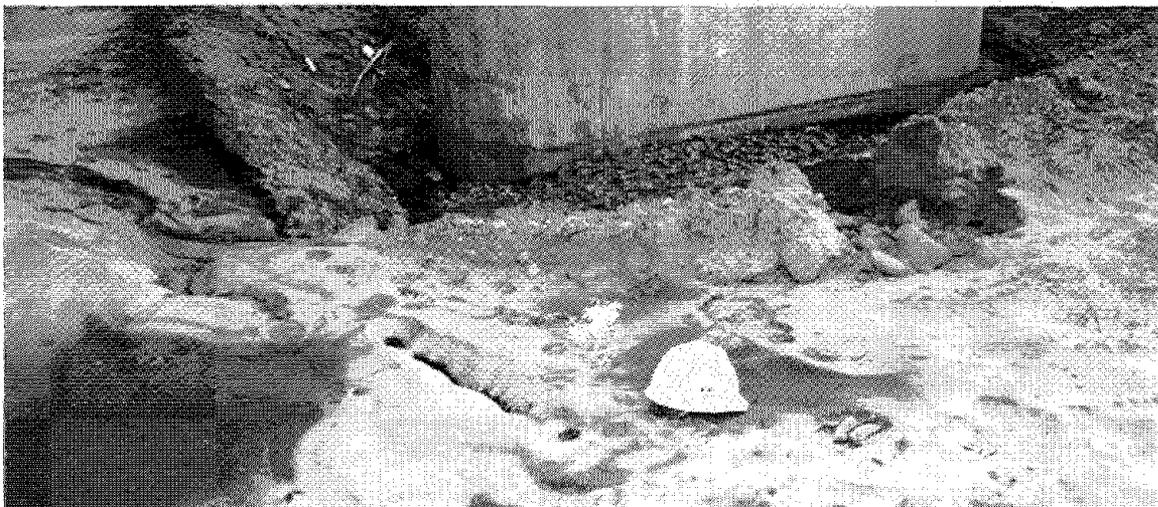
Fig. 4.73: Sand boil near bridge pier, Highway 23 crossing over Santa Clara River

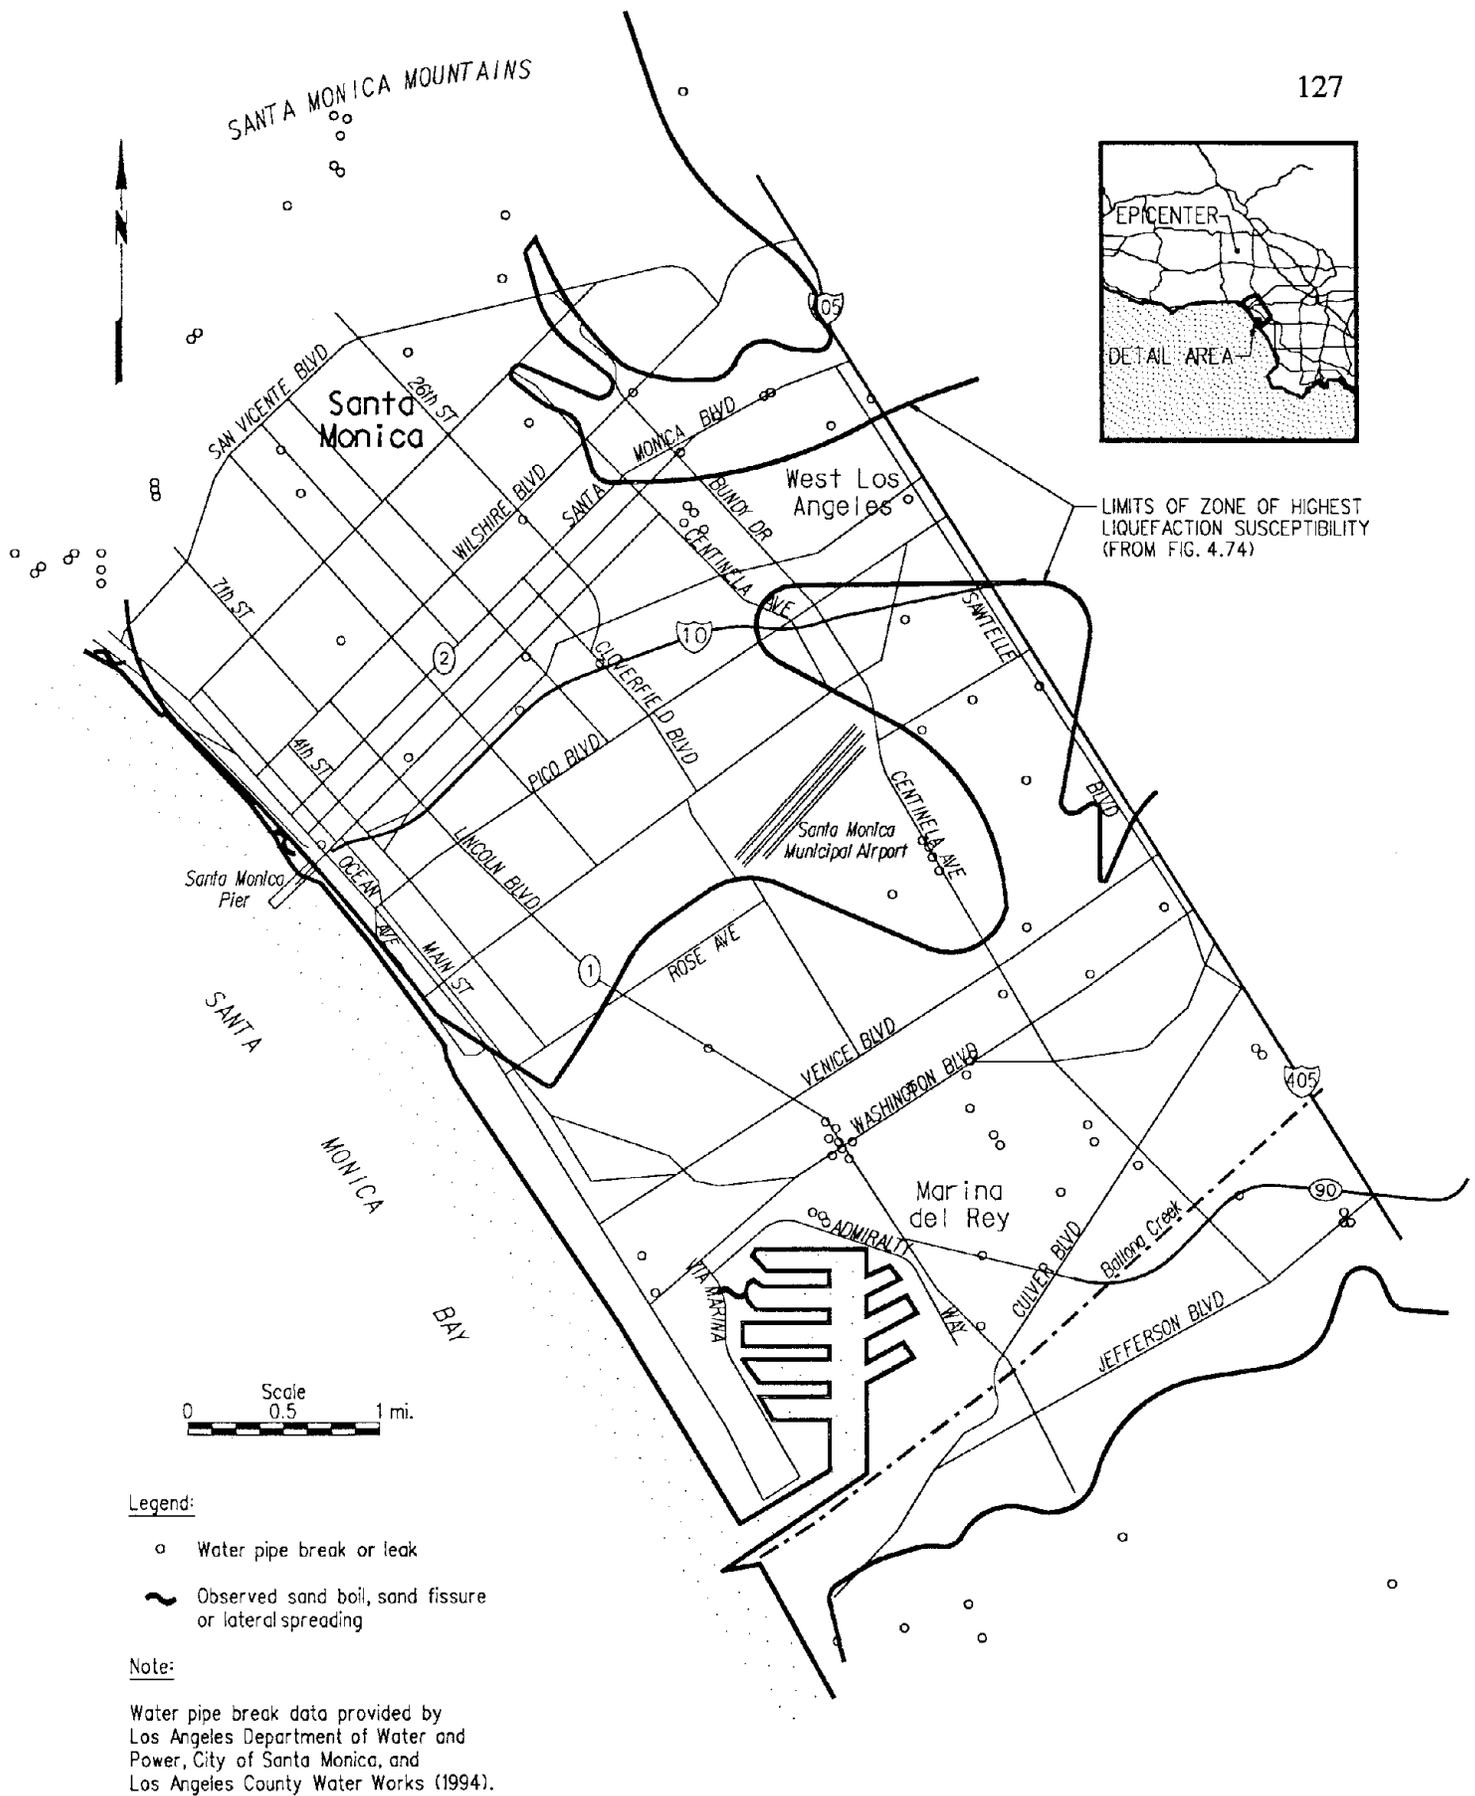
Relatively minor ground failure occurred in the Santa Monica-West Los Angeles-Marina del Rey areas during the Northridge Earthquake. Figure 4.75 shows the distribution of pipe breaks in the area along with the outline of "liquefiable" soil zones from Figure 4.74 (City of Santa Monica, City of Los Angeles, and Los Angeles County Water Works, 1994). Also shown in Figure 4.75 are the locations of observed liquefaction features such as sand boils, sand fissures, and lateral spreads. In Santa Monica, liquefaction occurred at several beach areas, but generally was notably absent from inland areas. Figure 4.76 shows an overview of a parking lot near the Santa Monica Municipal Pier where sand fissures, lateral spreading and settlement occurred. A large sand fissure from the parking lot is shown in Figure 4.77. Pavement cracking in the parking lot occurred subparallel to the coastline with horizontal and vertical offsets on the order of 1½ to 5 inches. Minor lateral spreading was also observed further north in a beach area near San Vicente Boulevard, though no sand fissures or boils were observed at this location.

Fig. 4.75: Pipe breakage in the Santa Monica-Marina del Rey region

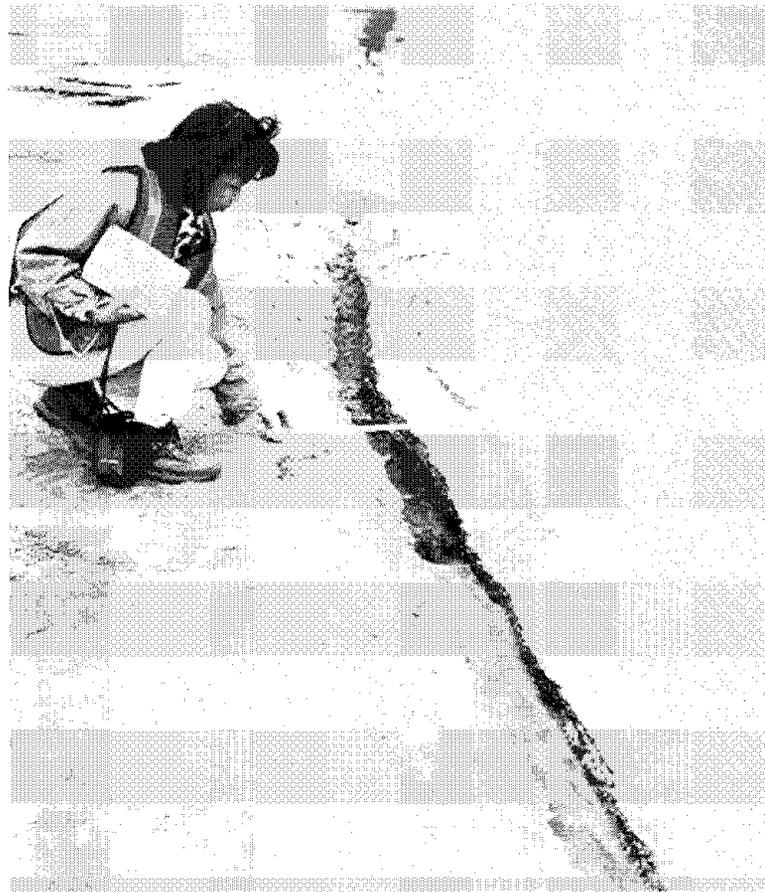
Fig. 4.77: Sand fissure in parking lot near Santa Monica Municipal Pier

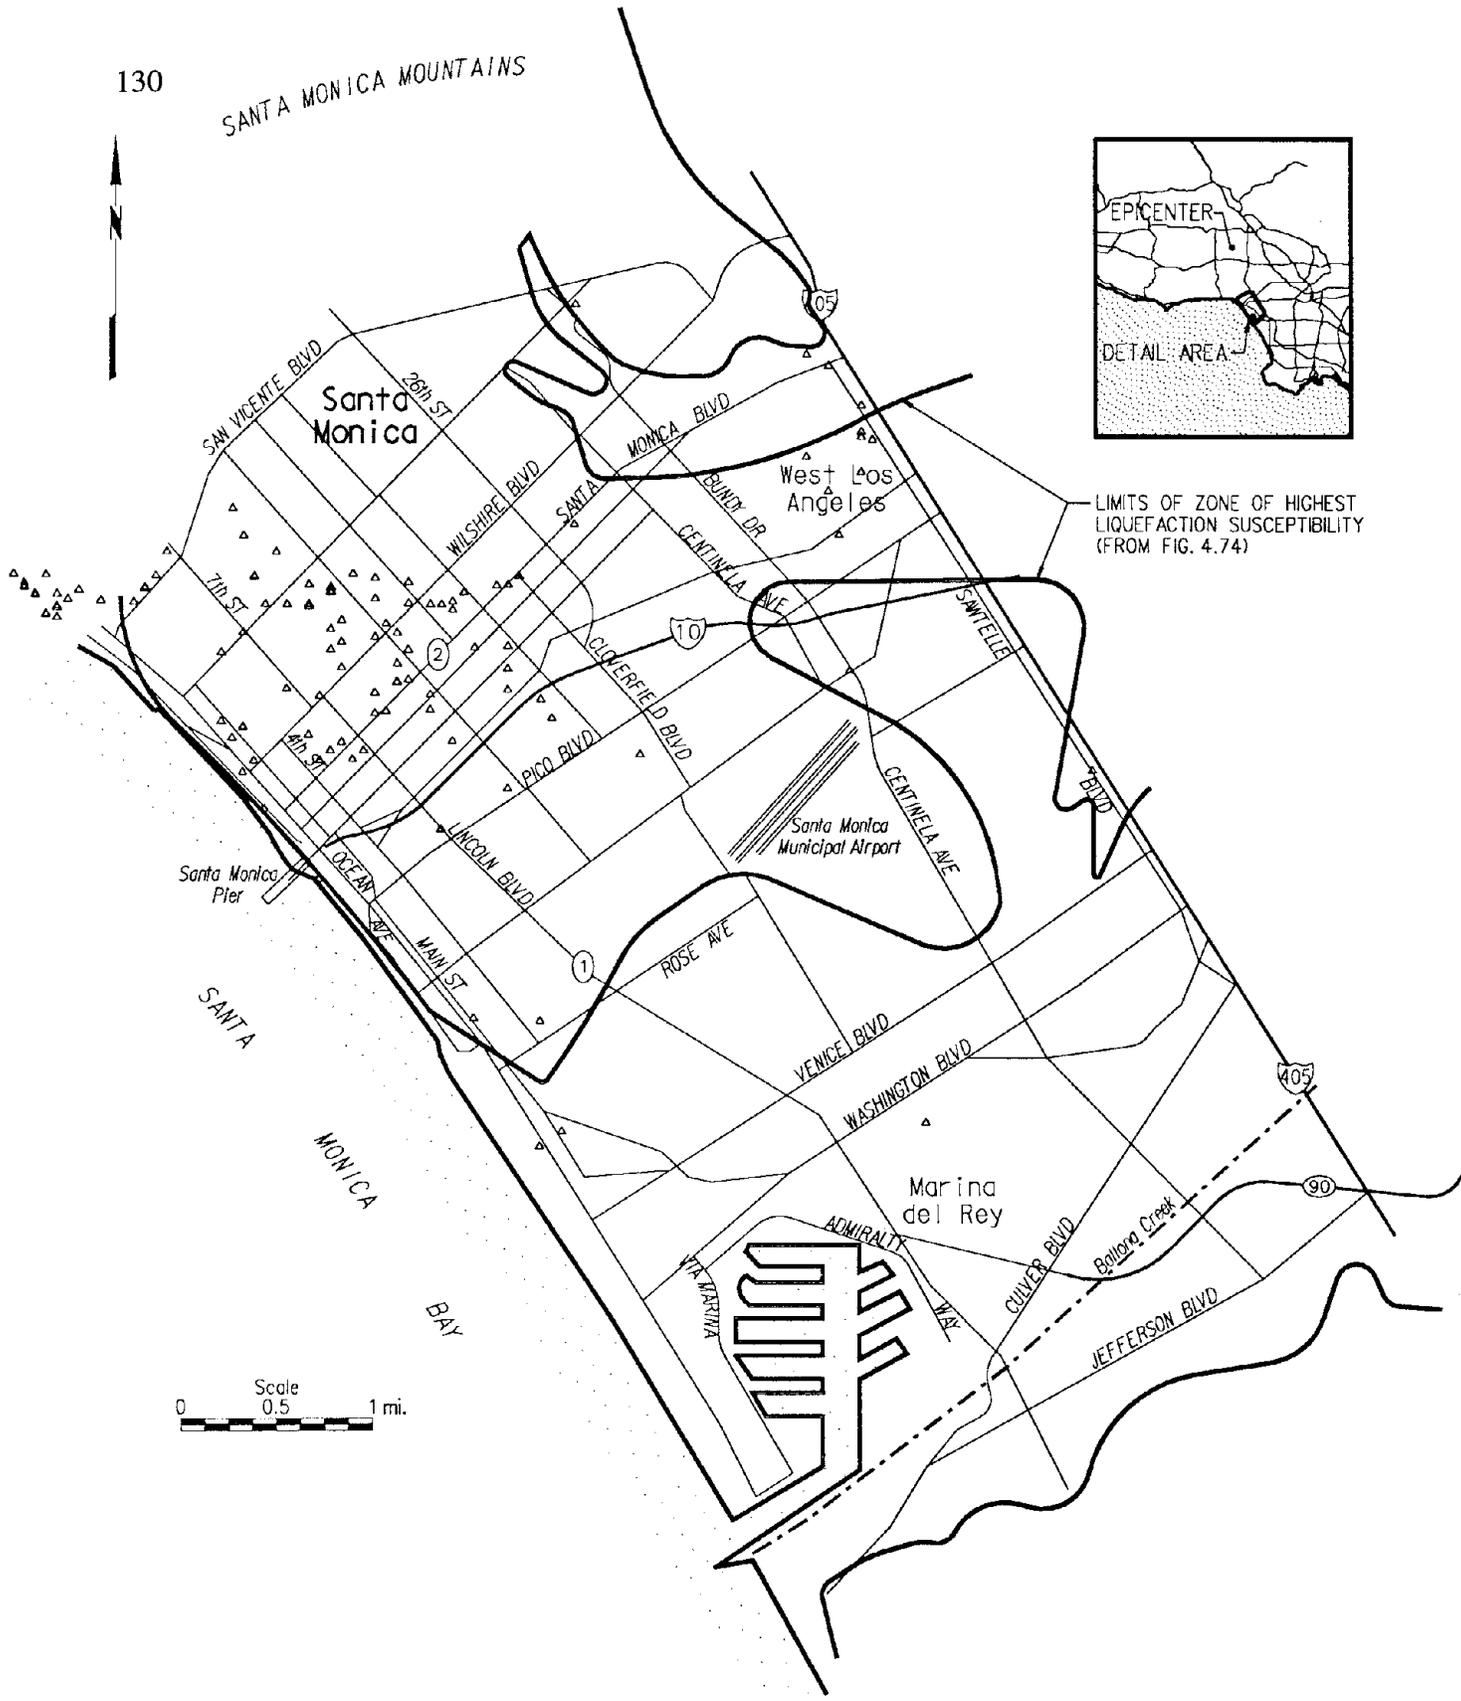
Figure 4.78 shows the locations of severely damaged structures, as indicated by red post-earthquake inspection tags, along with the outline of "liquefiable" soils from Figure 4.74. As shown in Figure 4.78, numerous structures were damaged in Santa Monica north of Interstate Highway 10, although relatively little damage occurred south of this freeway. Based on the lack of pipe break concentrations or ground cracking in the heavily damaged portions of Santa Monica, as well as the geologic conditions in the highly damaged zones, ground failure does not appear to have been a significant contributor to the large concentration of structural damage in the area.

Fig. 4.78: Heavily damaged (red-tagged) structures in the Santa Monica-Marina del Rey region (Source: FEMA, 1994)

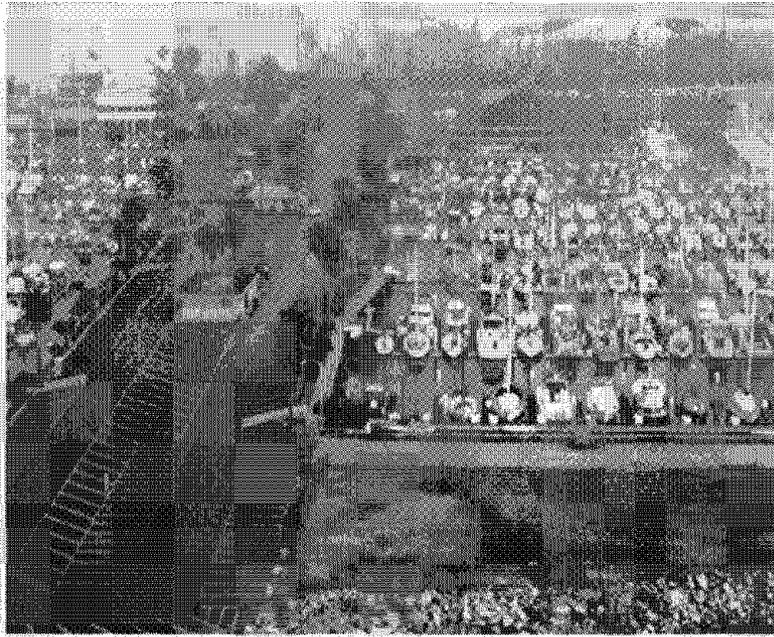
Fig. 4.80: Overview of Mole B at King Harbor, Redondo Beach
(photo courtesy of John Tinsley, U.S. Geological Survey)

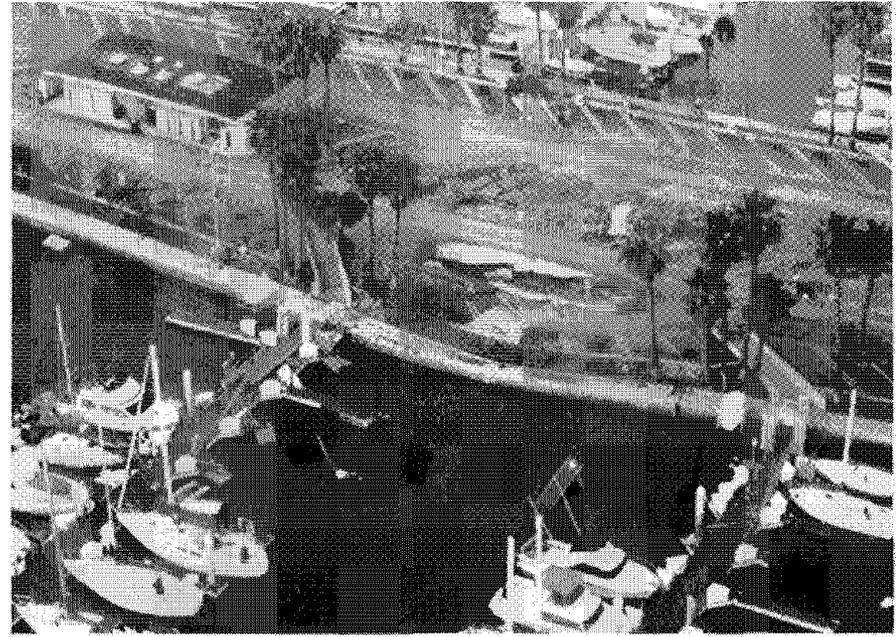
Fig. 4.81: Overview of wall failure and distress in parking area,
Mole B at King Harbor, Redondo Beach
(photo courtesy of John Tinsley, U.S. Geological Survey)

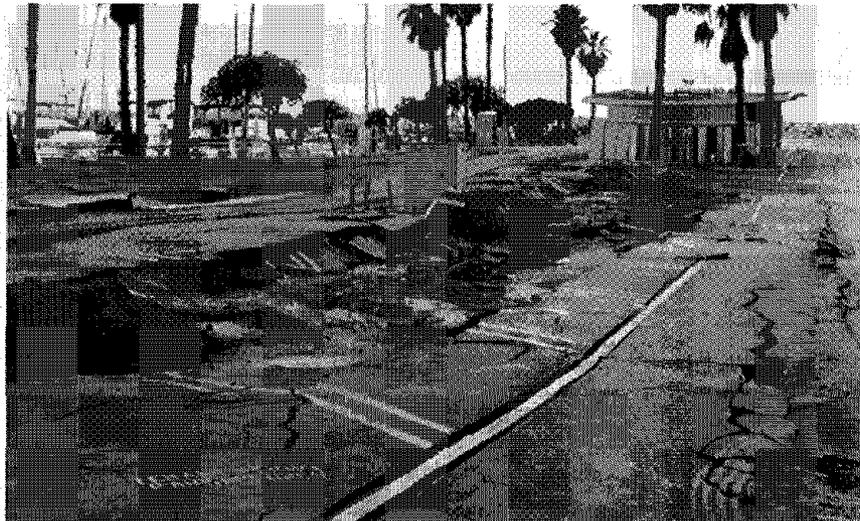
Fig. 4.82: Damage in parking area behind failed wall section at Mole B

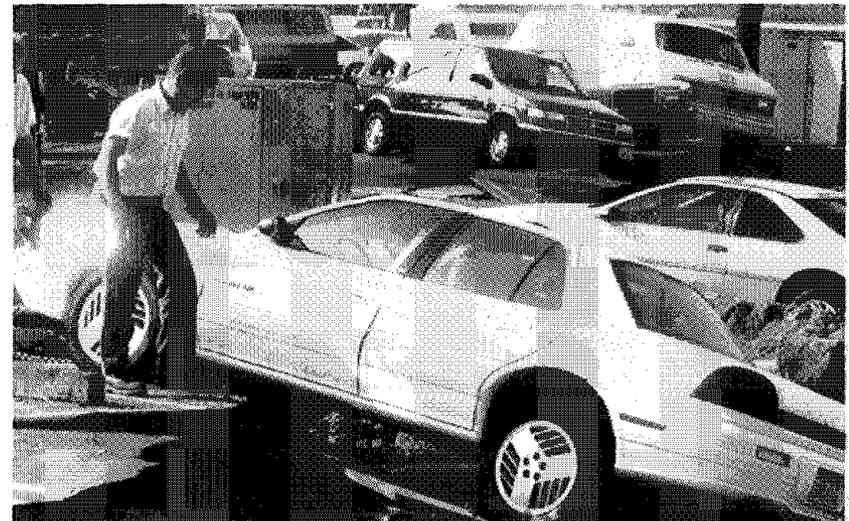
Fig. 4.83: Liquefaction-induced bearing capacity failures
beneath cars in parking lot at Mole B. Photo by
Los Angeles Times.

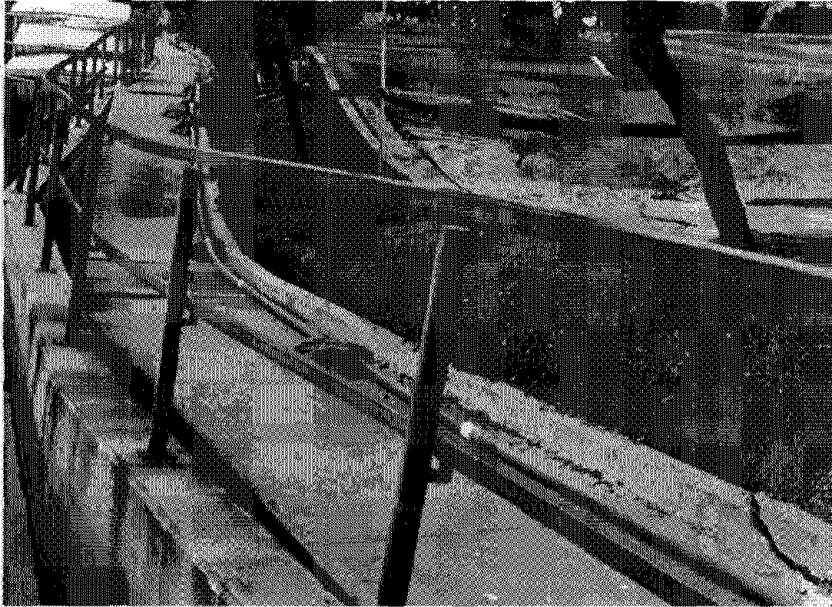
Fig. 4.84: View of failed retaining wall near maximum displacement section at Mole B

Re-construction of the Mole B area is planned in conjunction with remedial efforts to reduce the liquefaction susceptibility of the sandy soils underlying the mole. Currently, proposed remediation techniques include the installation of stone columns through the fill materials and underlying beach and lagoonal deposits, and vibrocompaction of the remaining fill soils underlying the mole (M & T Agra, Inc., 1994).

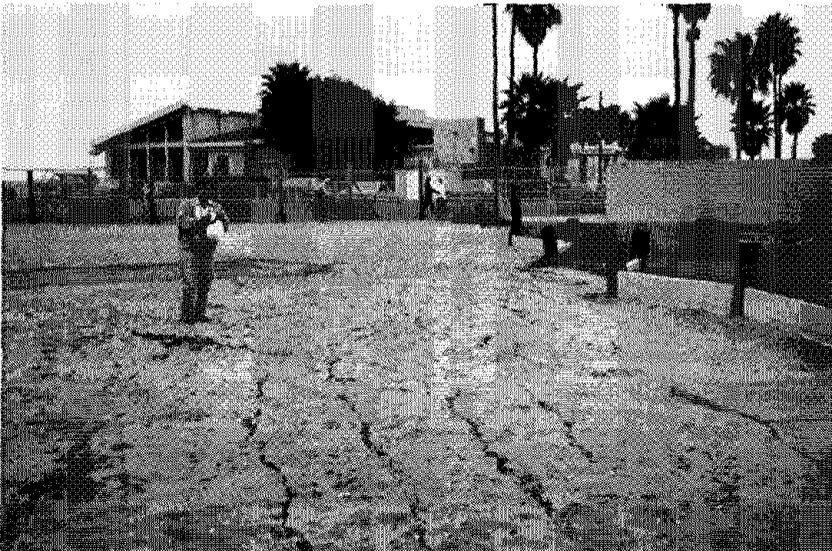
Fig. 4.86: Ground cracking from lateral spreading adjacent to Seaside Lagoon

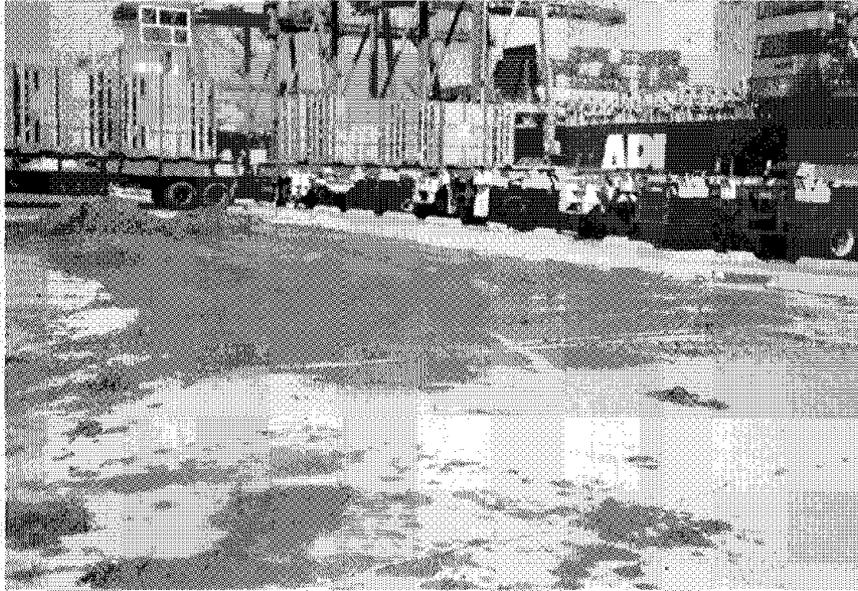
The most significant occurrences of liquefaction at the port were near Berths 121 to 126 and at Pier 300. At Berths 121-126, a paved area 200 feet in diameter behind a dike and wharf experienced lateral spreading and settlement from liquefaction of the underlying loose, silty and sandy fill soils. Cone penetration testing performed after the earthquake indicated the fill soils in this area had relative densities on the order of 20 to 50 percent, based on penetration resistance correlations with relative density. Some of the damage and clean-up operations in this area are shown in Figures 4.88 to 4.90. Lateral spreading in the area caused 2 to 3 inch movements of the wharf structure, and several 1 to 2-inch wide cracks 500 to 600 feet in length behind the wharf. Settlements of 6 to 8 inches occurred to pavements, and approximately 10 cubic yards of sand emerged from large boils which penetrated the 7-inch thick asphalt in the area (Hayden, 1994).

Fig. 4.88: Sand ejecta in parking area adjacent to Berths 121 to 126, Port of Los Angeles (photo courtesy of Doug Thiessen, Port of Los Angeles)

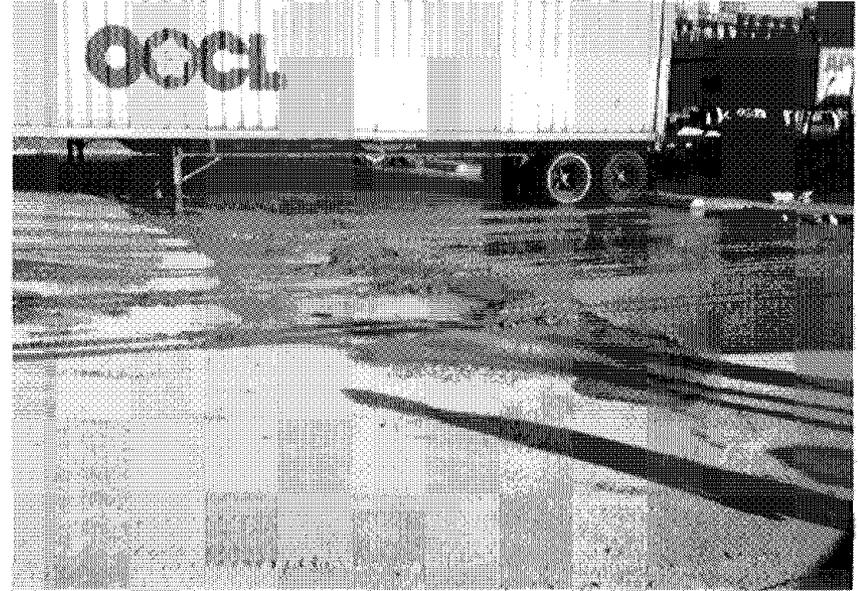
Fig. 4.89: Sand ejecta in parking area adjacent to Berths 121 to 126, Port of Los Angeles (photo courtesy of Doug Thiessen, Port of Los Angeles)

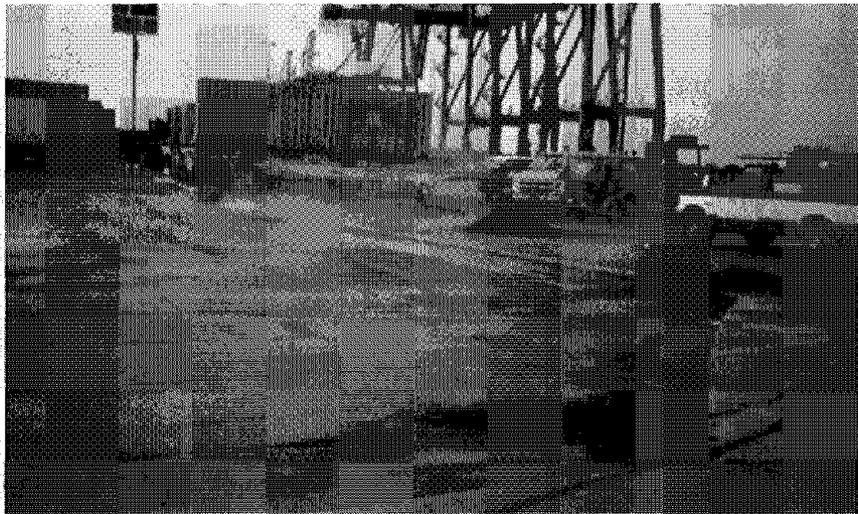
Fig. 4.90: Clean up of sand ejecta at Port of Los Angeles (photo courtesy of Doug Thiessen, Port of Los Angeles)

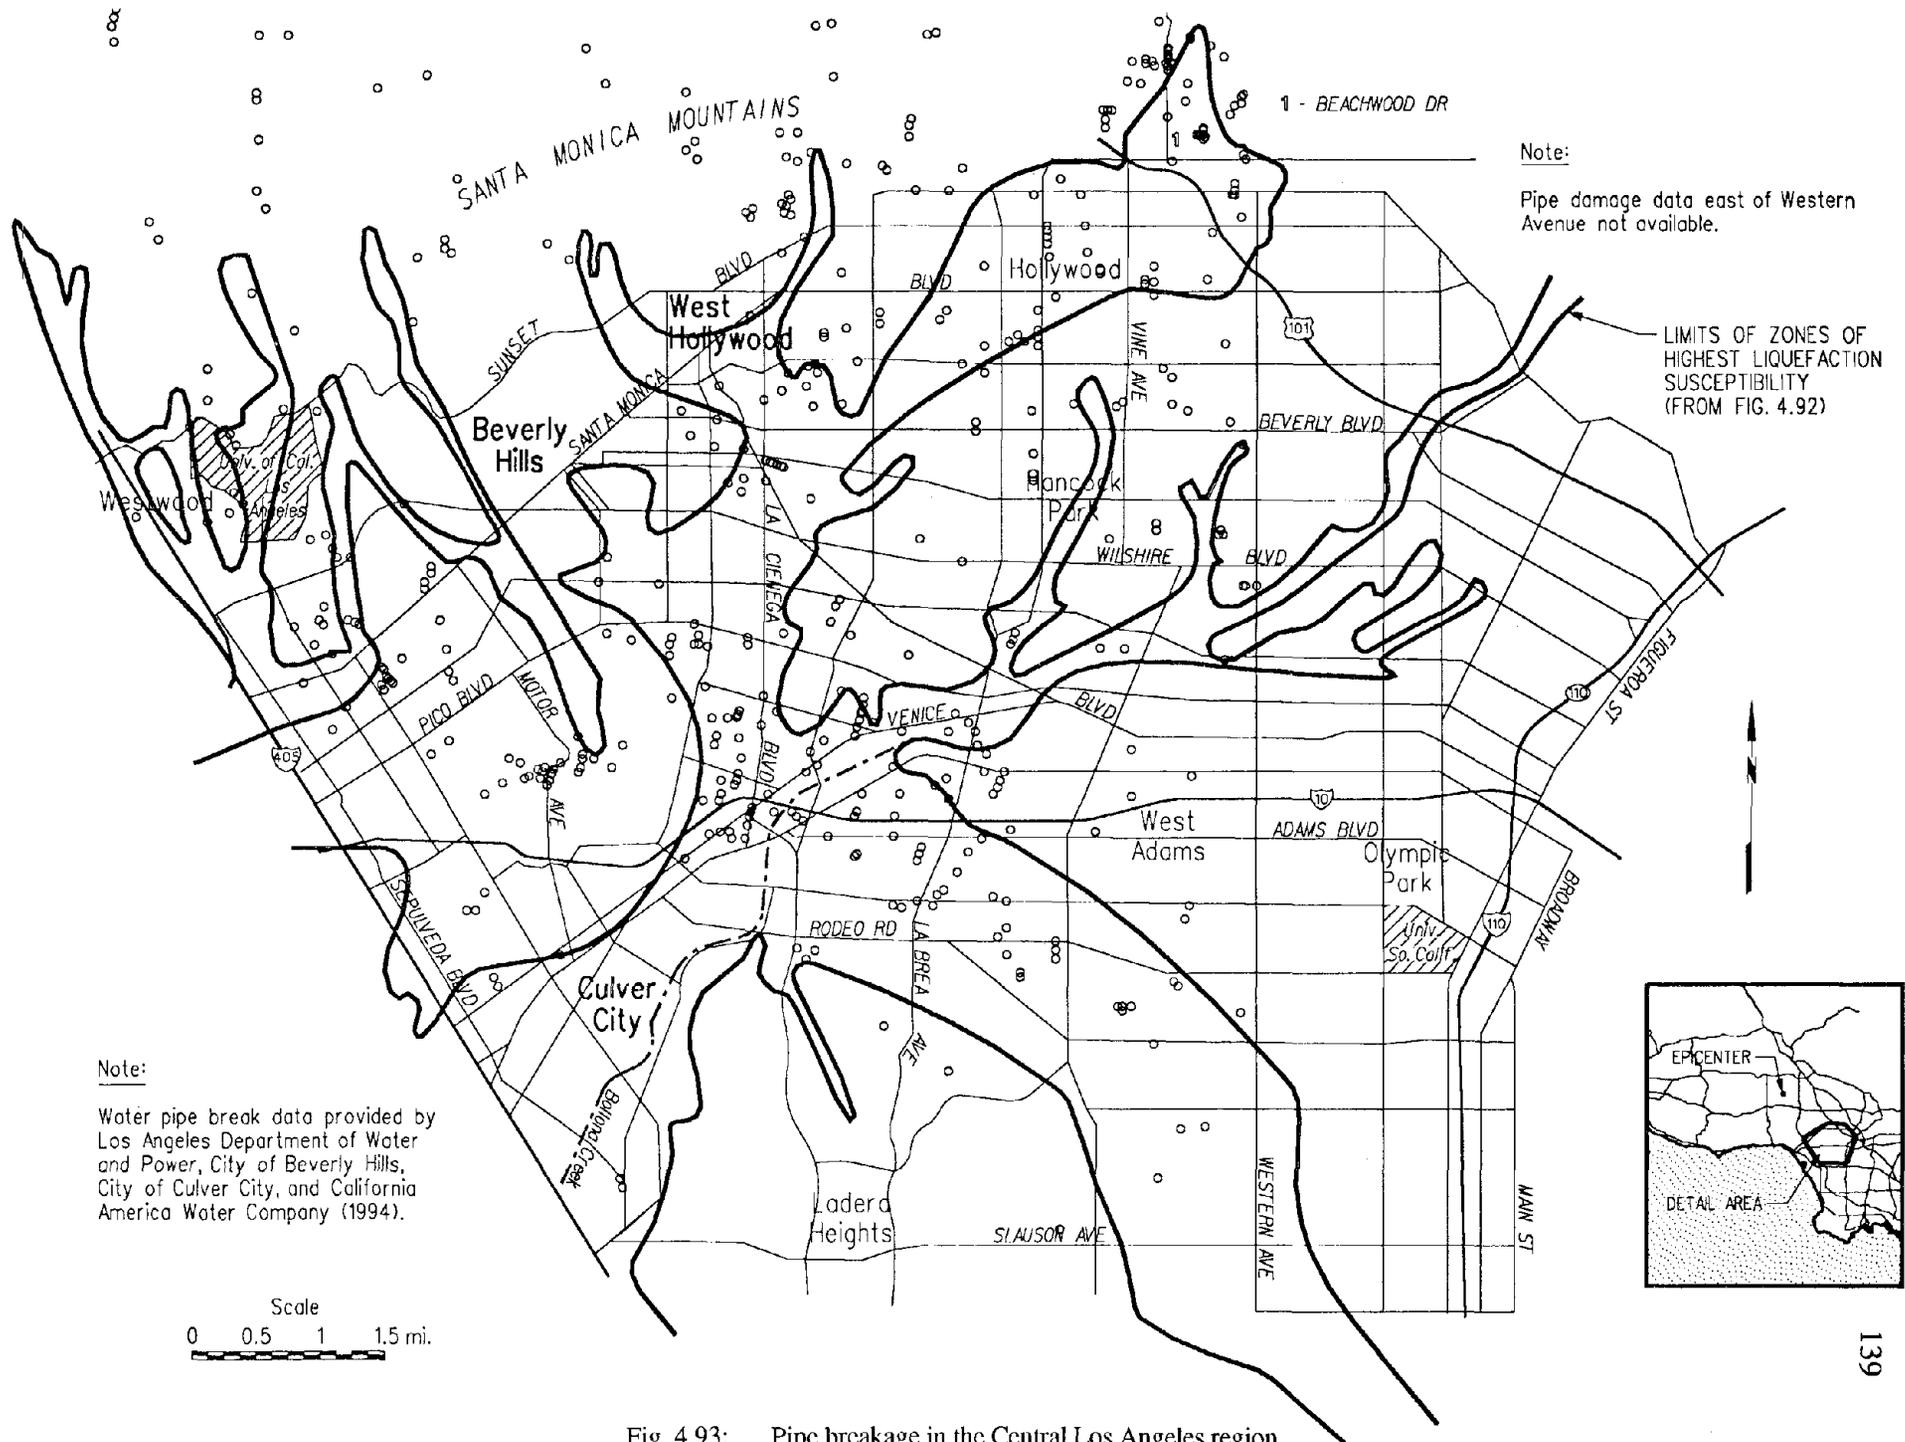
During and immediately after the Northridge Earthquake, over 450 pipe breaks occurred within the central Los Angeles region. Figure 4.93 shows the distribution of pipe breaks and leaks in the area along with the outline of mapped "liquefiable" soil zones from Figure 4.92 (City of Los Angeles, City of Beverly Hills, City of Culver City, and California American Water Company, 1994). Based on the pipe breakage patterns shown in Figure 4.93, ground failures appear to have occurred in the vicinity of La Cienega Boulevard at Interstate Highway 10 (near the collapsed highway bridge structures), at a portion of Motor Avenue south of Pico Boulevard, in the Beverly Hills-West Hollywood area southeast of Santa Monica Boulevard, in Hollywood between Sunset and Beverly Boulevards, southwest of the West Adams area, and throughout the Santa Monica Mountains north of Sunset Boulevard. It should be noted that detailed data on pipe break locations east of Western Avenue was not available for inclusion in Figure 4.93 at the time this report was prepared, but that relatively few pipe breaks or leaks were reported to have occurred in the area (City of Los Angeles, 1994).

Other than the distress to the water distribution system shown in Figure 4.93, relatively little evidence of ground failure in the central Los Angeles area was found. Reconnaissance of the area revealed very little ground or pavement cracking from settlement or lateral spreading, and no sand boils or sand fissures are known to have occurred.

Fig. 4.93: Pipe breakage in the Central Los Angeles region

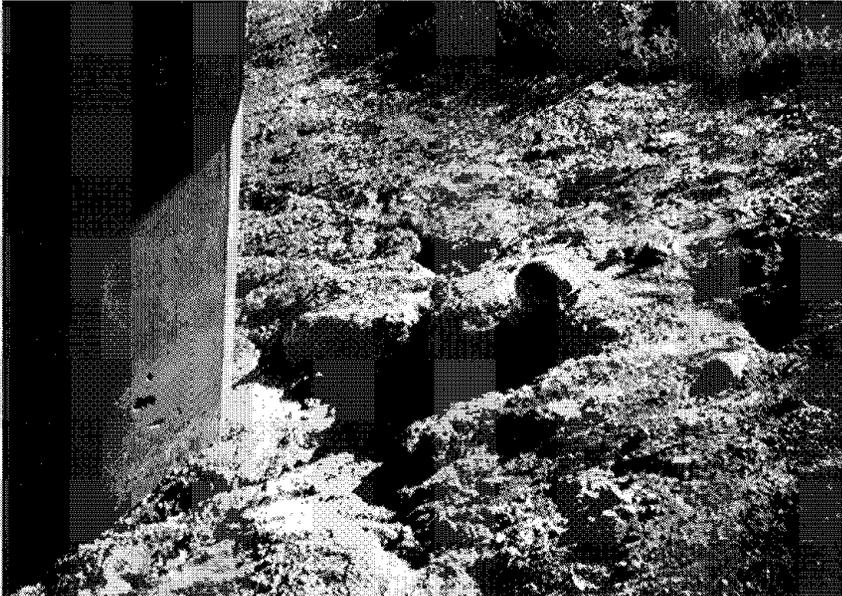
To date, no cases have been reported of ground failure resulting from the Northridge Earthquake causing severe distress to deep foundations such as piles or piers, although it should be noted that such distress would be intrinsically difficult to observe. At several locations, however, structural inertial forces were found to have induced permanent displacements of pile/pier caps. One such case was at the Highway 14-Interstate Highway 5 interchange, where several collapses of bridge structures occurred. This interchange is located in steep terrain with shallow bedrock. Several columns for the bridge structures were observed to have suffered residual lateral displacements in the downslope direction, as shown in Figure 4.95. These displacements are believed to have resulted from permanent distortion of the foundation elements under seismically-induced inertial forces from the bridge superstructure, and do not appear to be associated with ground failure or landsliding. It is not known to what extent these movements of the pile/pier cap may have influenced the structural collapse.

Fig. 4.95: Ground cracking and graben formation behind bridge column due to downslope movement of pile/pier cap, Highway 14 - Interstate Highway 5 interchange

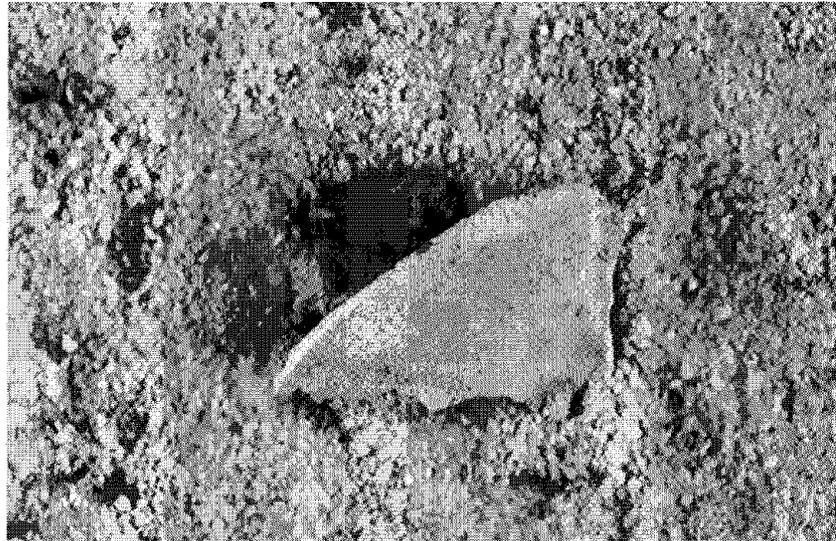
Fig. 4.98: Close-up view of salt ejecta from Figure 4.97 showing coarse sand-sized particles and fine 2-inch "plaster" block. The plaster was originally found beneath the coarse material.

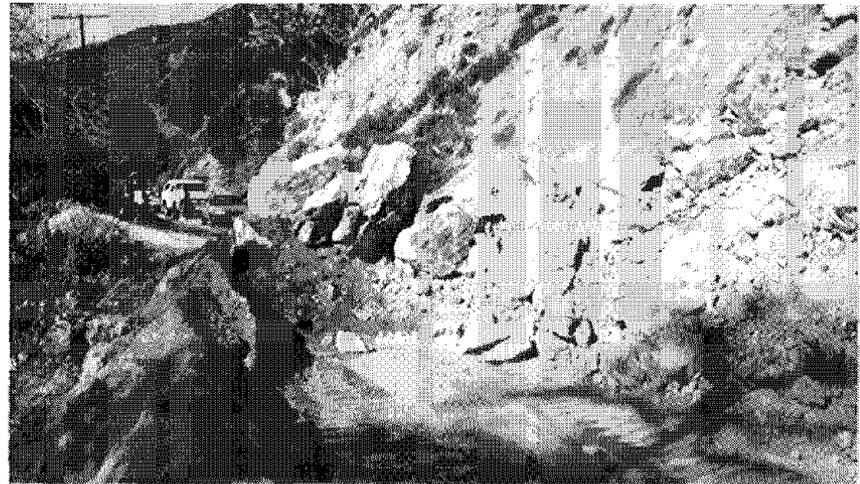
Fig. 5.6: Road closure at Dillon Divide, Little Tujunga Road. (Photo courtesy of Ray Salehpour, County of Los Angeles Department of Public Works)
