REPORT NO.
UCB/EERC-94/08
JUNE 1994

EARTHQUAKE ENGINEERING RESEARCH CENTER

**PRELIMINARY REPORT ON THE
PRINCIPAL GEOTECHNICAL ASPECTS
OF THE JANUARY 17, 1994
NORTHRIDGE EARTHQUAKE**

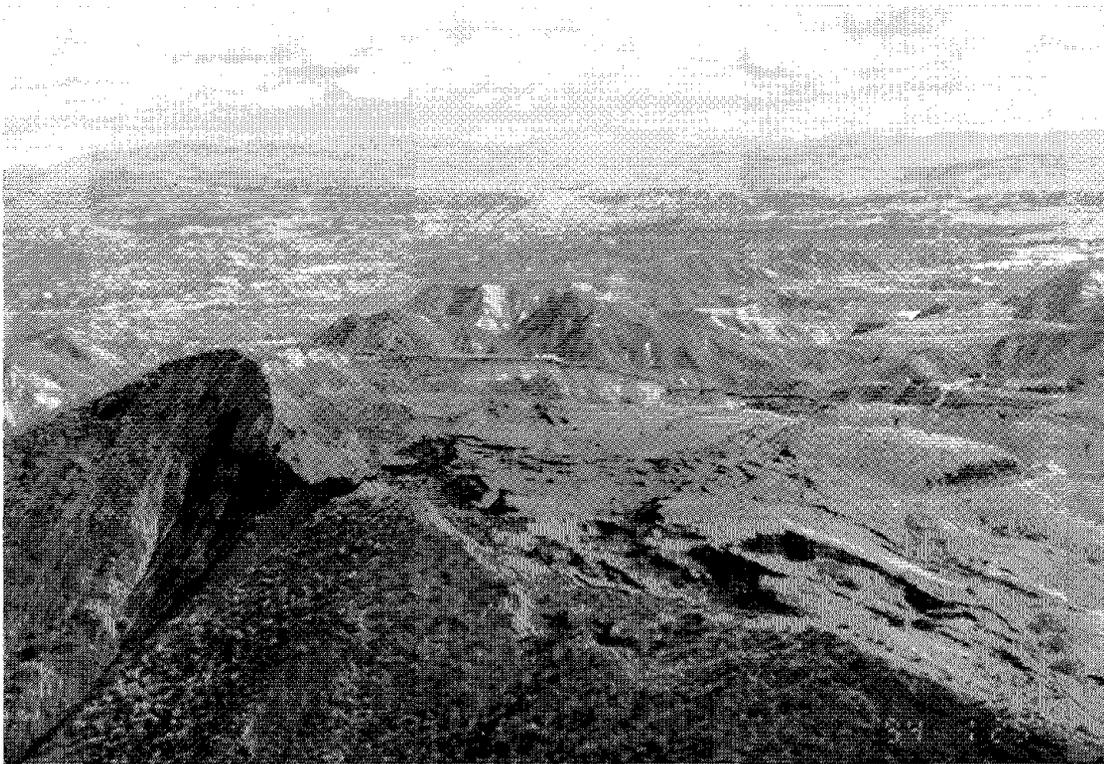
Fig. 5.8: View of Del Valle landslide headscarp, looking east. (Photo courtesy of T. McCrink, California Division of Mines and Geology)

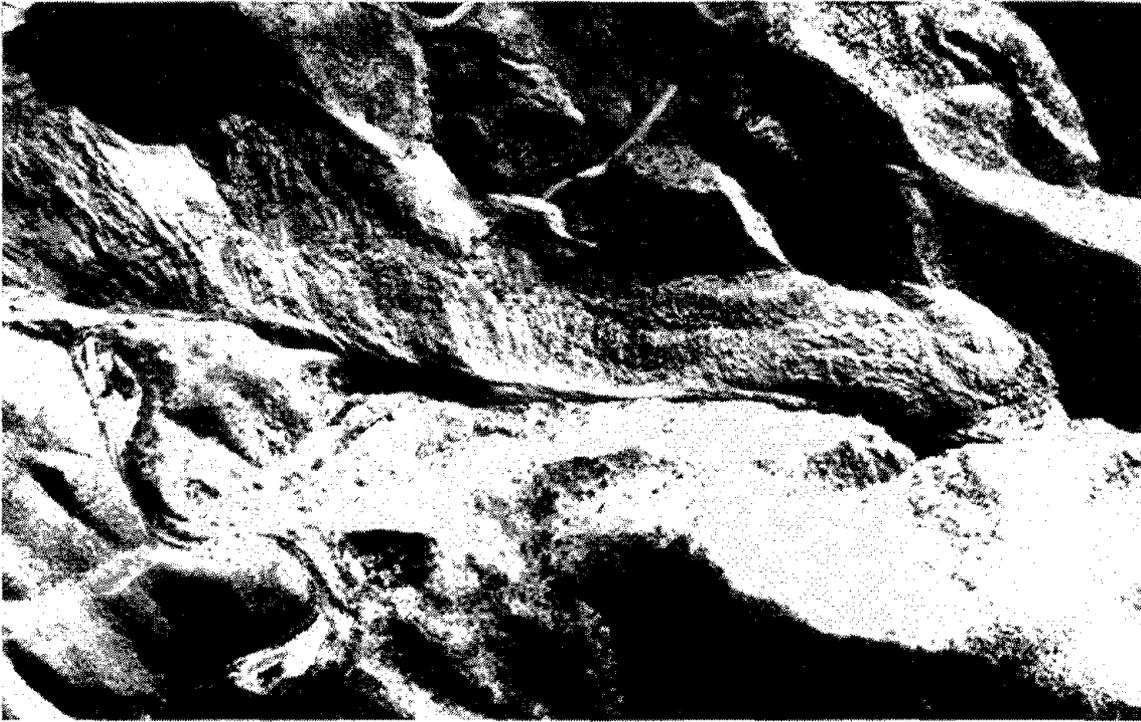
Fig. 5.9: Aerial view of landslide at Ramona Oil Field. (Photo courtesy of USAF - Beale AFB, 9th ISS)

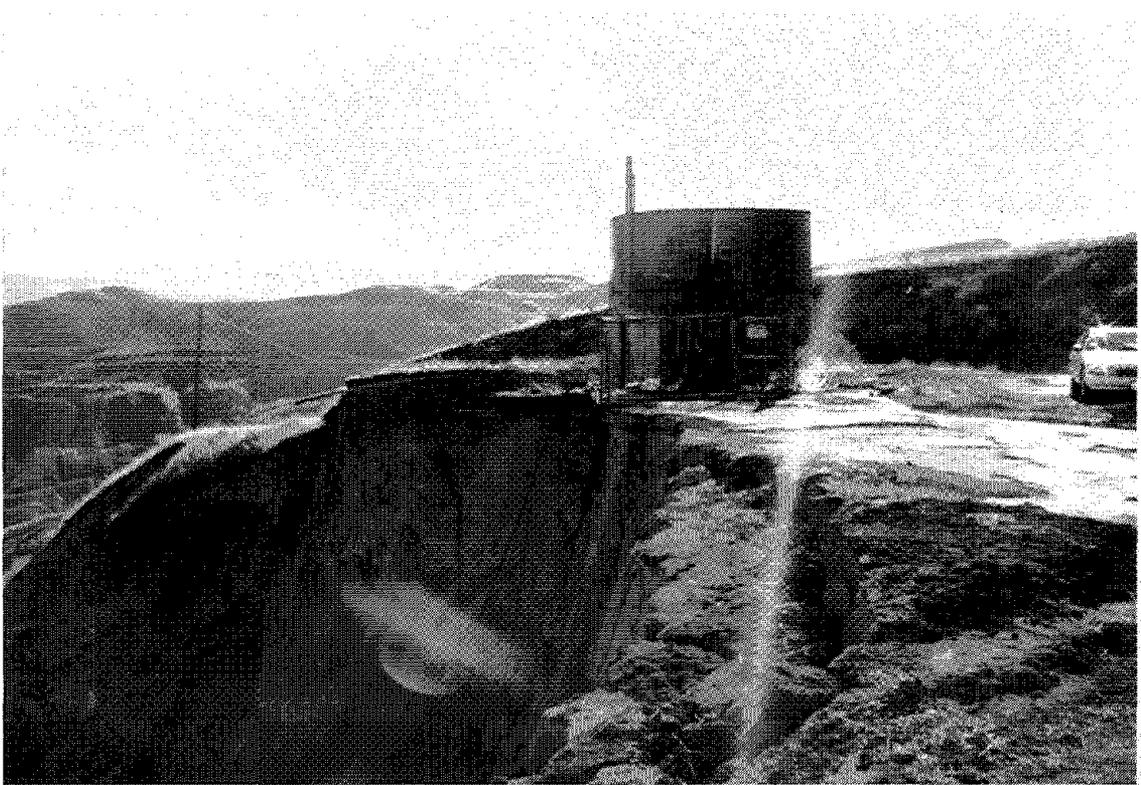
Fig. 5.10: Oil well at headscarp of landslide at Ramona oil field. (Photo courtesy of T. McCrink, California Division of Mines and Geology)

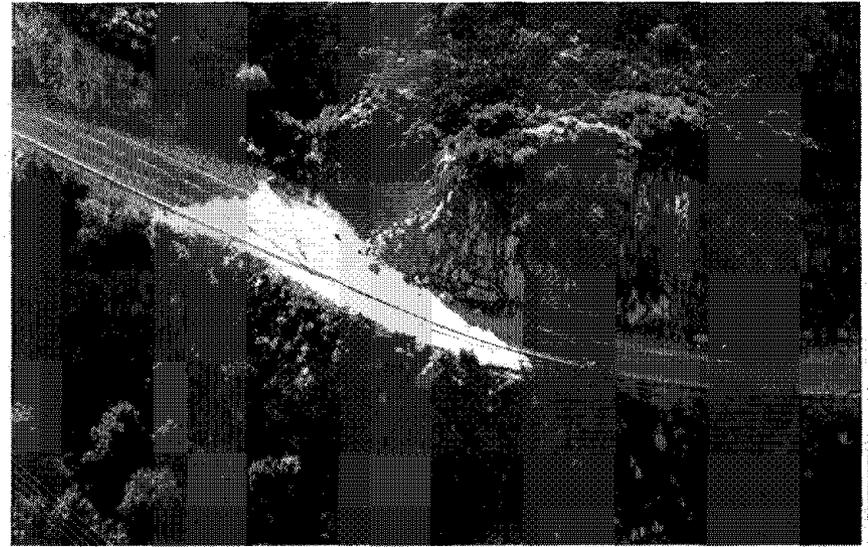
A section of the Santa Susana Pass Road, a two-lane roadway that parallels Highway 118 and connects the San Fernando Valley with Simi Valley, was closed due to slides. The road is approximately 5 miles from the epicenter and is cut into cemented sand and weak sandstone canyon walls that slope at 2H:1V and greater. Slope failures and landslides occurred both downslope and upslope of the road, and varied from 25 feet to more than 100 feet in height (Figure 5.12). Debris from upslope failures was generally large enough to block the near-slope lane of the road. Blocks as large as 5 feet in diameter were noted, and at least one of the slides appeared to be a failure along intersecting joint planes. Downslope failures created extensional cracks 10 to 30 feet away from the edge of the slope and parallel with the road. One larger slide caused vertical differential subsidence of 5 inches in the roadway and an additional 12 to 18 inches along the shoulder.

Fig. 5.12: Rockslide along Santa Susana Pass Road, near the pass.

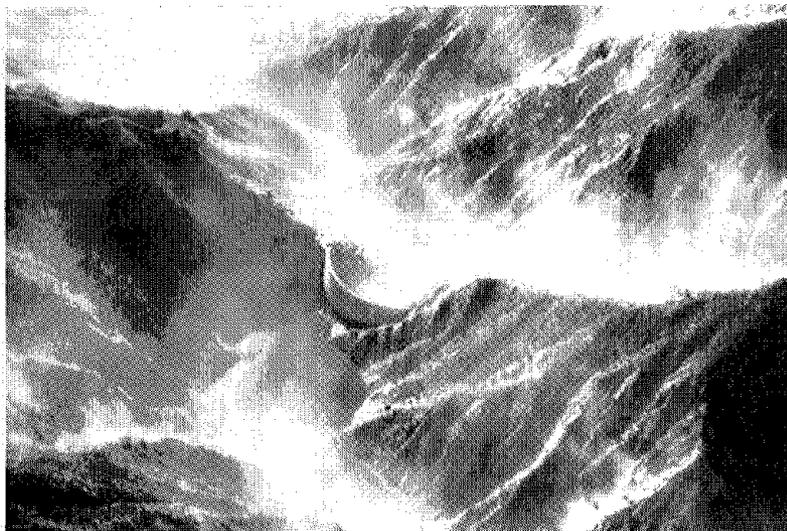
Fig. 6.2: Aerial photograph of Pacoima Dam taken January 17, 1994 (photo courtesy of U.S. Air Force)

Following the 1994 Northridge Earthquake, additional fracturing of the rock on the steep abutments developed and there were numerous rock falls. Figure 6.2 presents an aerial photograph taken a few hours after the Northridge earthquake which shows some of the dust from rock falls produced in the vicinity of the dam as a result of aftershocks. The rock falls caused significant damage to walkways (see Figure 6.5) and partially filled the spillway chute. In addition to the rock falls, many of the shotcrete-covered rock slopes in the vicinity of the dam suffered extensive fracturing and cracking. Fissures several inches in width were commonly found in the shotcrete cover, along with buckled and shattered blocks of shotcrete in some areas (see Figure 6.6). A timber tramway leading up to the top of the dam on the left abutment suffered extensive damage due to foundation movements and consequent lack of support.

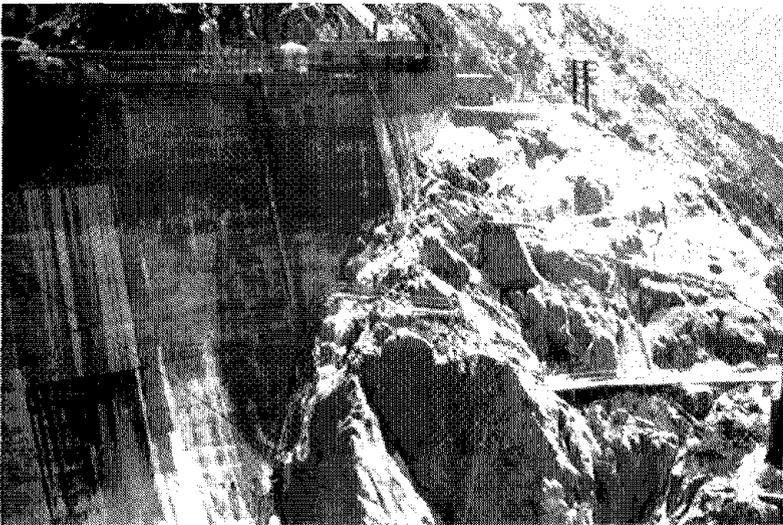
The most significant damage appeared to be related to movements of the left abutment relative to the dam (see Figure 6.7). A $\frac{1}{4}$ to $\frac{1}{2}$ inch wide crack in the thrust block ran diagonally up the block to merge with the vertical joint between the block and the concrete arch (see Figures 6.8 through 6.10). In addition, there were also diagonal hairline cracks extending several feet into the concrete arch from the joint near the thrust block crack. The vertical joint also opened up and widened towards the crest of the dam. At the dam crest, the joint had opened to a width of about 2 inches (see Figure 6.11). The thrust block side of the joint was also offset about $\frac{1}{2}$ inch downstream and $\frac{3}{4}$ of an inch down relative to the concrete arch. Thus, apparently the left abutment had moved away and downstream relative to the arch. This distress and behavior was similar to what had happened following the 1971 San Fernando Earthquake, but was more severe following the 1994 event.

Fig. 6.7: Photograph of Pacoima Dam left abutment thrust block

During both the 1971 and the 1994 earthquakes, the reservoir level was relatively low, and it is uncertain how much more damage would have been sustained had the reservoir been full. However, it is important to point out that this structure has probably been twice subjected to some of the highest peak seismic loads ever experienced by a dam. Since the Northridge earthquake, the reservoir elevation has been restricted to about $\frac{2}{3}$ the height of the dam pending the results of more thorough investigations. Surveys, crack mapping, and drilling explorations (see Figure 6.12) are being performed in order to assess the effects of the movements and to determine what remedial measures are warranted.

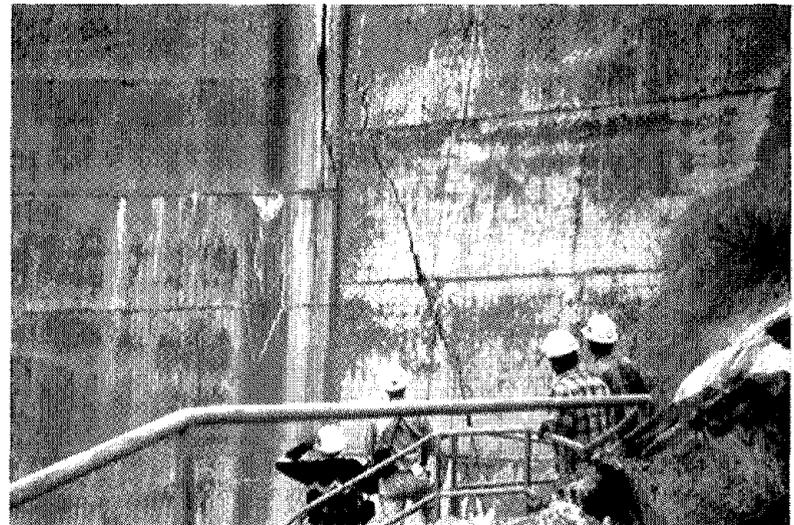
Fig. 6.8: Photograph of cracking in Pacoima Dam thrust block (photo courtesy Division of Safety of Dams)

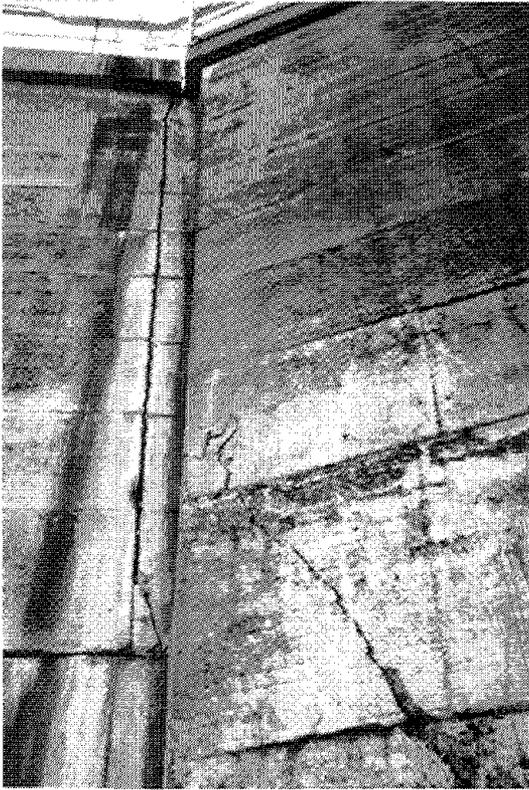
Fig. 6.9: Photograph of vertical joint between Pacoima Dam arch and left abutment thrust block

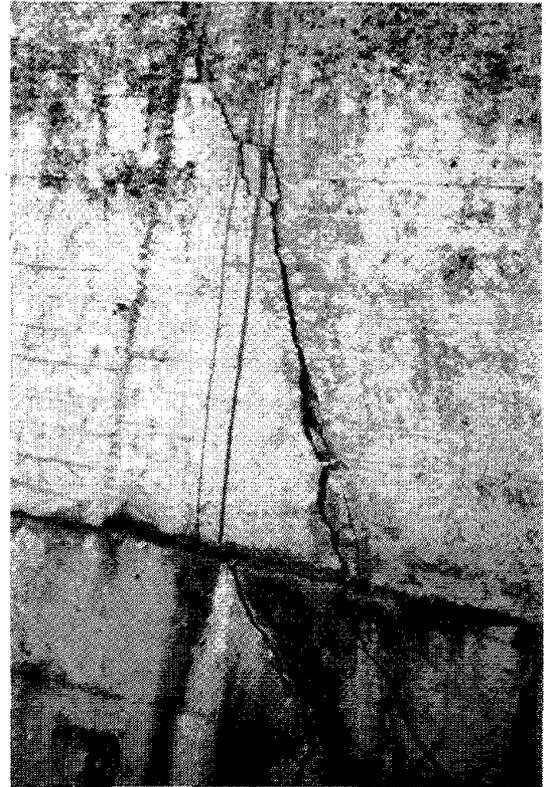
Fig. 6.10: Close-up photograph of cracking in Pacoima Dam thrust block

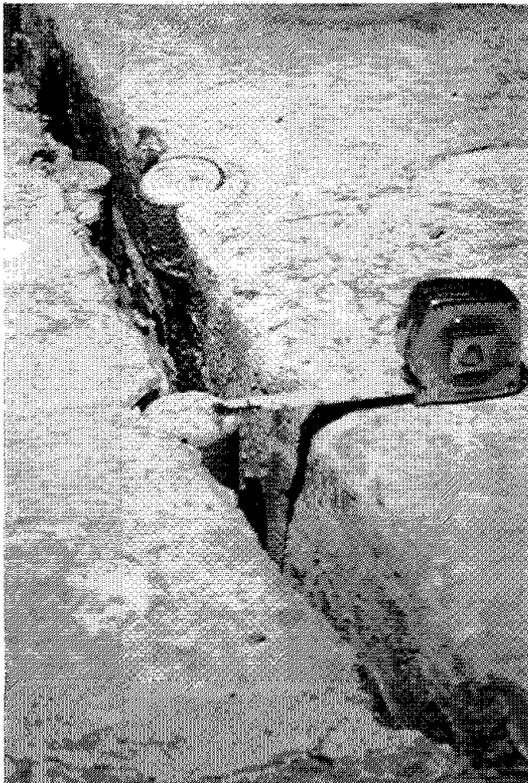
Fig. 6.11: Close-up photograph of opened thrust block vertical joint on Pacoima Dam crest

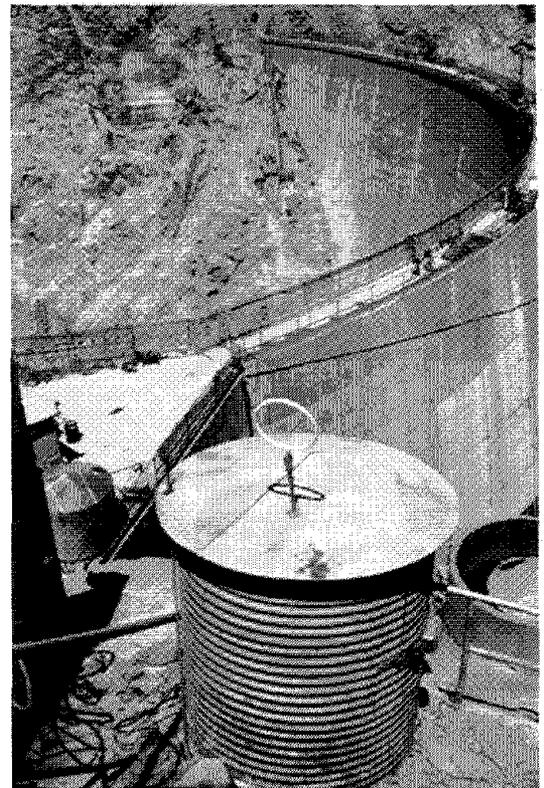
Fig. 6.12: View of Pacoima Dam from left abutment. Note seismograph in foreground and lift joint water stains on upstream slope caused by water testing in boreholes

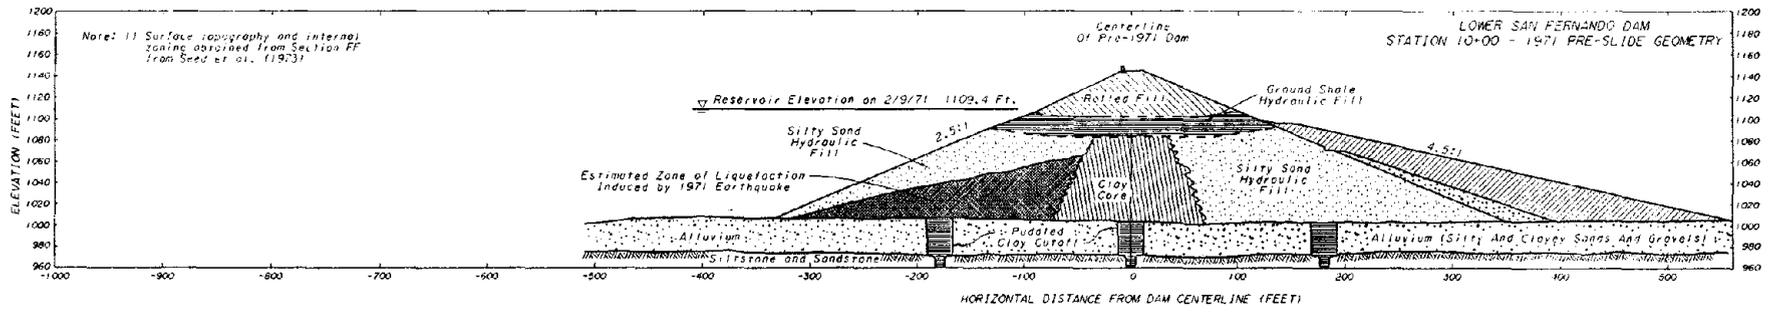
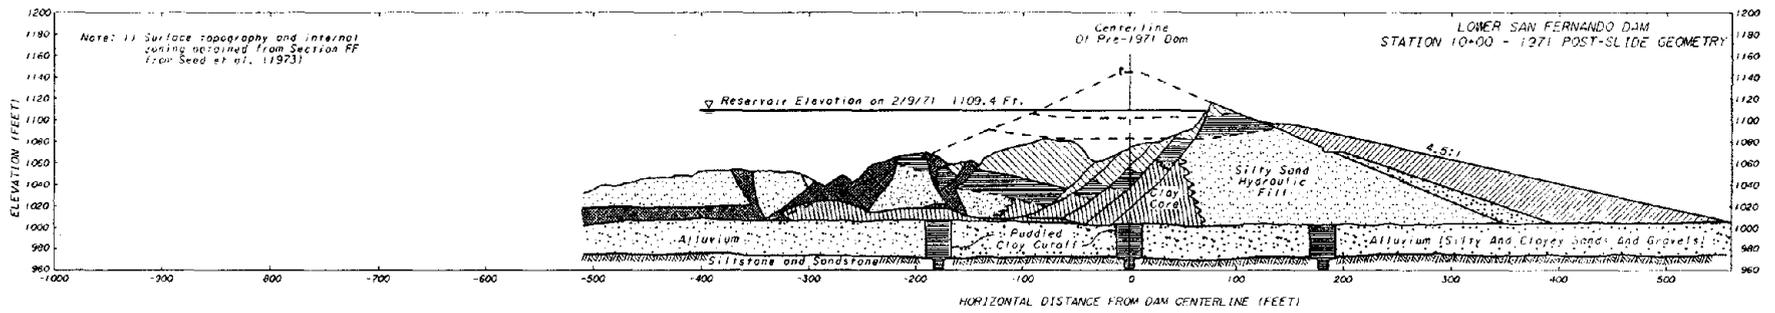
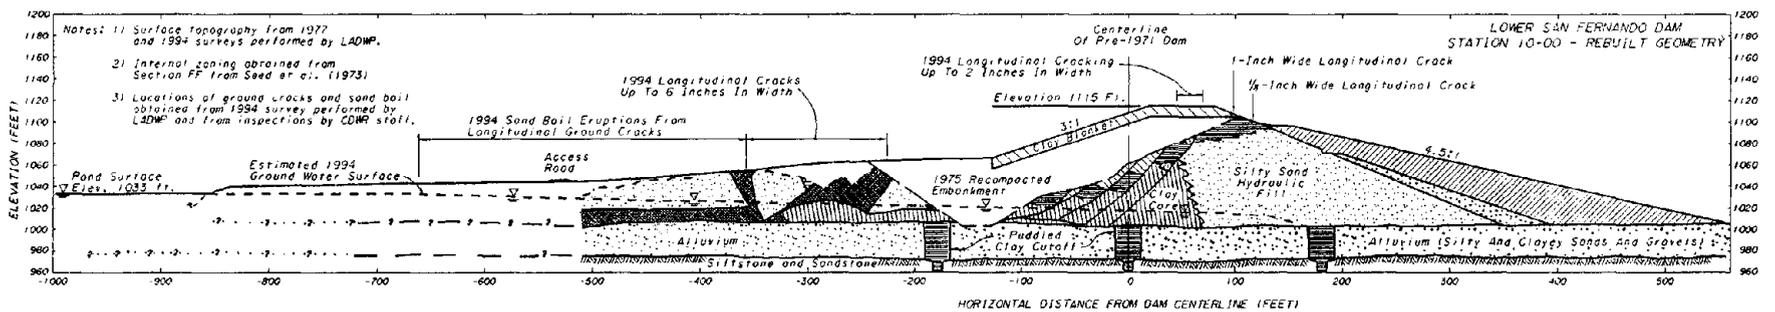
Fig. 6.13: Cross sections of Lower San Fernando Dam at Station 10+00

During the 1971 San Fernando Earthquake, the dam site experienced a peak ground acceleration of about 0.55g. As a result of the strong ground motions, a portion of the upstream hydraulic fill liquefied, resulting in a major upstream slide approximately 20 to 30 seconds after the earthquake. Shown in Figures 6.13(a) and 6.13(b) are cross sections of the dam at Station 10+00 before and after the slide took place. Shown in Figure 6.13(a) as a dark wedge upstream of the core is the zone of sandy hydraulic fill that was estimated by Seed et al. (1973) to have liquefied. As a result of the liquefaction, intact blocks of fill slid out into the reservoir, riding on top of the liquefied material (see Figure 6.13(b)). Following the earthquake, portions of the upstream toe of the dam were found to have slid out into the reservoir by as much as 200 feet. Several researchers have used the performance of this dam to calibrate various methods of analysis and exploration tools for use in assessing other dams. It comprises a particularly useful case history because the upstream and downstream hydraulic fill sections are only marginally different, yet one failed and the other did not.

The Lower San Fernando Dam is located approximately 6 miles northeast of the epicenter of the 1994 Northridge Earthquake, and about 6 miles away from the estimated fault rupture plane. The estimated peak ground acceleration at the dam site during the 1994 event was between 0.4g and 0.6g. As a result of the shaking, the reworked slide mass liquefied again,

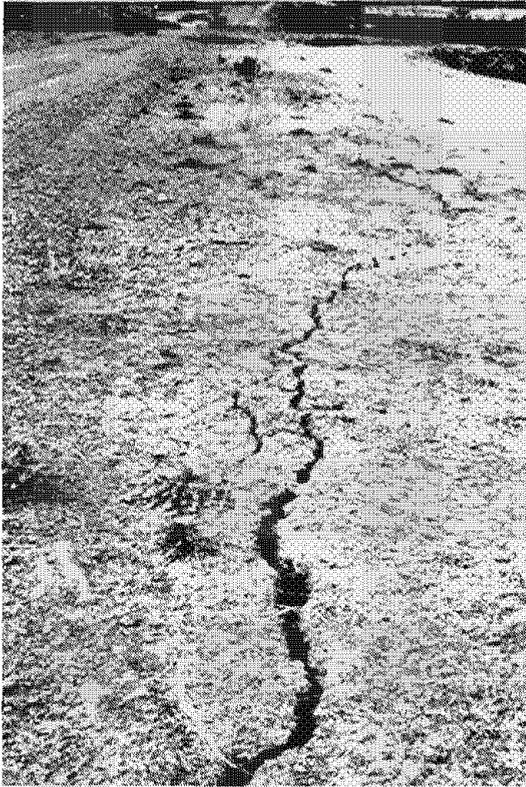
which resulted in lateral spreading upstream towards the small pond. The lateral spreading resulted in widespread longitudinal cracking running hundreds of feet. On the dam crest, cracks were generally less than about 2 inches in width (see Figure 6.14). Upstream of the recompacted portion, longitudinal cracks had widths as much as 6 inches, together with vertical offsets of several inches (see Figure 6.15). Additional cracking further upstream towards the lower access road and pond was accompanied by numerous sediment boils (see Figures 6.16 and 6.17). These sediment boils were generally composed of silty sands. The locations of significant cracks and sediment boils were mapped by staff of the City of Los Angeles Department of Water and Power and are shown in Figure 6.18.

Fig. 6.14: Photograph of 2-inch wide longitudinal crack on crest of Lower San Fernando Dam

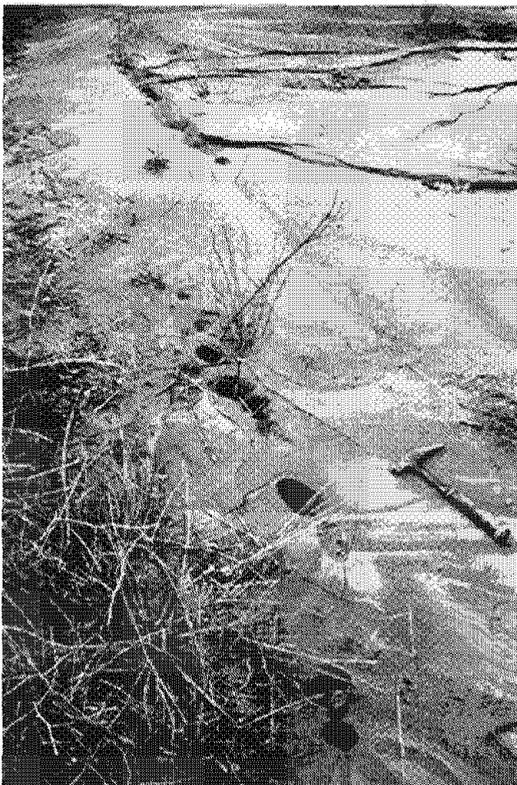
Fig. 6.16: Photograph of sediment boil at Lower San Fernando Dam located on old slide downstream of lower access road

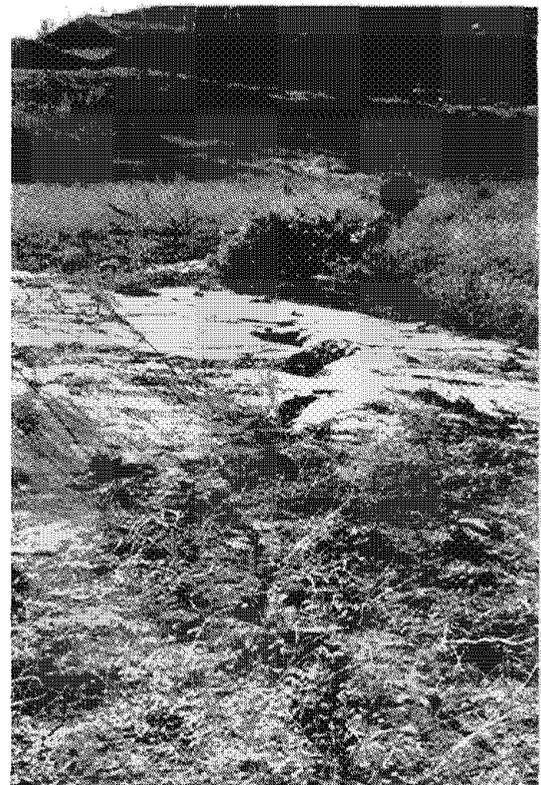
Fig. 6.17: Photograph of sediment boil at Lower San Fernando Dam on old slide upstream of lower access road

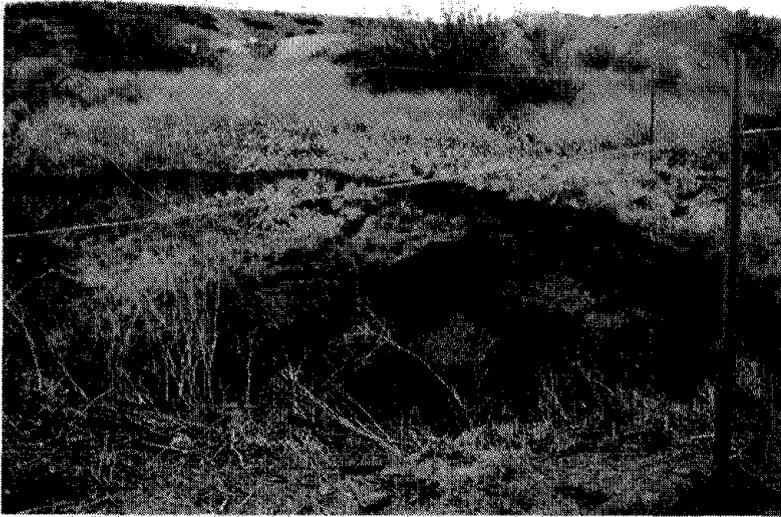
The most serious distress sustained by the rebuilt Lower San Fernando Dam consisted of a sinkhole which developed near the right edge of the upstream cracking (see Figures 6.18 and 6.19). This sinkhole had a width (parallel to the dam axis) of 26 feet, a length (normal to the dam axis) of about 42 feet, and a maximum depth of about 13 feet. The sinkhole was later found to be centered on the corrugated metal pipe connecting the old outlet pipe to the upstream pond. The corrugated metal pipe was excavated in May 1994 and found to have sustained near complete lateral collapse, presumably due to increased lateral pressures caused by the earthquake (see Figures 6.20 and 6.21). During the excavation, additional sinkholes were discovered. Apparently, erosion caused by the water flowing through the partially collapsed pipe removed soil which entered through tears in the pipe, thus causing the sinkholes. Following the replacement of the outlet pipe and perhaps regrading of some of the cracks, the dam is expected to resume its function of providing limited flood control.

Fig. 6.19: Photograph of sinkhole at Lower San Fernando Dam

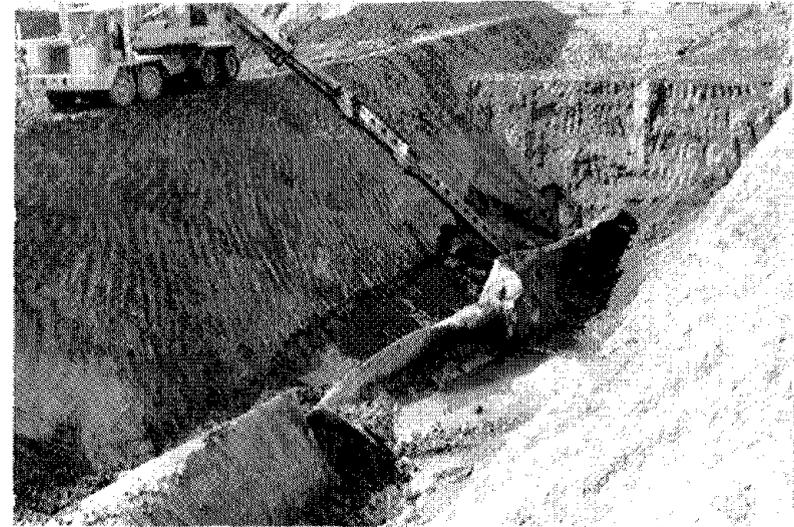
Fig. 6.20: Photograph of collapsed CMP outlet pipe at Lower San Fernando Dam

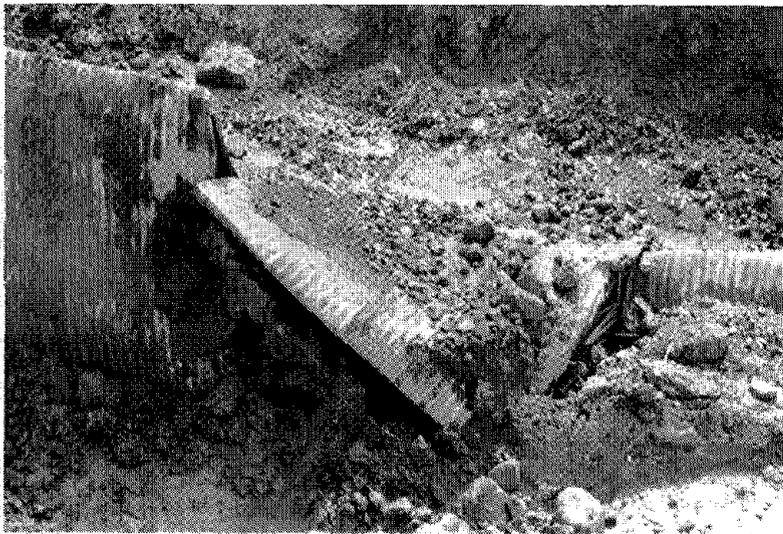
Fig. 6.21: Photograph of portion of collapsed CMP directly beneath sinkhole at Lower San Fernando Dam

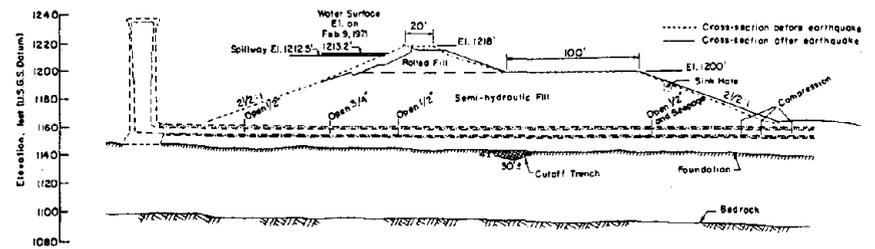
Fig. 6.22: Cross section of Upper San Fernando Dam following 1971 San Fernando Earthquake (Source: Seed, et al. 1973)

During the 1971 San Fernando Earthquake, this dam also developed liquefaction-induced distress. Although no flow slides resulted, the dam sustained significant settlements and downstream movements. The downstream movement of the dam was in the form of lateral spreading and led to the development of several longitudinal cracks along the upstream slope of the dam. According to Seed et al. (1973), the upstream cracks appeared to be multiple shear scarps. Maximum crest movements caused by the 1971 earthquake were 3.2 feet of settlement and about 5 feet of horizontal downstream movement. However, monuments along the outlet pipe on top of the semi-hydraulic fill recorded downstream horizontal movements as high as 7 feet. The lateral movements induced cracking in the concrete outlet pipe and resulted in a sinkhole within the semi-hydraulic fill above the outlet pipe (see Figure 6.22).

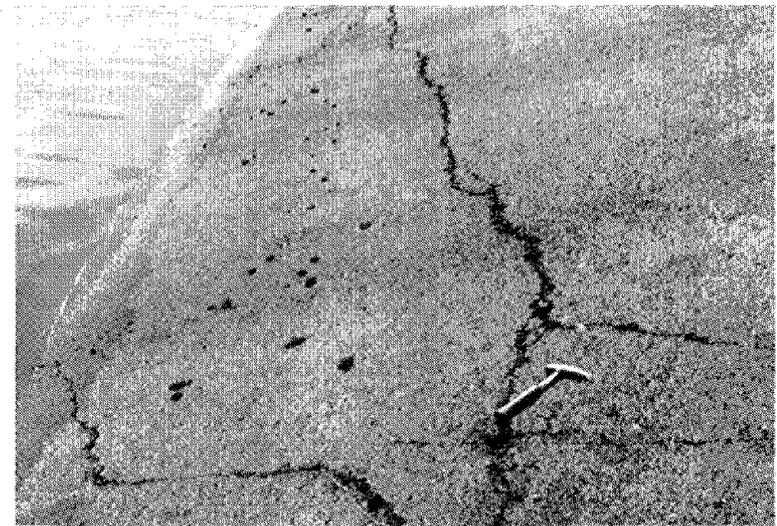
Fig. 6.27: Cracking of upstream asphalt concrete slope protection on Los Angeles Reservoir North Dike

The 1994 Northridge Earthquake induced settlements of about 3.5 inches at the Main Dam and about 1 inch at the North Dike, along with fairly extensive cracking of the upstream asphalt concrete slope protection (see Figure 6.27). The largest of these cracks was about 1-inch wide. There was also a ¼-inch wide transverse crack across the crest of the North Dike near its left abutment (see Figure 6.28). This crack extended across a 30-inch deep pre-existing utility trench and was only about a hairline in width at the bottom of the trench.

In light of the relatively high levels of shaking, the Los Angeles Dam can be considered to have performed reasonably well. The cracking appears to be of minor significance. The staff of the Los Angeles Department of Water and Power plan to patch some of the cracks, remedy the displaced walkway of the outlet tower, and to closely monitor the seepage at the North Dike.

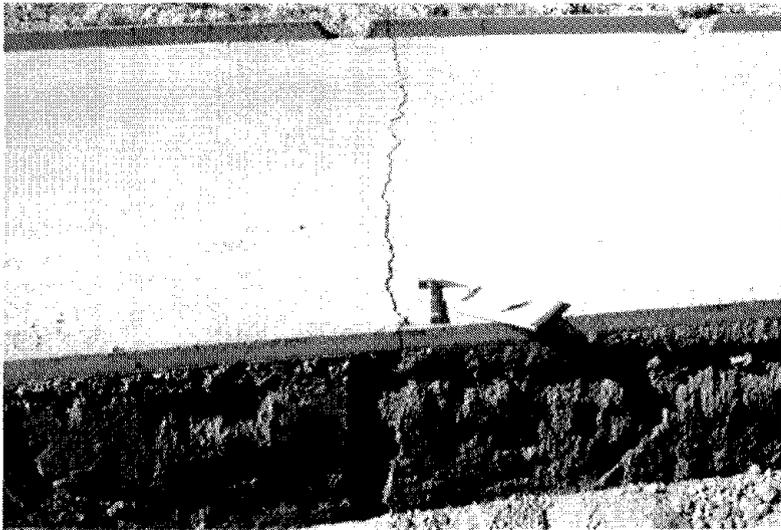
Fig. 6.28: Photograph of transverse crack on crest of Los Angeles Reservoir North Dike near its left abutment

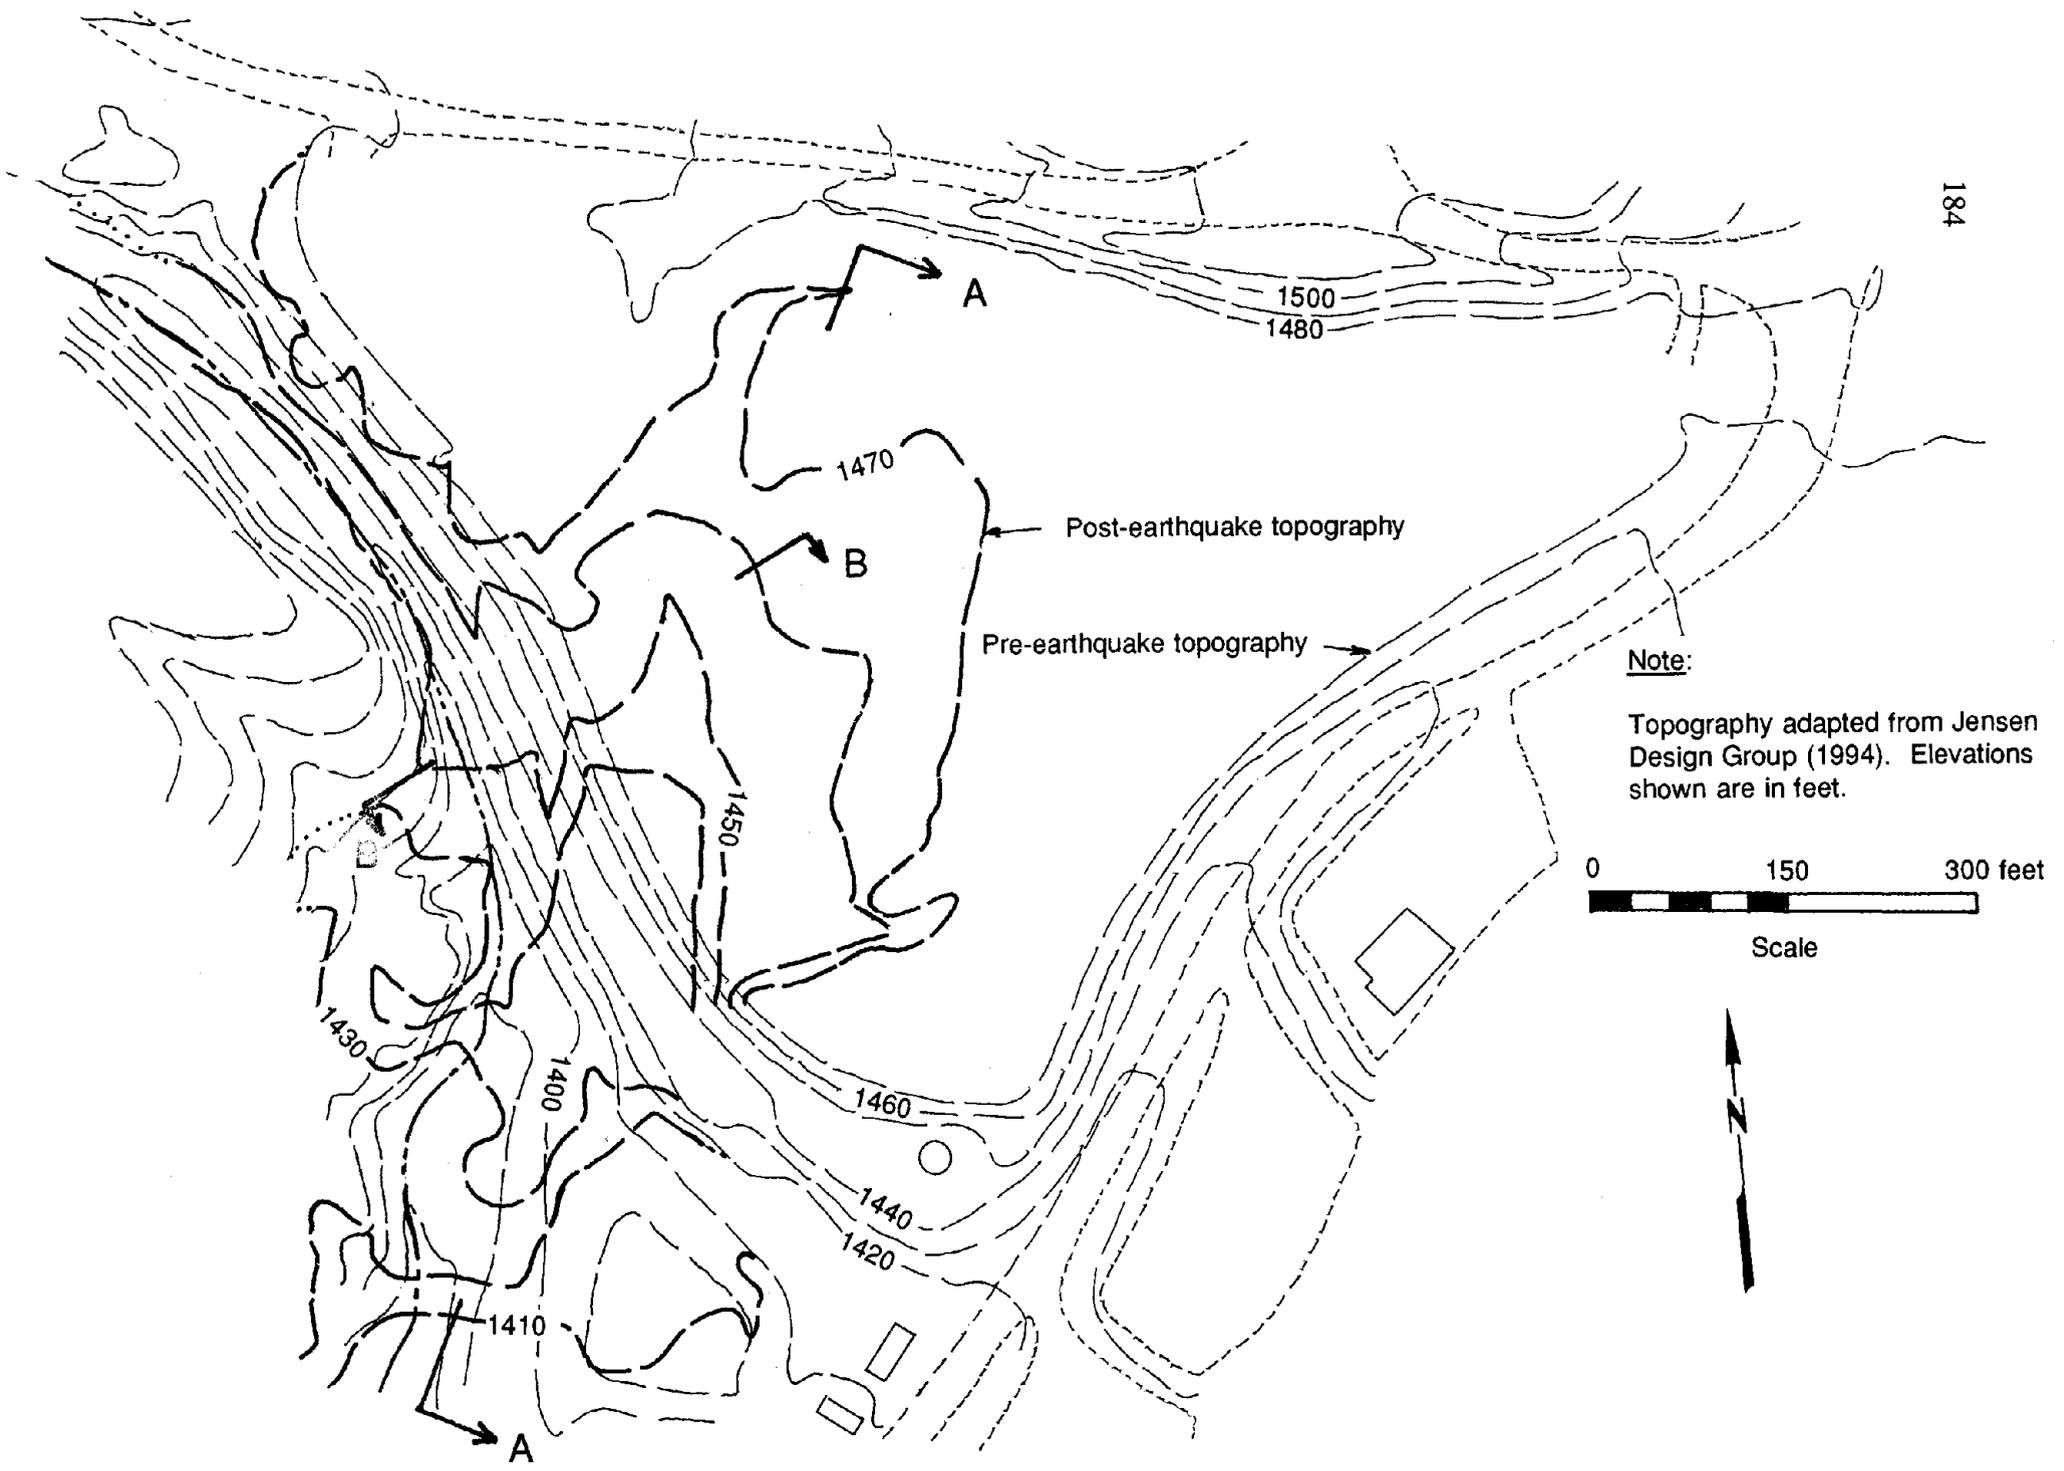
Fig. 6.39: Topography at Tapo Canyon Pond No. 6 prior to and following the Northridge Earthquake

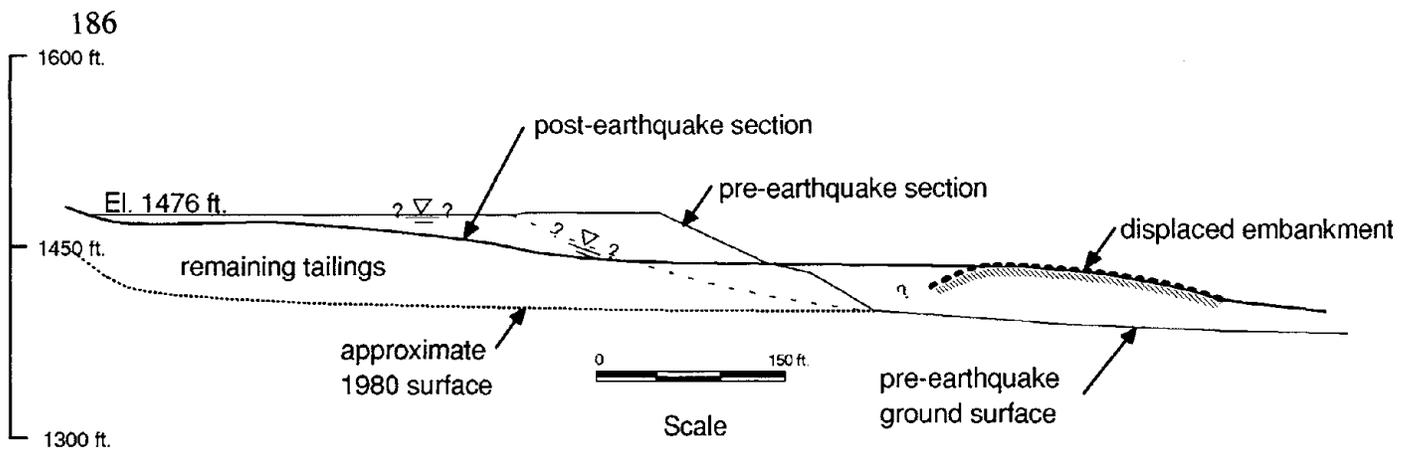
The flow slide resulted from the failure of an approximately 200-foot long section of the tailings dam near the southwest part of the pond. In this area, the dam slid out and broke up into at least two pieces which were found approximately 200 and 300 feet downstream of their original positions, respectively. The breach of the tailings dam occurred in the same area where available information indicates that a gap was created in the natural rock ridge and mine waste embankments left from mining of the original hill. This is the location of the highest fill and is the only location where the pond was apparently being retained by the later retention embankments alone. Following the failure of the tailings dam, some of the retained tailings flowed out of the breach in a viscous flow which travelled over 600 feet downstream. Within the pond, the surface of the remaining tailings sloped down concentrically towards the breach in a manner similar to a viscous fluid passing through a funnel. The surface layer of waste concrete on the eastern pond surface broke up into large blocks and spread apart. Figures 6.38 through 6.51 present photographic, topographic and schematic information describing the behavior of the flow slide.

Fig. 6.41: Section A-A from Figure 6.39, showing failed tailings dam and resulting flow slide.

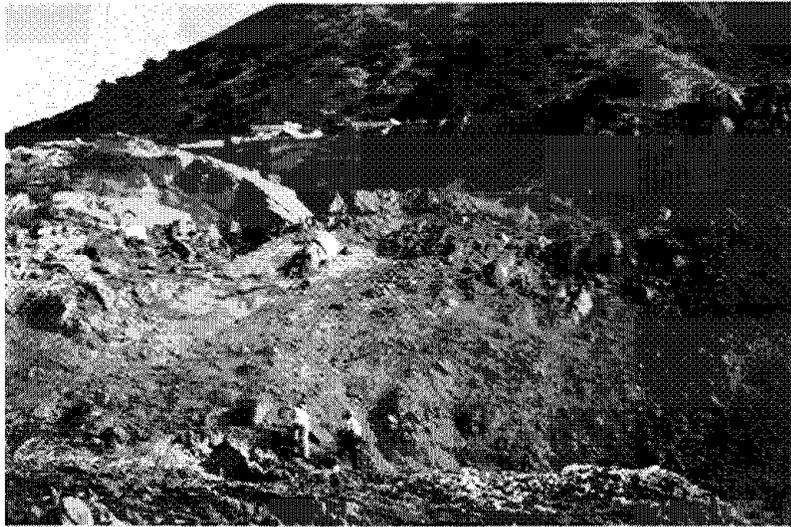
Fig. 6.42: View looking east across flow slide within breach towards southeast embankment

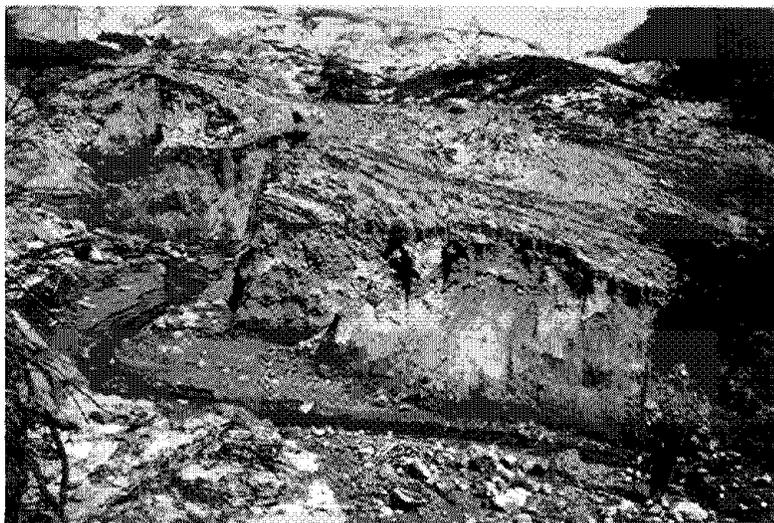
Fig. 6.43: Edge of lobe of viscous tailings flow near creek, photograph taken 600 feet downstream of the failed pond, looking north.

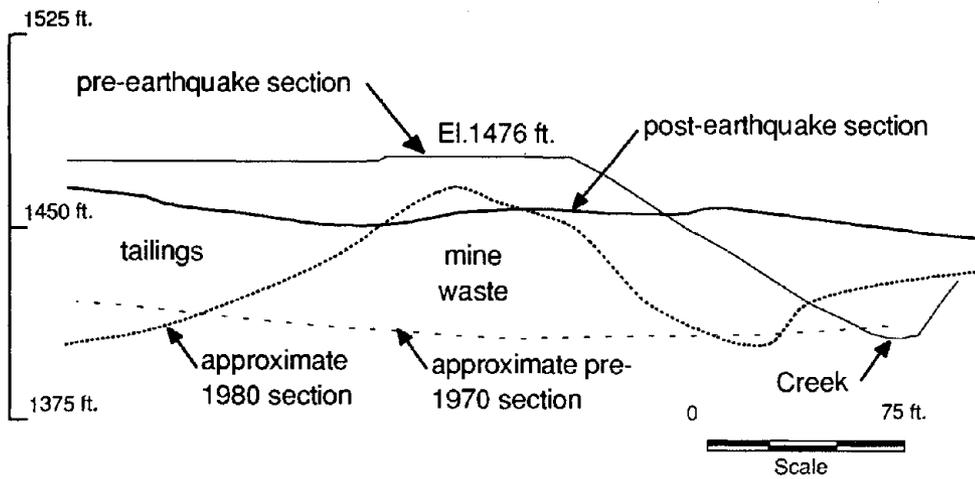
Fig. 6.44: Section B-B from Figure 6.39, failed embankment section northwest of breach

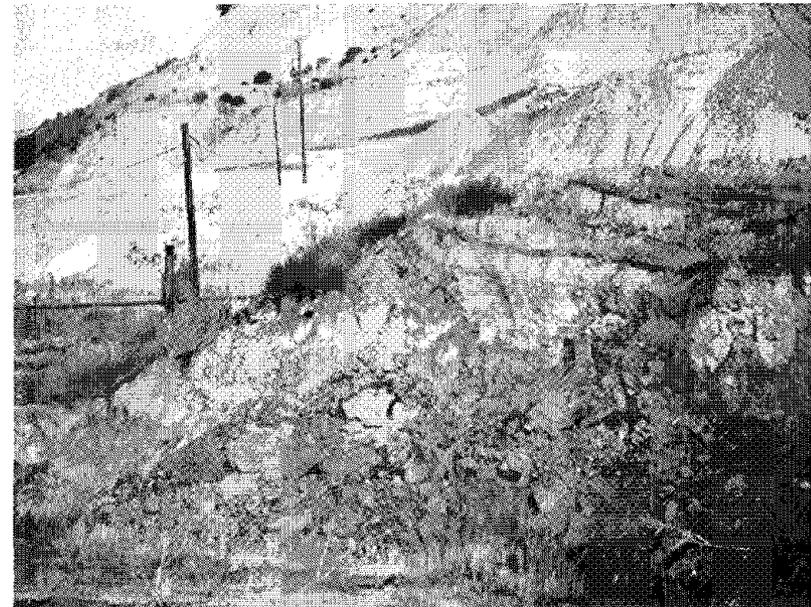
Fig. 6.45: Offset in roadway on north portion of southwest embankment

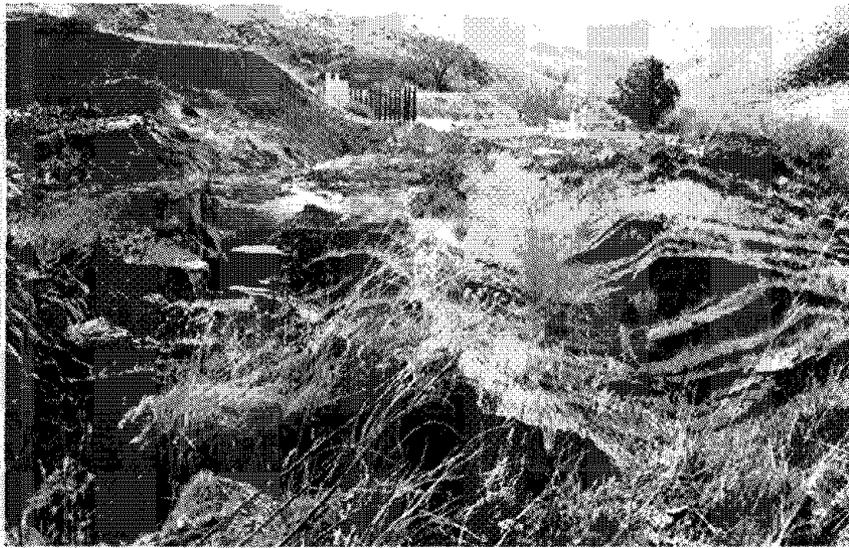
Fig. 6.46: "Split" crest area of failed southwest embankment

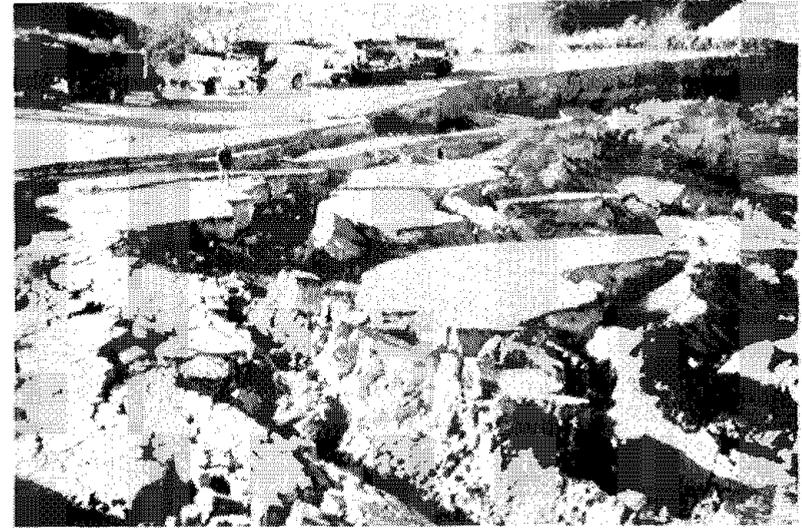
Fig. 6.49: Photograph of displaced concrete blocks on pond surface

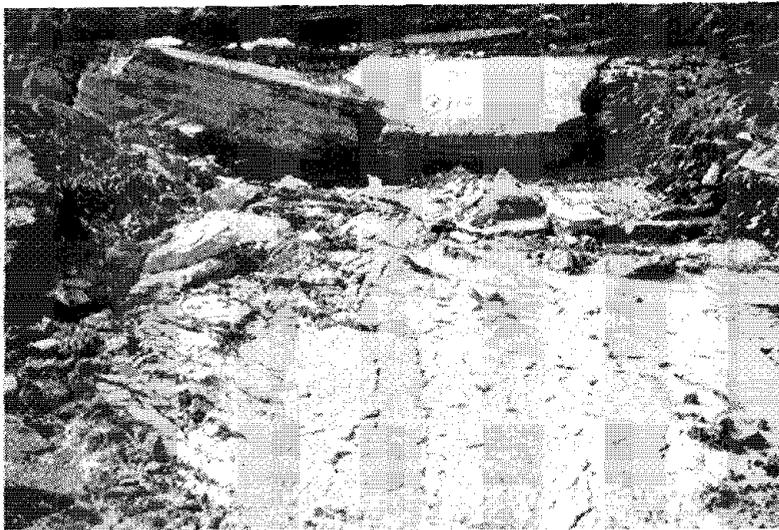
Fig. 6.50: Photograph of pair of concrete blocks which traveled 84 feet across pond surface

One of the more notable features of the flow slide was the fact that some of the blocks of concrete waste on the eastern surface of the pond exhibited significant surface displacements (see Figures 6.48 and 6.49). These blocks, typically 4 to 6 feet thick and weighing hundreds of tons, were found to have moved directly across the pond surface as the surface sloped down towards the breach. Figure 6.49 shows a portion of the broken concrete surface and the displacements between blocks (note person and trucks in background for scale). Track marks left in the surface of the tailings could be found behind the displaced blocks. Shown in Figures 6.50 and 6.51 are photographs of a pair of blocks which slid over 84 feet down the sloping pond surface following the breach of the tailings dam. Each block is approximately 24 feet across and weighs over 200 tons. The surface across which the blocks travelled has a slope of approximately 12.5 degrees from the horizontal. The blocks' lateral movements were apparently halted by either reaching the bottom of the slope, as in the case with the pair in Figure 6.50, or by the buildup of tailings material ahead of the block (note waves of pushed up material in Figure 6.49).

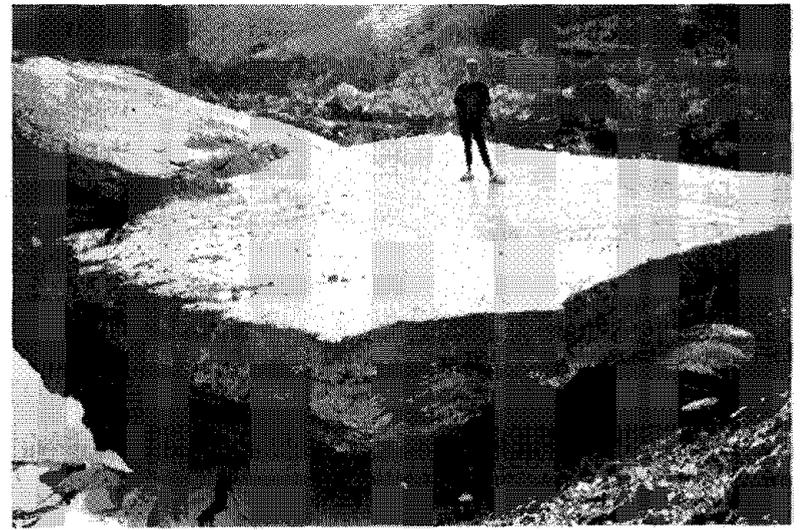
Fig. 6.51: Close-up photograph of 200-ton concrete block

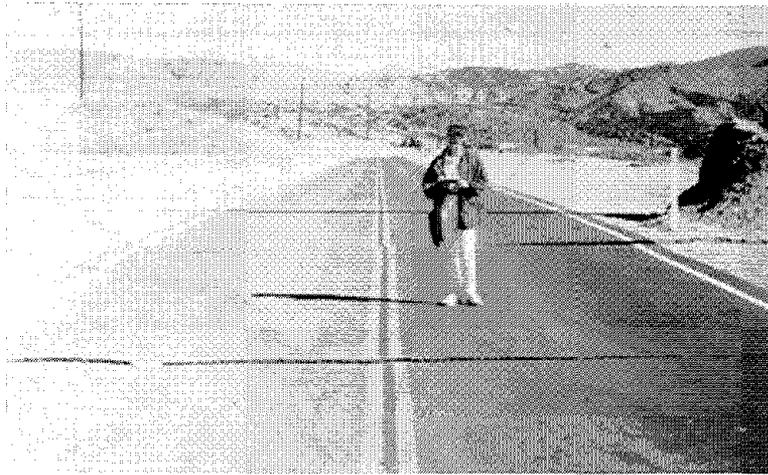
One particularly recent fill damaged by the Northridge Earthquake is located along Highway 126 just west Interstate Highway 5. A new post office which was not yet occupied is located in the vicinity of this fill and was severely damaged by the earthquake. It is not known whether the post office was underlain by the fill soils or a natural rock ridge. However, the fill does underlie an access road to the post office which experienced several inches of lateral and vertical ground movements, as shown in Figures 6.53 and 6.54.

Fig. 6.53: Pavement cracking due to movements of underlying fill, access road for Newhall post office.
