REPORT NO.
UCB/EERC-94/08
JUNE 1994

EARTHQUAKE ENGINEERING RESEARCH CENTER

**PRELIMINARY REPORT ON THE
PRINCIPAL GEOTECHNICAL ASPECTS
OF THE JANUARY 17, 1994
NORTHRIDGE EARTHQUAKE**

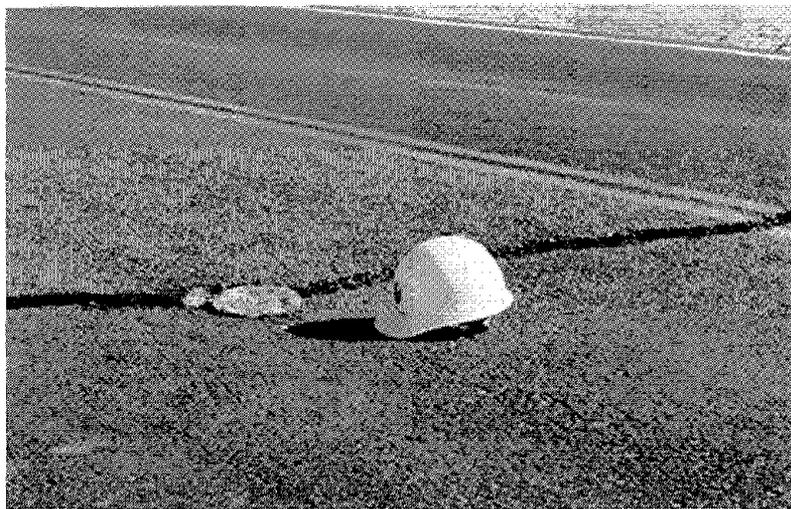
One particularly recent fill damaged by the Northridge Earthquake is located along Highway 126 just west Interstate Highway 5. A new post office which was not yet occupied is located in the vicinity of this fill and was severely damaged by the earthquake. It is not known whether the post office was underlain by the fill soils or a natural rock ridge. However, the fill does underlie an access road to the post office which experienced several inches of lateral and vertical ground movements, as shown in Figures 6.53 and 6.54.

Fig. 6.54: Pavement cracking from fill movements below Newhall Post Office

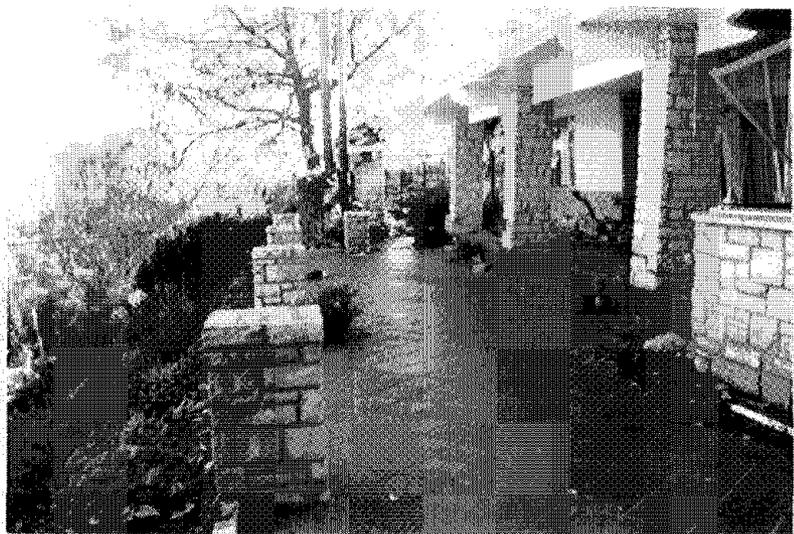
Many of the damaged hillside homes were constructed on "wedge" fills having geometry similar to that shown in Figure 6.55. Typical damage to hillside homes on these fills are shown in Figures 6.56 to 6.59. Localized vertical and horizontal soil displacements of several inches were observed in many instances within the fill portions of the building pads. Significant structural distress occurred when these movements developed within the building envelope. In addition, cracks resulting from these movements could collect surface runoff and thereby contribute to future static slope instability. In many cases, the areas closest to the tops of slopes were most severely damaged, possibly due in part to topographic/geometric amplification effects which may have locally increased the severity of ground shaking and resultant inertial forces in these locations.

Fig. 6.56: Structure damaged by movements in "wedge" fill, view is along top of fill slope

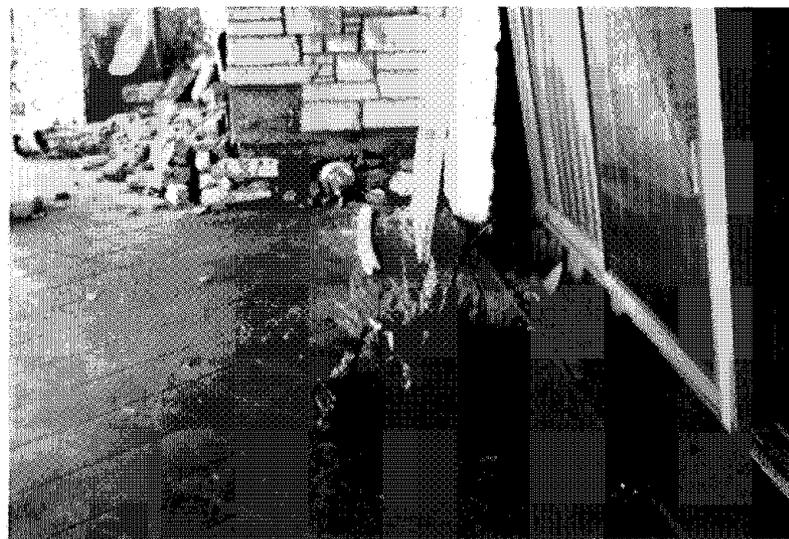
Fig. 6.57: Evidence of extensional ground movements near back of structure shown on Figure 6.56

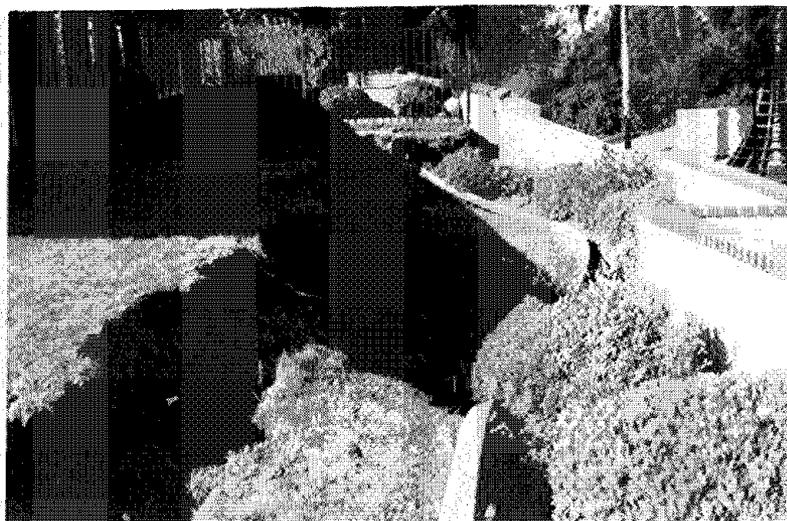
Fig. 6.58: Slumping near top of "wedge" fill slope

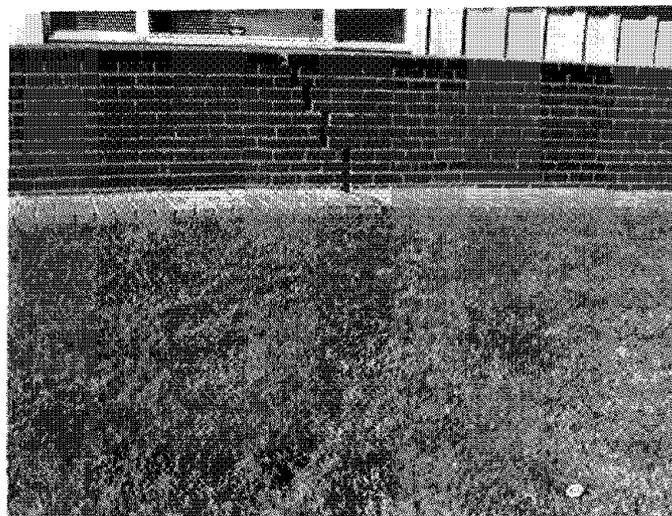
Fig. 6.59: Extensional ground cracking near cut-fill interface of "wedge" fill. Note extension of crack into structure and resulting damage.

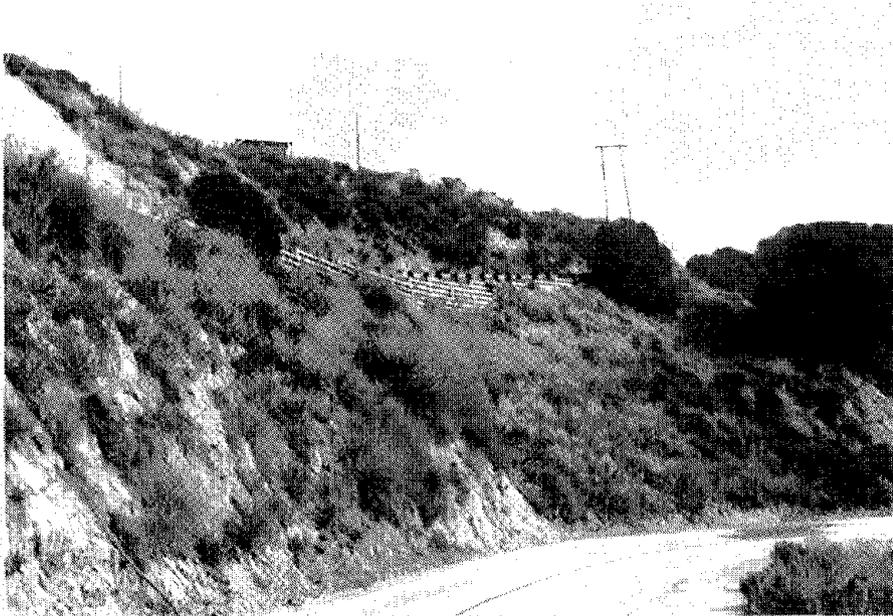
Fig. 6.61: Typical reinforced concrete crib wall in the Angeles National Forest. The scarp on the top left side of the picture is from a landslide induced by the earthquake.

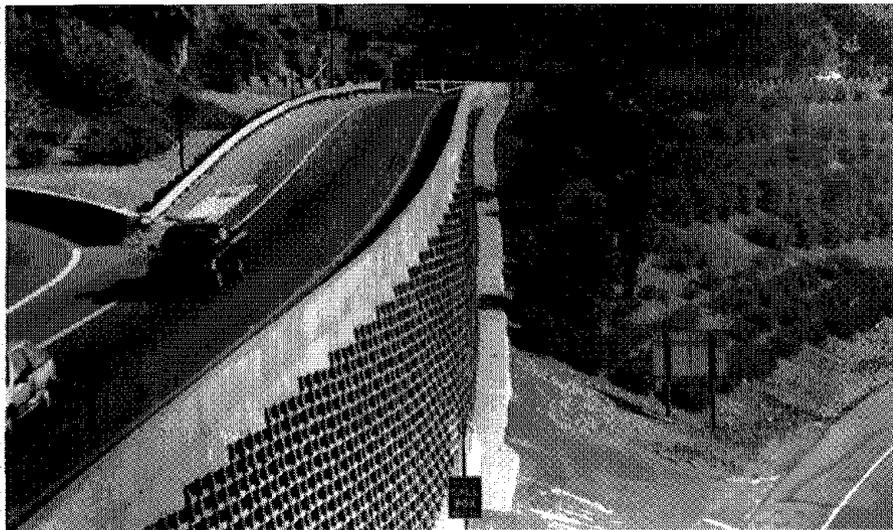
Signs of earthquake-induced distress were found on structures located in Universal City along Highway 101 at the Universal Center Drive Overcrossing. Three large, up to 12 m (40 ft) high crib walls with segmental concrete facing units have been privately built at this location. The walls are located approximately 19 km (12 miles) from the epicenter of the earthquake. Based on data from nearby stations, the estimated peak horizontal ground acceleration at the site appears to have been approximately 0.35g. The southern-most wall at this location showed evidence of distress and movements during the earthquake, as shown in Figure 6.62. Continuous cracks more than 25 mm (1 inch) in width were observed on the paved surface, parallel and approximately 1.5 m behind the wall facings. Settlements of the backfill of up to 50 mm in relation to the retaining structure occurred along the cracks (Figure 6.63). A second set of cracks, also parallel to the facing, were located approximately 6 m

Fig. 6.62: Southern-most crib wall at University Center Drive Overcrossing. Note pavement cracking parallel to wall.

behind the wall. These cracks occurred at a location where the wall foundation transitions from natural ground to an engineered fill slope. This foundation transition occurs at the highest section of the structure, and it is not clear whether the localization of cracking was influenced by the fill height, the foundation transition, or both. Analysis of the cross section of the reinforced concrete crib wall shows that the location of the continuous line of cracking near the wall corresponds to the inboard end of the concrete crib. The vertical differential settlements likely resulted from either earthquake-induced compaction of the retained fill or, most probably, lateral deflection of the crib wall which resulted in settlement of the retained backfill.

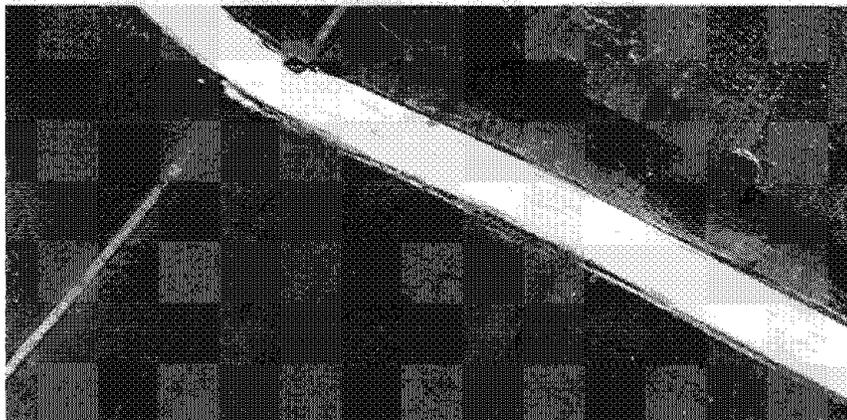
Minor cracking occurred at a number of locations on the faces of the slopes of the OII landfill, mainly but not exclusively at or near to the berm roads. Figure 6.67 is an air photo showing some of the cracks observed along the slope of the north face at the OII landfill three days after the earthquake. Figure 6.68 and 6.69 show typical cracks along the berm roads on the north face of the landfill. The cracks were generally on the order of 5 to 15 cm or less at their widest point, and post-earthquake trenching indicated that surficial cracks did not appear to extend fully through the soil cover system into the underlying waste at this landfill. The cracking appeared to represent brittle cracking of the stiffer compacted soil veneers overlying the more ductile waste fill and did not appear to represent any threat of incipient instability. However, cracking of the cover veneers can provide pathways for the

Fig. 6.67: Crack along north side slope near to a berm road at the OII Landfill

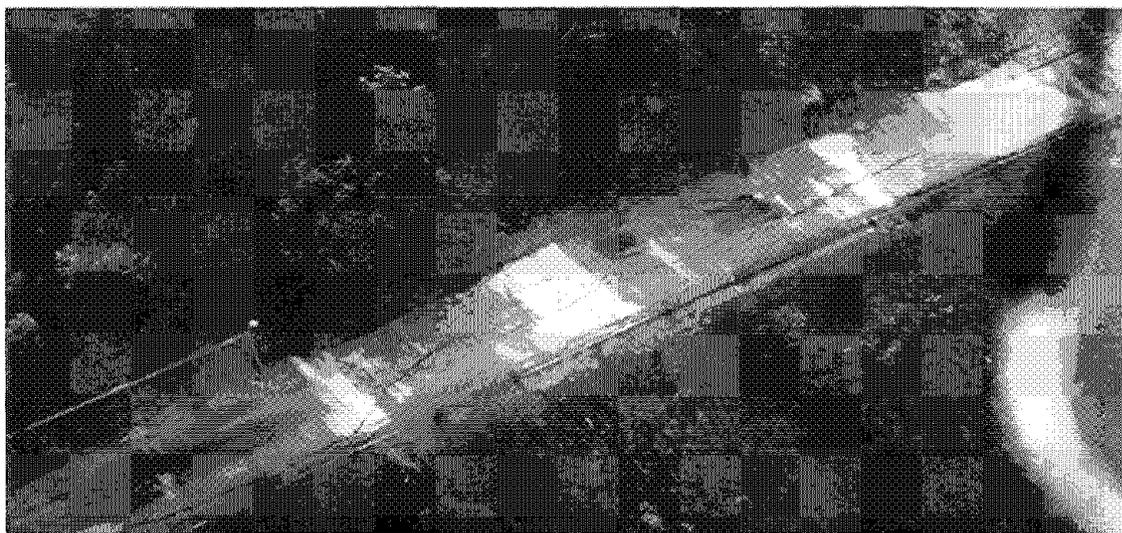
Fig. 6.68: Crack along berm road north side of the OII Landfill

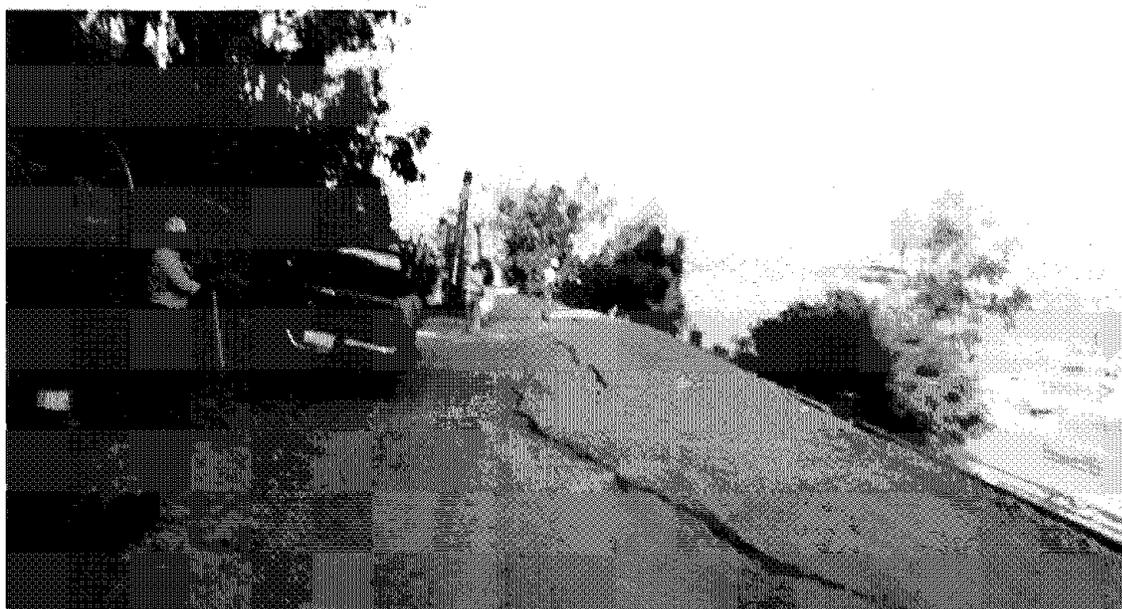
Fig. 6.69: Crack along berm road, north side of the OII landfill

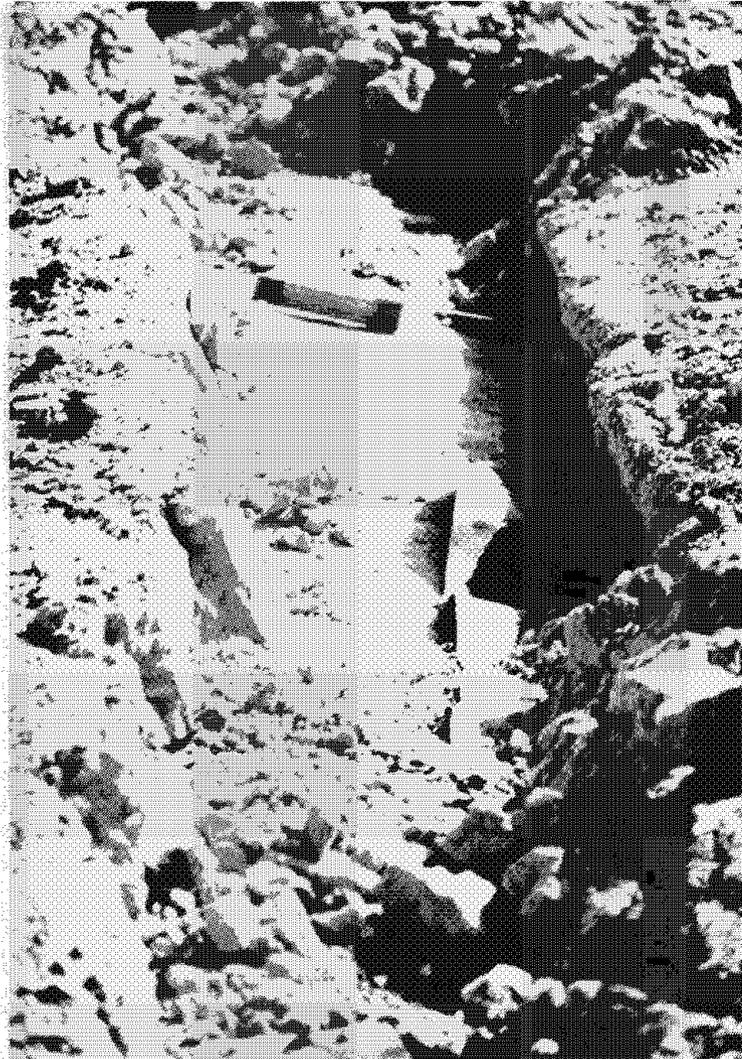
After the earthquake, cracks were observed in all cells of the landfill. Immediately after the earthquake, longitudinal cracks were observed at the top of the landfill along the interface between the landfill liner and the waste fill in Phase 1, Cell C. The cracks were approximately 30 cm wide at their widest, with a vertical offset of 15 to 30 cm, causing a localized tear in the geomembrane in one area of Cell 1. The tear, which occurred at the top of the slope near the anchor trench, was approximately 4 m long and 23 cm wide. Figure 6.79 shows the tear in the geomembrane liner at Chiquita Canyon. This tear occurred close to the anchor trench where the largest static (pre-seismic) stresses in the HDPE geomembrane would be expected as a result of the settlement and compaction of the waste fill.

Fig. 6.79: Tear in HDPE geomembrane liner system, Cell C, Chiquita Canyon Landfill (photo courtesy of Calif. EPA, Integrated Waste Management Board)

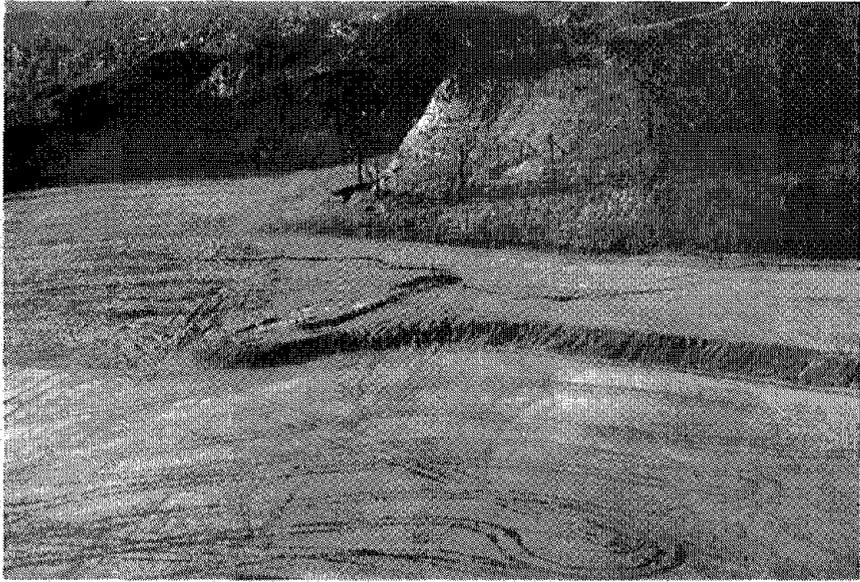
At the Sunshine Canyon site, longitudinal cracks were observed along the top of the waste fill along the interface with the natural canyon walls. The cracks varied from less than 2 cm to as much 30 cm wide, showing in some areas 15 to 30 cm of differential vertical offset. Figures 6.83, 6.84 and 6.85 show the cracking observed in the soil cover of the top deck at the western end of the Sunshine Canyon landfill after the earthquake. Figure 6.86 shows the crack in the soil cover in the center of the landfill near the water tank which was built on natural ground. This cracking did not appear to represent any threat of overall instability. It appeared instead to have been caused by settlement of the waste fill which occurred as a result of the earthquake shaking. However, it is difficult to differentiate cracking associated with ground shaking induced settlements from cracking at the back of the waste fill potentially resulting from limited downslope movement of waste along a failure plane. The landfill gas extraction system was temporarily shutdown due to a loss of power, and was restarted several days later.

Fig. 6.83: Air photo of crack along the top deck at the western end of the Sunshine Canyon Landfill

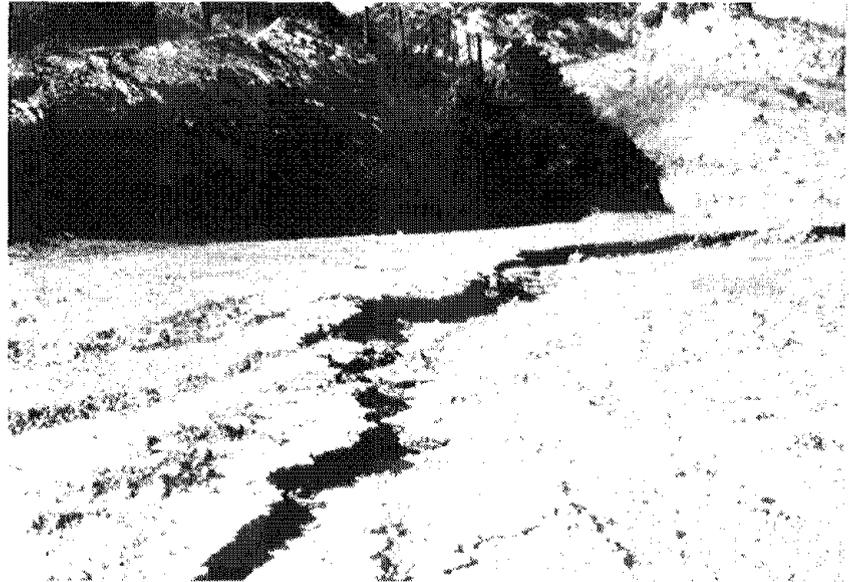
Fig. 6.84: Crack along the top deck at the western end of the Sunshine Canyon Landfill (photo courtesy of Calif. EPA, Integrated Waste Management Board)

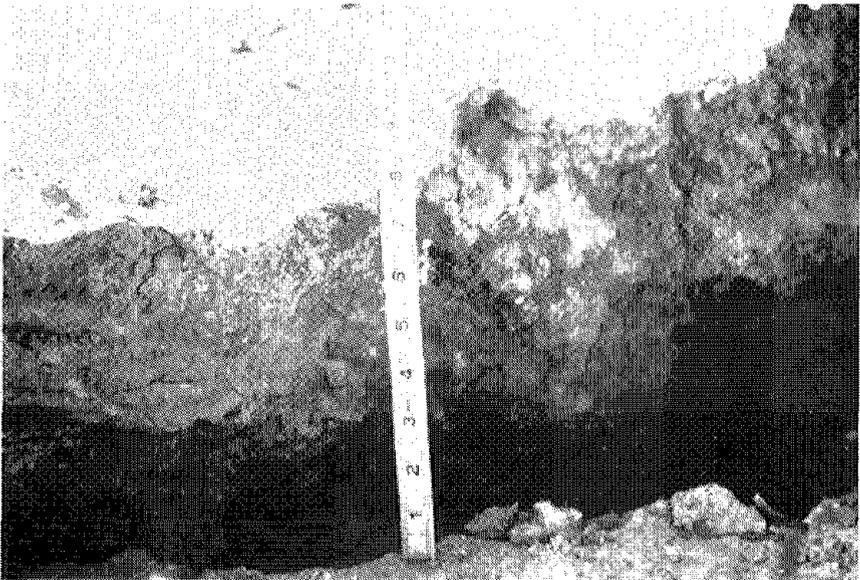
Fig. 6.85: Close-up of crack along the top deck at the western end of the Sunshine Canyon Landfill (photo courtesy of Calif. EPA, Integrated Waste Management Board)

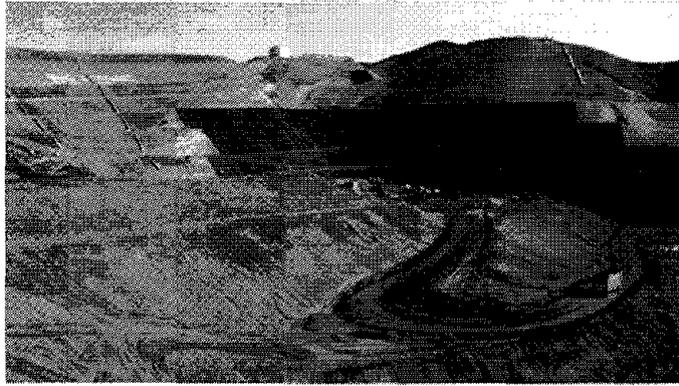
Fig. 6.89: Photo looking northeast towards the water tank taken from the southwestern end of Disposal Area C, Disposal Area AB+ is visible on the left hand side

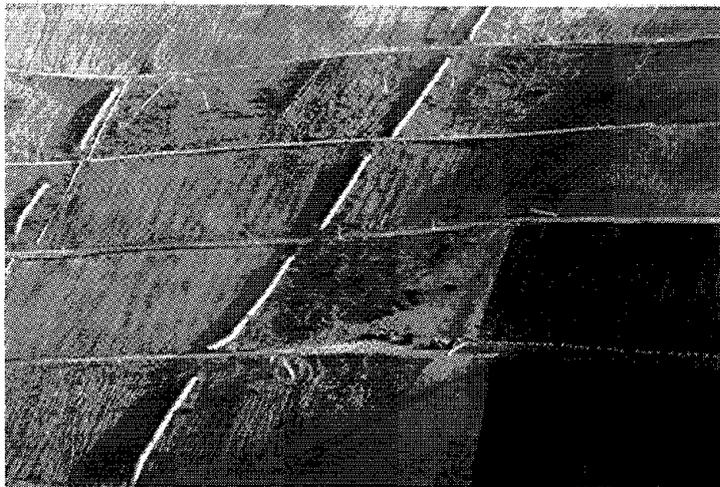
At Lopez Canyon, minor cracking was observed in the interim soil cover at the interface between the older unlined waste fills and the natural canyon slopes. Landfill slopes in the unlined landfill cells are approximately 90 m high with an average slope angle of 2H:1V and locally as steep as 1.75H:1V. Figure 6.90 shows the interface between the southeastern end of Area AB and the natural canyon wall where cracks were observed. The cracks in this area were minor, typically being on the order of 2-3 cm wide (Figure 6.91). The cracking in the interim cover soils appeared to be brittle cracking caused by the difference in the relative stiffnesses of the older waste fill areas and the canyon walls. There was no sign of permanent relative displacement between the waste fill and the subgrade in the newer geosynthetically lined areas. The 1 million gallon water tank visible in Figure 6.89 ruptured during the earthquake. However, the water, which probably drained slowly since the rupture could not be located, was removed by the surface water runoff collection system shown in Figures 6.89 and 6.90 without erosion of the interim cover system. The landfill also suffered minor damage to the surface gas extraction system which was quickly repaired.

Fig. 6.90: Photo of the interface between the waste fill of Disposal Area AB+ and the natural canyon walls where cracking was typically observed

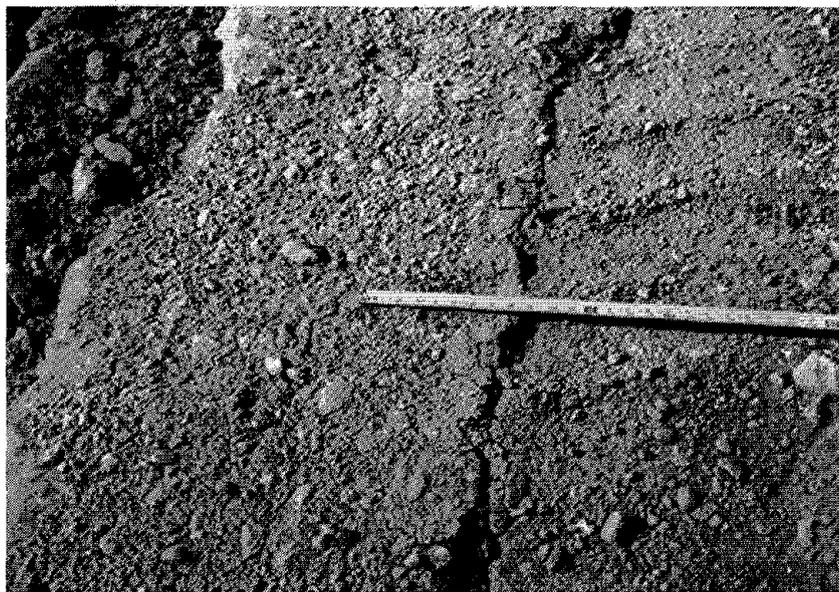
Fig. 6.91: Close-up of crack observed at the interface between the waste fill and the natural canyon walls
