**The Northridge, California Earthquake
of January 17, 1994:
Performance of Gas Transmission Pipelines**

T.D. O'Rourke and M.C. Palmer
Cornell University
School of Civil and Environmental Engineering
Ithaca, New York 14853

Technical Report NCEER-94-0011

May 16, 1994

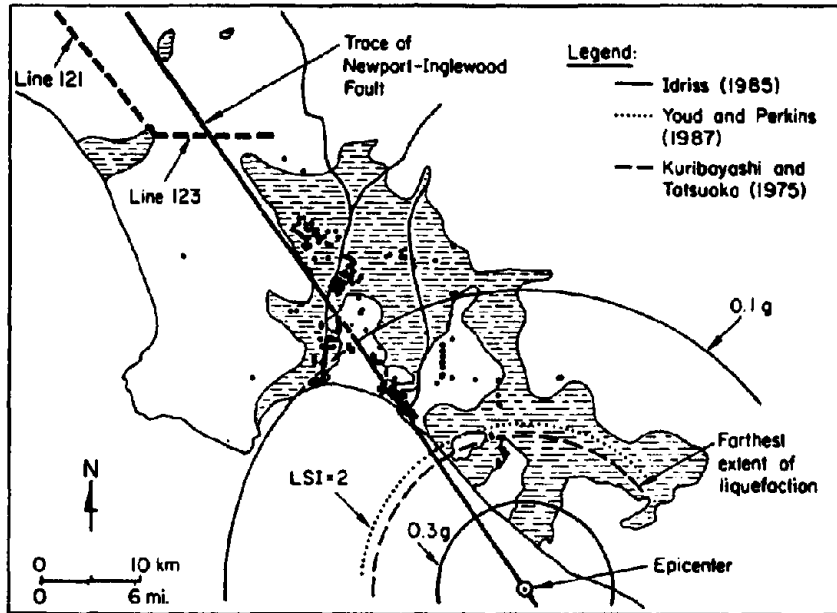
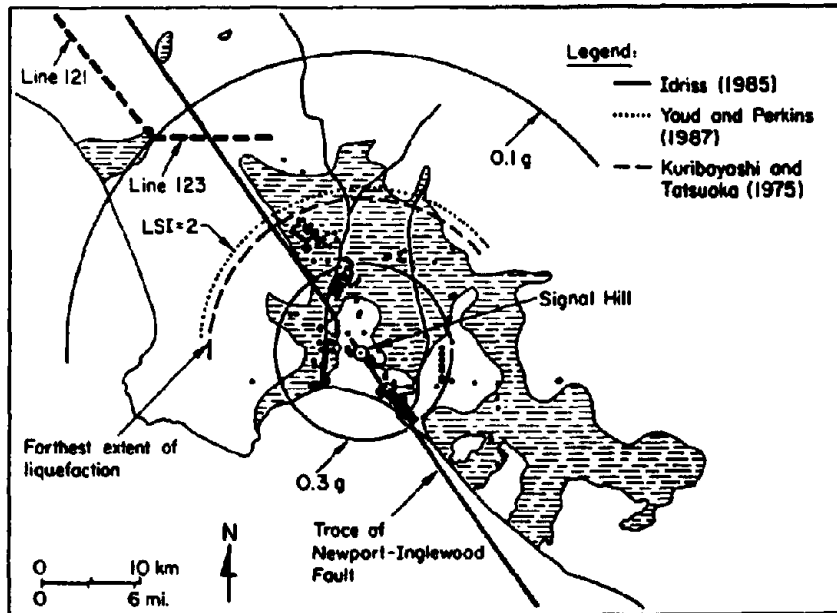
FIGURE 2-3. Contours of Peak Ground Acceleration, LSI - 2, and Maximum Distance to Liquefaction

Figure 2-3a shows circular contours of equal peak ground acceleration, $LSI = 2$, and maximum distances to liquefaction as determined from the empirical relationships described above, all with reference to the coordinates generally taken as the actual epicenter of the earthquake [Wood, 1933; Richter, 1958]. Benioff [1938] has pointed out that these coordinates, in fact, represent the location at which fault rupture originated and then propagated northward. Benioff

The radial distances centered on the coordinates generally associated with the main shock result in circular contours of equal peak acceleration and farthest extent of liquefaction, which are inconsistent with the pattern of pipeline damage. The preponderance of liquefaction effects and pipeline damage fall well beyond the limits of LSI = 2 and maximum epicentral distance derived from the Kuribayashi and Tatsuoka relationship. Moreover, the locations of concentrated liquefaction and pipeline damage at North Long Beach and Compton are outside the radial distance for 0.1 g peak acceleration.

Figure 2-3b provides an alternative plot in which the seismic source is chosen as the northern limit of surface faulting near Signal Hill. The resulting contours of equal peak acceleration, LSI = 2, and farthest extent of liquefaction are consistent with the locations of pipeline damage and reported incidents of liquefaction. The pipeline damage apparently provides supplemental evidence regarding the direction and dispersion of seismic energy. Taking the seismic source as the northern limit of faulting results in a damage scenario which is conformable with the peak accelerations and liquefaction occurrences extrapolated from empirical data.

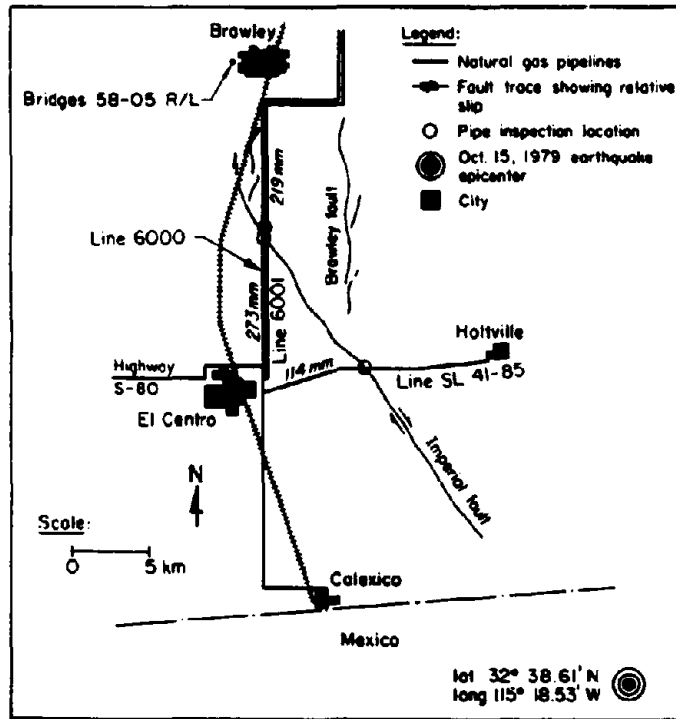
FIGURE 2-6. Locations of Gas Pipelines Crossing the Imperial Fault [adapted from Dobry, et al., 1992]

Lines 6000 and 6001, 200 and 250 mm (8 and 10 in.) in diameter, respectively, crossed the Imperial fault at two places along Dogwood Road, approximately 9.5 km (5.9 mi.) north of the city of El Centro. The locations of fault-pipeline intersection are shown in Figure 2-6. Between the time of installation and excavation after the earthquake, approximately 400 mm (16 in.) and 315 mm (12.6 in.)

of cumulative fault displacement had been imposed on Lines 6000 and 6001, respectively. Vertical displacements also were imposed on the lines. Hart [1981] measured 50 mm (2 in.) of vertical displacement twelve days after the earthquake. Neither pipeline was damaged. Due to the compressive deformation of Line 6001 generated by fault movement, SoCalGas personnel elected to relieve stresses in the pipeline using a carefully planned procedure. Details of the stress removal operation carried out in February, 1981 are presented in McNorgan [1989]. To relieve the compressive stresses, a 3-m- (10-ft)-long section of pipe was removed. After removing the pipe section and excavating 61 m (200 ft) of the line, approximately 120 mm (4.7 in.) of expansion were observed.

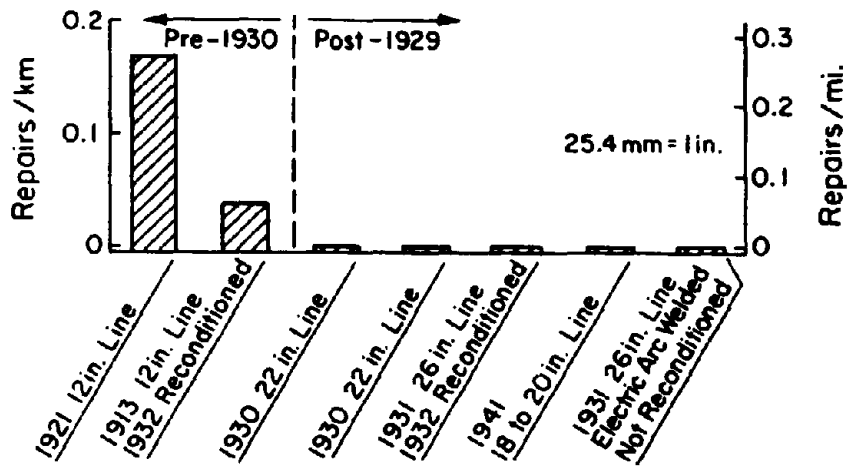
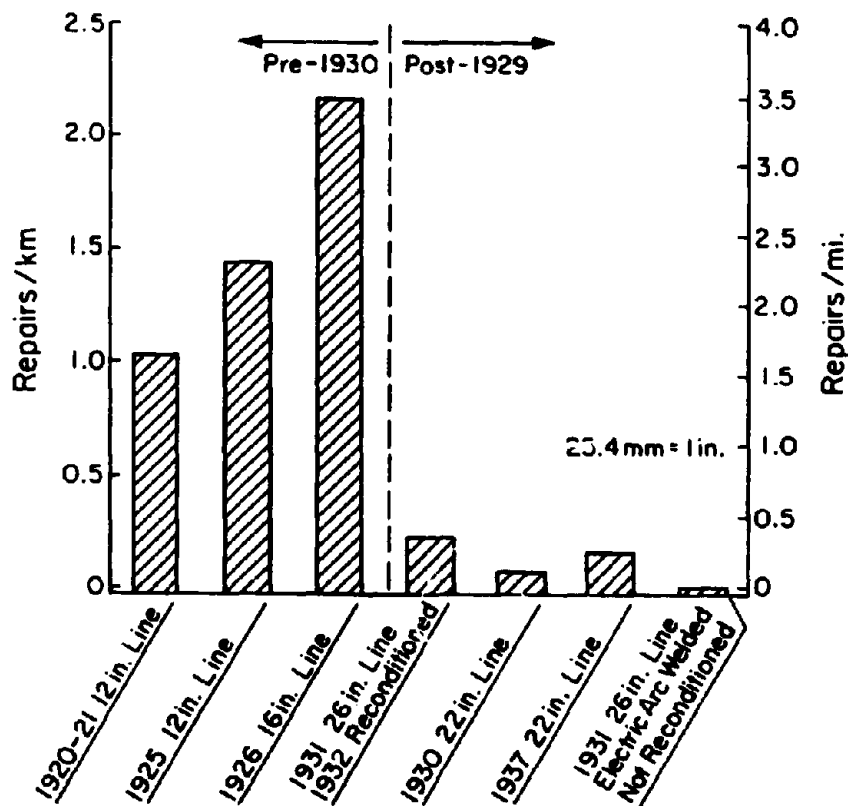
FIGURE 2-7. Damage Rates for Gas Transmission and Supply Lines Affected Predominantly by Traveling Ground Waves

A review of the repair records, and discussions with welders who repaired lines after the 1971 San Fernando earthquake, indicate that the damage listed in Table 2-III was predominantly at oxy-acetylene welds. This observation does not mean

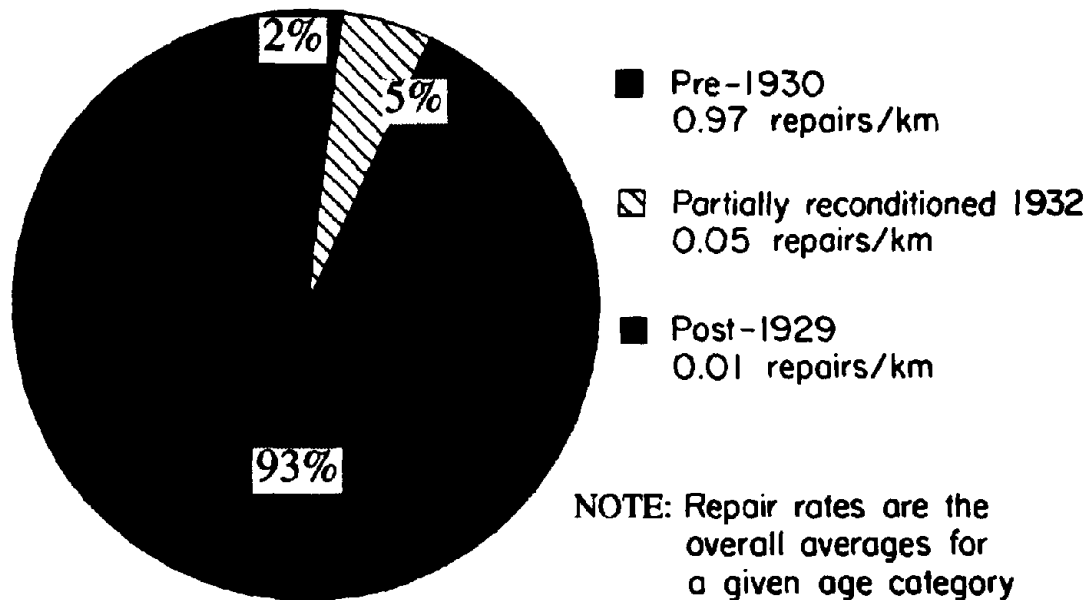
FIGURE 2-8. Pie Chart Showing Relative Proportions of Damage by Pipeline Age Category

Figure 2-8 shows the data for both earthquakes expressed as a pie chart in which pre-1930, post-1929, and 1932 reconditioned pipelines are distinguished. It should be recognized that virtually all pipelines in the post-1929 category are known to have been electric arc welded, with the exception of Line 80.90 and a portion of Line 119, for which no records could be found about the types of welds. Pre-1930 pipelines account for approximately 93% of all damage associated with traveling ground waves. Only 2% of the damage was in unreconditioned post-1929 lines. Moreover, there is a substantial difference in the overall average repair rate associated with a given age category. The pre-1930 damage rate is nearly 20 times larger than the 1932 partially reconditioned pipeline rate, and nearly 100 times that of the post-1929 damage frequency.

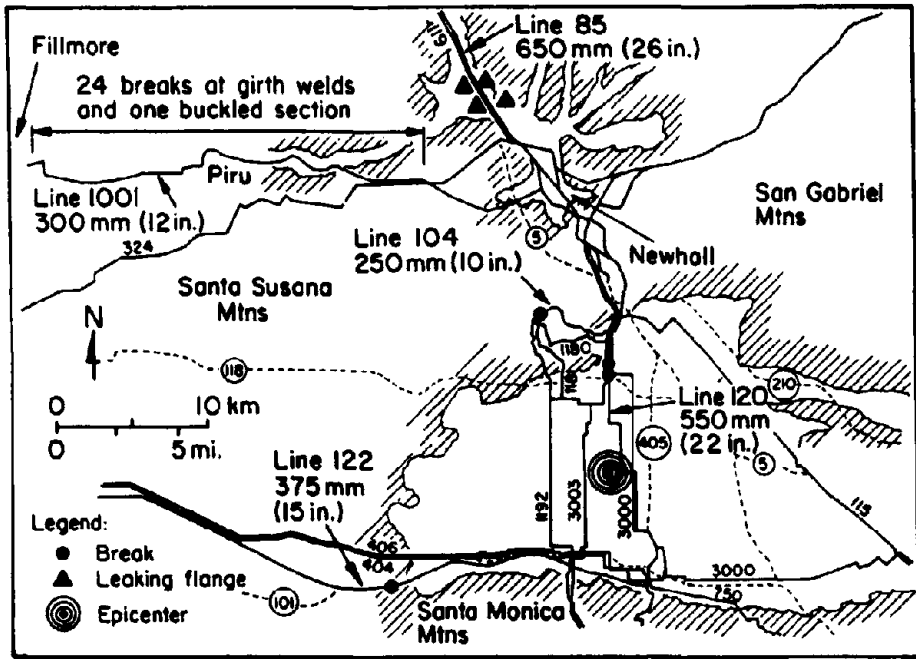
FIGURE 3-1. Map of Gas Transmission Pipelines in the Area of Strong Ground Shaking

There were 35 non-corrosion related repairs in the transmission system, of which 27 were at cracked or ruptured oxy-acetylene girth welds in pre-1932 pipelines. Figure 3-1 shows a plan view of selected transmission pipelines in the area of most severe ground shaking. Locations of damage in the form of pipeline breaks and leaking flanges are shown in the figure.

As shown in Figure 3-1, there were 24 breaks at oxy-acetylene girth welds and one location of buckled pipe in Line 1001, which conveys gas between Newhall and Fillmore, many of which were in Pico and Potrero Canyons. Line 1001 was constructed in 1925, and was operated at the time of the earthquake at 1.7 MPa (245 psi) internal pressure. The pipeline is 300 mm (12 in.) in diameter, with 5.6-mm- (0.22-in.)-thick wall of unknown grade steel.

Of the 25 repairs in Line 1001, 18 were made in Potrero Canyon. Six breaks in oxy-acetylene welds were located in areas adjacent to the Santa Clara River east of Piru and west of Potrero Canyon. One oxy-acetylene weld ruptured at the eastern city limits of Fillmore, leaving a crater approximately 2.7 m (9 ft) deep

and 4.5 m (15 ft) by 6 m (20 ft) in area. Gas escaping at the location of this break under Highway 126 was ignited by a downed power line.

Flange leaks occurred at the four locations shown in Figure 3-1 at sections of aboveground piping. There was also a break in an oxy-acetylene weld in Line 85 at a location approximately 39 km (24 mi.) northwest of Newhall, which is not shown in the figure. Damage was mainly in the form of flange separation and leaking gaskets. One of the flanges shown in Figure 3-1 was fractured. At the damaged locations, Line 85 is a 650-mm- (26-in.)-diameter pipeline with a pipe wall 6.4 mm (0.25 in.) thick, of Grade A steel, operated at MAOP of 2.2 MPa (317 psi). The ruptured oxy-acetylene weld and four leaking flanges occurred in a partially reconditioned portion of Line 85, which is described in Subsection 2.3.3. The weld failure was at an original oxy-acetylene weld.

A fractured oxy-acetylene girth weld was repaired in Line 122 at the location shown in Figure 3-1. Although this pipeline is not operated as a transmission line, it nevertheless is described in this report because of its relatively high operating pressure of 1 MPa (150 psi). The pipeline was installed in 1927 with oxy-acetylene girth welds, 6.4-mm- (0.25-in.)-thick wall, and steel of unknown grade.

As shown in Figure 3-1, there was a break in Line 104 inside the Aliso Canyon Gas Storage Field. The pipeline is 250 mm (10 in.) in diameter and has an MAOP of 1.6 MPa (228 psi). It was constructed with electric arc girth welds in 1941. The pipe has a 5.2-mm- (0.203-in.)-thick wall of unknown grade steel.

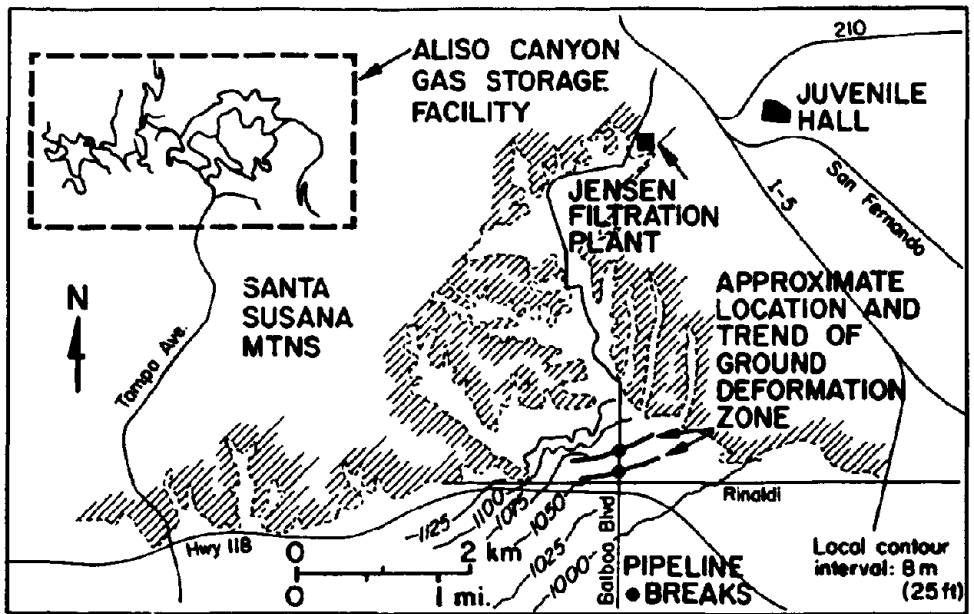
FIGURE 3-2. Map of the Area North of the Northridge Earthquake Epicenter

Figure 3-2 is a map of the area just north of the earthquake epicenter, showing the Aliso Canyon Gas Storage Facility and the locations of two gas transmission line breaks on Balboa Blvd. The Aliso Canyon facility, which covers some 14.7 km² (3,600 acres) and 56 km (35 mi.) of access road, is used to store gas in an underground reservoir that once was used for oil production. Gas is injected during low demand summer months and withdrawn during high demand winter months. Earthquake effects in the facility included deformation of aboveground pipe supports, displacements of runs of injection and withdrawal lines, and structural damage to a fin fan unit used to cool compressed gas before its injection in storage wells. The supply of gas from Aliso Canyon was interrupted for five days.

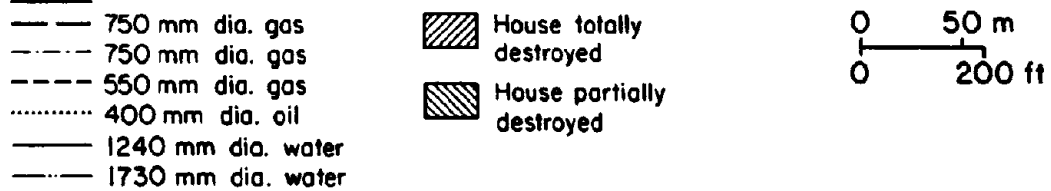
FIGURE 3-9. Map of Major Pipelines, Fire Damage, and Ground Deformation on Balboa Boulevard

Figures 3-9 and 3-10 show maps of the pipelines in Balboa Blvd. near the zones of permanent ground deformation. In addition to numerous distribution mains, there were six transmission and water trunk lines at this site. There were two 750-mm- (30-in.)-diameter gas transmission lines constructed of X-52 steel in the 1950s which were not damaged. There was a 400-mm- (16-in.)-diameter petroleum pipeline, operated by the Mobil Oil Corporation, which was not damaged. The pipeline was composed of X-52 steel and installed in 1991. Two water trunk lines, the 1,240-mm- (49-in.)-diameter Granada and the 1,730-mm- (68-in.)-diameter Rinaldi Trunk Lines, failed in tension and compression in the tensile and compressive zones of ground deformation, respectively.

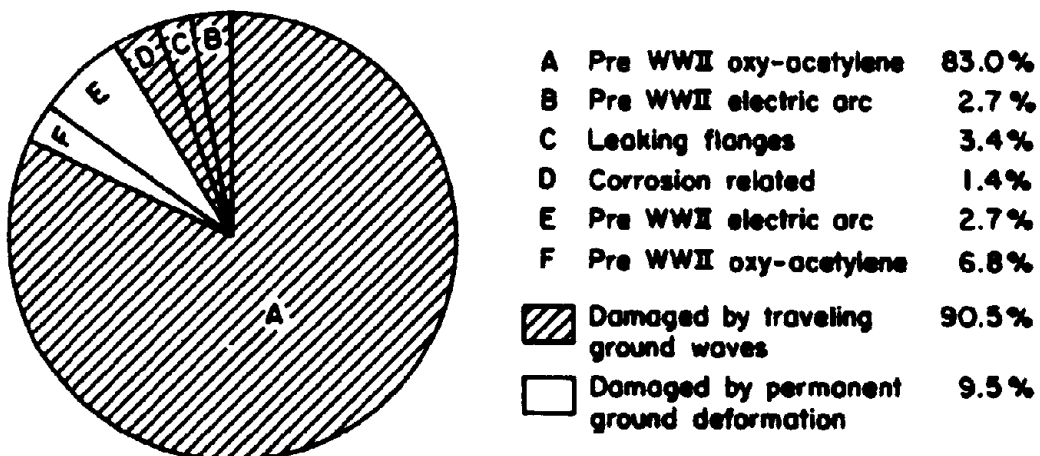
FIGURE 4-1. Pie Chart Showing Relative Proportions of Earthquake-Related Repairs Associated with Various Categories of Damage

Table 4-1 summarizes all gas transmission pipeline repairs which can be related to earthquake effects, covering more than 60 years of earthquake experience in southern California, from the 1933 Long Beach to the 1994 Northridge earthquake. Figure 4-1 presents similar information in the form of a pie chart. During this time, there were 11 earthquakes with local magnitudes equal to or greater than 5.8 with epicenters inside the area of transmission facilities operated by SoCalGas. Evidence of transmission line damage could be found for only four of these events, including the 1952 and 1954 Kern County, 1971 San Fernando, and 1994 Northridge earthquakes. The table includes damage from traveling ground waves and permanent ground deformation. Damage is listed for breaks in both pre-WWII oxy-acetylene and electric arc welded pipelines, leakage at locations of corrosion, and leaking flanges.

Table 4-I and Figure 4-1 have been developed on the basis of existing repair records. It should be recognized that the oxy-acetylene welded Line 1001 was so heavily damaged by the 1971 San Fernando earthquake that over 8 km (5 mi.) of the line were abandoned. Hence, an accurate account of repairs to this section of pipeline could not be included in the data set.
