REPORT NO.
UCB/EERC-95/11
OCTOBER 1995

STUDIES IN STEEL MOMENT RESISTING BEAM-TO-COLUMN CONNECTIONS FOR SEISMIC-RESISTANT DESIGN

BRENT BLACKMAN
EGOR P. POPOV

UCB/EERC-95/11
Earthquake Engineering Research Center
College of Engineering
University of California at Berkeley

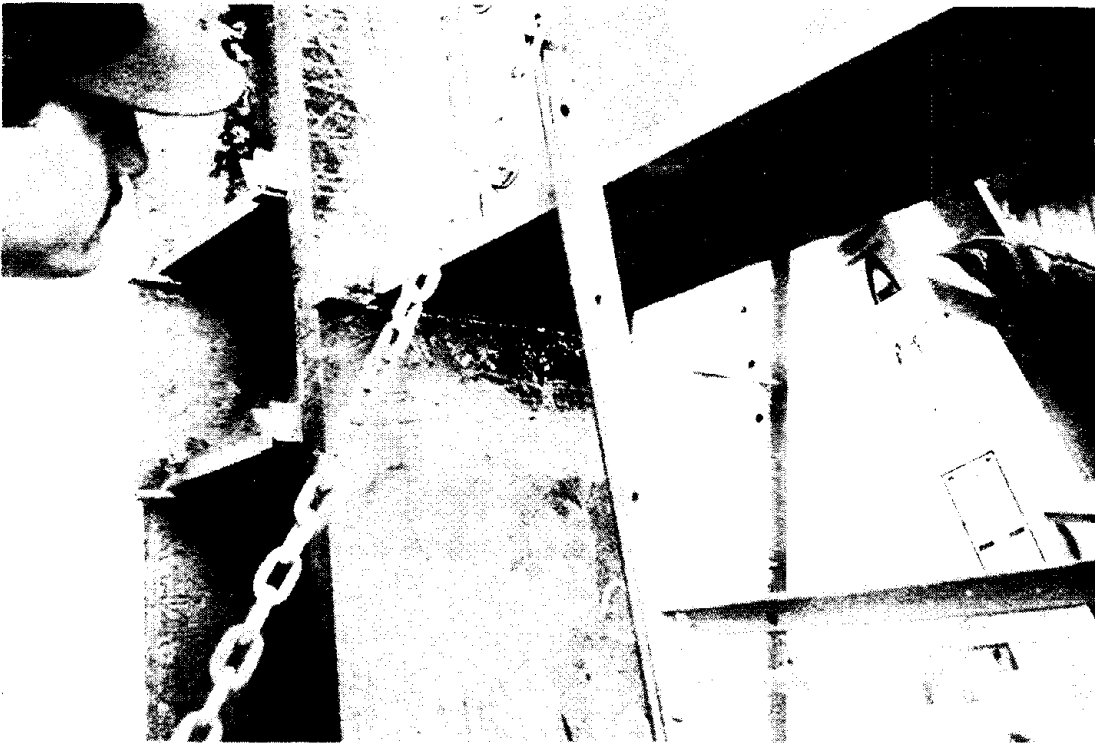
Figure 4-9. Visual Inspection of Bottom Beam Flange Weld after Backup Bar Removal

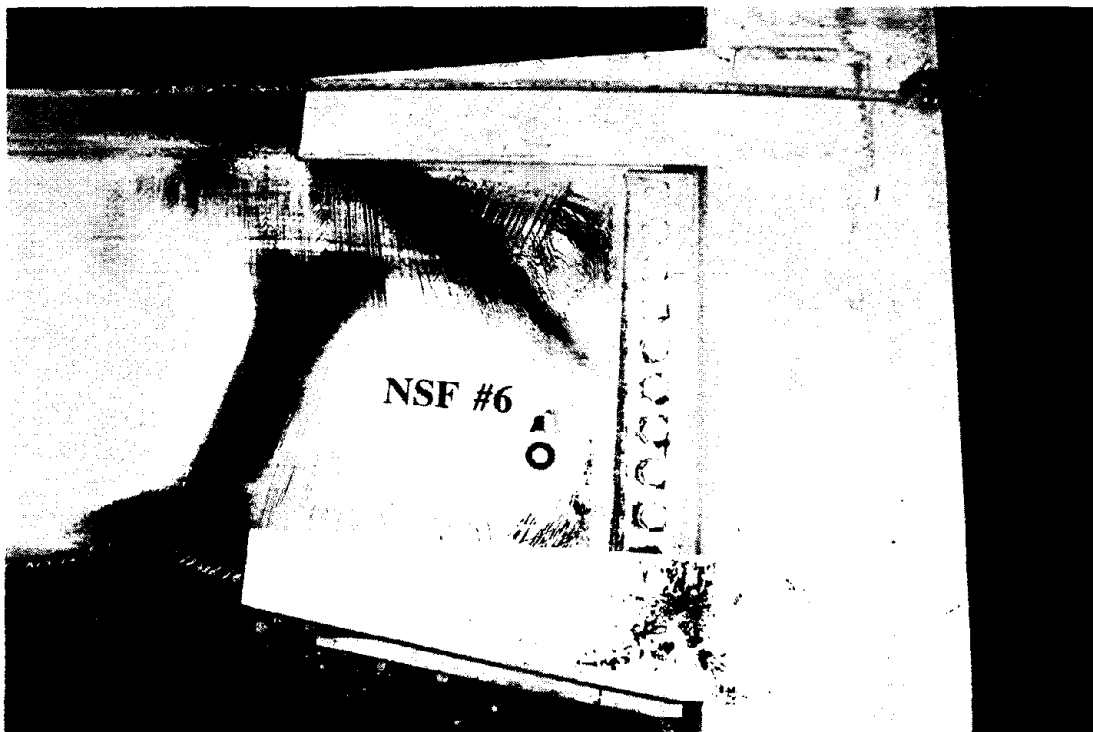
Figure 4-30. NSF Specimen #6 Joint after Test

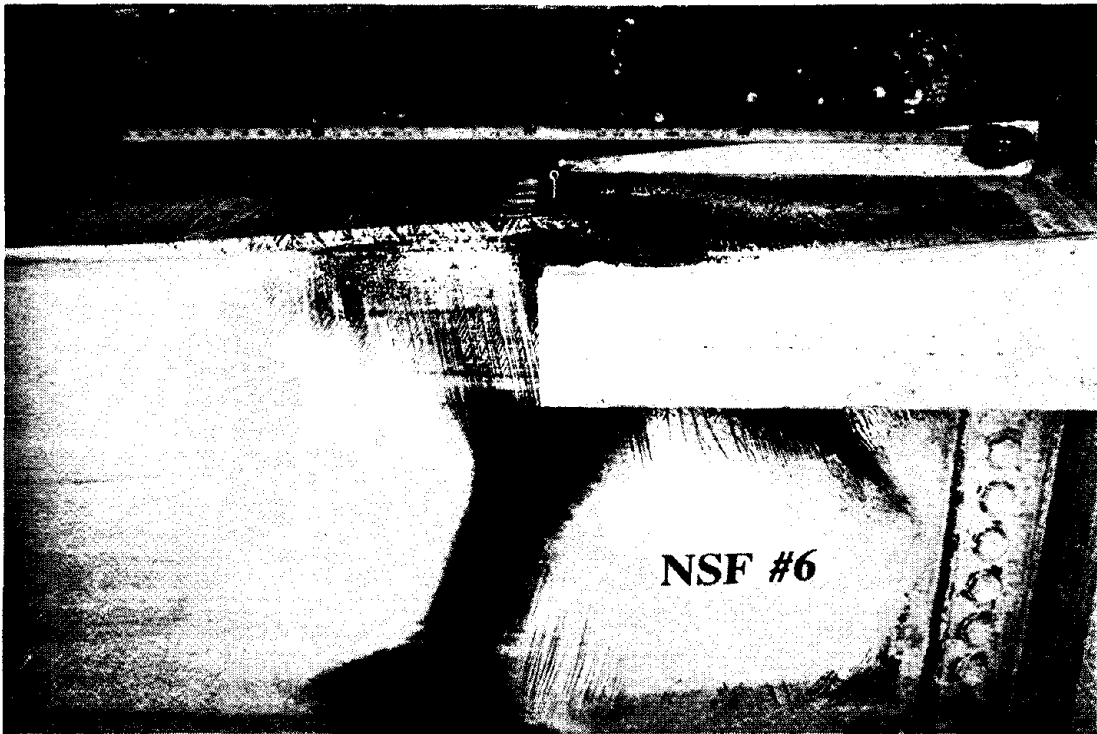
Figures 4-39 through 4-43 show the damaged connection after the test. Both top and bottom beam flanges yielded over a length of approximately 4 ft. from the column face. Yielding also occurred across the depth of the beam at the end of the tees. Likewise, both top and bottom beam flanges as well as the web buckled near the end of the reinforced area; a plastic hinge formed at this location. As discussed, two of the beam flange-to-tee web welds gradually tore during the experiment. One tear was apparently the result of the top beam flange buckling. On the other hand, the second tear, which prematurely unzipped at the bottom beam flange, was most likely due to a poor quality weld. Nonetheless, it is suggested that these welds be oversized near the end to the tees in an effort to accommodate local flange buckling of the beam. Another method to prevent peeling of the beam flanges from the tees would be to bolt the web of each tee to the beam flanges near the end of the reinforcement.

Figure 4-39. Yield Pattern over 4-ft. Length of Top Beam Flange at End of Test

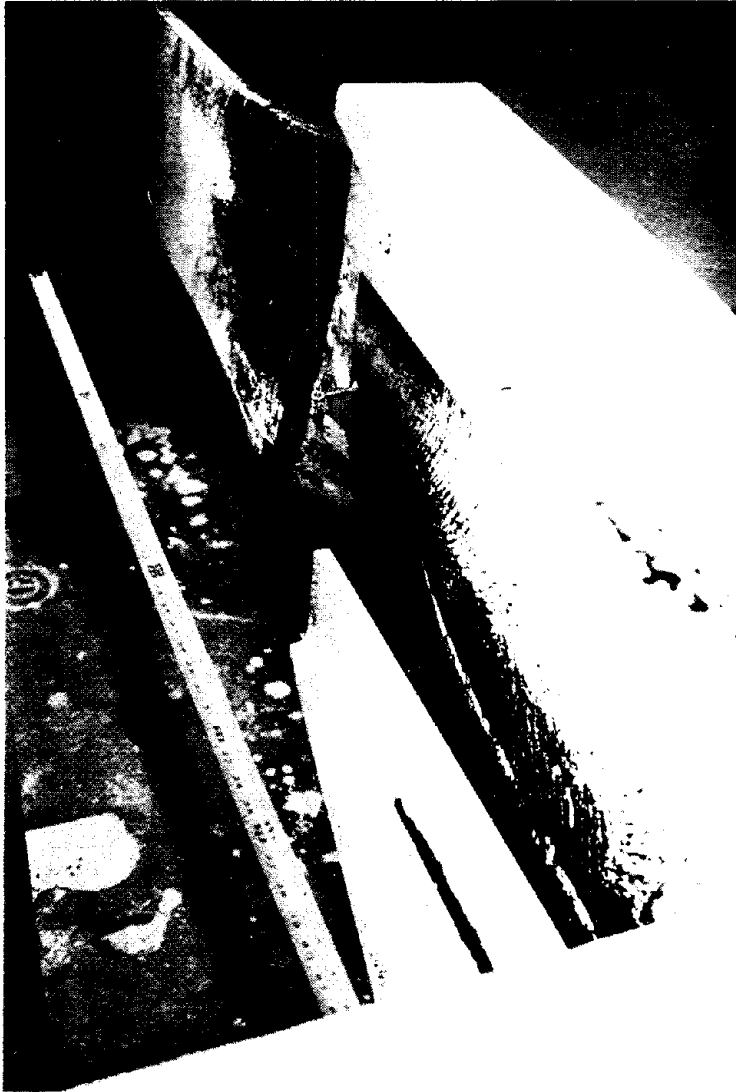
Figure 4-41. Yield Pattern and Buckling of Bottom Beam Flange after Test
