REPORT NO.
UCB/EERC-95/01
AUGUST 1995

EARTHQUAKE ENGINEERING RESEARCH CENTER

**GEOTECHNICAL RECONNAISSANCE
OF THE EFFECTS OF THE
JANUARY 17, 1995,
HYOGOKEN-NANBU EARTHQUAKE, JAPAN**

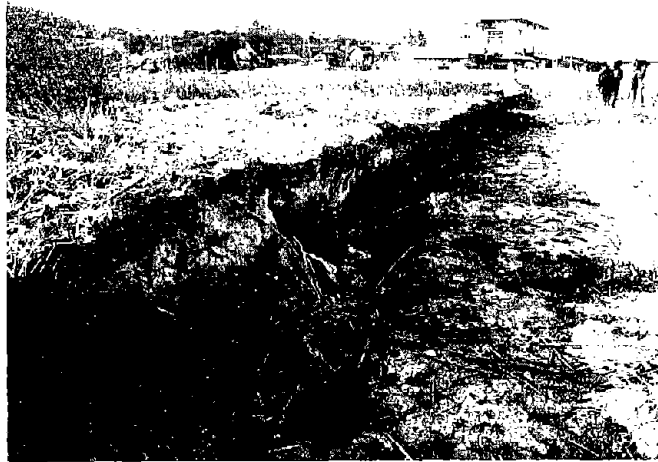
Figure 2.8: Scarp of the Nojima fault on Awaji Island showing both vertical and horizontal offset. Source: Newsweek, February 1, 1995, Japan edition.

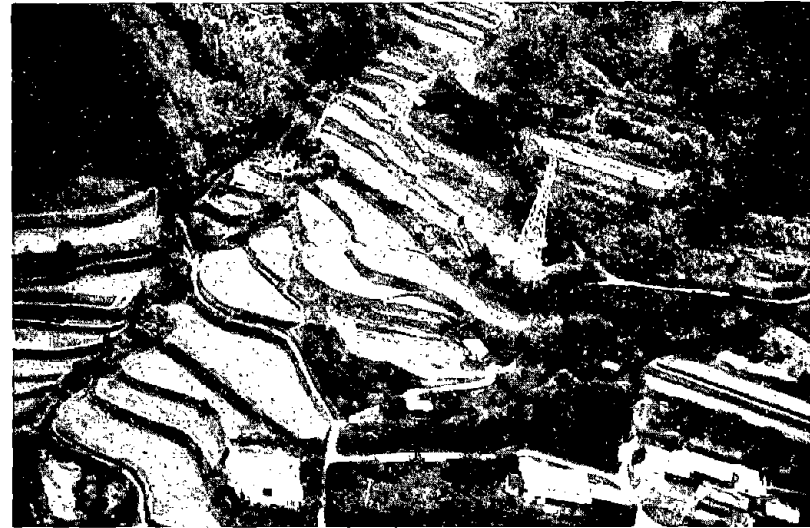
The earthquake produced surface rupture with an average horizontal displacement of 1 to 1.5 m and a maximum recorded horizontal displacement of 1.7 m on the Nojima fault, which runs along the northwest shore of Awaji Island (Nakata, personal communication, 1995). Figure 2.7 illustrates the general characteristics of the topography along the Nojima fault and the surface expression of the predominantly strike-slip faulting. A close-up view of a scarp of the Nojima fault, which showed both vertical and horizontal offsets (at one spot, these offsets were measured to be approximately 1.2 m right-lateral and 15 cm dip-slip (east side up), respectively) is shown in Figure 2.8. The house shown in the background in Figure 2.8 was nearly offset by the surface fault rupture, but it appeared to be only slightly damaged by the ground shaking. Just to the north of this area, the Nojima fault cut across a number of wet rice paddies before continuing along the base of the hills formed from the uplift of Pre-Miocene bedrock. It was more difficult to see the surface expression of the faulting in the wet rice paddies, and in areas the faulting was expressed as an echelon shears with minor offsets across them. At numerous locations the observed surface expression of the fault was fairly narrow (<5 m wide), and this is consistent with the style of faulting (fairly linear strike slip faulting through shallow soil deposits overlying the bedrock). However at a few locations, the ground breakage zone was noticeably wider. For example, at the northern end of the surface expression of the Nojima fault where it travels offshore of Awaji Island, about 1 m of horizontal displacement was spread across a zone roughly 50 m wide, which contained several ground cracks. Most of the offset was concentrated on three or four cracks within the middle of this zone. Vertical displacement across the observed surface rupture of the Nojima fault varied considerably with an average vertical displacement of 0.5 to 1 m (east side up) and a maximum vertical displacement of 1.3 m (east side up). At the southern end of the exposed ground rupture, the observed vertical displacement decreased and was actually in the opposite sense with the west side moving up slightly (<0.2 m) with respect to the east side.

Figure 2.7: Aerial view of northwest shore of Awaji Island showing the surface rupture of the faulting. Note the surface rupture that cuts across the middle of the picture.

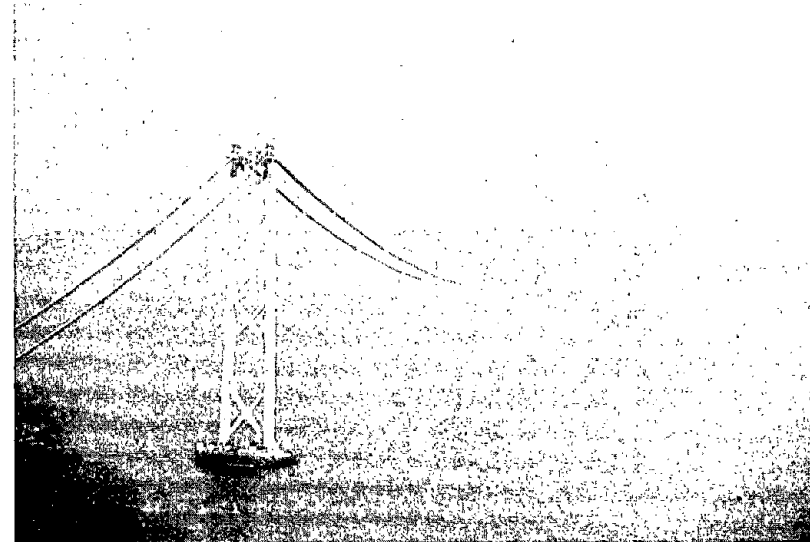
in a right lateral sense with respect to the northern tower (Fig. 2.9). The surveys also found two fault rupture segments that span a length of about 7 km in the region offshore from the northeast tip of Awaji island, parallel to the Nojima fault but offset from it by about 5 km. Near the onshore projection of these underwater rupture segments, a releveling survey after the earthquake found a change in elevation of 26 cm over a distance of 6 km between Tarumi and Suma Wards in western Kobe. Ground surface deformations, which are possibly associated with surface ruptures, have been identified east of Kobe in the Takarazuka area on a number of active fault strands just south of the Arima-Takatsuki fault zone (see Figure 2.10, M. Seo and Y. Yoshimi, personal communication, 1995). Aerial reconnaissance identified possible right lateral surface rupture expressions to the southwest of this area across the Muko River along the general trend of the strike of identified active faults in the area. A close-up view of a tennis court which shows ground cracks with noticeable right lateral offsets is shown in Figure 2.11. This feature has not been field-checked, and there are numerous fills and buried stream deposits in the area, so ground cracking may have resulted from phenomena other than faulting. However, field data provided by M. Seo and general observations of damage in the Takarazuka area suggest that there may be a correlation between some concentrations of heavily damaged areas (both buildings and transportation systems) and active fault segments that expressed some ground movement during the Kobe Earthquake. Additional study is warranted to confirm these preliminary observations.

Figure 2.9: Akashi Kaikyo suspension bridge. The tower in the foreground was offset 1.1m RL with respect to the tower to the north. The distance between the towers is 2000 m.

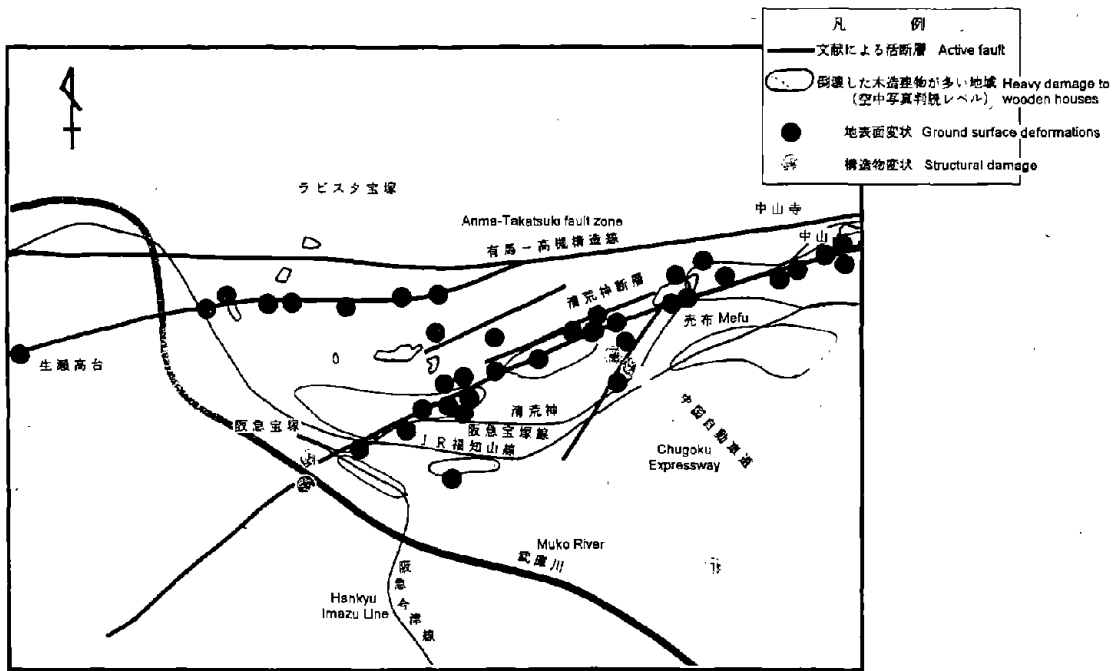
Figure 2.10: Map of the Takarazuka area showing locations of ground surface deformations, active faults, and associated damage. Source: M. Seo of Kokusai Kogyo Co., Ltd.

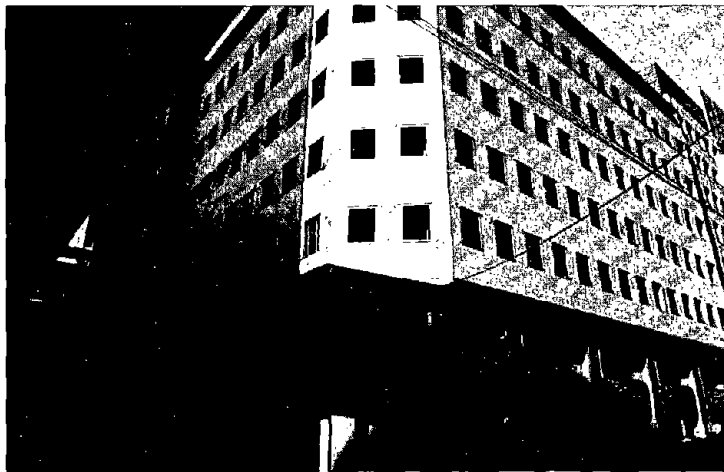
direction. For example, the seven story office building shown in Figure 2.16 has shear cracking of the building cladding, with extensive window damage, in the fault-normal direction and little damage in the fault-parallel direction. Buildings characteristically displayed interstory damage, such as that shown in Figure 2.17, in the fault-normal direction. Moreover, the collapse of the Hanshin elevated expressway appeared to result from strong displacement pulses in the fault-normal direction, which is perpendicular to the orientation of the highway.

Figure 2.16: Office building in Kobe with significant cladding damage in the fault-normal direction (left side) and little damage in the fault-parallel direction. Photograph courtesy of C. Thewalt, UC Berkeley.

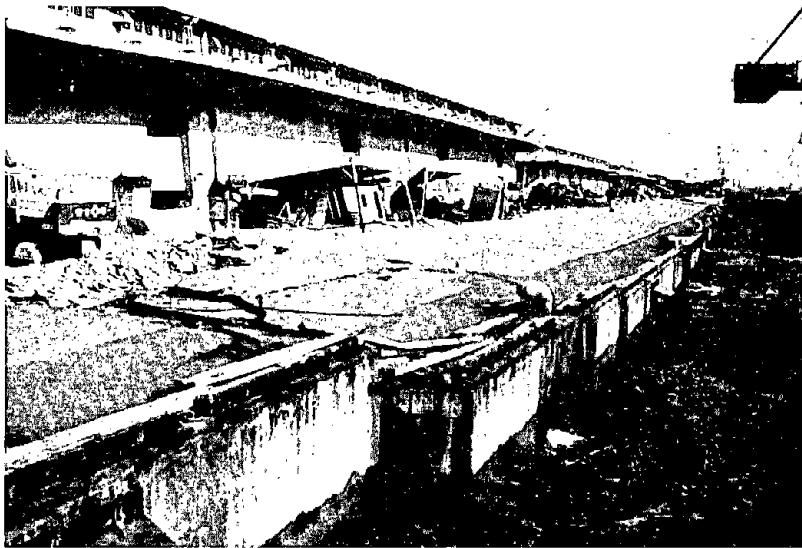
Figure 3.12: Example of lateral displacement of older quay walls on Port Island.

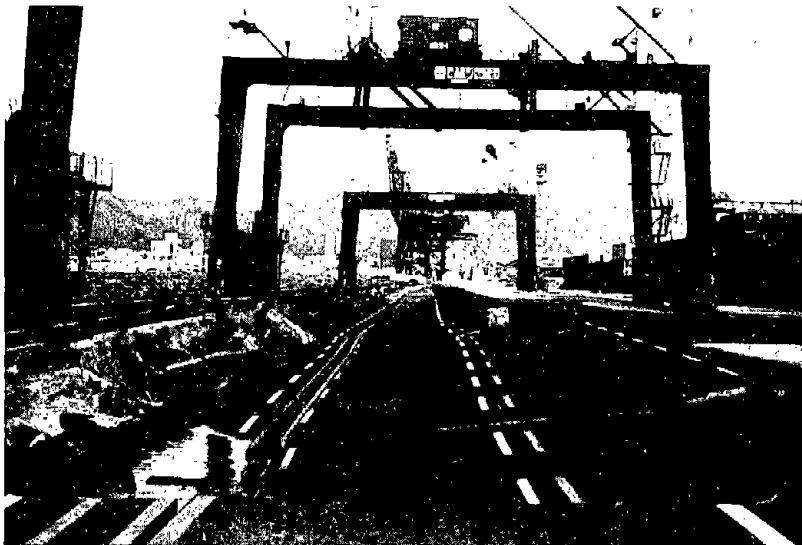
Depressions and grabens, as deep as 4 m and as wide as 30 m, formed pervasively behind the quay walls, and lateral spreading caused ground fissures parallel to the walls as far as 200 m inland. Unfortunately, nearly all of the major cranes used for transferring containers and other freight to and from ships were located within the graben or lateral spread zones. These structures were pulled apart at their bases by lateral ground movements and tilted by the subsidence. Supporting crane rails were also displaced and deformed (Figures 3.14 and 3.15). The extensive damage to the giant cranes was particularly evident on Rokko Island (Figure 3.16). The outward movement of the sea wall by as much as 3 m spread the crane legs off the wheel bogeys and, in a few instances, led to collapse of the cranes (Figure 3.17). In other instances, the movement led to deformation of crane legs and formation of plastic hinges above or within the horizontal brace (Figure 3.18). The consequences of the loss of the port facilities is dramatically illustrated in Figure 3.19 by the large number of vans and trucks ready for export before the earthquake, which were trapped in the flooded settled areas behind the displaced sea wall.

Figure 3.14: Graben caused by lateral displacement of the quay wall on Port Island. Note the cranes straddling the graben and the lateral deformation of the crane rails.

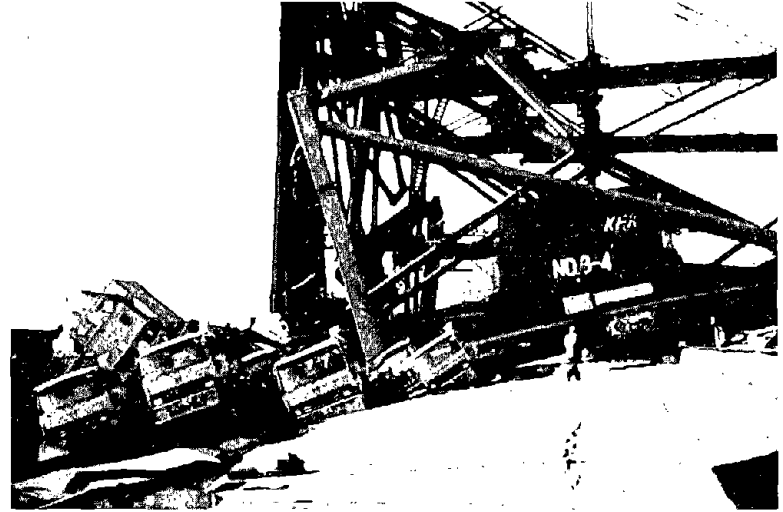
Figure 3.17: Collapse of crane due to lateral movement (~2 m) of quay wall on Rokko Island. Note settlement of 1-2 m also occurred behind wall.

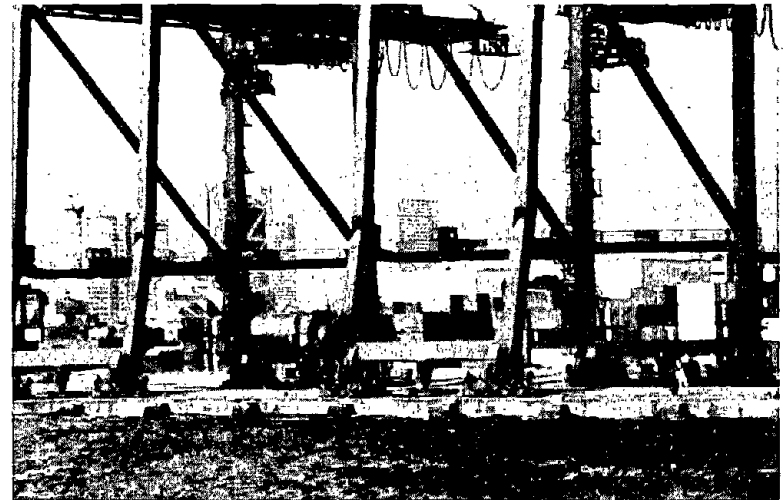
Figure 3.18: Buckled or plastically yielded crane legs due to about 2 m of spreading between crane rails as a consequence of lateral caisson displacement.

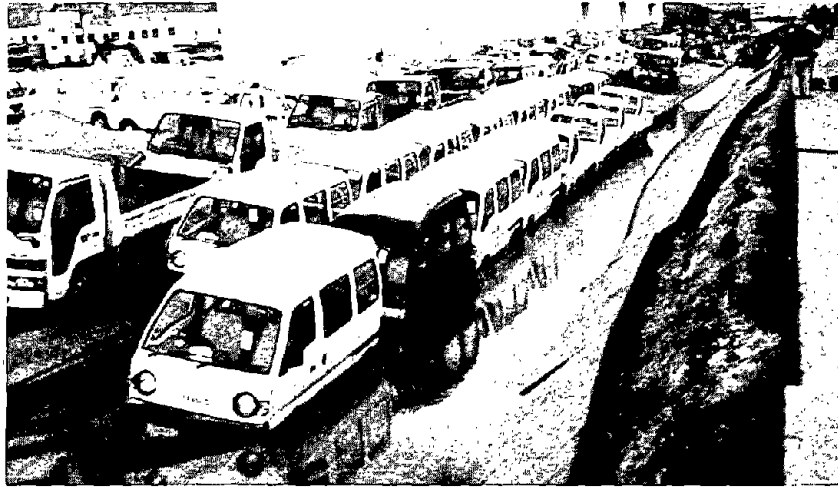
Figure 3.19: Vans and trucks ready for shipment before earthquake. Lateral spreading caused 1.5 m-2 m drop of paved surface and local flooding.

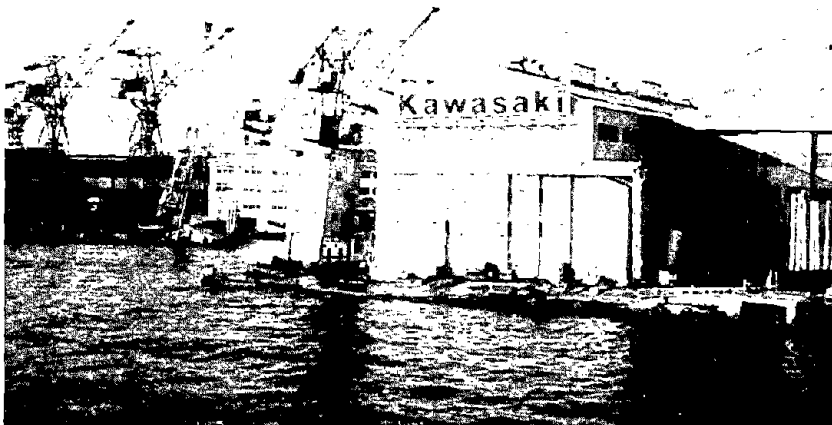
Kawasaki Heavy Industries. A Kawasaki Heavy Industries facility is located on the mainland waterfront south of the Harbor Land ferry terminal, as shown in Figure 3.1. The quay walls around one large warehouse were displaced laterally and settled vertically enough to drop the apron slabs below the water level and to severely tilt a large crane beside the warehouse (Figure 3.20). Damage also occurred to quay walls, warehouses, and crane facilities south and north of the warehouse.

Figure 3.20: Quay walls around a large Kawasaki warehouse displaced laterally and vertically enough to drop apron slabs below the water level and tilt large cranes.

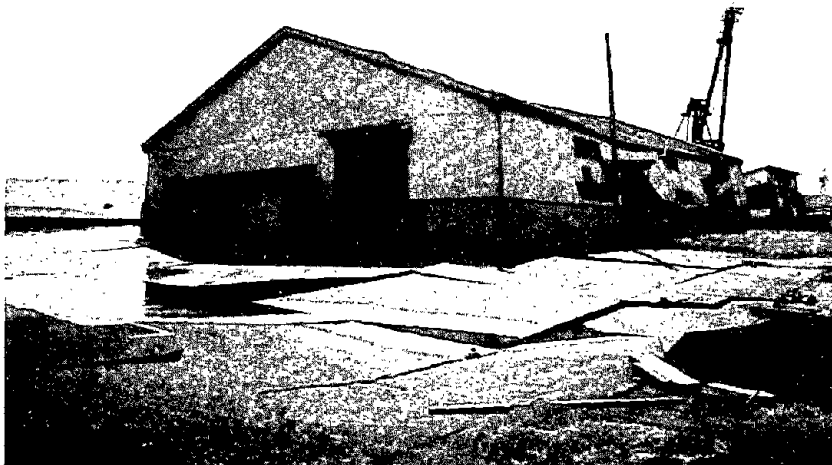
Figure 3.21: Damage to the end of Hyogo Pier No. 1

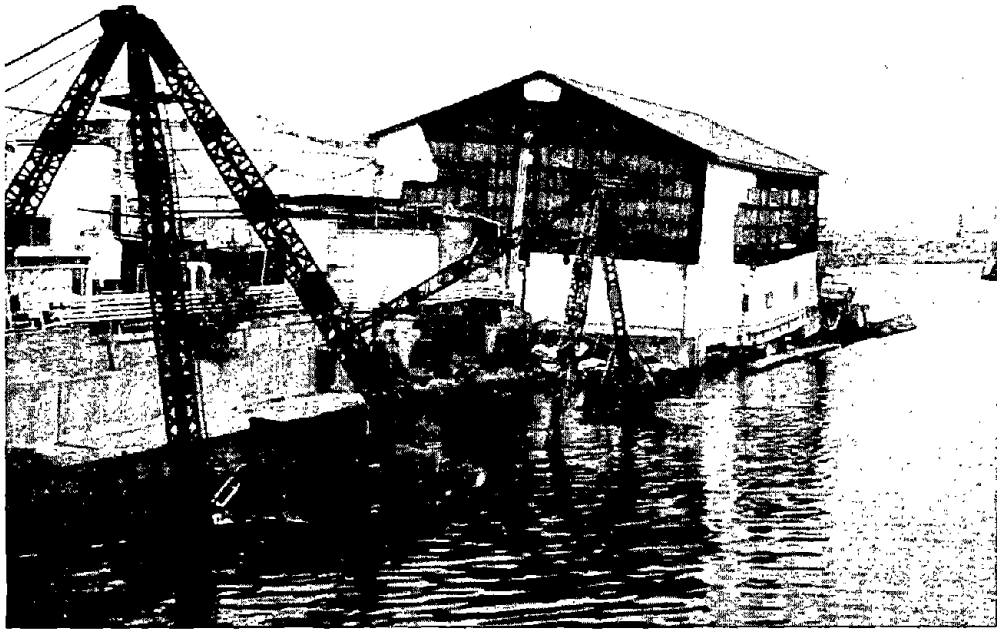
Figure 3.26: Channel on north side of Karumojima-cho (looking east).

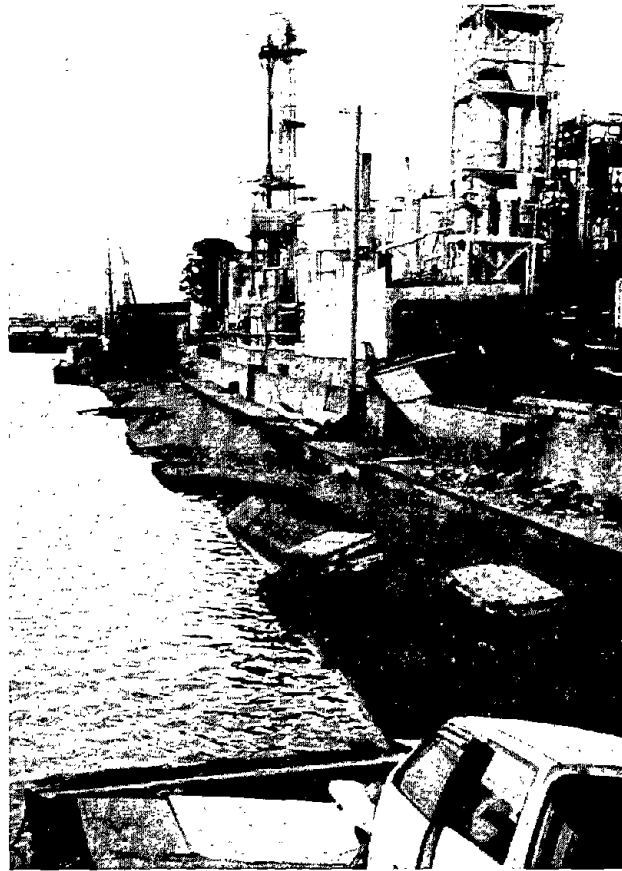
Figure 3.27: Channel on north side of Karumojima-cho (looking west).

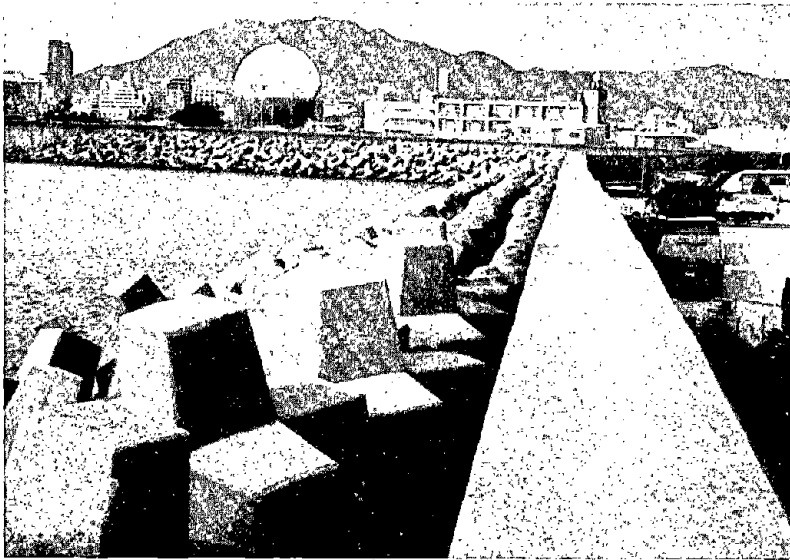
Figure 3.28: Dolos buttressed quay wall along west side of Karumojima-cho.

indicates that buttressing with reinforced concrete rip-rap had a beneficial restraining effect on wall movements at this location. The relatively good performance of buttressed quay walls was in sharp contrast to the large deformations of the non-buttressed quay wall. This difference in behavior warrants additional study. Similar beneficial buttressing was noted at Piers A, B, and C, at Maya-Futo (described below), except that in these instances the buttressing effect was through a pile-supported relieving platform.

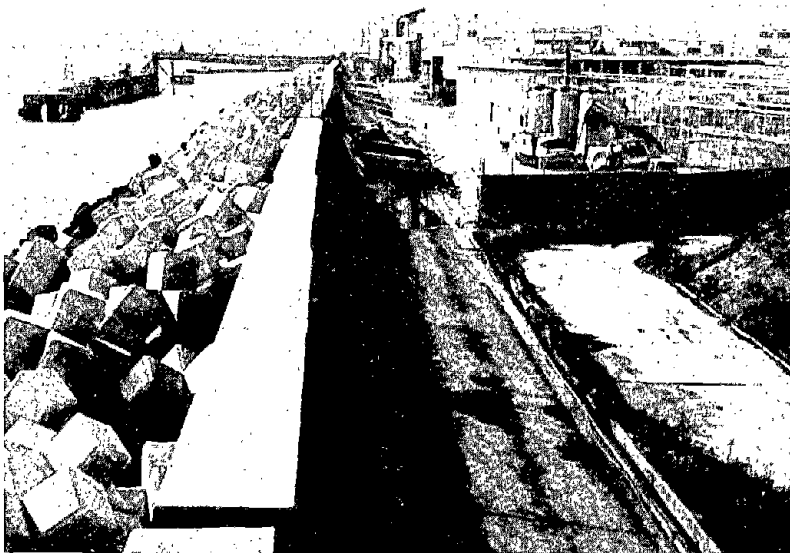
Figure 3.29: Dolos buttressed quay wall along south side of Minami Komaecho.

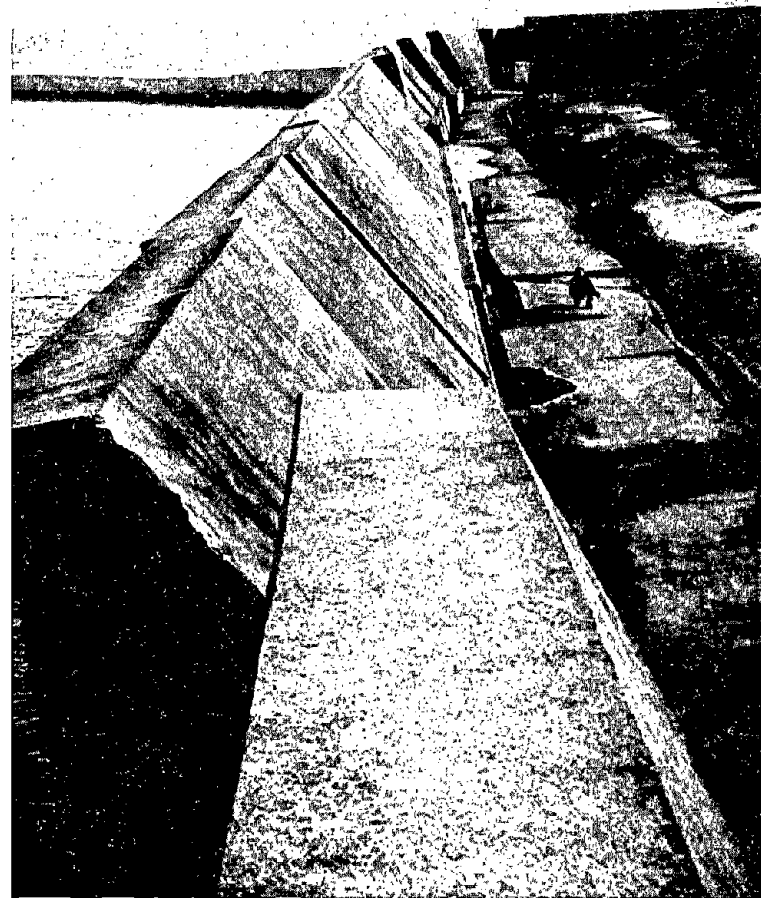
Figure 3.30: Quay wall along east side of Minami-Komaecho.

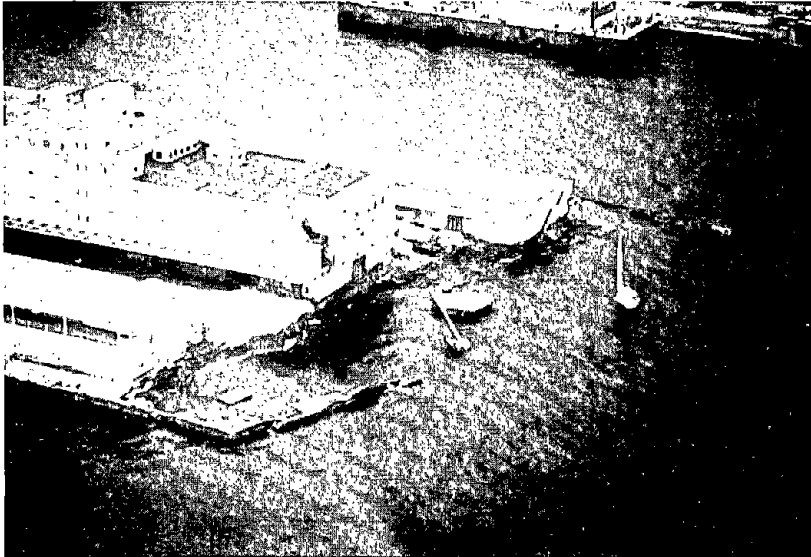
Onohama-cho. Onohama-cho is located north of Port Island (Figure 3.1). The quay walls at the south end of Shinko Pier No. 5 (the largest southward-extending pier) were severely deformed, dropping the foundation for a crane and much of the surrounding apron slabs below the water level. An aerial view of this damage is shown in Figure 3.31. The channel to the north of Onohama-cho was ringed with displaced quay walls and associated damage.

Figure 3.31: Pier No. 5 on Onohama-cho.

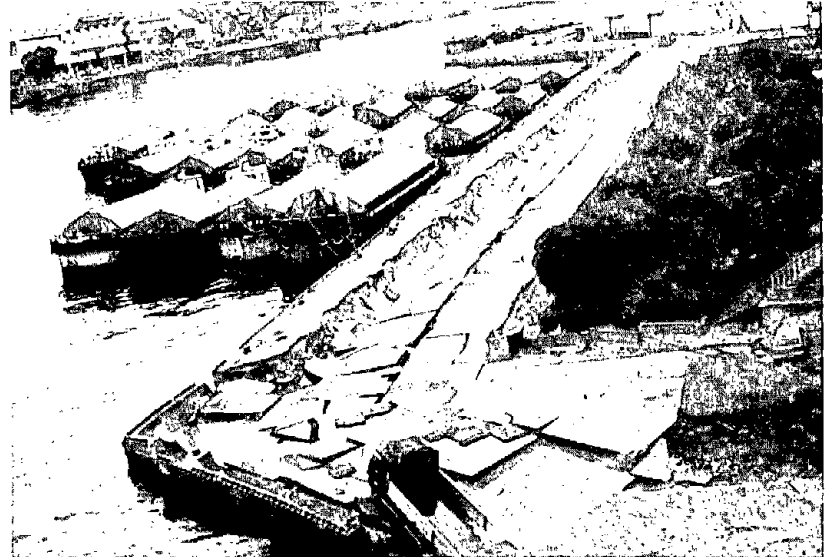
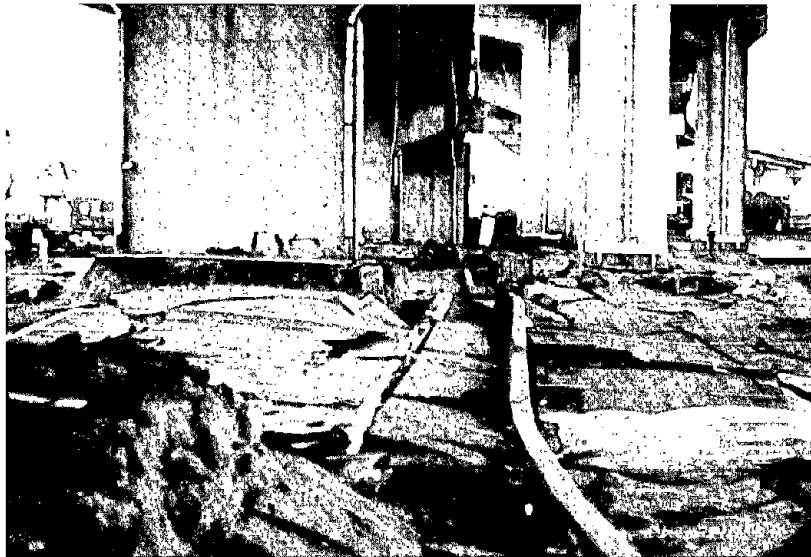
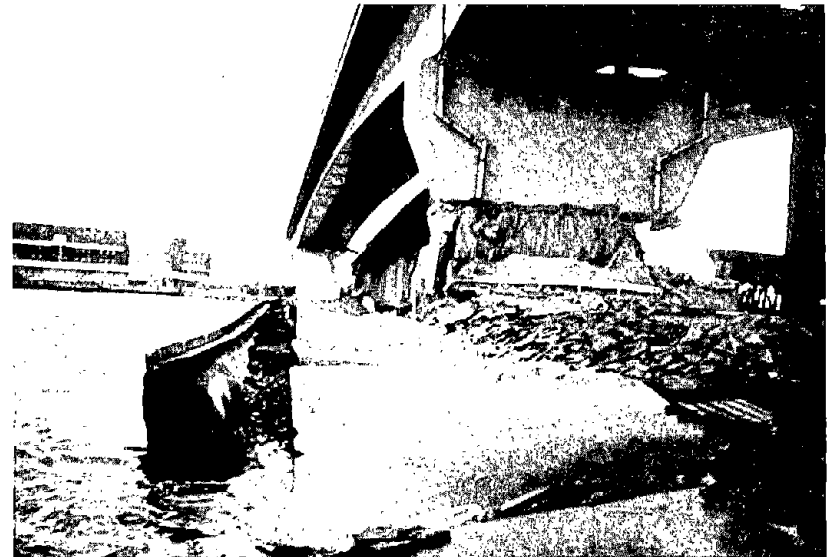
East Bank of the Maya-ohashi Bridge (Harbor Expressway). The Maya-ohashi bridge on the Harbor Expressway spans a channel between Onohama-cho and Maya-Futo north of Port Island. The eastern end of this bridge is elevated above a spit of land extending off Maya-Futo. Severe lateral spreading and differential settlements occurred on both the north and south sides of this spit beneath the Maya-ohashi bridge. On the north side of this spit, the outward displacement of a quay wall created a large graben and dropped a large truck halfway into the water (Figure 3.32). Differential settlements of roughly 1 m occurred around the piers of the elevated highway in the middle of this spit, as illustrated in Figures 3.33 and 3.34. These photographs also show the severe damage to the reinforced concrete bridge piers.

Figure 3.32: East bank of Maya-ohashi bridge: north side.

Figure 3.33: East bank of Maya-ohashi bridge: beneath elevated roadway.

Figure 3.34: East bank of Maya-ohashi bridge: south side.

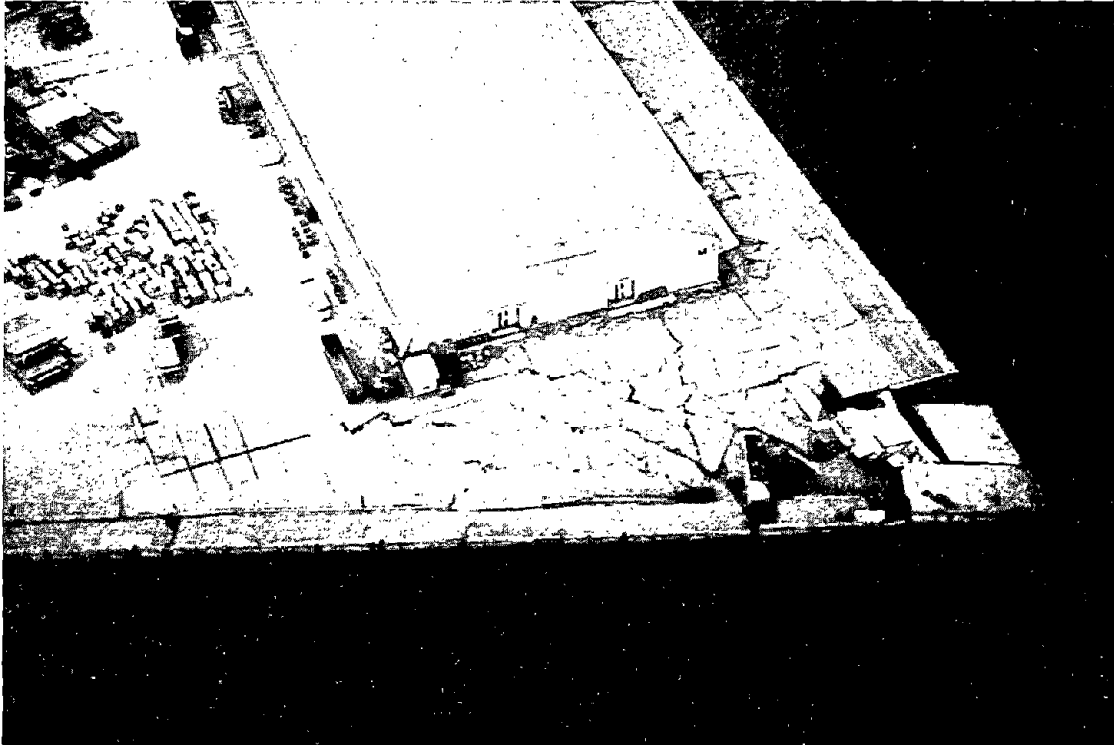
Maya-Futo. Maya-Futo is located to the north of Port Island, east of Onohama-cho (Figure 3.1). The quay walls for the four piers extending southward from the mainland were designed with strong pile foundations to resist seismic loading. An aerial view of the western-most pier (Figure 3.35) shows extensive cracking in the asphalt pavement and sand ejected by liquefaction across the entire pier. Quay walls at the southeast corner of this western-most pier were the most significantly deformed, with large gaps between quay wall blocks. Elsewhere, however, the quay walls experienced relatively little deformation.

Figure 3.35: Aerial view of western piers on Maya-Futo.

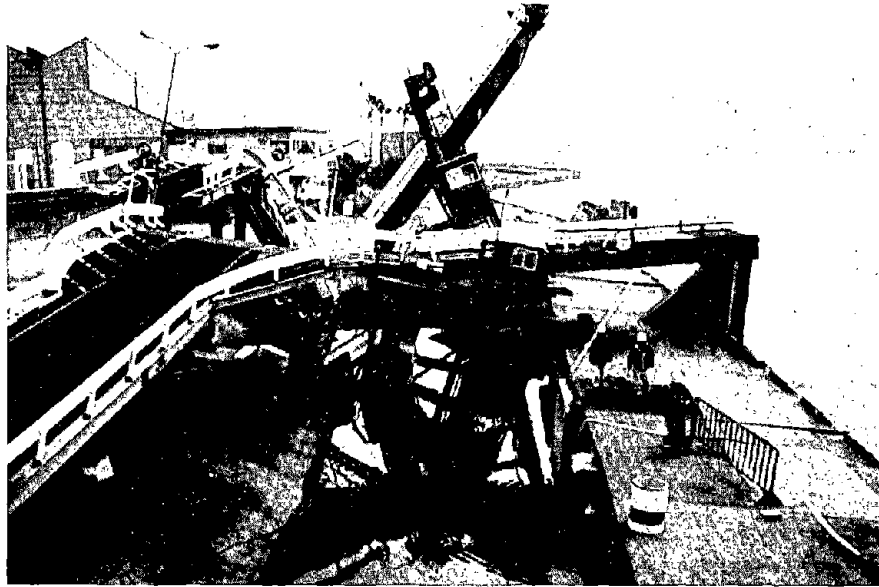
Higashi-Kobe Ferry Pier. The Higashi-Kobe Ferry Pier is located on the mainland to the north of Uozaki-Hamacho, as shown in Figure 3.1. This ferry pier includes four different berths with loading ramps for automobiles and passengers. The eastern two berths were inspected and, at both berths, the quay walls were displaced outward and large grabens formed that were 6 to 10 m wide and 2 to 3 m deep. The ramps for the east-end berth straddled the graben, were torn apart, and had collapsed (Figure 3.37). The columns supporting the inboard side of these ramp structures were apparently supported by groups of one to four piles. The exposed piles were approximately 30-cm-diameter steel pipe piles. Pile caps were dislodged from the supporting piles in several locations, as shown in Figures 3.38 and 3.39. The exposed piles were generally hollow, although some were partially filled with concrete. Embedment of piles into the pile cap appeared limited, with no apparent connecting steel ties, dowels, or other strengthening details.

Figure 3.37: Ramp structure at Higashi-Kobe ferry pier.

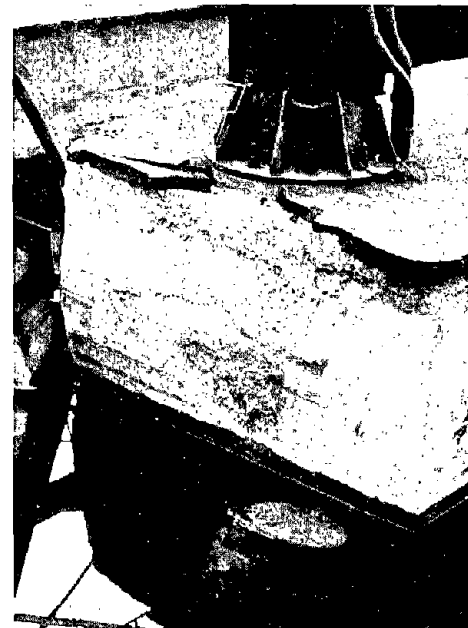
The inboard columns of the damaged ramp structures and the graben behind the displaced quay wall east of the terminal building were apparently supported by piles, in groups of four. These piles were approximately 35-cm-diameter steel pipe piles filled with concrete with some vertical reinforcing steel connecting the pile to the cap. The damage to the pile-to-pile-cap connection in the exposed piles at this location is shown in Figure 3.40. Overall, the damage to the pile foundations of the loading ramps at the Higashi-Kobe Ferry Pier was clearly a consequence of severe lateral displacement of the surrounding ground. This poor behavior contrasts with the good performance of pile-supported structures where liquefaction led to ground settlement, but not to large lateral ground deformations. This better behavior is described following section.

Figure 3.38: Pile caps for ramp structure at Higashi-Kobe ferry pier.

Figure 3.39: Pile caps for ramp structure at Higashi-Kobe ferry pier.

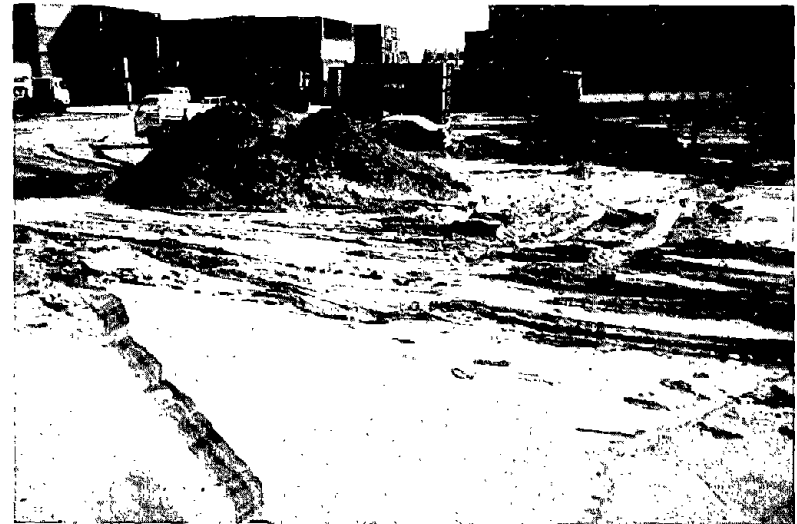
The interiors of the Rokko and Port islands settled as much as one meter with an average of about 0.5 m. This settlement was accompanied by pervasive eruption of large sand boils that flooded many areas and covered much of the island with sand boil deposits as thick 0.5 m (Figure 3.41). Ground settlements were relatively uniform, with most roadways and other open areas showing little evidence of differential ground deformation. Many fissures, however, opened in these areas and formed conduits through which sand boils erupted. Most of the structures on these islands, including many low- and high-rise buildings and a monorail system on Port Island, are founded on deep foundations, presumably piles and piers, that extend to competent material below the fill. These deep foundations generally performed well, remaining in place and providing uninterrupted support for the overlying structures. In nearly all instances, the ground subsided around the buildings, with the foundations remaining at the constructed elevation and providing a reference for estimating ground settlement (Figure 3.42). A common consequence of settlement was the protrusion of pile-supported structures above ground surface. For example, the ground around piers supporting the monorail on Port Island settled as much as 0.5 m relative to the pier caps (Figure 3.43).

Figure 3.41: View of sand deposits, as deep as 0.5 m, generated by eruption of sand boils and associated ground settlement. Pile of sand in center of photo was scraped up in preparation for transport from area.

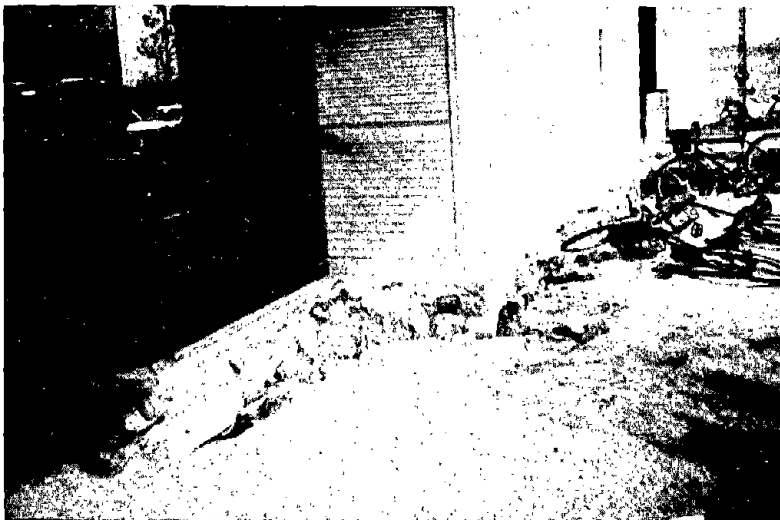
Figure 3.42: Approximately 0.3 m ground settlement around ferry terminal on Port Island.

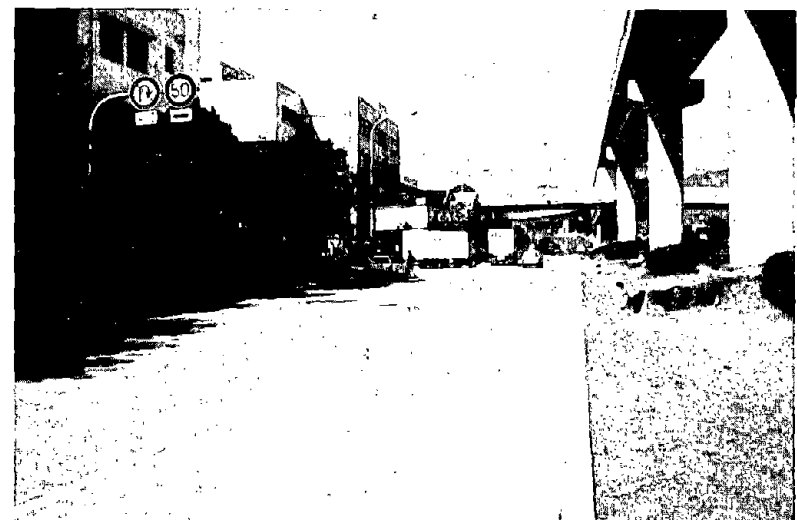
Figure 3.43: Pier supporting a section of elevated railway on Port Island rose relatively about 0.4 m as a consequence of ground settlement.

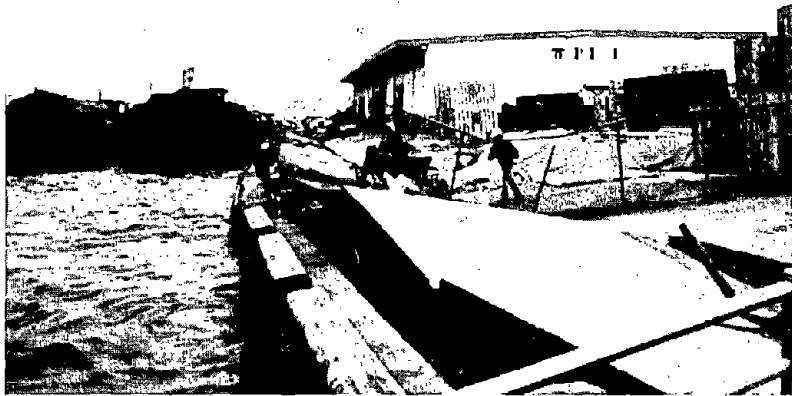
Many buildings on piles near the piers suffered little damage (Figure 3.44). However, inspection of foundation elements that were exposed to ground displacements beneath some buildings, revealed severe damage to piles due to lateral ground displacement. For example, Figure 3.45 shows a badly cracked pile with buckled reinforcing steel; this pile supported the corner of a low-rise building. This pile evidently was cast with nominal reinforcement and had been designed to resist vertical loads only. Another hollow concrete tube pile with nominal reinforcement under the same building fractured completely and was displaced about 20 cm (Figure 3.46).

Figure 3.44: Extensive lateral spreading, ~2 m, and associated settlement exposed warehouse foundation piles on Port Island.

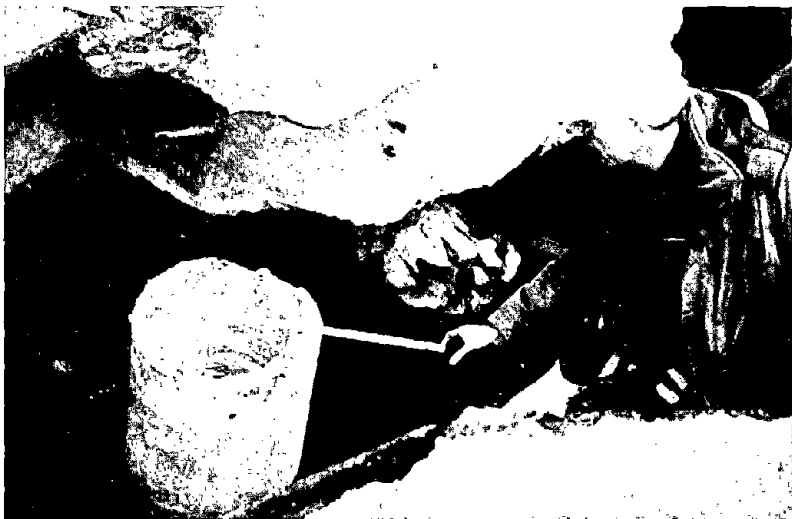
Figure 3.46: Sheared and translated hollow-tube pile which had little lateral resistance. Pile had supported warehouse building shown in Figure 3.44.

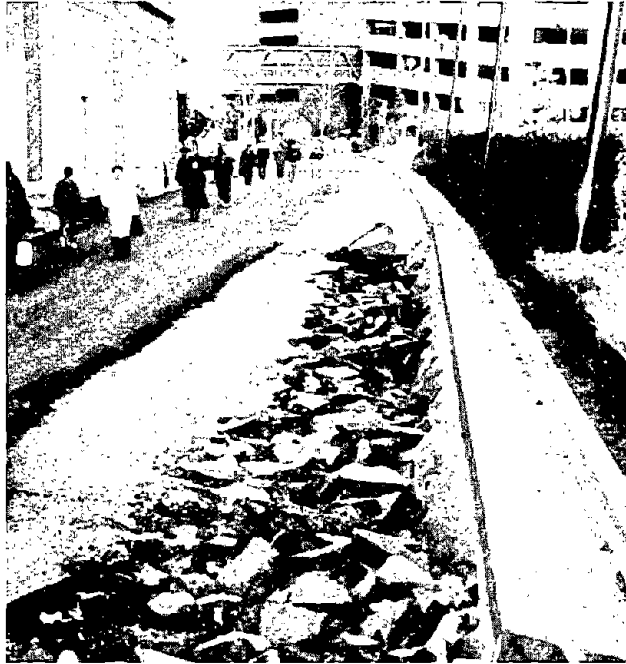
Figure 3.51: Lateral spreading on north side of Harborland ferry terminal.

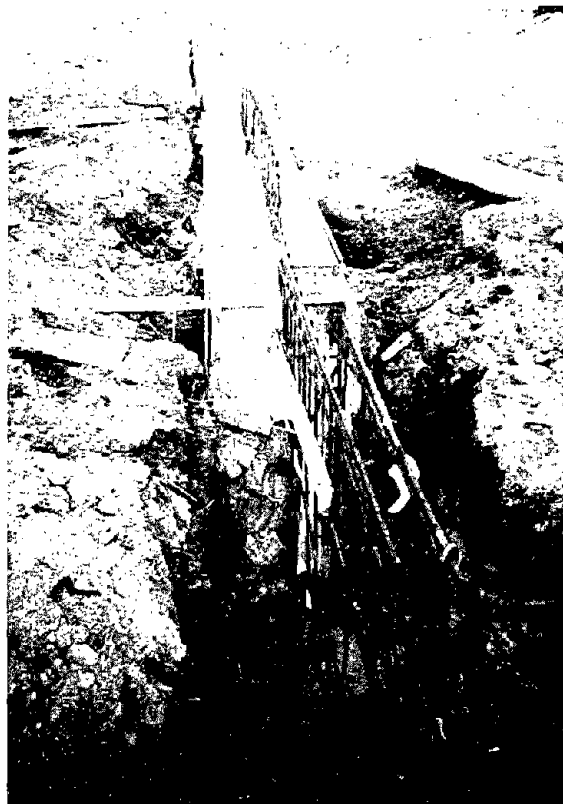
Figure 3.54: Foundation under construction for house in Kobe area. Note that perimeter and interior wall footings are well reinforced and tied together. Foundations of this type allowed houses in areas affected by liquefaction to survive the earthquake with no damage except for slight tilting of a few units.

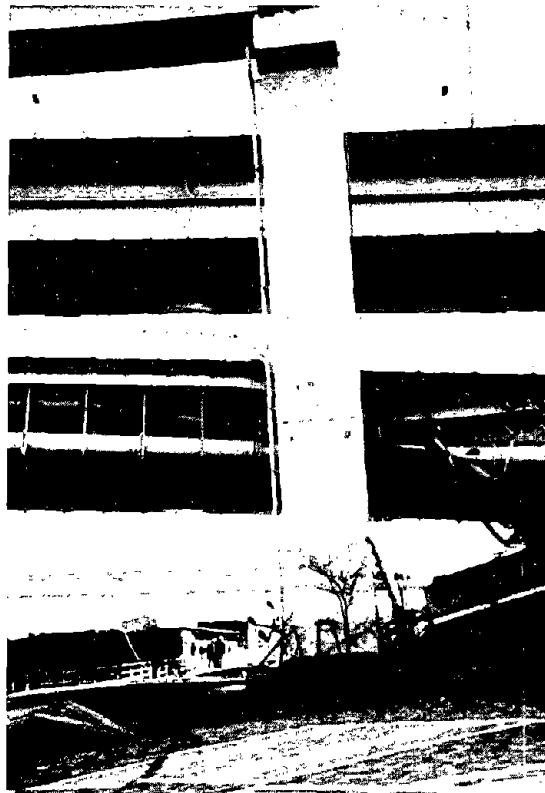
For some new bridges, especially those with tall piers, ground conditions were an important factor leading to bridge damage. Liquefaction apparently reduced resistance to lateral forces on foundation piles, while lateral spreading imposed increased lateral loads on these same elements. As a consequence, several bridge foundations shifted laterally which caused lateral displacement or tilting of the supported bridge piers. In a few instances, pier displacements were large enough to dislodge bridge girders, causing the girders and deck to fall to the ground. An example of this type of failure is shown in Figure 3.56, where a bridge pier tilted and shifted sufficiently to allow one end of the bridge deck to slip off its bridge seat and fall to the ground. That bridge formed part of a causeway from the mainland to Rokko Island.

Figure 3.56: Tilting of support on Rokko Island causeway (~40 cm at top) led to drop of girder.

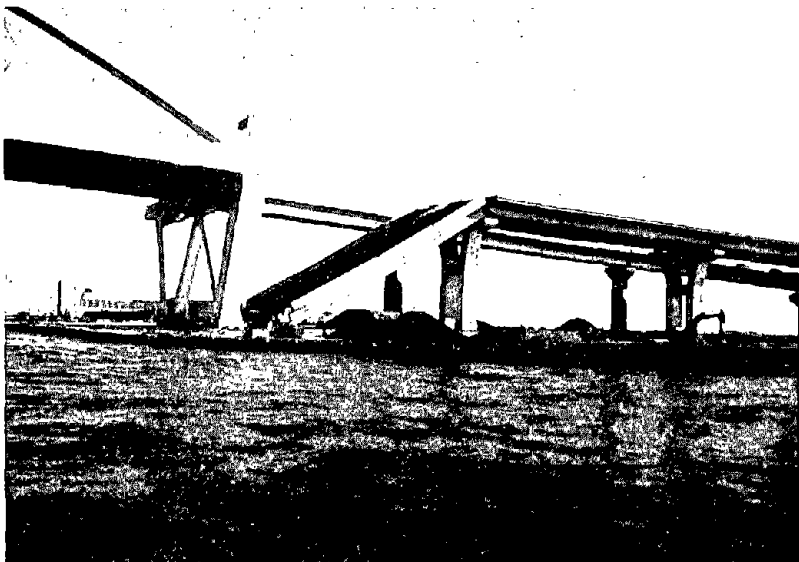
Liquefaction and lateral spreading may have also played a part in the collapse of a section of the Nishinomiya Bridge (Figure 3.57). The entire fill beneath the approach to the failed bridge was disturbed by liquefaction and lateral spreading (Figure 3.58). The lateral ground displacements may have displaced the bridge pier leading to the collapse.

Figure 3.57: Collapse of a span of the Nishihomiya bridge on the new Harbor Expressway.

The damage to bridges with tall columns in areas of liquefaction and lateral ground displacement suggest that more attention should be devoted to making reliable estimates of displacements of bridge columns during earthquakes. Such an analysis should realistically model the response of column and the pile foundation.

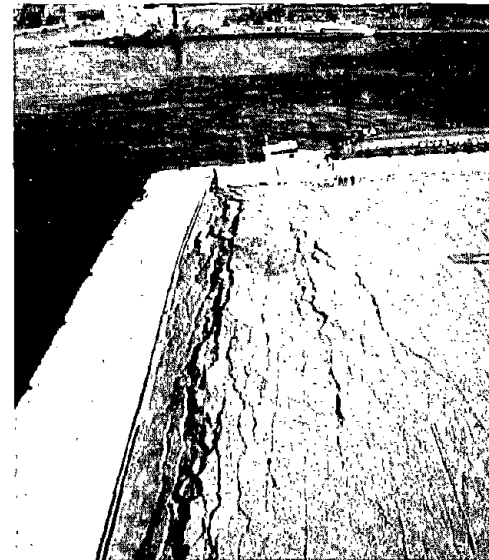
Figure 3.58: Note liquefaction induced lateral spread fissures and sporadic sand boils near pier of Nishihomiya bridge which previously supported collapsed freeway section.

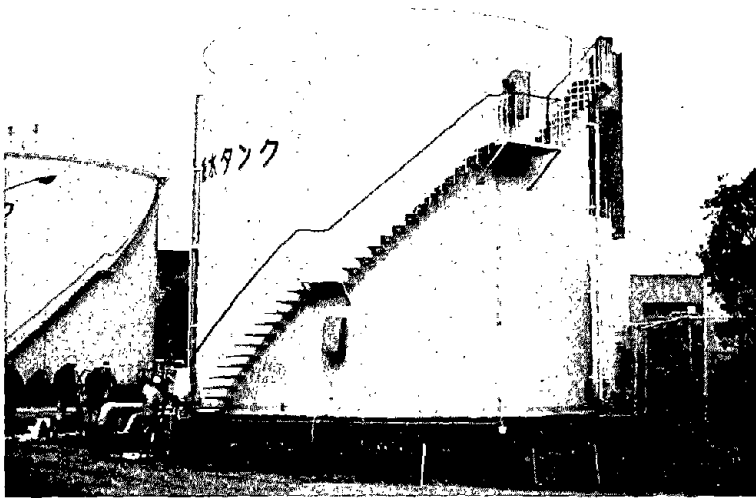
Figure 3.61: Damaged pile-supported tank at the Higashinada PowerStation.

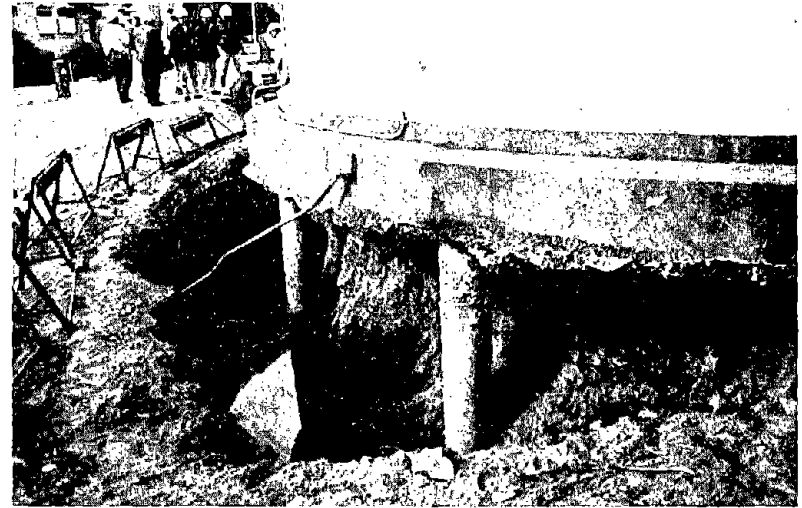
Figure 3.62: Close up view of the exposed perimeter piles supporting the tank shown in Figure 3.61.

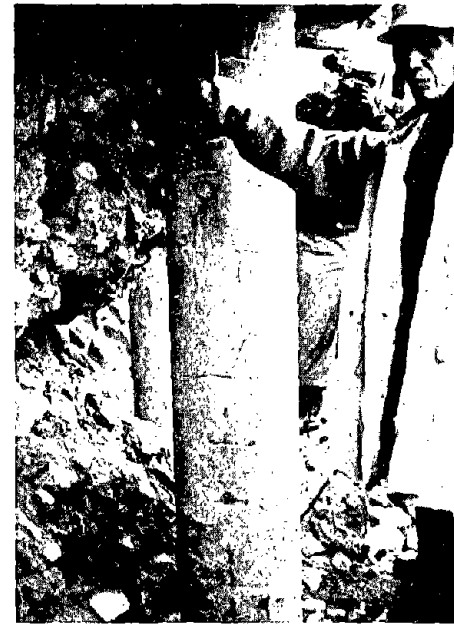
Damage to the exposed portions of the piles appeared to be relatively light. Several piles contained hairline cracks in the upper meter or two (Figures 3.64). At least one pile contained intersecting cracks that could allow large of concrete to spall out. The most seriously damaged piles were located along the northwestern part of the perimeter. The piles appeared repairable and thus were not classified as having failed.

Figure 3.64: Excavated upper part of pile foundation beneath the tank shown in Figure 3.61.

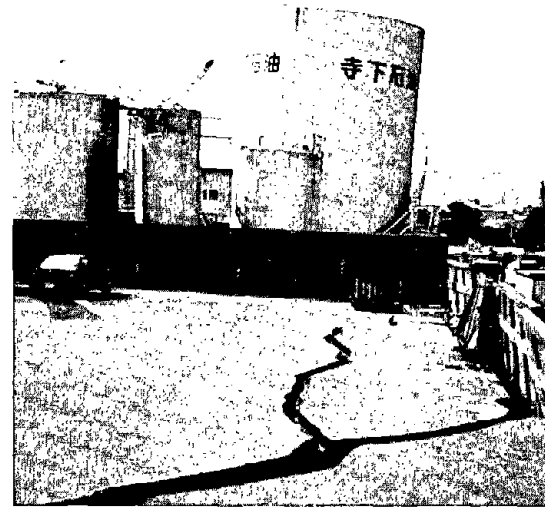
The tilting of the smaller diameter tanks appeared to be a result of one side of the foundation mat sinking into the ground, presumably a result of liquefaction. Although there was no information available regarding foundation type and no excavation had been made at the site, the performance of the mats for the smaller tanks suggested that they were founded at shallow depth and were not supported by piles. The tilting of the large tank is thought to have occurred in a similar manner. However, the large tank had a perimeter concrete collar ring which separated from the tank as the tank settled into the ground (Figure 3.68). Although this separation led to an offset of several centimeters at the collar ring, it is not known if a structural failure of the mat was involved.

Figure 3.66: Listing tank at the Karumojima tank farm. Note the ground cracking due to lateral spreading in the foreground.

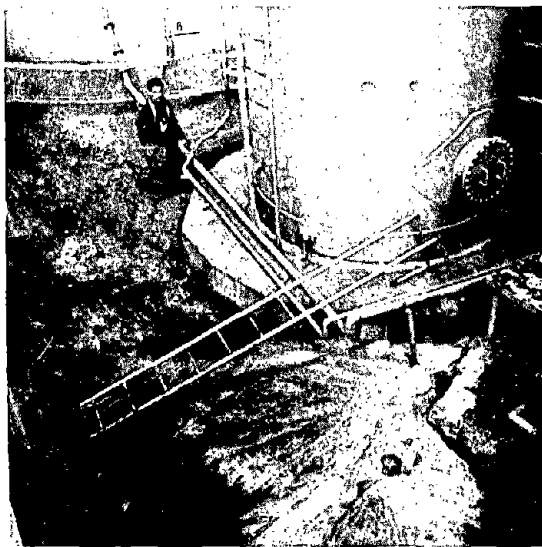
Karumojima Tanks. Field reconnaissance in the western Kobe area of Karumojima near the Port of Nagata identified several small tank farms. Most of this area consists of man-made fills situated around the channelized mouths of the Karumo and Minato Rivers. This area was estimated to have sustained peak ground accelerations of between 0.5 and 0.7g. Extensive liquefaction was observed in this area in the form of sand boils, differential settlements, and quay wall distress. Figure 3.66 shows a view along one of the channels affected by slumping of quay walls. In the background of the photograph are several tanks which tilted in one or more directions. The ground around these tanks contained several large fissures, presumably associated with the lateral spread, and sand boils had erupted through many of the fissures (Figures 3.67).

Figure 3.67: Fissures and sand boils within Karumojima tank farm.
