REPORT NO.
UCB/EERC-95/01
AUGUST 1995

EARTHQUAKE ENGINEERING RESEARCH CENTER

**GEOTECHNICAL RECONNAISSANCE
OF THE EFFECTS OF THE
JANUARY 17, 1995,
HYOGOKEN-NANBU EARTHQUAKE, JAPAN**

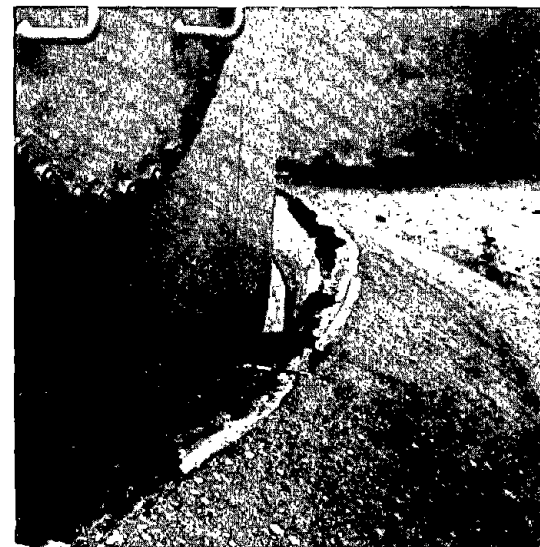
The tilting of the smaller diameter tanks appeared to be a result of one side of the foundation mat sinking into the ground, presumably a result of liquefaction. Although there was no information available regarding foundation type and no excavation had been made at the site, the performance of the mats for the smaller tanks suggested that they were founded at shallow depth and were not supported by piles. The tilting of the large tank is thought to have occurred in a similar manner. However, the large tank had a perimeter concrete collar ring which separated from the tank as the tank settled into the ground (Figure 3.68). Although this separation led to an offset of several centimeters at the collar ring, it is not known if a structural failure of the mat was involved.

Figure 3.68: Displaced collar ring around a large tank in the Karumojima tank farm.

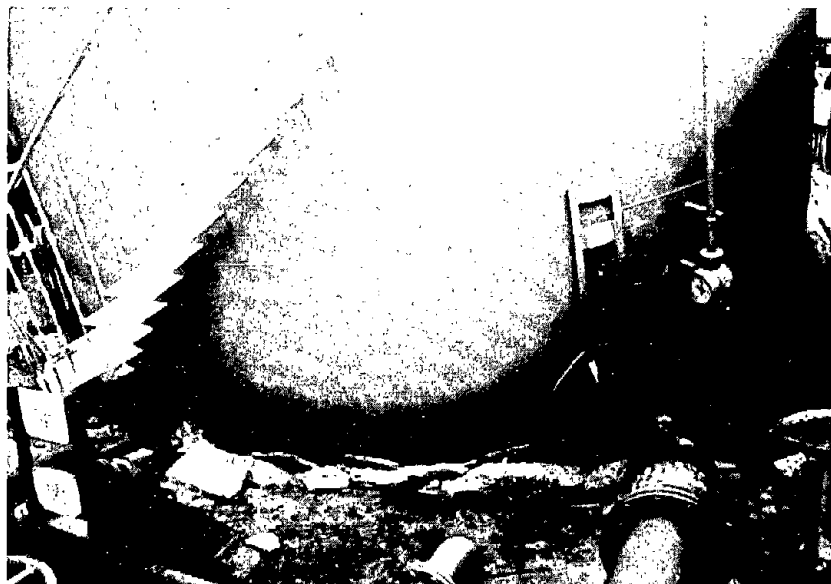
Figure 3.71: Differential settlement at the base of a water tank in the Nippon Gatx complex.

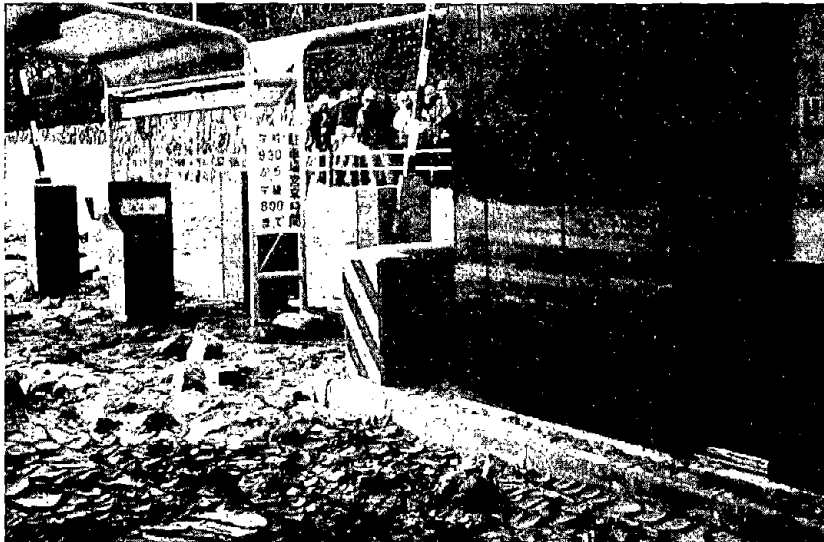
A narrow parking lot is located along the south side of the park, between a retaining wall for the park to the north at an elevation about 2 to 3 m higher than the parking lot, and the original Port Island Phase I sea wall that parallels the park wall to the south. The concrete pavement slabs separated along the long axis of the parking lot and soil ejecta (predominantly sand) covered the entire parking lot, as may be seen in Figure 4.2. Water marks on the entrance kiosk showed that the parking area filled to a depth of roughly 1 m (Figure 4.3).

Figure 4.3: Parking lot kiosk showing high water level caused by sand liquefaction.

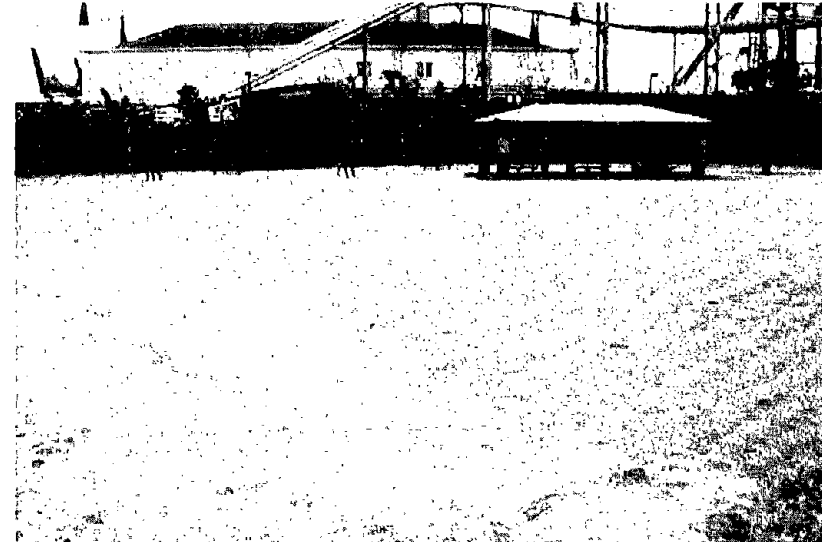
The west side of the park is next to the grassy area of a public park. Large sand boils and many ground cracks were seen in the grassy area near the amusement park (Figure 4.4). A differential settlement of roughly 30 cm was observed between a ramp to the elevated railway and the surrounding ground near the northwest corner of the amusement park (Figure 4.5).

Figure 4.4: Sand boils and ground cracks in the grassy area near the amusement park.

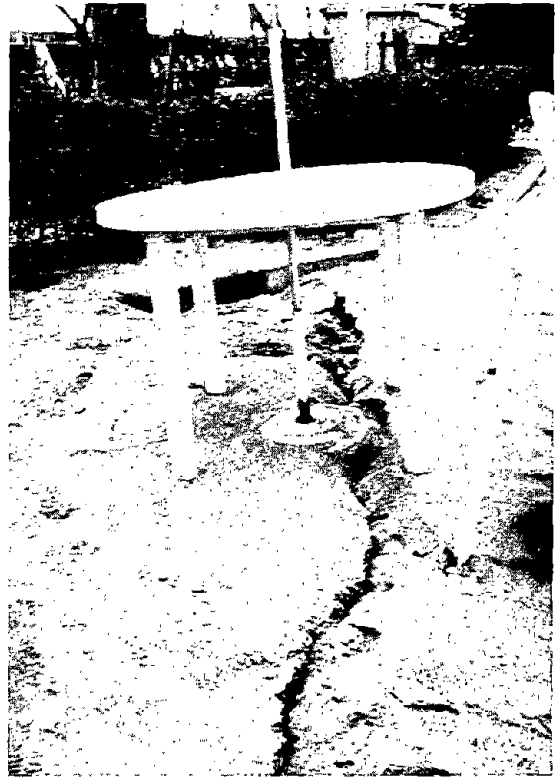
Clear evidence of liquefaction inside the amusement park was limited to a small area near the southwest corner, where ground cracking and sand boils were observed as shown in Figure 4.6. Additional cracking and ejecta were observed along most of the southern boundary of the park (Figure 4.7), although some of this may have been the result of a broken water line. Over the remainder of the park the only apparent damage consisted of occasional cracks and separations in pavement materials that were generally less than 5 mm wide, but up to 25 mm wide in some spots, with Figure 4.8 being an example. Cracks and separations generally were smallest near the northern boundary and became progressively larger toward the south. Many large areas in the park had no visible cracks, separations, or differential settlements, as illustrated in Figure 4.9.

Figure 4.6: Sand boil at the southwest corner of the amusement park.

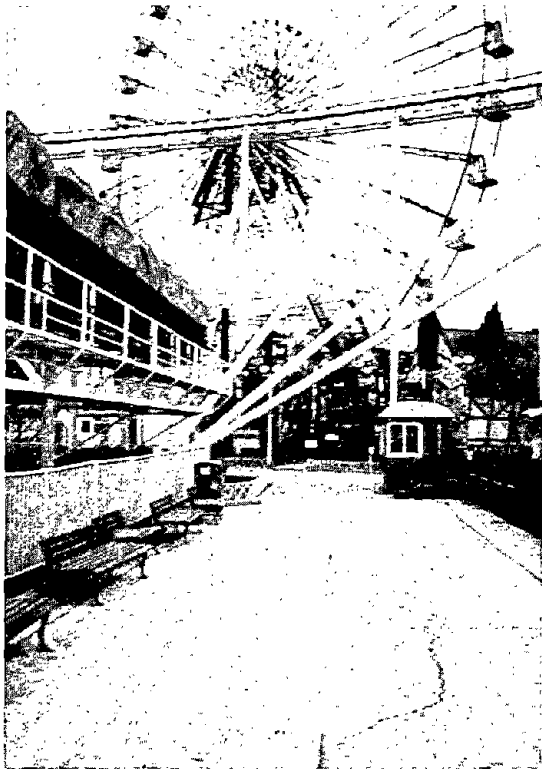
Figure 4.7: Cracks and ejecta along the southern boundary of the amusement park.

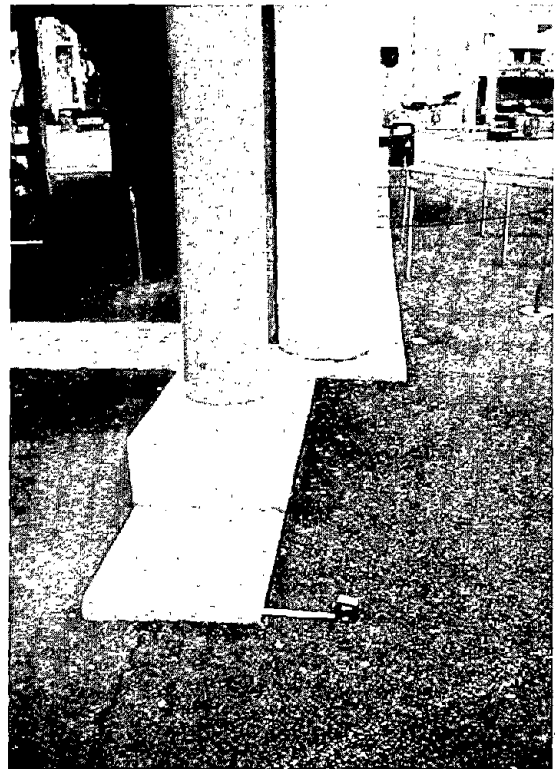
Figure 4.8: Small separation between pavement and concrete in the amusement park.

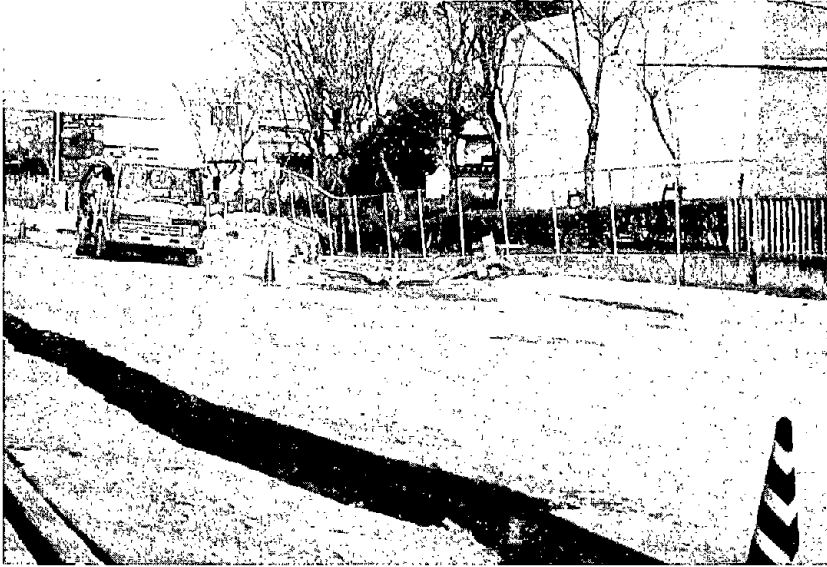
Ground settlement, cracking, and sand ejecta were widespread on all four roads bounding the facility, with Figure 4.13 showing the road on the north side being a good example. Two warehouses, both apparently on untreated ground, designated #2 and #3 in Figure 4.10 are located north of the facility. The concrete floor slab inside warehouse #2 was badly damaged by differential settlement and ground cracking. Warehouse #3 was not entered. A warehouse across the street to the west had its concrete slab crack away from the apparently pile-supported column footings and the slab then settled uniformly about 50 cm relative to the footings. Sand ejecta

Figure 4.13: Cracking, settlement and ejecta along the road north of the facility.

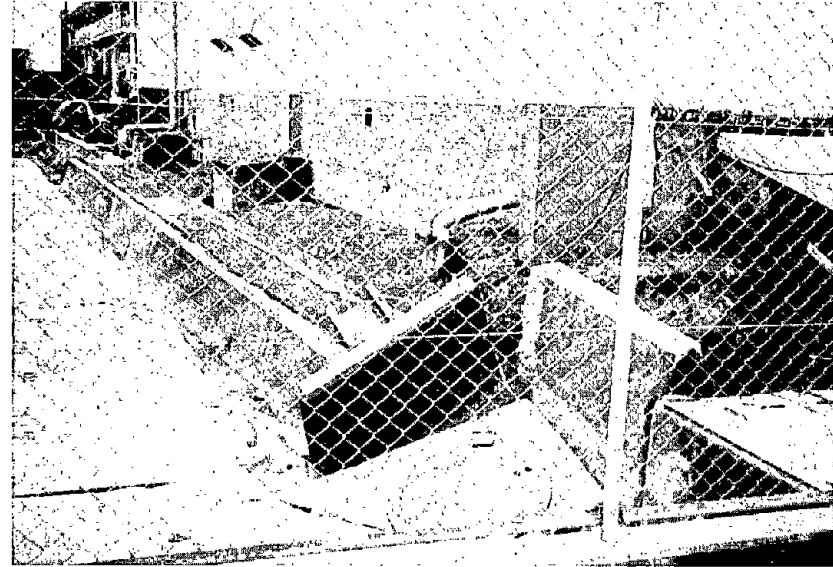
covered the concrete slab. There were large settlements and large differential settlements adjacent to a pile supported warehouse on untreated ground across the street to the south of the treated site, as may be seen in Figure 4.14.

Figure 4.14: Settlement of untreated ground at building across the street to the south of the warehouse facility.

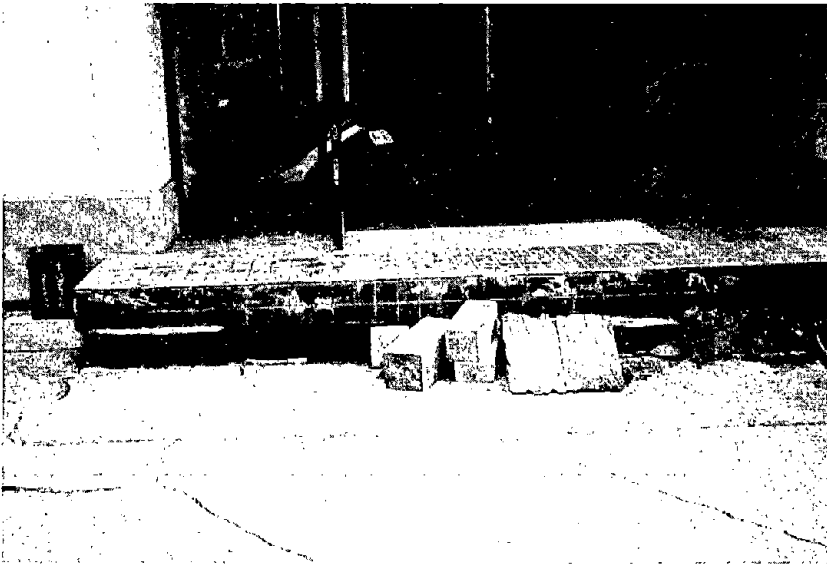
The "Office", which is the only pile-supported structure within the warehouse complex, was not entered; however, no structural damage was observed from the exterior. Some settlement and cracked glass were observed at the entrance, as seen in Figure 4.15. There was about 30 cm of differential ground settlement at the southeast corner of this building.

Figure 4.15: Cracked glass and settlement at the entrance to the pile-supported office building at the farehouse facility.

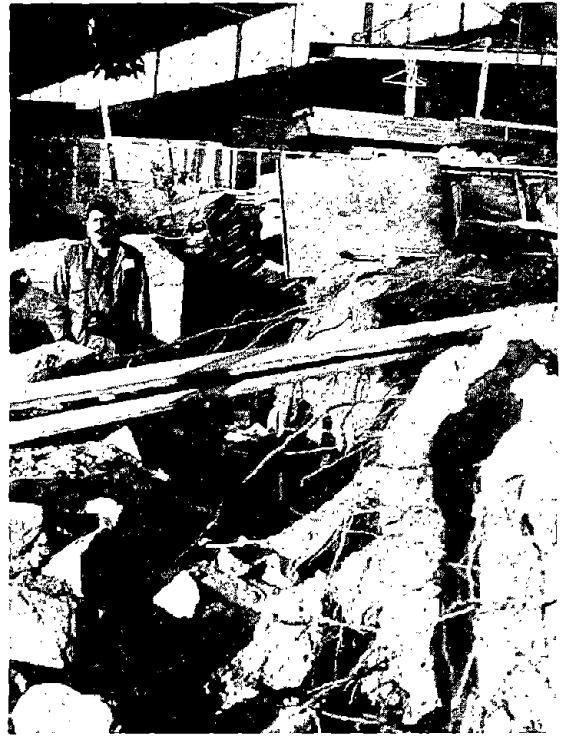
Warehouse #21 had the worst damage observed within the treated area. Concrete slabs had been removed from the northern portion of #21 as a result of excessive cracking. In the southern portion the concrete slabs had cracks up to 5 cm wide and differential settlements up to 5 cm relative to the column footings. A large ground crack, 0.3 m wide and 1 m deep was found in the outside unpaved area near the southwest corner of Warehouse #21 (Figure 4.18).

Figure 4.18: Large ground crack outside the southwest corner of Warehouse #21.

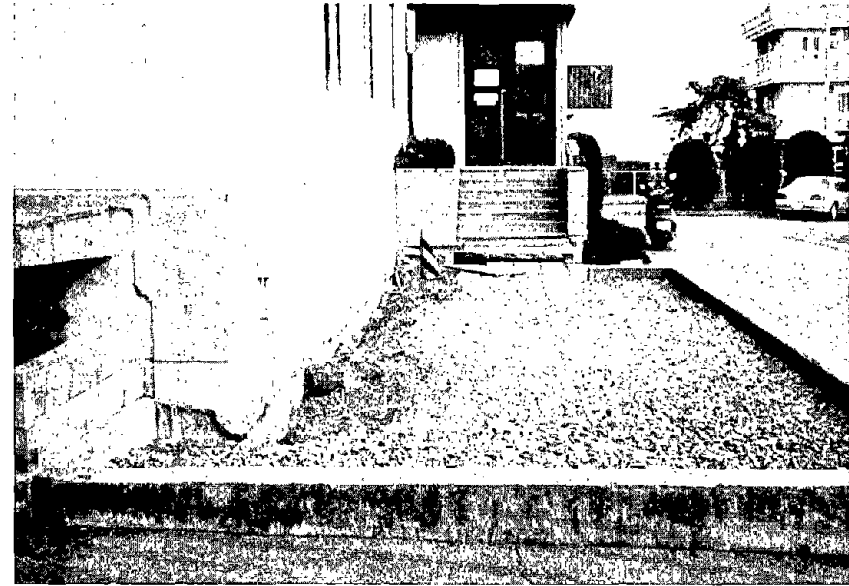
The post-earthquake conditions at the treated site are shown in Figure 4.22. The building itself appeared undamaged, and the settlements around it were considerably smaller than observed in the untreated areas.

Figure 4.22: Limited settlement of treated ground adjacent to pile-supported building, southeast corner of Port Island Phase I.

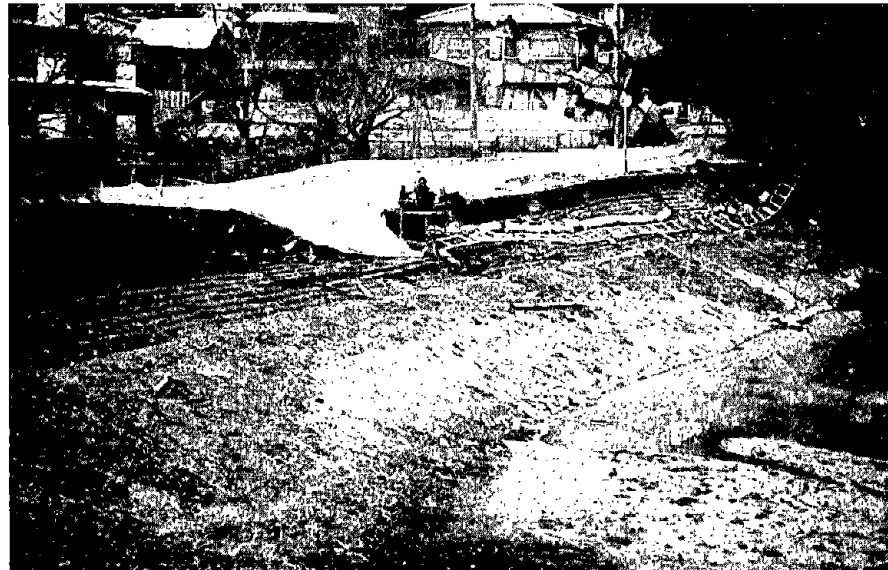
Figure 5.3: Upstream slope of Lower Niteko Dam.

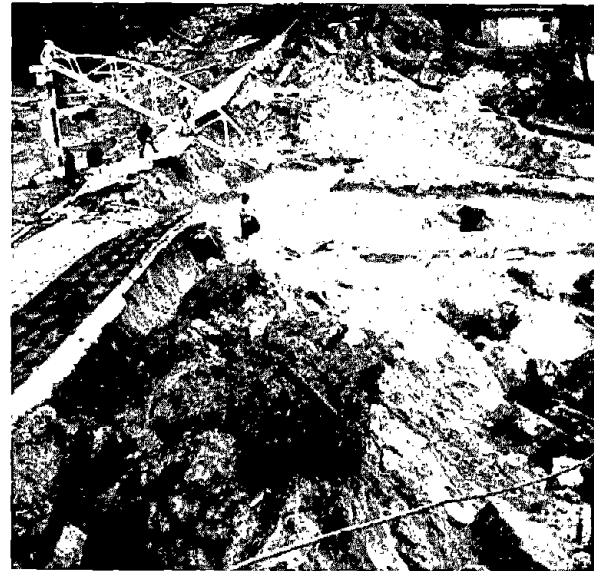
The flow movement of the Middle dam appeared to be almost entirely in the downstream direction, although examination of the remaining portions of upstream slope near the abutments indicated minor slumping towards the reservoir. The small outlet structure at the upstream toe near the center of the dam appeared to be nearly vertical with a possible slight upstream tilt, although the catwalk to the structure had collapsed (Figure 5.5). Exposures of the upper portion of the dam near the abutments indicated a layered fill composed of sandy silt and silty sand with gravel. However, the slide debris seemed composed mostly of sandy silt. All of the fill soils were believed to originate from decomposed granite.

Figure 5.5: Crest alignment of failed Middle Niteko Dam.

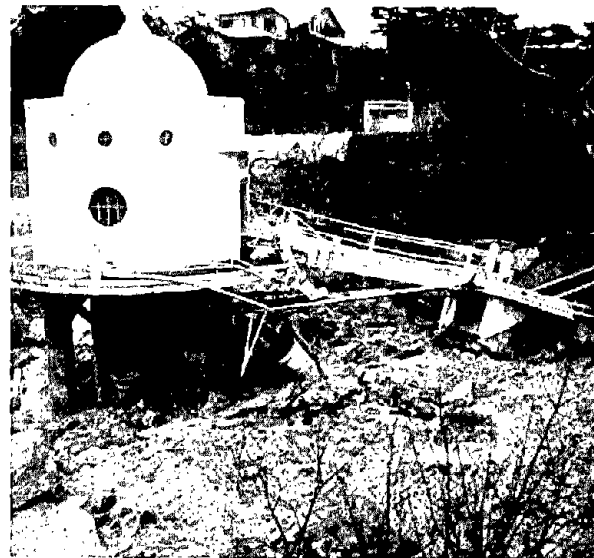
Figure 5.6: Downstream outlet tower at Upper Niteko Dam.

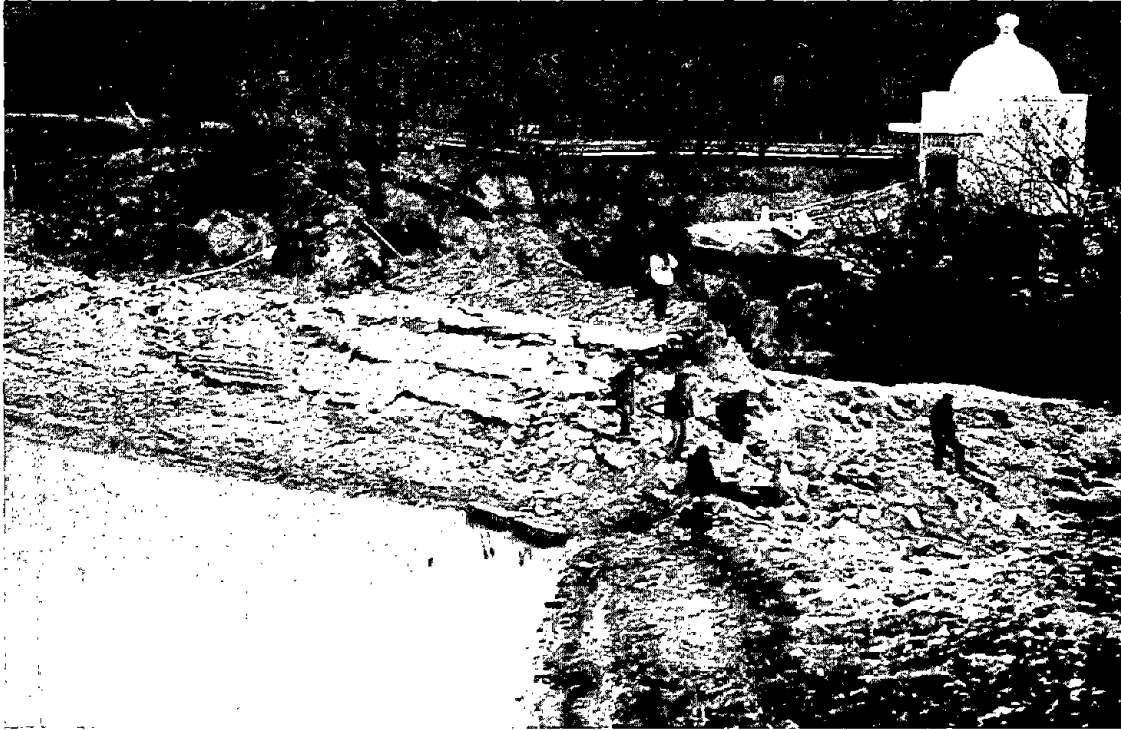
The Upper Niteko Dam also had a maximum height of approximately 10 meters and a crest length of about 80 meters prior to the earthquake. Its crest width had also been 2 1/2 meters and it was also estimated to have had 2:1 to 2.5:1 upstream and downstream slopes. The Upper dam sustained a flow failure very similar to the failure observed at the Middle Dam. The upper two-thirds of the central Upper dam appeared to have also flowed as much as 60 to 70 meters downstream of the dam's centerline (Figure 5.4). Portions of the flow passed around a downstream outlet tower. This tower appeared to have remained stable, together with a possible slight downstream tilt, with little exterior damage observable. The exception to this was the damage sustained as a result of its catwalk being jammed through its doorway into the tower interior by the flowing ground (Figure 5.6). As at the Middle dam, the flow failure observed at the Upper dam seemed to be almost entirely in the downstream direction. However, there was somewhat more slumping of the remaining upstream slope than that observed at the Middle dam (Figure 5.7).

Figure 5.7: Upstream slope of Upper Niteko Dam.

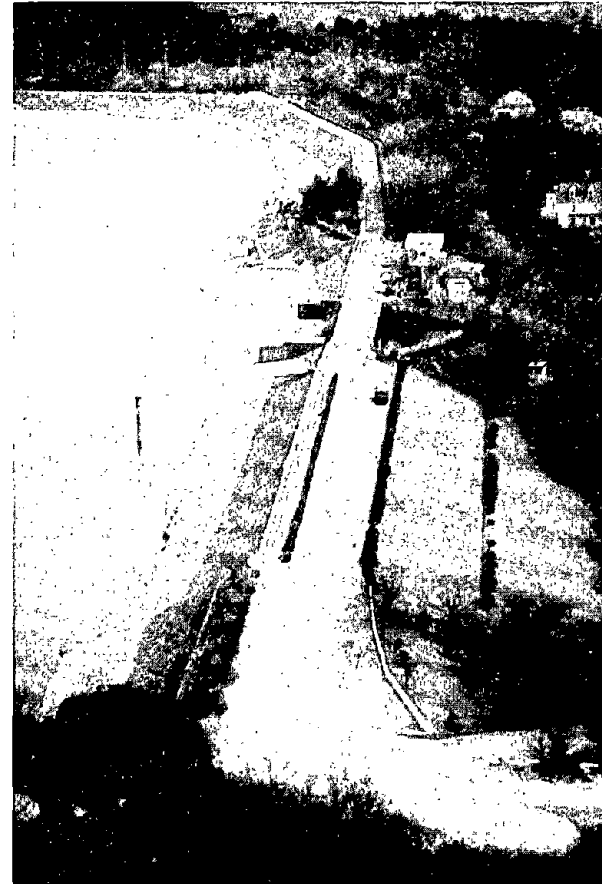
Figure 5.10: Aerial photograph of Kitayama South Dam.

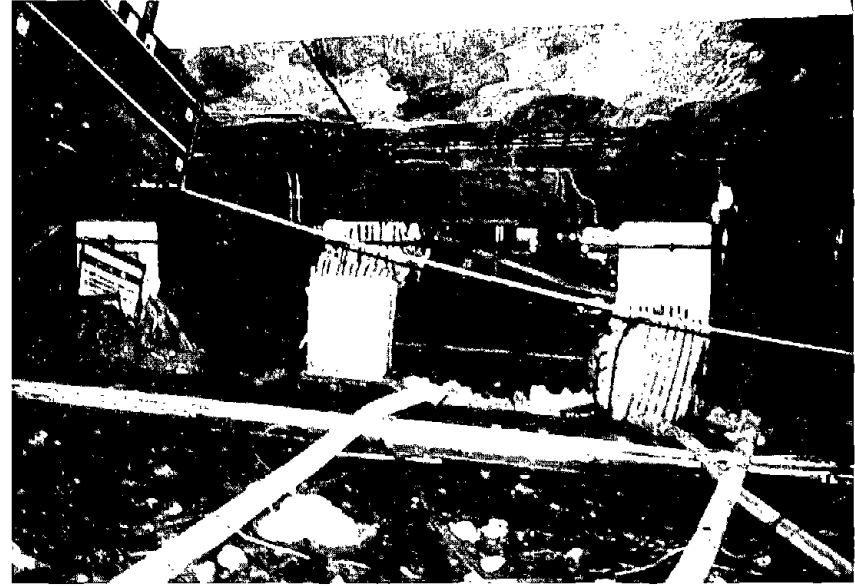
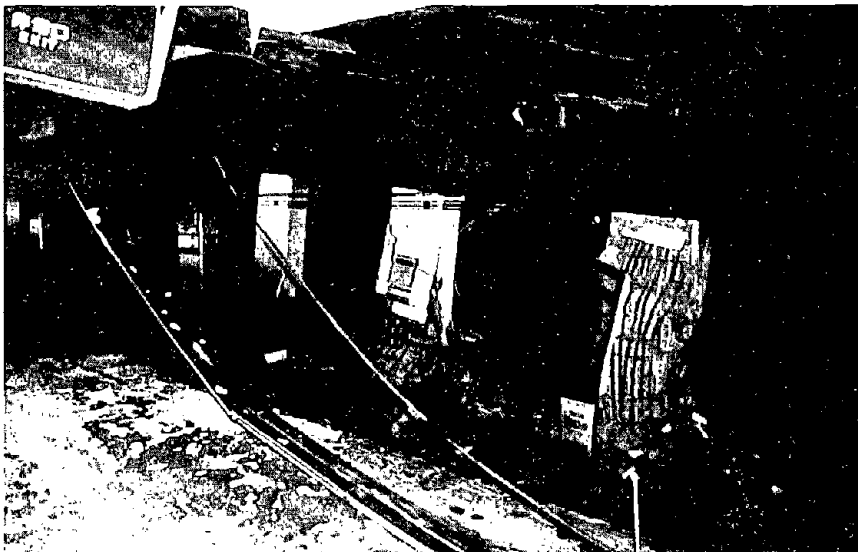
of the structure. The stratigraphy at the site consists of sands underlain by medium to stiff clay, with the water table at a depth of 3 m. The central reinforced concrete columns of the station failed, apparently by a combination of shear and vertical loading. There was only nominal confining steel (9 mm diameter on 180 mm spacing) for the 20 mm diameter longitudinal rebar on 140 mm centers in the concrete. Collapse of the columns caused subsidence at the street surface of a maximum 2.5 m, with substantial settlement over an area of 100 m by 20 m. Apart from the structural collapse-induced movement, there was no clear evidence of permanent ground deformation at the site induced by other causes, such as liquefaction.

Figure 6.4: Collapsed reinforced concrete columns at Daikai Station.

Figure 6.5: Same as Figure 6.4.

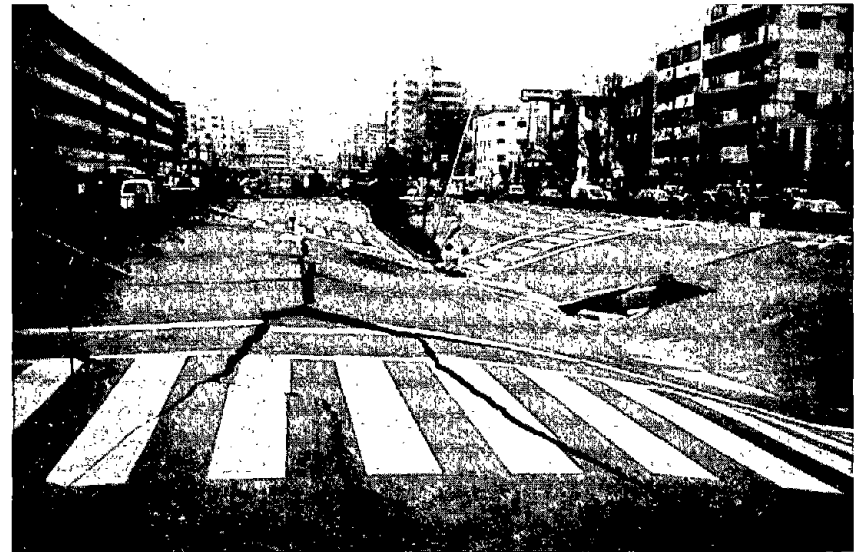
This failure is highly significant because it is the first instance of severe earthquake damage to a modern tunnel for reasons other than fault displacement or instability near the portal. Photographs in Figures 6.3 through 6.5 show the interior portions of the collapsed station. The resulting subsidence at the street surface over the station can be seen in Figure 6.6. In addition to the station collapse, many pipelines and conduits in the street failed. It is noteworthy that two lifelines did not fail. A 400 mm welded steel gas pipeline, although substantially deformed, did not rupture or leak. In addition, an NTT fiber optic cable continued to provide a suitable signal despite severe distortion.

Figure 6.6: Collapsed street surface over Daikai Station.

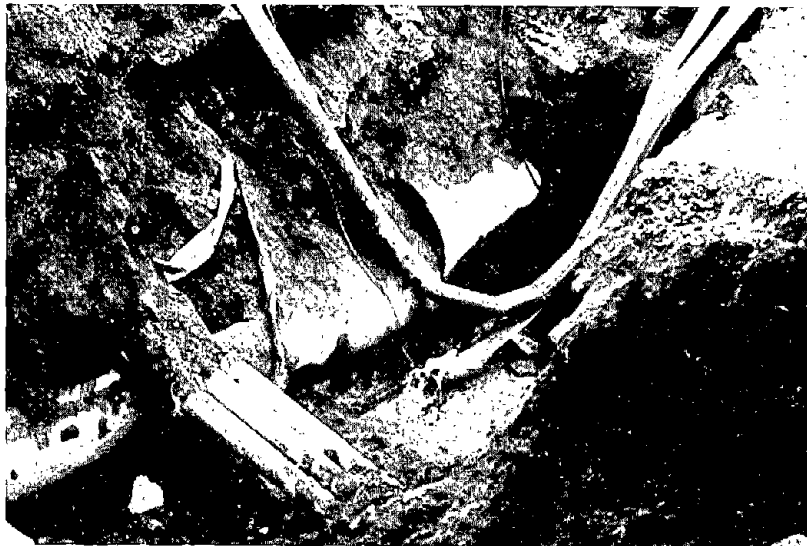
Figure 6.11: Weld rupture of 700-mm-diameter steel water trunk main on Port Island.

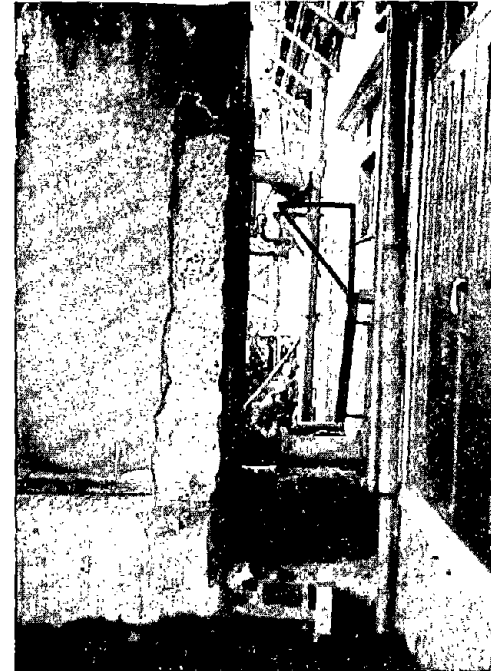
Figure 6.14: Severe lateral displacement at the inverted siphon of the plant. The pressurized pipeline siphon carried all sewage treated by the plant.

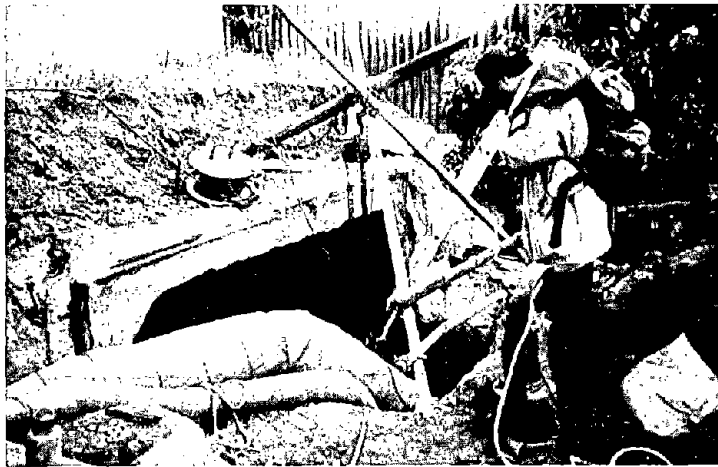
Figure 6.15: Rupture of the main sewage treatment conduit caused by lateral spreading and settlement.

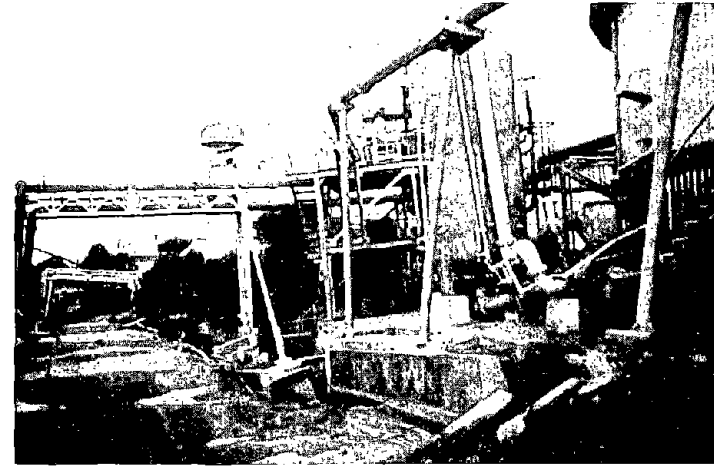
Lateral deformation caused severe damage to underground structures and facilities founded on spread footings (Figure 6.16). Differential settlement of approximately 600 mm of soil relative to the pile supported sand filter building was observed (see Figure 6.17); and there was cracking and spalling at the tops of reinforced concrete piles which support this structure. Elsewhere, at the digester tanks closest to the canal, cracking at the tops of reinforced concrete piles was visible at several pits excavated to inspect the foundations.

Figure 6.16: Plant facility damage due to lateral ground deformation and settlement.

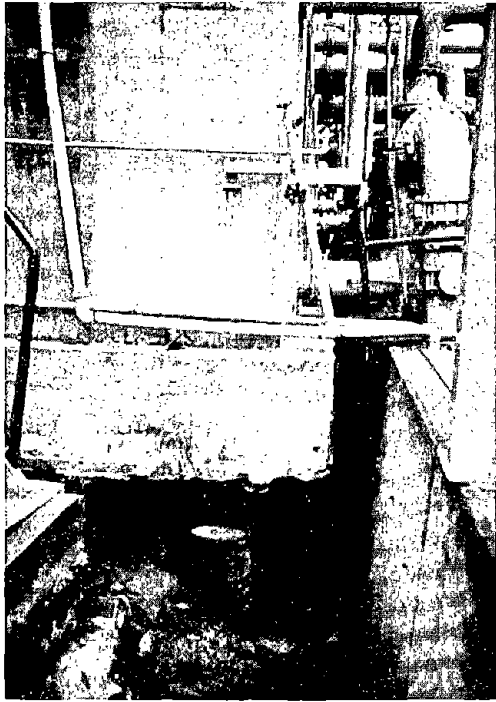
Figure 6.17: Differential settlement of soil relative to pile-supported structure containing sand filters.

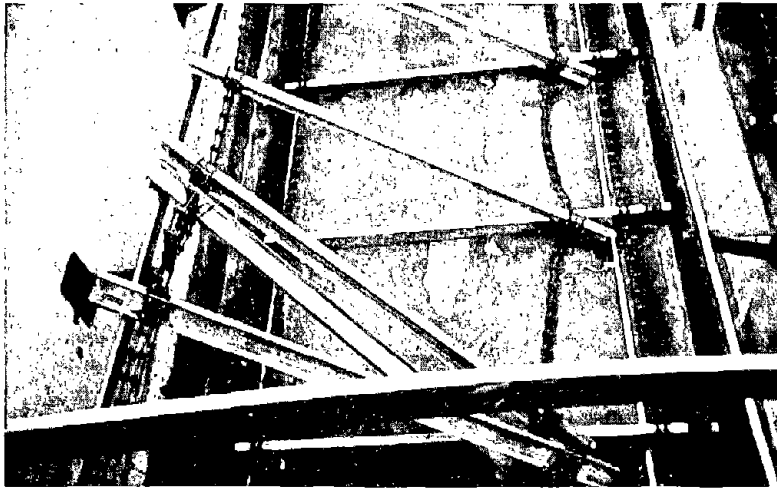
Figure 6.18: Damage to sludge scrapers at the sedimentation tanks.

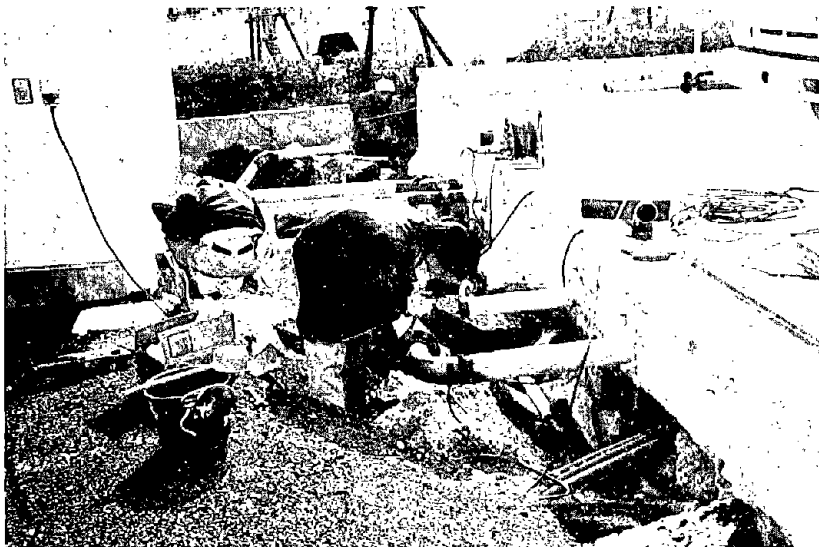
Figure 6.21: Repair of pipes separated by lateral spreading between a building and adjacent concrete slab near Nakahara Wharf, Port Island.

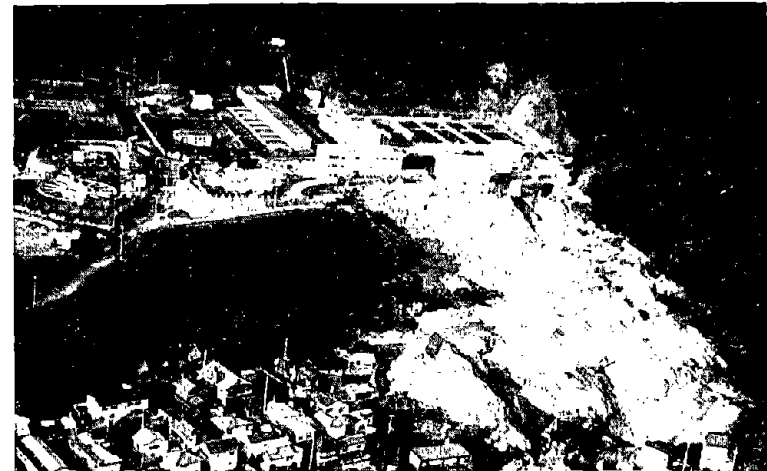
The Nigawa landslide appears to have been a rapidly moving debris slide in decomposed granite. The slide occurred immediately adjacent to the Uegahara filtration plant, along the edge of a large terrace/bench at an elevation of about 100 m. The aerial view of the site in Figure 7.2 shows the head scarp of the slide and most of the deposition area at the toe. Figure 7.3 shows the evidence of runup of the debris on a building at the base of the slope (second from the bottom left in Figure 7.2). The length of the head scarp was approximately 100 m and the distance from the headscarp to the toe of the slide was about 250 m, with a vertical drop on the order of 30 to 40 m.

Figure 7.2: Aerial view of the Nigawa landslide showing the steep arcuate head scarp and a flatter depositional area at the toe.

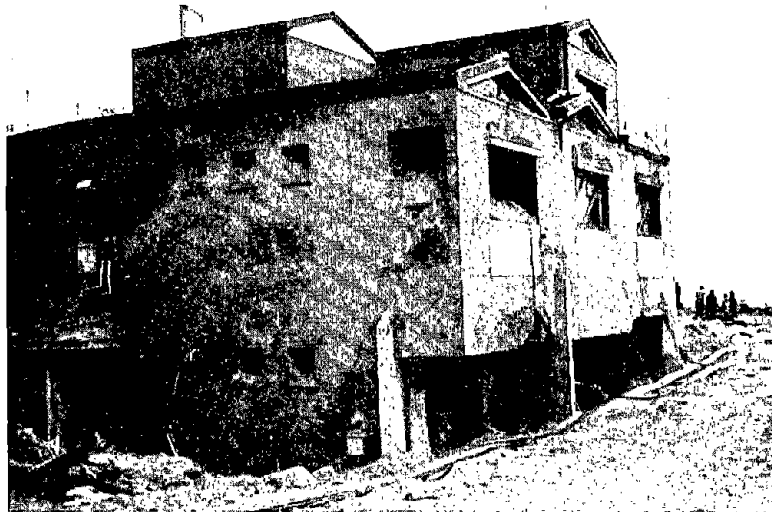
Figure 7.3: Debris stained 3 story building at the toe of the slide (the building is second from the left at the bottom of the photograph in Figure 7.2). Note that the debris invaded the structure without causing extensive structural damage to the exterior walls.

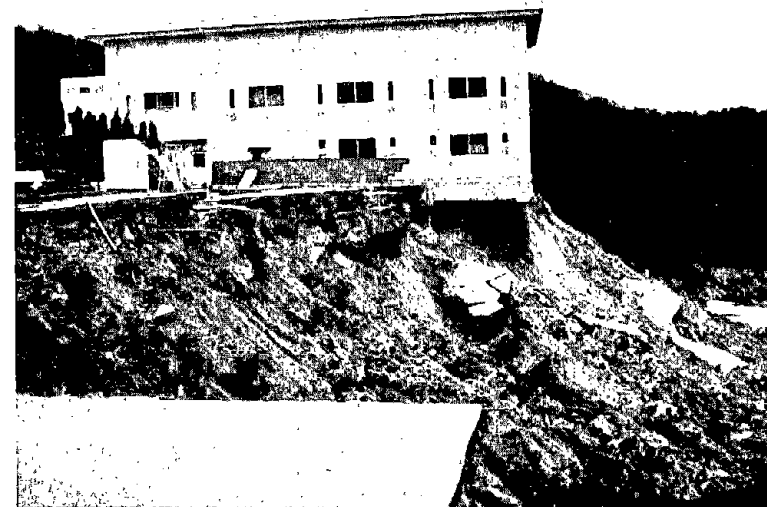
The failed portion of the terrace appears to have been a part of a cut-and-fill extension of a pre-existing natural ridge and saddle, and the mobilized material seemed to be a combination of decomposed granite fill and intact saprolite. The presence of fill was evident along the headscarp which undermined a building, exposing its pile foundation (Figure 7.4). The upper portion of the slope was heavily wooded, and a housing development was built along a series of terraced slopes starting about 15 to 20 m below the crest of the slope. As can be seen from the photographs, the houses in the path of the slide mass were completely obliterated and buried by the slide debris.

Figure 7.4: Head scarp of the Nigawa landslide. The stratification of soil below the pavement suggests that this upper material is fill. The foundation of the building is pile supported.

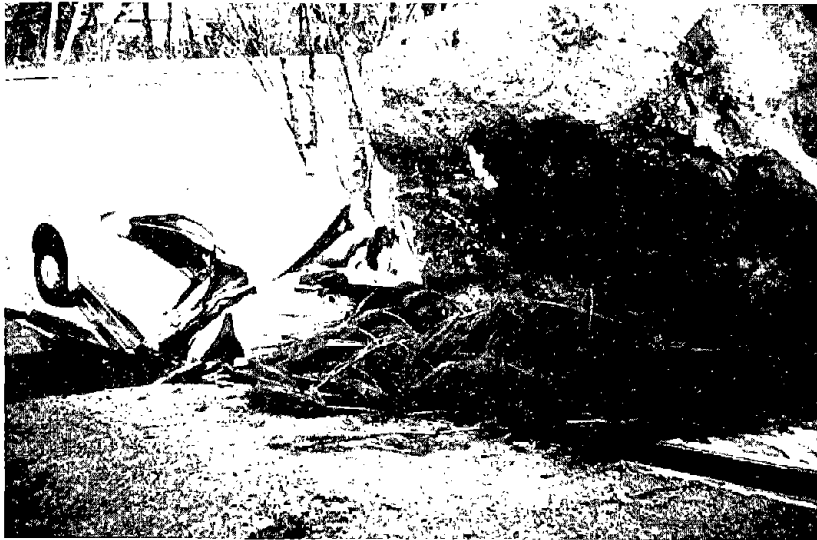
Figure 7.5: A car was flattened by this boulder, approximately 3m in diameter, the largest of several which rolled down the hillside.

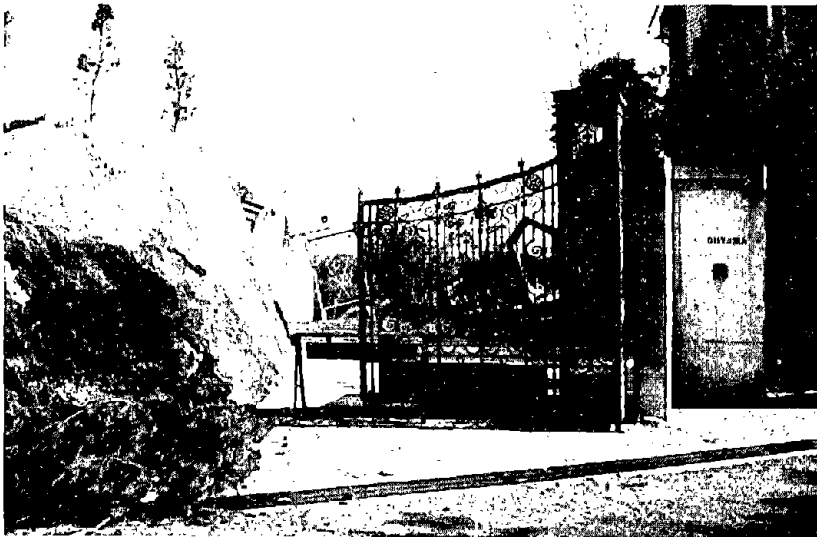
Figure 7.6: A view of the boulder shown in Figure 7.5 resting against the gate at the entrance to a driveway.

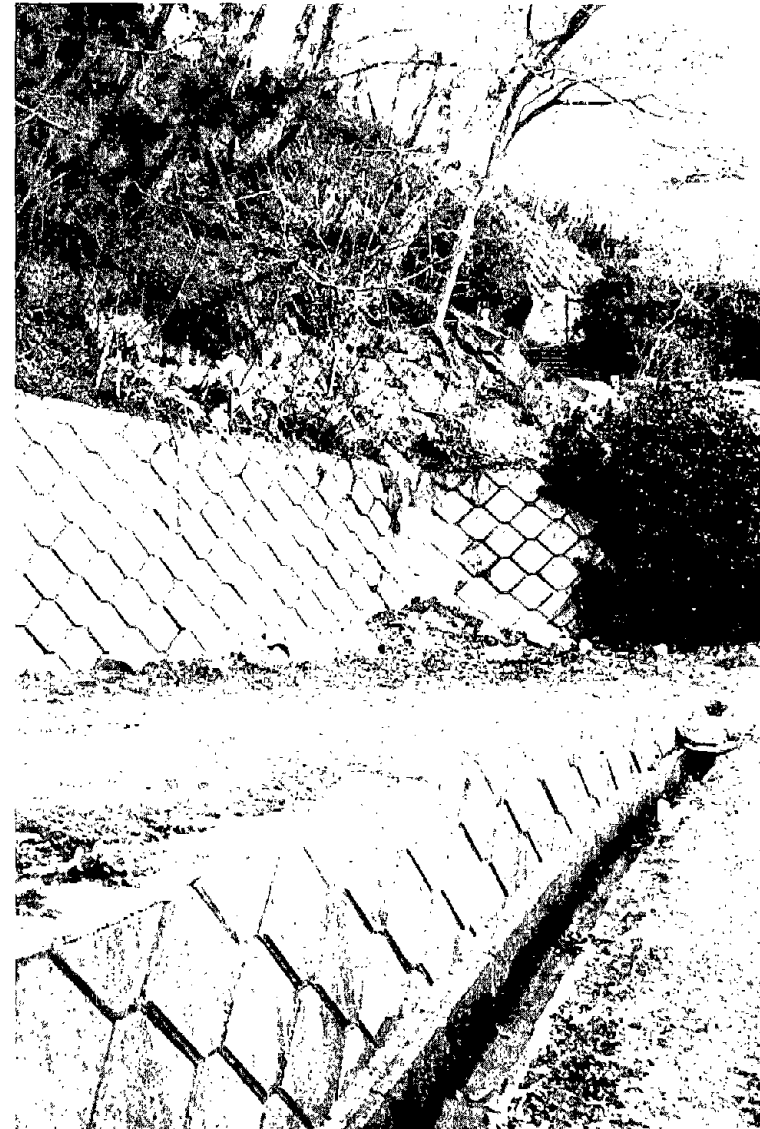
Isolated rock falls occurred from natural and cut slopes in the residential area of Nishinomiya. The natural weathering of the granitic rocks leads to the exposure of isolated, rounded granitic boulders precariously perched on the hillslopes. Once loose, they tend to roll downhill quite easily. A boulder approximately 3 m in diameter descended several tens of meters down a wooded slope, crossed a paved road, and crushed a mid-size car and damaged a wrought iron gate at an entrance to a residence (Figures 7.5 and 7.6). At another location, smaller rocks fell from a cut slope behind a residential building, but did not cause any damage because the slope support system was designed to deflect falling rock (Figures 7.7).

Figure 7.7: Freshly fallen rock at the base of a retaining wall in a residential area.

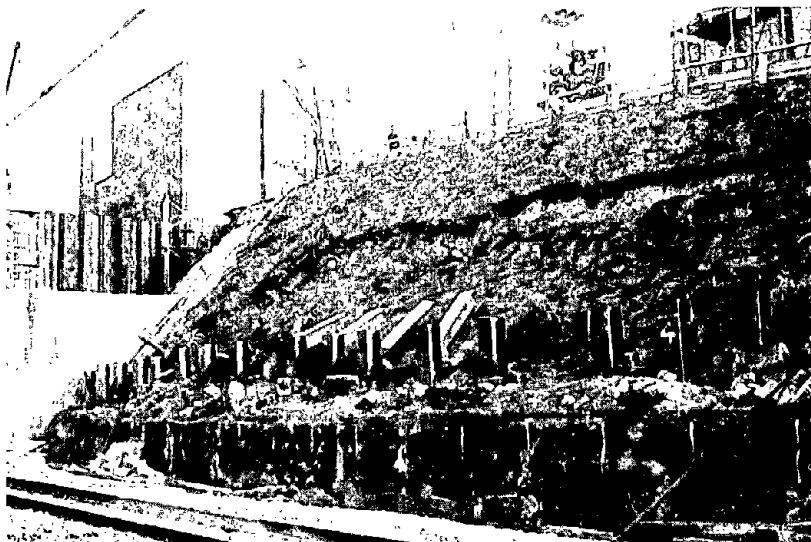
Localized failures of railroad and road embankments occurred throughout the region. In many instances these failures appeared to be directly related to liquefaction of the foundation soil, but more traditional slope failures were also evident. Figure 7.8 shows a typical failure of an embankment above railroad tracks. The slope was initially supported by a low wall, which is now being replaced by a driven steel pile wall. This method of repair was extensively used by the railroads in the wake of the earthquake.

Figure 7.8: Failure of an embankment above railroad tracks in Kobe.

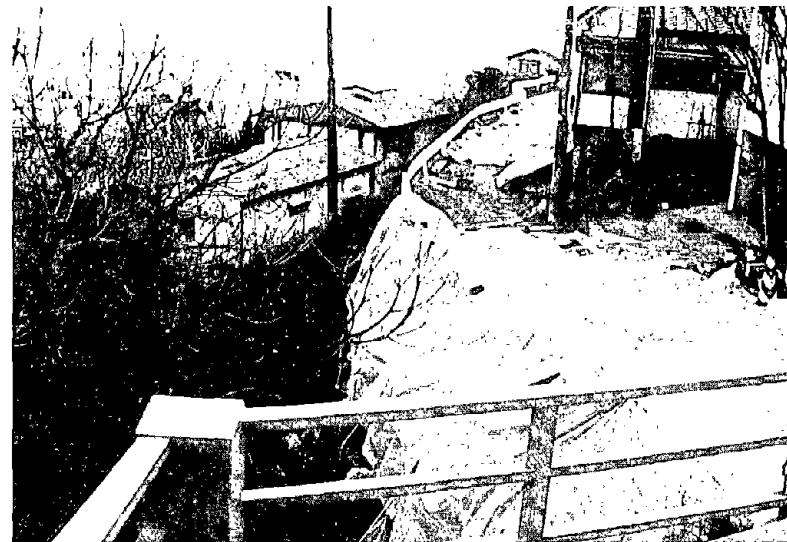
Figure 7.10 A road fill settled and moved laterally several meters.

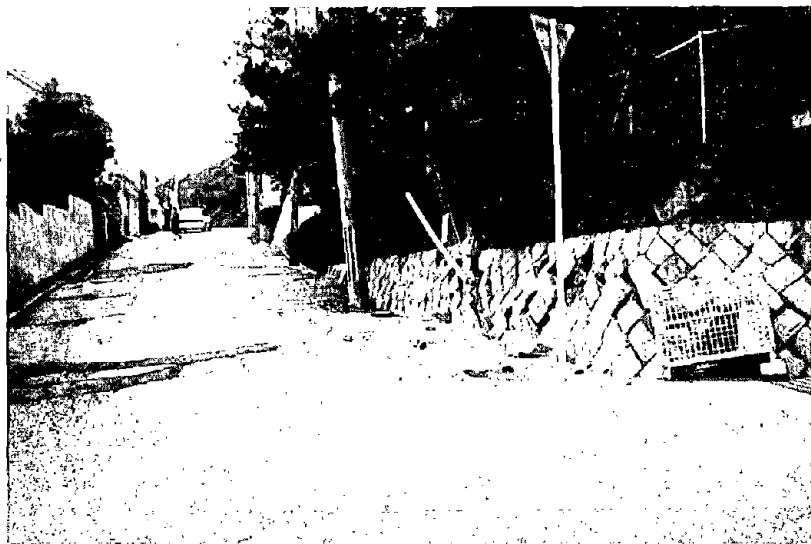
Figure 7.9: Pavement deformation and damage to rock retaining wall caused by seismically induced deformation of sidehill fill.

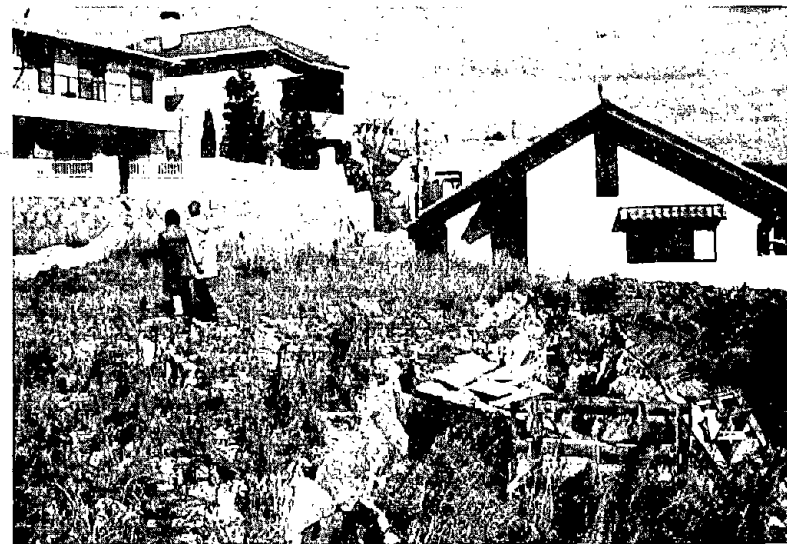
Evidence of downhill extension and displacement of structural fills and stone retaining walls was particularly evident in parts of residential developments extending into the hills. The incidence of these failures seemed to be highest along the extension of the strike of the faulting, and typically involved sidehill fills for roads and residential lots. The fills appeared to be composed of compacted decomposed granite, which is relatively coarse with little apparent cohesion. The deformation of the fills caused displacement and cracking of pavements and retaining walls (Figure 7.9), and in at least one location a road embankment essentially failed leaving the road unservicable (Figure 7.10). The damage to some of the residential lots is illustrated in (Figure 7.11), showing deep extension cracks running parallel to the slope contours. The failures of the fills appeared to be the result of a combination of inadequate compaction and inadequate keying into the bedrock, and the retaining walls lacked adequate capacity to resist seismic loading (Figure 7.12). In addition to structural damage, these failures broke underground utilities, disrupting gas, sewer, and water service to entire neighbourhoods.

Figure 7.11: Deep tension cracks in a sidehill fill on a residential lot. Note the separation in the rock retaining wall in the background. This type of damage was typical in this neighborhood.

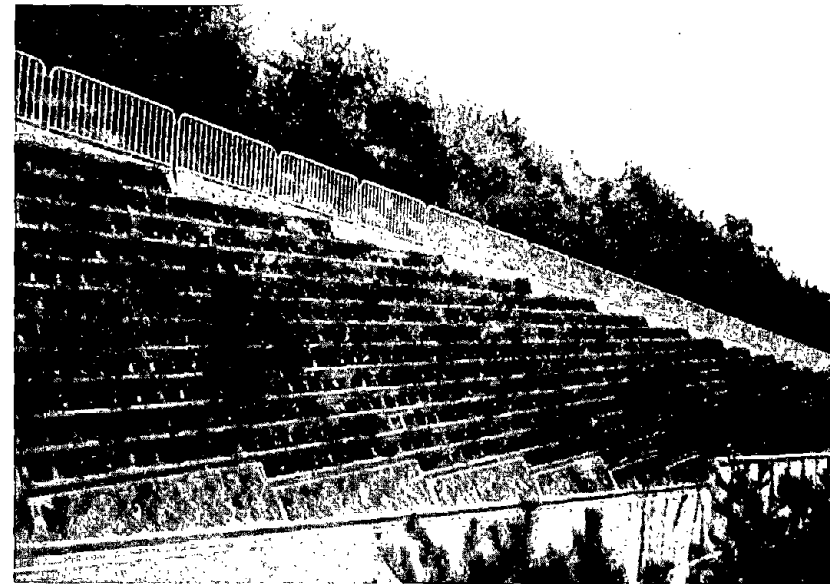
In comparison to the residential construction, many large retaining structures for major roads and railways seemed to perform much better. Figures 7.13 and 7.14 show two fairly substantial retaining walls which performed well and showed no apparent signs of distress.

Figure 7.13: Undamaged crib retaining structure in Ashiya.

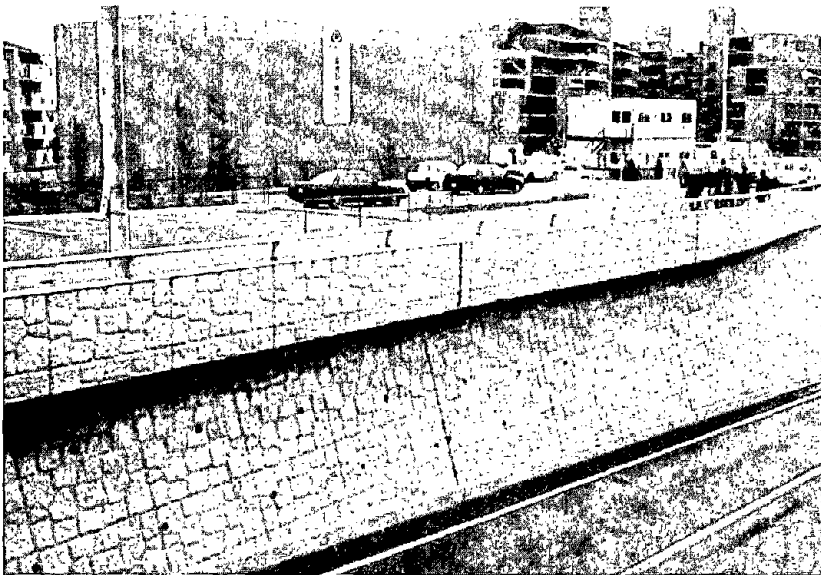
Figure 7.14: Undamaged reinforced earth wall supporting a roadway in Ashiya.
