REPORT NO.
UCB/EERC-95/01
AUGUST 1995

EARTHQUAKE ENGINEERING RESEARCH CENTER

**GEOTECHNICAL RECONNAISSANCE
OF THE EFFECTS OF THE
JANUARY 17, 1995,
HYOGOKEN-NANBU EARTHQUAKE, JAPAN**

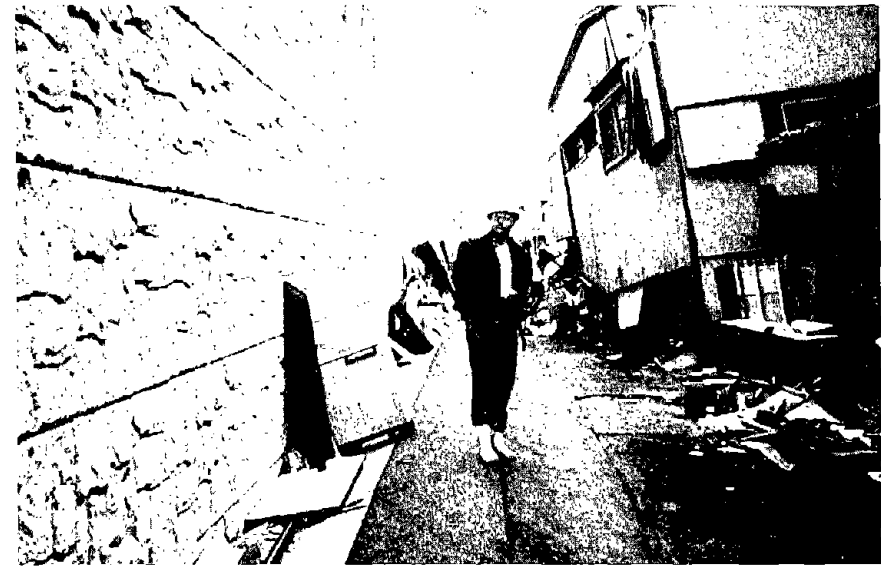
The Tanata wall (Figure 7.17) is located between the Ashiya and Setsu-Motoyama JR stations, near the slide shown in Figure 7.8. The wall is somewhat more than 6 m high, with PVC fiber grid reinforcements 2.5 m in length, and cohesionless backfill. A typical cross section is shown in Figure 7.18. The reinforced soil wall is founded directly on the original ground without deep foundation support. Nonetheless, the wall retained its stability, with outward deformations of about 22 cm at the top and 10 cm at the base (Figure 7.19). According to Tatsuoka et al. (1995) several reinforcement layers near the top of the wall could not be extended to the full design length owing to construction limitations, and this may have resulted in the tilting being greater than it might have been otherwise. There was settlement of all four sets of railroad tracks running along the embankment above caused by the dynamic loading; however, the track located above the reinforced backfill settled the least.

Some minor spalling of the concrete facing panels was noted near the top at a construction joint, it appeared that the joint width may have opened to about 2 cm, and some hairline cracking was noted that is suggestive of longitudinal shear in the panels. However, given the extensive

Figure 7.17: Post-earthquake view of the Tanata GRS-RW wall.

damage in the area (most of the buildings directly across the street from the wall had or were heavily damaged collapsed, as seen in Figure 7.17), the GRS-RW demonstrated excellent seismic resistance.
