SEISMOLOGICAL AND ENGINEERING ASPECTS OF THE 1995 HYOGOKEN-NANBU (KOBE) EARTHQUAKE

REPORT NO.
UCB/EERC-95/10
NOVEMBER 1995

EARTHQUAKE ENGINEERING RESEARCH CENTER

A reconnaissance report by
teams funded by

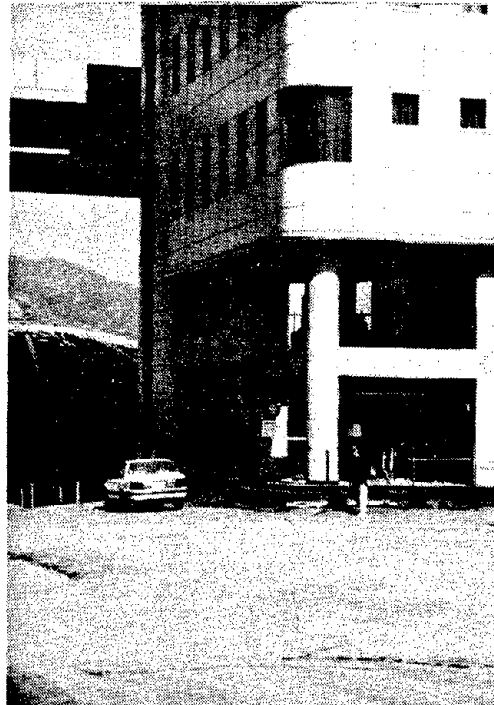
Fig. 4.5 Apparently undamaged pile-supported building. The magnitude of liquefaction-induced differential settlement at the site is ≈ 30 cm.

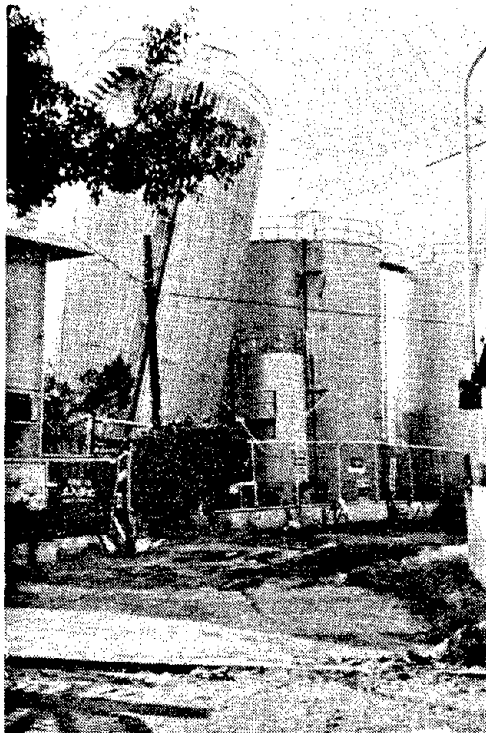
Fig. 4.9 Listing tank in the Nippon Gatx tank farm.

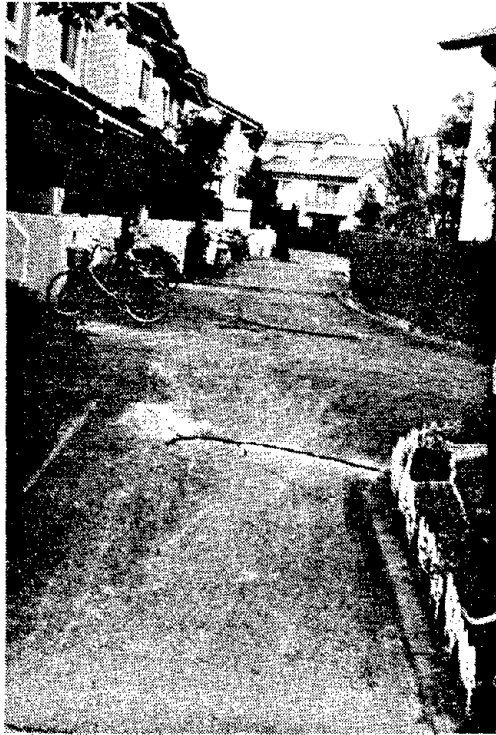
Fig. 4.10 No significant structural damage was evident in this modern residential development in spite of extensive ground deformation due to liquefaction.

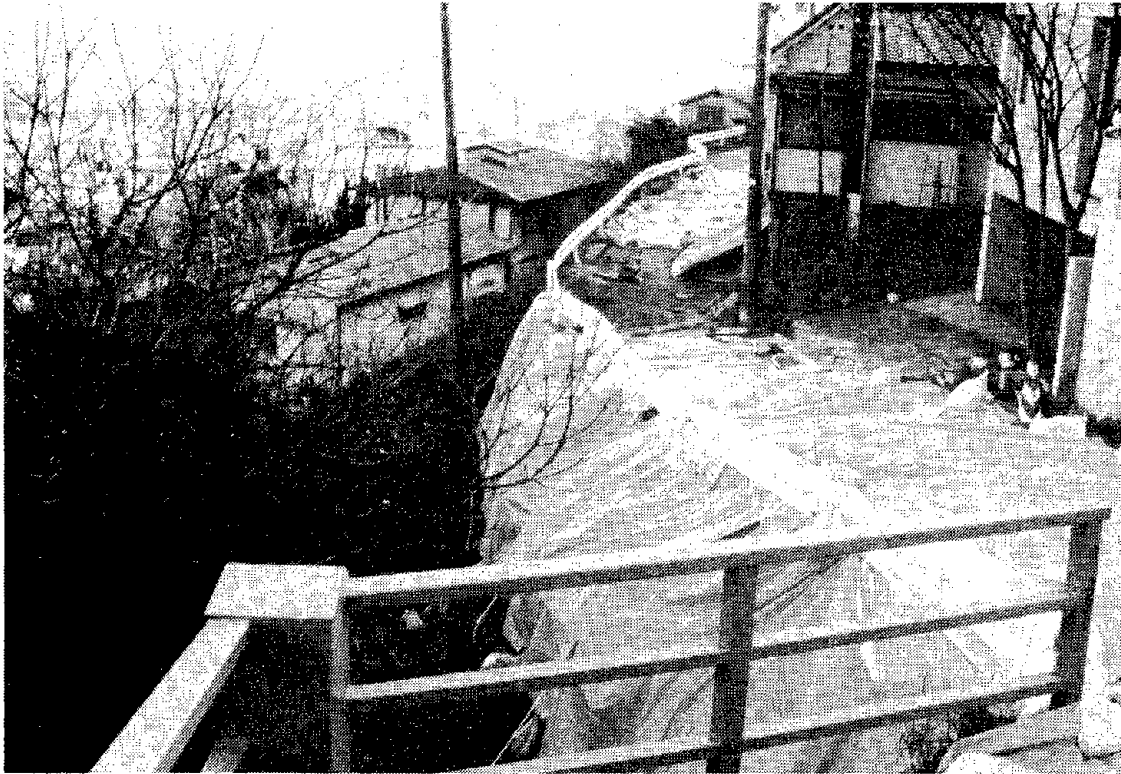
Fig. 4.18 Road embankment deformed by lateral and vertical displacements.

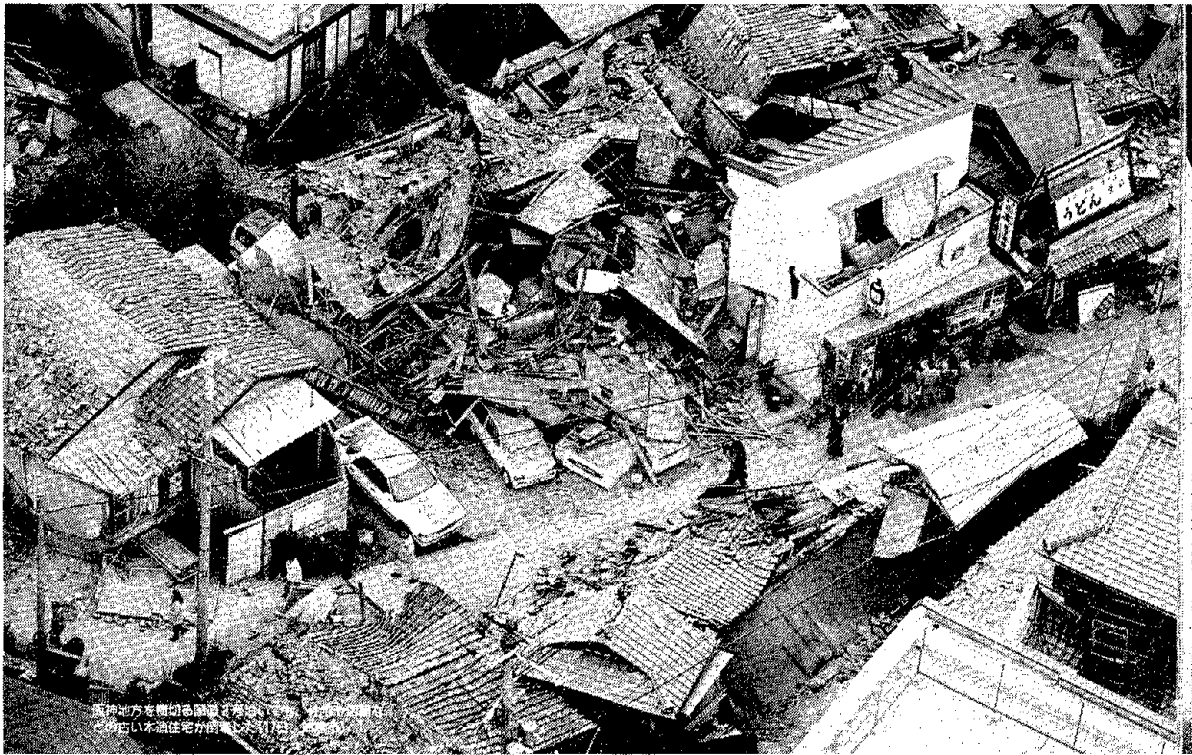
Fig. 5.3 The collapse of machiyas along the Kokudo route 2 in Ashiya. Note the collapses seem to have occurred as buildings twisted under the weight of the tile roofs. (ill.: *Asahigraph, Special edition on Kansai Earthquake*, February 1, 1995)

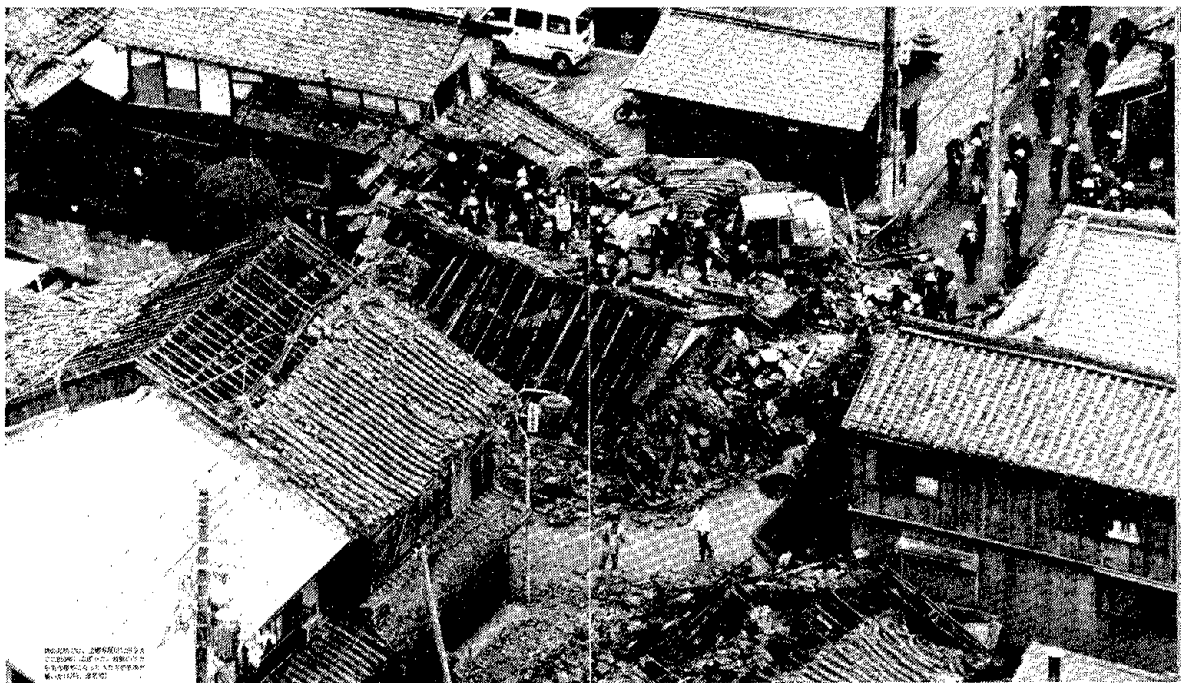
Fig. 5.4 Traditional machiyas in Tsuna-cho, on the northern part of the island of Awaji-shima. Note the lack of diaphragms in the roofs. The machiya at the bottom left resembles a classic Kyoto machiya. The one in the central illustrates the long narrow lot with residence behind. (ill. *Asahigraph, Special edition of Kansai Earthquake*, February 1, 1995)

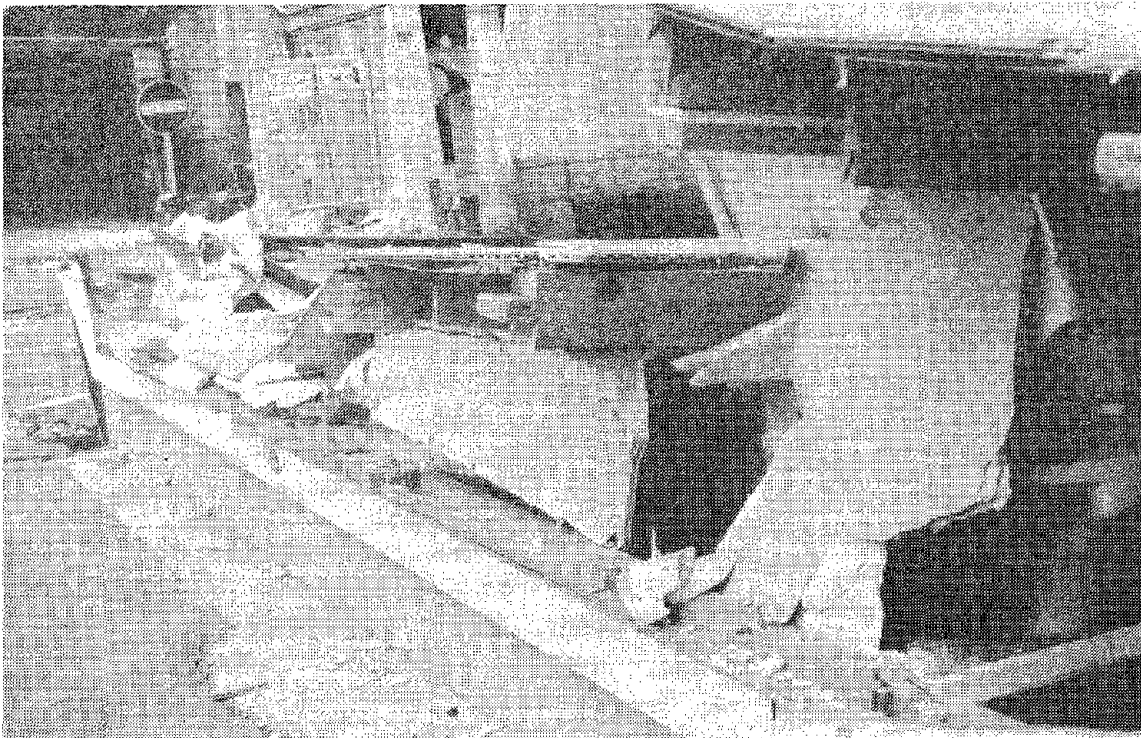
Fig. 5.12 Detail of Fig. 11 illustrating the uncoupling of mortise-tenon. The system could not sustain the lateral forces and the mortise detached from the tenon although it was extensively nailed.

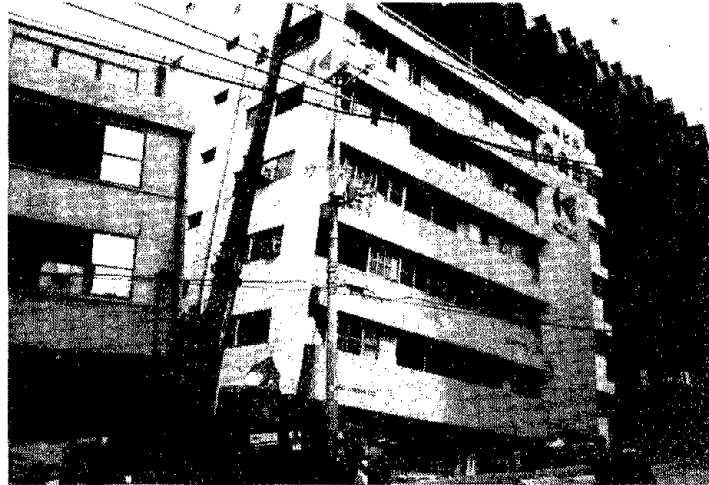
Examples of weak and soft story failures in older reinforced concrete structures, at both first and mid-height stories, are presented in Figures 6.25, 6.26, 6.27, and 6.28. The exact causes of failure in these buildings are not known.

Reinforced concrete buildings constructed prior to 1971 fared poorly in this earthquake. Many instances of total collapse (Figure 6.54) and partial collapse (Figures 6.25, 6.26, 6.27, 6.28, and 6.55) were documented. The causes of failure in older frame and frame-wall buildings, along with descriptions of damage to a number of buildings are outlined in Section 6.4.2 above.

Fig. 6.26 First story collapse

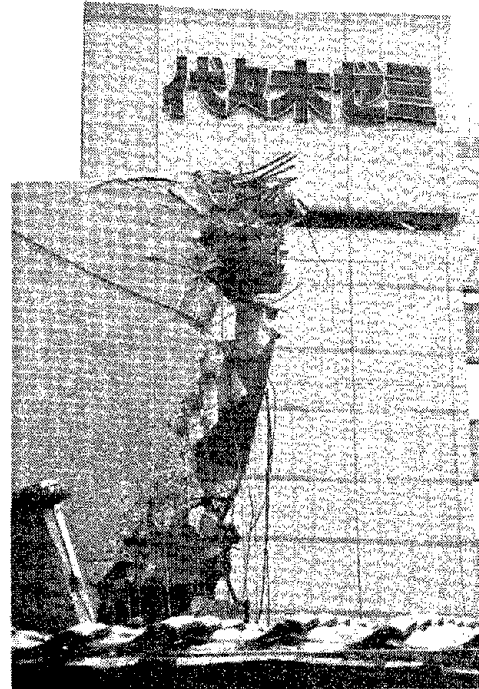
Fig. 6.32 Overturned nine-story building

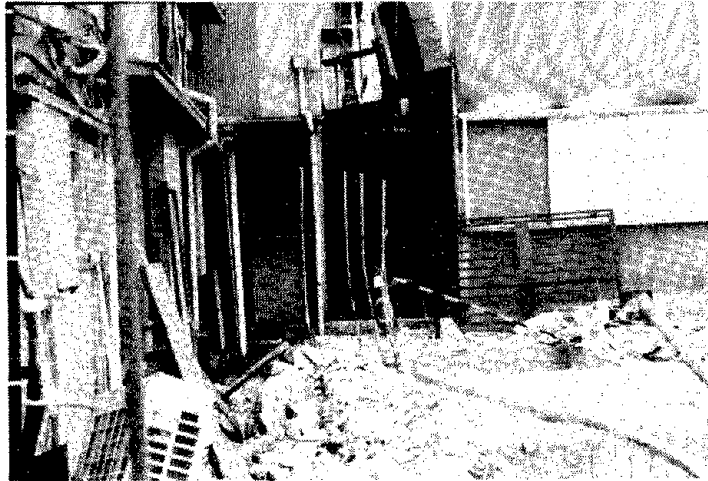
Fig. 6.34 Foundation details - overturned nine-story building

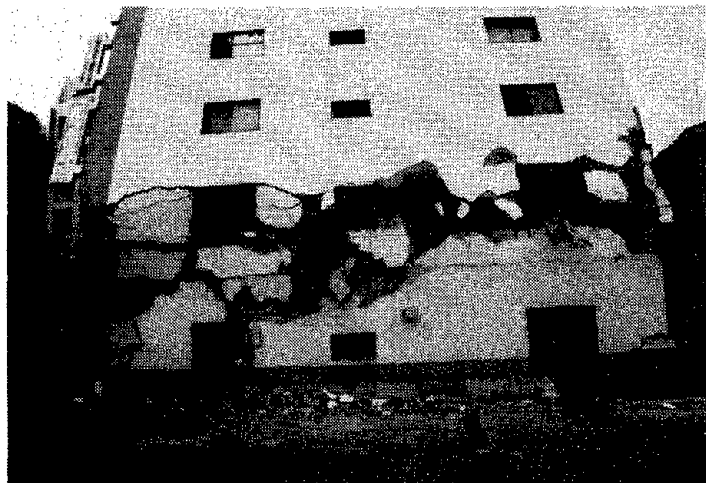
frame-wall construction. This corner building overturned as described in Section 6.4.2.3 above. The framing system was irregular in plan: moment frames on each of the two faces of the building fronting a street (see Figure 6.35) and frame-wall construction on the other two faces of the building (see Figure 6.36). The first and second stories of the eastern segment of this building collapsed. The frame-wall construction on the western face of the building failed in net tension. The quantity of debris and level of damage made it impossible to identify the cause(s) of failure with certainty. A possible cause of failure is that combined translational and torsional response in the building (as evinced by the at-rest position of the building after the earthquake) resulted in shear failure in the columns of the moment frame; the torsional response resulted from the eccentricity of the centers of mass and stiffness in the building.

Fig. 6.36 Tension failure of frame-wall - overturned six-story building

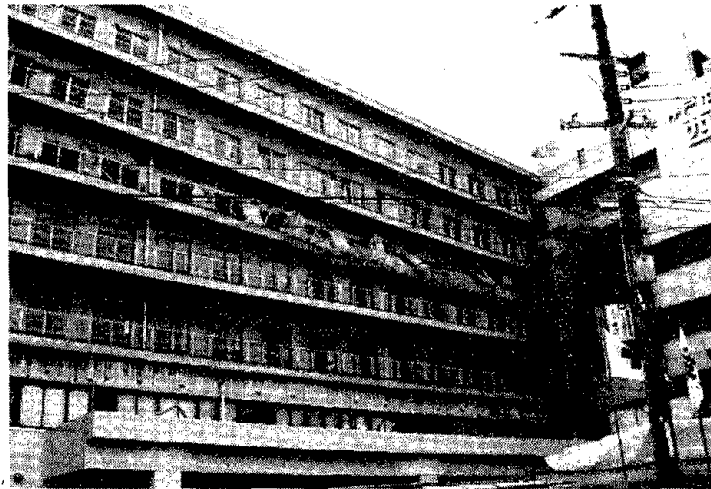
Fig. 6.39 Mid-height story collapse - West City Hospital

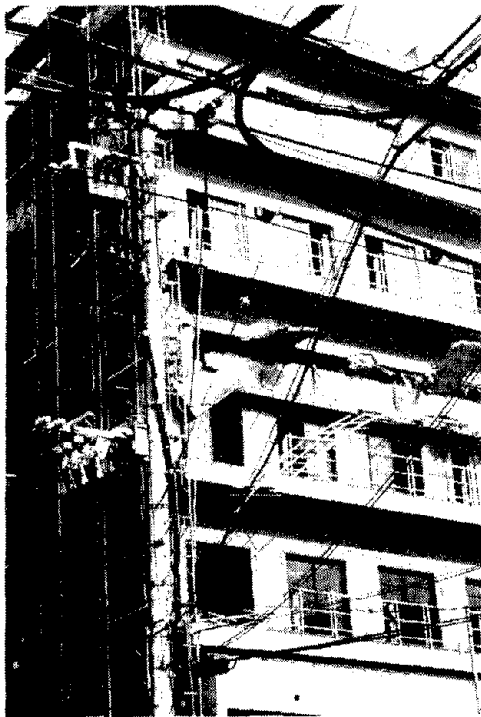
Fig. 6.40 Failed columns (piers) - West City Hospital

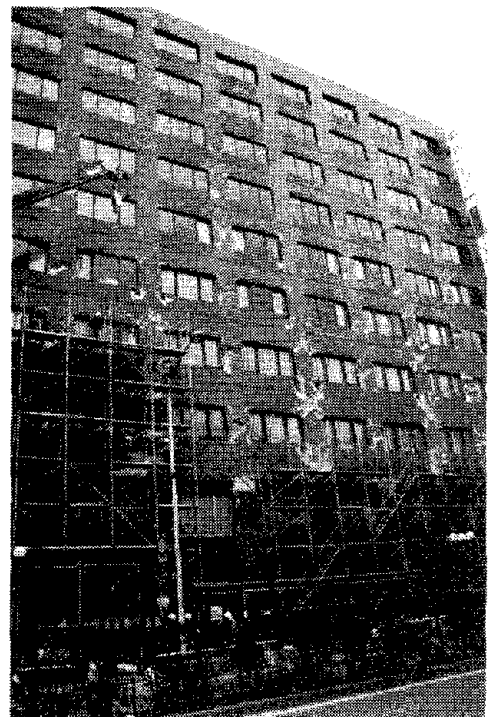
Fig. 6.41 Damage to shear-critical reinforced concrete columns; post-1981 construction

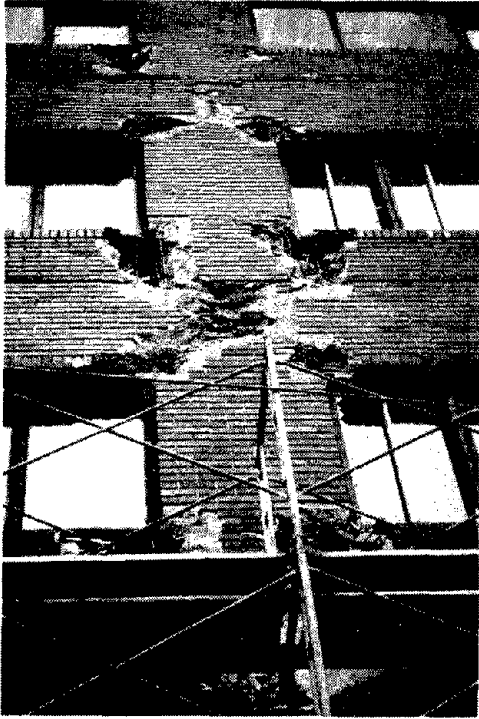
Fig. 6.45 Shear-cracking in a beam-column joint; post-1981 construction

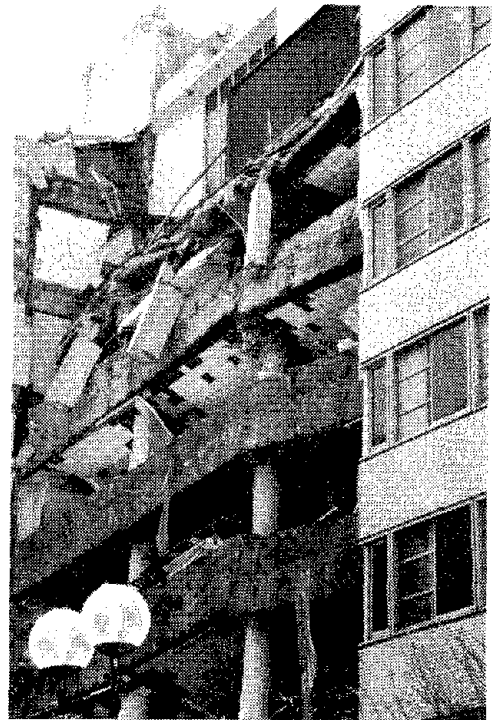
Fig. 6.48 Damage to a haunched beam-circular column joint; pre-1971 construction

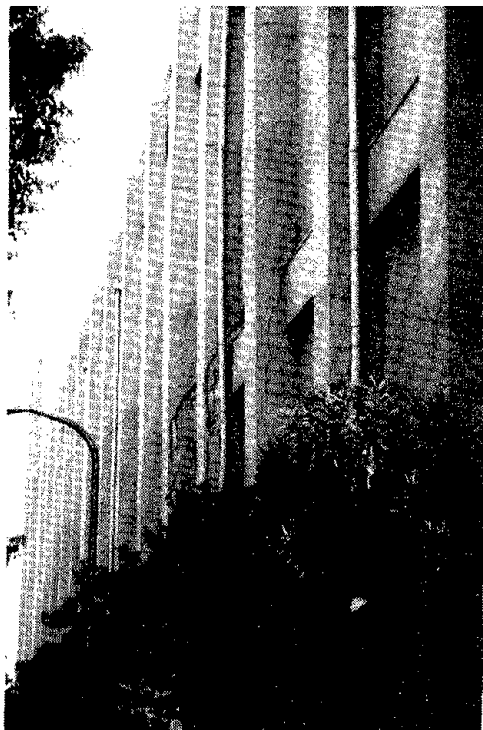
Fig. 6.49 Damage to a beam-column joint

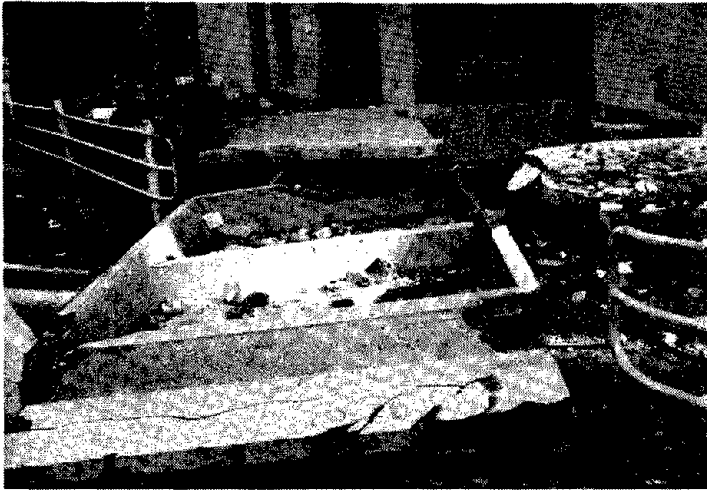
Damage to precast concrete facade or cladding elements was observed in numerous instances. Although failure of such elements rarely leads to building collapse, the consequence of failure can be substantial loss of life if heavy cladding elements fall from the building into the street below. One example of the failure of precast concrete cladding elements is presented in Figure 6.51 — if the earthquake had struck during daylight hours in Kobe, the failure of these cladding elements would likely have led to substantial loss of life.

The causes of failure of the precast cladding shown in Figure 6.51 are unknown, but external inspection of the building, and close inspection of the damaged precast panels lying in the street, would suggest that (a) the primary seismic framing system was not sufficiently stiff to protect the cladding elements from excessive deformation, and (b) the strength and deformation capacity of the panel restraint connections was insufficient to prevent the panels dislodging from the building.

Fig. 6.51 Failure and collapse of precast concrete cladding

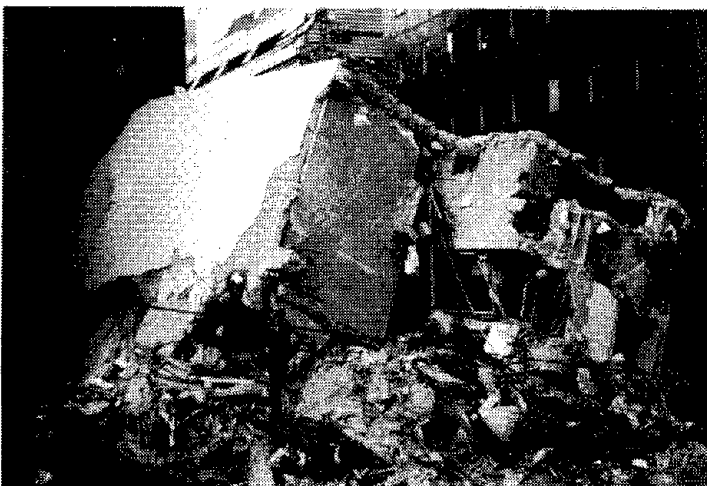
Fig. 6.54 Complete collapse of reinforced concrete building; pre-1971 construction

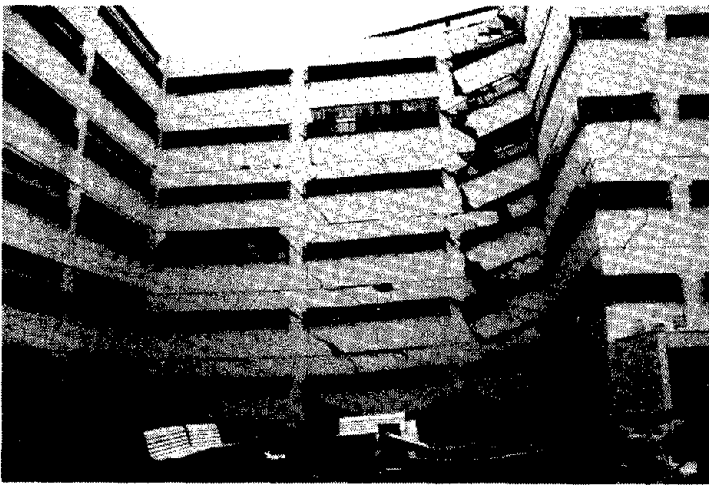
Fig. 6.63 Elevation of courtyard wall in the collapsed building

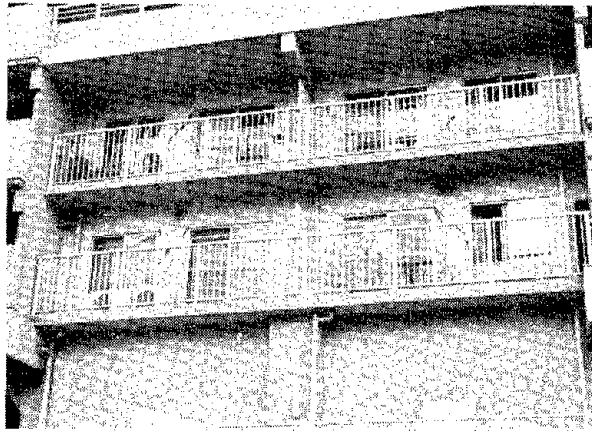
Fig. 6.66 Shear cracking in short wall piers; post-1981 construction

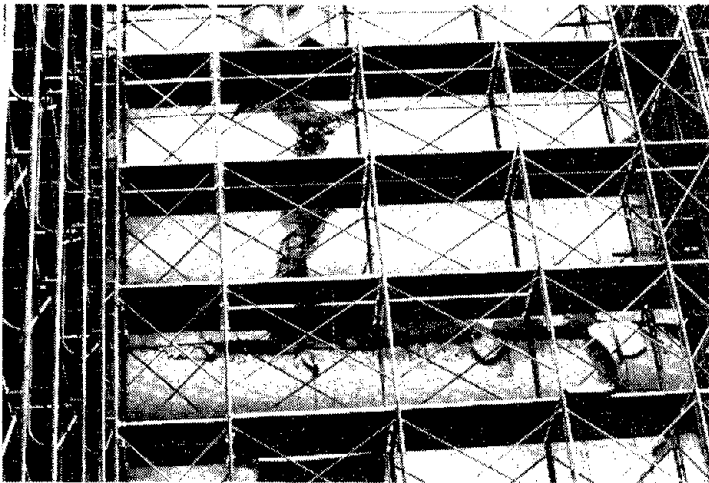
Fig. 6.69 Heavy damage to reinforced concrete structural walls

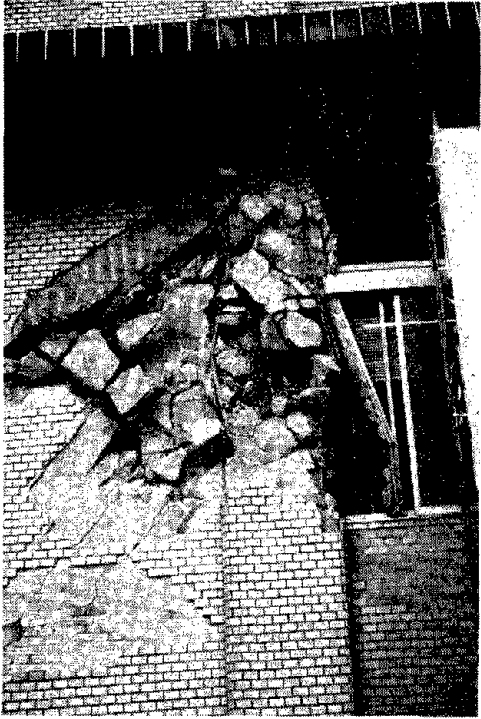
Fig. 6.74 Failed SRC boundary element at the edge of the wall shown in Figure 6.72

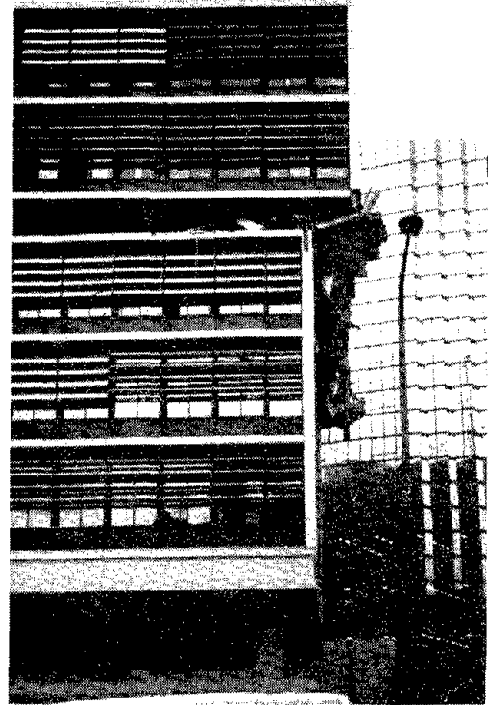
Fig. 6.78 View of end of Annex building showing offset above collapsed story

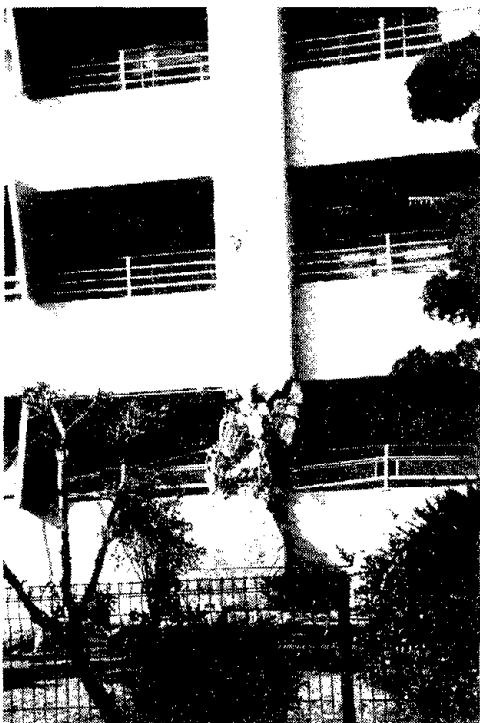
Fig. 6.79 Shear failure of first-story, SRC columns

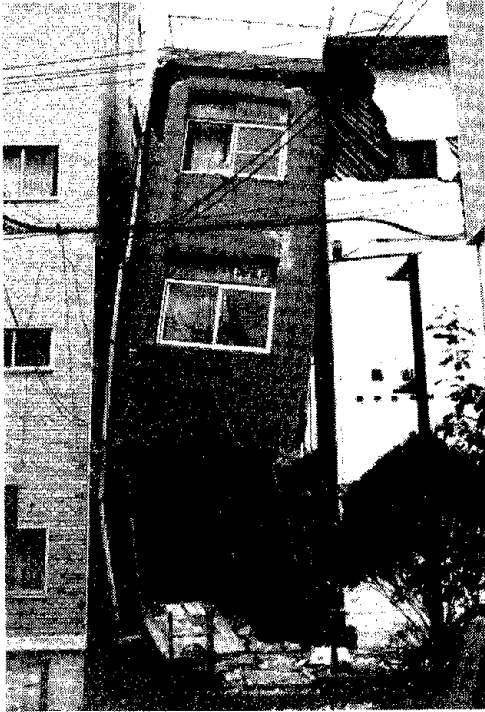
There was little evidence of the failure of steel buildings due to either weak or soft stories. The three-story steel moment frame building shown in Figure 6.88 could be considered to have failed due to either a soft first story or a weak first story — the first story is soft with respect to the infilled masonry frame in the second and third stories and weak with respect to the lateral strength of the infilled frame in the upper two stories.

Fig. 6.88 Soft and weak story failure of a steel moment frame building

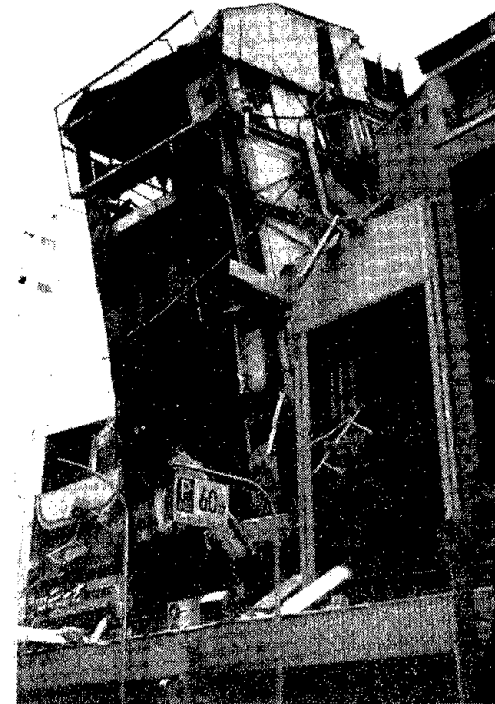
Complete overturning and failure due to excessive sway (Figure 6.91) of steel framed buildings was documented by the reconnaissance team, and determined to be the result of one or more of the following:

In the building shown in Figure 6.91, the column-to-beam connections were effectively pinned through the use of web shear (non-moment) connections. Failure of the slender braces led to a dramatic reduction in the lateral strength and stiffness of the building, and the resulting excessive sway of the building.

The slender braces in the seven-story building shown in Figure 6.91 failed during the earthquake, likely causing the building's large permanent displacement. The axial strength of the failed braces (ignoring the important issues associated with the likely hysteresis of the braces) is small, and there is no doubt that the pre-earthquake seismic strength of the building was insufficient for the building to survive moderate or severe earthquake shaking.

Fig. 6.91 Excessive sway due to fracture of slender braces

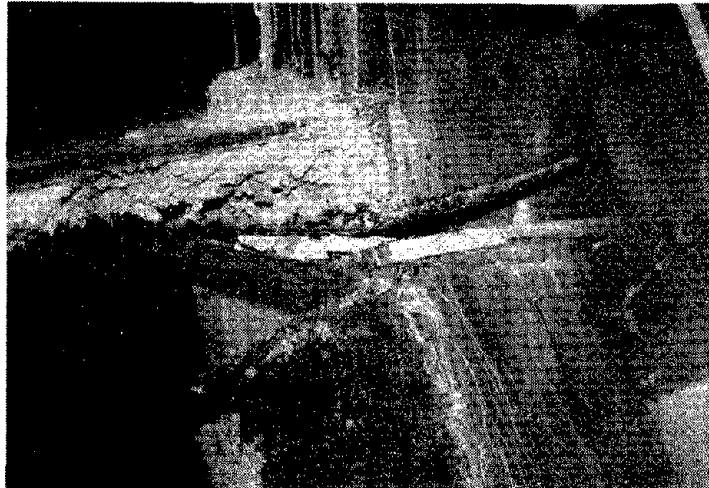
- Fracture of a column-to-beam continuity plate connection — typically a fillet welded connection (Figure 6.92)
- Fracture of a beam connection to the column (Figure 6.93)
- Failure of the bolted baseplate-to-pedestal connection (Figure 6.94)
- Fracture of flat bar and rod bracing elements (Figure 6.91)

Fig. 6.92 Failed column-beam connection at continuity plate

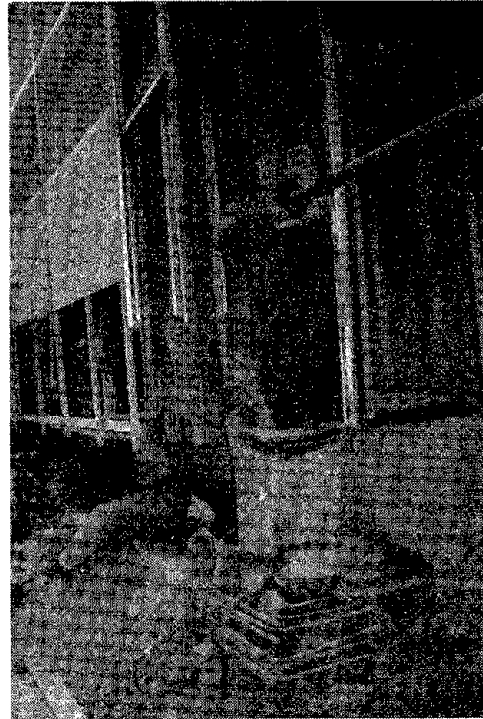
Fig. 6.96 Fracture of box column immediately above grade beam

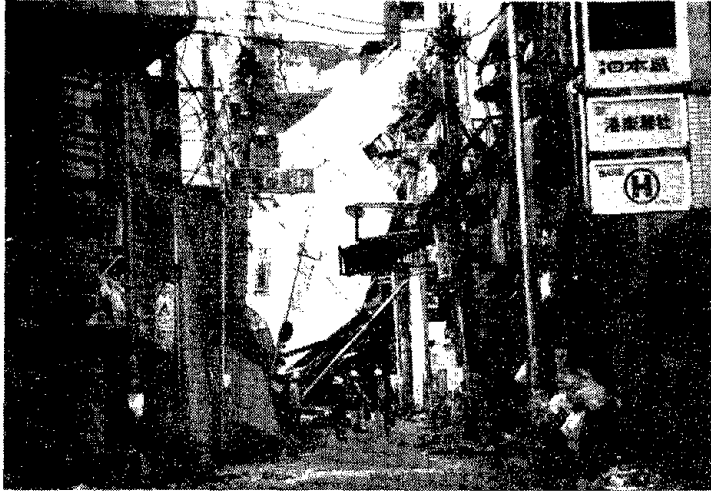
Fig. 6.103 Overturned steel moment-frame building

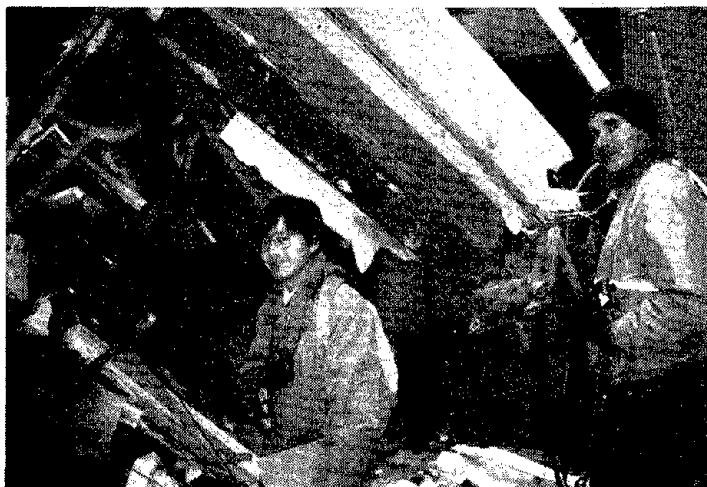
Fig. 6.105 View of a failed baseplate connection

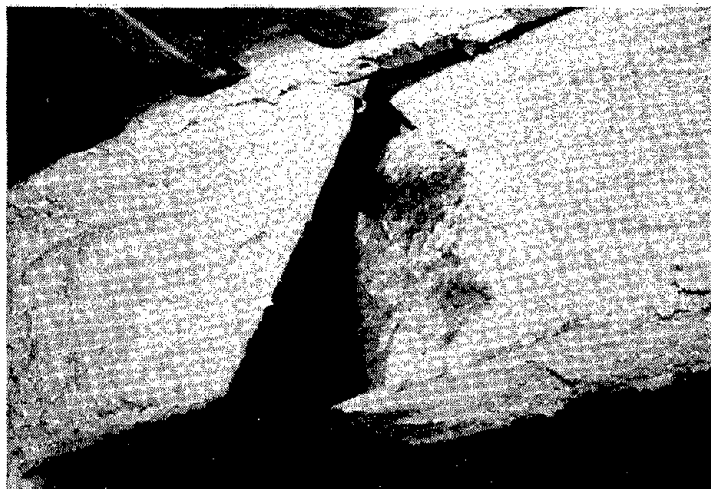
Fig. 6.117 Failed beam-column connection

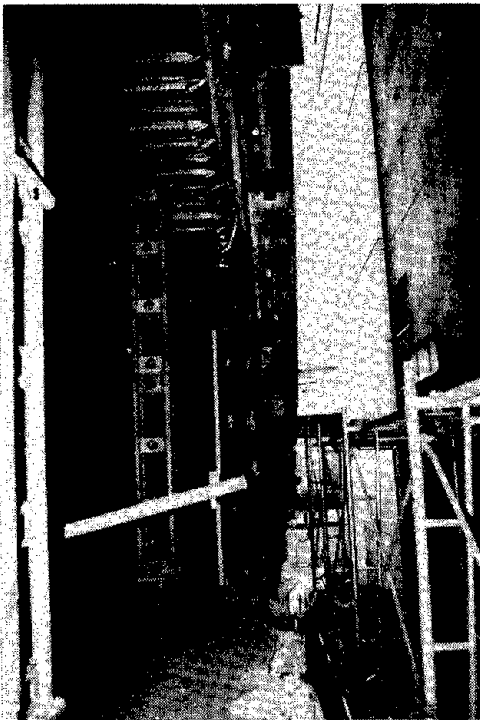
Fig. 6.119 View of buckled concentric brace

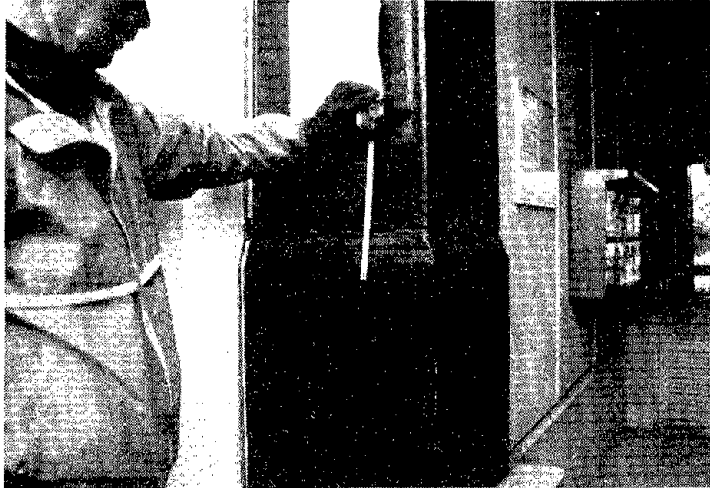
Many of the failures [AIJ, 1995b] were located within 200 mm (8 inches) of the welded junction of the pedestal and the box column (Figures 6.130 and 6.131). Note that in the lowest level of the vertical towers (Figure 6.132), the heavy longitudinal braces were eliminated, thus changing the framing system from braced to moment-resisting.

Fig. 6.130 Net-section tension failure in column at welded splice

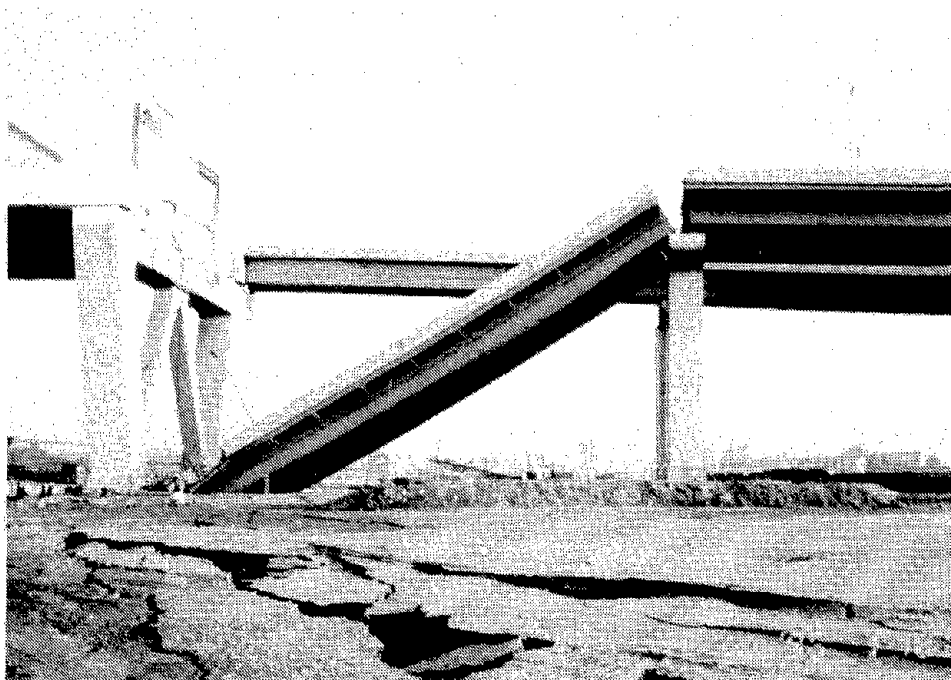
The approach span on the Koshien Island side of the bridge had fallen off its support at the tied arch end, fracturing the restrainers (Figures 7.16 and 7.17). The steel box-girder span had been simply supported at pier 98 (opposite the arch end of the span). When the arch end of the span fell, the expansion joint was broken at pier 98 and the girder nearly dropped at that end also (Figures 7.18 and 7.19). The Hanshin Expressway Public Corporation reported that a fixed bearing at pier 100 on the opposite side of the channel had also broken.

Fig. 7.18 View of collapsed span from the south

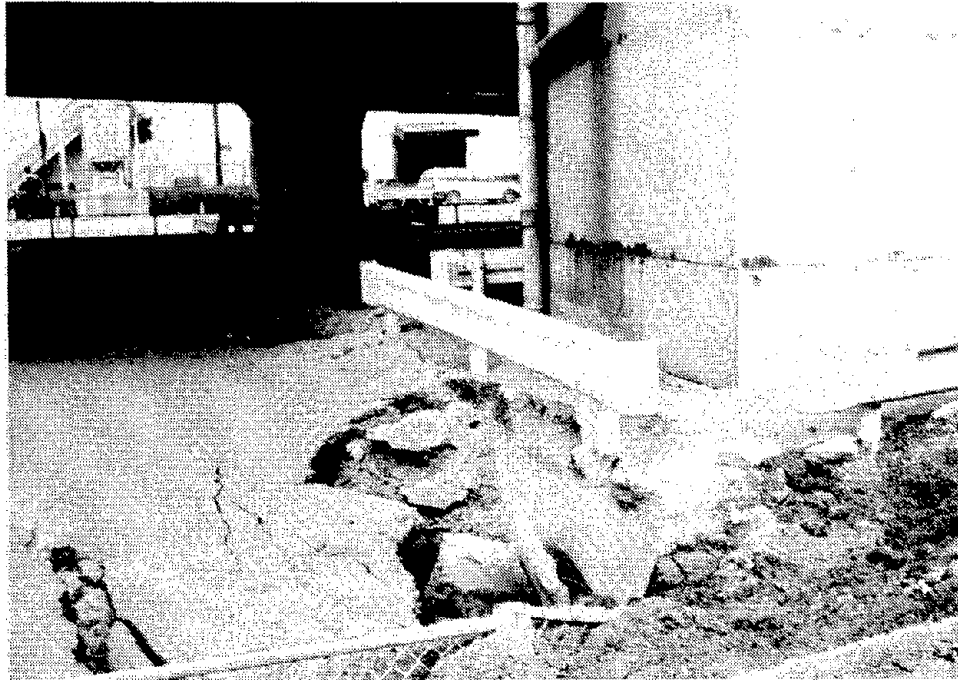
Fig. 7.32 Settlement around piers at south end of Port Island bridge

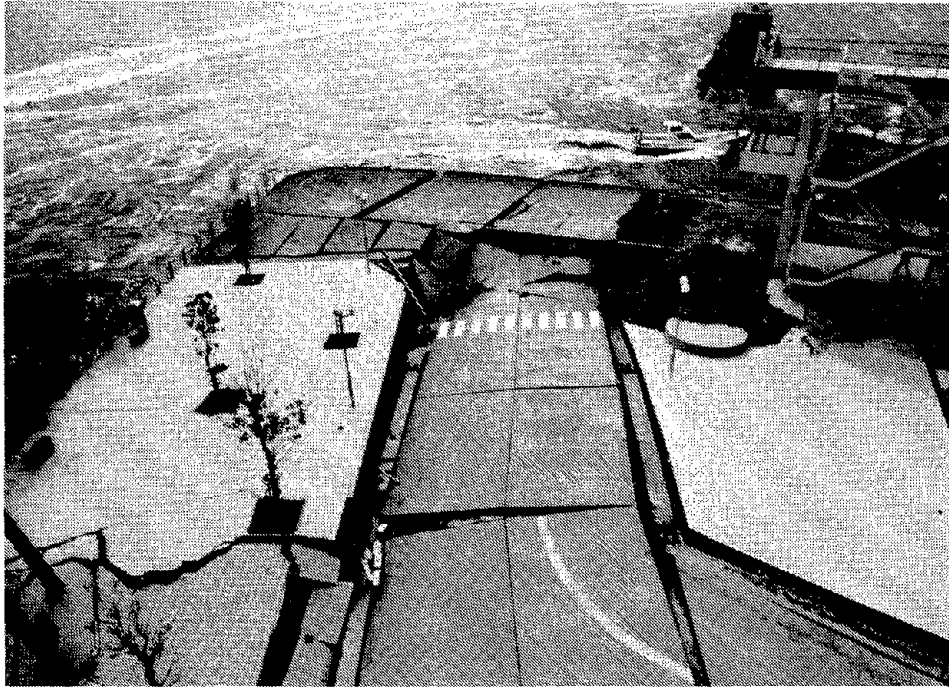
Fig. 7.38 Settlement on northeast side of Port Island bridge

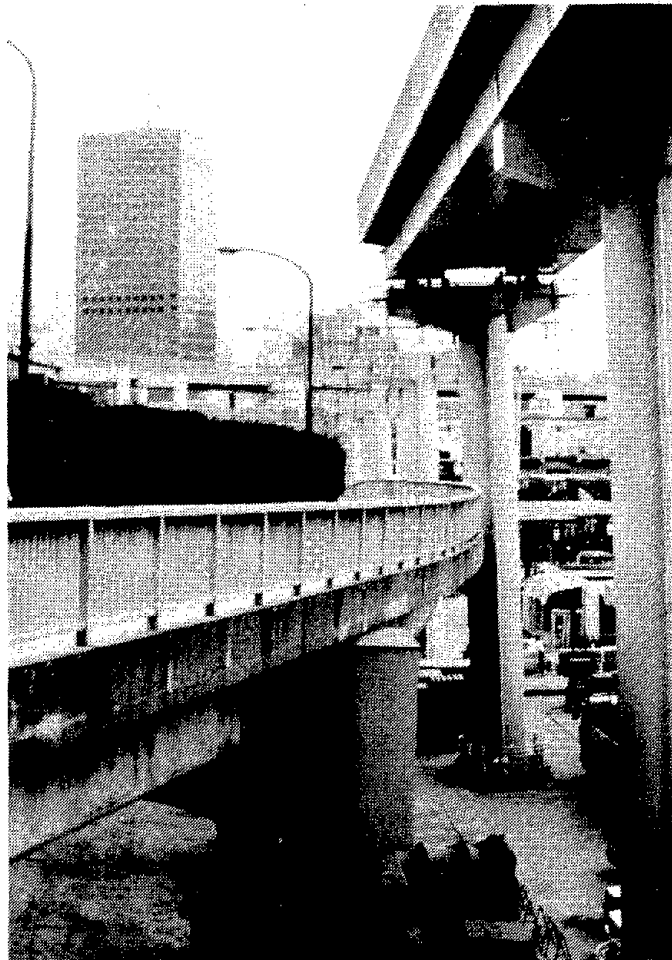
Fig. 7.41 Inclined piers on elevated railway

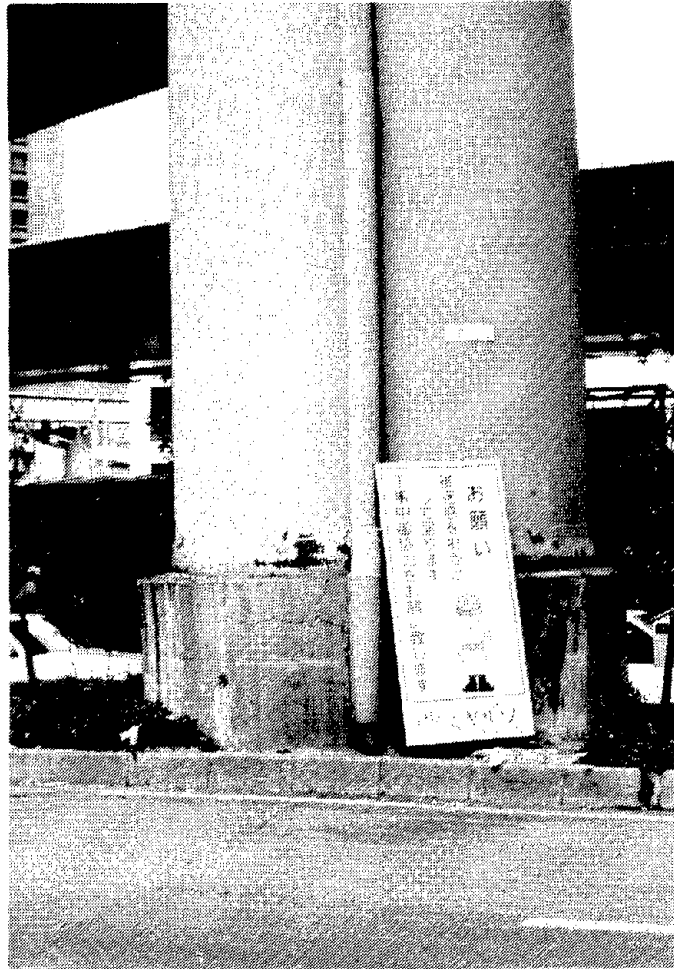
Also at the Kobe end of the approach spans, several highways came together creating a complex set of intersections at several elevations. One of the circular cross section columns of a steel bent displayed evidence of yielding and local buckling (Figure 7.42). One circular cross section concrete column of another bent had a flexural failure at mid-height that apparently resulted from fracture of the longitudinal steel at welded splices (Figure 7.43). Another steel column buckled about 2.4 meters (7.5 ft) above a one-meter high concrete pedestal (Figure 7.44).

Fig. 7.42 Buckling at base of steel column
