# The Loma Prieta, California, Earthquake of October 17, 1989—Landslides

STRONG GROUND MOTION AND GROUND FAILURE

U.S. GEOLOGICAL SURVEY PROFESSIONAL PAPER 1551-C

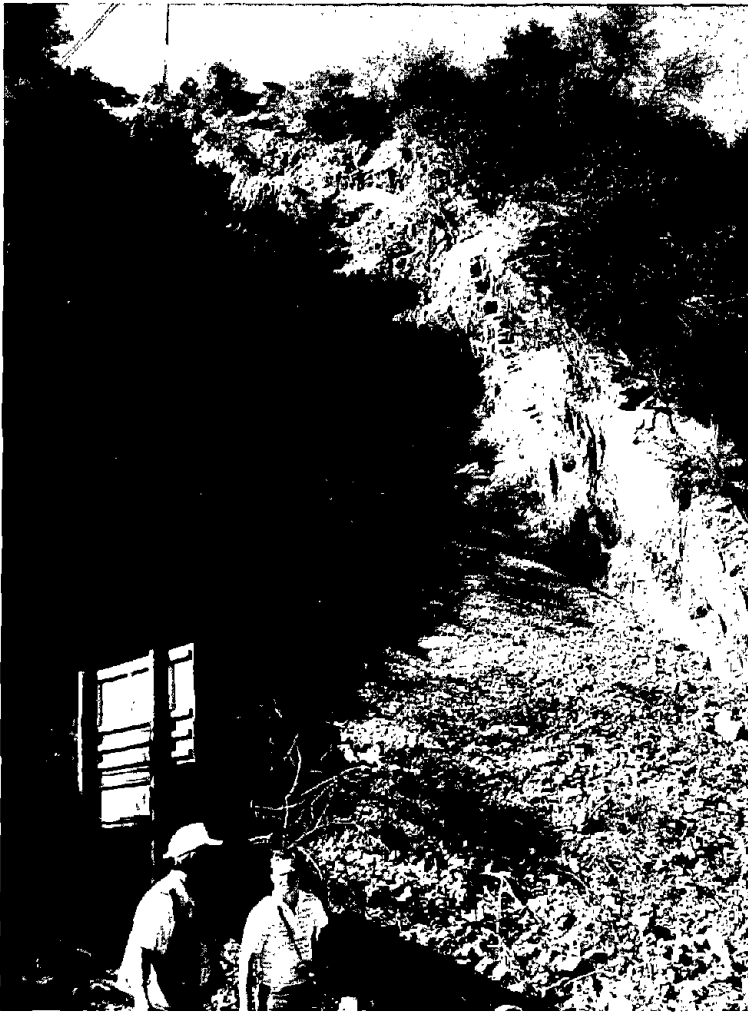
Another complex of rock falls and rock slides, which resulted from failures of cut slopes on both sides of California Highway 17, temporarily blocked that highway at the Santa Cruz-Santa Clara County line (fig. 2). The landslide source was a sequence of steeply dipping beds of sandstone and shale of the Vaqueros Sandstone, which were massive but locally closely fractured. Rock falls were generated only within the shale beds, and open fissures on the ridgecrest above the source west of the highway indicated that these rock falls were related to an incipient slope failure which was much larger and deeper. Together, the rock falls and rock slides at this locality contained an estimated several hundred cubic meters of material.

Figure 2.—Part of deposit from complex of rock falls and rock slides along California Highway 17 at Santa Cruz-Santa Clara County line (see pl. 1 for location). Landslide source was in intensely fractured rock.

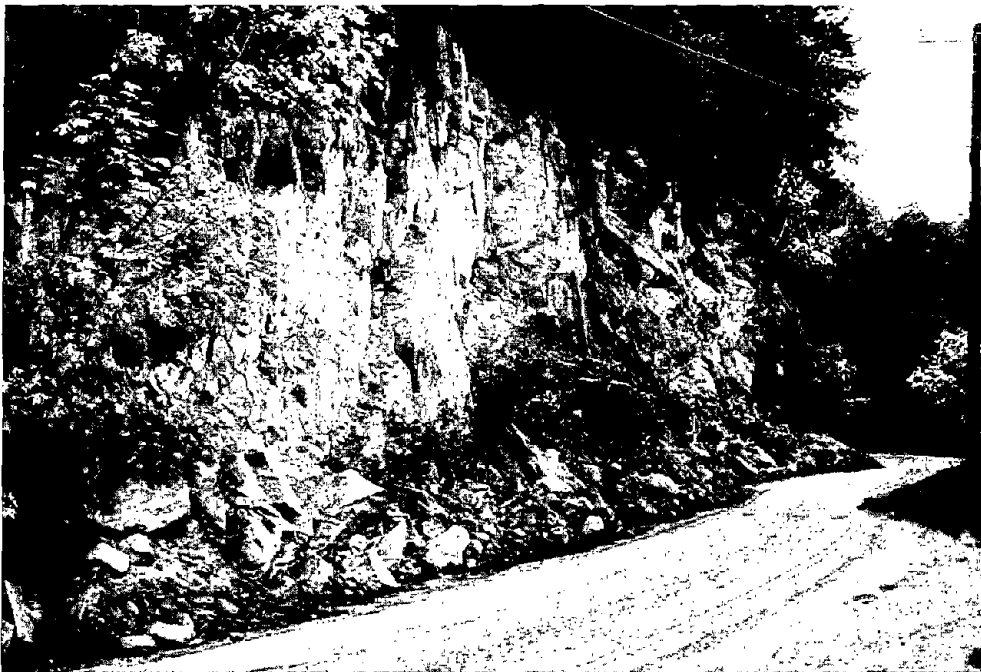
Figure 3.—Rock fall from near-vertical cut along Old San Jose Road, about 0.9 km northwest of Sugarloaf Mountain (see pl. 2 for location). Source rock is weakly to moderately cemented sandstone, broken by conspicuous, through-going joints. Estimated volume of deposit is 500 to 1,000 m<sup>3</sup>.

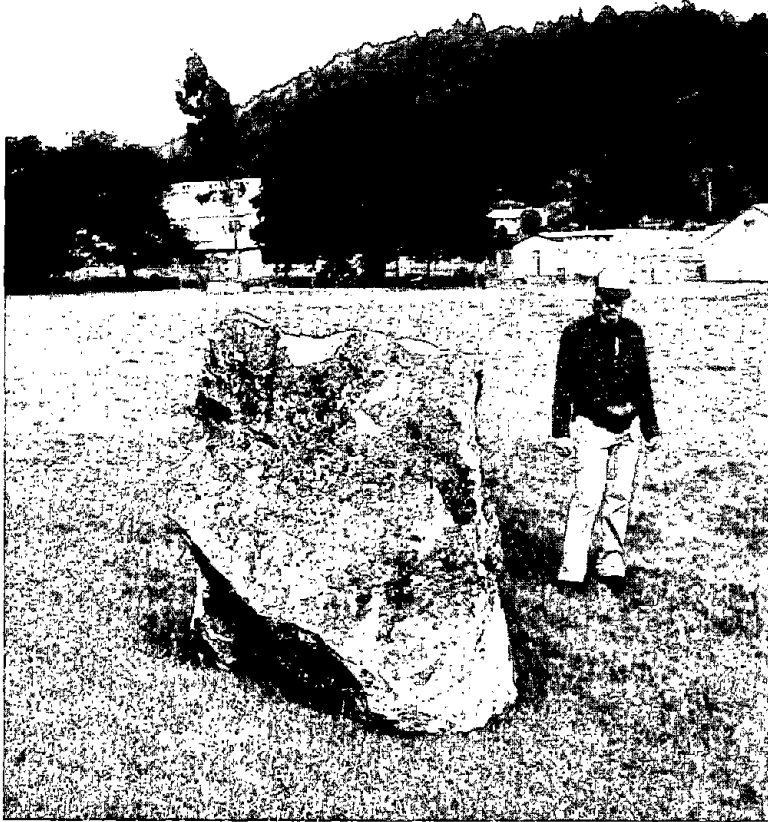
Figure 4.—Boulder, approximately 1.5 m in maximum diameter, from earthquake-induced rock fall near conference ground about 2.5 km north of Soquel (see pl. 2 for location). Several boulders of nearly comparable size bounced and rolled into gently sloping field from steep slope above.

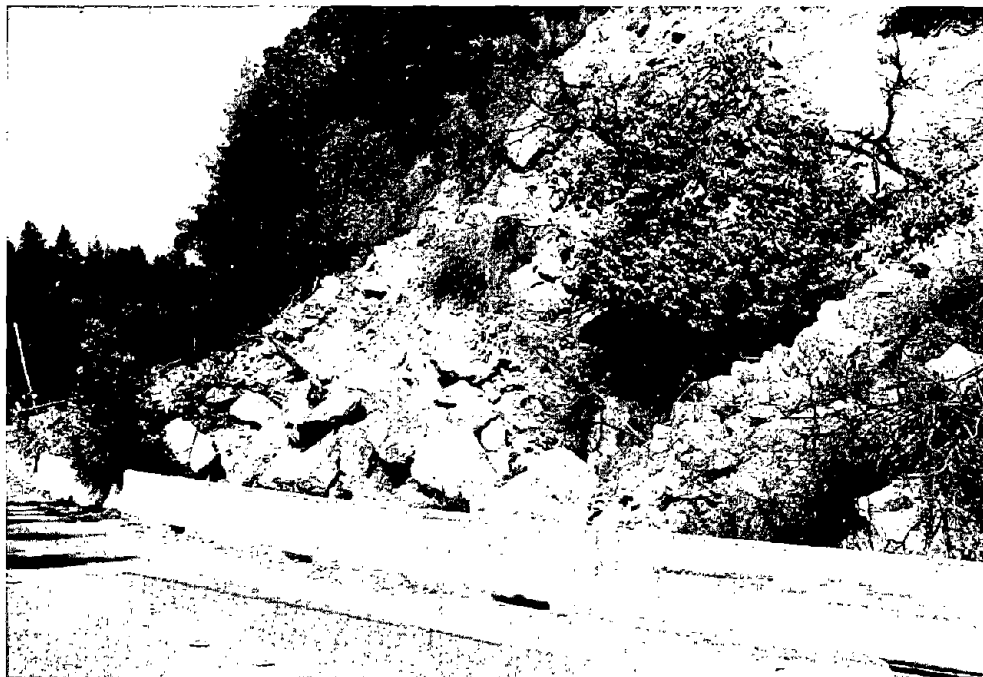
Figure 5.—Part of rock-fall deposit from cut slope above California Highway 17 in Glenwood area (see pl. 2 for location).

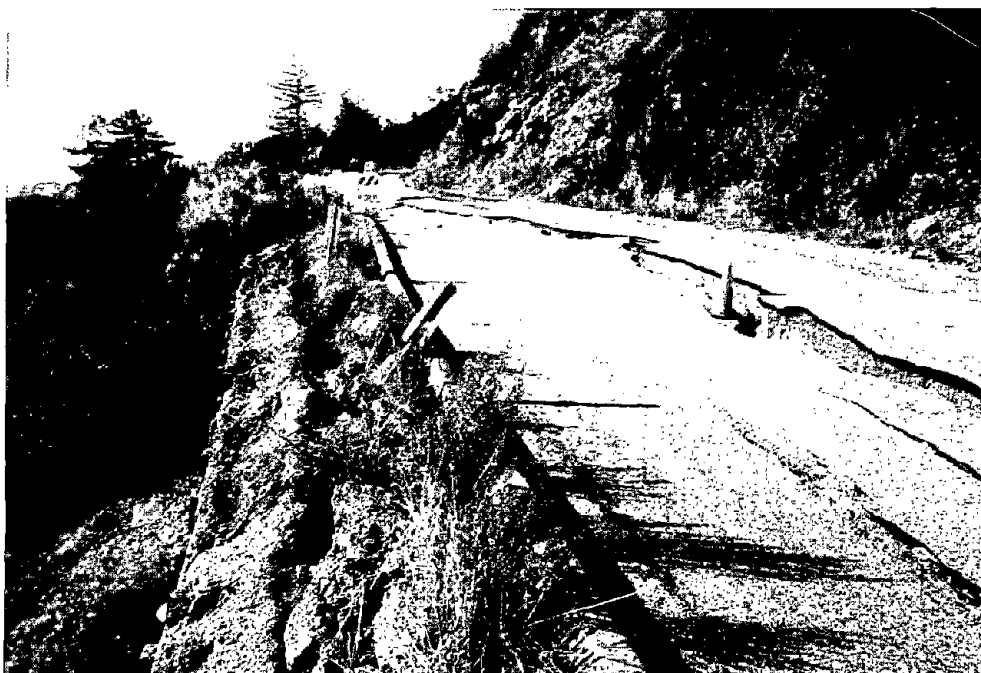
Figure 7.—Small slump in road fill near Bean Hill (see pl. 2 for location). Note arcuate, concave-downslope main scarp nearly parallel to long axis of road. Slumps in fill were most common type of category II landslides in the southern Santa Cruz Mountains. Photograph by David M. Peterson, U.S. Geological Survey.

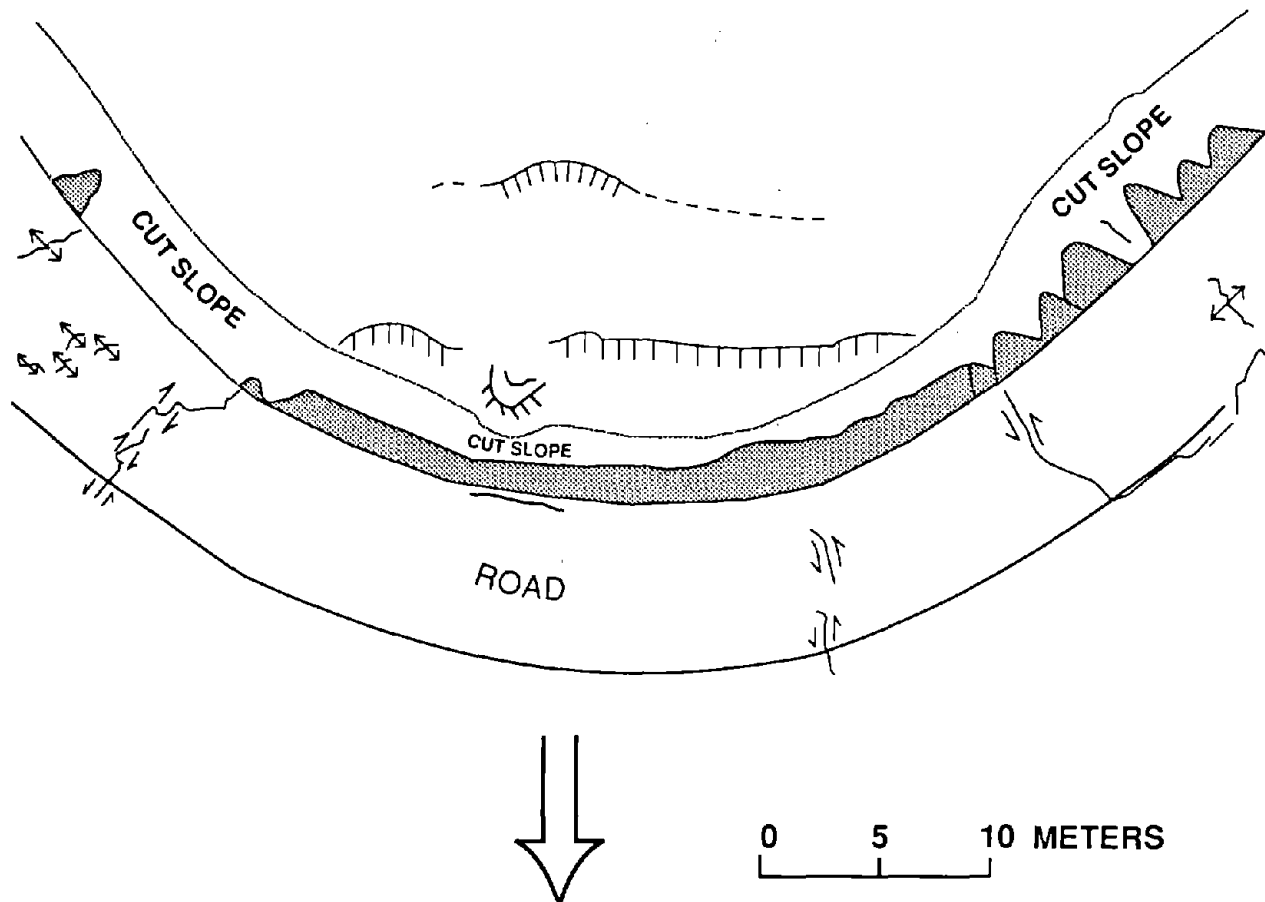
Figure 10.—Sketch map showing rock fall and block slide from end of ridge in Big Basin Redwoods State Park (see pl. 1 for location). Road curves around end of ridge in midslope position. Prominent scarps on ridgecrest above road (hachured on downdropped side, dashed where approximately located) showed as much as 6 cm of downslope displacement. Small arrows denote relative senses of motion on cracks in road, which typically trend perpendicular to long axis of roadway. Maximum local lateral displacement was 1.5 cm. Large arrow indicates approximate, inferred direction of movement of slide. No compressional features were found in heavily vegetated area downslope from road. Rock and soil falls (shaded areas) occurred on cut slope above road.

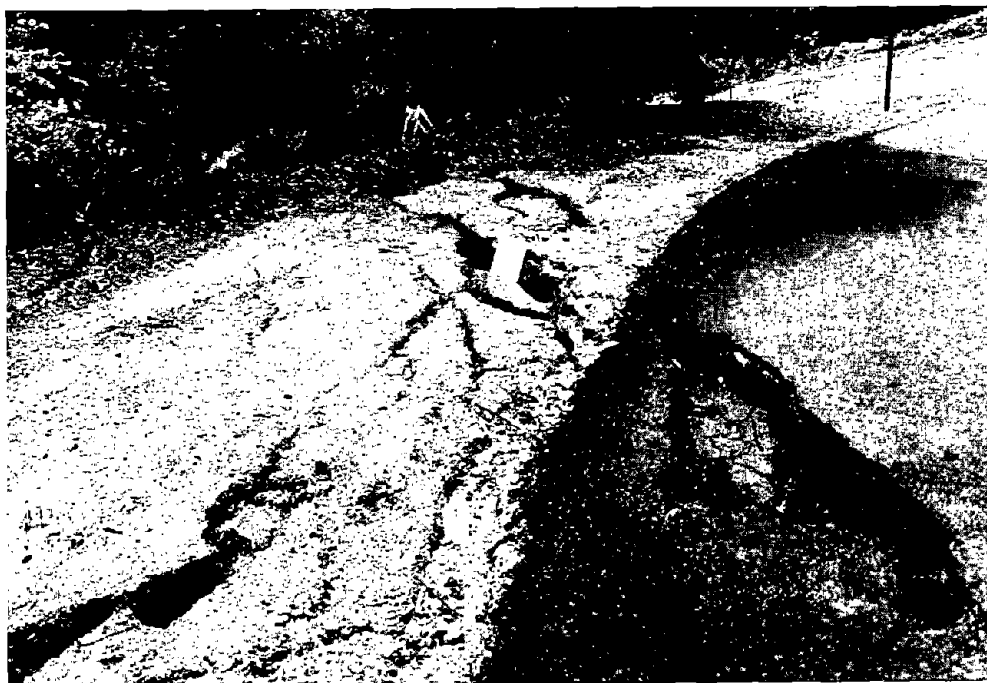
Figure 11.—Part of main scarp of rock block slide on end of ridge near Laurel (see pl. 2 for location). Notebook is 20 by 27 cm.

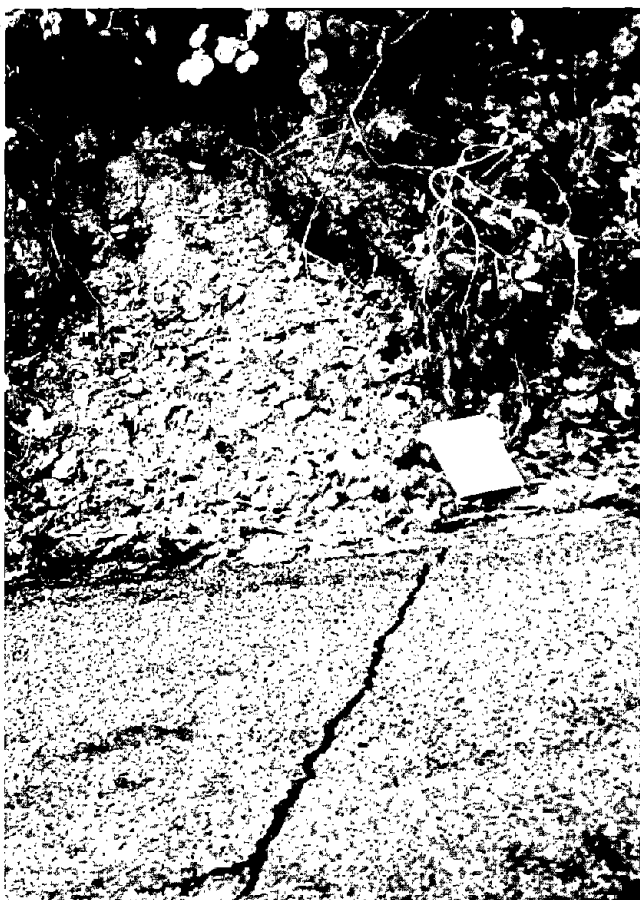
Figure 12.—Lateral margin (left flank) of block slide near Laurel (see pl. 2 for location) defined by crack across road, showing left-lateral movement. Note small rock fall where crack intersects steep cut slope across road.

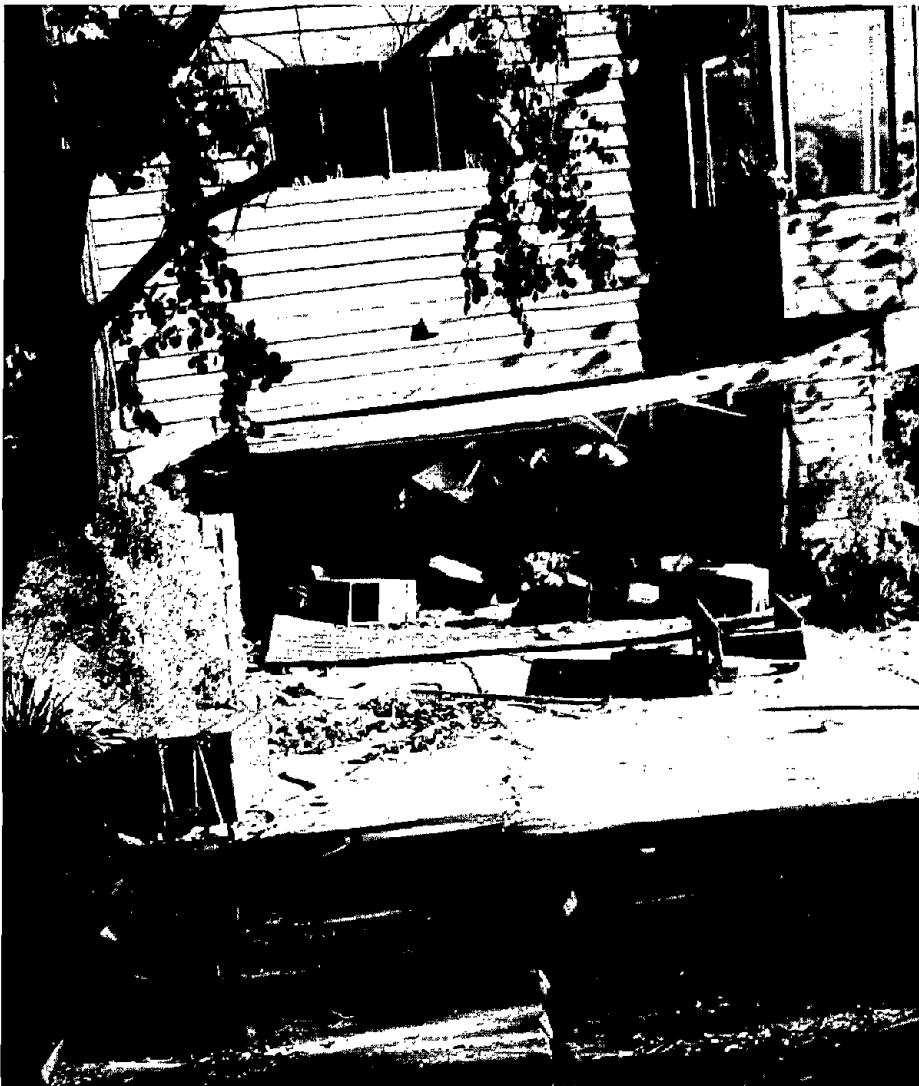
A

Figure 13.—Ridgecrest fissure and associated landslide along Robinwood Way (see pl. 2 for location). *A*, Ground crack, also breaking pavement and foundation slab. Crack is nearly linear, trends parallel to long axis of steep, high, narrow ridge, and is immediately upslope from slump shown in figure 13*B*. Downslope direction is toward right. *B*, Rotational slump originating on edge of ridgecrest, immediately below ground crack shown in figure 13*A*. Position and orientation of crack and relation to slump indicate that crack is an incipient landslide feature.

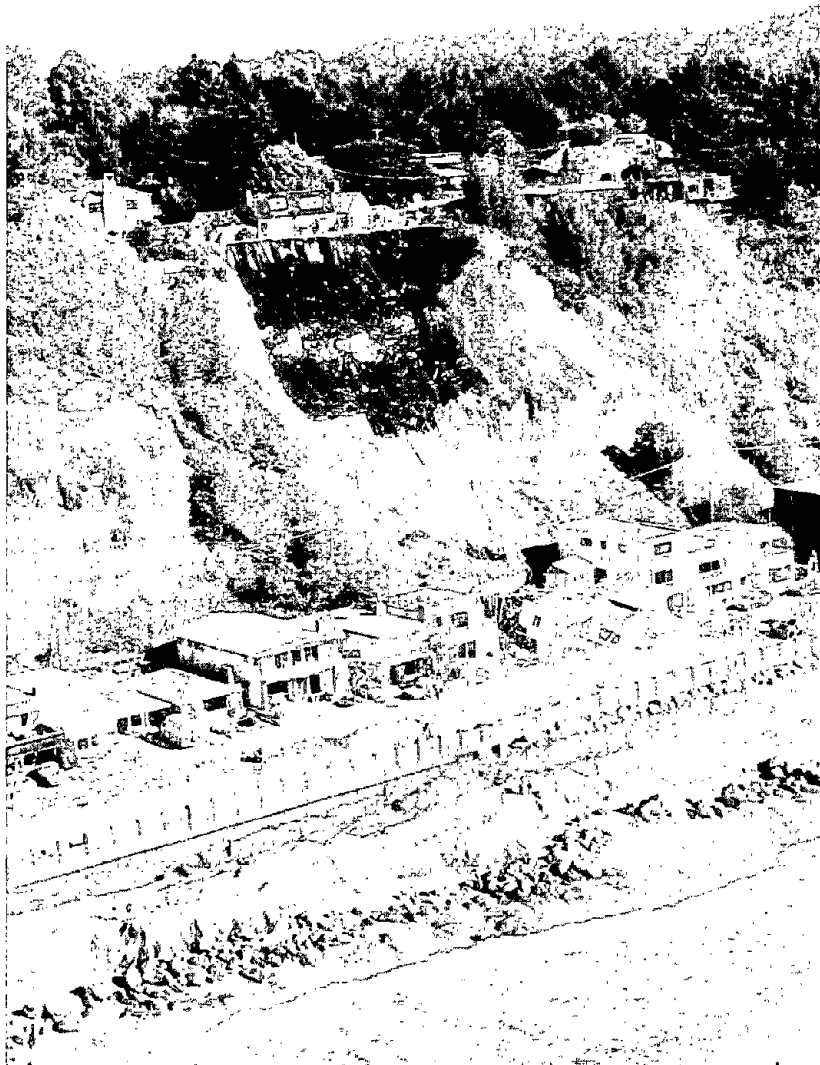
Figure 1.—Coastal-bluff failure in Rio Del Mar (see fig. 4 for location) during a 100-yr 24-hour rainstorm in January 1982.

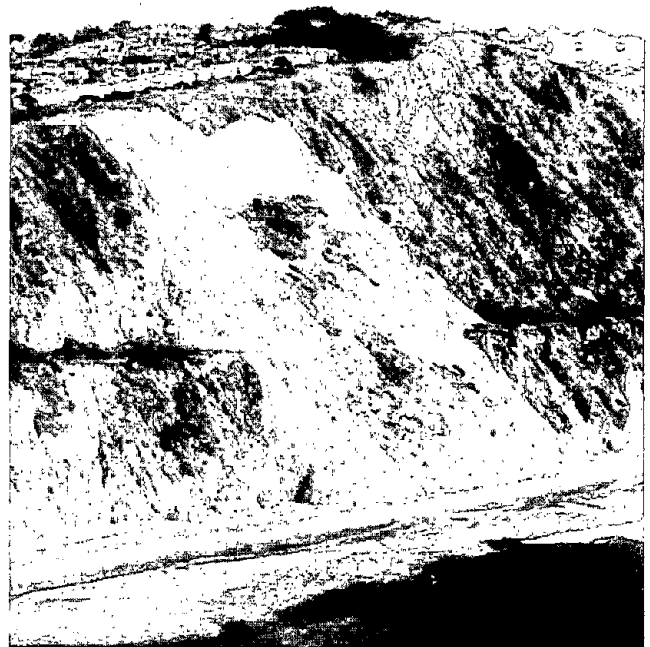
Figure 6.—Large coastal landslide near Daly City (fig. 4) resulting from 1989 Loma Prieta earthquake. Note proximity of cliff-top houses to headscarp.

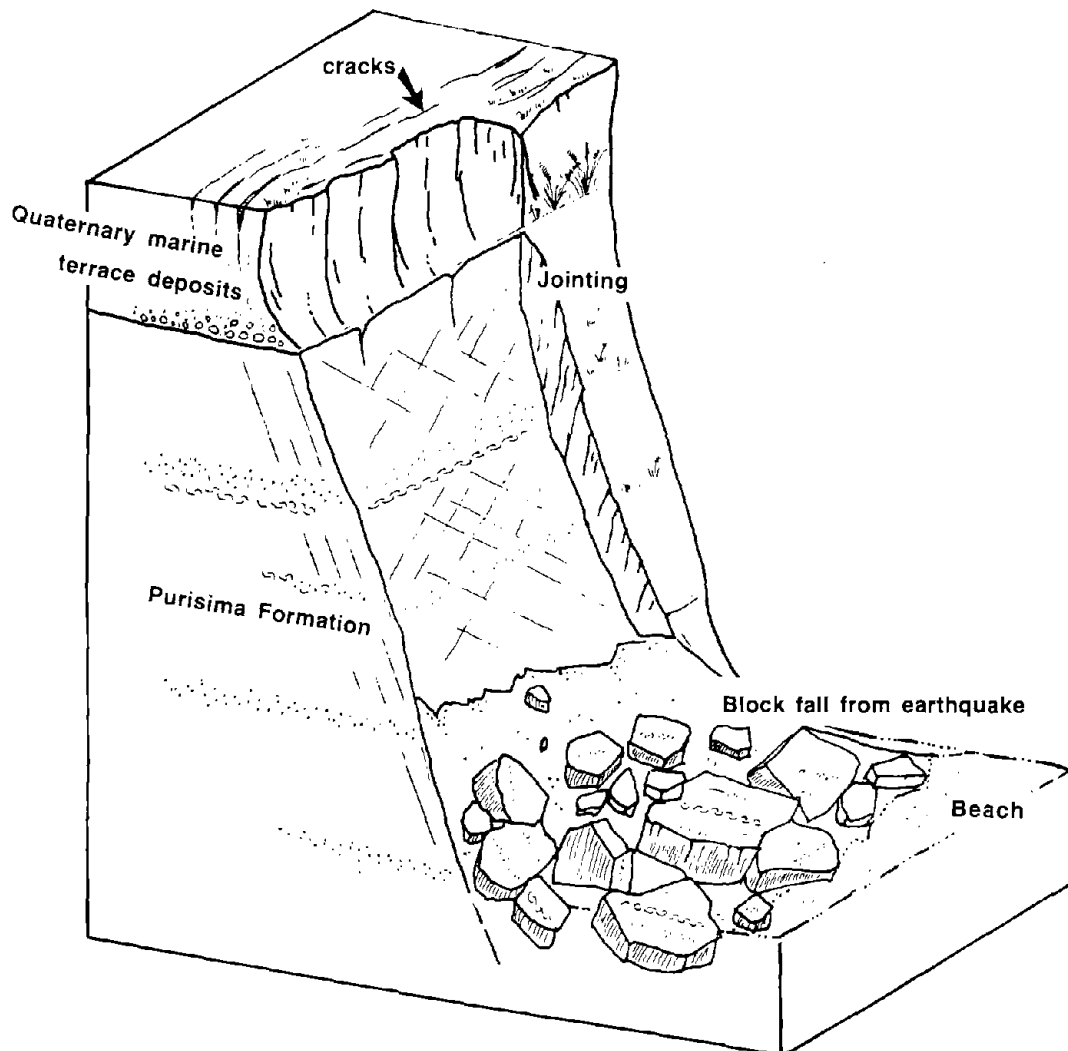
ries toppled downslope, blufftop terrace deposits collapsed, and weakened bedrock failed. Horizontal and downslope separation along joint surfaces allowed large blocks to separate from more intact rock (fig. 7). The size of these failures was a function of joint spacing and orientation, frictional or cohesive strength along the joint surface, cliff height, and toe support. High cliffs with widely spaced, subvertical joints and poor toe support sustained the largest instantaneous and incipient failures in weakened or undercut sedimentary rocks.

Figure 7.—Geologic structure and style of typical rockfall in seacliffs underlain by well-jointed siltstone of the Purisima Formation. Note undercut cliff and tension cracks in Pleistocene terrace deposits.

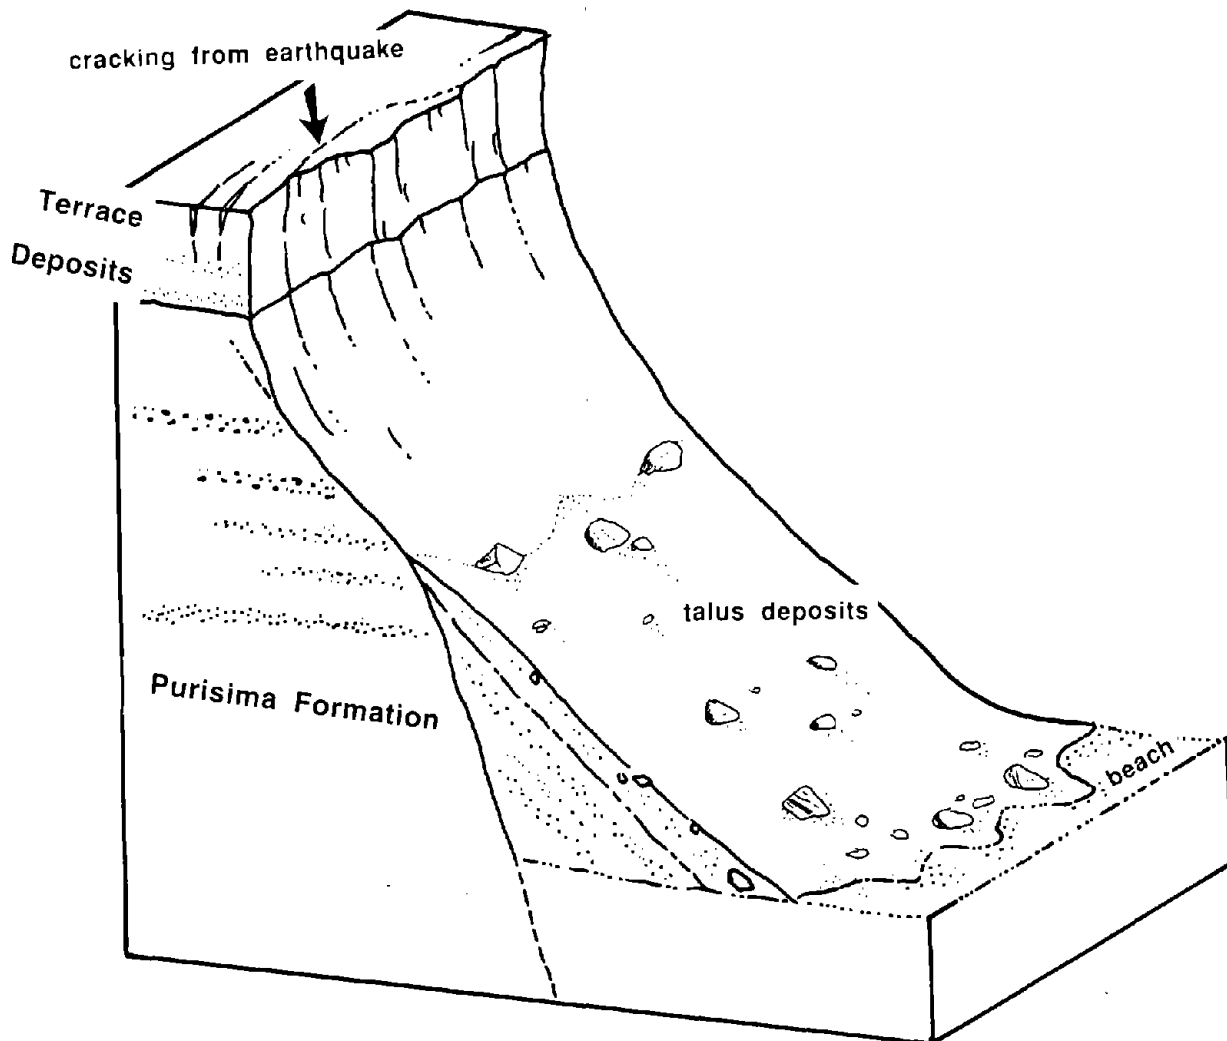
Translational failure along joints or weathering surfaces produced many large (30–60 m wide) concave upward scarps in the upper 12 to 15 m of the cliff in this area (figs. 8, 12). These scarps tended to cut vertically through the terrace deposits and then flatten to parallel the slope as they approached the Purisima Formation. Deep tension cracks cut through the upper terrace deposits and soils as far as 6 m landward of many of the scarps; this distance tended to increase with the size of the scarp and the height of the cliff. Coherent blocks overlying loose soil disintegrated as they cascaded down the cliff face. Talus piles, as much as 12 m high, blocked access to homes (fig. 14) and partly buried automobiles. Two blufftop homes ultimately were demolished because of such failures, which produced deep tension cracks through the building sites

Figure 8.—Geologic structure and typical debris slide in seacliffs underlain by sandstone of the Purisima Formation.

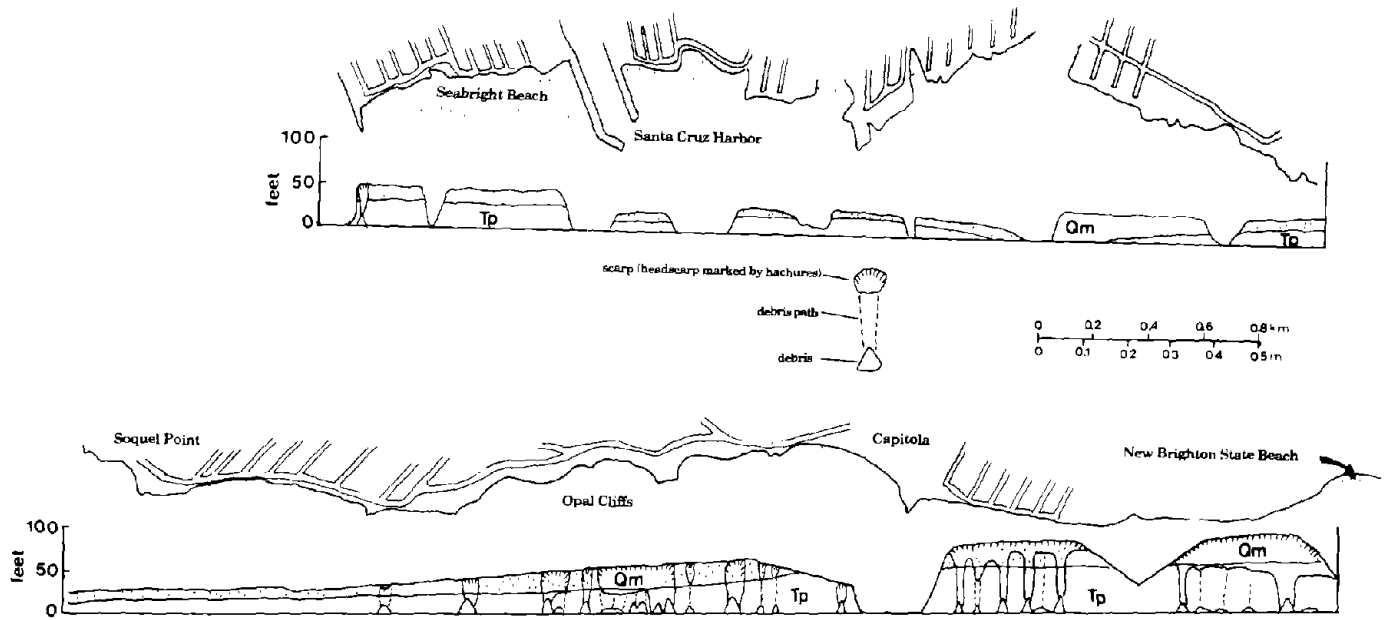
Seismic shaking during the earthquake initiated numerous rockfalls and block slides along this section of the coast (fig. 10). Undercut bedrock and fractured promonto-

Figure 10.—Plan view and longitudinal section showing locations and sizes of earthquake-induced seaciff failures and geology between Seabright Beach and Soquel Point (A) and between Soquel Point and New Brighton State Beach (B) (see fig. 5 for locations). Units: Qm, marine-terrace deposits (Quaternary); Tp, Purisima Formation (late Miocene and Pliocene).

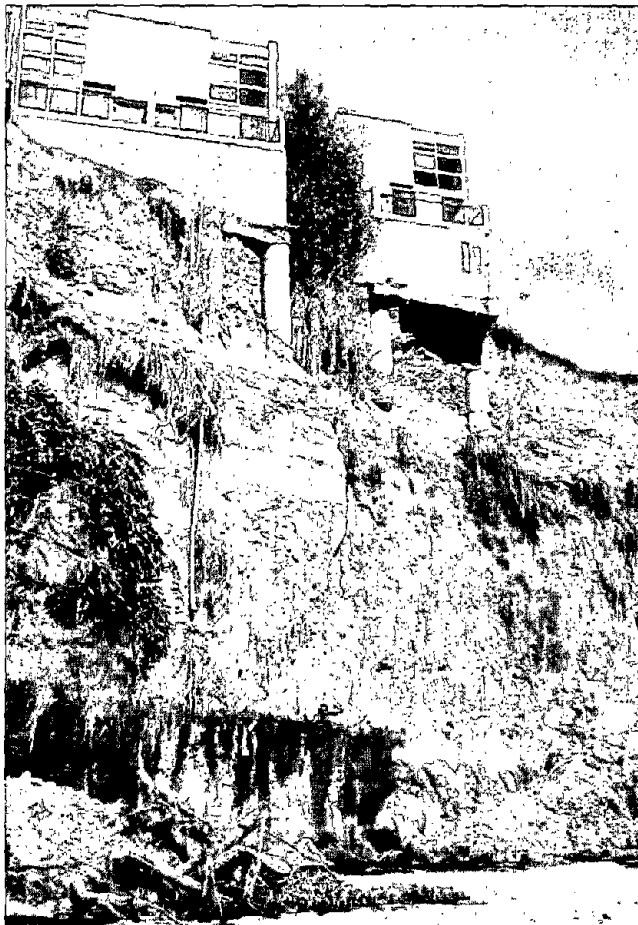
Damage to private property and public infrastructure was minimal along the cliffs in this area, except for those immediately east of Capitola (fig. 4). An apartment complex that was already overhanging the seacliff was additionally undermined as both bedrock and terrace deposits toppled to the beach below (fig. 11). Earthquake-induced failure led to partial loss of concrete caisson support and cracking of the foundation slab and perimeter wall of six apartments. Tension cracks were visible as far as 10 m inland of the cliff edge.

Figure 11.—Collapse of terrace deposits and underlying jointed bedrock of the Purisima Formation at Capitola (fig. 5) as a result of the 1989 Loma Prieta earthquake. These six apartment units were subsequently demolished, owing to blufftop cracking and loss of foundation support.

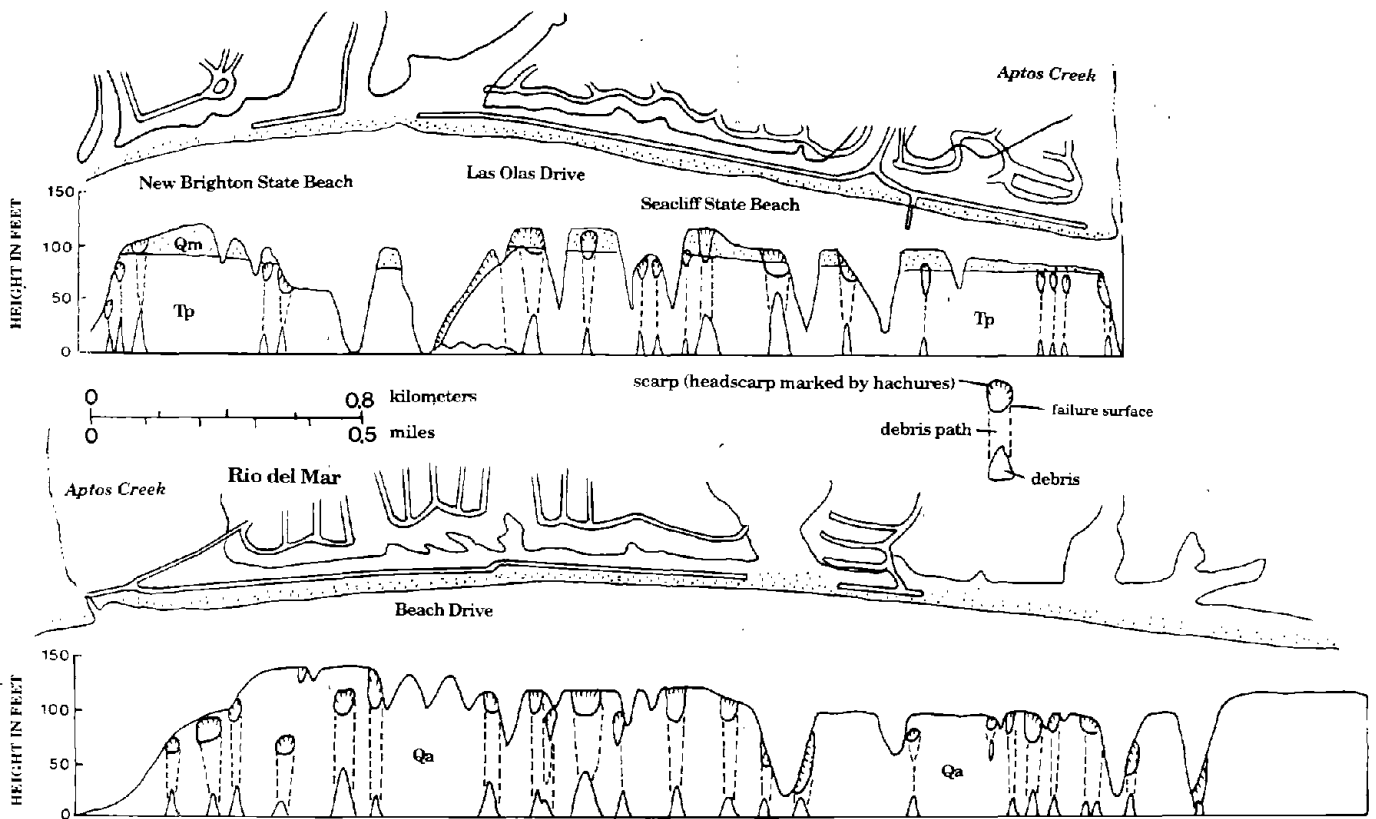
Figure 13.—Plan view and longitudinal section showing locations and sizes of seaciff failures and geology between New Brighton State Beach and Aptos Creek (A), and between Aptos Creek and Rio Del Mar (B) (see fig. 5 for locations). Units: Qa, Aromas Sand (Pleistocene); Qd, dune sand (Quaternary); Qm, marine terrace deposits (Quaternary); Tp, Purisima Formation (late Miocene and Pliocene).

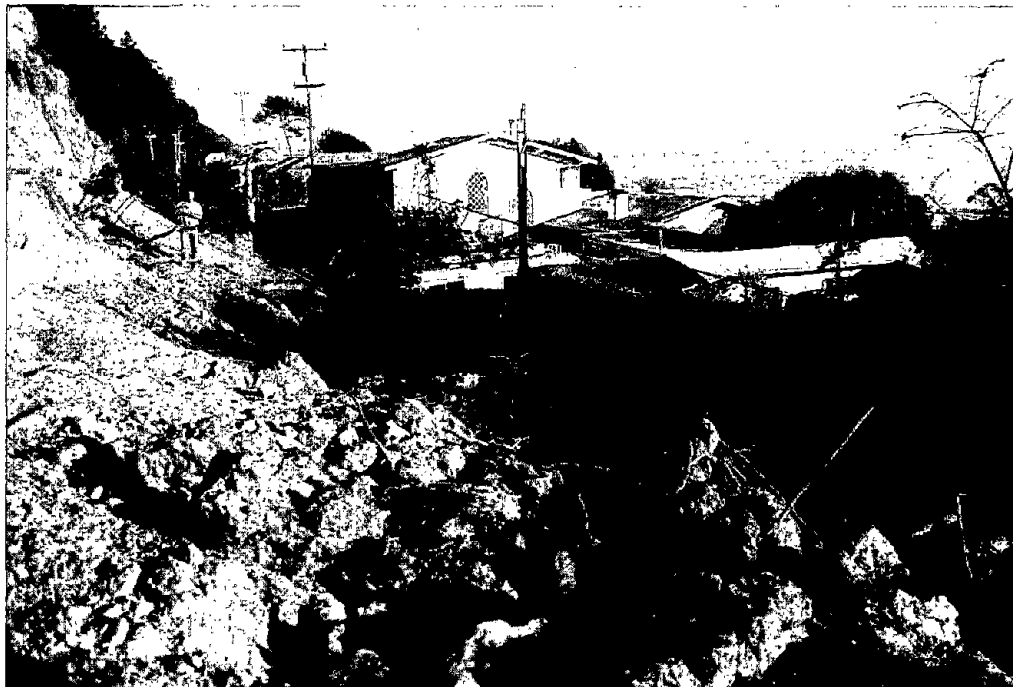
Figure 14.—Base of seaciff in area of figure 12 where material from bluff failure has blocked access to beach-front homes.

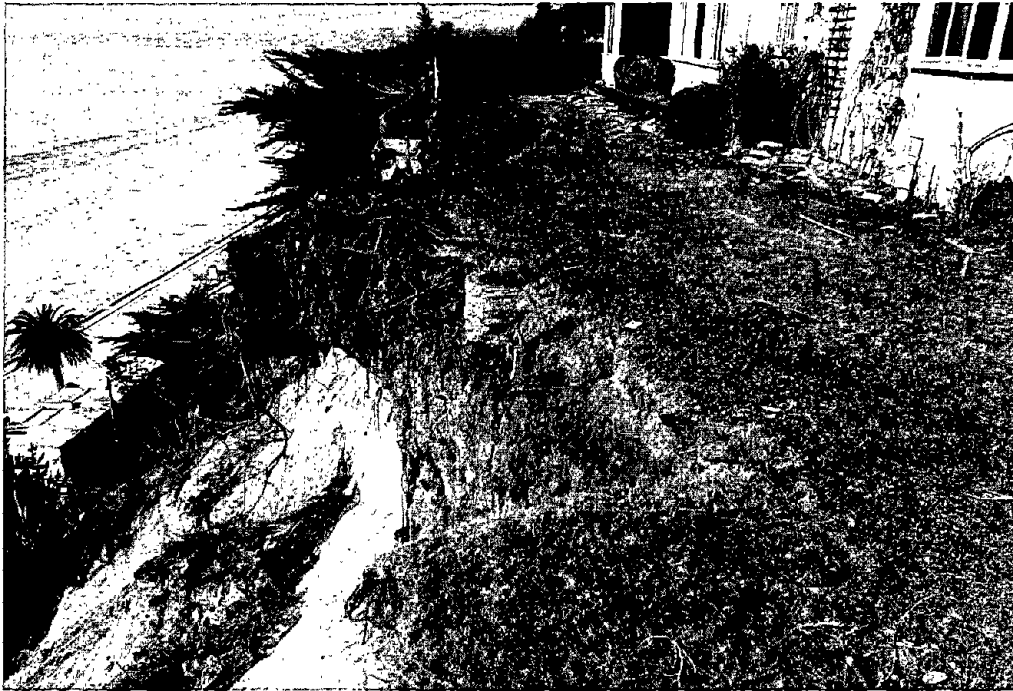
(fig. 15). Both homesites were on narrow, steep-sided peninsulas along the crest of the coastal bluff, locations where seismic shaking appears to have been particularly severe.

Figure 15.—Deep tension cracks (arrows) in terrace deposits in Rio Del Mar (fig. 5). Cracks cut through house foundation and indicate potential extent of future failure. At this site, house was demolished, and unstable material was removed to stabilize site.

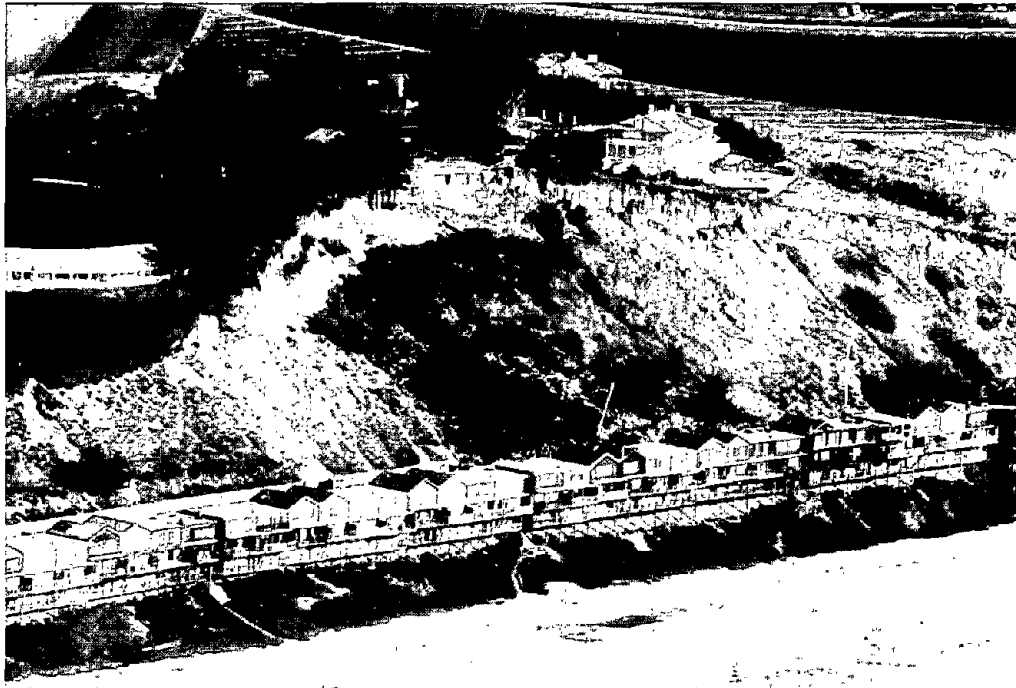
Several types of earthquake-induced failures were typical along this stretch of coastal bluffs. The first type consisted of shallow (1–3 m deep), large (max 100 m wide) translational slides (figs. 8, 16, 17). At one site, such a failure undermined 5 to 10 m of the clifftop, leading to collapse and toppling of large cohesive blocks of soil. These detached masses rolled downslope and blocked access to condominiums built on the talus slope at the base of the bluff (fig. 18). This same failure also undermined a blufftop home that was subsequently demolished.

Figure 17.—Large translational slide above condominium development south of Rio Del Mar (fig. 5). One house at top of bluff had to be demolished; homes at base of bluff were threatened, and access partly blocked (see fig. 18).

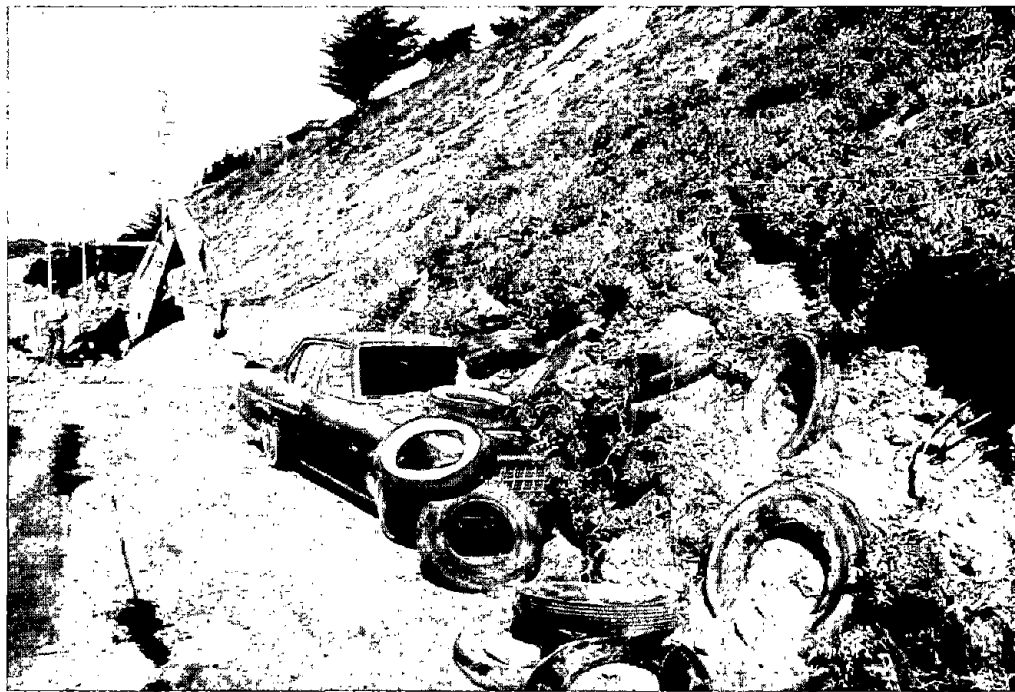
Figure 18.—Weakly consolidated sand of the Aromas Sand disintegrated and flowed downhill to block access and threaten condominiums at base of bluff (see fig. 16). Tires had been placed on slope in an attempt to control erosion.

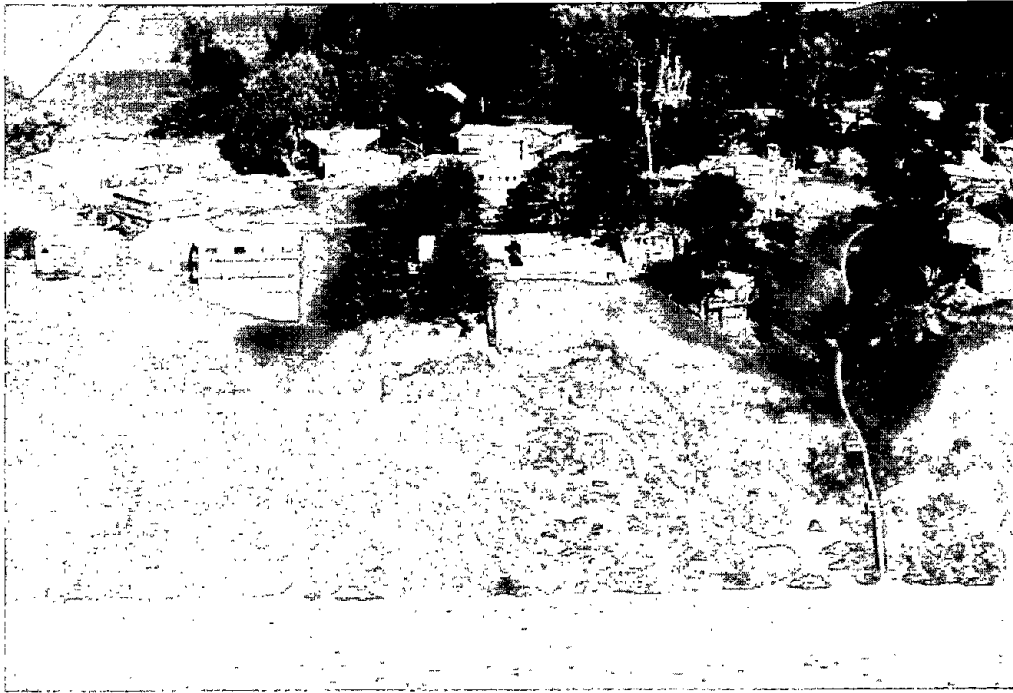
Figure 19.—Large sandflows above Sunset State Beach (fig. 5). One blufftop house was to be relocated.

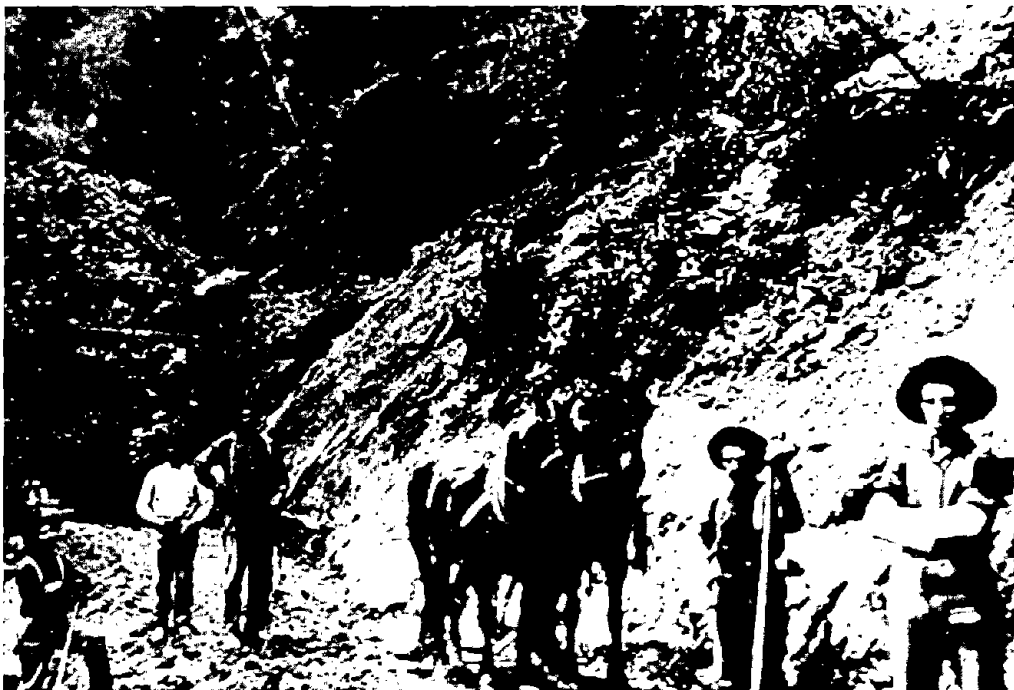
Figure 3.—Workers removing toe of earthquake-induced landslide that dammed Hinckley Creek at Olive Springs sawmill in 1906 (see fig. 4 for location). Landslide killed nine workers at Olive Springs and formed a 20-m-deep impoundment where it dammed the creek. Photograph courtesy of California Department of Parks and Recreation.

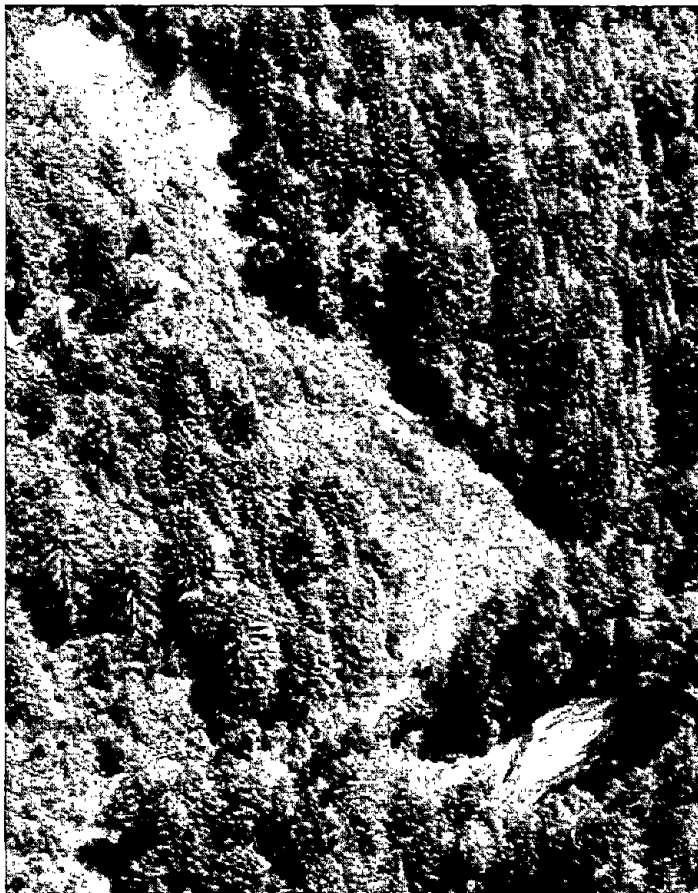
The rockslide on West Branch Soquel Creek (fig. 6), which occurred on a rather remote stretch of the creek (fig. 4), is the largest of the five 1989 landslides discussed in this paper. This slide was approximately 250 m long, averaged 50 m in width, and had an estimated maximum thickness of 6 m and a volume of  $50,000 \text{ m}^3$ . The slide began in Purisima Formation sandstone, siltstone,

Figure 6.—Toe of this 50,000-m<sup>3</sup>-volume earthquake-induced slide dammed West Branch Soquel Creek (see fig. 4 for location). Dam failed in December 1989, 61 days after 1989 Loma Prieta earthquake. Photograph taken in May 1992.

and mudstone at the site of a spring on the valley wall. Initial failure probably occurred in a weak layer of silt or clay in the Purisima Formation. The slide crosses the Zayante fault (Clark and others, 1989) on a slope averaging  $26^\circ$ , and its toe lies on rocks of the Eocene Butano sandstone in the valley bottom. The existing, nearly vertical headscarp in Purisima Formation rocks is 12 m high and 30 m long and has a spring issuing from its base. As indicated by Clark and others, the strike of the Purisima Formation beds at this site approximately parallels West Branch Soquel Creek, and the dip is back into the valley wall. Thus, this slide was not a dip-slope failure; instead, failure probably was related to the low shear strength of mudstone and siltstone that had been saturated locally by ground water from the spring.

Then, 61 days after the earthquake, the dam failed, causing minor downstream flooding in the channels of West Branch Soquel Creek and Soquel Creek. Channel capacity was not exceeded; thus, no damage occurred as a result of flooding.

On the day after the earthquake, the landslide dam on West Branch Soquel Creek (fig. 6) was noted from the air (Capt. Dennis Smith, Santa Cruz County Sheriff's Office, oral commun., 1989). However, because this landslide dam was in an unpopulated, untraveled area and its impoundment was small, no mitigative measures were undertaken.

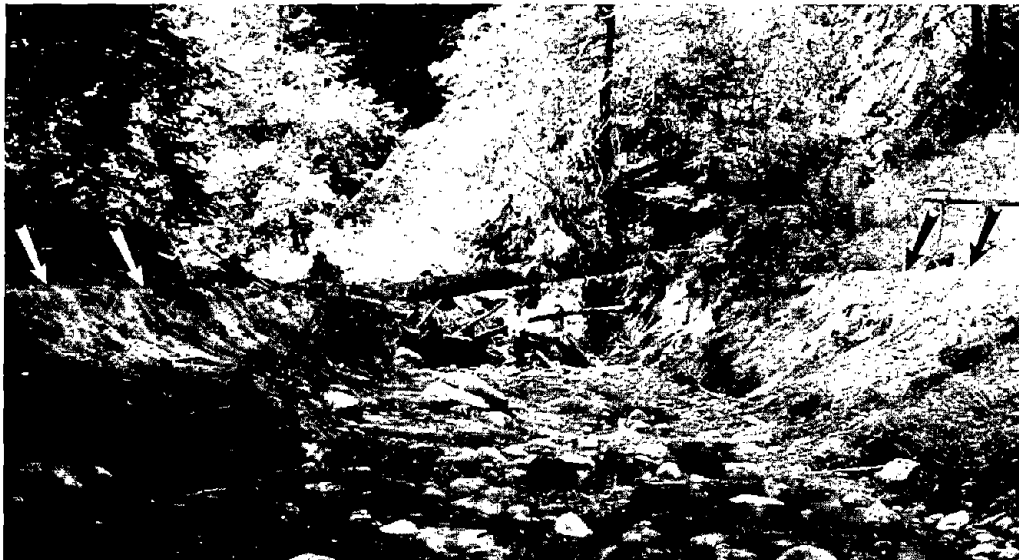
Figure 9.—Downstream view of remnants of 1989 Hinckley Creek landslide dam after it had failed in February 1992. Arrows denote previous shoreline of now-drained 4-m-deep impoundment. Photograph taken May 1992.

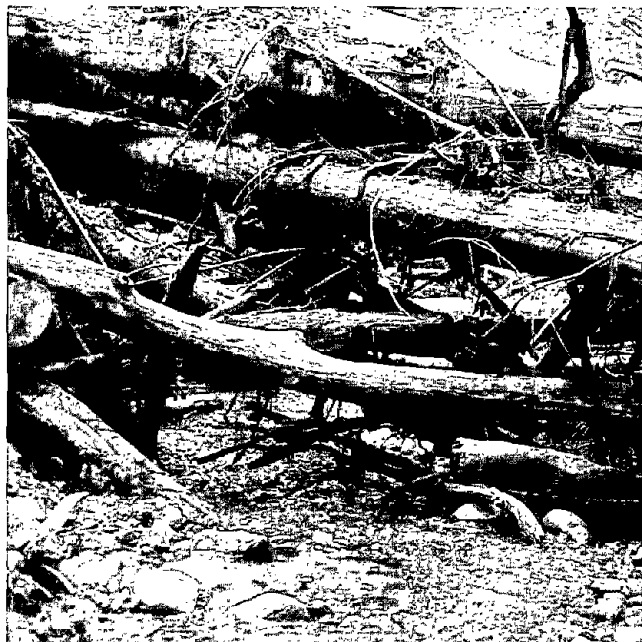
Figure 10.—Closeup of log/brush remnant of 1989 Hinckley Creek landslide dam after soil matrix of dam had eroded away in February 1992. Photograph taken May 1992.
