# The Loma Prieta, California, Earthquake of October 17, 1989—Landslides

STRONG GROUND MOTION AND GROUND FAILURE

U.S. GEOLOGICAL SURVEY PROFESSIONAL PAPER 1551-C

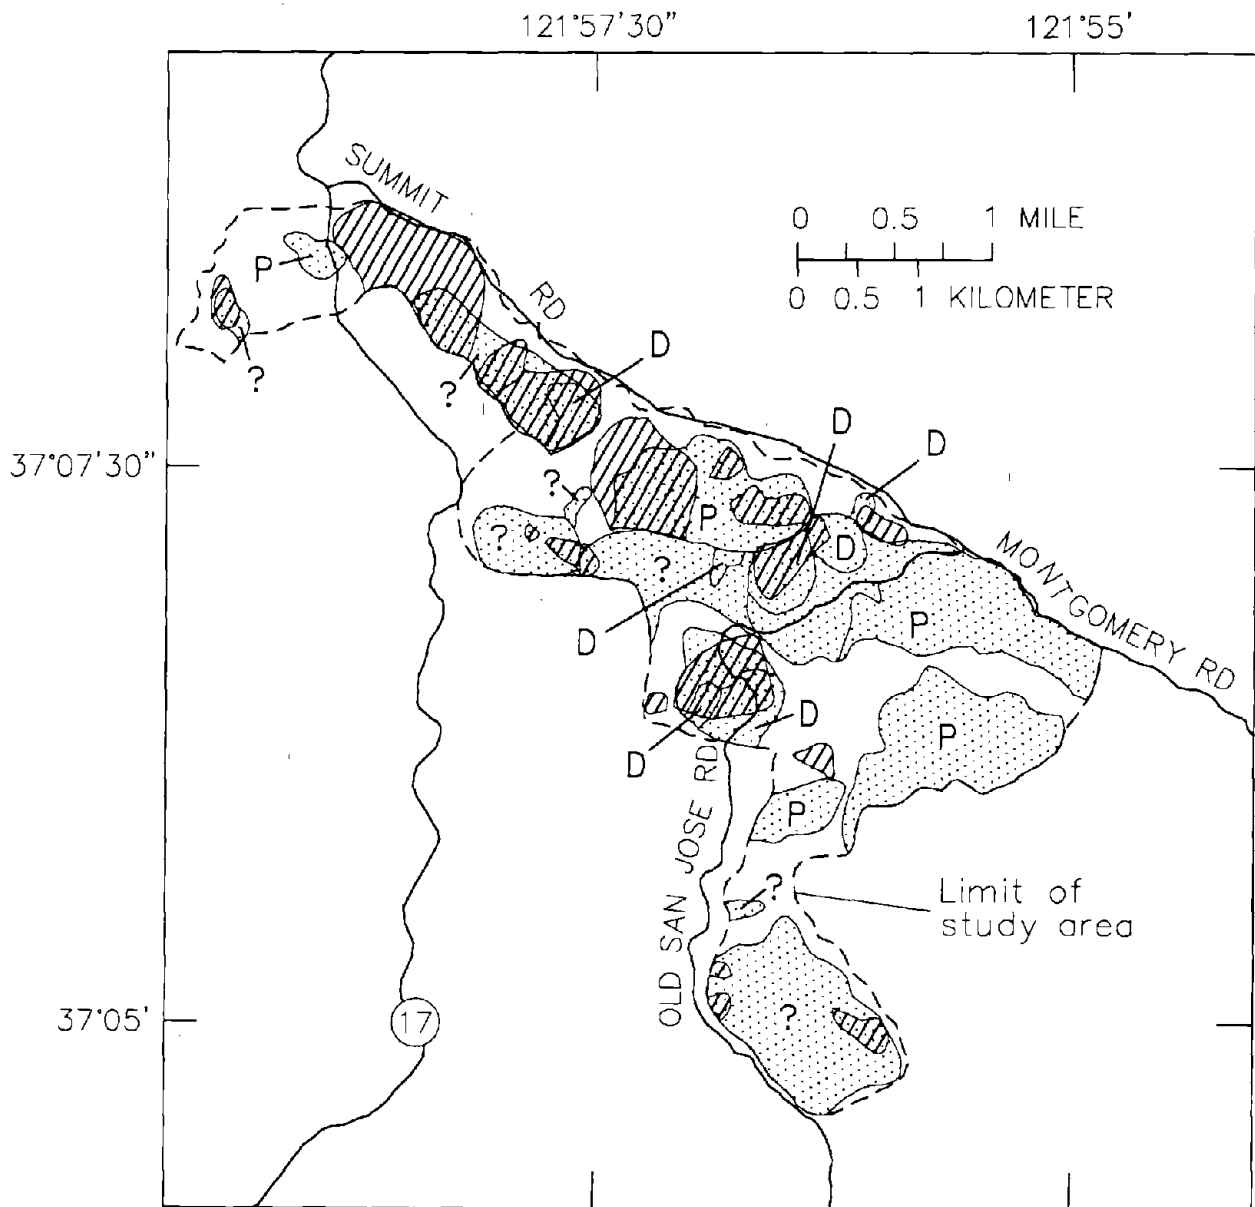
Figure 4.—Summit Ridge study area, showing generalized boundaries of large earthquake-generated landslides (diagonal-lined areas) in relation to generalized landslide deposits and landslide scarps (dotted areas) identified on preearthquake landslide-hazard map of Cooper-Clark and Associates (1975); D, definite; P, probable; ?, questionable.

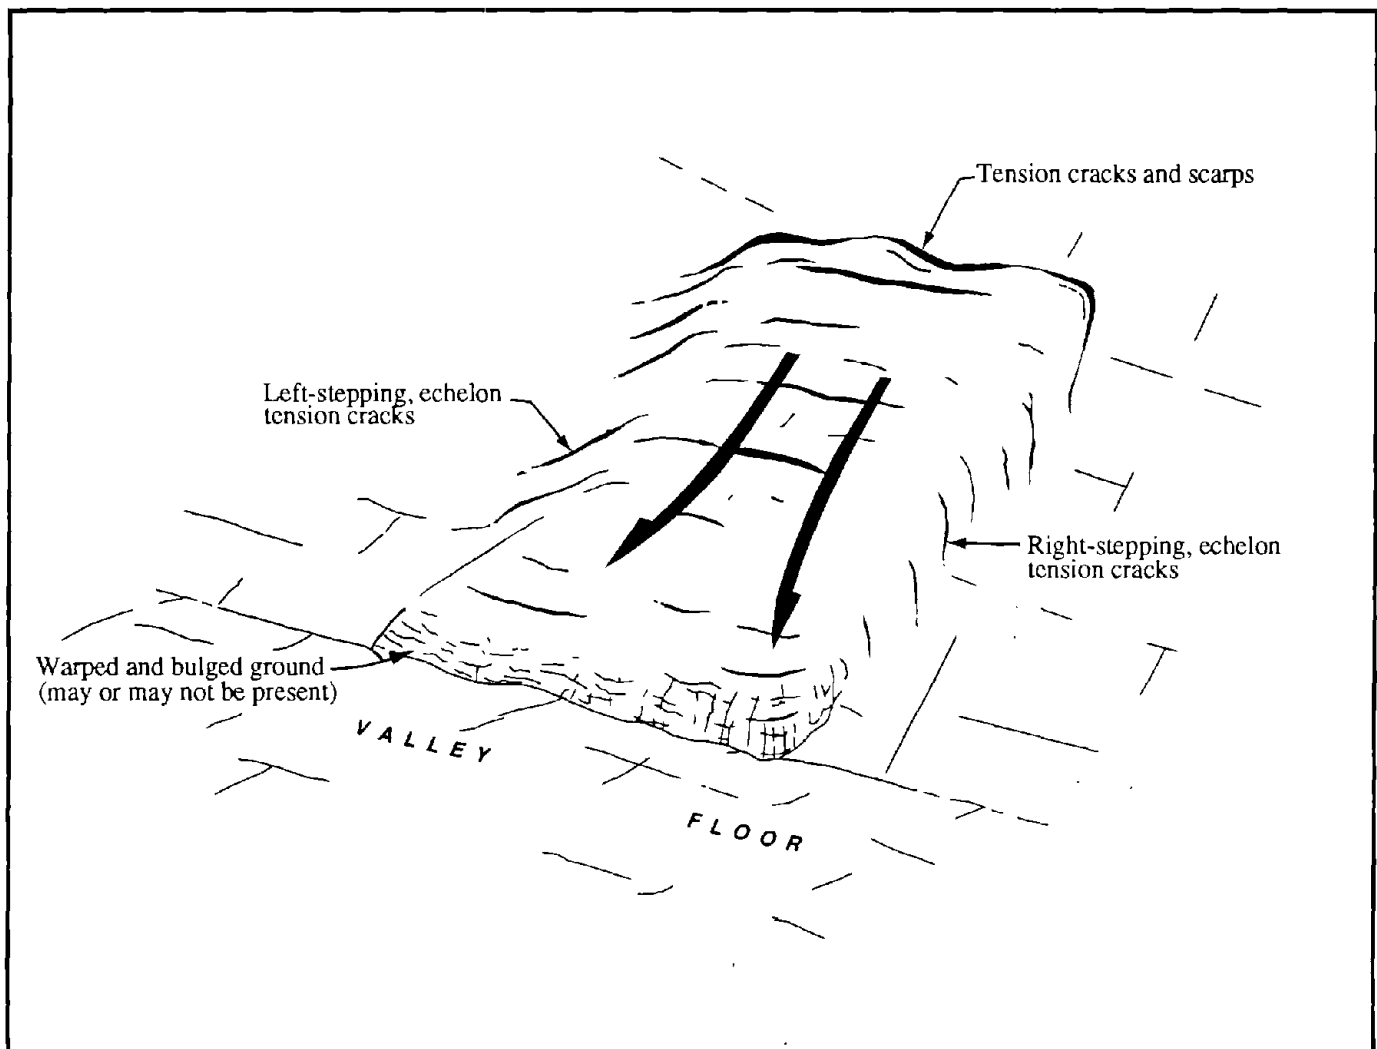
Downslope from the main scarps, landslide flanks were delineated either by cracks trending nearly parallel to gradient or by complex sets of echelon cracks (fig. 6). In some places, flank cracks were continuous with the main scarps farther upslope. These flank cracks exhibited relative displacements consistent with downslope movement, with components of right-lateral shear along right flanks and left-lateral shear along left flanks.

Figure 6.—Idealized landslide bounded by discontinuous surface features, as was typical for large landslides in Summit Ridge area (modified from William Cotton and Associates, Inc., 1990).

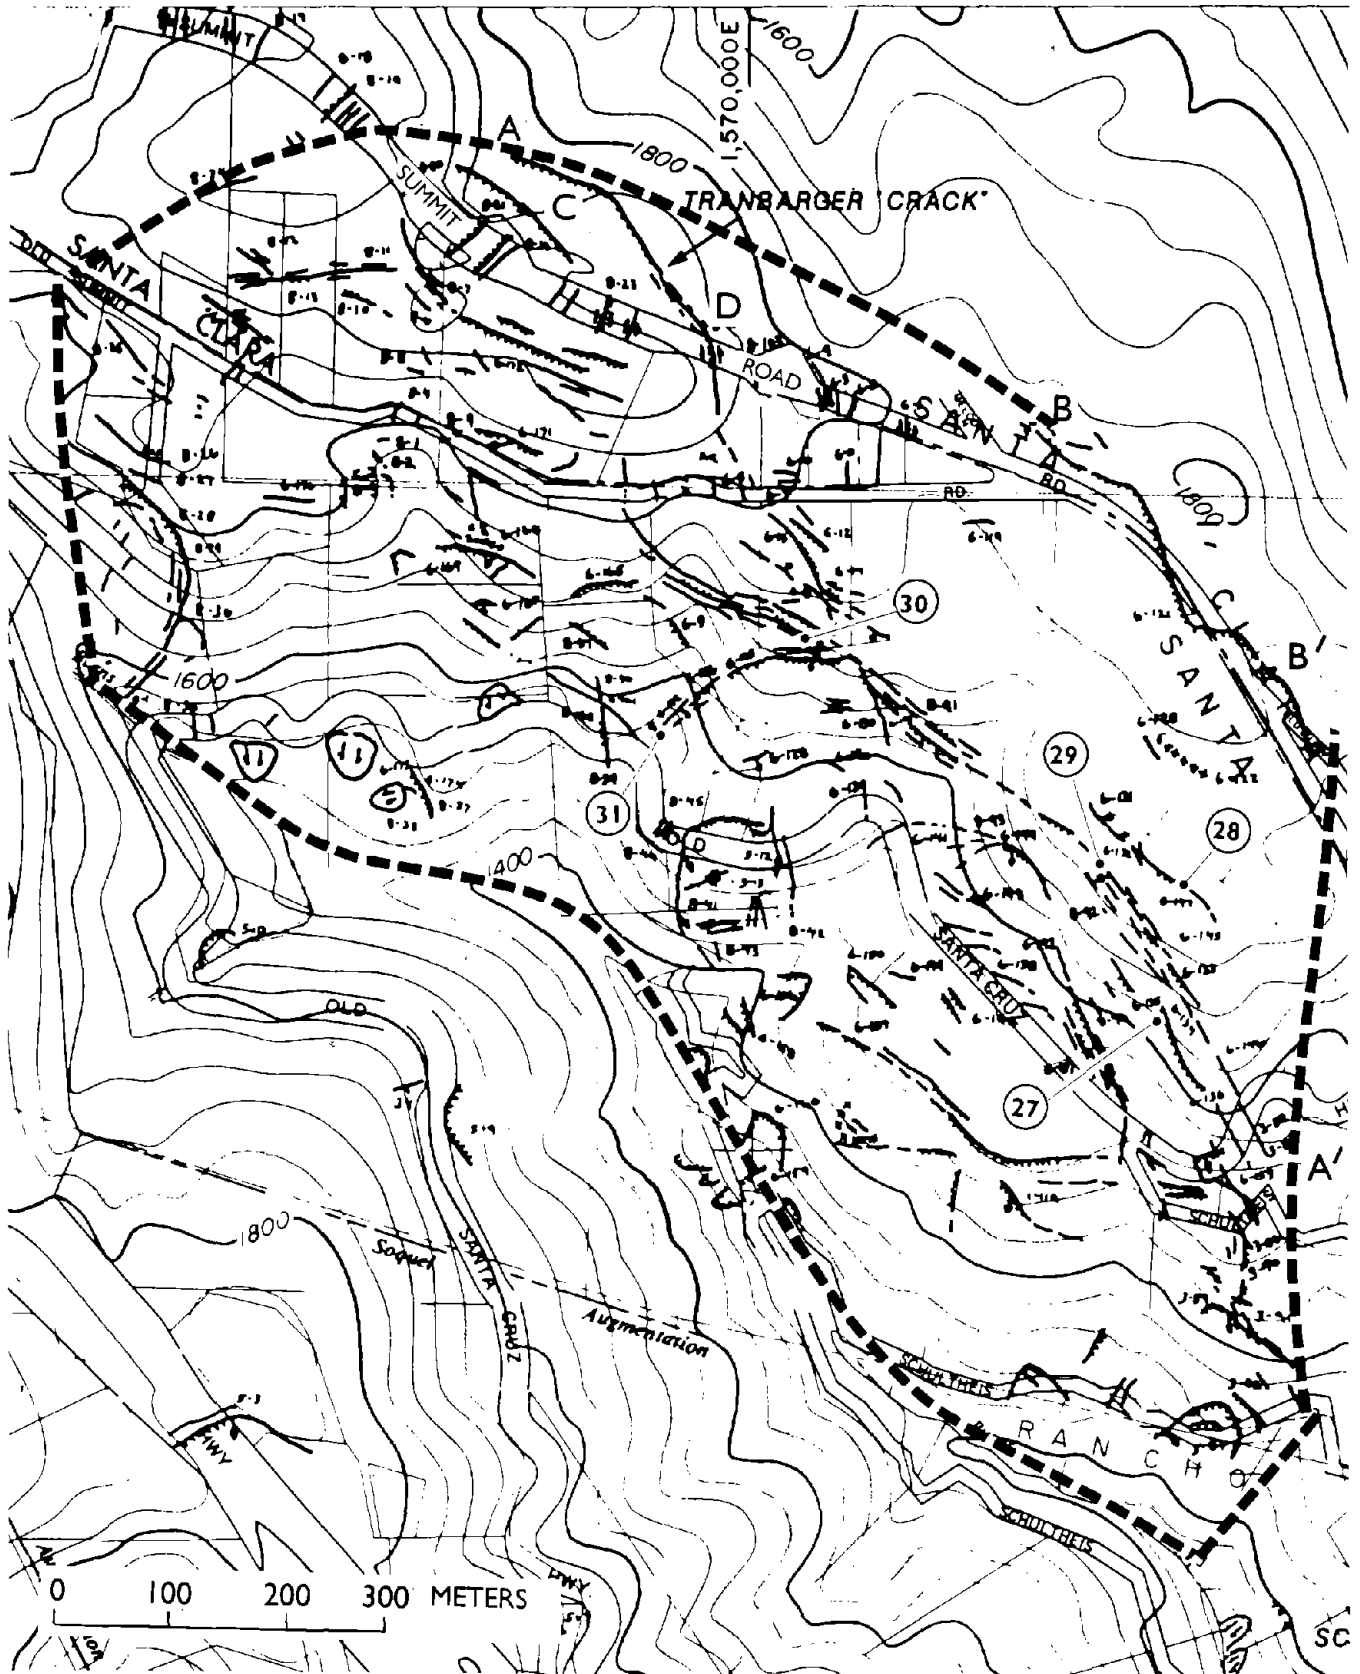
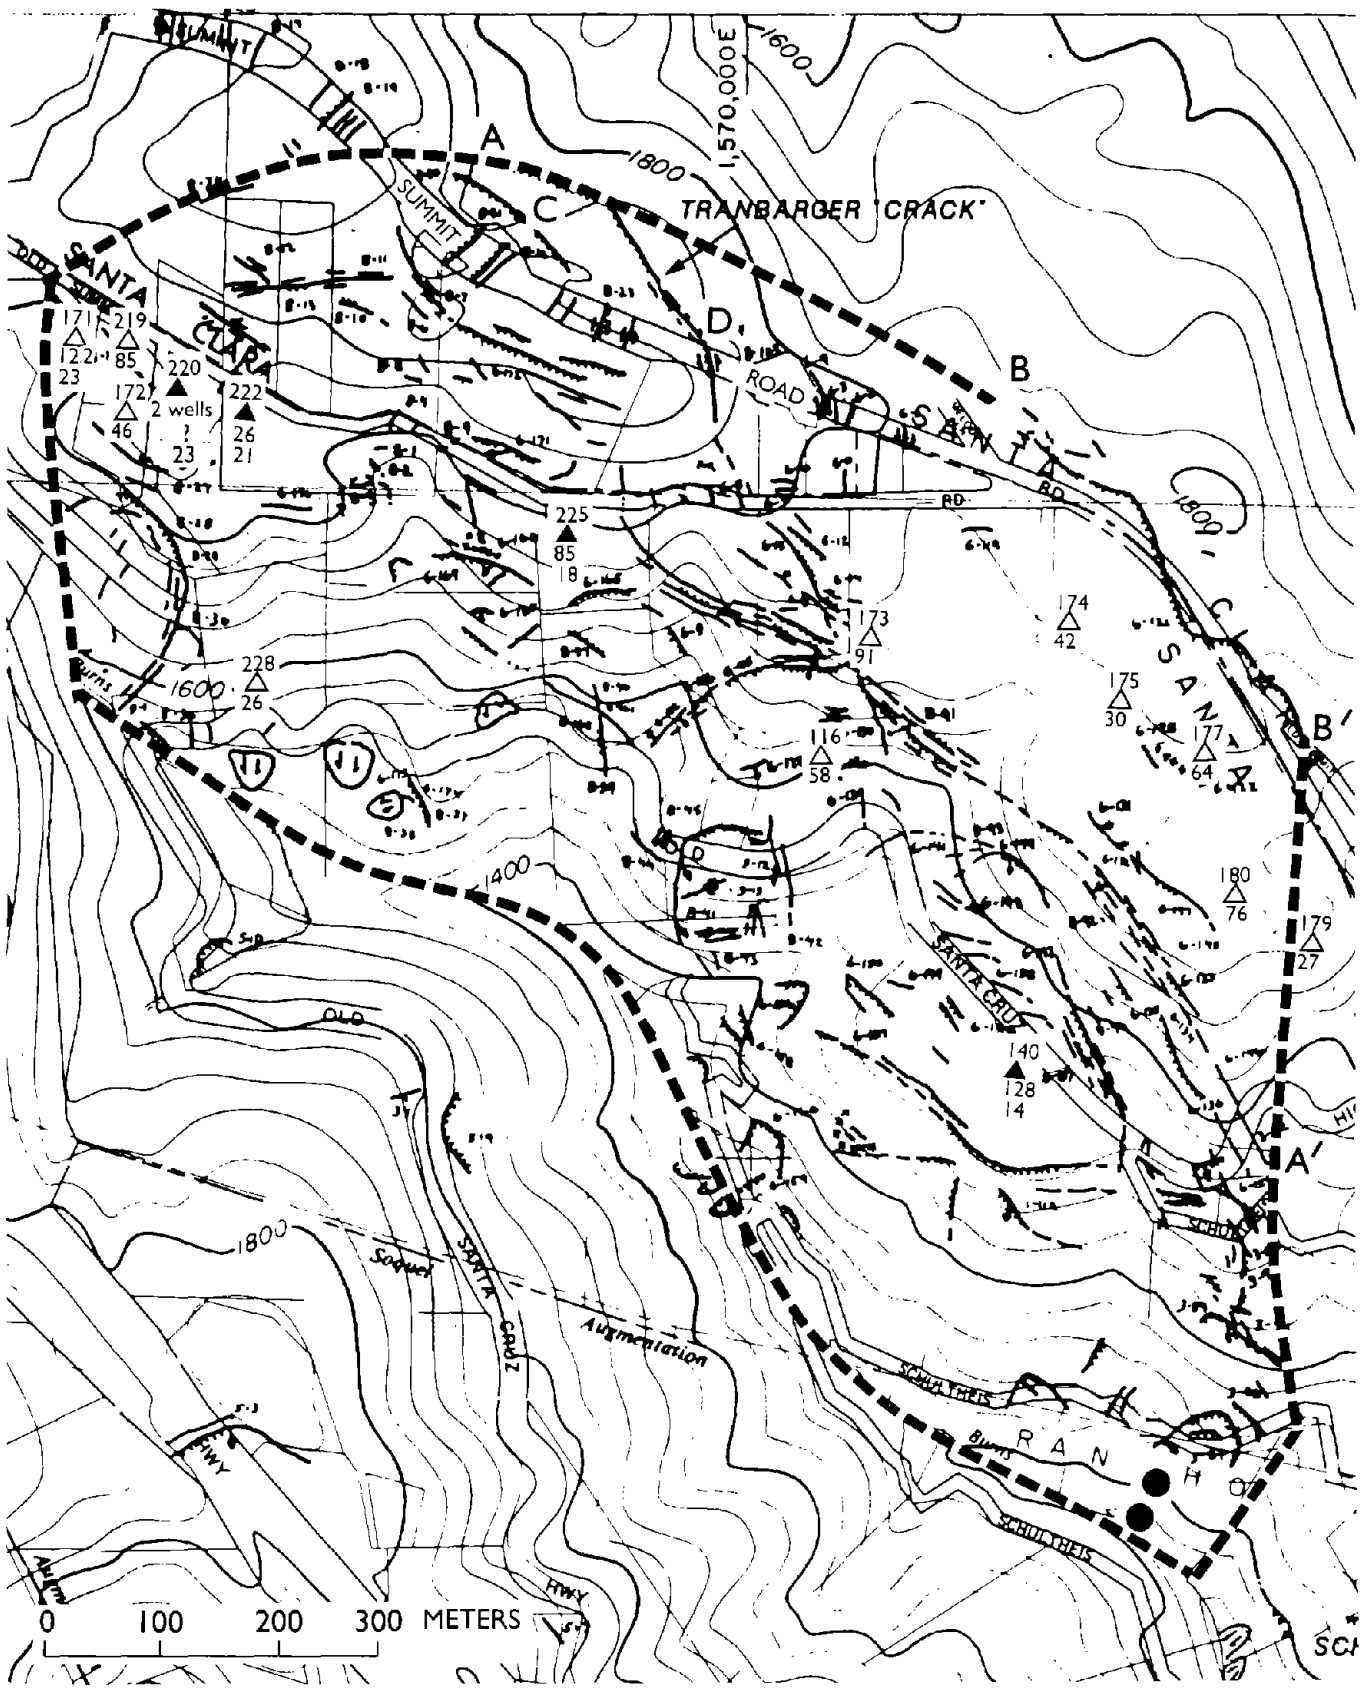
B

The longest ground-cracking feature within this area is a nearly continuous, southeast-trending line of cracks and scarps (fig. 8), approximately 1,200 m long (leg A-A', fig. 7A). Displacements across this feature vary along its length; maximum displacement components are about 60 cm vertical (down to the southwest), 75 cm left lateral, and 15 cm extensional.

100 m deep or with movement produced by some other deep-seated process. Damage to wells immediately east of California Highway 17 and south of Old Summit Road (wells 171, 220, 222, fig. 7B), all reportedly disturbed at depths of 21 to 23 m (Brumbaugh, 1990), indicates that a 21- to 23-m-deep landslide shear surface underlies that area.

cracks and other features that indicate the presence of several smaller, shallower landslides. These scarps, cracks, and other features, which include localized areas of compression or bulging ground, indicating landslide toes, are so numerous as to form a virtually continuous landslide complex between the longest ground-cracking feature and Burns Creek (fig. 7).

◀ Figure 7.—Old Santa Cruz Highway landslide complex, showing boundary of landslide and locations of (A) surficial features, surface-monitoring stations, and localities discussed in text and of (B) boreholes (from Cole and others, 1991) and water wells (from Brumbaugh, 1990). Ground cracks and compressional features from Spittler and Harp (1990); landslide boundaries from Keefer (1991). Base from Towill, Inc., using topography from U.S. Geological Survey Los Gatos, Calif., 7.5-minute quadrangle and culture from County of Santa Cruz planimetric base and interpretation of aerial photographs taken July 24, 1990. Contour interval, 40 ft.

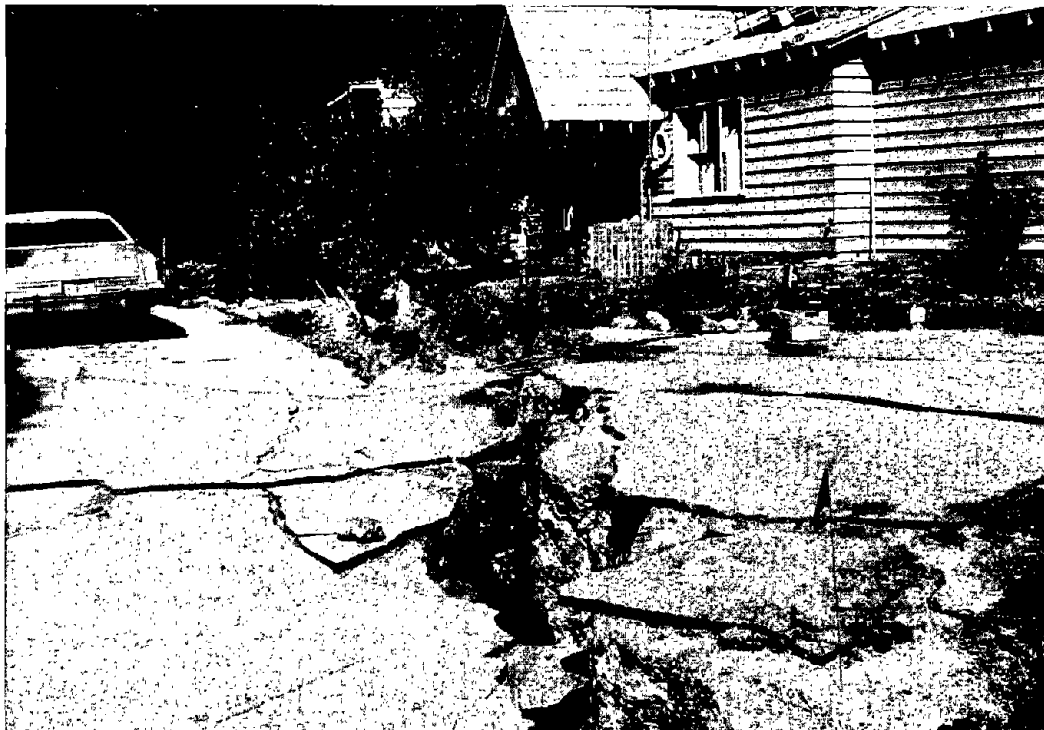
Figure 8.—Segment of Tranbarger fracture (leg A-A', fig. 7A), a 1,200-m-long zone of scarps and cracks in Old Santa Cruz Highway landslide complex. View northwestward from north edge of Summit Road (loc. D, fig. 7A).

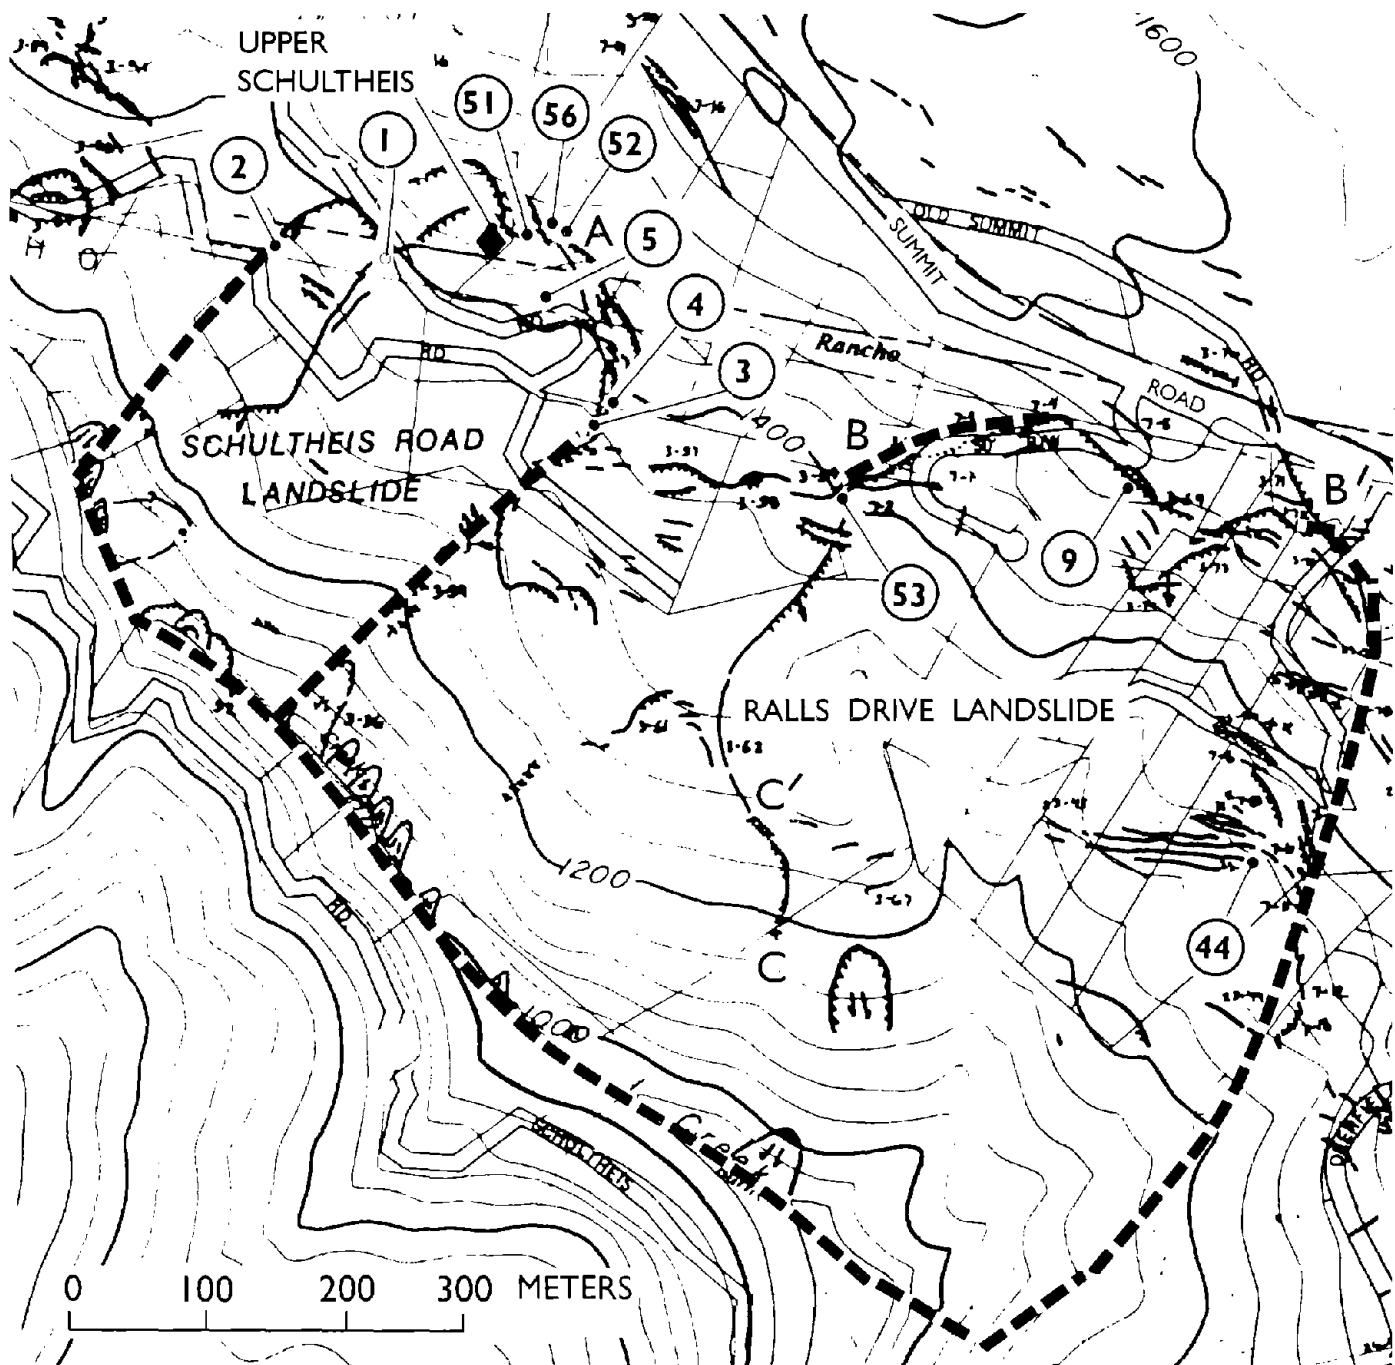
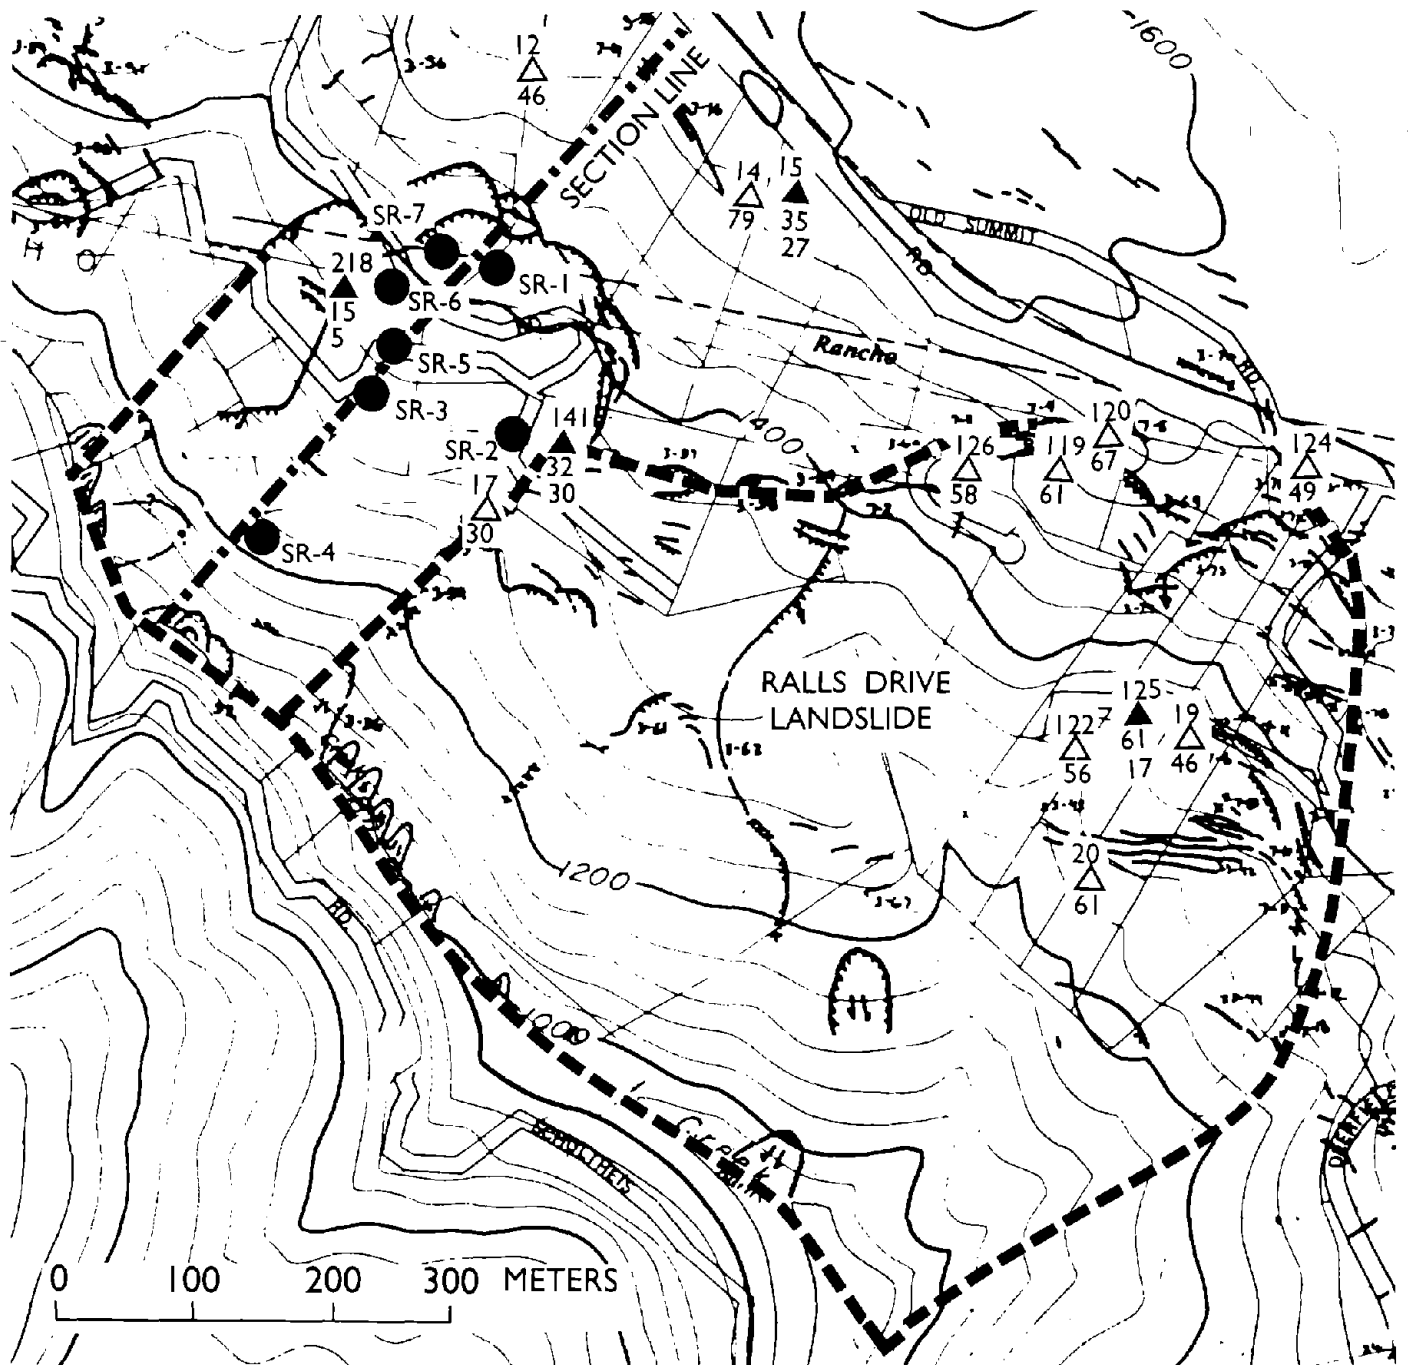
B

Displacements measured along a transect across the main scarp indicate that the head of the landslide moved 1.16 m downslope. An additional 1.28 m of downslope displacement was measured across a series of internal fissures and scarps that extended for 62 m downslope from the main scarp. The total measured displacement of the landslide along that transect was thus 2.44 m.

Two of three known water wells within the landslide were reportedly damaged during the earthquake. In well 141 (fig. 9B), located less than 30 m from borehole SR-2, the well-pump motor was reportedly broken off, and the motor shaft bent to a 45° angle at 30-m depth, corresponding closely to the 27-m depth of the shear zone in borehole SR-2. In well 218, about 3 m from borehole SR-6 (fig. 9B), an offset of 20 to 30 cm was reported to have occurred at about 4.5-m depth in a 76-cm-diameter casing. This offset corresponds closely in depth to the shallower shear zone. These correspondences indicate that landslide displacements during the earthquake probably occurred in both the shallower and deeper shear zones. A cross section showing the inferred landslide basal shear surfaces is shown in figure 11. If the average landslide thickness is assumed to be half of the maximum thickness shown on this cross section, the total volume of the landslide is  $4.3 \times 10^6 \text{ m}^3$ .

Within the Ralls Drive landslide, one well (125, fig. 9B) was reportedly damaged at 17-m depth, whereas five wells (19, 20, 119, 122, 126, fig. 9B), 46 to 61 m deep, were reportedly undamaged by the earthquake. Three of the reportedly undisturbed wells are near the main scarp, and the other three are within the eastern block. The reported absence of damage to these wells could indicate either that local displacements were not large enough to damage the wells or that the basal shear surface is deeper than 46 to 61 m. The damage to well 125 may thus indicate a shallower, subsidiary shear surface, or it may be unrelated to landslide movement.

Figure 9.—Upper Schultheis Road and Ralls Drive landslides, showing boundary of landslides and locations of (A) surficial features, surface-monitoring stations, and localities discussed in text and of (B) boreholes (from William Cotton and Associates, 1990, and Cole and others, 1991).

cross section in figure 11, and water wells (from Brumbaugh, 1990). Ground cracks and compressional features from Spittler and Harp (1990); landslide boundaries from Keefer (1991). See figure 7 for explanation and base-map information.

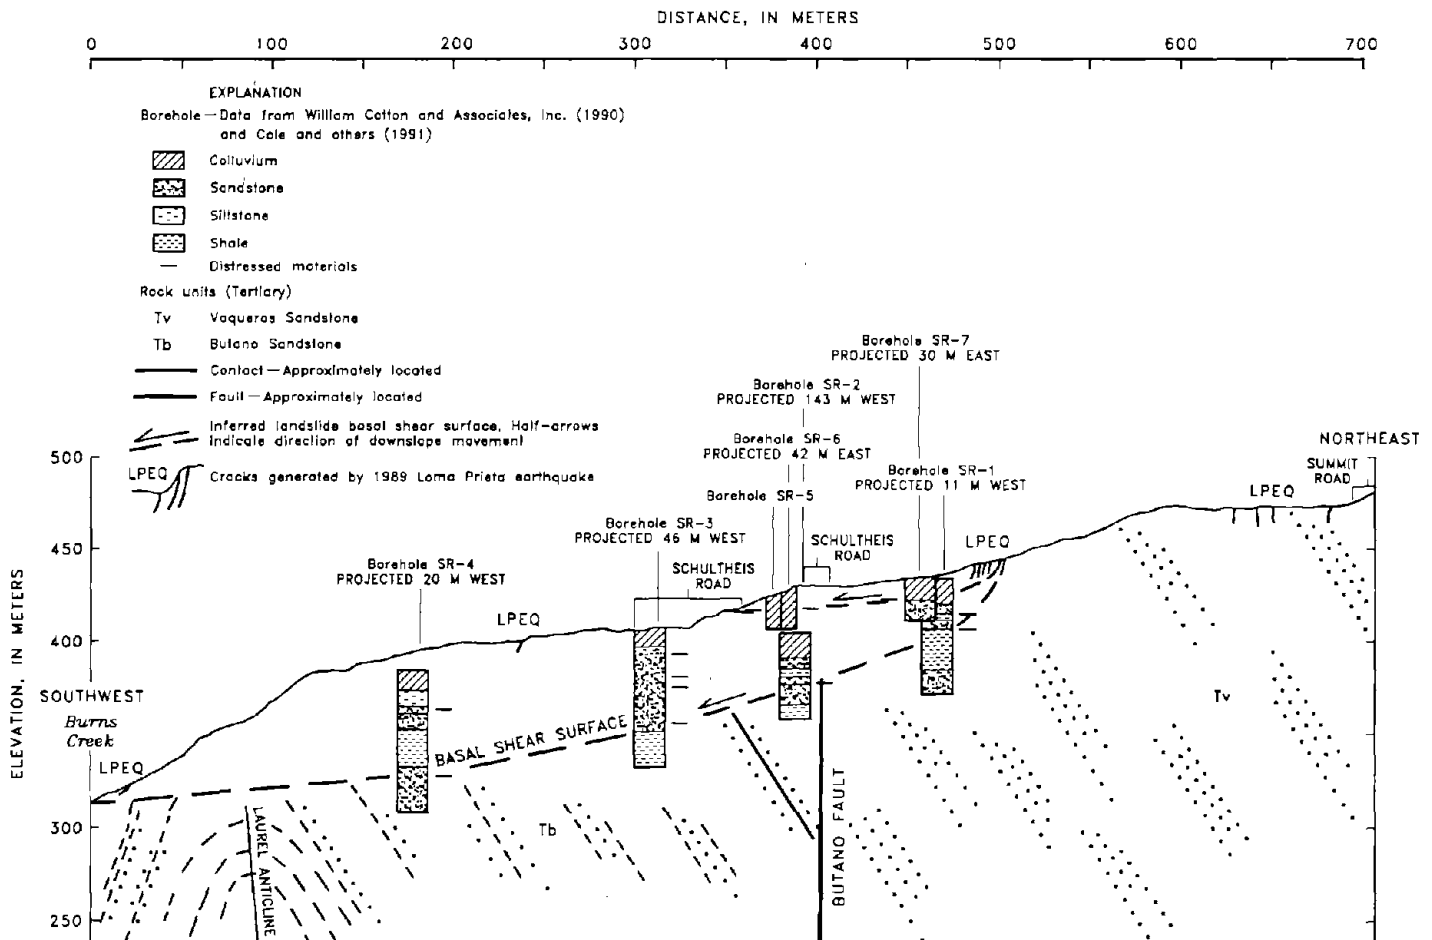
Particularly conspicuous shear zones were penetrated in borehole SR-2 at a depth of 27.1 to 27.4 m, and in the larger-diameter boreholes SR-5, SR-6, and SR-7 at depths of 6.7, 5.3 to 6.7, and 10.4 m, respectively (figs. 9B, 11). The deeper shear zone contained a sheared mixture of highly plastic clay, silty clay, sandstone, and fractured shale overlying 0.5 to 1.3 cm of sheared, mixed silty clay and clayey silt of varying plasticity (William Cotton and Associates, Inc., 1990); the shallower shear zone separated intensely weathered and oxidized materials from unoxidized rocks (Cole and others, 1991). In borehole SR-5, this shallower shear zone consisted of 3 to 13 cm of sheared siltstone and clay with polished surfaces; in borehole SR-6, the zone contained three separate faulted and sheared contacts; and in borehole SR-7, the zone was a 5- to 10-cm-thick layer of swelling clayey siltstone, which separated an overlying brecciated and fractured siltstone from an underlying sandstone (Cole and others, 1991).

Figure 11.—Geologic cross section through Upper Schultheis Road landslide (fig. 9B). Locations of landslide basal shear surfaces inferred from borehole data of William Cotton and Associates, Inc. (1990), and Cole and others (1991).

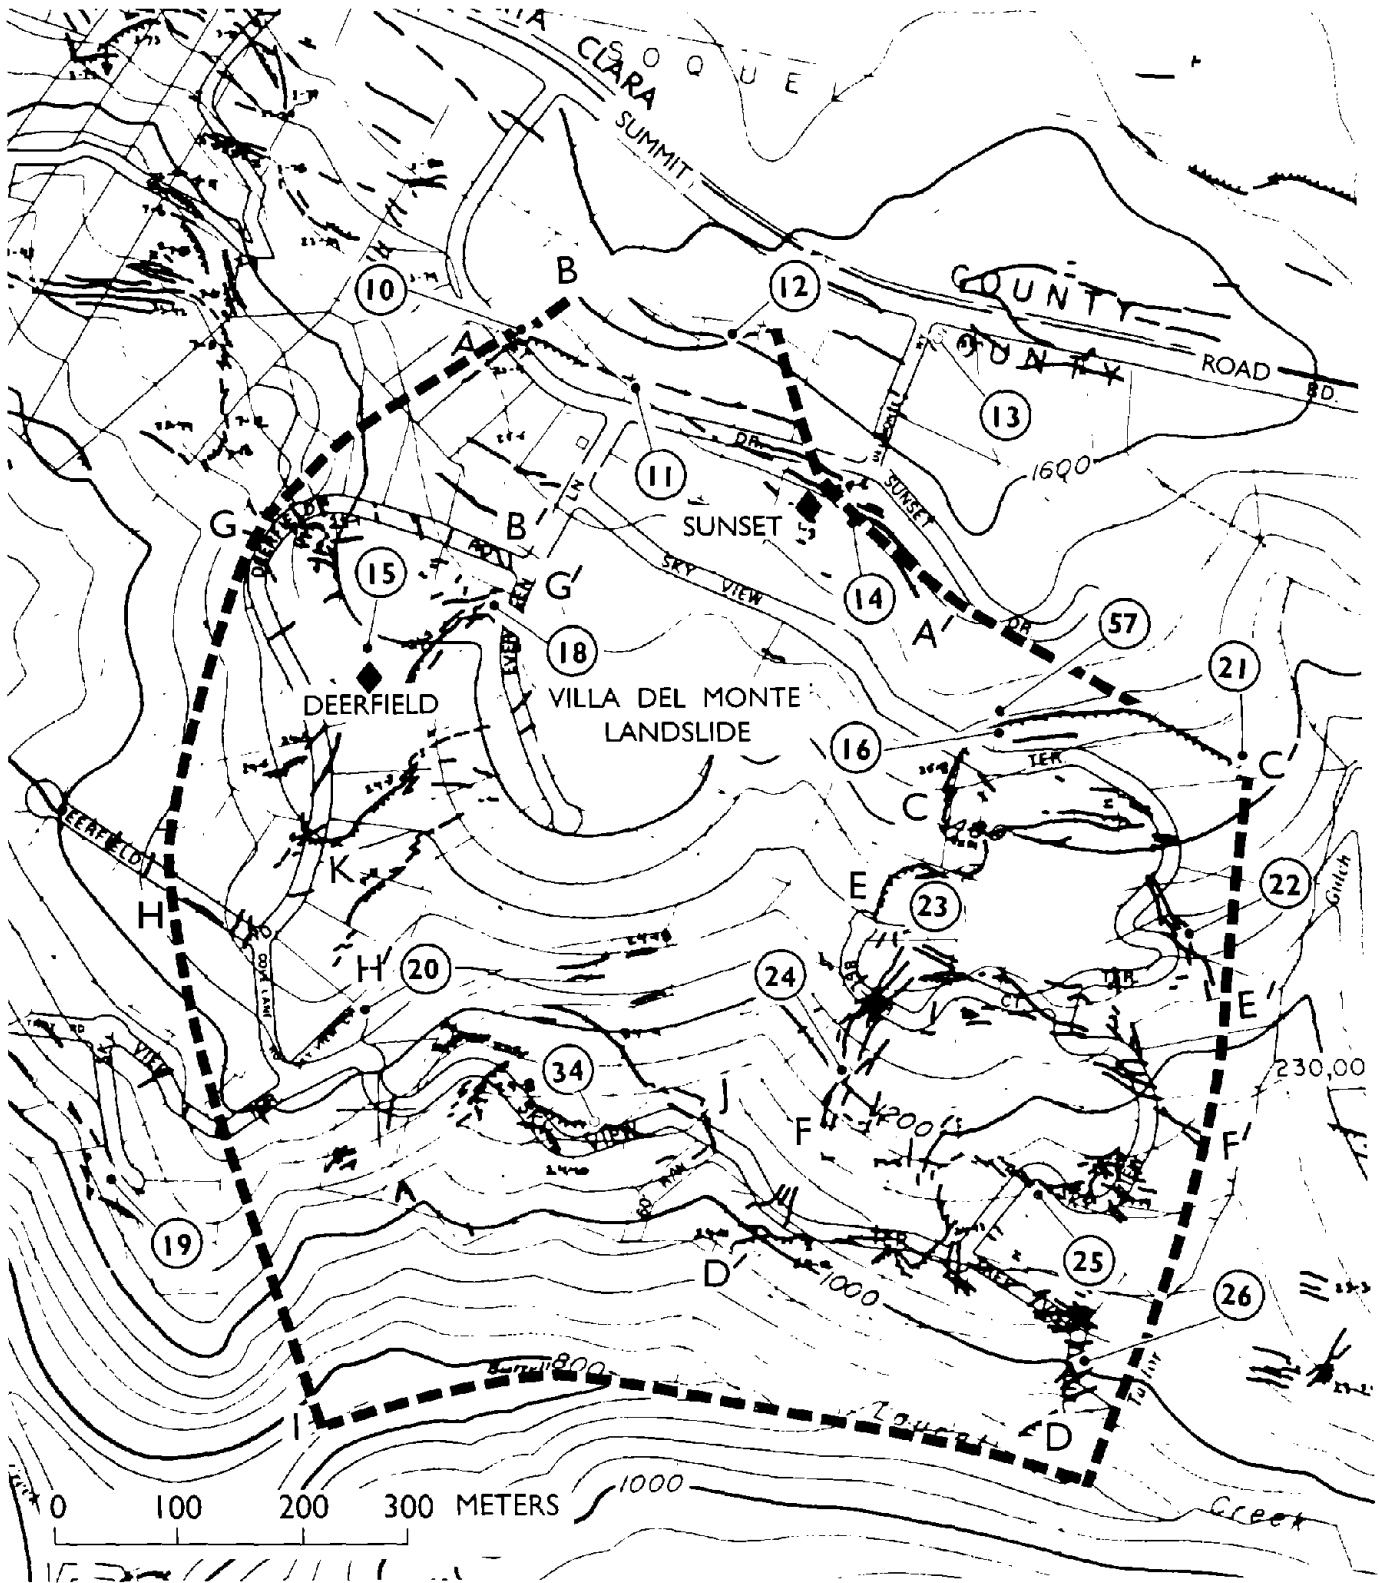
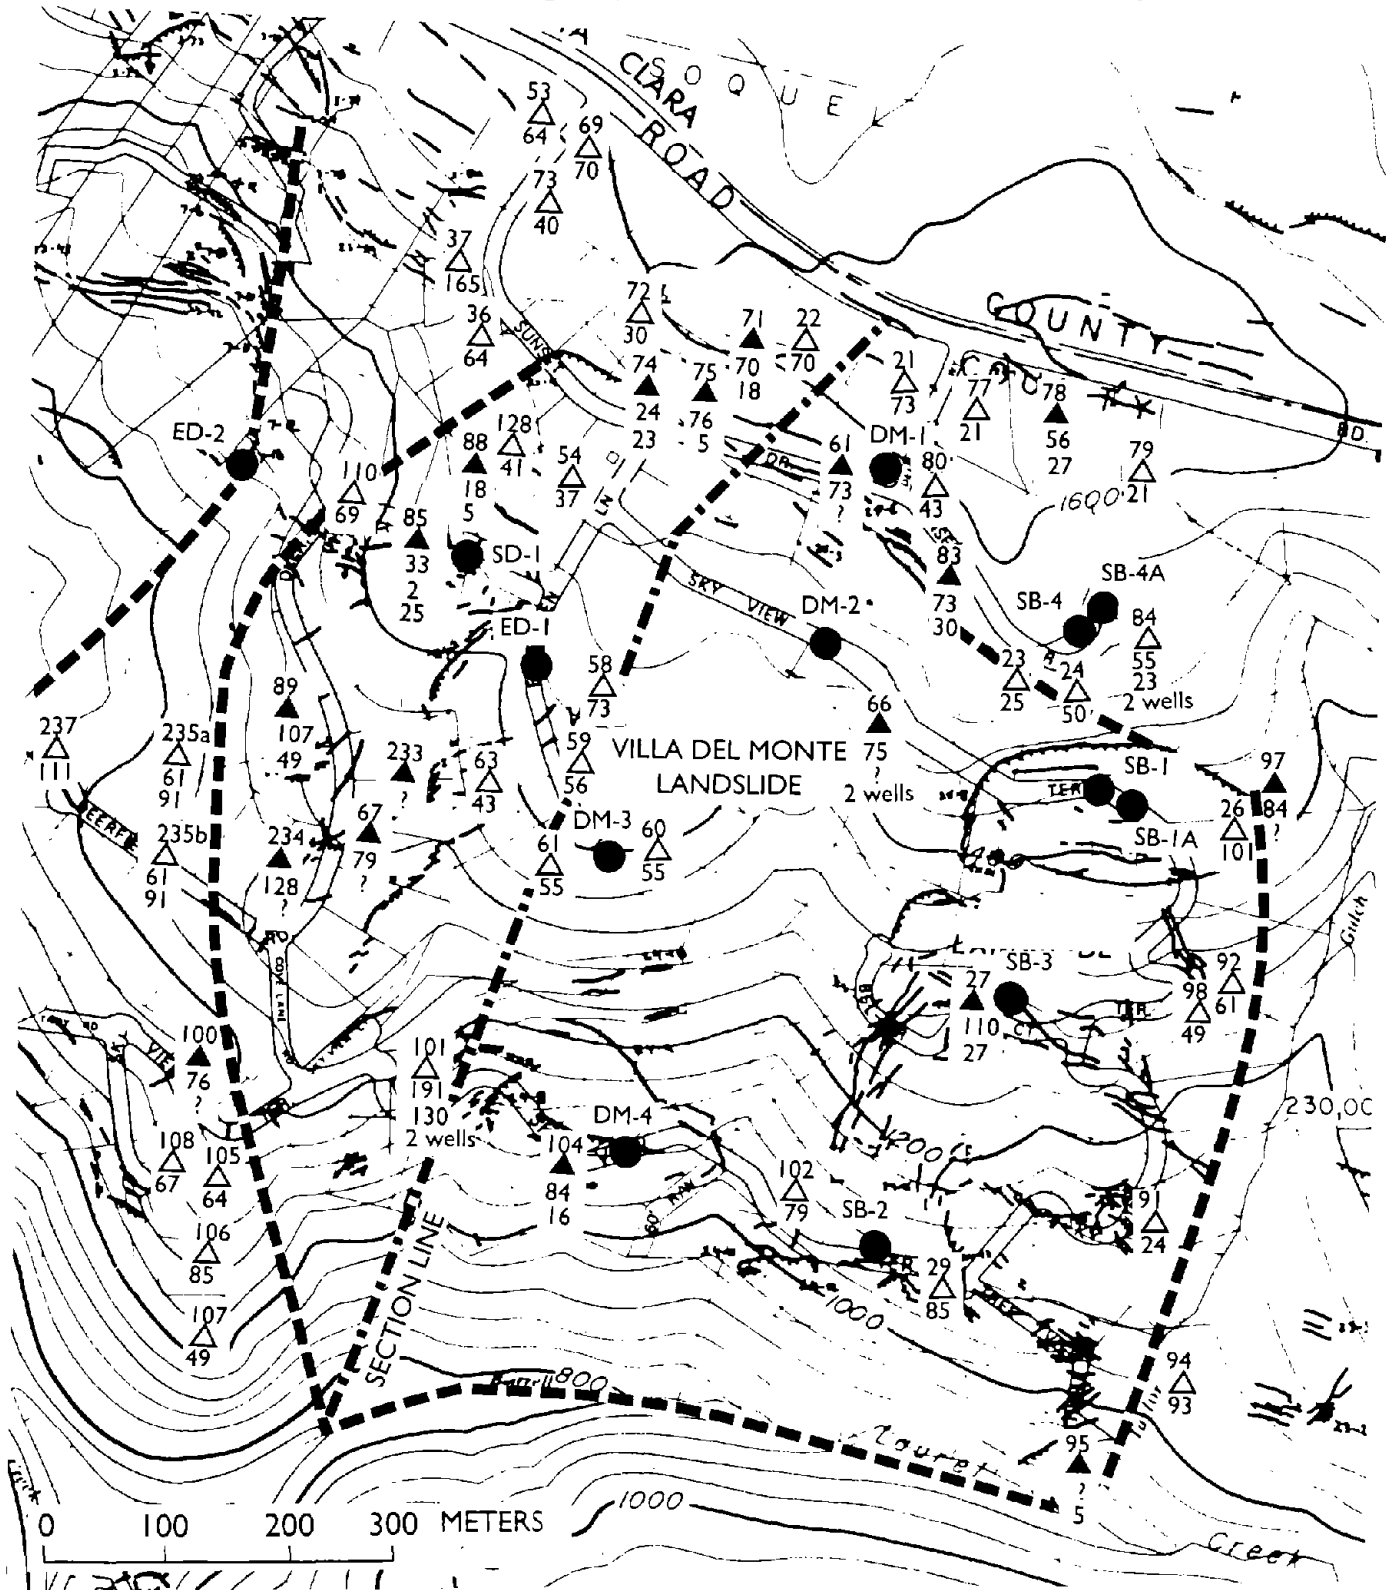
A

In the western part of the Villa Del Monte area, another major zone of ground cracks, scarps, and pressure ridges occurs along Deerfield Road and between Deerfield Road and Evergreen Lane (area G-G'-H-H', fig. 12A). This zone extends approximately 240 m from west to east and 370 m downslope (fig. 12). The cracks and scarps (fig. 15) in the zone strike predominantly northeast, oblique to the main structural elements in the bedrock (see pl. 3). Displacement measurements show predominantly southeastward to locally southwestward movement of 5 to 41 cm. Both the strike of the main ground cracks and the predominantly southeastward direction of displacements indicate that this zone forms the west (or right) flank of the landslide.

All five wells in this zone, along Deerfield Road (wells 85, 88, 89, 233, 234, fig. 12B), were reportedly damaged

Figure 12.—Villa Del Monte landslide, showing boundary of landslide and locations of (A) surficial features, surface-monitoring stations, and localities discussed in text and of (B) boreholes (from William Cotton and Associates, 1990, and Cole and others, 1991), cross section in figure 16, and water wells (from Brumbaugh, 1990). Ground cracks and compressional features from Spittler and Harp (1990); landslide boundaries modi-

by the earthquake. However, seven of the eight wells along westernmost Deerfield Road and westernmost Skyview Terrace (wells 105-108, 235a, 235b, 237, fig. 12B) were

reportedly undamaged. This zone of undamaged wells suggests that the smaller zones of ground cracks farther west (fig. 12) were not part of the larger landslide. These

westernmost ground cracks were almost certainly associated with smaller landslides. Although the boundary of the large landslide is inferred to lie generally in the area between the damaged and undamaged wells (approx between locs. H and I, fig. 12A), the landslide limits in this area were poorly defined by the available data.

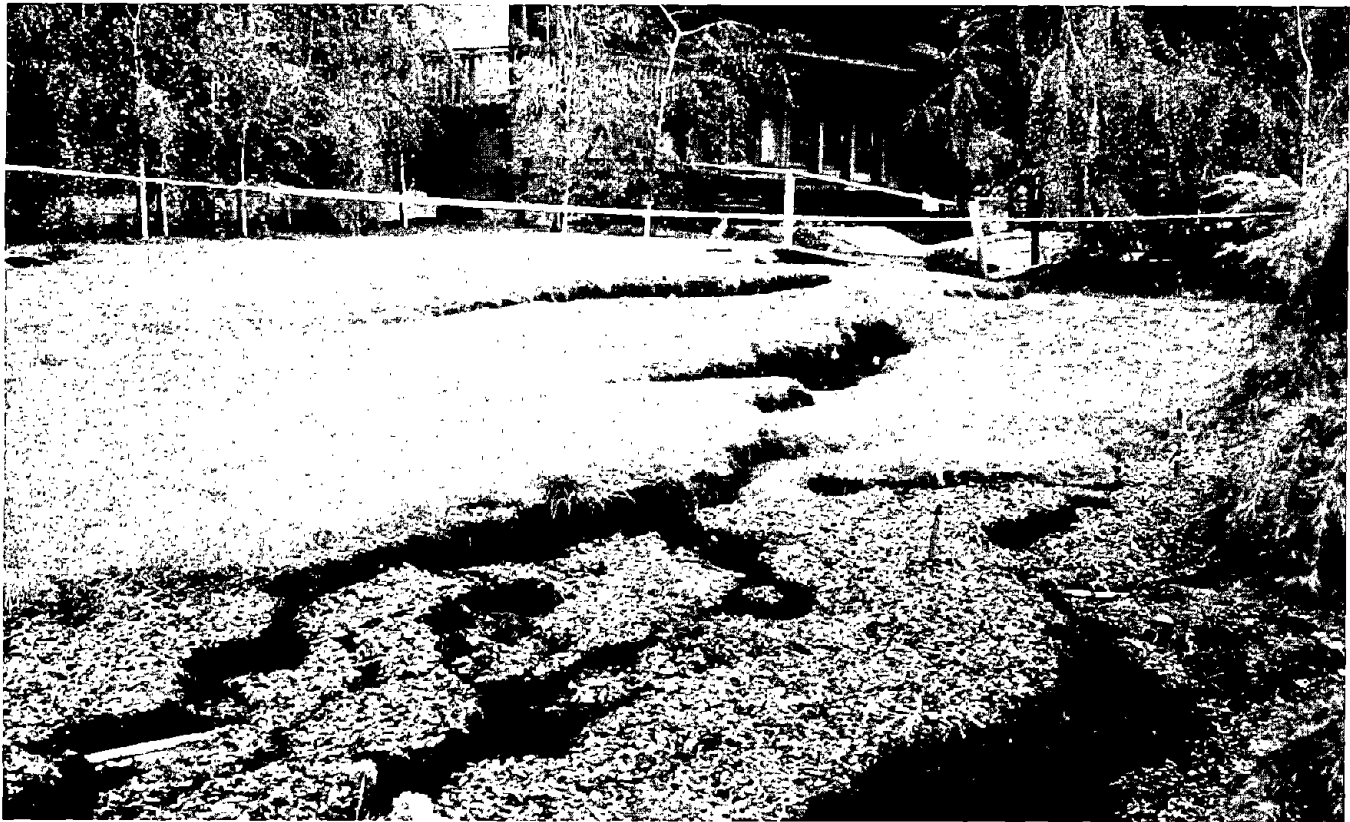
A

Figure 15.—Internal scarps and compressional features of Villa Del Monte landslide in Deerfield Road area. *A*, Internal scarps, which are part of a zone about 200 m long. View northeastward from just east of Deerfield Road (loc. K, fig. 12A). *B*, Internal ridge, consisting of compressed ground, marked by broken and buckled pavement. View northwestward from near east end of Deerfield Road (loc. *B'* on fig. 12A).
