# The Loma Prieta, California, Earthquake of October 17, 1989—Landslides

STRONG GROUND MOTION AND GROUND FAILURE

U.S. GEOLOGICAL SURVEY PROFESSIONAL PAPER 1551-C

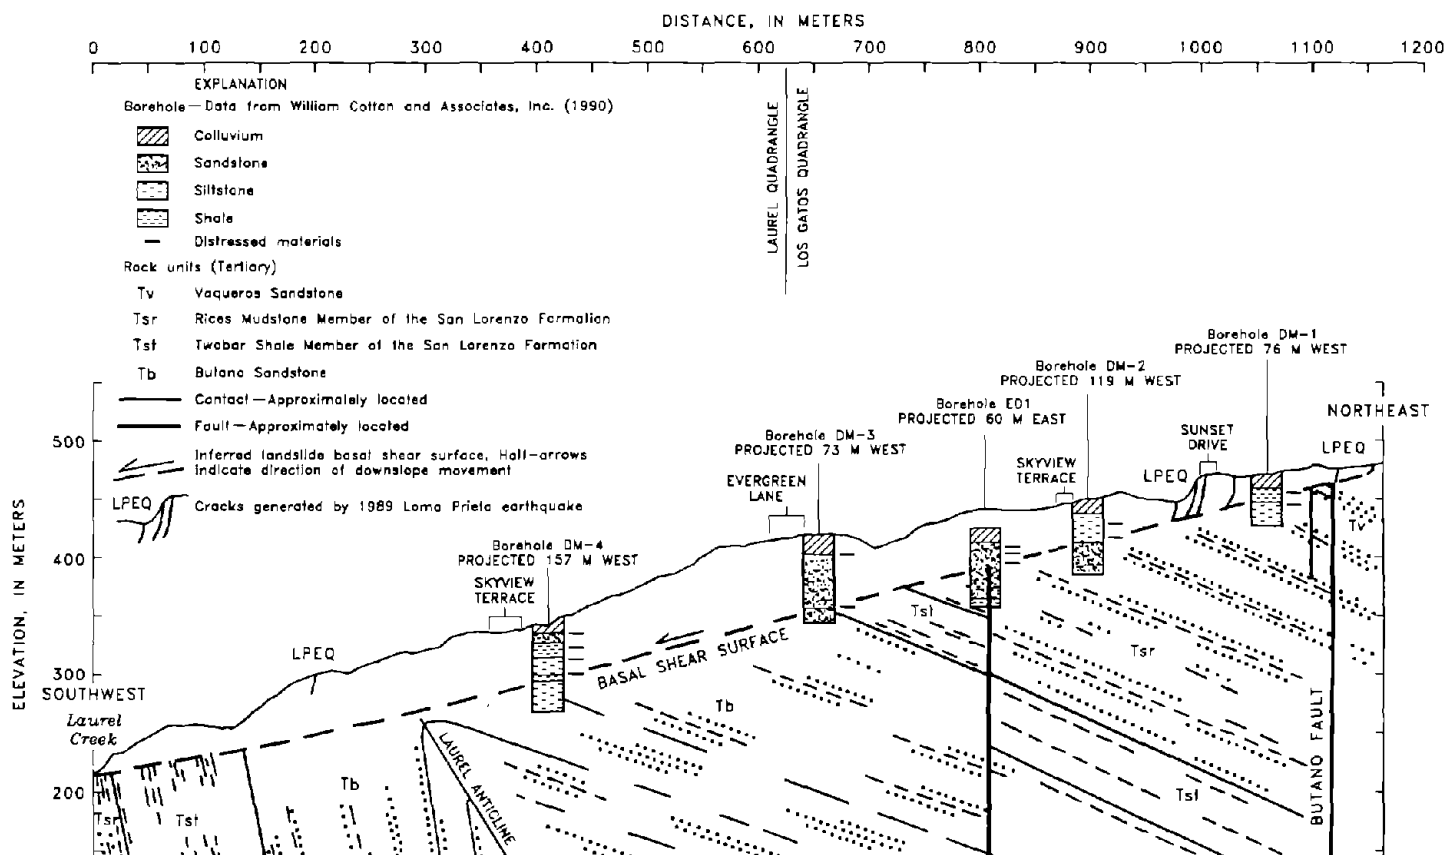
The soil, weathered rock, and bedrock contained approximately 45 intervals in the boreholes with indications of distressed materials—sheared, intensely fractured, or faulted rocks; very soft zones; crushed materials; intervals of collapsing or caving of the boreholes; or zones of lost circulation (fig. 16; William Cotton and Associates, Inc., 1990). These zones occurred in all rock types at depths from near the surface to near the maximum depth of drilling. However, the small diameters, discontinuous sampling, and absence of geophysical logging of the boreholes made identification of landslide shear surfaces within the boreholes uncertain. The numerous zones with indications of disturbance and reports of water well damage at various depths (fig. 12B) indicate that localized internal shearing occurred at several depths during landslide movement. An inferred deep basal shear surface, which is compatible with the drilling and surface data, is shown in figure 16. If the average landslide thickness is assumed to be half of the maximum thickness shown on this cross section, the landslide volume is  $27 \times 10^6 \text{ m}^3$ .

Figure 16.—Geologic cross section through Villa Del Monte landslide (see fig. 12B for location). Basal shear surface inferred from borehole data of William Cotton and Associates, Inc. (1990). See figure 11 for explanation.

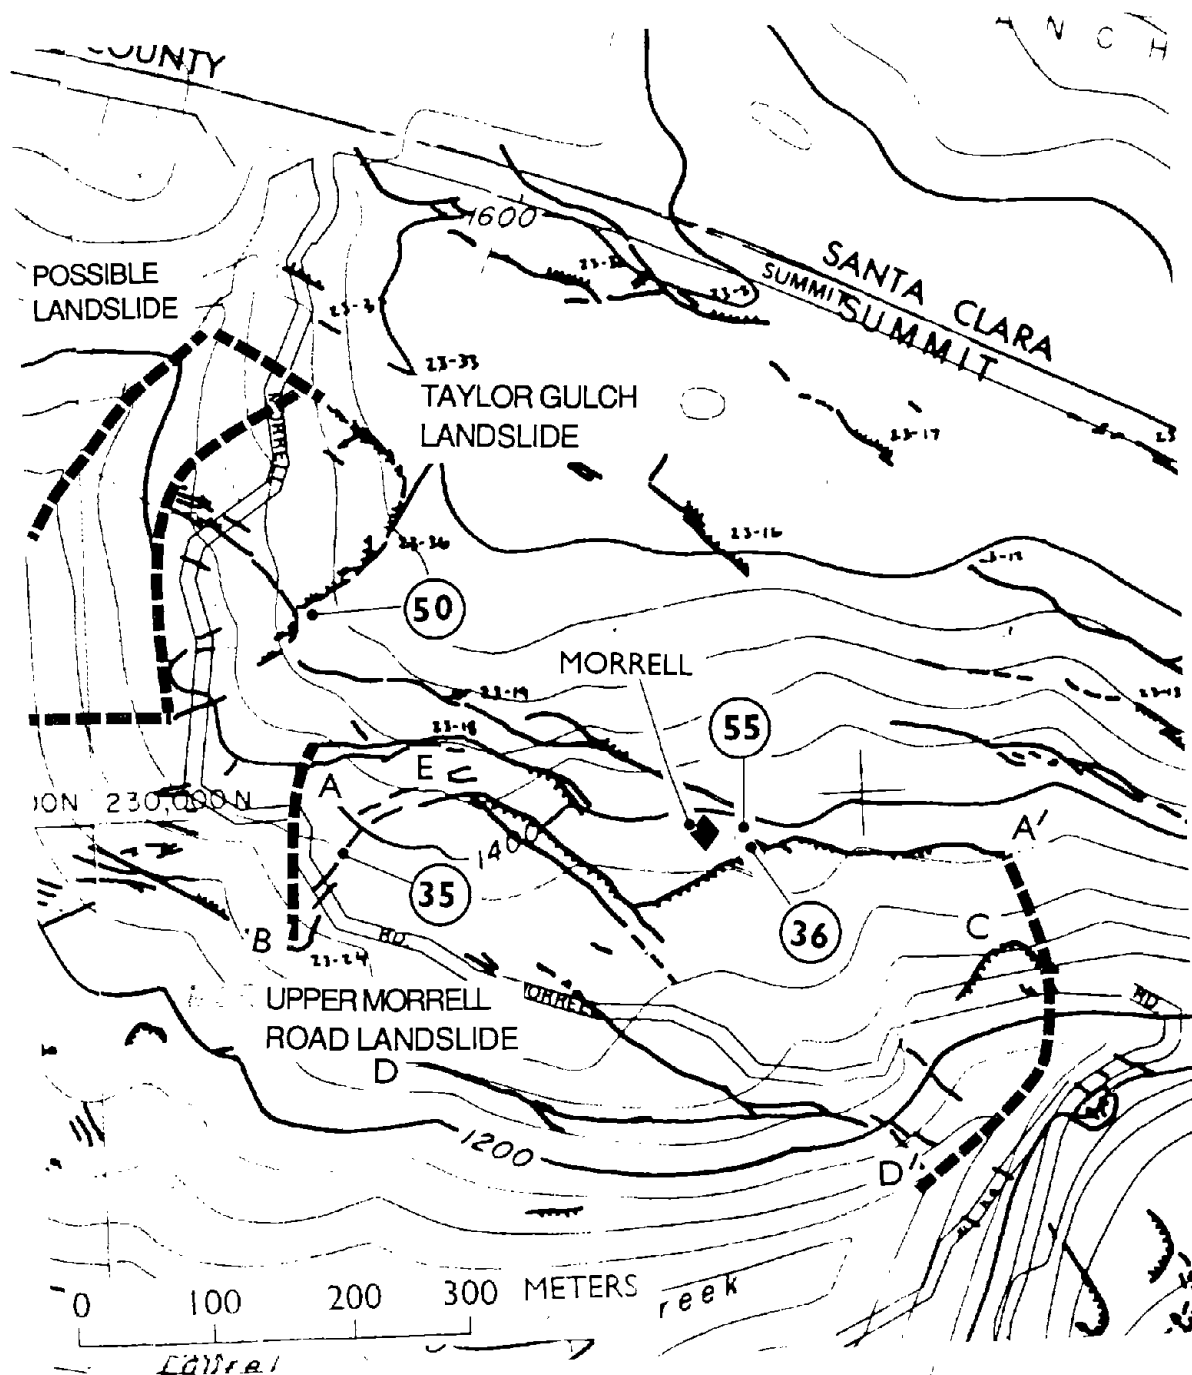
The Upper Morrell Road landslide is on the south flank of Summit Ridge east of Taylor Gulch (area 7, pl. 3). The main scarp of the landslide is made up of two adjoining zones of ground cracks and scarps, each of which is arcuate, concave downslope in plan view (leg A-A', fig. 17). Together, these zones extend approximately 550 m across the slope. The orientation of ground cracks in these zones

and the relation of these cracks to other northwest-striking cracks nearby (leg B-B', fig. 17) suggest significant control by bedrock structures. Displacement measurements across the main zones of cracks (fig. 18) indicate downslope movement of as much as 2.01 m. Southeast of the main scarp, a shorter scarp is inferred to mark part of the east flank of the landslide (loc. C, fig. 17).

Figure 17.—Taylor Gulch and Upper Morrell Road landslides. Ground cracks and compressional features from Spittler and Harp (1990); landslide boundaries from Keefer (1991). See figure 7 for explanation and figure 12 for base-map information.

downslope from the main scarp. A zone of fractures and grabens along the crest of this bulge is evidence of local extension of the ground that accompanied upward bulging of the landslide toe. Between the crown cracks and the toe, the landslide encompasses an area of approximately 14 ha.

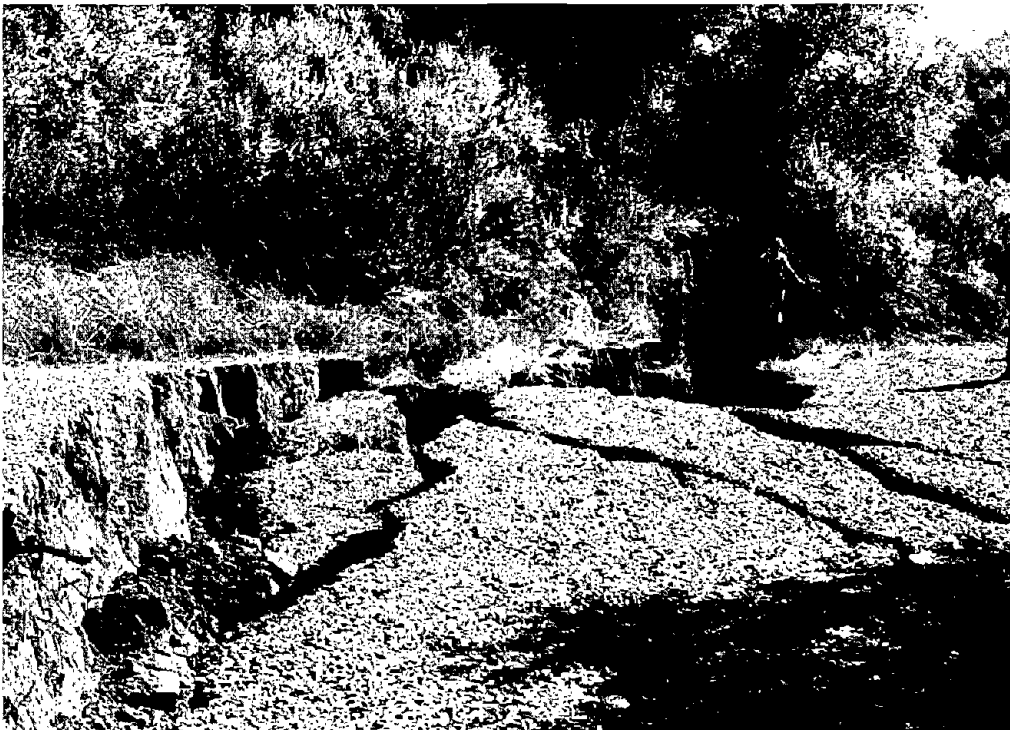
Figure 18.—Part of main scarp of Upper Morrell Road landslide where scarp crosses gravel road. View northeastward from just east of Morrell Road (loc. E, fig. 17).

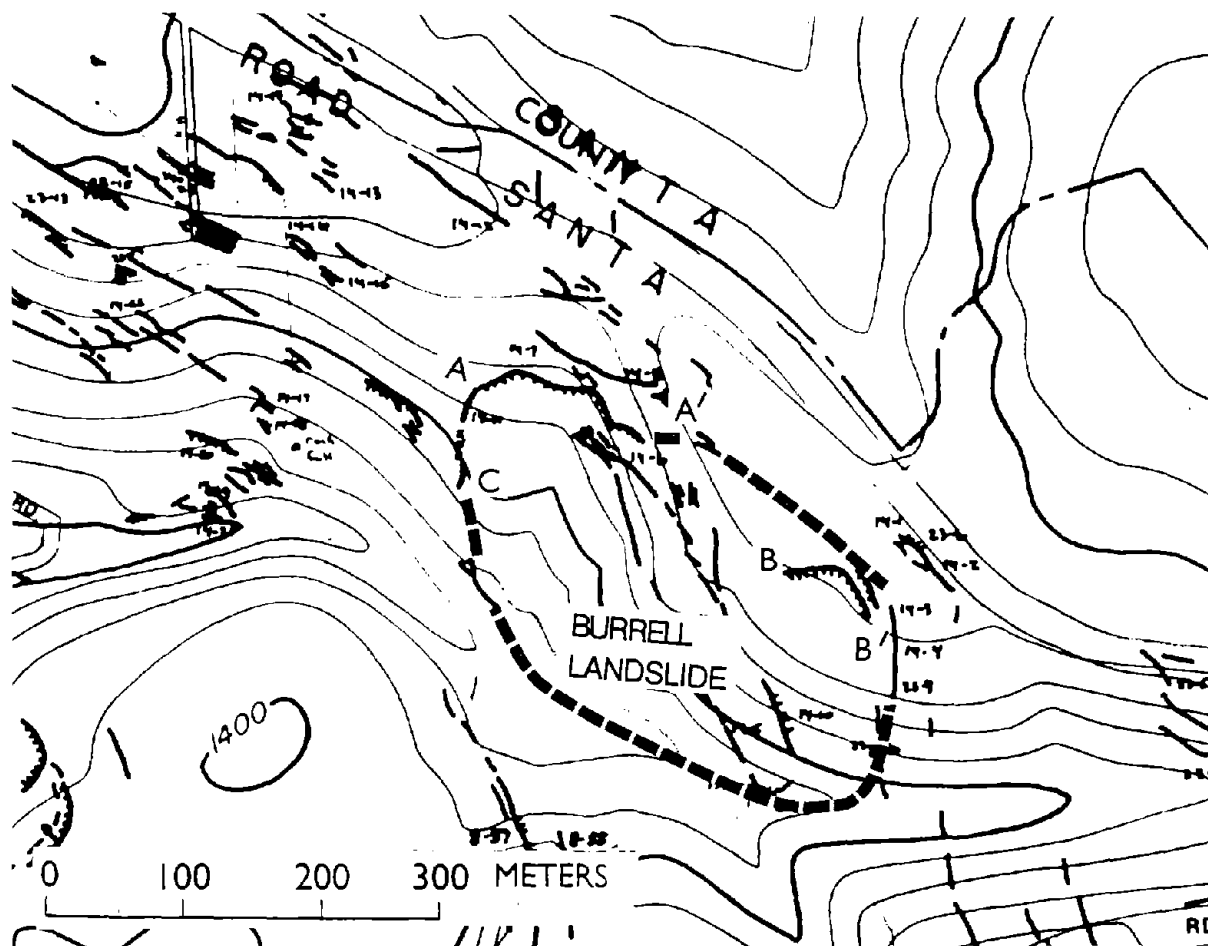
of two landslide blocks (legs A-A', B-B', fig. 19) were differentiated from other ground cracks in the area on the basis of their arcuate forms, their location at the upslope margin of a gently sloping topographic bench, and the occurrence of a pressure ridge downslope from one of them, which partly delineates the landslide toe (loc. C, fig. 19). These two main scarps were separated by a zone of discontinuous cracks. The landslide is approximately 230 m long by 460 m wide and encompasses an area of about 9 ha. Downslope displacements measured across the main scarps were from 28 to 71 cm. The slope averages 15°–20°, and bedrock is the Butano Sandstone (see pl. 3), which dips east to northeast, oblique to the slope direction.

Figure 19.—Burrell landslide. Ground cracks and compressional features from Spittler and Harp (1990); landslide boundaries from Keefer (1991). Base from Towill, Inc., prepared using topography from U.S. Geological Survey Laurel, Calif., 7.5-minute quadrangle and culture from County of Santa Cruz planimetric base and interpretation of aerial photographs flown July 24, 1990. See figure 7 for explanation. Contour interval, 40 ft.

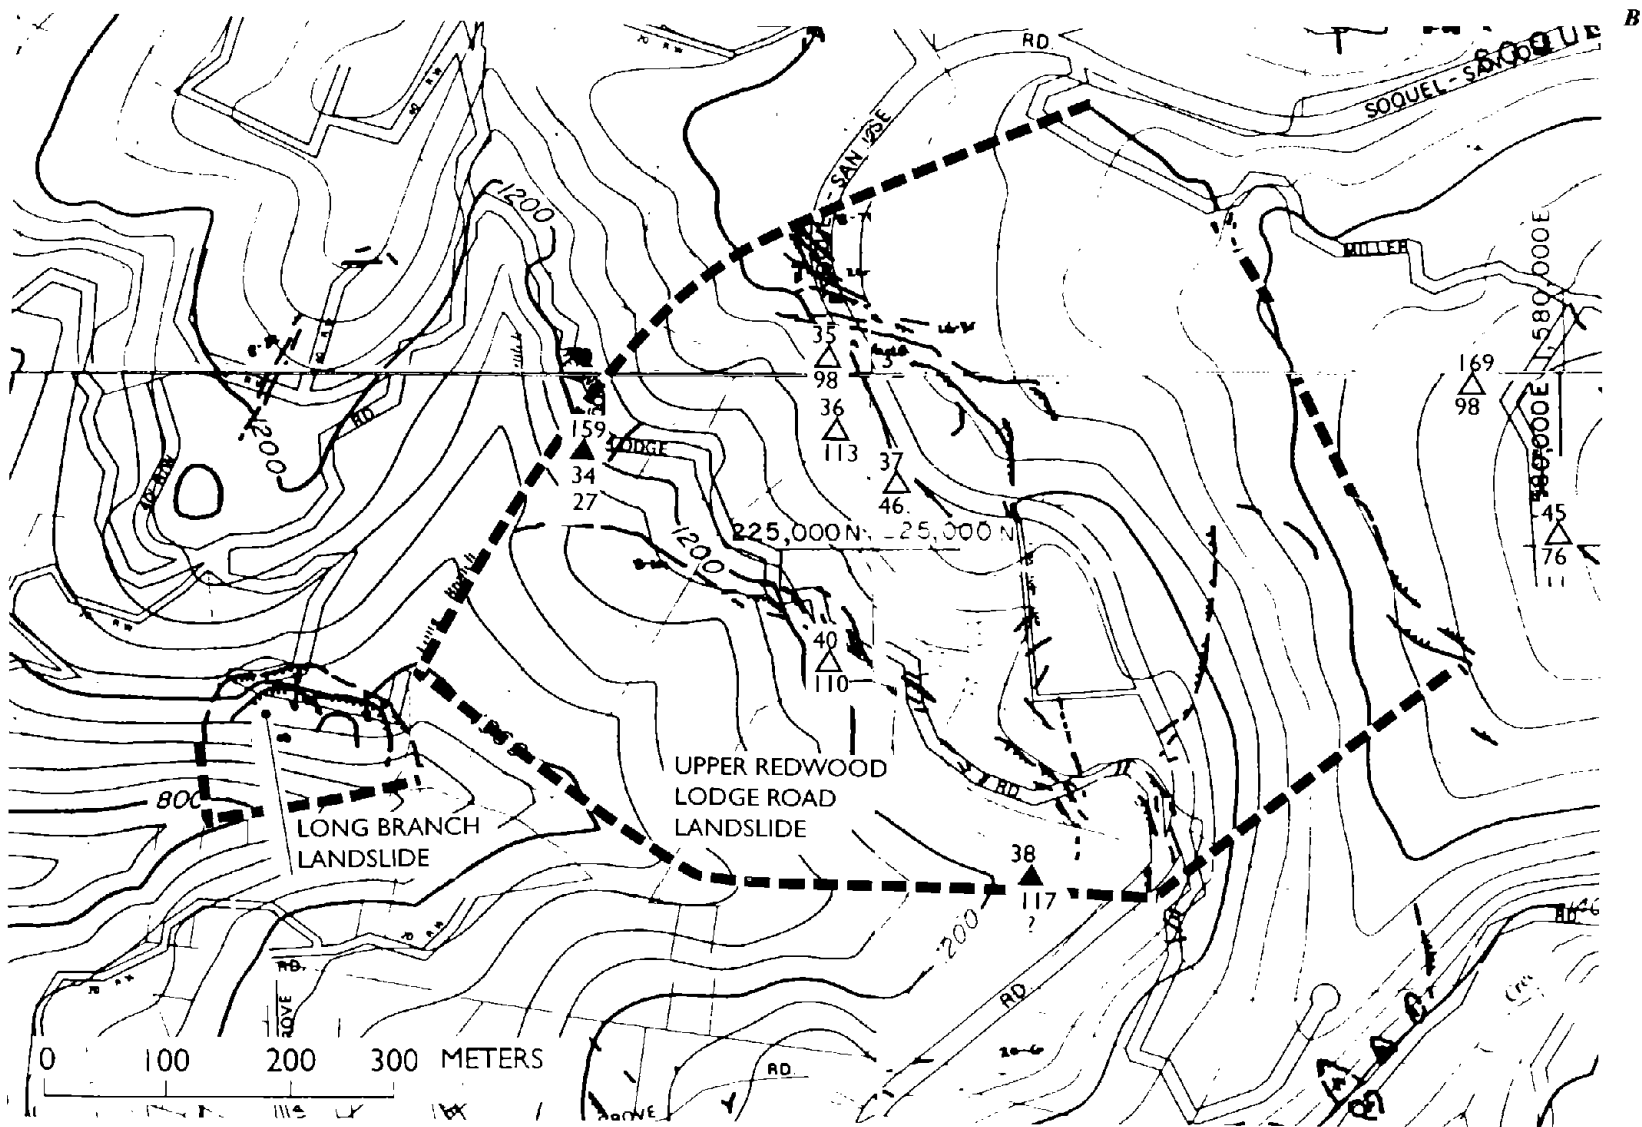
Figure 20.—Upper Redwood Lodge Road and Long Branch landslides, showing locations of (A) surficial features, surface-monitoring stations, and localities discussed in text and of (B) water wells (from Brumbaugh, 1990). Ground cracks and compressional features from Spittler and Harp (1990); landslide boundaries from Keefer (1991). See figure 7 for explanation and figure 19 for base-map information.

cracks and scarps (fig. 20); the landslide is thus at least 640 m wide. The southwest (downslope) boundary is likewise not marked by any surface features, but the position and pattern of the westernmost cracks and scarps suggest that the landslide extends to the creek at the base of the slope (fig. 20). The landslide is thus about 820 m long and at least 37 ha in area. The slope through the landslide averages 15°–20°.

Two wells within the landslide were reportedly damaged by the earthquake—well 159, at a depth of 27 m and well 38, at undetermined depth—and four wells (35–37, 40, fig. 20B), with depths of 45 to 113 m, were reportedly undamaged (Brumbaugh, 1990). The two damaged wells are both located near the margins of the landslide. The four reportedly undamaged wells are farther from these margins, and the absence of reported damage could indicate either a basal shear surface locally deeper than the wells or local displacements too small to cause damage.

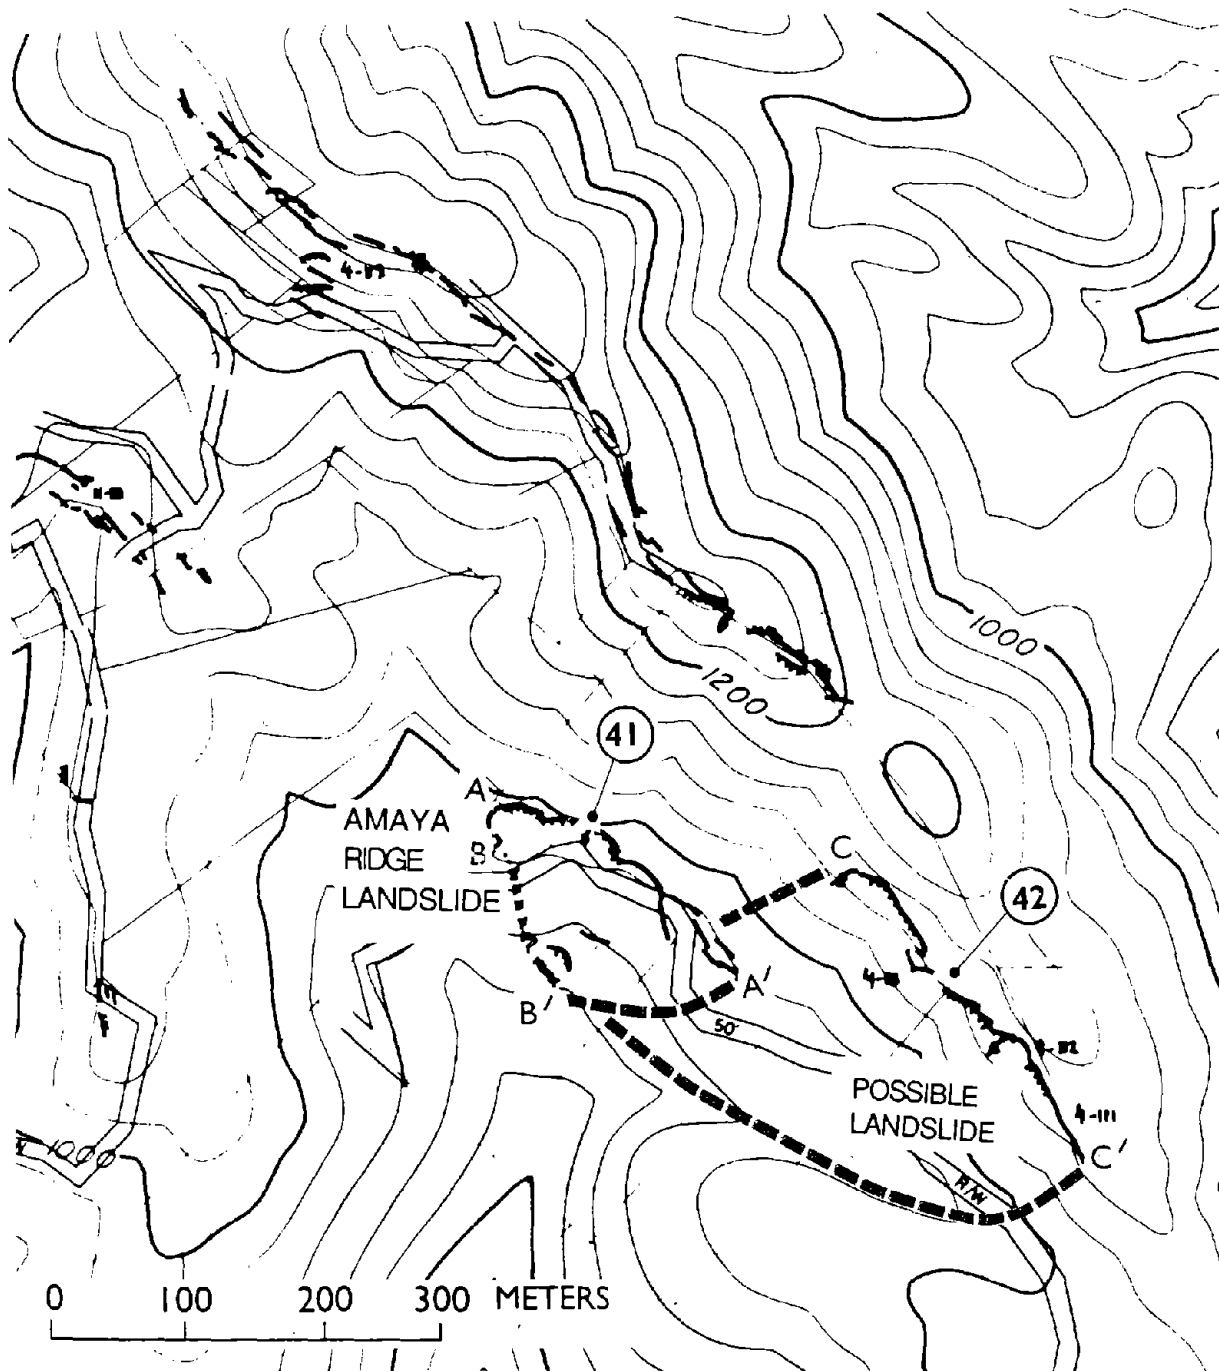
The Amaya Ridge landslide is on the southwest flank of Amaya Ridge, in the southern part of the study area (area 13, pl. 3). Two sets of ground cracks and associated features are present (fig. 21). The northwestern set consists of a relatively continuous, arcuate zone of ground cracks that are concave downslope in plan view (leg A–A', fig. 21), and a nearly straight compression feature farther downslope (leg B–B', fig. 21). These features are interpreted to be, respectively, the main scarp and toe of a landslide, approximately 120 m long, 240 m wide, and 1.6 ha in area. Measurements across the main scarp indicated local downslope displacements of 8 to 100 cm or more.

Southeast of the landslide is a 300-m-long zone of ground cracks and scarps (line C–C', fig. 21) that is linear to slightly arcuate, parallel, and echelon to the main scarp to the northwest. This southeastern set of ground cracks and scarps may represent the main scarp of a separate landslide, an easterly and upslope extension of the other landslide, or cracks produced by some other process: One displacement measurement across a ground crack in this set indicated movement of 15 to 20 cm downslope, to the

Both sets of ground cracks and scarps (legs A–A', C–C', fig. 21) are near breaks in slope; the slope above them is relatively steep, and the slope below them is a broad, gently sloping bench, 90 m wide. A topographic profile surveyed through the northwestern set of ground cracks and scarps shows an average slope inclination of 22° and an inclination of the steep segment above the scarps of 24°. Marshy areas just below the base of the steep stretch of slope indicate a local water table near the surface.

Figure 21.—Amaya Ridge landslide. Ground cracks and compressional features from Spittler and Harp (1990); landslide boundaries from Keefer (1991). See figure 7 for explanation and figure 19 for base-map information.

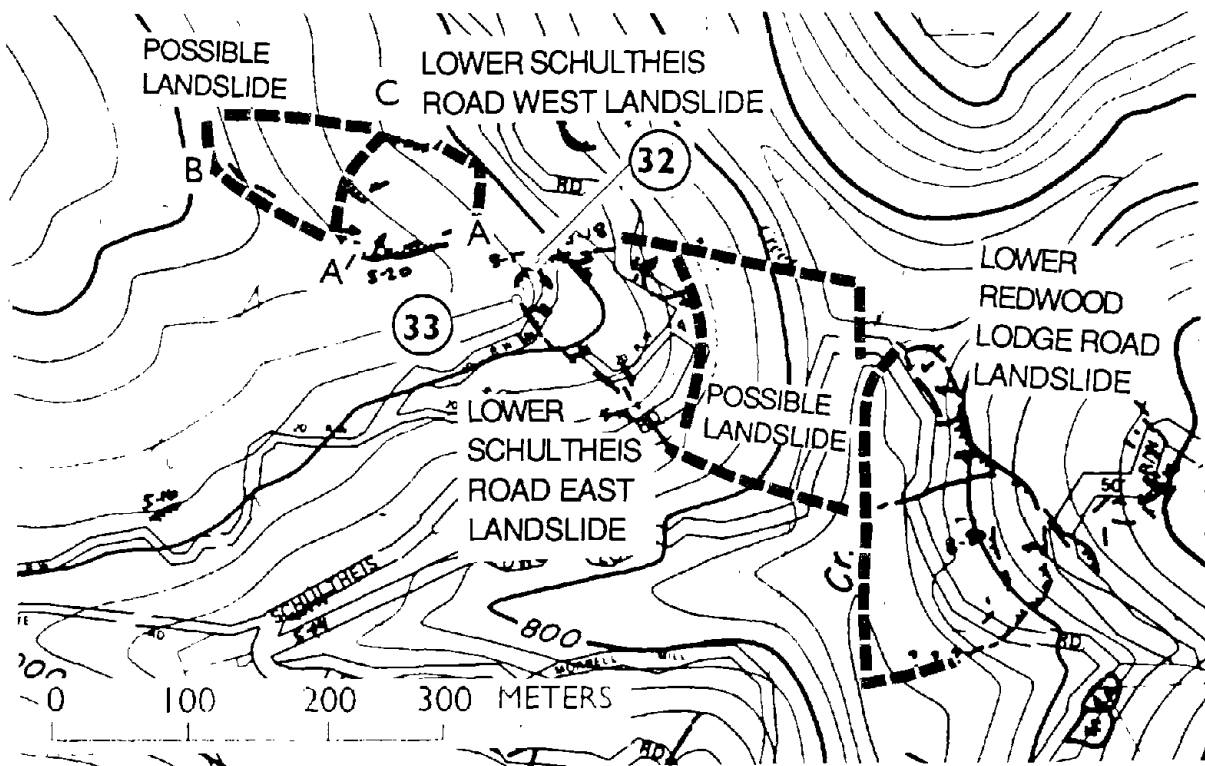
The Lower Schultheis Road West landslide is near Laurel, on a short ridge immediately south of Summit Ridge (area 18, pl. 3). The main scarp of the landslide is a 90-m-long series of slightly arcuate cracks and a graben (leg A–A', fig. 22). For part of its length, this main scarp is south of the ridge crest (fig. 23), and so part of the ridge crest is involved in the landslide, having been displaced to the north. Measurements along the scarp showed 30 to 65 cm of northward displacement.

A set of discontinuous ground cracks (leg A'–B, fig. 22) west of the scarp indicates that the landslide may extend an additional 90 m in that direction. These ground cracks also nearly parallel the bedrock strike (see pl. 3), suggesting that they and, by extension, the better developed main scarp to the east probably are structurally controlled. An elongate bulge in the ground about 110 m downslope from the main scarp marks part of the landslide toe (loc. C, fig. 22). The landslide defined by this bulge and the main scarp is at least 110 m long, 110 m wide, and 1.2 ha in area; if the landslide also encompasses the zone of ground cracking to the north and also extends there as far downslope as the bulge, its area may be as large as 2 ha. The slope through the landslide averages 15°–20°.

Figure 22.—Lower Redwood Lodge Road, Lower Schultheis Road East, and Lower Schultheis Road West landslides. Ground cracks and compressional features from Spittler and Harp (1990); landslide boundaries from Keefer and others (1991). See figure 7 for explanation and figure 19 for base-map information.

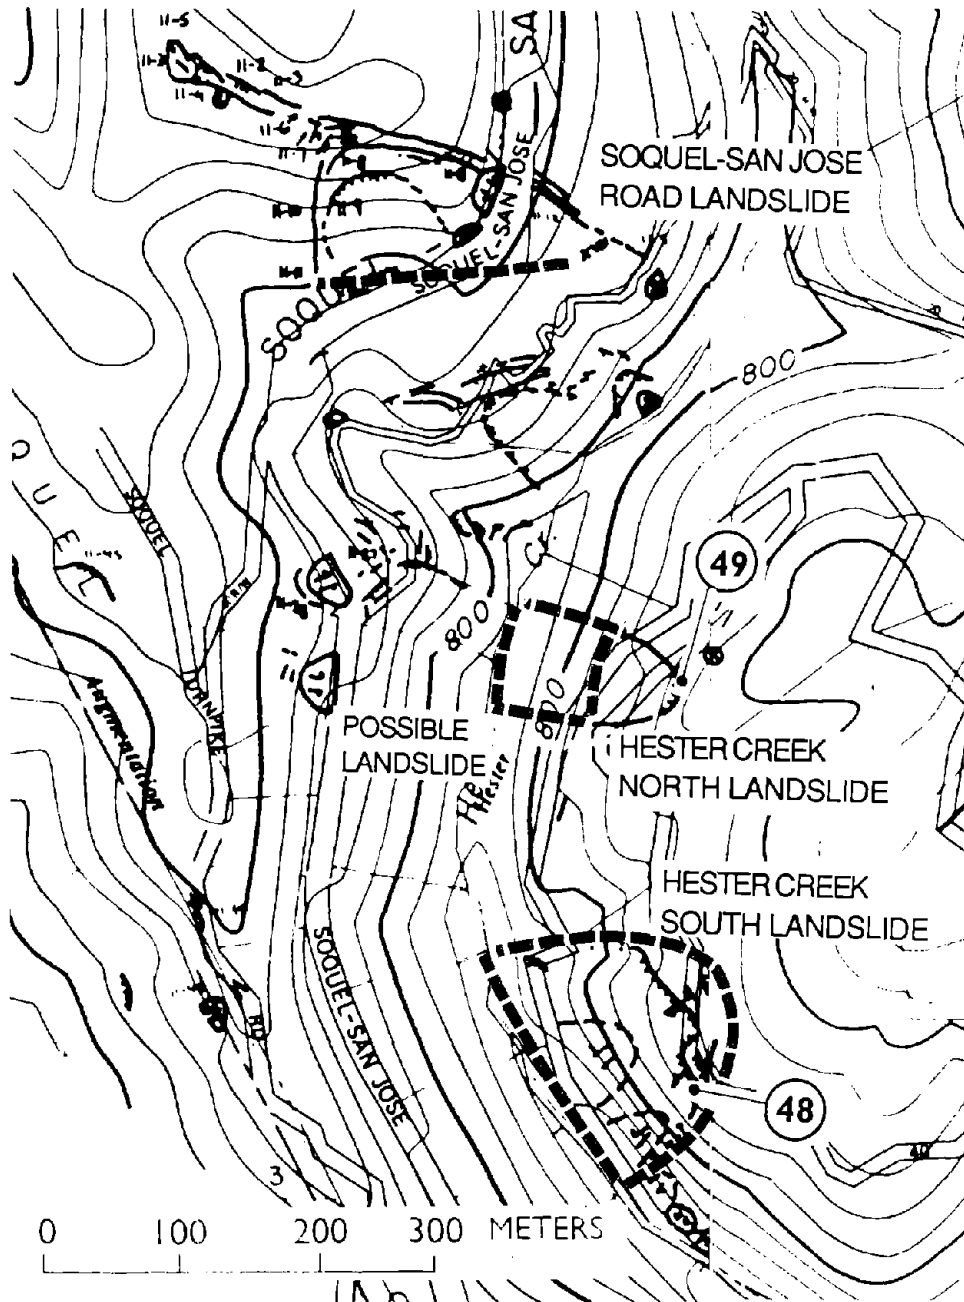
Renewed displacement was first detected along the main scarp of the Hester Creek North landslide on March 19, 1991. Measurements at quadrilateral array 49 (fig. 27) indicated 2 cm of extension between March 15 and 19,

and on March 25, measurements at the site revealed an additional 2 cm of extension. During the March 25 survey, renewed minor cracking was also observed across the unpaved access road, downslope from quadrilateral array 49 (fig. 27), at both localities where the road crossed the main scarp. Those cracks were 1 to 2 cm wide and showed slight vertical displacements.

Figure 27.—Hester Creek North, Hester Creek South, and Soquel-San Jose Road landslides. Ground cracks and compressional features from Spittler and Harp (1990); boundaries of Hester Creek North and South landslides from Keefer (1991). See figure 7 for explanation and figure 19 for base-map information.

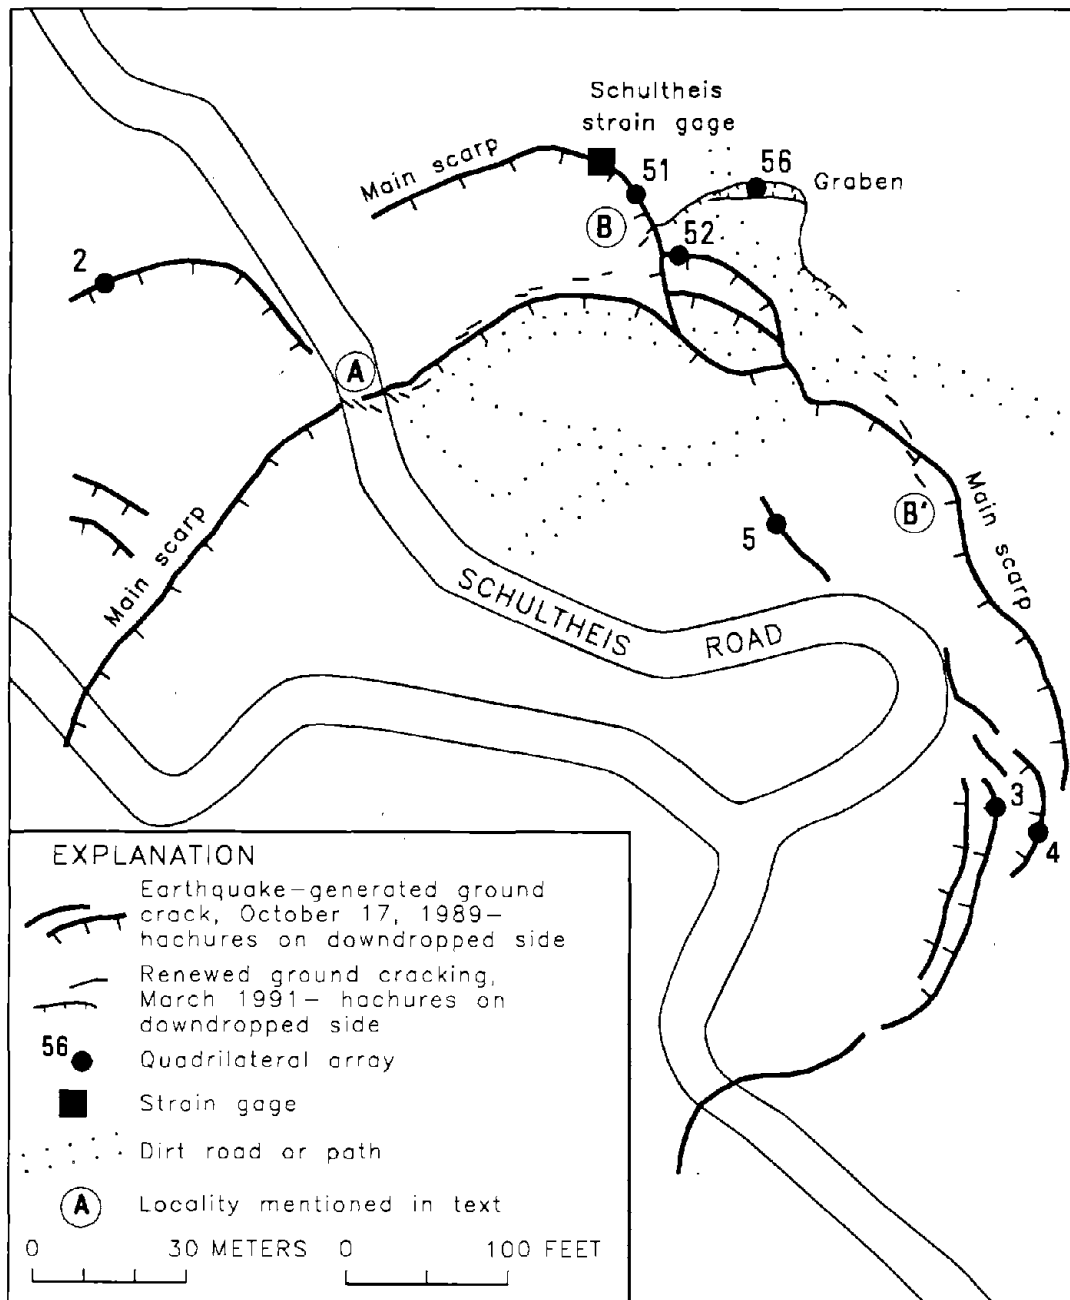
The first evidence of postearthquake ground cracking related to landslide movement was discovered on March 5, 1991, when new echelon cracks were observed on repaired pavement where Schultheis Road crosses the main scarp of the Upper Schultheis Road landslide (loc. A, fig. 29). The cracks were 1.5 to 3 m long and 1 to 2 cm wide, and showed as much as 2 cm of downslope vertical displacement. Observations on March 15 and 19, after additional rain, revealed increases of 1 to 2 cm in crack widths and vertical displacements, and increases of 0.5 to 1 m in crack lengths (Marshall and Griggs, 1991).

On March 25, a new set of cracks was observed upslope from the main scarp that formed during the earthquake (leg B–B', fig. 29). Because these new cracks did not occur along the traces of the preexisting, earthquake-induced cracks, associated displacements were not detected at nearby quadrilateral arrays 51 or 52 or by the adjacent

Schultheis strain gage (fig. 29). The new set of cracks extended eastward and southeastward from a point (B, fig. 29) on the earthquake-generated main scarp. From there eastward, a new crack was virtually continuous for about 50 m. This crack was arcuate and concave downslope in plan view, and along part of the crack was a graben, 15 m long, 2 to 3 m wide, and 0.5 m deep, that showed 20 to 30 cm of net vertical displacement between its upslope and downslope margins. Elsewhere, the crack was 5 to 10 cm wide and showed 5 to 10 cm of vertical displacement. Southeast of the continuous crack, shorter echelon cracks continued for an additional 50 m (to loc. B', fig. 29). These shorter cracks were 10 to 20 cm wide and showed

A new quadrilateral array (56, figs. 9A, 29) was installed on March 27, 1991, across the newly formed graben. Measurement of this array 2 weeks later, on April 11, showed 3 cm of additional downslope displacement. Subsequent measurements on April 18, 23, and 30, May 8, and July 17 indicated no additional displacements, but field observations during those surveys showed that minor ground cracking had occurred in several places along the main scarp (between locs. A and B, fig. 29).

Figure 29.—Area around main scarp of Upper Schultheis Road landslide, showing ground cracks and scarps that resulted from earthquake; ground cracks, scarps, and grabens formed during period of heavy rainfall in March 1991; and locations of quadrilateral arrays and strain gage.

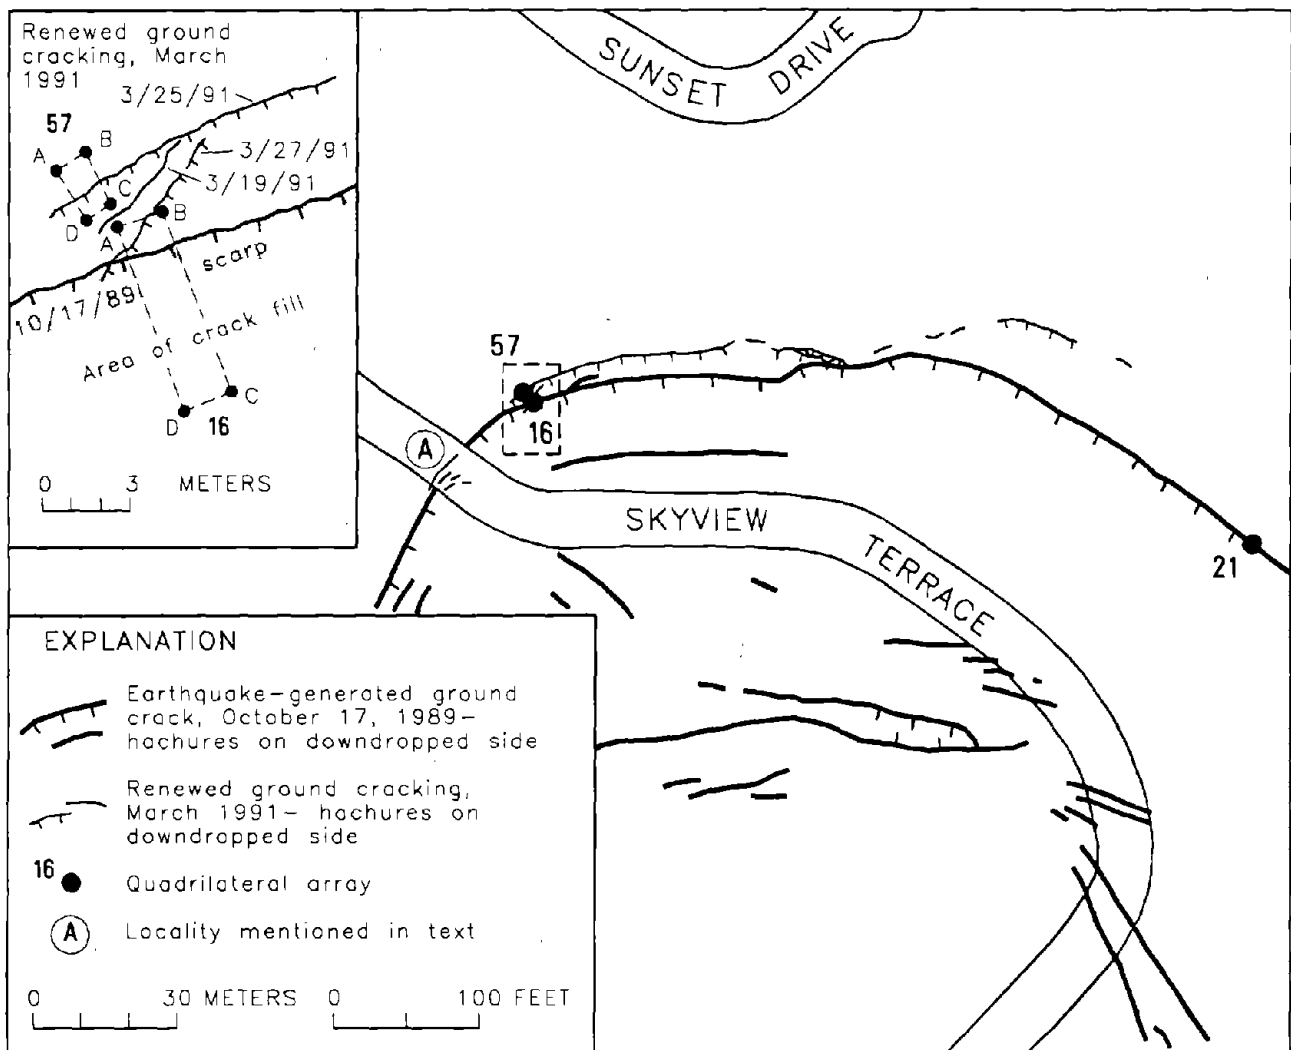
Renewed ground cracking and displacement along the major scarp near upper Skyview Terrace was detected on March 19, 1991, when a survey of quadrilateral array 16 (figs. 12, 30), showed 1 to 2 cm of contraction. Field inspection revealed that the contraction was associated with extension across a new crack, less than 1 m upslope from the site (inset, fig. 30). This crack, which formed sometime between March 15 and 19, was 2 to 5 cm wide and showed no vertical displacement. The crack was traceable 10 m eastward from the array, until lost beneath thick vegetation. Small cracks, less than 1 cm wide, also broke the pavement of upper Skyview Terrace near quadrilateral array 16 (point A, fig. 30).

Measurements at quadrilateral array 16 on March 25 revealed additional contractions of 11 to 19 cm. The new crack noted on March 19 appeared to be unchanged, but a larger crack, about 1 m farther upslope, had formed between March 19 and 25. This new crack, 5 to 15 cm wide and showing 5 to 15 cm of downslope vertical displacement, was subparallel to the preexisting scarp

and traceable continuously approximately 40 m eastward. From that point east, a series of shorter cracks were traceable an additional 70 to 80 m. These shorter cracks were 5 to 15 cm wide and showed vertical displacements of as much as 15 cm. The cracks in Skyview Terrace (loc. A, fig. 30) had also become larger by March 25.

On March 27, another new crack was observed, trending obliquely upslope, northeast from the earthquake-generated scarp (inset, fig. 30). This crack, which averaged 5 cm in width and showed as much as 5 cm of vertical displacement, was traceable for 4 m and passed between two of the stakes in quadrilateral array 16 (stakes A, B, inset, fig. 30). The March 27 survey showed 11 cm of cross-crack contraction on the two legs involving stake B (that is, legs B-C, B-D) and no significant change on the two legs involving stake A (that is, legs A-C, A-D). On March 27, a new quadrilateral array (57, figs. 12A, 30) was installed across the new crack observed on March 25 (fig. 30). Subsequent measurements made at both quadrilateral arrays 16 and 57 on April 11, 18, and 23 and May 8, 1991, showed that no additional displacements had occurred.

Figure 30.—Area around part of upper Skyview Terrace on Villa Del Monte landslide, showing ground cracks and scarps that resulted from earthquake; ground cracks and scarps formed during period of heavy rainfall in March 1991; and locations of quadrilateral arrays.

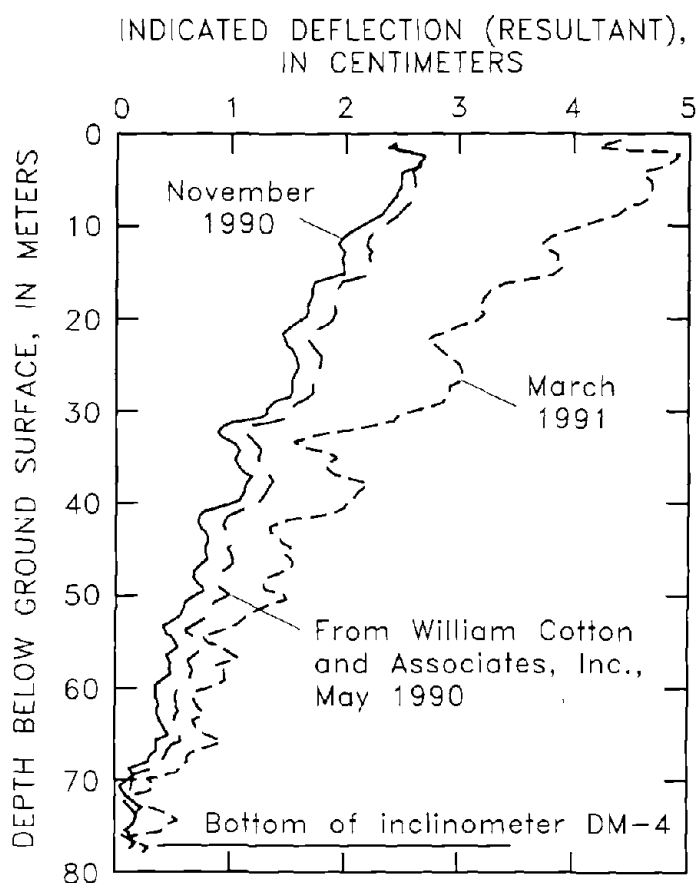
Figure 31.—Deflections measured by inclinometer in borehole DM-4 on Villa Del Monte landslide (see fig. 12B for location).

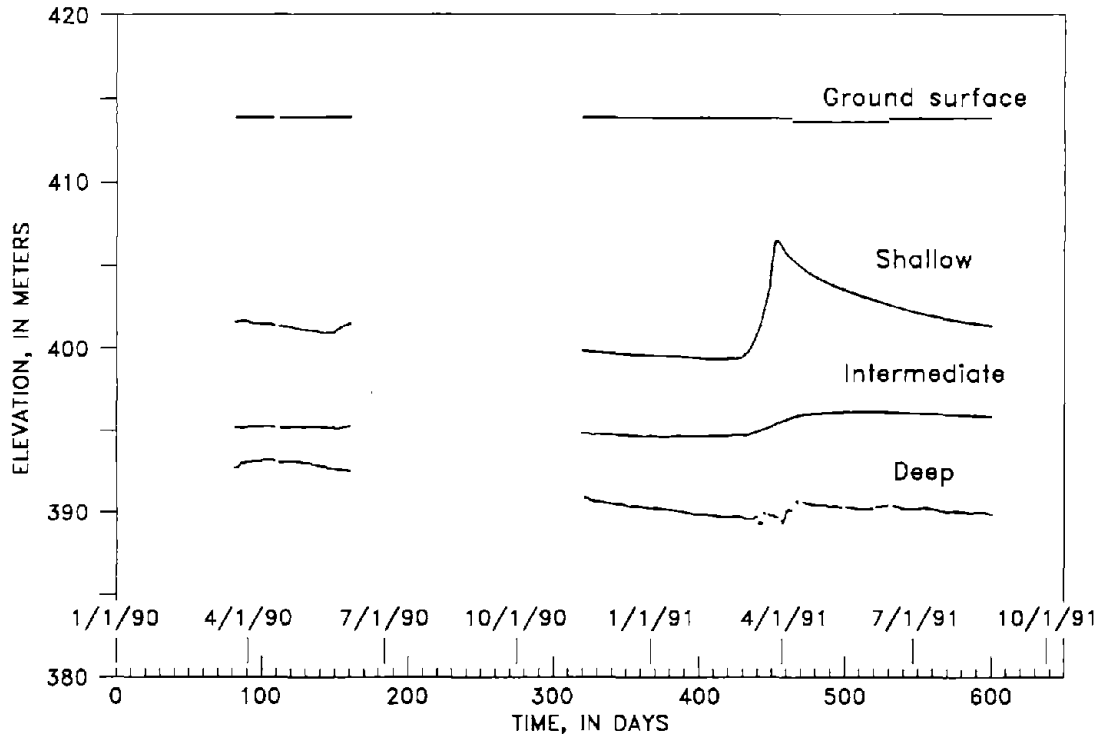
Figure 32.—Elevation of piezometric surface versus time for piezometers in borehole SR-3 on Upper Schultheis Road landslide (see fig. 9B for location).

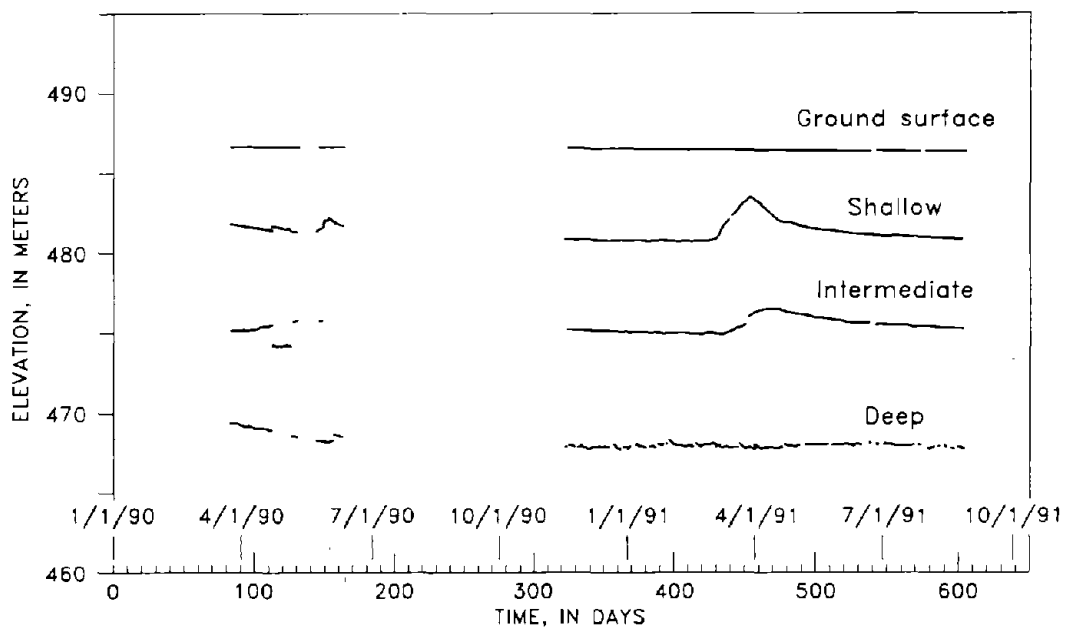
Figure 33.—Elevation of piezometric surface versus time for piezometers in borehole DM-1 on Villa Del Monte landslide (see fig. 12B for location).

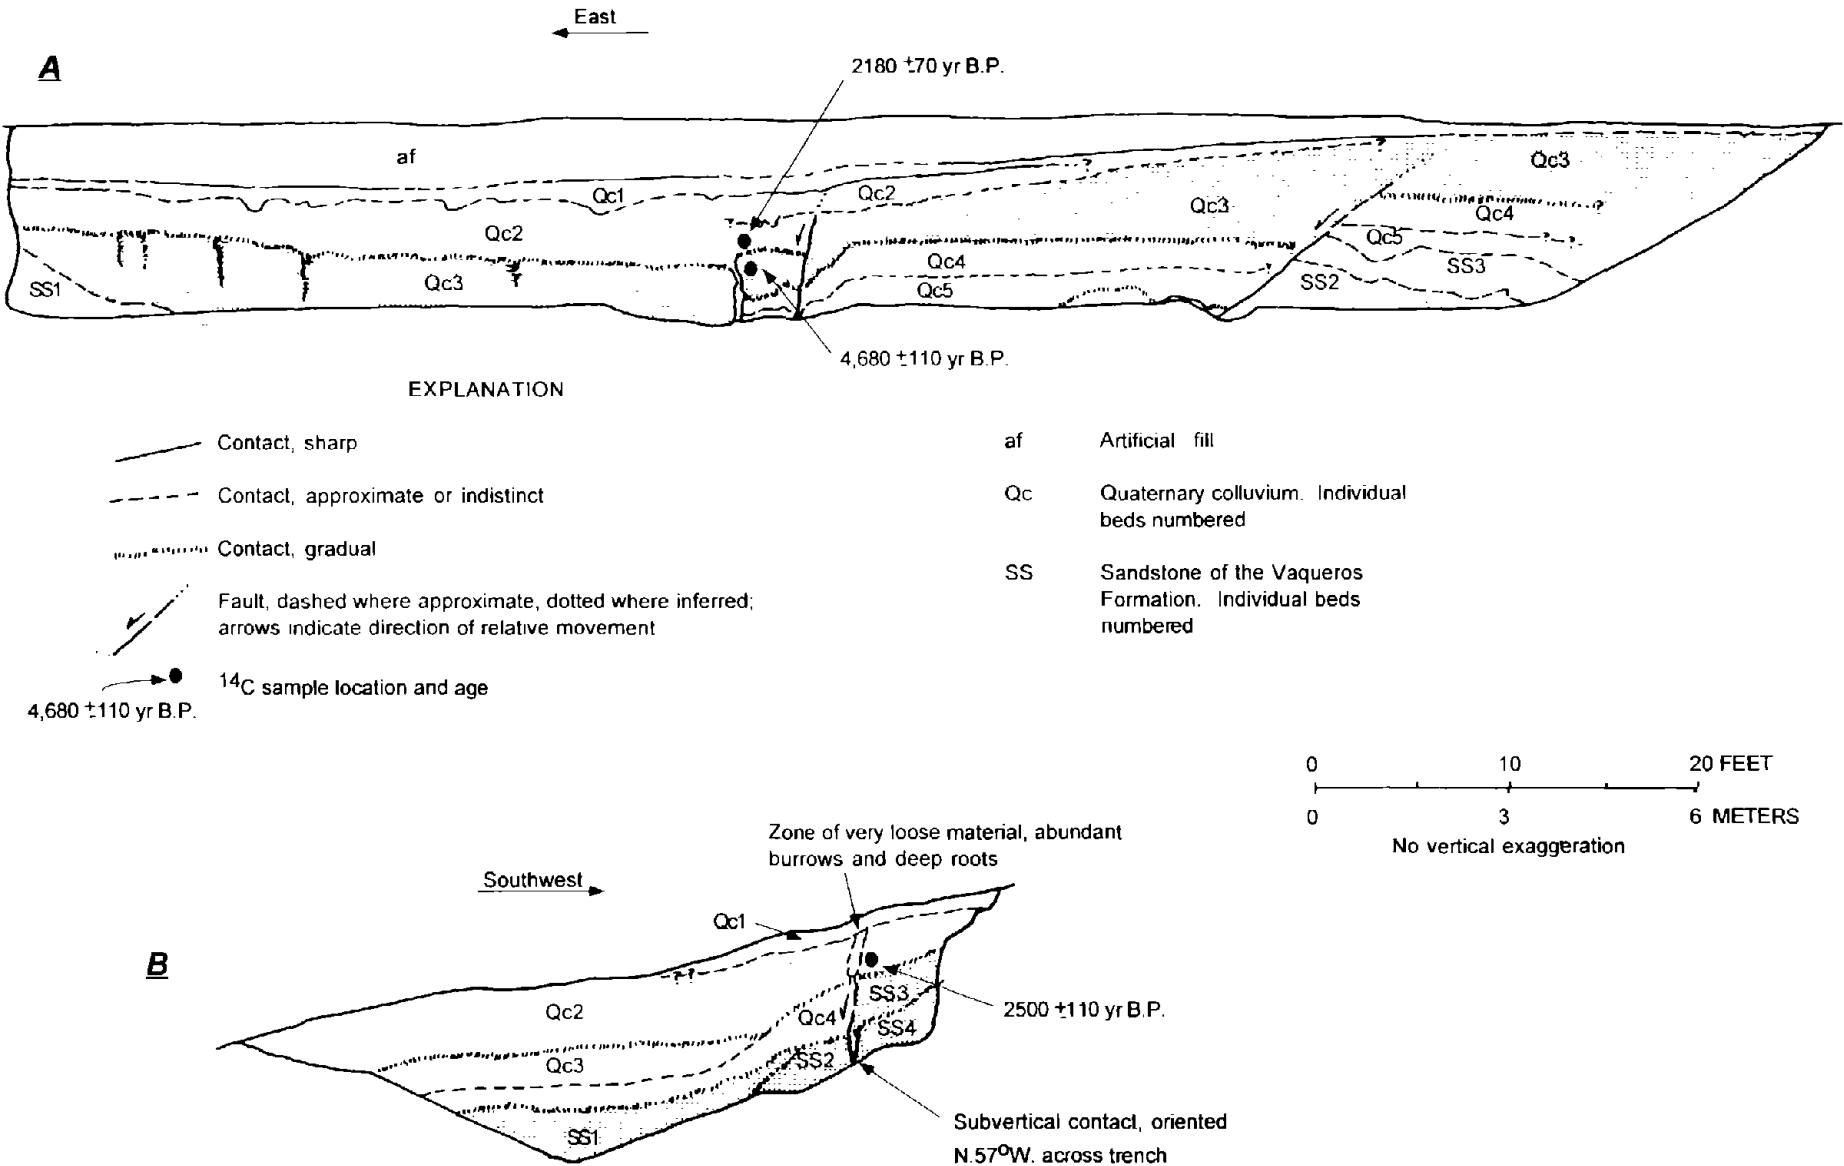
Figure 5.—Logs of trenches 3 (A) and 4 (B), showing evidence for active faulting found during preearthquake trenching investigation. Fault in center of trench 3 was reactivated during 1989 Loma Prieta earthquake, causing as much as 15 cm of down-to-the-northeast displacement under classroom unit 2. Modified from Rogers E. Johnson and Associates (1989).

room building 2 and decreased to the northwest and southeast. The deformation occurred as flexure of the ground surface, northeast side down, probably as a result of normal slip at depth. Maximum vertical displacement was approximately 15 cm across a zone of flexure about 3 m wide.

As a result of the geologic investigation, the consultant recommended that the school site be abandoned. This recommendation, however, was not followed by the school board, and so the school was in use, though not in session, when the earthquake struck. The administration building and classroom units 2 and 3 were moderately to severely damaged by ground cracking, but no structural collapse took place. The school was subsequently abandoned.
