# The Loma Prieta, California, Earthquake of October 17, 1989—Landslides

STRONG GROUND MOTION AND GROUND FAILURE

U.S. GEOLOGICAL SURVEY PROFESSIONAL PAPER 1551-C

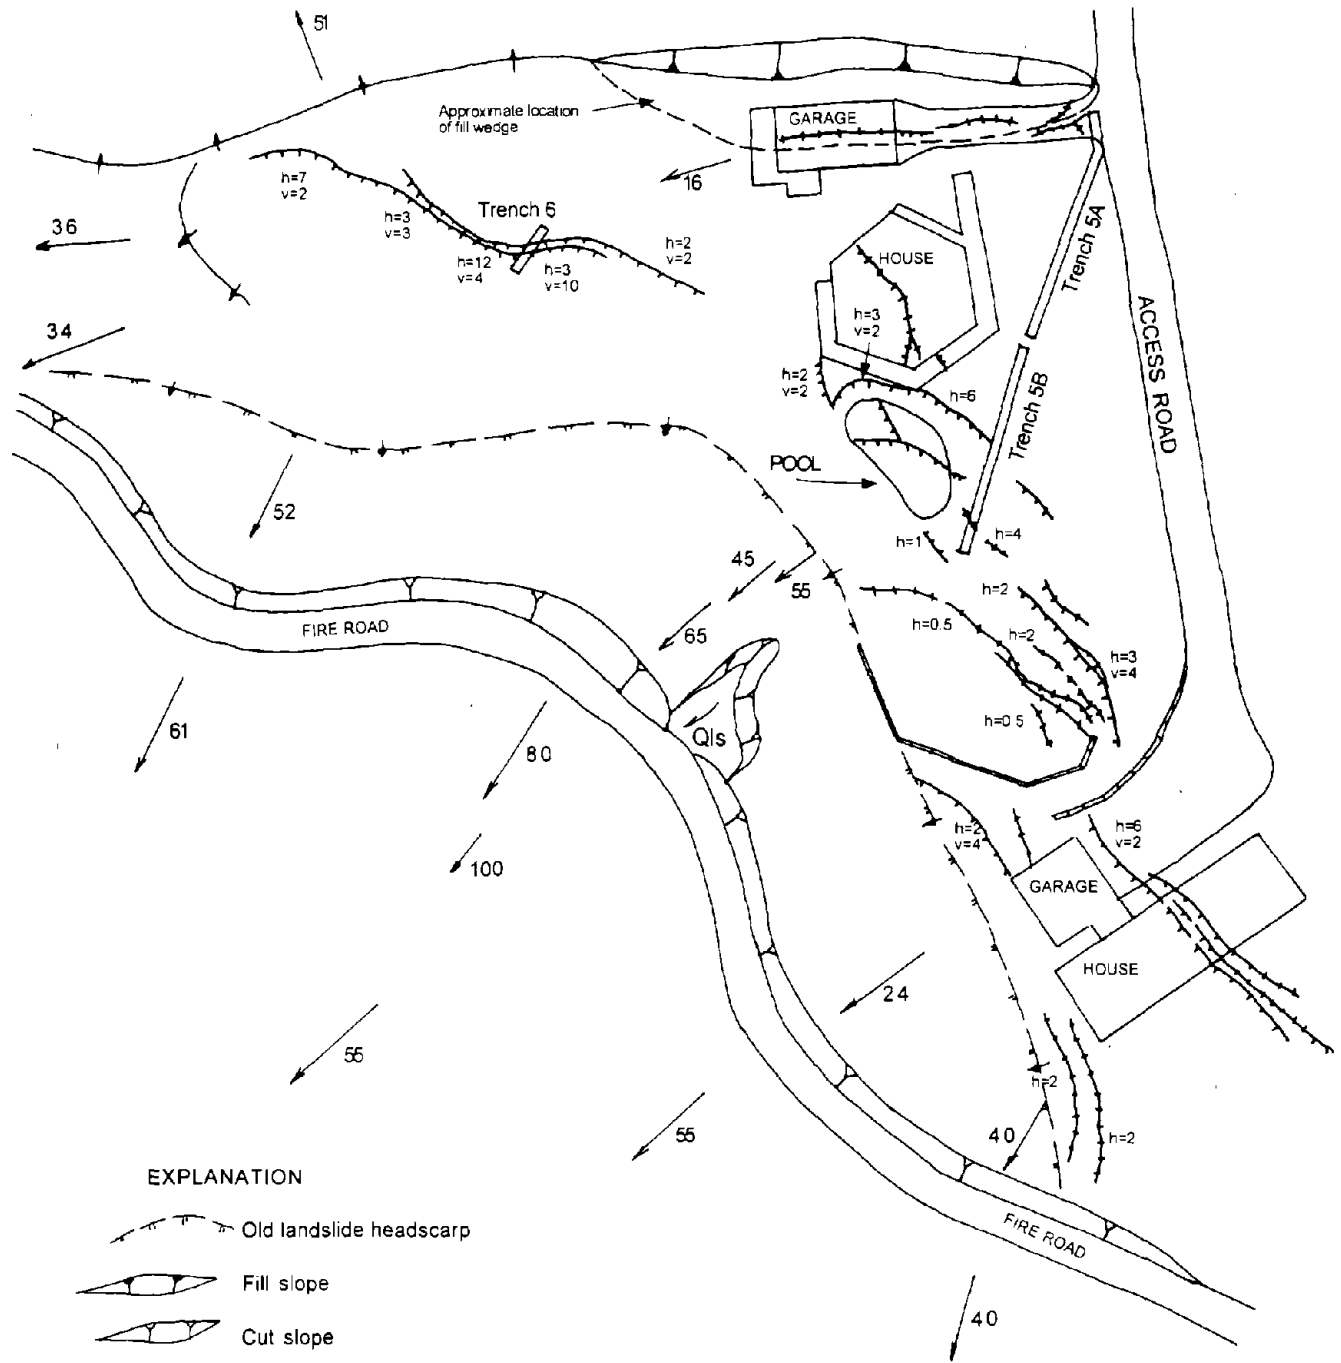
Weber and Associates (1990a) investigated the site of a single-family residence near the intersection of Summit Road and California Highway 17 (see pl. 5; loc. 20, table 2). The house and property were severely damaged by strong seismic shaking and a broad, arcuate zone of ground cracking (fig. 6). The ground cracks had extensional displacements of 3 to 30 cm and southwest-side-down vertical separations of as much as 25 cm, reflecting movement of the earth materials toward the steep-walled drainage on the southwest.

Figure 6.—Area of case history 2 (see pl. 5 for location), showing pattern and dimensions of ground cracking that occurred during 1989 Loma Prieta earthquake. Trenches across ground-cracks showed evidence for many previous episodes of ground cracking in the same places. From G.E. Weber and Associates (1990a).

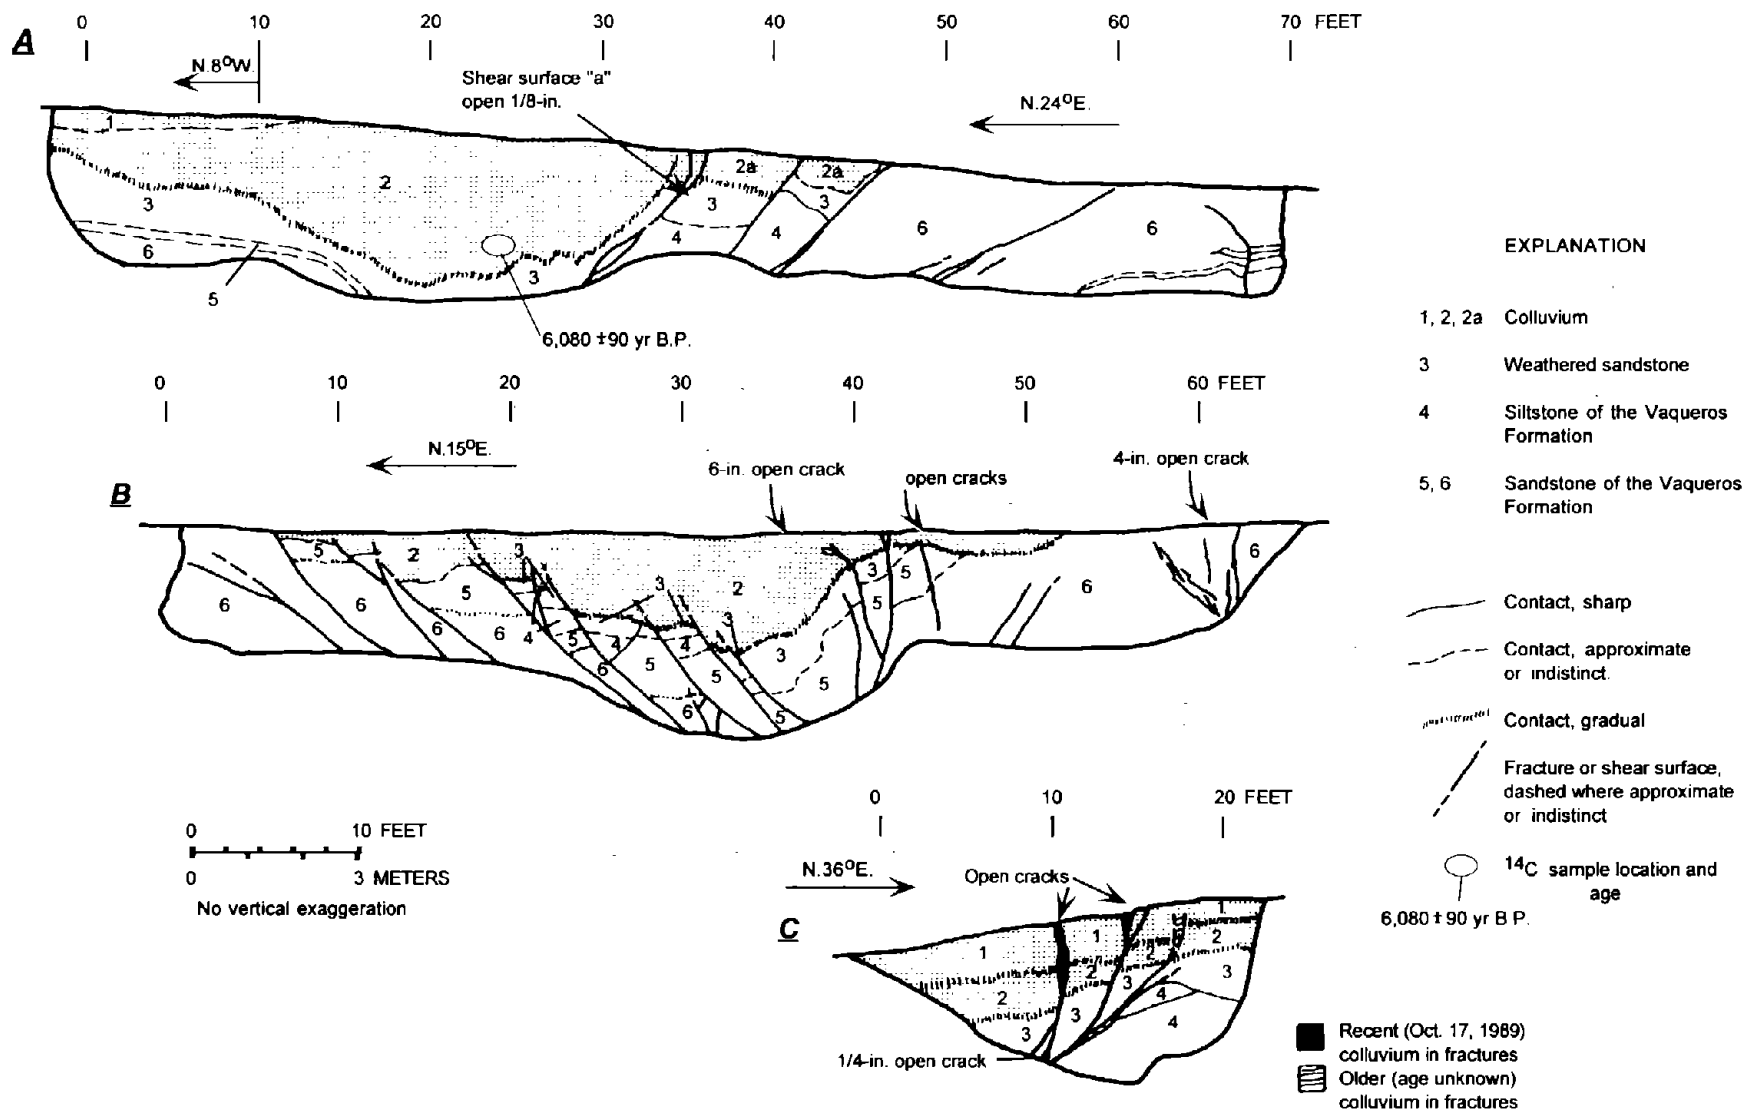
Trenches 5B and 6 (fig. 7) were excavated across the ground cracks. In trench 5B, the ground cracks coincided with a large, colluvium-filled graben formed by normal displacement on bounding slip surfaces, indicating a history of displacement at this site. Previous episodes of movement were also indicated by trench 6, where 1989 ground cracks were associated with larger displacements of bedrock stratigraphy and soil horizons, as well as older generations of infilled ground cracks (fig. 7).

In trench 5B, a 6-in.-wide ground crack at the surface could not be traced into the subsurface (fig. 7). The subsurface material here (unit 2) is a massive, very loose silty sand that evidently accommodated extension as distributed shear throughout, rather than as the single open crack seen at the surface. Similar behavior was observed in loose, granular sediment in other case-history localities. The disappearance of ground cracks, even very large ones, at shallow depth should not therefore be taken as conclusive evidence that no deeper seated failure has occurred. This point is particularly important at sites where the potential for catastrophic slope failure is being evaluated. In more cohesive materials, such as those in trench 6, surficial cracks generally persist at depth (fig. 7).

Trench 5A is a northward continuation of trench 5B (figs. 6, 7). A second colluvium-filled basin was exposed in this trench. Although no ground cracks were observed at the surface in this locality (except for a few cracks due

to fill failure under the driveway), careful inspection of slip surfaces exposed in the trench revealed 3 to 6 mm of extension across shear surface a (fig. 7) that was not visible at the surface.

Although one of the smaller ground cracks ruptured the foundation, the home on this site was destroyed primarily by seismic shaking. The ground-crack system trending through trenches 5B and 6 was considered particularly dangerous because the cracks dip toward a steep slope (50- to 80-percent gradient) and could therefore facilitate landsliding, with potentially catastrophic displacements.

Figure 7.—Logs of trenches 5A (A), 5B (B), and 6 (C) across area of major ground cracks. A, Trench 5A crosses a colluvium-filled graben that was not perceptibly reactivated in 1989. B, Trench 5B shows a second colluvium-filled graben where ground cracks cross trench, indicating many previous episodes of ground cracking in the same place. C, Trench 6 shows bedrock and soil offsets much larger than 1989 displacements, clear evidence for earlier episodes of movement. From G.E. Weber and Associates (1990a).

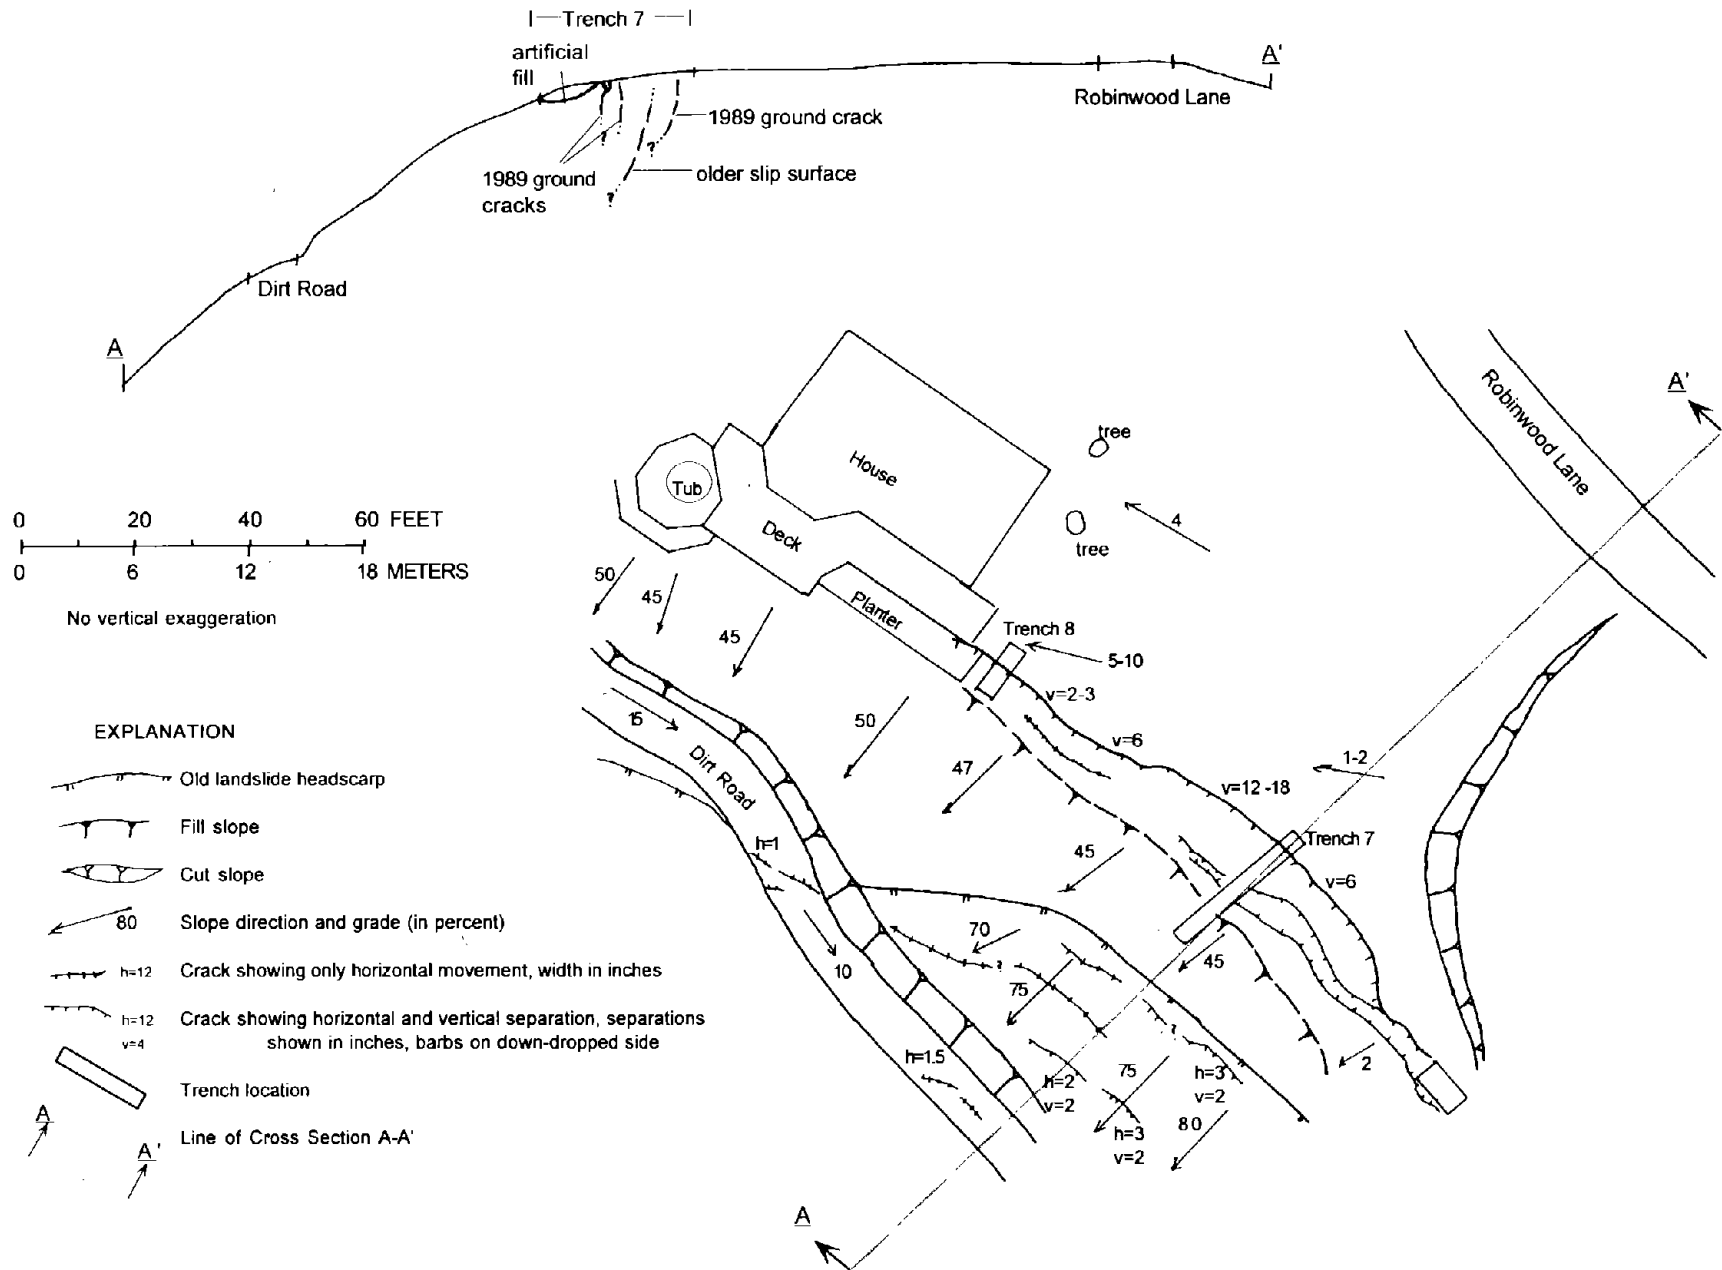
Figure 8.—Area of case history 3 (see pl. 5 for location), at the crest of a narrow, steep-sided ridge, and cross section A-A'. Ground cracking occurred continuously along crest and southwest facing flank of ridge for a distance of more than 0.5 km. A total of 12 trenches across this series of cracks revealed evidence for multiple earlier movements on 1989 ground cracks but also several previous ground cracks that were not reactivated by 1989 Loma Prieta earthquake. From G.E. Weber and Associates (1990b).

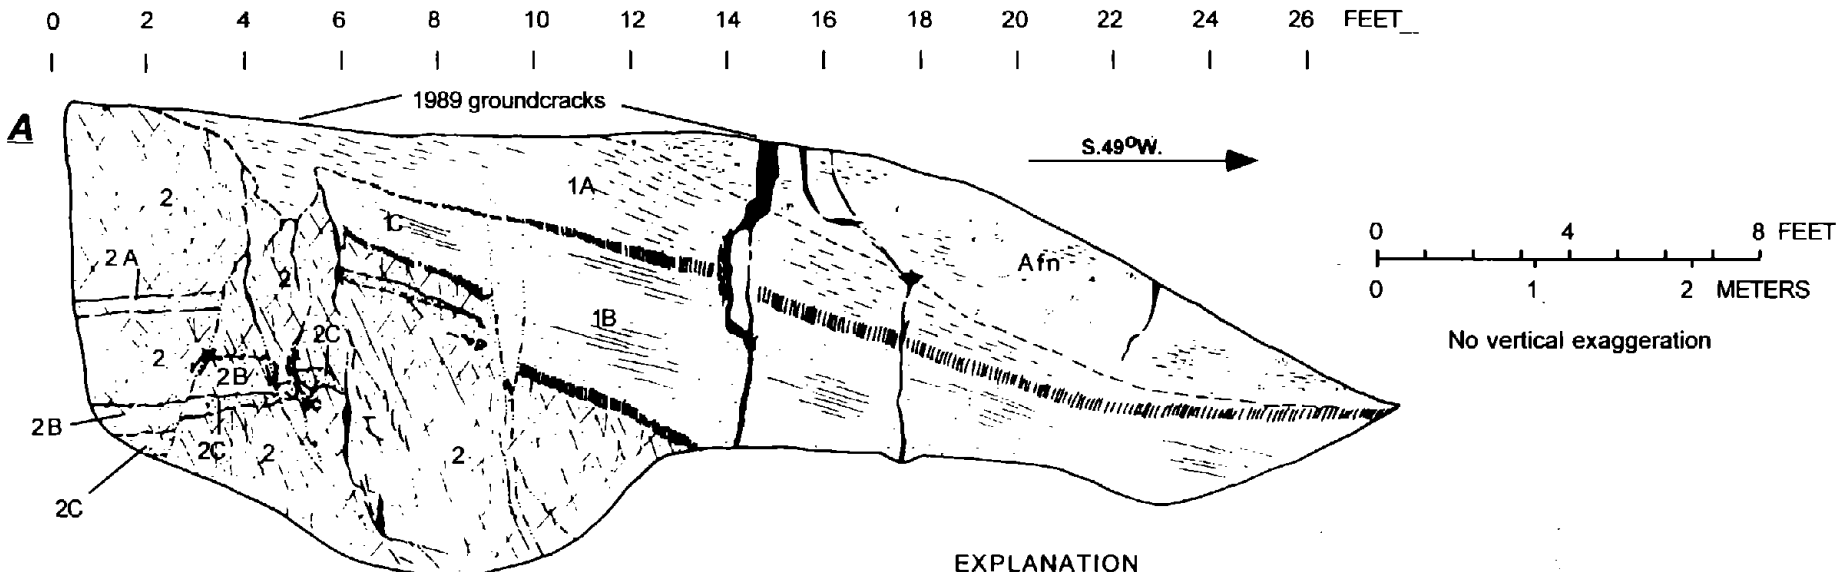
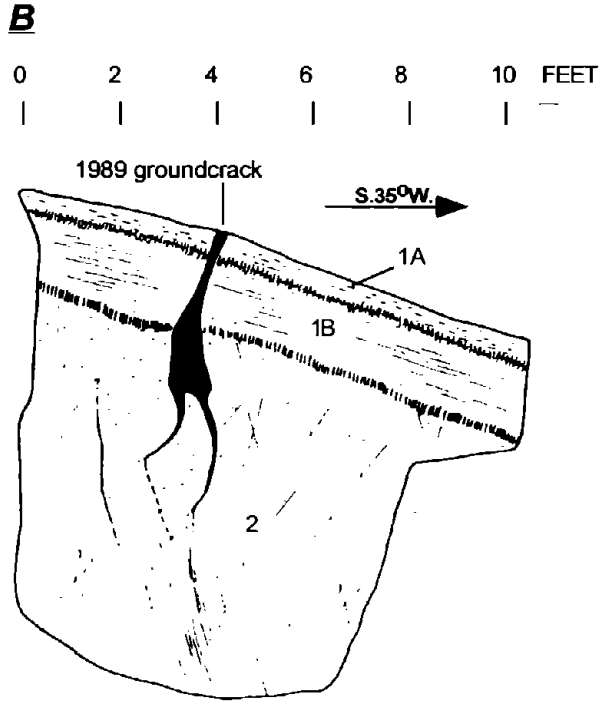
Figure 9.—Logs of trenches 7 (A) and 8 (B), showing ground cracks caused by surface-parallel slip of a relatively loose, surficial soil layer. Relatively large ground crack in trench 8 was not accompanied by evidence of pre-1989 displacements, a relatively rare observation. From G.E. Weber and Associates (1990b).

trench 7 (fig. 9) shows features associated with both types of movement. At the northeast end of the trench (near the 4-ft marker along the scale) is a zone characterized mainly by extensional deformation. The lower contact of unit 1A is not displaced across this zone but appears to be subsiding into a small graben created by extension. At the same time, several of the larger ground cracks mapped in the section curve abruptly into a ground-surface parallel orientation toward the bottom of the trench. These relations suggest formation of the graben by translation of a near-surface layer moving approximately parallel to the ground surface. Infilled older fissures show that several episodes of movement have occurred.

In contrast to this zone of extensional deformation, a large, discrete, vertical displacement of soil horizon B (units 1B, 1C) was also observed (at 8 ft along the scale). Unit 1B is a well-developed argillic horizon that was partly stripped from the footwall after being offset; unit 1C is a relict of the partly stripped soil horizon B. No movement occurred on this slip surface during the 1989 Loma Prieta earthquake.

In contrast to trench 7 and the other trenches included in the review, the crack observed in trench 8 (fig. 9) exhibits a large displacement at the surface (15 cm), yet any evidence for earlier movement would probably not have been observed, had trenching been conducted at this site before the earthquake. The slight shear fabric depicted in the trench log (fig. 9) is weakly expressed and could have formed in the most recent event. The geometry of the ground crack indicates that it results from nearly surface parallel slip (downhill translation) of the shallow weathered sandstone, rather than deep-seated offset. This type of failure appears to be associated with sites underlain by loose sand and was not observed at hard-bedrock sites. The adjacent residence was thrown off its foundation by shaking but was not damaged by ground cracking.

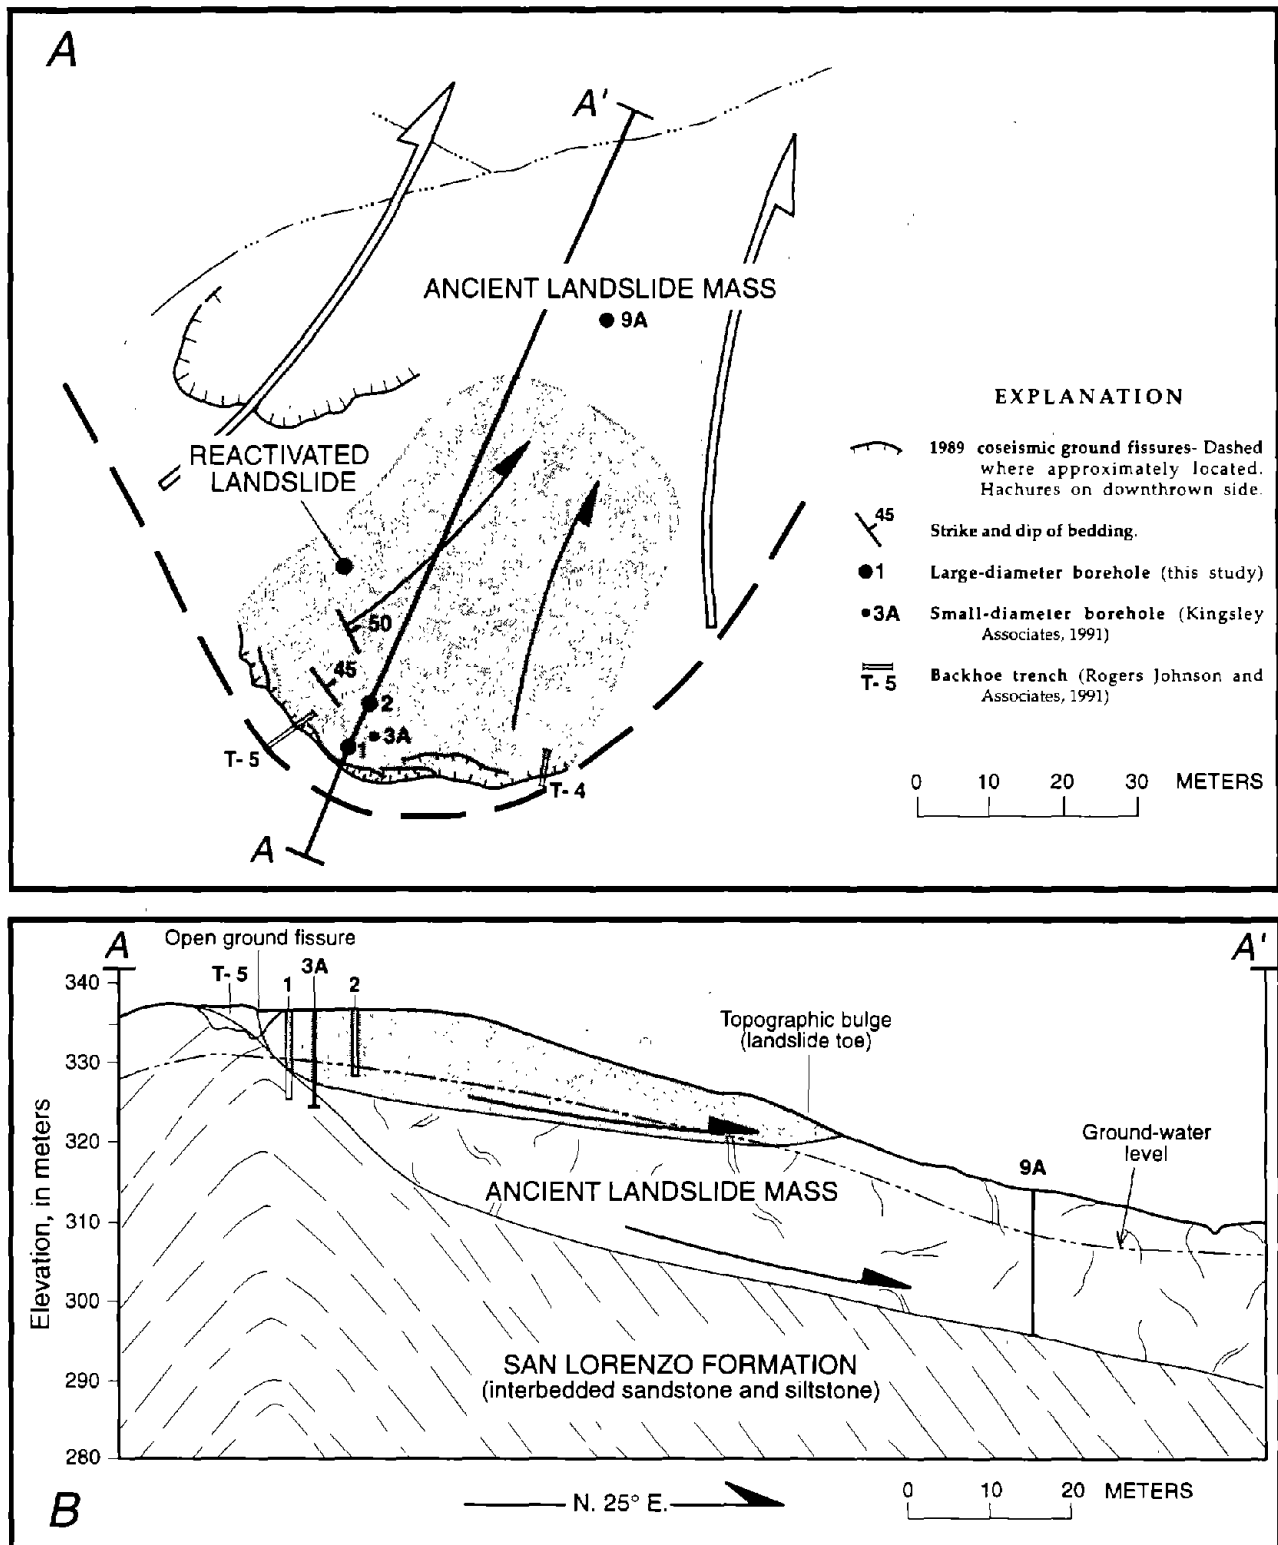
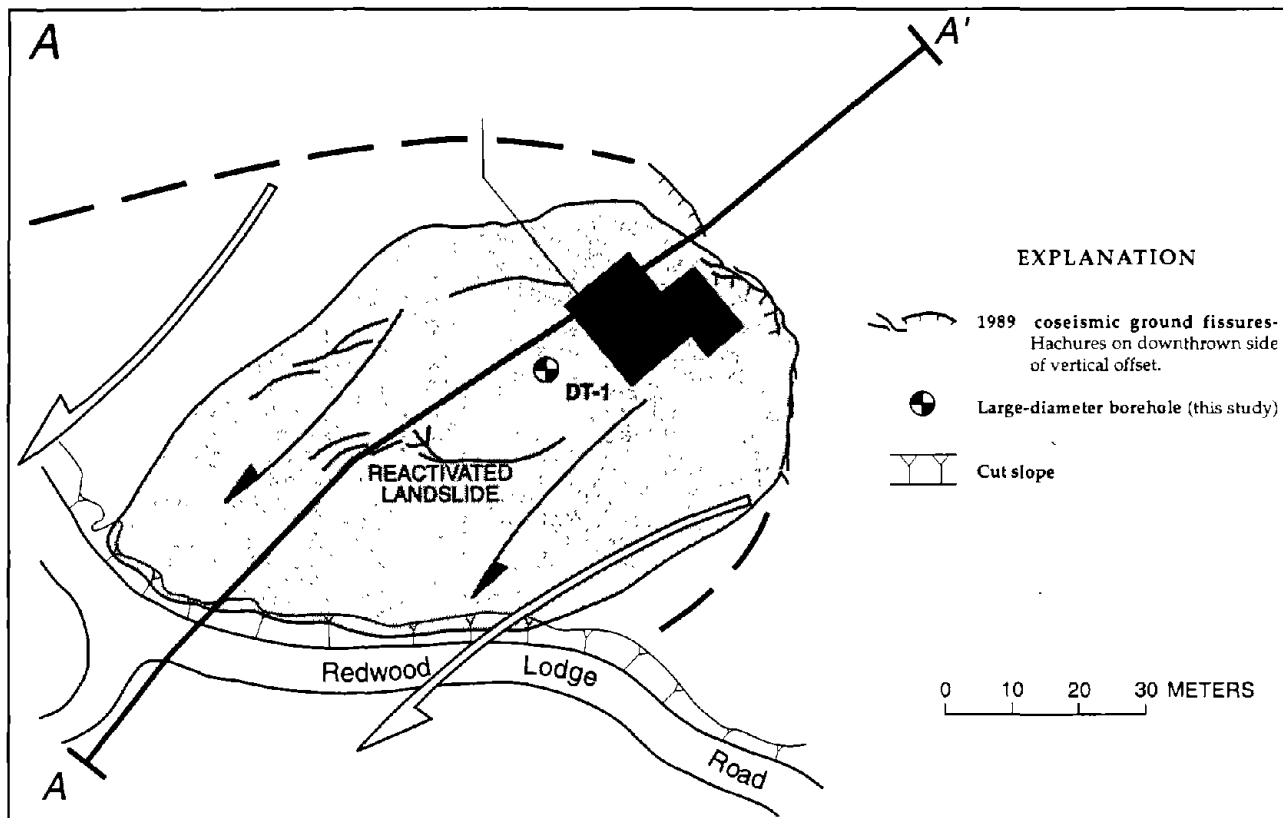
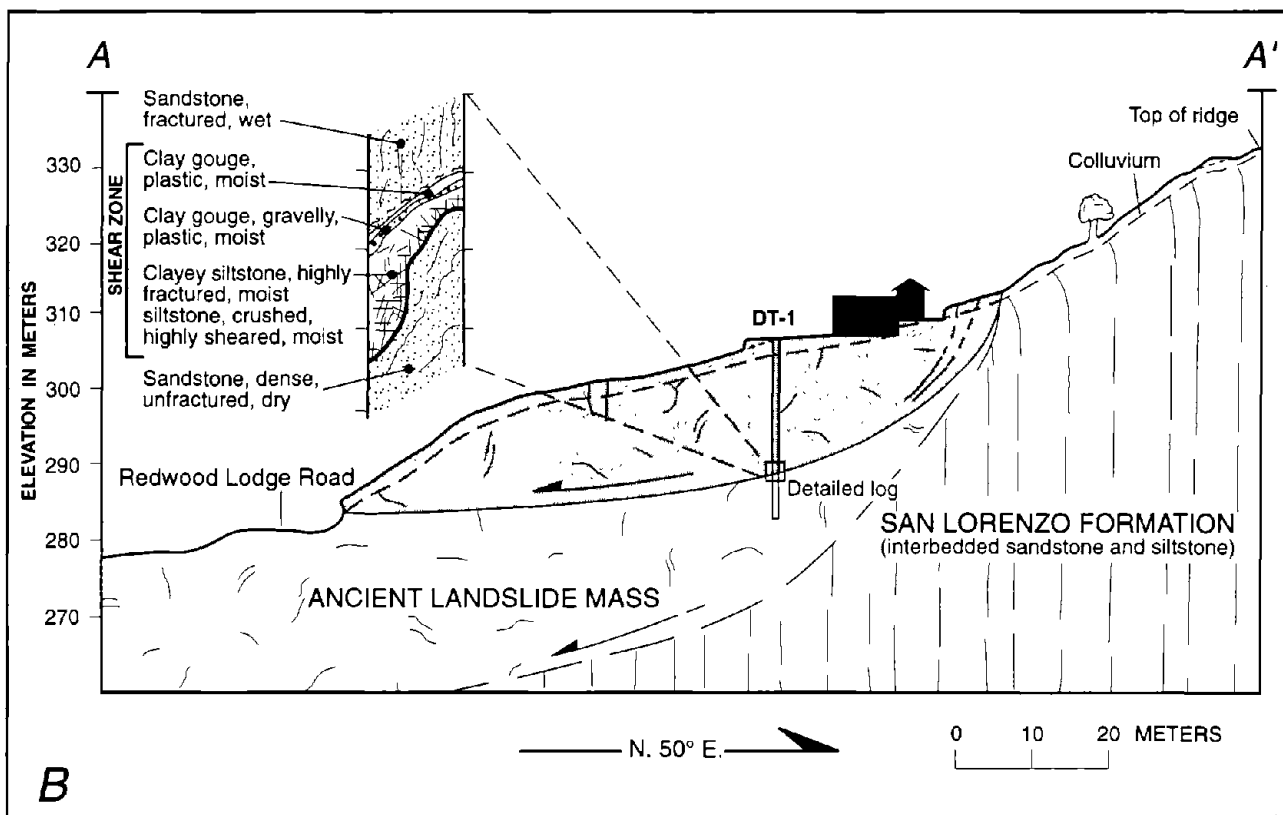
Figure 4.—Simplified geologic map (A) and cross section (B) of Ditullio landslide (see fig. 2 for location). Half-arrows indicate direction of downslope movement.

A large-diameter borehole, DT-1 (fig. 4), was located about 40 m downslope from the headscarp cracks. Borehole DT-1, which was drilled and downhole logged to 22.5-m depth, exposed a well-developed, slickensided shear surface at about 18-m depth. The gradational oxidized-unoxidized contact is at 20.7-m depth; however, oxidized sandstone bedrock immediately below the landslide plane is very dense. Figure 4, which includes a detailed log of the landslide rupture surface, illustrates the relation between the 1989 reactivation, the underlying ancient landslide material, and deeper bedrock structure.

No ground water was penetrated in borehole DT-1, even after remaining open for 12 days.

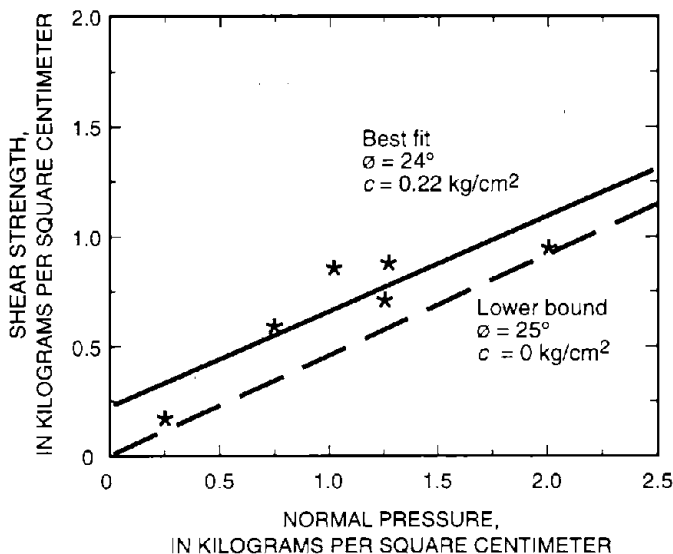
The residual shear strengths measured in direct shear tests are approximately 70 to 75 percent of the peak values. This result approximates the reduction to 80 percent of peak shear strength estimated by Makdisi and Seed (1977) and recommended by Hynes-Griffin and Franklin (1984), owing to cyclic-loading effects. Therefore, we used the residual shear strengths to characterize the cyclic strength of the basal rupture surfaces. Two measures of residual shear strength, lower-bound and average or "best fit" curves, were drawn by linear regression through the data points (fig. 6). The shear-strength parameters, in terms of angle of internal friction ( $\phi$ ) and cohesion ( $c$ ), that describe the lower-bound and best-fit values are  $\phi=25^\circ$ ,  $c=0$  kg/cm<sup>2</sup> and  $\phi=24^\circ$ ,  $c=0.22$  kg/cm<sup>2</sup>, respectively.

Figure 6.—Residual shear strength versus normal pressure in laboratory consolidated-undrained tests on landslide rupture surface material.

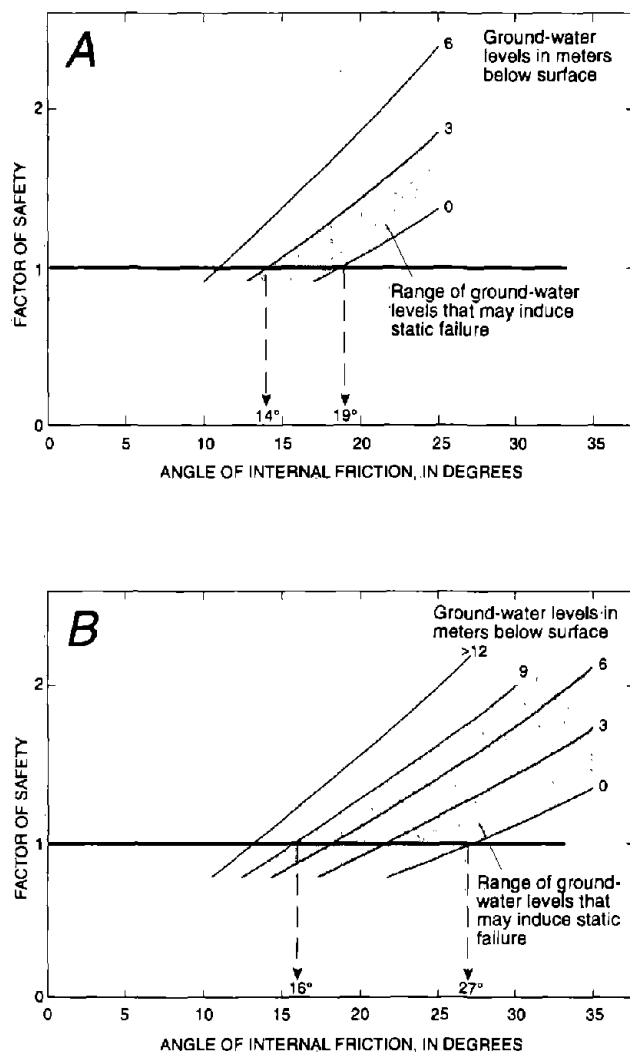
Figure 7.—Factor of safety versus shear strength (expressed as angle of internal friction) at various ground-water levels in Lower Schultheis Road West (A) and Ditullio (B) landslides (see fig. 2 for locations).

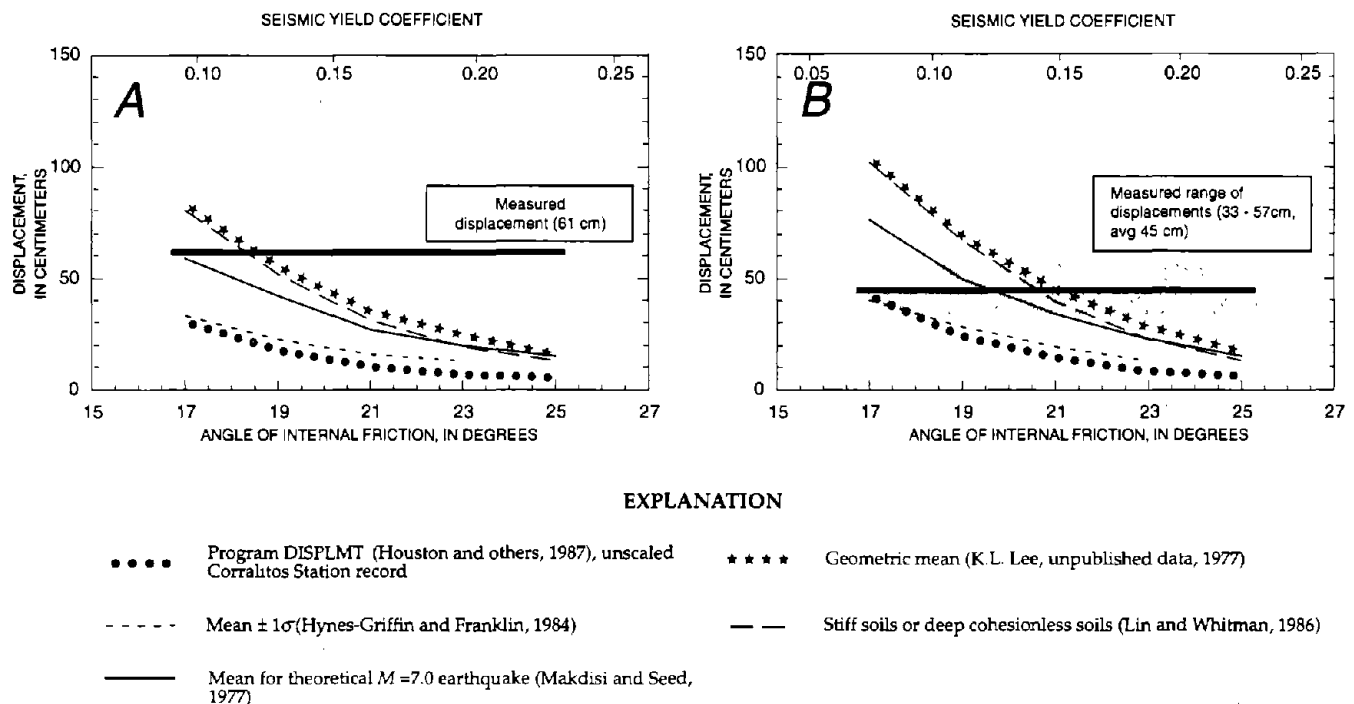
Figure 9.—Predicted displacement versus shear strength (expressed as angle of internal friction) calculated by five cumulative-displacement methods, using peak horizontal ground acceleration of 0.63 g from station at Corralitos (see fig. 1 for location). A, Lower Schultheis Road West landslide. B, Ditullio landslide.

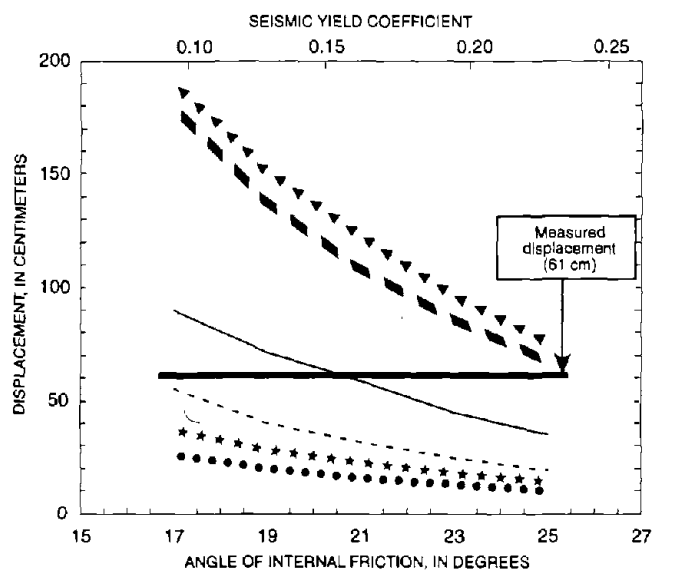
The displacements that can be calculated for an  $M=7.0$  earthquake, using the three curves of Makdisi and Seed (1977) and Hynes-Griffin and Franklin (1984) for the Lower Schultheis Road West landslide, are plotted in figure 10. Because of the bilateral rupture, the 1989 Loma Prieta earthquake was of considerably shorter duration than most other earthquakes of similar magnitude. Therefore, we might expect the measured displacements to fall in the lower part of the range of calculated displacements. Figure 10 shows, however, that they do so only for the smallest  $\phi$  values. If we assume that the appropriate  $\phi$  value should be about  $21^\circ$ , then the measured displacements fall in the middle of the range of displacements in the data sets of both Makdisi and Seed (1977) and Hynes-Griffin and Franklin (1984).

Figure 10.—Predicted displacement versus shear strength (expressed as angle of internal friction) calculated by two cumulative-displacement methods for Lower Schultheis Road West landslide (see fig. 2 for location).
