## Repair/Upgrade Procedures for Welded Beam to Column Connections

PEER  
98/03  
MAY 1998

Report No. PEER-98/03  
Pacific Earthquake Engineering Research Center  
College of Engineering  
University of California, Berkeley  
May 1998

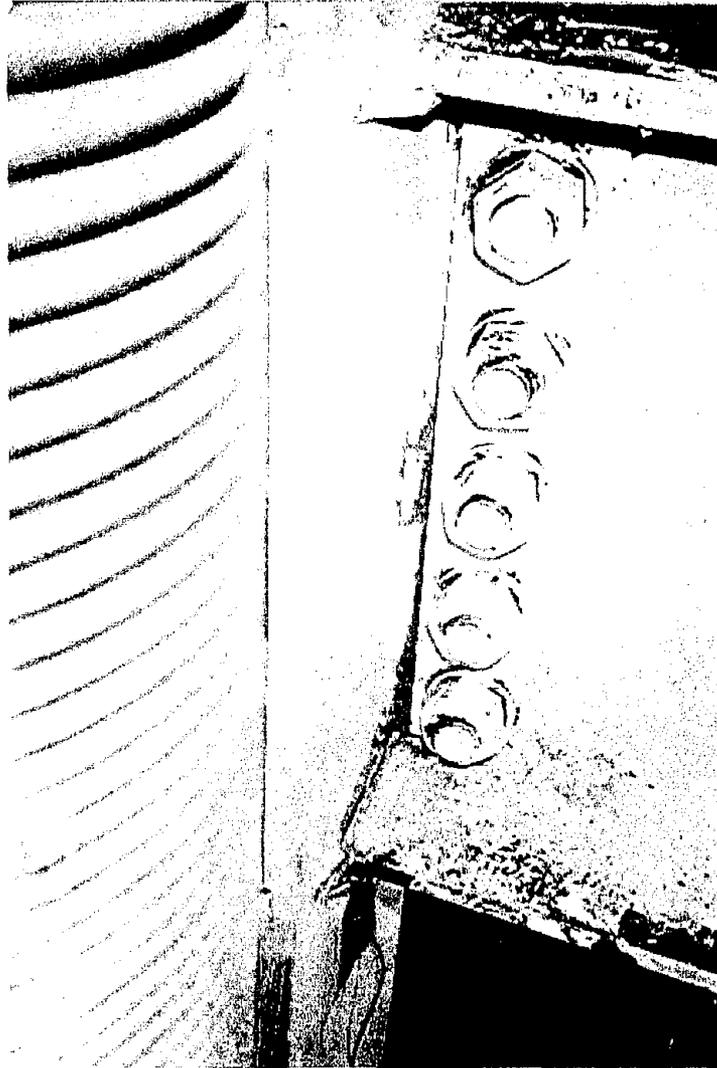
Figure 4.1.4 Bottom Flange Pullout, Sec. 1

The specimen sustained three displacement cycles at each amplitude of 1/2 inch, 1 inch and 1 1/4 inches. On the third cycle at a displacement amplitude of 1 1/2 inches, the specimen experienced a pullout at the bottom beam flange (**Figure 4.1.4**) during an upward stroke of the hydraulic cylinder. This type of failure is similar to those experienced by many welded moment frames during the Northridge earthquake. The test was stopped at this point so that the specimen would not be damaged beyond repair.

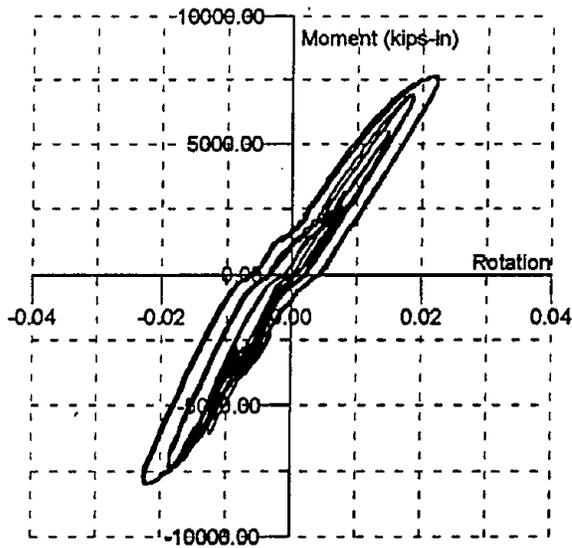
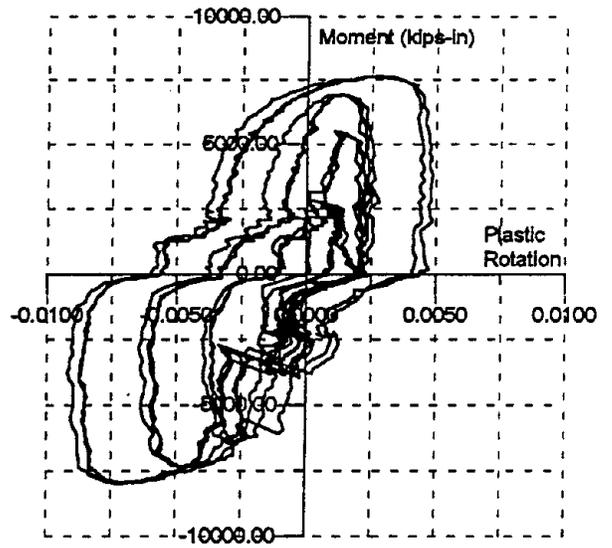
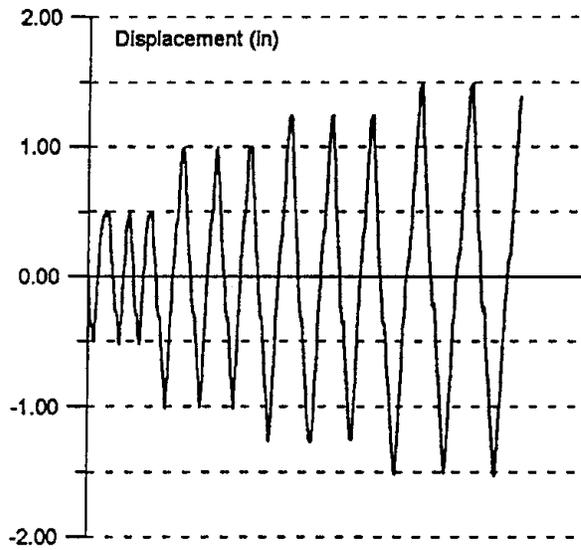
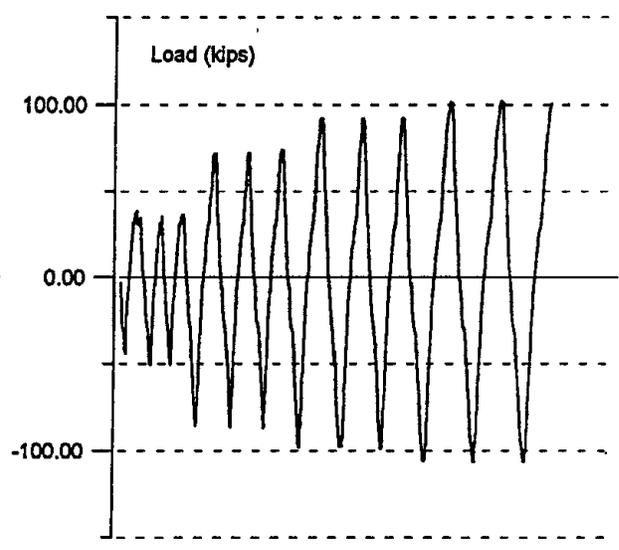
Figure 4.1.5 Cyclic Behavior, Spec. 1

The cyclic performance of the specimen is summarized in **Figure 4.1.5**. The total rotation was 2.3 percent (**Figure 4.1.5a**), however, the plastic rotation was only 0.5 percent (**Figure 1.5b**). The displacement history, shown in **Figure 4.1.5c**, indicates the nine displacement cycles the specimen was able to sustain. The history of the force at the beam tip, shown in **Figure 4.1.5d**, indicates that there was no unloading of the specimen prior to failure suggesting a sudden type of pullout. At a tip displacement of 1 1/2 inches, the finite element analysis estimated a force of 108 kips (**Figure 4.1.1**). This agrees very well with the 108 kips measured at the beam tip (**Figure 4.1.5d**).

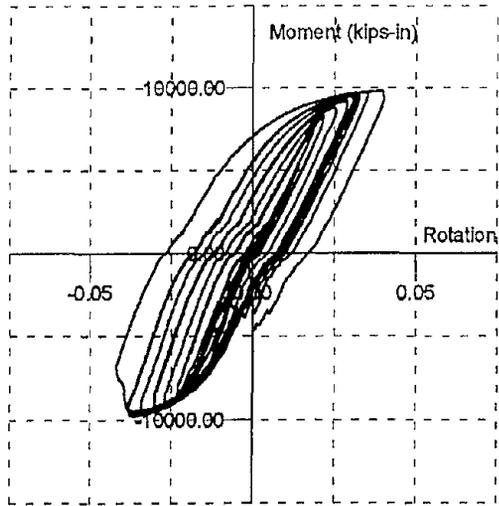
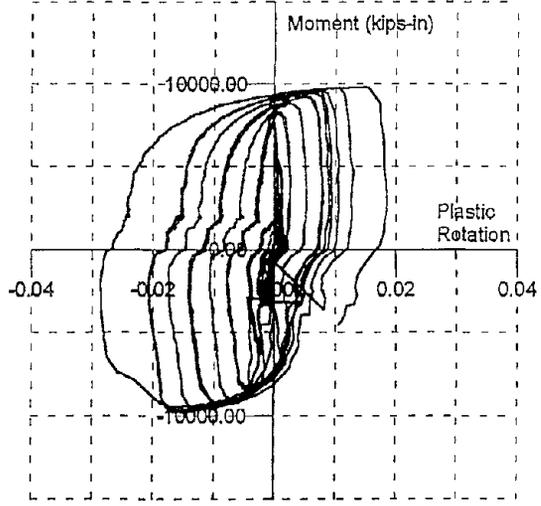
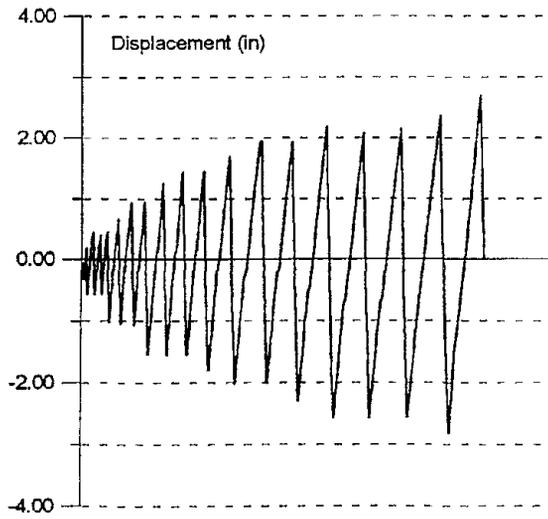
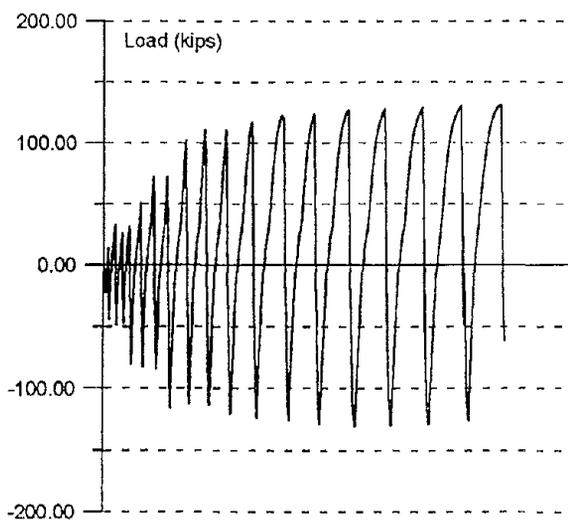
Figure 4.2.3 Cyclic Behavior, Spec. 1R

The cyclic behavior of the specimen after repair is summarized in **Figure 4.2.3**. It can be seen that there is a significant increase in the deformation capacity of the connection. The connection was able to sustain 17 cycles of increasing displacement (**Figure 4.2.3c**) and developed a total rotation of 4.0% (**Figure 4.2.3a**). However, the plastic rotation increased to only 1.5% (**Figure 4.2.3b**), which is still not considered to be adequate. No unloading of the specimen occurred prior to failure (**Figure 4.2.3d**). Failure occurred when a crack opened in the top beam flange (**Figure 4.2.4**). It can be seen that the crack appears to have started in the web cope and then propagated across the beam flange. Whitewash on the beam indicated the formation of a plastic hinge as shown in **Figure 4.2.5**. On the last full cycle, prior to failure, both the top and bottom beam flanges buckled. The moment capacity was increased by 33%.

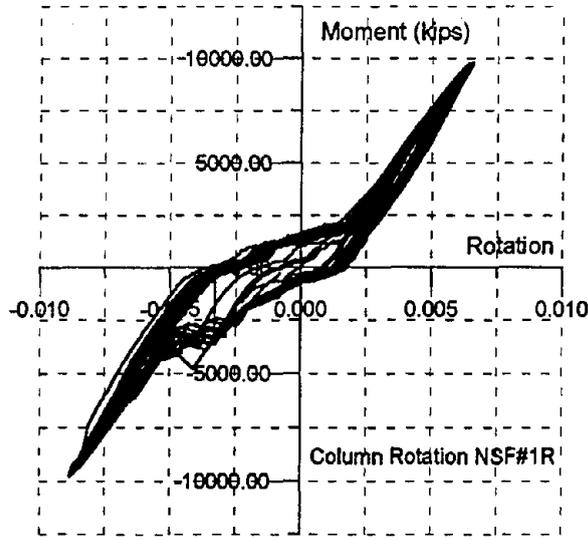
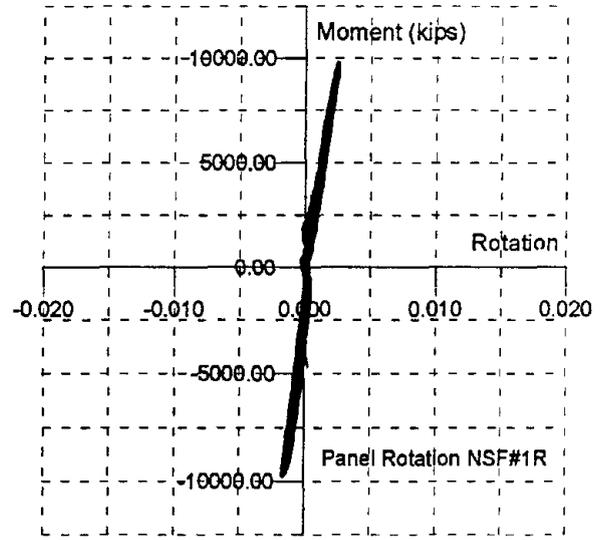
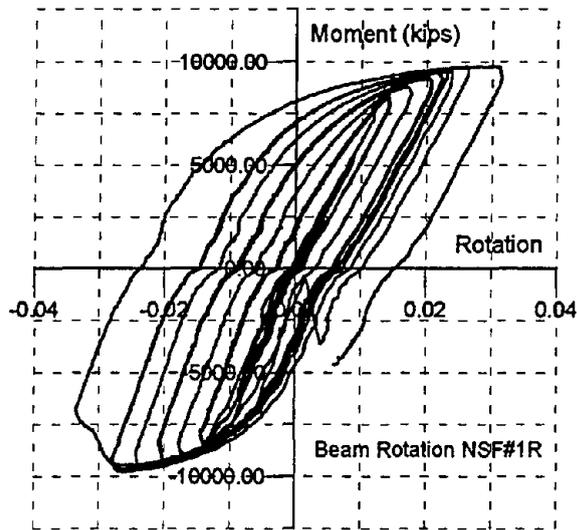
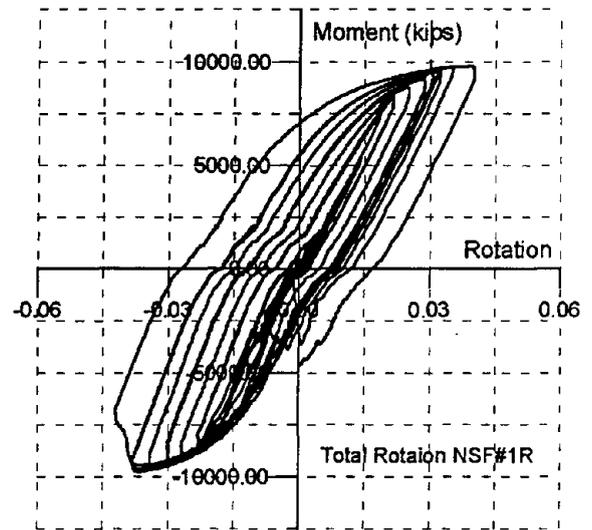
Figure 4.2.6 Rotation Components, Spec. 1R

The rotation components for the repaired specimen are shown in **Figure 4.2.6**. This figure indicates that the panel zone rotation is .25%, the column rotation is .62% and the beam rotation is 3.12% for a total of 4.0%. Since the panel zone remained elastic during the initial test, it was possible to measure strains at this location during the test in

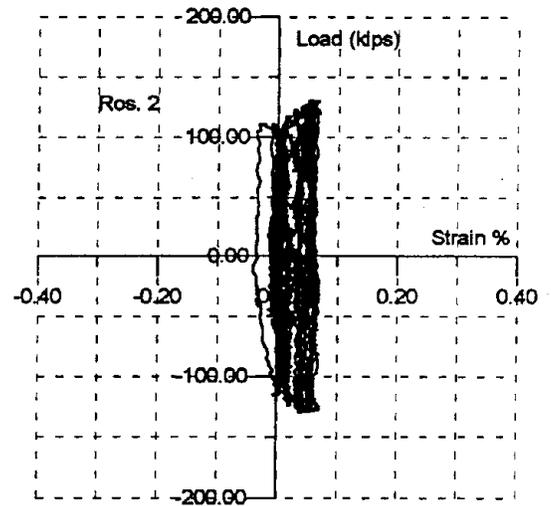
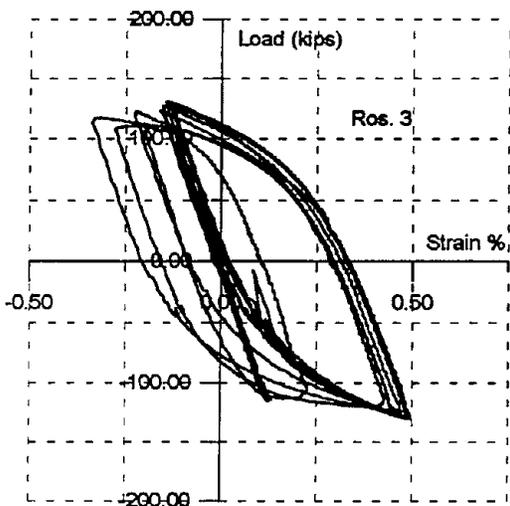
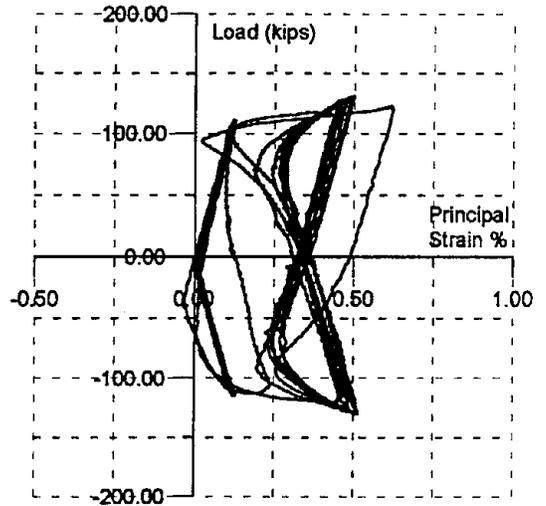
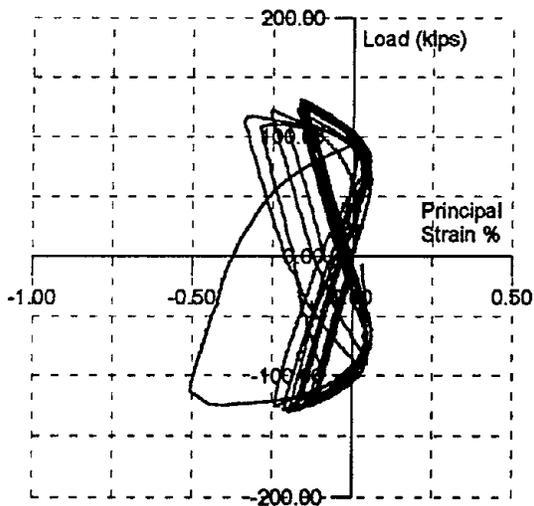
the repaired condition (**Figure 4.2.7**). Strain measurements indicate that yielding occurred in the panel zone with strains reaching 0.5%.

Figure 4.2.7 Panel Zone Strains, Spec. 1R

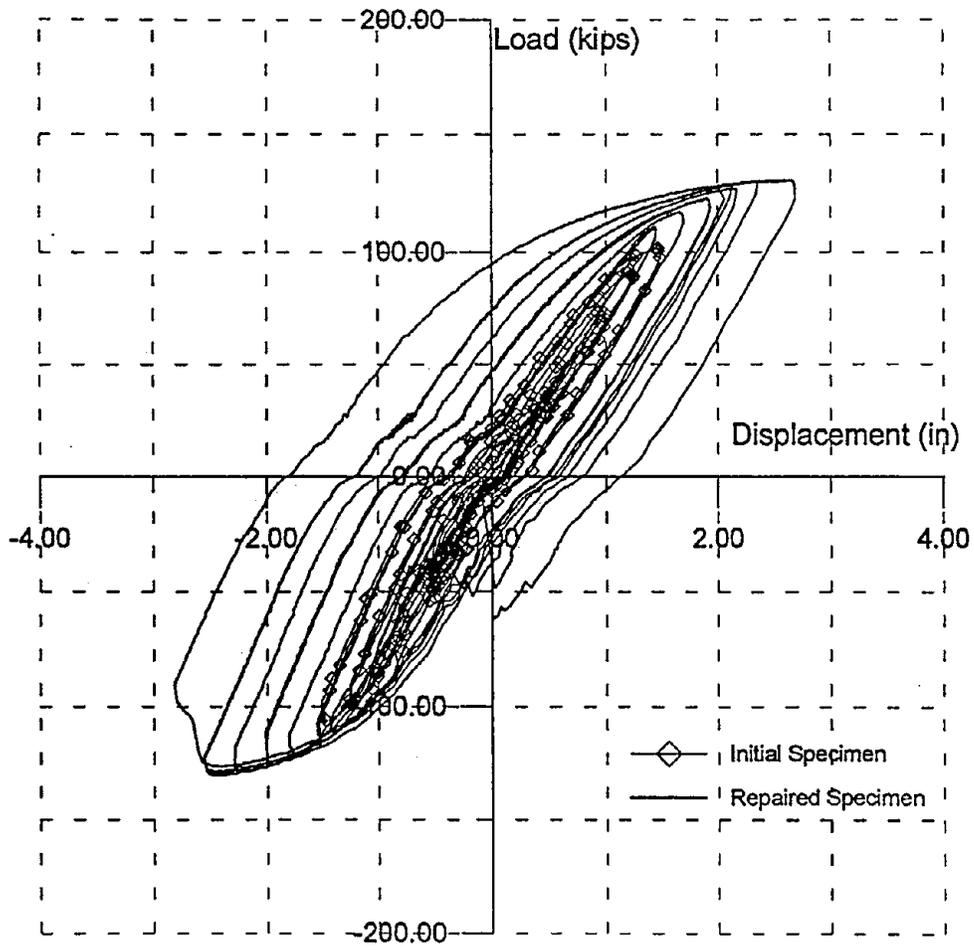
Note that the weld at the top beam flange was made using FCAW with E70T-4 wire and the one at the bottom was made using SMAW with E7018 electrode. Plots of the load versus displacement hysteresis for the original test and for the repair test are compared in **Figure 4.2.8**. This result tends to imply that if the welds on the "standard connection" are done properly and the back-up bar is removed and replaced by a reinforcing fillet weld, the connection will perform in a reasonable manner, at least for the smaller sections considered in this study.

Figure 4.2.8 Comparative Hysteretic Behavior (1 & 1R)

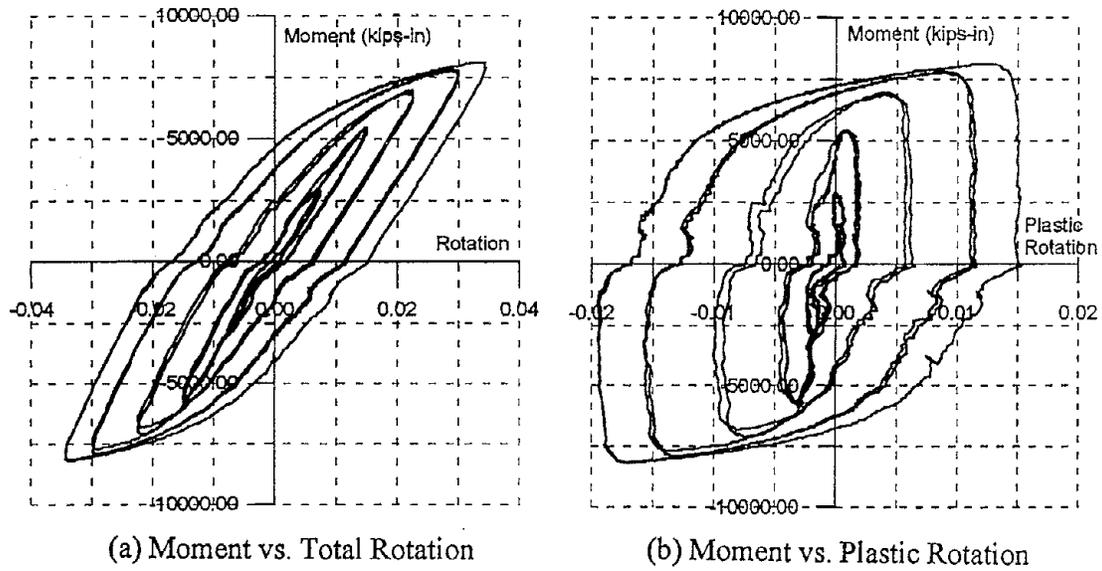
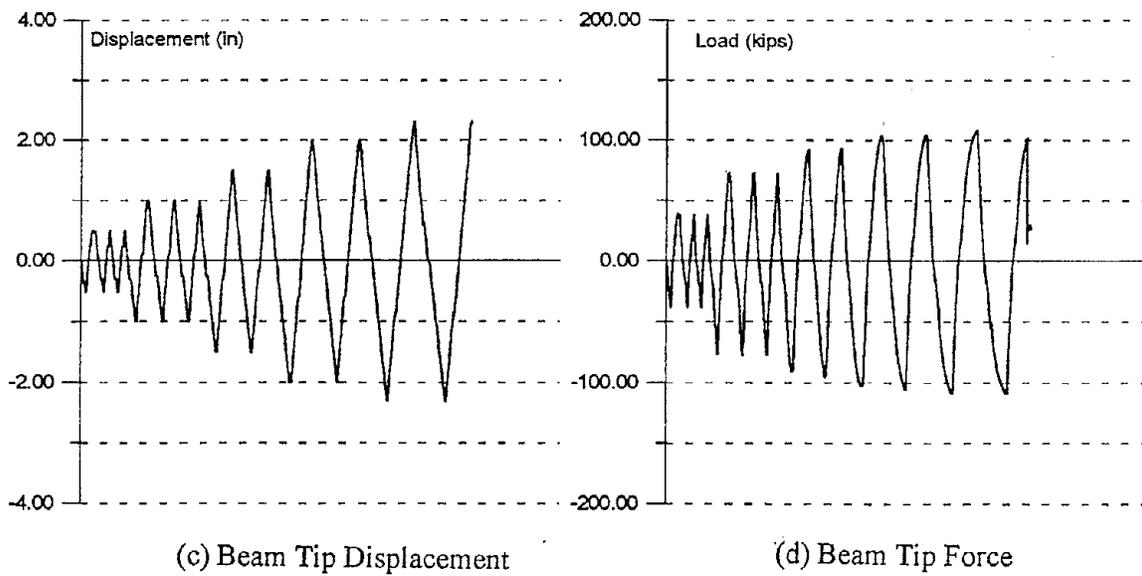
The cyclic performance of the specimen is shown in **Figure 4.3.4**. The specimen was only able to sustain 11 cycles of increasing displacement as shown in **Figure 4.3.4c**, reaching a maximum displacement of 2 1/4 inches which is representative of a total rotation of 3.4 percent (**Figure 4.3.4a**). The plastic rotation was approximately 1.52 percent as shown in **Figure 4.3.4b**. The history of the load at the beam tip, shown in **Figure 4.3.4d** indicates there was no unloading of the specimen prior to failure.

Figure 4.3.4 Cyclic Behavior, Spec. 2

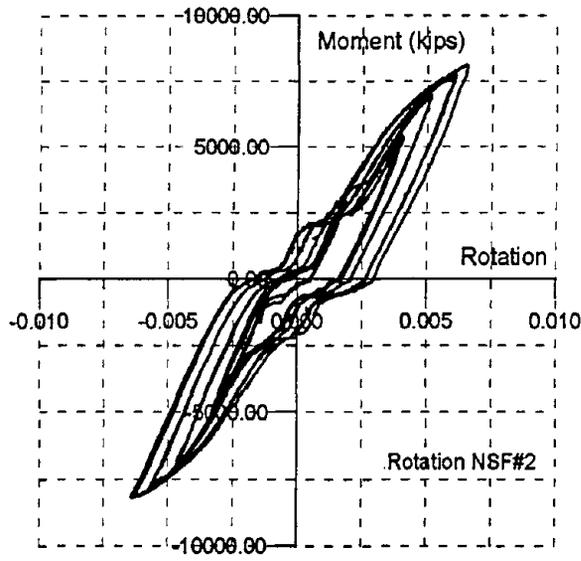
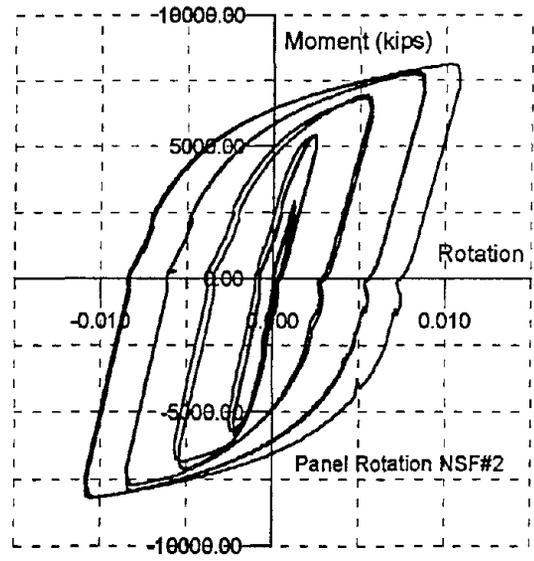
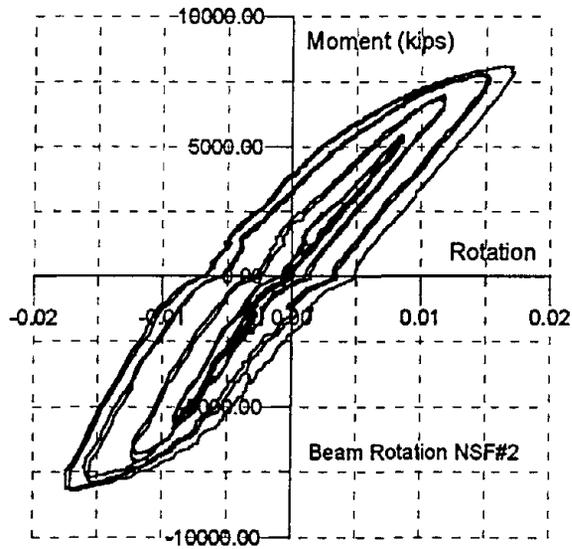
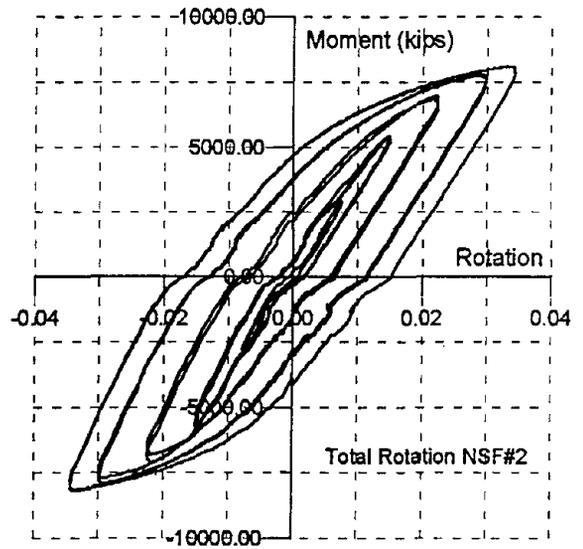
Figure 4.3.5 Rotation Components, Spec. 2

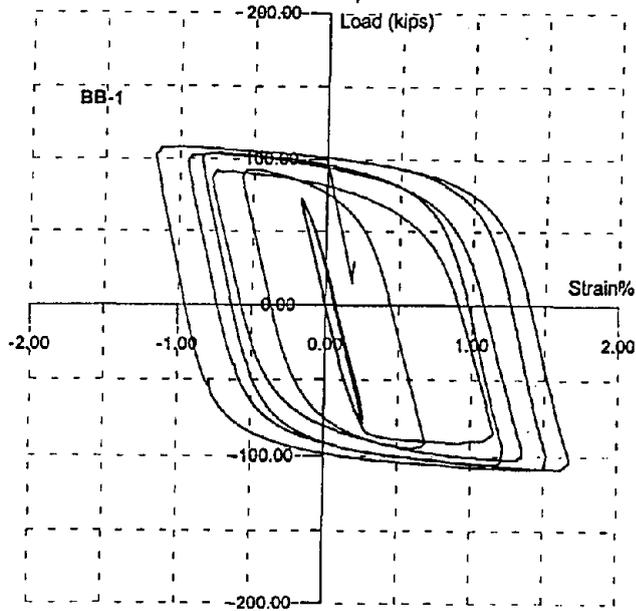
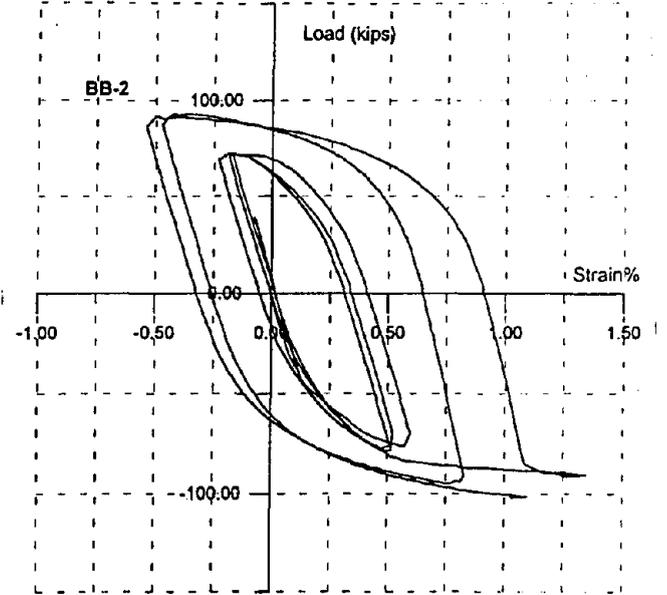
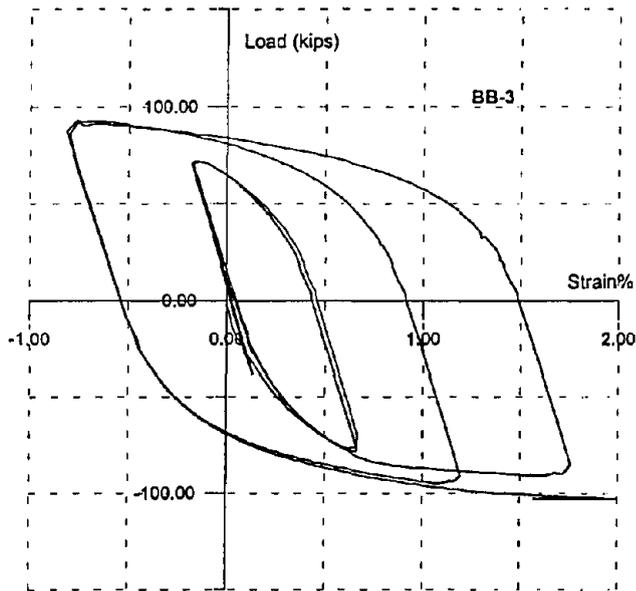
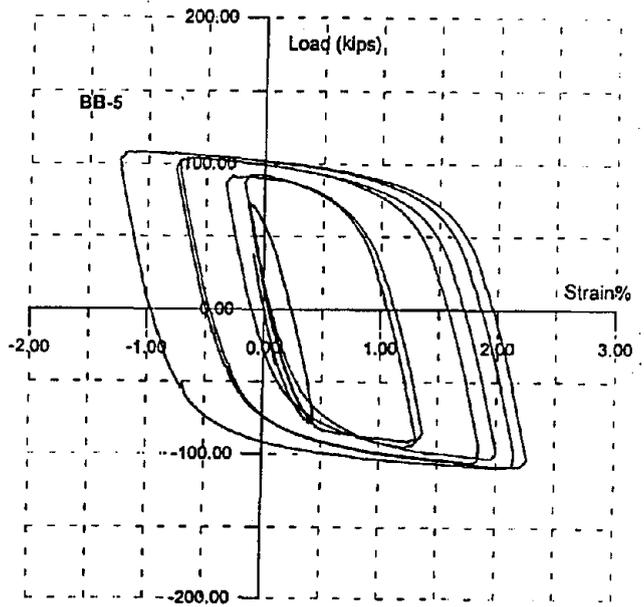
Figure 4.3.6 Beam Bottom Flange Strains, Spec. 2

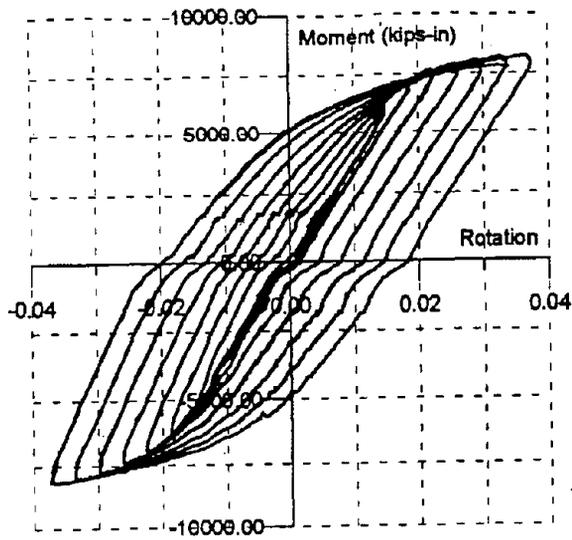
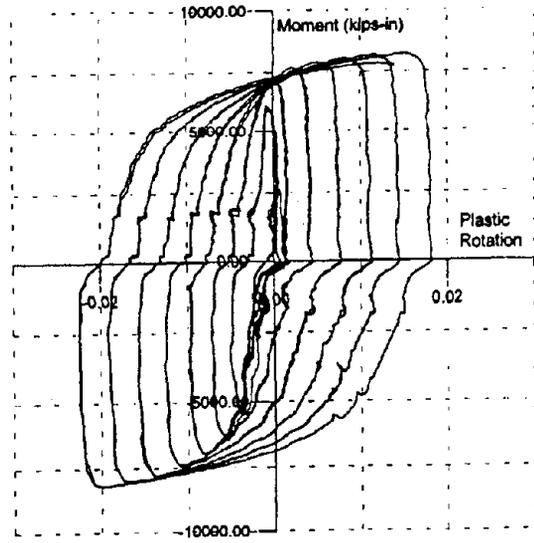
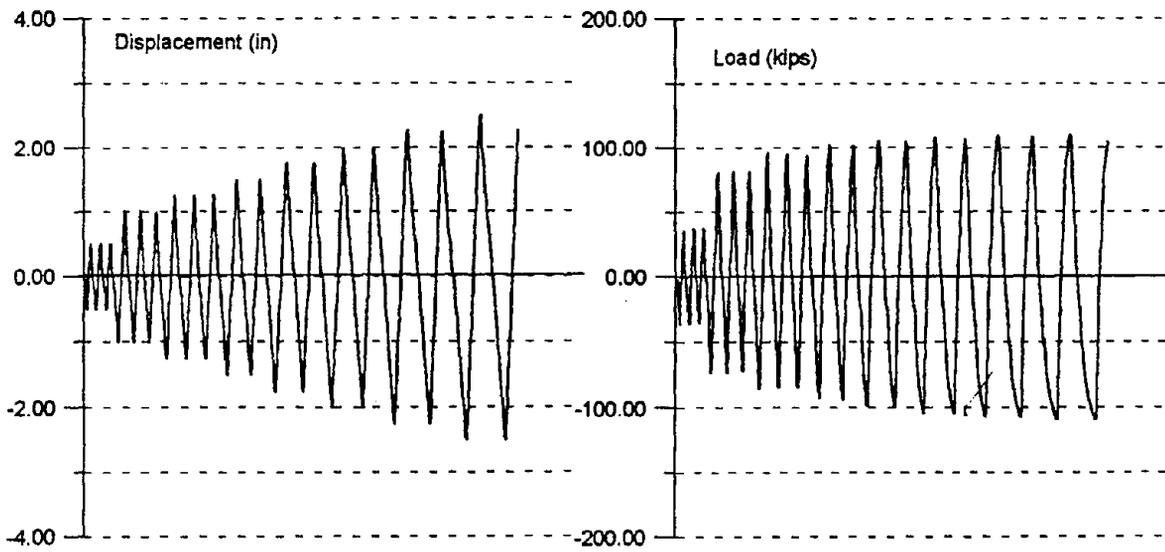
The cyclic performance is summarized in **Figure 4.4.4**. The specimen was able to sustain 18 cycles of increasing displacement prior to failure (**Figure 4.4.4c**). The total rotation capacity was 3.7% (**Figure 4.4.4a**) of which 2.4% was plastic rotation as shown in **Figure 2.8b**. As indicated in **Figure 4.4.4d**, there no unloading of the specimen prior to failure. The rotation components, shown in **Figure 4.4.5**, indicate that the column rotation was .8%, the panel zone rotation was 1.3% and the beam rotation was 1.6% for a total of 3.7%. Plots of the load versus displacement hysteresis for the original test (#2) and for the repair test (#2R) are compared in **Figure 4.4.6**. Here it can be seen that the capacity of the repaired specimen is equal to that of the initial specimen.

Figure 4.4.4 Cyclic Behavior, Spec. 2R

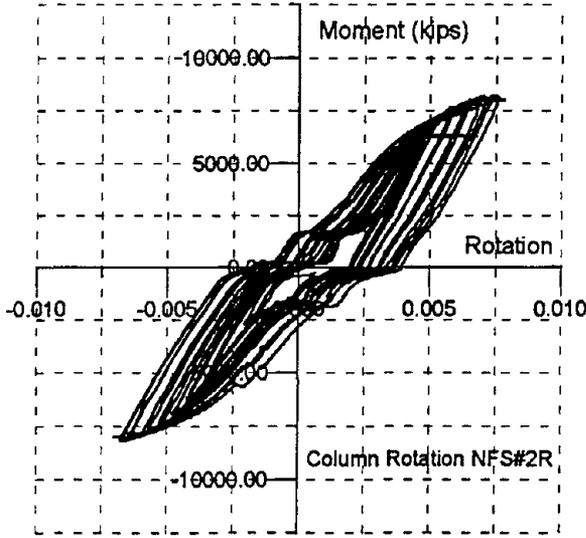
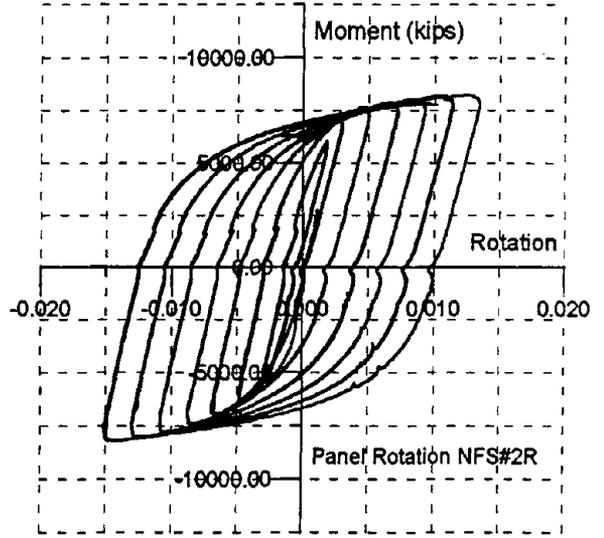
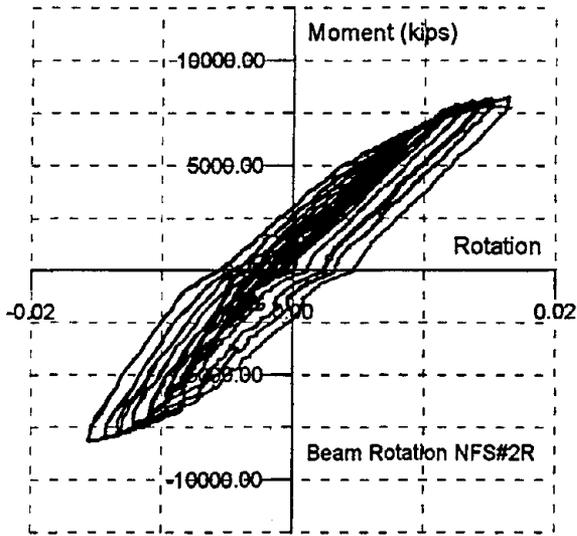
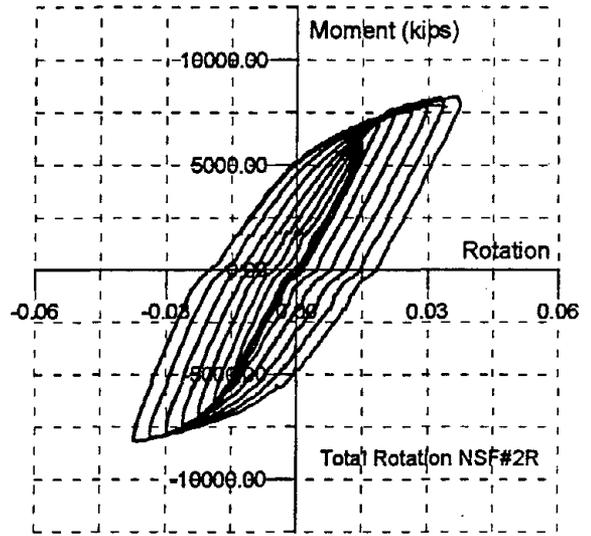
Figure 4.4.5 Rotation Components, Spec. 2R

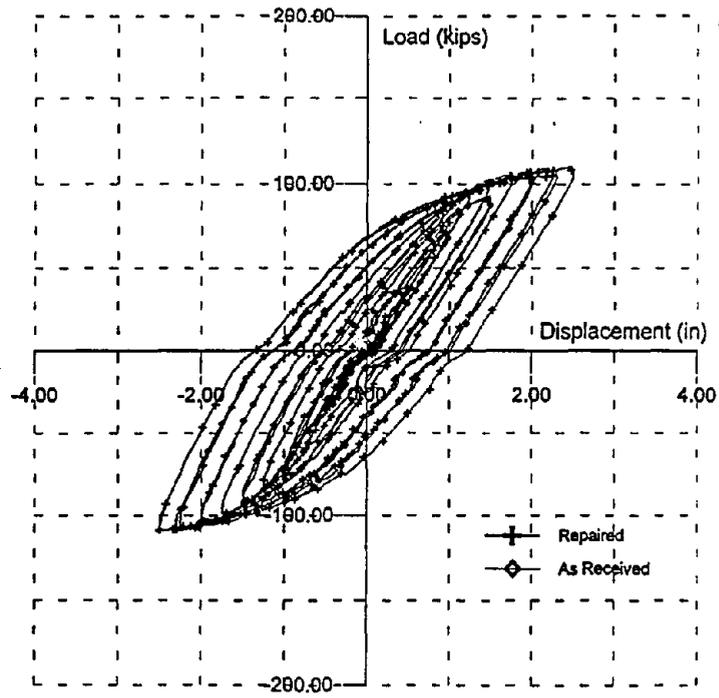
Figure 4.4.6 Comparative Hysteretic Behavior (2 & 2R)

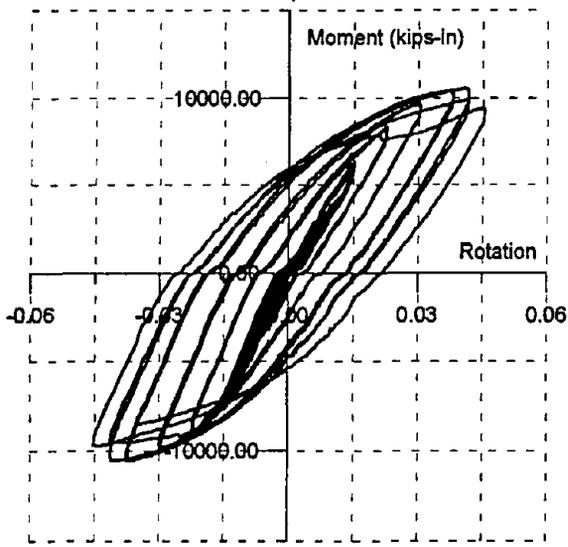
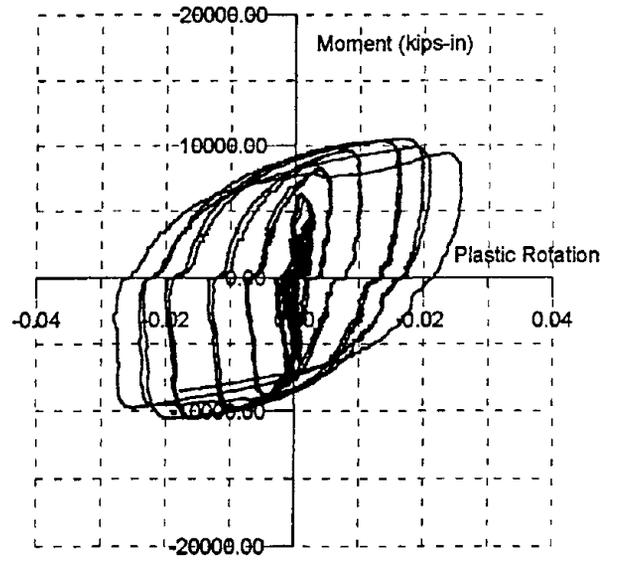
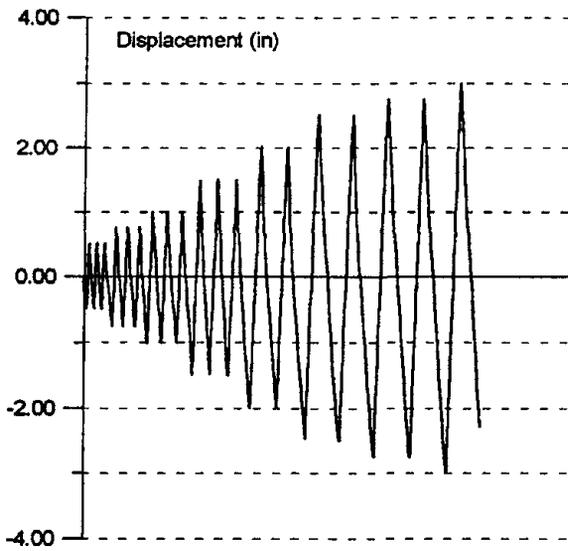
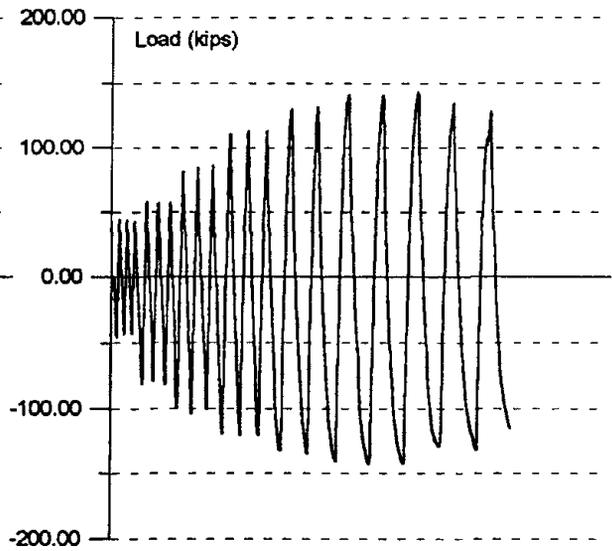
The cyclic behavior of the specimen is summarized in **Figure 5.1.7**. The plot of moment versus rotation (**Figure 5.1.7a**) indicates a total rotation capacity of 4.5 percent with plastic rotation of 2.5 percent as shown in **Figure 5.1.7b**. The displacement history, **Figure 5.1.7c**, indicates that the specimen was capable of sustaining 18 cycles of increasing displacement, reaching a maximum displacement of 3 inches. The load history,

Figure 5.1.7 Cyclic Behavior, Spec. 3

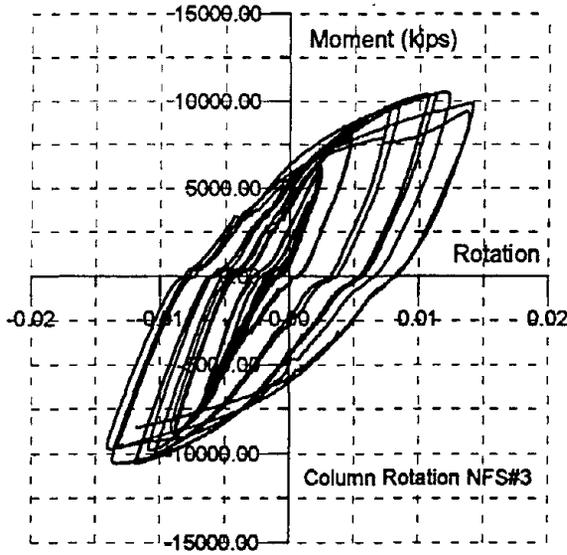
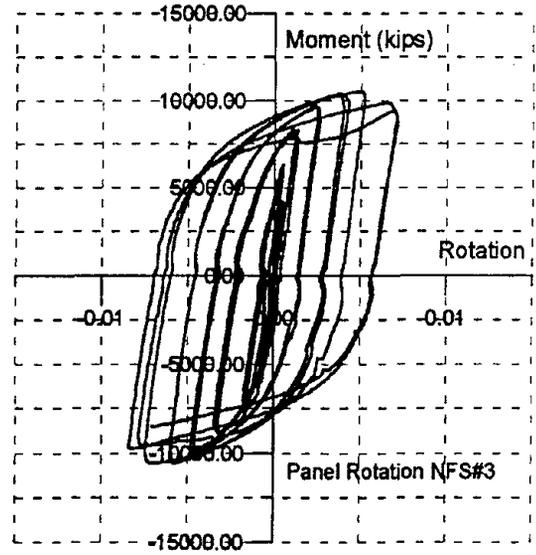
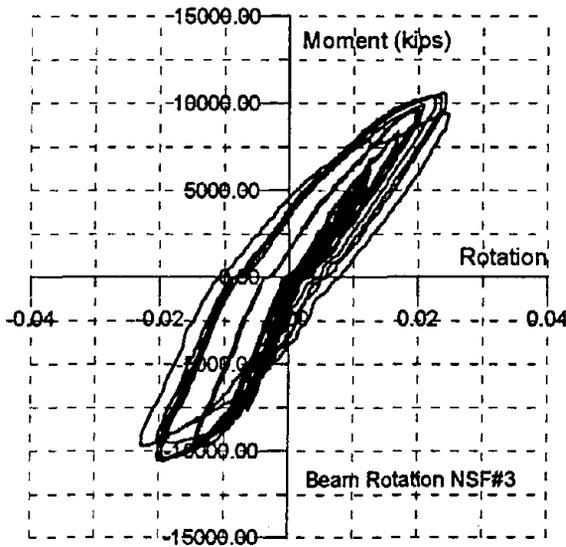
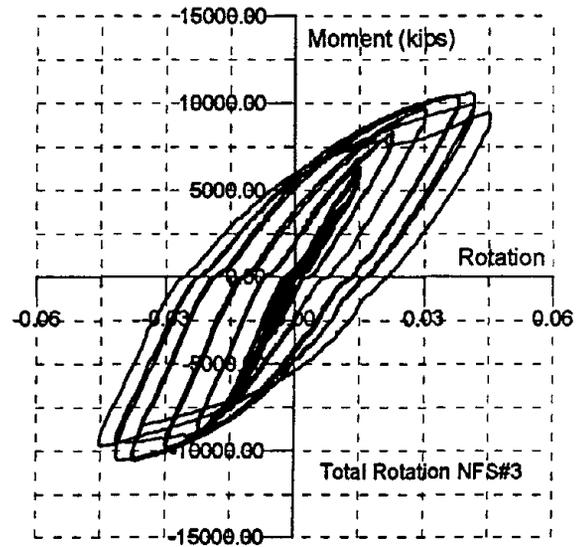
Figure 5.1.8 Rotation Components, Spec. 3

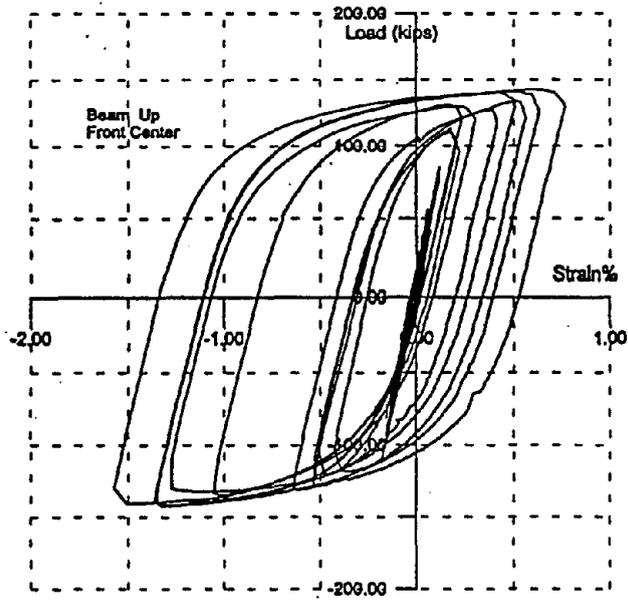
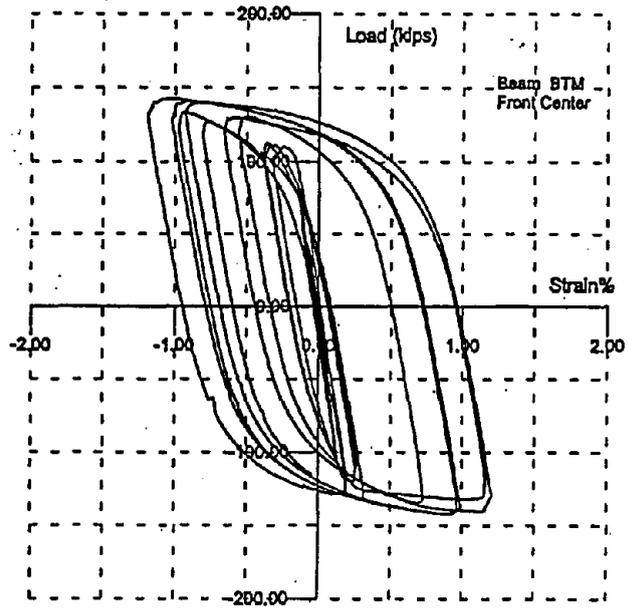
Figure 5.1.9 Beam Flange Strains, Spec. 3

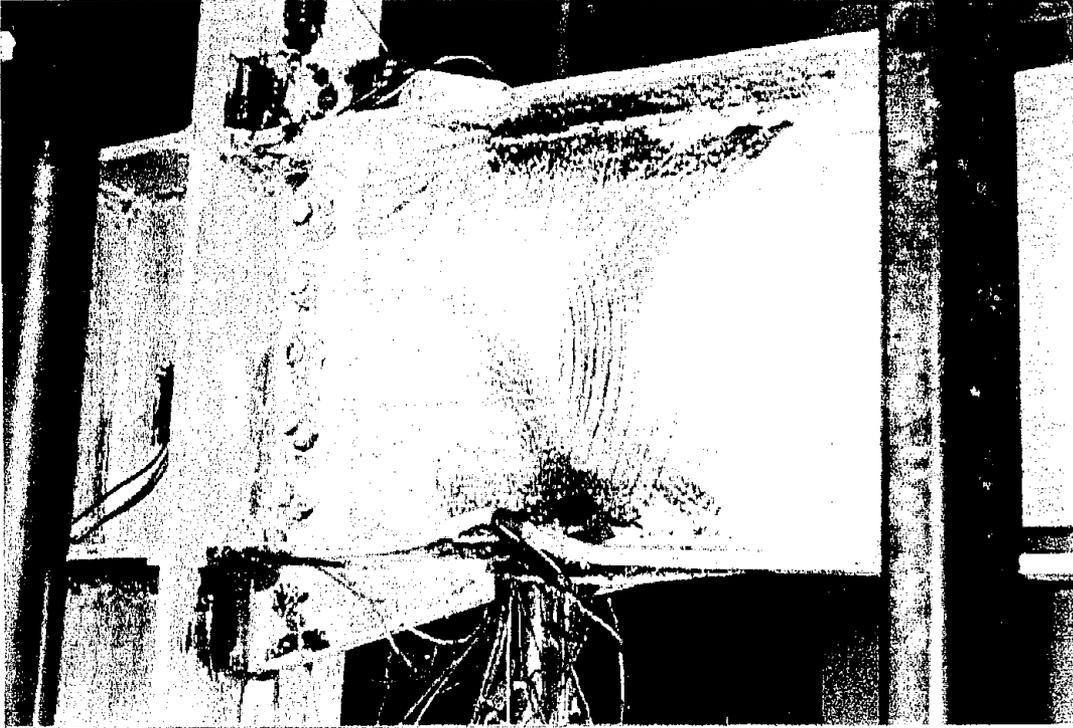
Figure 5.2.6 Plastic Hinge, Spec.4

The specimen was subjected to 15 cycles of load and reached a total rotation of more than 4%. The test was stopped at this point due to severe deformation in the beam and the concern for damaging the testing equipment. At this point, the top and bottom beam flanges had developed buckles of 1 3/4 inches at the bottom and 2 inches at the top (**Figure 5.2.6**) and the beam web had buckled out of plane. There was only a small crack in the weld at the toe of one of the triangular fins which was due to the prying action of the buckled beam flange. The plastic hinge developed 17 inches from the face of the column at the location of the buckling. By moving the hinge away from the column face, the problems with the web copes which have led to failures in previous specimens were eliminated.

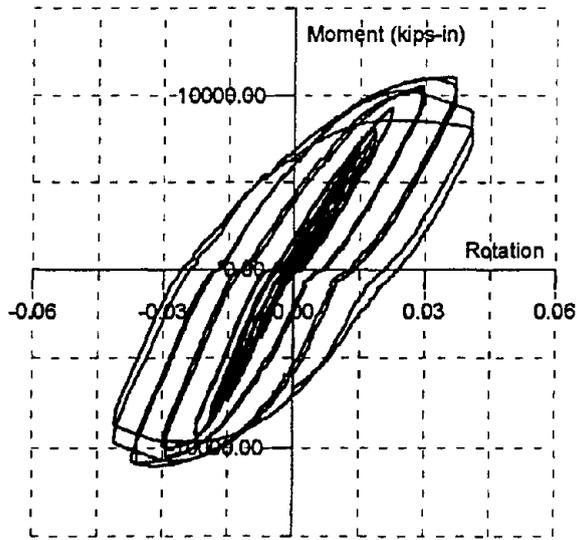
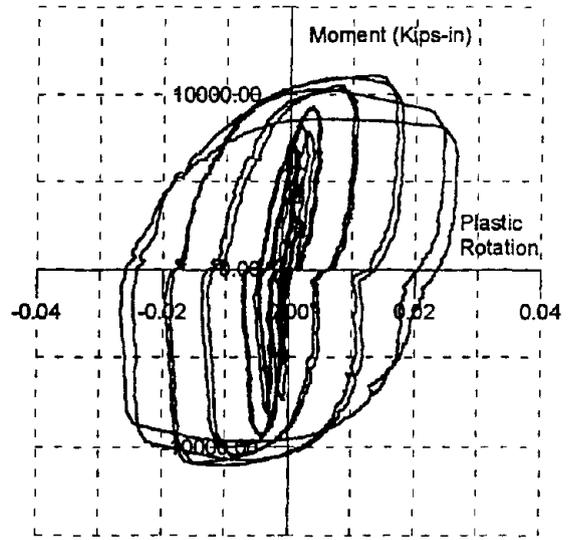
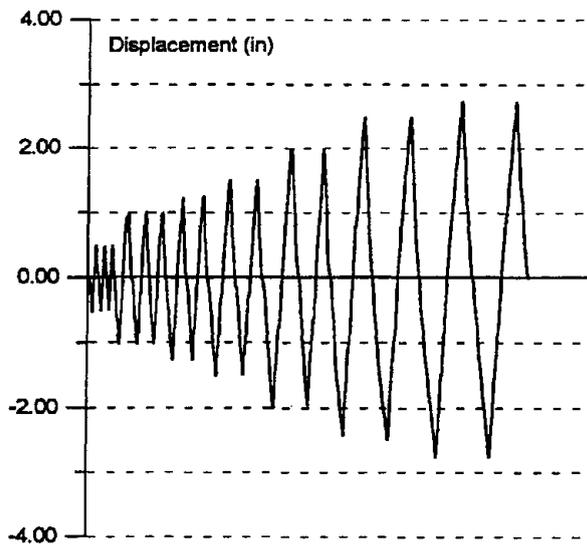
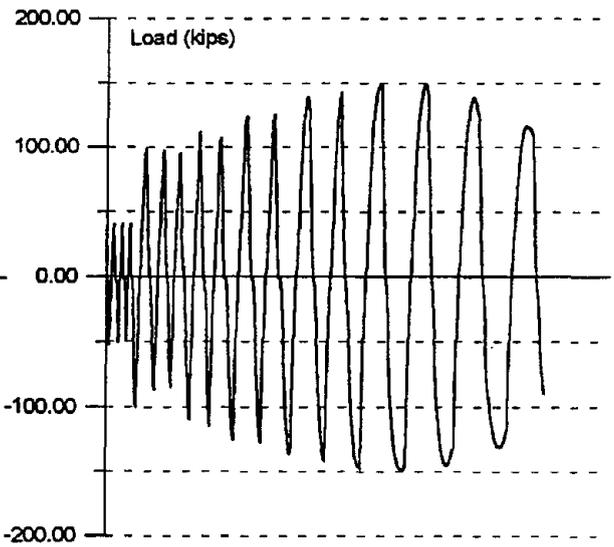
Figure 5.2.7 Cyclic Behavior, Spec. 4

The cyclic performance is summarized in **Figure 5.2.7**. The total rotation, shown in **Figure 5.2.7a**, reaches a maximum value of 4.2% of which 2.5% is plastic rotation as shown in **Figure 5.2.7b**. The connection was able to sustain 15 cycles of increasing displacement, reaching a maximum amplitude of 2.75 inches as shown in **Figure 5.2.7c**. The load history, shown in **Figure 5.2.7d**, indicates that the specimen began to unload during the last two cycles due to the buckling of the flanges and web of the beam after developing a maximum force of 150 kips. The displacement of 2.75 inches and the force of 150 kips compare well with the finite element results.

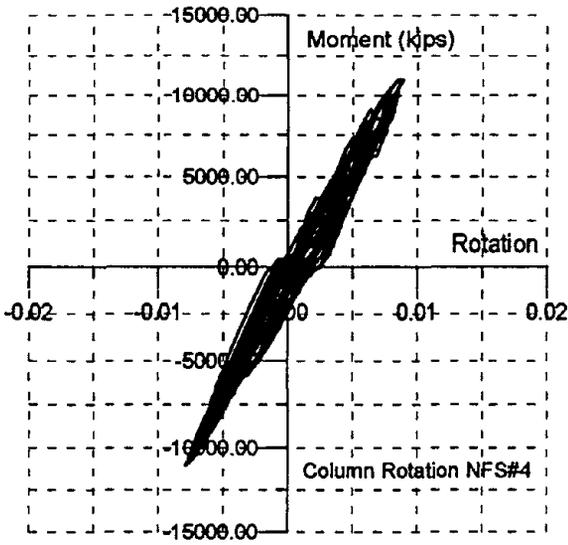
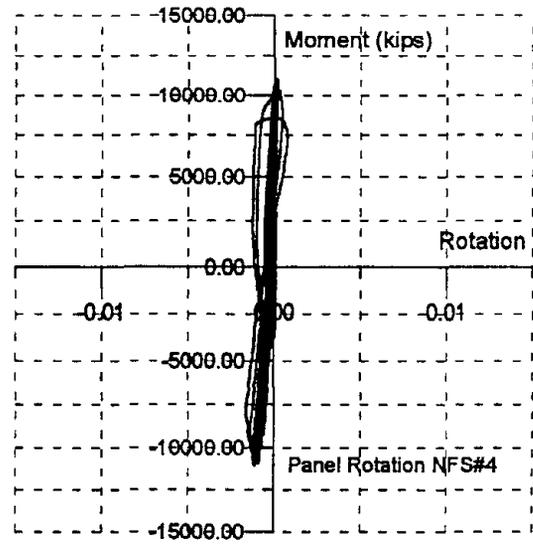
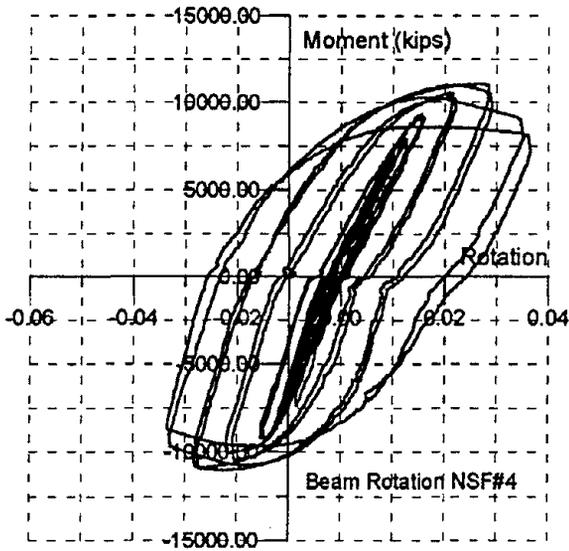
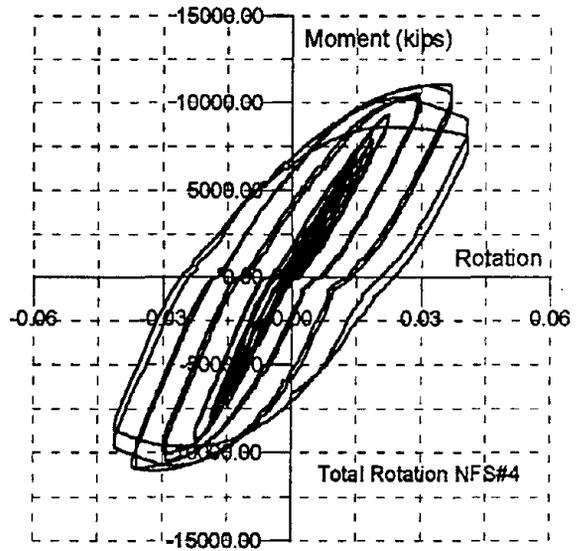
Figure 5.2.8 Rotation Components, Spec. 4

The connection rotation components are shown in **Figure 5.2.8**. This figure indicates that the column rotation was 0.8%, the panel zone rotation was 0.1% and the beam rotation was 3.5% for a total of 4.4%. Measured strains in the top flange of the beam are shown in **Figure 5.2.9**. The strain to the left of the fin near the column face, shown in **Figure 5.2.9a**, reaches a maximum of 0.7%. Just in front of the fin and to the left, the strain reaches 1.3% (**Figure 5.2.9b**). Strains measured on the bottom flange of the beam are shown in **Figure 5.2.10**. Directly in front of the fin, the strain is approximately 2%, however, on the final two cycles, the strain increases to more than 5% (**Figure 5.2.10a**). Recorded strains to the left, in front of the fin are just slightly less as shown in **Figure 5.2.10b**. Strains in the panel zone, shown in **Figure 5.2.11**, reach a maximum of 0.5% which indicates yielding and compares well with the finite element results. The fin increases the moment capacity of the connection by approximately 20%.

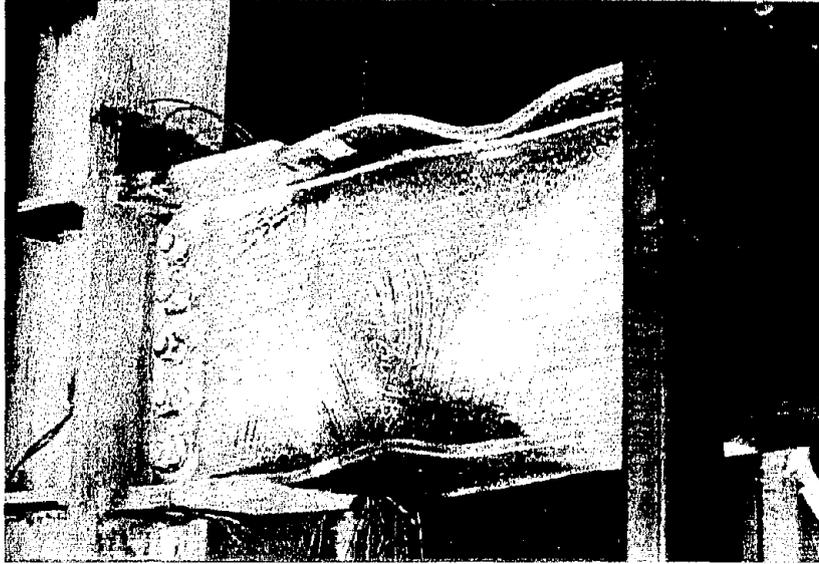
Figure 6.1.7 Plastic Hinge, Spec. 5
