## Repair/Upgrade Procedures for Welded Beam to Column Connections

PEER  
98/03  
MAY 1998

Report No. PEER-98/03  
Pacific Earthquake Engineering Research Center  
College of Engineering  
University of California, Berkeley  
May 1998

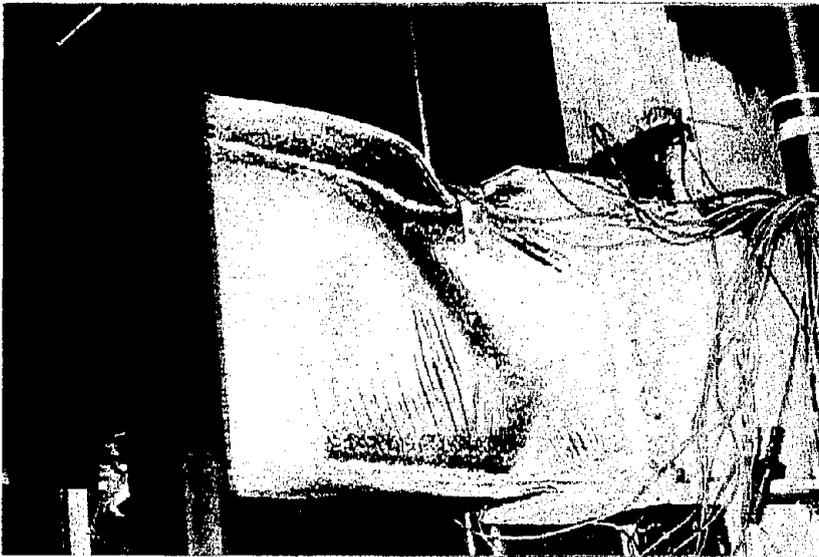
Figure 6.1.8 Flange Buckle, Spec. 5

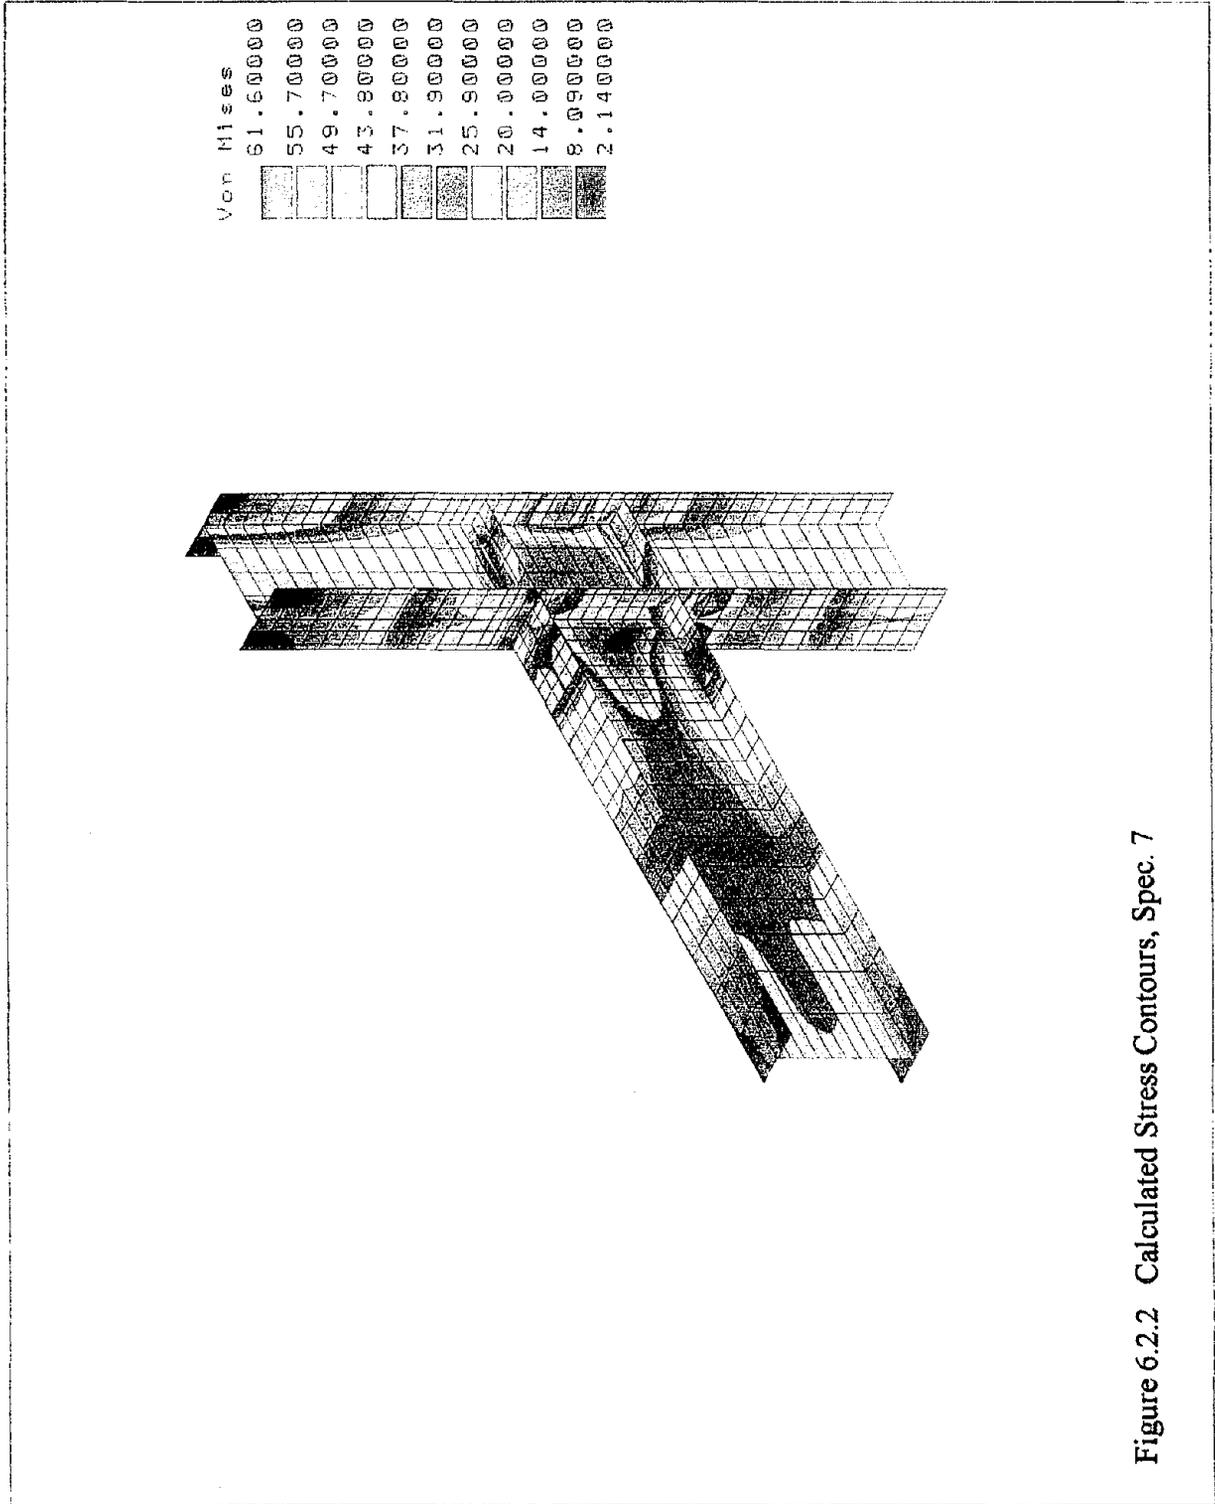
Figure 6.2.2 Calculated Stress Contours, Spec. 7

reduced stiffness when the doubler is removed. At maximum displacement of 4.5 inches, a load of 120 kips is required. A color plot of the Von Mises stress contours, shown in **Figure 6.2.2**, shows that yielding is just beginning to occur at the ends of the flange plate, however, the stresses in the column are much higher than for Specimen #5. A region of high stress occurs in the unstiffened panel zone indicating yielding. This indicates that most of the deformation is occurring in the panel zone and not in the beam. A distorted view of the connection is shown in **Figure 6.2.3**. This clearly indicates the distortion in the panel zone when the doubler is omitted with almost no deformation occurring in the beam.

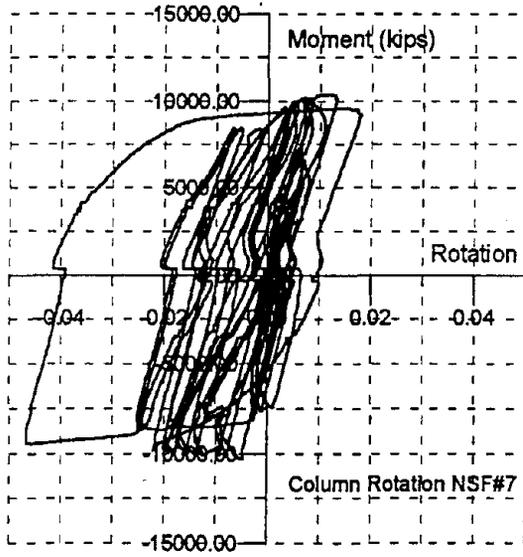
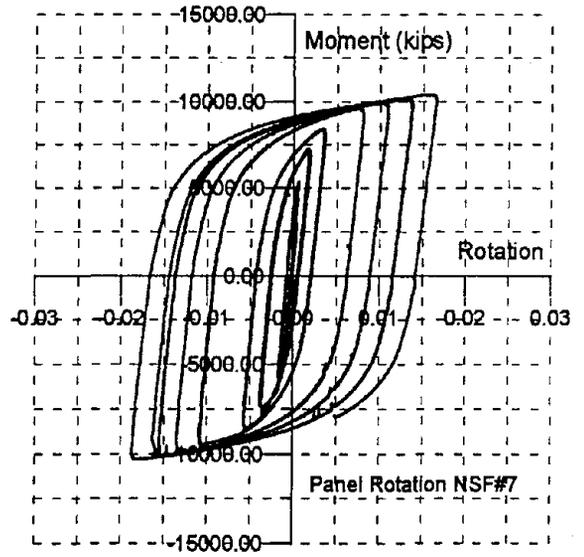
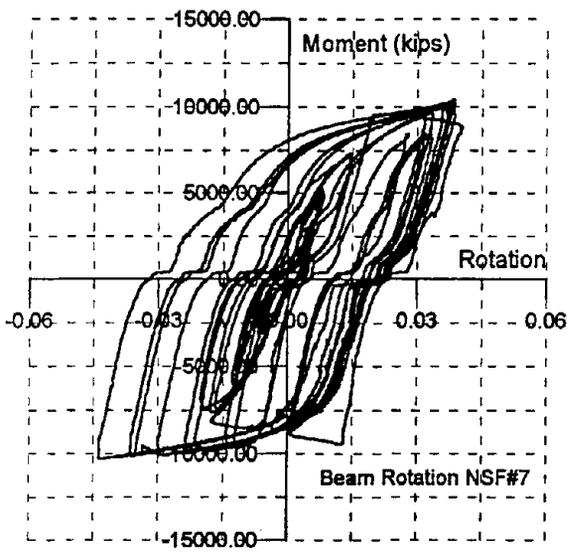
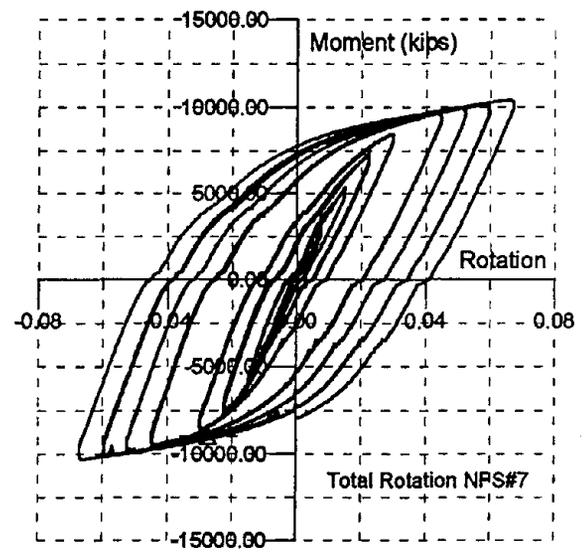
Figure 6.2.7 Rotation Components, Spec. 7

Since there was no column doubler, there was extensive plastic deformation in the panel zone. Contributions to total rotation, shown in **Figure 6.2.7**, were divided as follows: 1.3% column rotation, 1.7% panel zone, 3.9% beam for a total of 6.9%. The effect of the panel zone thickness can be seen by comparing these results with those of specimen #5.

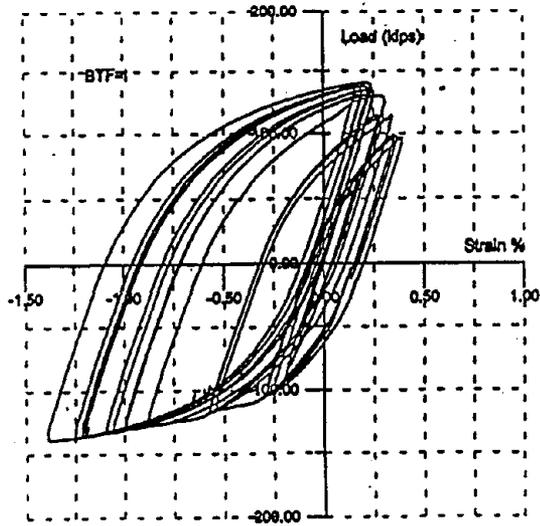
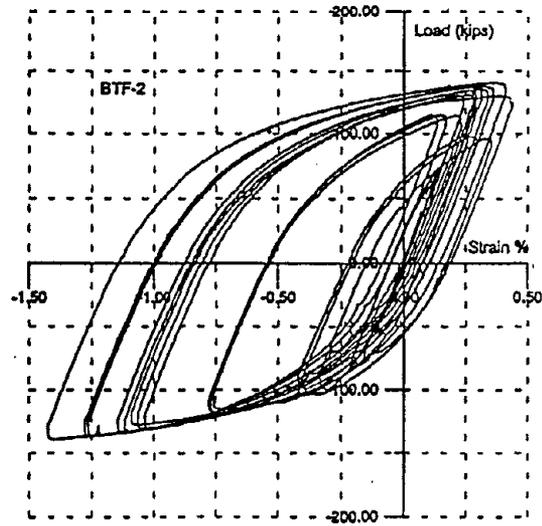
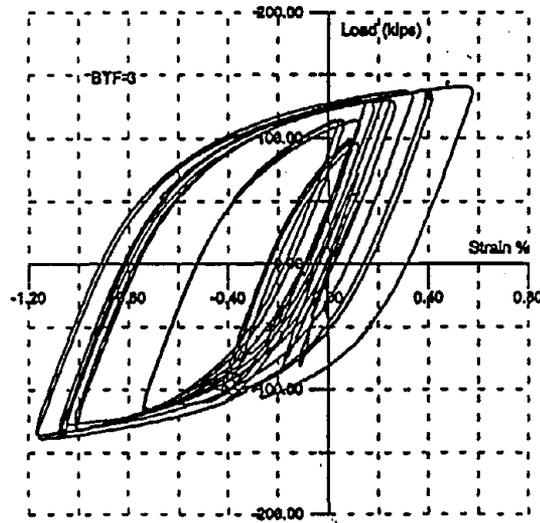
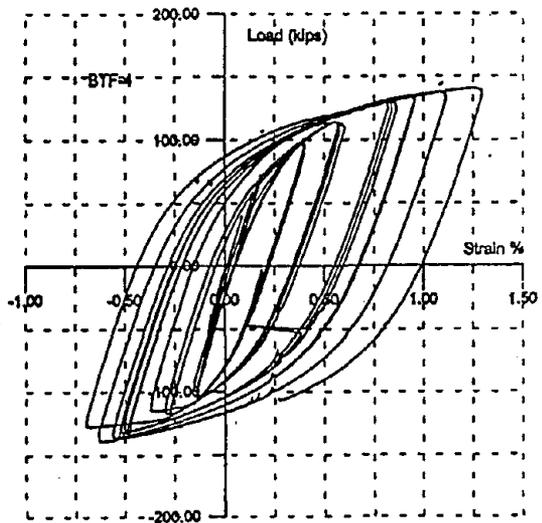
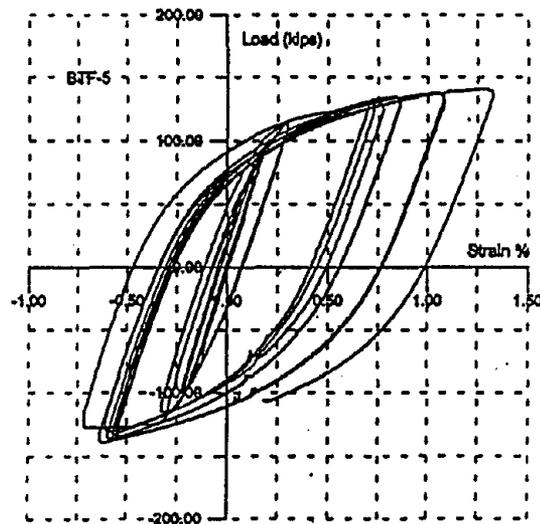
Figure 6.2.8 Top Flange Plate Strains, Spec. 7

The strain distribution across the top flange plate near the column face can be seen in **Figure 6.2.8**. At the center, **Figure 6.2.8a**, the maximum strain was approximately 1.4%. At the middle of the flanges, **Figures 6.2.8b and 6.2.8c**, the strains were recorded as 1.4% and 1.2%. At the edges of the flange plate, strains of 1.3% were measured on both sides as shown in **Figures 6.2.8d and 6.2.8e**. Strains in the top flange of the beam just in front of the flange plate are shown in **Figure 6.2.9**. At the center of the beam, **Figure 6.2.9a**, the maximum strain is 2%, whereas, on either side of the beam, the strains are 2.5% and 2.1% as shown in **Figures 6.2.9b and 6.2.9c**. This compares well with the

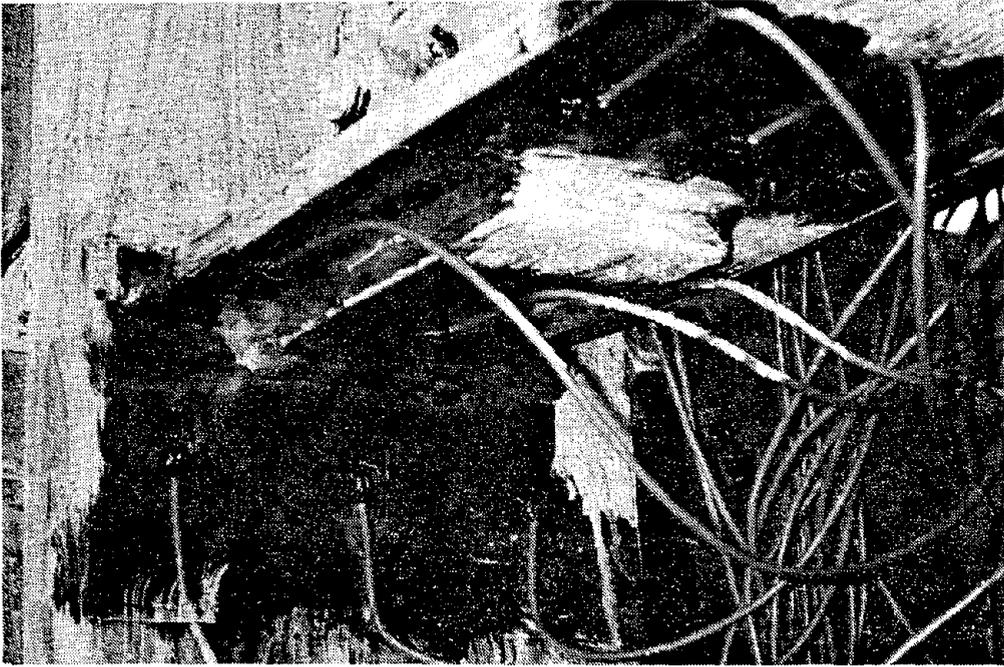
Figure 6.3.3 Test Specimen with Miniplate

The welded miniplate on the bottom flange of the beam is shown in **Figure 6.3.3**. As can be seen in **Figure 6.3.4**, the cyclic performance of the modified connection was very good. The specimen was able to sustain 19 cycles of increasing displacement (**Figure 6.3.4c**) and reached a total rotation of 6% (**Figure 6.3.4a**). A plastic rotation capacity of 4% (**Figure 6.3.4b**) was achieved although the specimen began to unload on the last three cycles as shown in **Figure 6.3.4d**. This occurred due to severe local buckling of the beam flanges and web, shown in **Figure 6.3.5**, and caused the test to be stopped after two cycles at 4.0 inches of tip displacement (6% total rotation). There was approximately a 32% reduction in maximum load due to this unloading. At this point there was no visible cracking on the test specimen, particularly the welds. However, it appeared the plastic hinge zone had just reached the column face, therefore, it does not seem advisable to reduce the length of the flange plates any further.

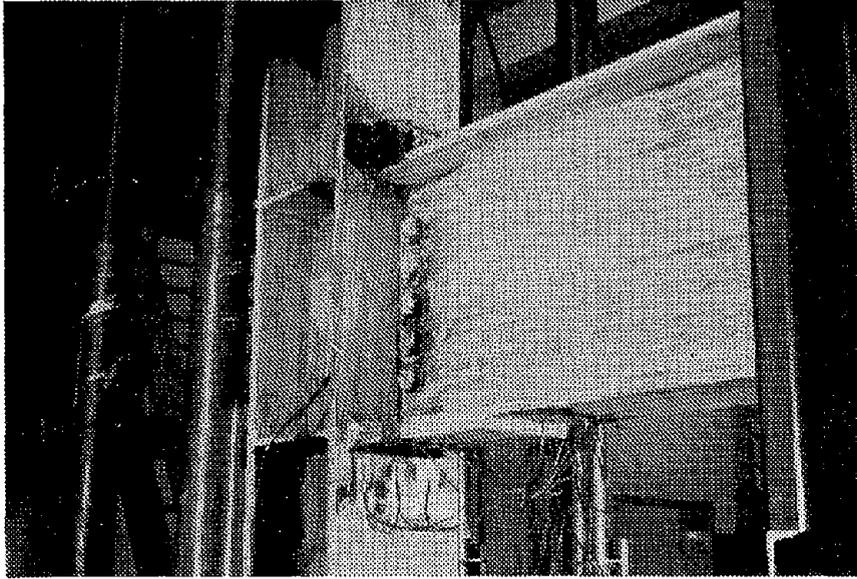
**Figure 6.4.3 Test Specimen With Single Flange Plate**

The test specimen with the single flange plate is shown in **Figure 6.4.3**. Cyclic performance, shown in **Figure 6.4.4**, was both predictable and not outstanding. The total rotation, shown in **Figure 6.4.4a** was 3.8% with a plastic rotation of only 1.7% (**Figure 6.4.4b**). The top flange of the beam, without the plate, was the first to show indications of yielding with yielding at the bottom flange occurring only near the end of the test. The specimen was able to sustain 14 displacement cycles as shown in **Figure 6.4.4c**. Unloading of the specimen occurred on the last displacement cycle resulting in a 24% drop in loading capacity (**Figure 6.4.4d**). During the 13th cycle at a displacement of 2.7 inches, inelastic buckling of the top beam flange led to the formation of a slit or tear (ductile crack) which started at the top web cope hole and extended across the top beam flange (**Figure 6.4.5**). At a displacement of 2 inches, the finite element analysis indicates a load of 129 kips at the beam tip. The test results show a load of 130 kips (**Figure 6.4.4d**)

This specimen was a W21x68 beam connected to a W12x106 column with a doubler plate on one side of the web. It was retrofitted using a procedure that was used extensively in the field for repair immediately after the earthquake. In most cases weld cracks were identified at the bottom flange of the beam and therefore a rectangular flange plate was welded to the beam at this location. In this study, a rectangular plate was attached using partial penetration welds along the sides, a full penetration weld to the column flange and a 5/8" fillet weld along the end of the plate using SMAW with E7018 electrodes. Nothing was done to the FCAW weld at the top beam flange.

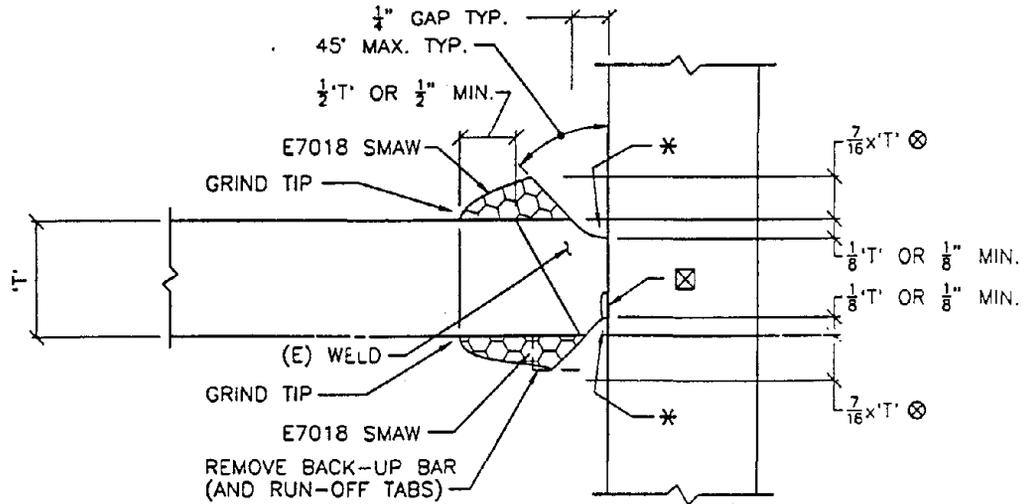
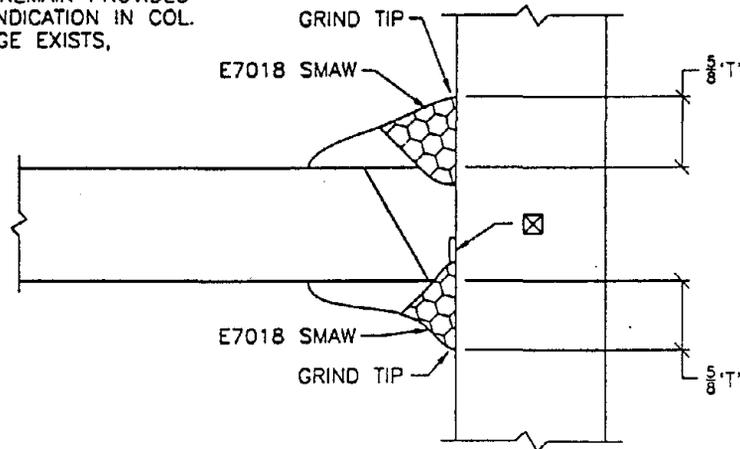
Figure 7.2.1 Class A Repair Detail

flange of the beam gave no indication of any cracking or defects. This offered an excellent opportunity to test the use of a "Class A" weld overlay. The DLW Task Group [11] defines a Class A weld repair as one in which the joint efficiency is under 50% or undetermined. In this case, a maximum weld overlay using SMAW should be applied to supplement the joint deficiency. A typical detail of a Class A repair is shown in **Figure 7.2.1**. For the connection under consideration, the repair will leave more than half of the crack in place under the overlay and will test the ability of the overlay to immobilize the crack and prevent propagation.

The crack at the bottom flange of the beam was repaired in the laboratory following the detail for a "Class A" type of repair. The existing crack was excavated using an air arc, as shown in **Figure 7.2.2**. It was also necessary to remove a small portion of the column flange in order to encompass all of the crack. On the underside of the beam flange, the backup bar was removed and part of the existing weld was removed by air arc according to the repair detail (**Figure 7.2.3**). Approximately 0.125 inches of the crack were removed from the top and bottom of the existing weld, leaving 0.375 inches of the crack in place. At the top flange of the beam, the backup bar was removed and the weld backgouged according to recommended practice. Since the top flange weld was tested and found to be sound, no action was taken on the upper side of this weld.

Overlays exceeding the minimum requirements of the "Class A" overlay were applied to both sides of the excavated connection at the bottom flange of the beam, using 23 passes for the upper side and 13 passes for the lower side. All overlay welding was done using SMAW with E7018 electrodes. The completed overlay weld on the top side of the bottom flange of the beam is shown in **Figure 7.2.4**. At the top flange of the beam an overlay weld was applied to only the bottom side of the flange. This simulates a repair without removal of the concrete slab above the top flange, a typical condition occurring in buildings.

- \* - GRIND GROOVE IN EXISTING WELD.
- ⊗ - BASED UPON 45° GROOVE ANGLE. INCREASE ACCORDINGLY IF SMALLER ANGLE USED.
- ⊠ - INDICATION TYPE W1b OR W2 STAGE 1 MAY REMAIN PROVIDED NO INDICATION IN COL. FLANGE EXISTS,

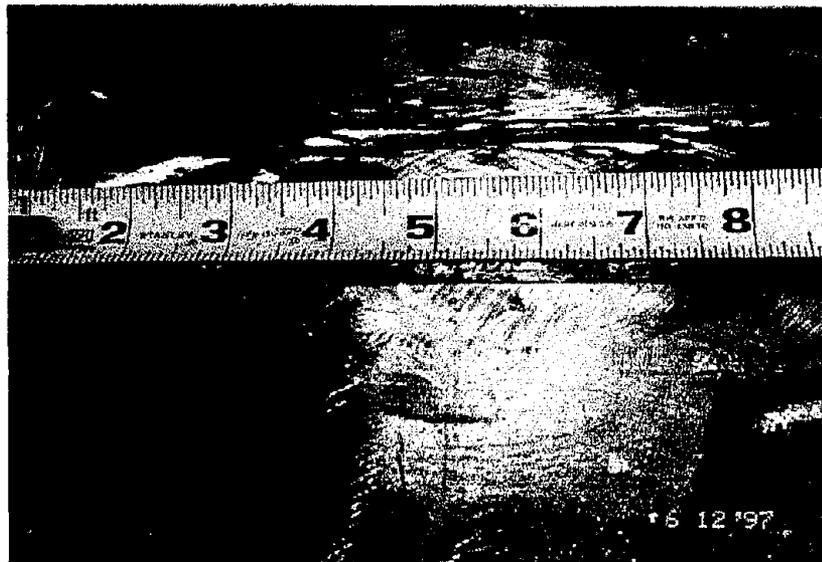
Figure 7.2.3 Gouged Out Bottom Side, Bottom Flange, Spec. 10

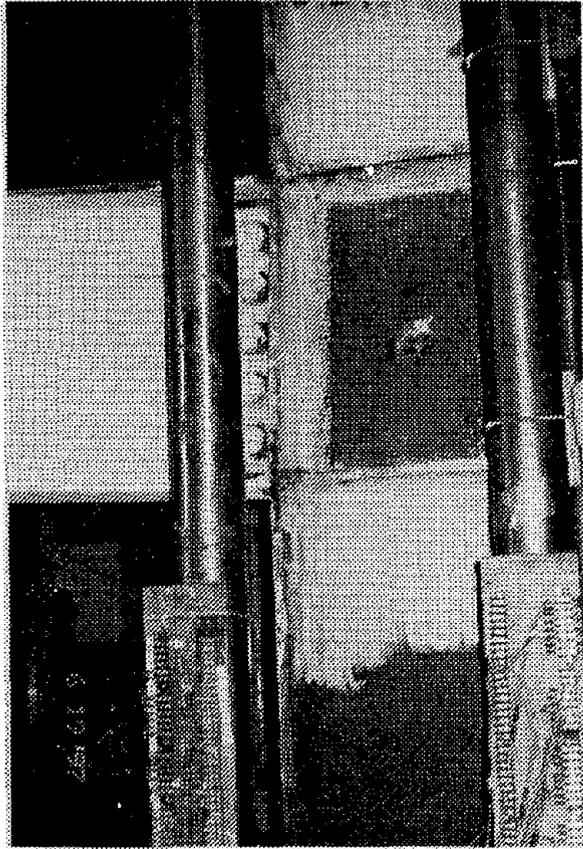
Figure 7.2.6 Panel Zone Deformation, Spec. 10

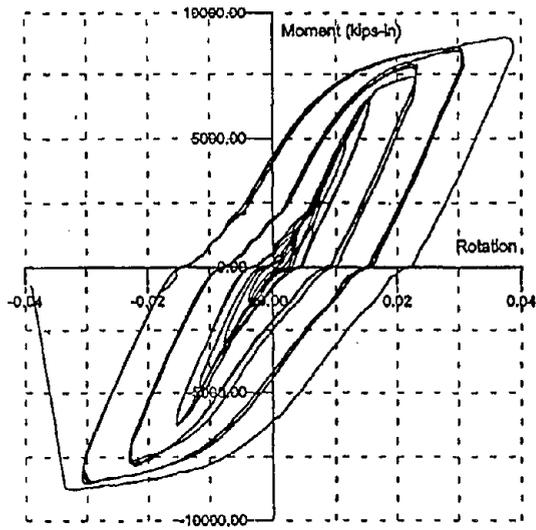
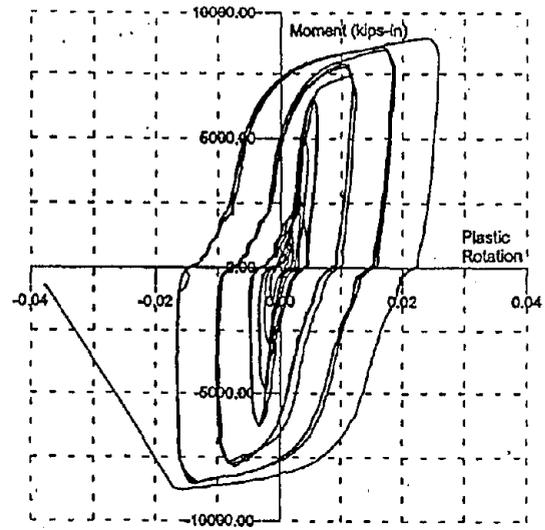
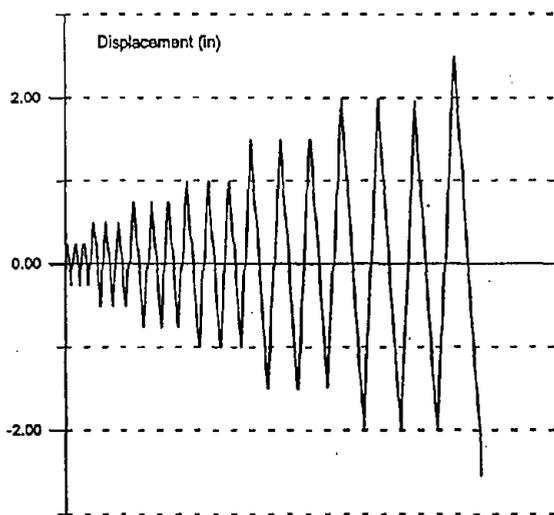
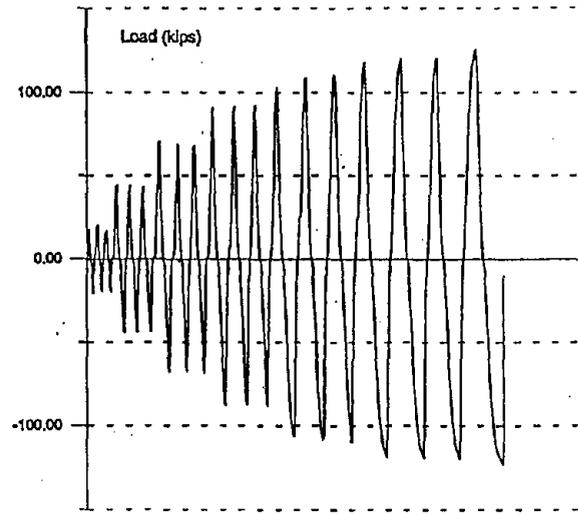
Figure 7.3.3 Cyclic Behavior, Spec. 11

The cyclic performance of the specimen is summarized in **Figure 7.3.3**. The specimen was able to sustain 19 cycles of increasing displacement as shown in **Figure 7.3.3c**. The moment versus rotation curve, shown in **Figure 7.3.3a**, indicates that the total rotation was just over 3.0% with plastic rotation of 1.6% as shown in **Figure 7.3.3b**. The loading history, shown in **Figure 7.3.3d**, indicates there was no unloading of the specimen until the last cycle when failure occurred during the first cycle at a displacement of 2.5 inches (4% rotation). On the first down stroke of this cycle the top flange of the beam suddenly fractured as shown in **Figure 7.3.4**. The crack appeared to start in the web cope and propagate outward to the edges of the beam flange. Note that the finite element analysis indicated a beam tip load of 112 kips at a displacement of 2 inches compared with 118 kips measured in the test.

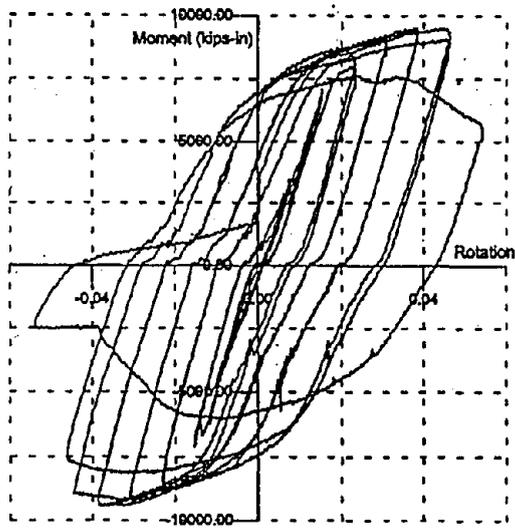
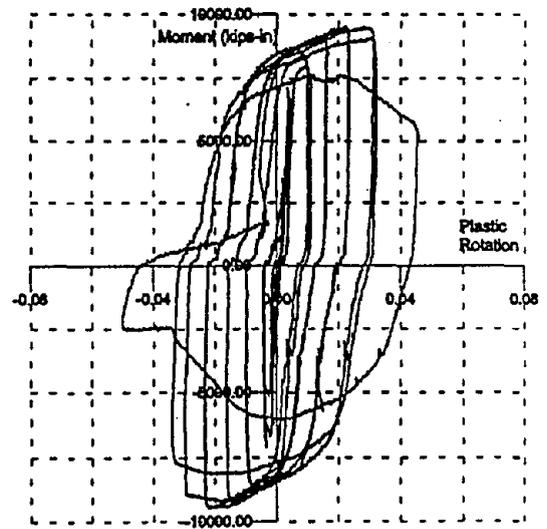
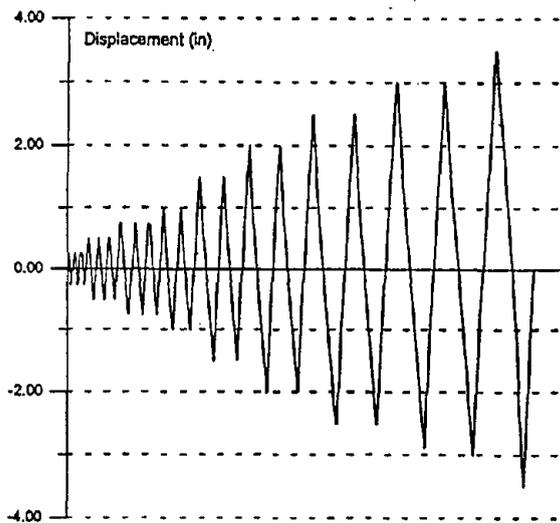
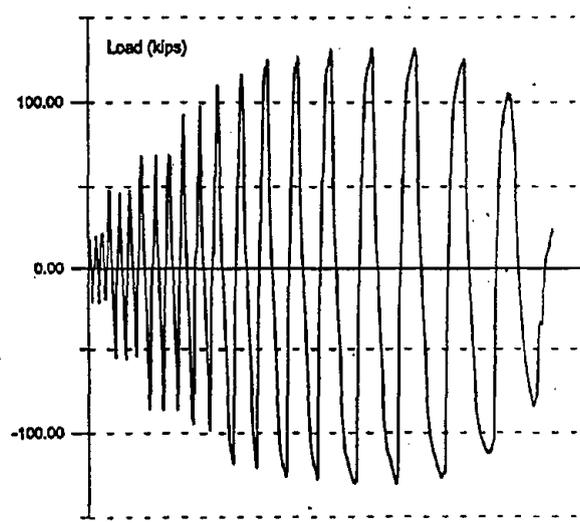
Figure 7.4.4 Cyclic Behavior, Spec. 14

Specimen performance again was very good as summarized in **Figure 7.4.4**. The specimen was able to sustain 20 cycles of increasing displacement (**Figure 7.4.4c**). It developed a total rotation of 4.7 percent (**Figure 7.4.4a**) with a plastic rotation of 3% (**Figure 7.4.4b**) before starting to unload as shown in **Figure 7.4.4d**. At a tip displacement of 2.5 inches (3.9% rotation) small horizontal cracks began to develop in the top and bottom k-line areas of the beam web. At both locations the plug welds in the web copes cracked away from the beam web. During the first cycle at a tip displacement of 3

inches (4.7% rotation) significant buckles began to form in the beam flanges about 4 inches at the top and about 10 inches at the bottom from the face of the column. This caused the specimen to start to unload as mentioned previously and during the last cycle at a tip displacement of 3.5 inches (5.5% rotation) the specimen lost approximately 33% of its moment capacity.

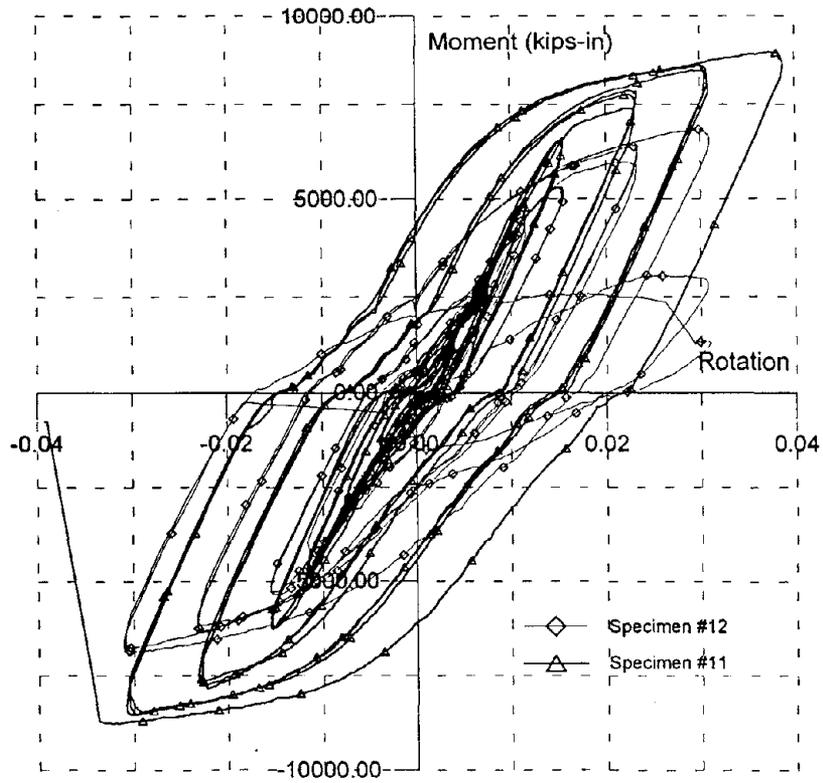
Figure 7.5.1 Comparative Behavior (#11 & #12)

The cyclic behavior of specimen #11 which has a web doubler plate is compared with that of specimen #12 which does not have a doubler plate in **Figure 7.5.1**. It can be seen that due to yielding of the panel zone in specimen #12, the moment capacity of the connection is considerably less than the moment capacity of specimen #11 which has the doubler plate. It can be shown that specimen #12 was only able to develop 90% of the plastic moment capacity of the beam whereas specimen #11 was able to develop 120%. It can also be seen that the change in stiffness between the two specimens is relatively small.

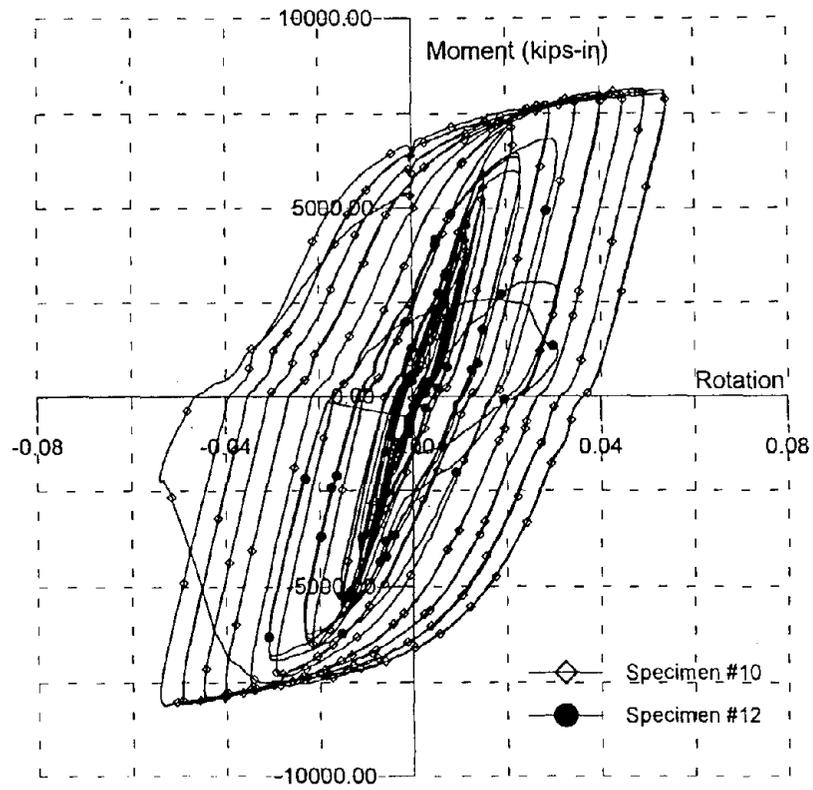
Figure 7.5.2 Comparative Behavior (#10 & #12)

The positive effect of a Class A overlay is shown in **Figure 7.5.2** by comparing the cyclic behavior of specimen #10 with that of specimen #12. The overlay repair has increased the total rotation capacity by 75% (0.031 to 0.054) and has increased the moment capacity by 18% (6833 in-kips to 8083 in-kips).

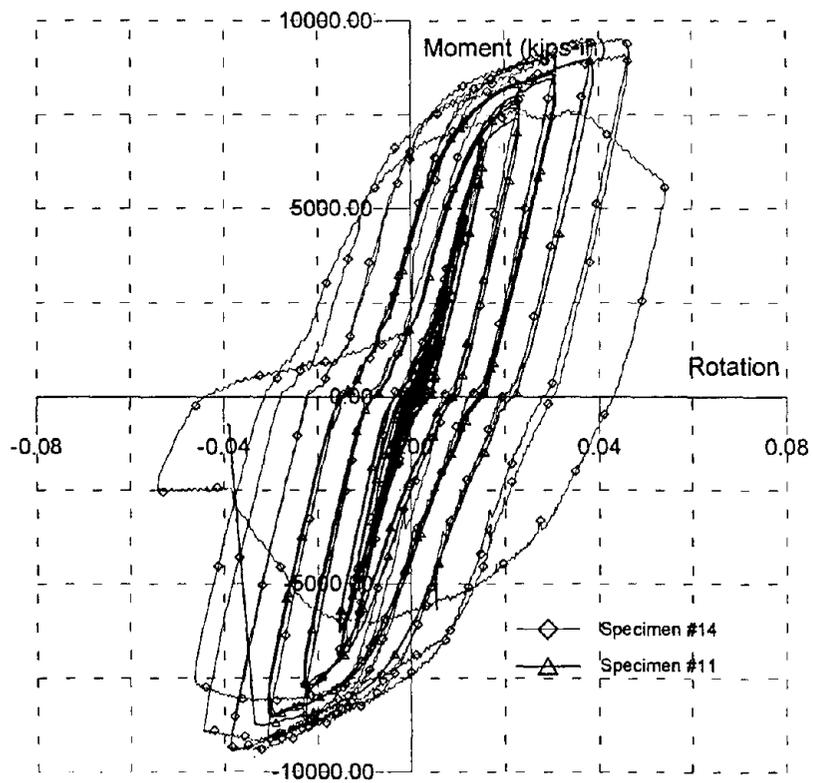
Figure 7.5.3 Comparative Behavior (#11 & #14)

The positive effect of a Class C overlay is shown in **Figure 7.5.3** by comparing the cyclic behavior of specimen #11 with that of specimen #14. This figure indicates that the connection modification using an overlay was able to increase the total rotation capacity by 18% (0.0393 to 0.0467) and to increase the moment capacity by 6.5% (9000 in-kips to 9583 in-kips).

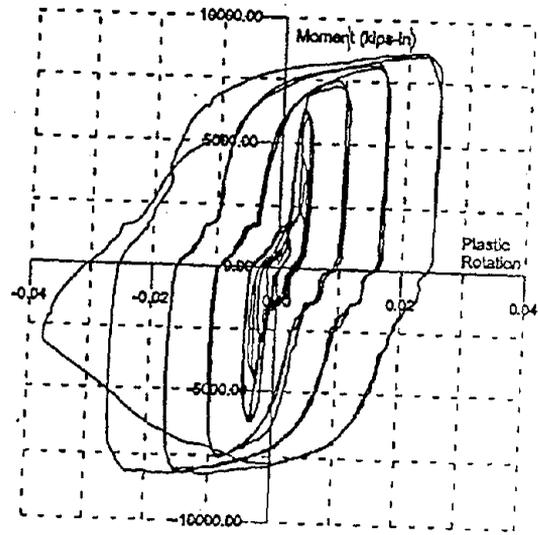
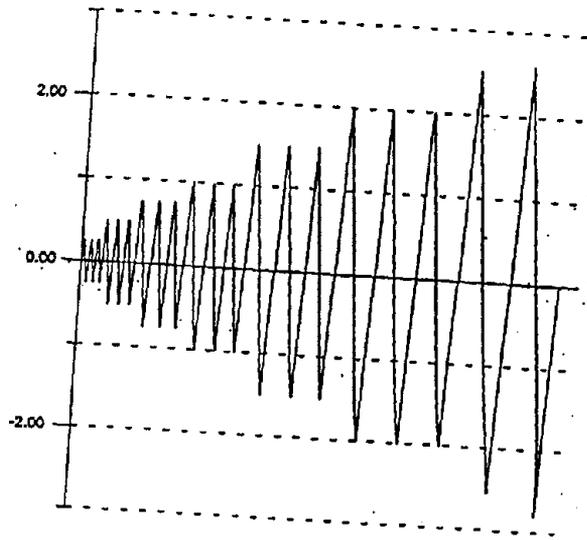
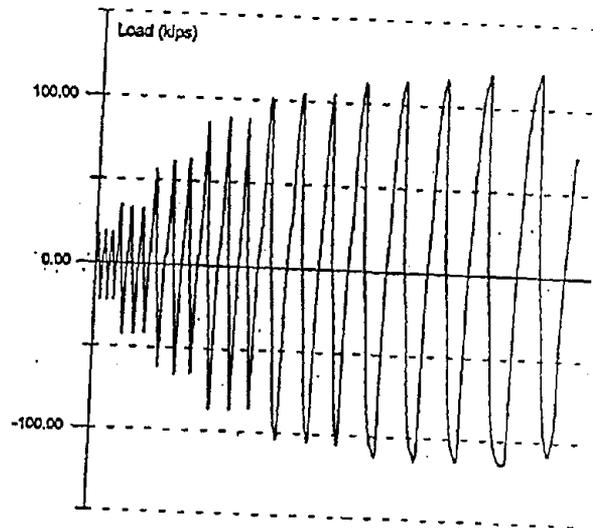
Figure 8.1.3 Cyclic Behavior, Spec. 13

The cyclic behavior of the specimen is summarized in **Figure 8.1.3**. The specimen was able to sustain 20 cycles of increasing displacement as shown in **Figure 8.1.3c**. The plot of moment versus total rotation, shown in **Figure 8.1.3a**, indicates that the specimen was able to develop a total rotation of 4 percent with a plastic rotation of 2.5% as shown in **Figure 8.1.3b**. The loading history shown in **Figure 8.1.3d** indicates there was no unloading of the specimen prior to failure. Failure occurred on the second cycle at a displacement of 2 1/2 inches (4% rotation) by the formation of a crack in the weld at the top flange of the beam (**Figure 8.1.4**). The crack appeared to start in the web cope and then propagate outward to the edges (**Figure 8.1.5**).

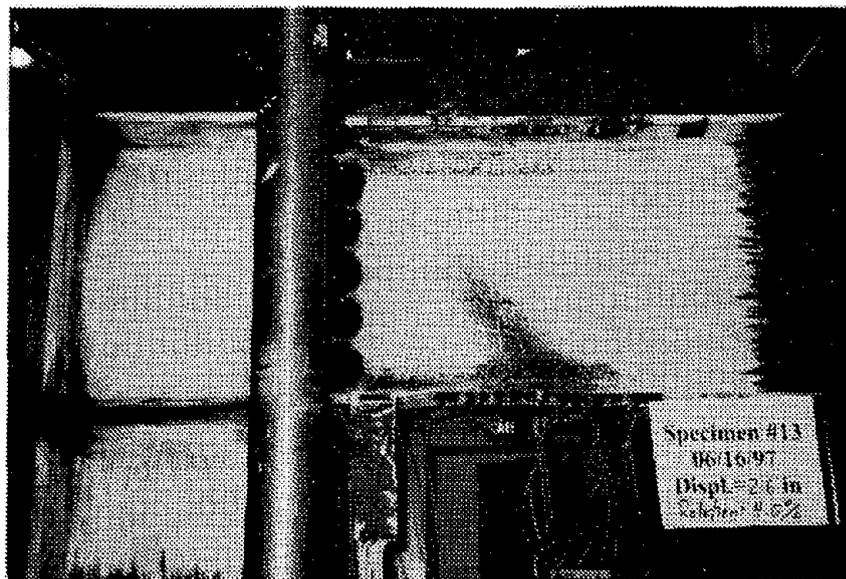
Figure 8.1.7 Plastic Hinge Formation, Spec. 13

have worked as planned and that there has been no tearing either between holes or between the hole and the edge of the flange. A yield band has developed between the hole pattern and the web of the beam.

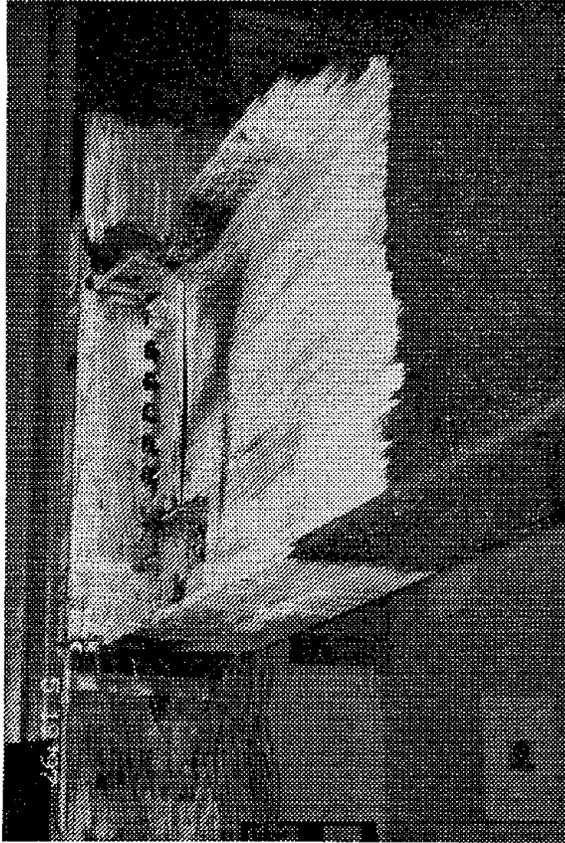
Figure 8.2.4 Buckled Beam Flange and Web, Spec. 15

The results of this test indicate that the performance of this type of repair can be improved by delaying or preventing the buckling of the beam web which appeared to be influenced by the window in the beam web and the nonsymmetry of the closure plate. Addition of a vertical stiffener at this location may further improve performance.

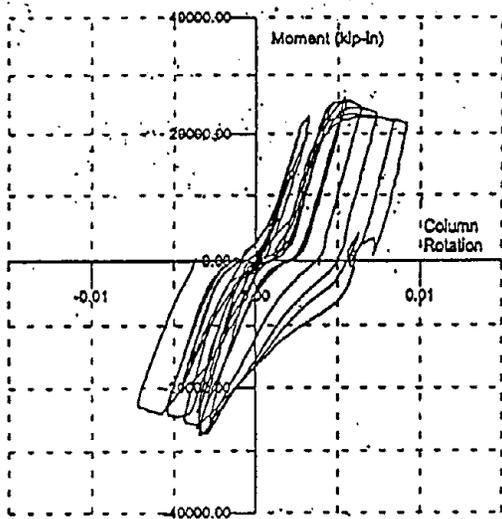
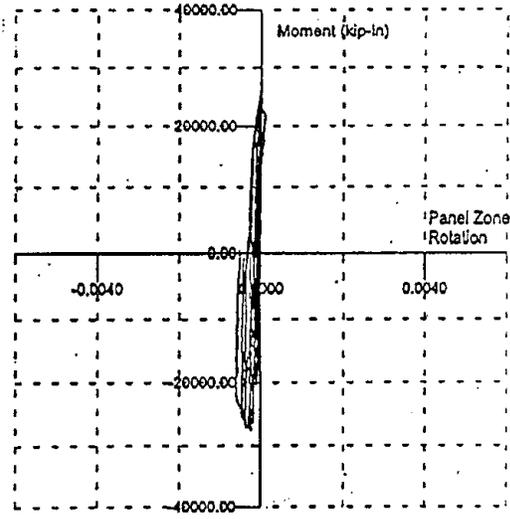
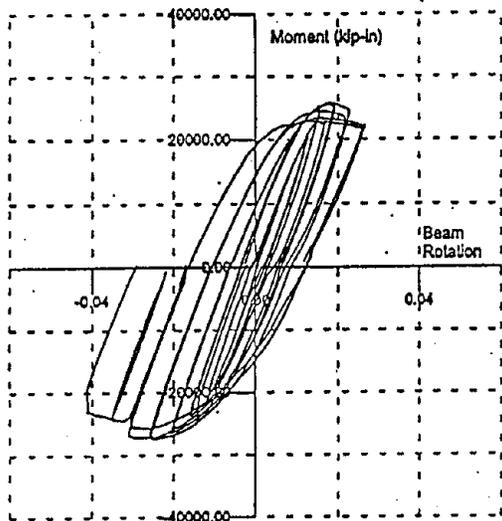
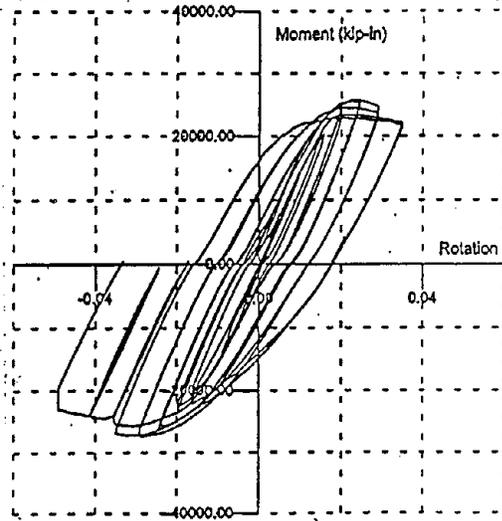
Figure 8.2.5 Rotation Components, Spec. 15

The rotation components of connection rotation are summarized in **Figure 8.2.5**. These results indicate that the rotation of the column is 0.9%, the panel zone rotation is almost zero and the beam rotation is 2.7% for a total rotation of 3.6%.

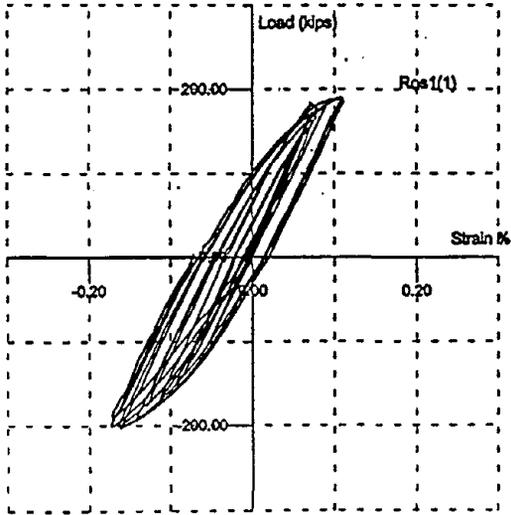
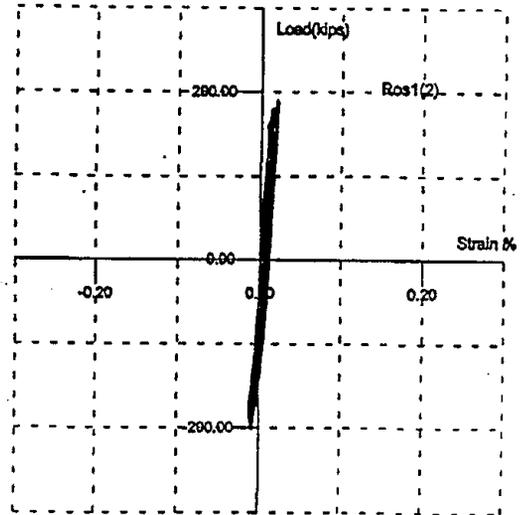
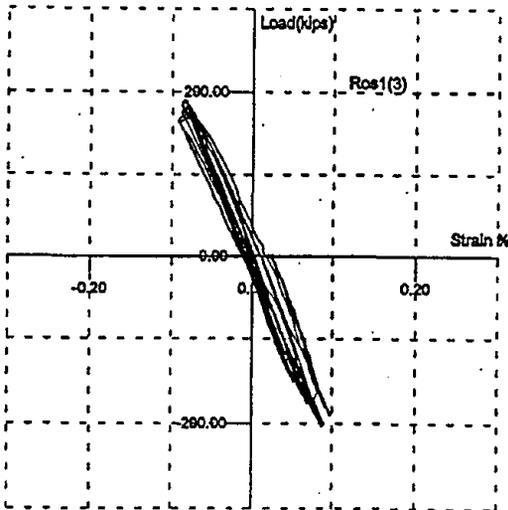
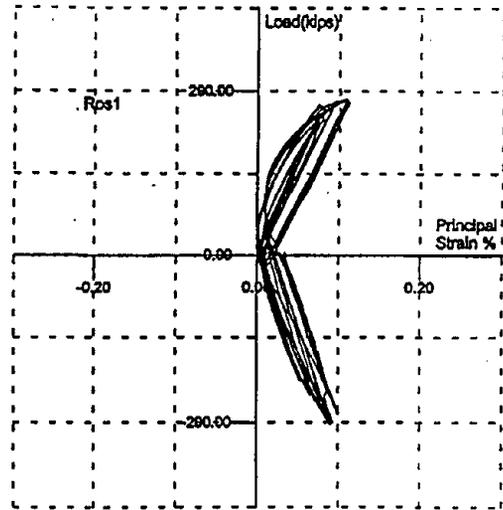
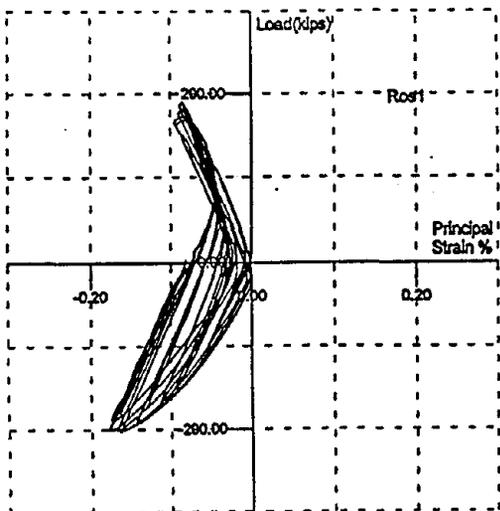
Figure 8.2.6 Column Web Panel Zone Strains, Spec. 15

Strain components obtained from a rosette at the center of the column web in the panel zone are shown in **Figure 8.2.6**. These results indicate that the behavior is predominately linear elastic. The results indicate that there may be some inelastic behavior due to the welding that has been in the vicinity of the windows. A second rosette was located at the center of the panel zone on the web doubler plate. The strains obtained from this gage, shown in **Figure 8.2.7**, indicate that the behavior is linear elastic with all strains less than 0.1 percent.

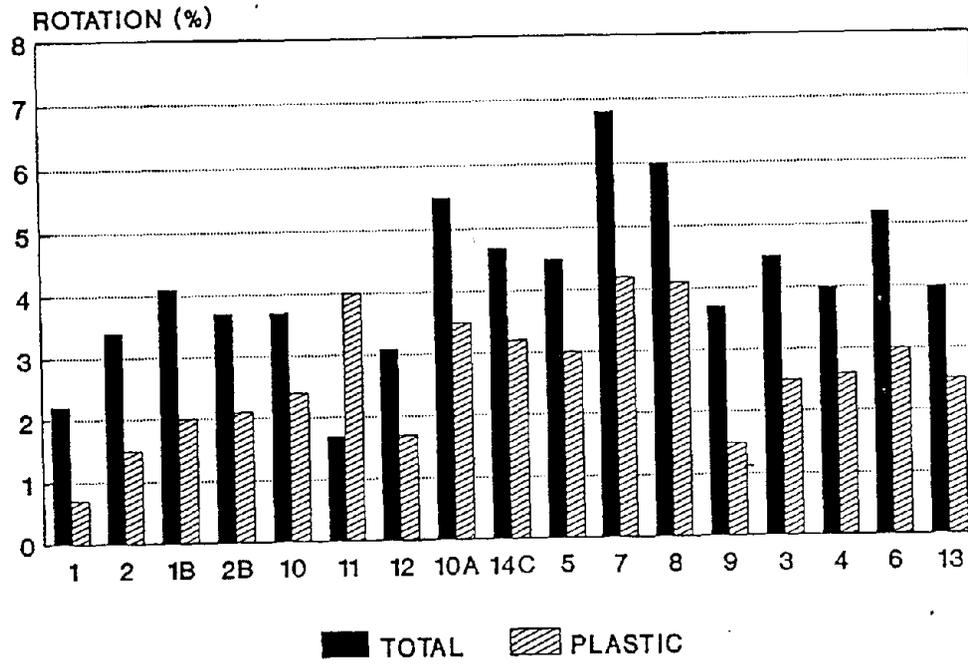
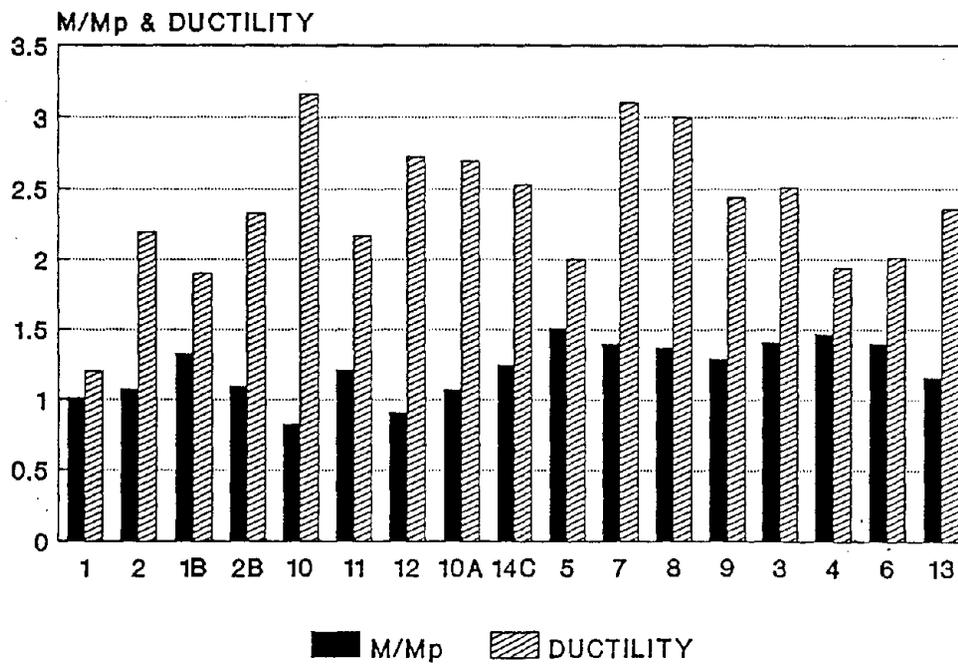
The next three specimens shown in the Figure 9.1, #10, #11, and #12, have a W16x77 column section and were tested in the "as received" condition. Specimen #10 developed a plastic rotation of 2.3% due to large panel zone deformations, however, the moment capacity was less than the plastic moment. Specimens #11 and #12 were only

able to develop plastic rotations on the order of 1.7% with specimen #12 having a moment capacity less than the full plastic value.

Specimen #10 was repaired using a Class A weld overlay with SMAW and E7018 electrodes and became specimen #10A. A 3/8 inch vertical crack at the column face was left in place and covered by the overlay weld. It can be seen that this specimen was able to develop a plastic rotation of 3.5% on retesting and the moment capacity was increased above unity. The overlay was successful in immobilizing the crack that was left in the existing weld. Specimen #14 was not tested prior to applying a weld overlay, therefore, this specimen represented a weld modification. After a minimum, Class C overlay was applied, this specimen became #14C. With the overlay, the specimen was able to develop a plastic rotation of 3%, the moment ratio increased to 1.25 and the ductility capacity increased to 2.5. *Both of the specimens repaired or modified using weld overlays were able to meet the performance criteria of 3% plastic rotation.*

Specimens #5, #7, and #8 have W12x106 columns and are modified using rectangular cover plates on the top and bottom flanges. Specimen #8 uses a mini-plate which is a half sized plate. It can be seen in Figure 9.1a that these three specimens performed very well developing plastic rotation capacities of 3%, 4.3% and 4.1% respectively. With the addition of the cover plates on the flanges, the moment capacity is increased and the moment ratios, shown in Figure 9.1b were 1.5, 1.4, and 1.4 respectively. Ductility ratios ranged between 2 and 3.1. *All three specimens modified by adding cover plates to the top and bottom beam flanges either met or exceeded the 3% plastic rotation criteria.*

Specimen #9 was modified by the addition of a rectangular plate to the bottom flange of the beam, a repair technique widely used following the earthquake. The behavior of this specimen was disappointing since it was only able to develop a plastic rotation of 1.5% before failing by a fracture at the top flange of the beam, however, the moment ratio was 1.5 and the ductility was almost 2.5. In a previous test [12], this type of repair resulted in much better performance, resulting in a plastic rotation capacity of more than 3%. Part of the reason for this improved behavior may be due to welding of the shear tab in the earlier test.

The final specimen shown in Figure 9.1 is #13. This specimen was modified by drilling holes in the beam flanges to have the shape of a tapered RBS ("dog bone"). The

performance of this specimen was good but not outstanding. It developed a plastic rotation of 2.5% prior to a failure of the weld at the top flange. It was able to develop the full plastic moment capacity of the section prior to failure and had a ductility ratio of 2.4. Recall that the intent of this test was to improve the performance of an existing connection without requiring any welding.
