Implications for Earthquake Risk Reduction in the United States from the Kocaeli, Turkey, Earthquake of August 17, 1999

U.S. Geological Survey Circular 1193

By U.S. Geological Survey

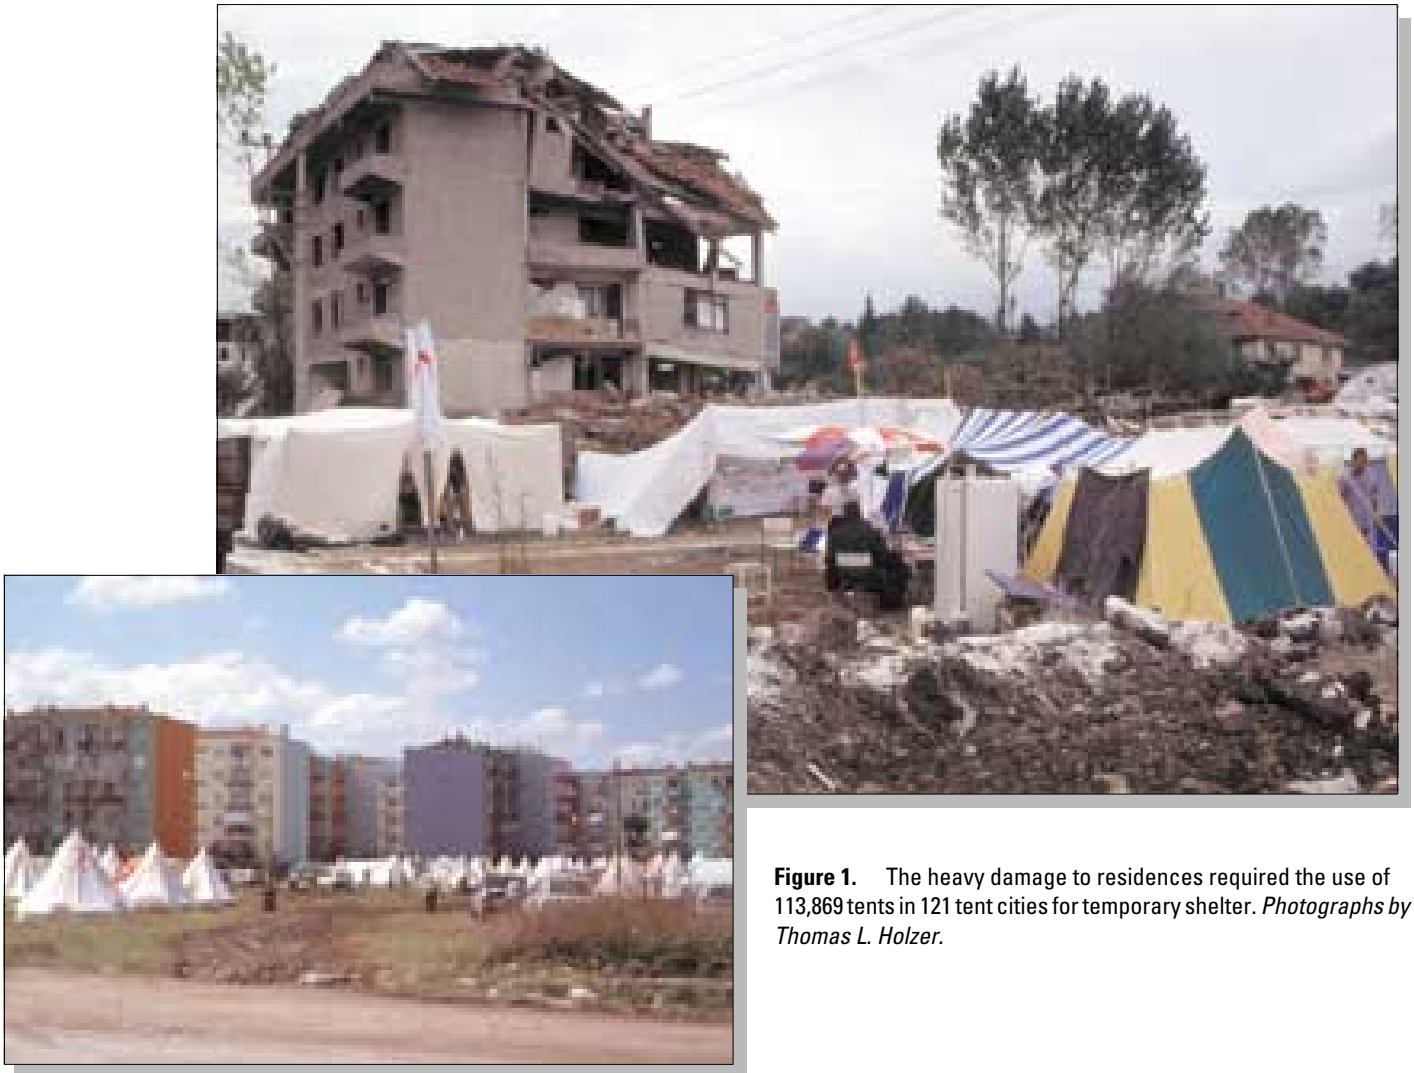
Figure 1. The heavy damage to residences required the use of 113,869 tents in 121 tent cities for temporary shelter. *Photographs by Thomas L. Holzer.*

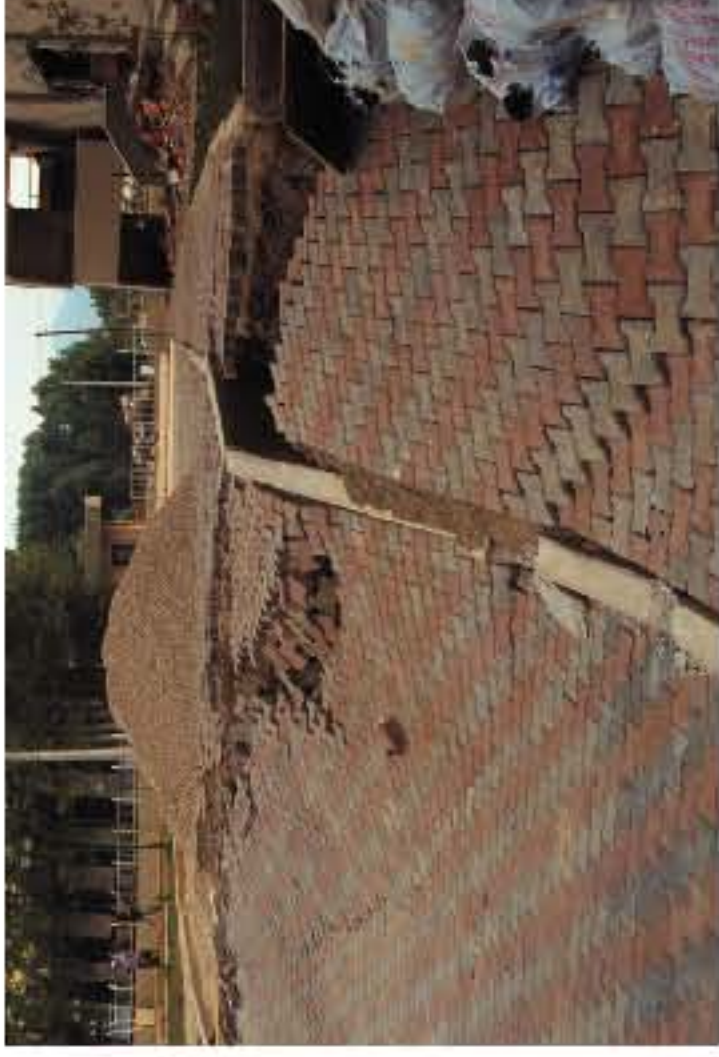
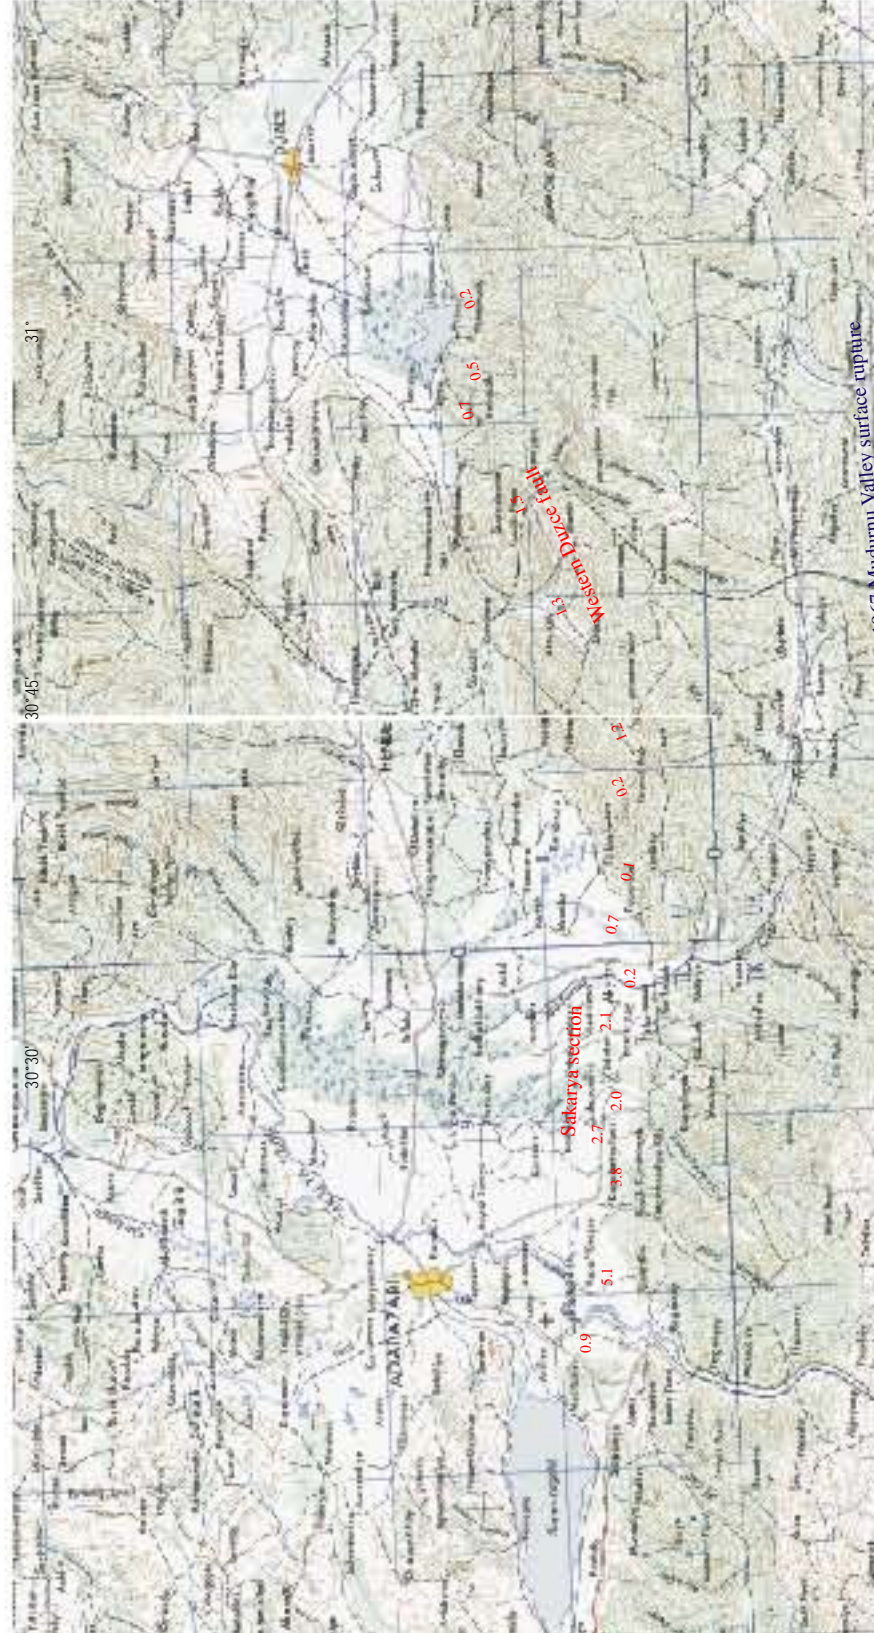
Figure 10. Tectonic scarp along the normal fault in Gölcük in a cobblestone pavement with both vertical (~1 m) and horizontal (~0.3 m) components of offset. *Photograph by Robert Langridge.*

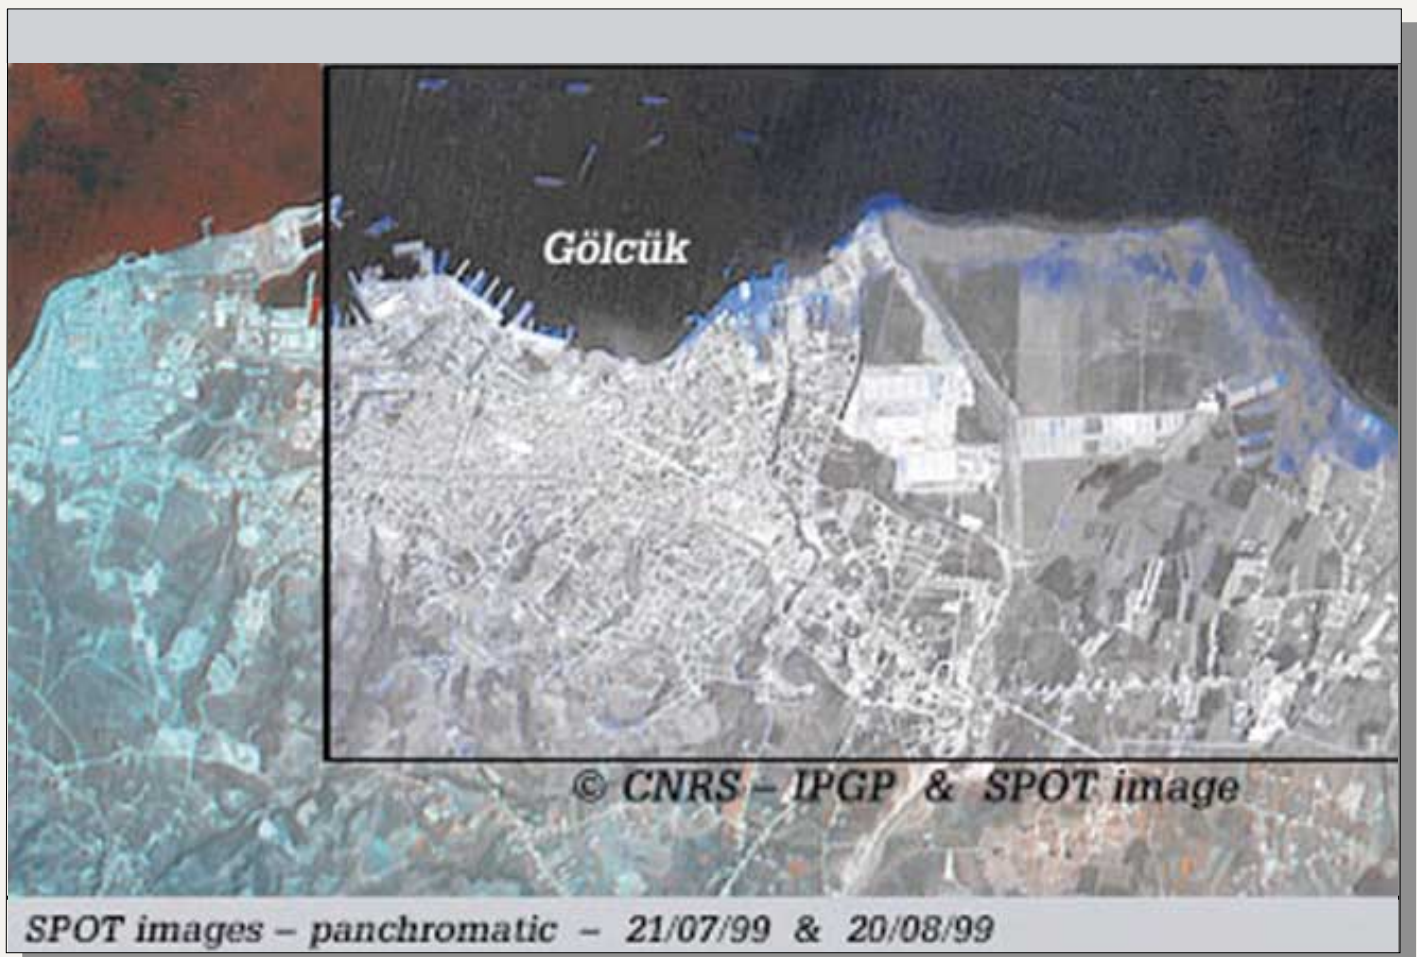
Figure 11. Satellite image of Gölcük area showing zones of coastal submergence (blue). Strike-slip faulting occurred through the port area (upper left) and oblique faulting occurred on the Gölcük (normal) fault. *Copyrighted image by CNRS-IPGP and SPOT image; used with permission.*

normal fault in Gölcük. Additional strike-slip faulting was not observed on the south side of Izmit Bay (B. Meyer, oral commun., 1999). The normal faulting in the Gölcük area caused regional subsidence that submerged part of the coast (fig. 11). Approximately 4 km of coastline on the south shore of Izmit Bay subsided about 2 to 3 m. Many structures built near the shore were inundated by the sea (fig. 12).

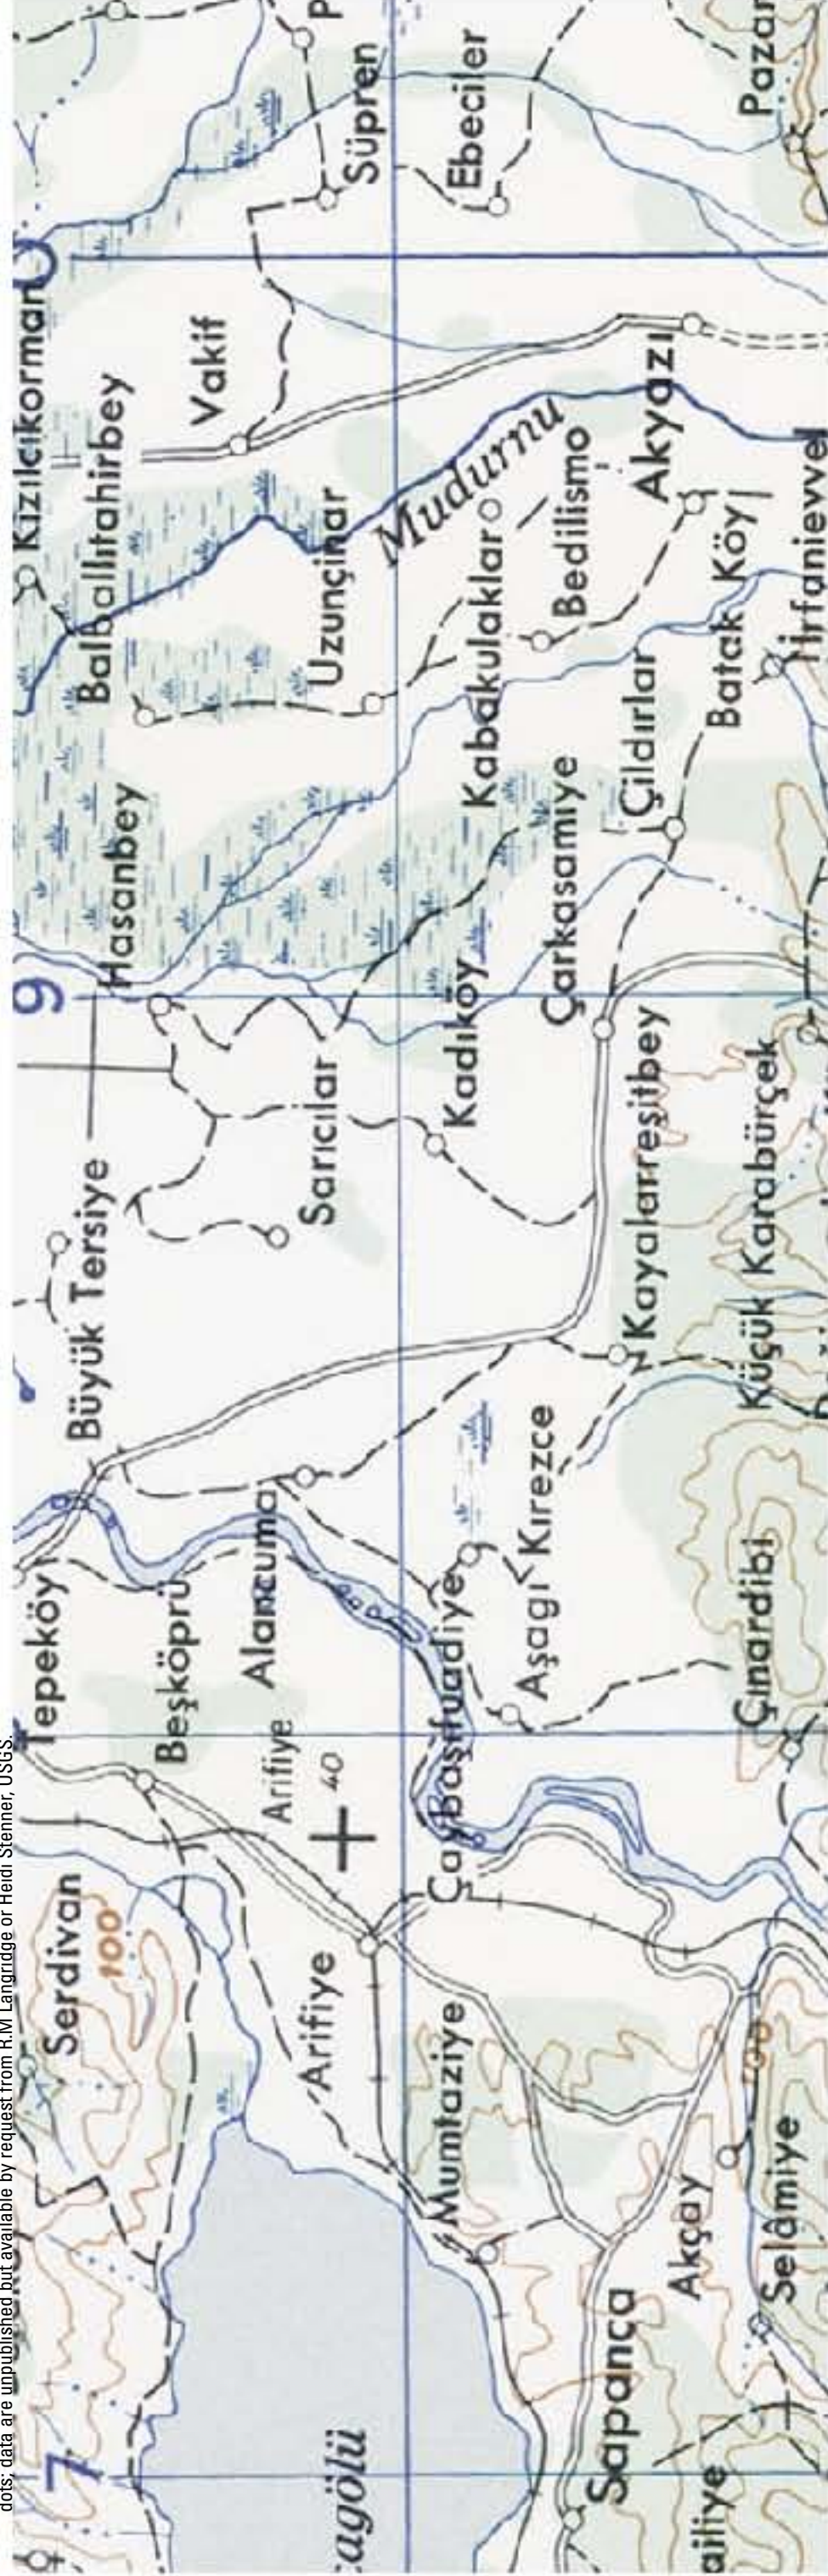
Figure 17. Offset poplar trees (2.7 m right lateral) along the surface rupture near Resitbey. The rupture traversed many poplar groves, cornfields, and arable land along the Sakarya River plain. *Photograph by Heidi Stenner.*

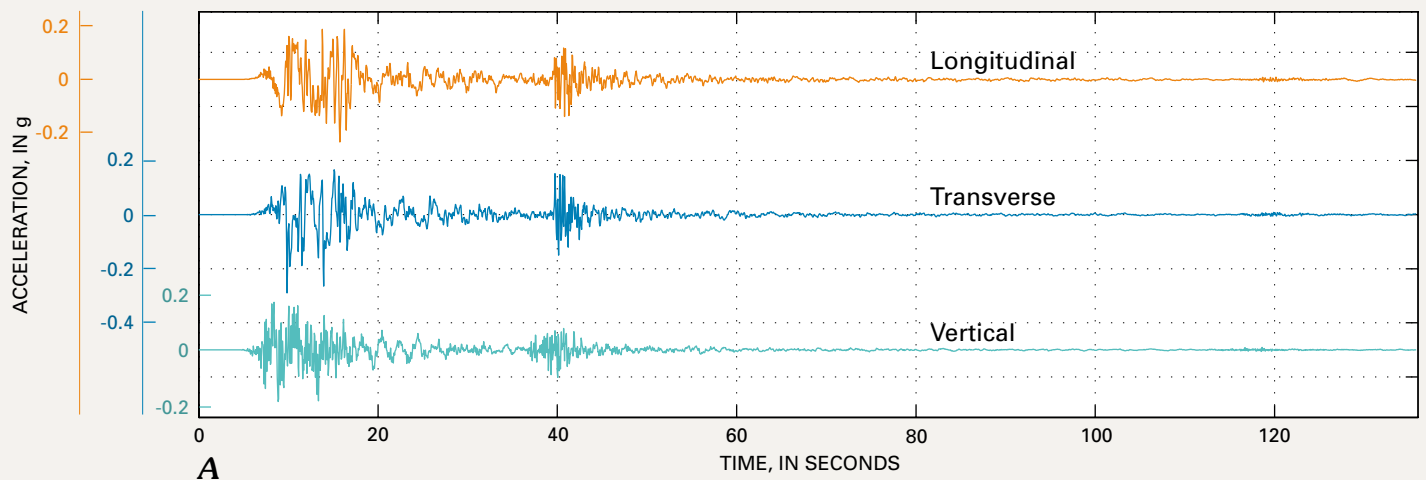
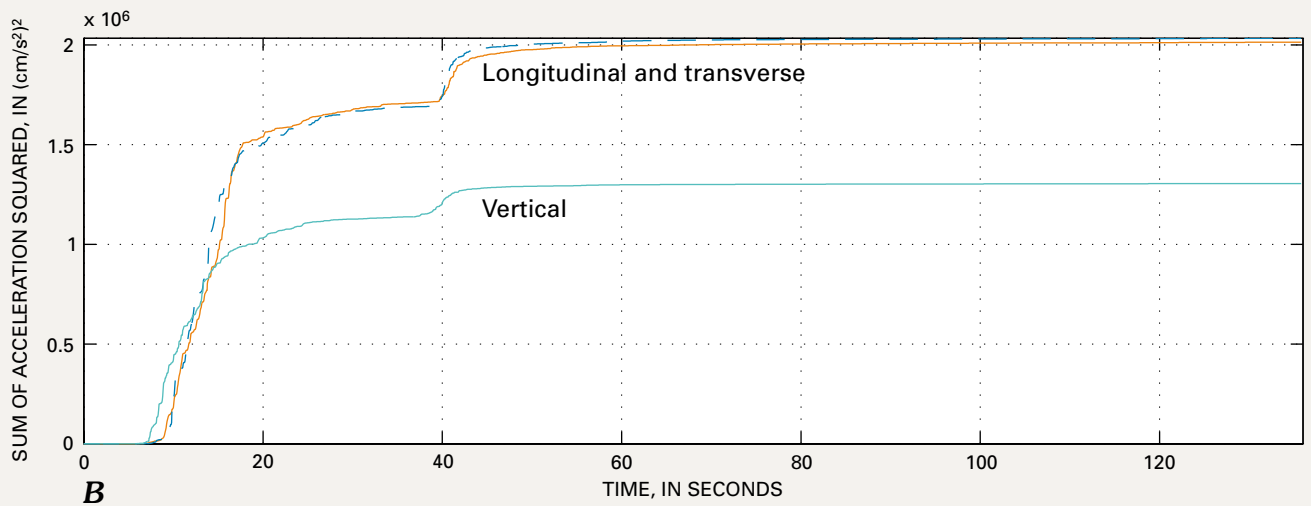
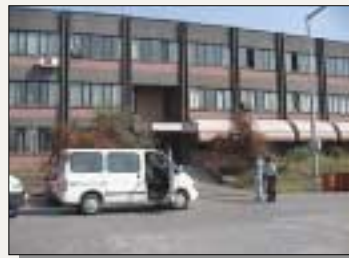
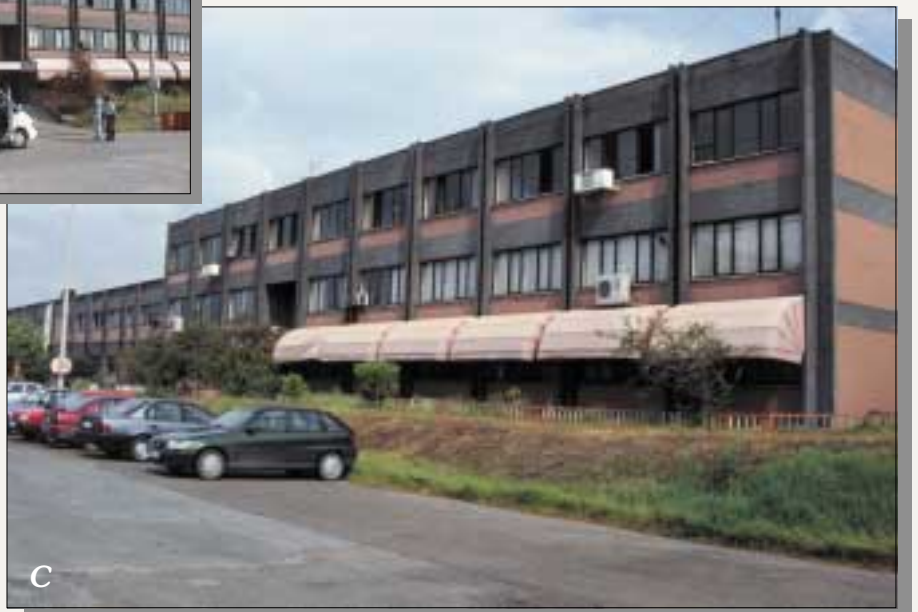
The time history of acceleration recorded at YPT (Petro-Chemical Plant in Korfez), a KOERI station, is shown in figure 24A. The station is located on alluvium. The time history reveals two distinct earthquake pulses. Figure 24B shows the cumulative sum of the square of acceleration, indicating an effective duration of approximately 15 s for the main shock. The main shock contributes approximately 85 percent of the significant ground shaking caused by the two events. The YPT instrument is housed on the first floor of a three-story building (fig. 23C).

Figure 24. *A*, Time histories of acceleration at YPT showing a second event approximately 33 s after the main shock. *B*, The main shock contributes approximately 85 percent of the total significant strong motion and its effective duration was about 15 s. Illustration by Mehmet Çelebi. *C*, Three-story building that houses the YPT accelerograph. Instrument is inside on first floor next to entrance. *Upper photograph* by Mehmet Çelebi, *lower photograph* by Thomas L. Holzer.

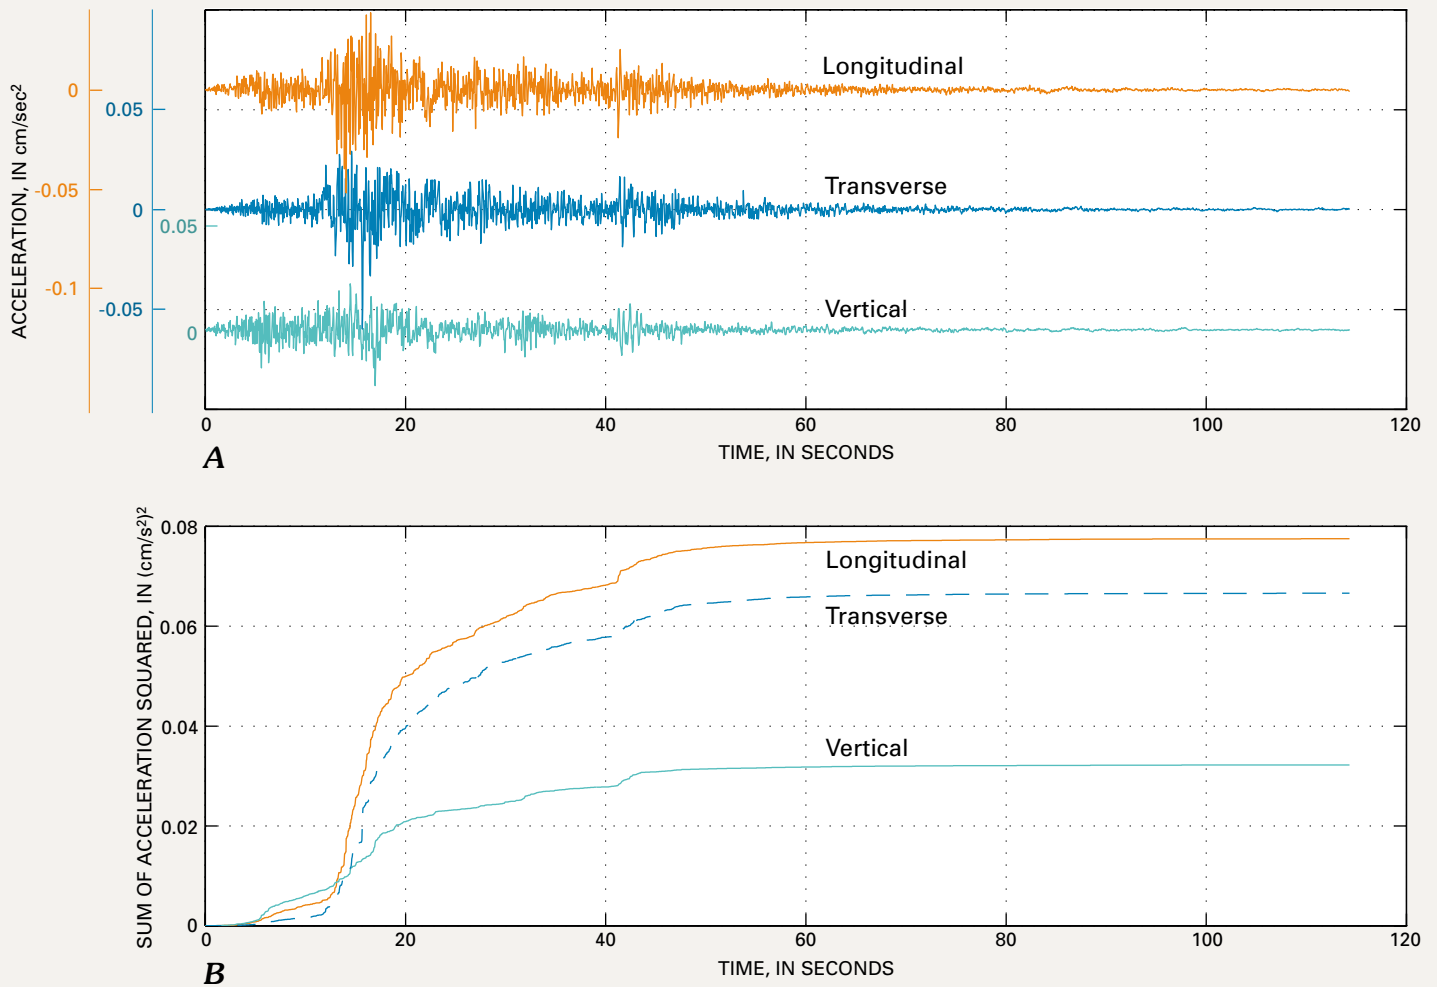
Figure 25. *A*, Time histories of acceleration at MCK in Istanbul. The plot shows several events. *B*, the cumulative sum of the squared acceleration values indicates the main shock contributed at least 90 percent of the total significant strong motion and the effective duration of strong motion was 36 s. *Illustration by Mehmet Çelebi.*

Figures 25A, B show the acceleration time history and the cumulative sum of the squared accelerations of the Mecidiyeköy (Istanbul) record (MCK), an İTÜ station. This station is located on rock.

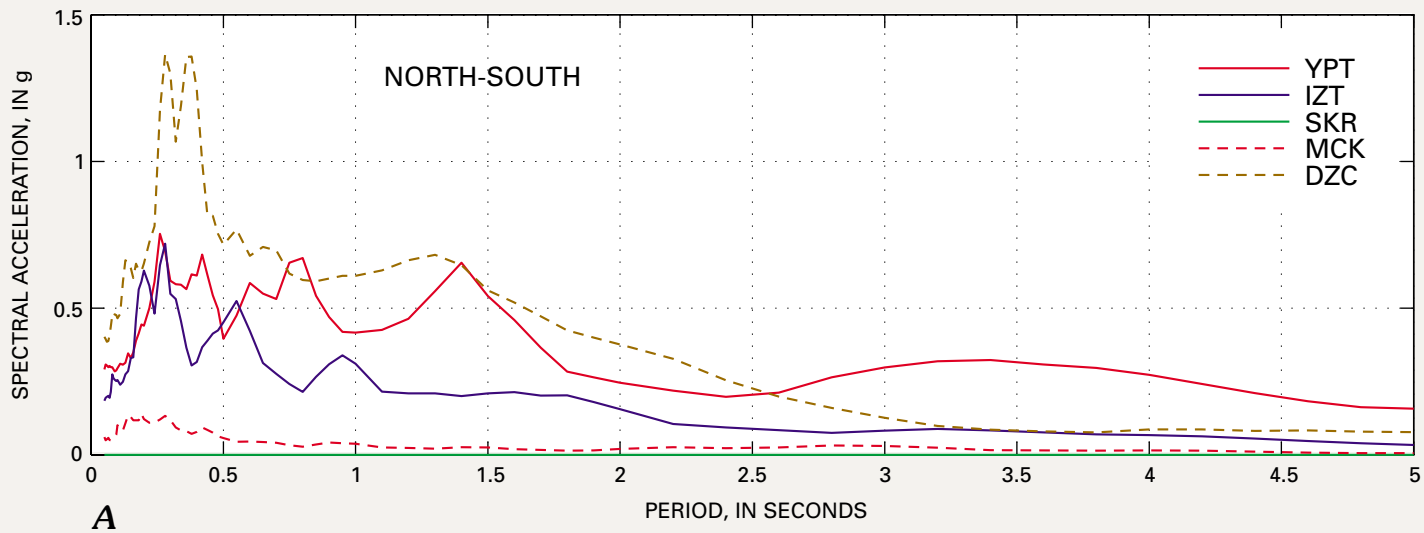
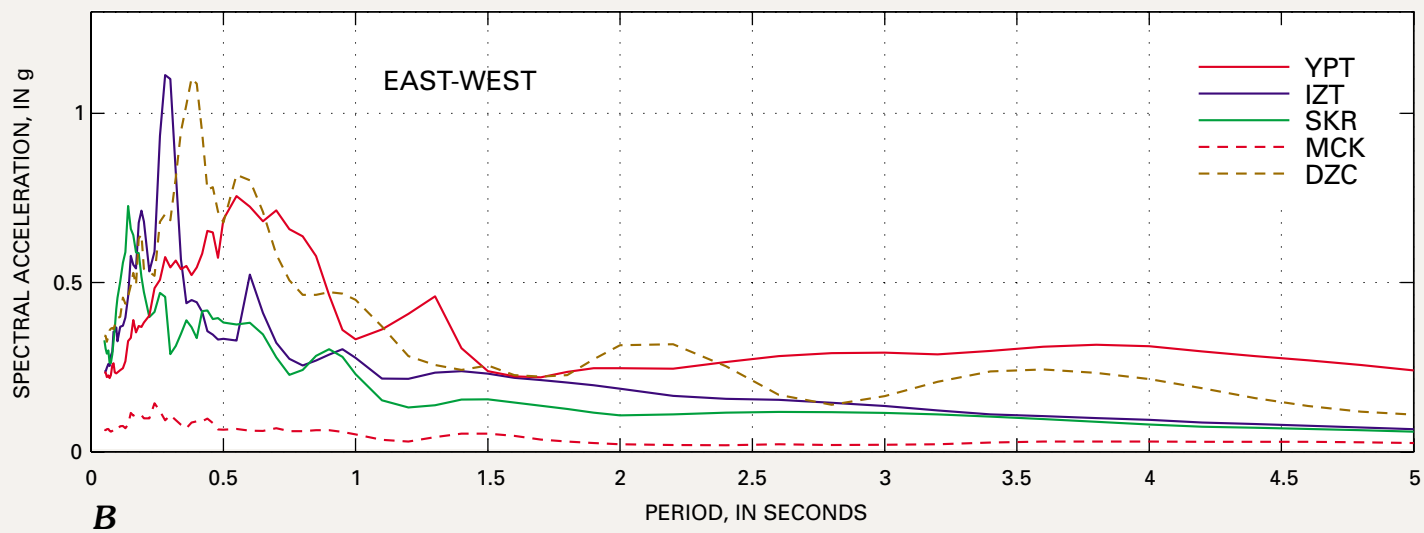
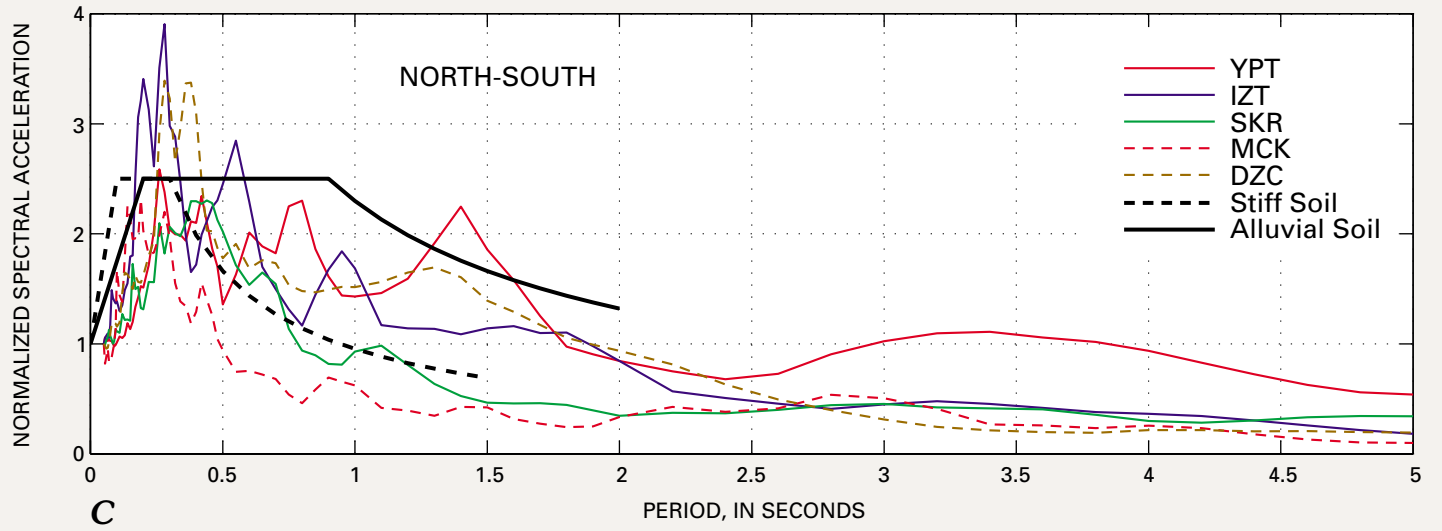
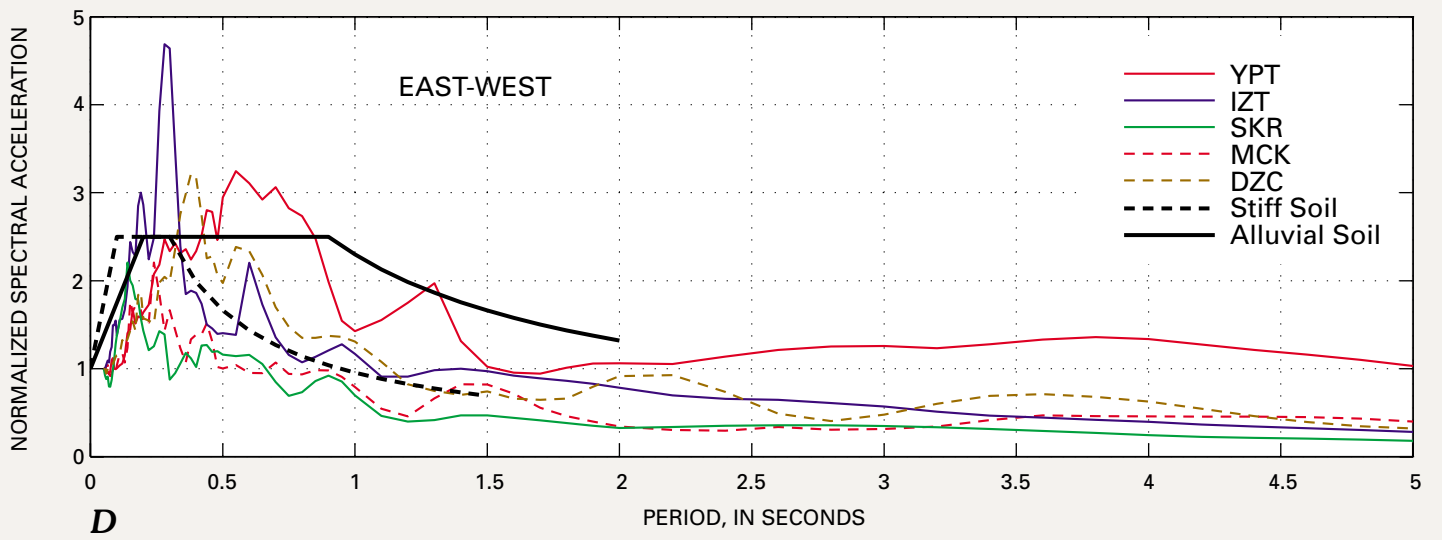
Figure 26 shows actual and normalized (with respect to zero-period accelerations) pseudo-acceleration response spectra, for north-south and east-west directions, respectively, for 5 stations, DZC, IZT, MCK, SKR, and YPT. Four of the stations (DZC, IZT, SKR, YPT) are in the epicentral area, two of which, (DZC, SKR) are near areas with heavy damage in the eastern part of the epicentral area. The fifth station (MCK) is in Istanbul. Three stations (DZC, IZT, YPT) are on alluvium whereas two stations (SKR, MCK) are on either stiff soil or soft rock. The response spectra reveal different resonant periods at each station. The normalized response spectra indicate that both YPT

and DZC have long resonant periods or low-frequency responses. For comparison, the design spectra for the current Turkish Building Code for soil and alluvial site conditions are also shown in figures 26C, D (Aydinoglu, 1998). For periods between 0.1 and 1 s, the design spectra, which are similar to those used in the United States, were either nearly or actually exceeded during the Kocaeli earthquake. The majority of the structures in the epicentral area were built to a lower design spectra before the 1998 code was implemented. Thus, the strength of many structures would have been insufficient to resist the forces generated by the Kocaeli earthquake even if the structures had been constructed according to existing codes.

Figure 26. Actual pseudo-acceleration response spectra (**A**, **B**) and normalized (with respect to zero-period acceleration) response spectra (**C**, **D**) for 5 stations. The normalized response spectra also show the response spectra of the 1998 Turkish Building Code for stiff and alluvial soil site conditions. *Illustration by Mehmet Çelebi.*

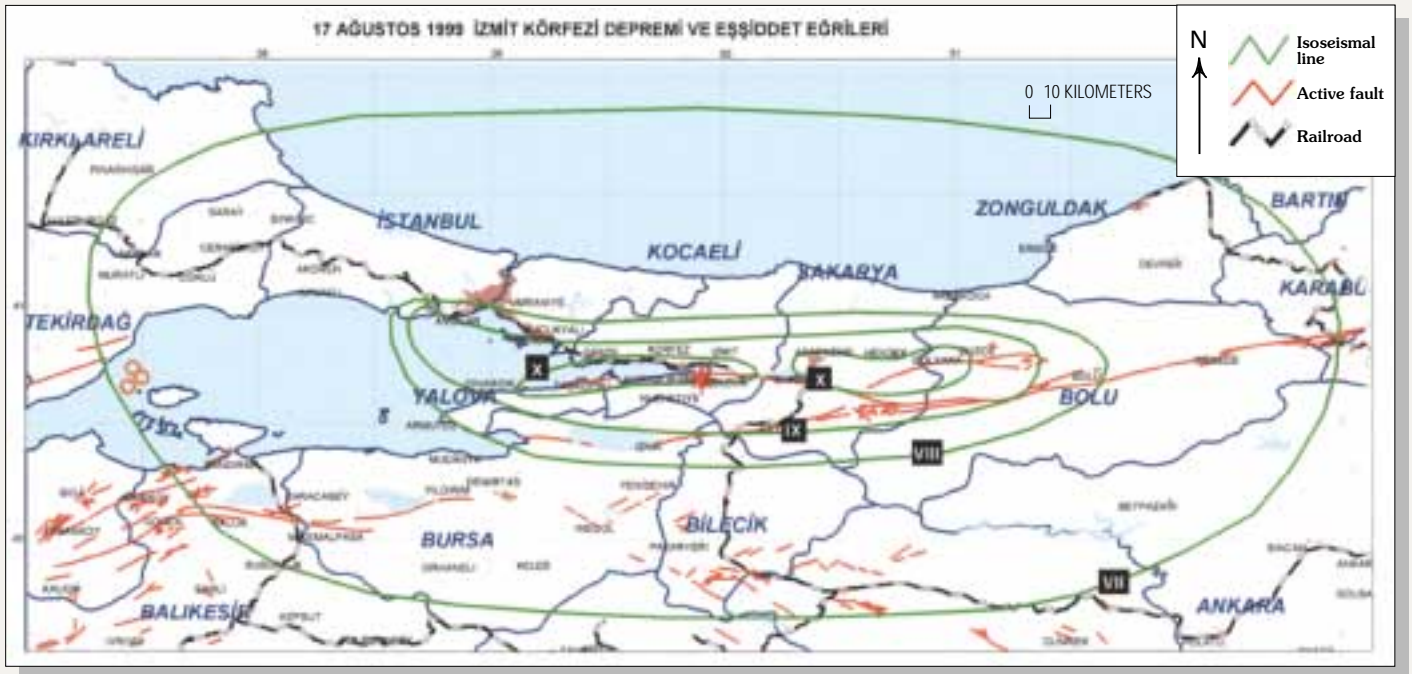
Figure 27. Preliminary isoseismal map of Modified Mercalli intensities (Roman numerals) of the August 17, 1999, Kocaeli earthquake. *Modified from Earthquake Research Department, Directorate for Disaster affairs, Ministry of Public Works and Settlement.*

The small number of strong-motion stations in the epicentral region that recorded the main shock precludes a detailed mapping of ground motions. However, the areal extent of strong shaking can be inferred from mapping damage and reports of felt shaking. The ERD of the Ministry of Public Works and Settlement issued a preliminary Modified Mercalli intensity map in late September 1999, a month after the main event (fig. 27). The Modified Mercalli scale uses observations of damage to infer the intensity of shaking (Wood and Neumann, 1931). About 150,000 km² was shaken at Modified Mercalli intensity VII or greater, intensities that prompt people to run outdoors.

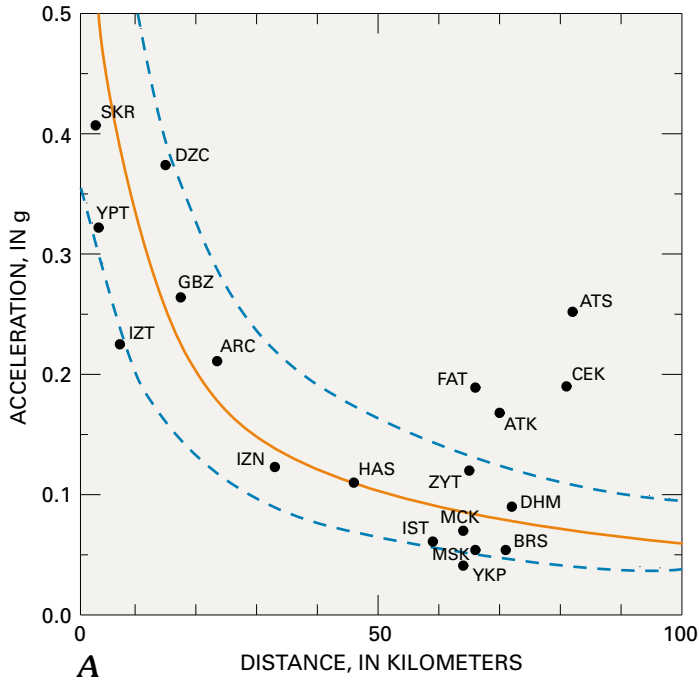
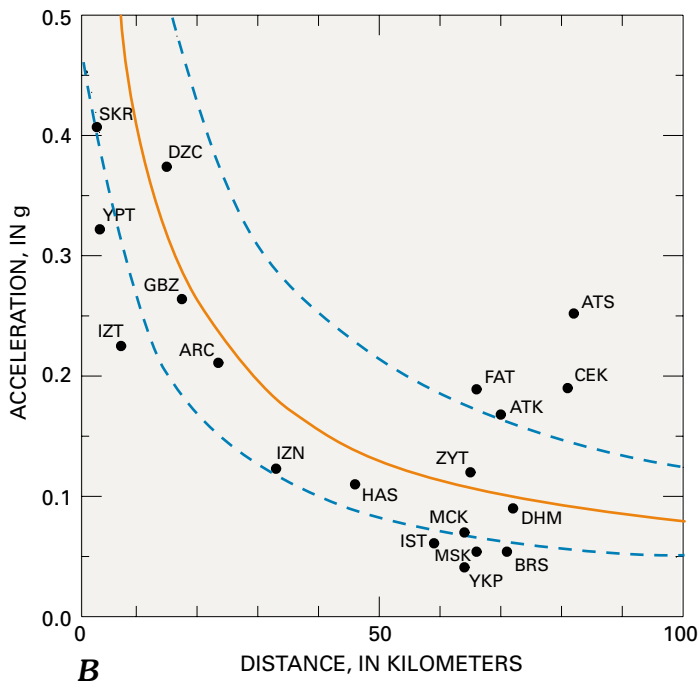
Figure 28. Values of peak horizontal acceleration recorded during the Kocaeli earthquake as a function of distance from the fault compared to values predicted by Boore and others (1994) for a M_W 7.4 earthquake in Western North America. **A**, Values predicted for sites with average shear wave velocities of 760 m/s. **B**, Values predicted for sites with average shear wave velocities of 360 m/s. Uncertainty is shown by the one standard deviation curves (dashed lines). *Illustration by Selcuk Toprak.*

Peak horizontal accelerations from the Kocaeli earthquake for the 19 stations compiled in table 1 are compared to values predicted by the empirical attenuation relation proposed by Boore and others (1994) in figure 28. Their attenuation relation, which predicts how peak accelerations decrease with distance from the surface rupture, is based on regression analyses of peak accelerations recorded in western North America. The comparison suggests that observed peak horizontal accelerations were below average within at least 7.5 km of the fault rupture for an M_W 7.4 earthquake. At greater distances from the fault, the values were more typical of those to be expected for an M_W 7.4 earthquake although values from recorded at distances from 10 to 50 km from surface rupture also are slightly on the low side. One of the factors in the regression is the soil condition at each recording site. Peak ground motions are generally higher at soil sites than rock sites. Because site conditions are poorly documented at most of the strong motion stations in Turkey, values are compared to attenuation curves for two different site conditions. Figure 28A compares the observed values to an attenuation curve for sites underlain by materials with an average shear wave velocity of 760 m/s in the upper 30 m. Figure 28B compares observed values to an attenuation curve for site conditions with an average shear wave velocity of 360 m/s in the upper 30 m beneath the station. The 760 m/s velocity is the boundary between rock and very dense soil/soft rock; the 360 m/s velocity is the boundary between very dense soil/soft rock and stiff soil (Federal Emergency Management Agency, 1998). Based on field inspection of the three stations that are closest to the surface rupture, one (SKR) is estimated to be near the 760 m/s boundary and two (IZT and YPT) are estimated to be near the 360 m/s boundary.

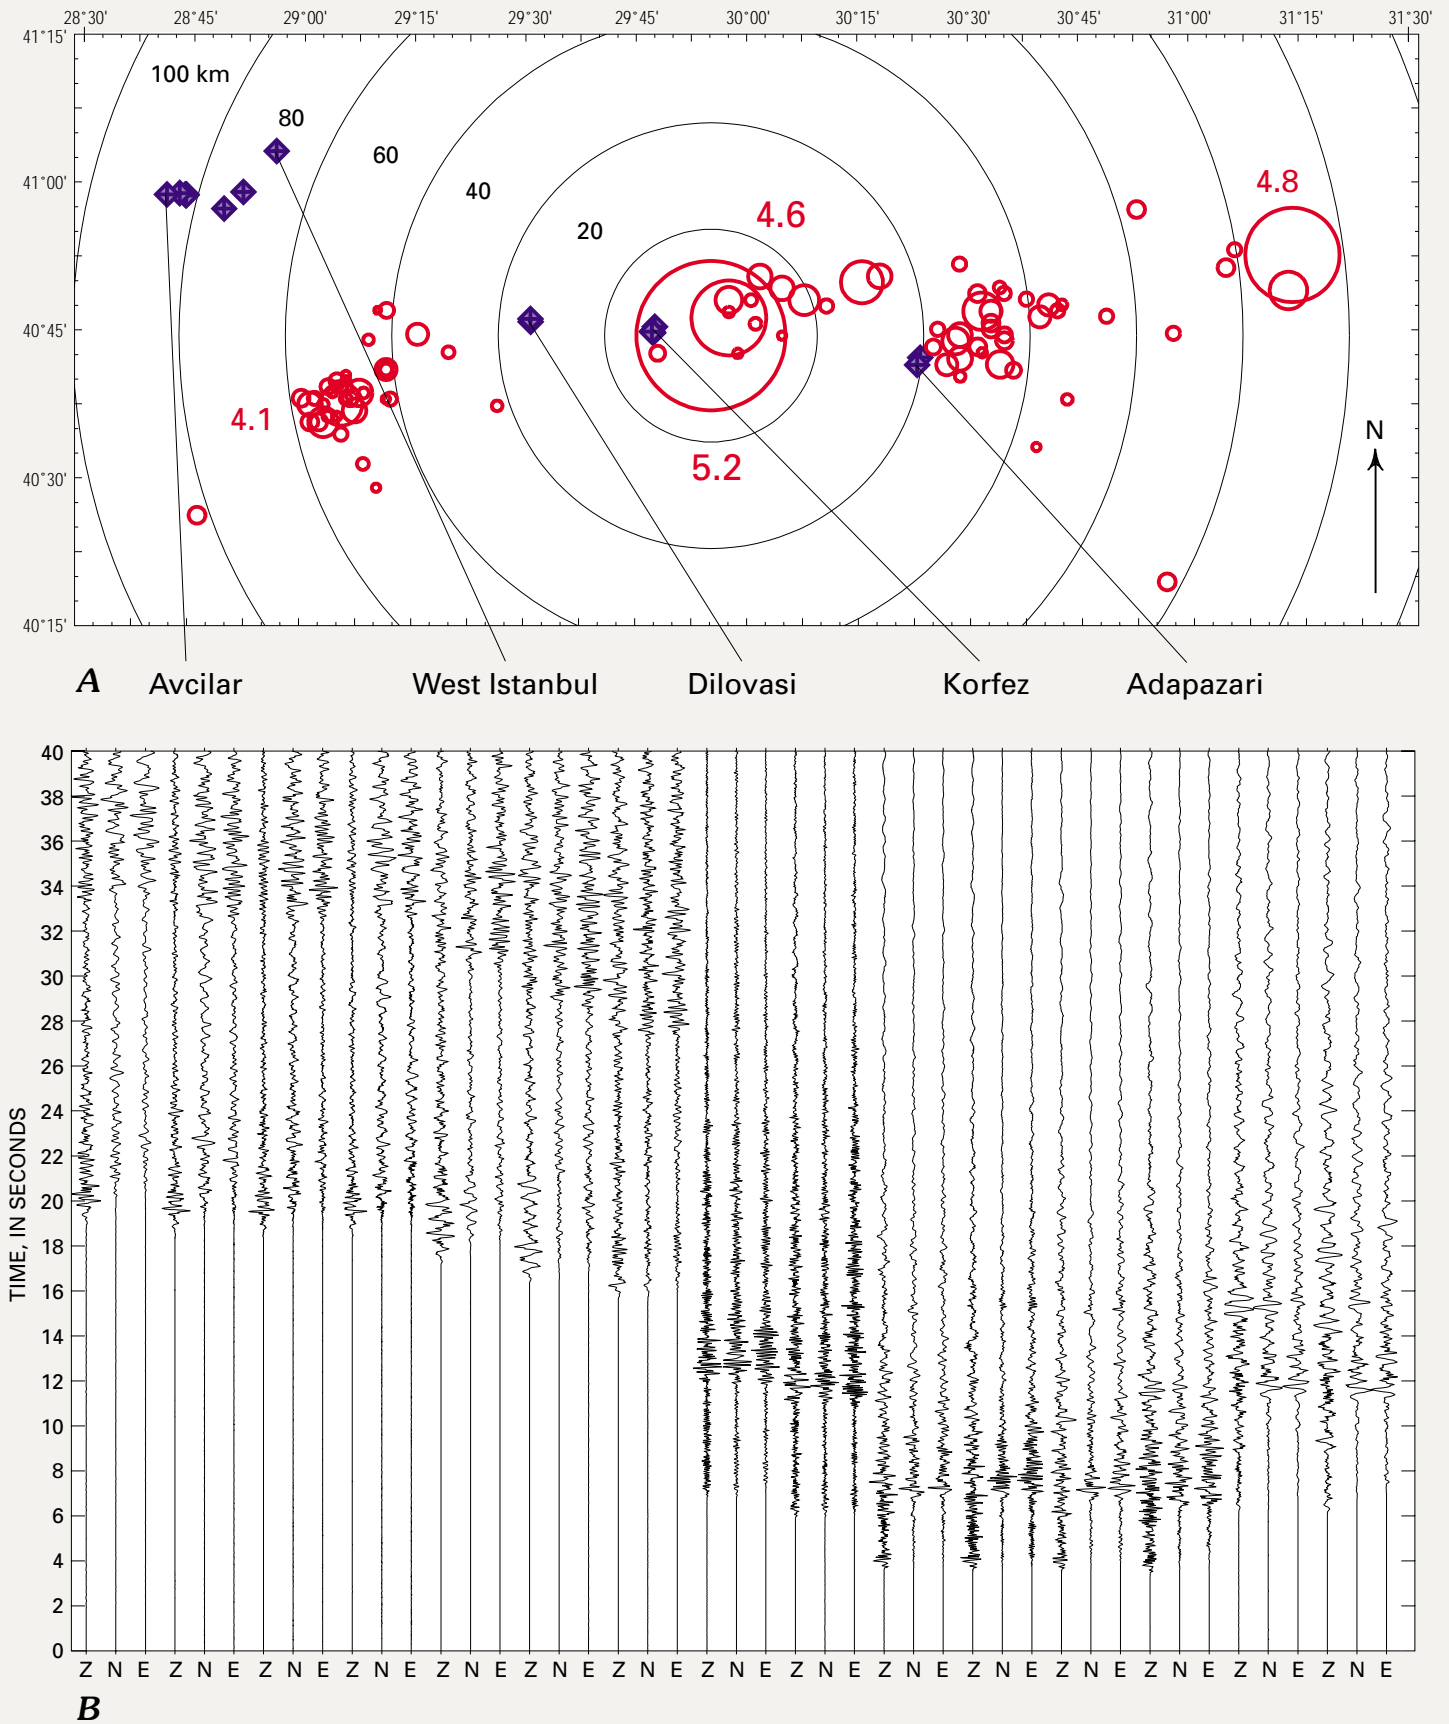
Figure 30. **A**, Map of Kocaeli earthquake aftershock zone and sites of USGS portable, digital seismographs (blue diamonds). Black concentric circles centered on the M 5.2 aftershock epicenter are in 20-km increments. Red circles are aftershock locations and their radii are proportional to their size; the magnitudes of the four largest events are annotated. **B**, The corresponding three components of ground motion for the M 5.2 aftershock recorded at the USGS sites are shown as a pseudo-record section of 40-s duration; Z, vertical, N, north-south, E, east-west. The amplitudes of each trace are normalized to the peak value of that trace. *Illustration by Edward Cranswick.*

Figure 30A shows the locations of USGS instruments and epicenters of aftershocks recorded by at least one station during the initial visit. The Avcilar district, an area of severe damage, is located west of the Istanbul airport and about 80 km from the end of the main-shock seismic source zone. The damage in Avcilar (fig. 31) was surprising, given its distance from the main shock and the fact that it is surrounded by areas that sustained little damage. Three instruments were located inside the zone of severe damage and four instruments were located in the surrounding area west of Istanbul. Dilovasi, 35 km west of the main-shock epicenter, is the site of planned port facilities and the northern abutment of a planned suspension bridge across the Gulf of Izmit. Two instruments were located in Dilovasi, one on rock and one on artificial fill. Korfez, 10 km west of the main-shock epicenter, suffered severe damage and four instruments were set up, three in a triangle-shaped array on young deposits near the city center (at the TUPRAS campus), and one on older deposits several kilometers away. Adapazari, 40 km east of the main-shock epicenter, was also heavily damaged and three instruments were located in a triangular array in an alluvial valley south of the city center (at the Toyota assembly plant).

Figure 30B illustrates the breadth and quality of the USGS ground-motion data. The plot shows three-component seismograms recorded at selected sites during a magnitude 5.2 aftershock (fig. 30A) on August 31. Figure 32A shows three-component seismograms (low-pass filtered at 4 Hz) recorded at the Dilovasi and Toyota sites recorded during a magnitude 4.1 aftershock (fig. 30A) on August 31. Plotted on a common amplitude scale, these seismograms illustrate two site effects. First, horizontal shaking at Dilovasi is clearly amplified at the seismograph located on fill when compared to the shaking at the seismograph located nearby on rock. Second, shaking is much stronger at the two Toyota plant sites in the alluvial valley south of Adapazari than at Dilovasi, even though the Toyota plant sites are located farther from the epicenter of the aftershock. Figure 32B shows the coherence of low-frequency ground motion (from the magnitude-5.2 aftershock, low-pass filtered at 0.25 Hz) recorded at each station in the triangular array in Korfez. Figure 33A is a map of the Avcilar area showing units of surface geology categorized according to geotechnical properties. Low-frequency ground motion (from the magnitude-5.2 aftershock, low-pass filtered at 0.25 Hz) is strongly amplified at sites in the damage area at Avcilar compared to nearby sites outside the damage area (fig. 33B).

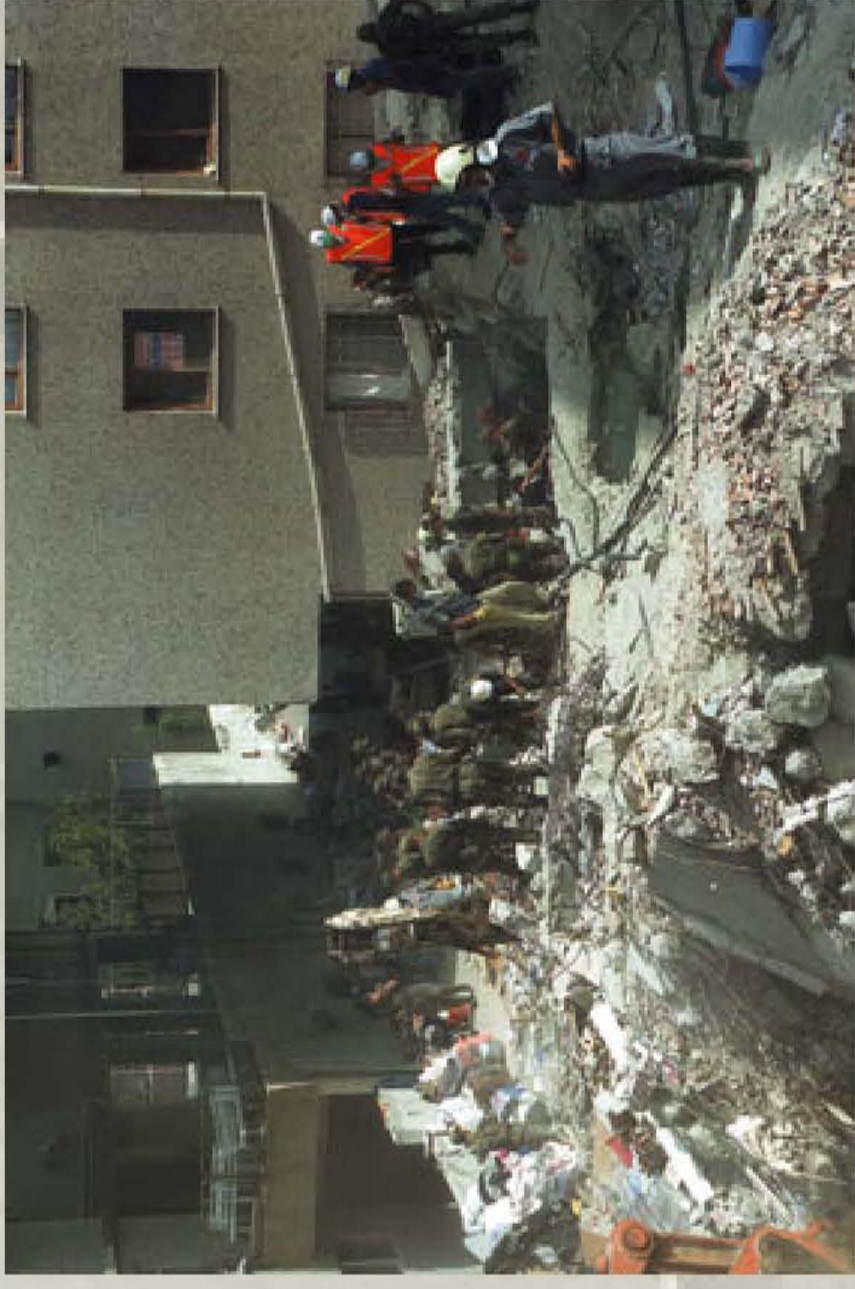
Figure 31. Rescue effort 4 days after the main shock at a collapsed building in area of concentrated damage in Avcilar. Photograph by Thomas L. Holzer.
