Implications for Earthquake Risk Reduction in the United States from the Kocaeli, Turkey, Earthquake of August 17, 1999

U.S. Geological Survey Circular 1193

By U.S. Geological Survey

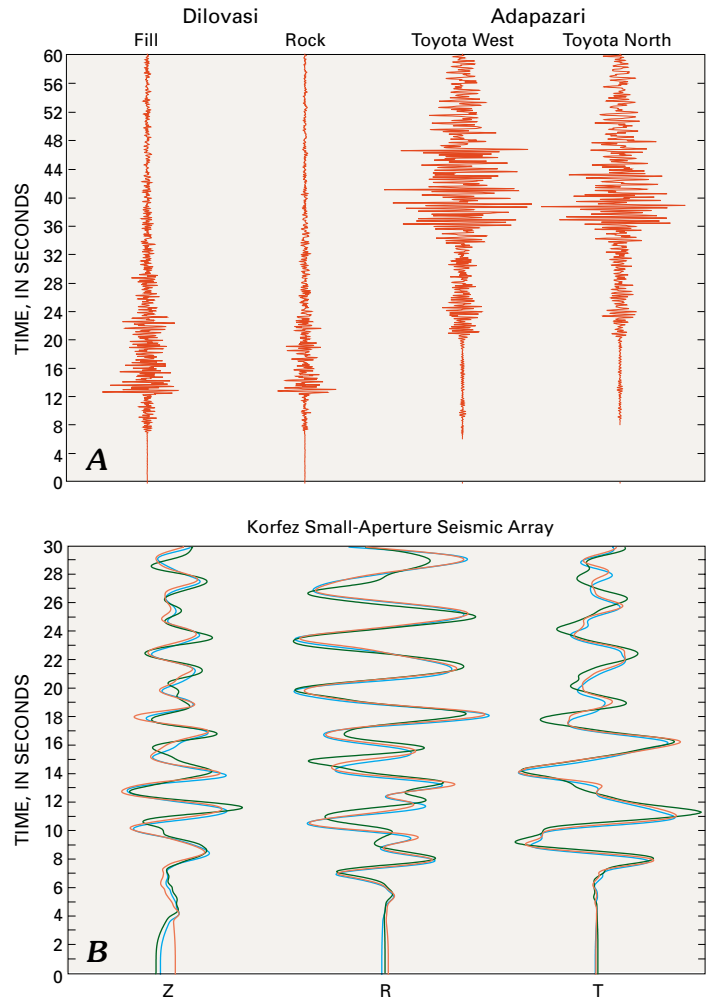
Figure 30B illustrates the breadth and quality of the USGS ground-motion data. The plot shows three-component seismograms recorded at selected sites during a magnitude 5.2 aftershock (fig. 30A) on August 31. Figure 32A shows three-component seismograms (low-pass filtered at 4 Hz) recorded at the Dilovasi and Toyota sites recorded during a magnitude 4.1 aftershock (fig. 30A) on August 31. Plotted on a common amplitude scale, these seismograms illustrate two site effects. First, horizontal shaking at Dilovasi is clearly amplified at the seismograph located on fill when compared to the shaking at the seismograph located nearby on rock. Second, shaking is much stronger at the two Toyota plant sites in the alluvial valley south of Adapazari than at Dilovasi, even though the Toyota plant sites are located farther from the epicenter of the aftershock. Figure 32B shows the coherence of low-frequency ground motion (from the magnitude-5.2 aftershock, low-pass filtered at 0.25 Hz) recorded at each station in the triangular array in Korfez. Figure 33A is a map of the Avcilar area showing units of surface geology categorized according to geotechnical properties. Low-frequency ground motion (from the magnitude-5.2 aftershock, low-pass filtered at 0.25 Hz) is strongly amplified at sites in the damage area at Avcilar compared to nearby sites outside the damage area (fig. 33B).

Figure 32. A, Pseudo-record section of ground motions from two pairs of stations at Dilovasi and Adapazari plotted on the same amplitude and time scales. Note the S-minus-P time of the first pair is approximately 5 s and that of the second is approximately 16 s. B, Overlay of Z, R, T components of closely spaced North, South, West stations at Korfez, all traces plotted on the same amplitude and time scales. *Illustration by Edward Cranswick.*

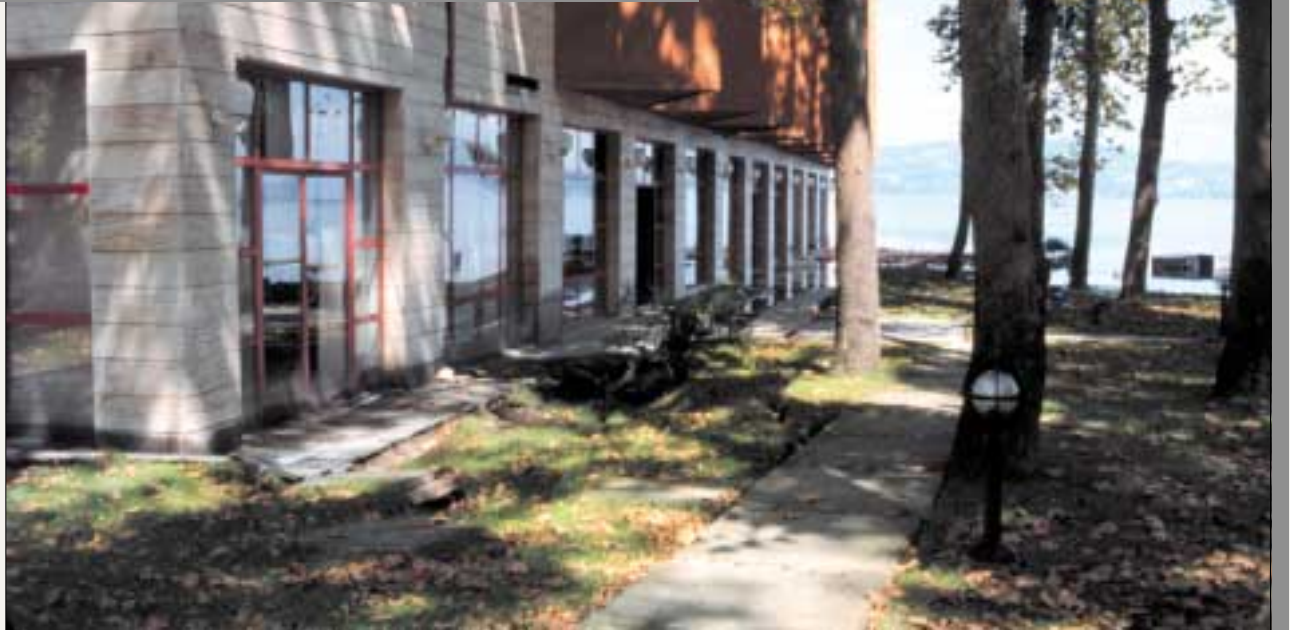
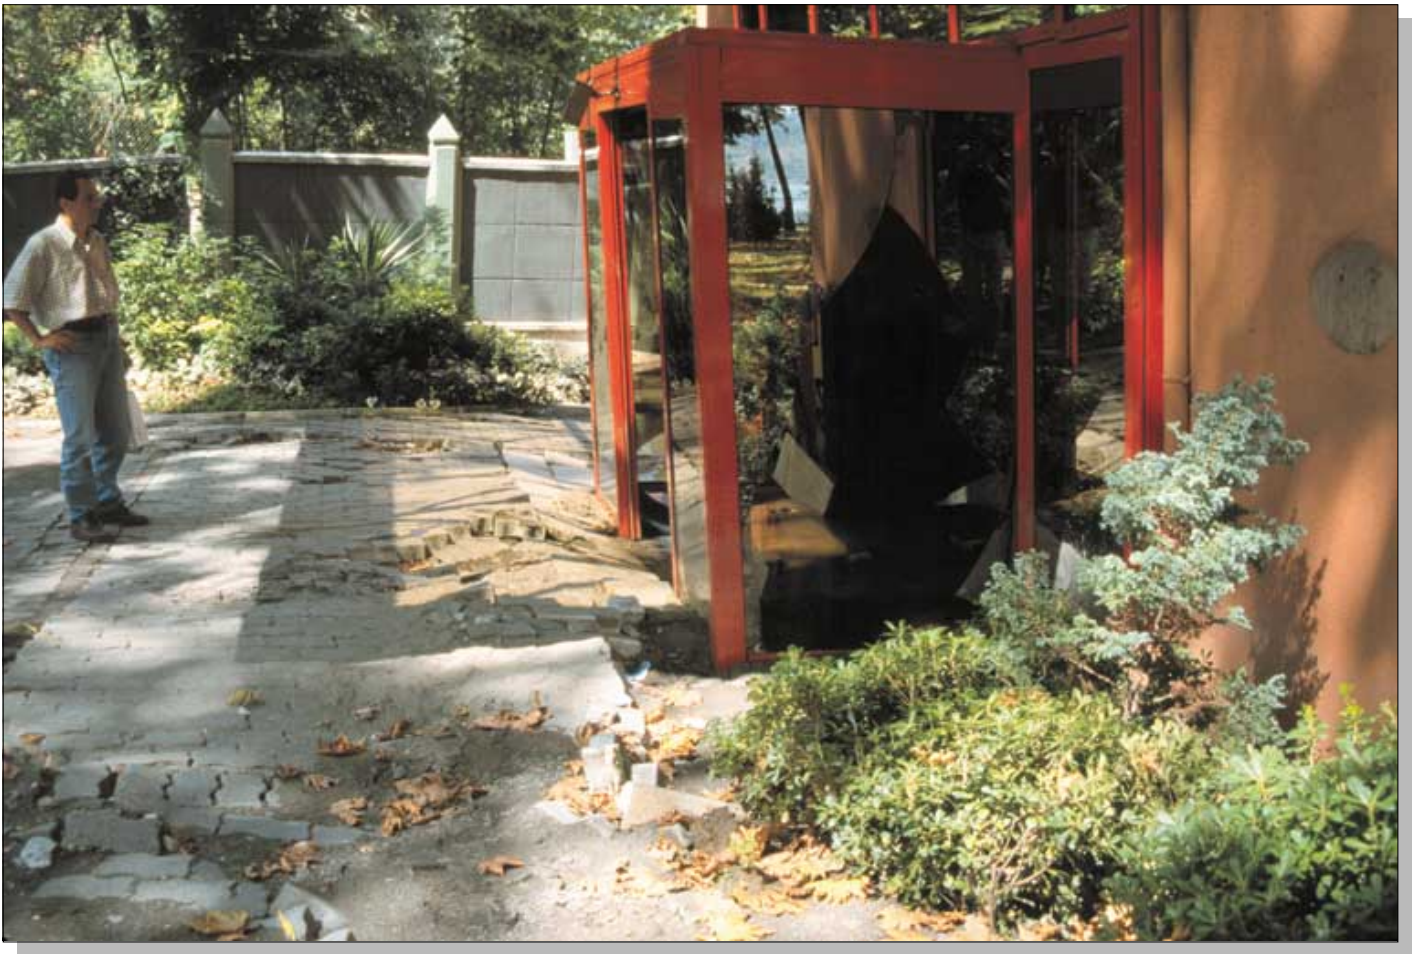
Along the southeast shore of Lake Sapanca, soils also liquefied and the Lake Sapanca Hotel was dramatically affected. The hotel, which was built on an old stream delta that had prograded into Lake Sapanca, sank about 0.3 m into the ground. The regional land surface around the hotel also lowered causing the shoreline to submerge (figs. 37, 38). In addition, the hotel was displaced about 0.5 m toward the lake by a lateral spread along the shoreline of the lake. Large quantities of subsurface sand vented to the surface and covered much of the driveway and the landscaping around the hotel.

Figure 38. Sunken entryway into Sapanca Hotel created when building sank into liquefied soil. *Photograph by Thomas L. Holzer.*

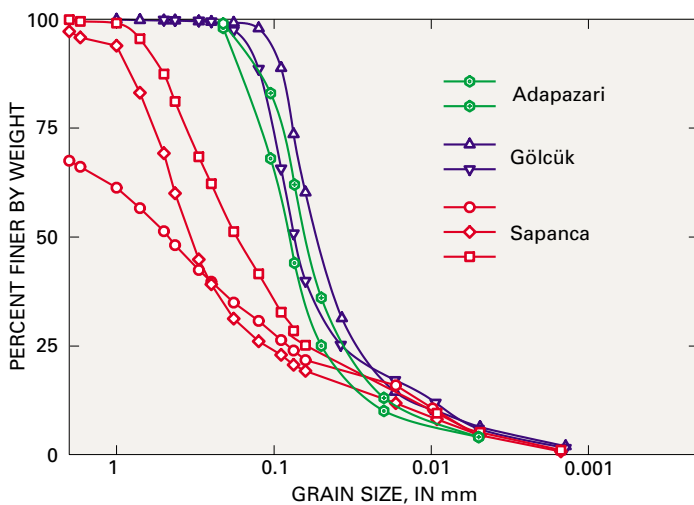
Figure 39. Grain-sized distributions of sand boils sampled near sites of sunken buildings in Adapazari, Gölcük, and Sapanca. Vertical axis is percent of sample by weight finer than the grain size shown on the horizontal axis. *Illustration prepared by Michael J. Bennett. Data from USGS and ERDC.*

Sand boils were sampled at Adapazari, Gölcük, and Sapanca. Liquefied material was predominantly fine grained; grain-size distributions of the material typically ranged from silts to silty sands (fig. 39). The two coarser sand boils sampled at the Sapanca site contained cobbles and other coarse-grained material. These sand boils may have been contaminated with cobbles contained in the base of a driveway. The other sand boil at Sapanca was in an open area and not susceptible to contamination.

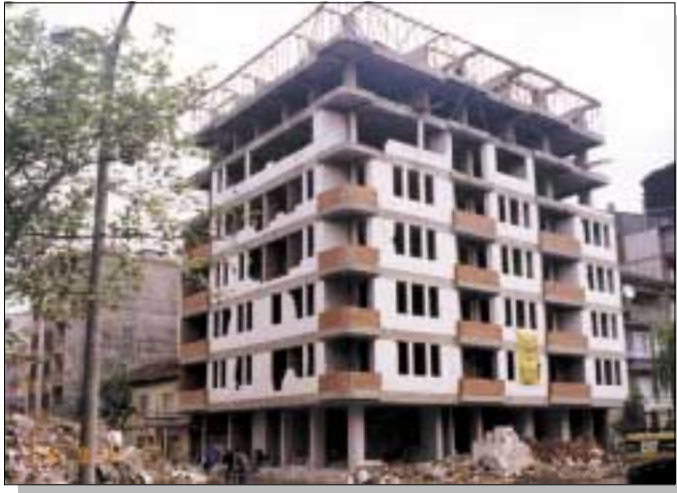
Figure 40 shows a building under construction illustrating common construction practice. In most cases of building collapse, there was no evidence of shear walls. Consequently, lateral resistance to the strong ground shaking was provided solely by frame action. Concrete compressive strength was not measured, but honeycombing was observed in similar new construction that did not collapse suggesting somewhat poorer concrete placement practices than typically found in U.S. construction. Furthermore, undeformed reinforcing bars were widely used for both flexural and shear reinforcement, a practice not permitted under U.S. building codes. Most of the reinforced concrete buildings can be characterized as having little or no ductility.

Figure 40. Building in Izmit under construction using reinforced concrete frame construction. Note absence of shear walls. *Photograph by National Institute of Standards and Technology.*

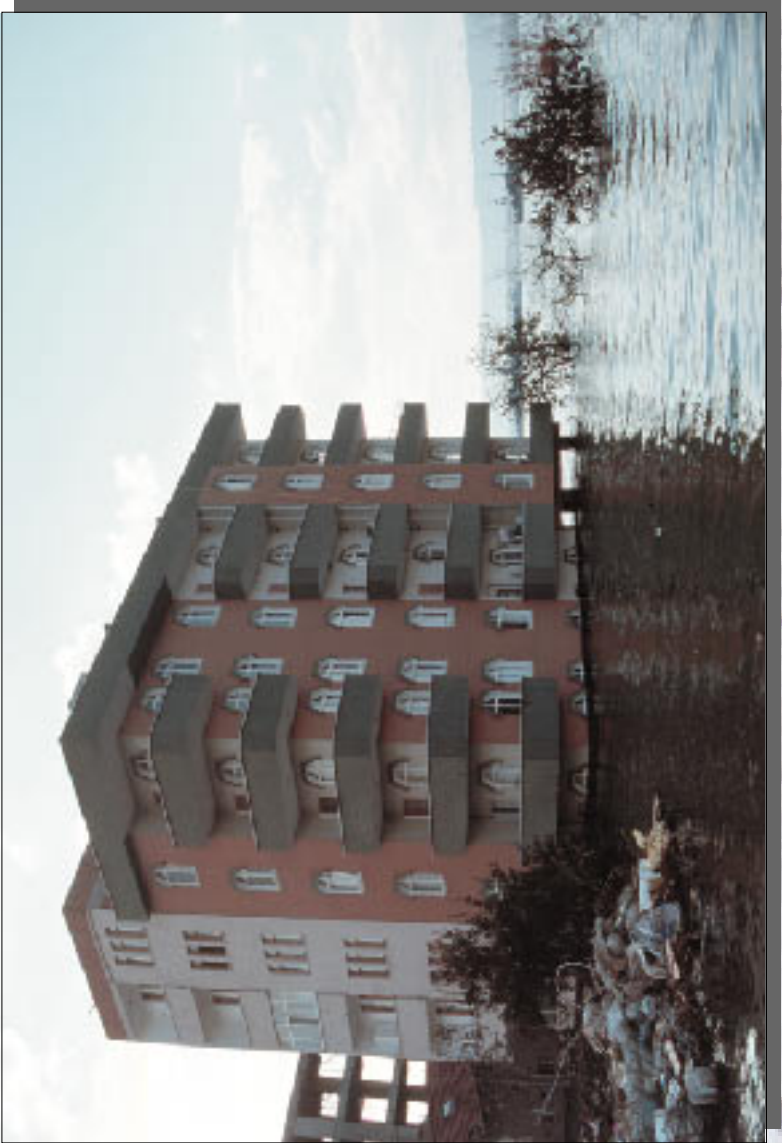
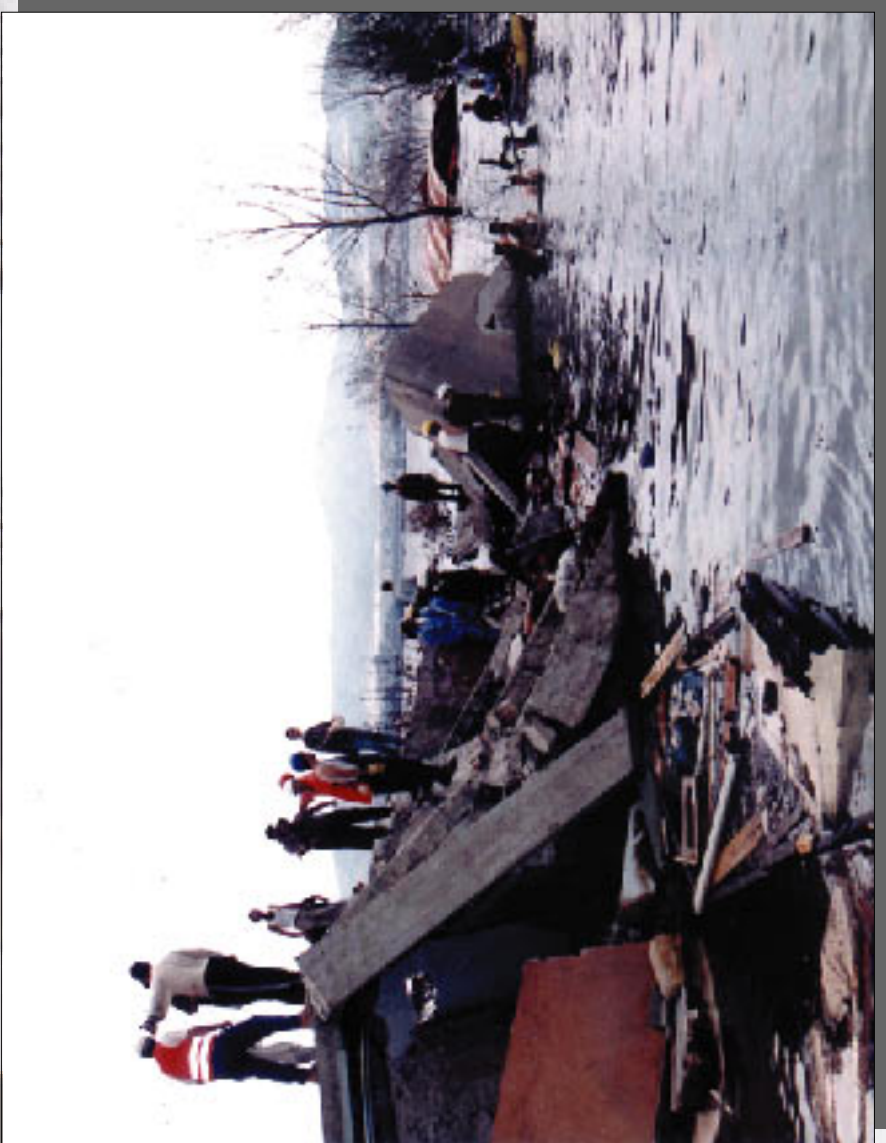
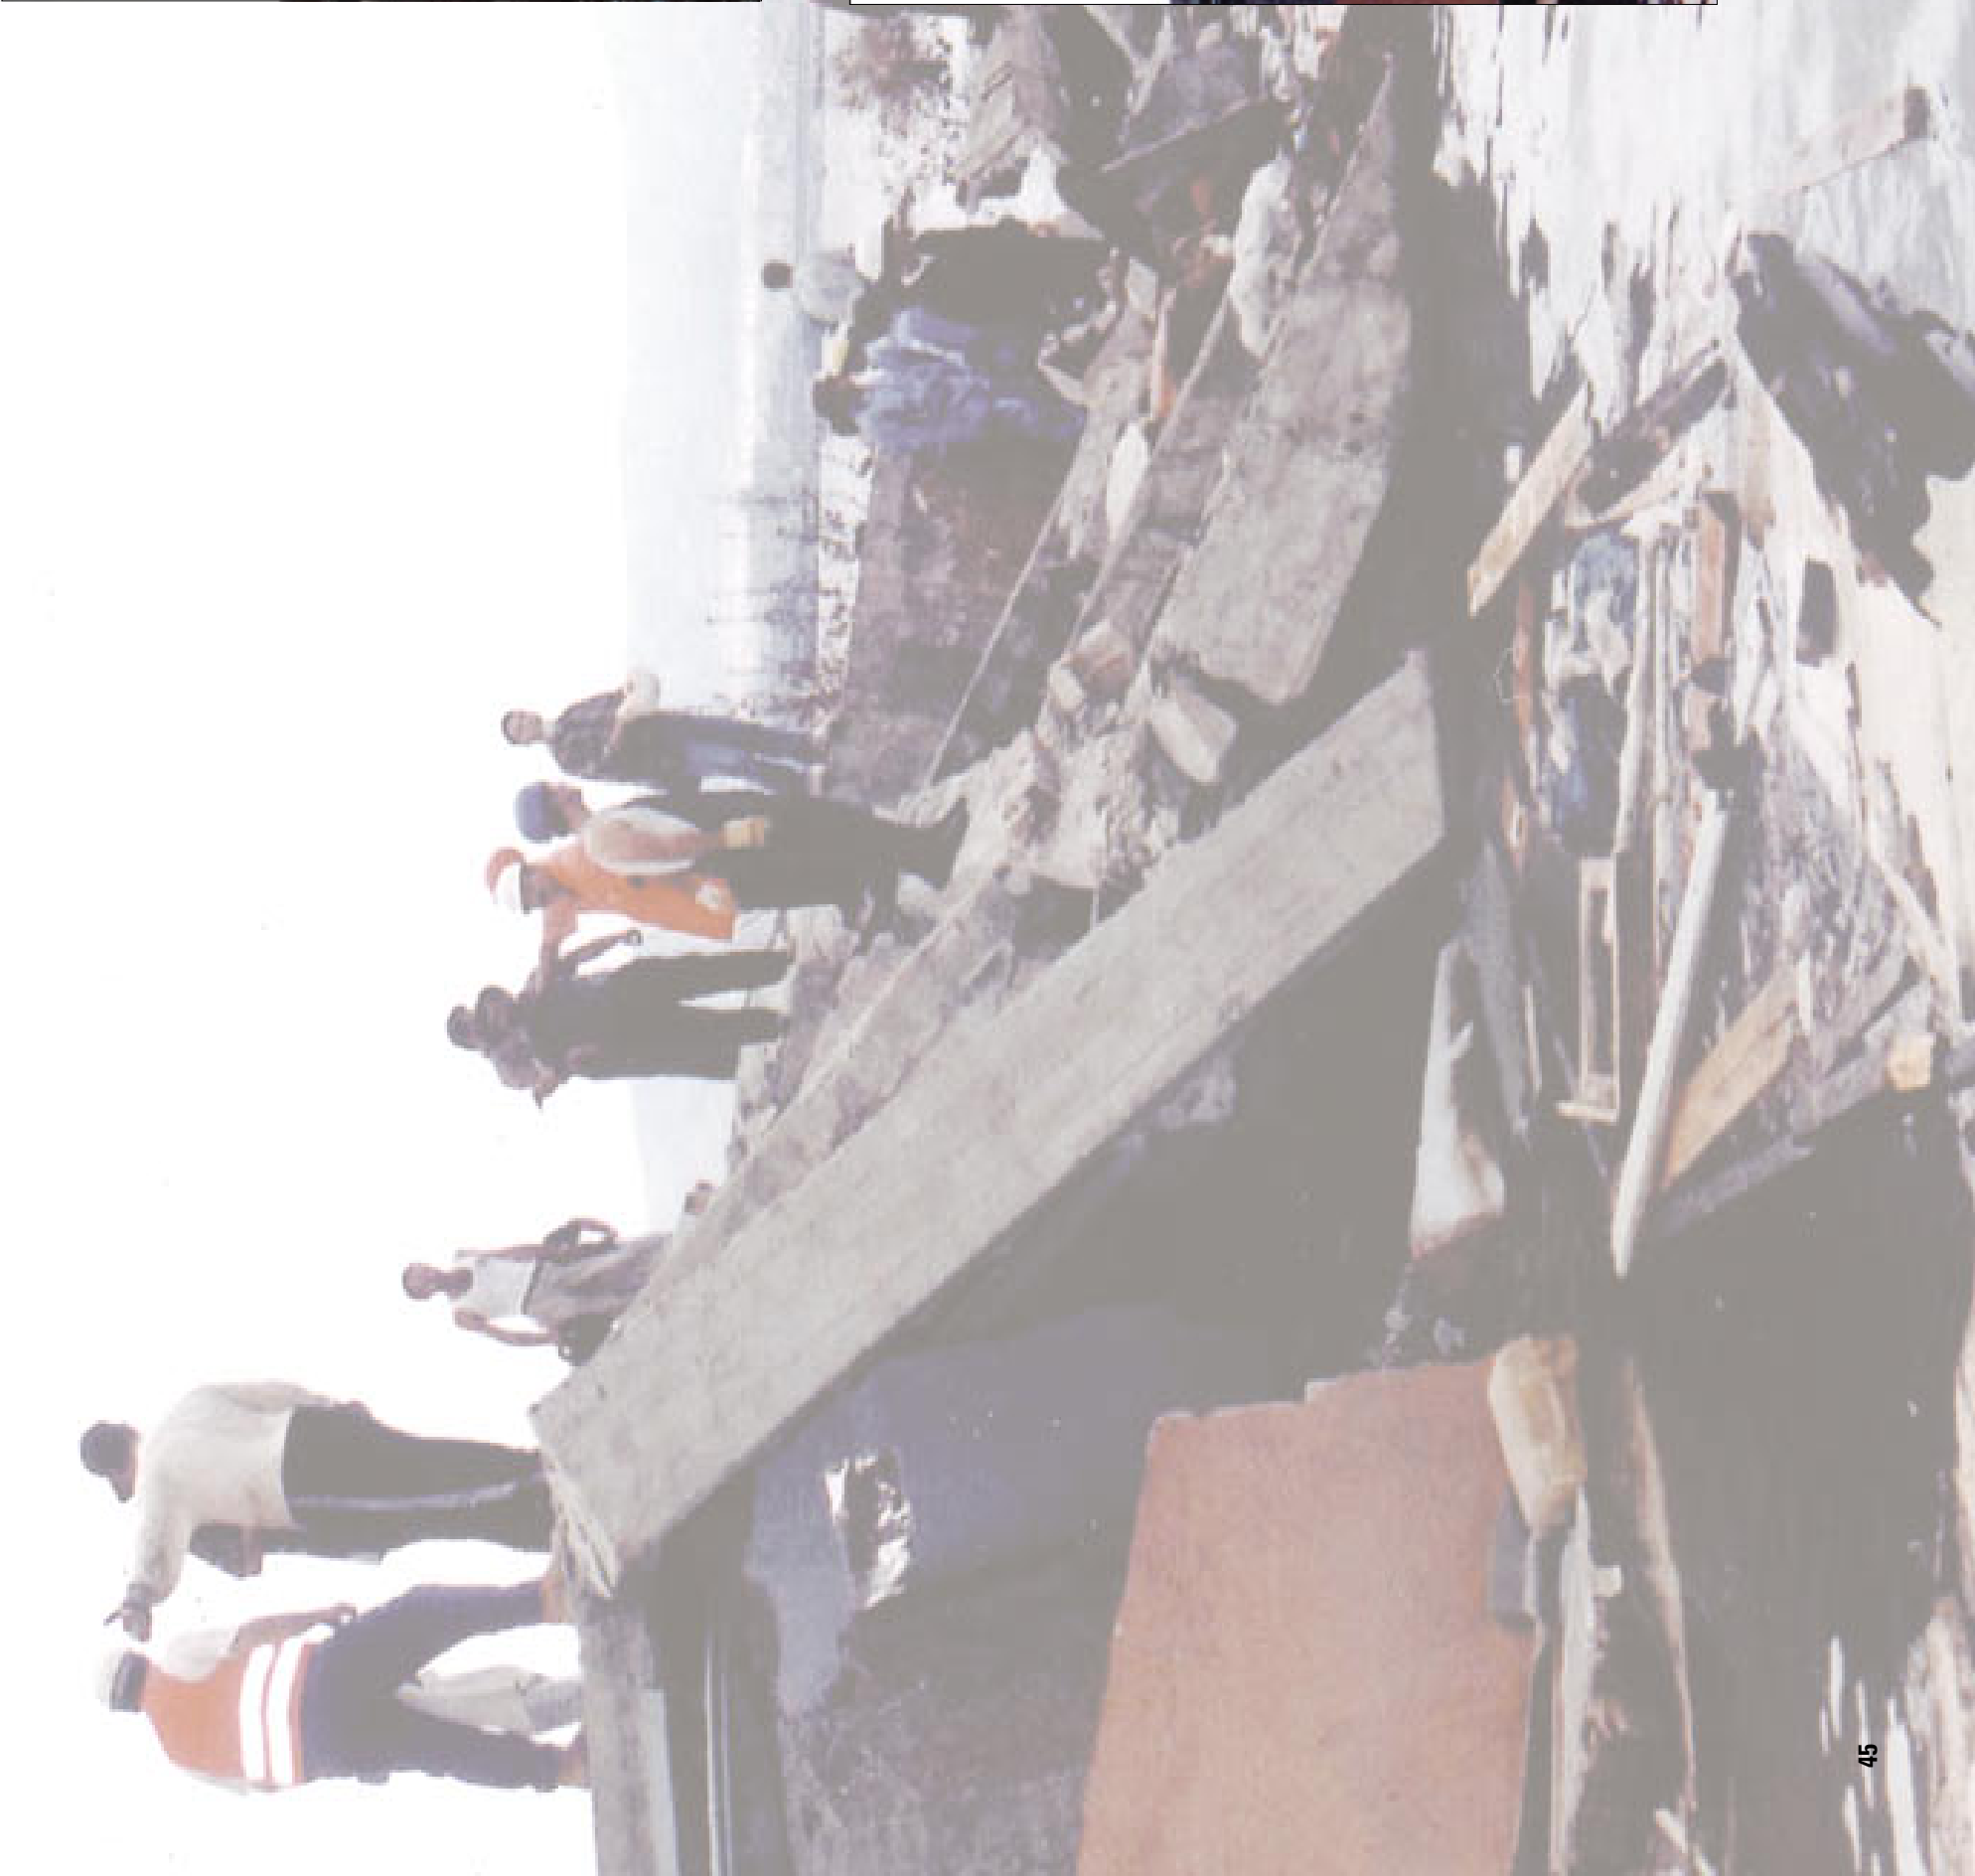
The Kocaeli earthquake also demonstrated the hazard posed by aftershocks to buildings following a large earthquake. Figure 47 shows a building in Gölcük before and after it collapsed during a M_W 5.9 aftershock on September 13. This aftershock, which was the largest magnitude aftershock at that time to follow the August 17 earthquake, killed 7 people, injured at least 239 people, and caused dozens of buildings to collapse in three cities near the epicenter.

Figure 47 (pages 45–46). Multistory residential building in Gölcük. Tectonic subsidence associated with faulting in the main shock caused the inundation of the first floor of the building. Upper photograph shows building standing after the August 17 main shock and before it collapsed in an aftershock; photograph by Thomas L. Holzer. Lower photograph shows building collapsed by M_W 5.9 aftershock four weeks after the main shock; copyrighted photograph by AP/Wide World Photos, used with permission.

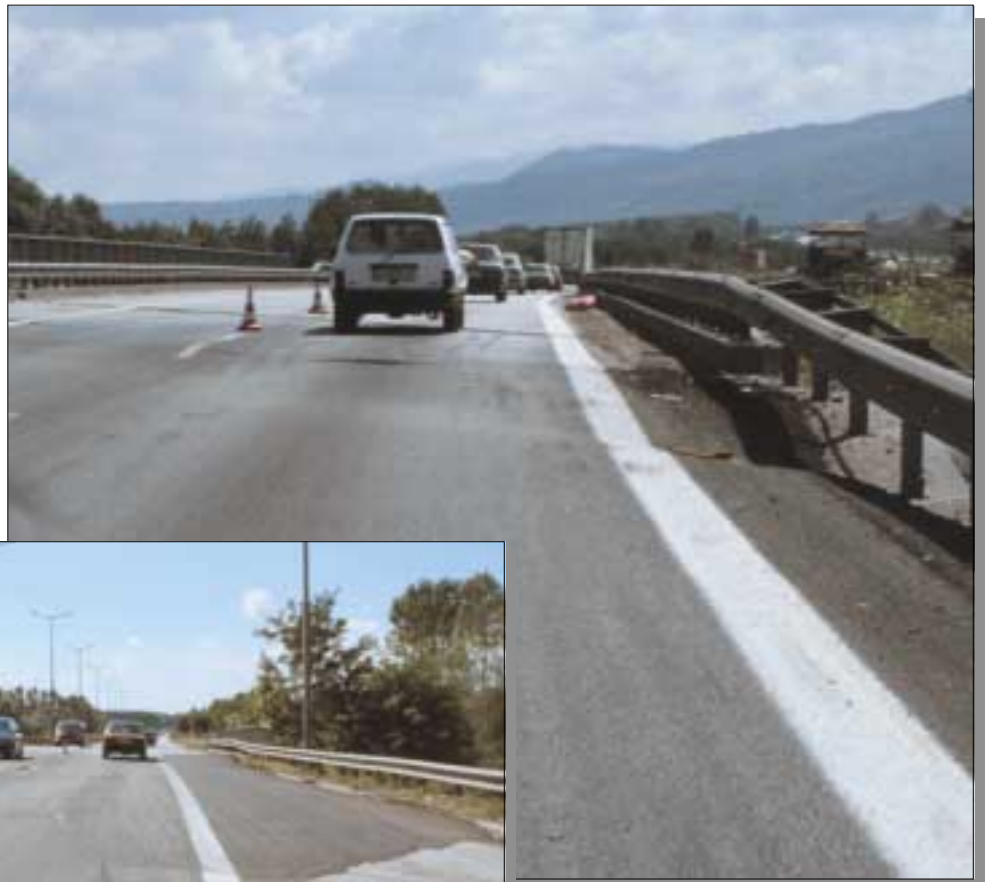
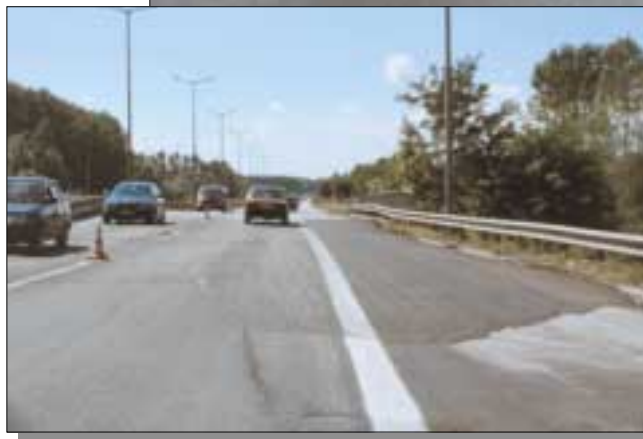
Figure 52. Densification of dry approach fill adjacent to bridges of the Trans European Motorway was widespread and caused disruption of the roadway. Immediately following the earthquake, Turkish highway engineers placed asphalt ramps on the roadway to reduce the hazard. *Photographs by Thomas L. Holzer.*

Permanent ground displacements, such as extensive cracks and settlement, caused significant damage to the roadway surface. Approximately 50 km of the TEM required resurfacing. Densification of dry fill commonly caused settlements in areas where the motorway approached bridges, viaducts, and culverts; some areas settled as much as 0.3 m. Figure 52 shows one example of settlement.

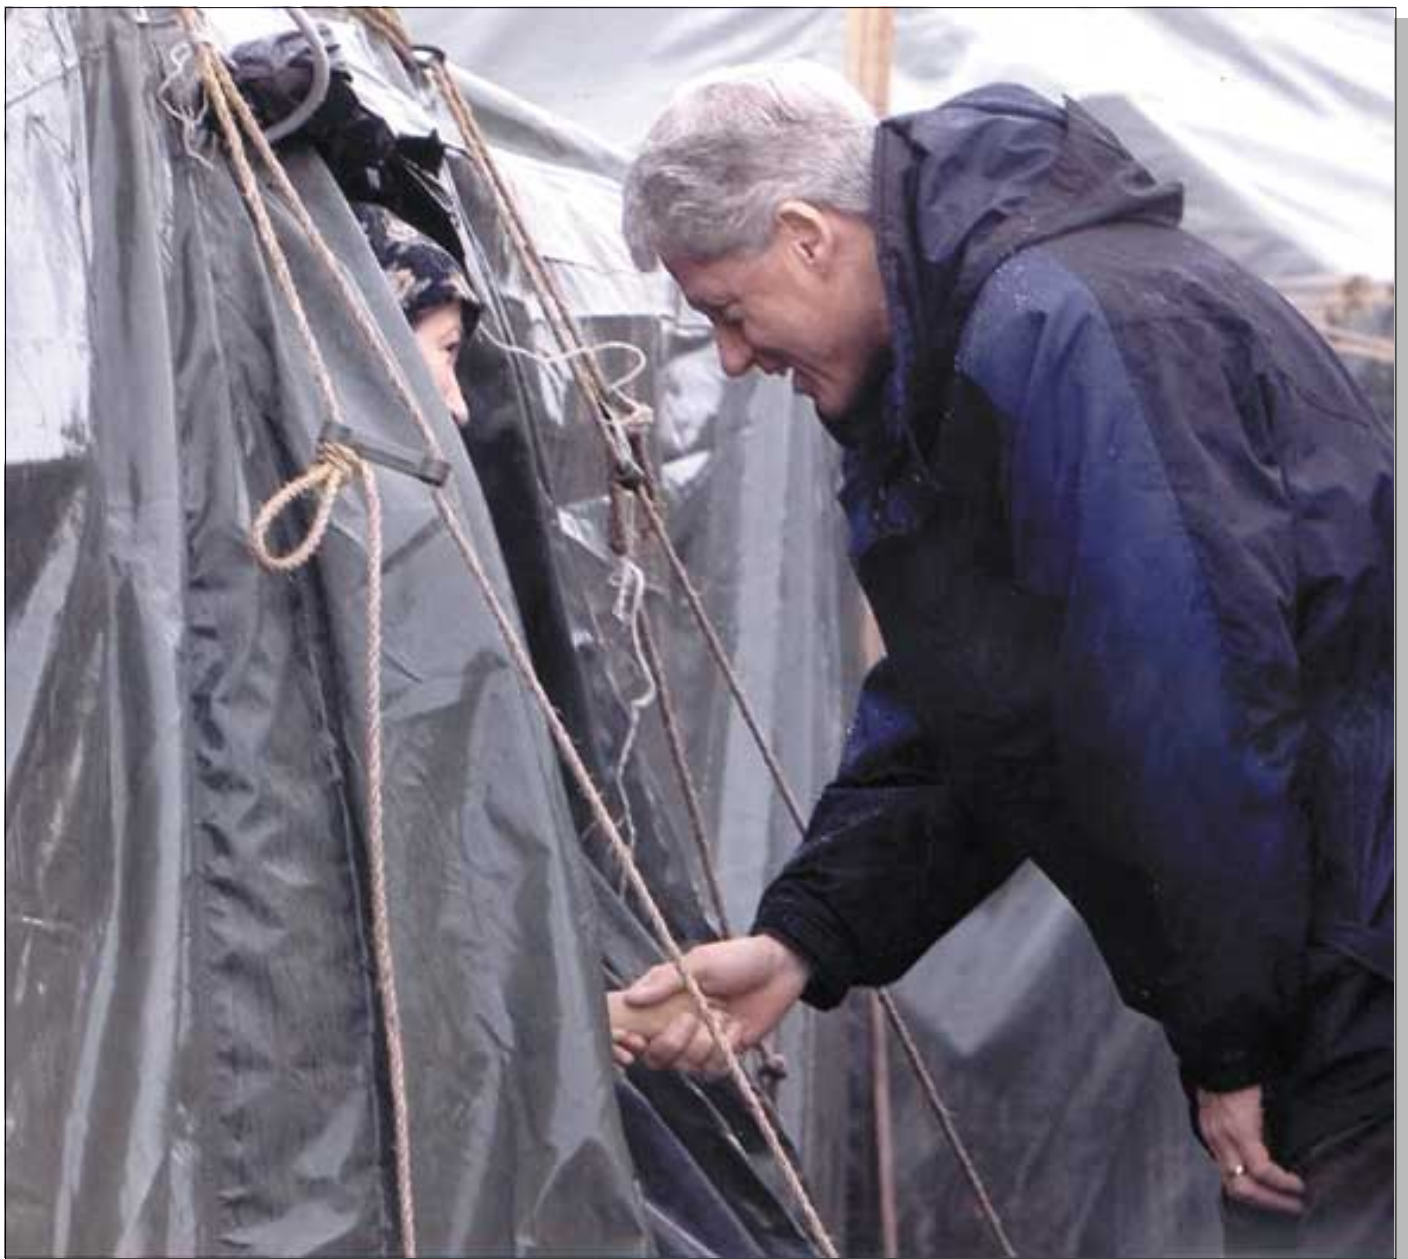
Figure 56. On November 16, 1999, President Clinton greets a displaced Turkish family living in a temporary tent city near Izmit since the August 17 Kocaeli earthquake. *Copyrighted photograph by J. Scott Applewhite, AP/Wide World Photos, used with permission.*

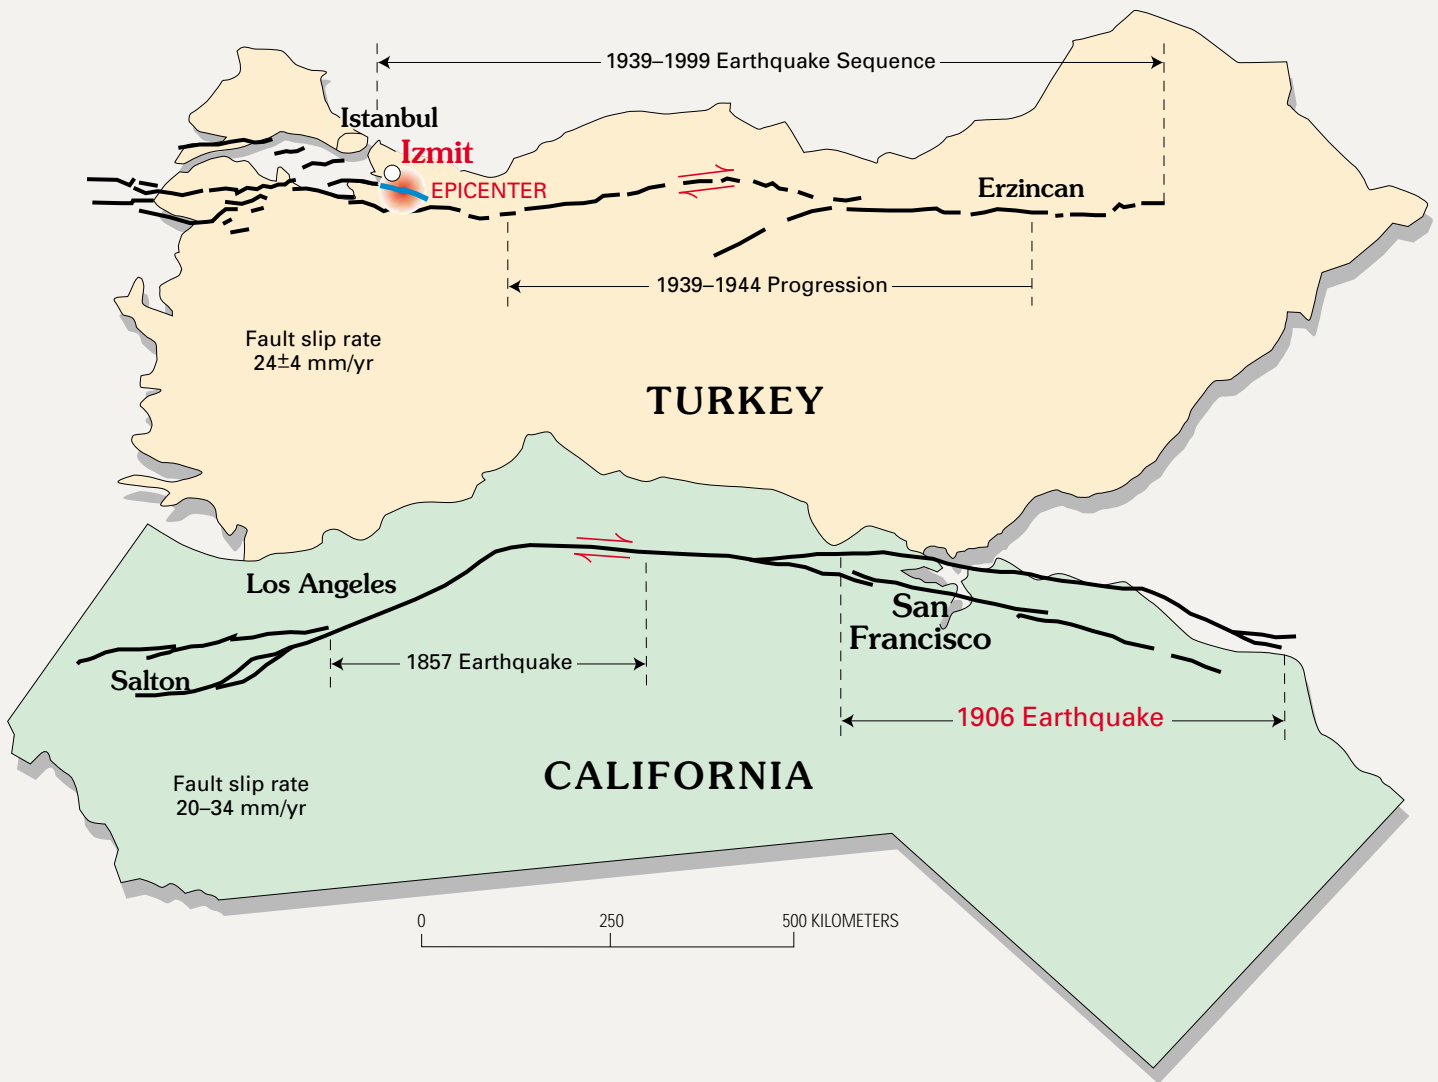
The North Anatolian fault system is a close analog of the San Andreas fault system in California. Both are boundaries between tectonic plates and have similar slip rates, total length and straightness (fig. 58). The systematic westward progression of earthquakes along 1000 km of the North Anatolian fault since 1939 suggests that each of the earthquakes in the progression in Turkey has triggered the next one. It is likely that the November 12, 1999, M_w 7.1 earthquake near Düzce was triggered because it occurred in an area where stress was increased by the August 17, 1999, main shock. Understanding this process may be useful for improving probabilistic earthquake forecasts in the United States. Such forecasting is increasingly being applied to the San Andreas fault system, where recent forecasts indicate a 70 percent probability of an $M_w > 6.7$ in the San Francisco Bay region in the next 30 years. The probability of an earthquake with a magnitude greater than or equal to that of the M_w 7.4 Kocaeli earthquake is 13 percent.

Figure 58. The striking resemblance of the San Andreas and North Anatolian fault systems is visible in this comparison. This suggests that understanding of fault mechanics from one fault system may be applied directly to the other. *Illustration prepared by Ross S. Stein.*
