EXPERIMENTAL TESTING OF ROOF TO WALL CONNECTIONS IN WOOD FRAME HOUSES

Michael A. Riley and Fahim Sadek

April 2003

Building and Fire Research Laboratory
National Institute of Standards and Technology
Gaithersburg, MD 20899-8611

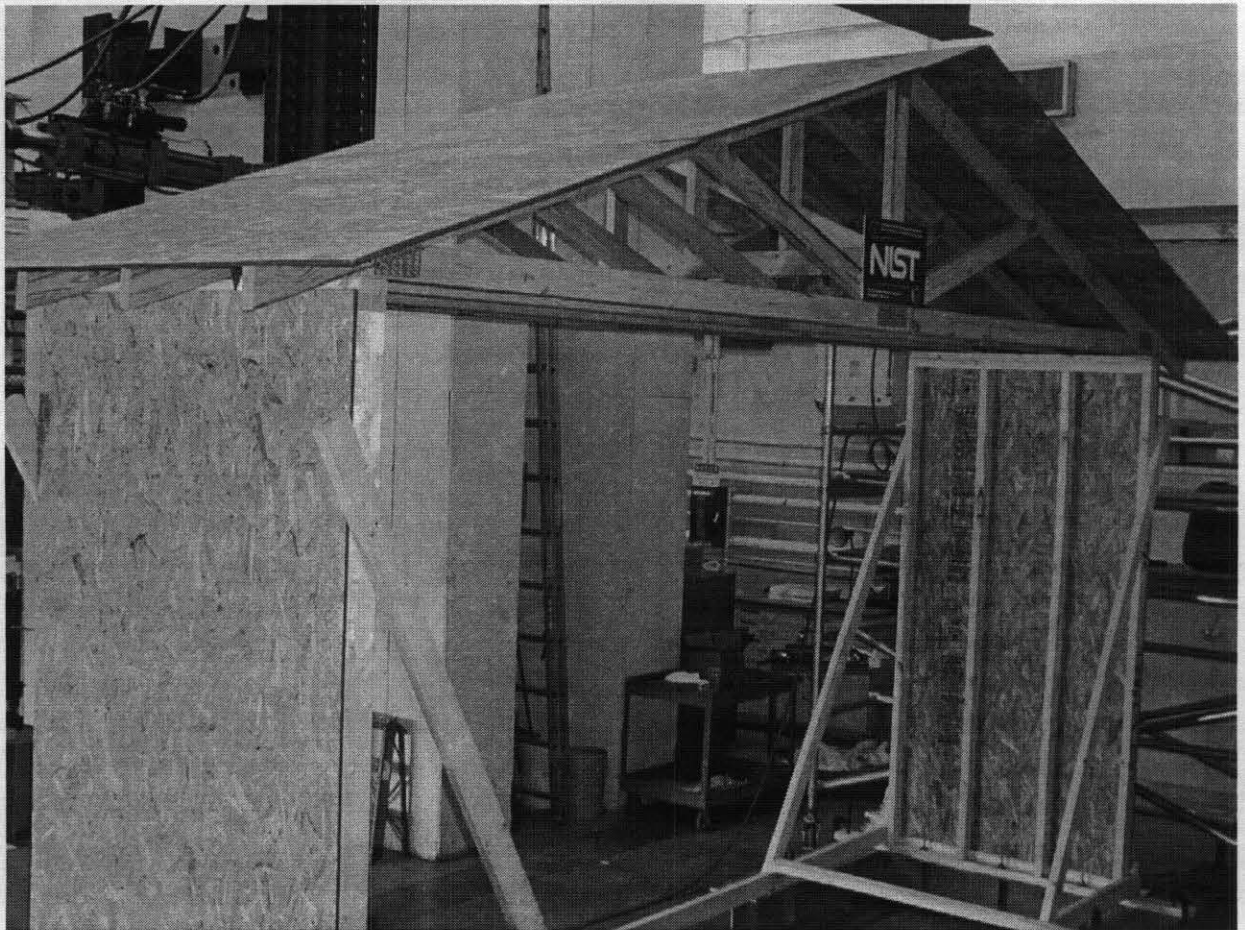
Figure 2.2. Typical test specimen before instrumentation.

The specimens represent a center cut through a simple wood-frame house. Each specimen consisted of two 1.22 m (4 ft) long by 2.47 m (8 ft 1.25 in) high shear walls that supported four roof trusses with spans of 4.88 m (16 ft). A sketch of a test specimen is shown in Figure 2.1, and a photo of one specimen is shown in Figure 2.2

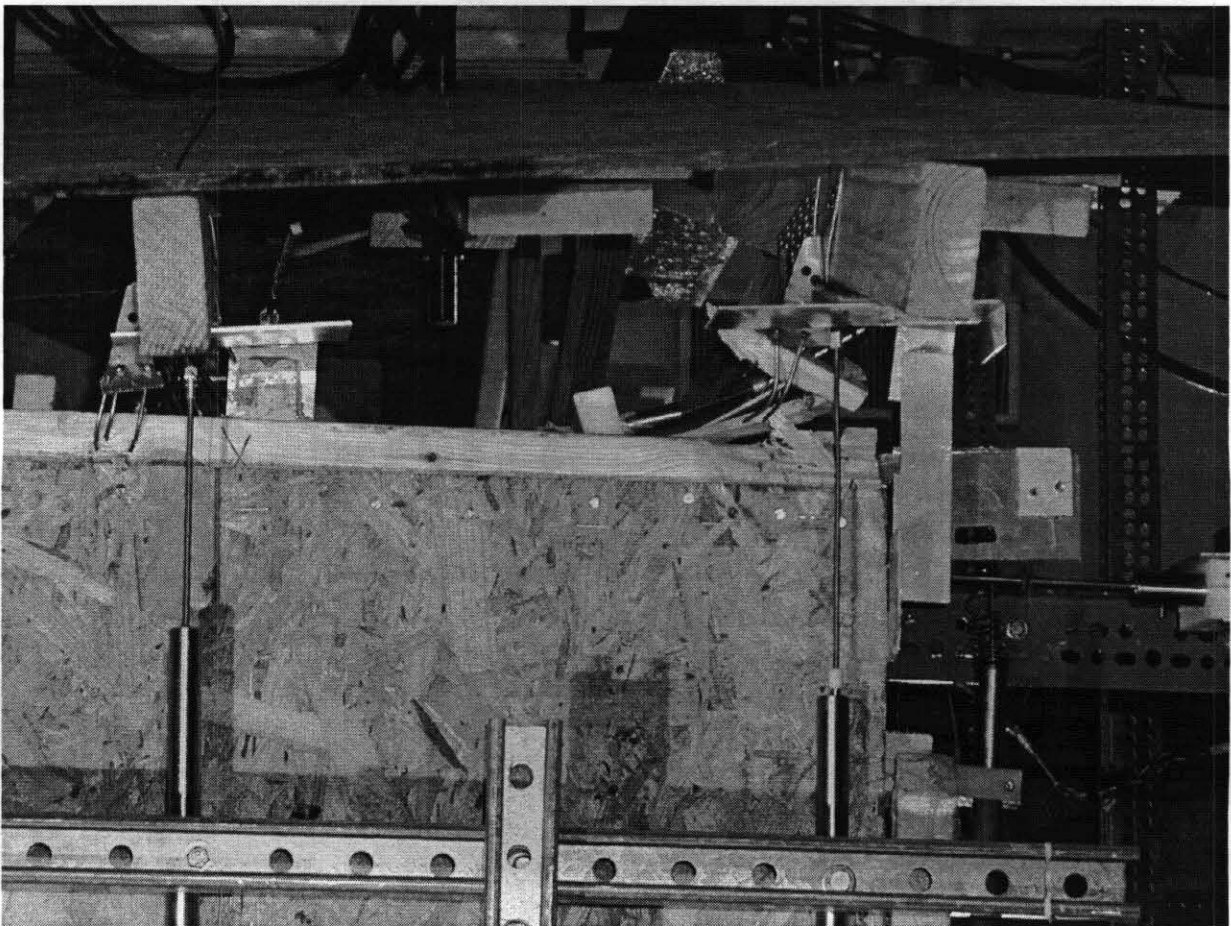
Figure 6.10. Failure of hurricane clip connection with combined load.

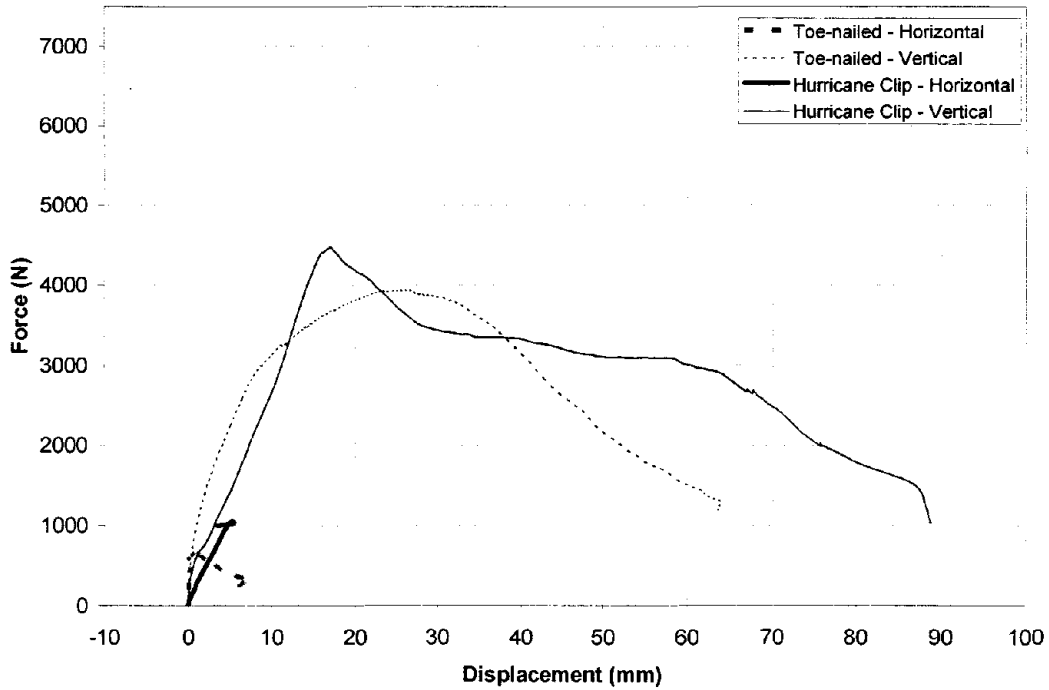
Figure 6.20. Comparison of responses of outer trusses.

A direct comparison of the responses at the east inner trusses with the two types of connections is shown in Figure 6.19, while the responses for the outer trusses are shown in Figure 6.20. The behavior of the inner trusses matches the behavior seen in other loading cases, with the hurricane clips providing a much greater capacity than the toe-nailed connections. However, as discussed above, and clearly visible in Figure 6.20, the outer truss hurricane clip connection that failed when the top plate of the wall split provided only a slightly greater capacity than the toe-nailed connection. These curves highlight the great variability that can occur in the response of wood frame construction, due to both the variabil-

ity in the materials and in the quality of workmanship. Note, however, that the overall strength of the specimen was not greatly compromised by the weak outer connection. The combined strength of the other three hurricane clips on that wall of the specimen allowed the specimen to resist almost 45% more load than the specimen with toe-nailed connections.
